## JOURNEY RISK MANAGEMENT (JRM) STUDY

### Salem Terminal TO SHREE VIGNESHWARA FUELS

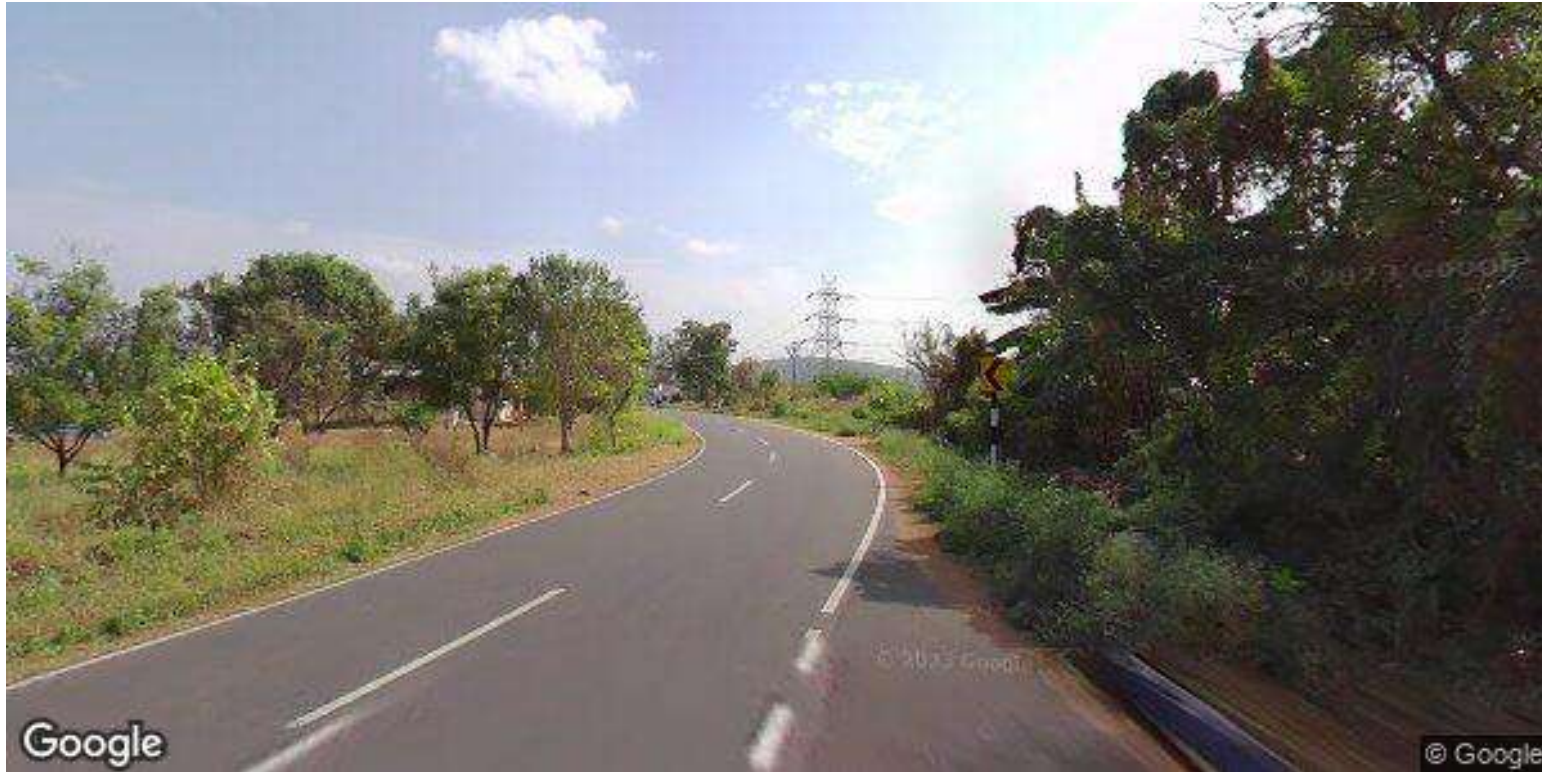
**Risk Type:** Turn  
**Risk Level:** Medium  
**Speed Limit:** 30 KM/Hr  
**Coordinates:** 11.55836, 77.65483

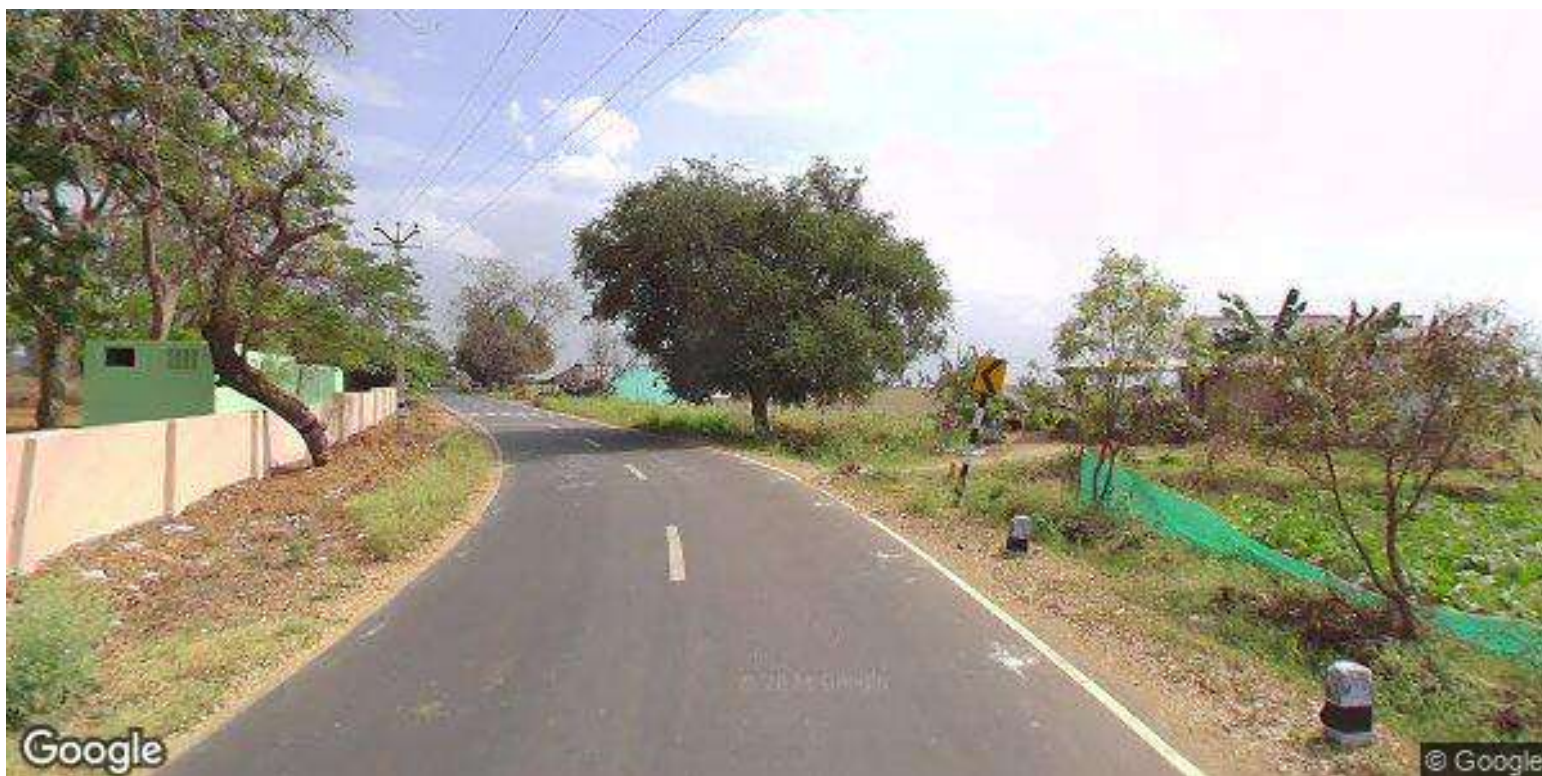
**Risk Type:** Turn  
**Risk Level:** Medium  
**Speed Limit:** 30 KM/Hr  
**Coordinates:** 11.56246, 77.64507

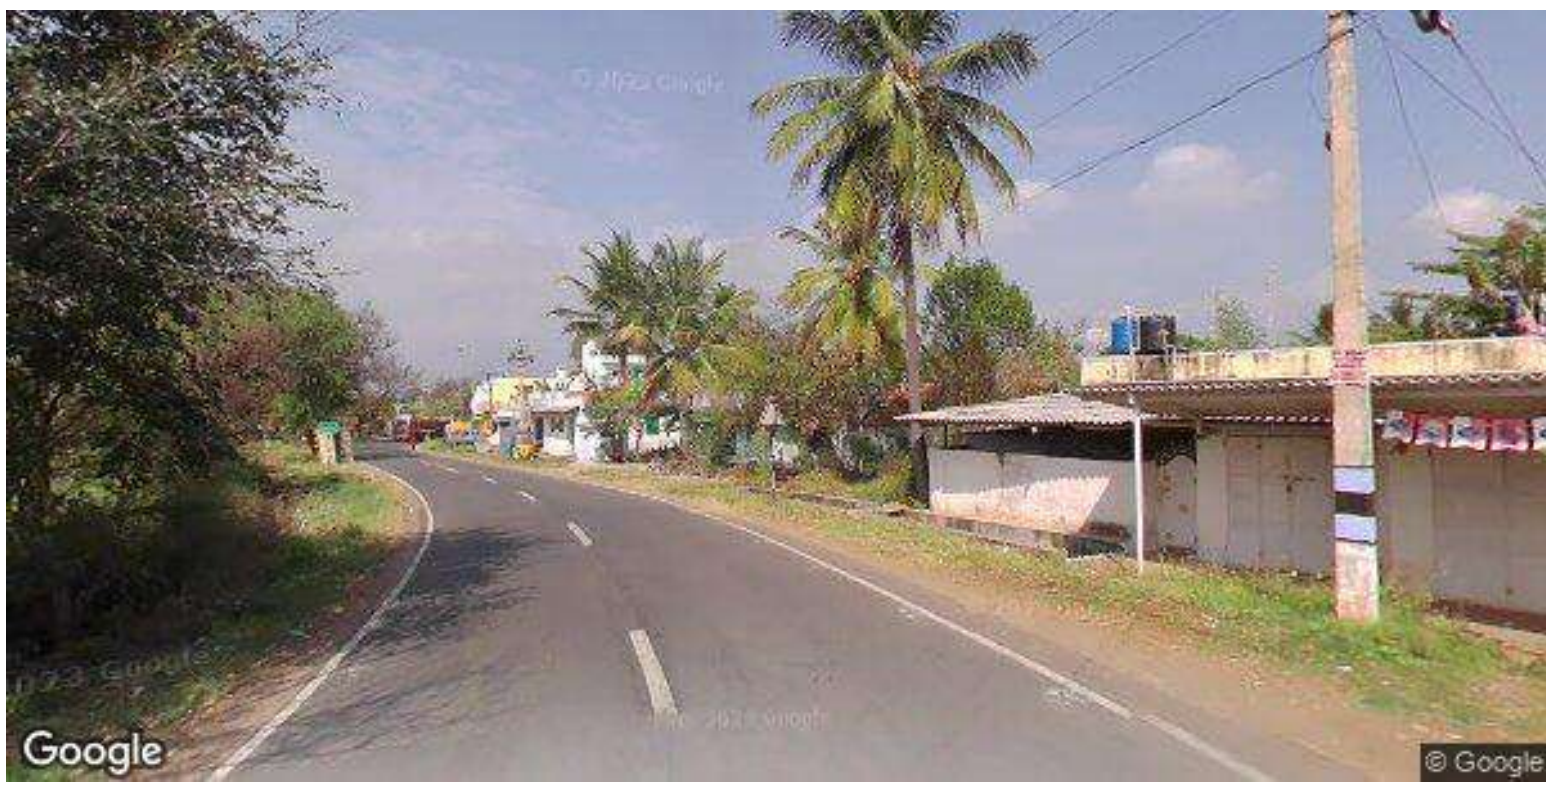
**Coordinates:** 11.56360, 77.64467

**Risk Type:** Turn

**Risk Level:** High

**Speed Limit:** 15 KM/Hr

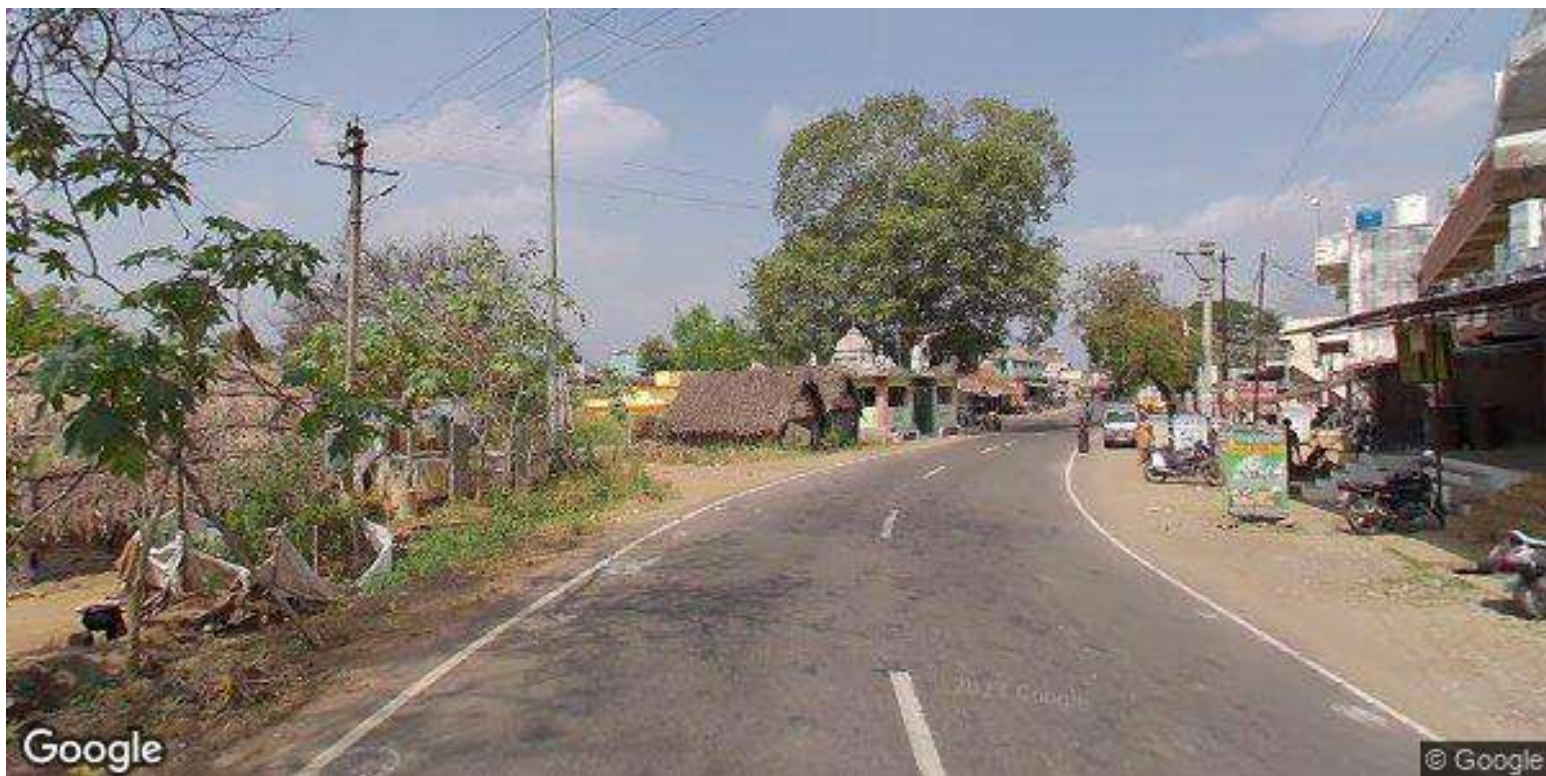
**Coordinates:** 11.56385, 77.64370

**Risk Type:** Turn

**Risk Level:** Medium

**Speed Limit:** 30 KM/Hr

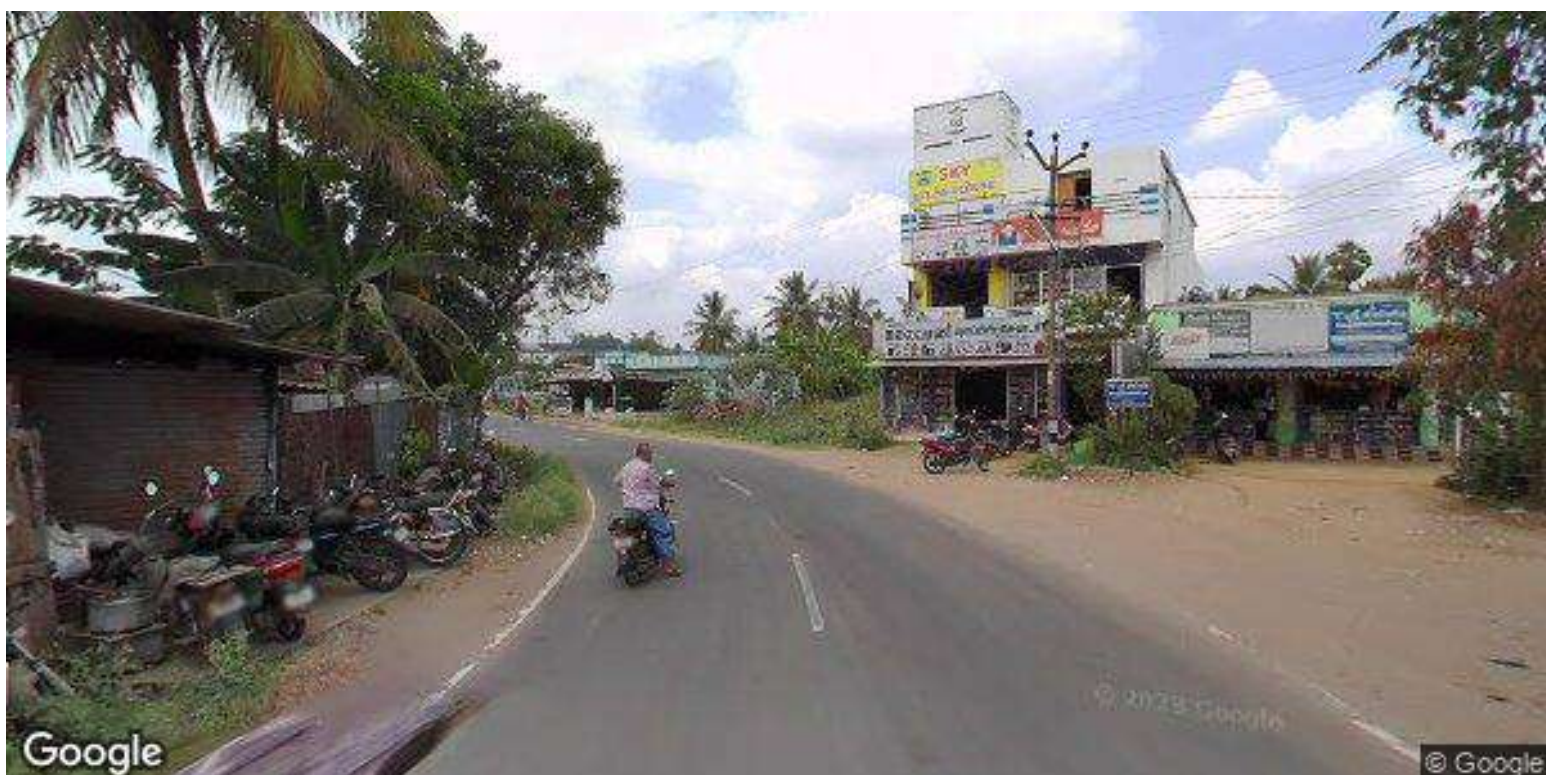
**Coordinates: 11.56828, 77.64184**

**Risk Type: Turn**

**Risk Level: Medium**

**Speed Limit: 30 KM/Hr**

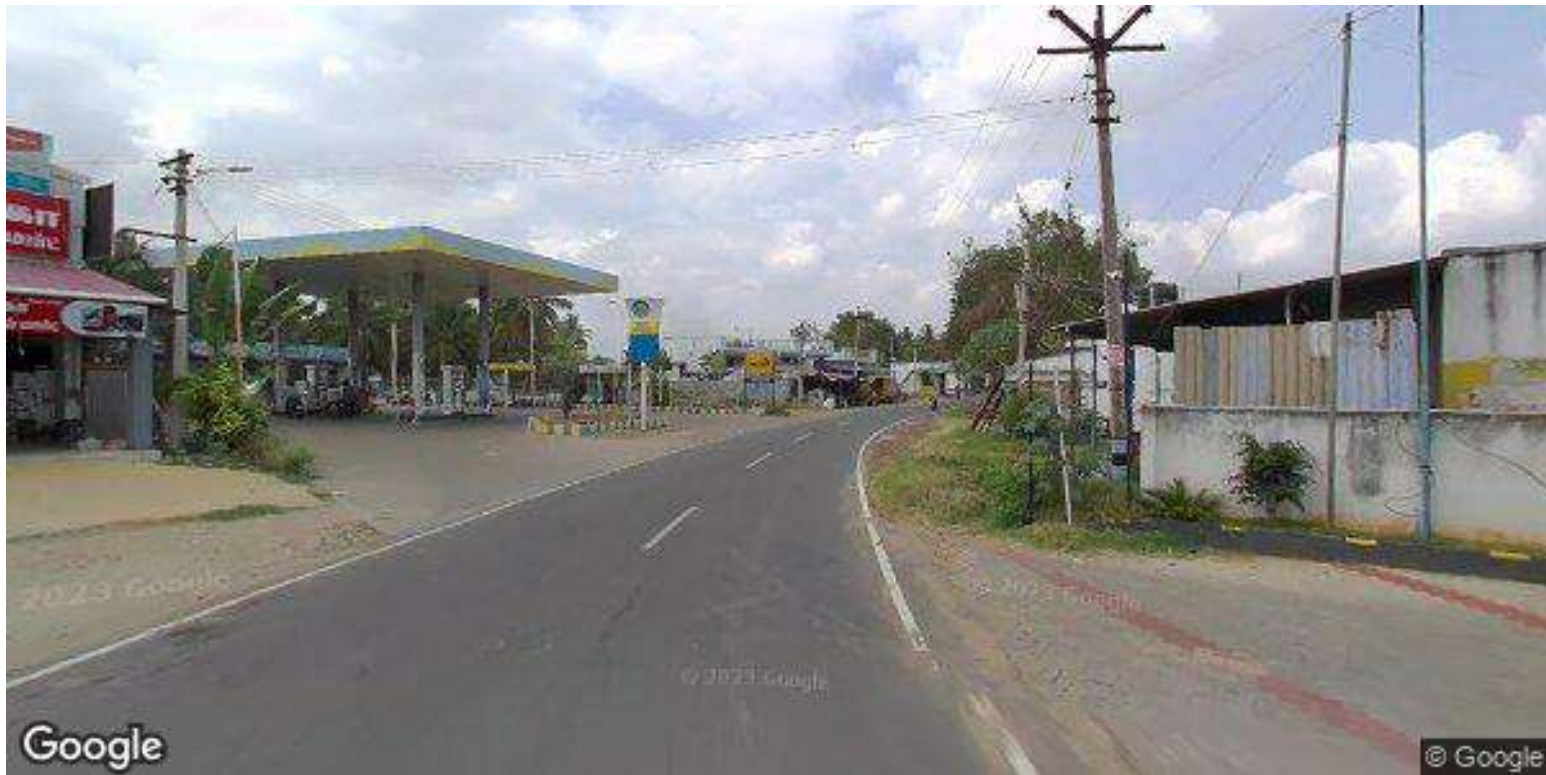
**Coordinates: 11.56883, 77.64088**

**Risk Type: Turn**

**Risk Level: Medium**

**Speed Limit: 30 KM/Hr**

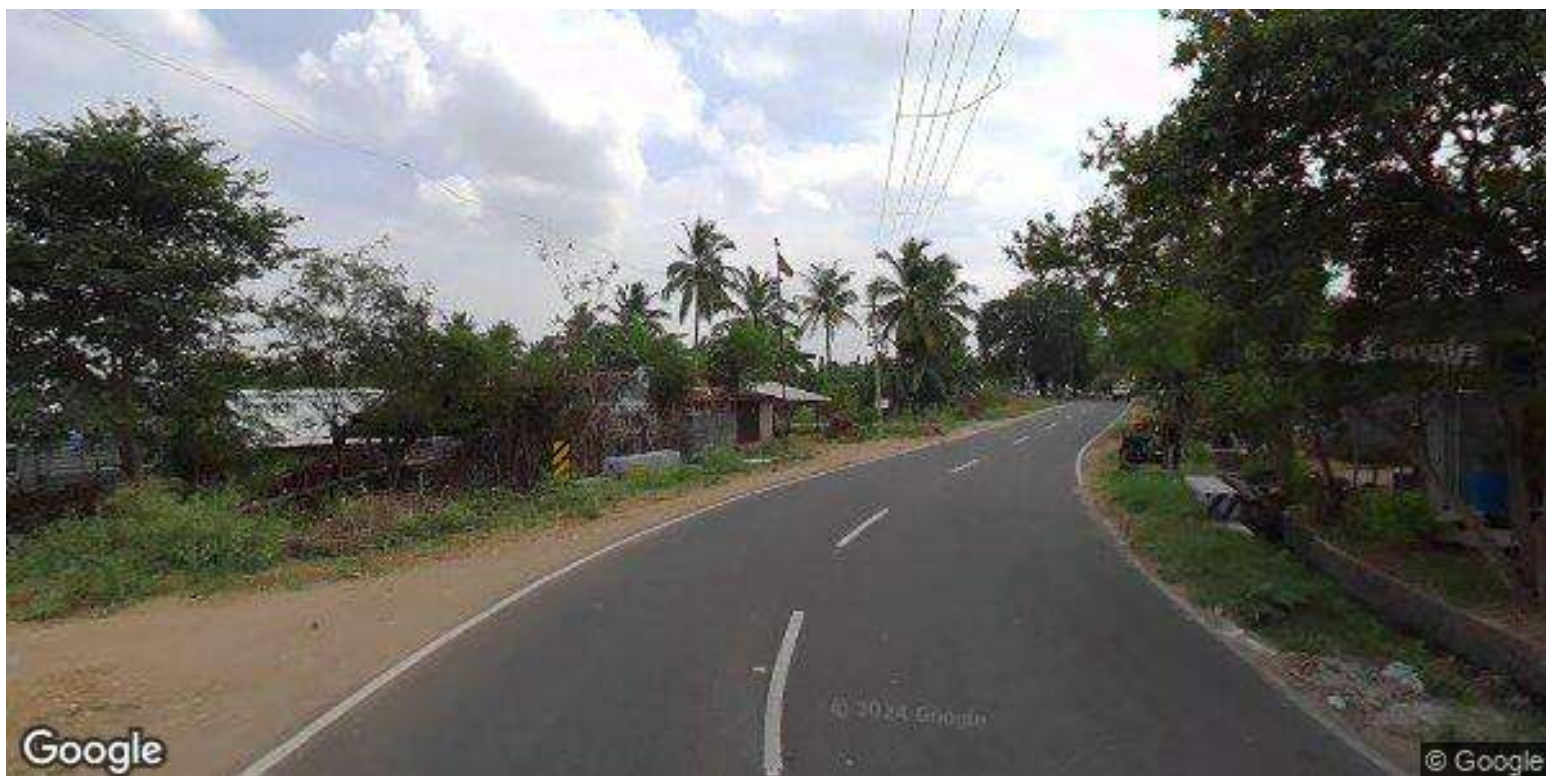
**Coordinates: 11.57445, 77.63827**

**Risk Type: Turn**

**Risk Level: High**

**Speed Limit: 15 KM/Hr**

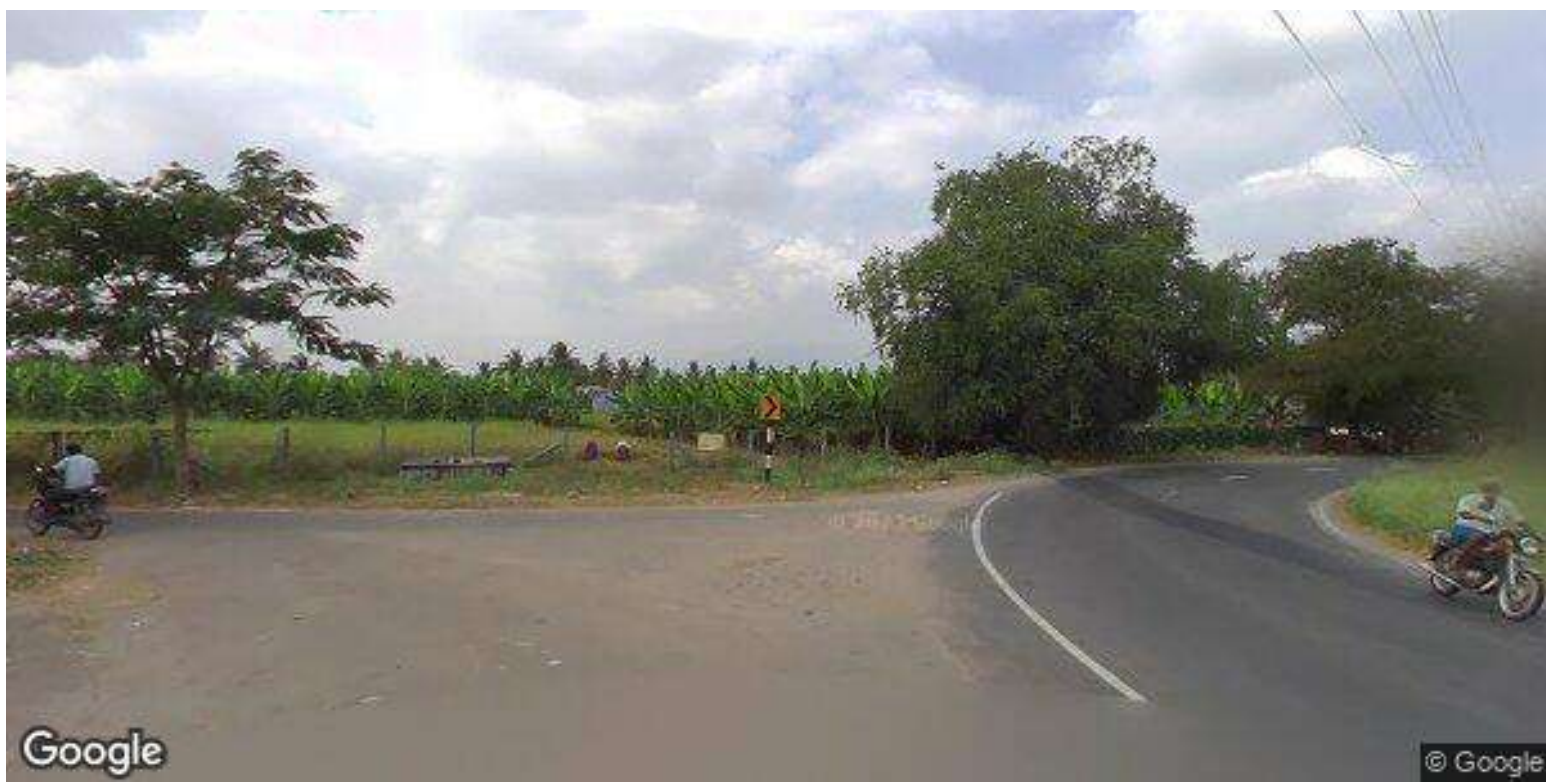
**Coordinates:** 11.57447, 77.63706

**Risk Type:** Turn

**Risk Level:** High

**Speed Limit:** 15 KM/Hr

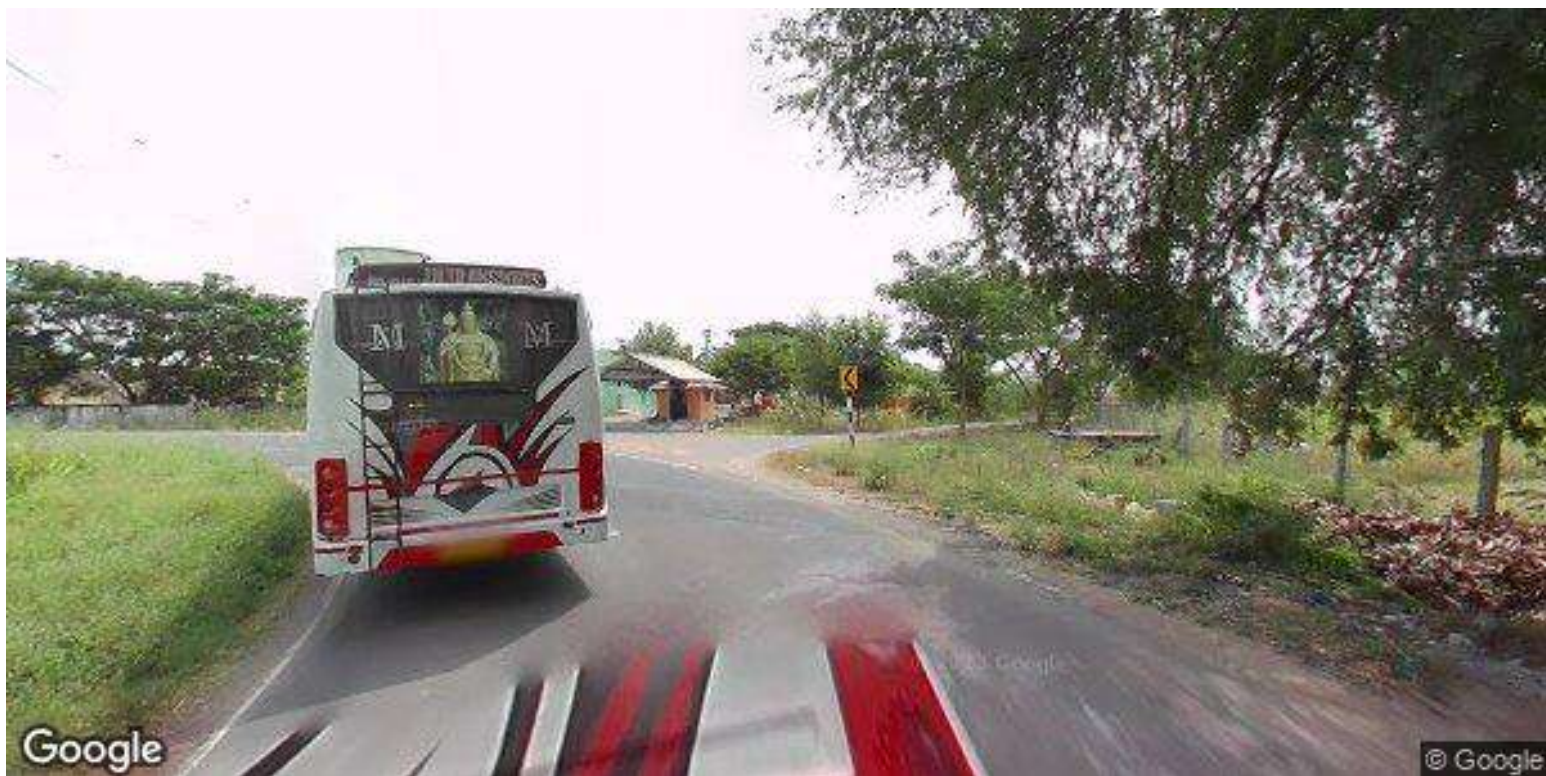
**Coordinates:** 11.57467, 77.63691

**Risk Type:** Turn

**Risk Level:** Medium

**Speed Limit:** 30 KM/Hr

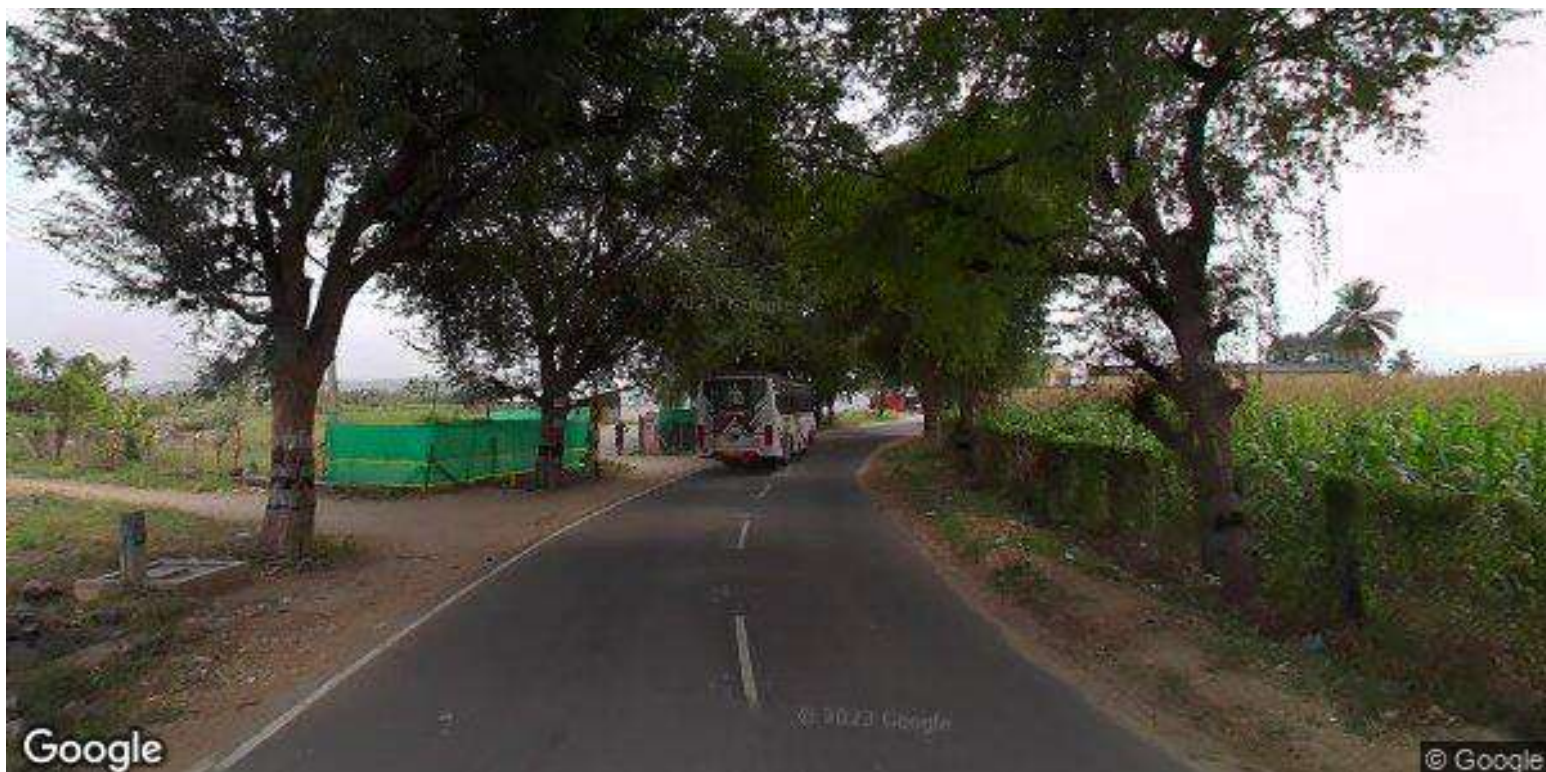
**Coordinates: 11.57975, 77.63548**

**Risk Type: Turn**

**Risk Level: Medium**

**Speed Limit: 30 KM/Hr**

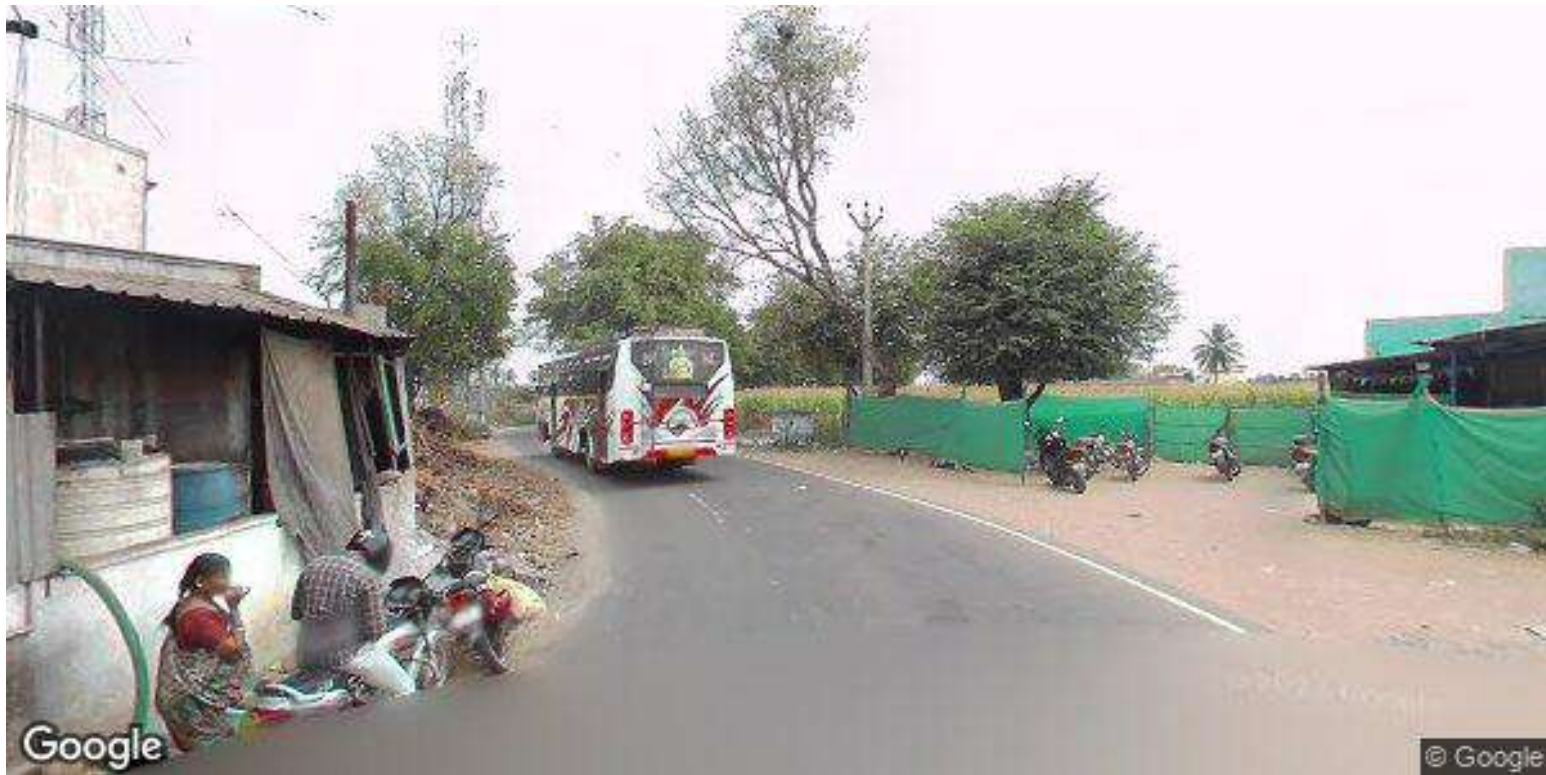
**Coordinates: 11.57991, 77.63495**

**Risk Type: Turn**

**Risk Level: High**

**Speed Limit: 15 KM/Hr**

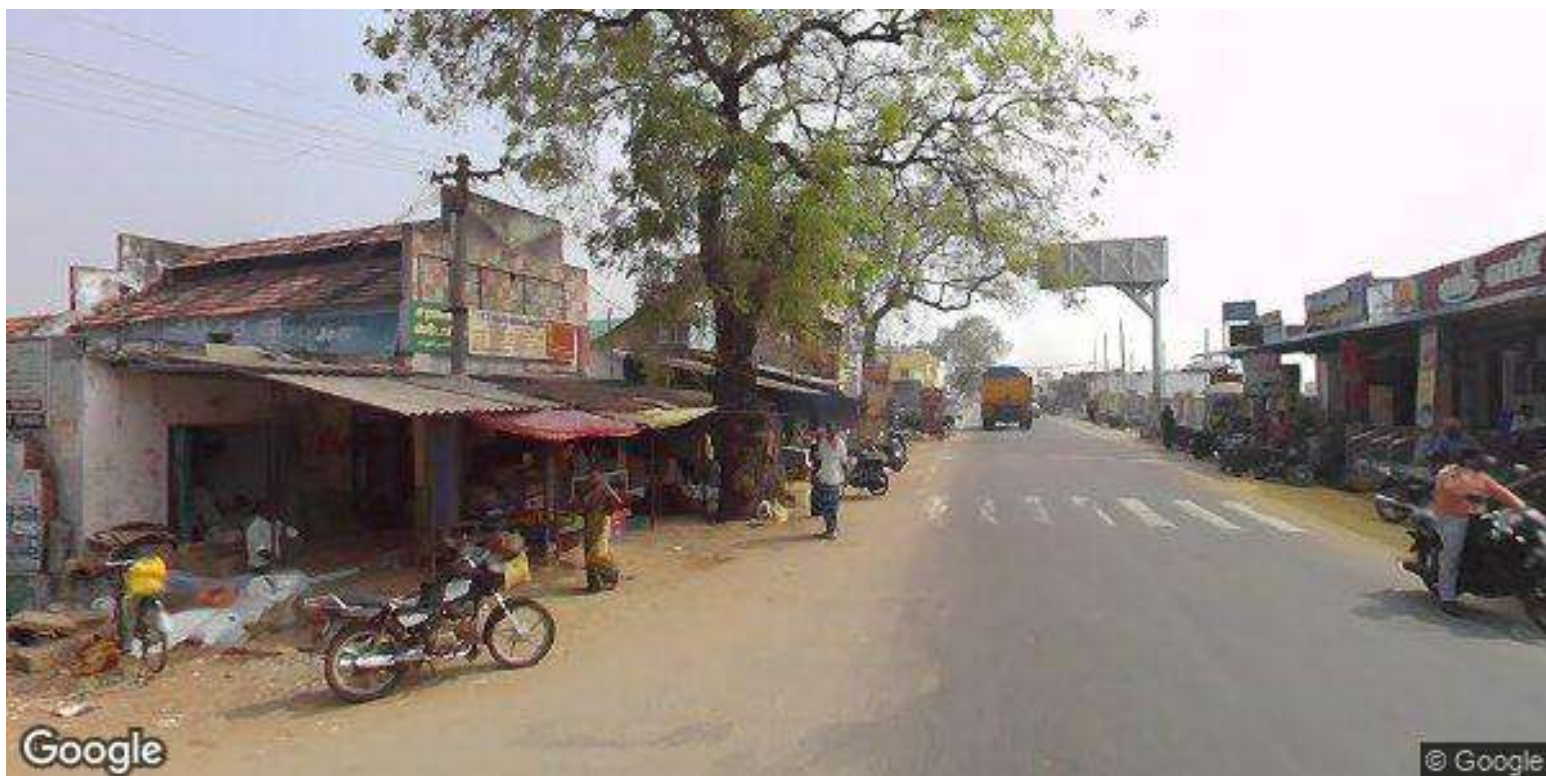
**Coordinates: 11.58056, 77.63456**

**Risk Type: Turn**

**Risk Level: High**

**Speed Limit: 15 KM/Hr**
