# IndianOil

## JOURNEY RISK MANAGEMENT (JRM) STUDY

### Salem Terminal to SRI THANGAMMAN TRADERS

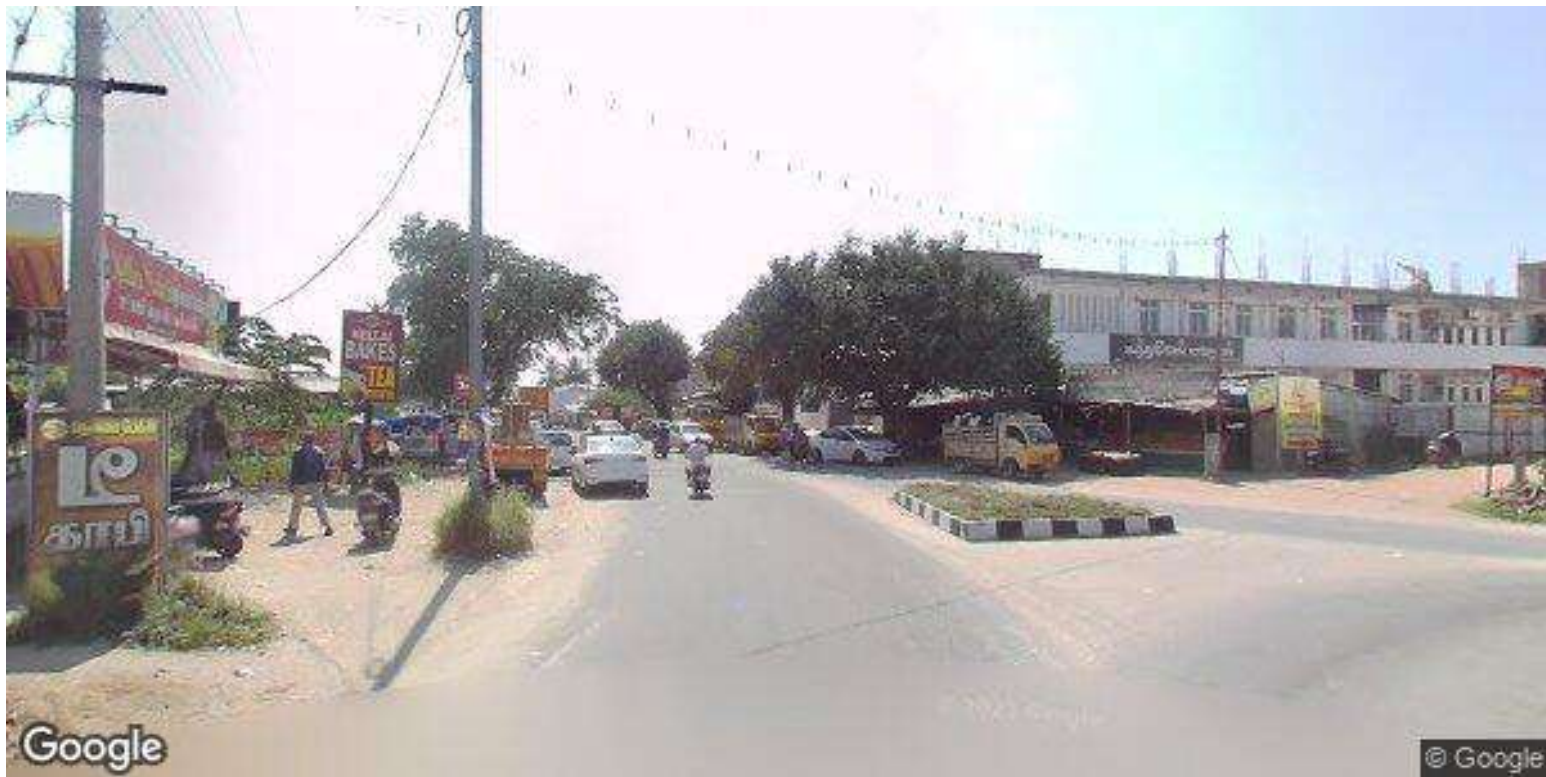
**Coordinates:** 11.17250, 77.26863

**Risk Type:** Roundabout

**Risk Level:** High

**Speed Limit:** 15 KM/Hr

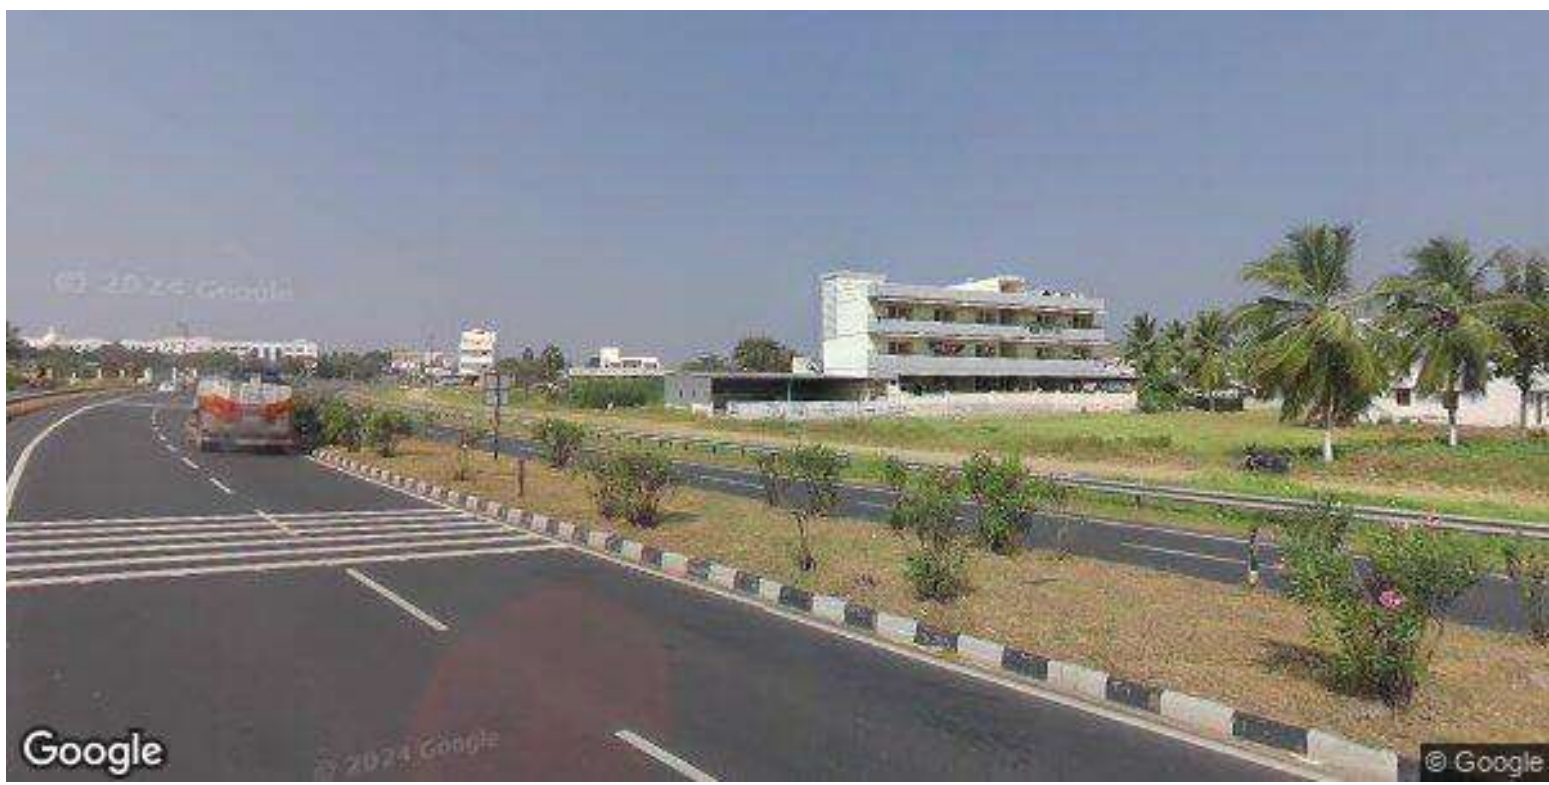
**Coordinates:** 11.44965, 77.77565

**Risk Type:** Turn

**Risk Level:** Medium

**Speed Limit:** 30 KM/Hr

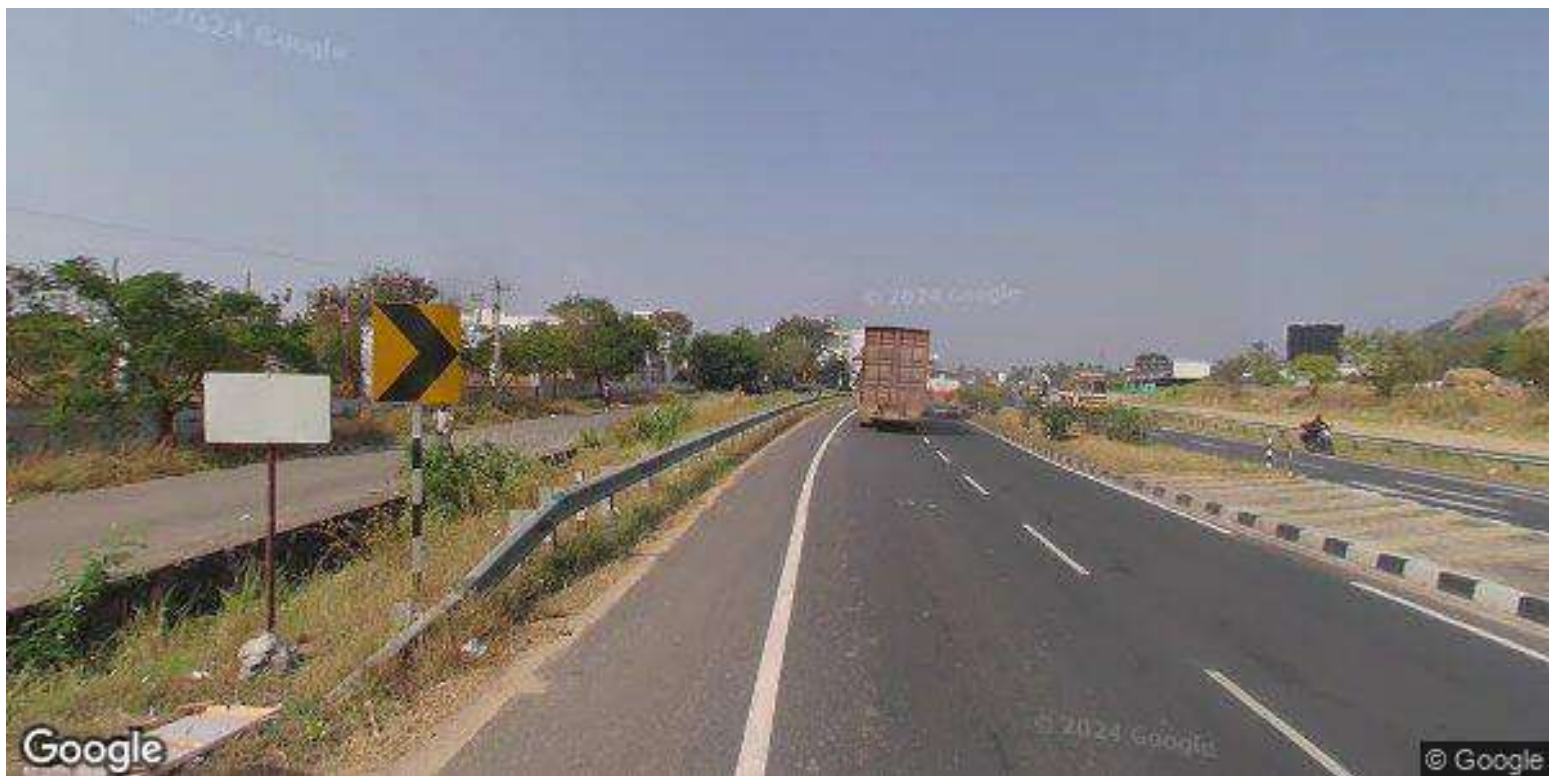
**Coordinates:** 11.44953, 77.77344

**Risk Type:** Turn

**Risk Level:** Medium

**Speed Limit:** 30 KM/Hr

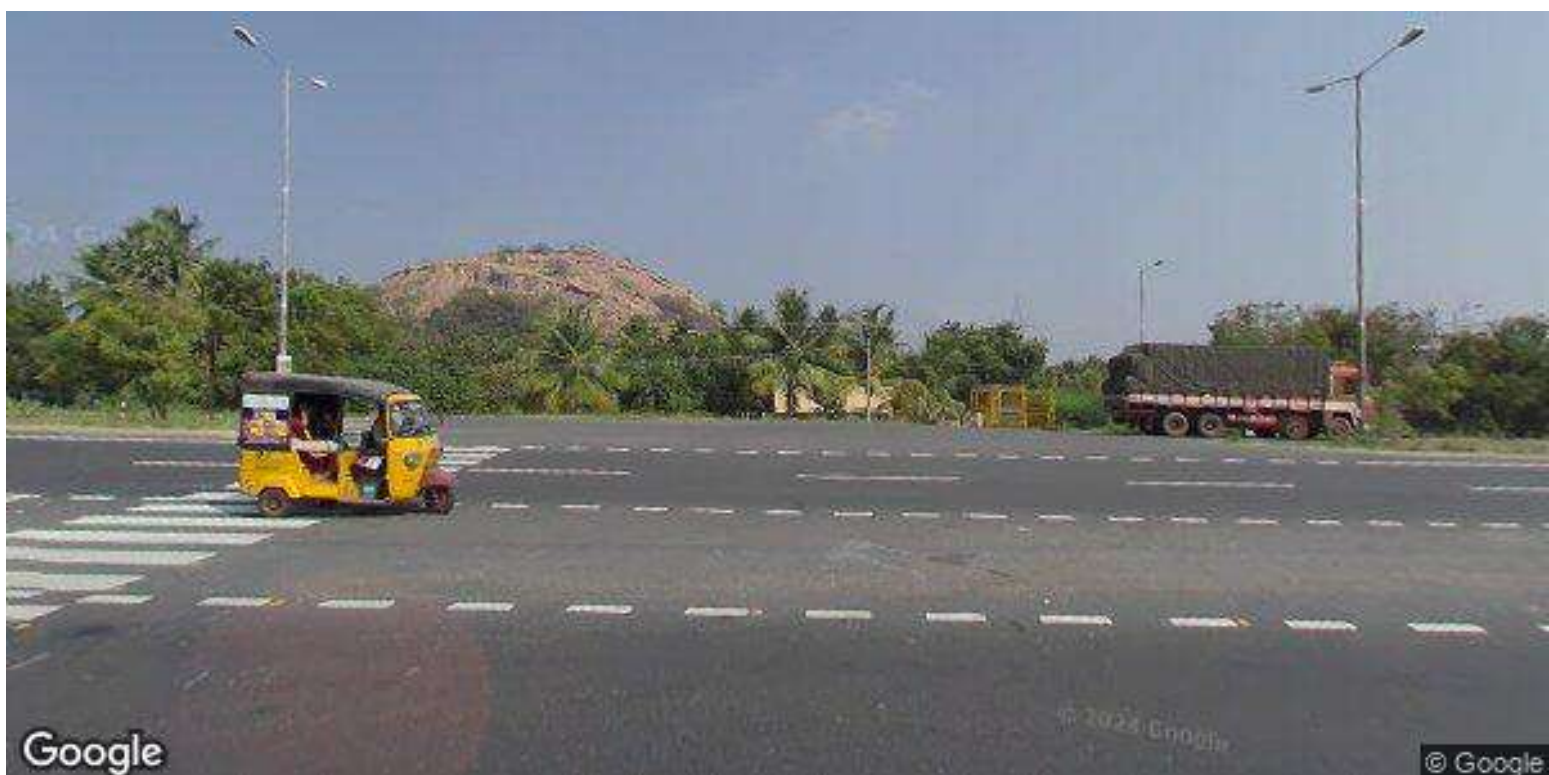
**Risk Type:** Turn  
**Risk Level:** Medium  
**Speed Limit:** 30 KM/Hr  
**Coordinates:** 11.45085, 77.77020

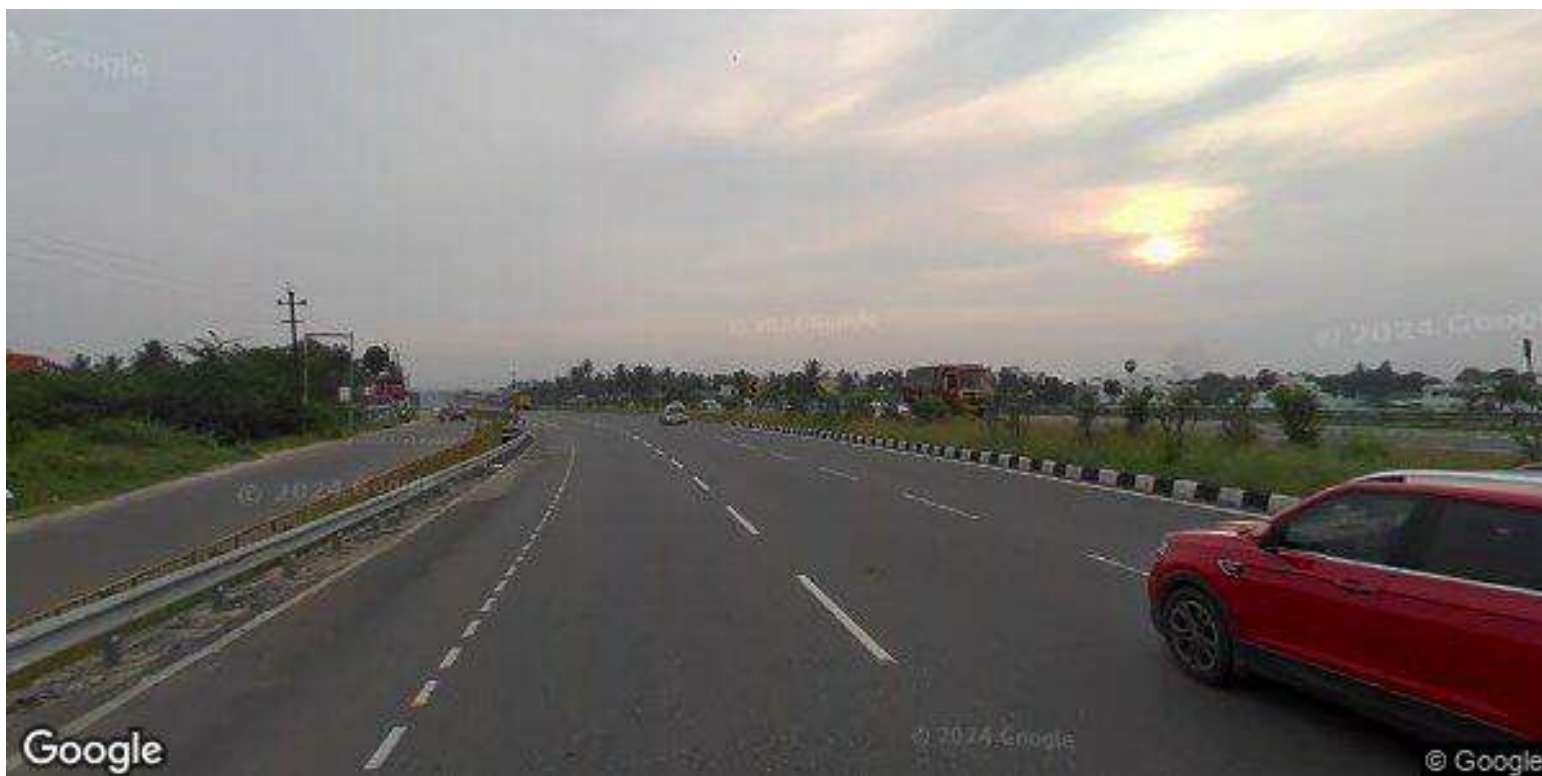
**Risk Type:** Turn  
**Risk Level:** Medium  
**Speed Limit:** 30 KM/Hr  
**Coordinates:** 11.18808, 77.28672

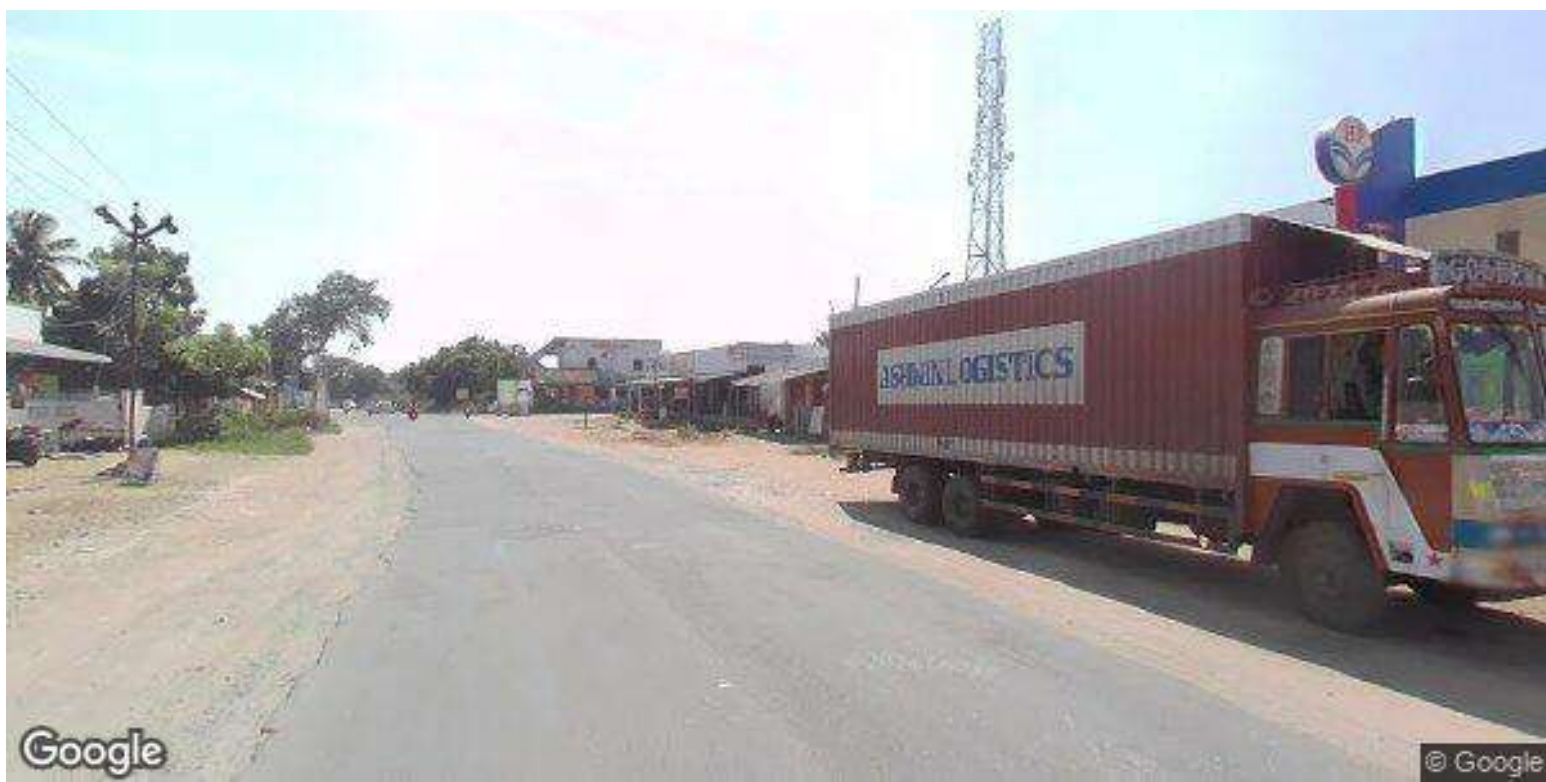
**Coordinates:** 11.16848, 77.26757

**Risk Type:** Turn

**Risk Level:** Medium

**Speed Limit:** 30 KM/Hr

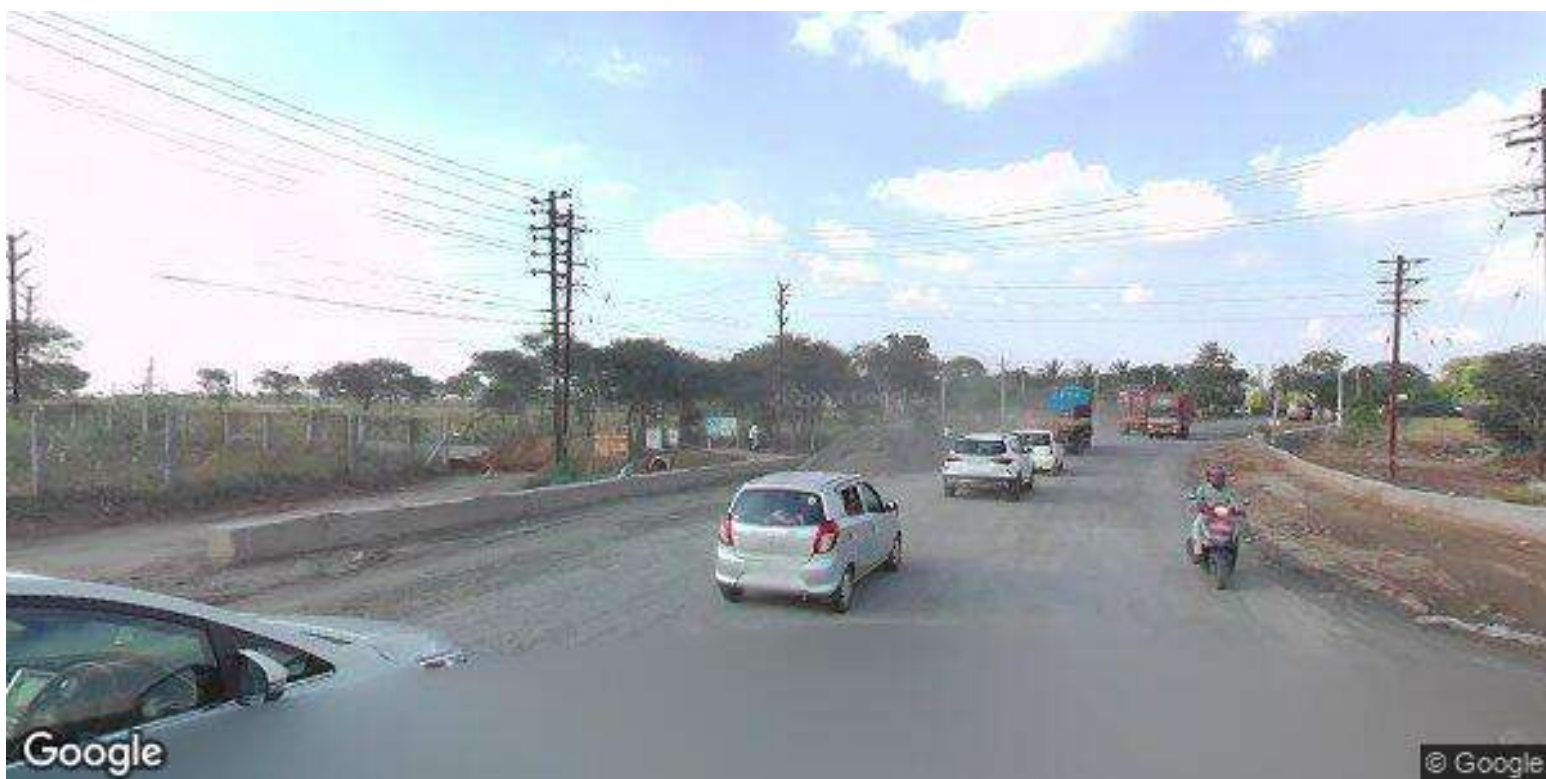
**Coordinates:** 11.14580, 77.26363

**Risk Type:** Turn

**Risk Level:** Medium

**Speed Limit:** 30 KM/Hr

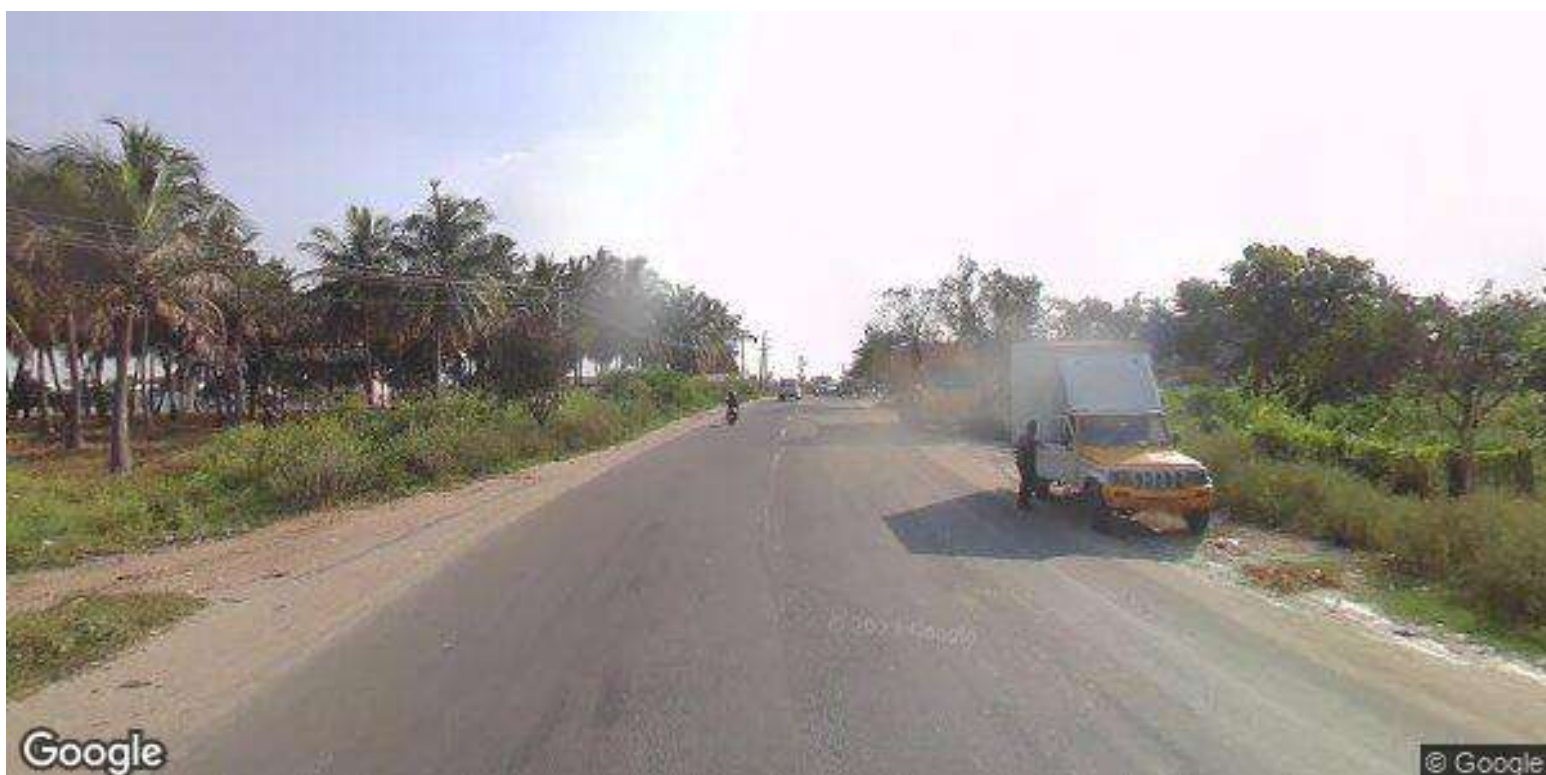
**Risk Type:** Turn  
**Risk Level:** Medium  
**Speed Limit:** 30 KM/Hr  
**Coordinates:** 11.10890, 77.27134

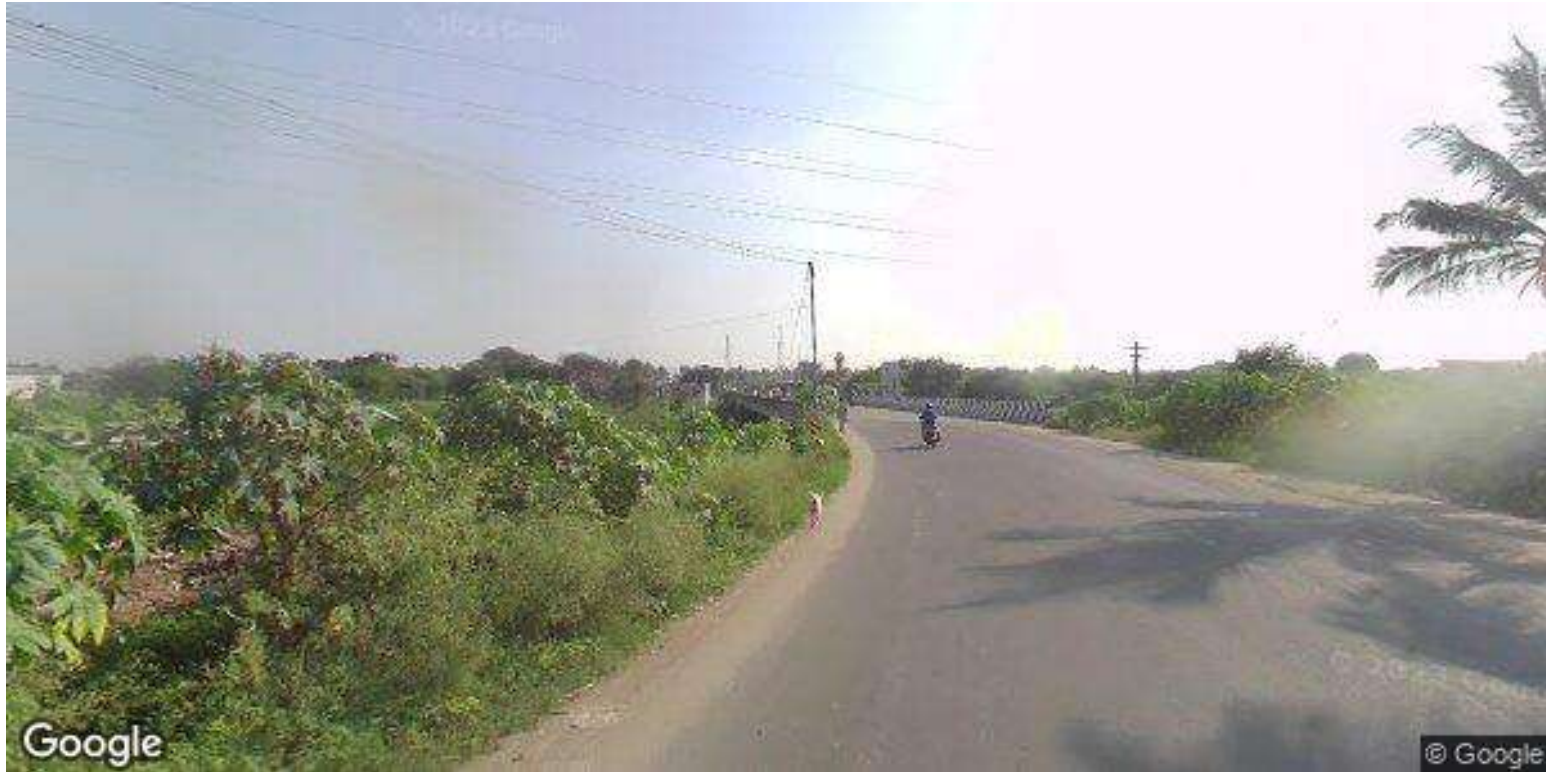
**Risk Type:** Turn  
**Risk Level:** Medium  
**Speed Limit:** 30 KM/Hr  
**Coordinates:** 11.10680, 77.27043

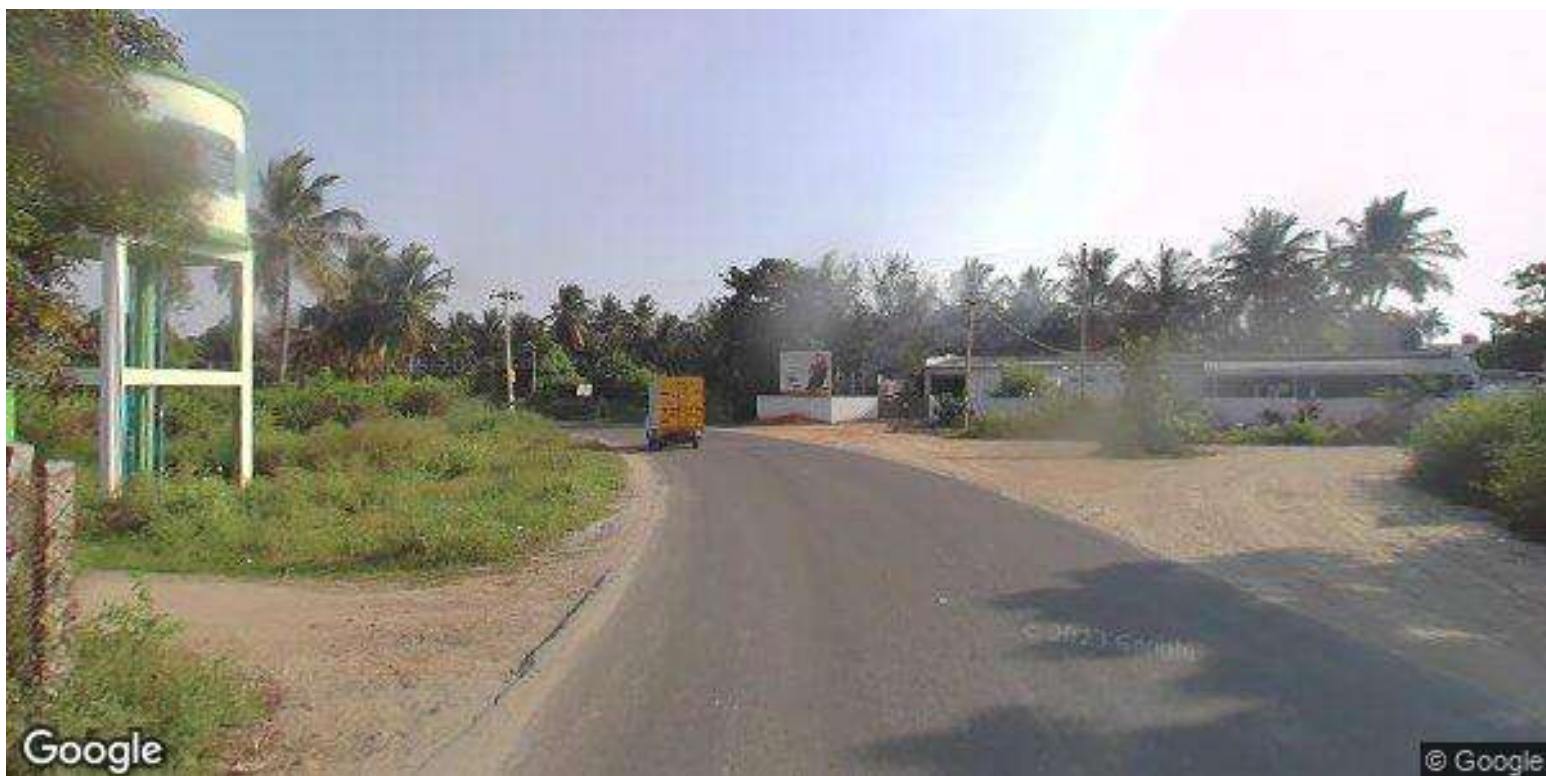
**Risk Type:** Turn  
**Risk Level:** Medium  
**Speed Limit:** 30 KM/Hr  
**Coordinates:** 11.06989, 77.26801

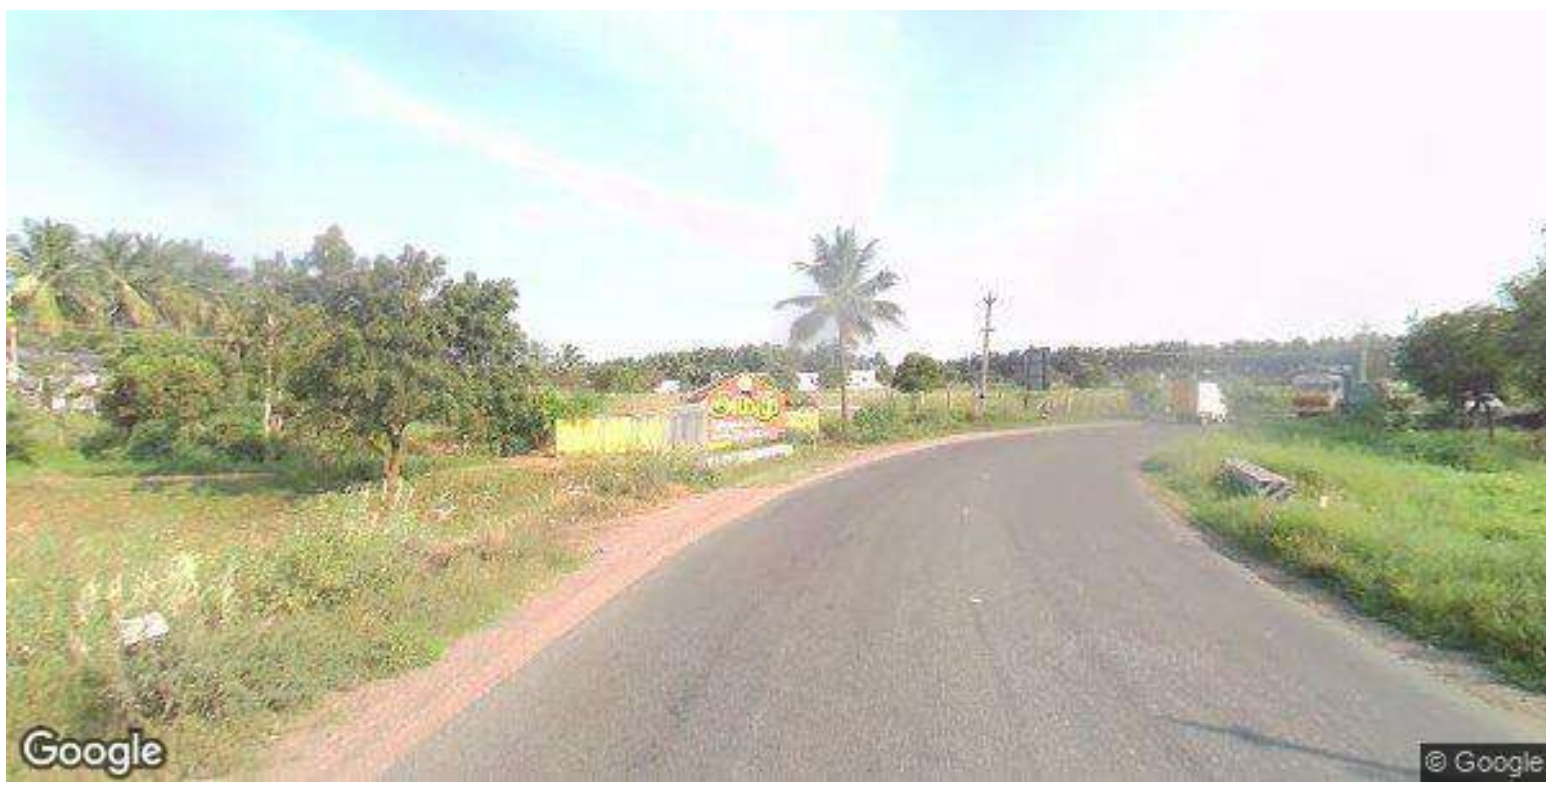
**Coordinates:** 11.06826, 77.27076

**Risk Type:** Turn

**Risk Level:** Medium

**Speed Limit:** 30 KM/Hr

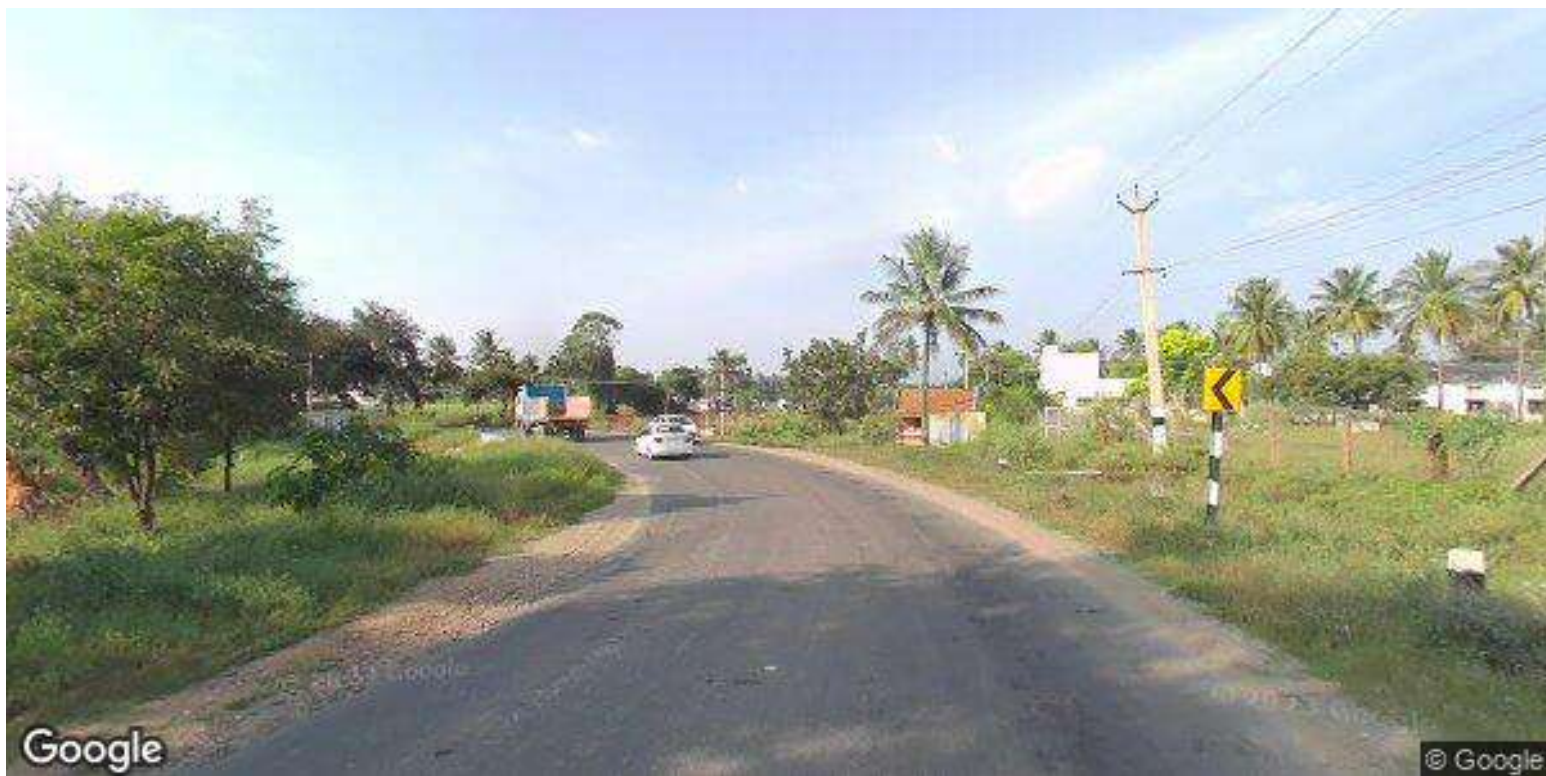
**Coordinates:** 11.06781, 77.27098

**Risk Type:** Turn

**Risk Level:** Medium

**Speed Limit:** 30 KM/Hr
