# IndianOil

## JOURNEY RISK MANAGEMENT (JRM) STUDY

### Salem Terminal to BAKYA LAKSHMI FUELS

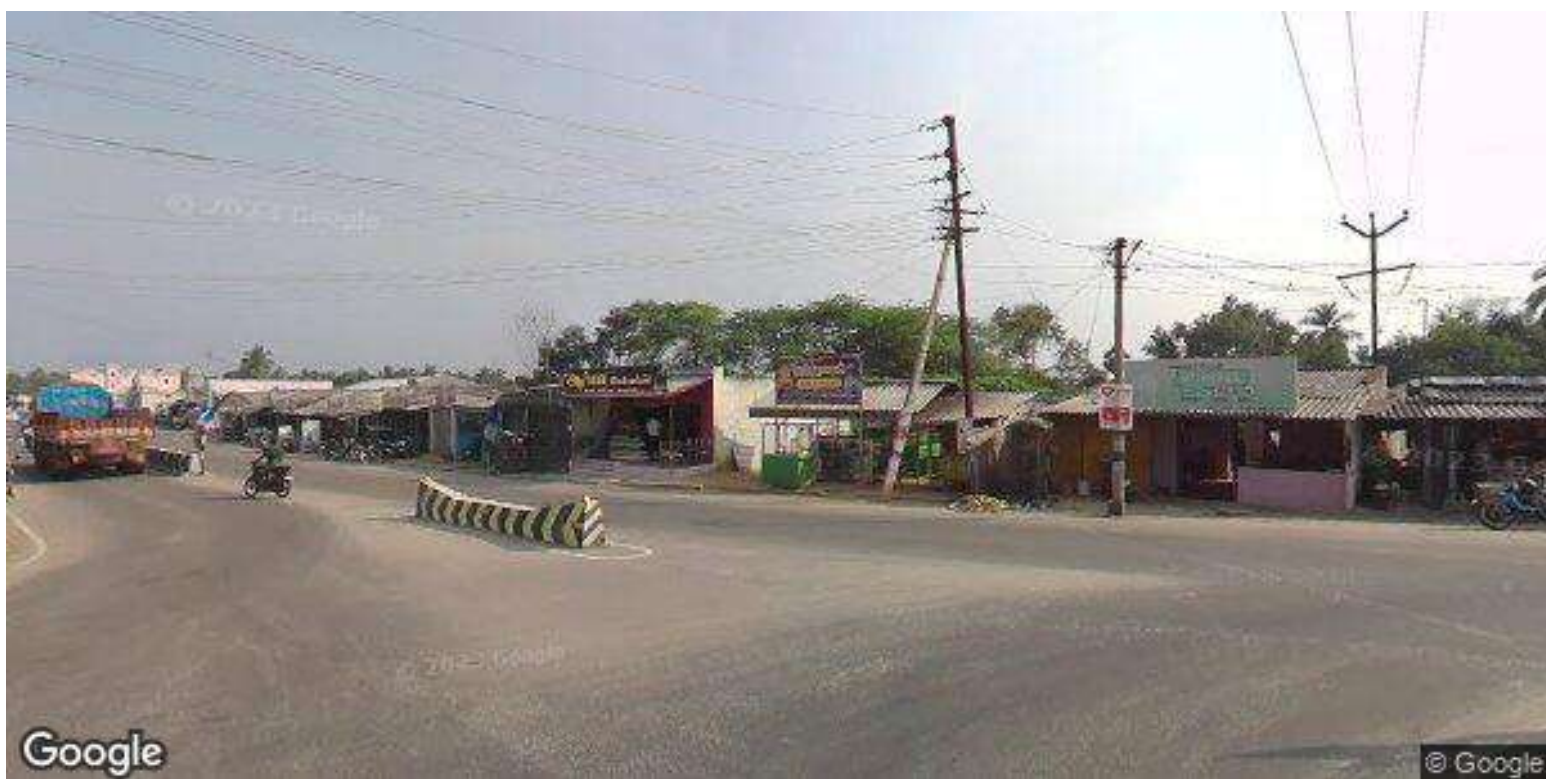
**Coordinates:** 11.04637, 77.73761

**Risk Type:** Roundabout

**Risk Level:** High

**Speed Limit:** 15 KM/Hr

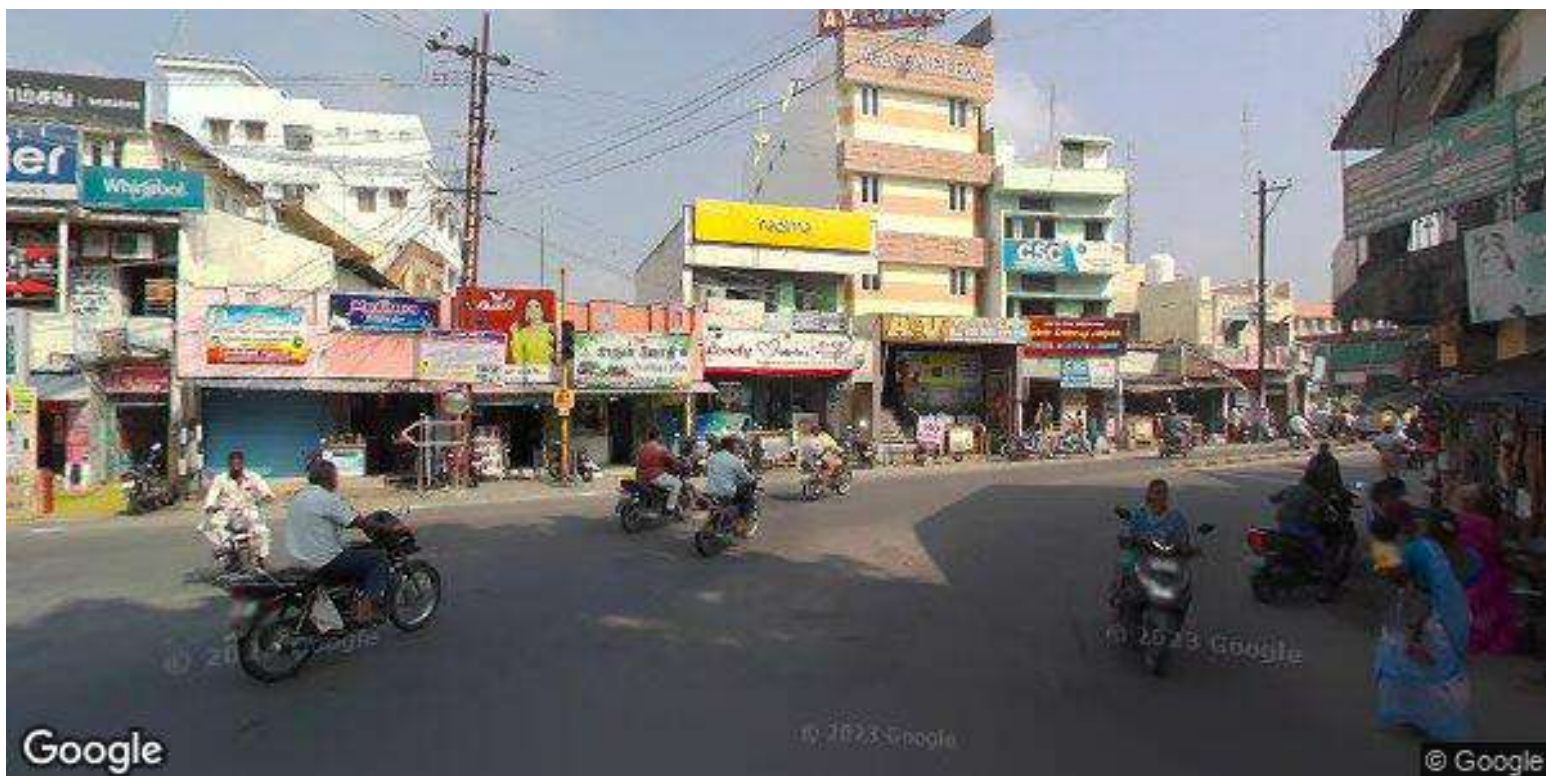
**Risk Type:** Turn  
**Risk Level:** Medium  
**Speed Limit:** 30 KM/Hr  
**Coordinates:** 11.37842, 77.89452

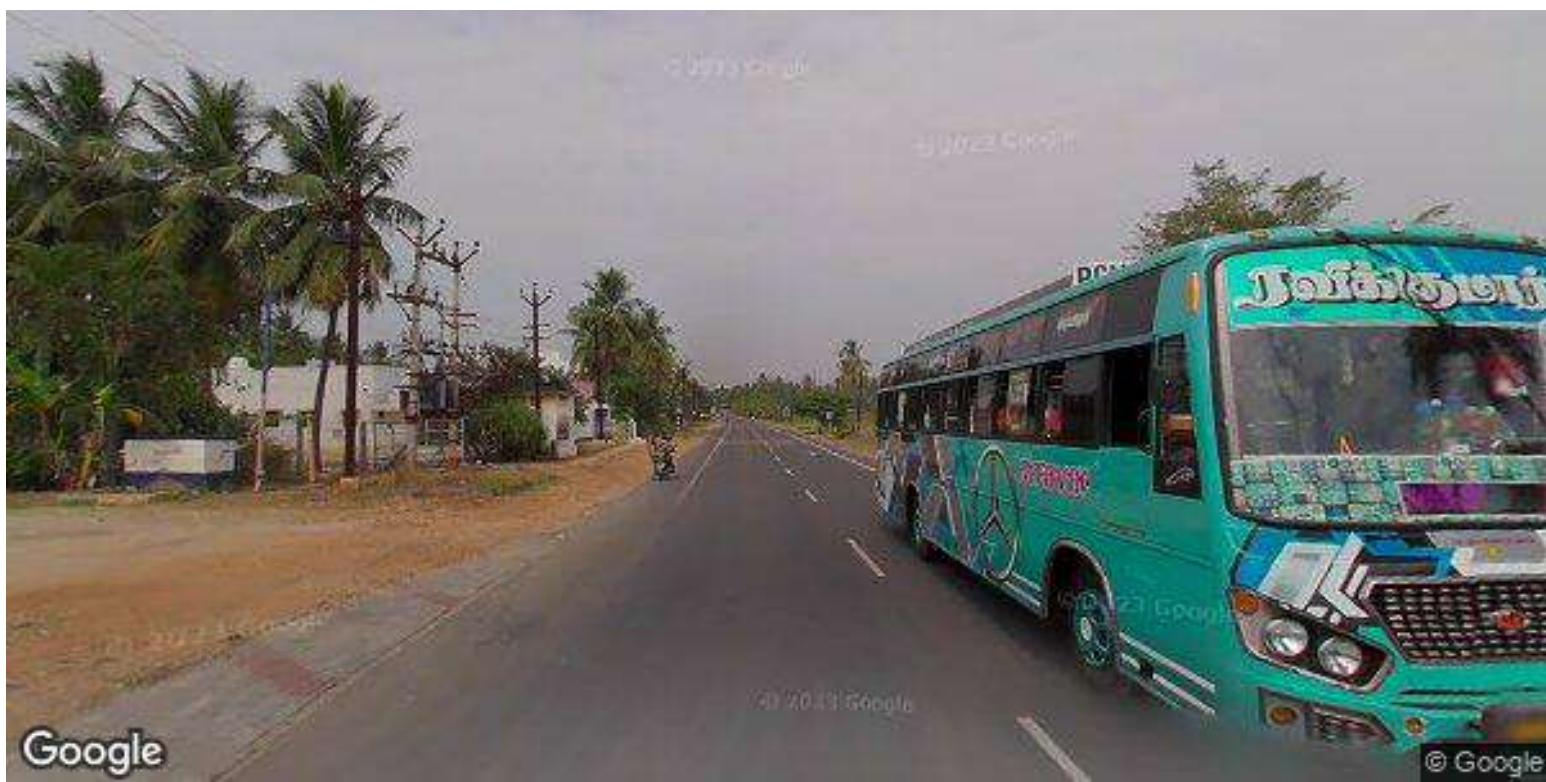
**Coordinates:** 11.30869, 77.92911

**Risk Type:** Turn

**Risk Level:** Medium

**Speed Limit:** 30 KM/Hr

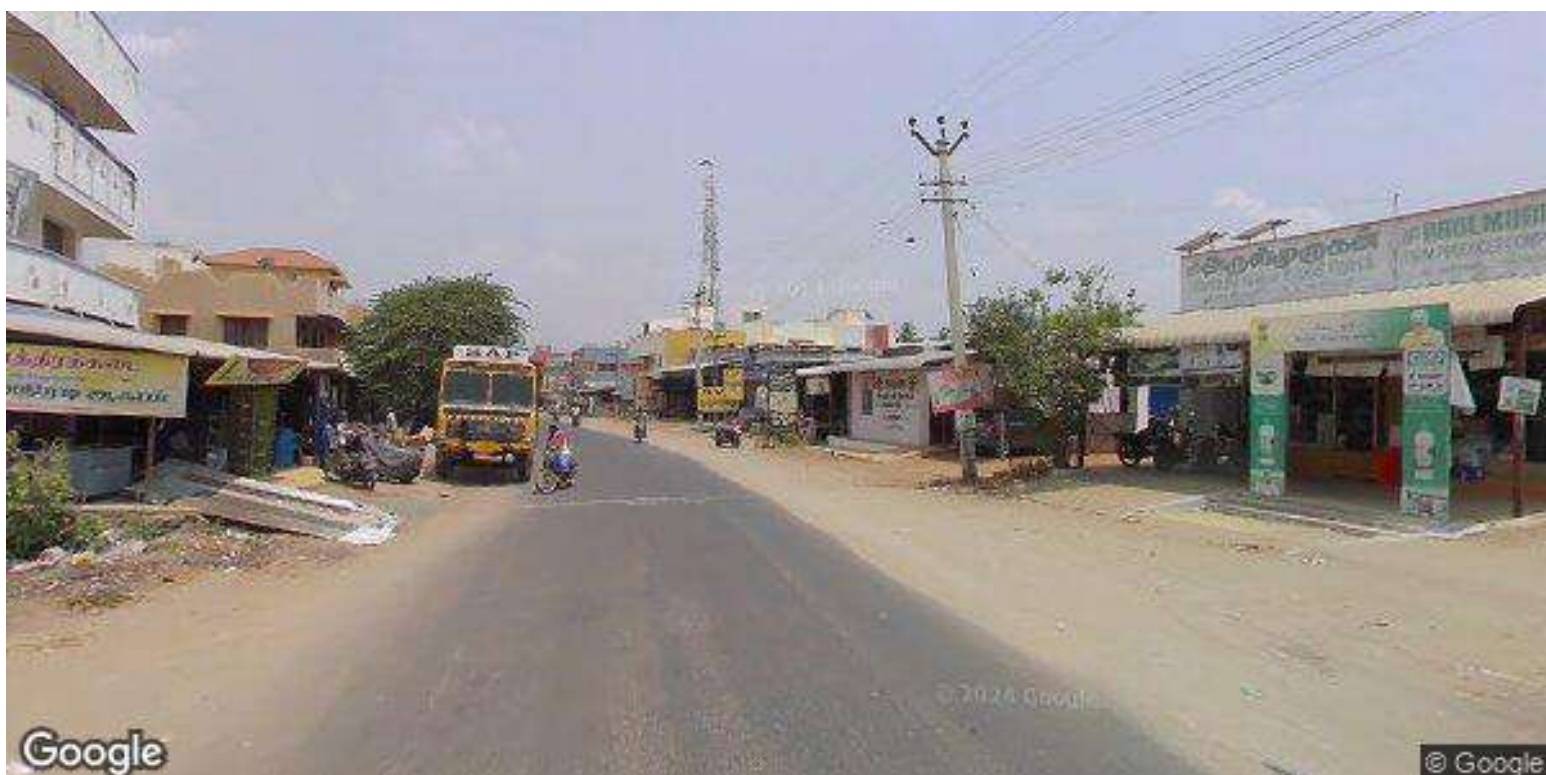
**Risk Type:** Turn  
**Risk Level:** Medium  
**Speed Limit:** 30 KM/Hr  
**Coordinates:** 11.24172, 77.87357

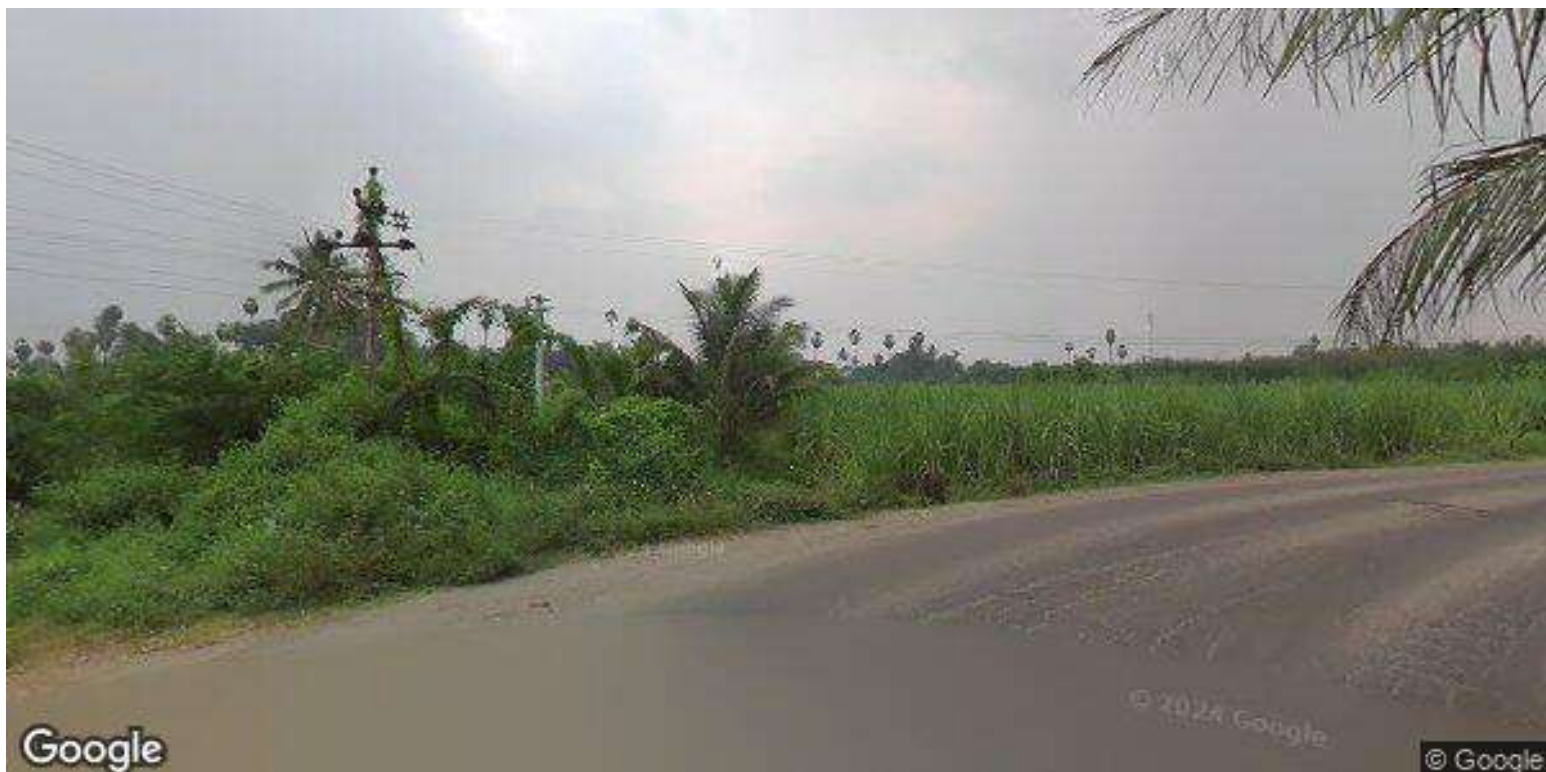
**Risk Type:** Turn  
**Risk Level:** Medium  
**Speed Limit:** 30 KM/Hr  
**Coordinates:** 11.24101, 77.86034

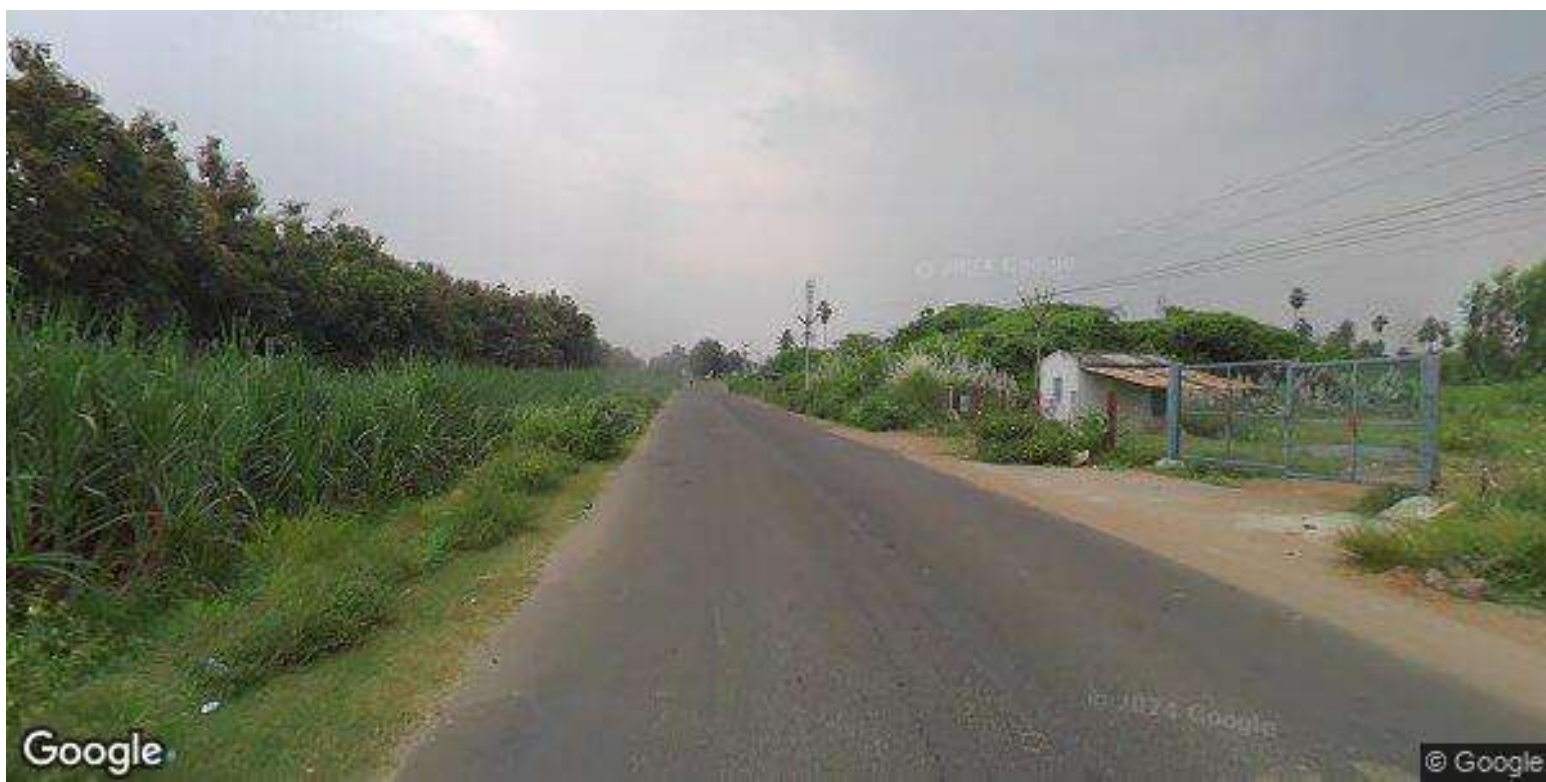
**Coordinates:** 11.24196, 77.85856

**Risk Type:** Turn

**Risk Level:** Medium

**Speed Limit:** 30 KM/Hr

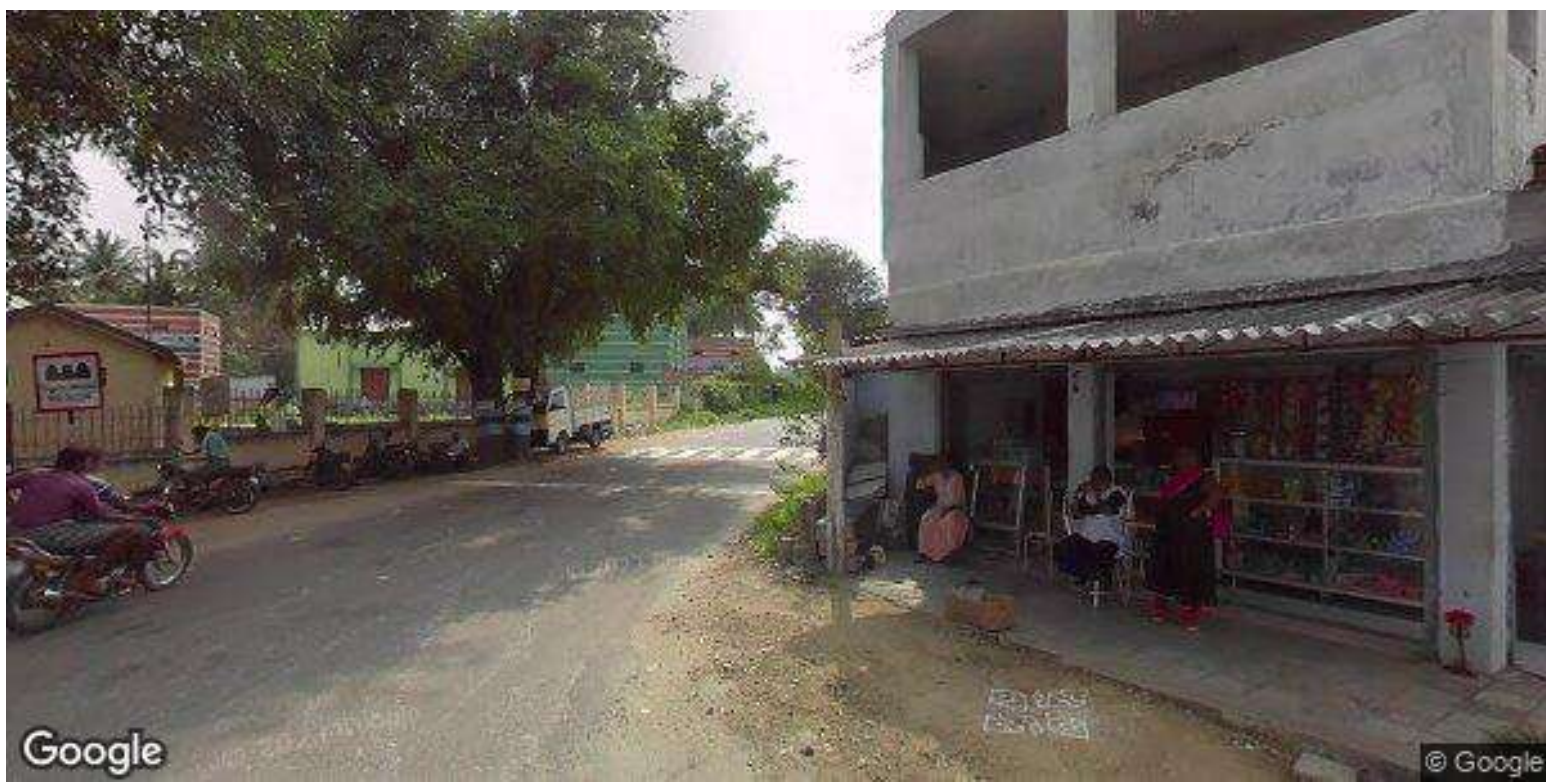
**Coordinates:** 11.13664, 77.76524

**Risk Type:** Turn

**Risk Level:** Medium

**Speed Limit:** 30 KM/Hr

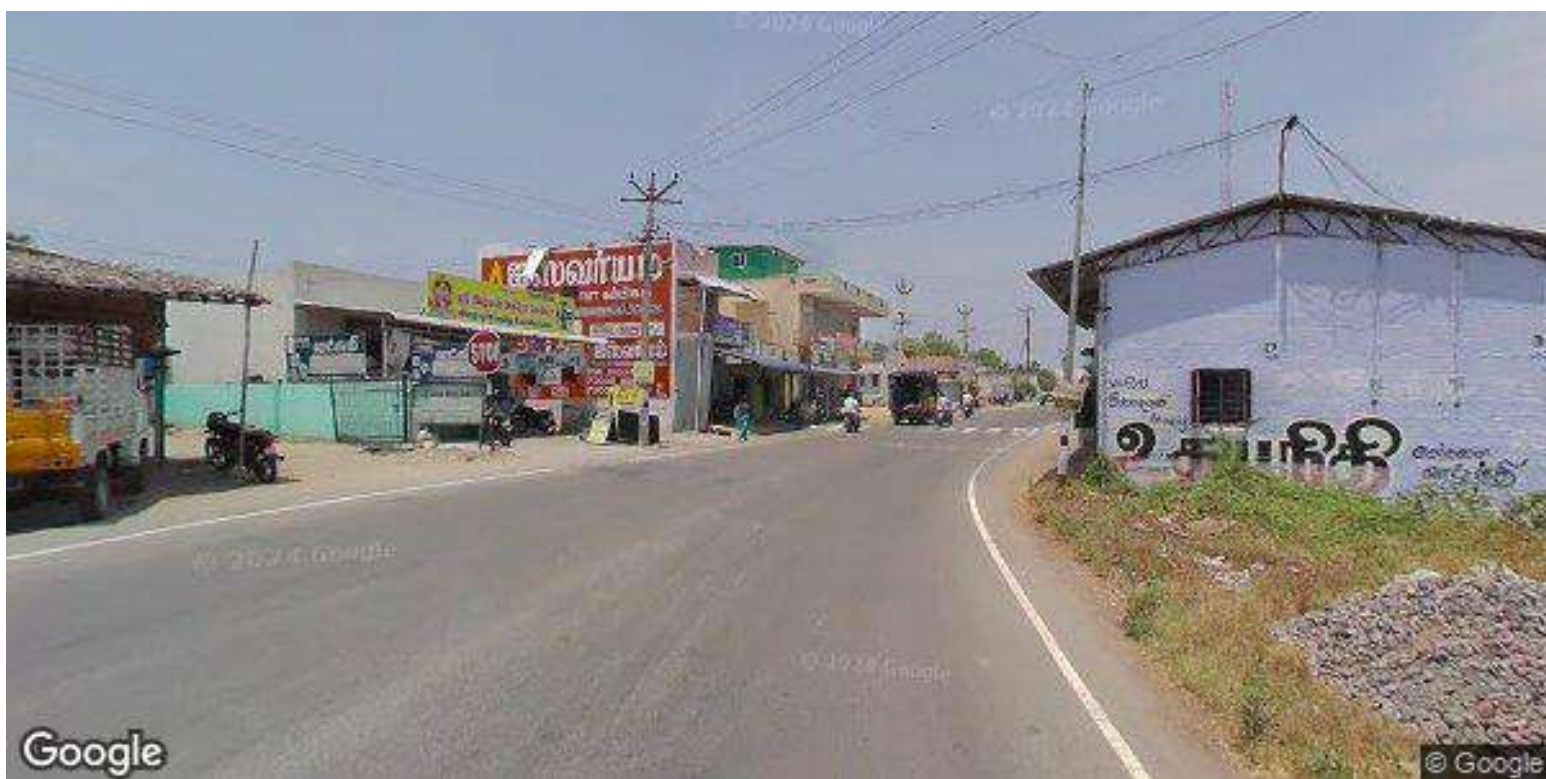
**Coordinates:** 11.04718, 77.73742

**Risk Type:** Turn

**Risk Level:** Medium

**Speed Limit:** 30 KM/Hr

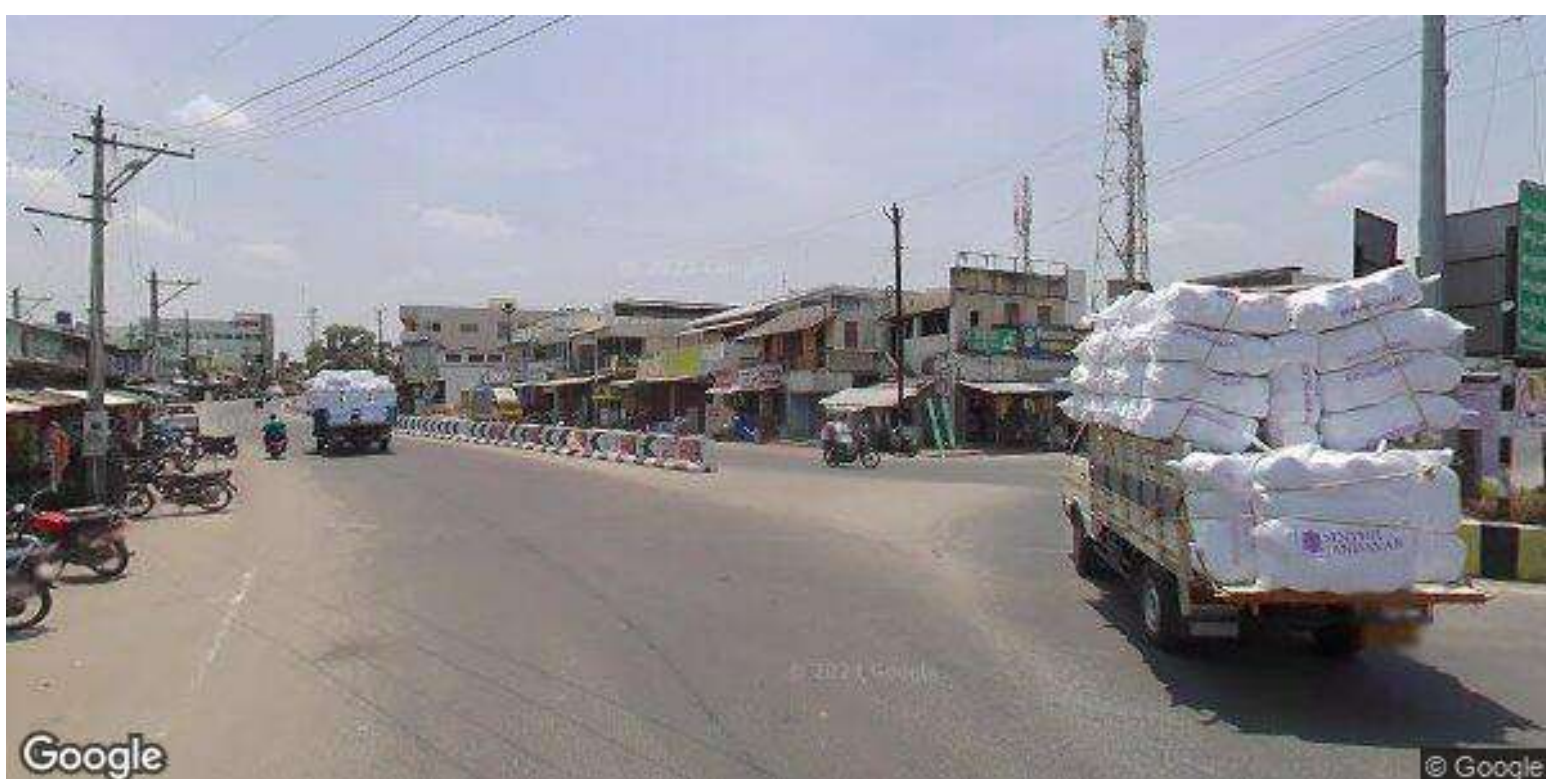
**Risk Type:** Turn  
**Risk Level:** High  
**Speed Limit:** 15 KM/Hr  
**Coordinates:** 11.04515, 77.73621

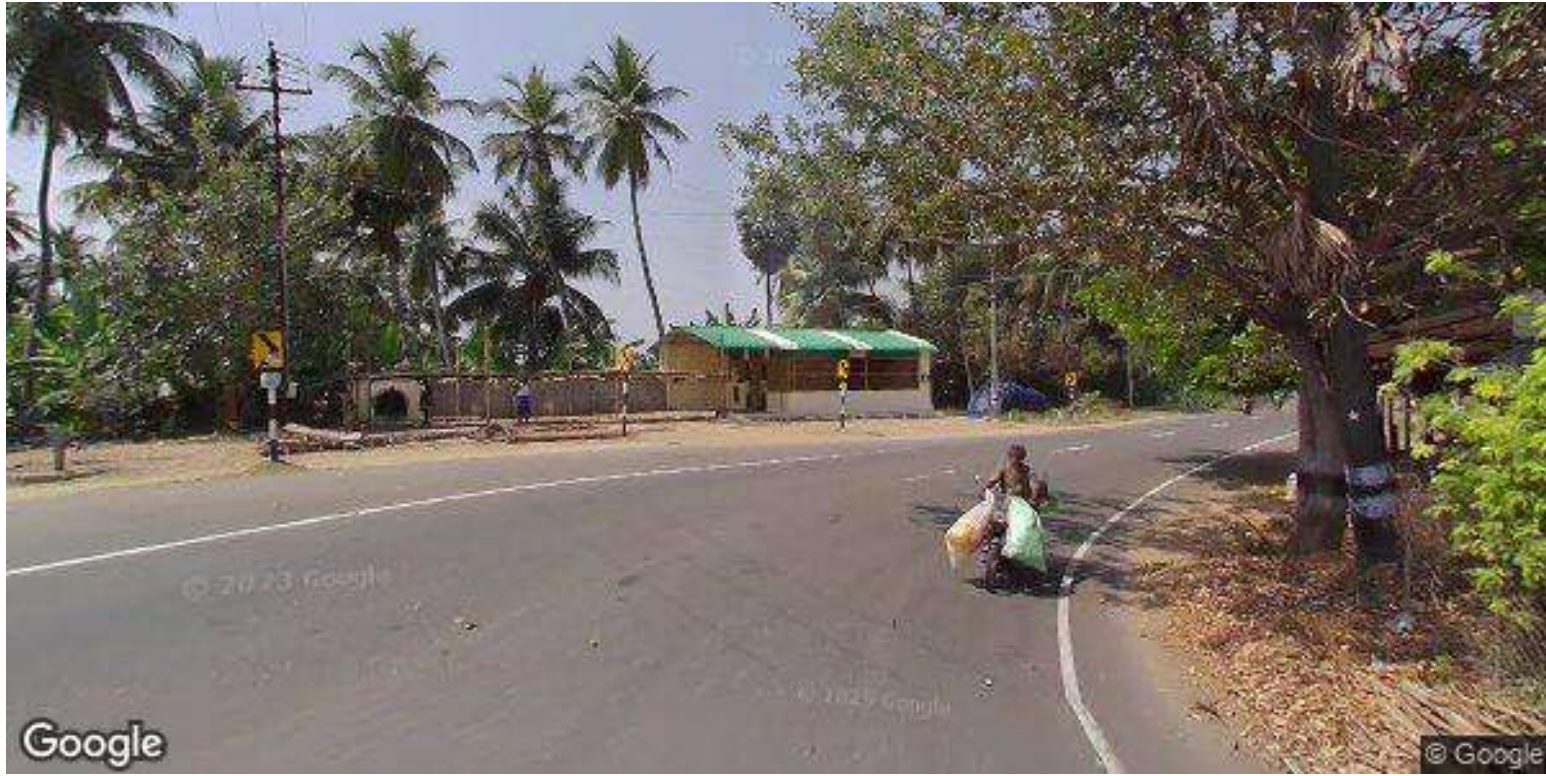
**Risk Type:** Turn  
**Risk Level:** High  
**Speed Limit:** 15 KM/Hr  
**Coordinates:** 10.99026, 77.72511

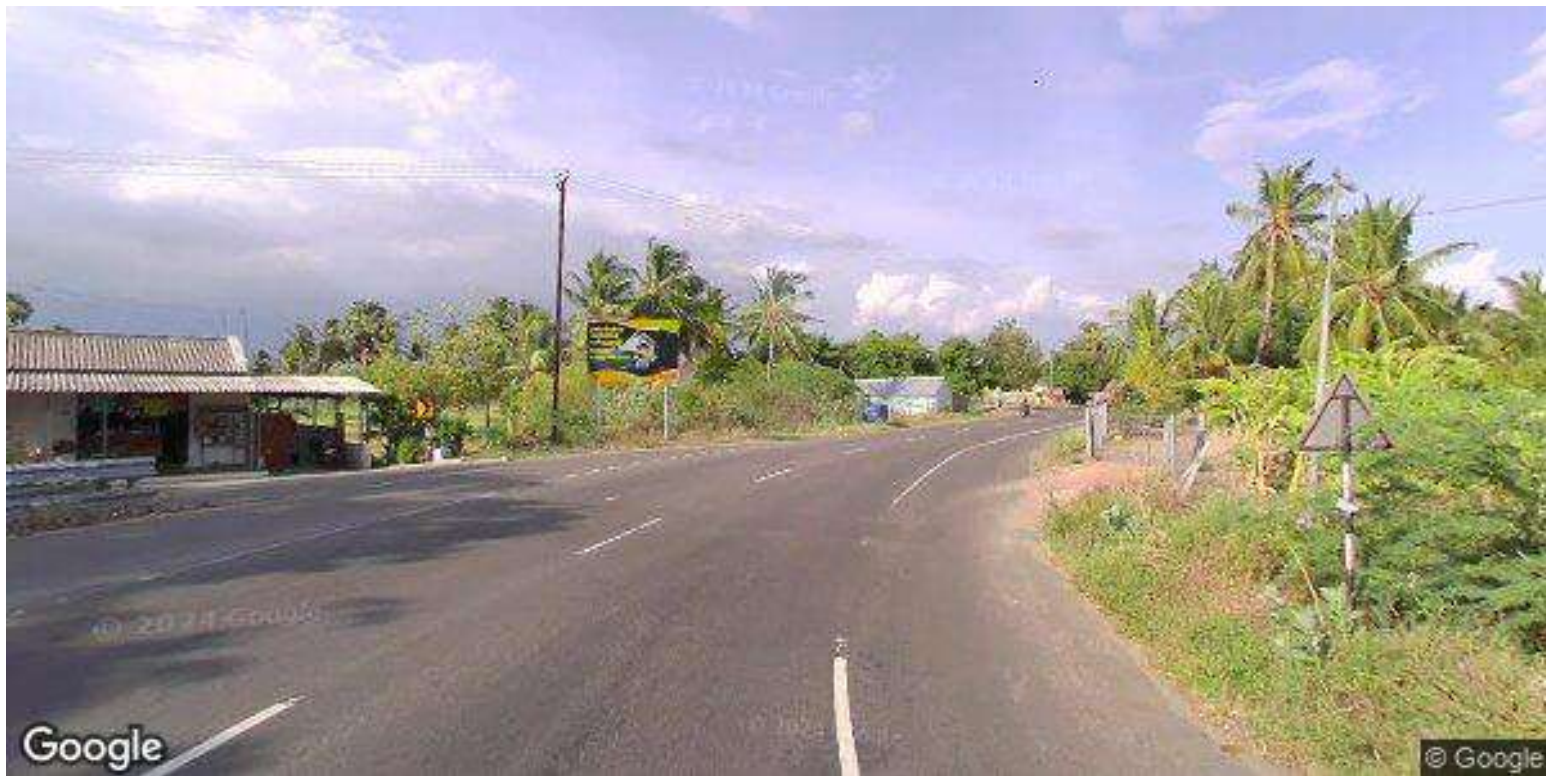
**Risk Type:** Turn  
**Risk Level:** High  
**Speed Limit:** 15 KM/Hr  
**Coordinates:** 10.98974, 77.72388

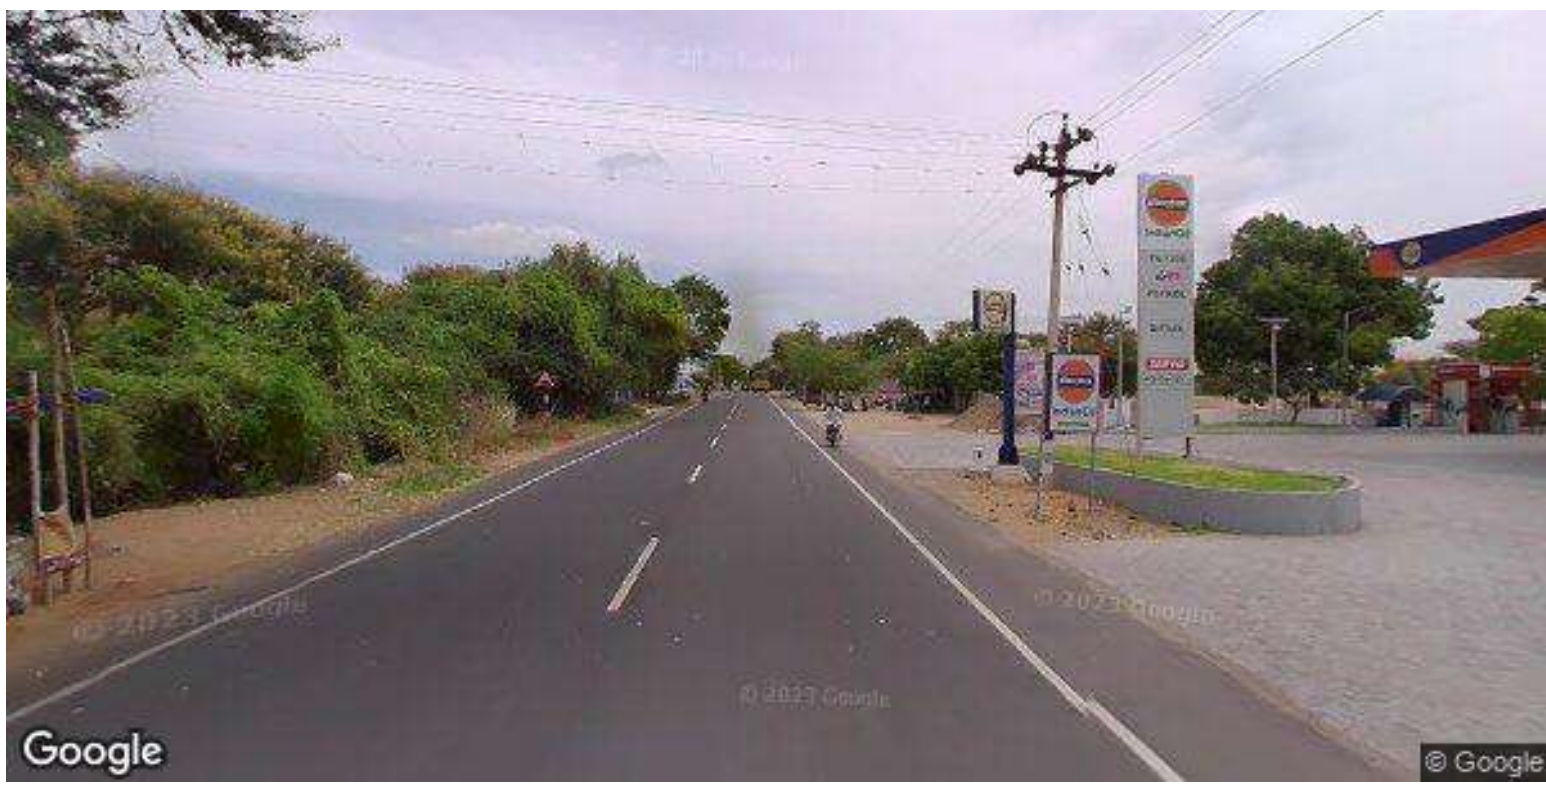
**Coordinates:** 10.96959, 77.71867

**Risk Type:** Blind Spot

**Risk Level:** Blind Spot

**Speed Limit:** 10 KM/Hr
