# IndianOil

## JOURNEY RISK MANAGEMENT (JRM) STUDY

### Salem Terminal to AMMAN ENTERPRISE

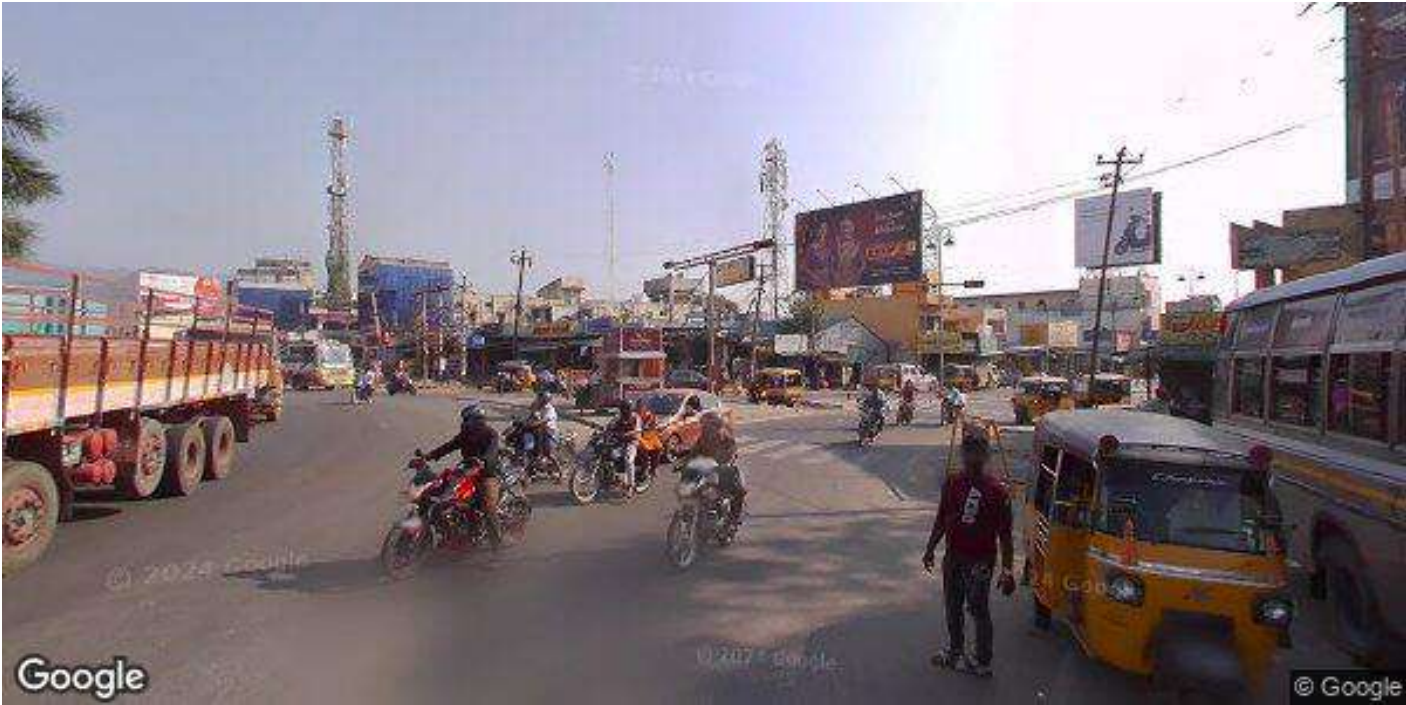
Coordinates: 11.63266, 78.12699

Risk Type: Roundabout

Risk Level: High

Speed Limit: 15 KM/Hr

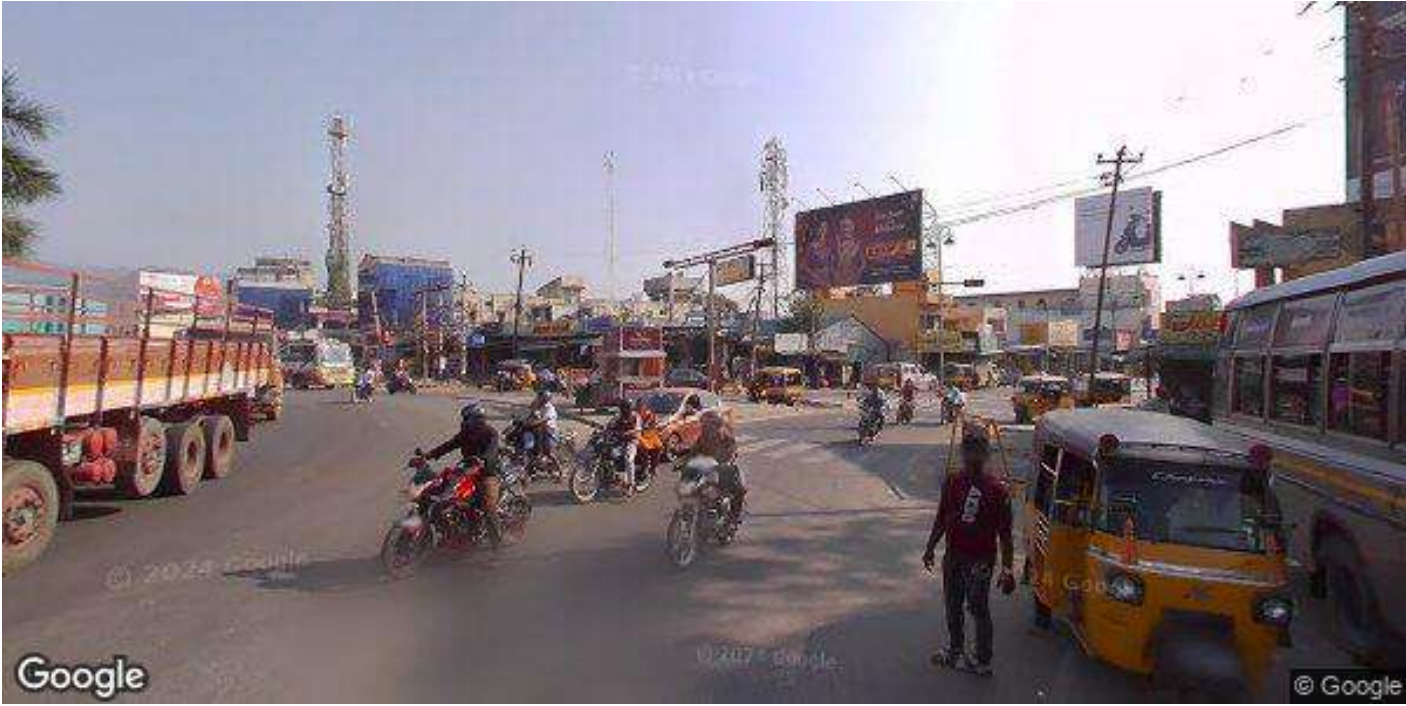
Coordinates: 11.63266, 78.12699

Risk Type: Roundabout

Risk Level: High

Speed Limit: 15 KM/Hr

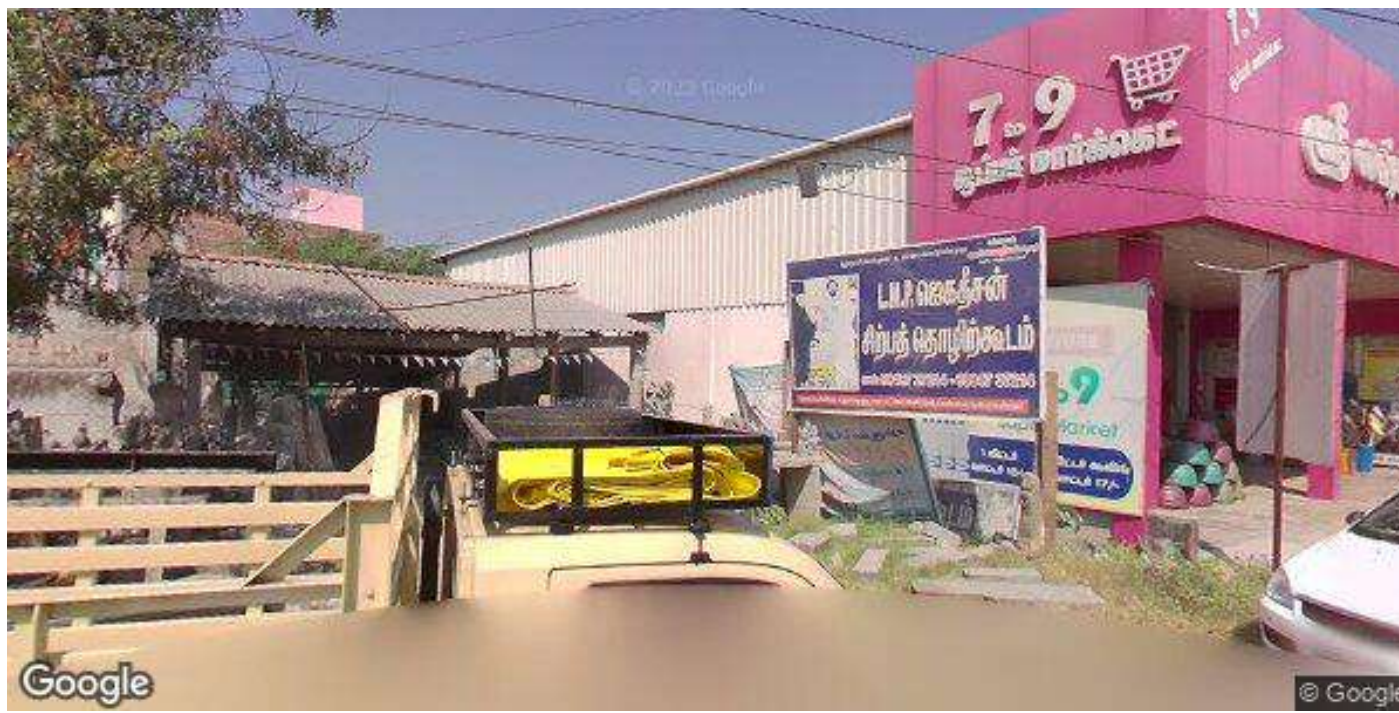
**Coordinates:** 11.6302987, 78.12452429999999

**Risk Type:** U-Turn

**Risk Level:** High

**Speed Limit:** 10 KM/Hr

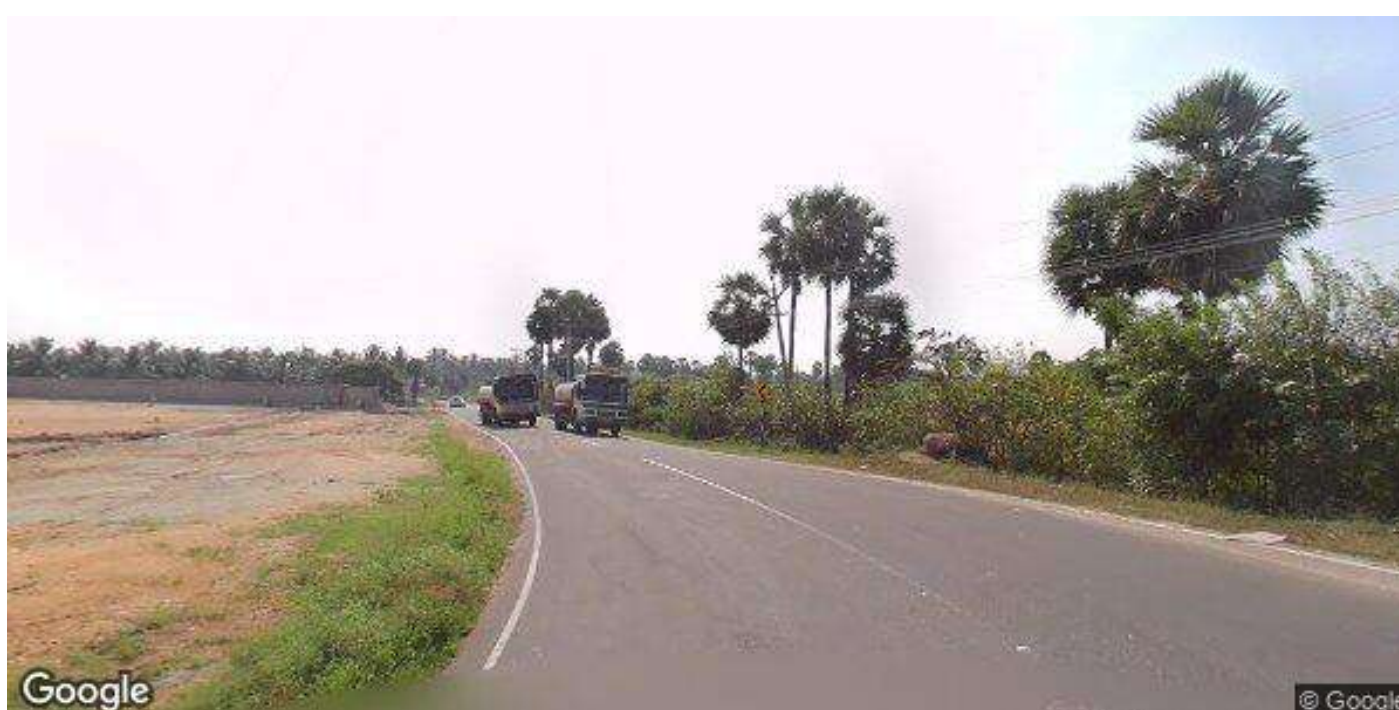
**Risk Type:** Turn  
**Risk Level:** Medium  
**Speed Limit:** 30 KM/Hr  
**Coordinates:** 11.45839, 77.85143

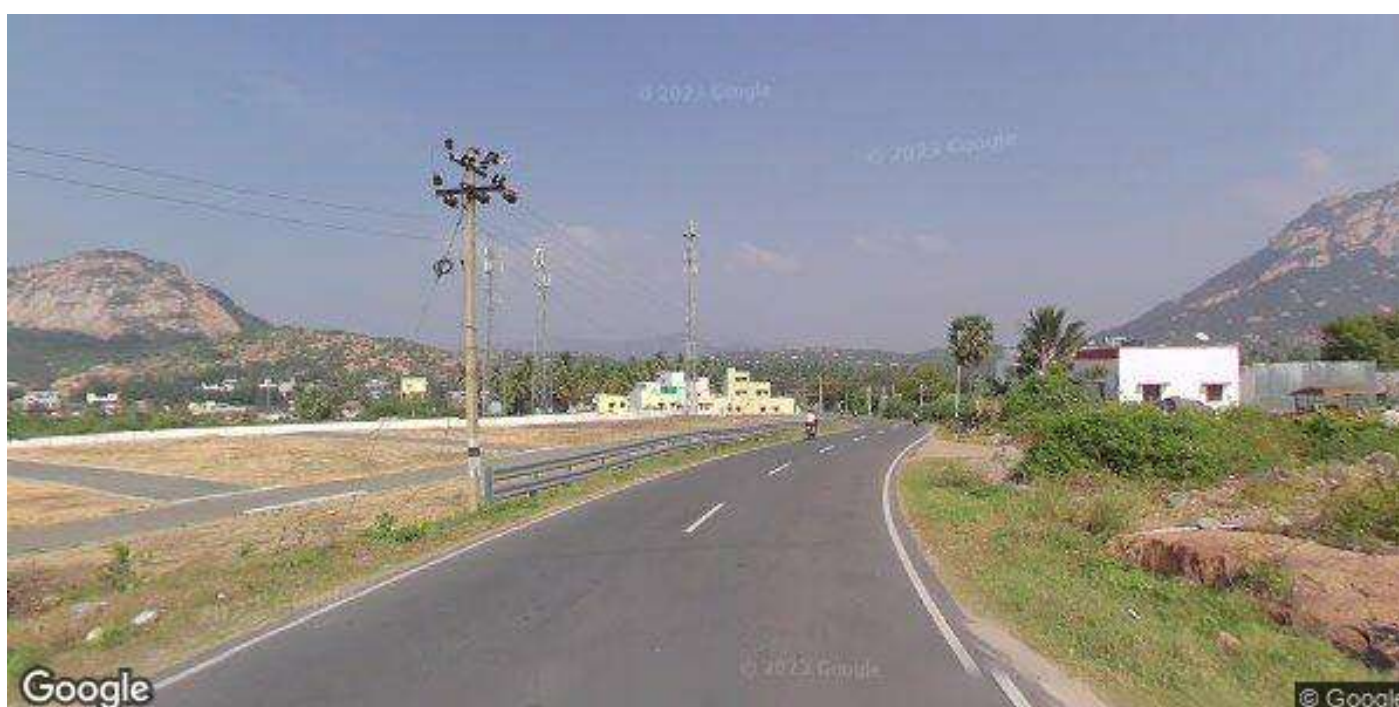
**Risk Type:** Turn  
**Risk Level:** Medium  
**Speed Limit:** 30 KM/Hr  
**Coordinates:** 11.46053, 77.85034

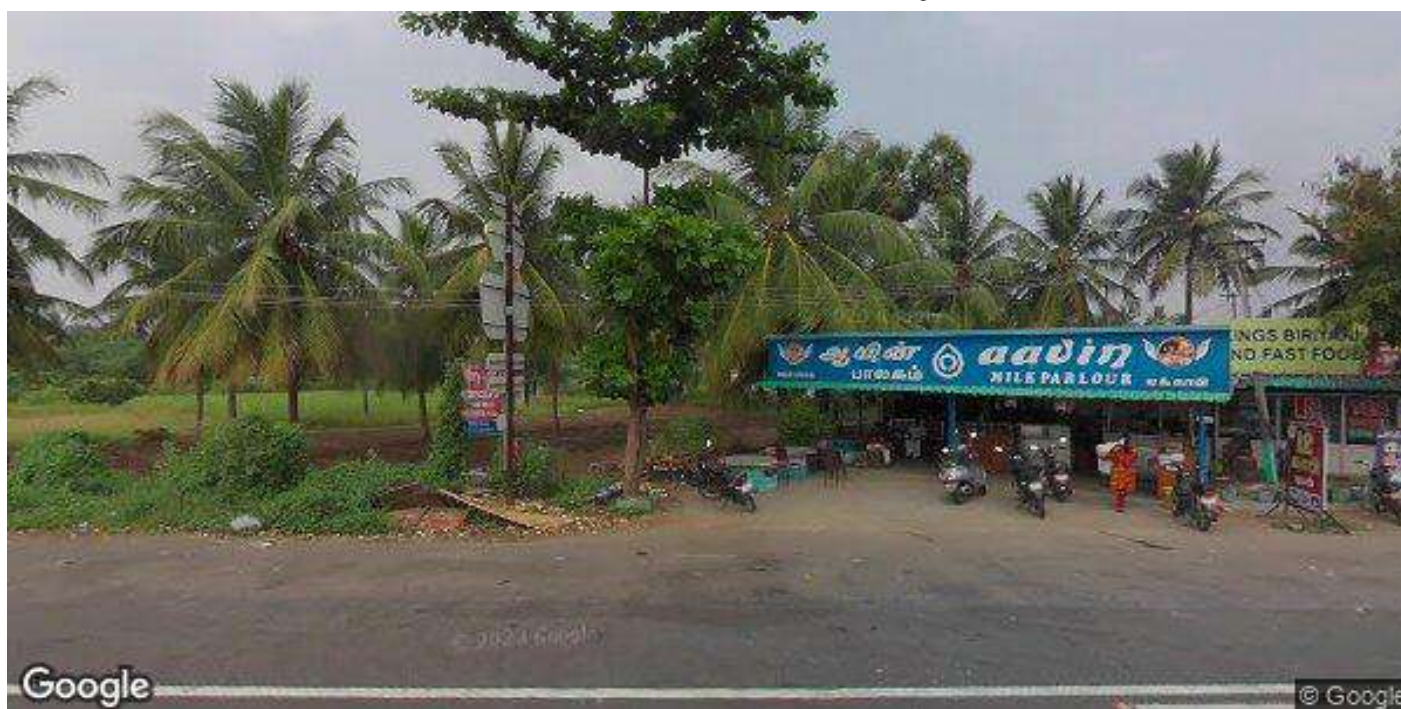
**Risk Type:** Blind Spot  
**Risk Level:** Blind Spot  
**Speed Limit:** 10 KM/Hr  
**Coordinates:** 11.45631, 77.81668

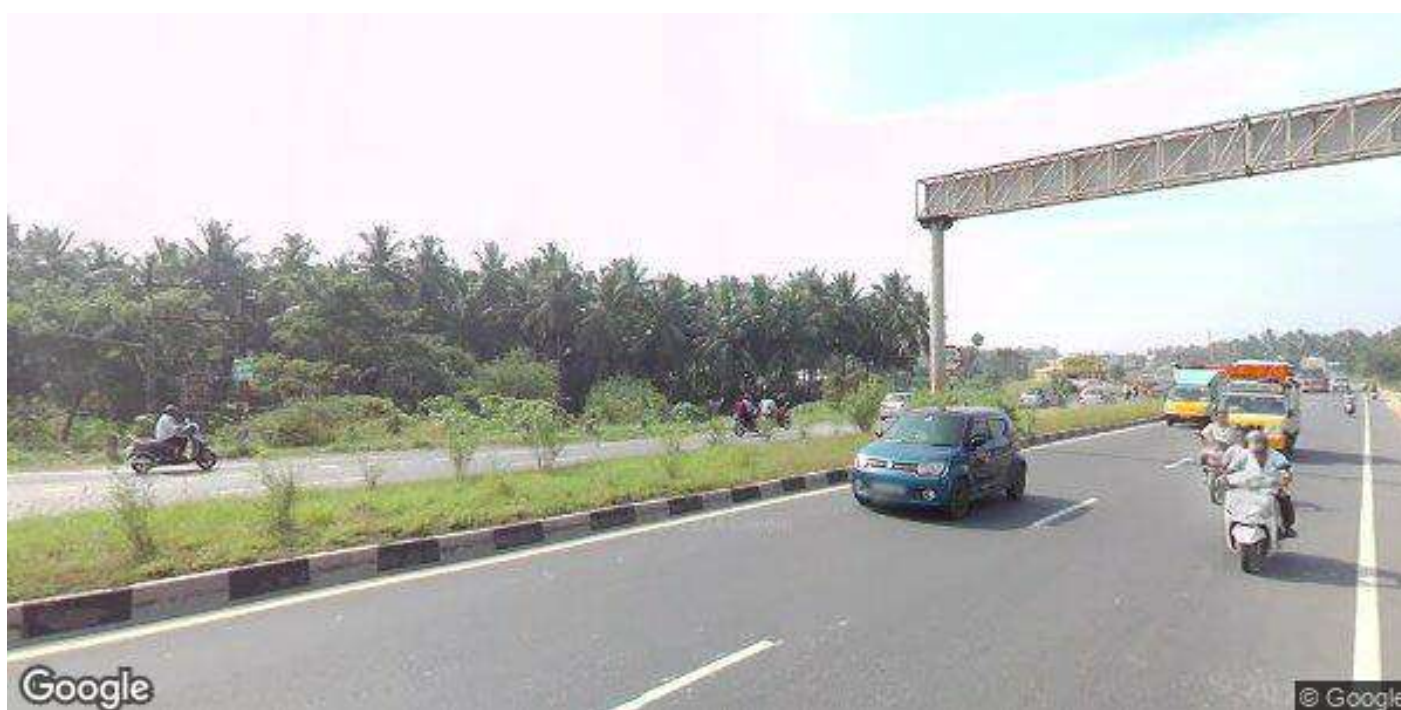
**Risk Type:** Turn  
**Risk Level:** Medium  
**Speed Limit:** 30 KM/Hr  
**Coordinates:** 11.60942, 78.10056

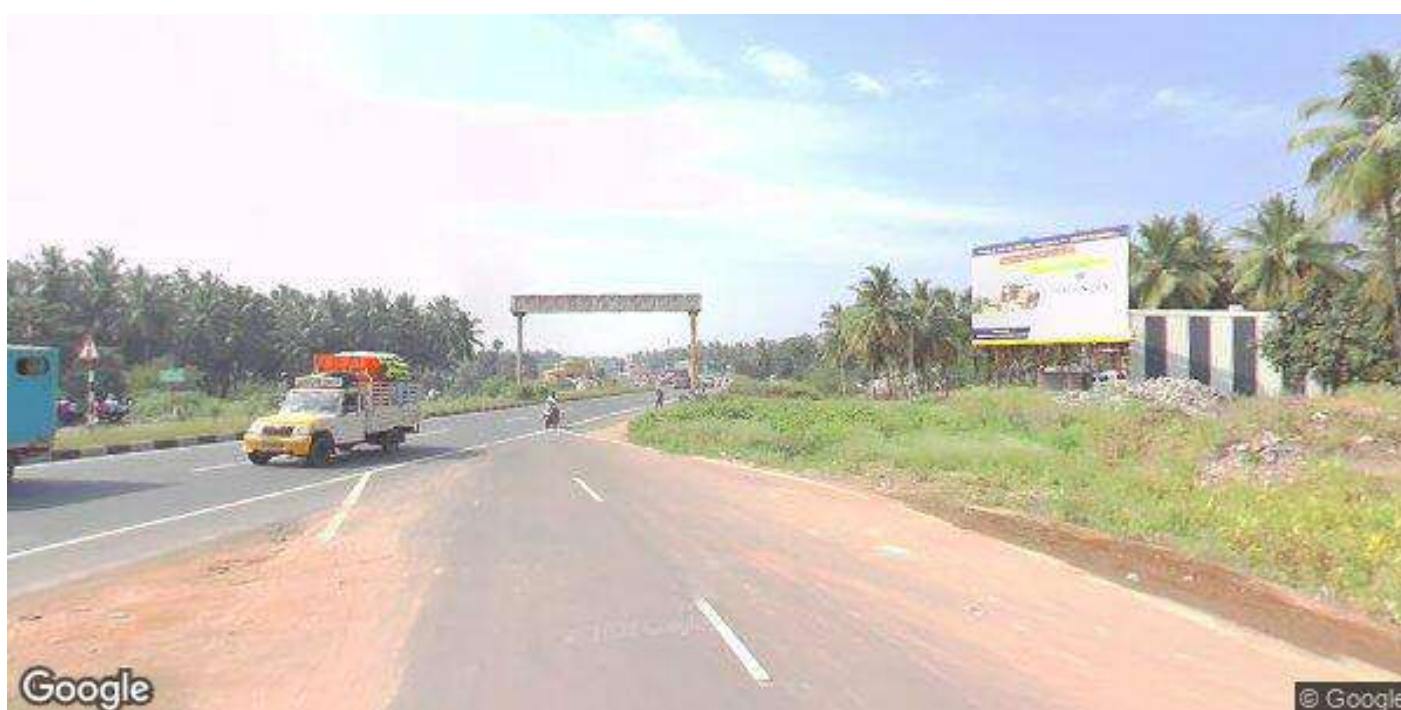
**Risk Type:** Turn  
**Risk Level:** Medium  
**Speed Limit:** 30 KM/Hr  
**Coordinates:** 11.60965, 78.10070

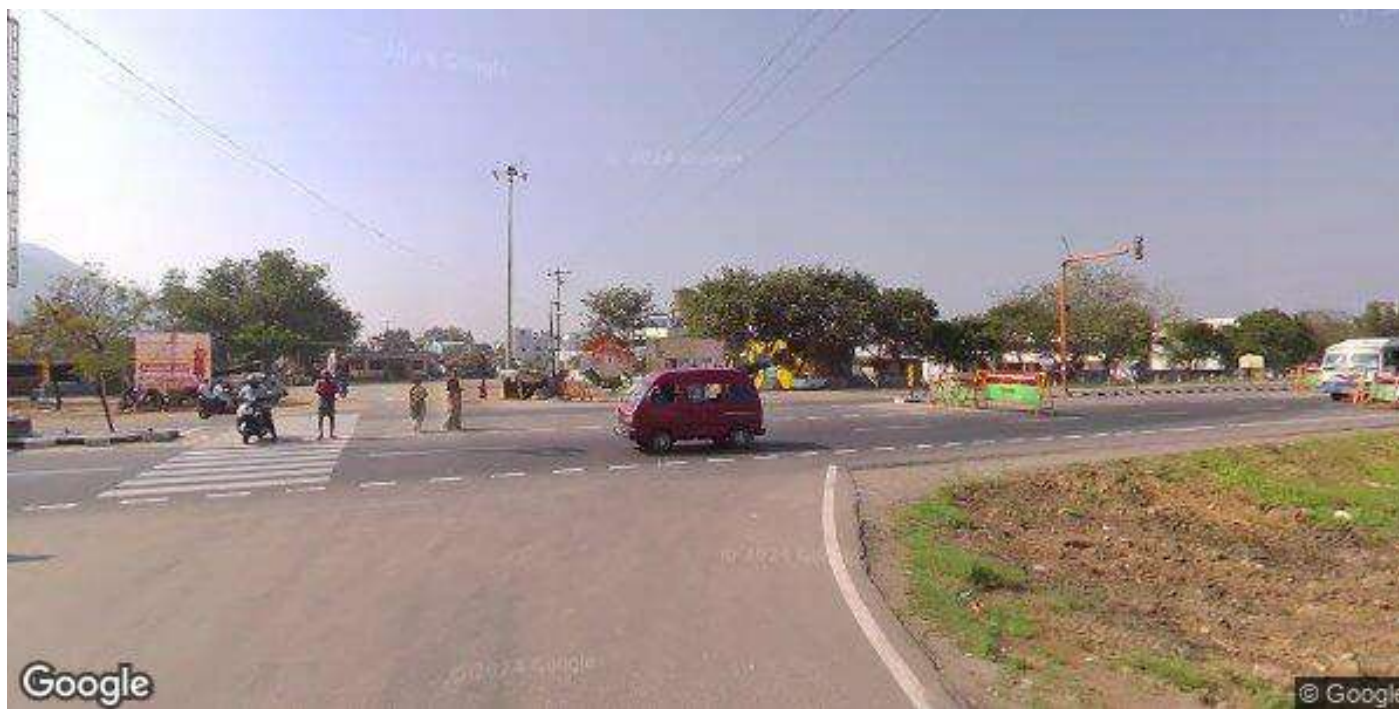
**Risk Type:** Turn  
**Risk Level:** High  
**Speed Limit:** 15 KM/Hr  
**Coordinates:** 11.62130, 78.10776

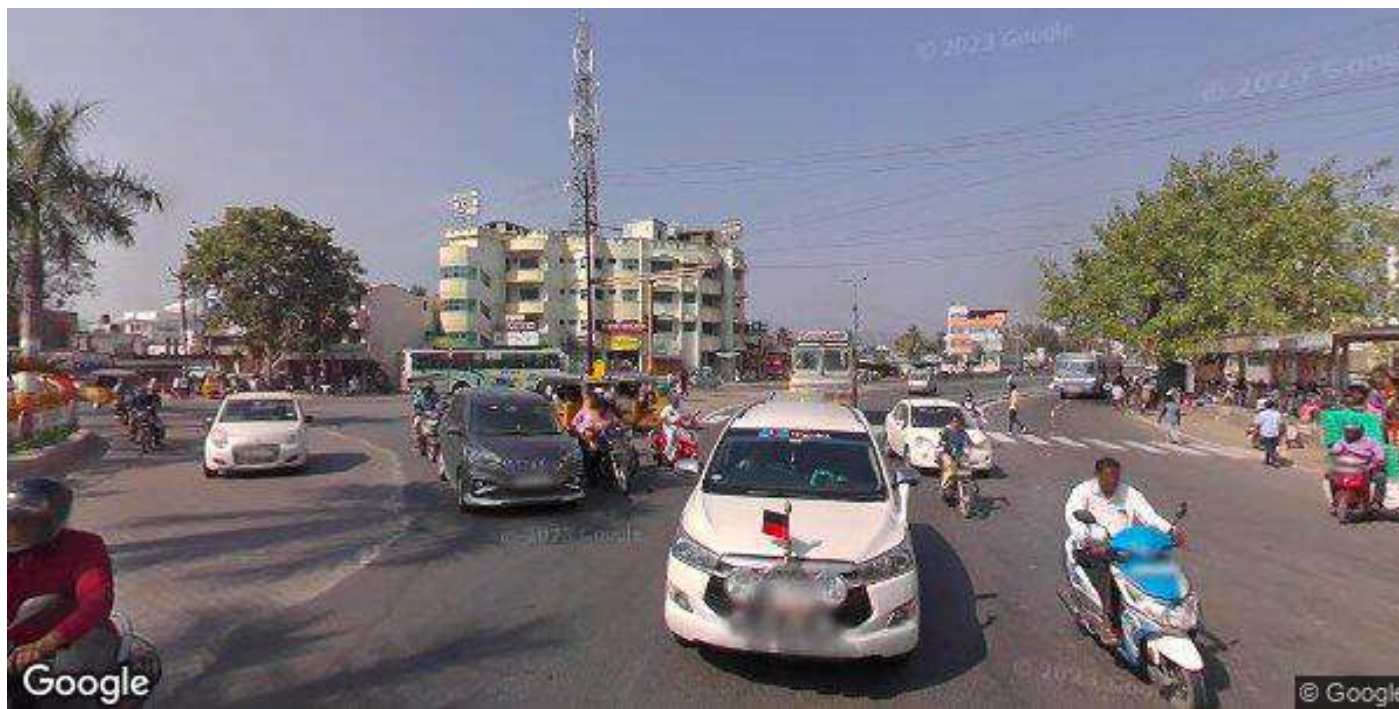
**Risk Type:** Turn  
**Risk Level:** High  
**Speed Limit:** 15 KM/Hr  
**Coordinates:** 11.63306, 78.12722

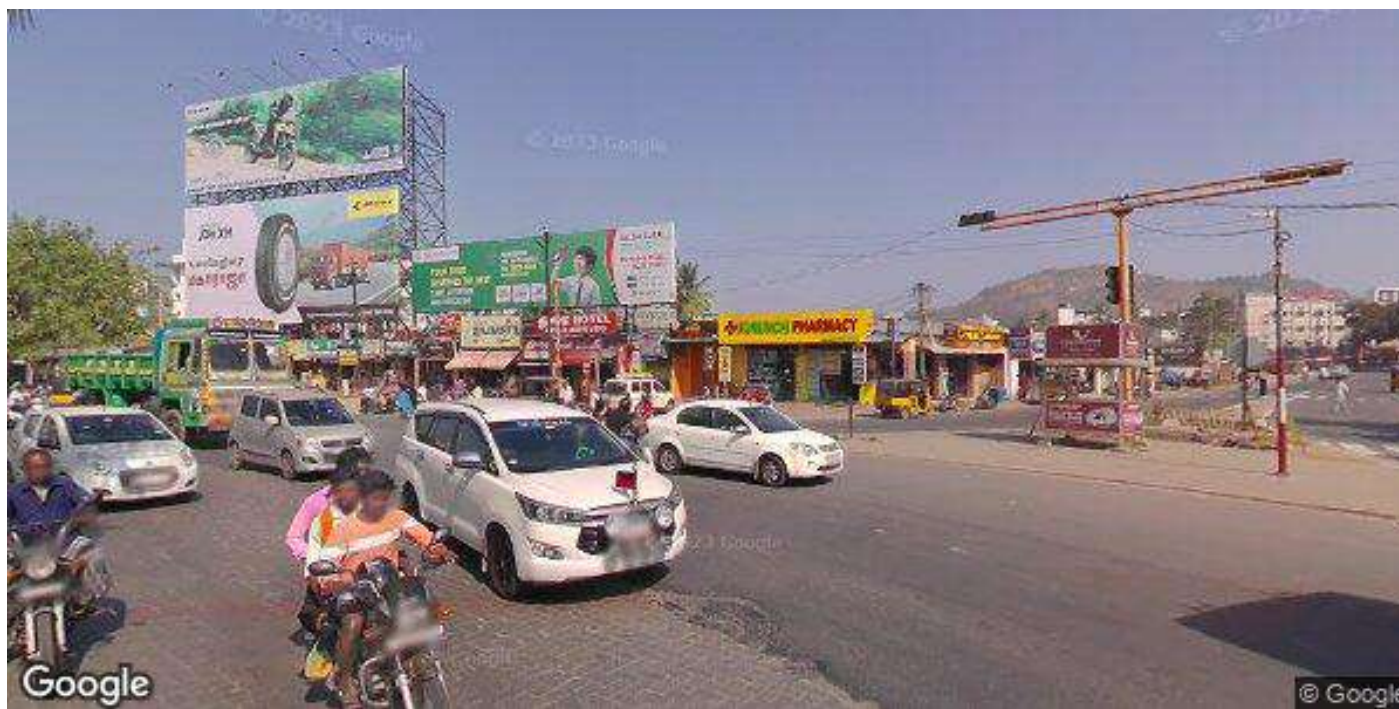
**Risk Type:** Turn  
**Risk Level:** Medium  
**Speed Limit:** 30 KM/Hr  
**Coordinates:** 11.63294, 78.12752

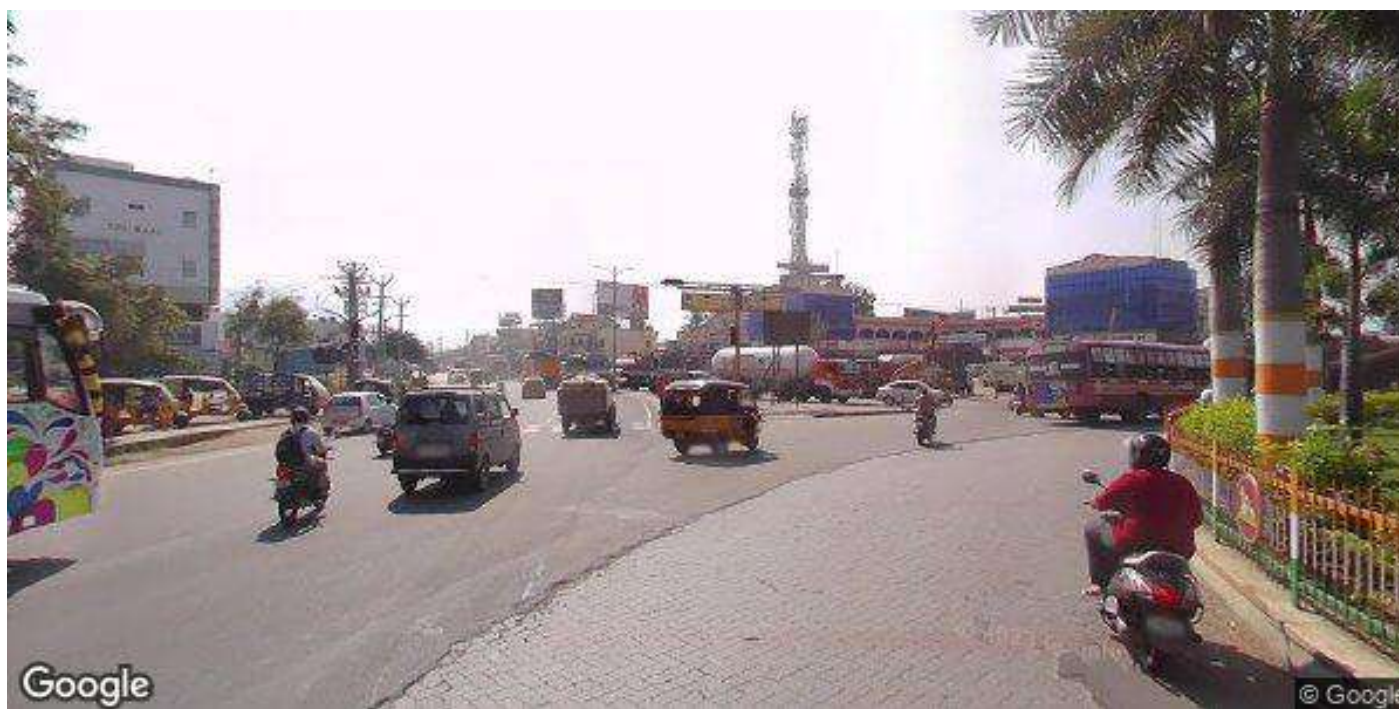
**Risk Type:** Turn  
**Risk Level:** Medium  
**Speed Limit:** 30 KM/Hr  
**Coordinates:** 11.63283, 78.12757

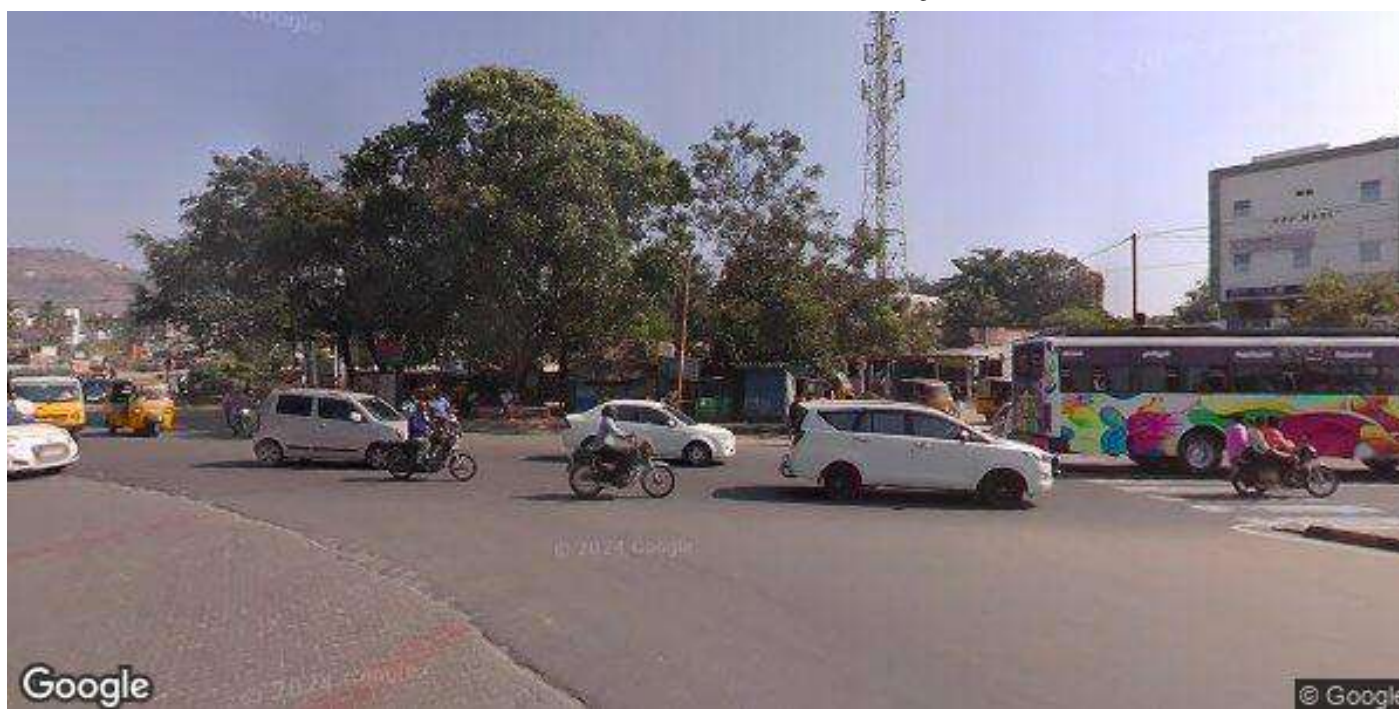
**Risk Type:** Turn  
**Risk Level:** High  
**Speed Limit:** 15 KM/Hr  
**Coordinates:** 11.63262, 78.12754

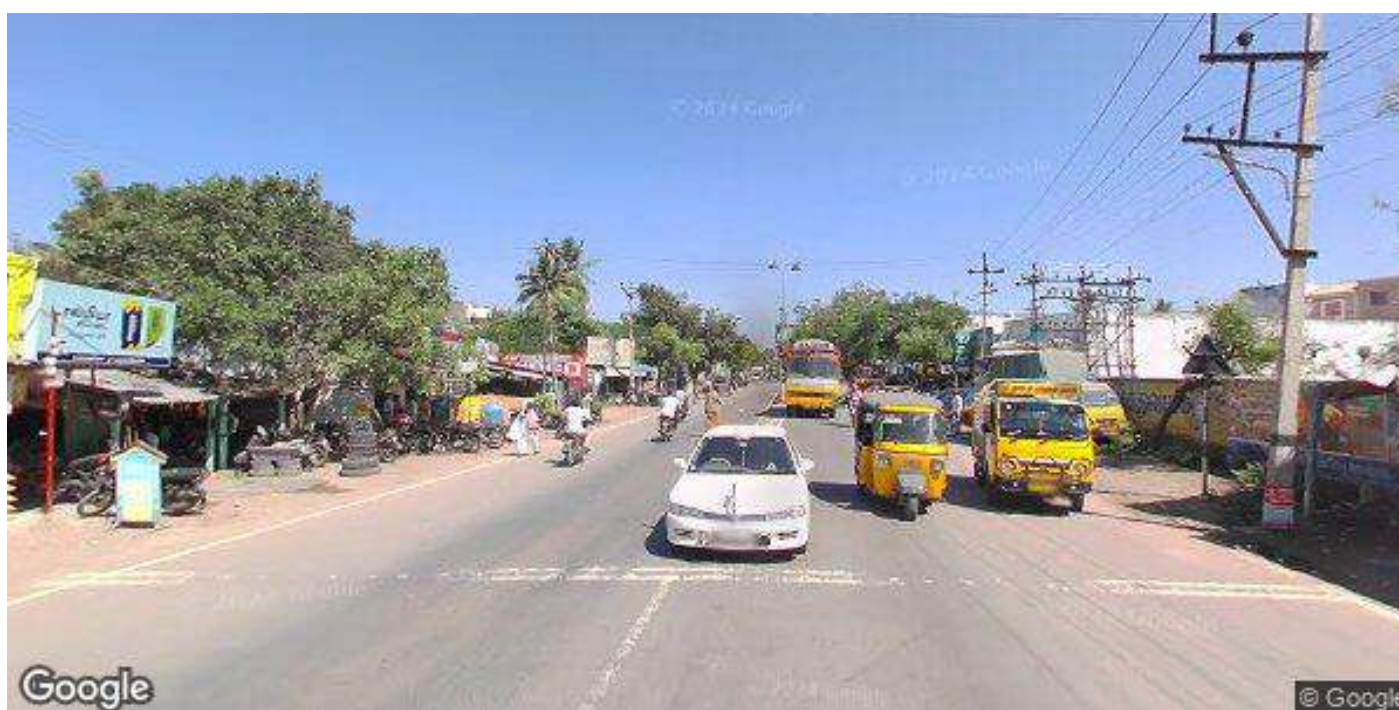
**Risk Type:** Turn  
**Risk Level:** Medium  
**Speed Limit:** 30 KM/Hr  
**Coordinates:** 11.63026, 78.12481

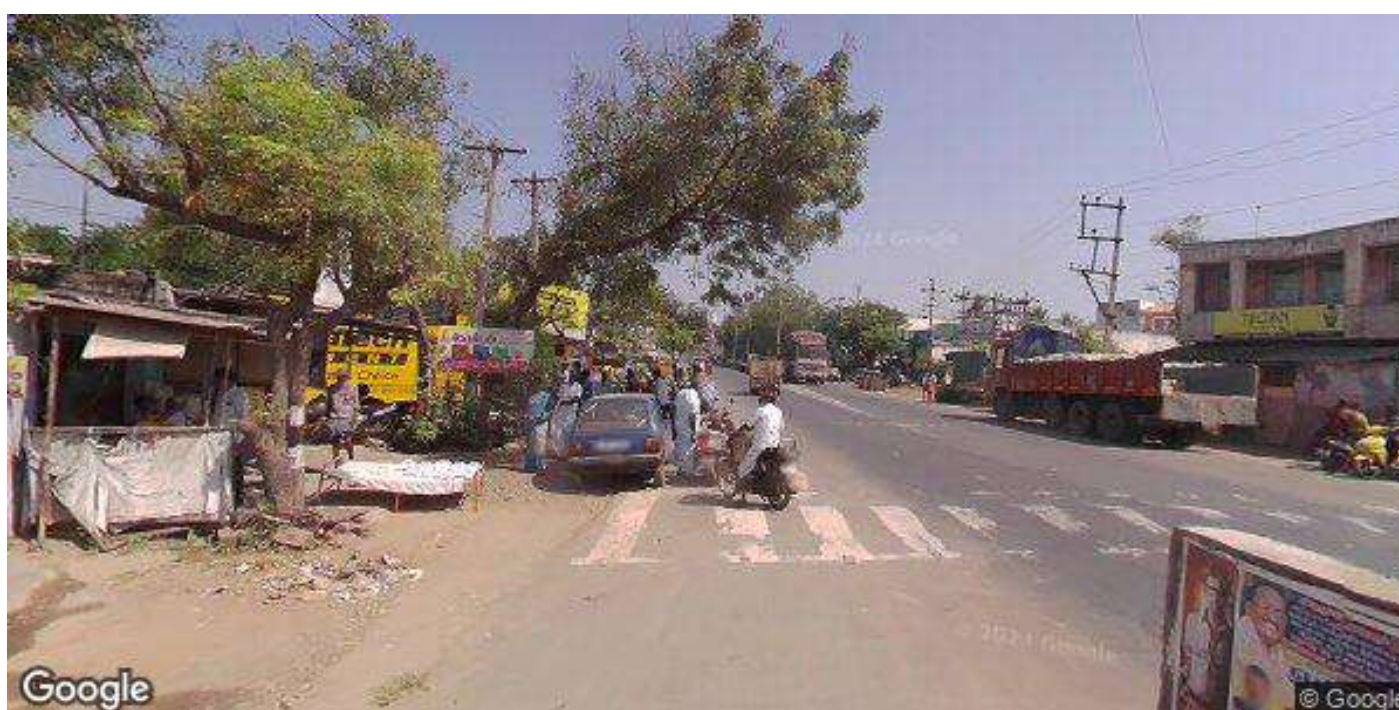
**Risk Type:** Turn  
**Risk Level:** Medium  
**Speed Limit:** 30 KM/Hr  
**Coordinates:** 11.63025, 78.12470

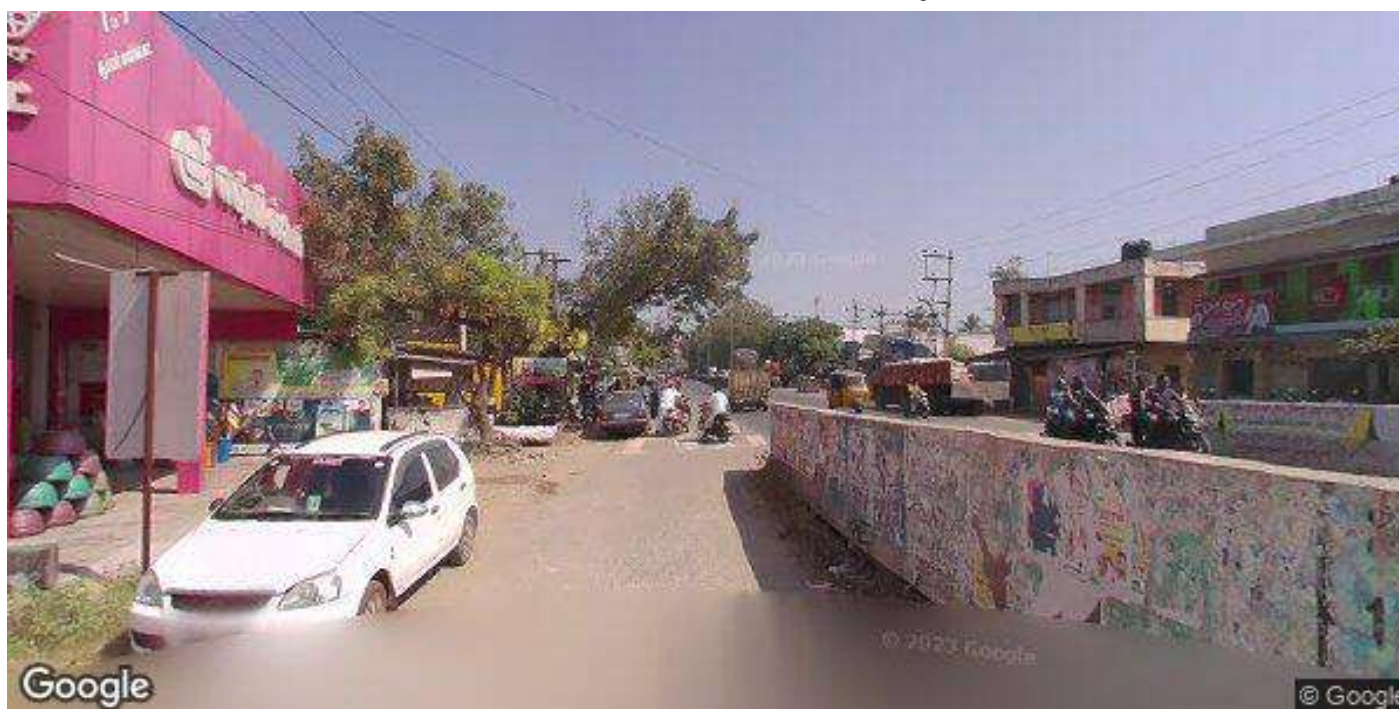
**Risk Type:** Blind Spot  
**Risk Level:** Blind Spot  
**Speed Limit:** 10 KM/Hr  
**Coordinates:** 11.63018, 78.12462

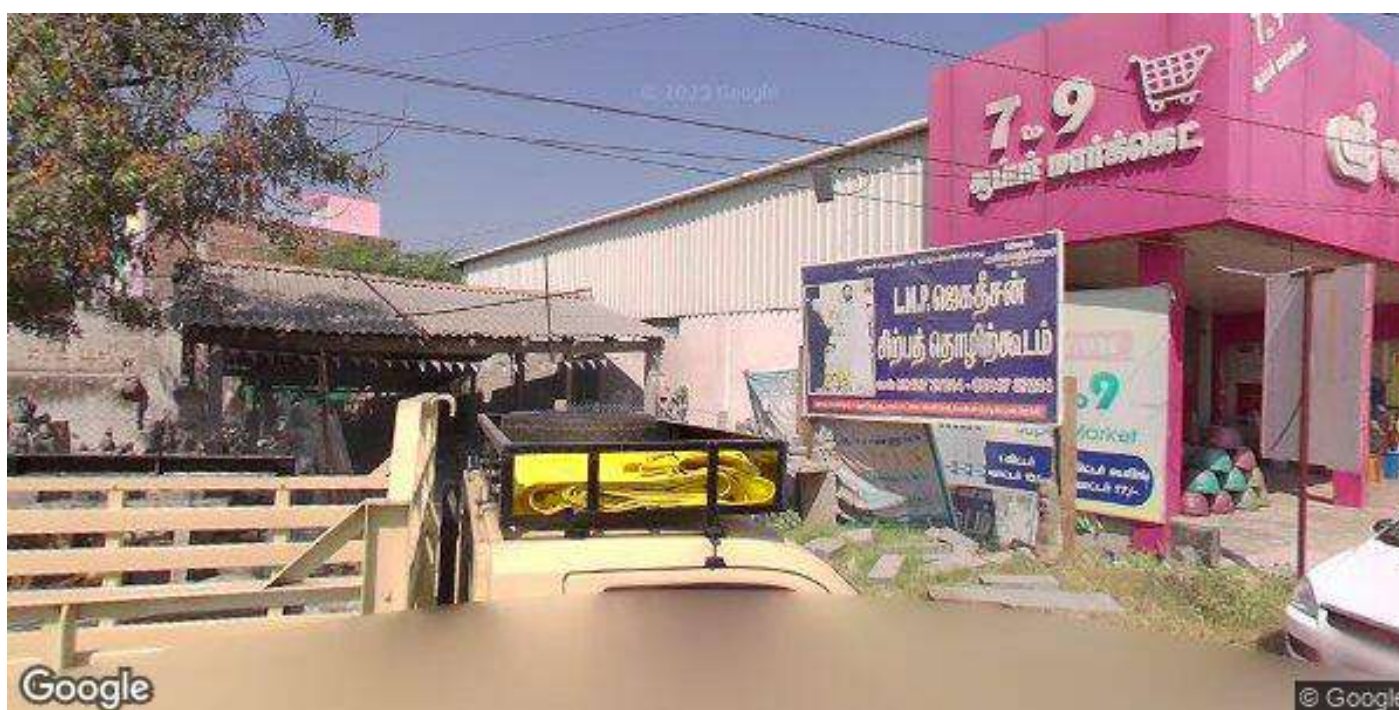
**Risk Type:** Blind Spot  
**Risk Level:** Blind Spot  
**Speed Limit:** 10 KM/Hr  
**Coordinates:** 11.63030, 78.12452

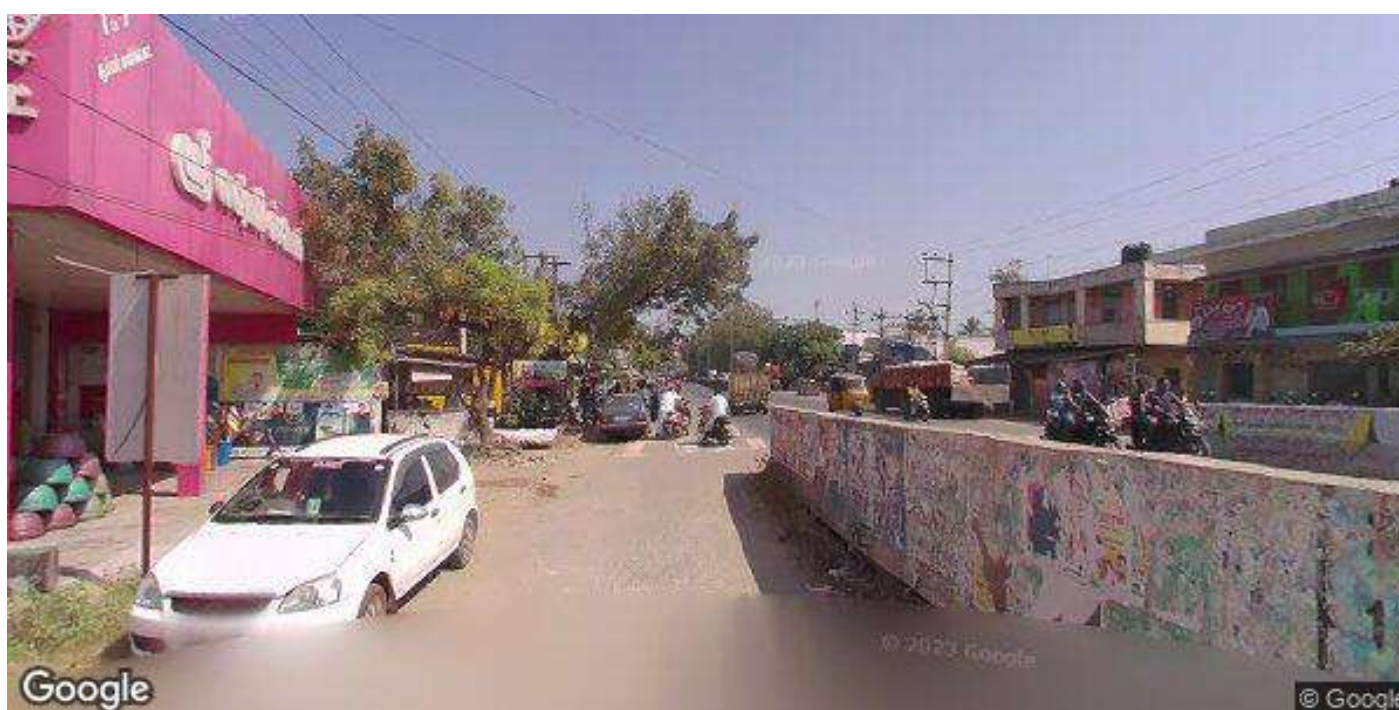
**Risk Type:** Blind Spot  
**Risk Level:** Blind Spot  
**Speed Limit:** 10 KM/Hr  
**Coordinates:** 11.63018, 78.12462

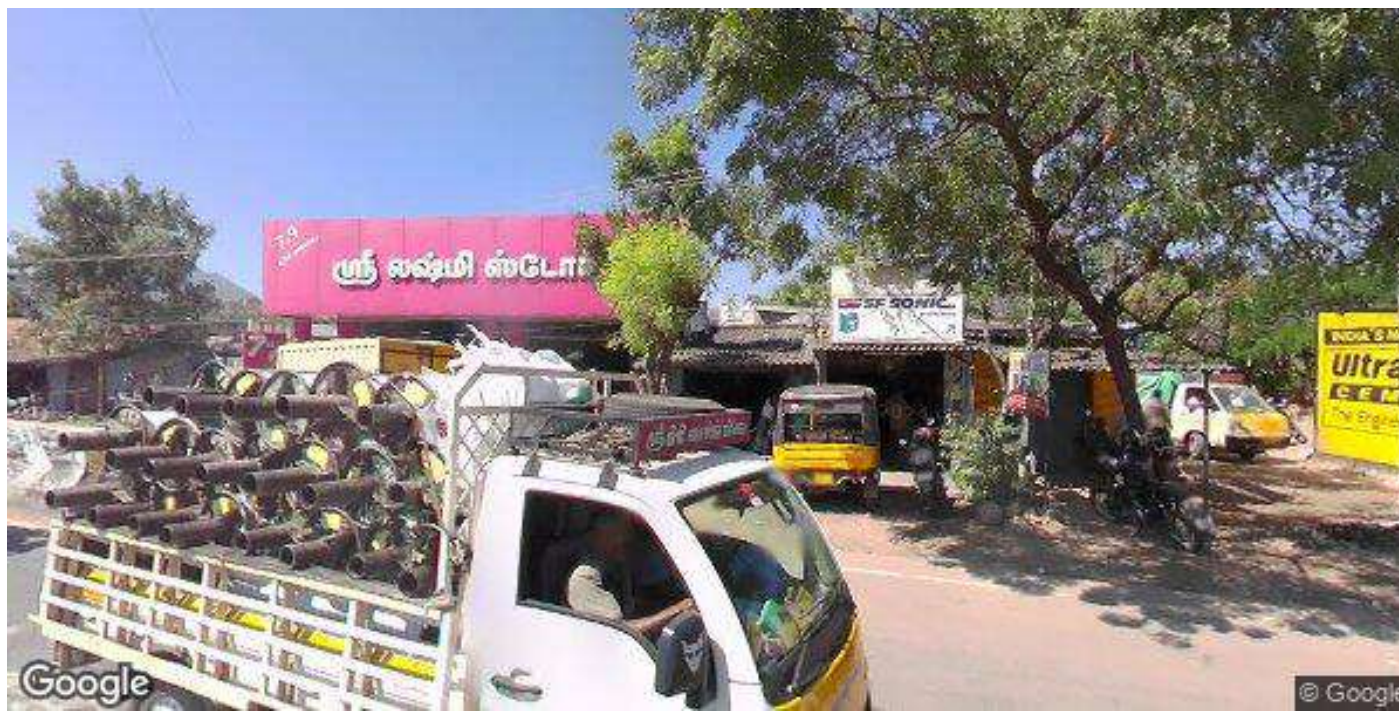
**Risk Type:** Turn  
**Risk Level:** High  
**Speed Limit:** 15 KM/Hr  
**Coordinates:** 11.63028, 78.12474

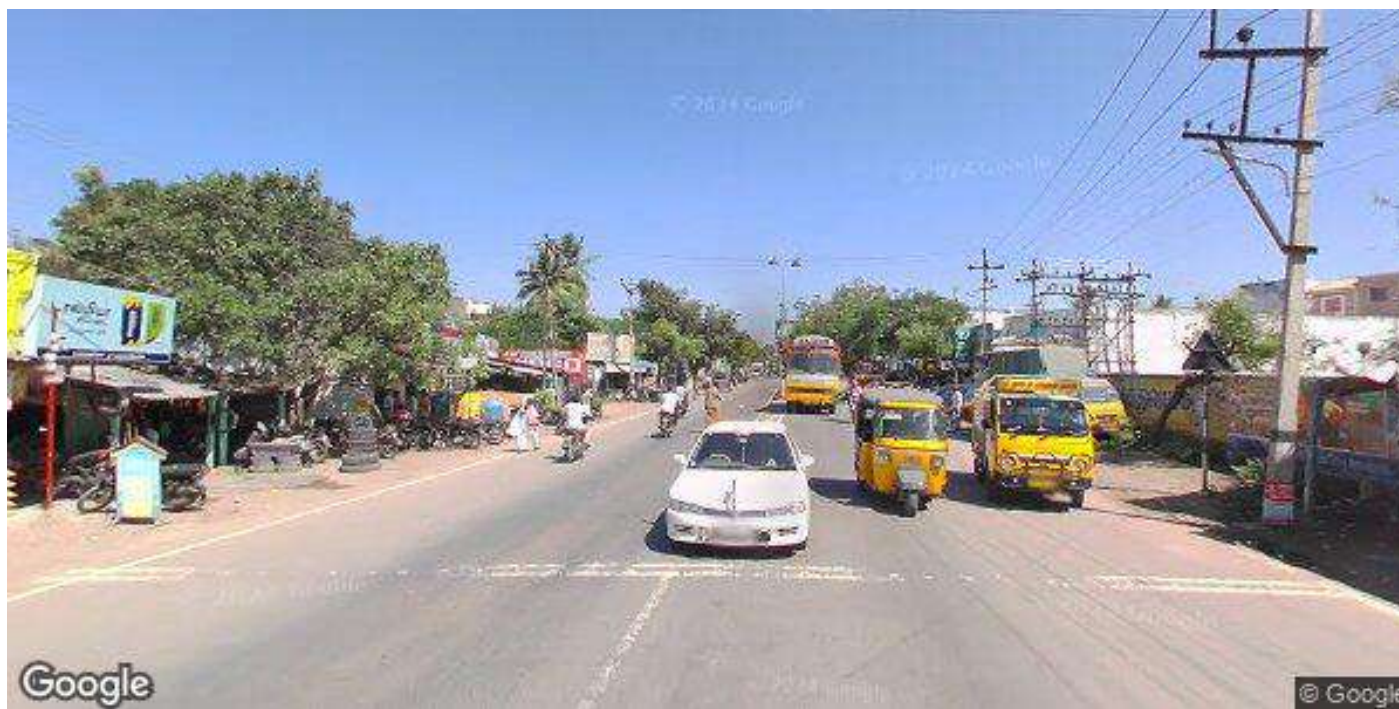
**Risk Type:** Turn  
**Risk Level:** High  
**Speed Limit:** 15 KM/Hr  
**Coordinates:** 11.63026, 78.12481

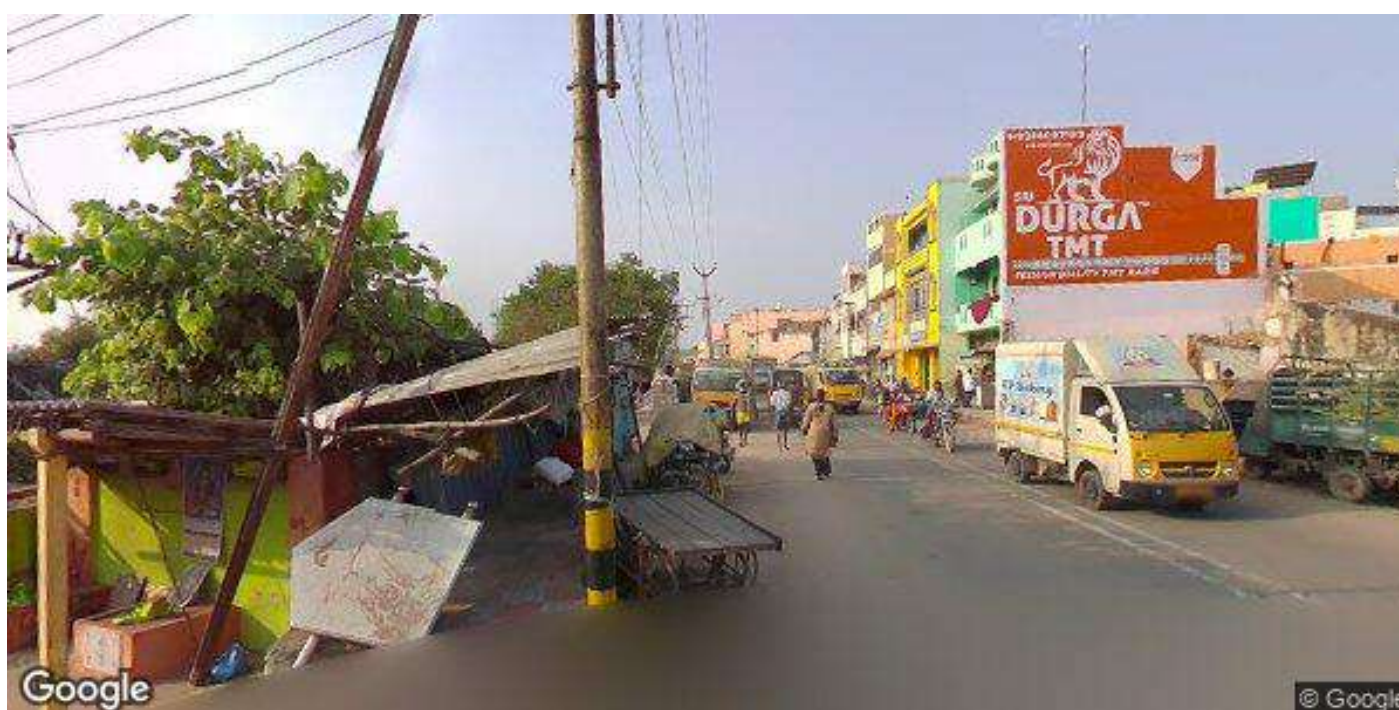
**Risk Type:** Turn  
**Risk Level:** Medium  
**Speed Limit:** 30 KM/Hr  
**Coordinates:** 11.64854, 78.14335

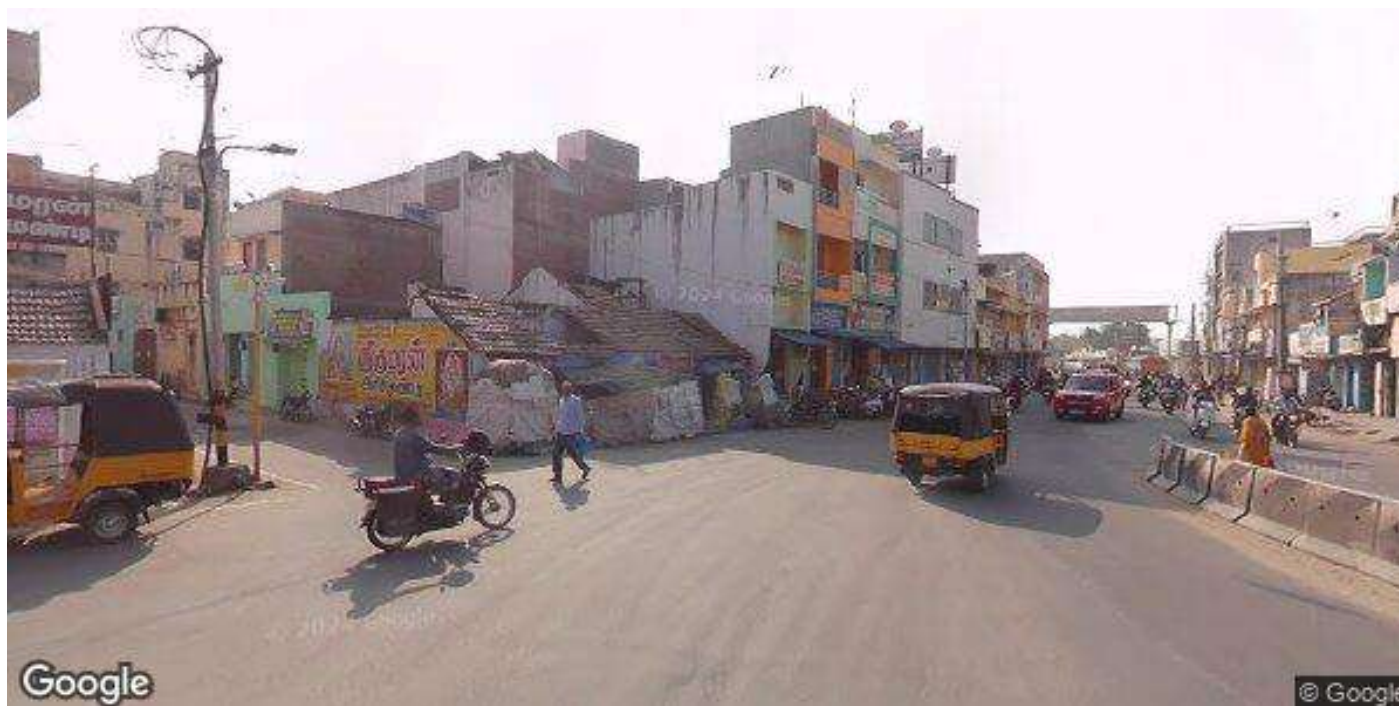
**Risk Type:** Turn  
**Risk Level:** Medium  
**Speed Limit:** 30 KM/Hr  
**Coordinates:** 11.65152, 78.14229
