# IndianOil

## JOURNEY RISK MANAGEMENT (JRM) STUDY

### Salem Terminal to AMMAN ENTERPRISE

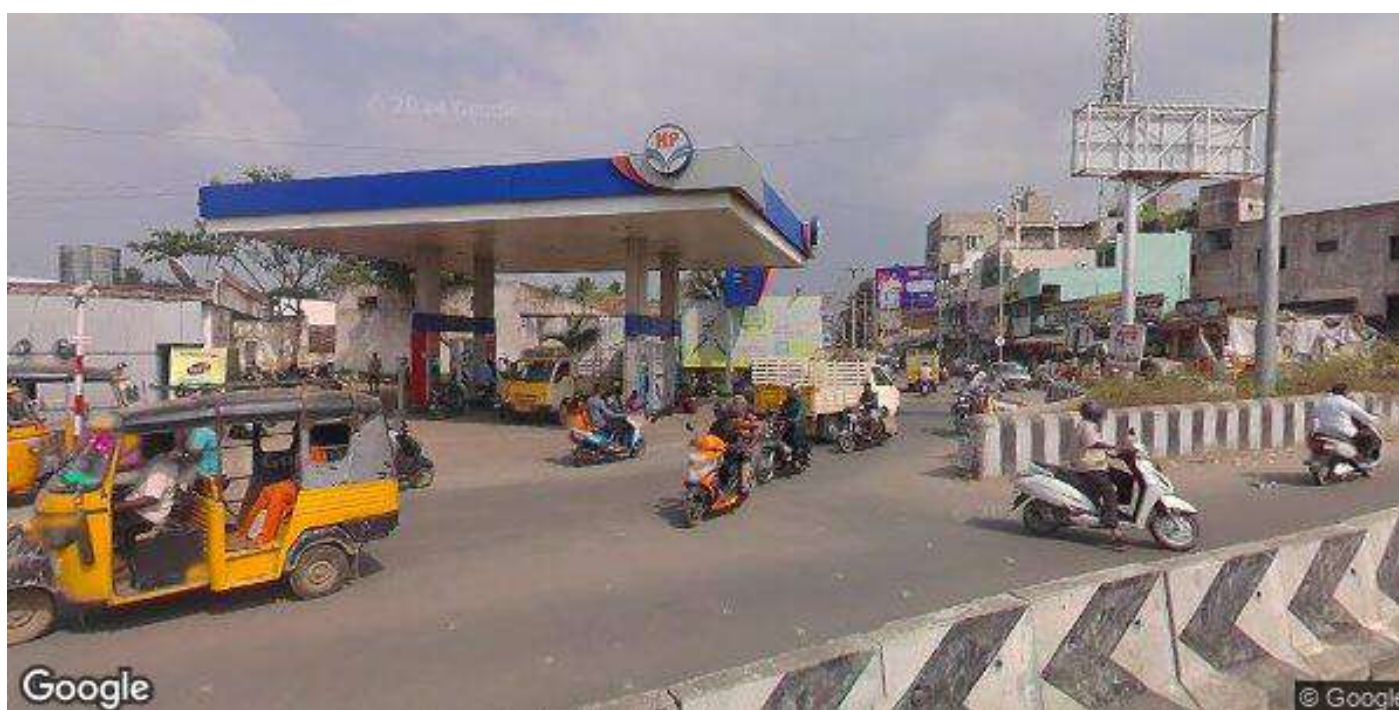
**Risk Type:** Blind Spot  
**Risk Level:** Blind Spot  
**Speed Limit:** 10 KM/Hr  
**Coordinates:** 11.65573, 78.13972

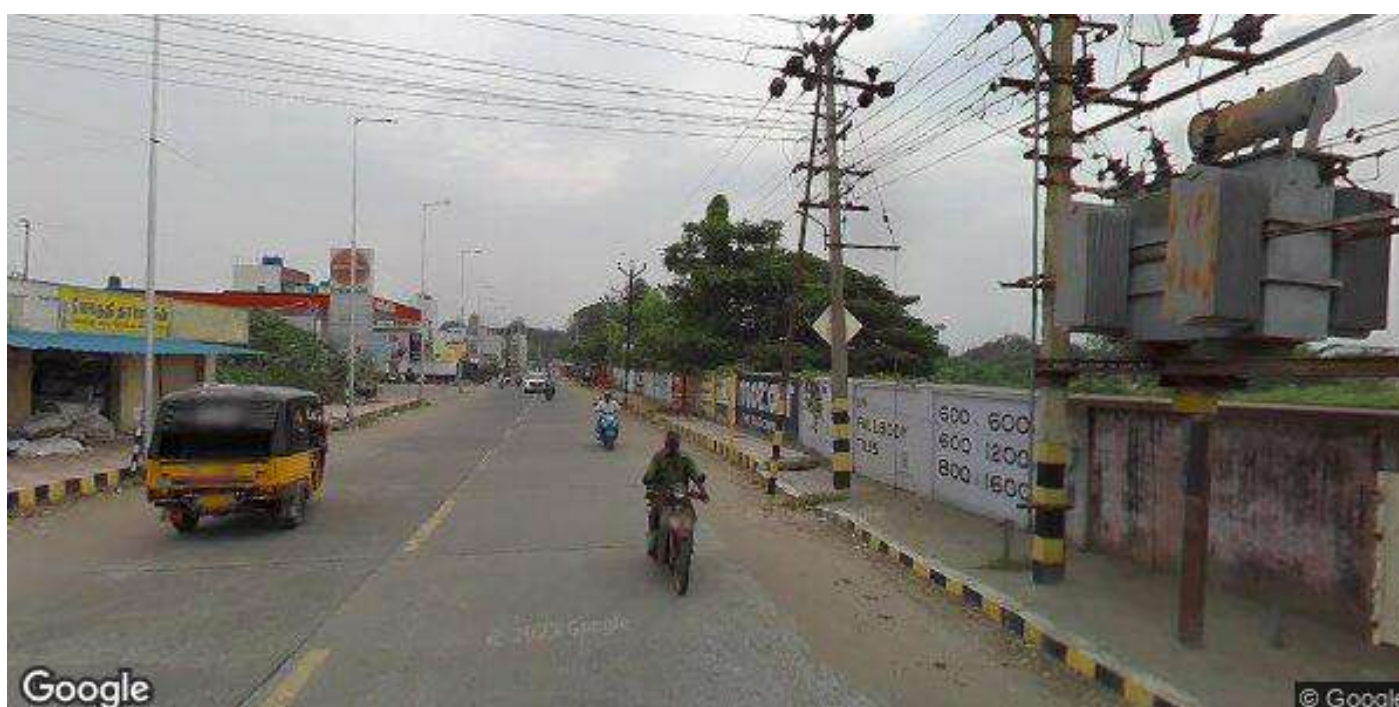
**Risk Type:** Turn  
**Risk Level:** High  
**Speed Limit:** 15 KM/Hr  
**Coordinates:** 11.65623, 78.14218

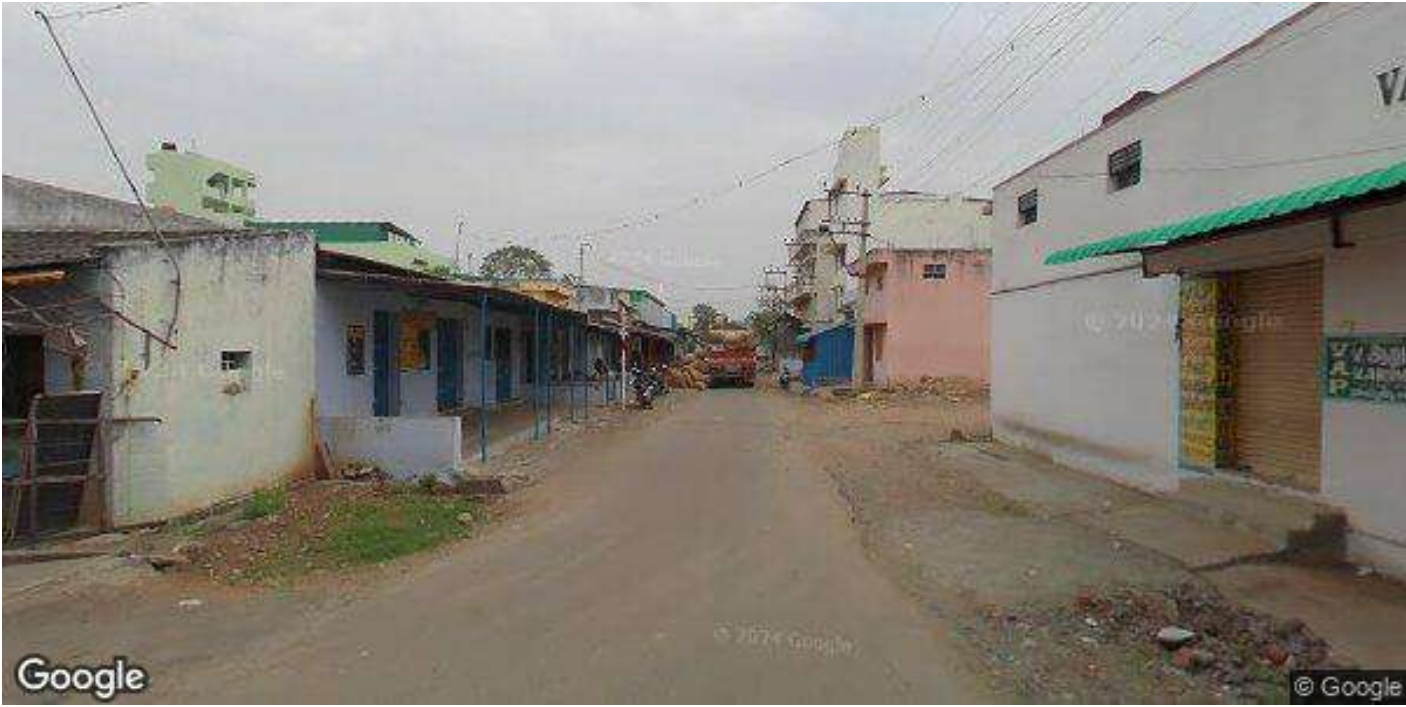
**Risk Type:** Turn  
**Risk Level:** High  
**Speed Limit:** 15 KM/Hr  
**Coordinates:** 11.65658, 78.14217
