# IndianOil

## JOURNEY RISK MANAGEMENT (JRM) STUDY

### Salem Terminal to SRI THAYARS AGENCY

### Route Safety Analysis: Sangagiri to Pungambadi West

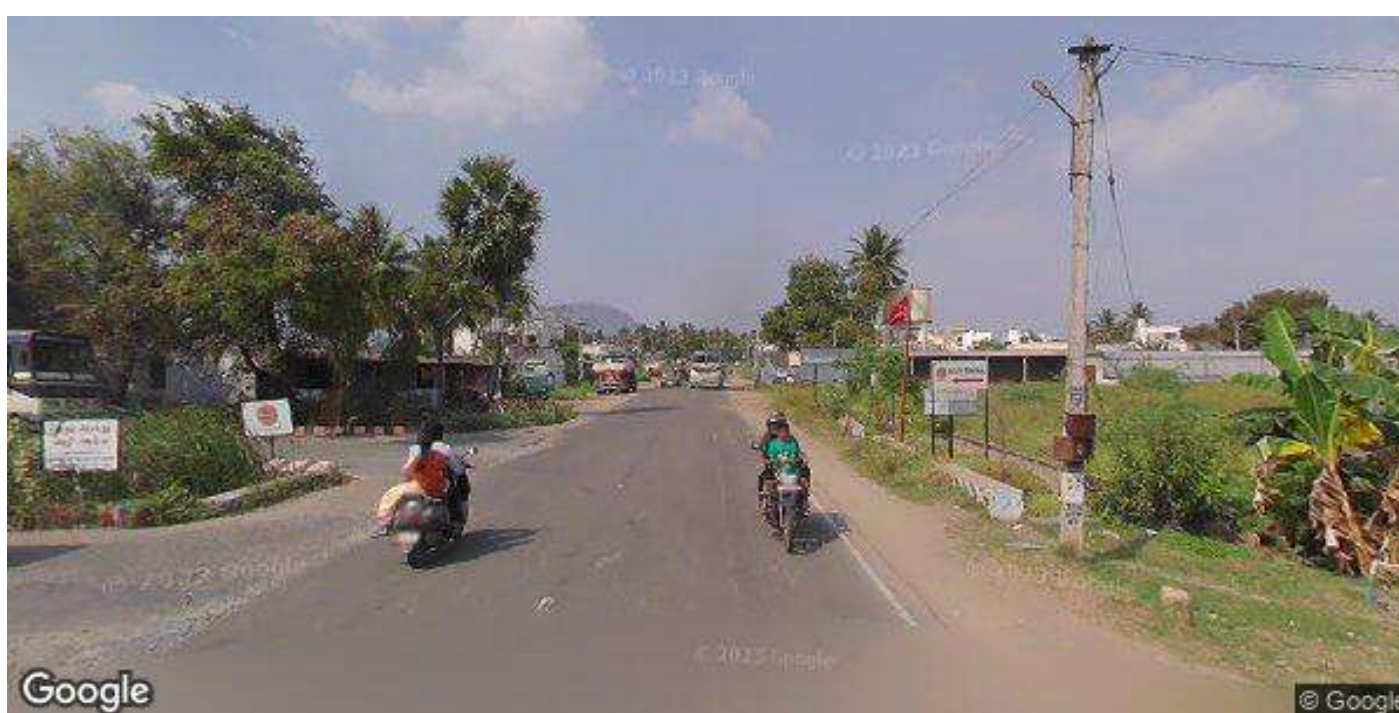
**Risk Type:** Turn  
**Risk Level:** High  
**Speed Limit:** 15 KM/Hr  
**Coordinates:** 11.44019, 77.87547

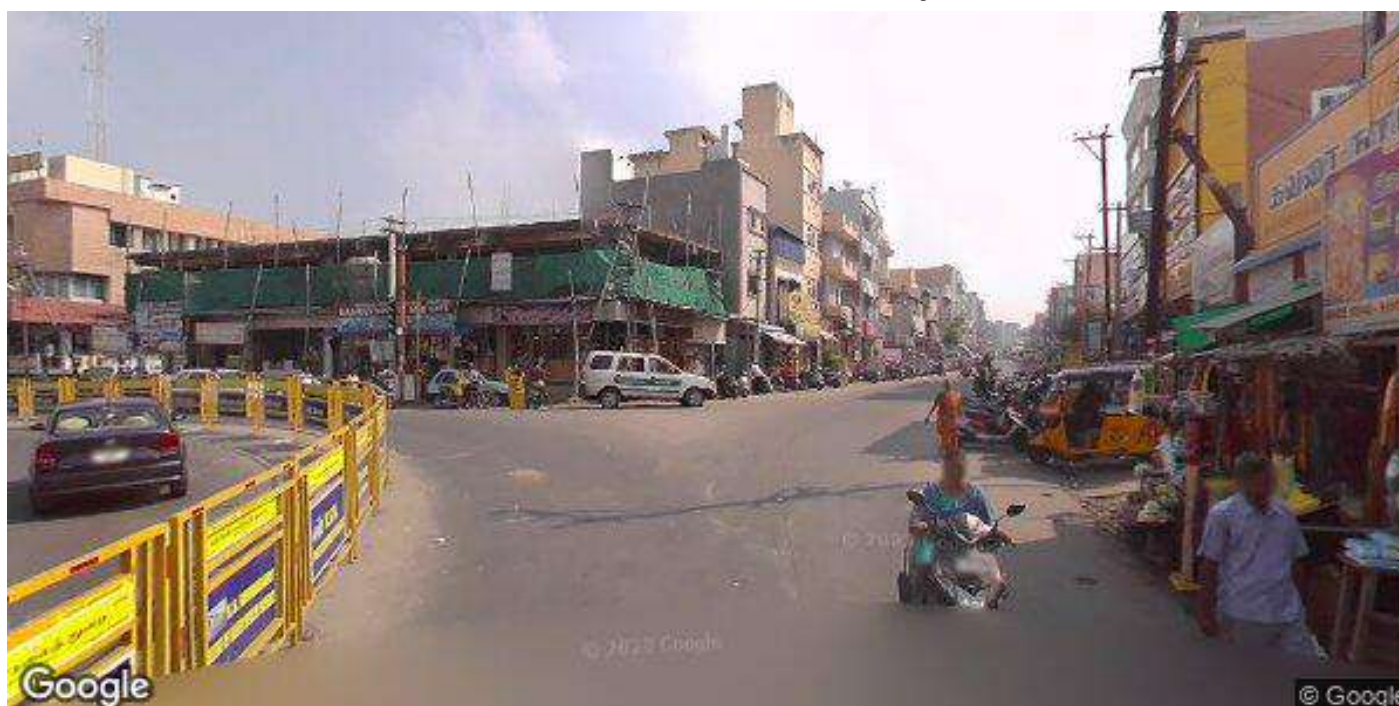
**Risk Type:** Turn  
**Risk Level:** High  
**Speed Limit:** 15 KM/Hr  
**Coordinates:** 11.37862, 77.89488

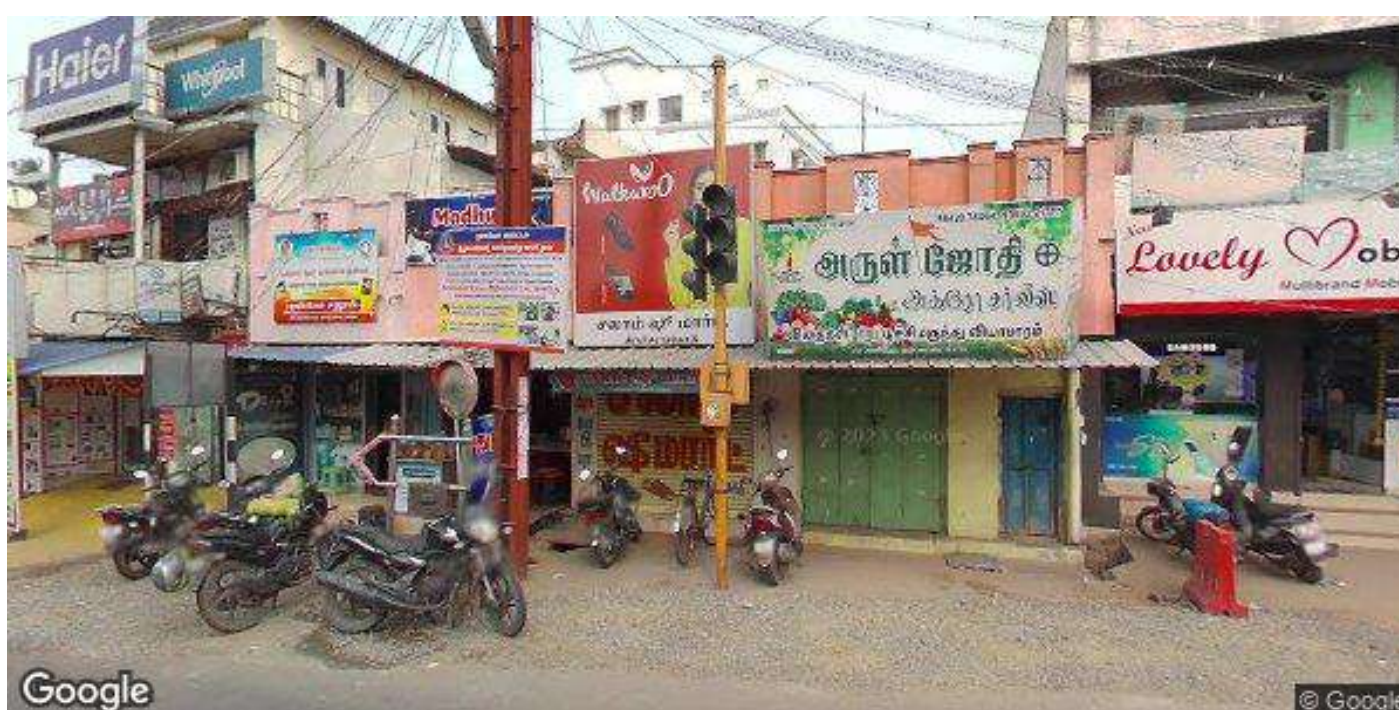
**Risk Type:** Turn  
**Risk Level:** High  
**Speed Limit:** 15 KM/Hr  
**Coordinates:** 11.37850, 77.89453

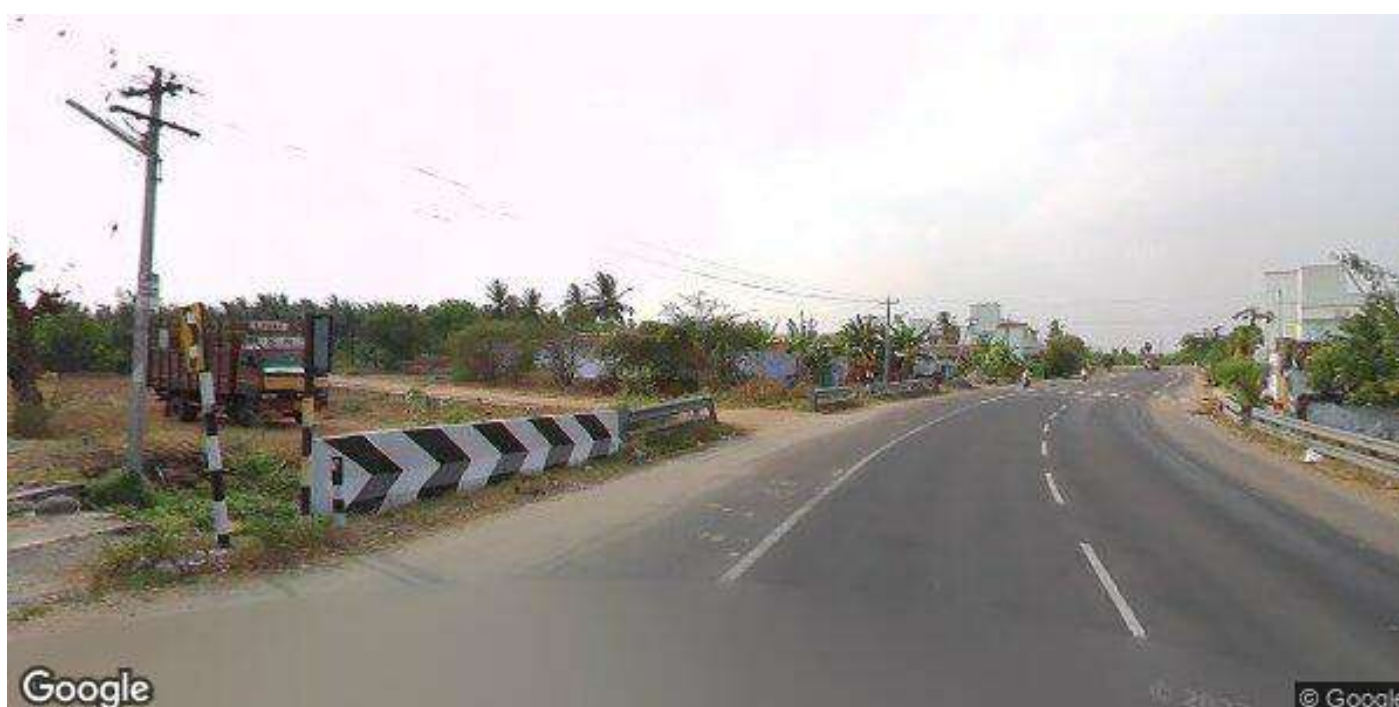
**Risk Type:** Turn  
**Risk Level:** Medium  
**Speed Limit:** 30 KM/Hr  
**Coordinates:** 11.16755, 78.01568

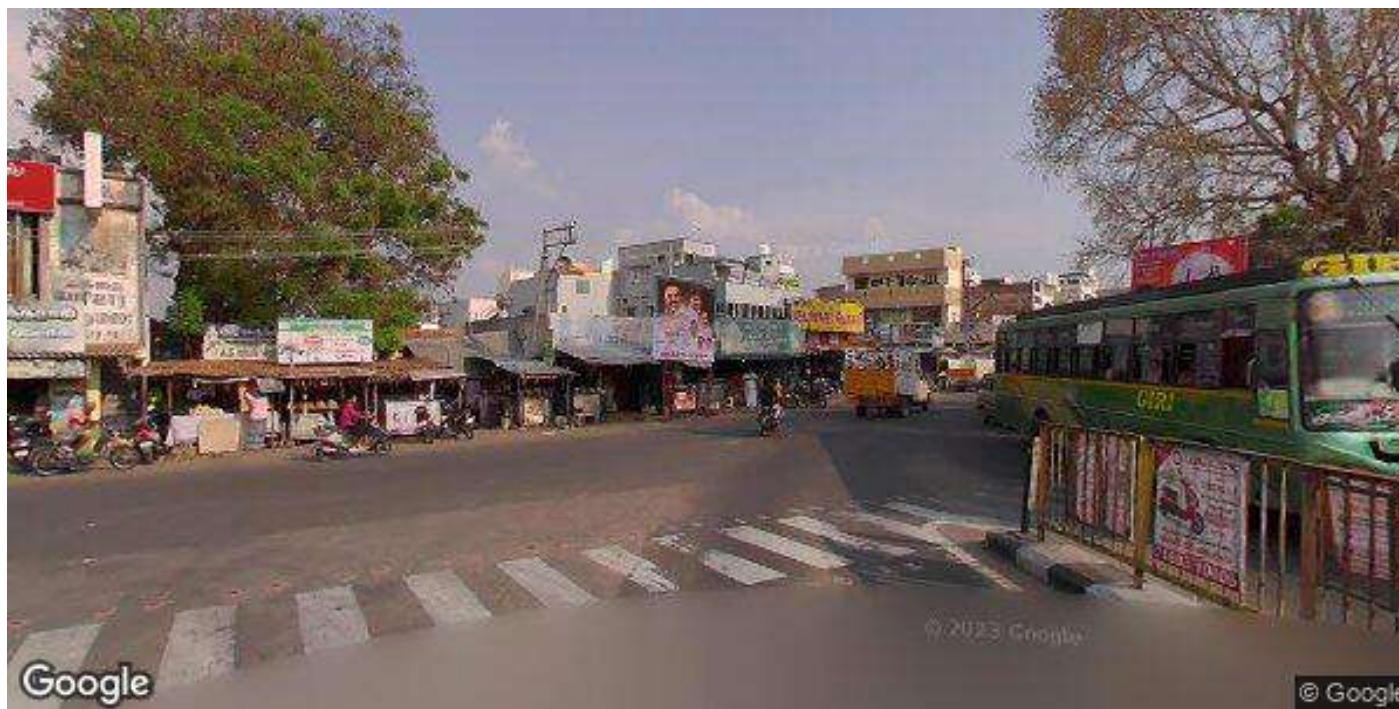
**Risk Type:** Turn  
**Risk Level:** Medium  
**Speed Limit:** 30 KM/Hr  
**Coordinates:** 11.15579, 78.02169

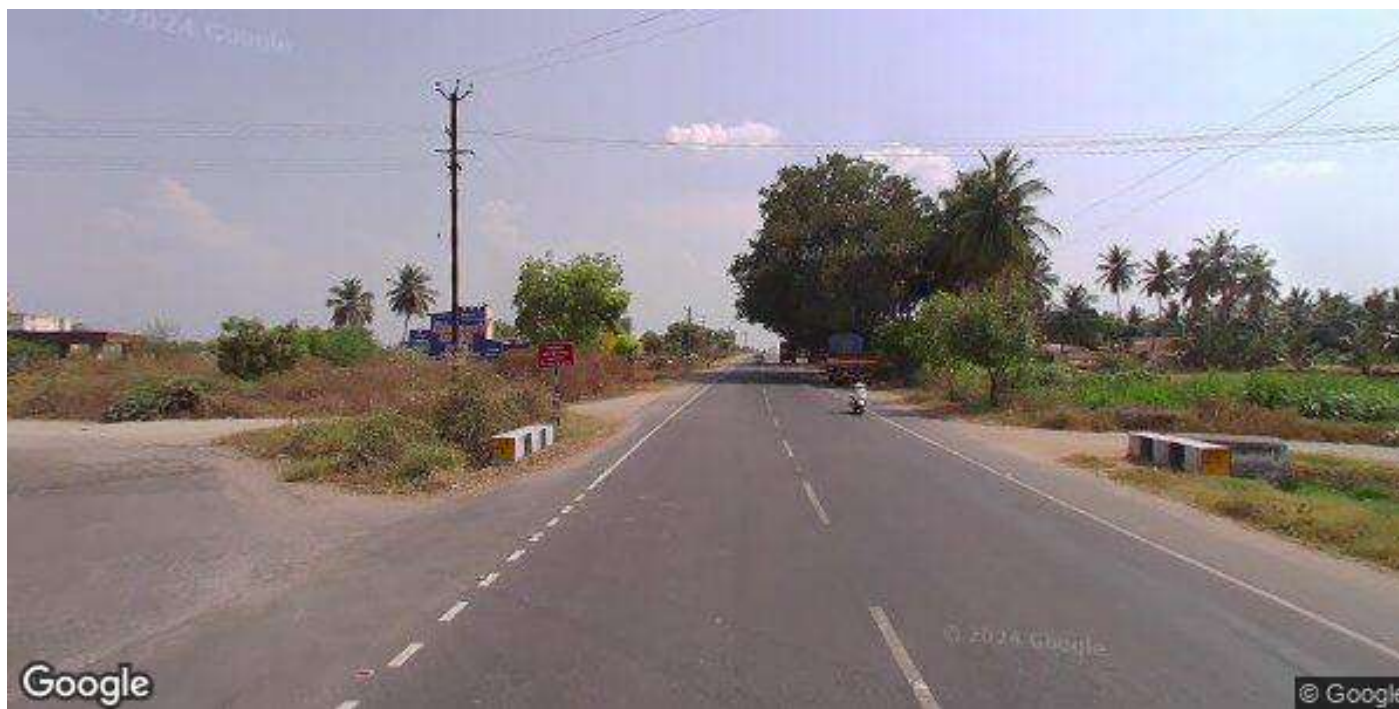
**Risk Type:** Turn  
**Risk Level:** High  
**Speed Limit:** 15 KM/Hr  
**Coordinates:** 11.14545, 78.02208

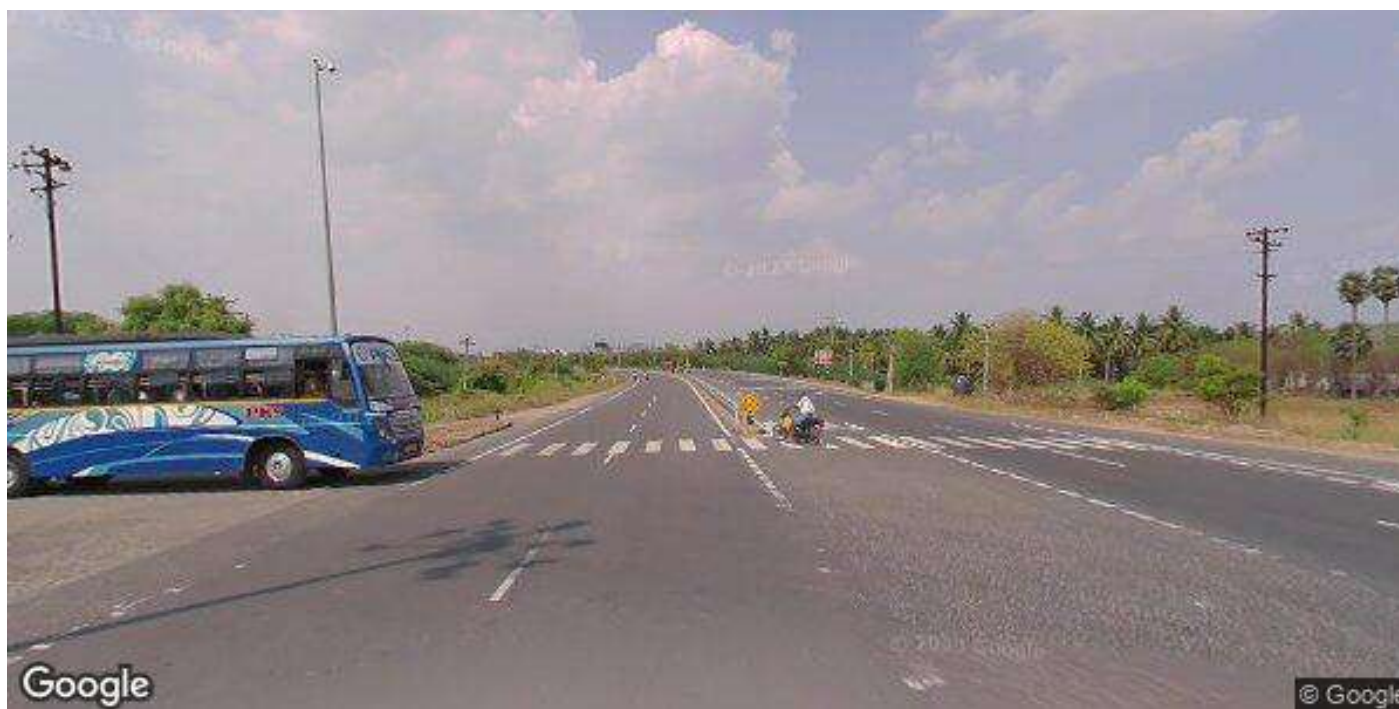
**Risk Type:** Turn  
**Risk Level:** High  
**Speed Limit:** 15 KM/Hr  
**Coordinates:** 11.14485, 78.02282

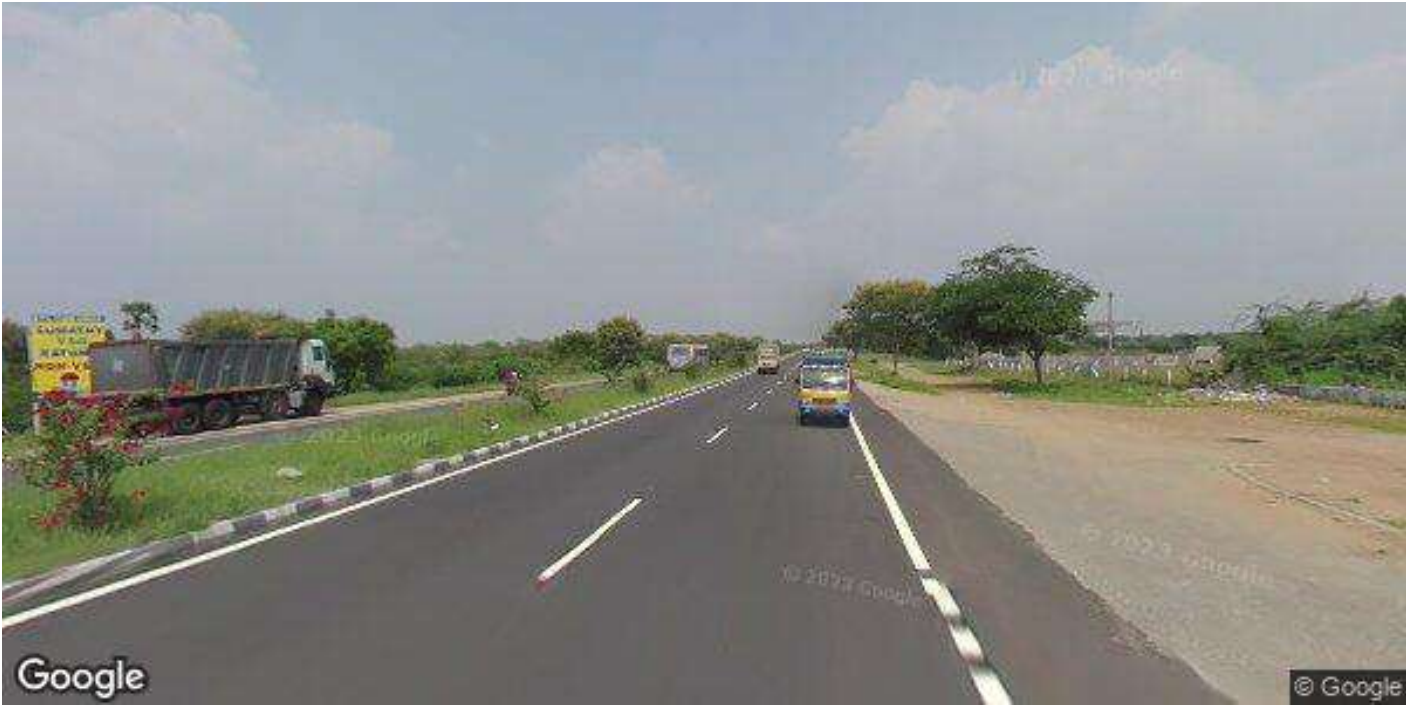
**Risk Type:** Turn  
**Risk Level:** High  
**Speed Limit:** 15 KM/Hr  
**Coordinates:** 10.80699, 77.93429

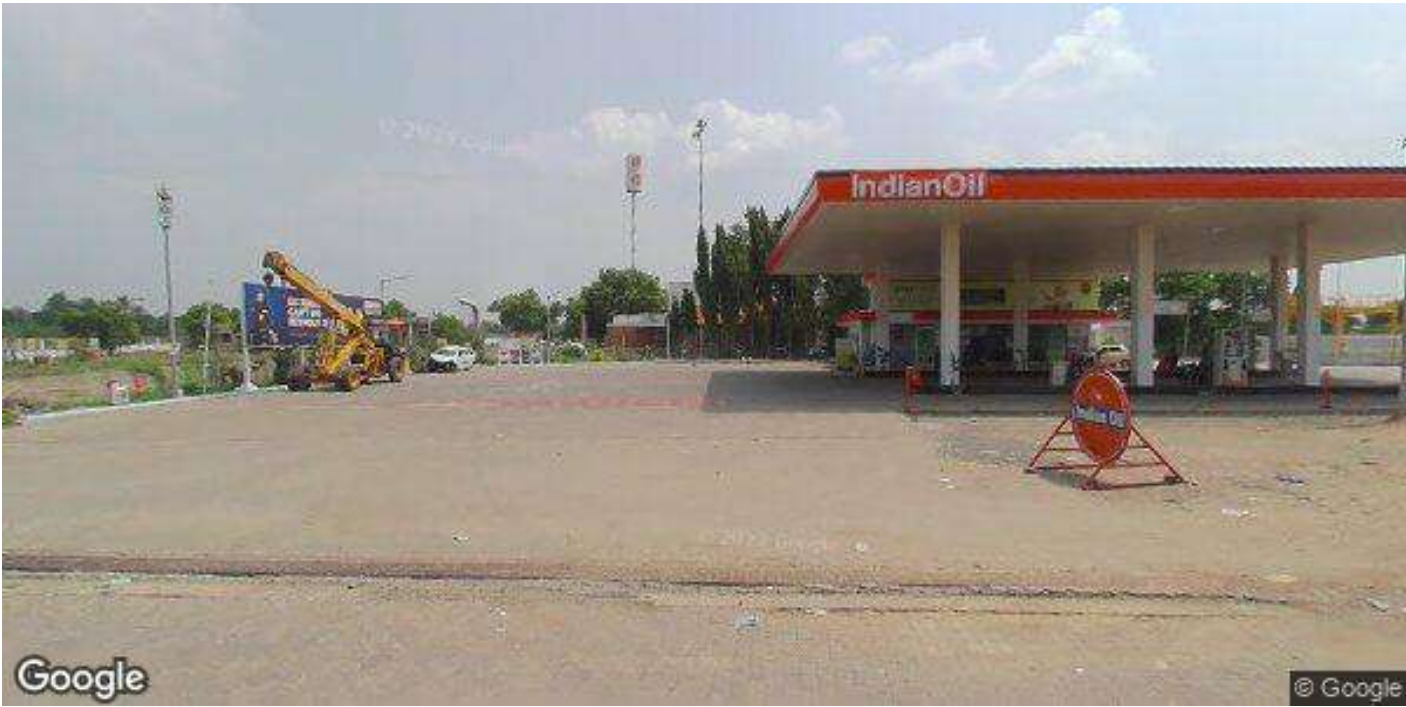
**Risk Type:** Turn  
**Risk Level:** High  
**Speed Limit:** 15 KM/Hr  
**Coordinates:** 10.80676, 77.93437
