IndianOil

## JOURNEY RISK MANAGEMENT (JRM) STUDY

### Salem Terminal to PRASANNA CORPORATION

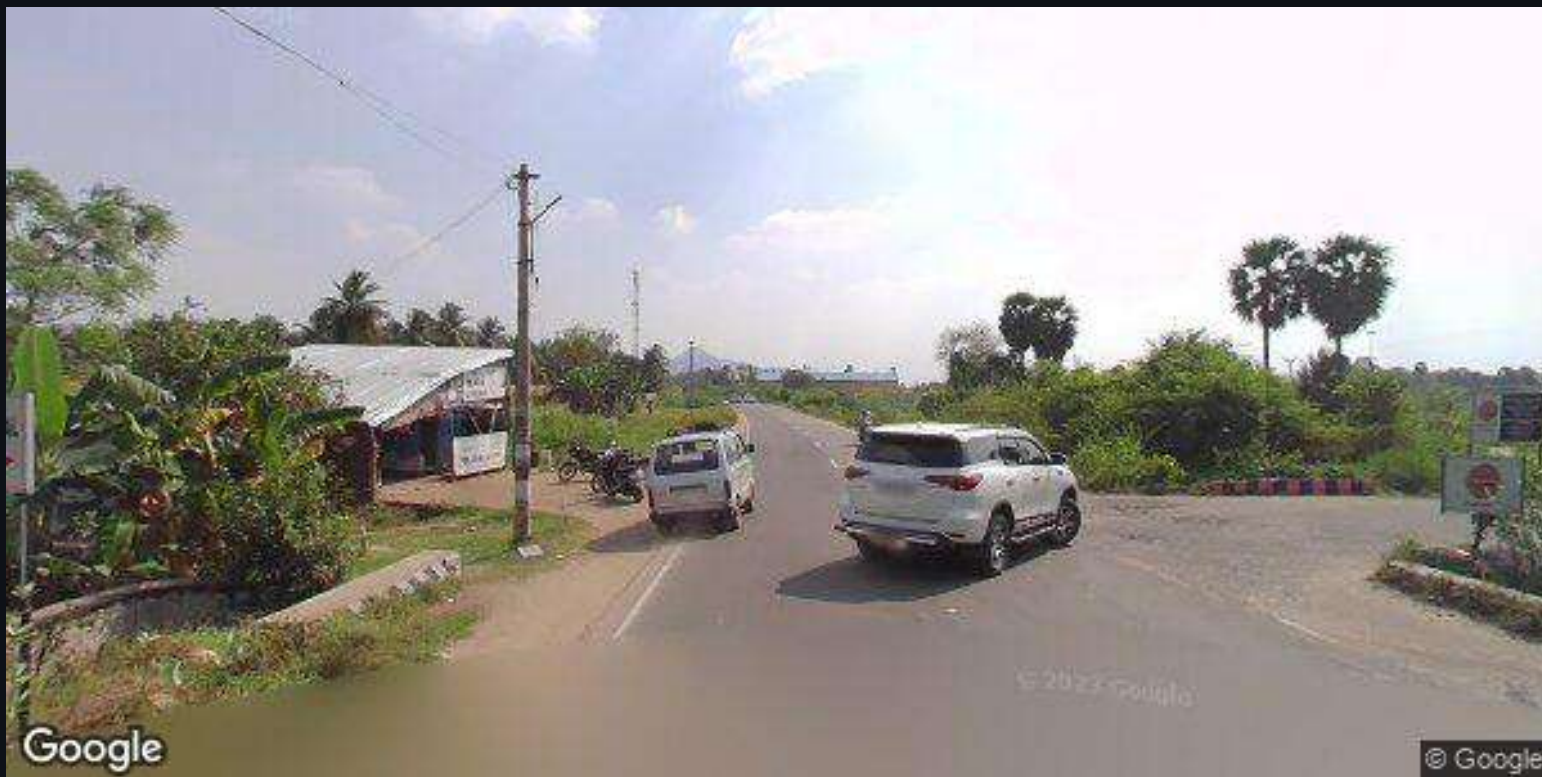
**Coordinates:** 11.44029, 77.87544

**Risk Type:** Turn

**Risk Level:** High

**Speed Limit:** 15 KM/Hr

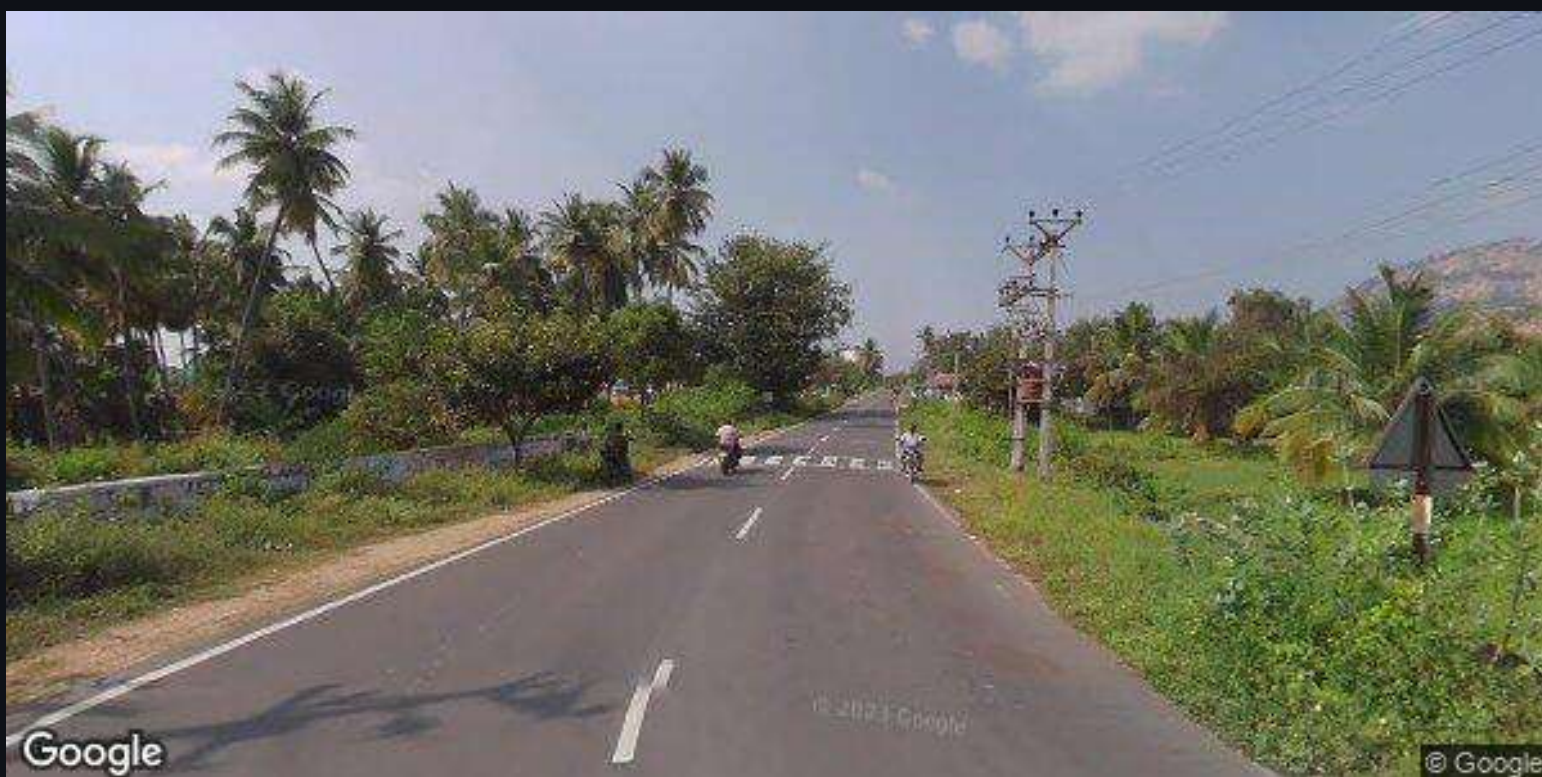
**Coordinates:** 11.45353, 77.85697

**Risk Type:** Turn

**Risk Level:** Medium

**Speed Limit:** 30 KM/Hr

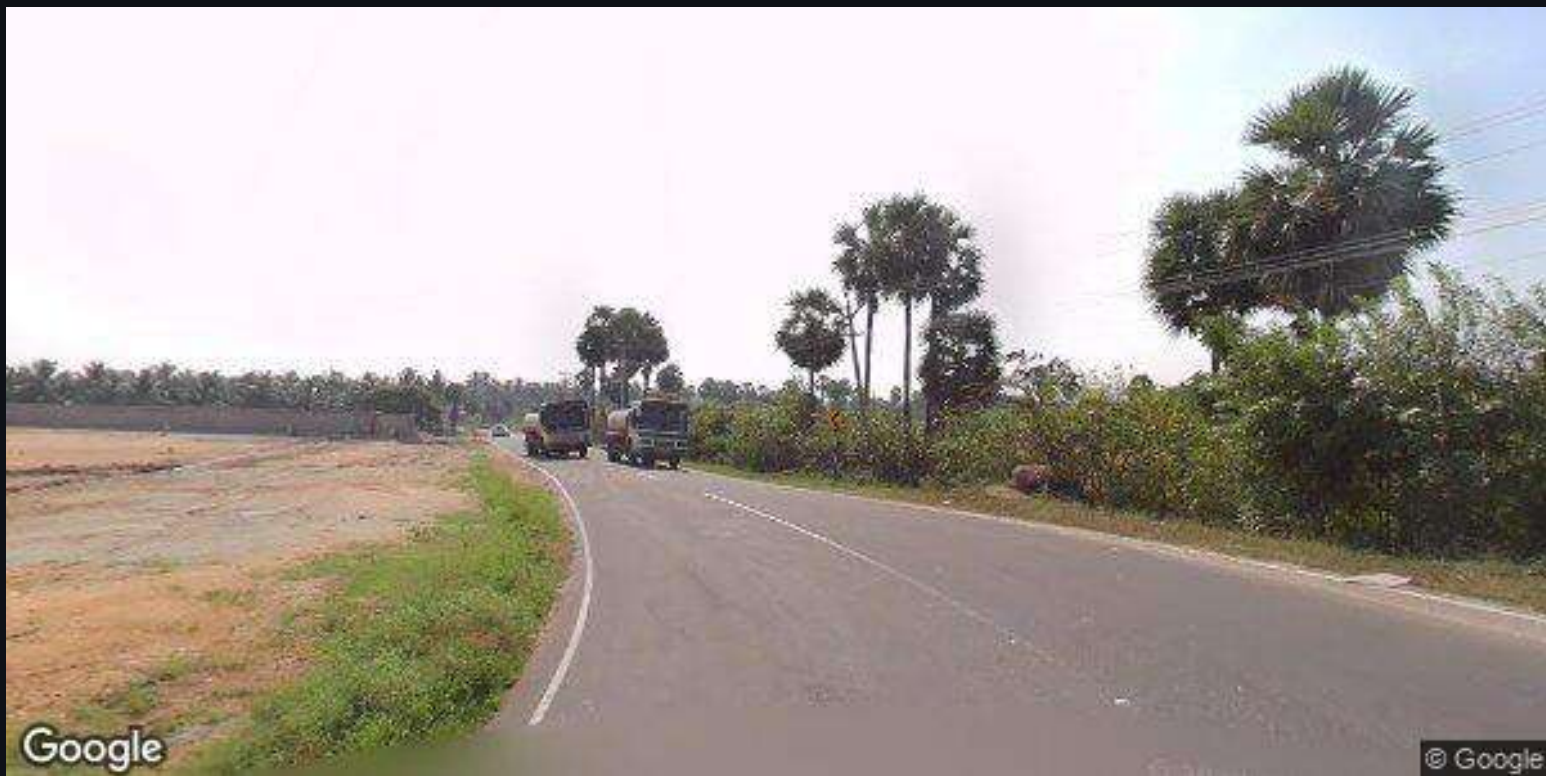
**Coordinates:** 11.45839, 77.85143

**Risk Type:** Turn

**Risk Level:** Medium

**Speed Limit:** 30 KM/Hr

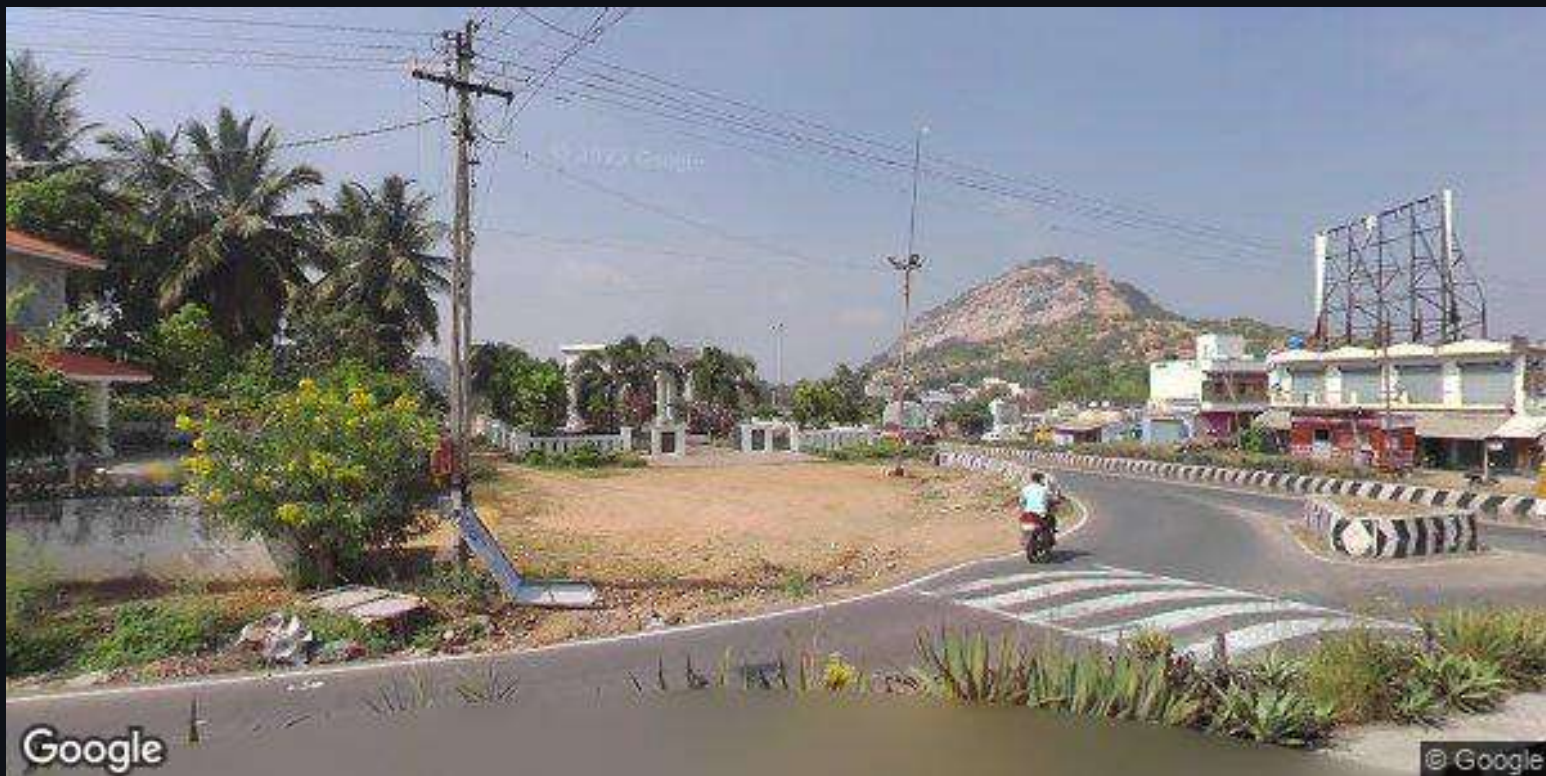
**Coordinates:** 11.46307, 77.84941

**Risk Type:** Turn

**Risk Level:** Medium

**Speed Limit:** 30 KM/Hr

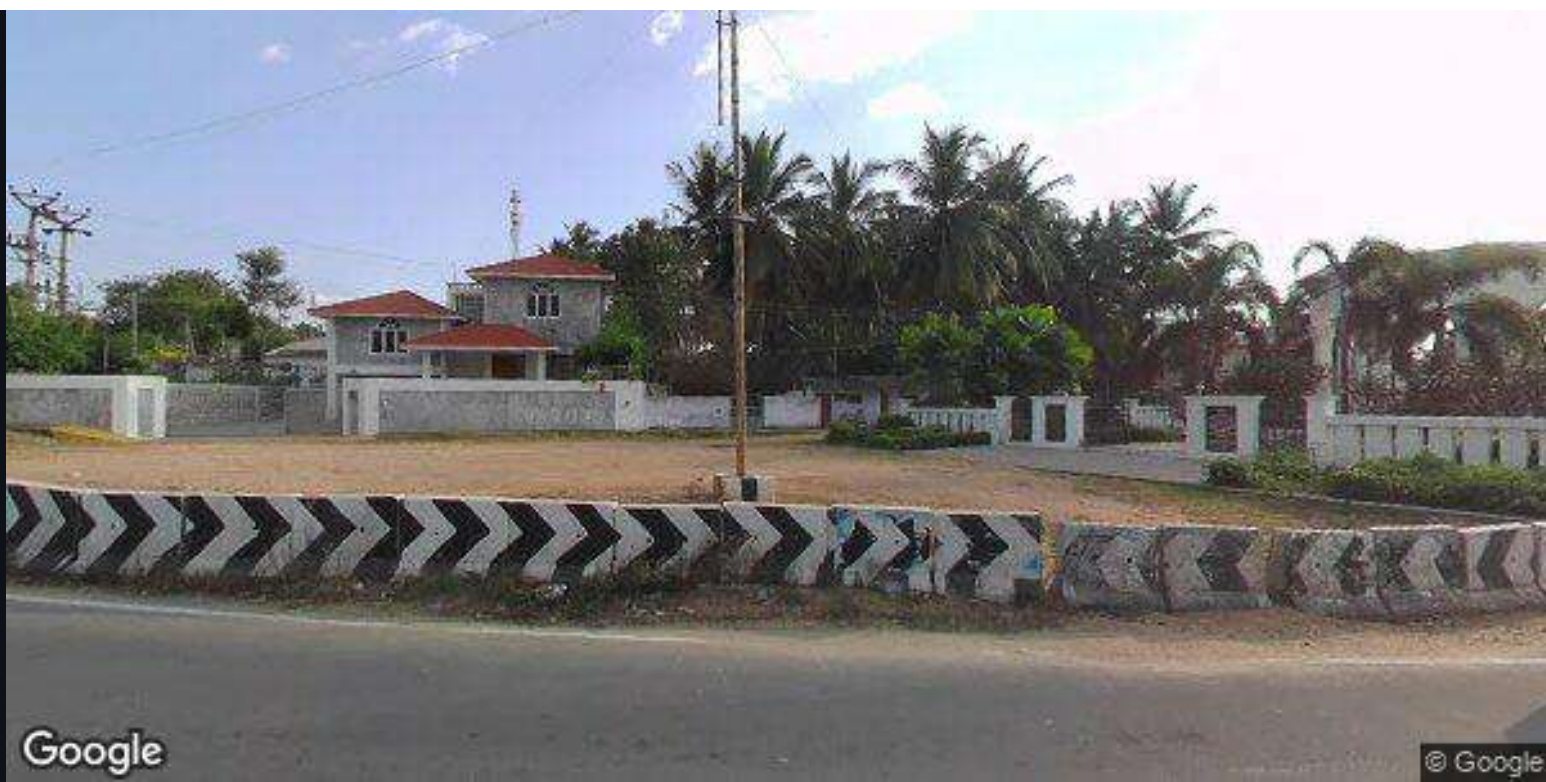
**Coordinates:** 11.46316, 77.84921

**Risk Type:** Turn

**Risk Level:** Medium

**Speed Limit:** 30 KM/Hr

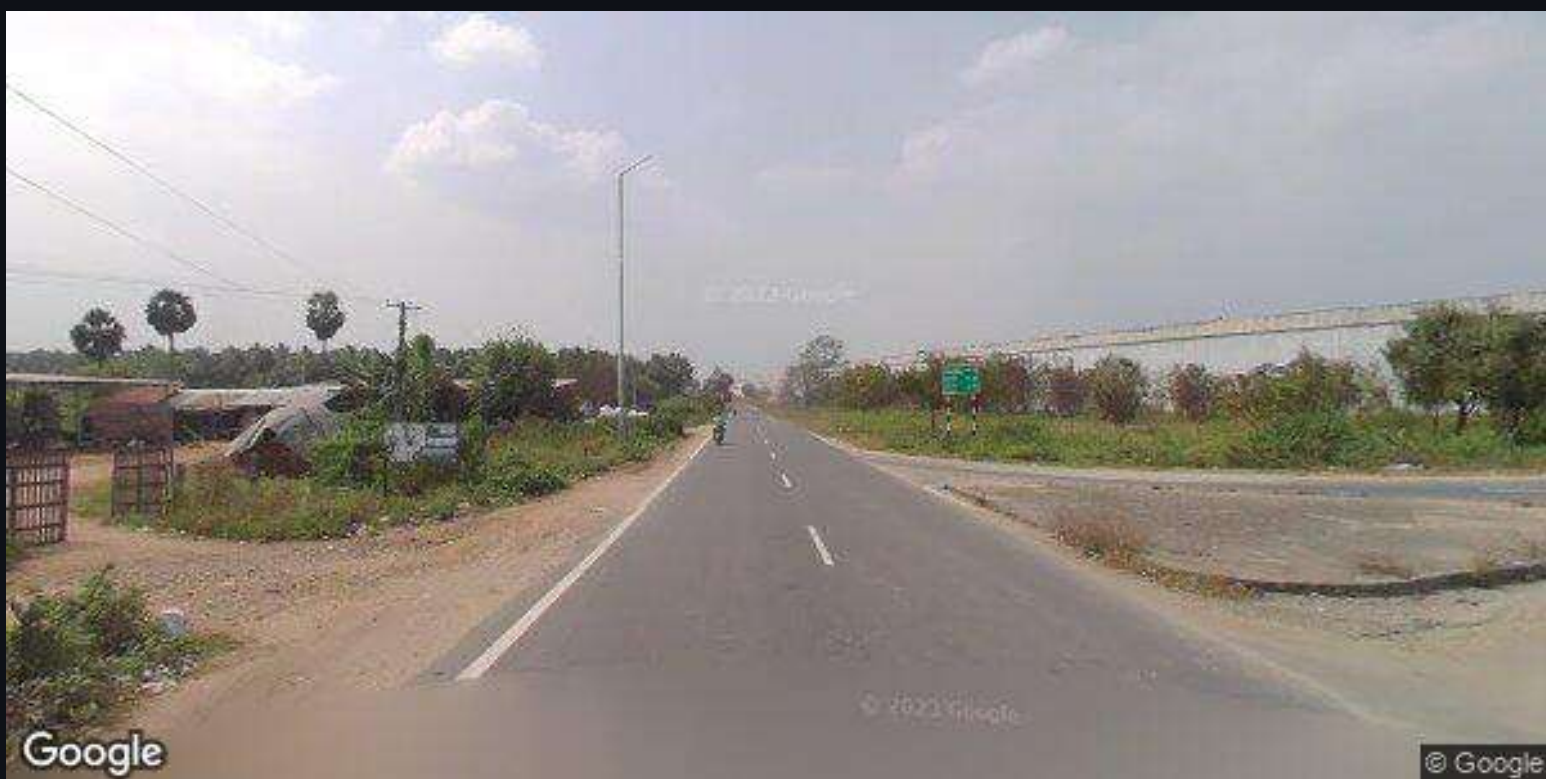
**Coordinates:** 11.45542, 77.81725

**Risk Type:** Turn

**Risk Level:** High

**Speed Limit:** 15 KM/Hr

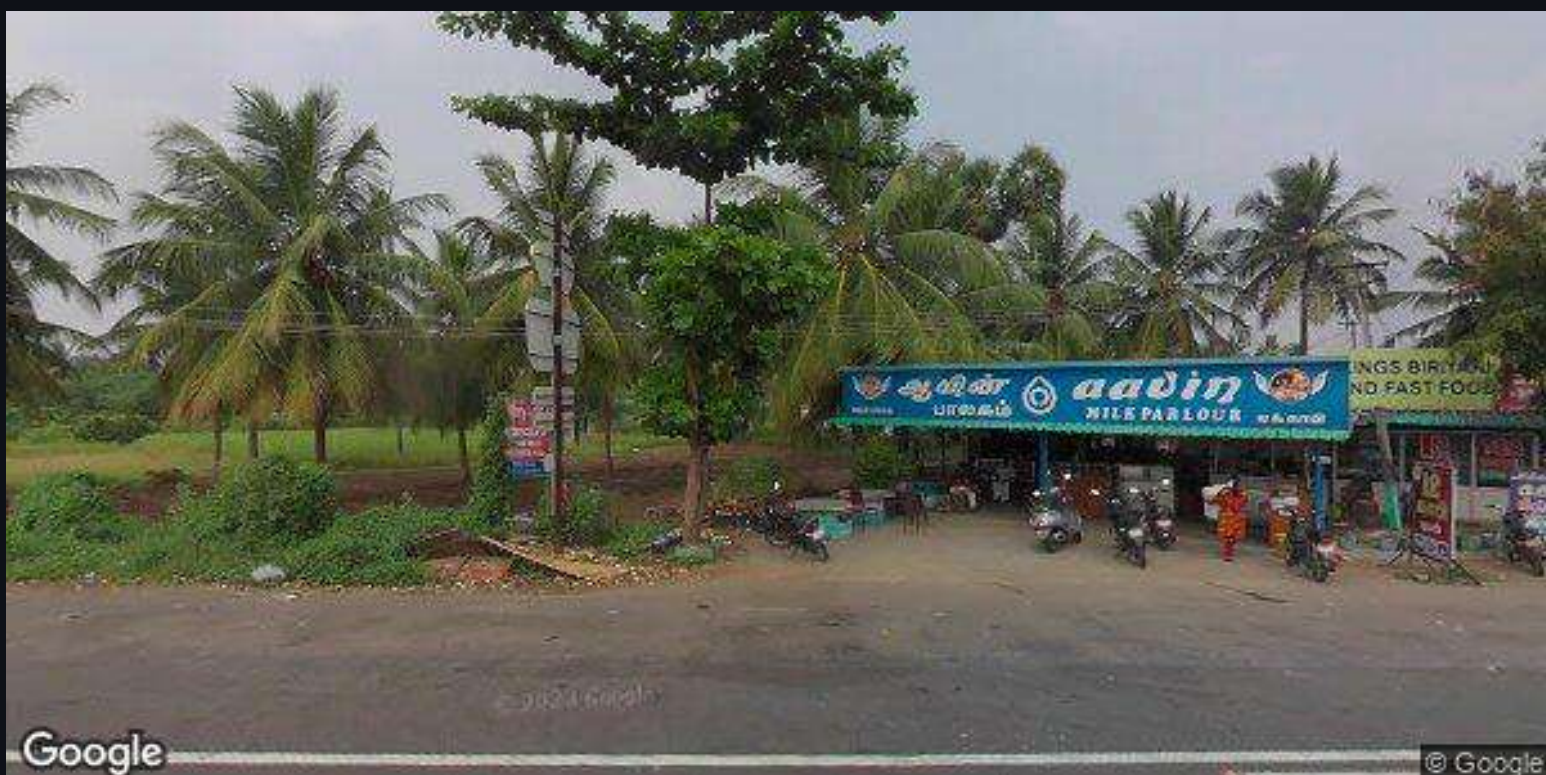
**Risk Type:** Blind Spot  
**Risk Level:** Blind Spot  
**Speed Limit:** 10 KM/Hr  
**Coordinates:** 11.45631, 77.81668

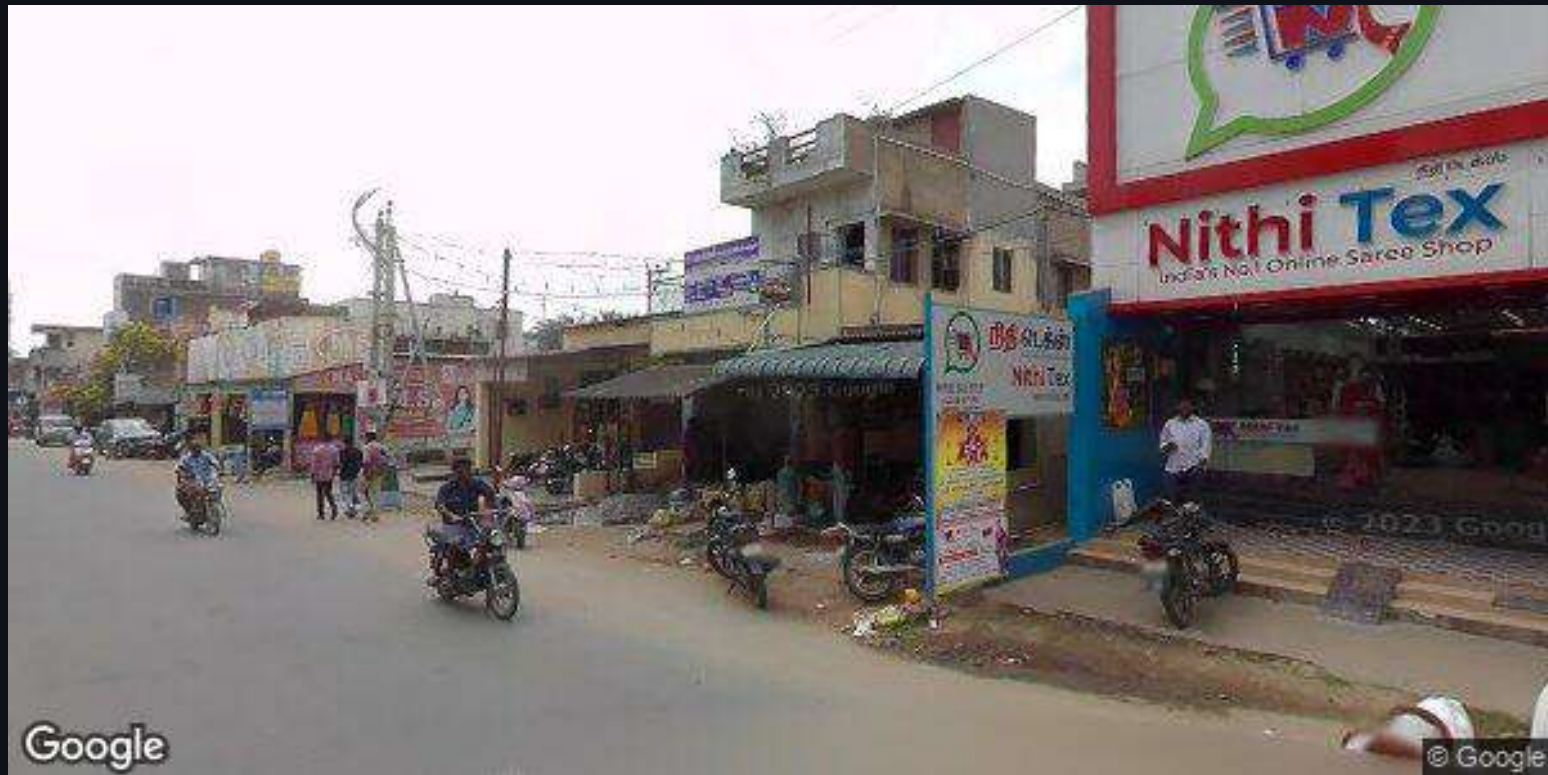
**Risk Type:** Turn  
**Risk Level:** Medium  
**Speed Limit:** 30 KM/Hr  
**Coordinates:** 11.60526, 78.00451

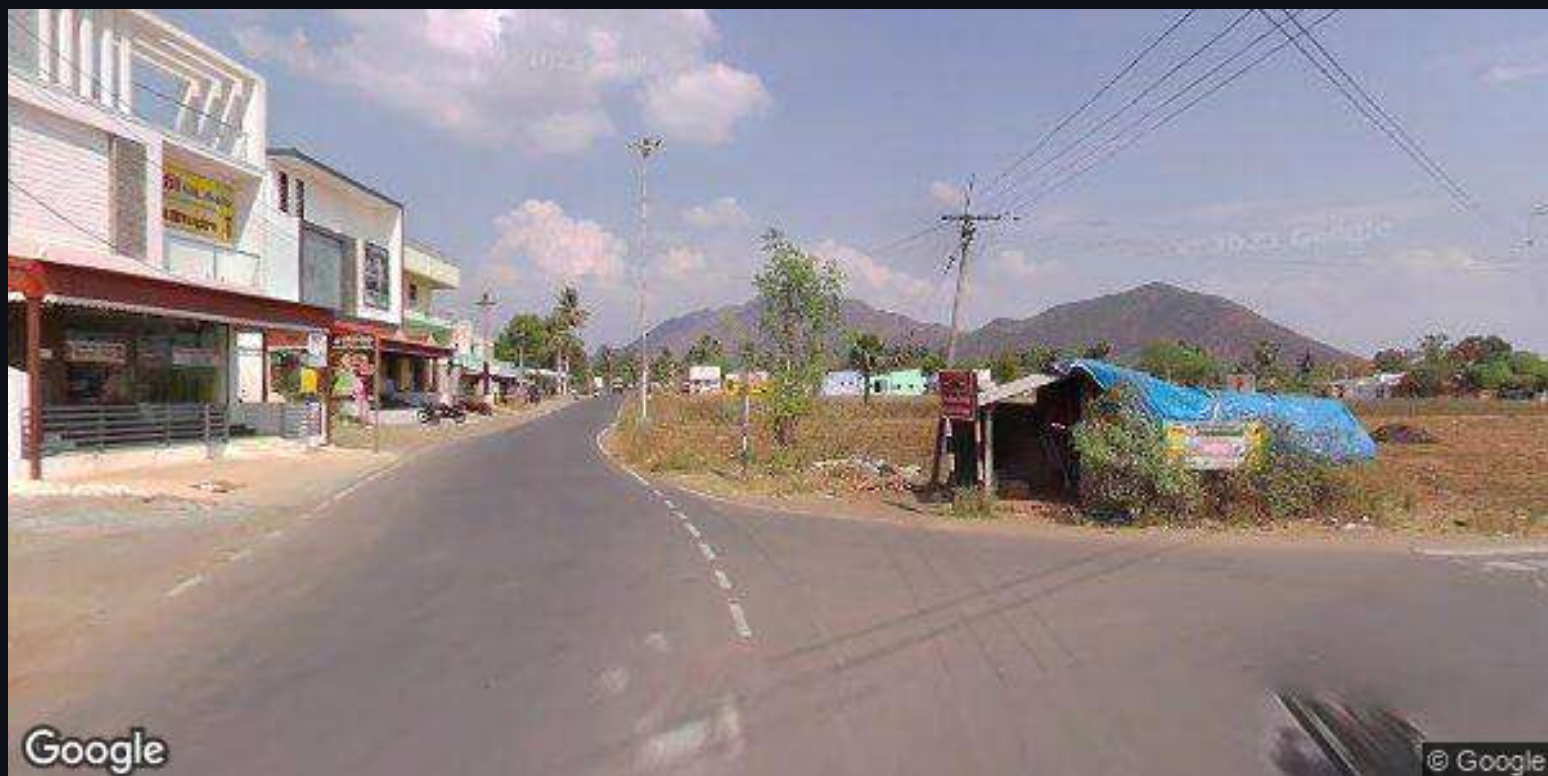
**Risk Type:** Turn  
**Risk Level:** High  
**Speed Limit:** 15 KM/Hr  
**Coordinates:** 11.62660, 78.00986

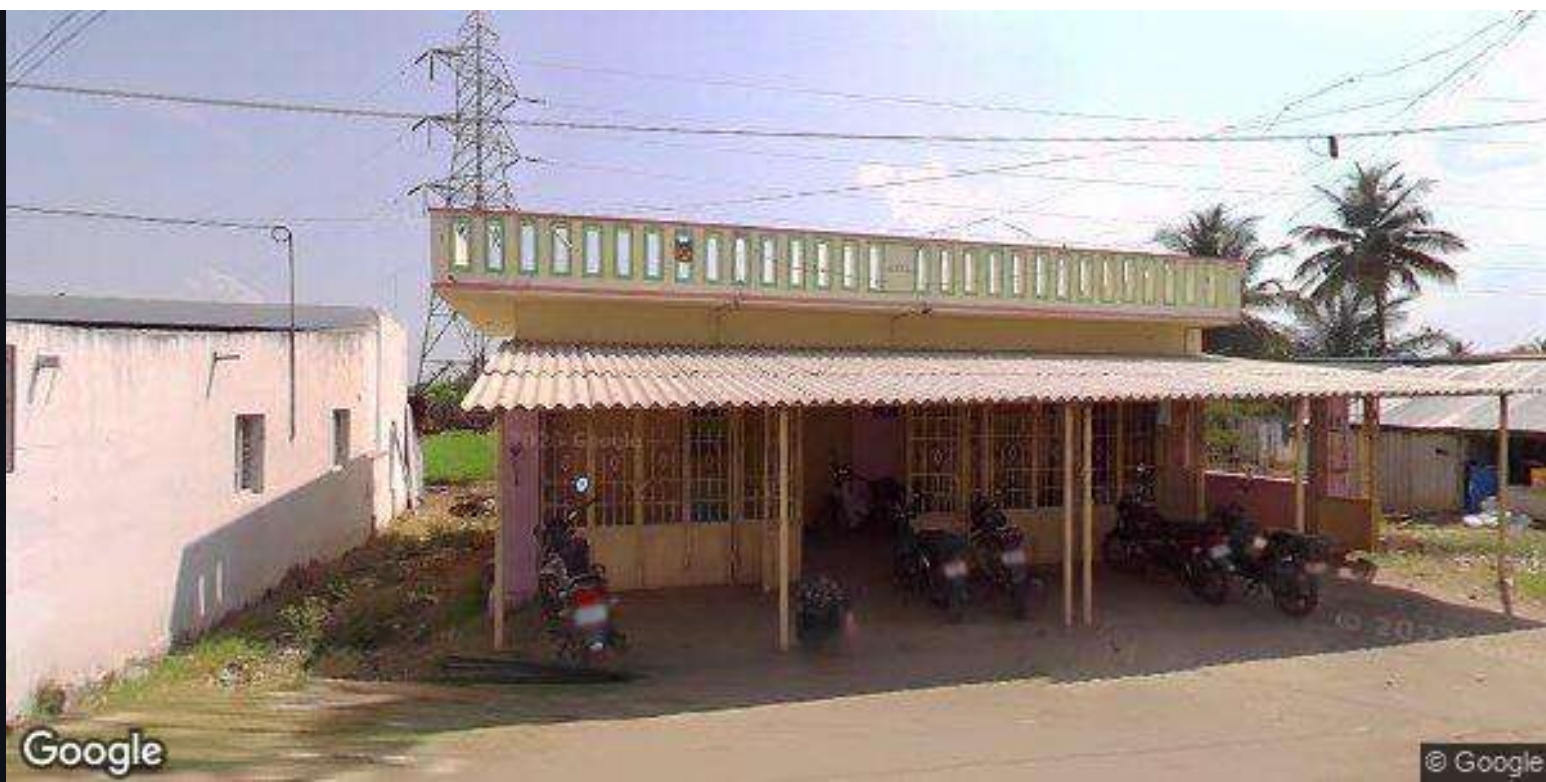
**Risk Type:** Turn  
**Risk Level:** High  
**Speed Limit:** 15 KM/Hr  
**Coordinates:** 11.62692, 78.00883

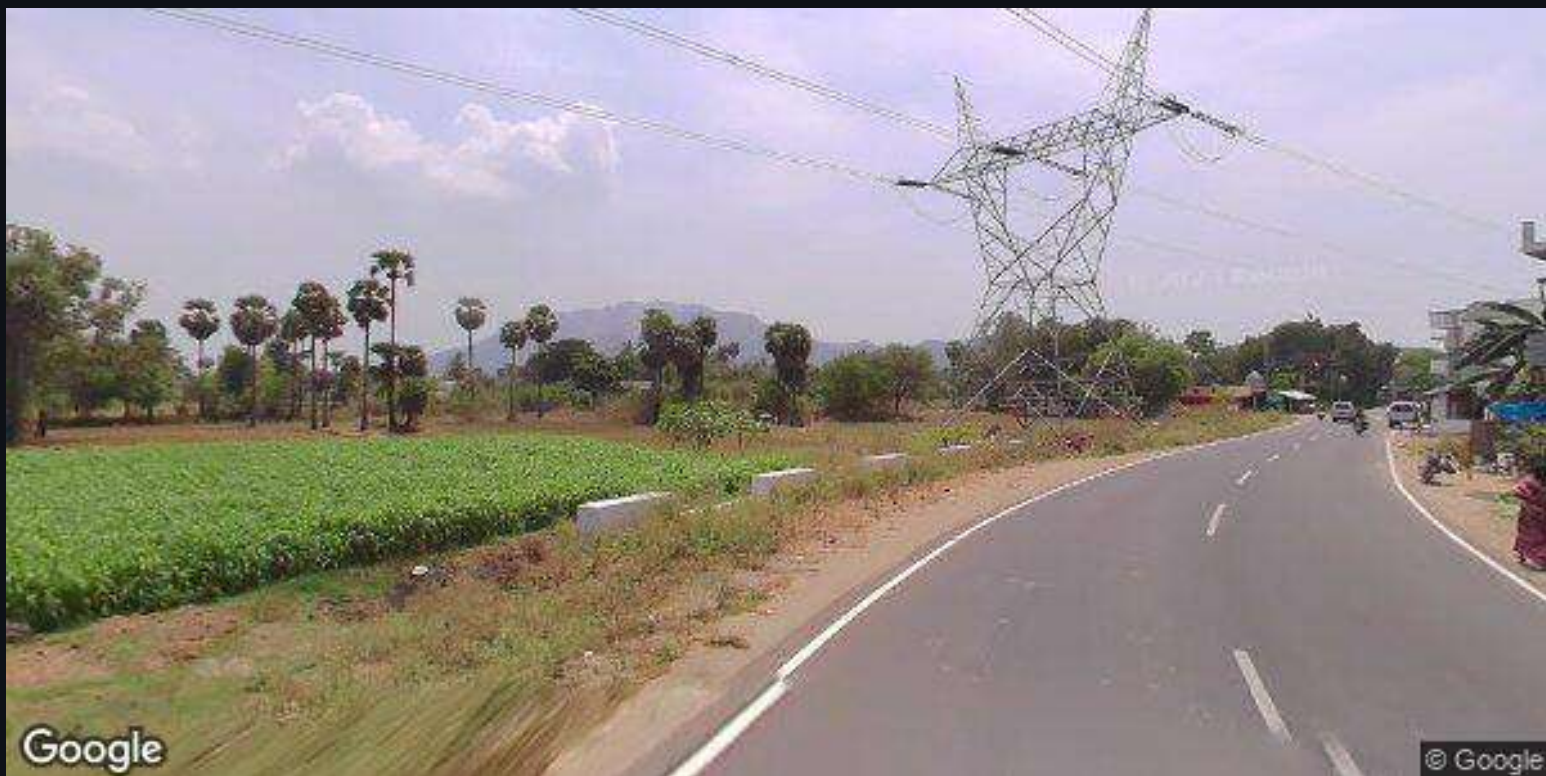
**Risk Type:** Turn  
**Risk Level:** Medium  
**Speed Limit:** 30 KM/Hr  
**Coordinates:** 11.64031, 78.00923

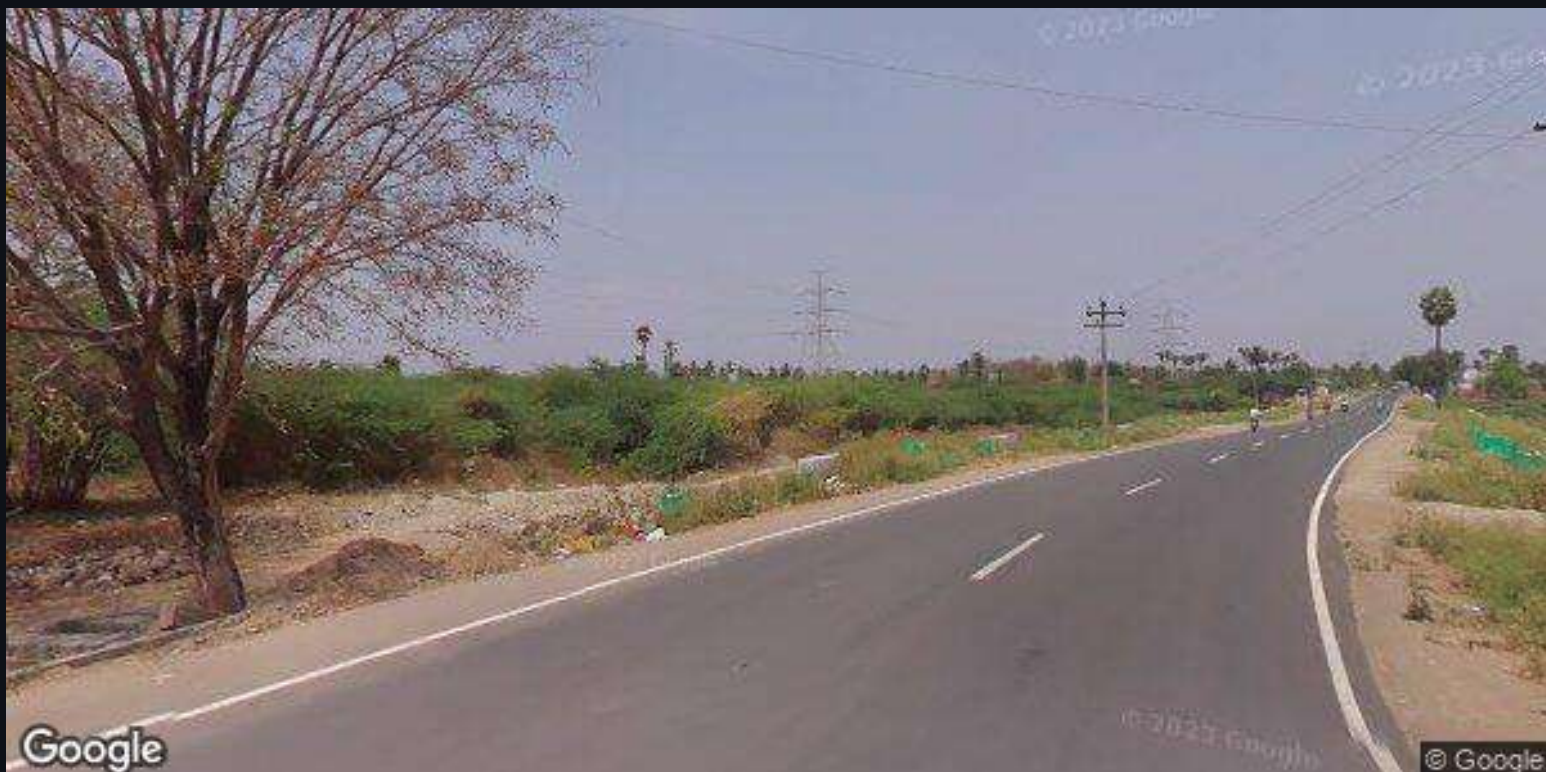
**Coordinates: 11.64874, 78.00717**

**Risk Type: Turn**

**Risk Level: Medium**

**Speed Limit: 30 KM/Hr**

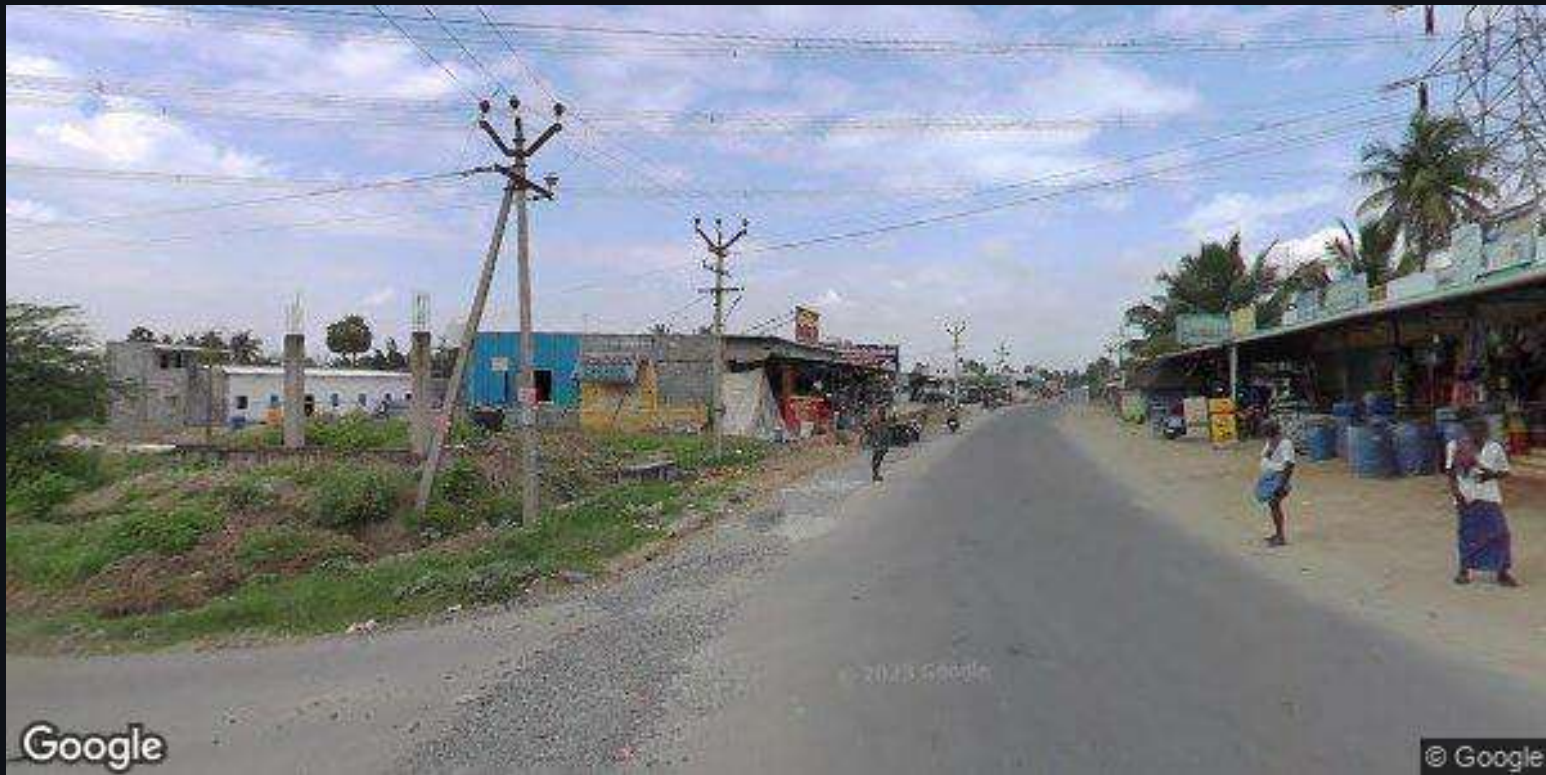
**Coordinates: 11.66821, 78.00077**

**Risk Type: Blind Spot**

**Risk Level: Blind Spot**

**Speed Limit: 10 KM/Hr**

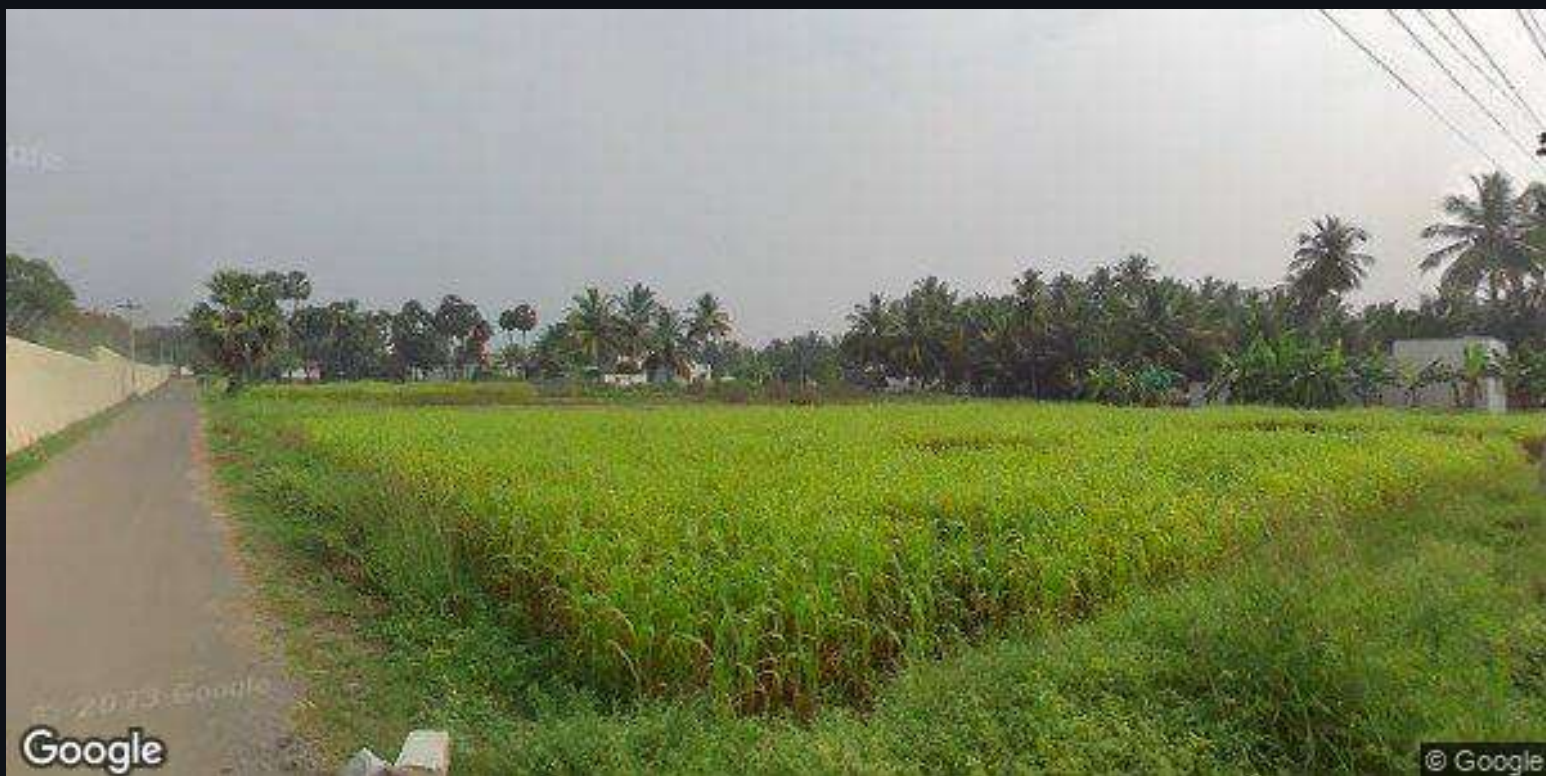
**Coordinates: 11.66762, 78.00863**

**Risk Type: Turn**

**Risk Level: High**

**Speed Limit: 15 KM/Hr**

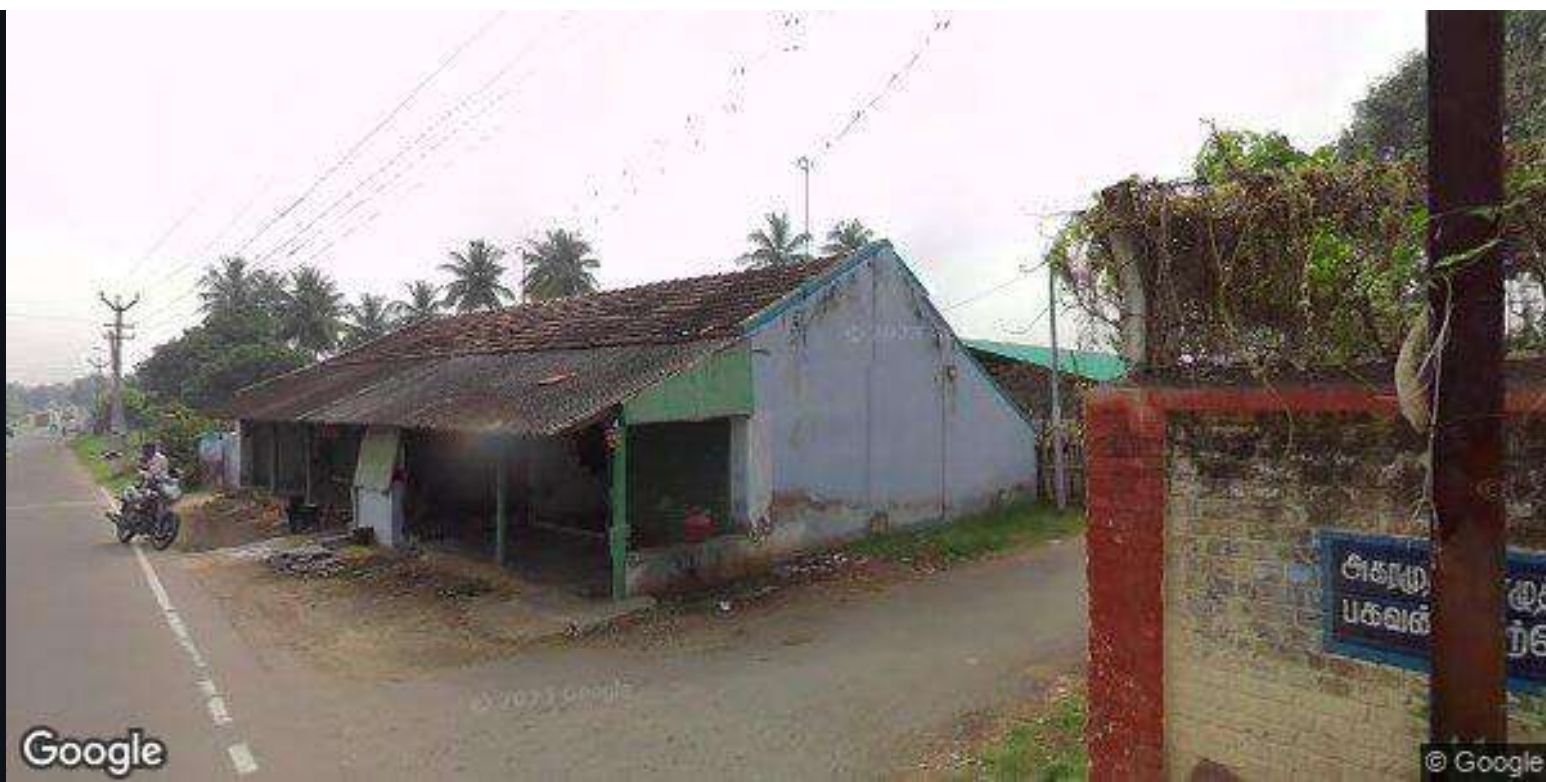
**Coordinates:** 11.67168, 78.00922

**Risk Type:** Blind Spot

**Risk Level:** Blind Spot

**Speed Limit:** 10 KM/Hr

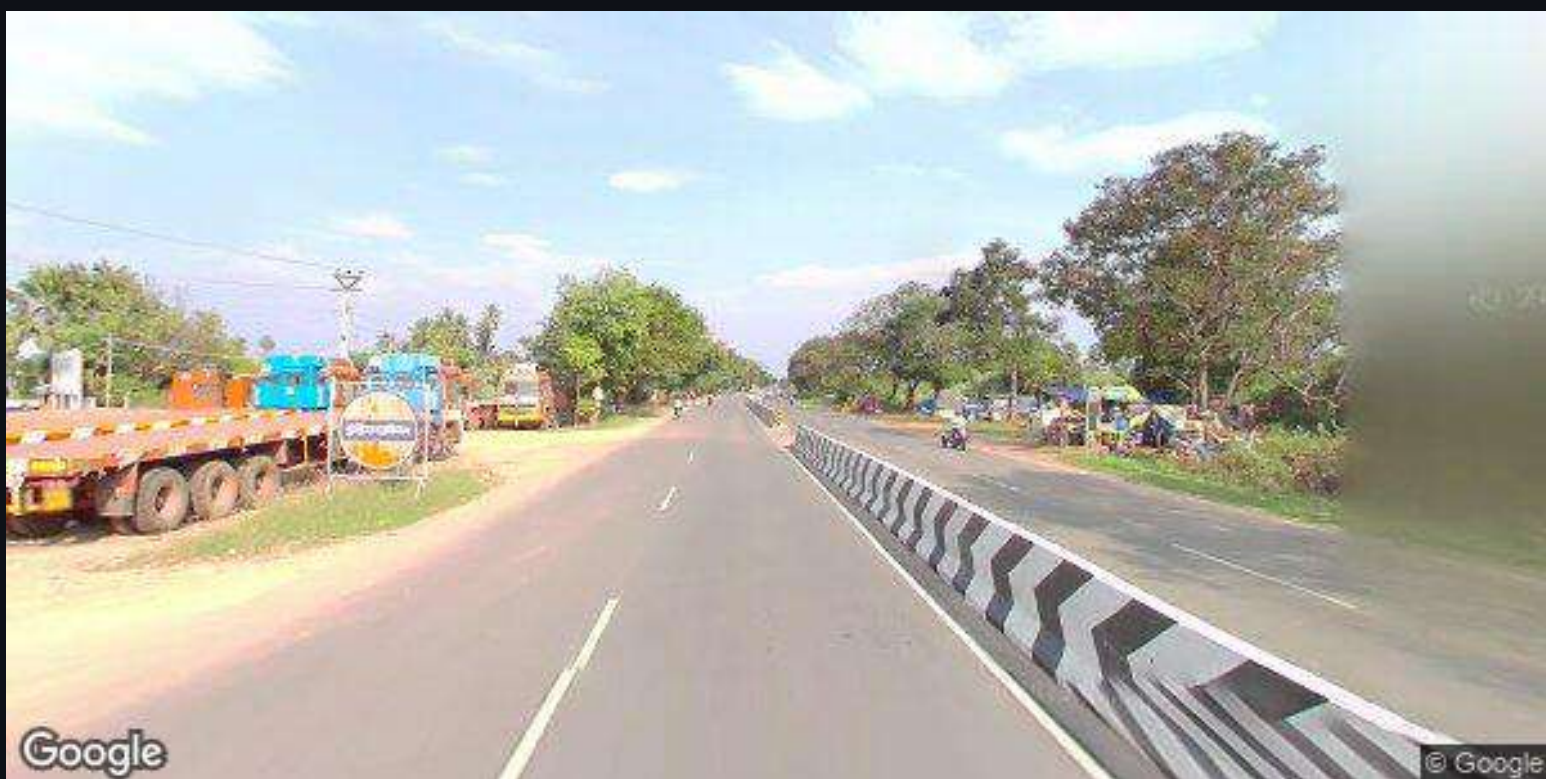
**Coordinates:** 11.67094, 78.05691

**Risk Type:** Turn

**Risk Level:** High

**Speed Limit:** 15 KM/Hr

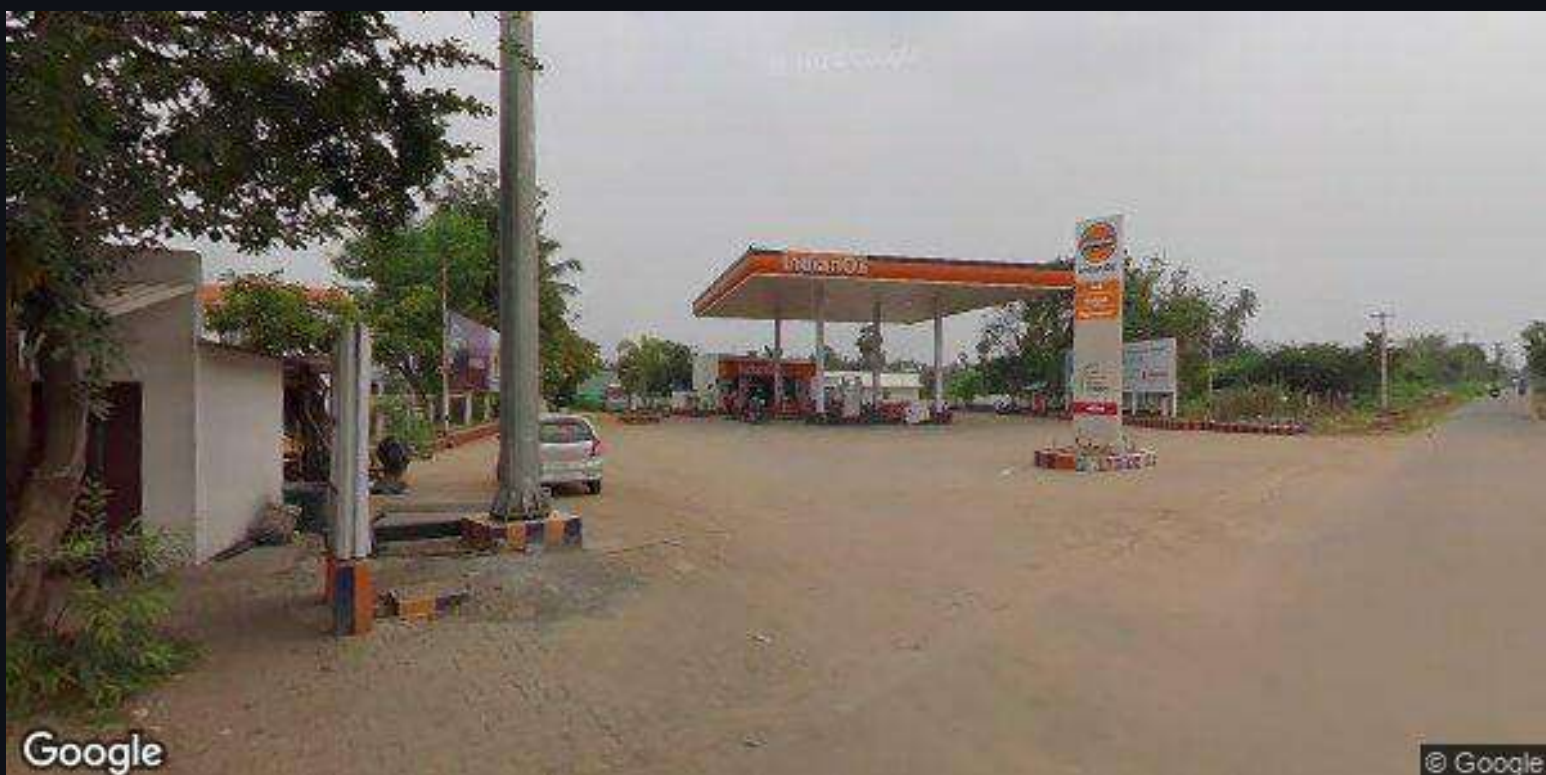
**Coordinates: 11.67120, 78.05691**

**Risk Type: Turn**

**Risk Level: Medium**

**Speed Limit: 30 KM/Hr**

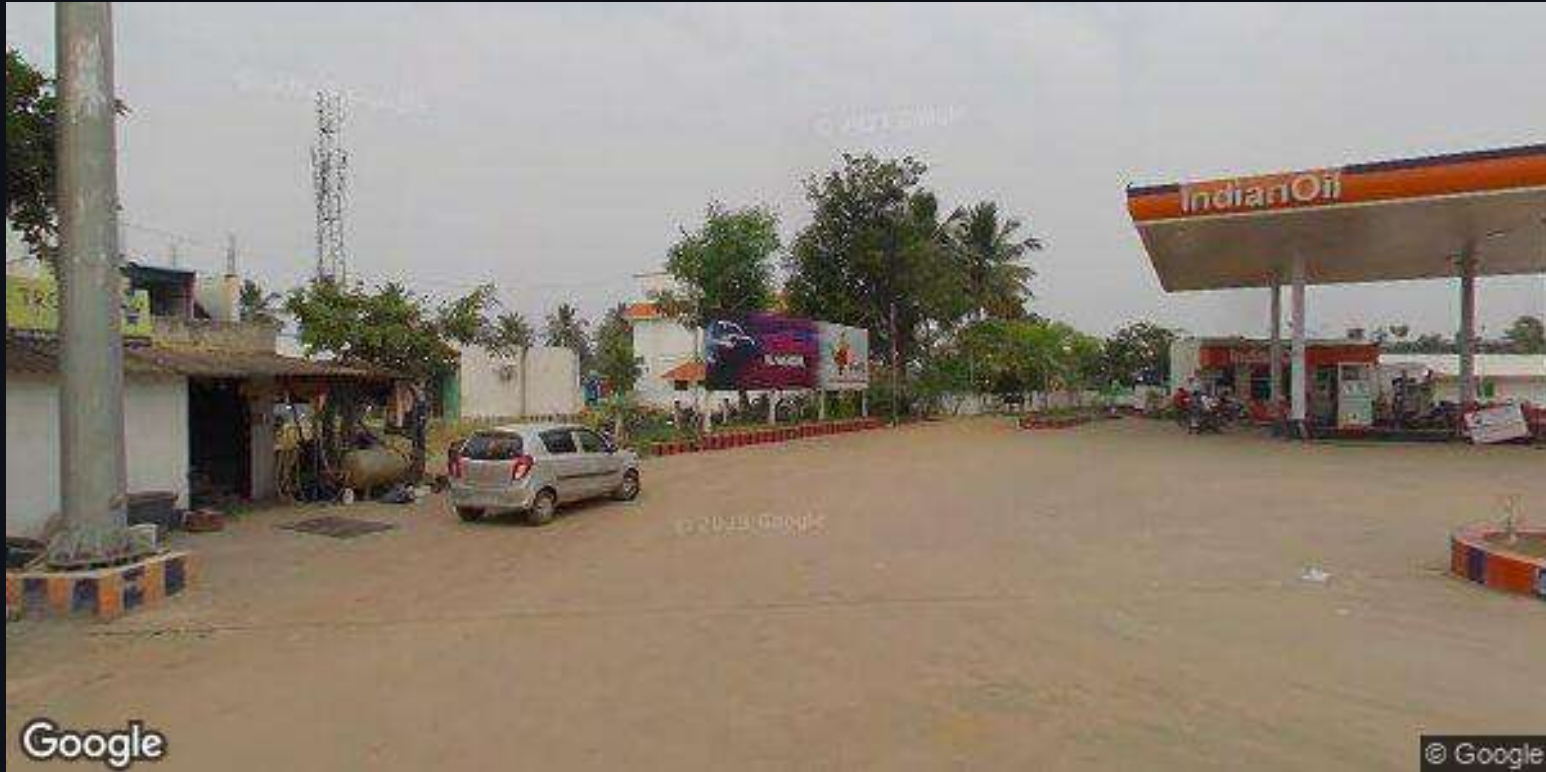
**Coordinates: 11.67126, 78.05696**

**Risk Type: Turn**

**Risk Level: Medium**

**Speed Limit: 30 KM/Hr**
