# IndianOil

## JOURNEY RISK MANAGEMENT (JRM) STUDY

### Salem Terminal TO Sri Annai Agencies

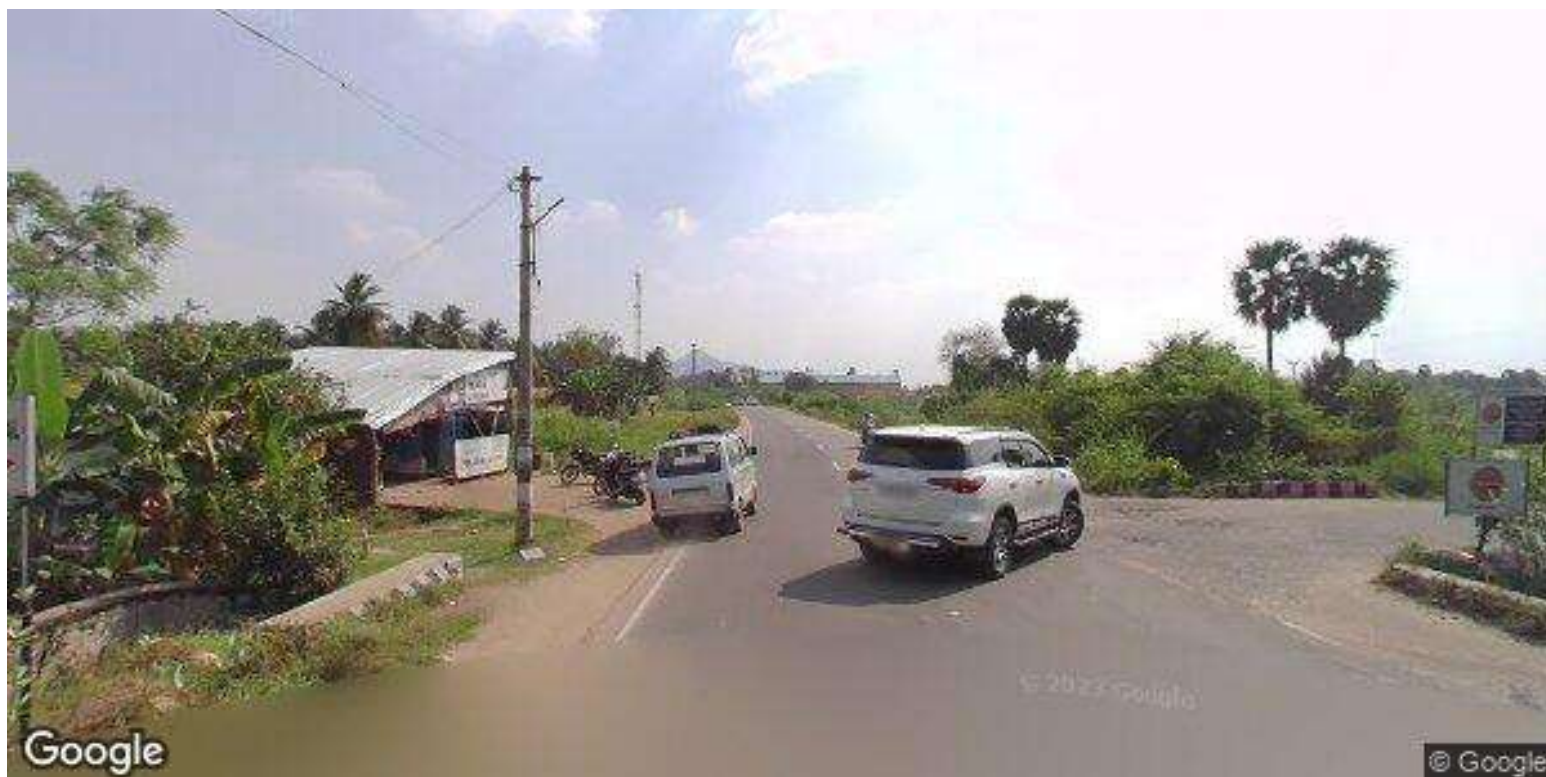
**Coordinates:** 11.44029, 77.87544

**Risk Type:** Turn

**Risk Level:** High

**Speed Limit:** 15 KM/Hr

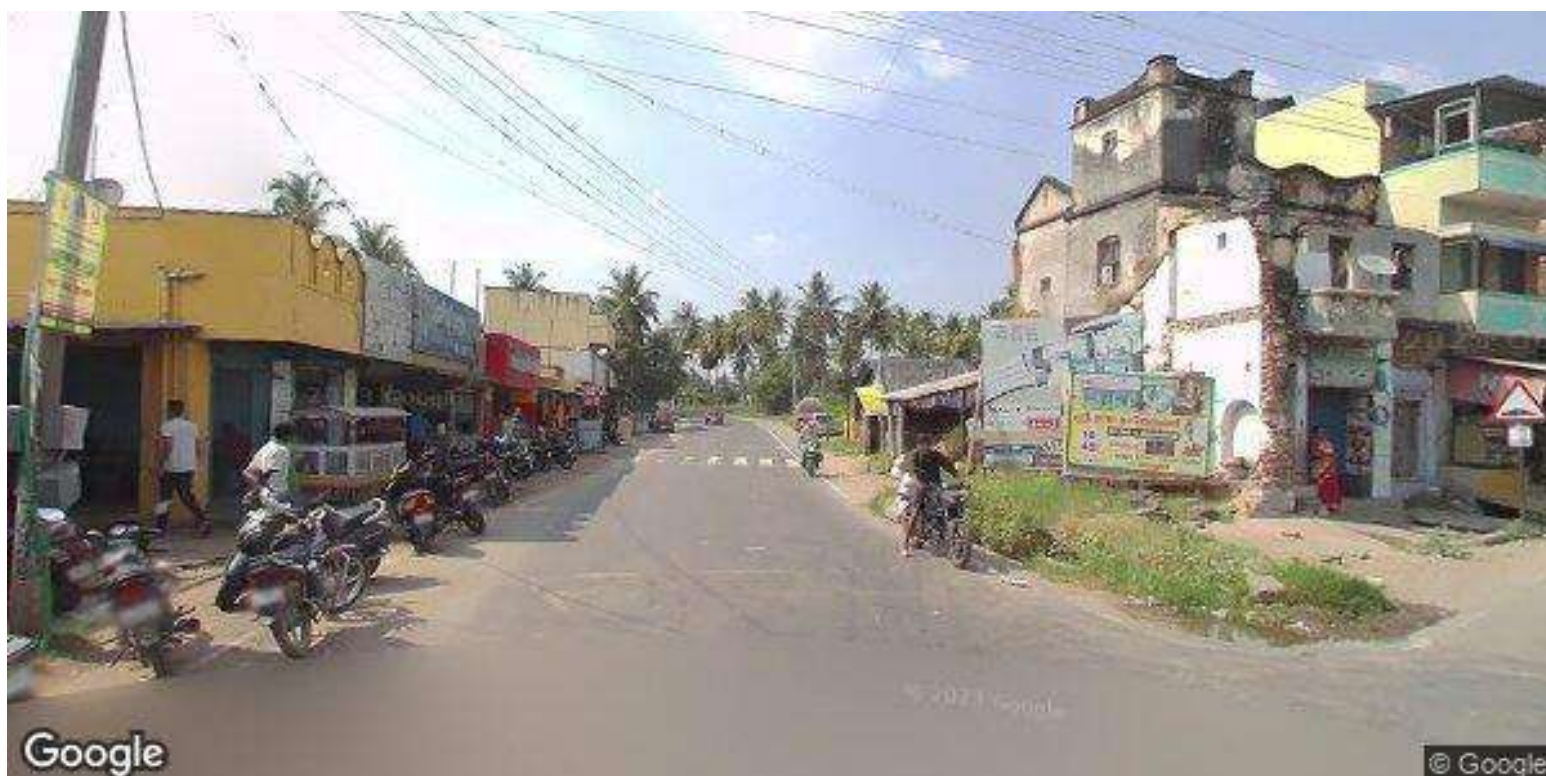
**Coordinates:** 11.45007, 77.87201

**Risk Type:** Turn

**Risk Level:** High

**Speed Limit:** 15 KM/Hr

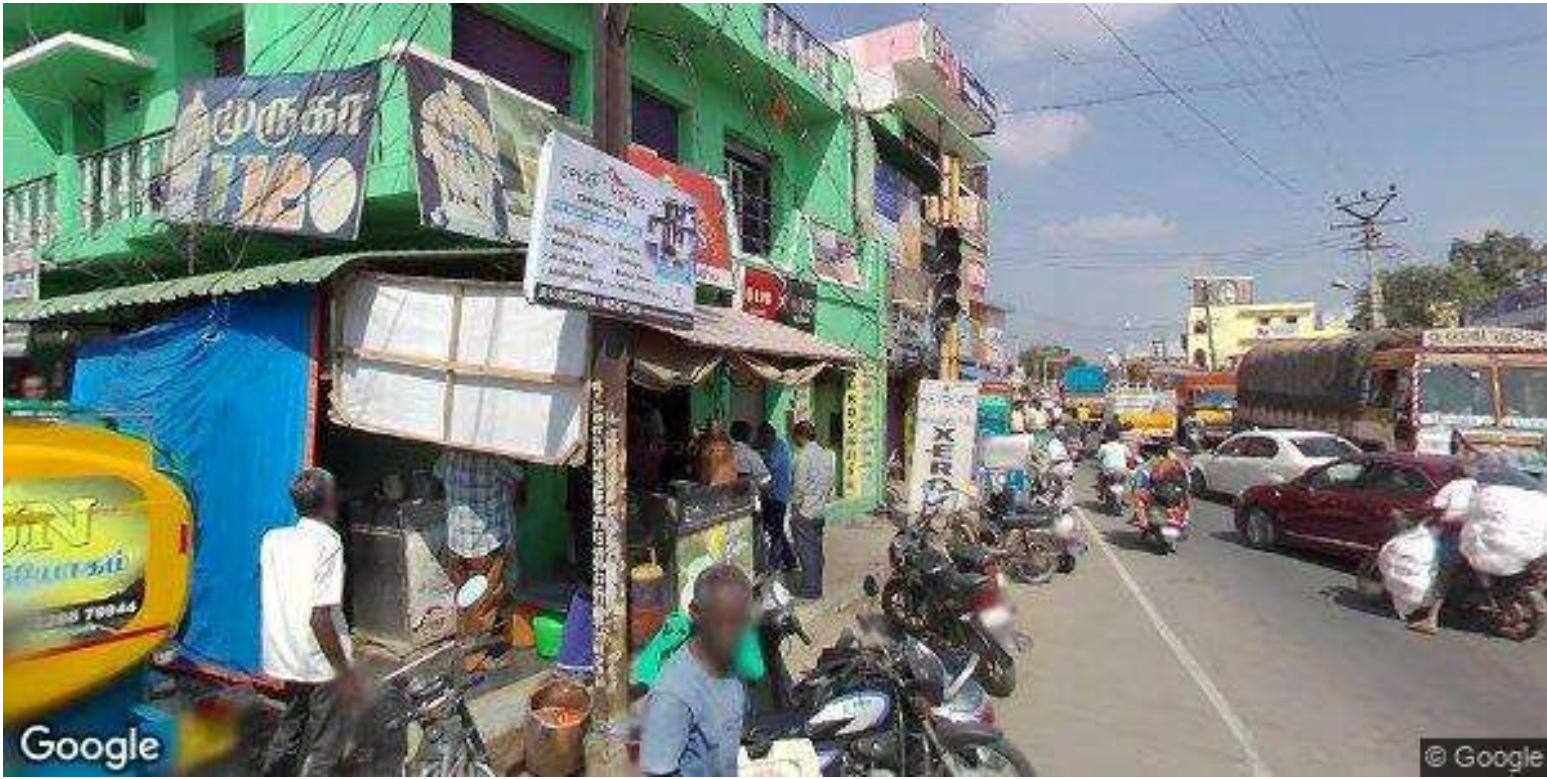
Risk Type: Turn  
Risk Level: High  
Speed Limit: 15 KM/Hr  
Coordinates: 11.47407, 77.86839

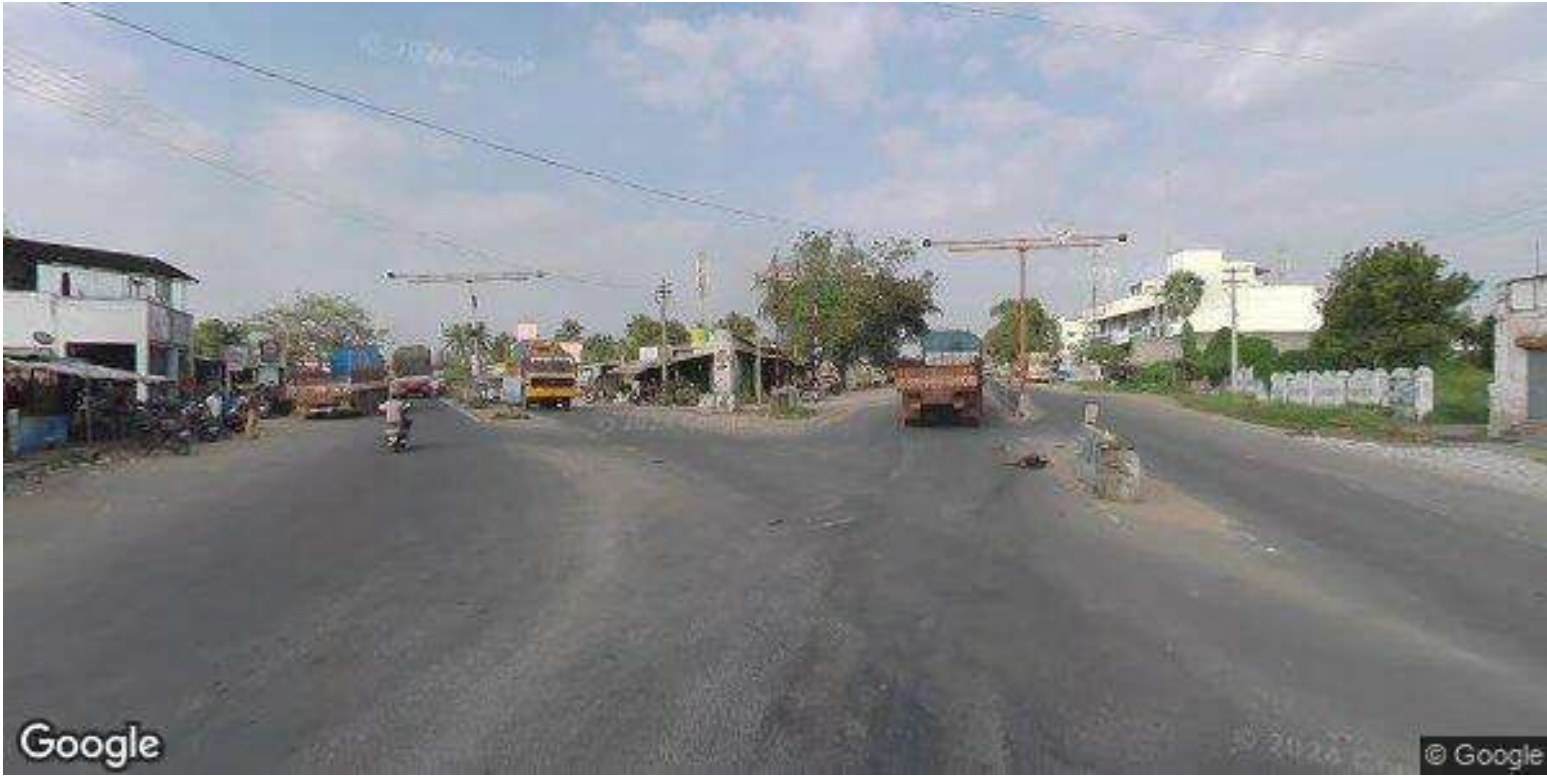
Risk Type: Turn  
Risk Level: Medium  
Speed Limit: 30 KM/Hr  
Coordinates: 11.48366, 77.88781

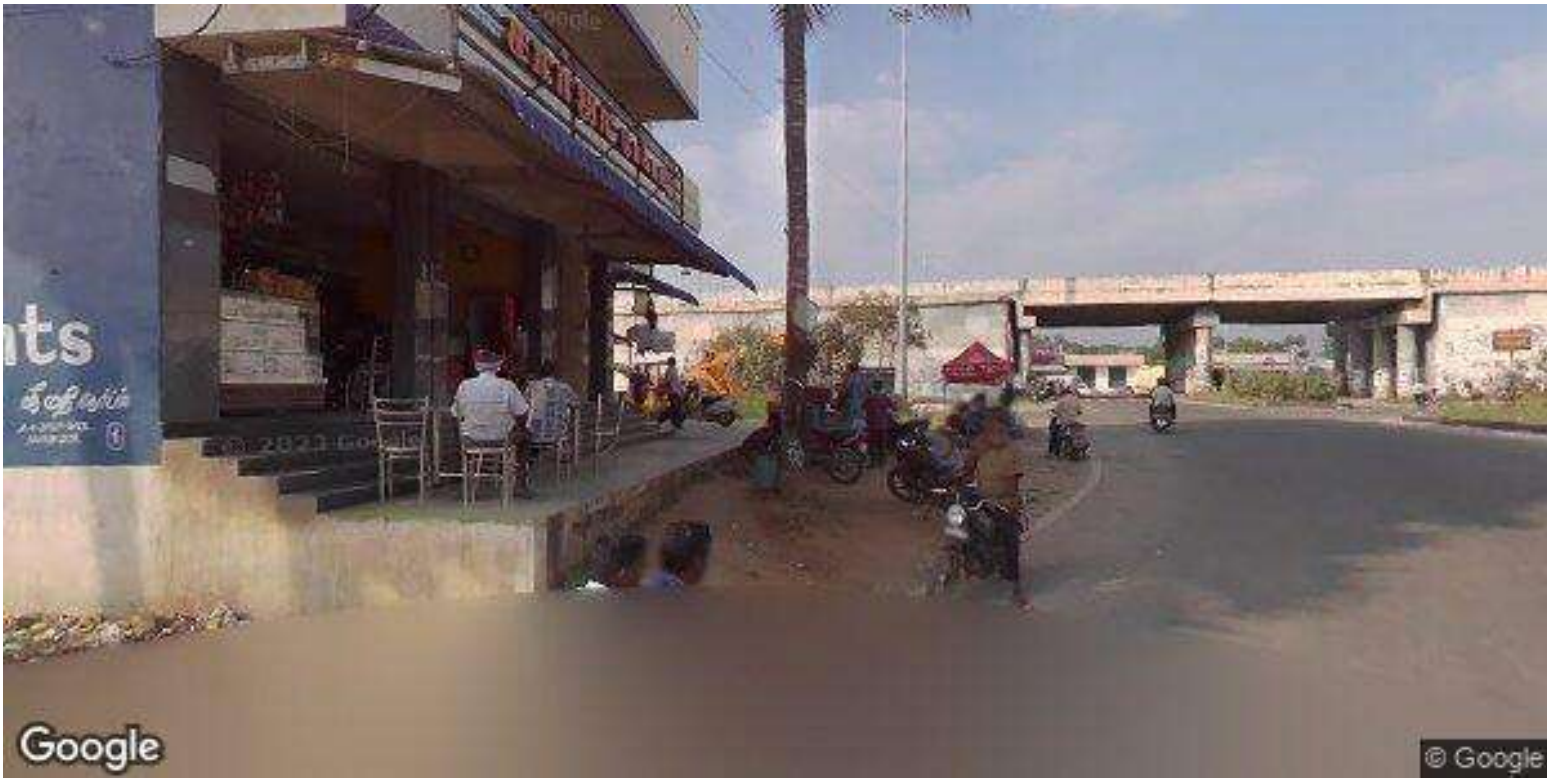
**Coordinates: 11.49149, 77.89601**

**Risk Type: Turn**

**Risk Level: High**

**Speed Limit: 15 KM/Hr**

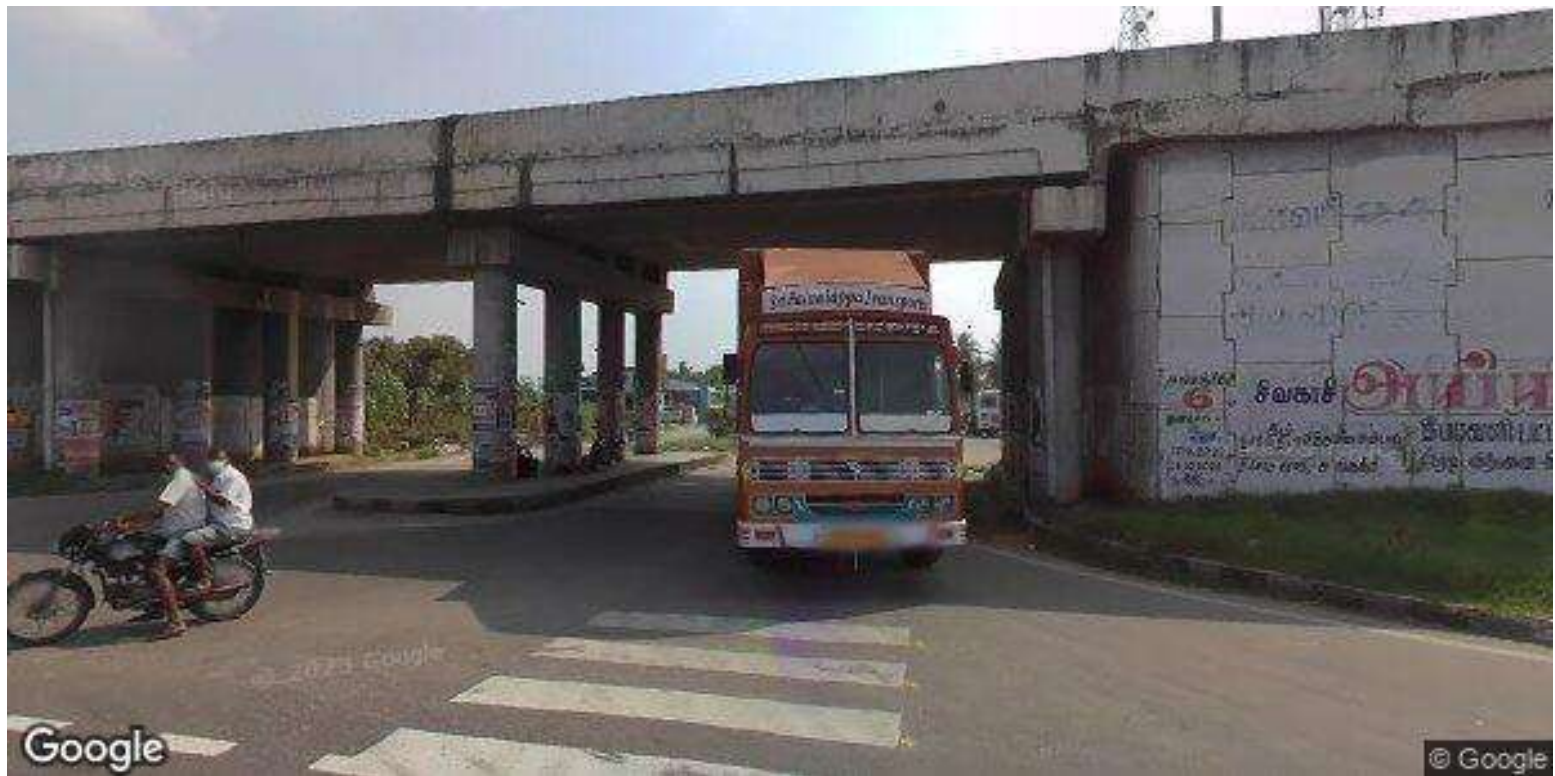
**Coordinates: 11.49224, 77.89601**

**Risk Type: Turn**

**Risk Level: High**

**Speed Limit: 15 KM/Hr**

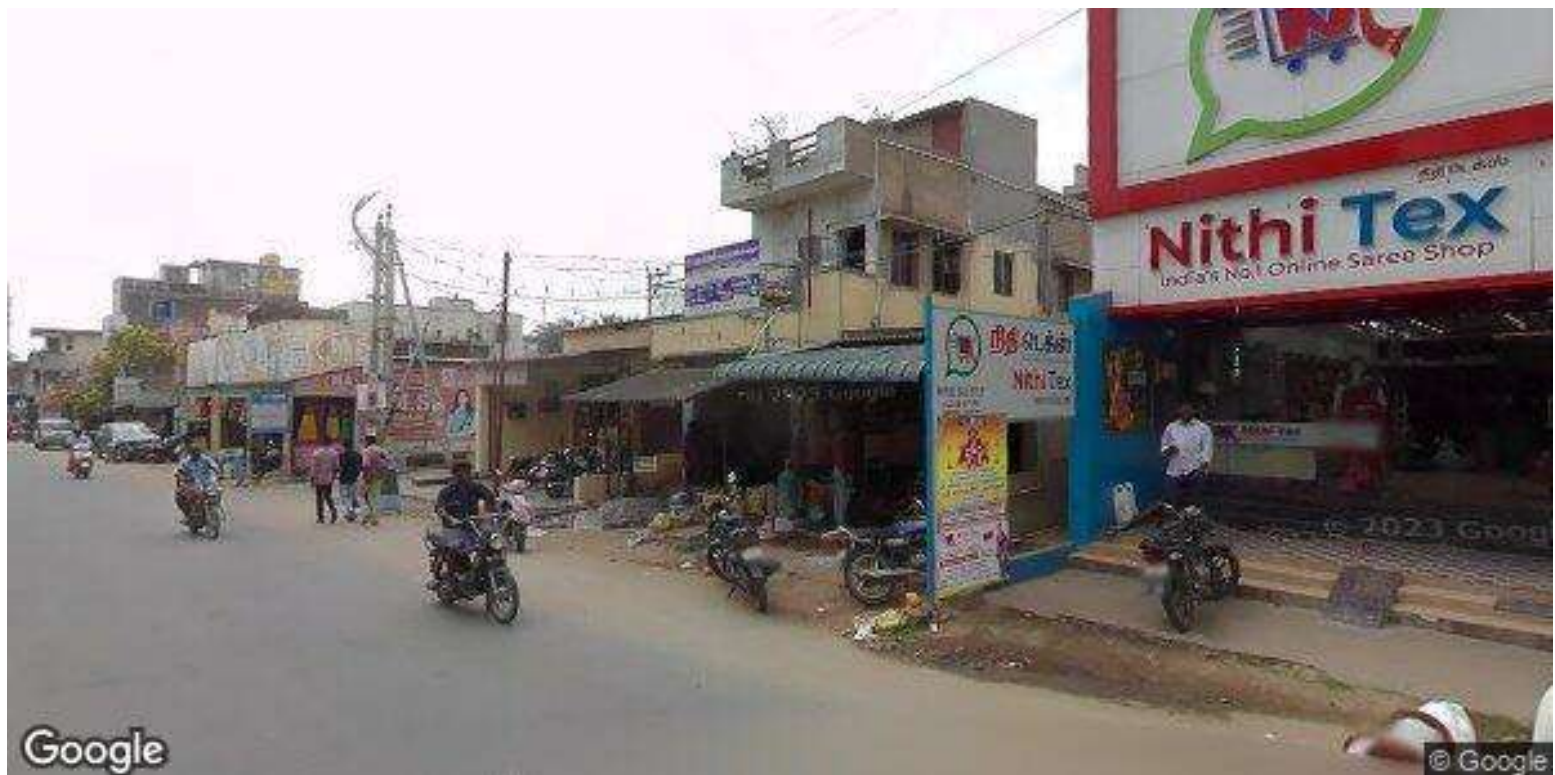
**Coordinates: 11.60526, 78.00451**

**Risk Type: Turn**

**Risk Level: Medium**

**Speed Limit: 30 KM/Hr**

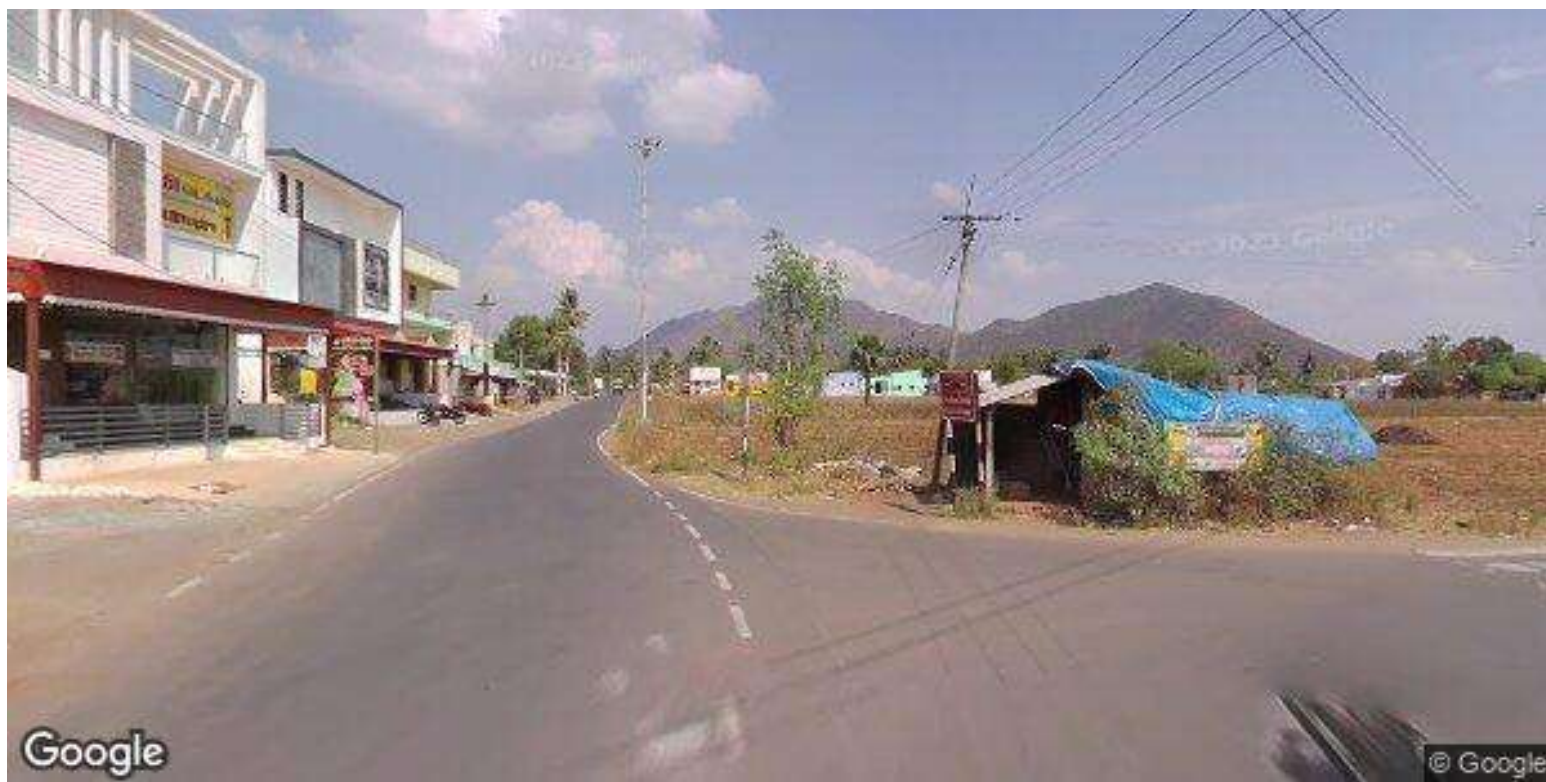
**Coordinates:** 11.62660, 78.00986

**Risk Type:** Turn

**Risk Level:** High

**Speed Limit:** 15 KM/Hr

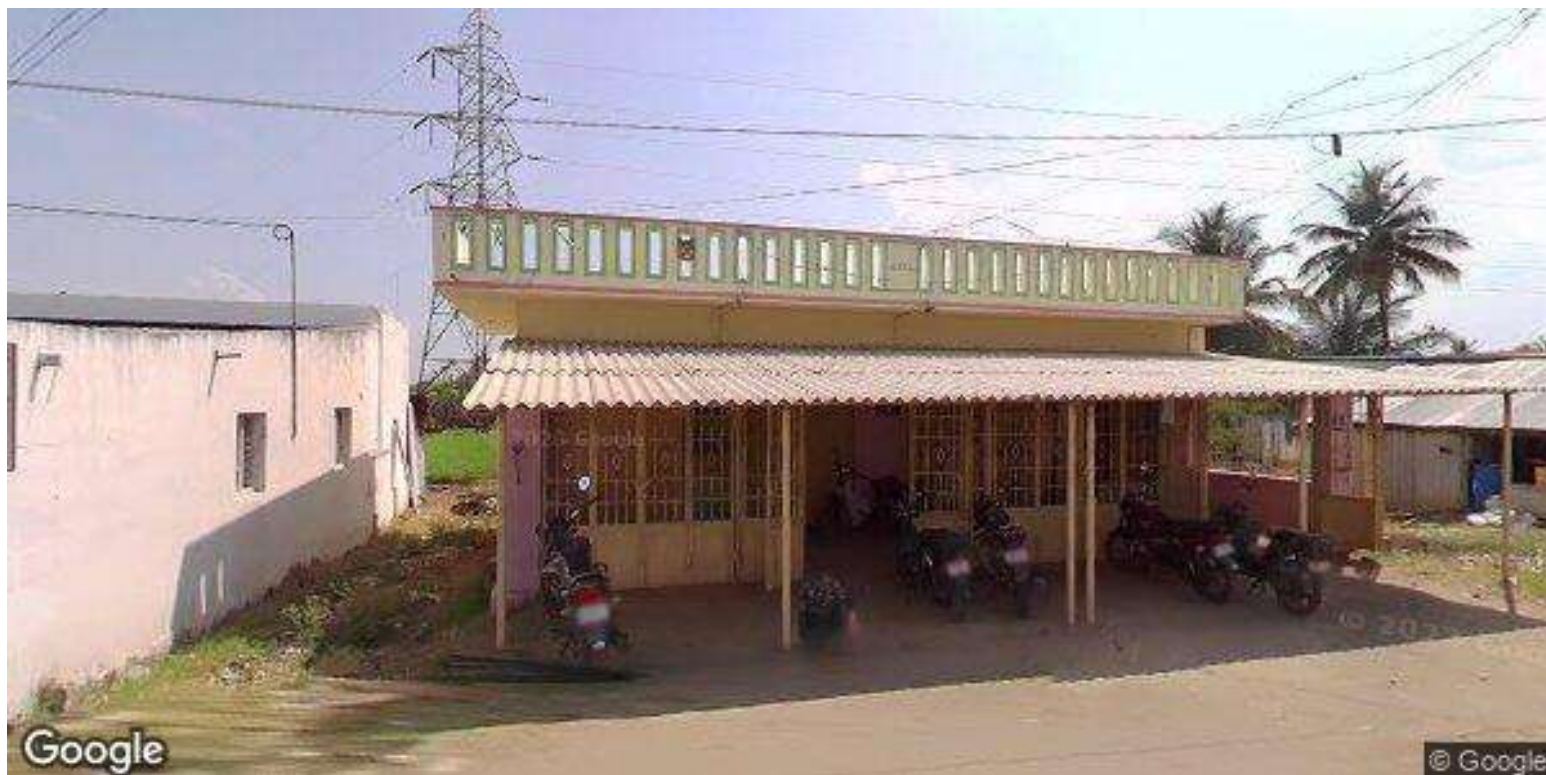
**Coordinates:** 11.62692, 78.00883

**Risk Type:** Turn

**Risk Level:** High

**Speed Limit:** 15 KM/Hr

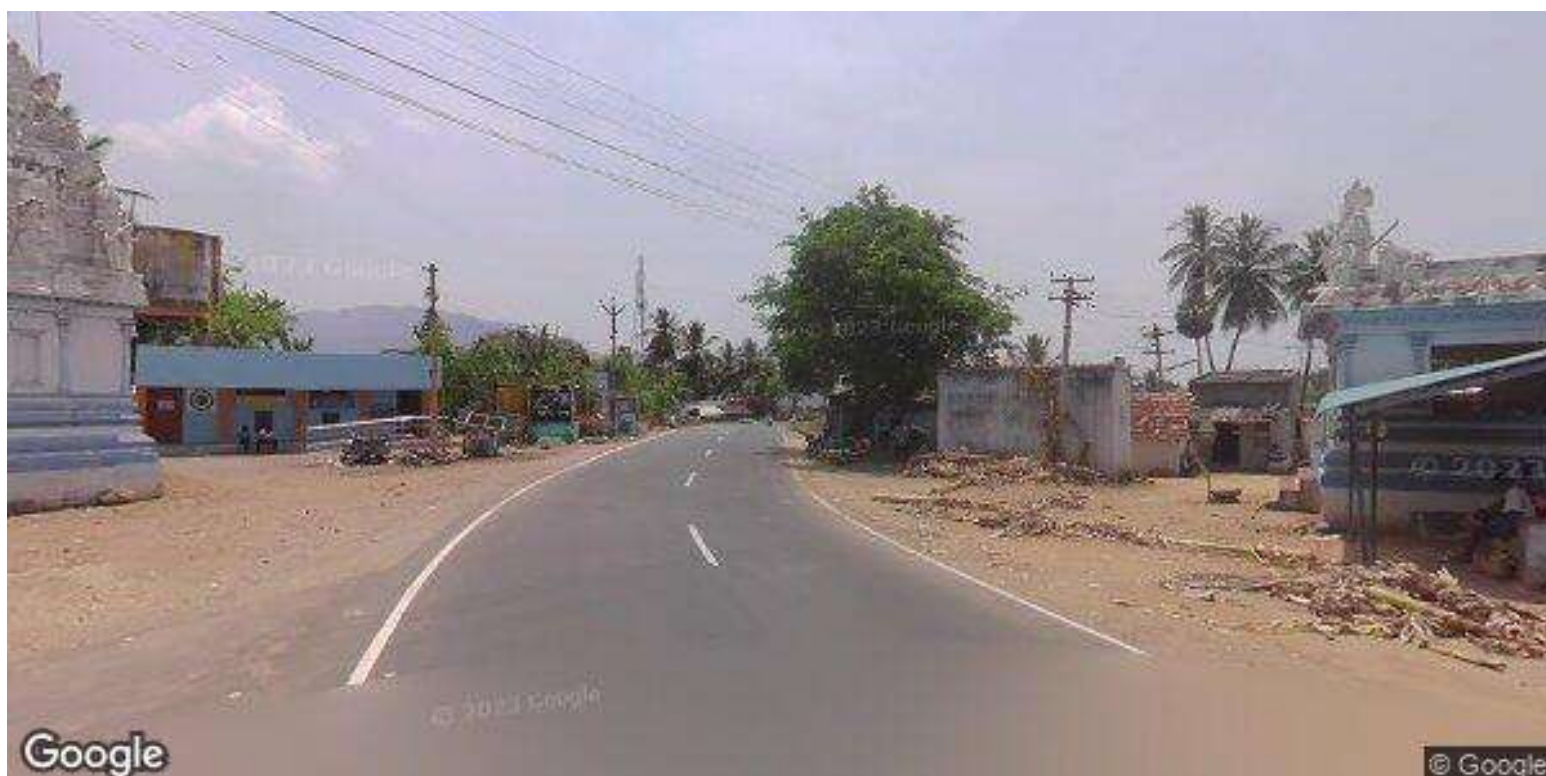
**Risk Type:** Turn  
**Risk Level:** Medium  
**Speed Limit:** 30 KM/Hr  
**Coordinates:** 11.64840, 78.00778

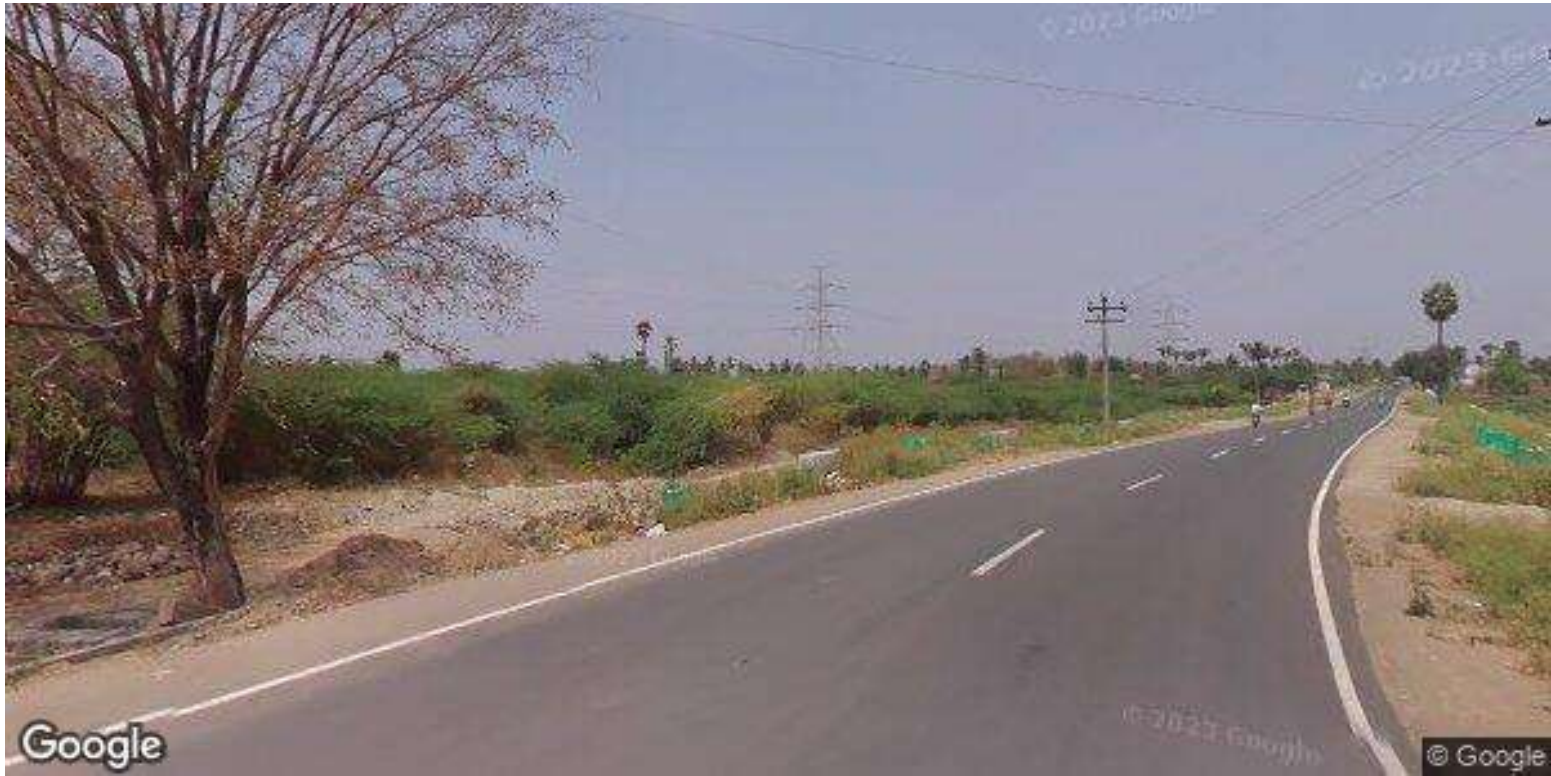
**Risk Type:** Turn  
**Risk Level:** Medium  
**Speed Limit:** 30 KM/Hr  
**Coordinates:** 11.64874, 78.00717

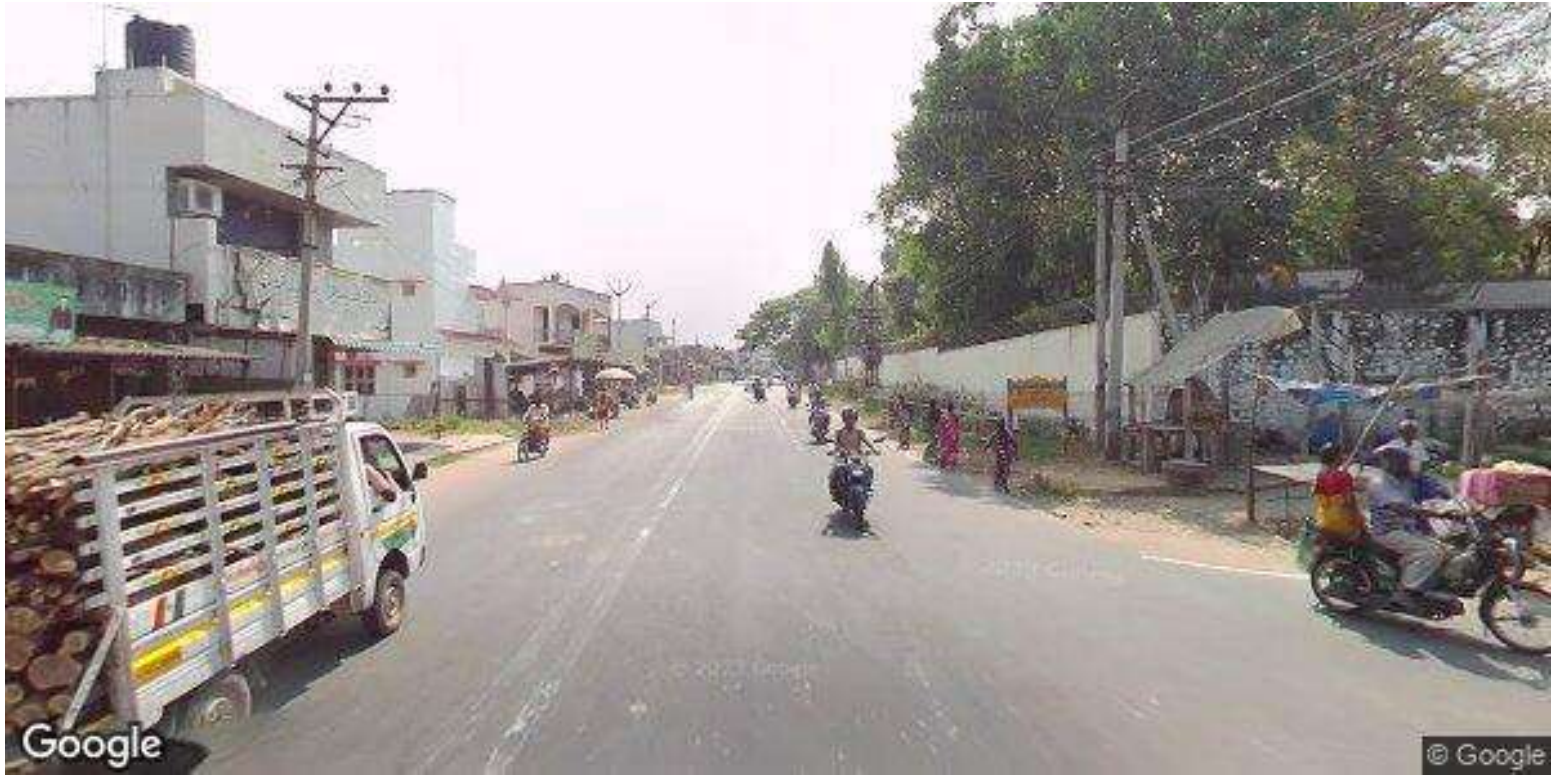
**Risk Type:** Blind Spot  
**Risk Level:** Blind Spot  
**Speed Limit:** 10 KM/Hr  
**Coordinates:** 11.67303, 78.00187
