# IndianOil

## JOURNEY RISK MANAGEMENT (JRM) STUDY

### Salem Terminal to Sri Valli Agencies

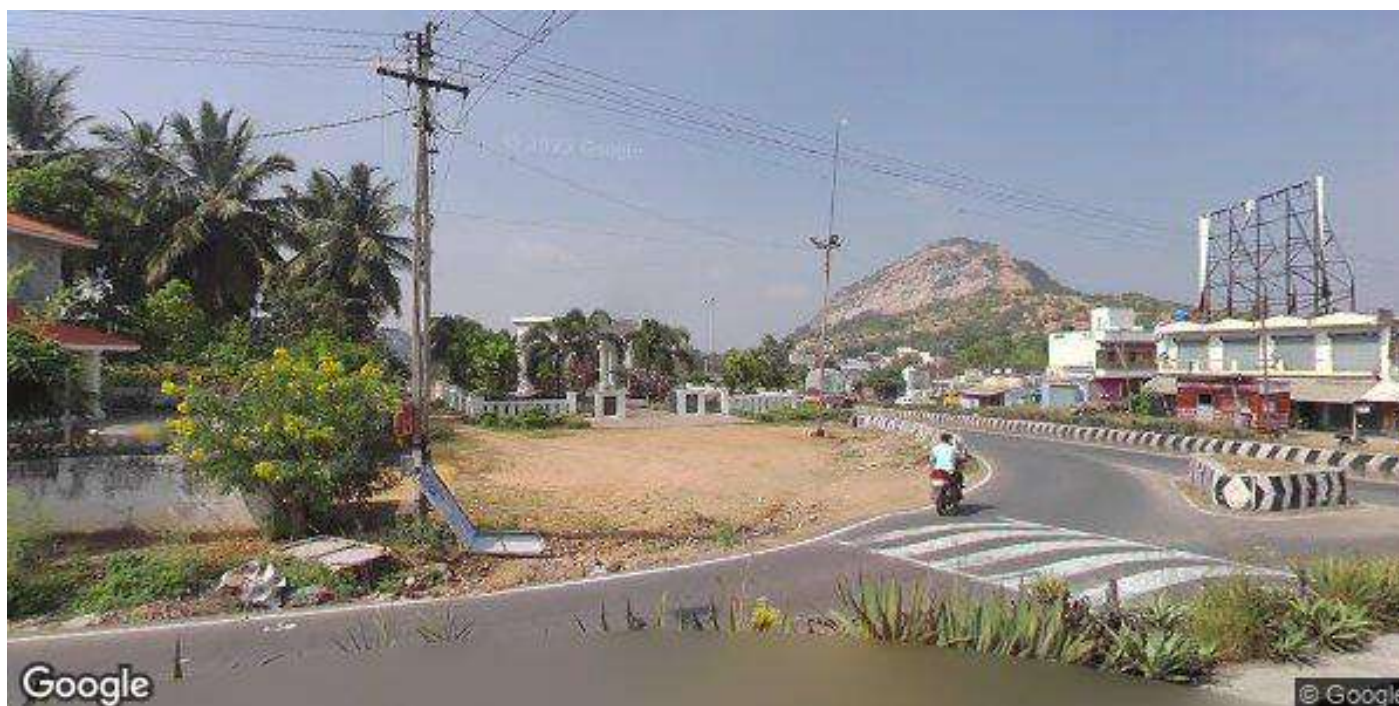
**Risk Type:** Turn  
**Risk Level:** Medium  
**Speed Limit:** 30 KM/Hr  
**Coordinates:** 11.46307, 77.84941

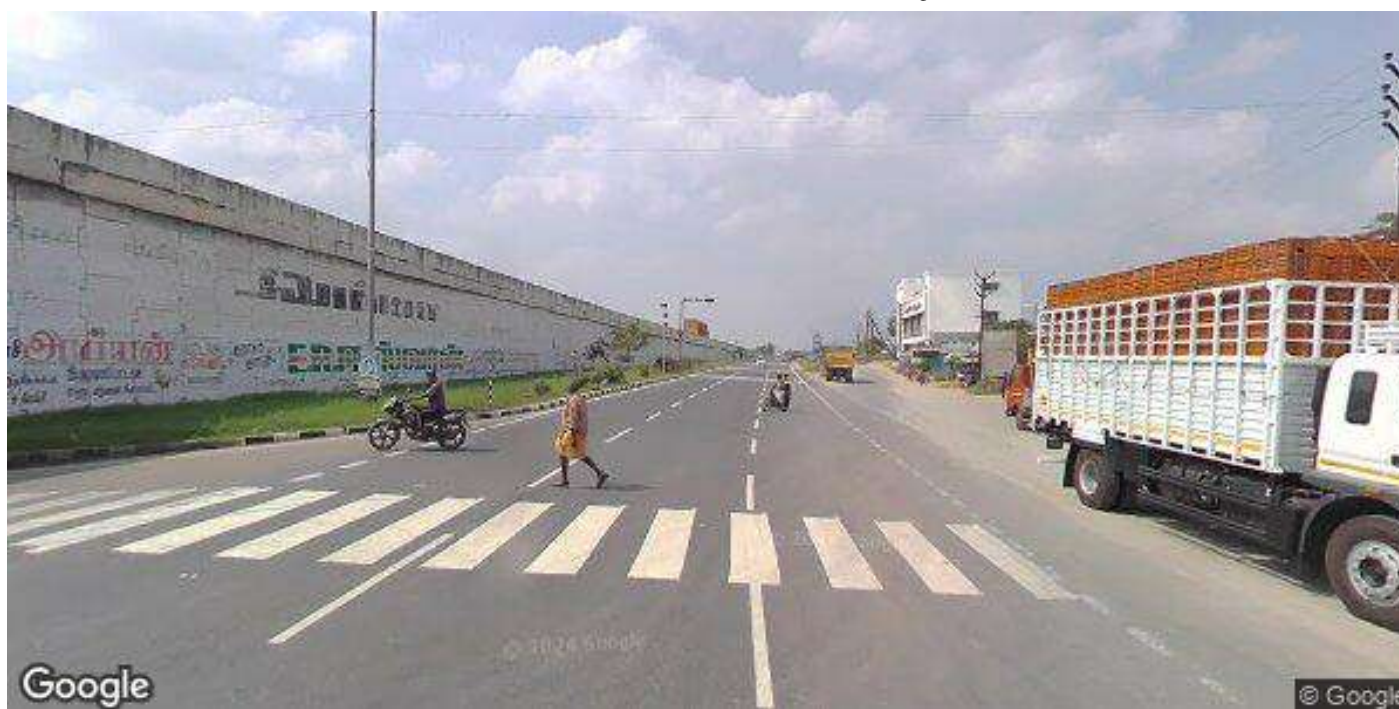
**Risk Type:** Turn  
**Risk Level:** High  
**Speed Limit:** 15 KM/Hr  
**Coordinates:** 11.49224, 77.89606

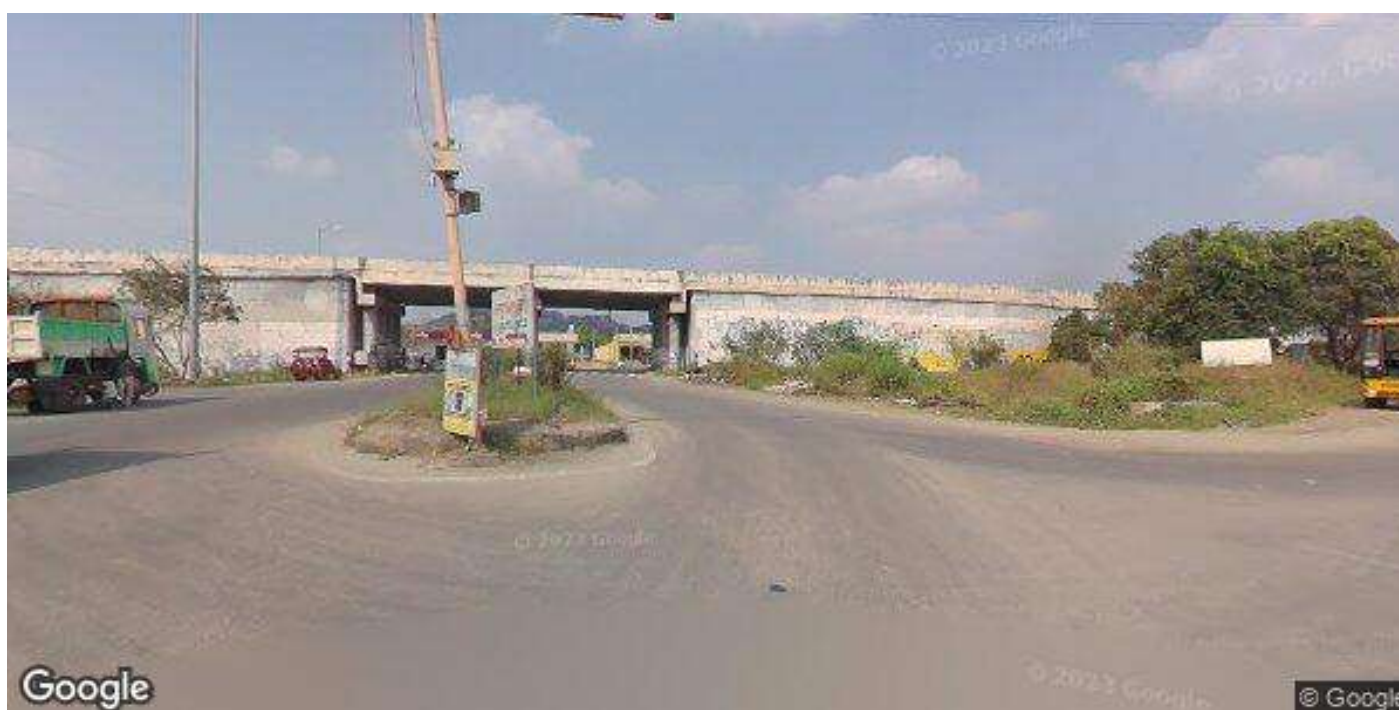
**Risk Type:** Turn  
**Risk Level:** High  
**Speed Limit:** 15 KM/Hr  
**Coordinates:** 11.49153, 77.89615

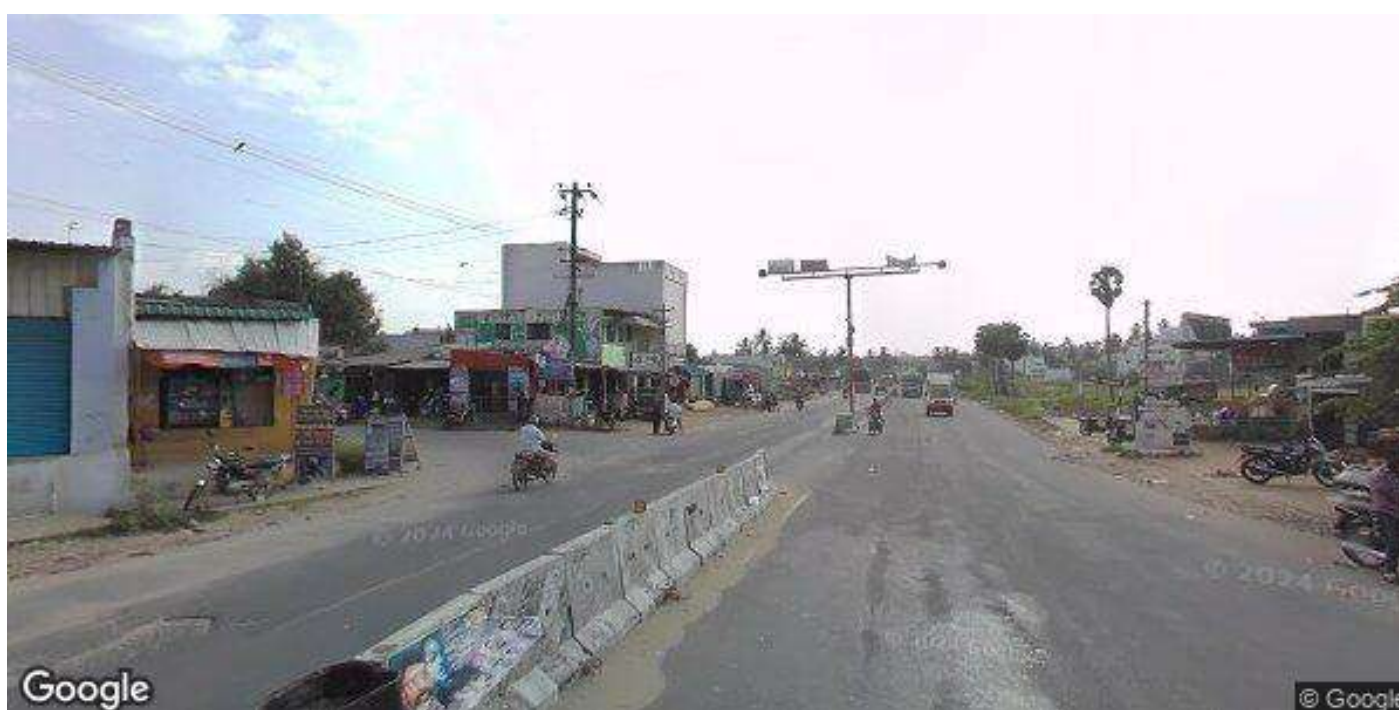
**Risk Type:** Blind Spot  
**Risk Level:** Blind Spot  
**Speed Limit:** 10 KM/Hr  
**Coordinates:** 11.48364, 77.88780

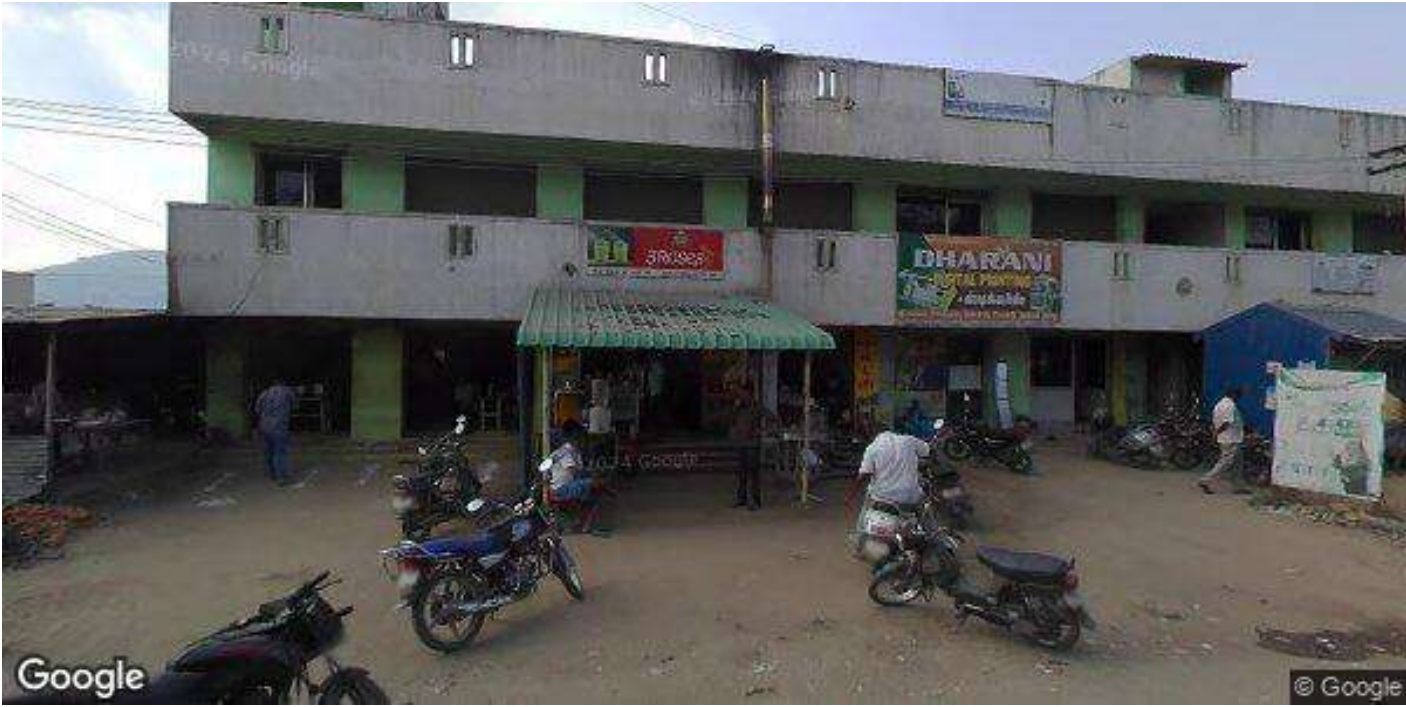
**Risk Type:** Turn  
**Risk Level:** Medium  
**Speed Limit:** 30 KM/Hr  
**Coordinates:** 11.49155, 77.88776

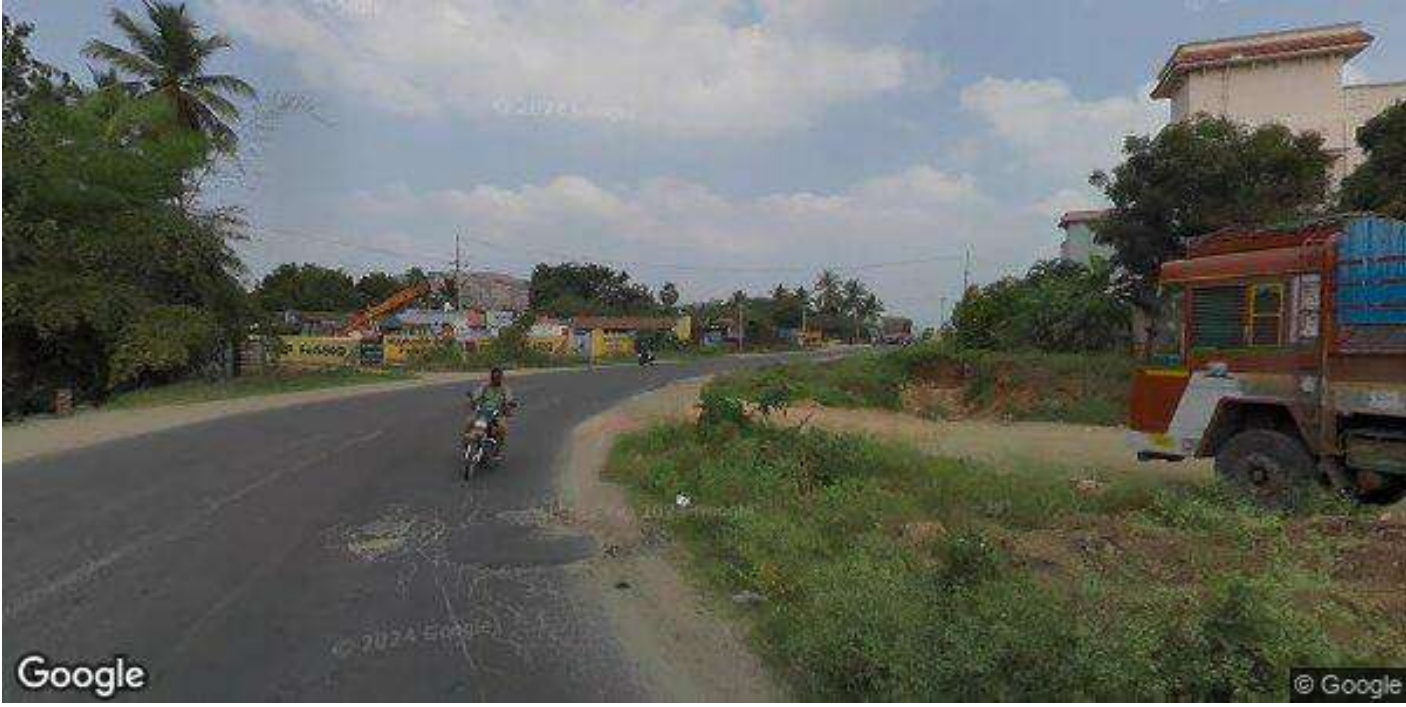
**Risk Type:** Turn  
**Risk Level:** Medium  
**Speed Limit:** 30 KM/Hr  
**Coordinates:** 11.49441, 77.88495

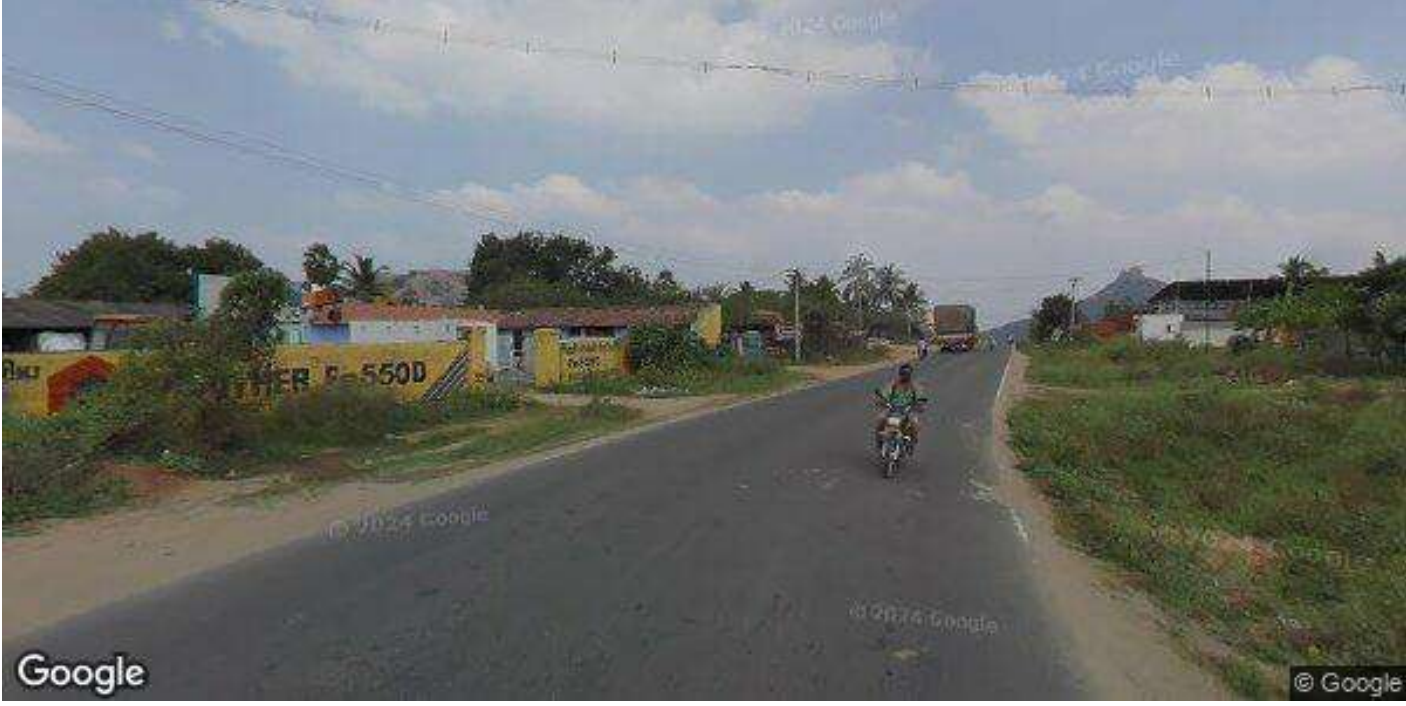
**Risk Type:** Turn  
**Risk Level:** Medium  
**Speed Limit:** 30 KM/Hr  
**Coordinates:** 11.49469, 77.88488

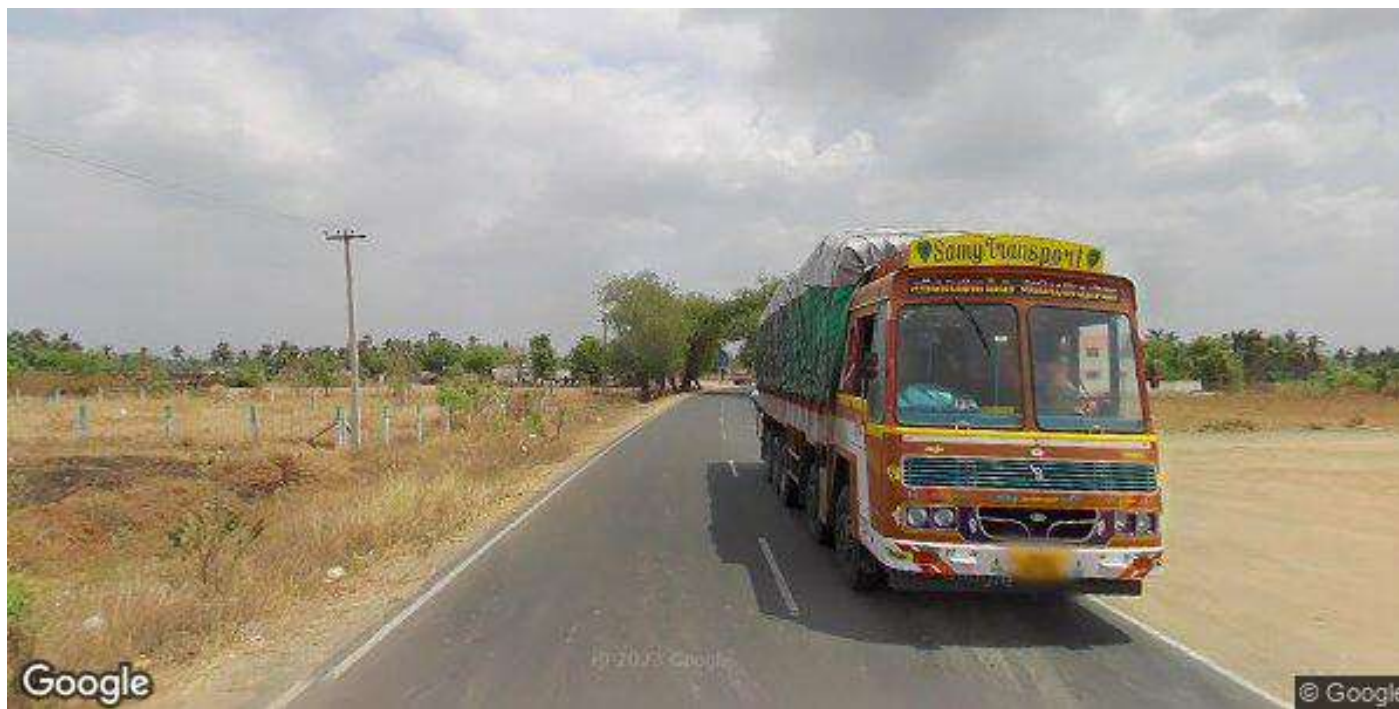
**Risk Type:** Turn  
**Risk Level:** High  
**Speed Limit:** 15 KM/Hr  
**Coordinates:** 11.55614, 77.89764

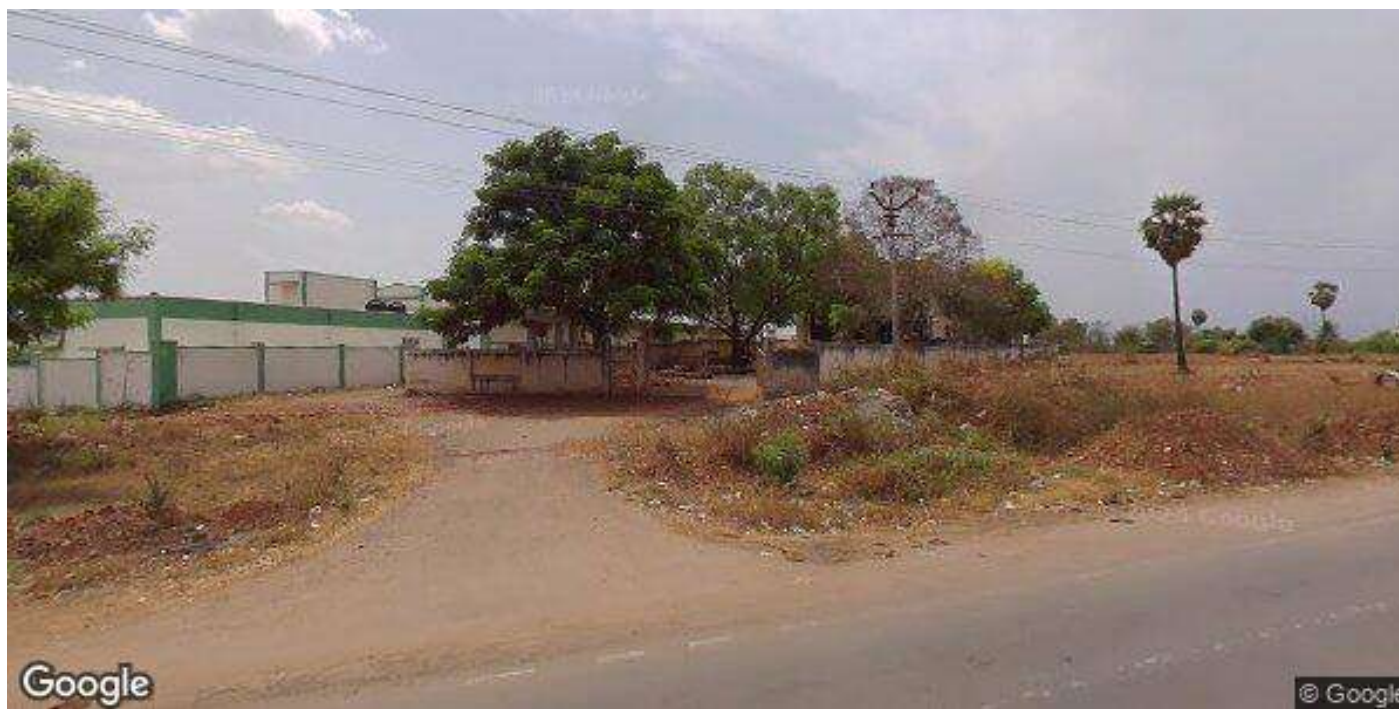
**Risk Type:** Turn  
**Risk Level:** High  
**Speed Limit:** 15 KM/Hr  
**Coordinates:** 11.58317, 77.90647

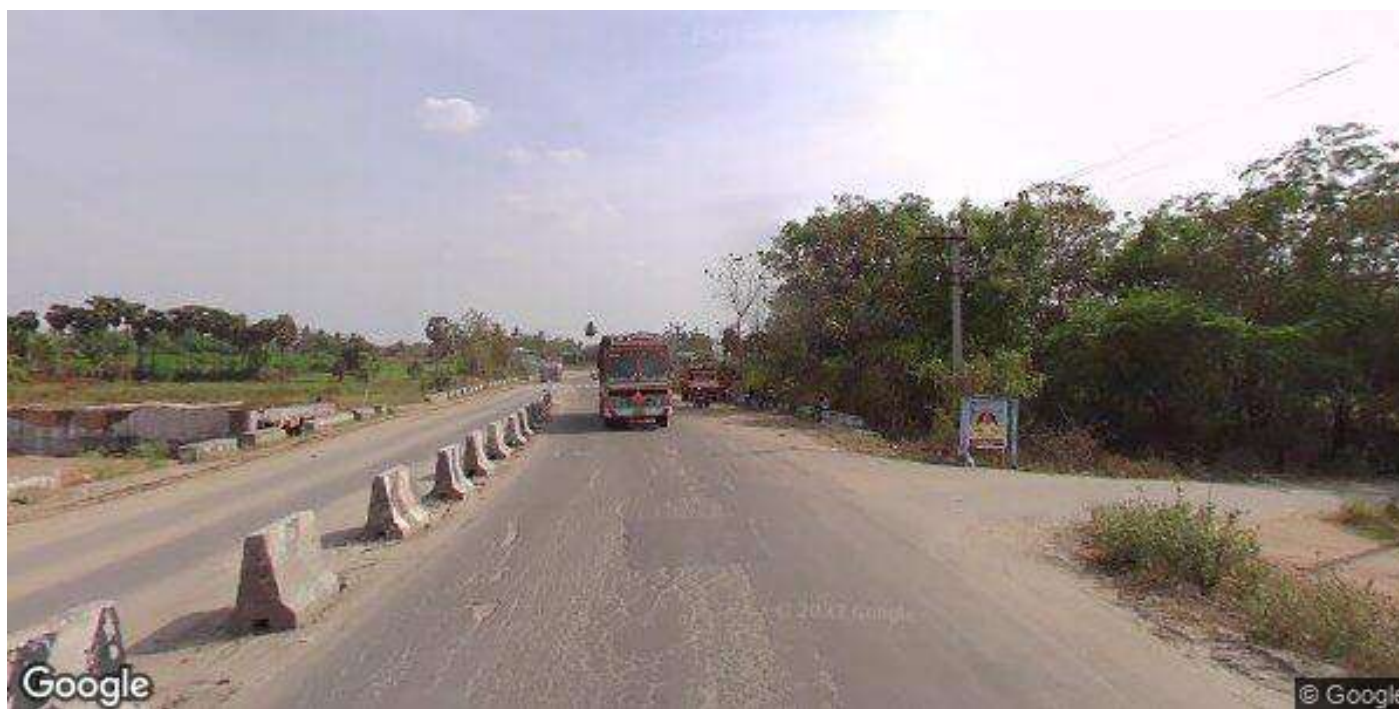
**Risk Type:** Turn  
**Risk Level:** Medium  
**Speed Limit:** 30 KM/Hr  
**Coordinates:** 11.63840, 77.94820

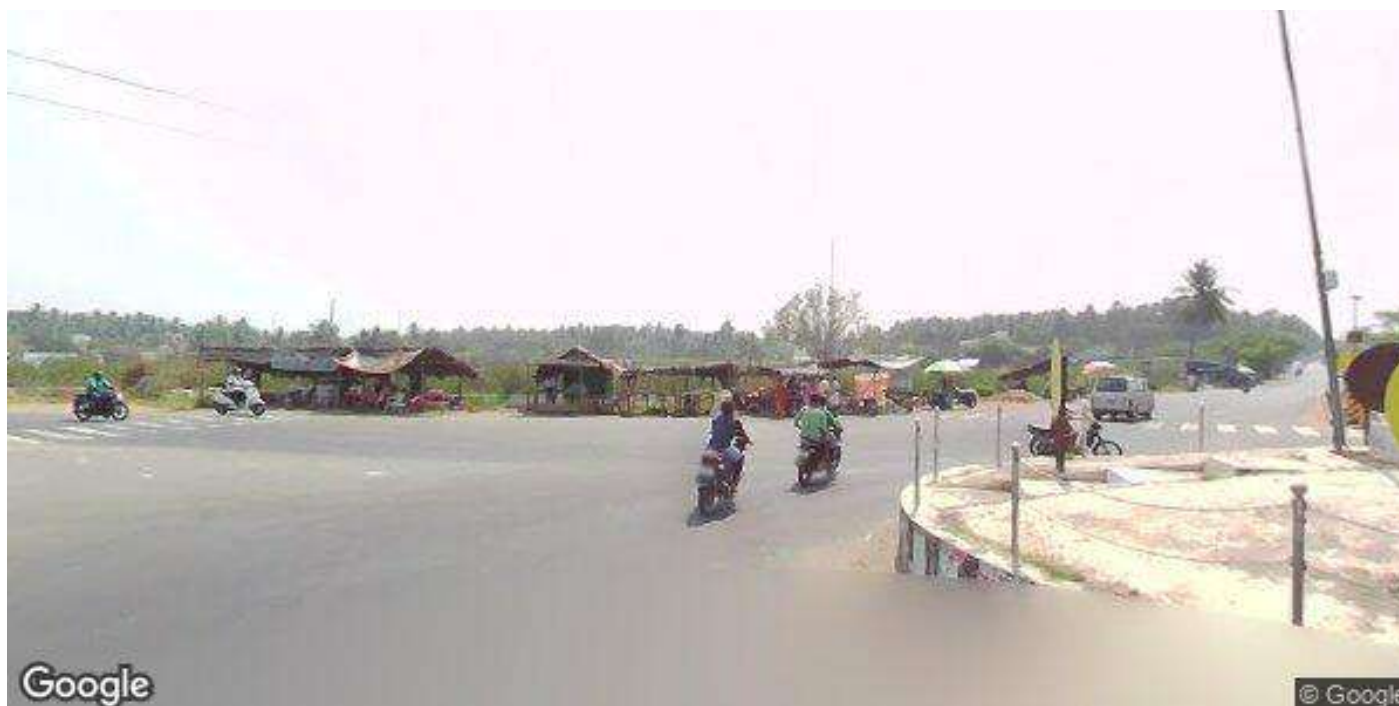
**Risk Type:** Turn  
**Risk Level:** Medium  
**Speed Limit:** 30 KM/Hr  
**Coordinates:** 11.68925, 77.97742

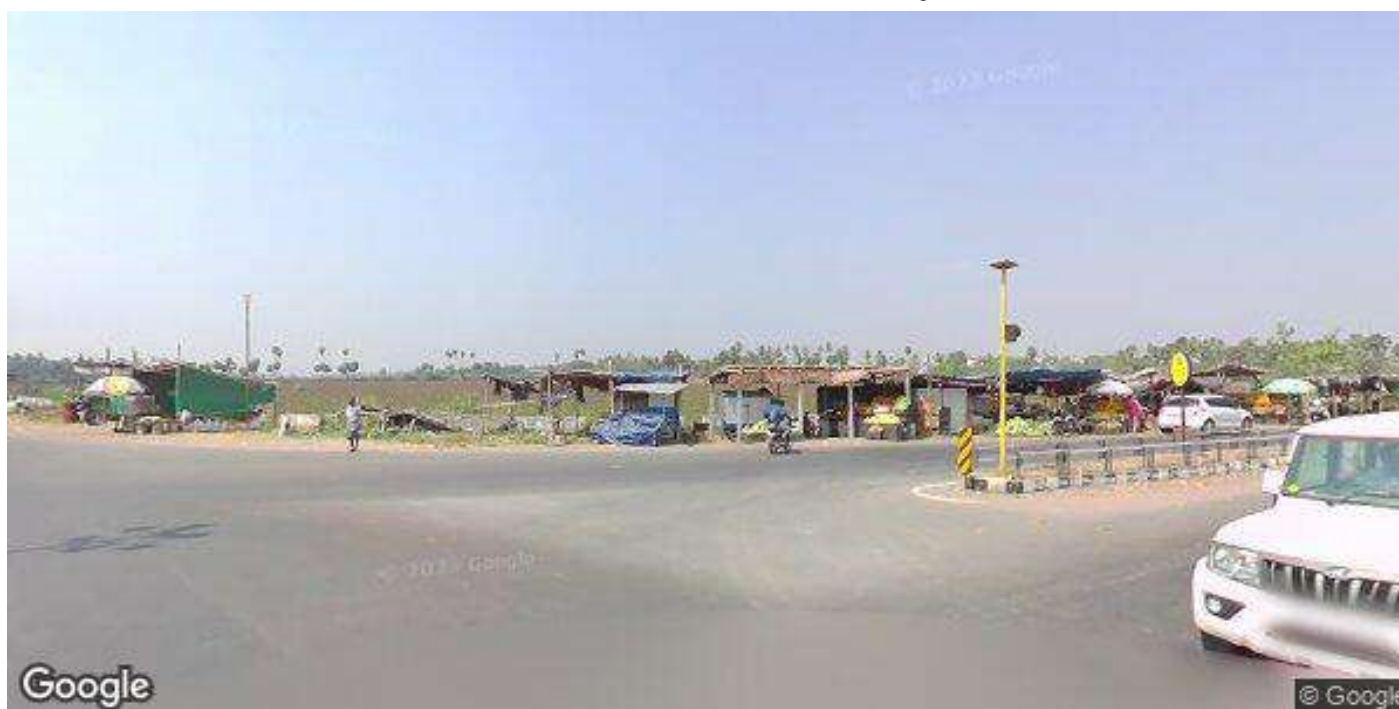
**Risk Type:** Turn  
**Risk Level:** High  
**Speed Limit:** 15 KM/Hr  
**Coordinates:** 11.68927, 77.97748

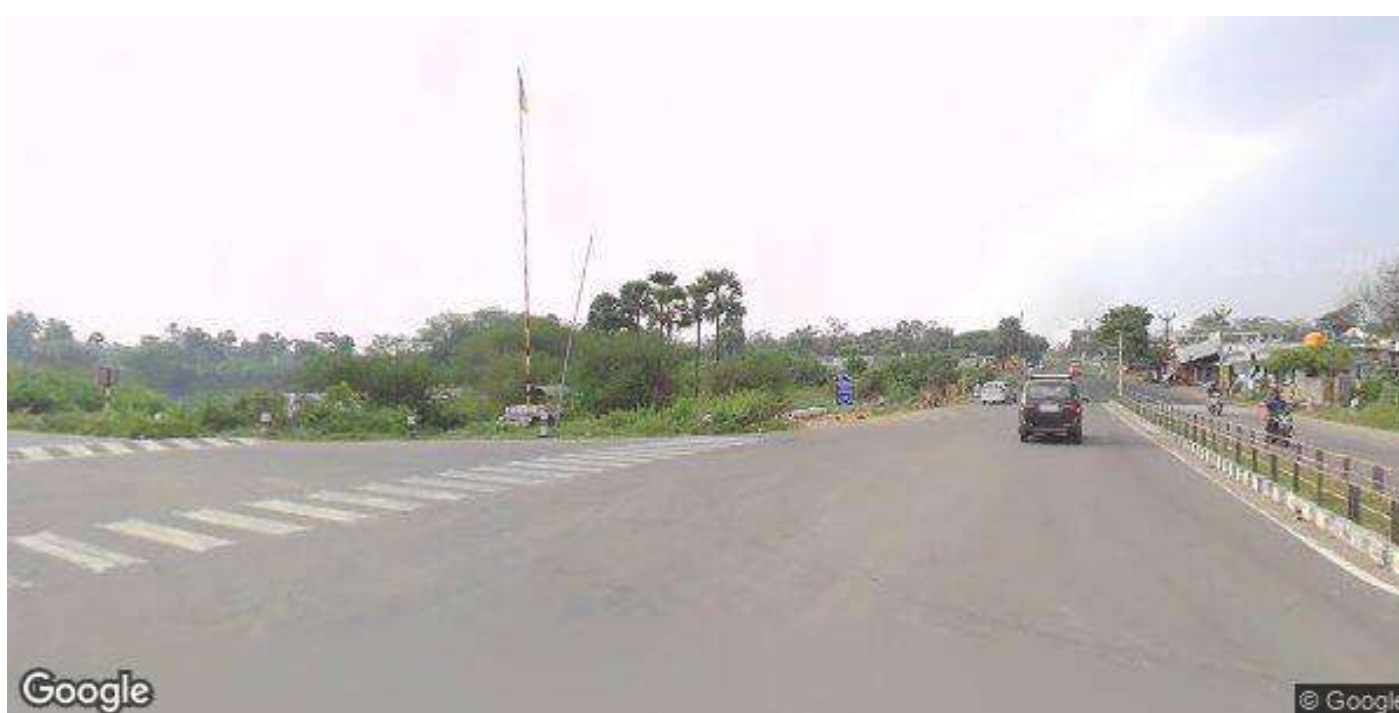
**Risk Type:** Turn  
**Risk Level:** Medium  
**Speed Limit:** 30 KM/Hr  
**Coordinates:** 11.70218, 77.97866

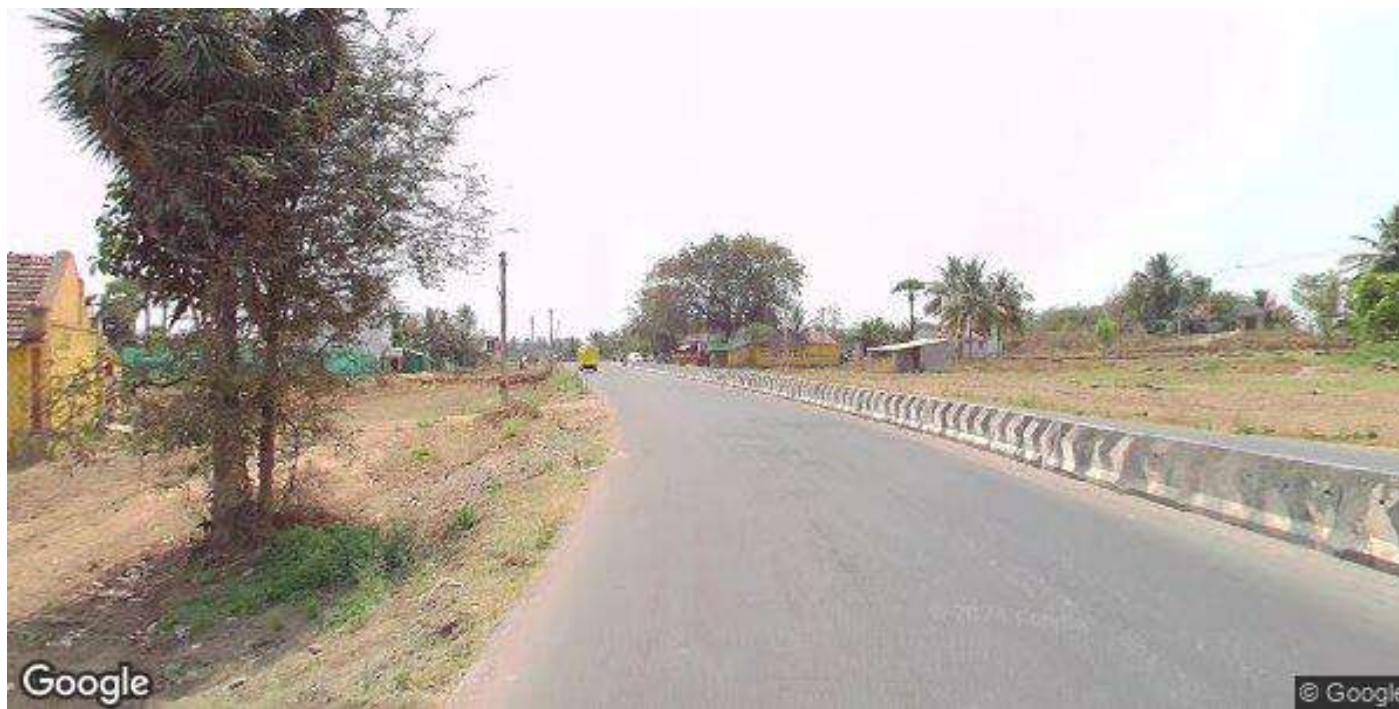
**Risk Type:** Turn  
**Risk Level:** Medium  
**Speed Limit:** 30 KM/Hr  
**Coordinates:** 11.72565, 78.01770

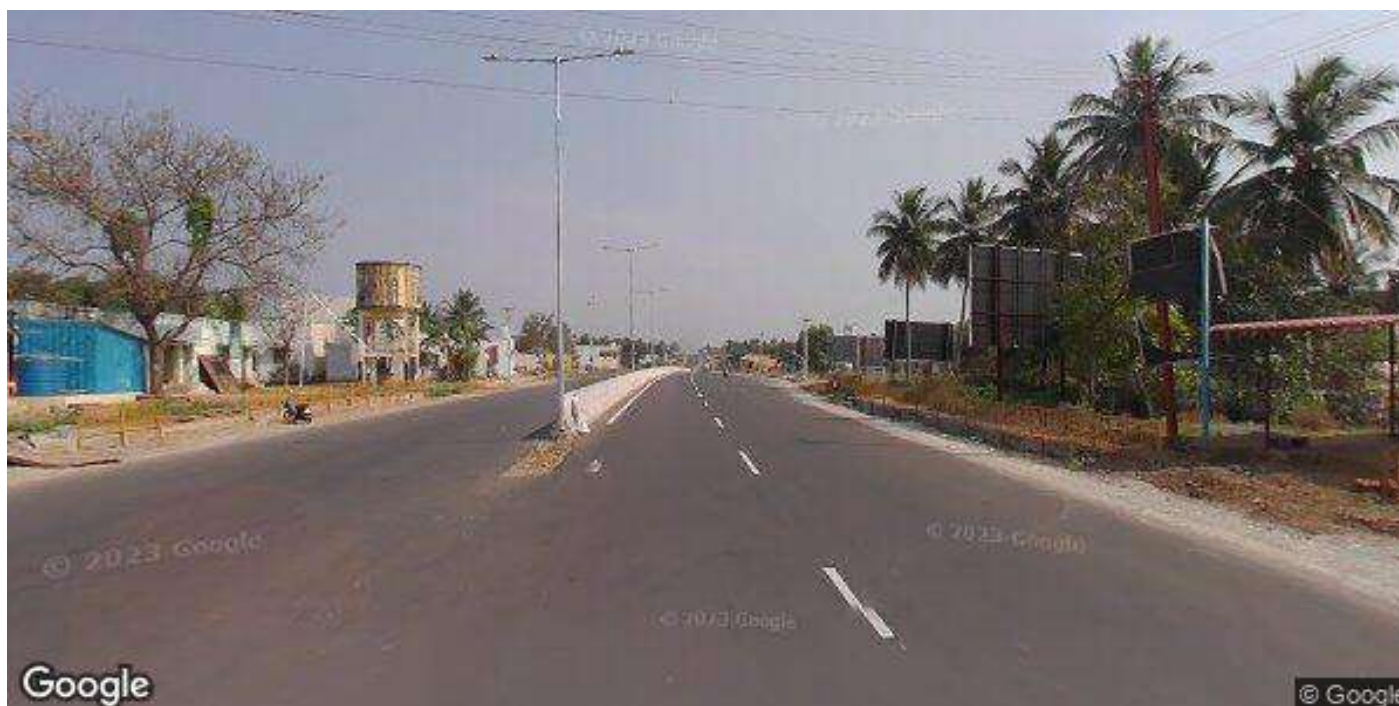
**Risk Type:** Turn  
**Risk Level:** High  
**Speed Limit:** 15 KM/Hr  
**Coordinates:** 11.76193, 78.01473

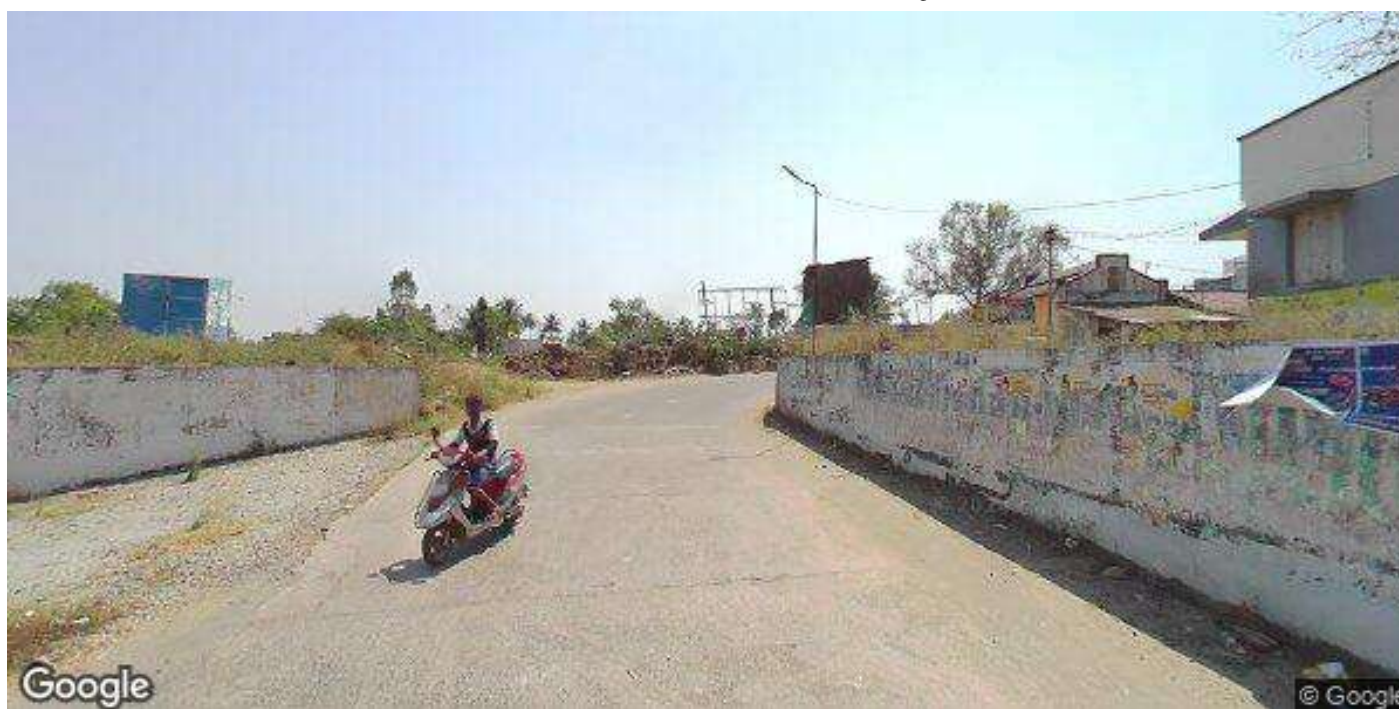
**Risk Type:** Turn  
**Risk Level:** High  
**Speed Limit:** 15 KM/Hr  
**Coordinates:** 11.78957, 78.02669

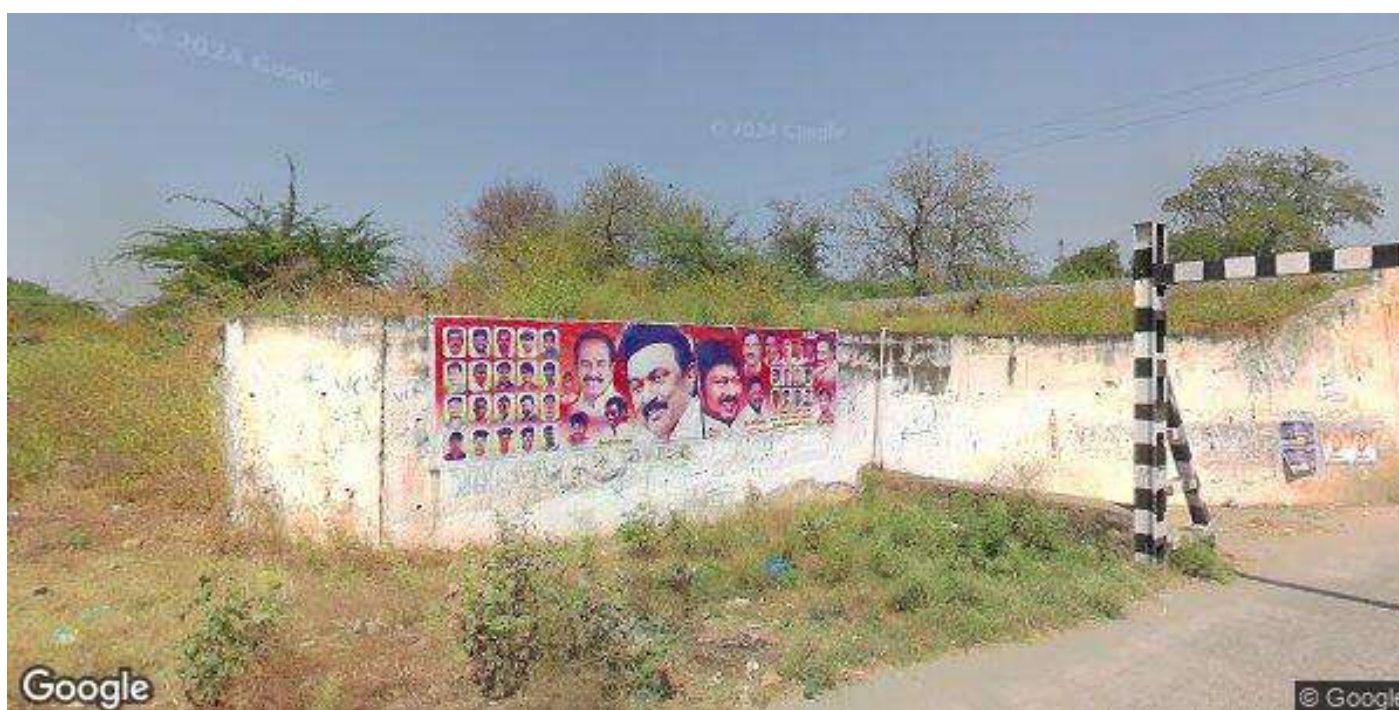
**Risk Type:** Turn  
**Risk Level:** High  
**Speed Limit:** 15 KM/Hr  
**Coordinates:** 11.78987, 78.02684

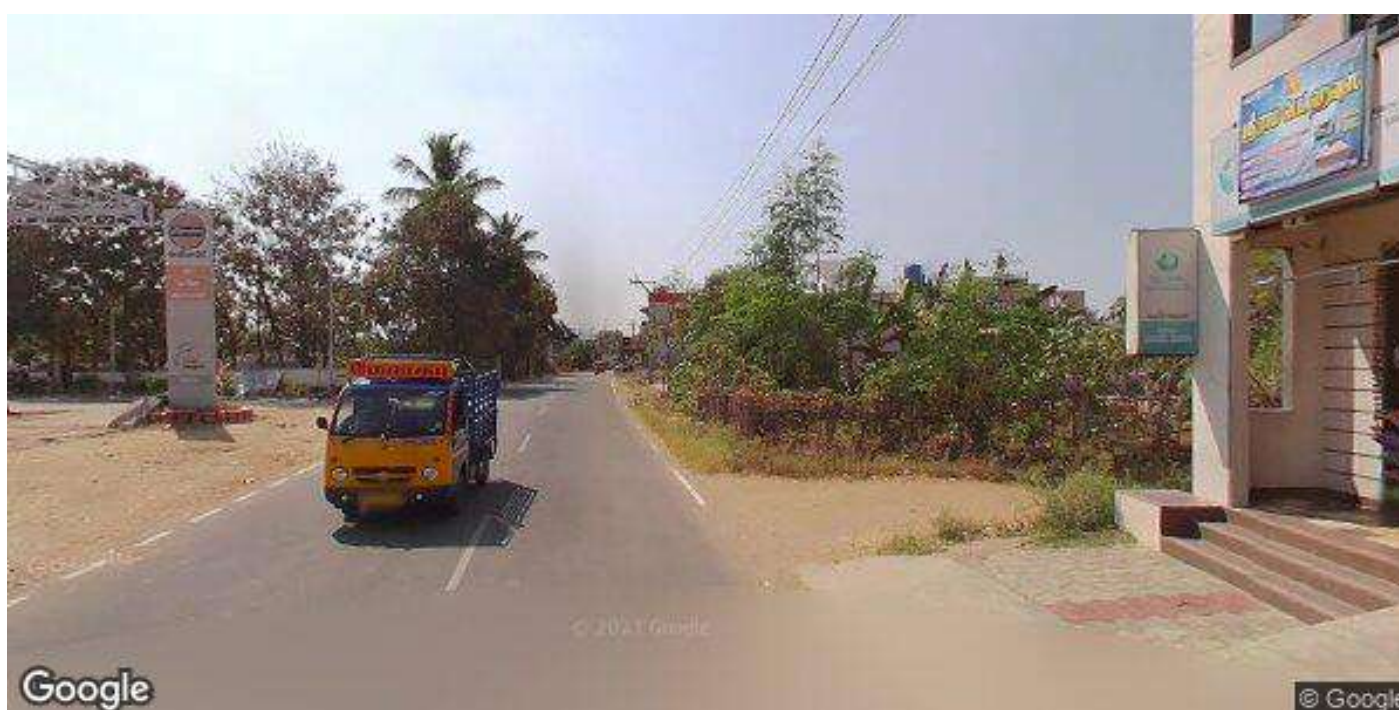
**Risk Type:** Blind Spot  
**Risk Level:** Blind Spot  
**Speed Limit:** 10 KM/Hr  
**Coordinates:** 11.79002, 78.03301
