# IndianOil

## JOURNEY RISK MANAGEMENT (JRM) STUDY

### Salem Terminal TO SREE SAPTHAGIRI AGENCIES

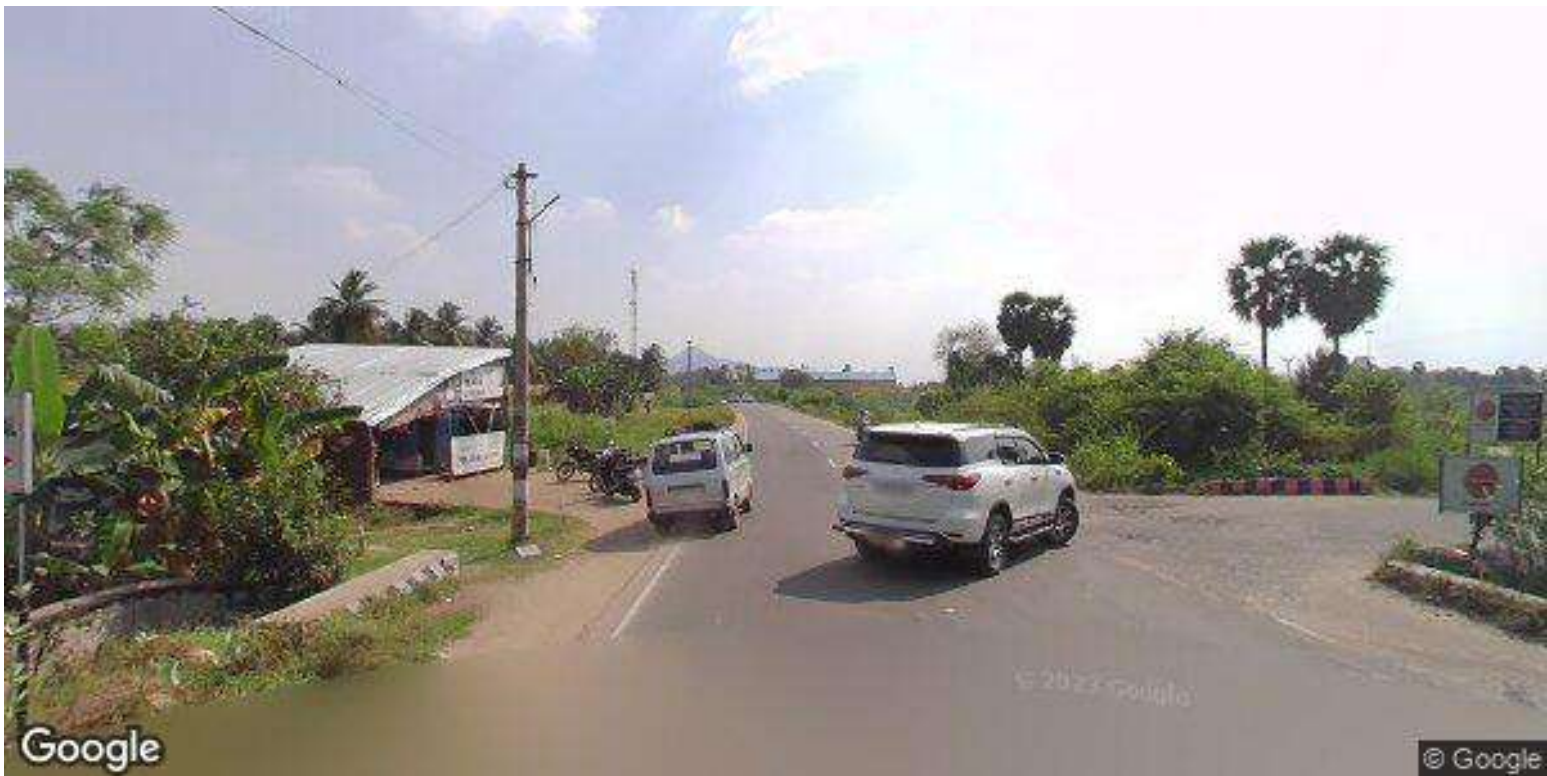
Coordinates: 11.44029, 77.87544

Risk Type: Turn

Risk Level: High

Speed Limit: 15 KM/Hr

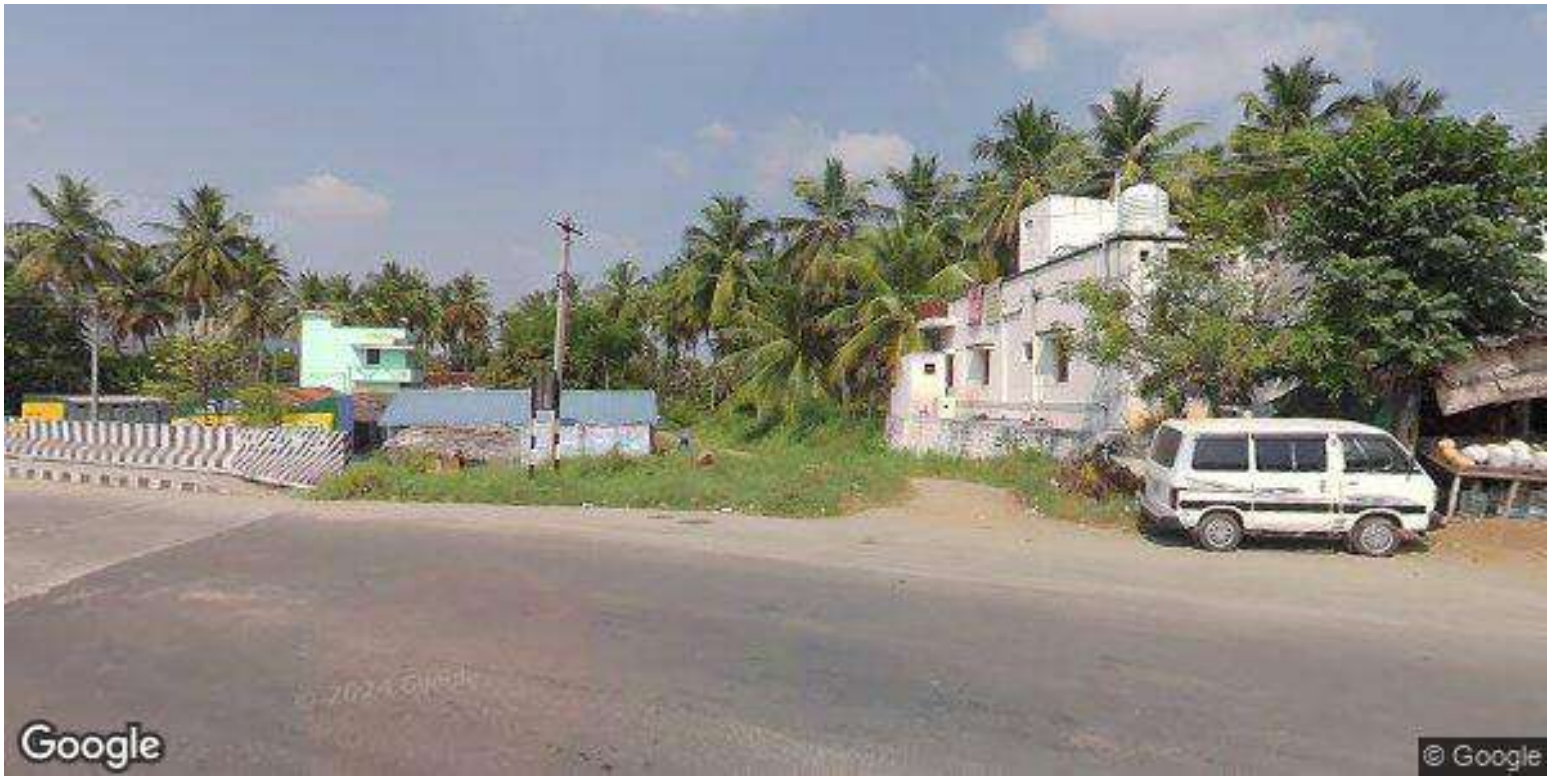
Risk Type: Turn

Risk Level: Medium

**Speed Limit: 30 KM/Hr**  
**Coordinates: 11.44898, 77.87410**

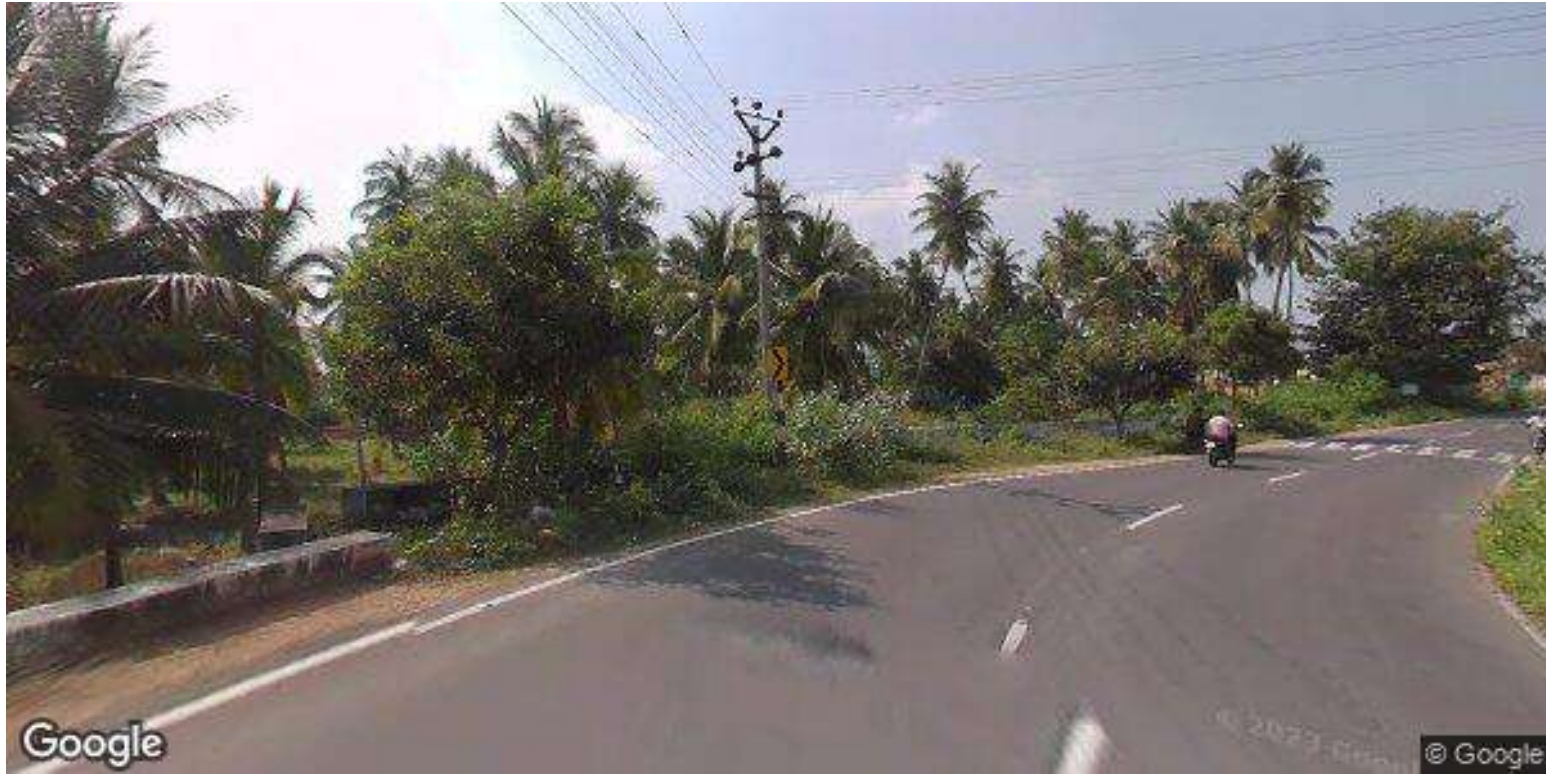
**Risk Type: Turn**  
**Risk Level: Medium**  
**Speed Limit: 30 KM/Hr**  
**Coordinates: 11.45348, 77.85706**

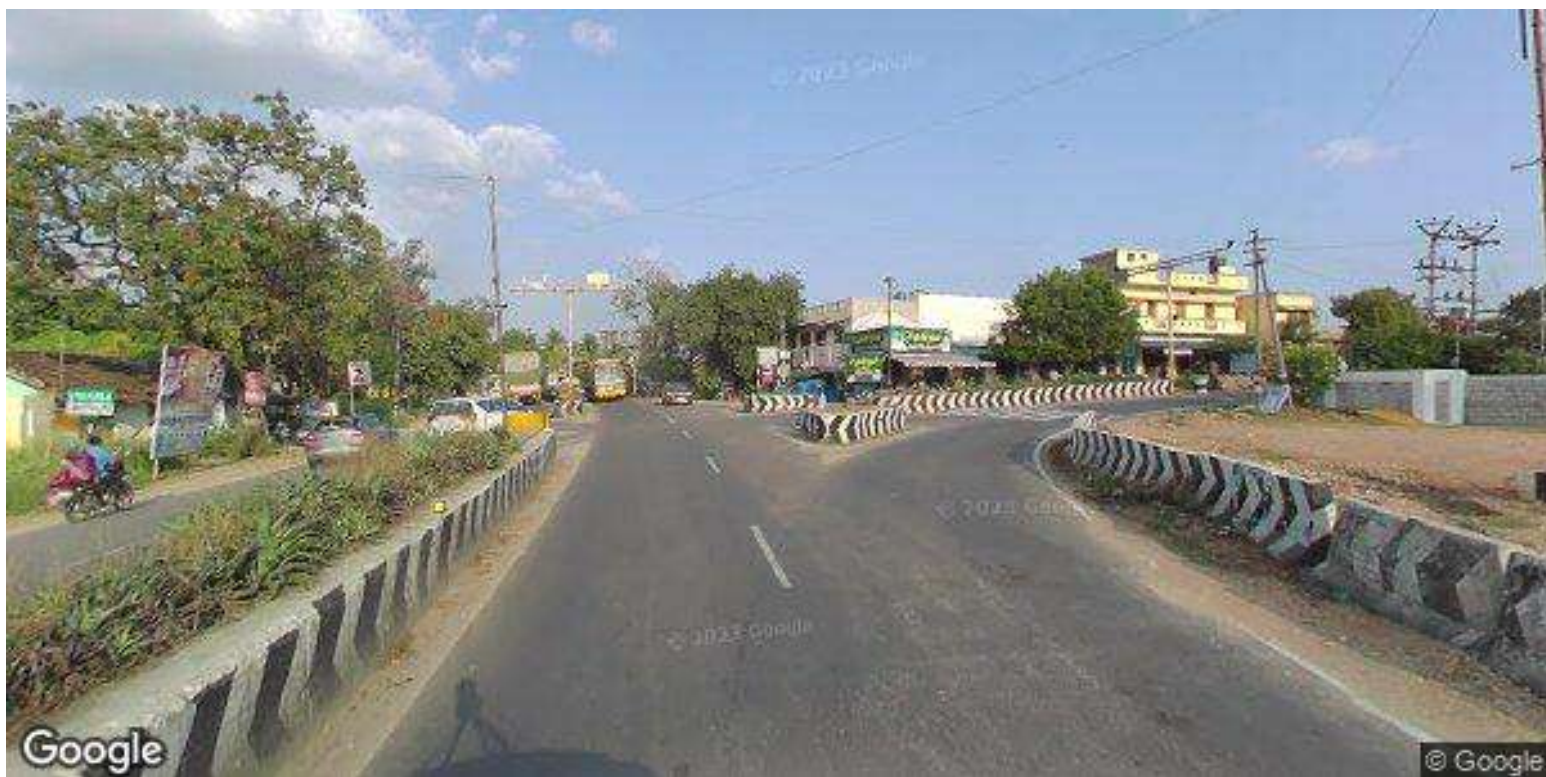
**Risk Type: Turn**  
**Risk Level: Medium**  
**Speed Limit: 30 KM/Hr**  
**Coordinates: 11.46318, 77.84913**

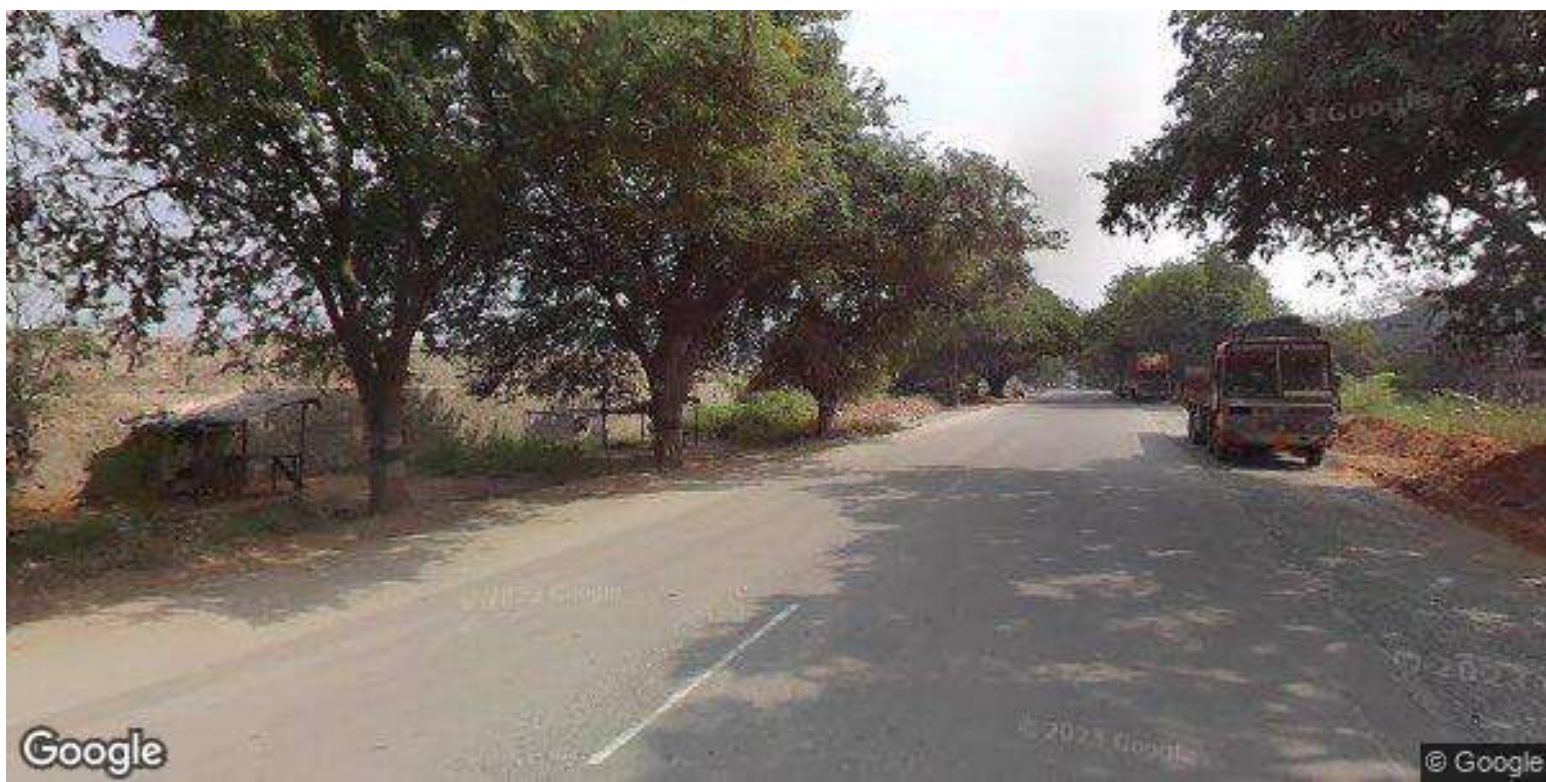
**Coordinates:** 11.45697, 77.82719

**Risk Type:** Turn

**Risk Level:** Medium

**Speed Limit:** 30 KM/Hr

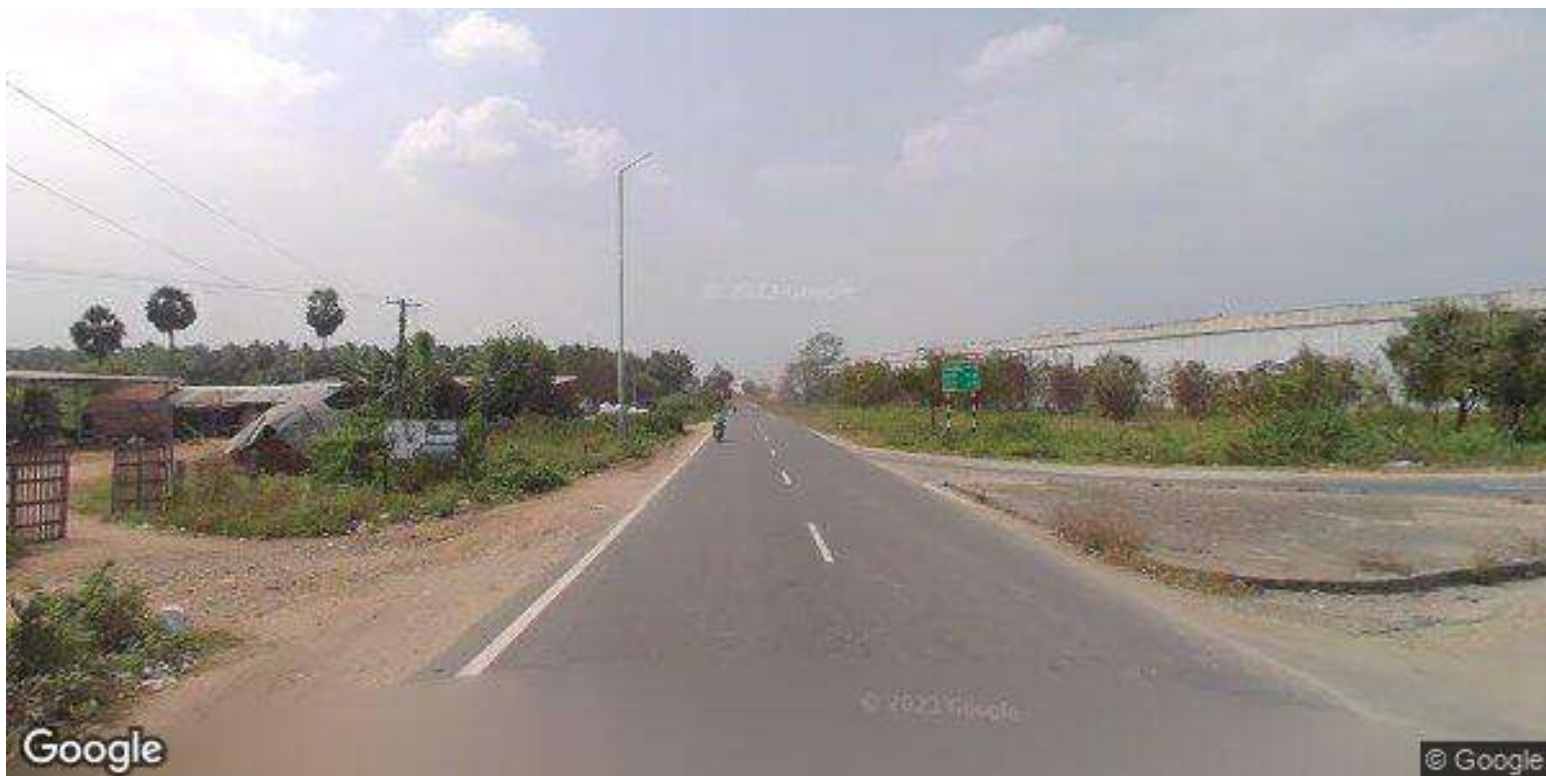
**Coordinates:** 11.45542, 77.81725

**Risk Type:** Turn

**Risk Level:** High

**Speed Limit:** 15 KM/Hr

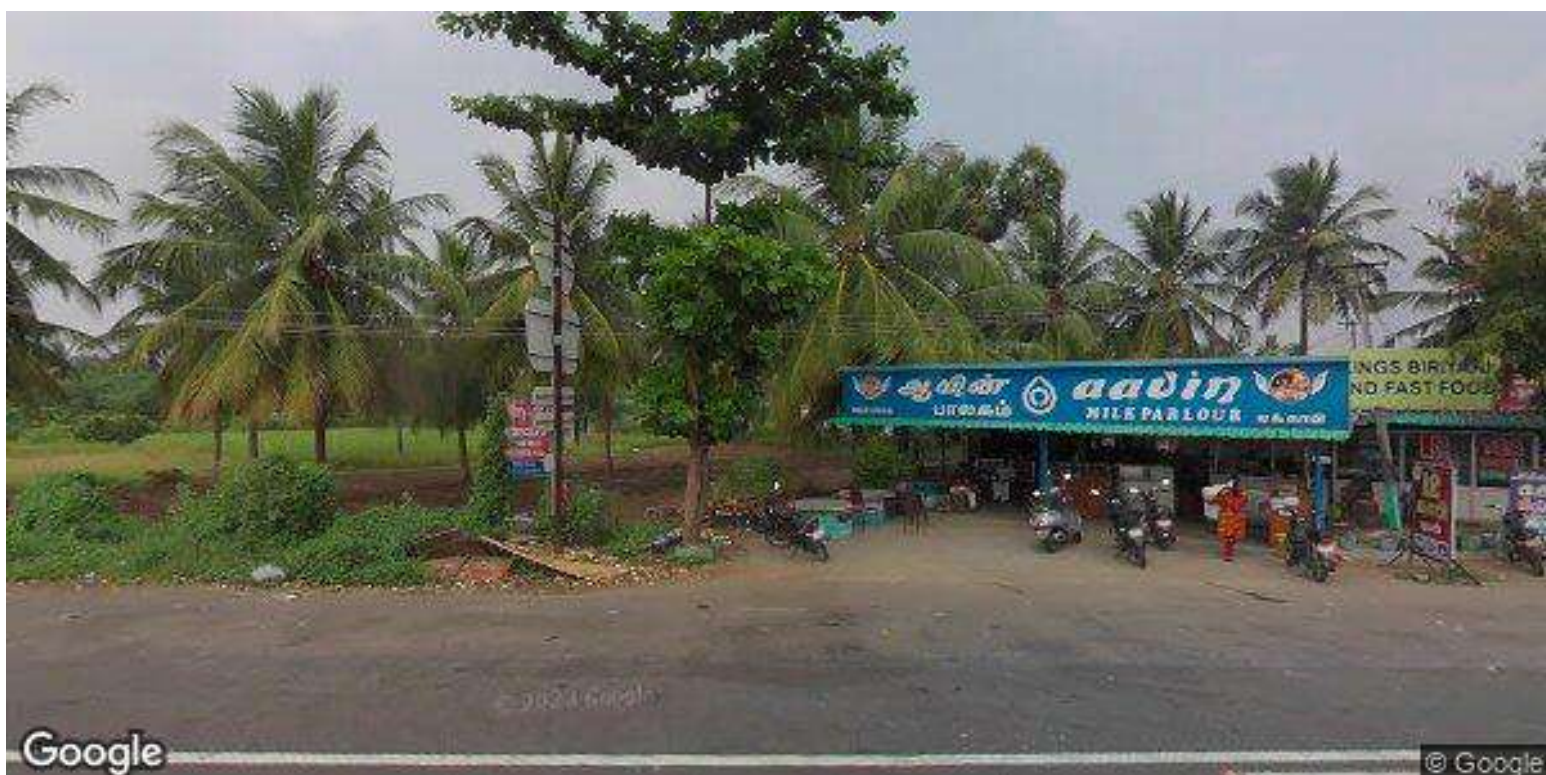
**Risk Type:** Turn  
**Risk Level:** High  
**Speed Limit:** 15 KM/Hr  
**Coordinates:** 11.45631, 77.81668

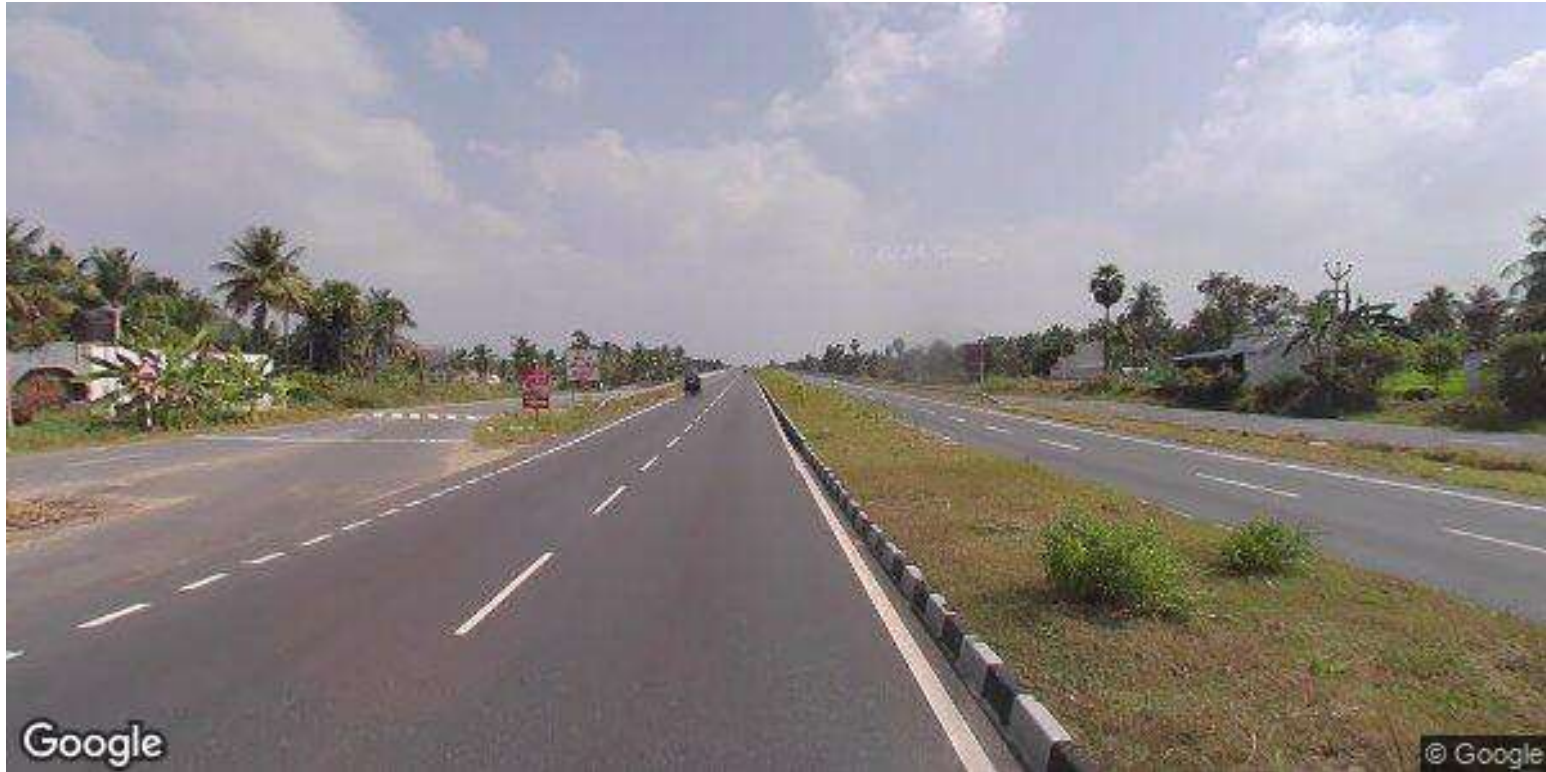
**Risk Type:** Turn  
**Risk Level:** Medium  
**Speed Limit:** 30 KM/Hr  
**Coordinates:** 11.49249, 77.85821

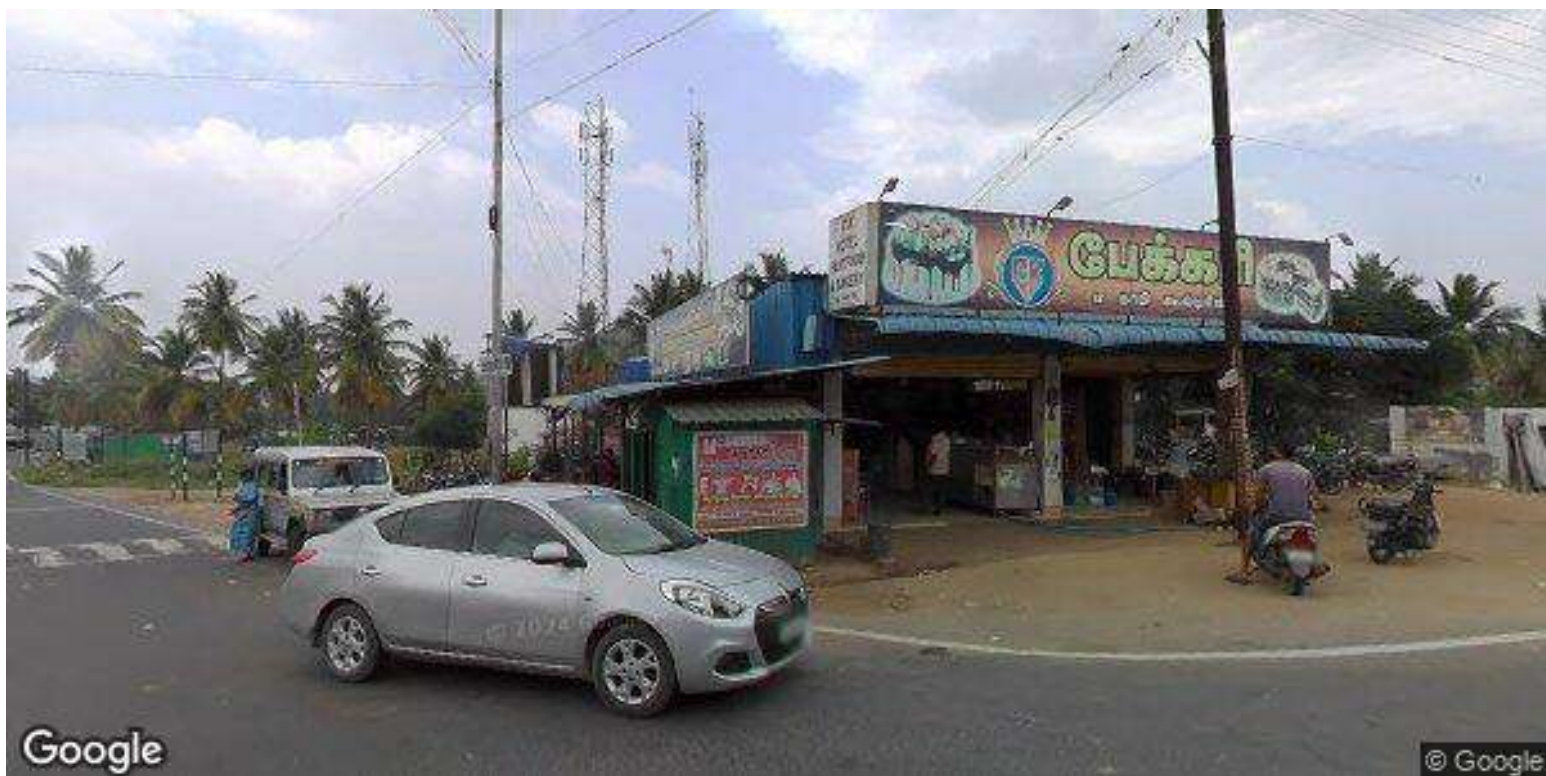
**Risk Type:** Blind Spot  
**Risk Level:** Blind Spot  
**Speed Limit:** 10 KM/Hr  
**Coordinates:** 11.49390, 77.86748

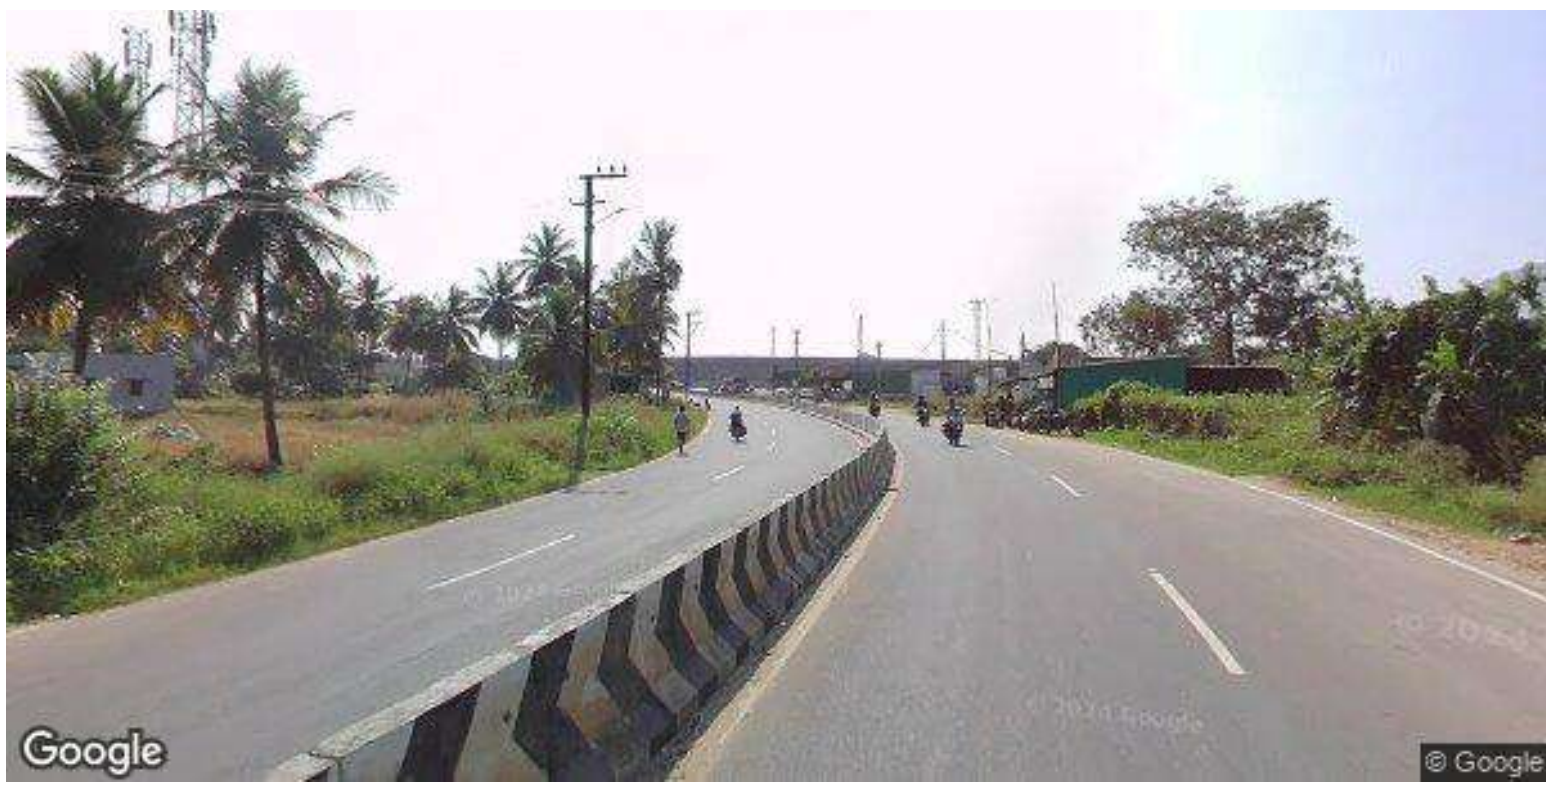
**Coordinates:** 11.49513, 77.86656

**Risk Type:** Turn

**Risk Level:** Medium

**Speed Limit:** 30 KM/Hr

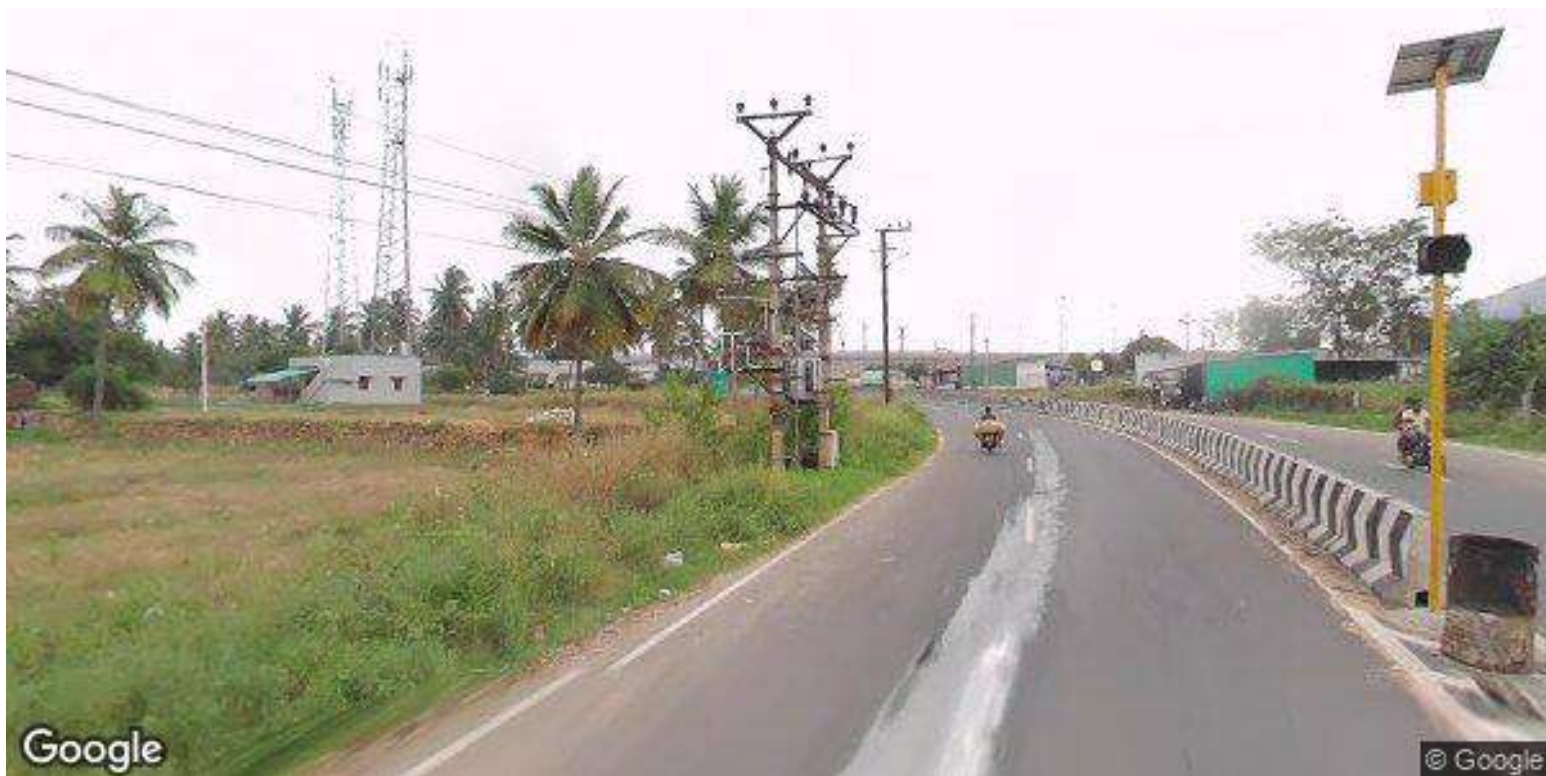
**Coordinates:** 11.49525, 77.86659

**Risk Type:** Turn

**Risk Level:** Medium

**Speed Limit:** 30 KM/Hr
