# IndianOil

## JOURNEY RISK MANAGEMENT (JRM) STUDY

### Salem Terminal to BAAGA FUELS

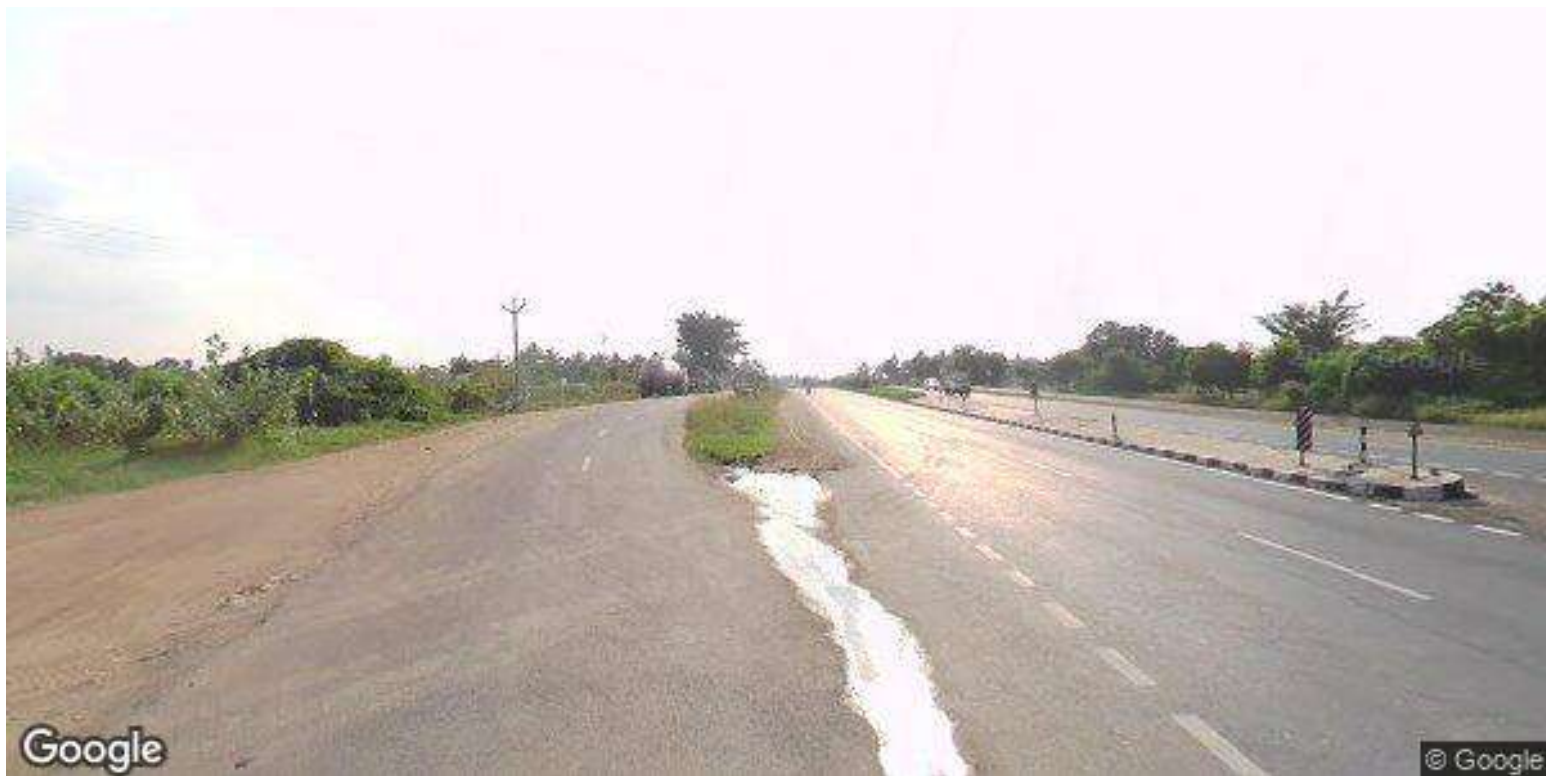
**Coordinates:** 11.3141552, 77.6131059

**Risk Type:** U-Turn

**Risk Level:** High

**Speed Limit:** 10 KM/Hr

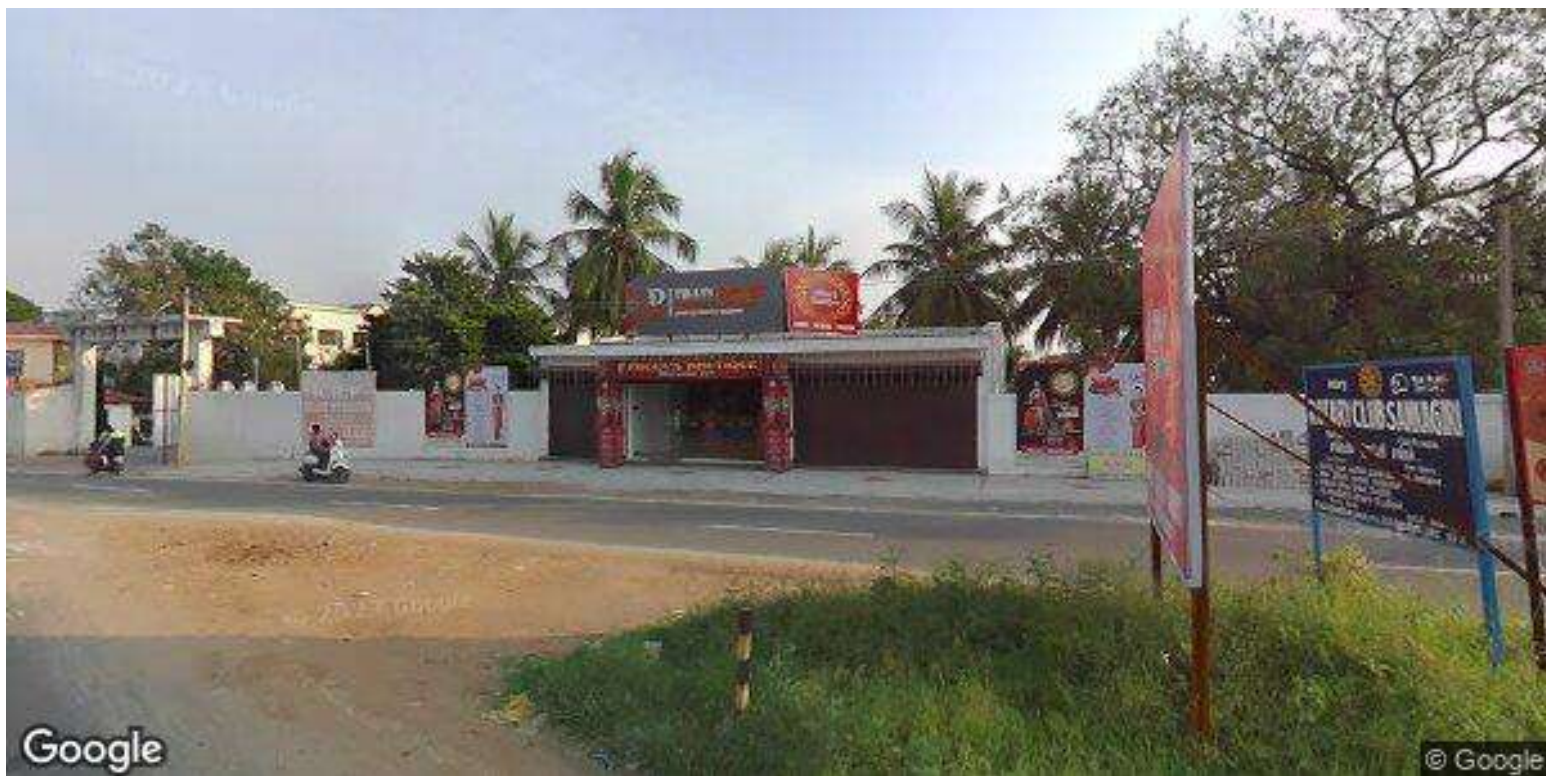
**Coordinates:** 11.45516, 77.81346

**Risk Type:** Turn

**Risk Level:** High

**Speed Limit:** 15 KM/Hr

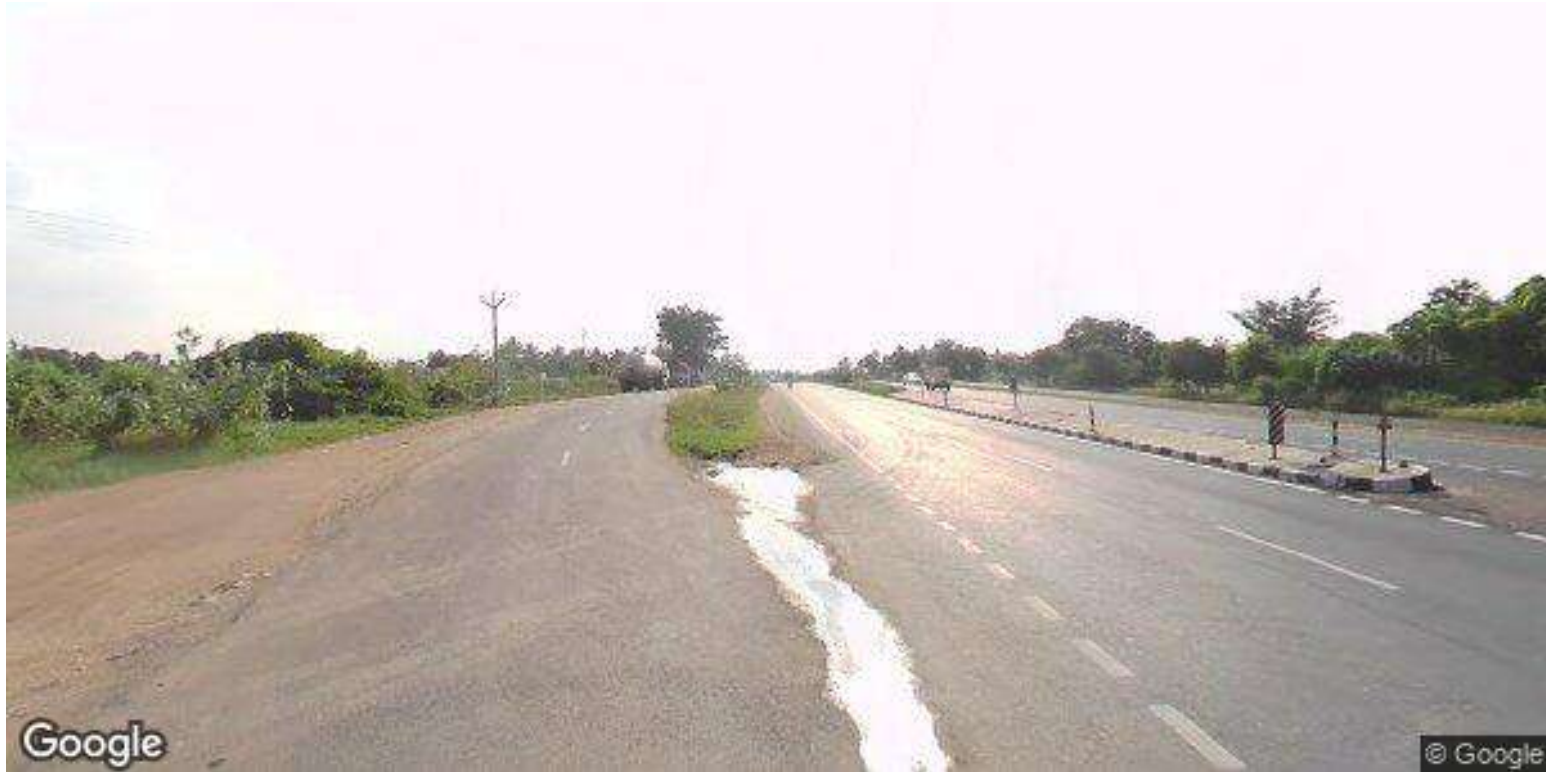
**Risk Type:** Blind Spot  
**Risk Level:** Blind Spot  
**Speed Limit:** 10 KM/Hr  
**Coordinates:** 11.31416, 77.61311

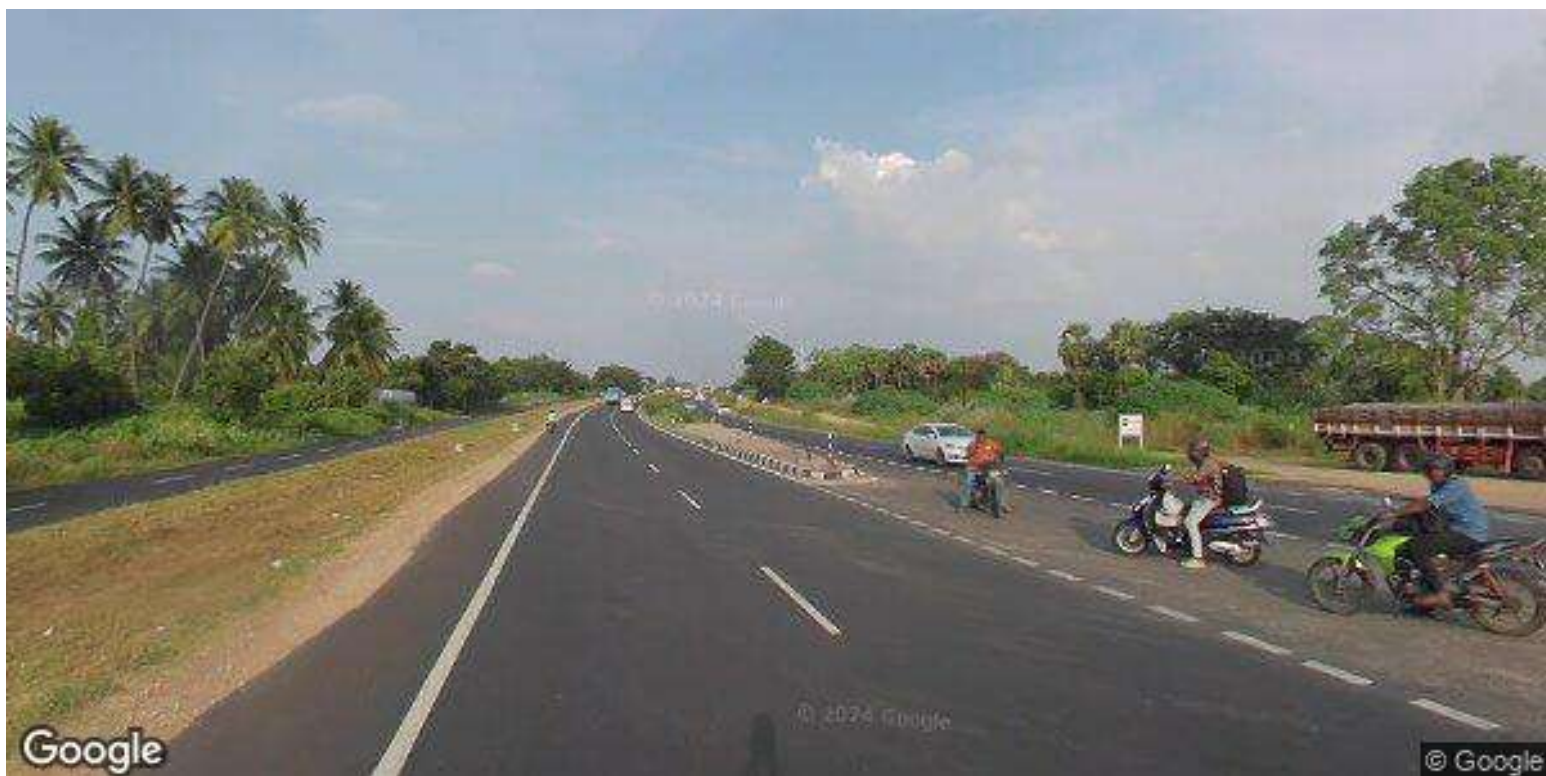
**Risk Type:** Turn  
**Risk Level:** High  
**Speed Limit:** 15 KM/Hr  
**Coordinates:** 11.31425, 77.61303

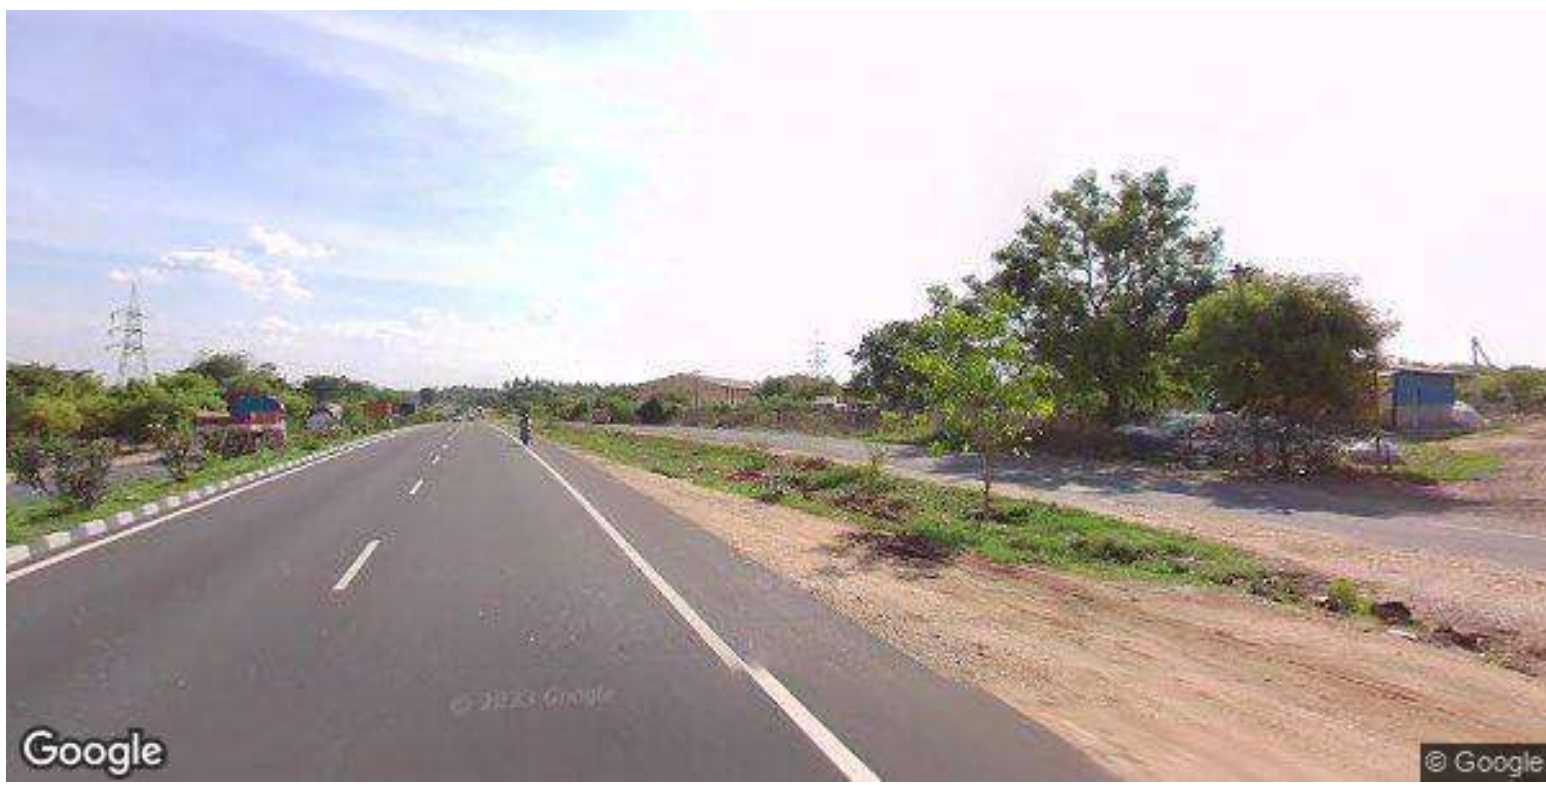
**Risk Type:** Blind Spot  
**Risk Level:** Blind Spot  
**Speed Limit:** 10 KM/Hr  
**Coordinates:** 11.31812, 77.61873

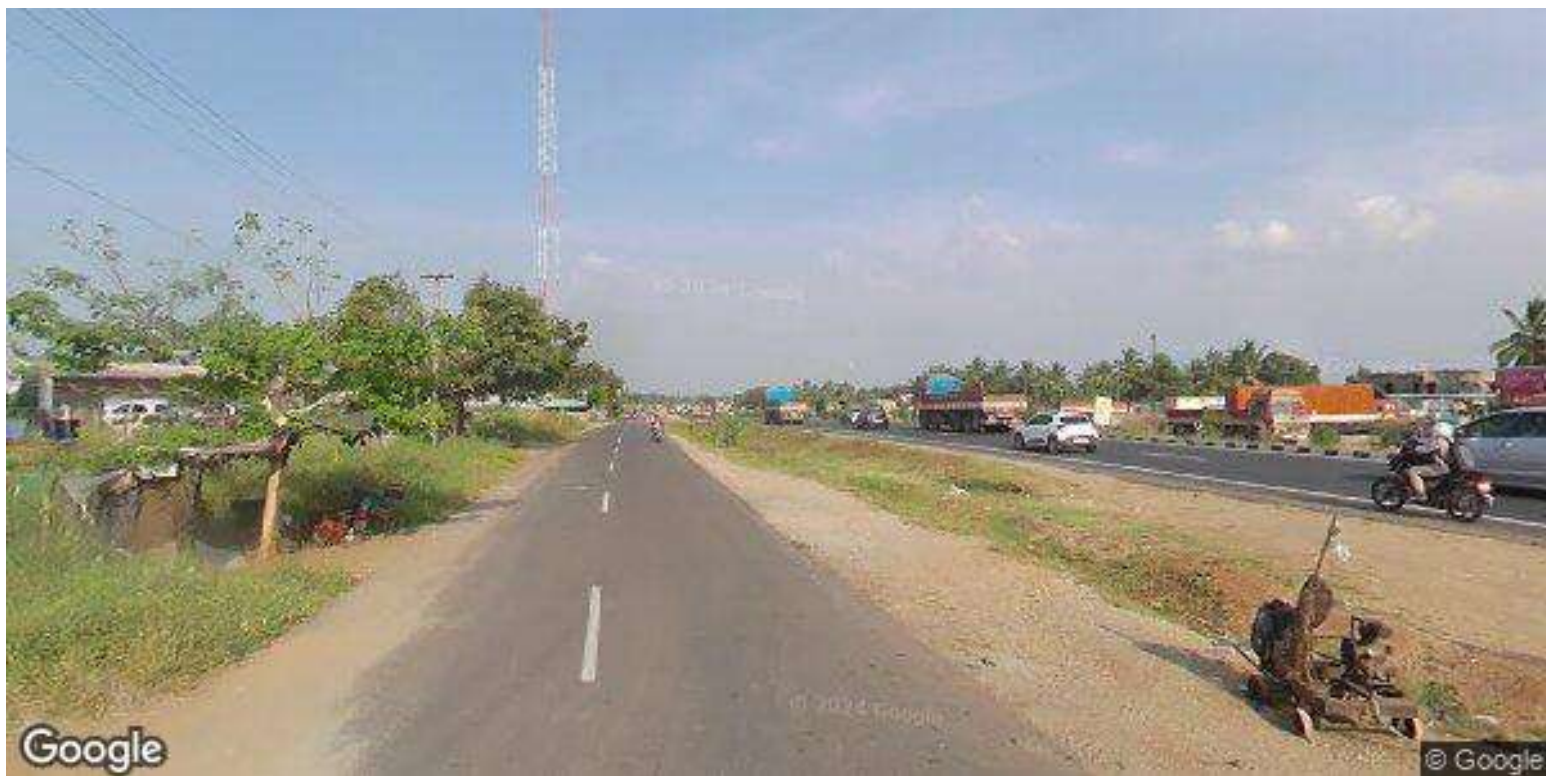
**Risk Type:** Blind Spot  
**Risk Level:** Blind Spot  
**Speed Limit:** 10 KM/Hr  
**Coordinates:** 11.31824, 77.61861

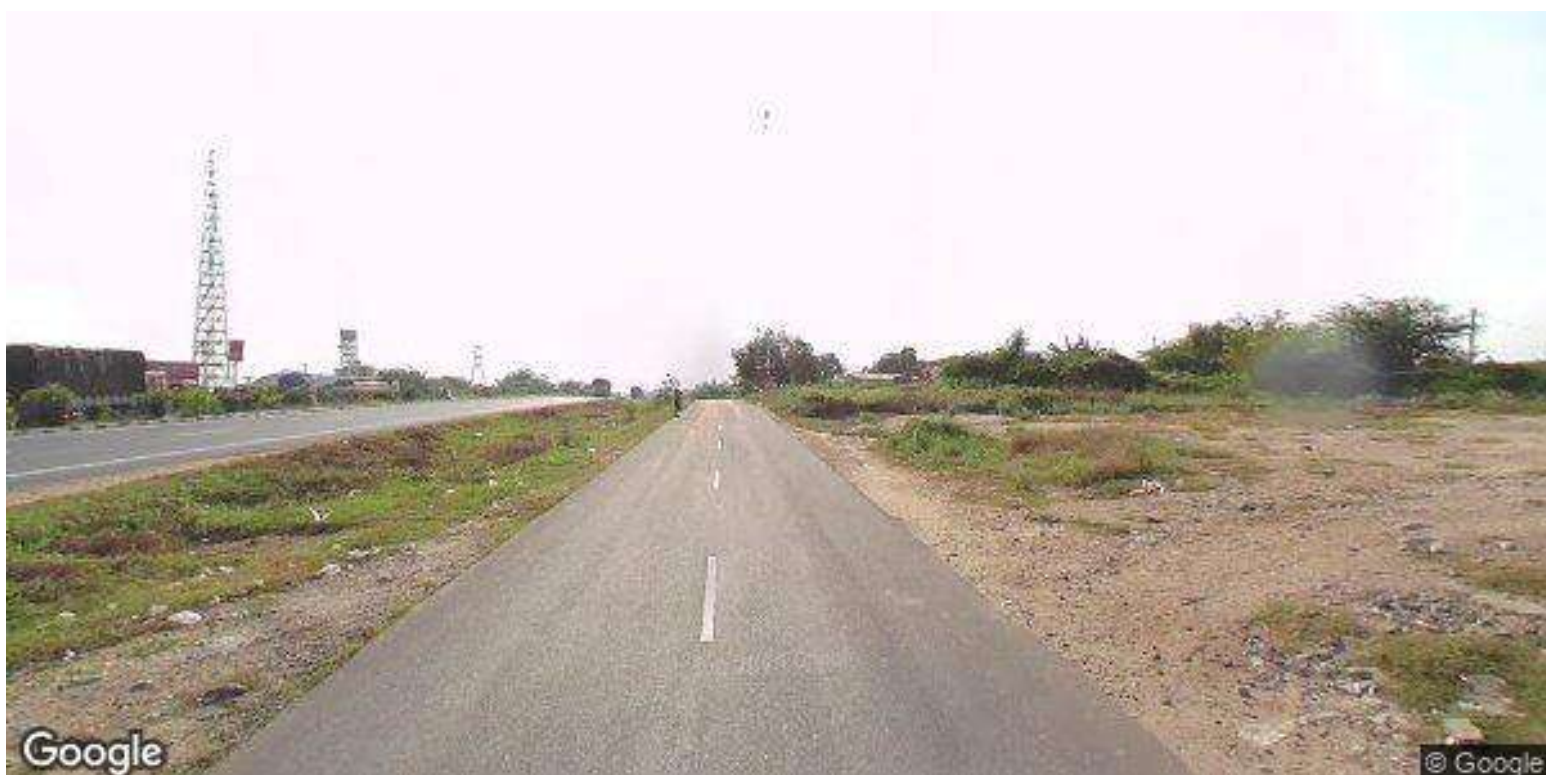
**Risk Type:** Blind Spot  
**Risk Level:** Blind Spot  
**Speed Limit:** 10 KM/Hr  
**Coordinates:** 11.31869, 77.61950

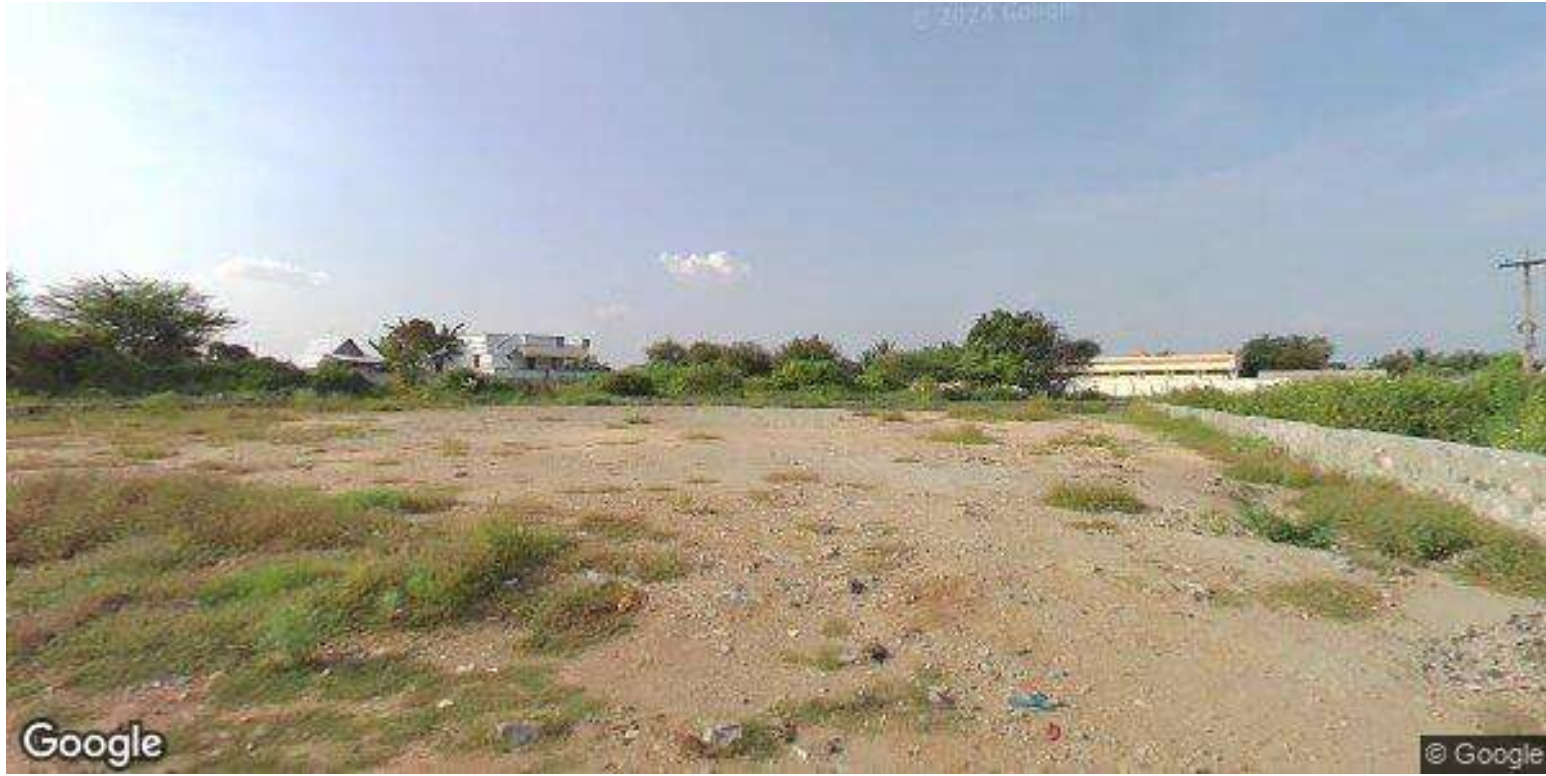
**Risk Type:** Turn  
**Risk Level:** High  
**Speed Limit:** 15 KM/Hr  
**Coordinates:** 11.31889, 77.61931
