# IndianOil

## JOURNEY RISK MANAGEMENT (JRM) STUDY

### Salem Terminal to THULASIMANI AGENCIES

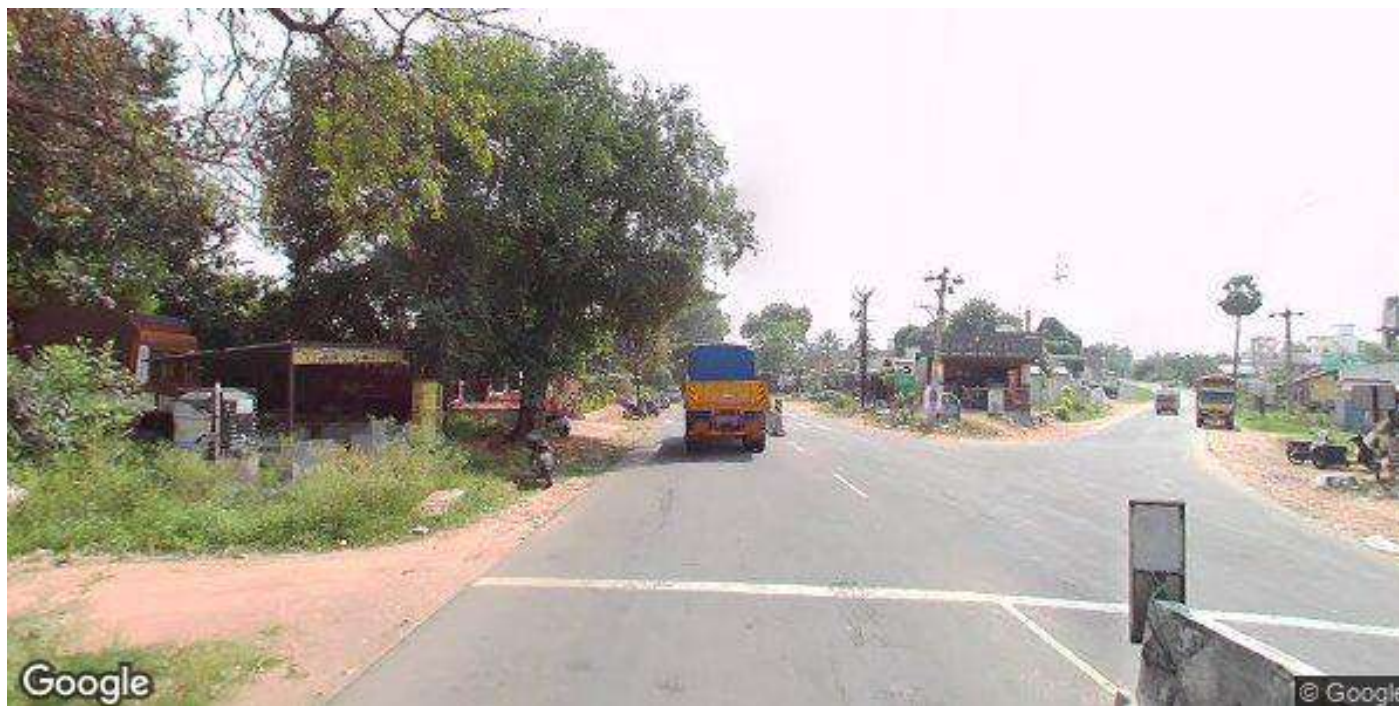
**Risk Type:** Turn  
**Risk Level:** Medium  
**Speed Limit:** 30 KM/Hr  
**Coordinates:** 11.35759, 77.89191

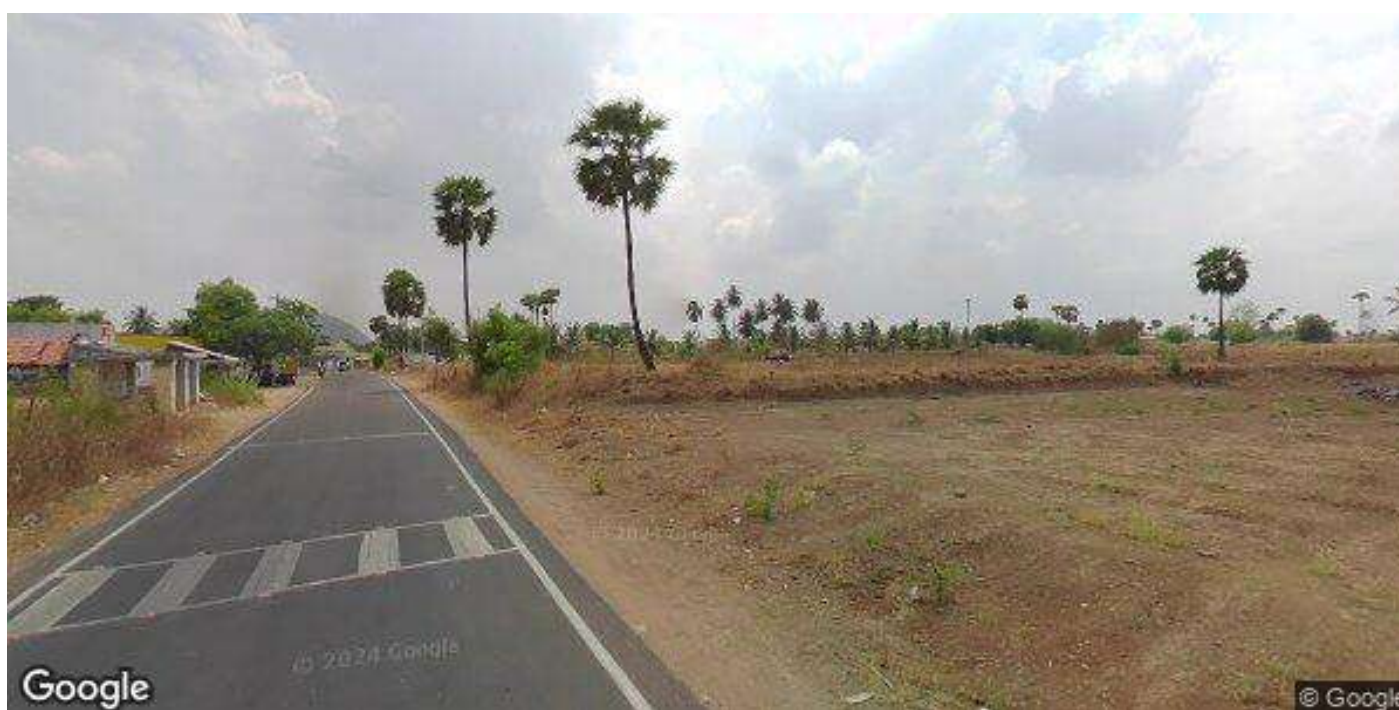
**Risk Type:** Turn  
**Risk Level:** Medium  
**Speed Limit:** 30 KM/Hr  
**Coordinates:** 11.33071, 77.88660

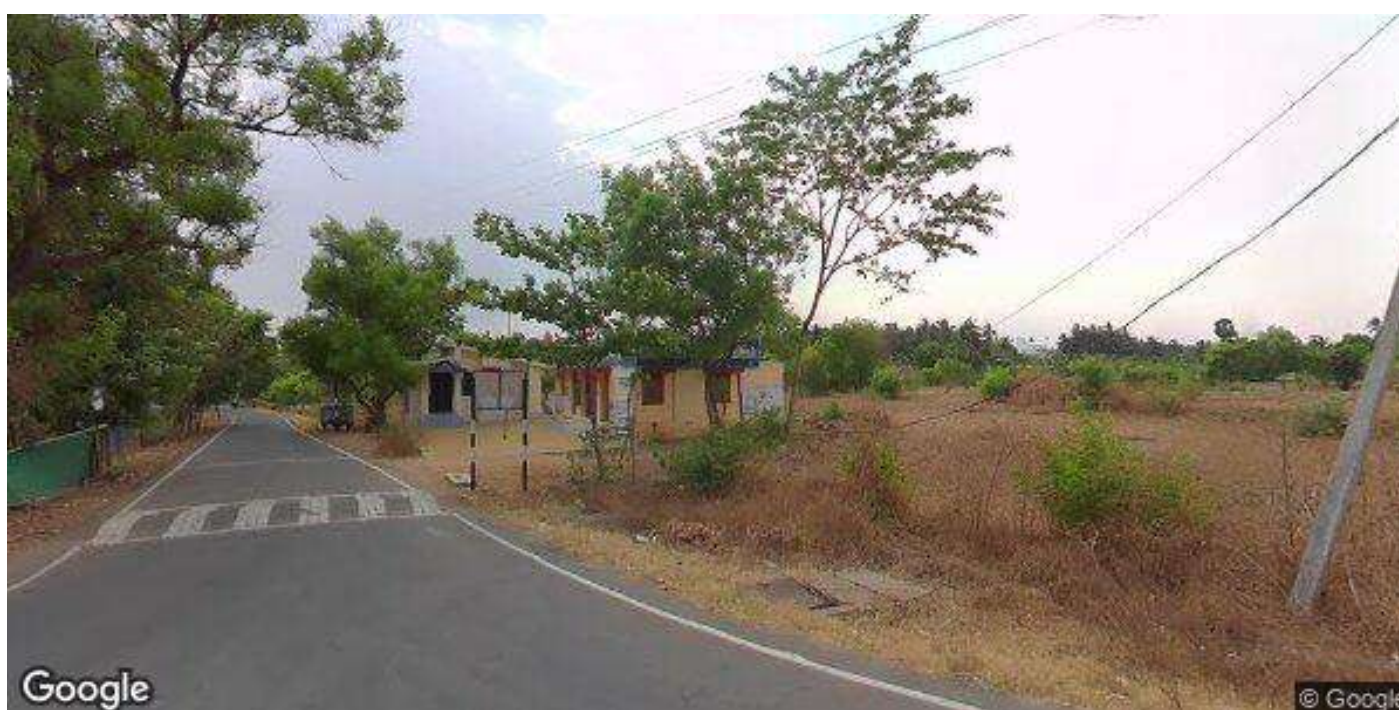
**Risk Type:** Turn  
**Risk Level:** High  
**Speed Limit:** 15 KM/Hr  
**Coordinates:** 11.33065, 77.88650

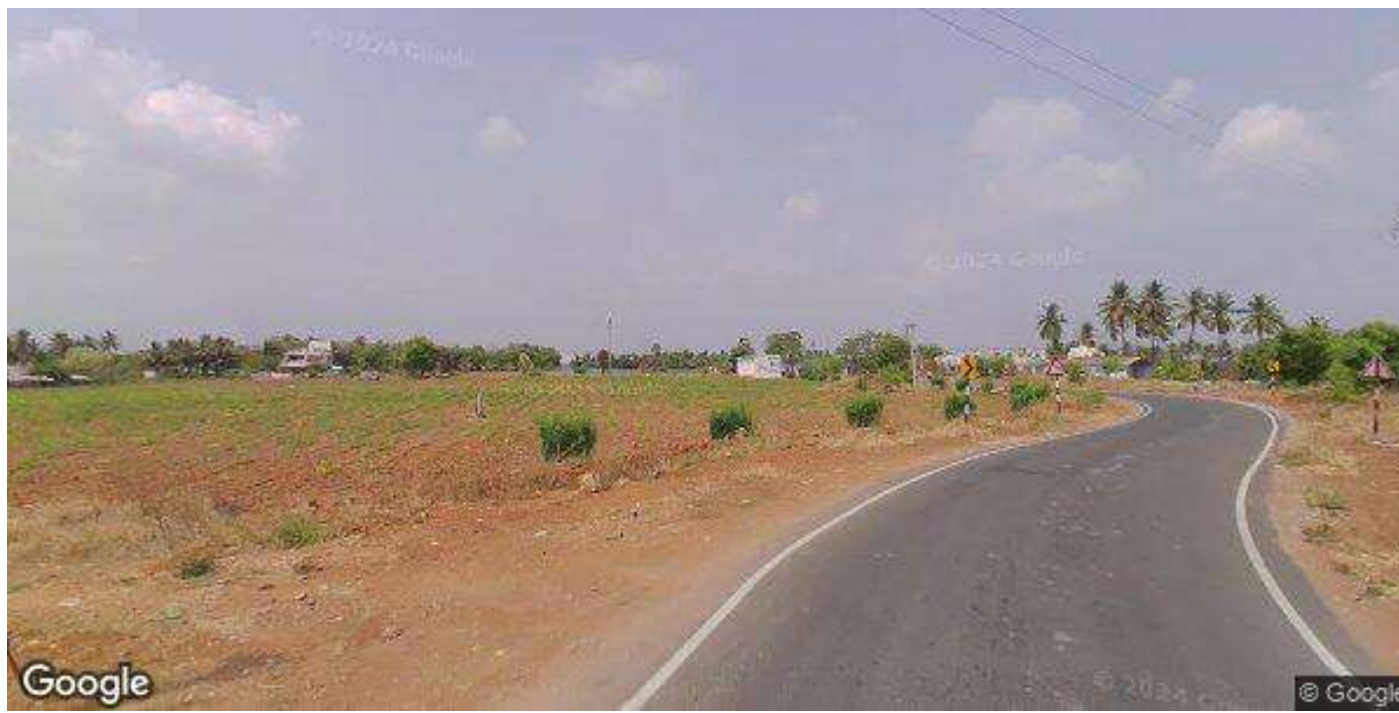
**Risk Type:** Turn  
**Risk Level:** Medium  
**Speed Limit:** 30 KM/Hr  
**Coordinates:** 11.32134, 77.88489

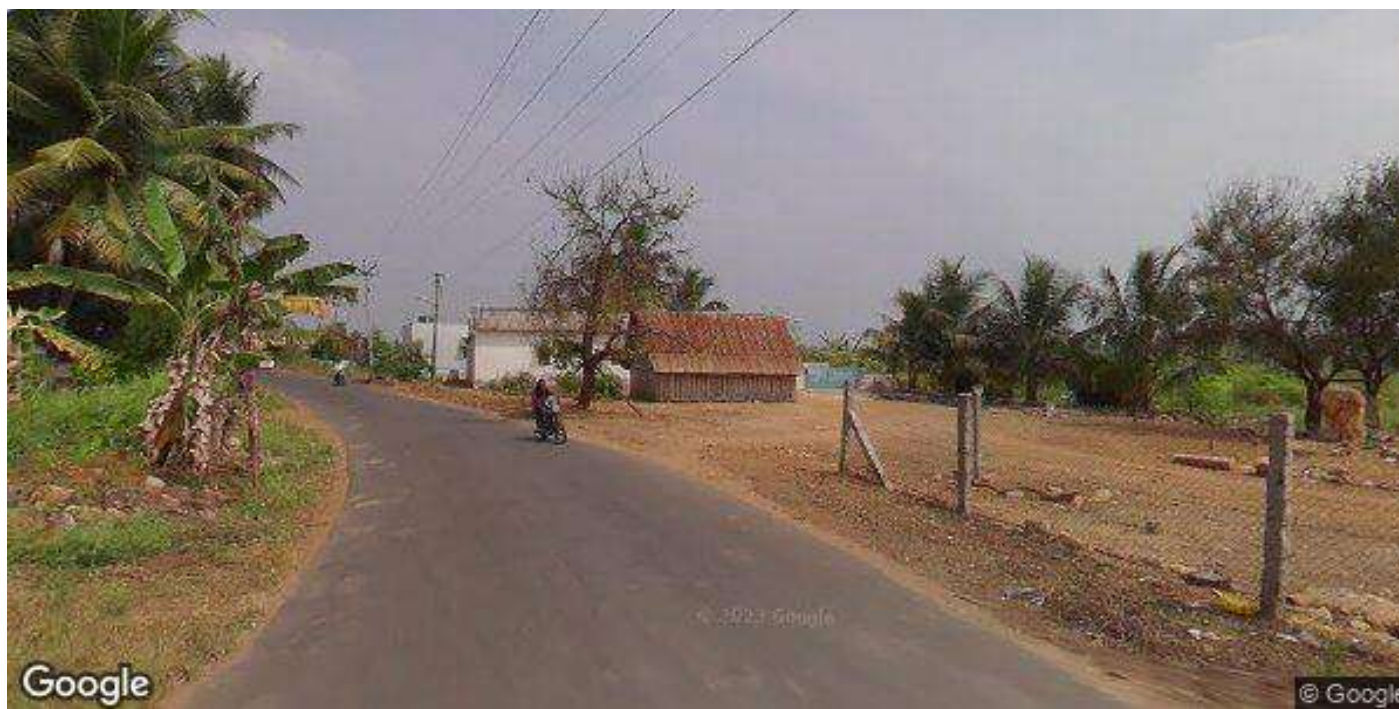
**Risk Type:** Turn  
**Risk Level:** Medium  
**Speed Limit:** 30 KM/Hr  
**Coordinates:** 11.31205, 77.88131

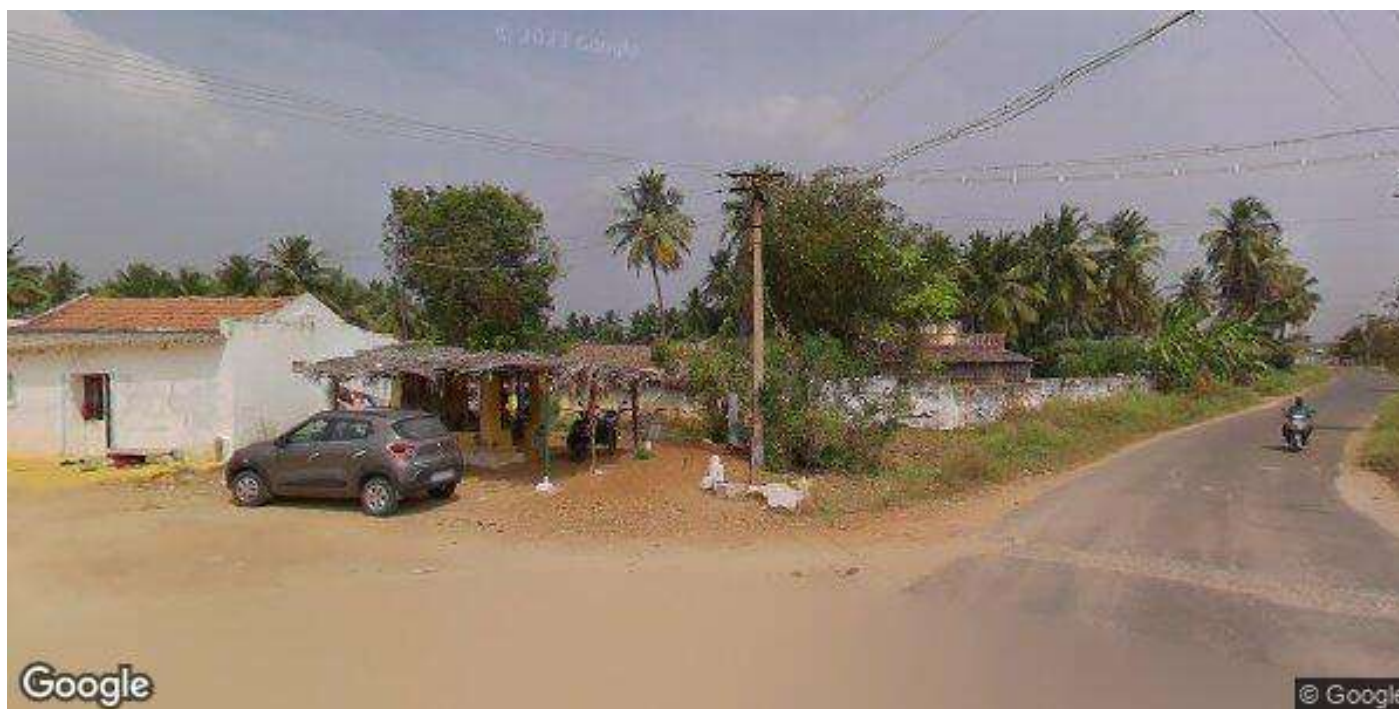
**Risk Type:** Turn  
**Risk Level:** Medium  
**Speed Limit:** 30 KM/Hr  
**Coordinates:** 11.31151, 77.88008

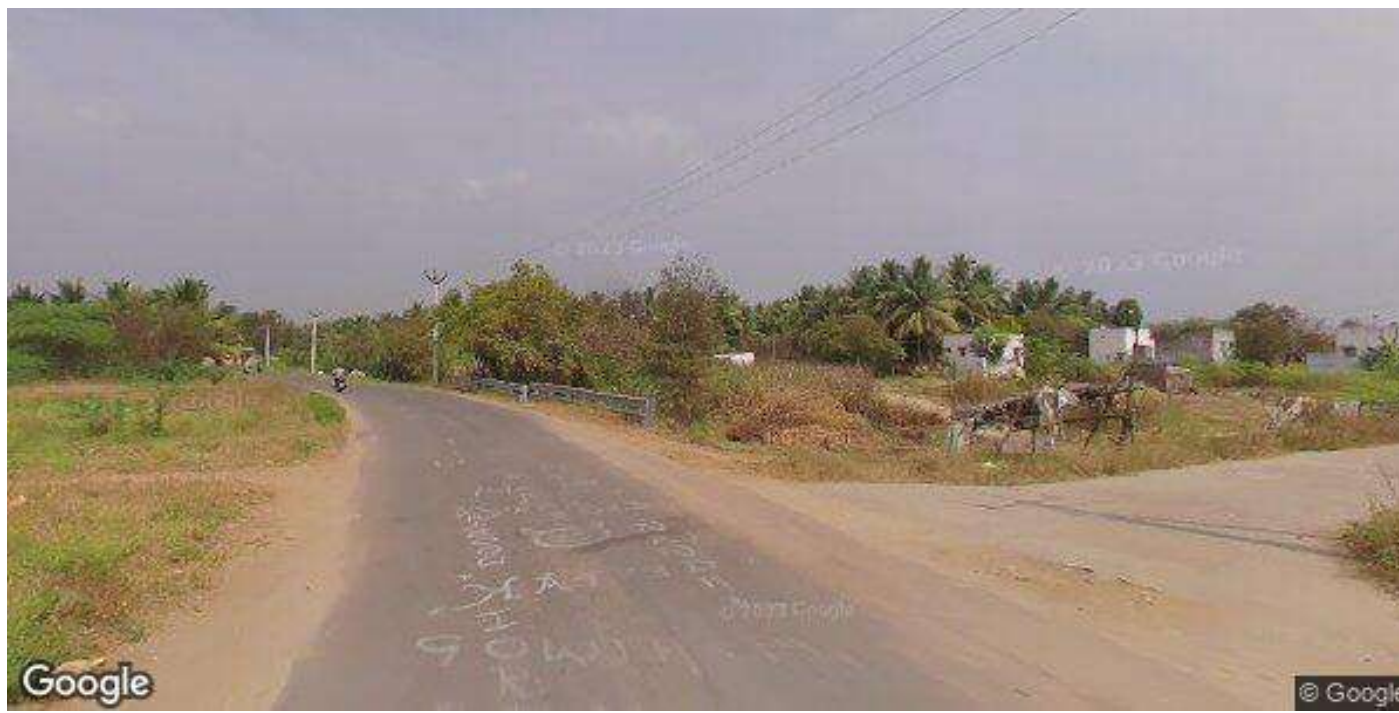
**Risk Type:** Turn  
**Risk Level:** Medium  
**Speed Limit:** 30 KM/Hr  
**Coordinates:** 11.30805, 77.87934

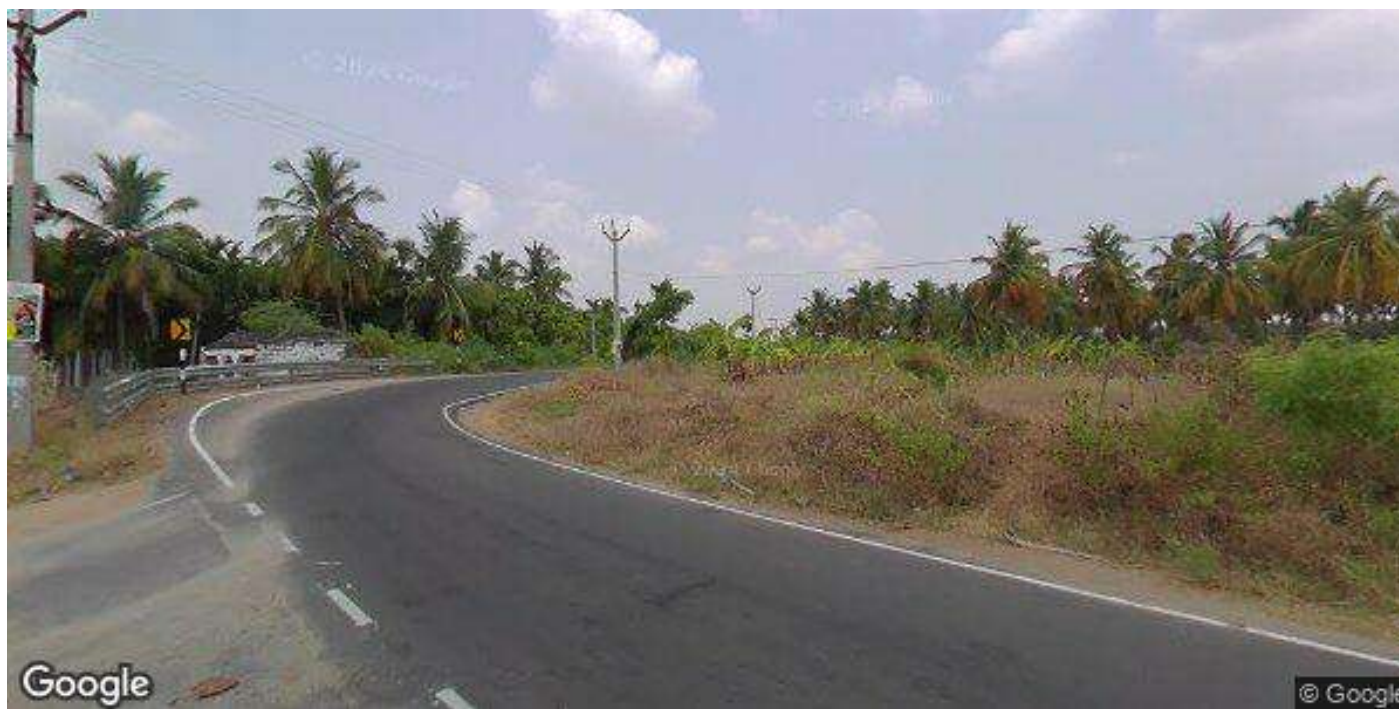
**Risk Type:** Turn  
**Risk Level:** High  
**Speed Limit:** 15 KM/Hr  
**Coordinates:** 11.29763, 77.87710

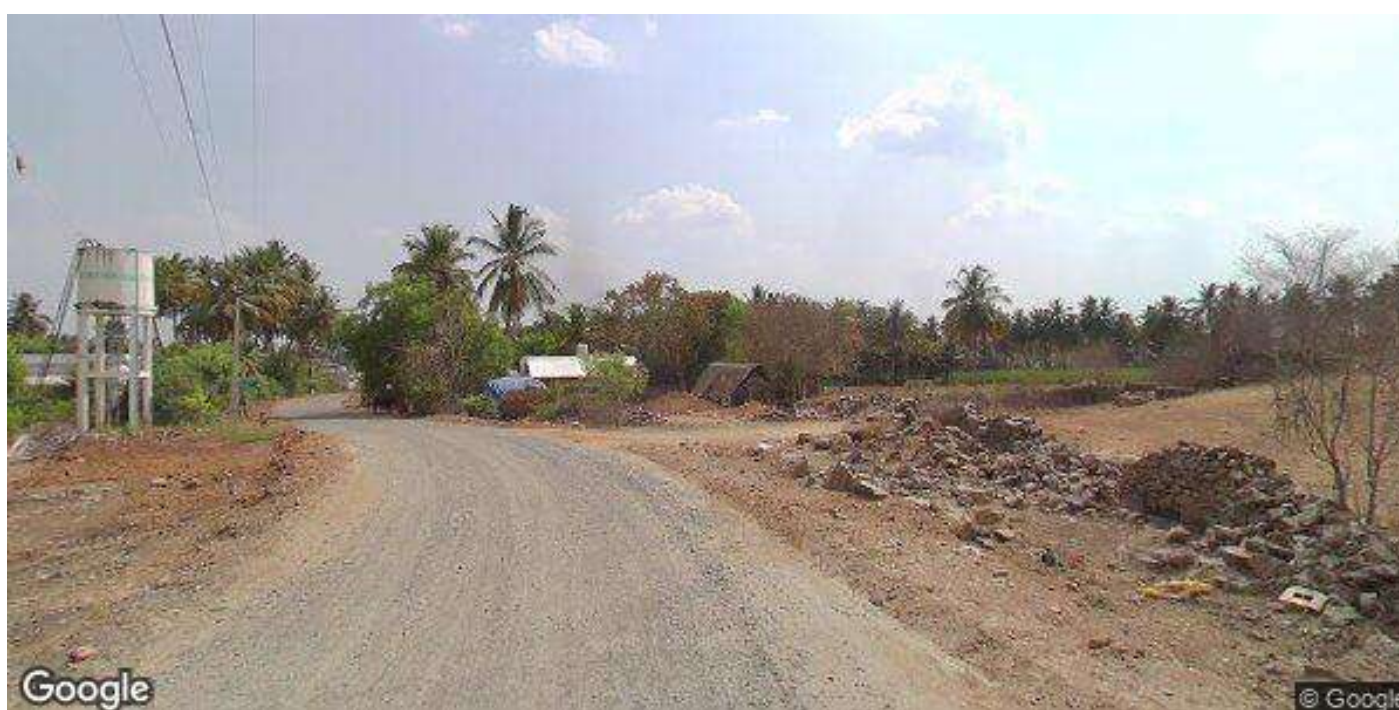
**Risk Type:** Turn  
**Risk Level:** Medium  
**Speed Limit:** 30 KM/Hr  
**Coordinates:** 11.27061, 77.86833

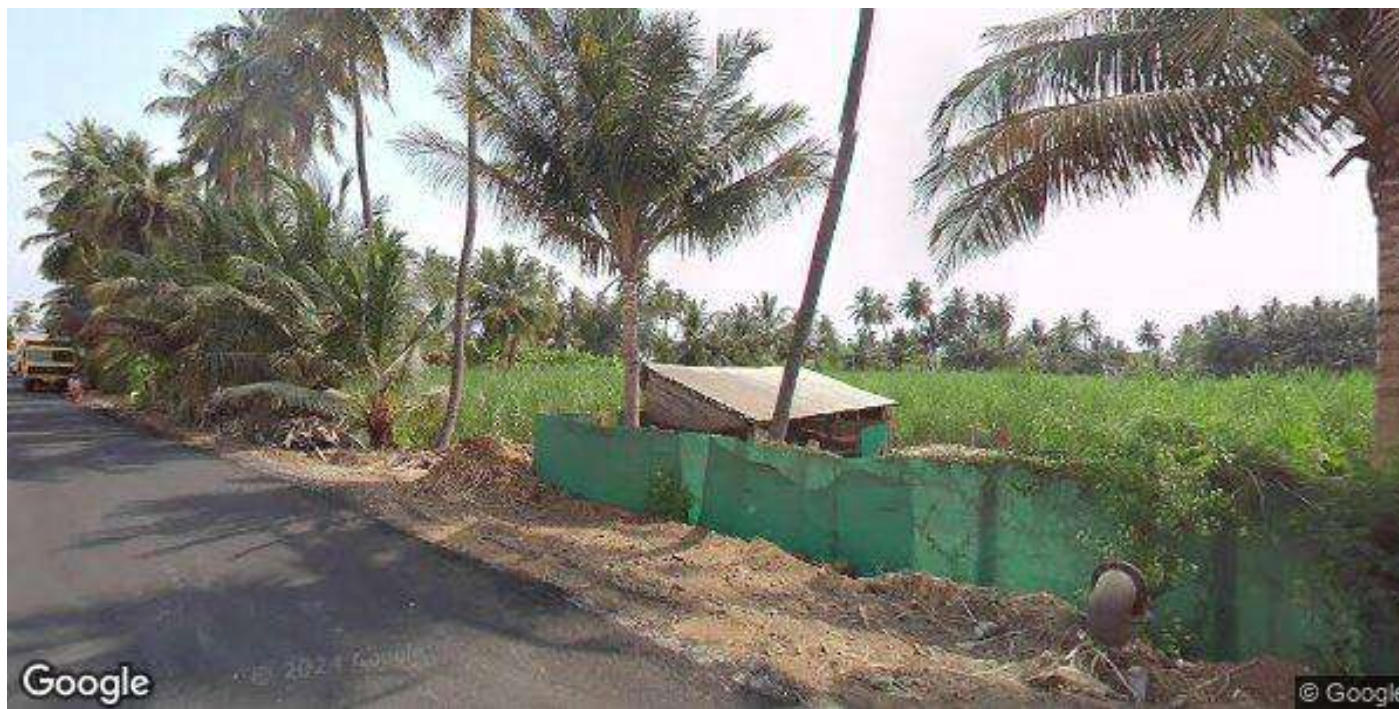
**Risk Type:** Turn  
**Risk Level:** High  
**Speed Limit:** 15 KM/Hr  
**Coordinates:** 11.26017, 77.85606

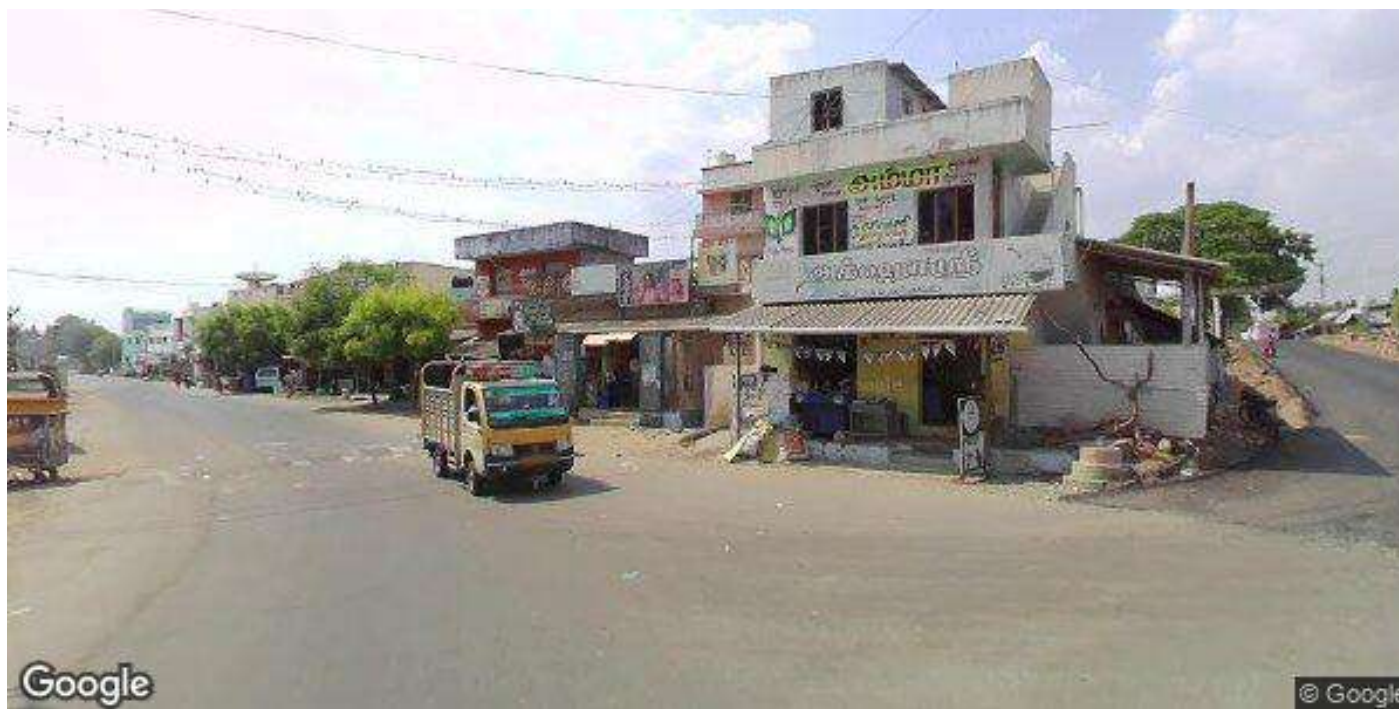
**Risk Type:** Blind Spot  
**Risk Level:** Blind Spot  
**Speed Limit:** 10 KM/Hr  
**Coordinates:** 11.25802, 77.85511
