# IndianOil

## JOURNEY RISK MANAGEMENT (JRM) STUDY

### Salem Terminal TO PONNSANKAR AGENCIES

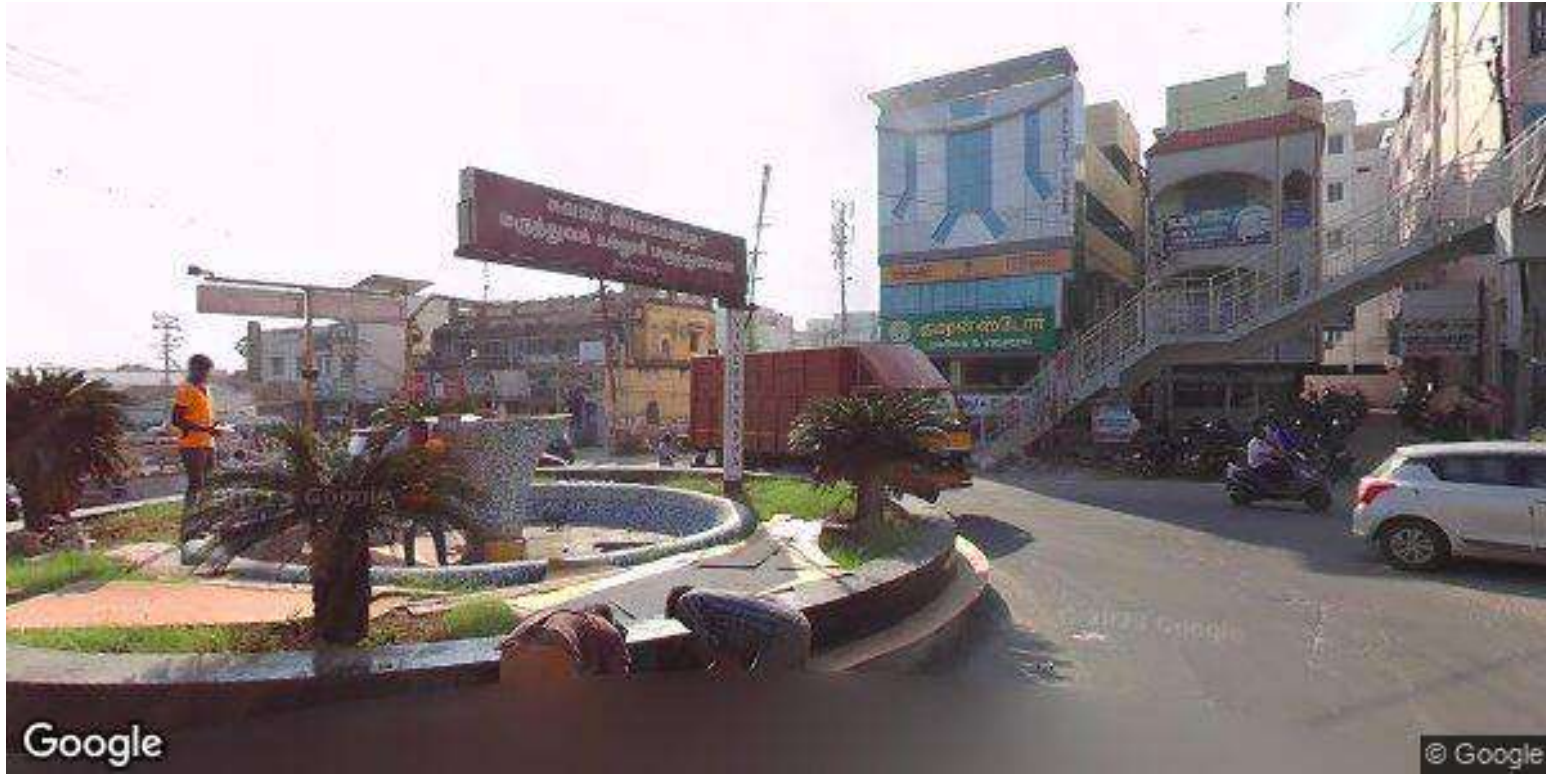
**Coordinates:** 11.38395, 77.89480

**Risk Type:** Roundabout

**Risk Level:** High

**Speed Limit:** 15 KM/Hr

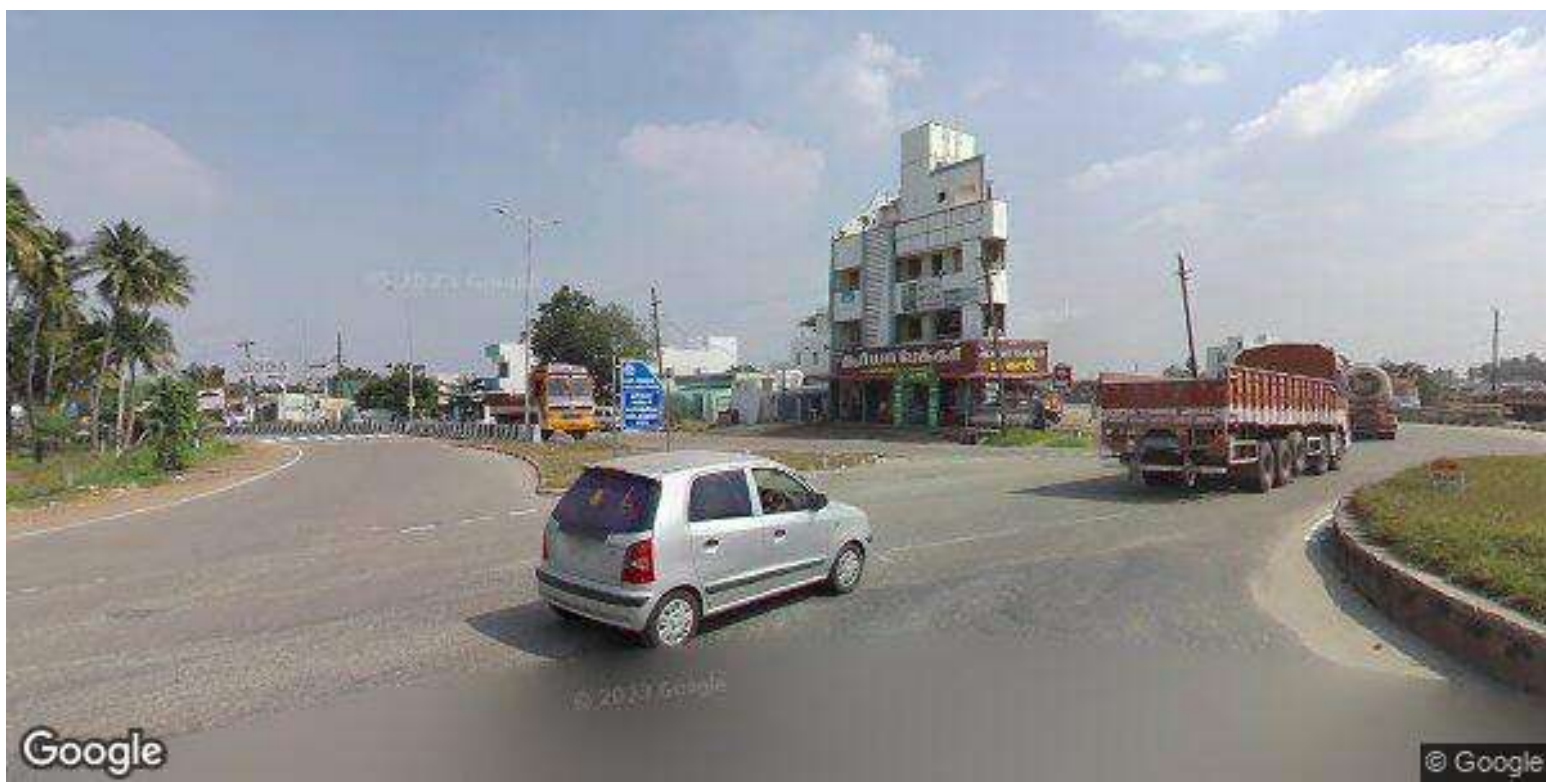
**Coordinates: 10.92958, 78.05452**

**Risk Type: Roundabout**

**Risk Level: High**

**Speed Limit: 15 KM/Hr**

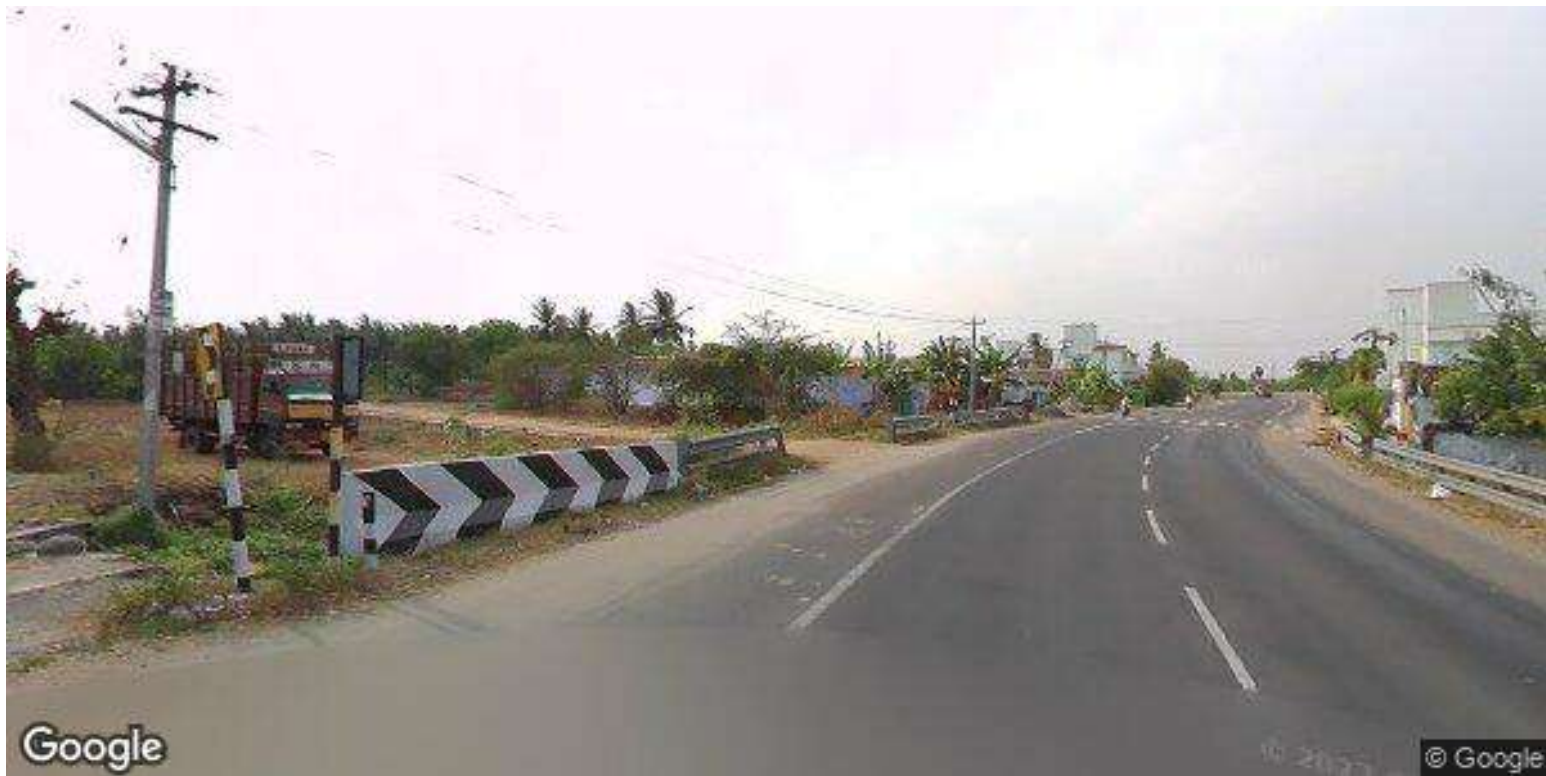
**Coordinates:** 11.16755, 78.01568

**Risk Type:** Turn

**Risk Level:** Medium

**Speed Limit:** 30 KM/Hr

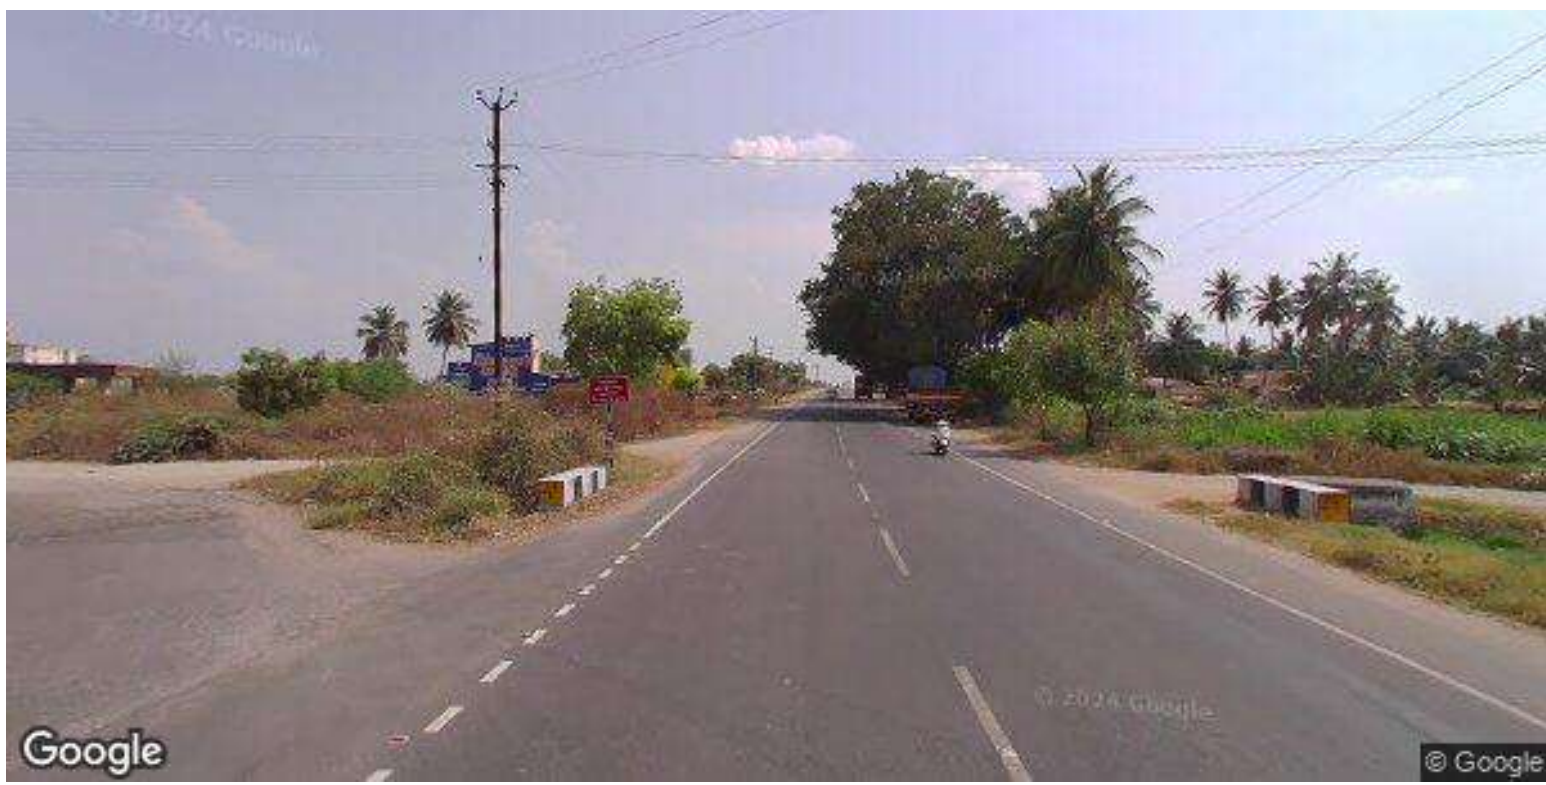
**Coordinates:** 11.14545, 78.02208

**Risk Type:** Turn

**Risk Level:** High

**Speed Limit:** 15 KM/Hr

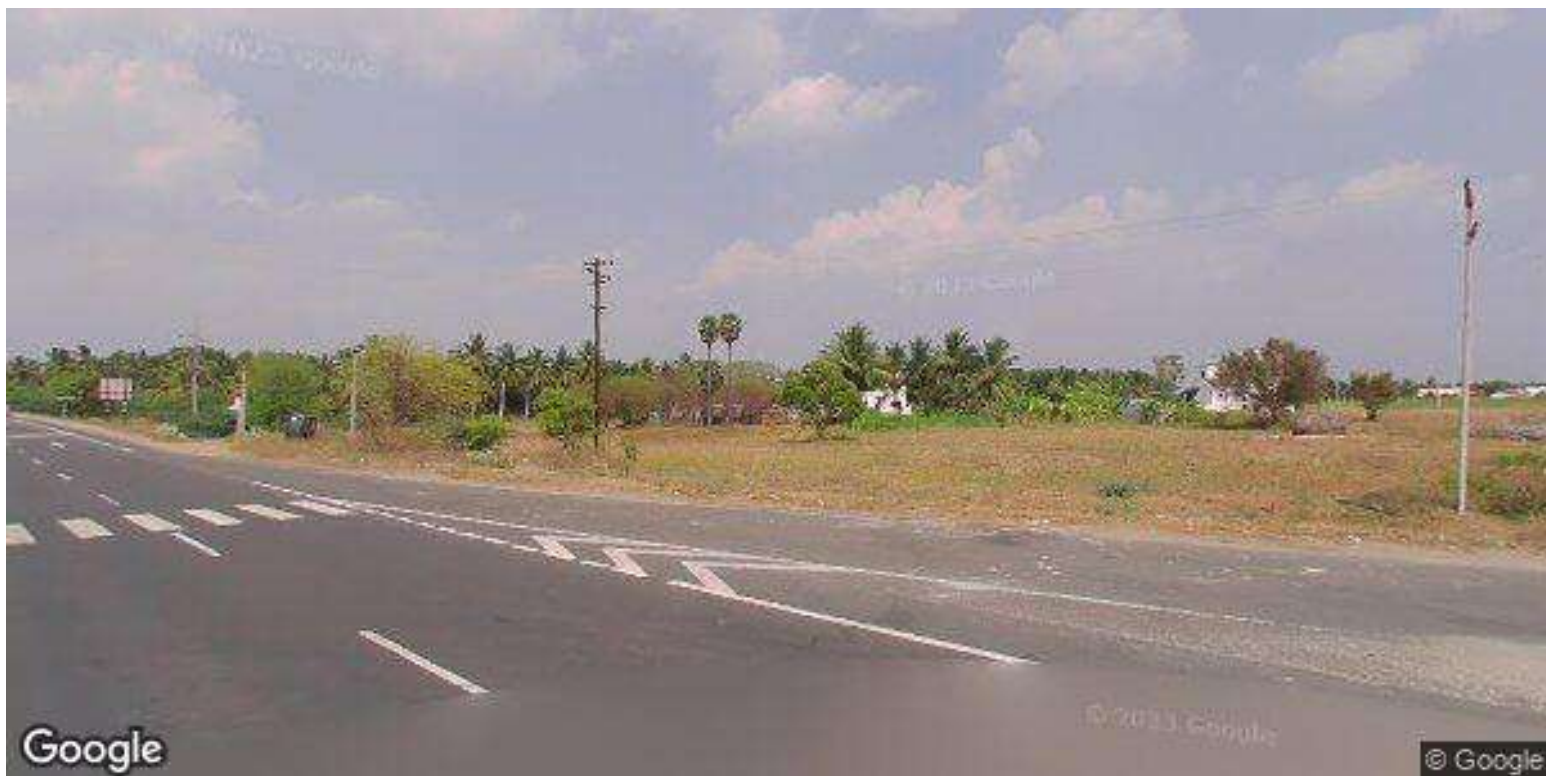
**Coordinates:** 11.14480, 78.02291

**Risk Type:** Turn

**Risk Level:** High

**Speed Limit:** 15 KM/Hr

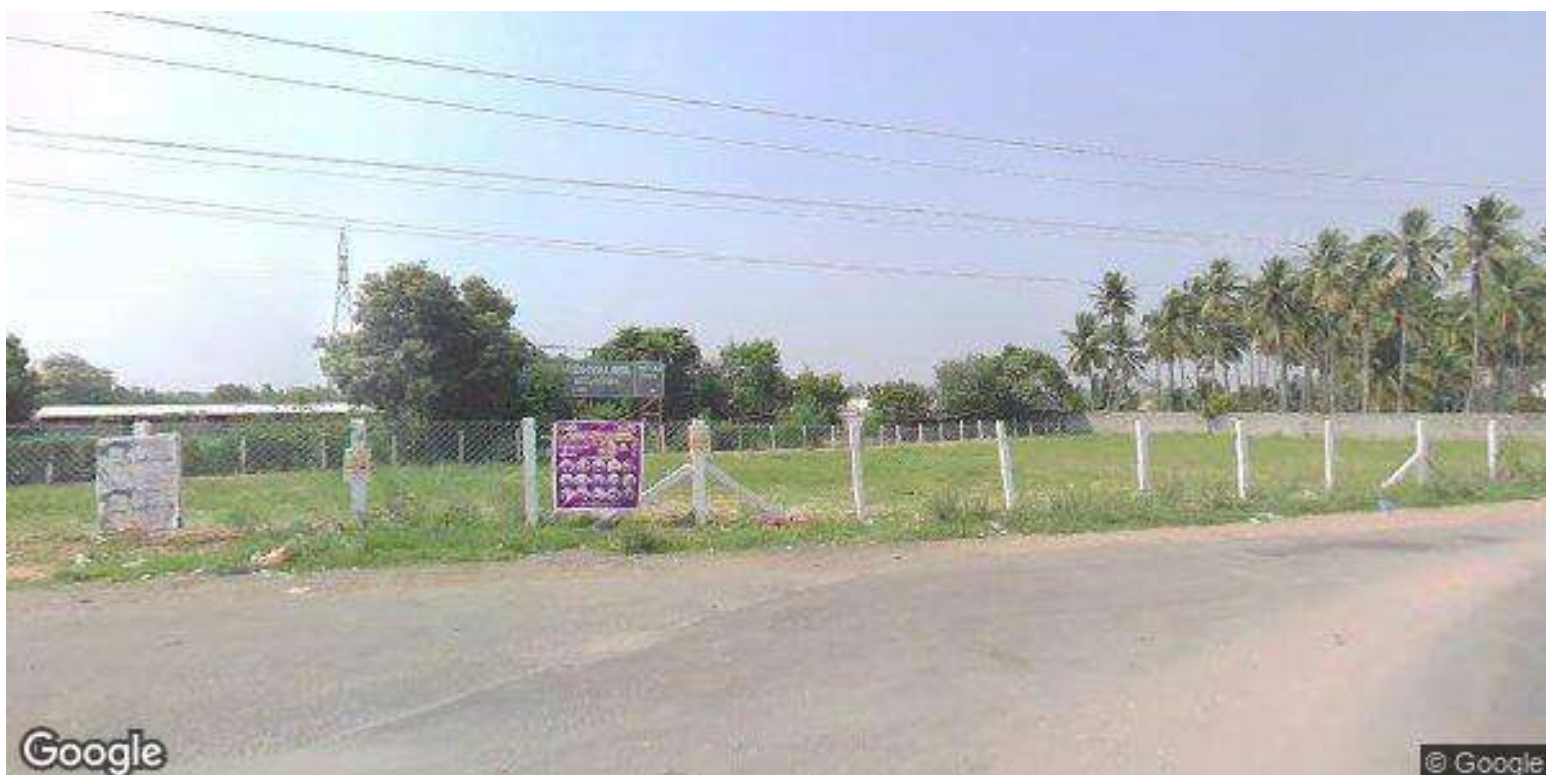
**Risk Type:** Turn  
**Risk Level:** High  
**Speed Limit:** 15 KM/Hr  
**Coordinates:** 10.92955, 78.05373

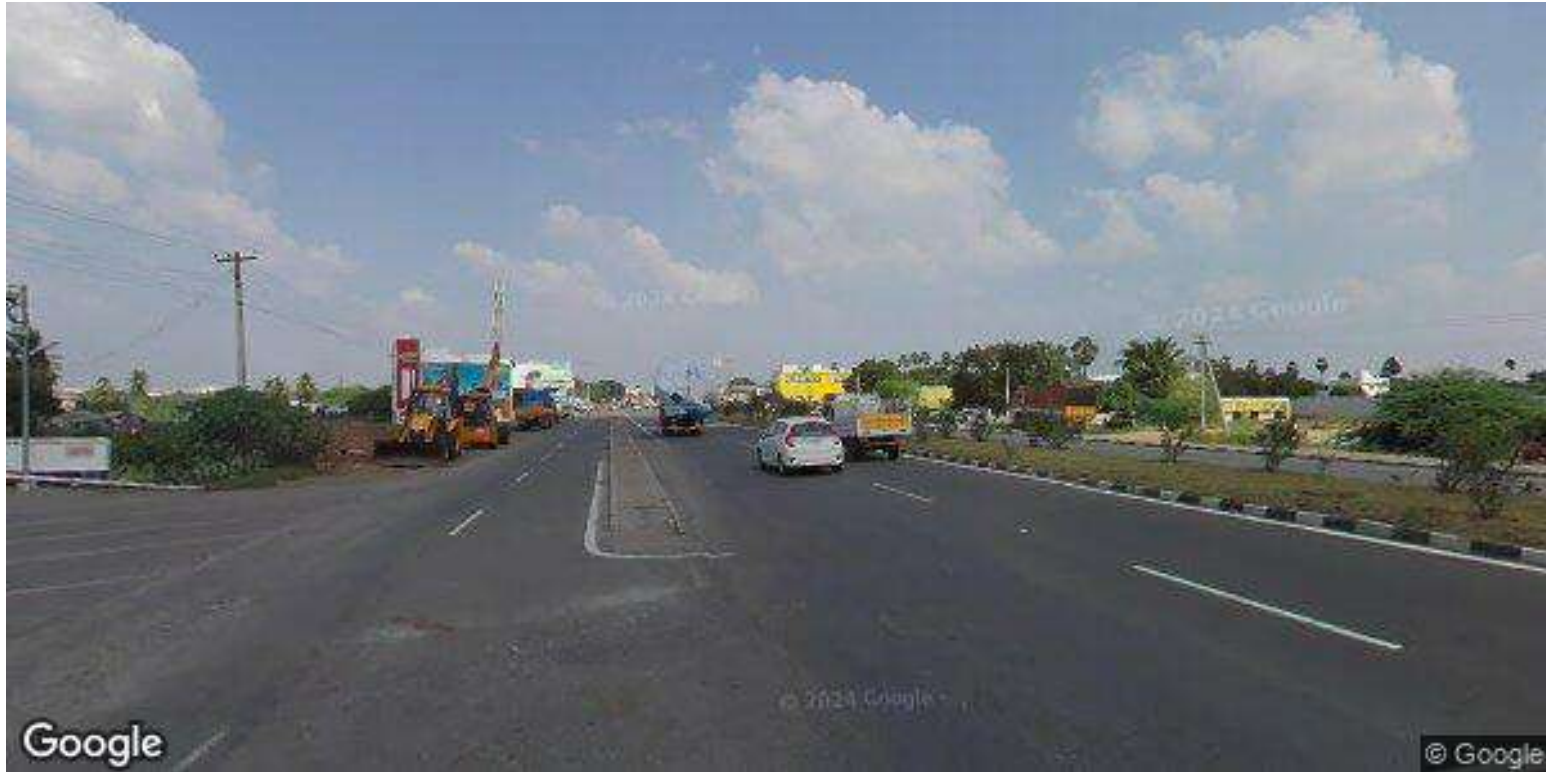
**Risk Type:** Turn  
**Risk Level:** High  
**Speed Limit:** 15 KM/Hr  
**Coordinates:** 10.93406, 78.05512

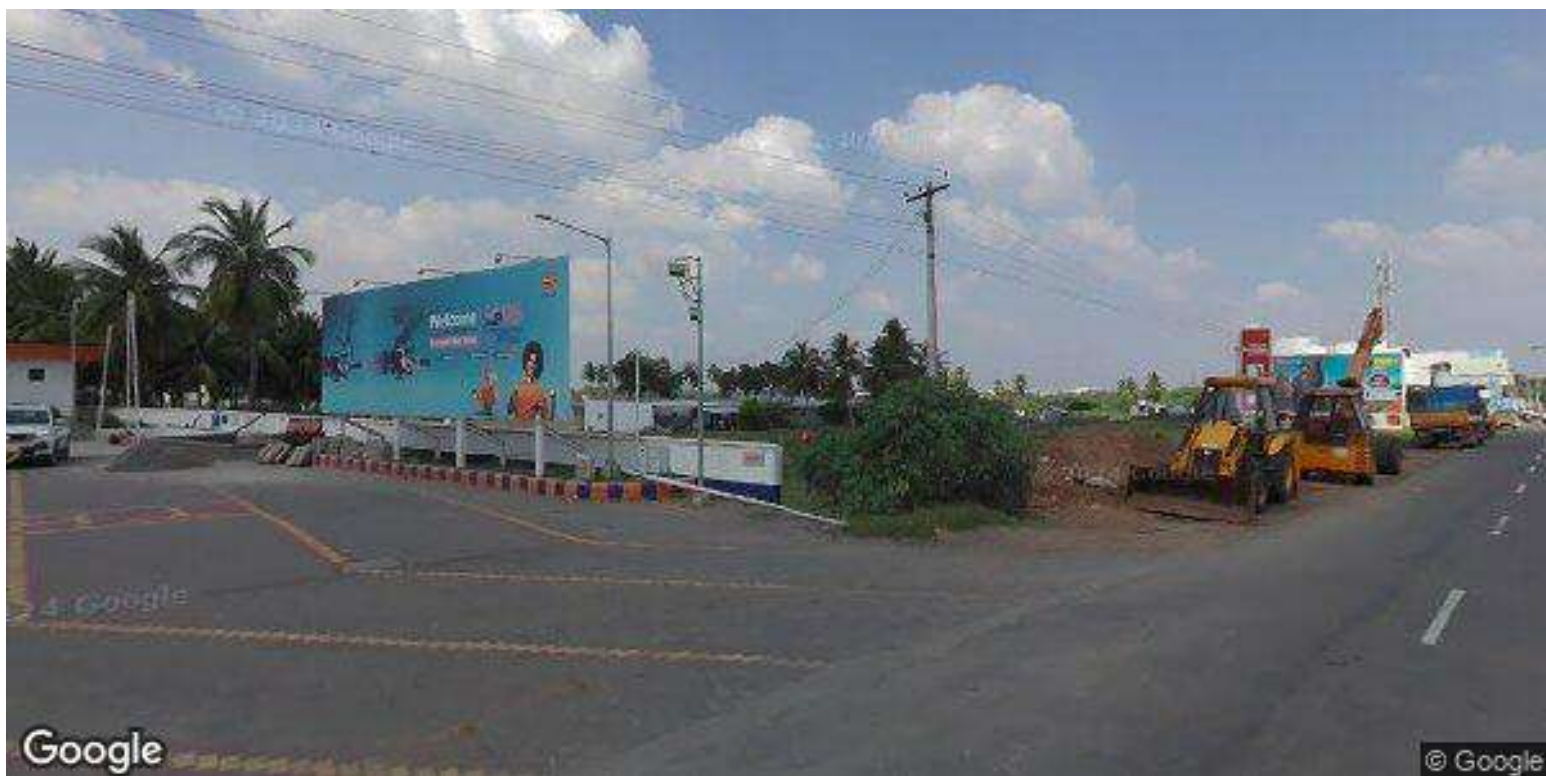
**Risk Type:** Turn  
**Risk Level:** High  
**Speed Limit:** 15 KM/Hr  
**Coordinates:** 10.93420, 78.05503
