# IndianOil

## JOURNEY RISK MANAGEMENT (JRM) STUDY

### Salem Terminal TO LAKSHMI AGENCIYES

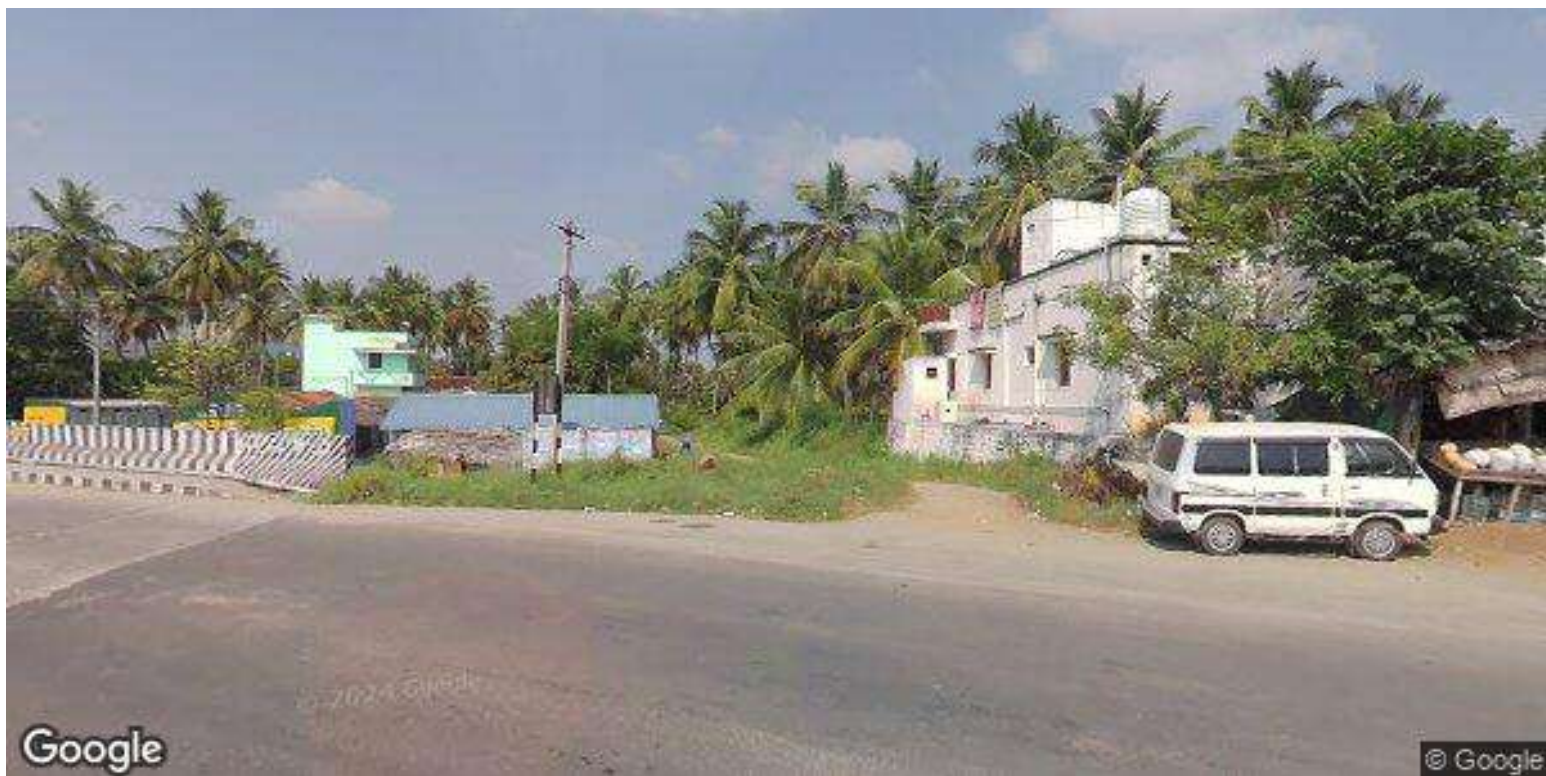
**Coordinates:** 11.44898, 77.87410

**Risk Type:** Turn

**Risk Level:** Medium

**Speed Limit:** 30 KM/Hr

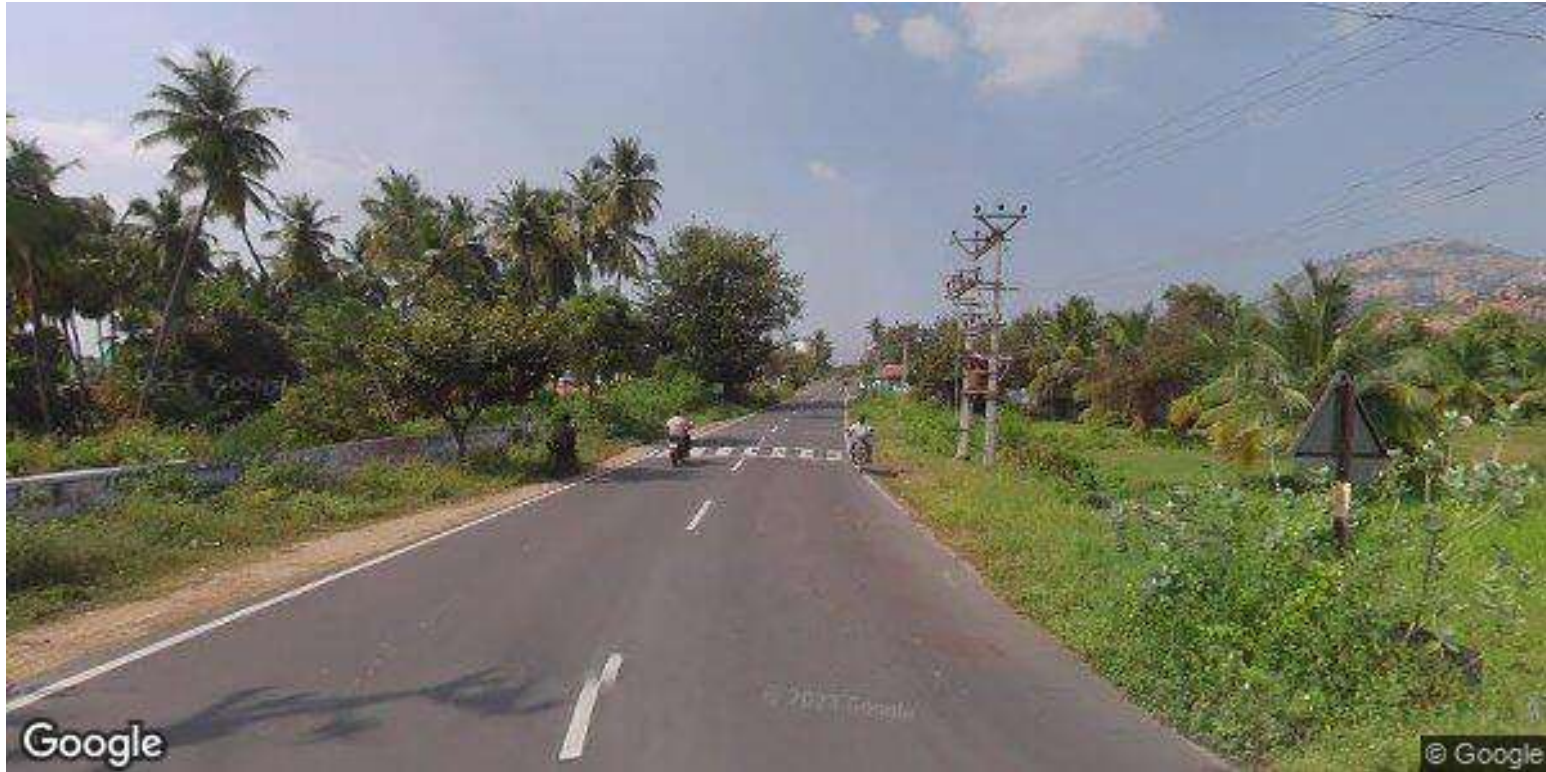
**Risk Type:** Turn  
**Risk Level:** Medium  
**Speed Limit:** 30 KM/Hr  
**Coordinates:** 11.45352, 77.85698

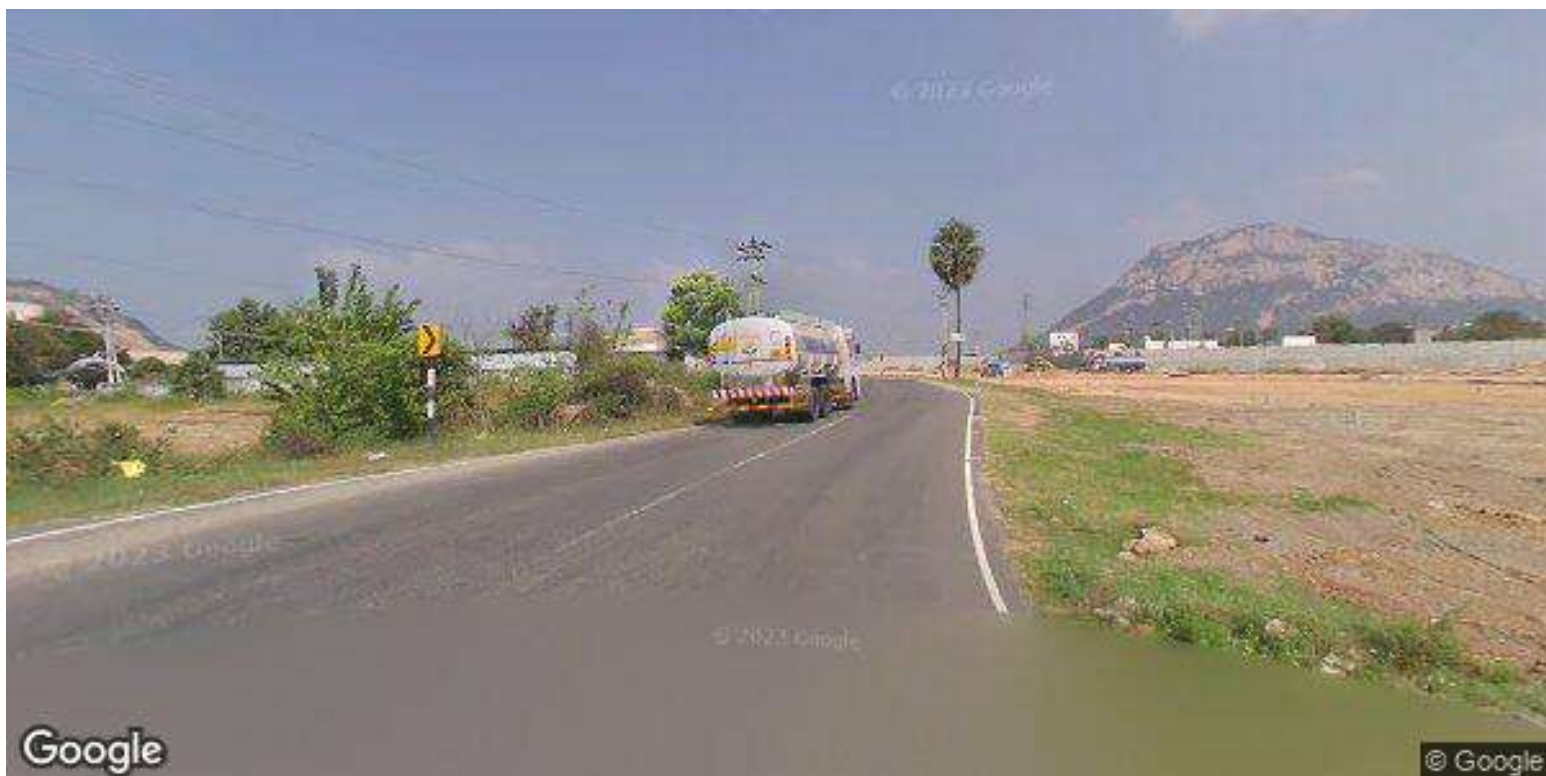
**Risk Type:** Turn  
**Risk Level:** Medium  
**Speed Limit:** 30 KM/Hr  
**Coordinates:** 11.45847, 77.85140

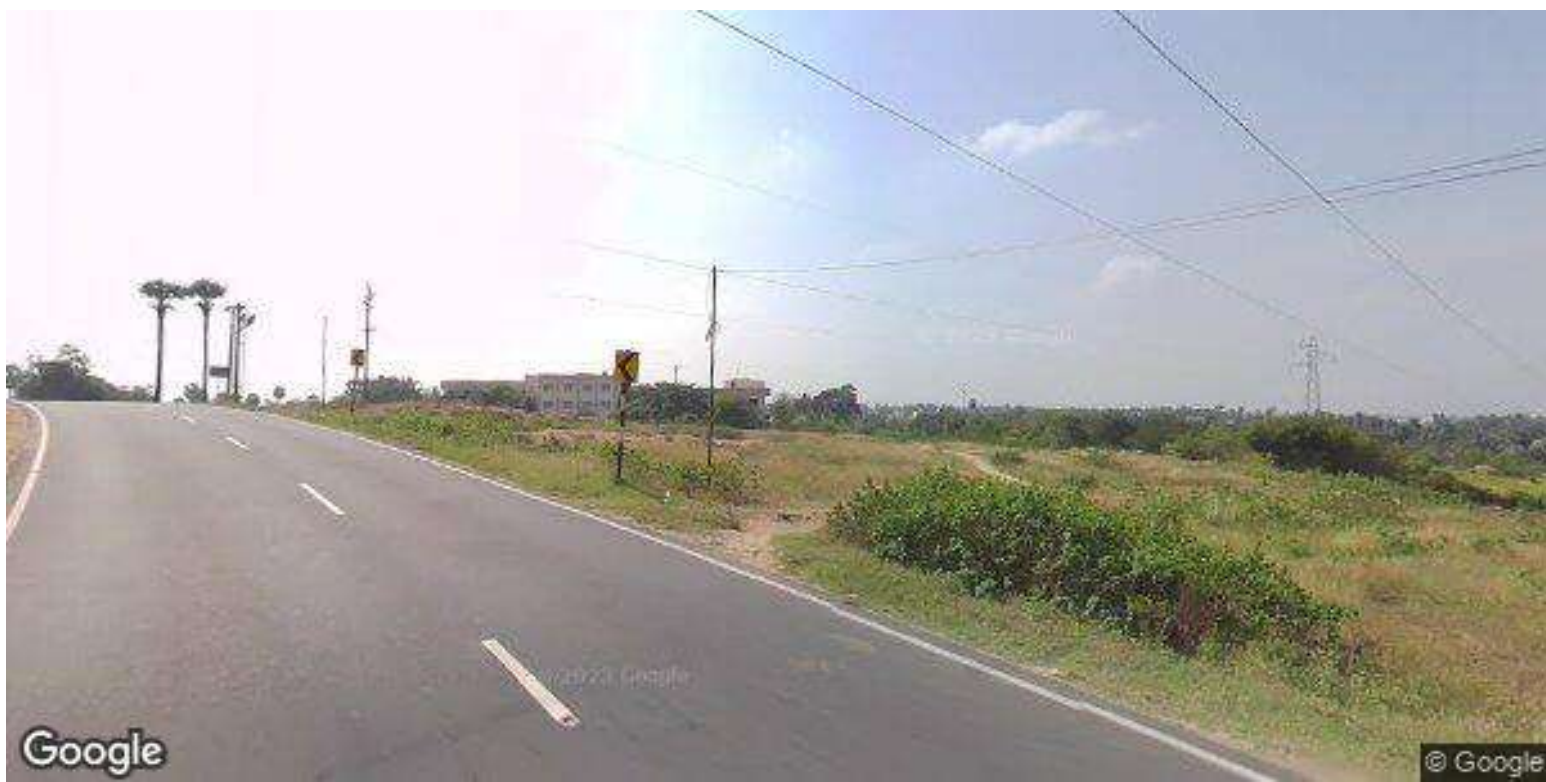
**Coordinates:** 11.46048, 77.85036

**Risk Type:** Turn

**Risk Level:** Medium

**Speed Limit:** 30 KM/Hr

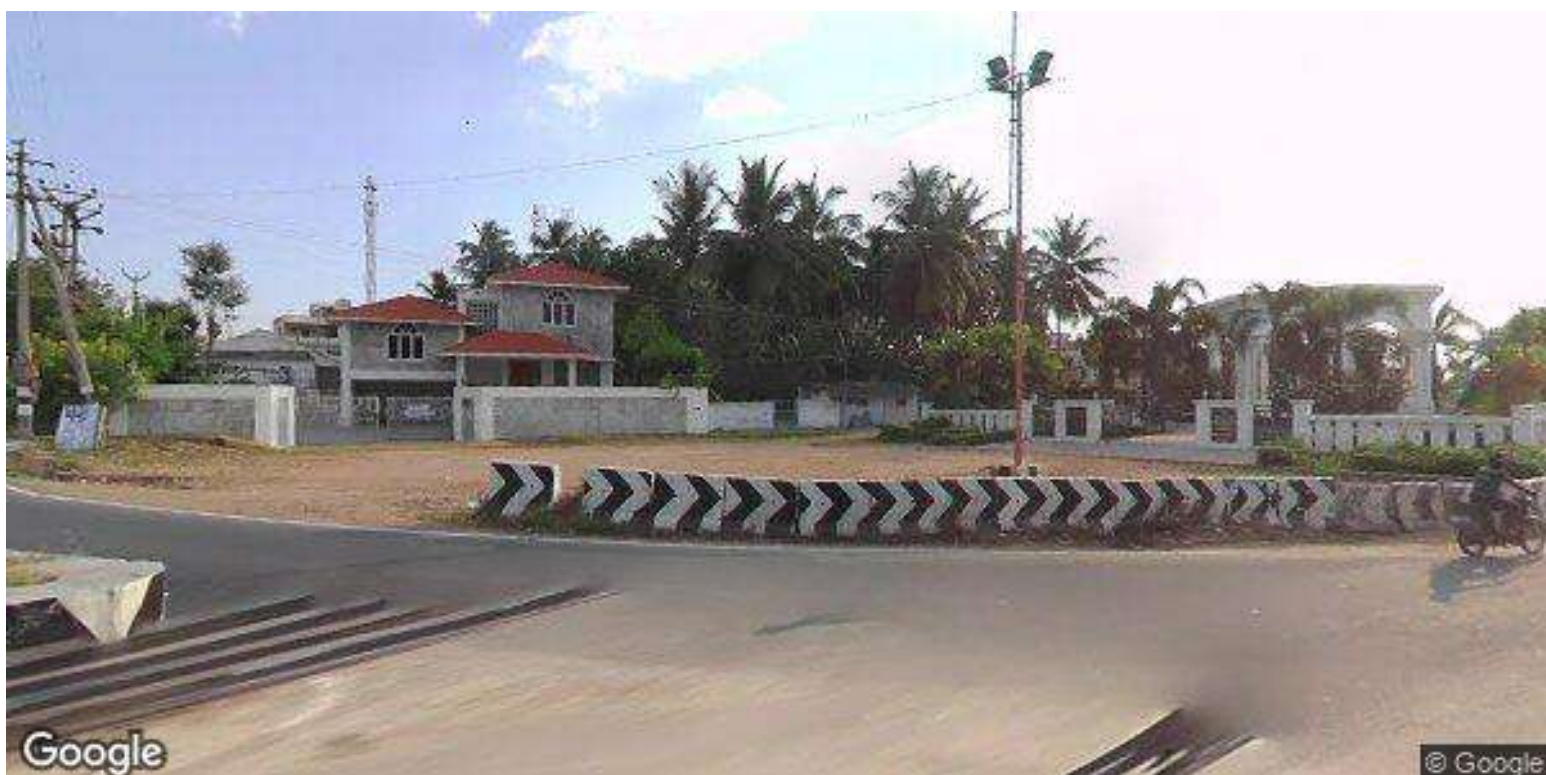
**Risk Type:** Turn  
**Risk Level:** Medium  
**Speed Limit:** 30 KM/Hr  
**Coordinates:** 11.46314, 77.84928

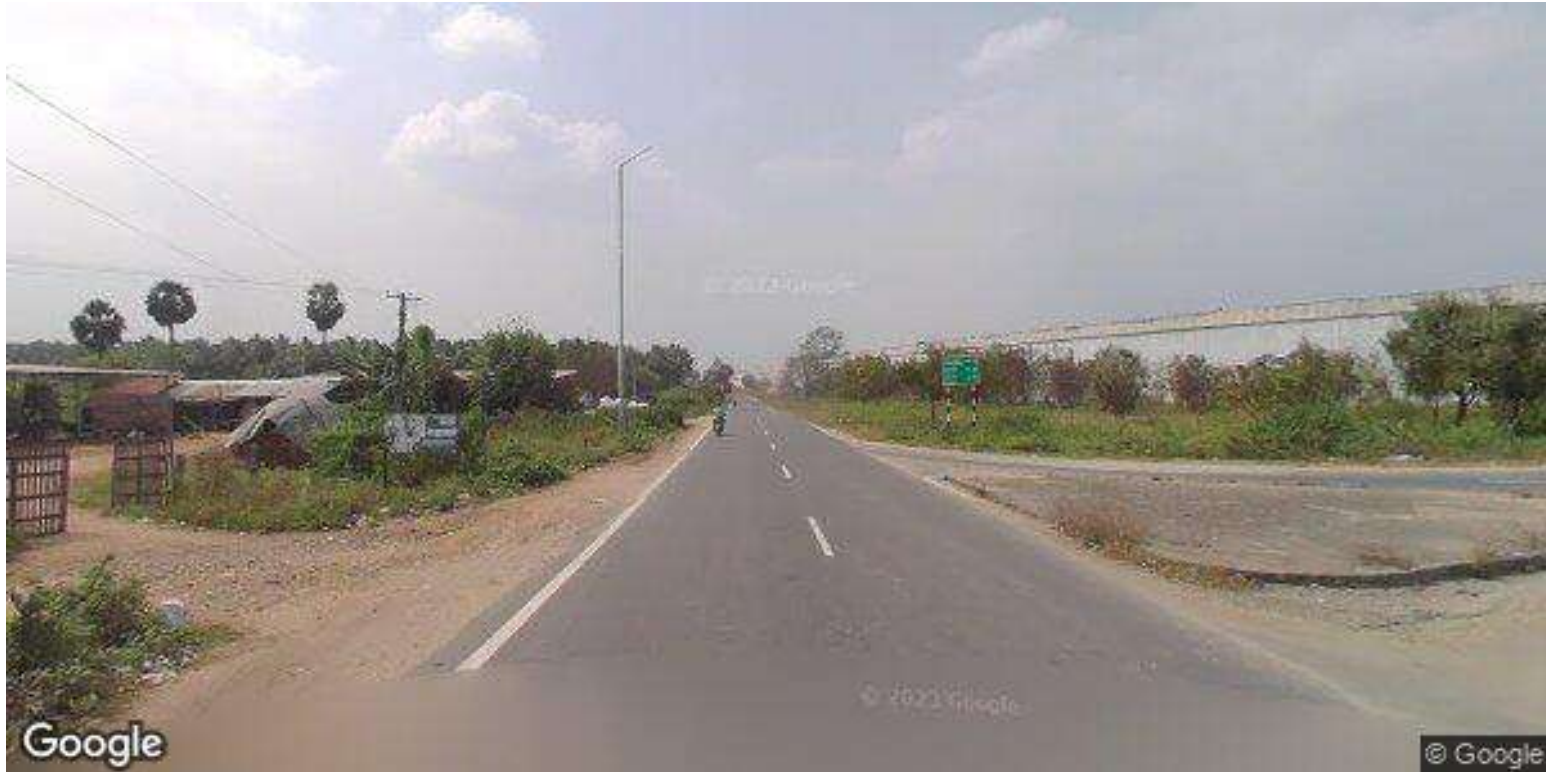
**Risk Type:** Turn  
**Risk Level:** High  
**Speed Limit:** 15 KM/Hr  
**Coordinates:** 11.45542, 77.81725

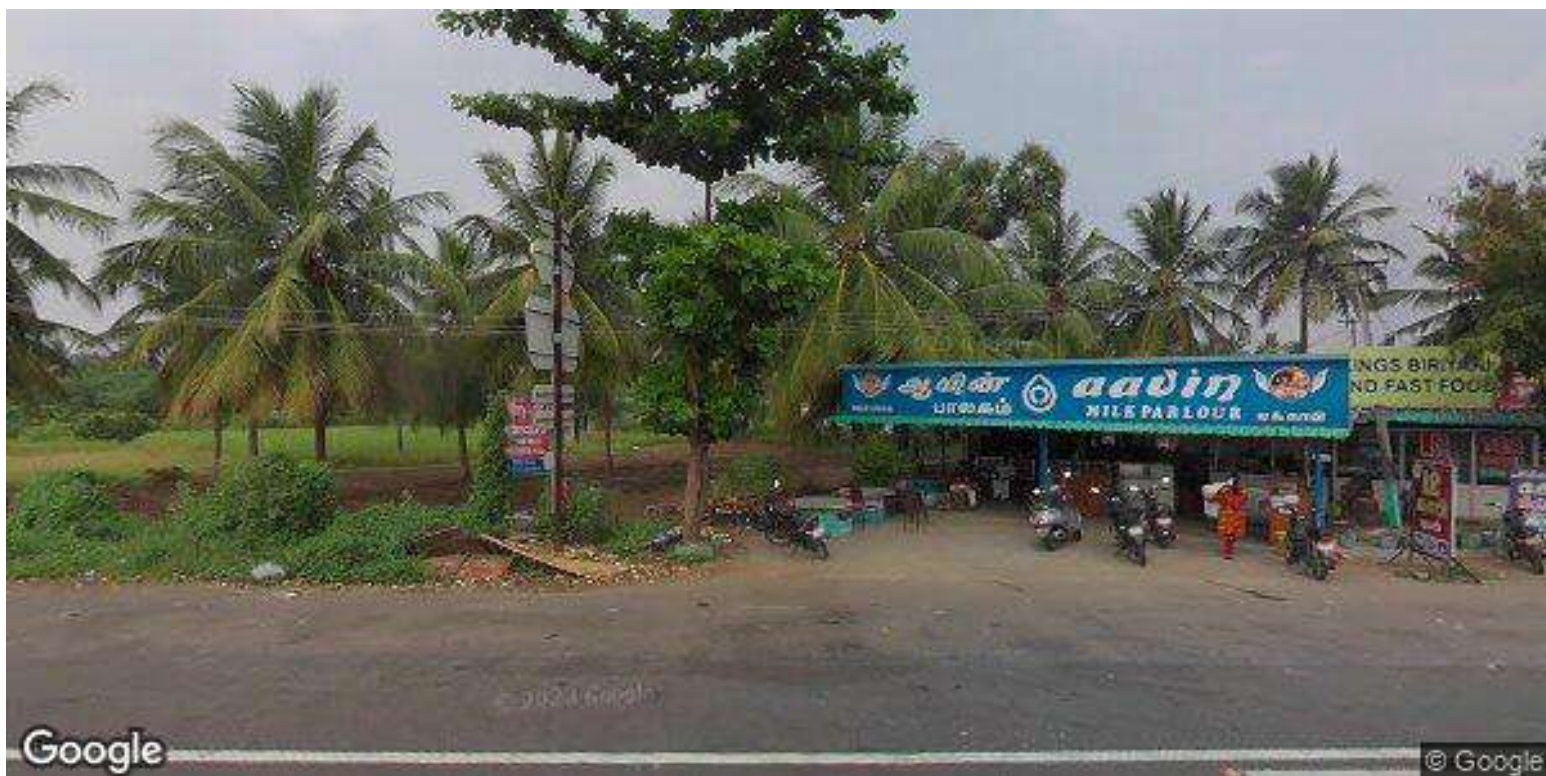
**Risk Type:** Turn  
**Risk Level:** High  
**Speed Limit:** 15 KM/Hr  
**Coordinates:** 11.45631, 77.81668

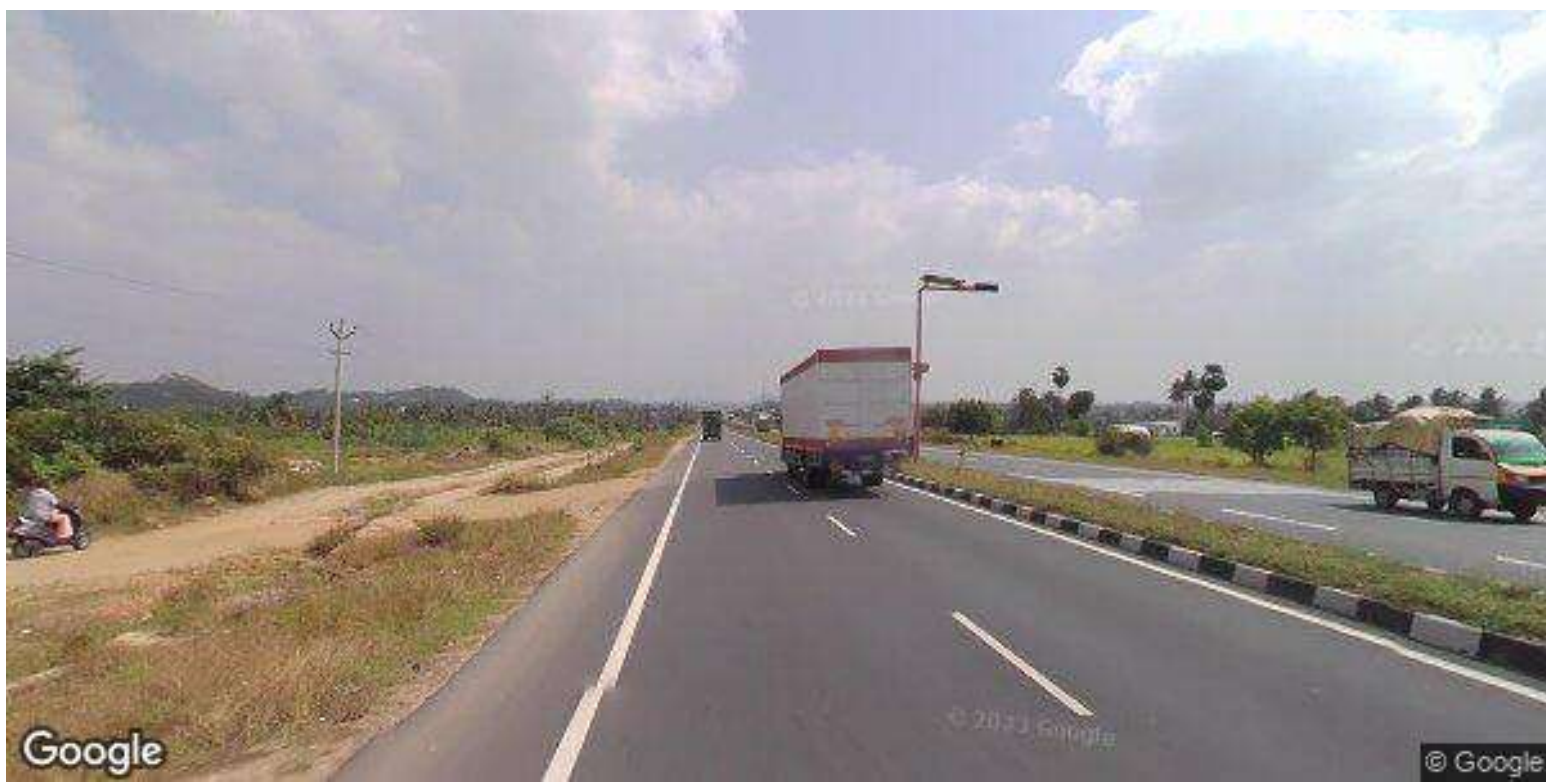
**Coordinates:** 11.49409, 77.88004

**Risk Type:** Turn

**Risk Level:** High

**Speed Limit:** 15 KM/Hr

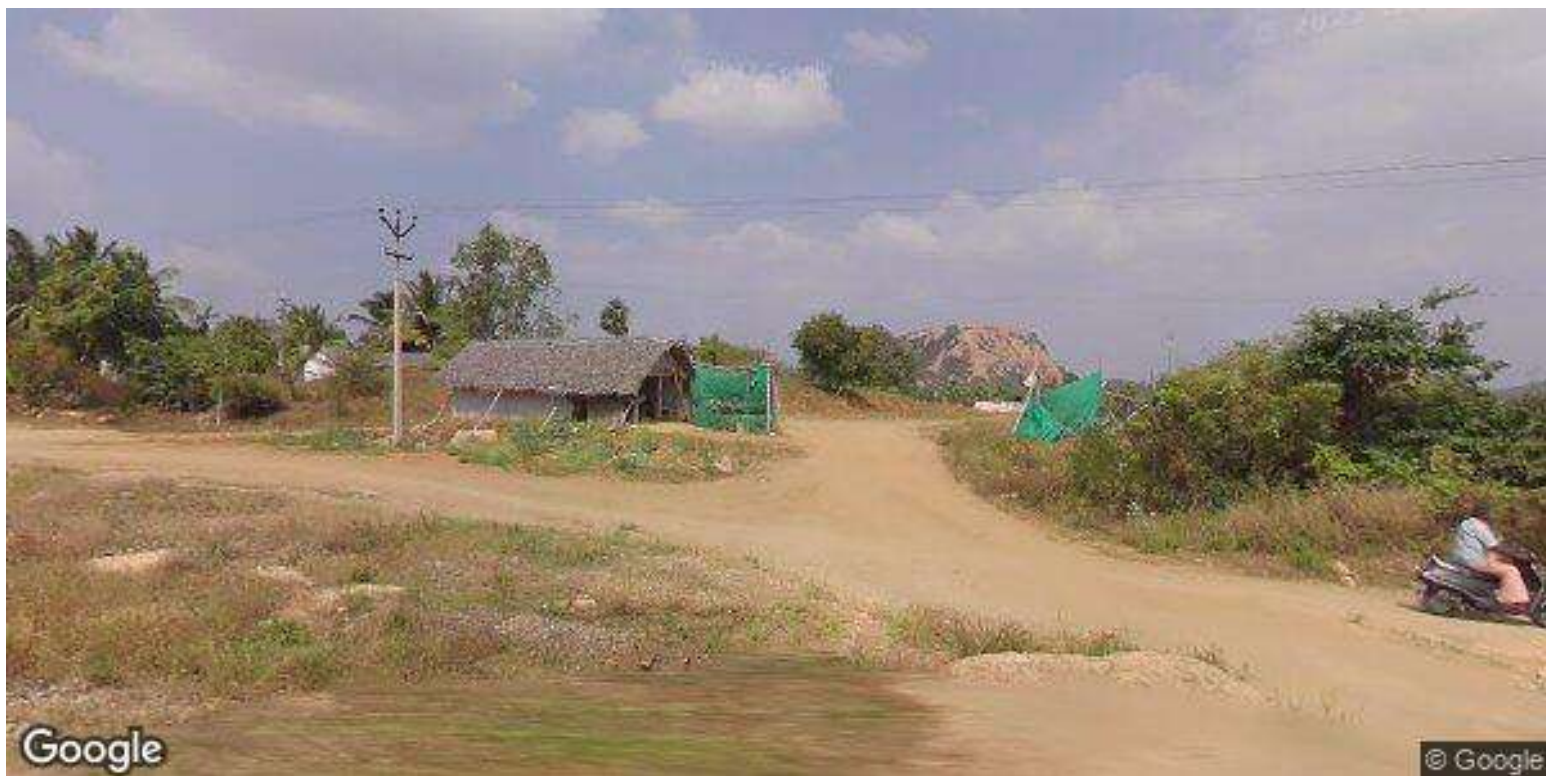
**Coordinates:** 11.49419, 77.88015

**Risk Type:** Turn

**Risk Level:** Medium

**Speed Limit:** 30 KM/Hr

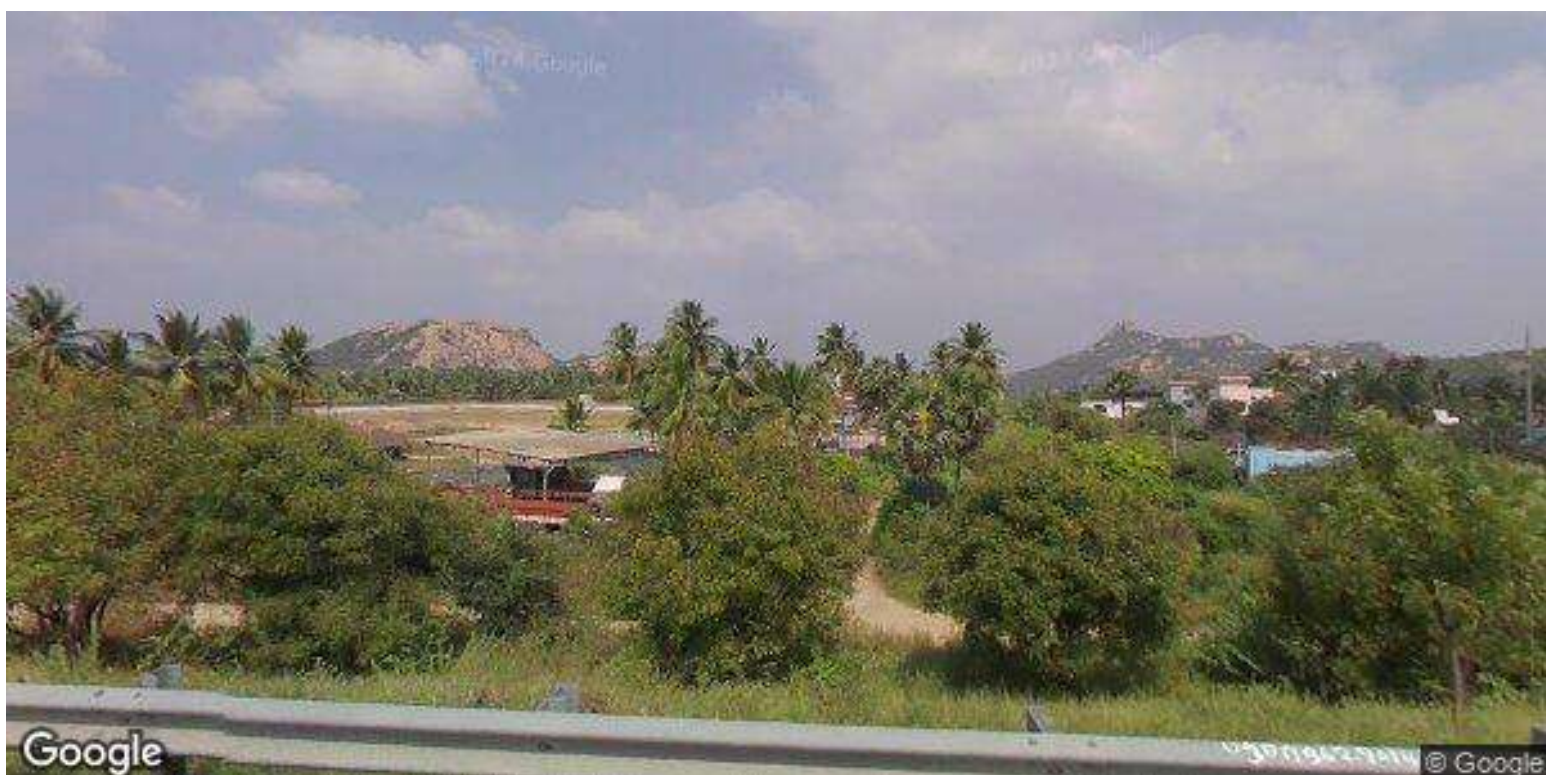
**Risk Type:** Turn  
**Risk Level:** High  
**Speed Limit:** 15 KM/Hr  
**Coordinates:** 11.49383, 77.88442

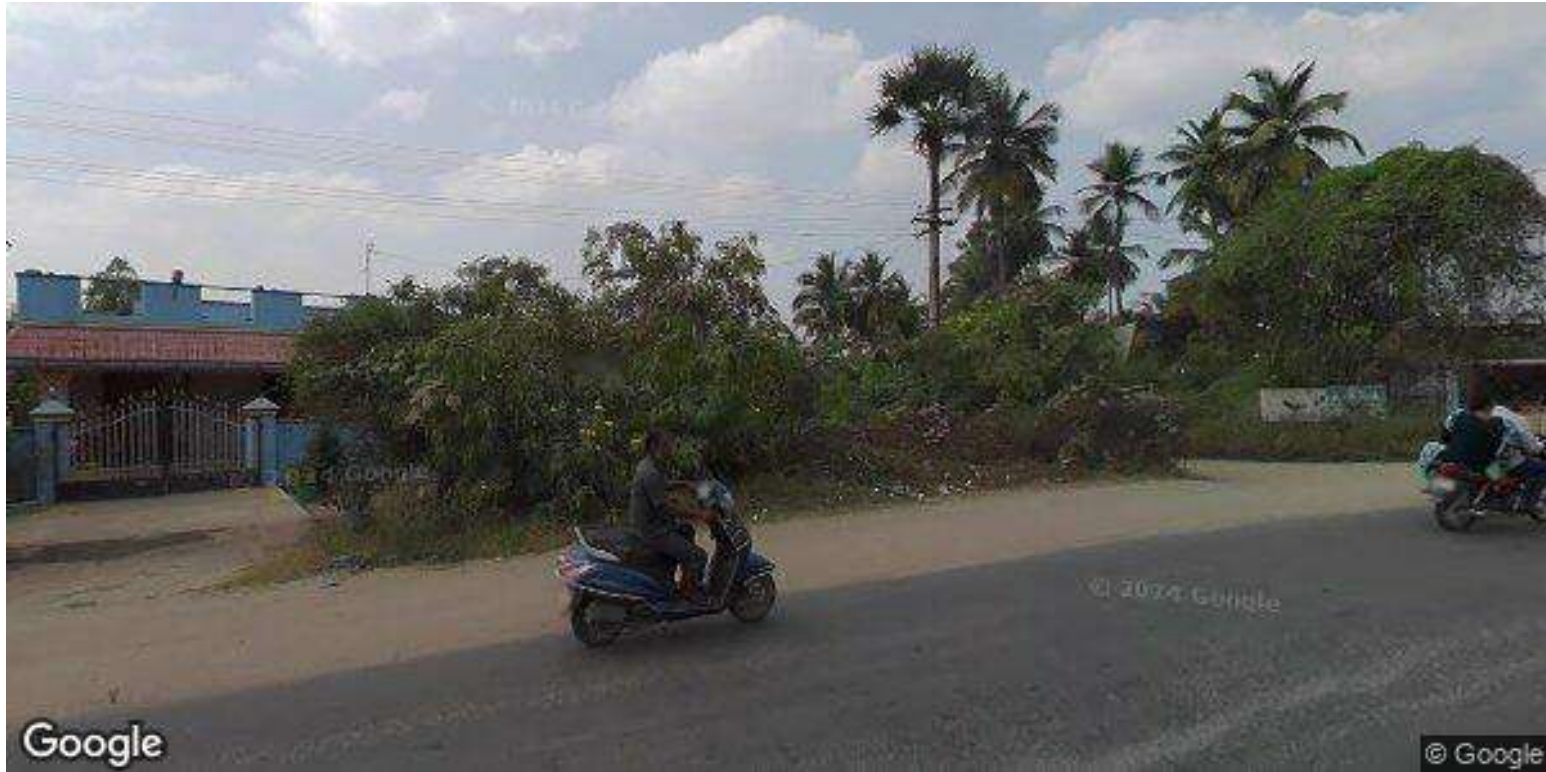
**Risk Type:** Turn  
**Risk Level:** Medium  
**Speed Limit:** 30 KM/Hr  
**Coordinates:** 11.49419, 77.88454

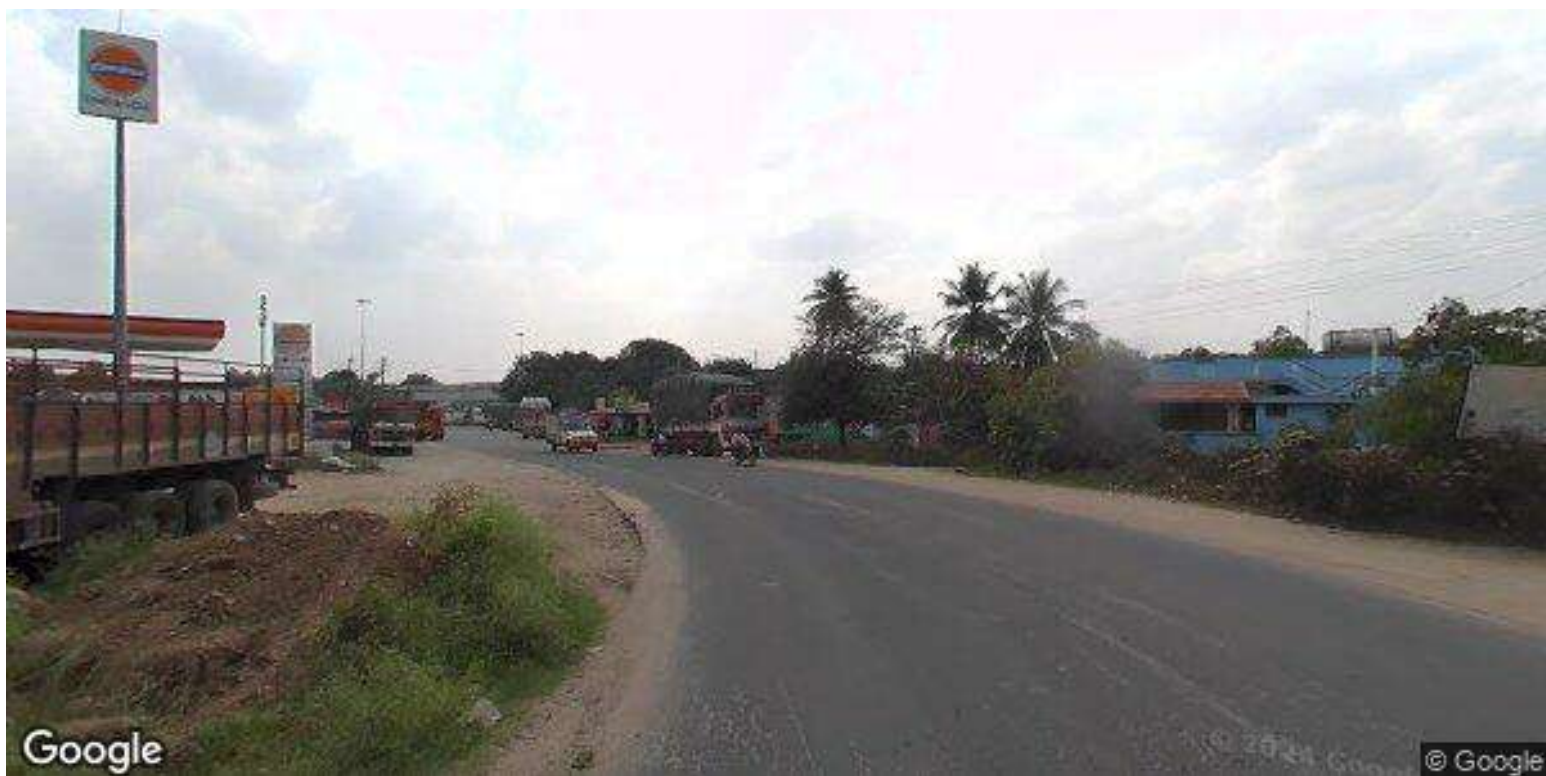
**Risk Type:** Turn  
**Risk Level:** Medium  
**Speed Limit:** 30 KM/Hr  
**Coordinates:** 11.49448, 77.88490

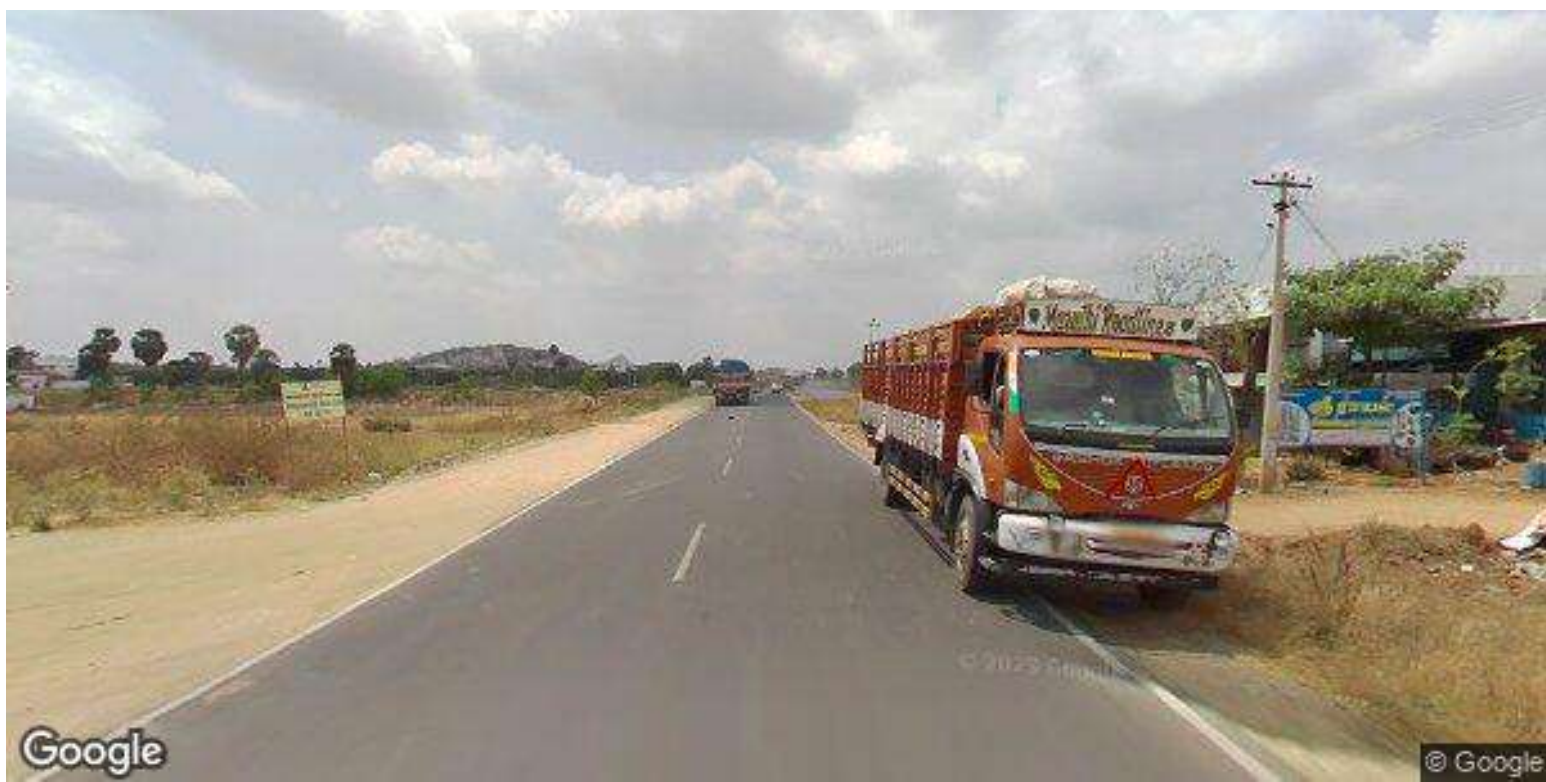
**Coordinates:** 11.55608, 77.89762

**Risk Type:** Turn

**Risk Level:** High

**Speed Limit:** 15 KM/Hr

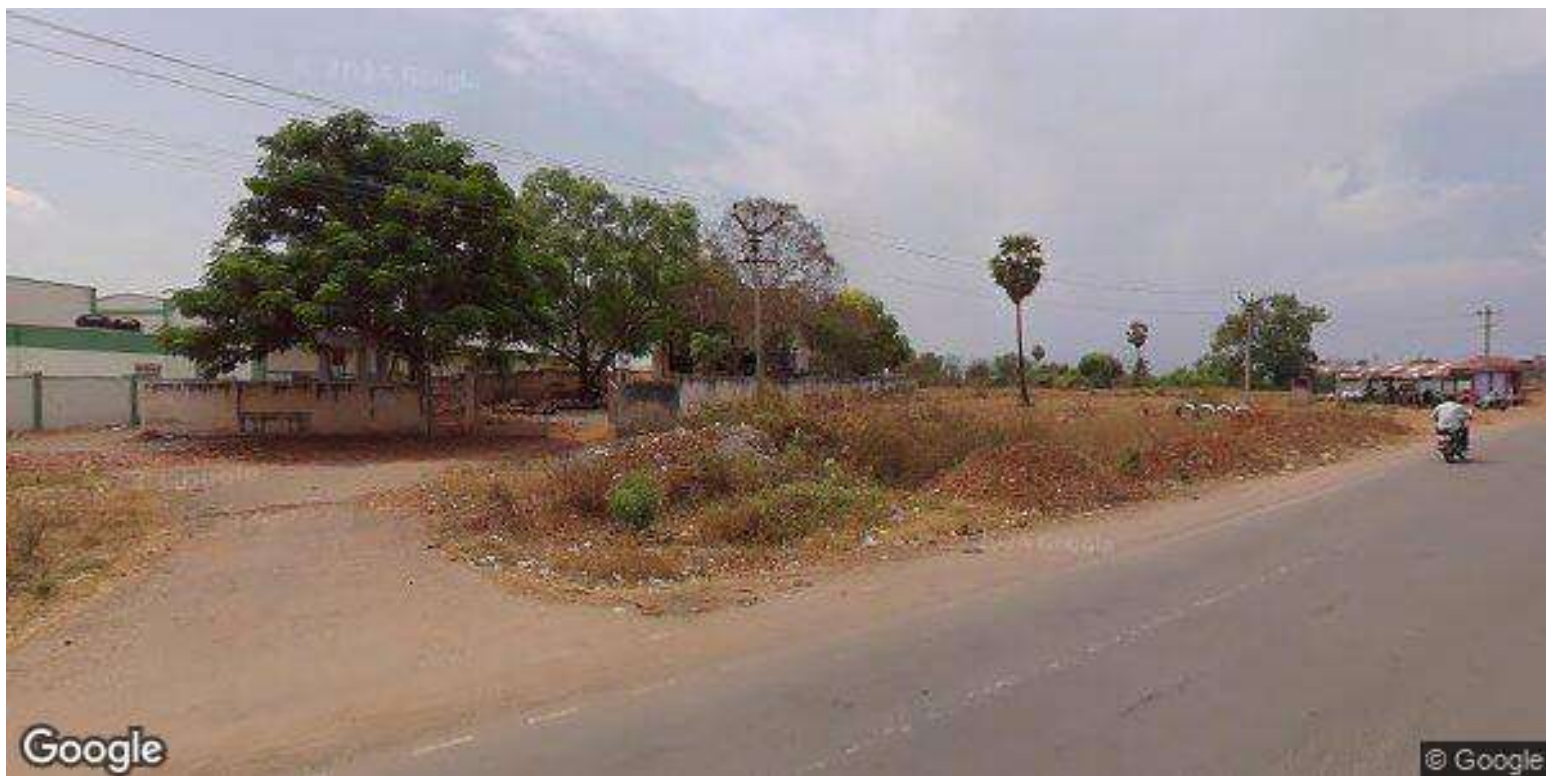
**Coordinates:** 11.58320, 77.90646

**Risk Type:** Turn

**Risk Level:** High

**Speed Limit:** 15 KM/Hr

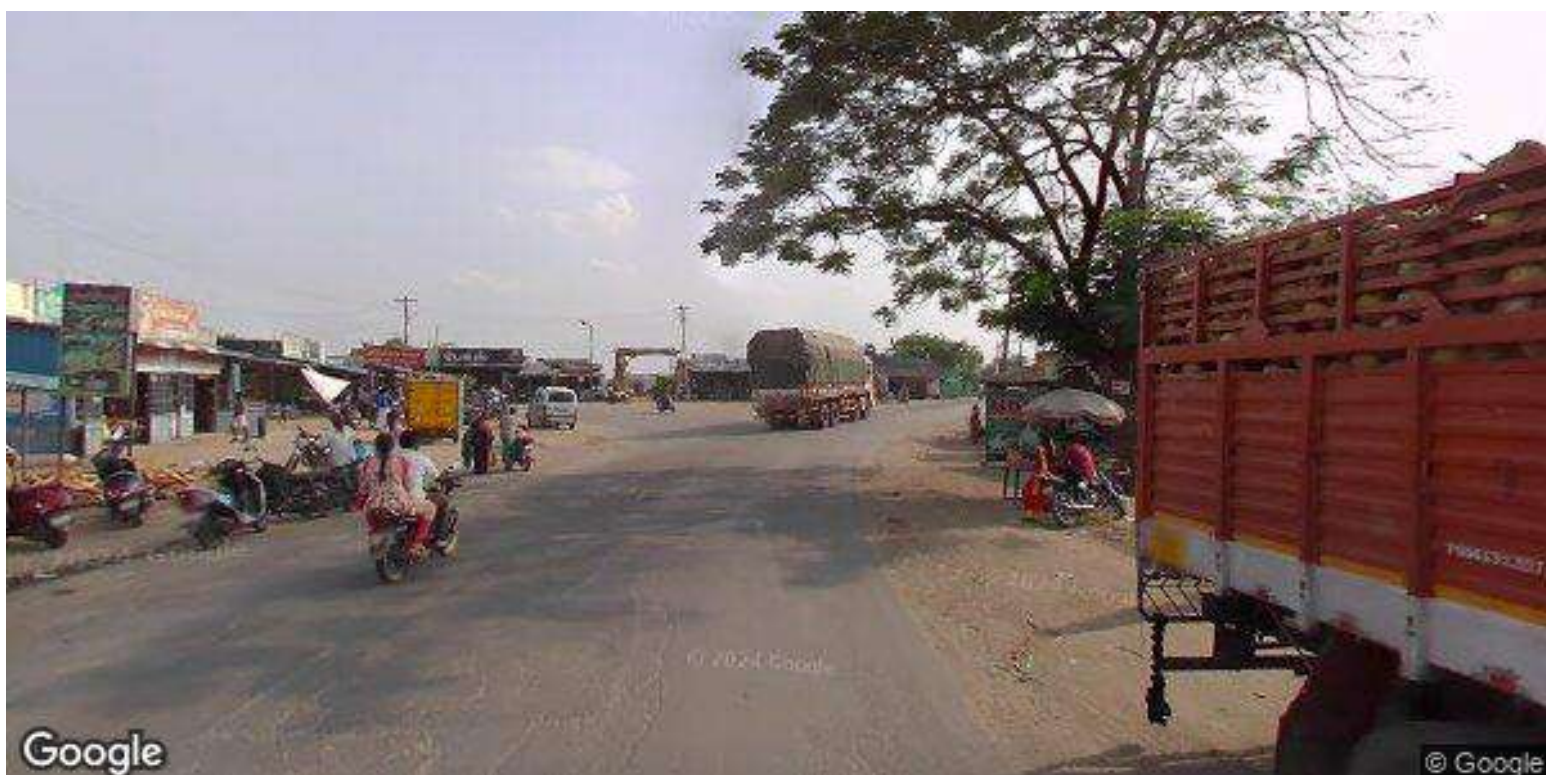
**Risk Type:** Turn  
**Risk Level:** Medium  
**Speed Limit:** 30 KM/Hr  
**Coordinates:** 11.64197, 77.95197

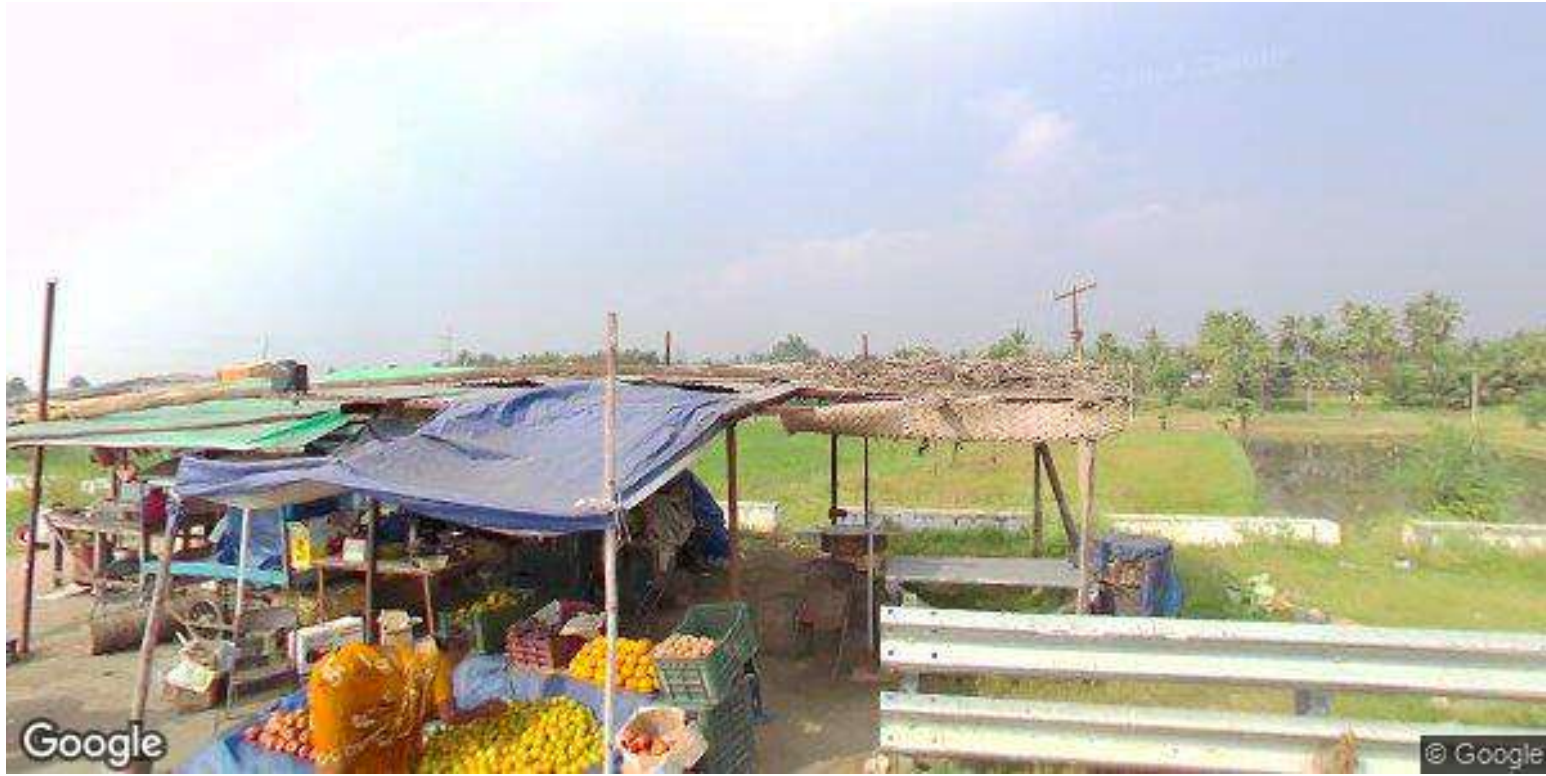
**Risk Type:** Turn  
**Risk Level:** Medium  
**Speed Limit:** 30 KM/Hr  
**Coordinates:** 11.67858, 77.96834

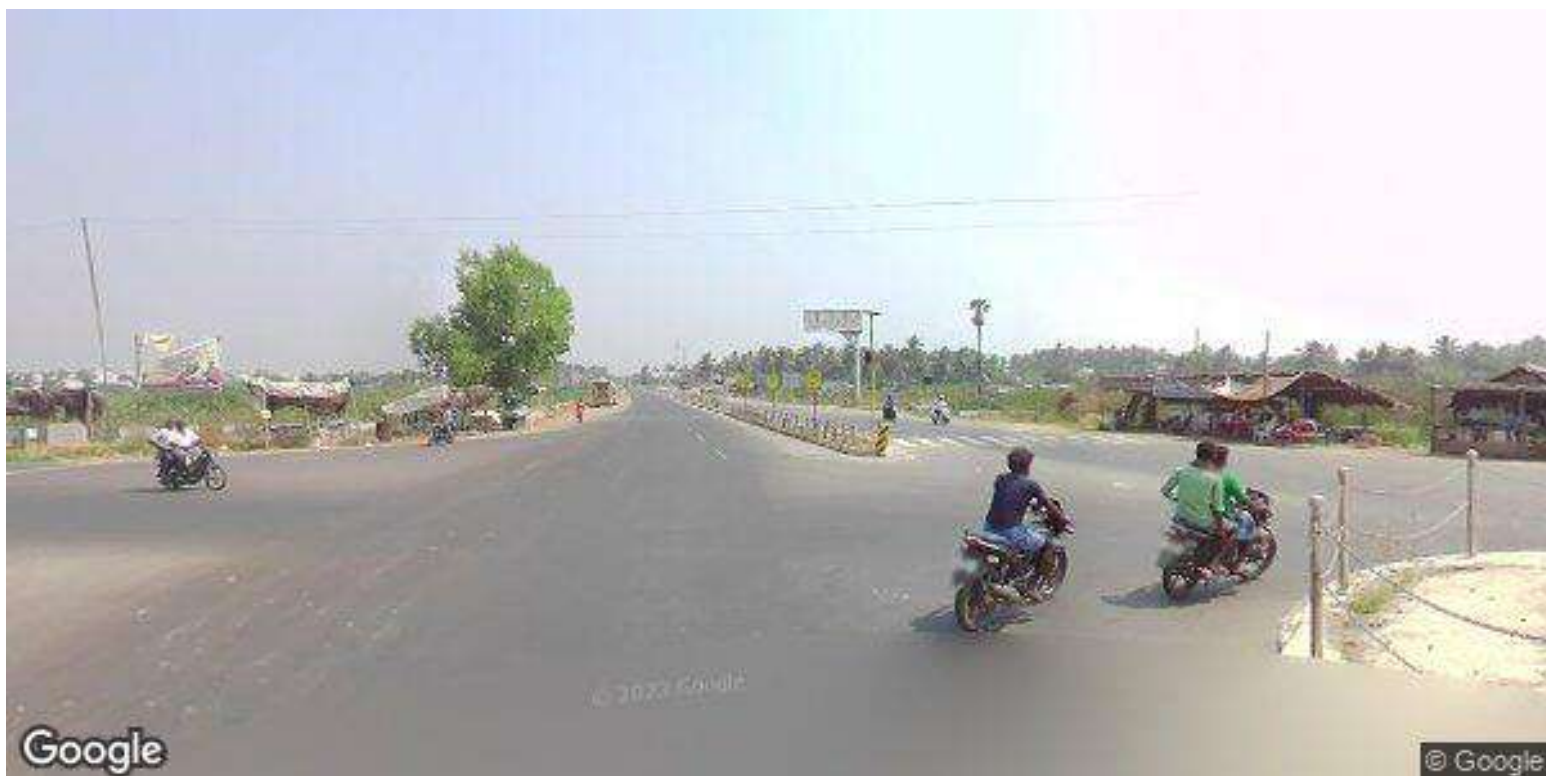
**Risk Type:** Turn  
**Risk Level:** High  
**Speed Limit:** 15 KM/Hr  
**Coordinates:** 11.68921, 77.97737

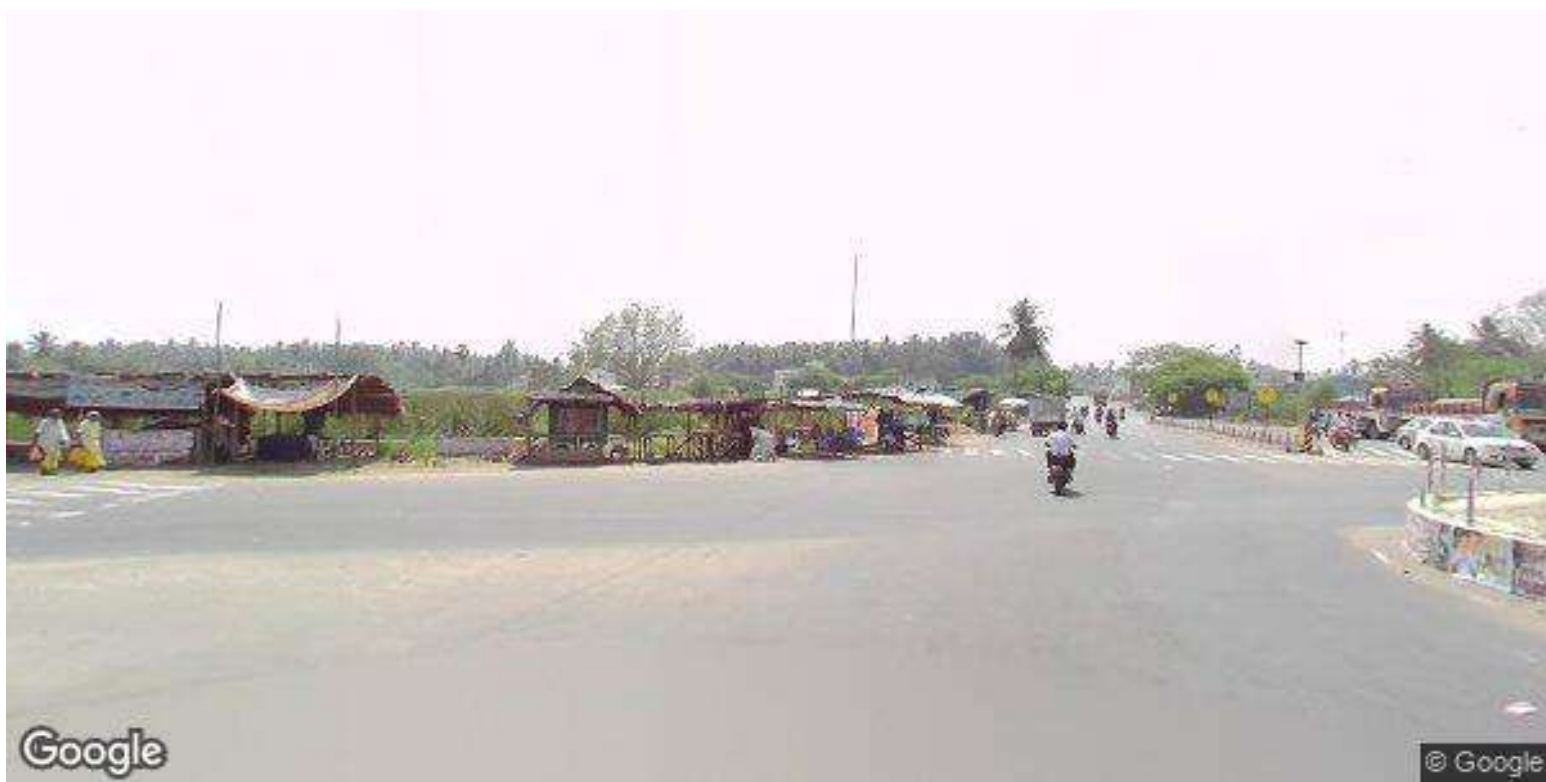
**Coordinates:** 11.68927, 77.97749

**Risk Type:** Turn

**Risk Level:** Medium

**Speed Limit:** 30 KM/Hr

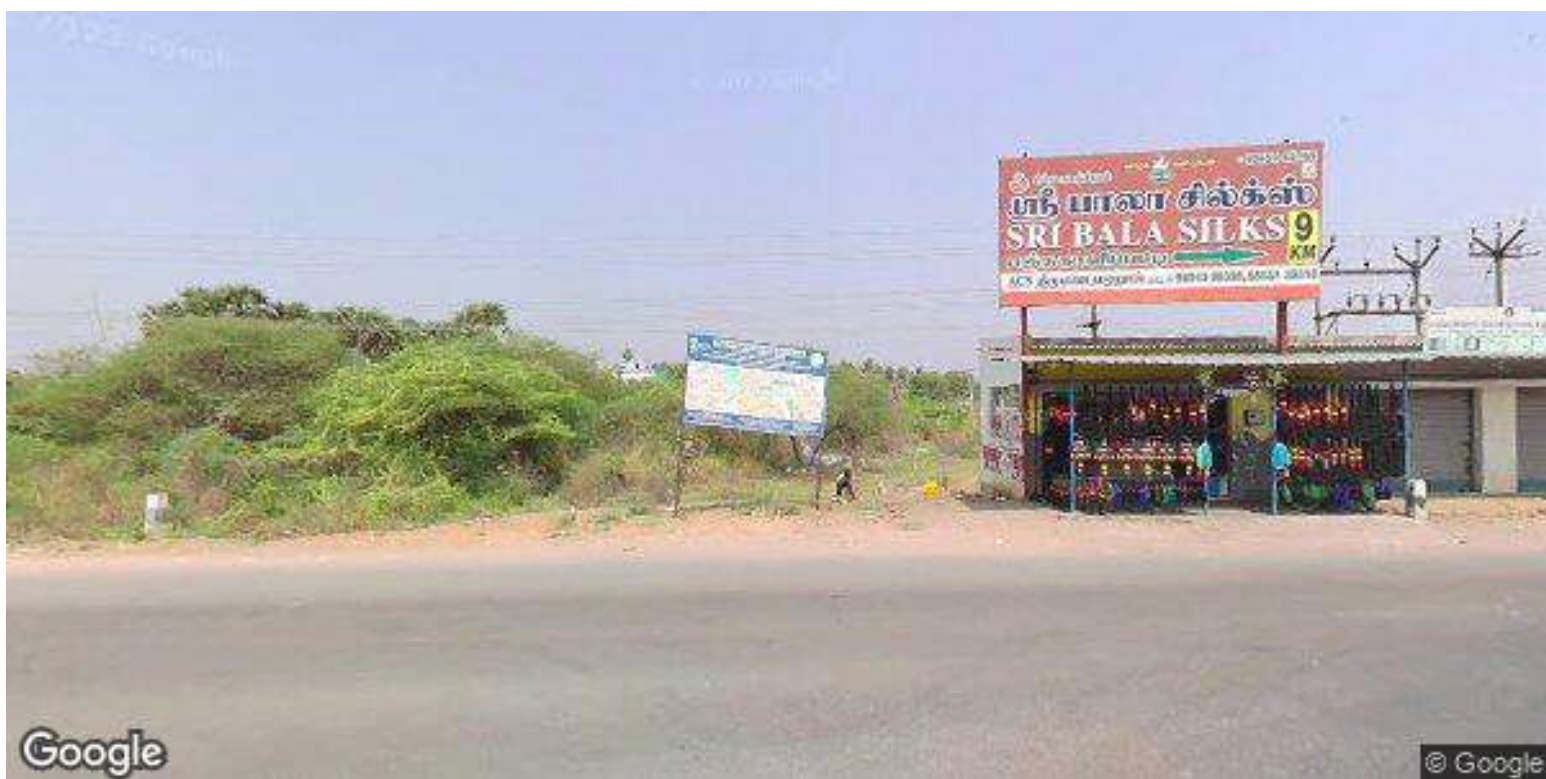
**Coordinates:** 11.70223, 77.97860

**Risk Type:** Turn

**Risk Level:** High

**Speed Limit:** 15 KM/Hr
