# IndianOil

## JOURNEY RISK MANAGEMENT (JRM) STUDY

### Salem Terminal TO LAKSHMI AGENCIYES

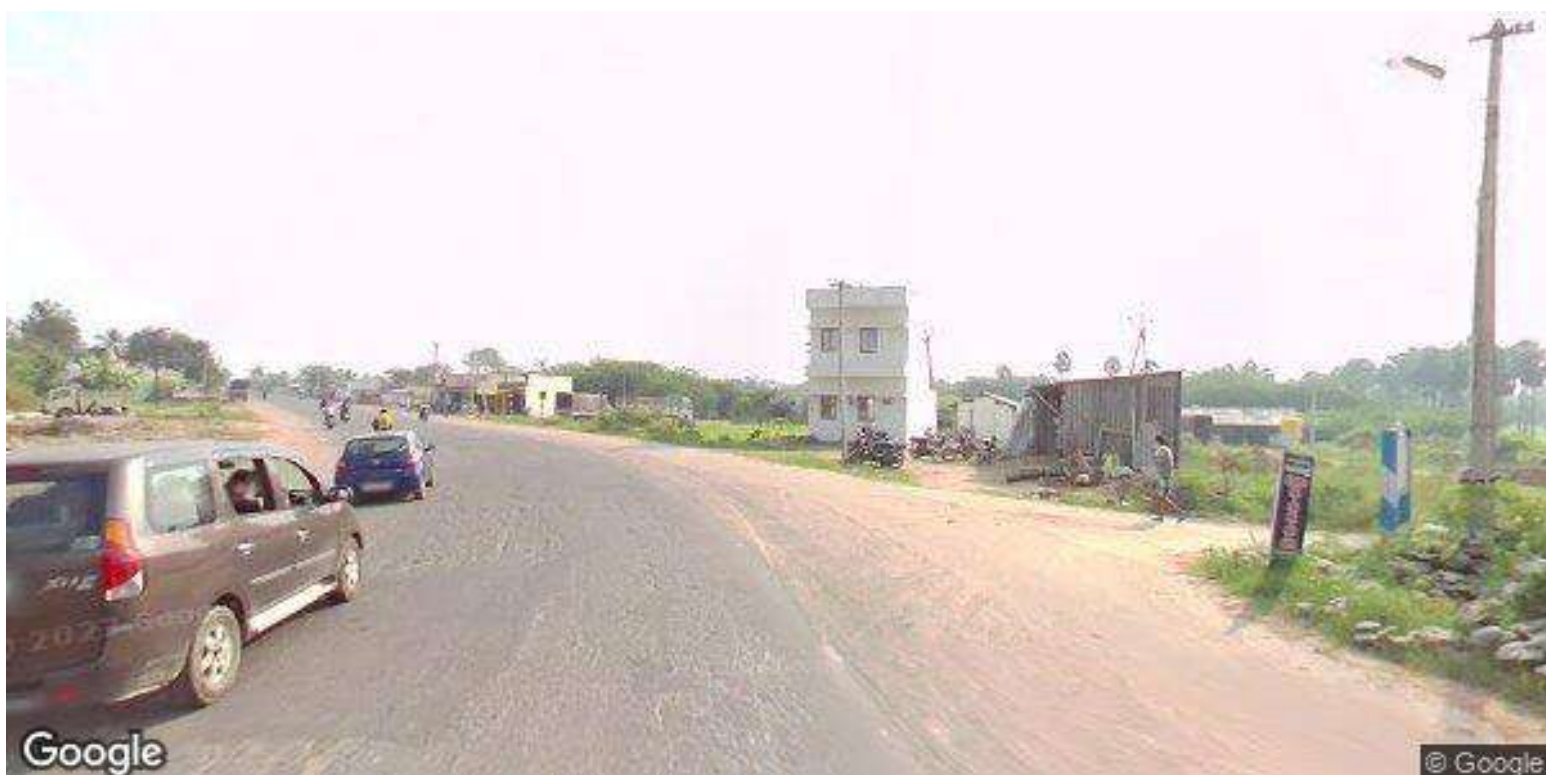
**Risk Type:** Turn  
**Risk Level:** Medium  
**Speed Limit:** 30 KM/Hr  
**Coordinates:** 11.71918, 78.01127

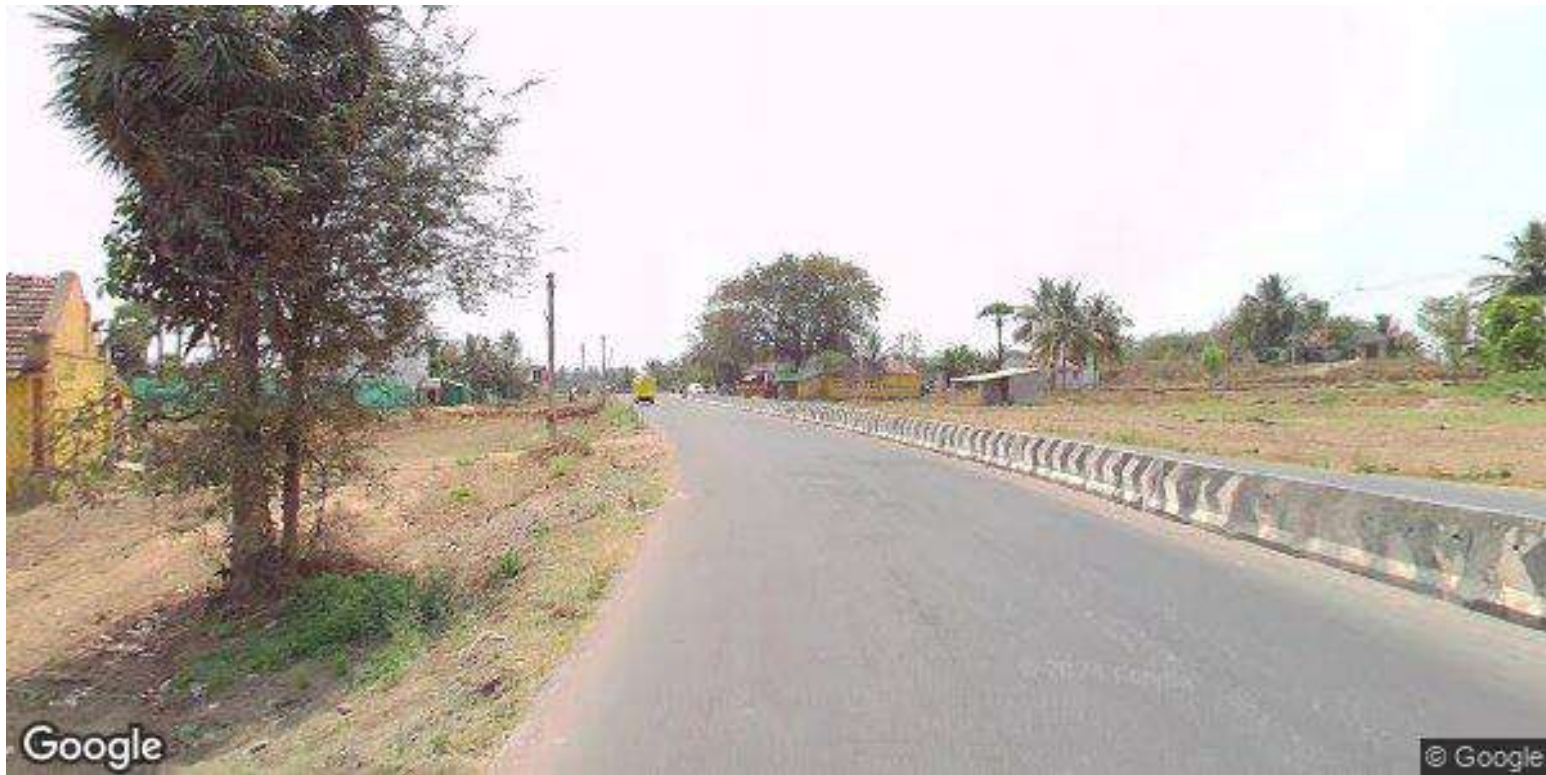
**Risk Type:** Turn  
**Risk Level:** Medium  
**Speed Limit:** 30 KM/Hr  
**Coordinates:** 11.72565, 78.01770

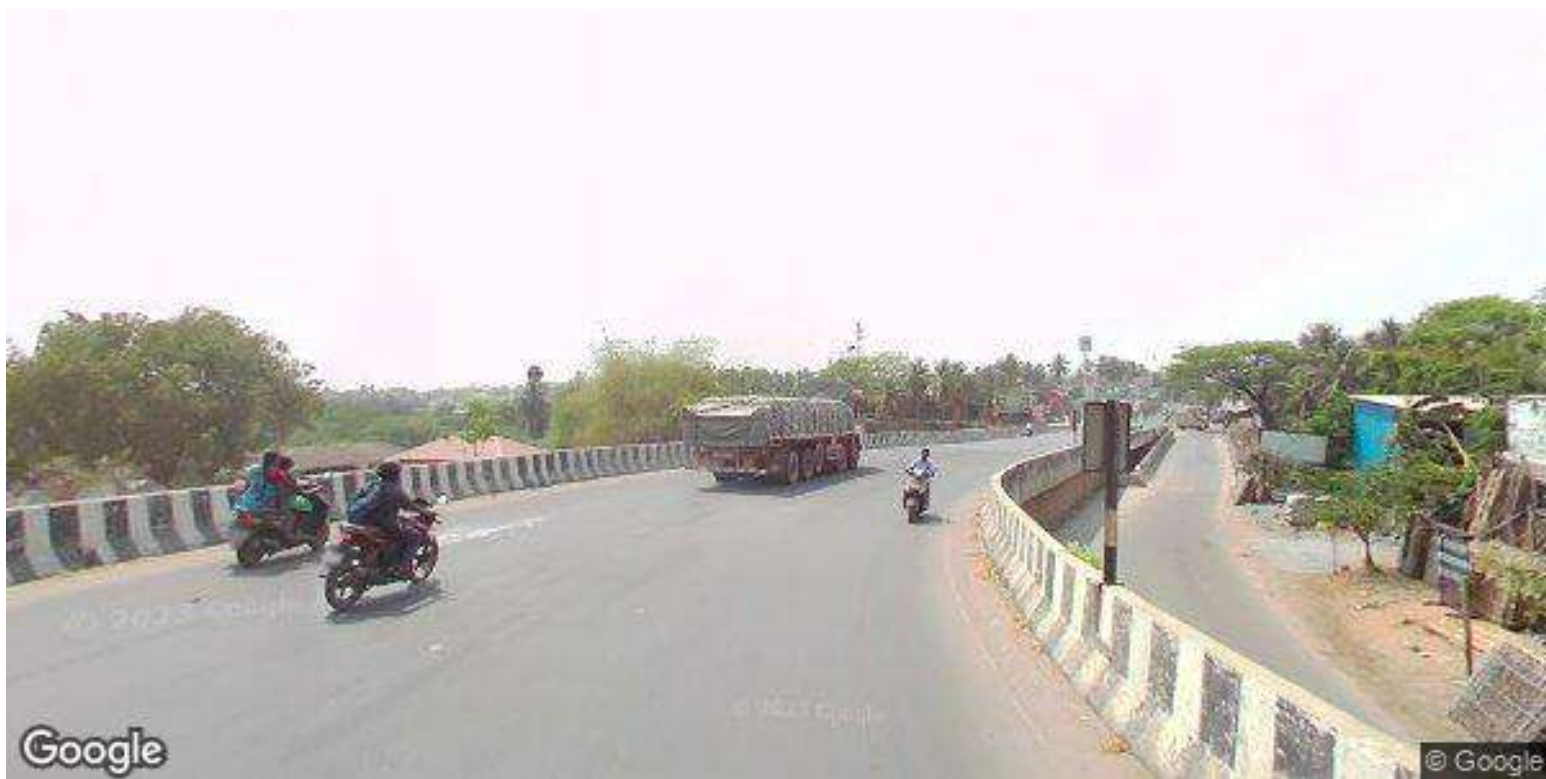
**Risk Type:** Turn  
**Risk Level:** Medium  
**Speed Limit:** 30 KM/Hr  
**Coordinates:** 11.73651, 78.03873

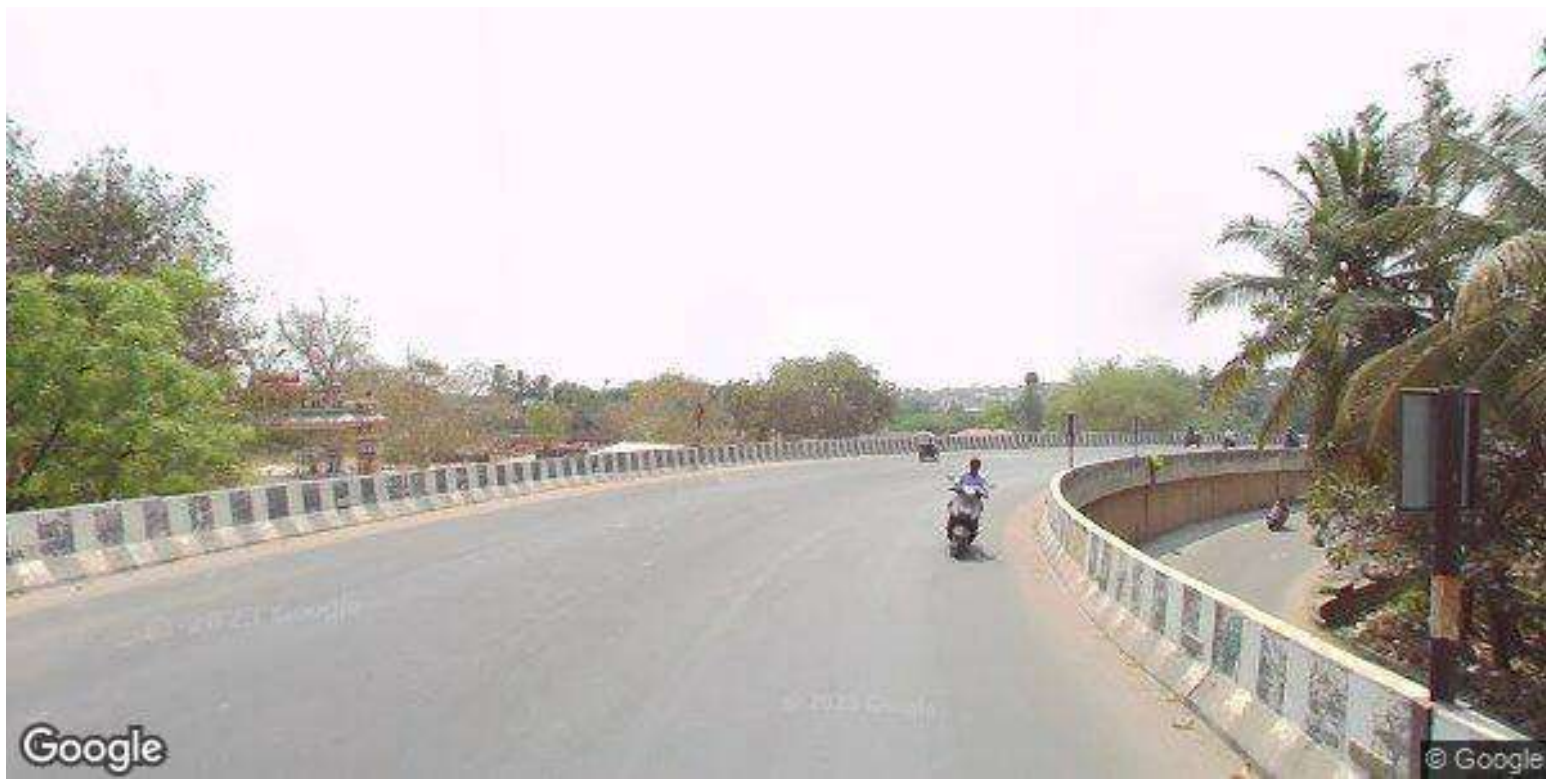
**Coordinates:** 11.73658, 78.03897

**Risk Type:** Turn

**Risk Level:** Medium

**Speed Limit:** 30 KM/Hr

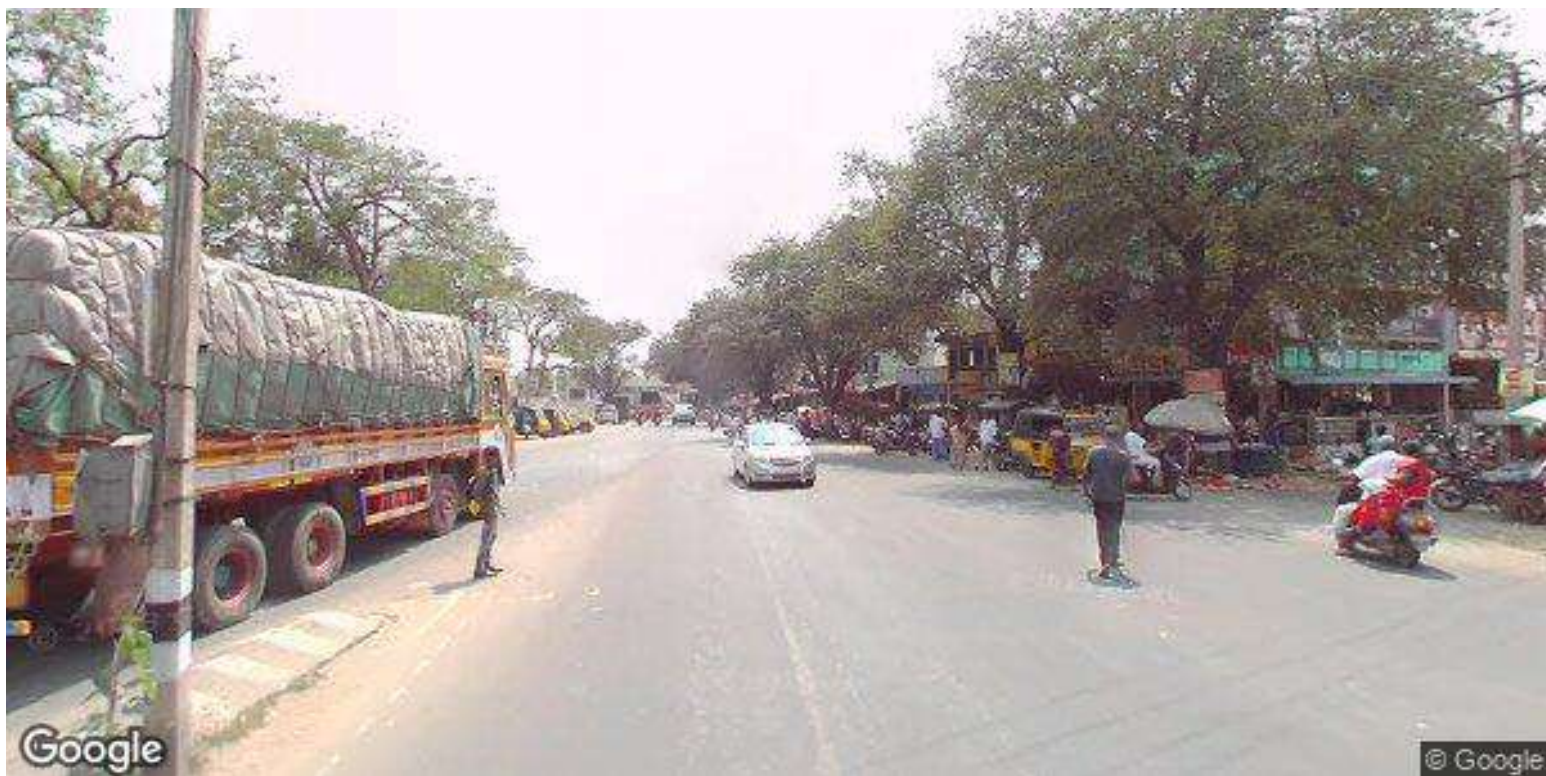
**Coordinates:** 11.74271, 78.04717

**Risk Type:** Turn

**Risk Level:** Medium

**Speed Limit:** 30 KM/Hr

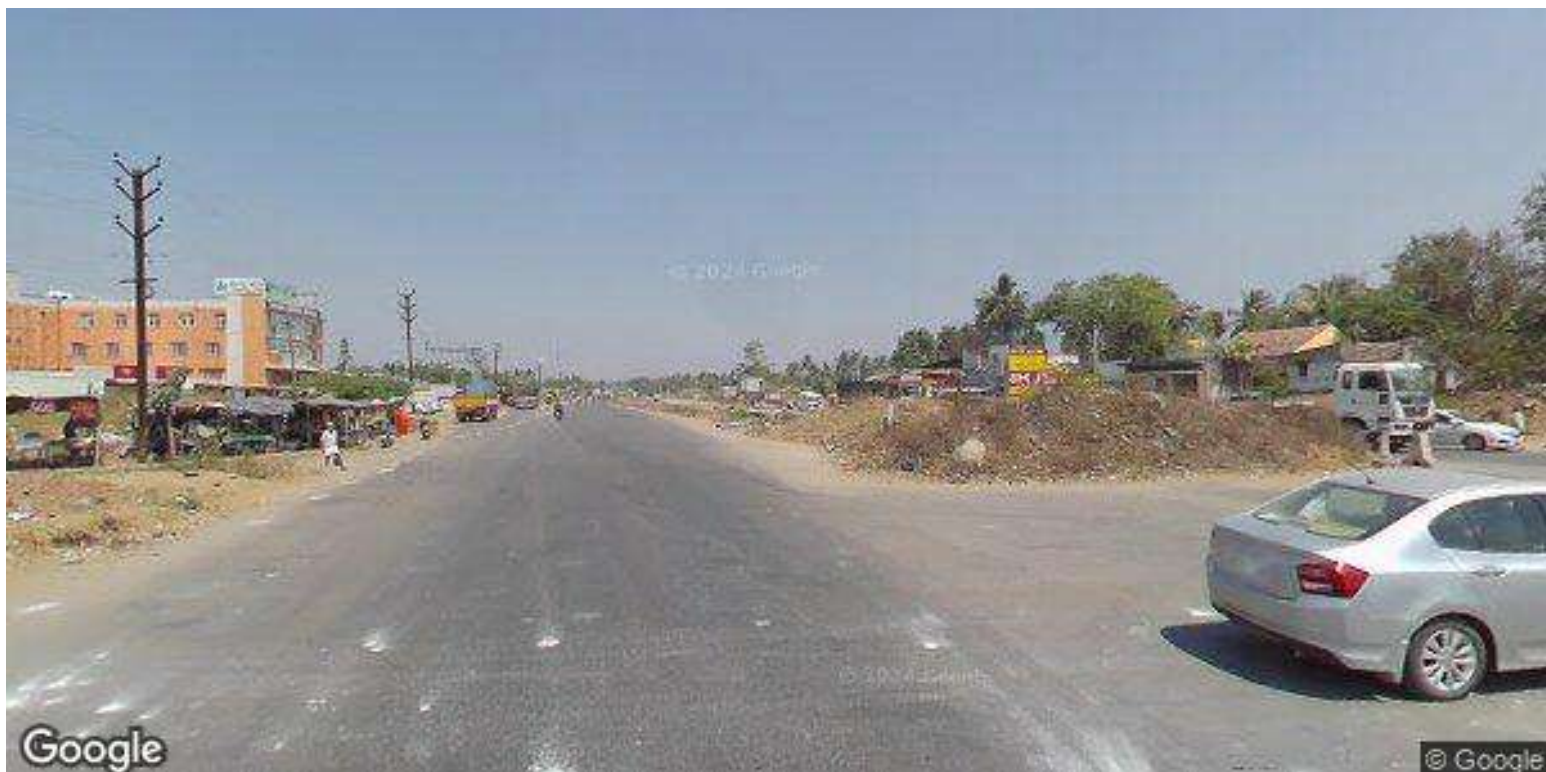
**Risk Type:** Blind Spot  
**Risk Level:** Blind Spot  
**Speed Limit:** 10 KM/Hr  
**Coordinates:** 11.77258, 78.05460

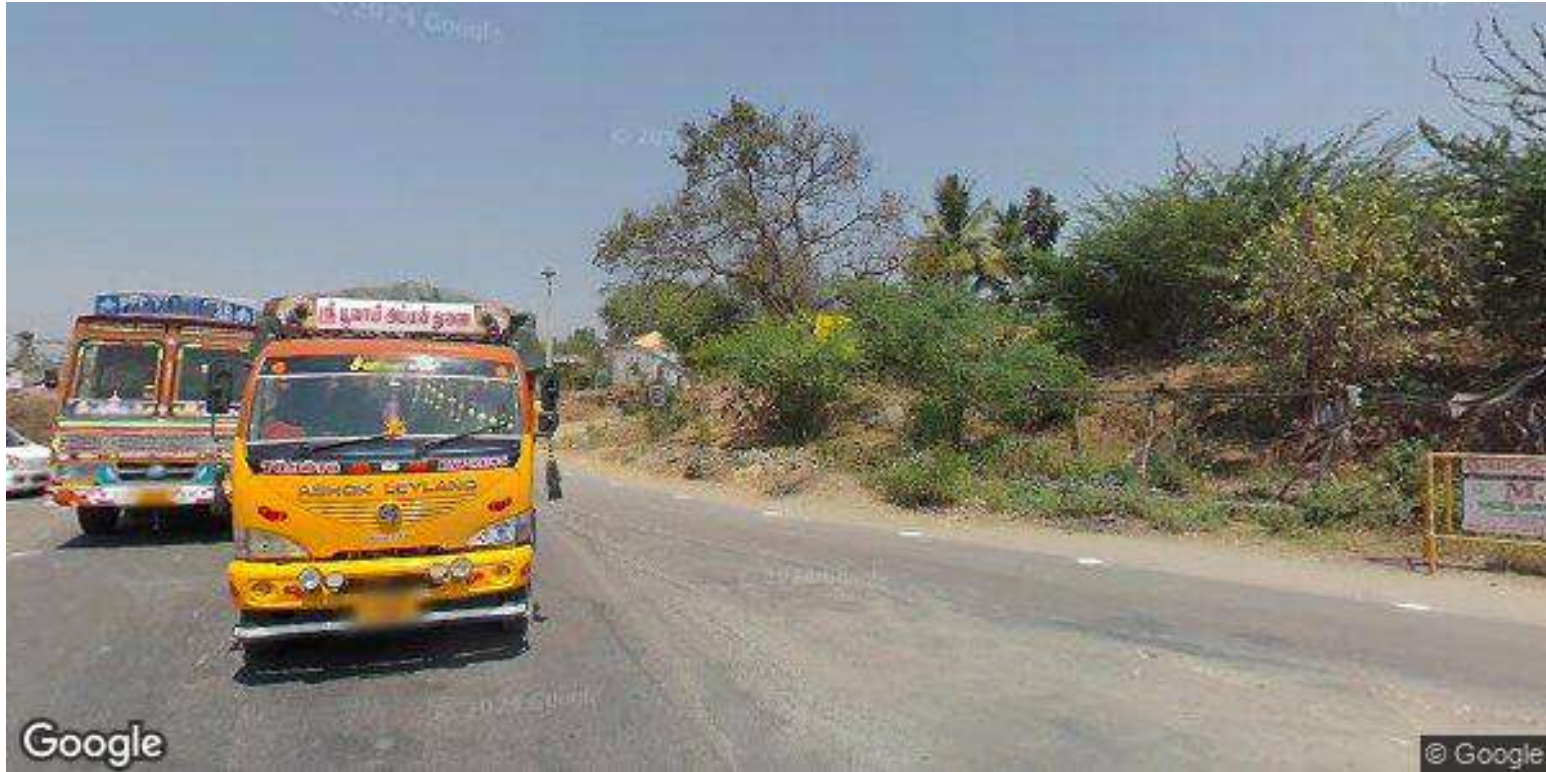
**Risk Type:** Turn  
**Risk Level:** High  
**Speed Limit:** 15 KM/Hr  
**Coordinates:** 11.77233, 78.05483

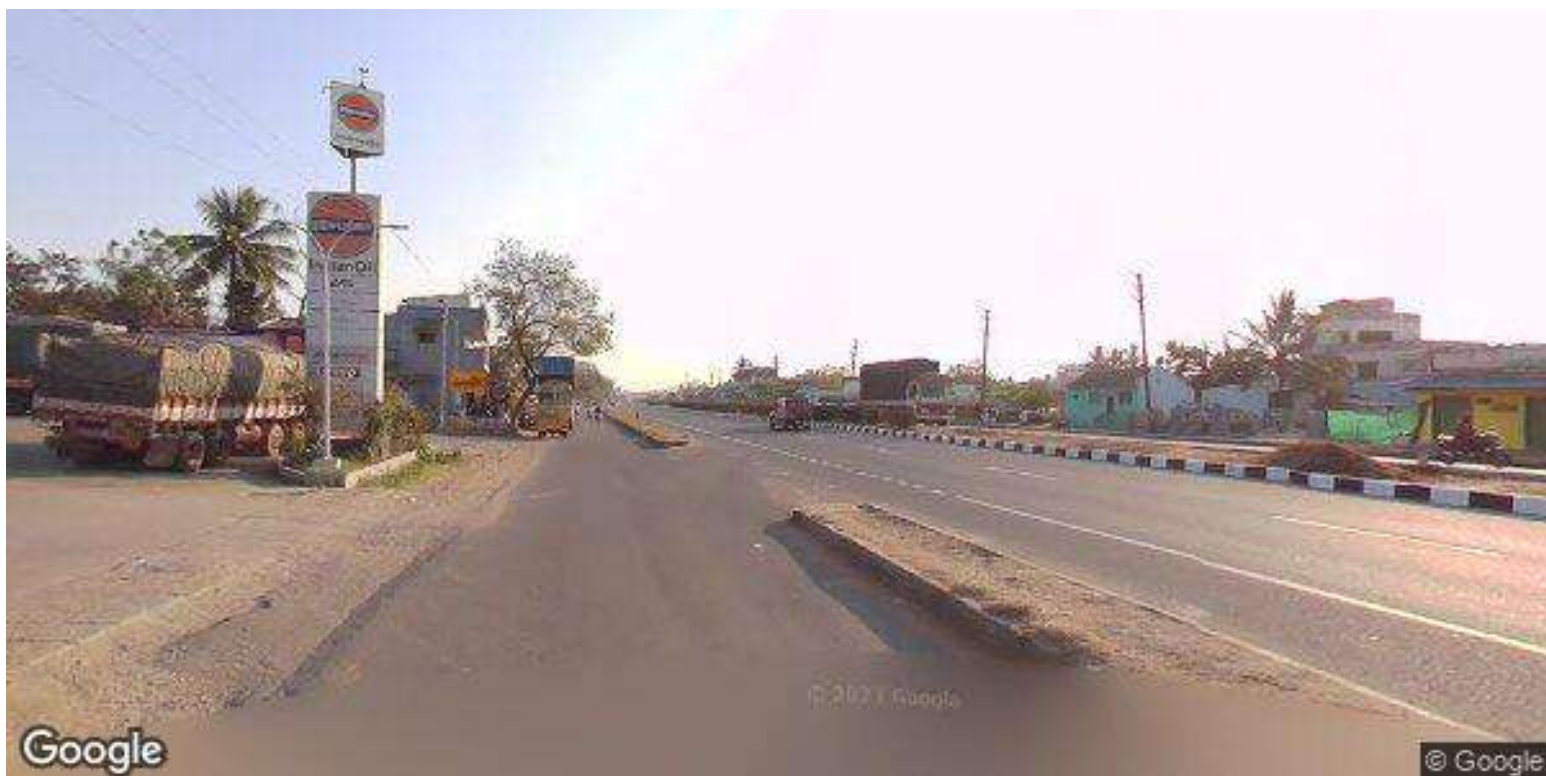
**Risk Type:** Blind Spot  
**Risk Level:** Blind Spot  
**Speed Limit:** 10 KM/Hr  
**Coordinates:** 11.76570, 78.05270
