## JOURNEY RISK MANAGEMENT (JRM) STUDY

### Salem Terminal to NAVANEE AGENCIES

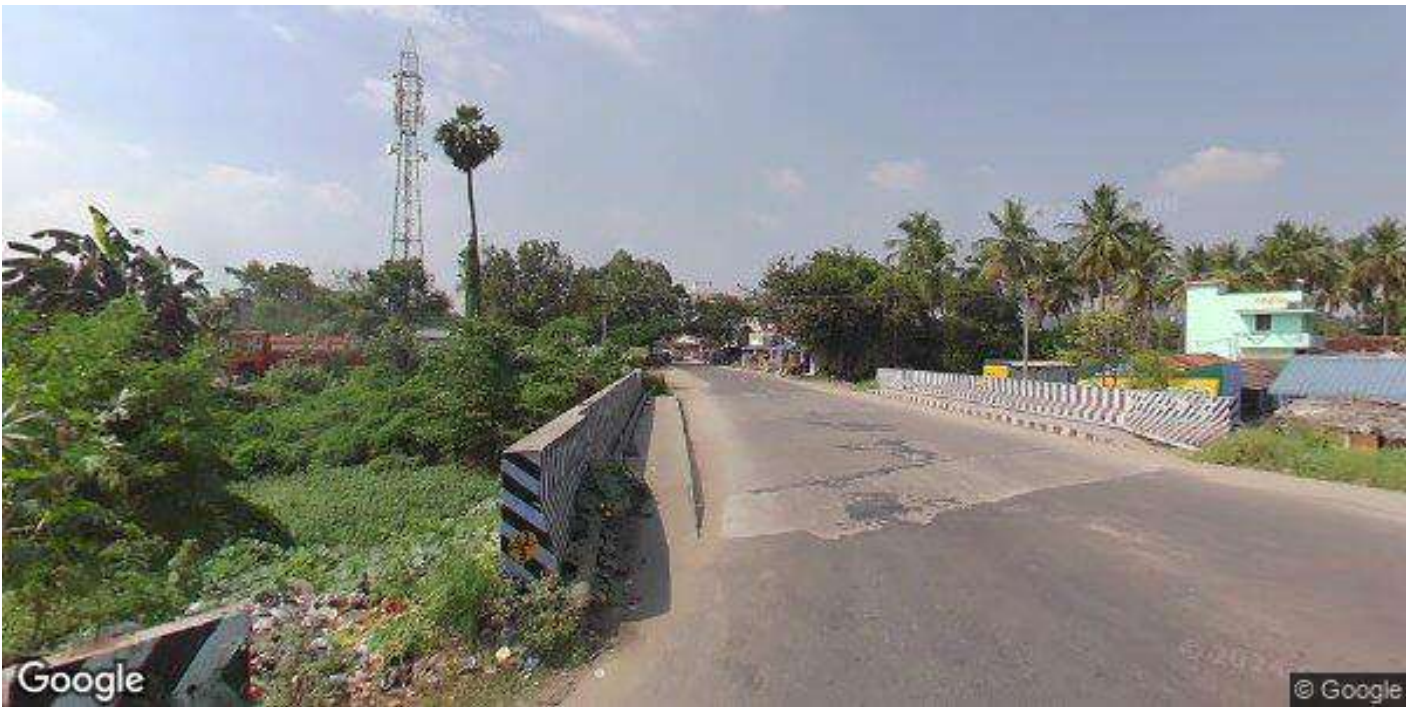
| | Risk Type | Risk Level | Coordinates | Speed Limit |
|---|---|---|---|---|
| 2 | Turn | High | 11.44900, 77.87406 | 15 KM/Hr |

Risk Type: Turn  
Risk Level: High  
Speed Limit: 15 KM/Hr  
Coordinates: 11.44900, 77.87406

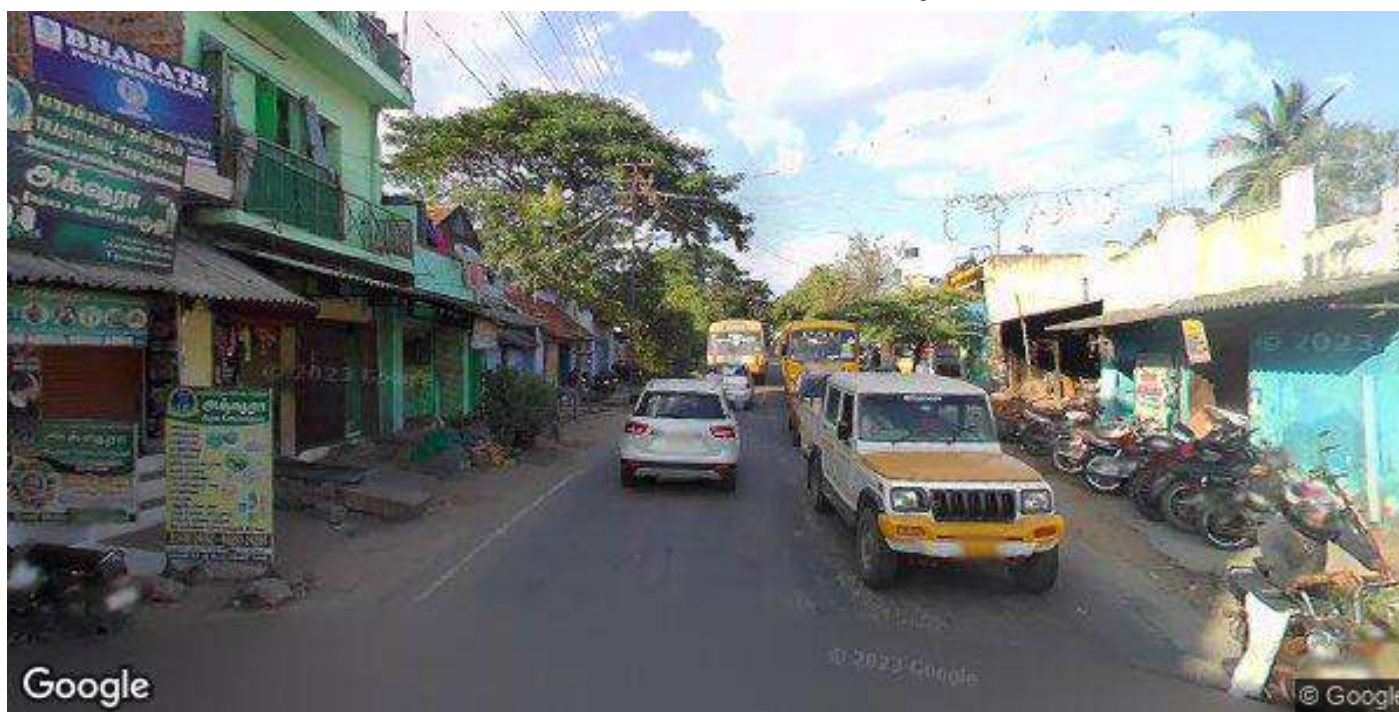
| | Risk Type | Risk Level | Coordinates | Speed Limit |
|---|---|---|---|---|
| 3 | Turn | High | 11.45028, 77.87202 | 15 KM/Hr |

**Risk Type:** Turn  
**Risk Level:** High  
**Speed Limit:** 15 KM/Hr  
**Coordinates:** 11.45028, 77.87202

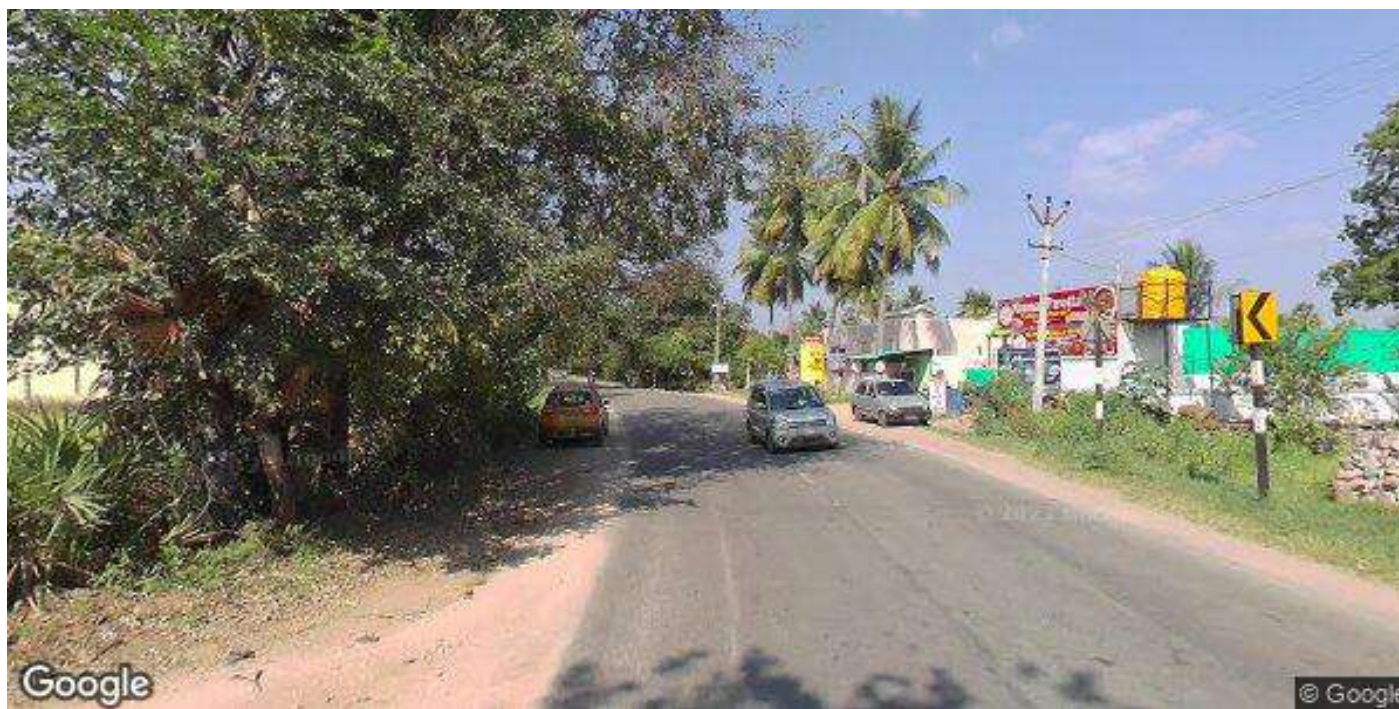
| | Risk Type | Risk Level | Coordinates | Speed Limit |
|---|---|---|---|---|
| 4 | Turn | Medium | 11.45309, 77.87325 | 30 KM/Hr |

**Risk Type:** Turn  
**Risk Level:** Medium  
**Speed Limit:** 30 KM/Hr  
**Coordinates:** 11.45309, 77.87325

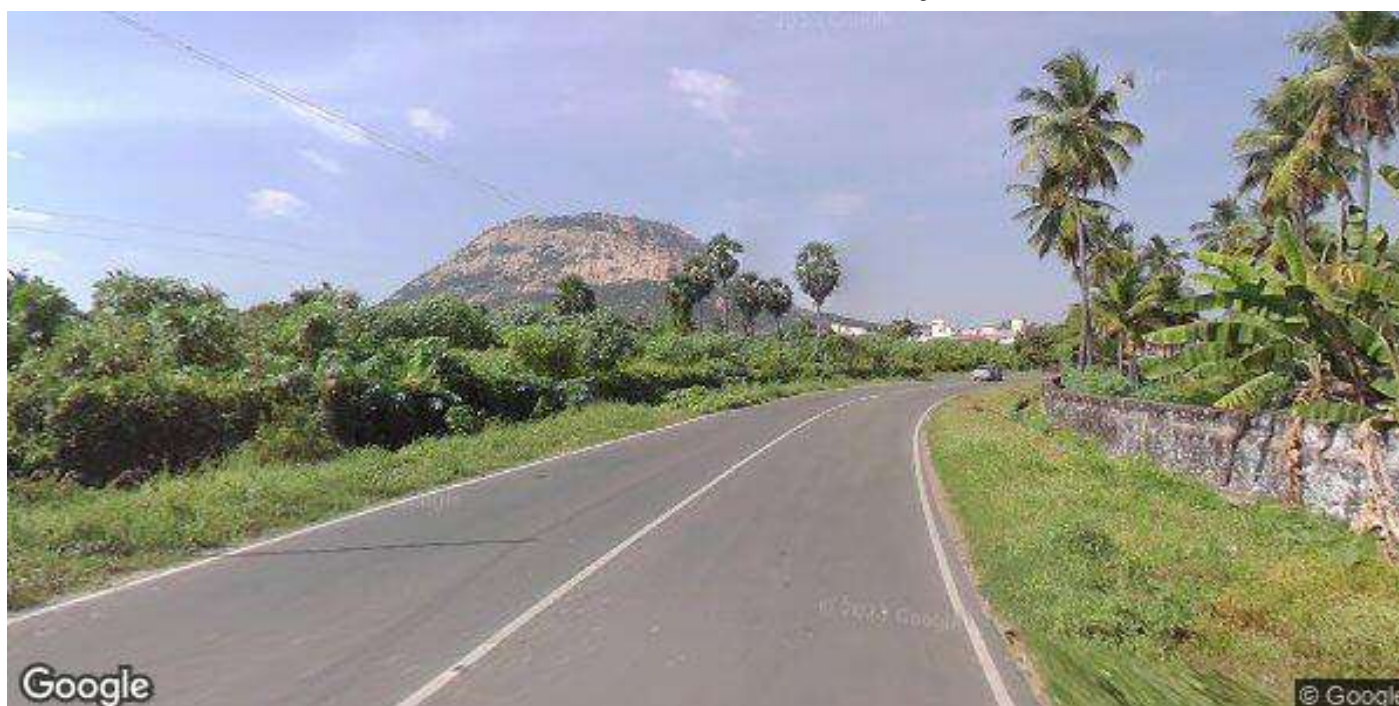
| | Risk Type | Risk Level | Coordinates | Speed Limit |
|---|---|---|---|---|
| 6 | Turn | Medium | 11.46765, 77.87037 | 30 KM/Hr |

**Risk Type:** Turn  
**Risk Level:** Medium  
**Speed Limit:** 30 KM/Hr  
**Coordinates:** 11.46765, 77.87037

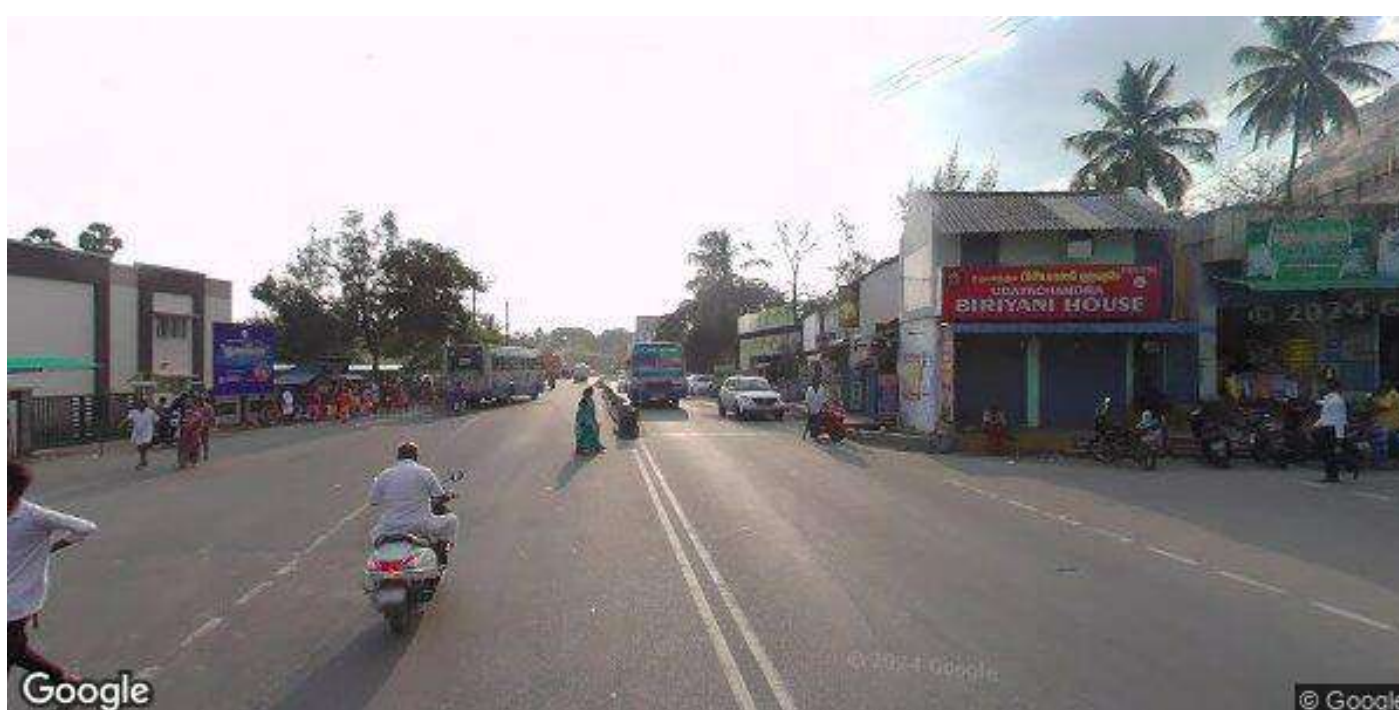
| | Risk Type | Risk Level | Coordinates | Speed Limit |
|---|---|---|---|---|
| 7 | Turn | High | 11.47403, 77.86841 | 15 KM/Hr |

**Risk Type:** Turn  
**Risk Level:** High  
**Speed Limit:** 15 KM/Hr  
**Coordinates:** 11.47403, 77.86841

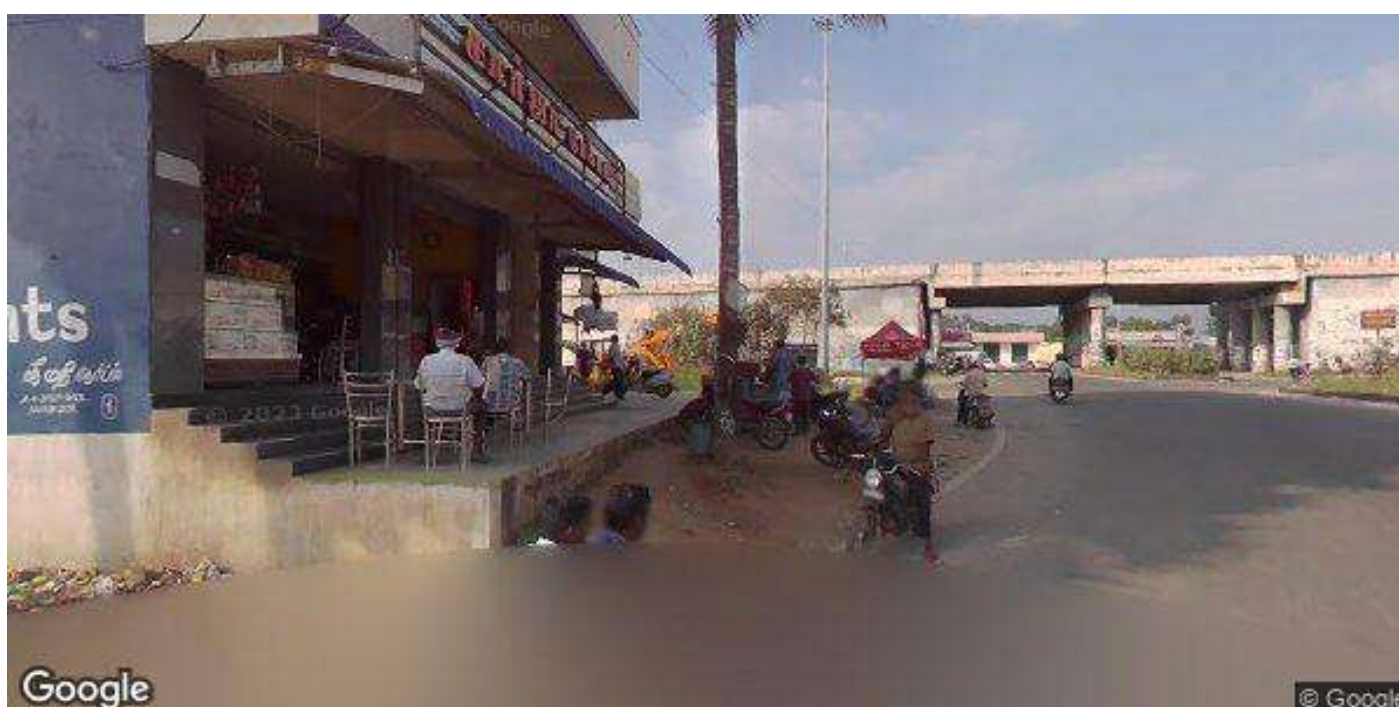
| | Risk Type | Risk Level | Coordinates | Speed Limit |
|---|---|---|---|---|
| 8 | Turn | High | 11.49149, 77.89601 | 15 KM/Hr |

**Risk Type:** Turn  
**Risk Level:** High  
**Speed Limit:** 15 KM/Hr  
**Coordinates:** 11.49149, 77.89601

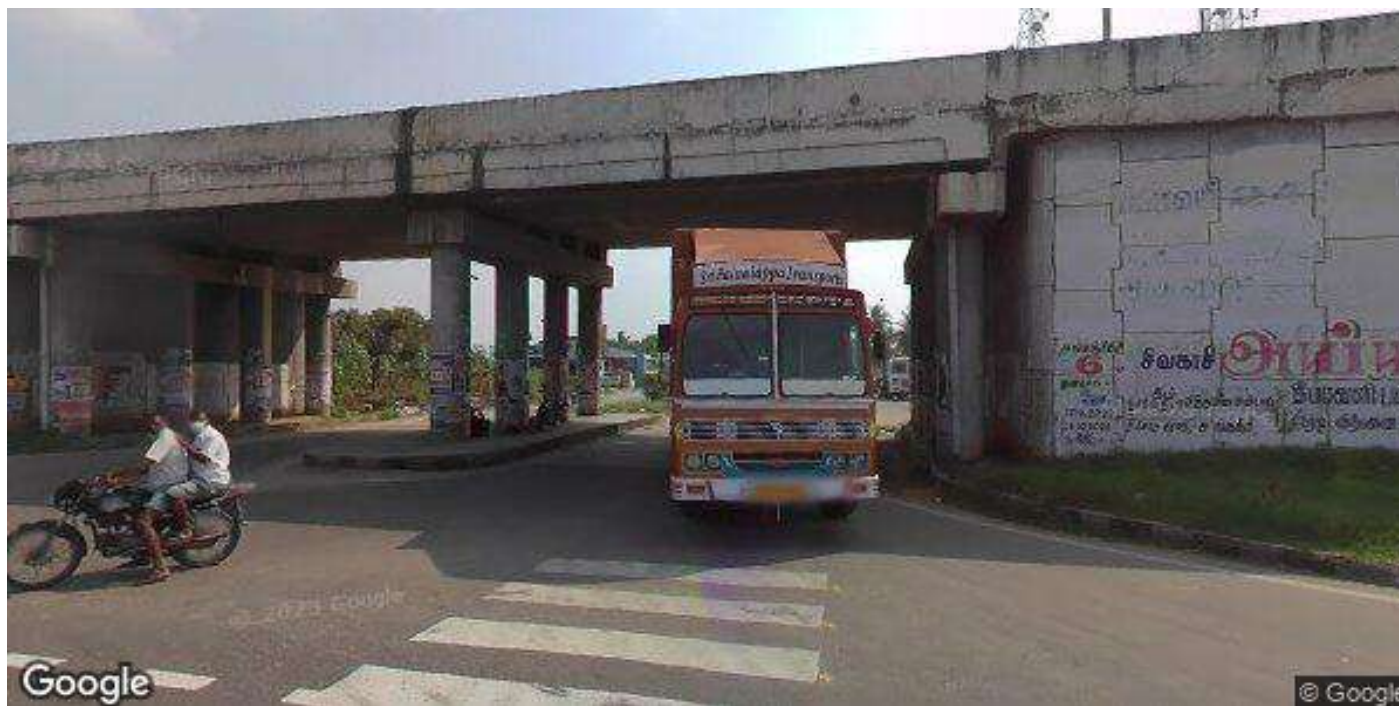
| | Risk Type | Risk Level | Coordinates | Speed Limit |
|---|---|---|---|---|
| 9 | Turn | High | 11.49224, 77.89601 | 15 KM/Hr |

**Risk Type:** Turn  
**Risk Level:** High  
**Speed Limit:** 15 KM/Hr  
**Coordinates:** 11.49224, 77.89601

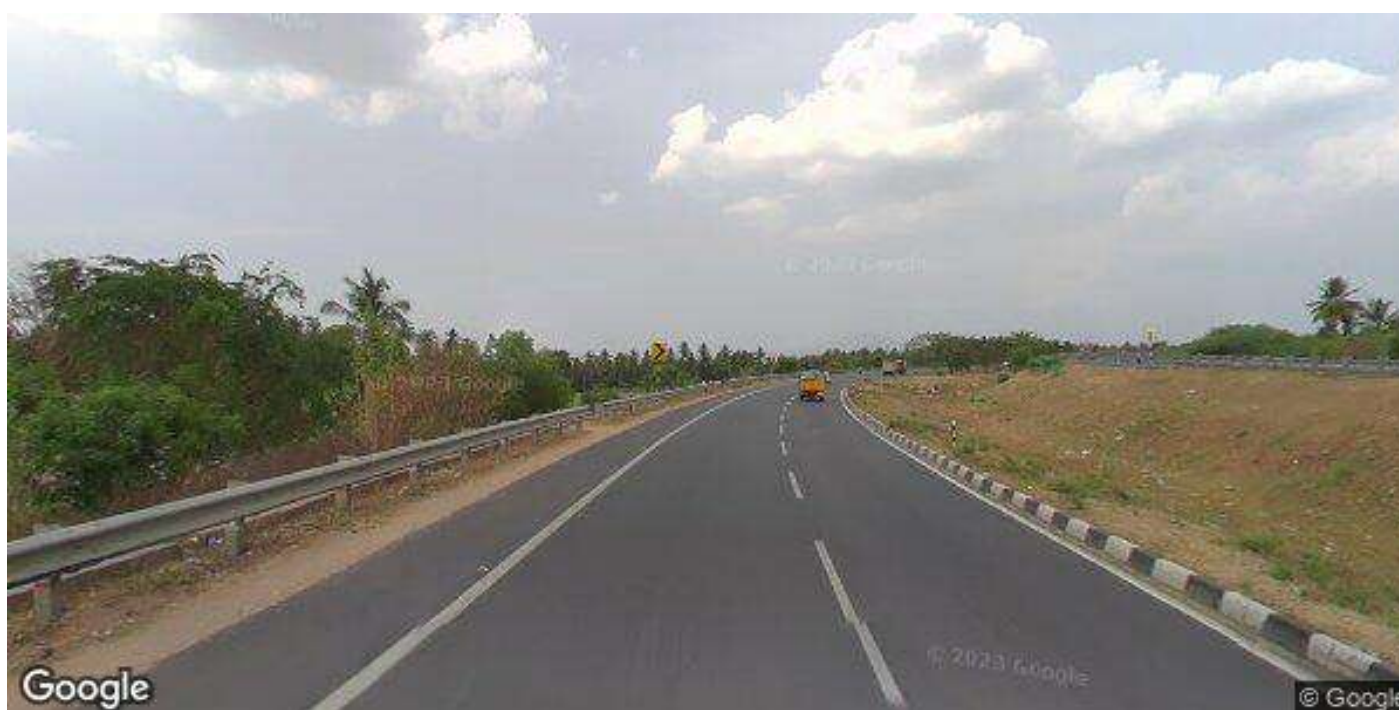
| | Risk Type | Risk Level | Coordinates | Speed Limit |
|---|---|---|---|---|
| 10 | Turn | Medium | 11.53501, 77.95707 | 30 KM/Hr |

**Risk Type:** Turn  
**Risk Level:** Medium  
**Speed Limit:** 30 KM/Hr  
**Coordinates:** 11.53501, 77.95707

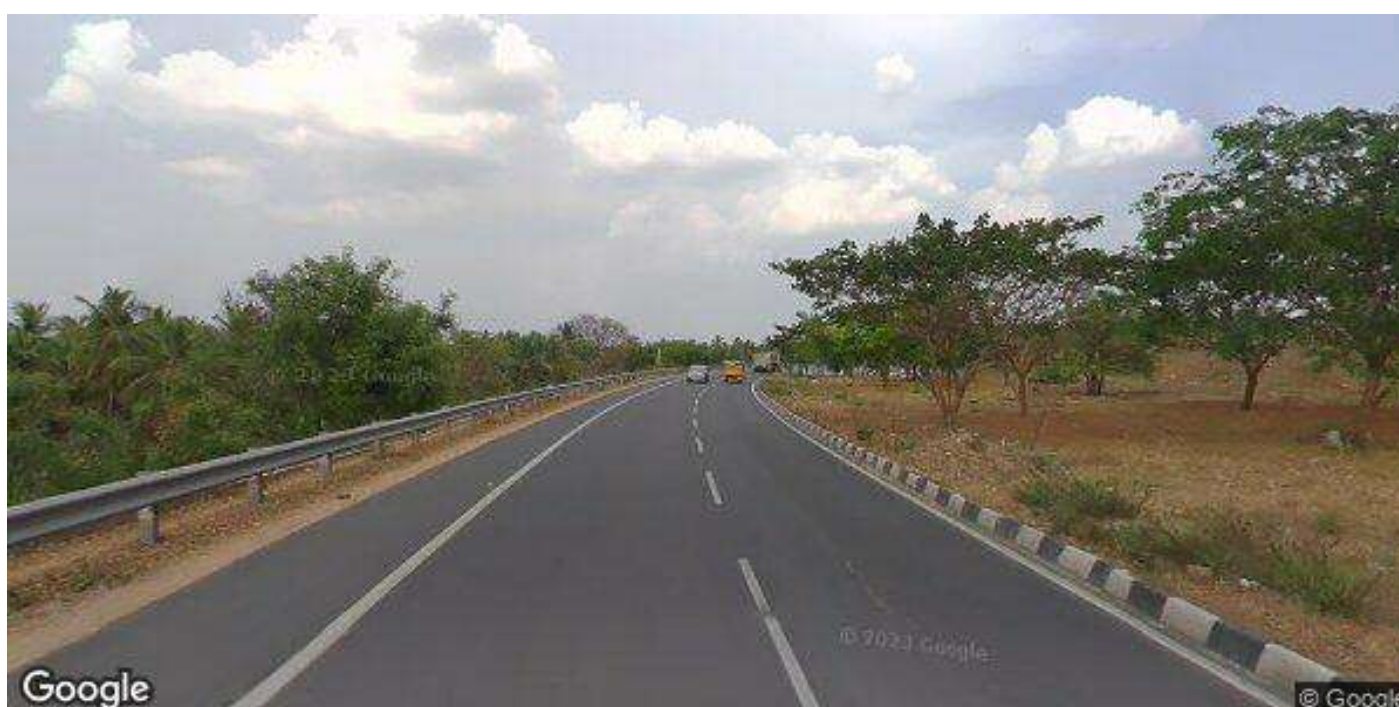
| | Risk Type | Risk Level | Coordinates | Speed Limit |
|---|---|---|---|---|
| 11 | Turn | Medium | 11.53601, 77.95856 | 30 KM/Hr |

**Risk Type:** Turn  
**Risk Level:** Medium  
**Speed Limit:** 30 KM/Hr  
**Coordinates:** 11.53601, 77.95856

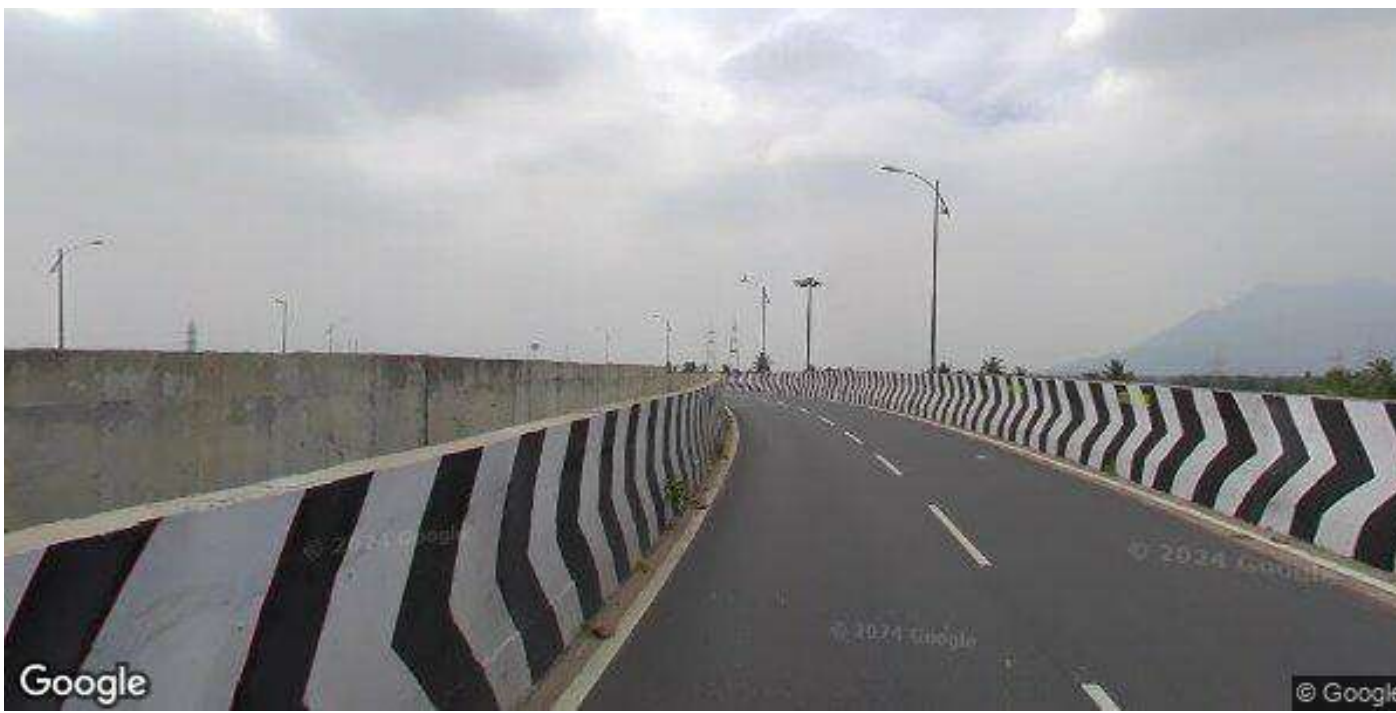
| | Risk Type | Risk Level | Coordinates | Speed Limit |
|---|---|---|---|---|
| 12 | Turn | Medium | 11.64180, 78.11808 | 30 KM/Hr |

**Risk Type:** Turn  
**Risk Level:** Medium  
**Speed Limit:** 30 KM/Hr  
**Coordinates:** 11.64180, 78.11808

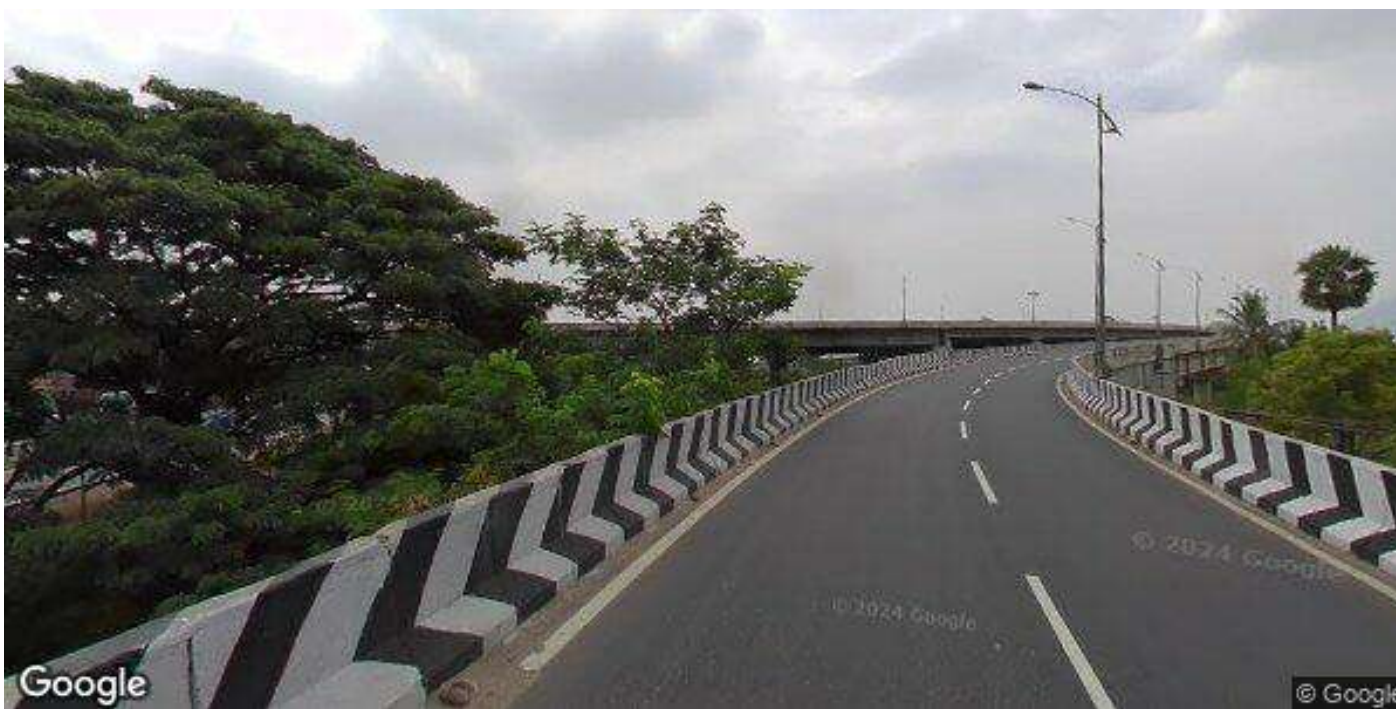
| | Risk Type | Risk Level | Coordinates | Speed Limit |
|---|---|---|---|---|
| 13 | Turn | Medium | 11.64325, 78.11993 | 30 KM/Hr |

**Risk Type:** Turn  
**Risk Level:** Medium  
**Speed Limit:** 30 KM/Hr  
**Coordinates:** 11.64325, 78.11993

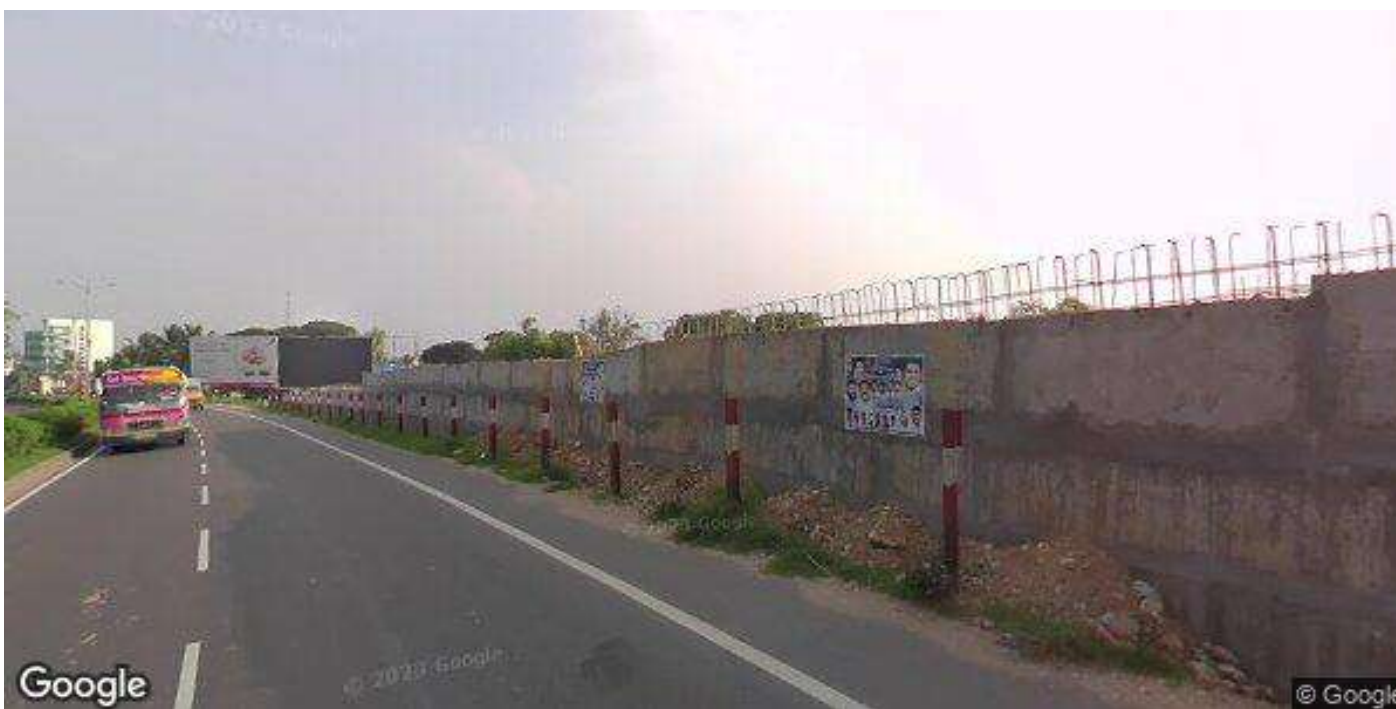
| | Risk Type | Risk Level | Coordinates | Speed Limit |
|---|---|---|---|---|
| 14 | Turn | Medium | 11.69519, 78.10775 | 30 KM/Hr |

**Risk Type:** Turn  
**Risk Level:** Medium  
**Speed Limit:** 30 KM/Hr  
**Coordinates:** 11.69519, 78.10775

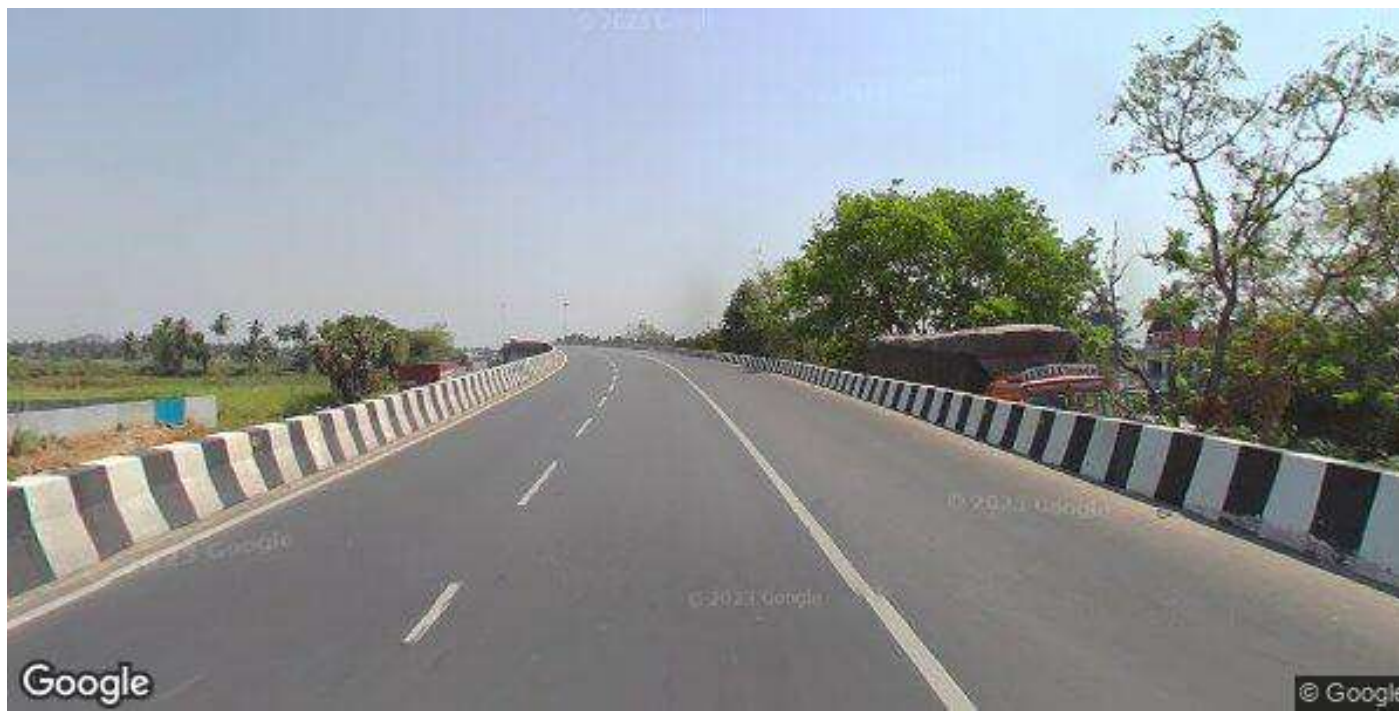
| | Risk Type | Risk Level | Coordinates | Speed Limit |
|---|---|---|---|---|
| 15 | Turn | Medium | 11.73958, 78.05105 | 30 KM/Hr |

**Risk Type:** Turn  
**Risk Level:** Medium  
**Speed Limit:** 30 KM/Hr  
**Coordinates:** 11.73958, 78.05105

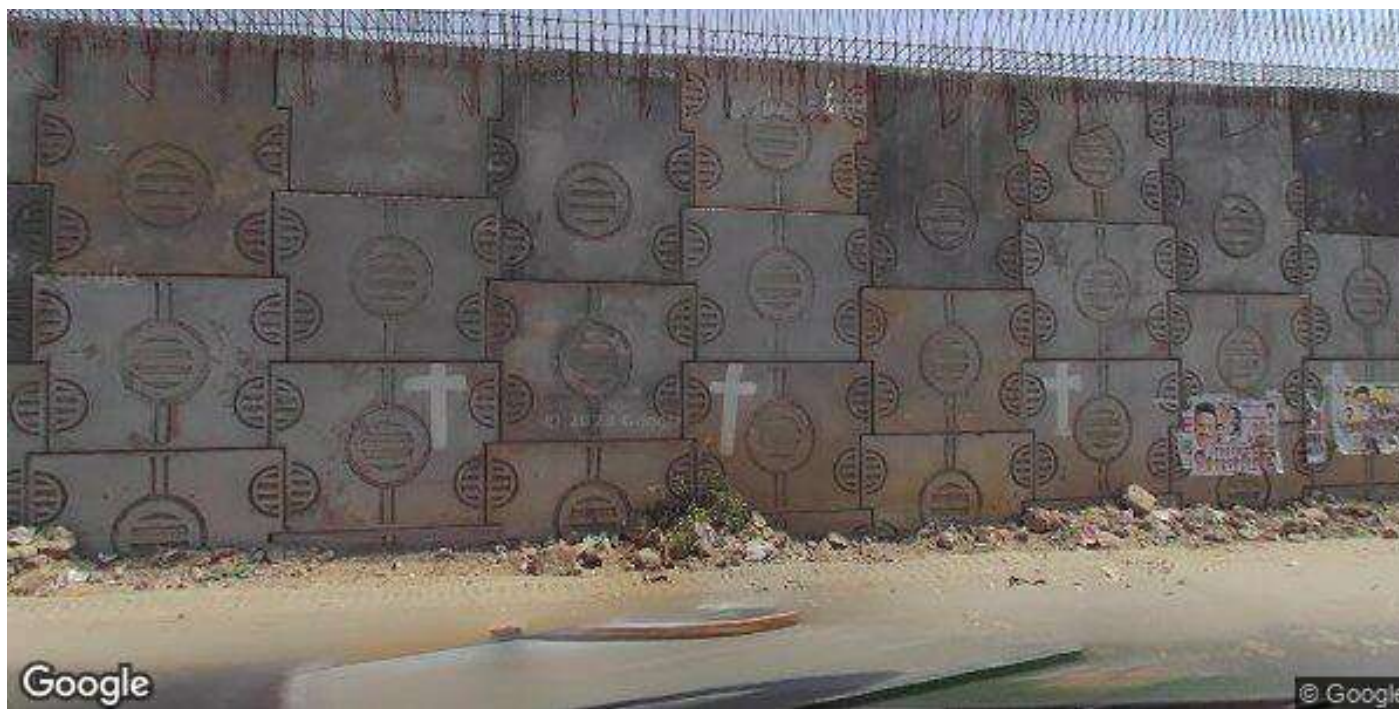
| | Risk Type | Risk Level | Coordinates | Speed Limit |
|---|---|---|---|---|
| 16 | Turn | Medium | 11.75835, 78.05016 | 30 KM/Hr |

**Risk Type:** Turn  
**Risk Level:** Medium  
**Speed Limit:** 30 KM/Hr  
**Coordinates:** 11.75835, 78.05016

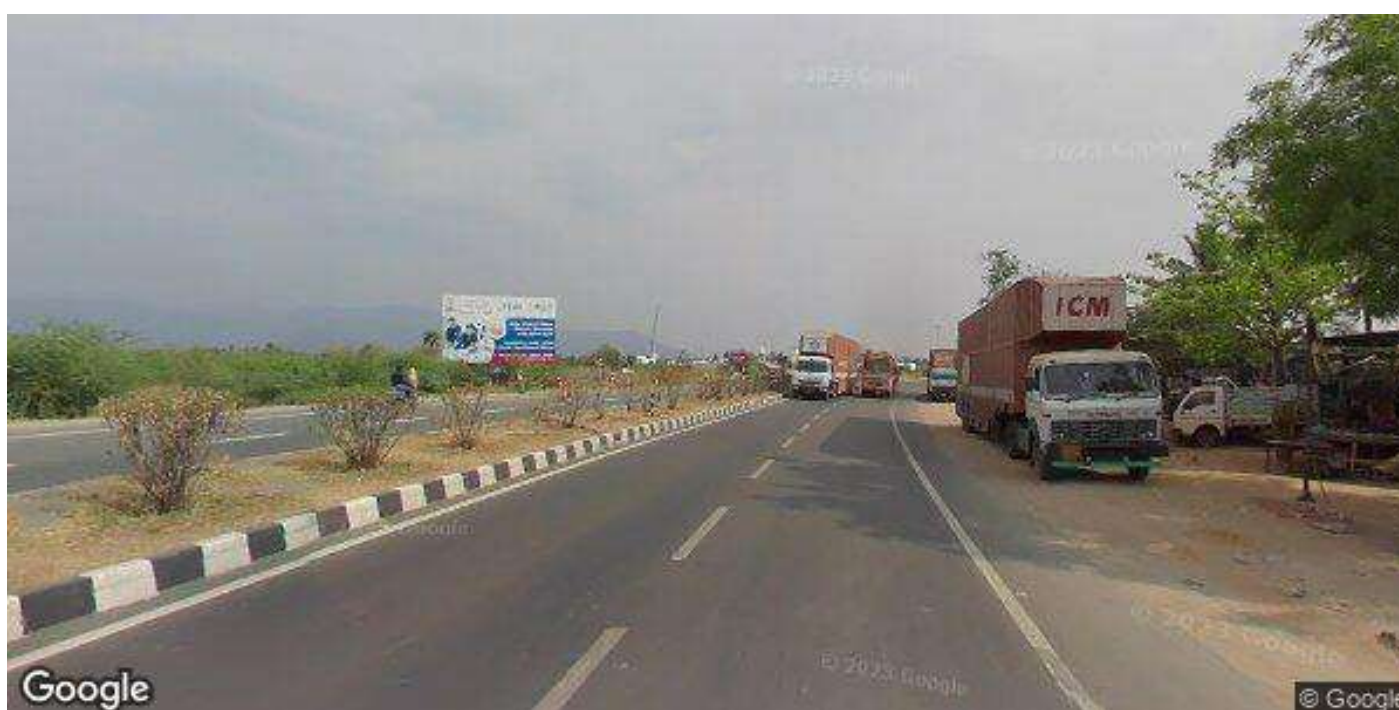
| | Risk Type | Risk Level | Coordinates | Speed Limit |
|---|---|---|---|---|
| 17 | Turn | Medium | 11.87942, 78.08197 | 30 KM/Hr |

**Risk Type:** Turn  
**Risk Level:** Medium  
**Speed Limit:** 30 KM/Hr  
**Coordinates:** 11.87942, 78.08197

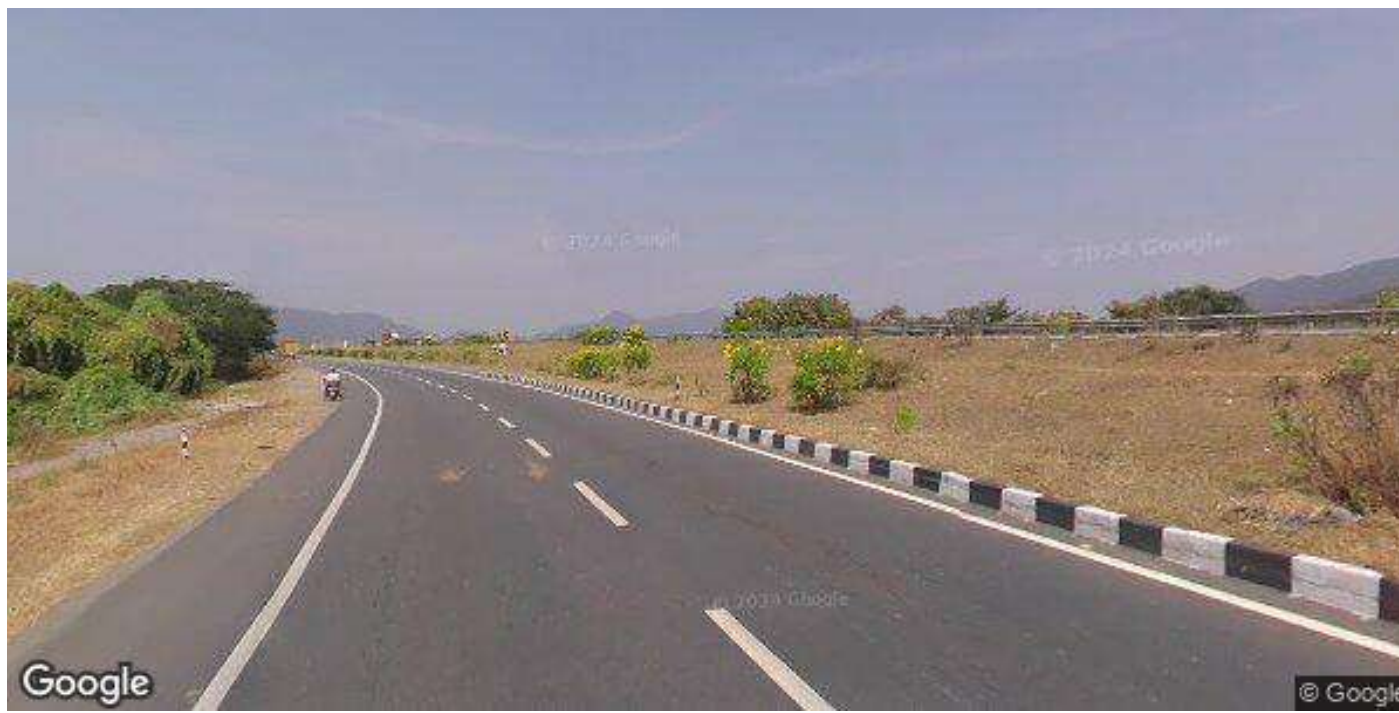
| | Risk Type | Risk Level | Coordinates | Speed Limit |
|---|---|---|---|---|
| 18 | Turn | Medium | 11.92585, 78.06507 | 30 KM/Hr |

**Risk Type:** Turn  
**Risk Level:** Medium  
**Speed Limit:** 30 KM/Hr  
**Coordinates:** 11.92585, 78.06507

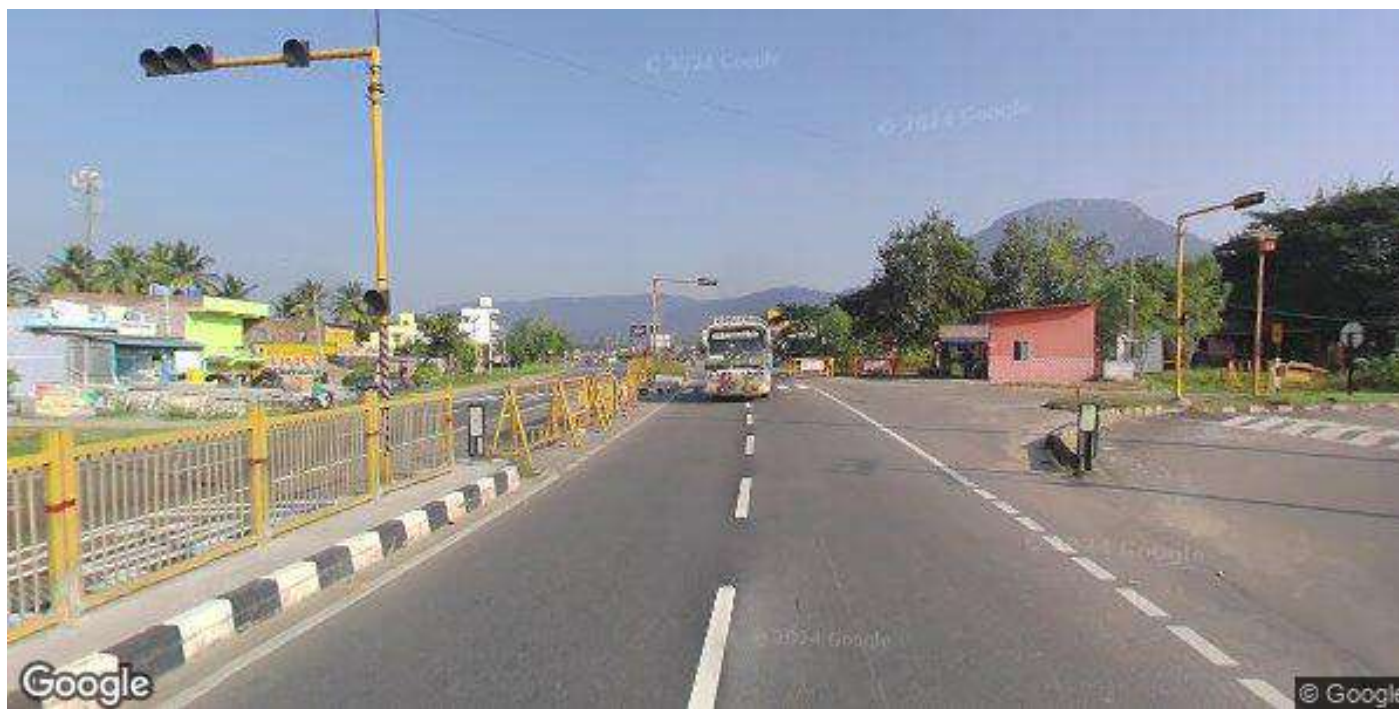
| | Risk Type | Risk Level | Coordinates | Speed Limit |
|---|---|---|---|---|
| 19 | Turn | Medium | 11.93704, 78.05402 | 30 KM/Hr |

**Risk Type:** Turn  
**Risk Level:** Medium  
**Speed Limit:** 30 KM/Hr  
**Coordinates:** 11.93704, 78.05402

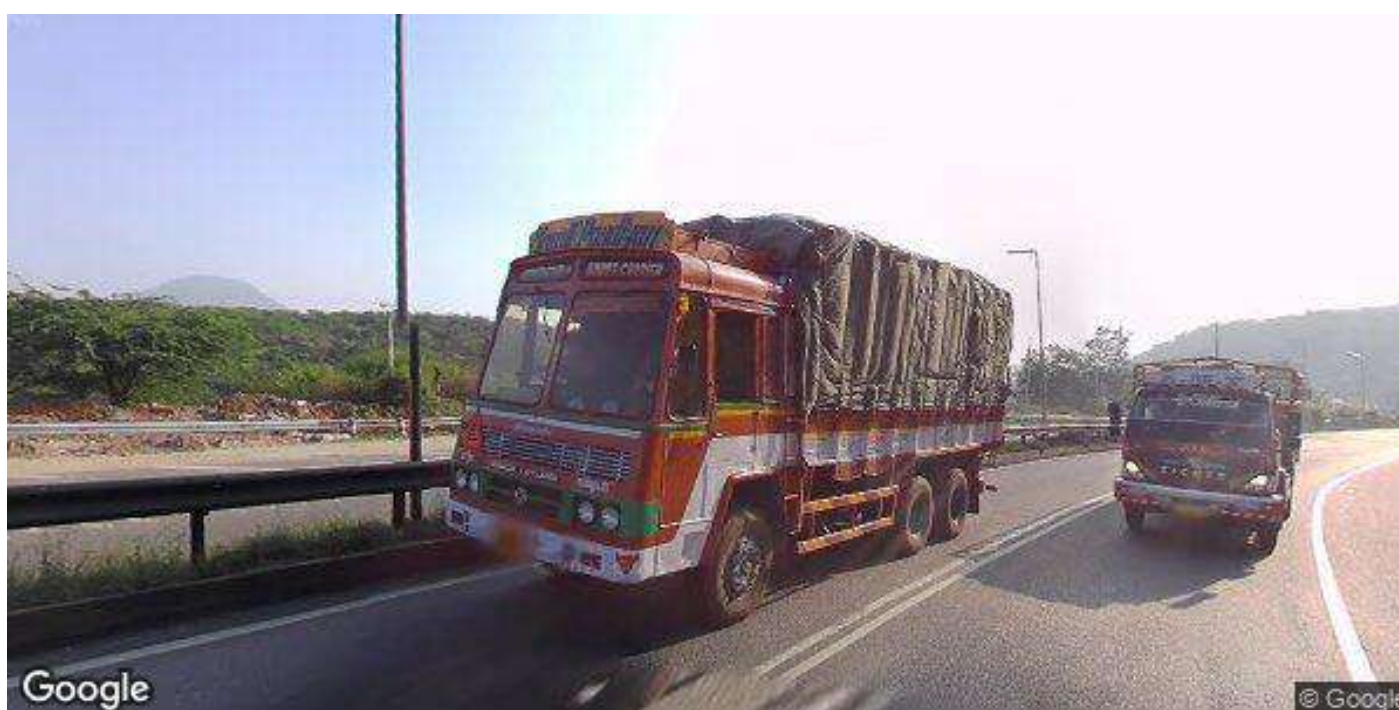
| | Risk Type | Risk Level | Coordinates | Speed Limit |
|---|---|---|---|---|
| 20 | Turn | Medium | 11.95818, 78.04978 | 30 KM/Hr |

**Risk Type:** Turn  
**Risk Level:** Medium  
**Speed Limit:** 30 KM/Hr  
**Coordinates:** 11.95818, 78.04978

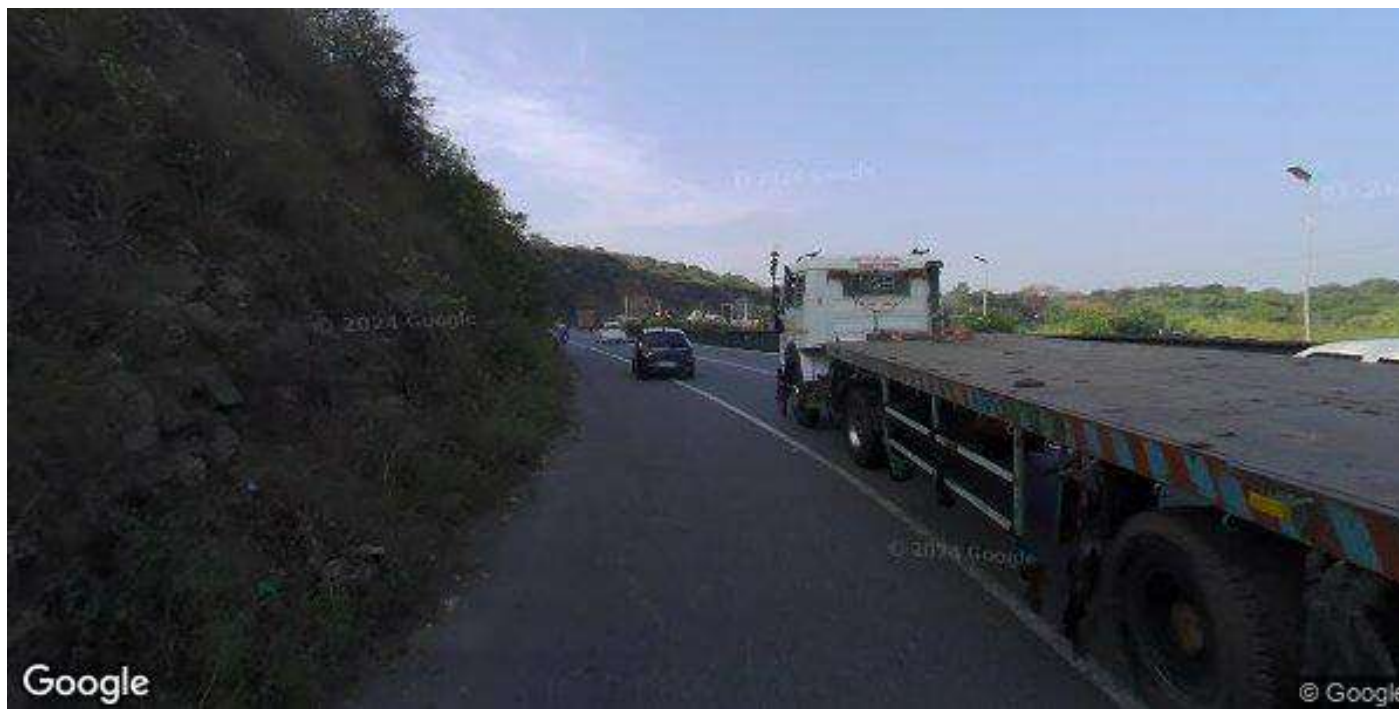
| | Risk Type | Risk Level | Coordinates | Speed Limit |
|---|---|---|---|---|
| 21 | Turn | Medium | 11.95876, 78.04990 | 30 KM/Hr |

**Risk Type:** Turn  
**Risk Level:** Medium  
**Speed Limit:** 30 KM/Hr  
**Coordinates:** 11.95876, 78.04990

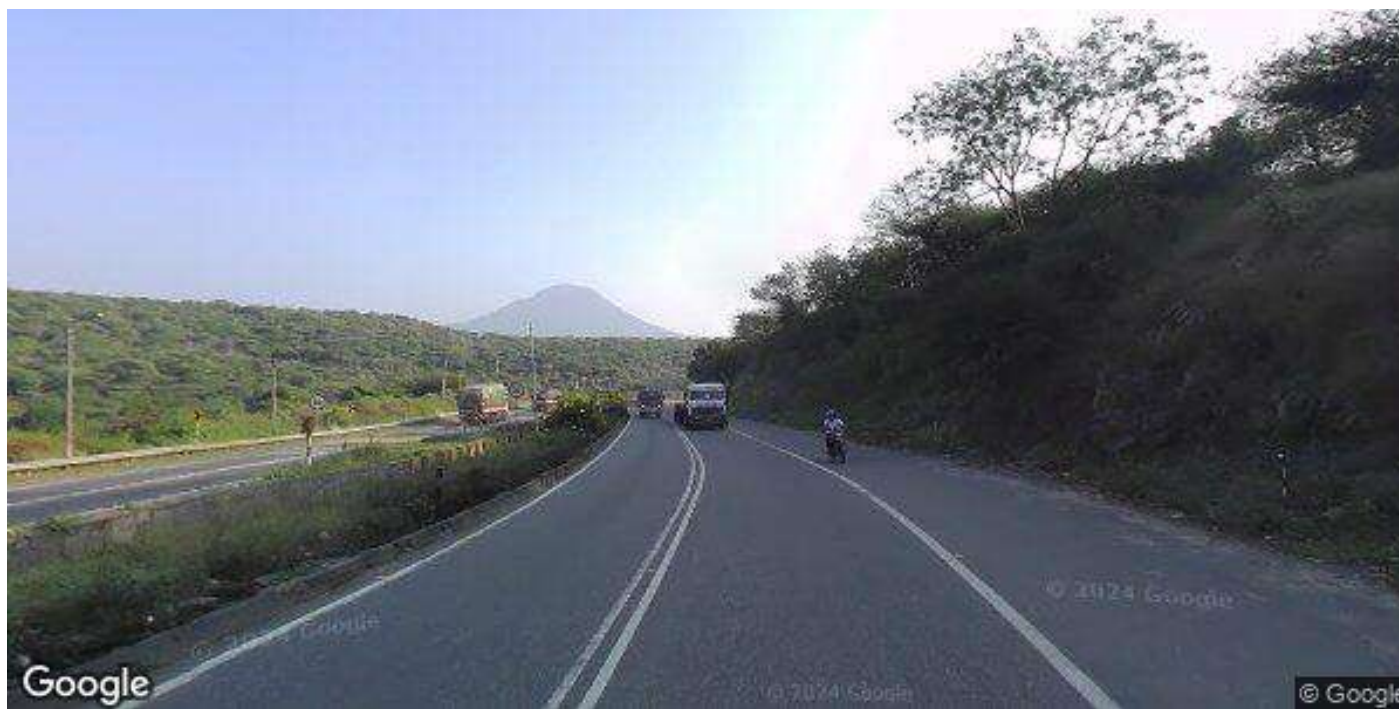
| | Risk Type | Risk Level | Coordinates | Speed Limit |
|---|---|---|---|---|
| 22 | Turn | Medium | 11.95988, 78.04948 | 30 KM/Hr |

**Risk Type:** Turn  
**Risk Level:** Medium  
**Speed Limit:** 30 KM/Hr  
**Coordinates:** 11.95988, 78.04948

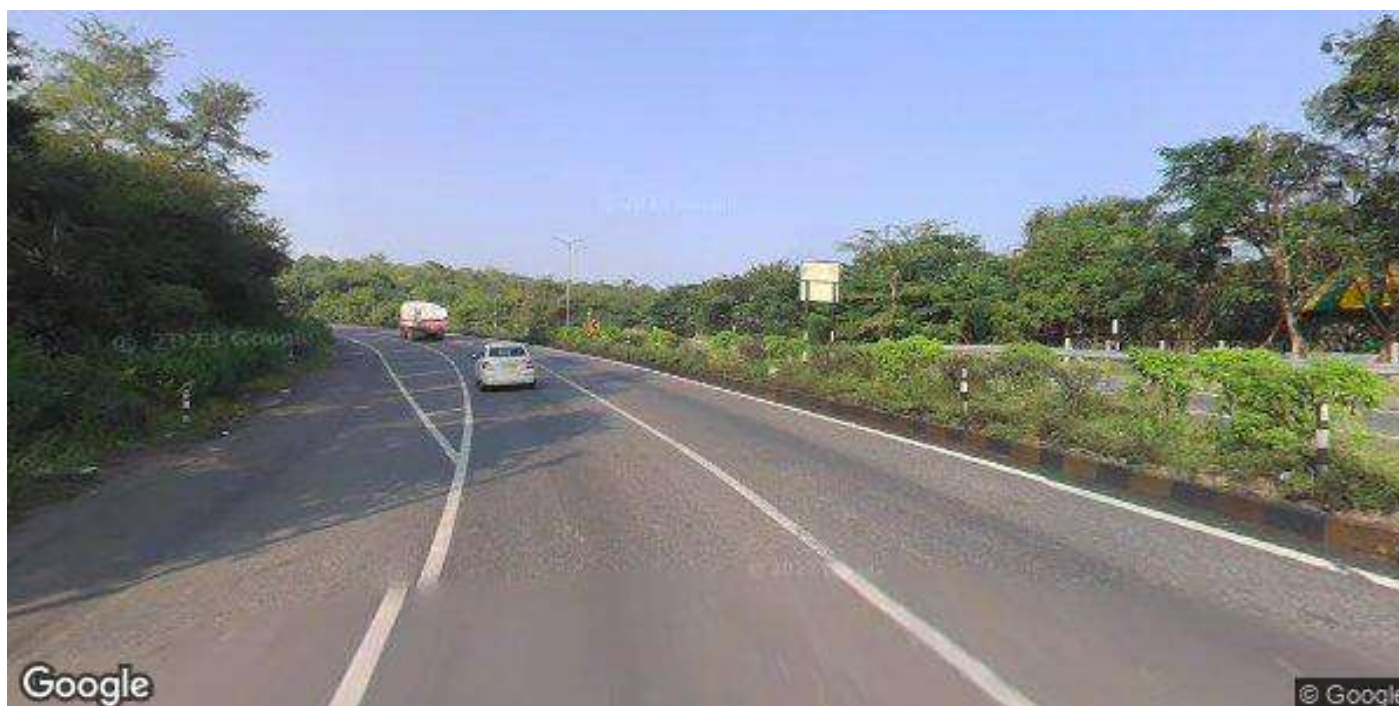
| | Risk Type | Risk Level | Coordinates | Speed Limit |
|---|---|---|---|---|
| 23 | Turn | Medium | 11.96304, 78.05136 | 30 KM/Hr |

**Risk Type:** Turn  
**Risk Level:** Medium  
**Speed Limit:** 30 KM/Hr  
**Coordinates:** 11.96304, 78.05136
