## JOURNEY RISK MANAGEMENT (JRM) STUDY

### Salem Terminal to NAVANEE AGENCIES

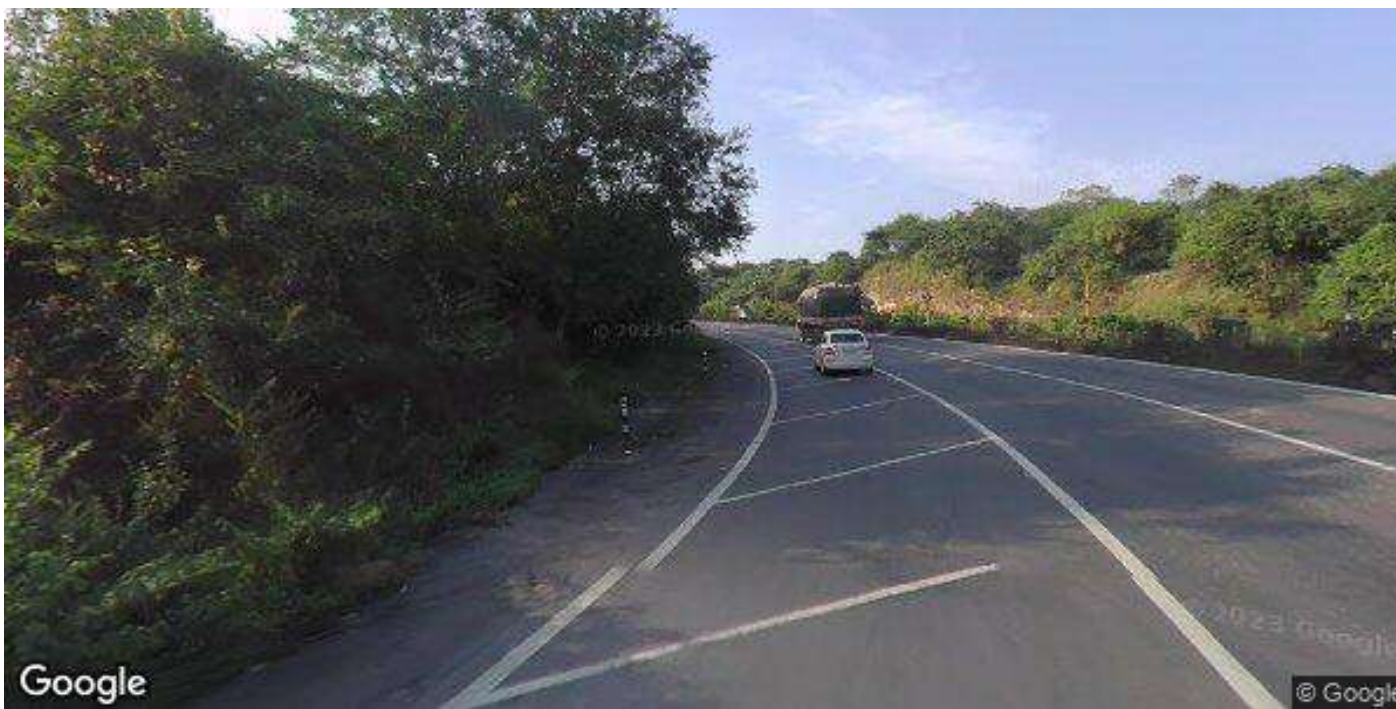
| | Risk Type | Risk Level | Coordinates | Speed Limit |
|---|---|---|---|---|
| 24 | Turn | Medium | 11.96399, 78.05135 | 30 KM/Hr |

**Risk Type:** Turn  
**Risk Level:** Medium  
**Speed Limit:** 30 KM/Hr  
**Coordinates:** 11.96399, 78.05135

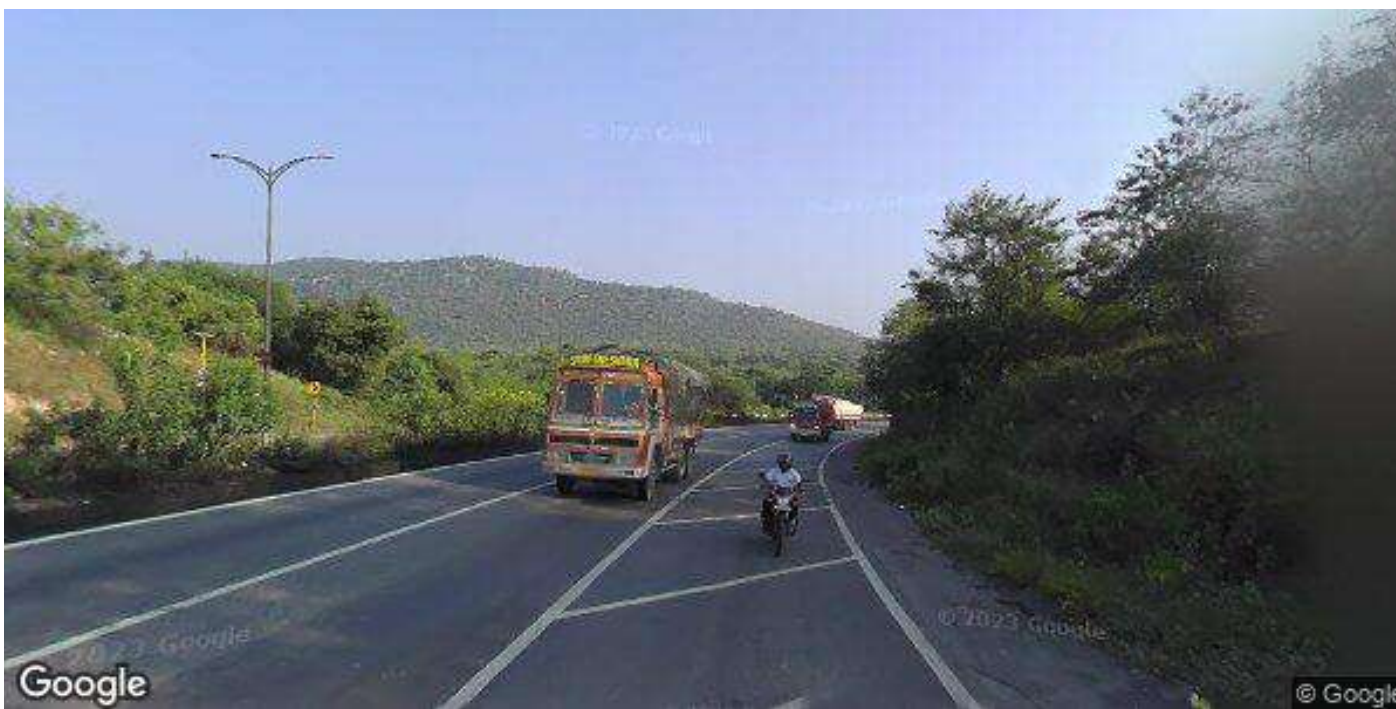
| | Risk Type | Risk Level | Coordinates | Speed Limit |
|---|---|---|---|---|
| 25 | Turn | Medium | 11.96458, 78.05084 | 30 KM/Hr |

**Risk Type:** Turn  
**Risk Level:** Medium  
**Speed Limit:** 30 KM/Hr  
**Coordinates:** 11.96458, 78.05084

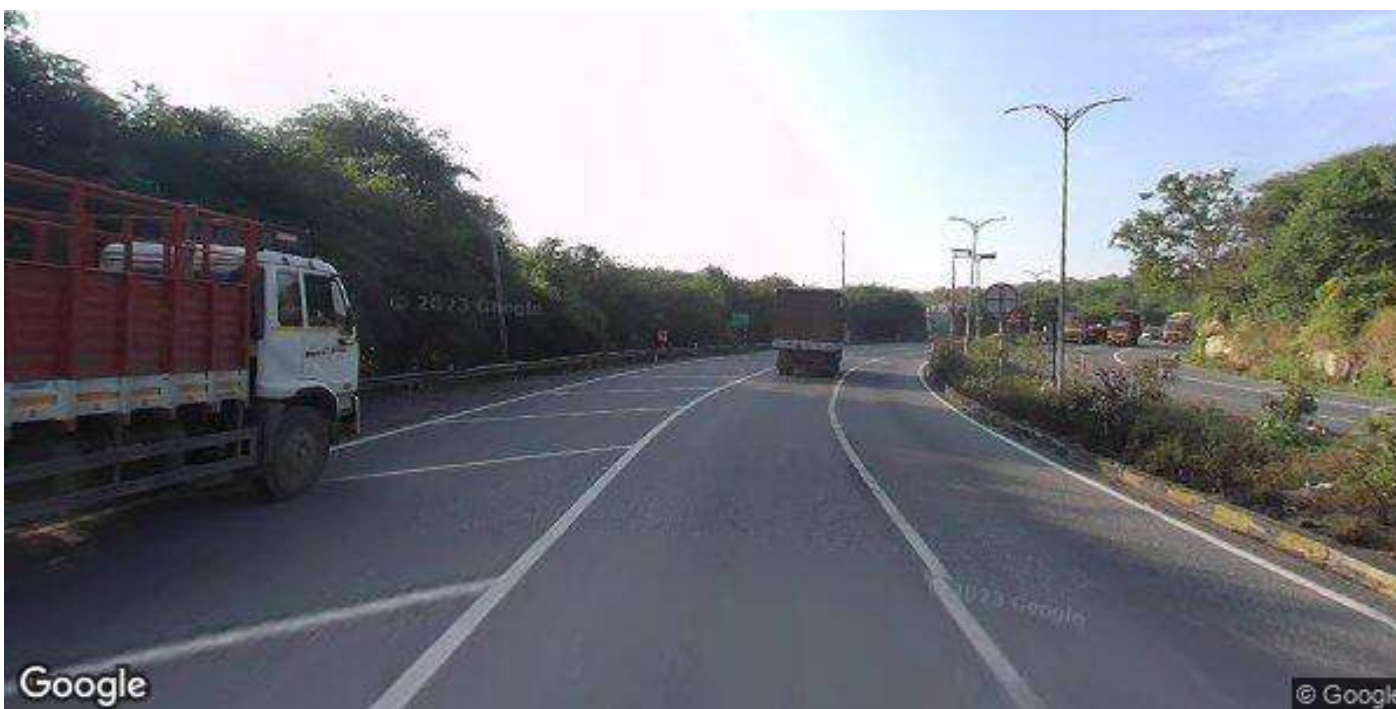
| | Risk Type | Risk Level | Coordinates | Speed Limit |
|---|---|---|---|---|
| 26 | Turn | Medium | 11.96496, 78.04988 | 30 KM/Hr |

**Risk Type:** Turn  
**Risk Level:** Medium  
**Speed Limit:** 30 KM/Hr  
**Coordinates:** 11.96496, 78.04988

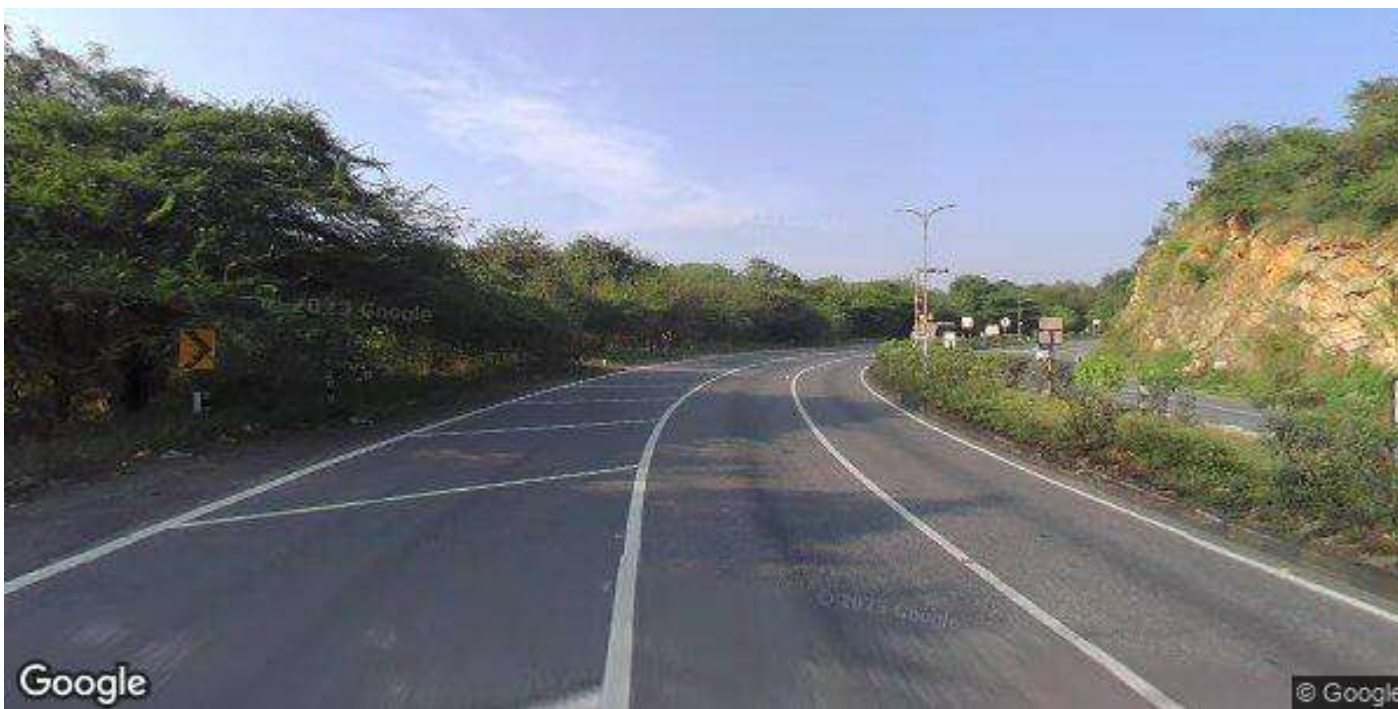
| | Risk Type | Risk Level | Coordinates | Speed Limit |
|---|---|---|---|---|
| 27 | Turn | High | 11.96580, 78.04923 | 15 KM/Hr |

**Risk Type:** Turn  
**Risk Level:** High  
**Speed Limit:** 15 KM/Hr  
**Coordinates:** 11.96580, 78.04923

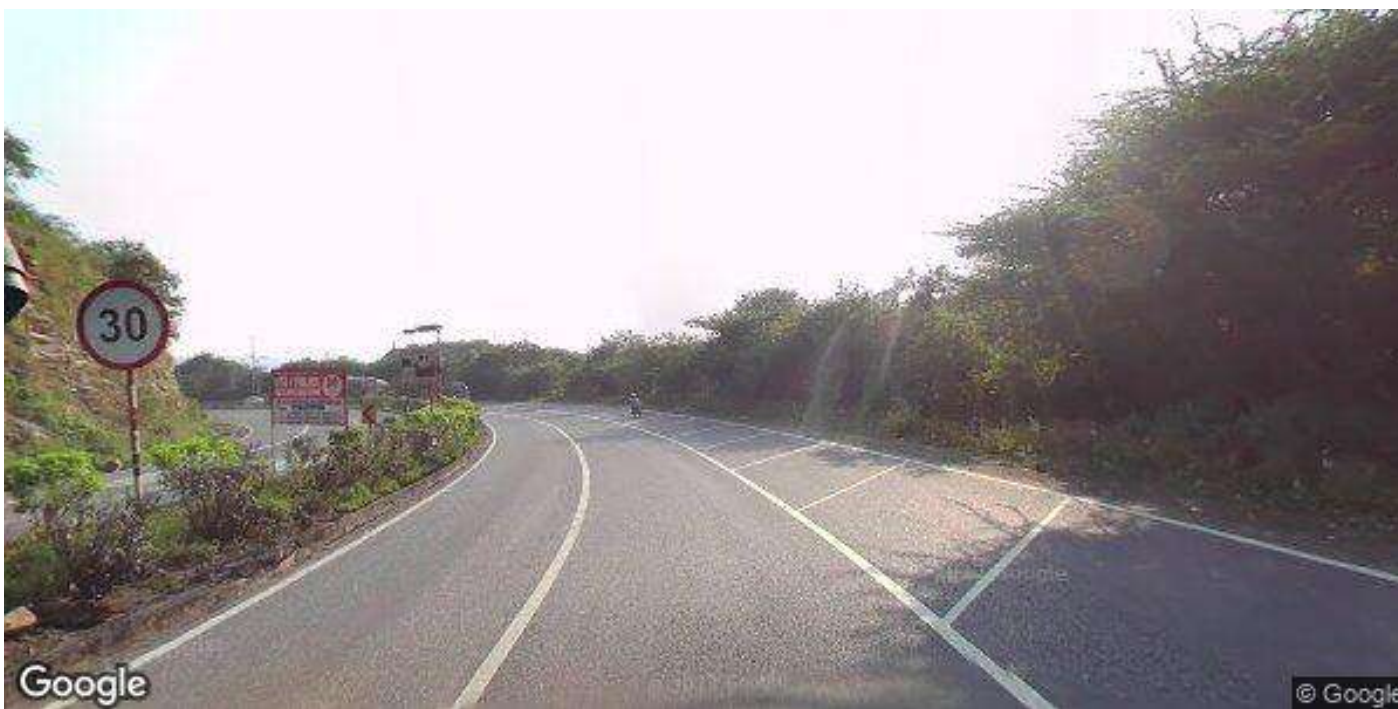
| | Risk Type | Risk Level | Coordinates | Speed Limit |
|---|---|---|---|---|
| 28 | Turn | Medium | 11.96675, 78.04939 | 30 KM/Hr |

**Risk Type:** Turn  
**Risk Level:** Medium  
**Speed Limit:** 30 KM/Hr  
**Coordinates:** 11.96675, 78.04939

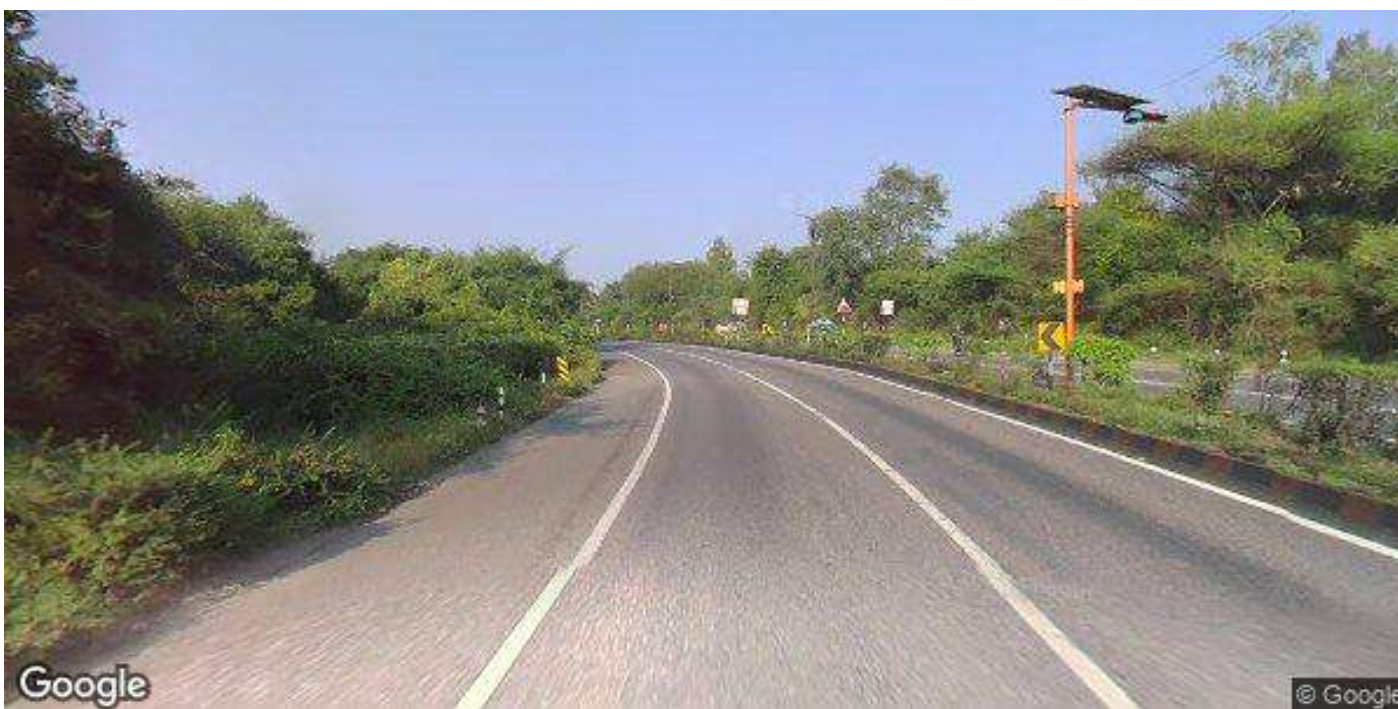
| | Risk Type | Risk Level | Coordinates | Speed Limit |
|---|---|---|---|---|
| 29 | Turn | Medium | 11.96791, 78.05070 | 30 KM/Hr |

**Risk Type:** Turn  
**Risk Level:** Medium  
**Speed Limit:** 30 KM/Hr  
**Coordinates:** 11.96791, 78.05070

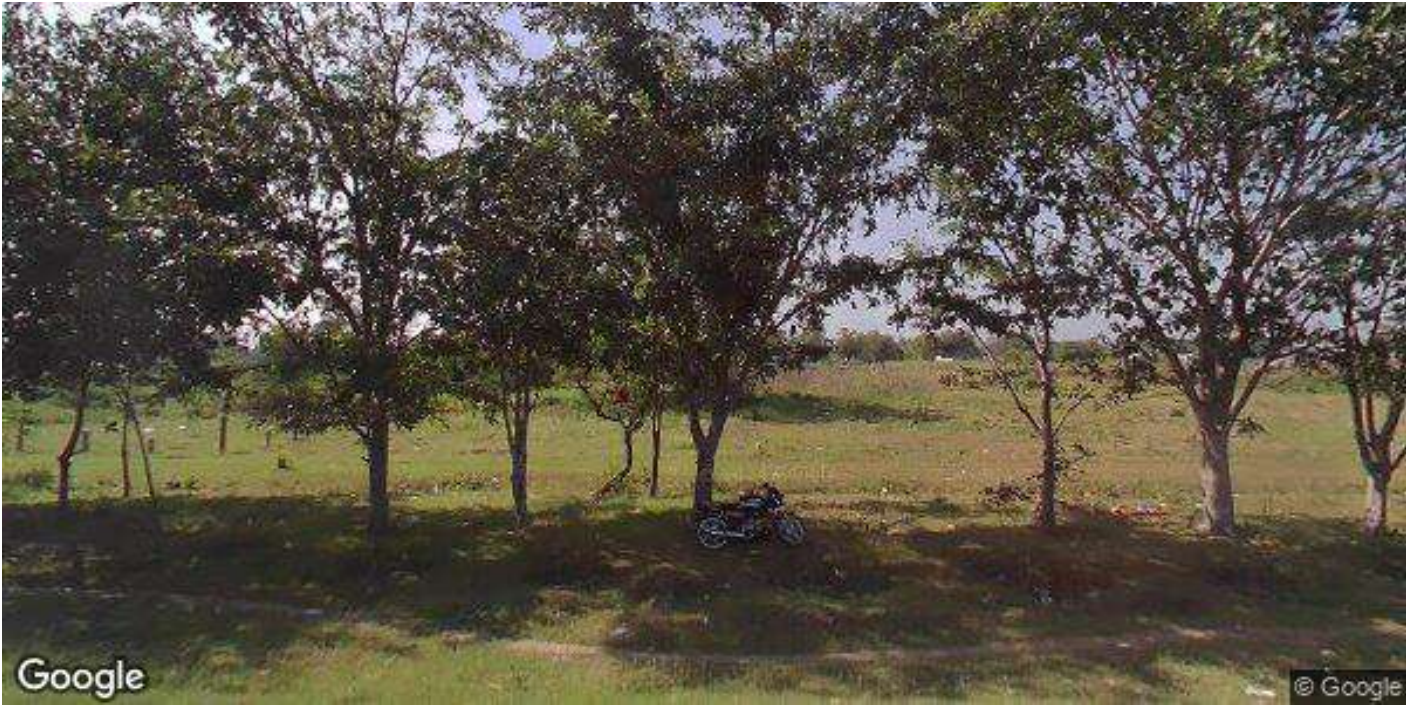
| | Risk Type | Risk Level | Coordinates | Speed Limit |
|---|---|---|---|---|
| 30 | Turn | Medium | 12.12058, 78.13283 | 30 KM/Hr |

**Risk Type:** Turn  
**Risk Level:** Medium  
**Speed Limit:** 30 KM/Hr  
**Coordinates:** 12.12058, 78.13283

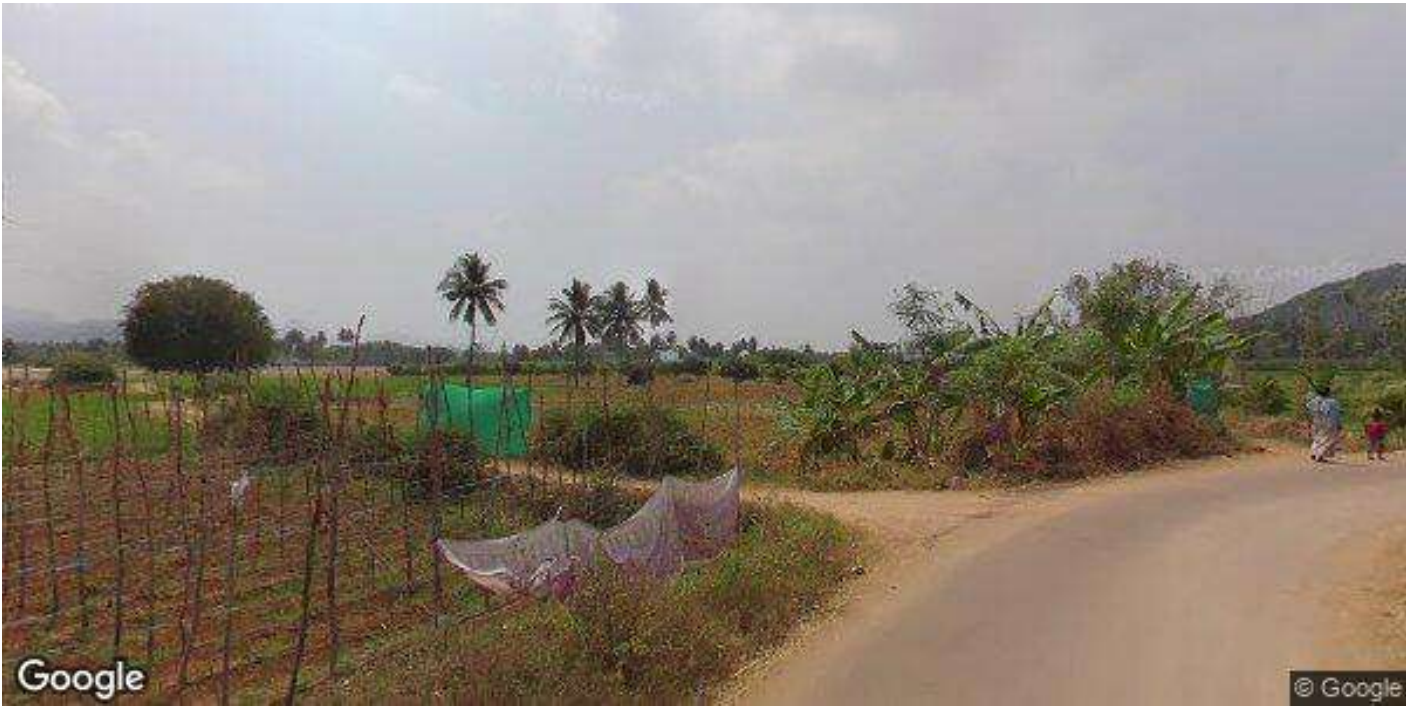
| | Risk Type | Risk Level | Coordinates | Speed Limit |
|---|---|---|---|---|
| 32 | Turn | High | 12.41674, 78.04642 | 15 KM/Hr |

**Risk Type:** Turn  
**Risk Level:** High  
**Speed Limit:** 15 KM/Hr  
**Coordinates:** 12.41674, 78.04642
