# IndianOil

## JOURNEY RISK MANAGEMENT (JRM) STUDY

### Salem Terminal TO A.C.M.PETROLEUM AGENCIES

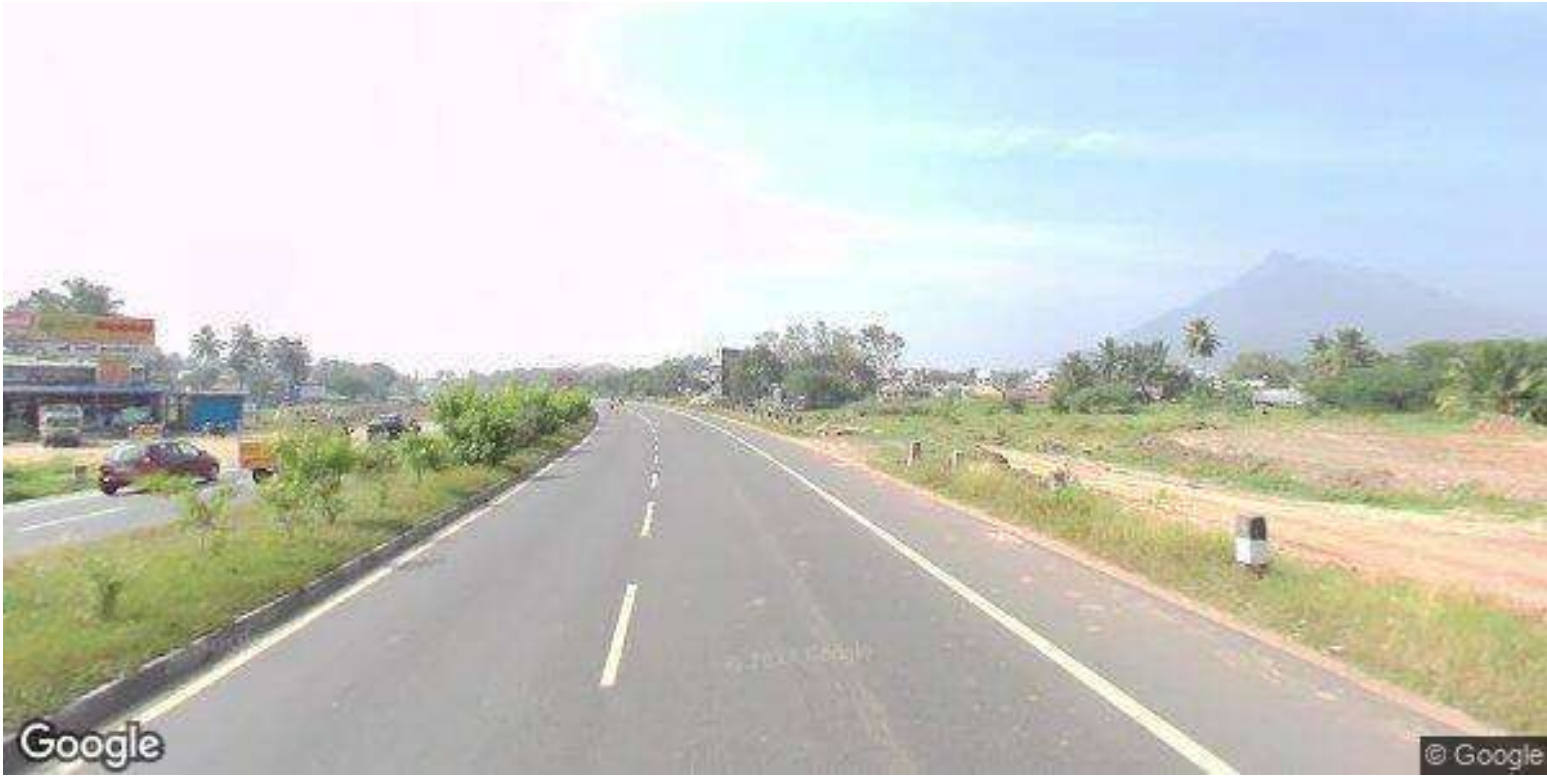
**Risk Type:** Turn  
**Risk Level:** Medium  
**Speed Limit:** 30 KM/Hr  
**Coordinates:** 11.62403, 78.10893

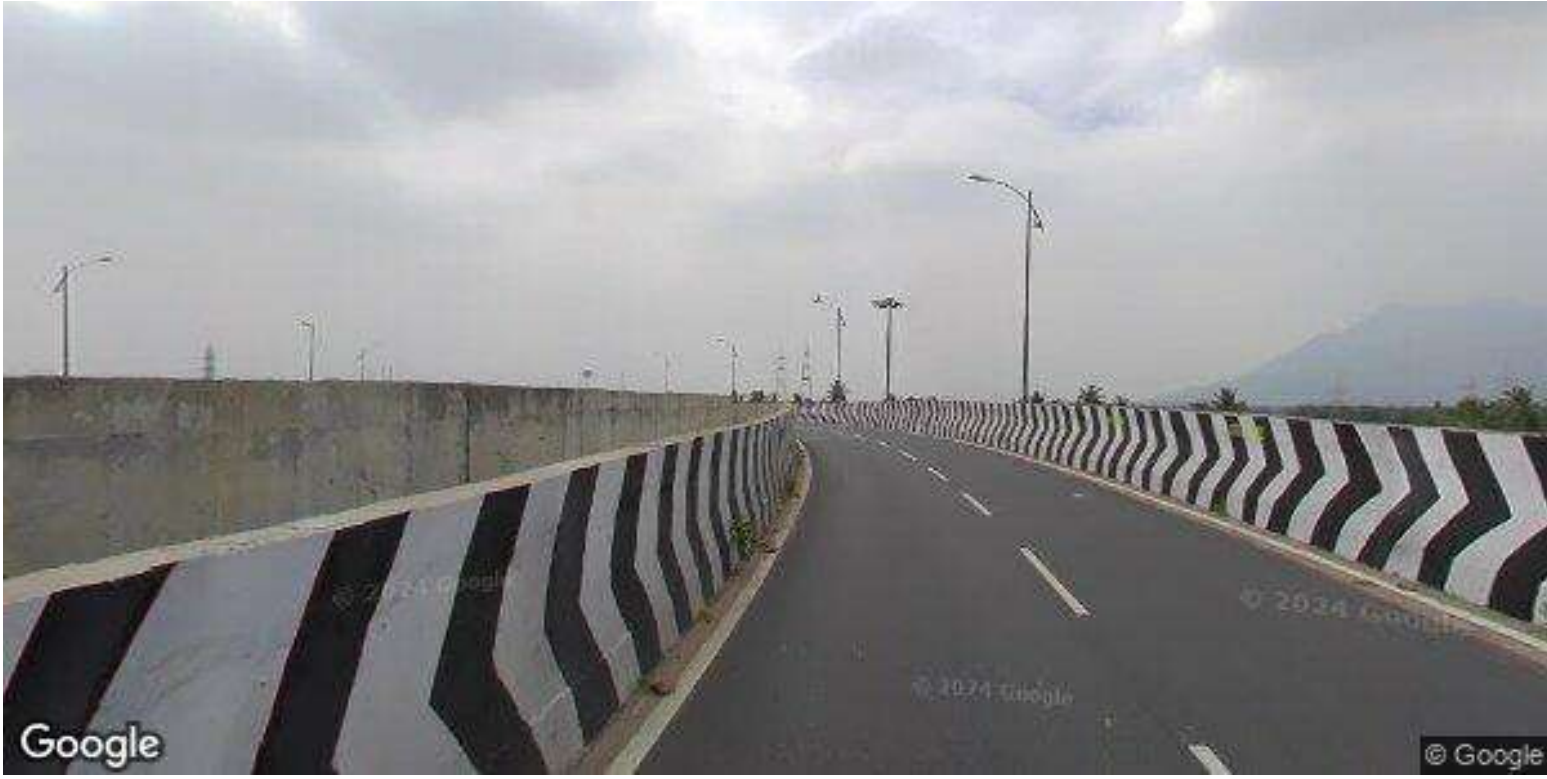
**Risk Type:** Turn  
**Risk Level:** Medium  
**Speed Limit:** 30 KM/Hr  
**Coordinates:** 11.64180, 78.11808

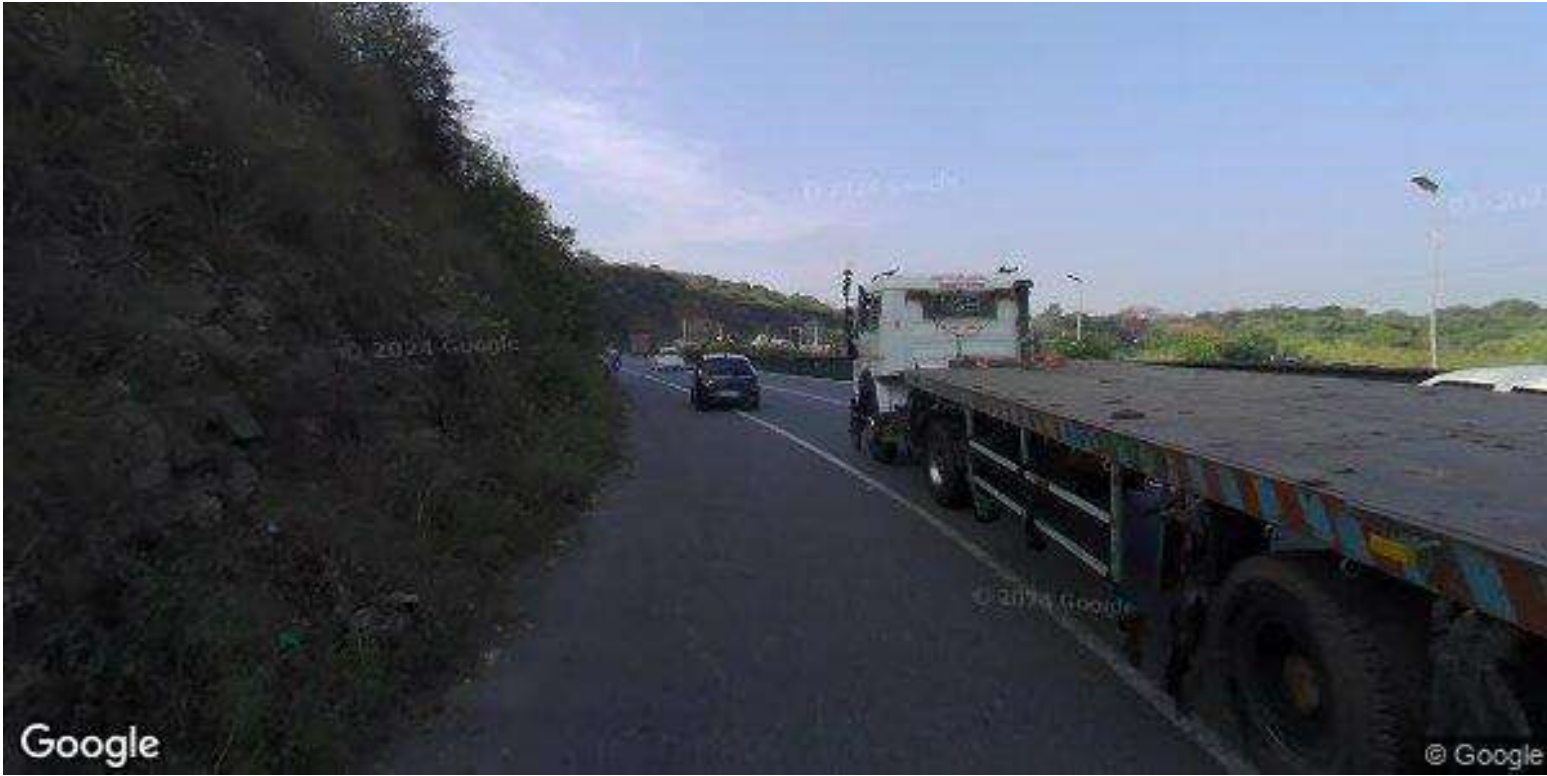
**Risk Type:** Turn  
**Risk Level:** Medium  
**Speed Limit:** 30 KM/Hr  
**Coordinates:** 11.95876, 78.04990

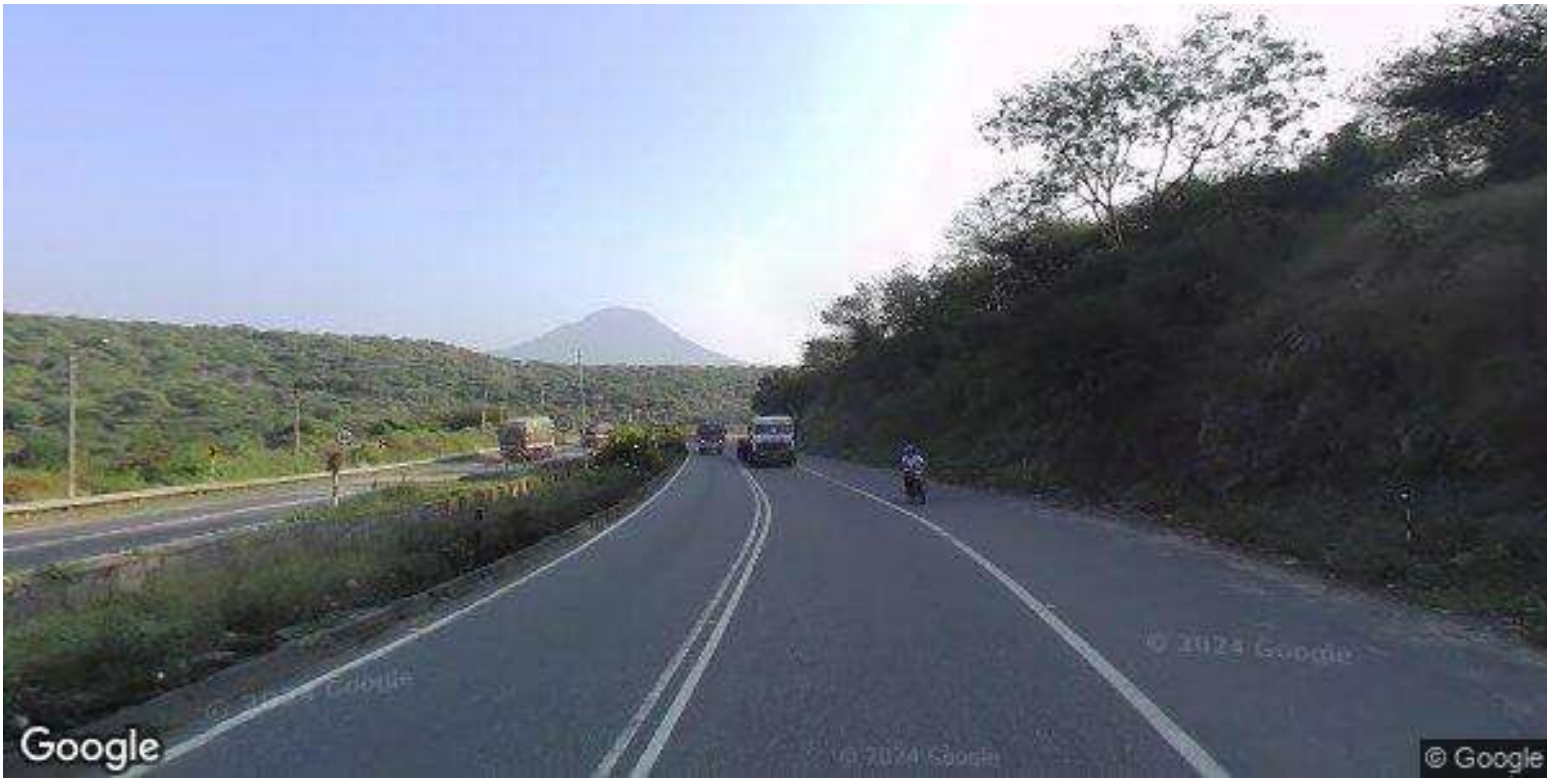
**Risk Type:** Turn  
**Risk Level:** Medium  
**Speed Limit:** 30 KM/Hr  
**Coordinates:** 11.95988, 78.04948

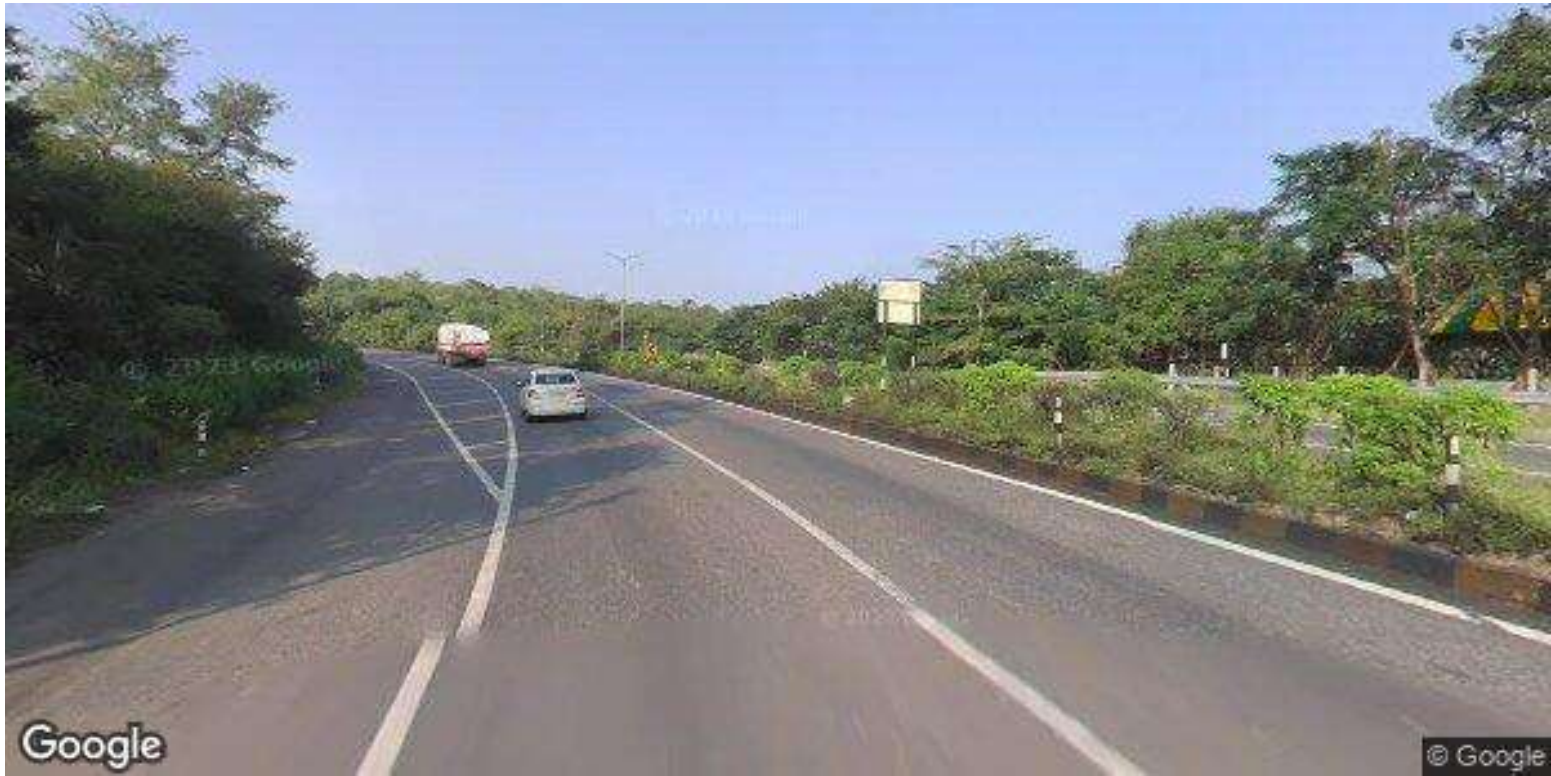
**Risk Type:** Turn  
**Risk Level:** Medium  
**Speed Limit:** 30 KM/Hr  
**Coordinates:** 11.96304, 78.05136

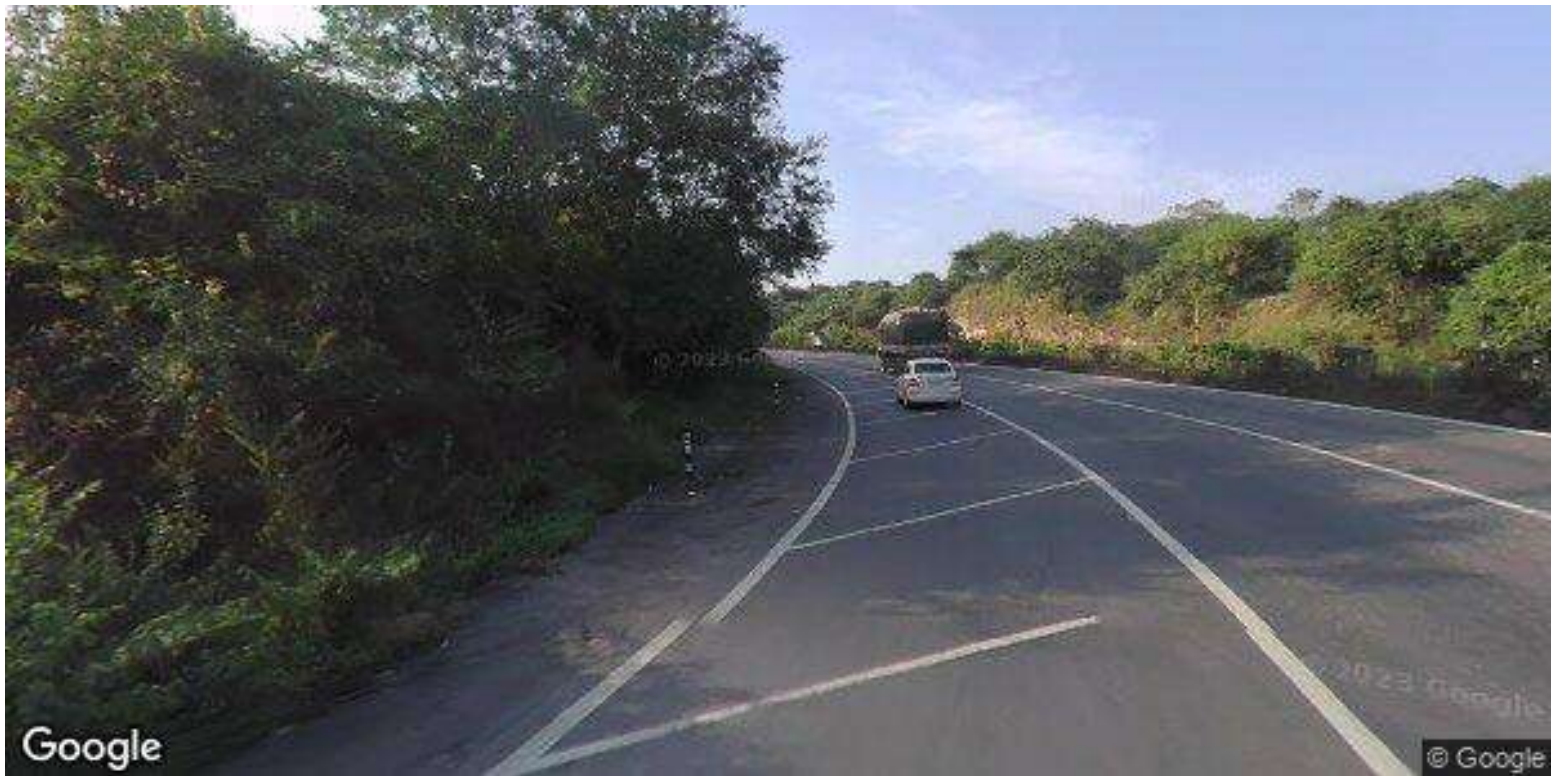
**Risk Type:** Turn  
**Risk Level:** High  
**Speed Limit:** 15 KM/Hr  
**Coordinates:** 11.96399, 78.05135

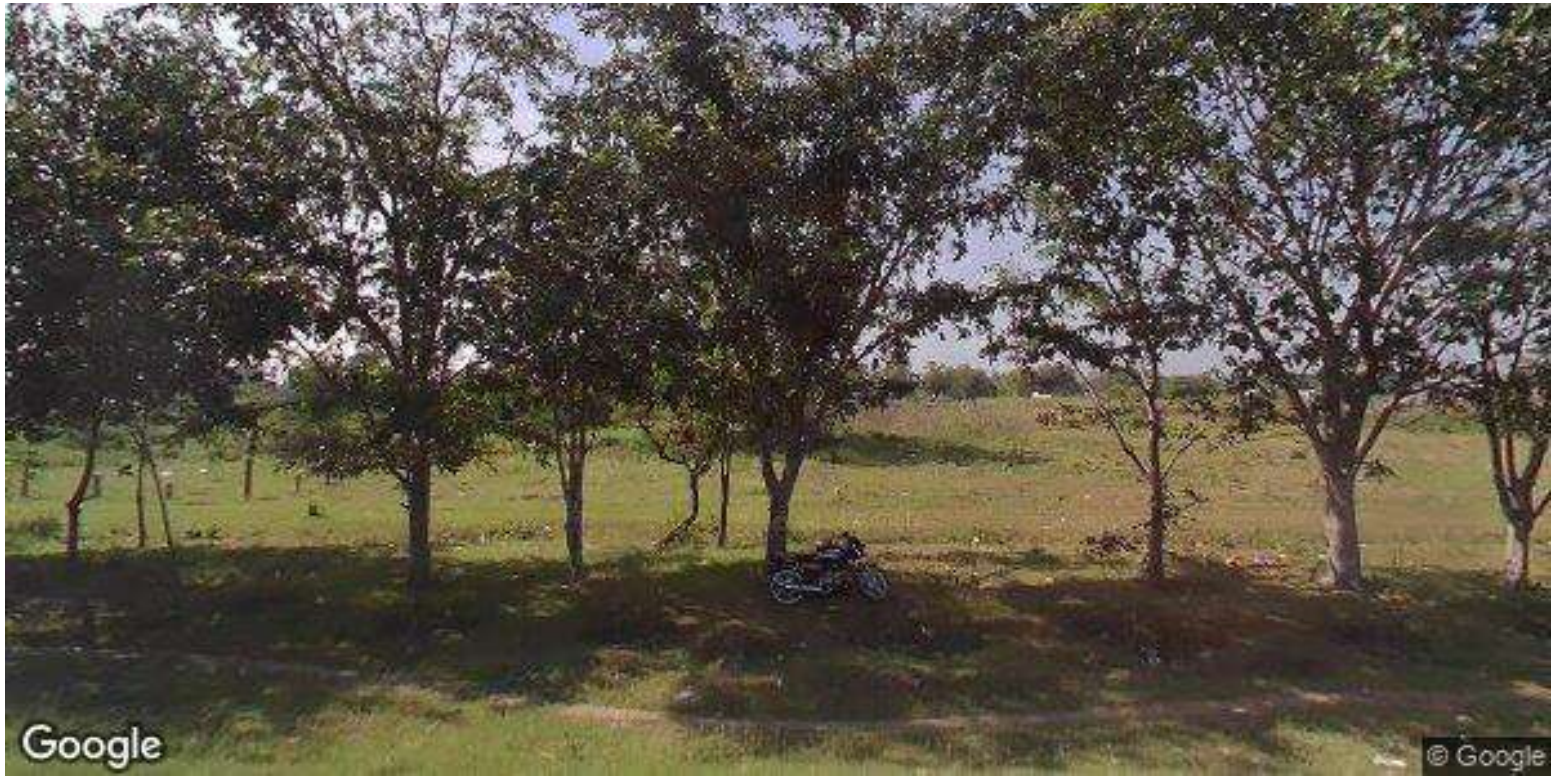
**Risk Type:** Turn  
**Risk Level:** Medium  
**Speed Limit:** 30 KM/Hr  
**Coordinates:** 12.12058, 78.13283

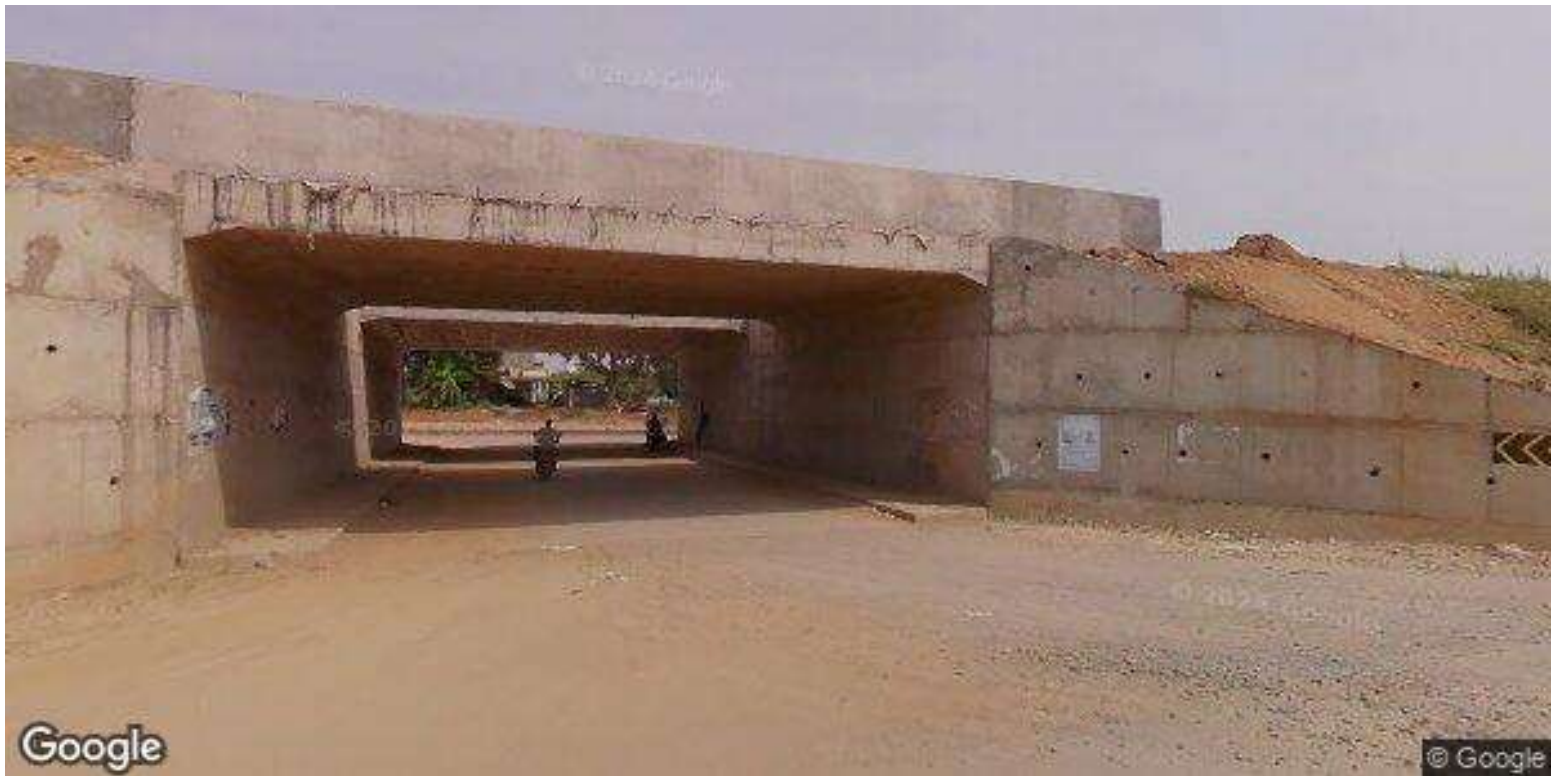
**Risk Type:** Turn  
**Risk Level:** High  
**Speed Limit:** 15 KM/Hr  
**Coordinates:** 12.26533, 78.08428

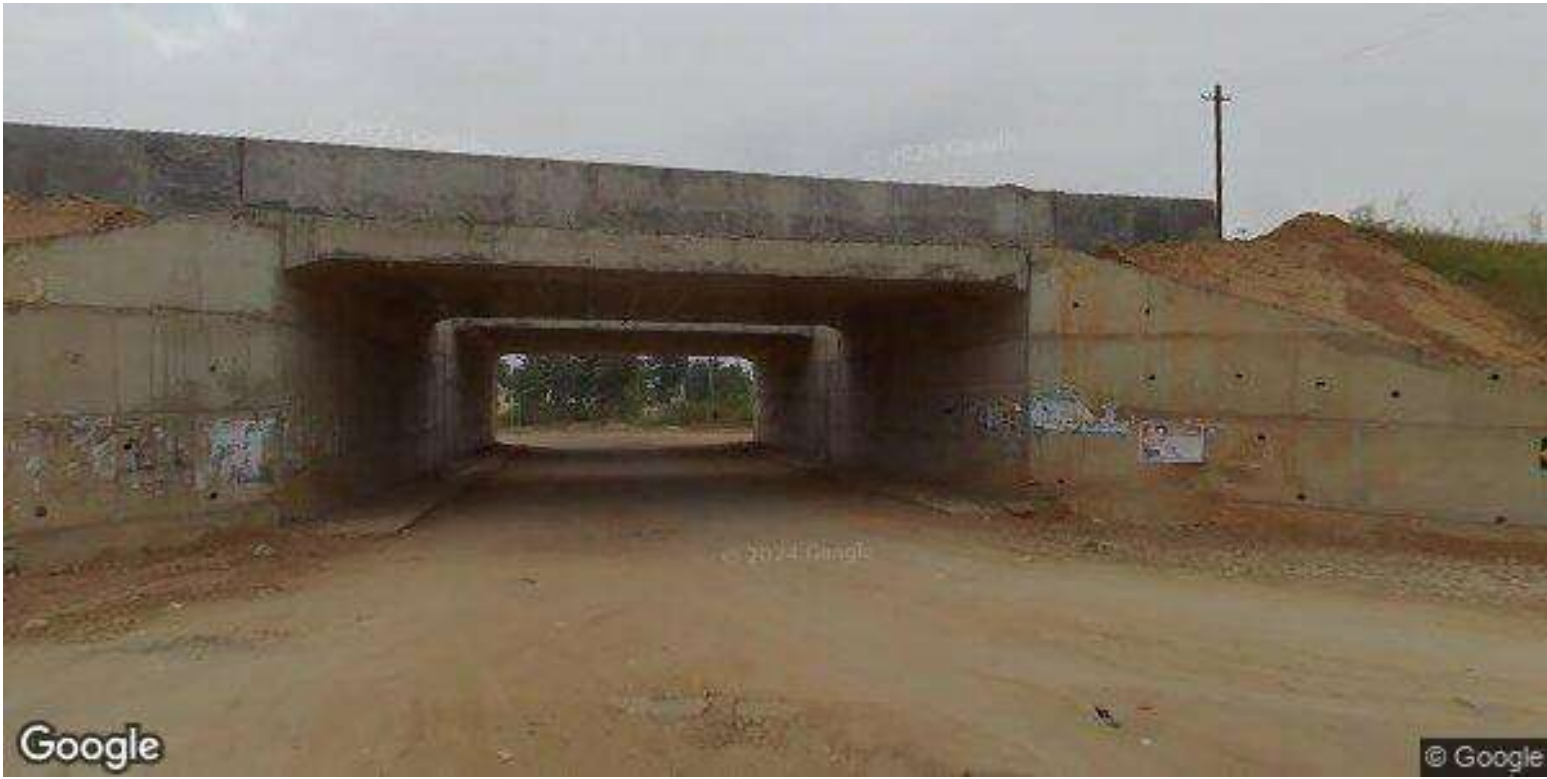
**Risk Type:** Turn  
**Risk Level:** High  
**Speed Limit:** 15 KM/Hr  
**Coordinates:** 12.26550, 78.08440

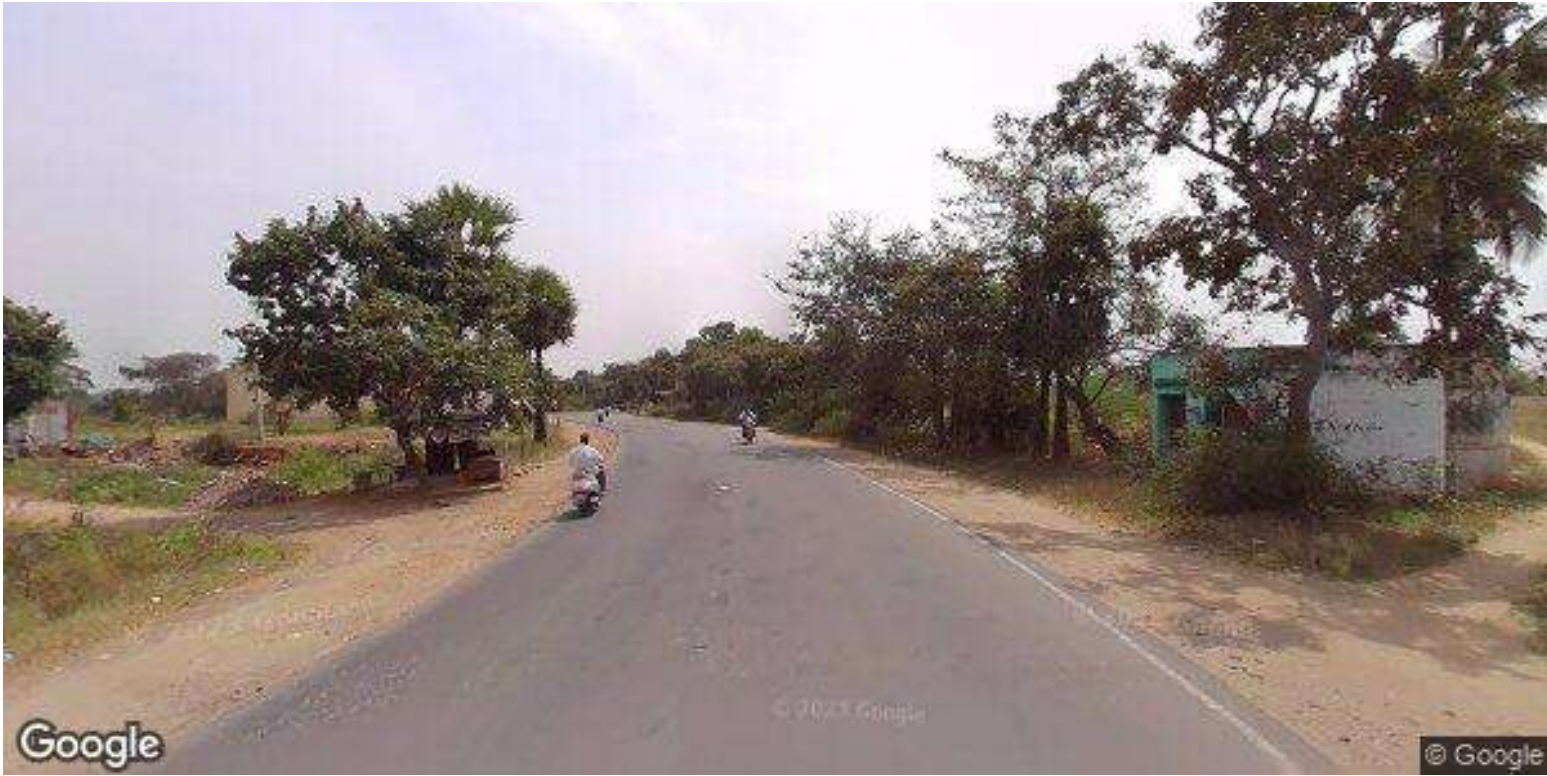
**Risk Type:** Turn  
**Risk Level:** Medium  
**Speed Limit:** 30 KM/Hr  
**Coordinates:** 12.27173, 78.08098

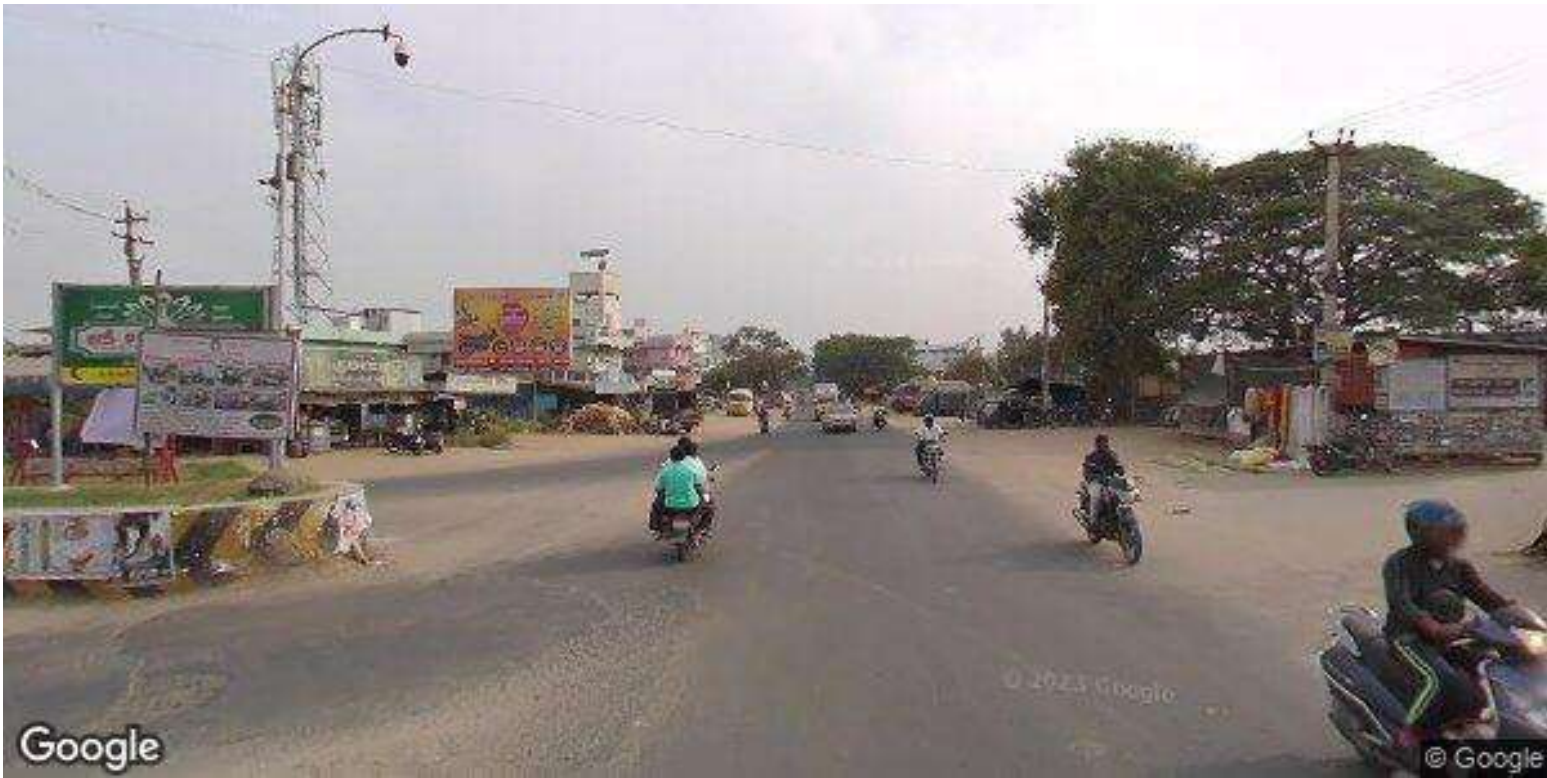
**Risk Type:** Turn  
**Risk Level:** High  
**Speed Limit:** 15 KM/Hr  
**Coordinates:** 12.29595, 78.07368

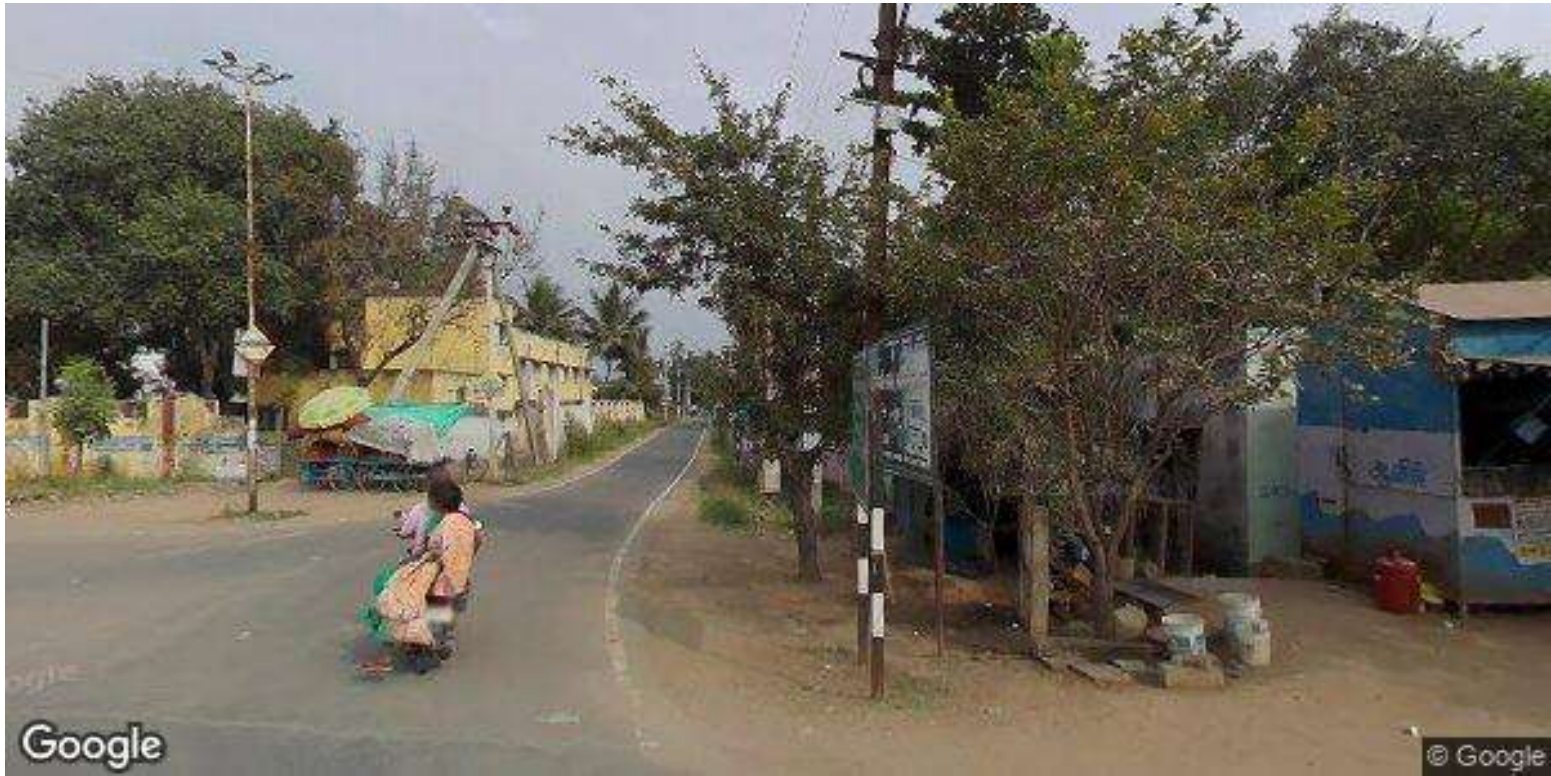
**Risk Type:** Turn  
**Risk Level:** Medium  
**Speed Limit:** 30 KM/Hr  
**Coordinates:** 12.29688, 78.07580

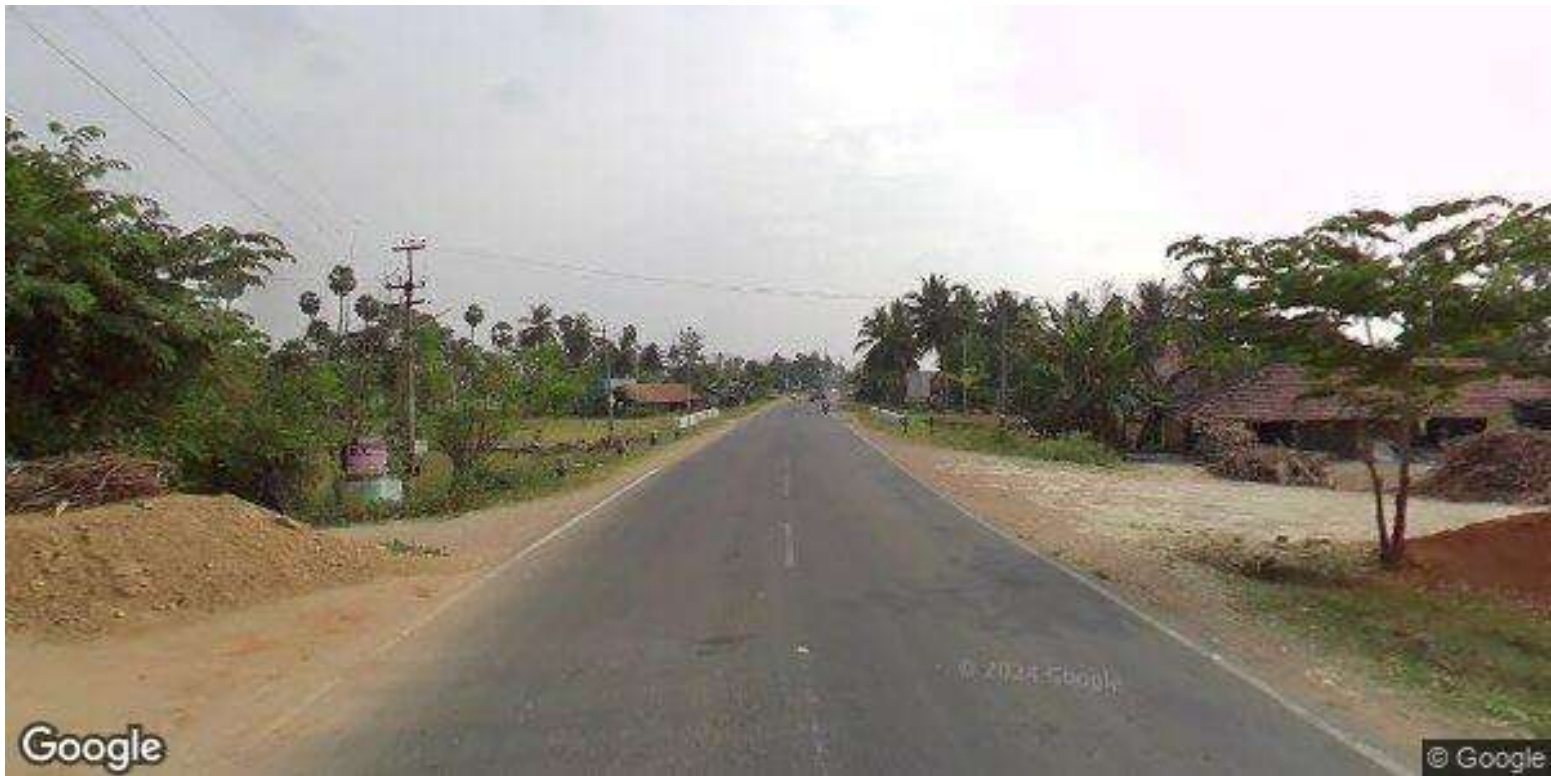
**Risk Type:** Turn  
**Risk Level:** Medium  
**Speed Limit:** 30 KM/Hr  
**Coordinates:** 12.31153, 78.07860

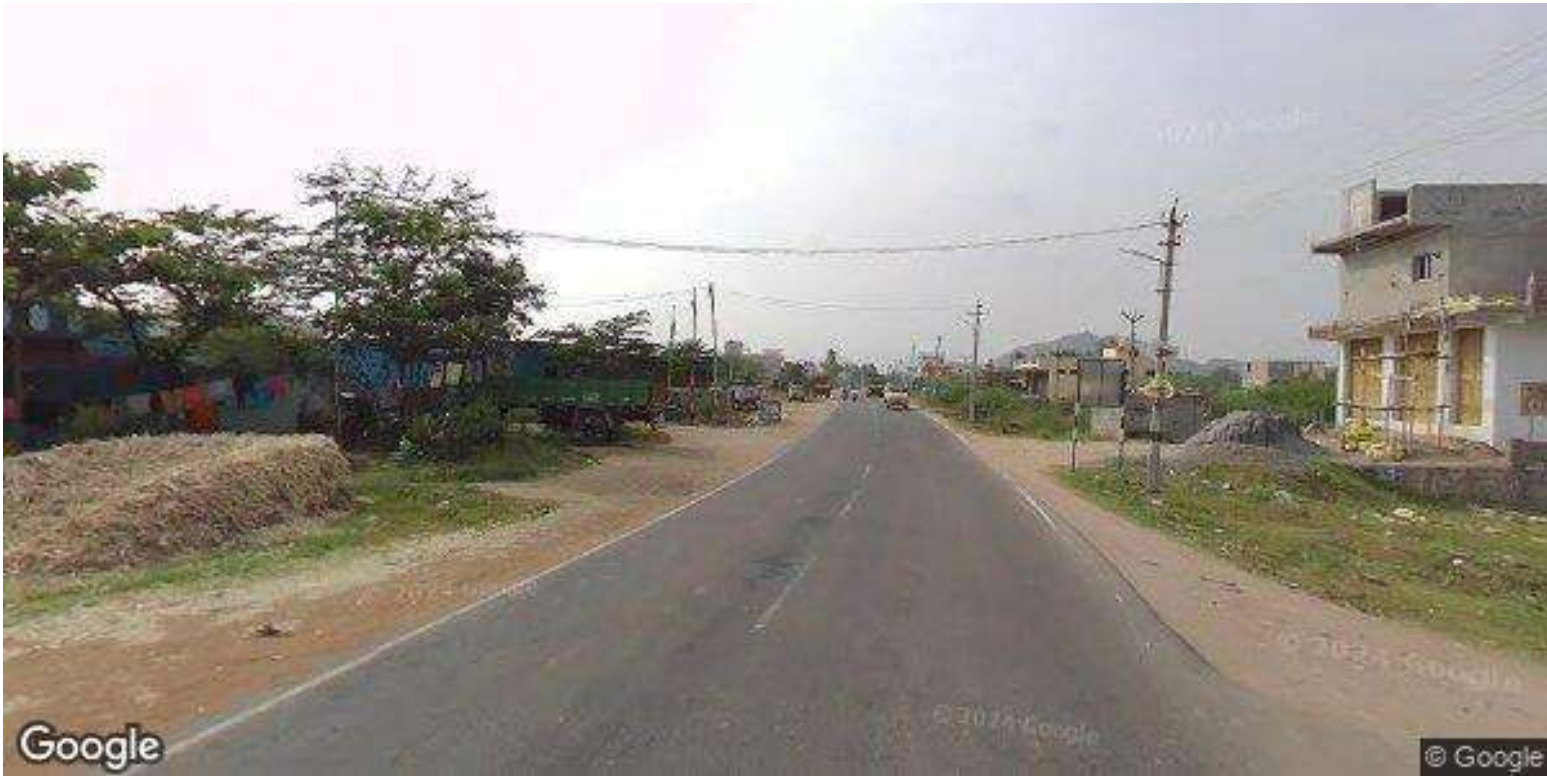
**Risk Type:** Turn  
**Risk Level:** Medium  
**Speed Limit:** 30 KM/Hr  
**Coordinates:** 12.31236, 78.07799

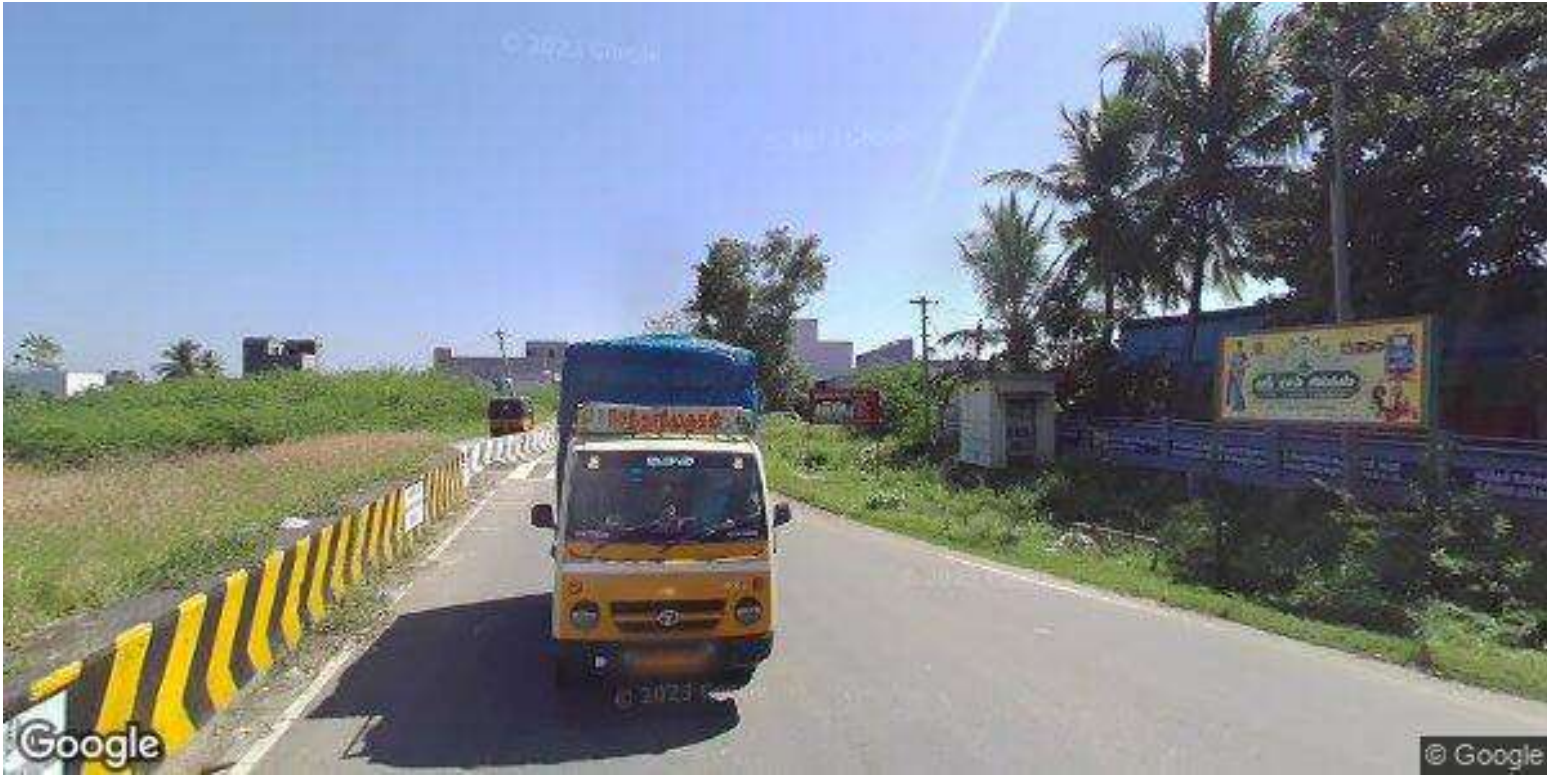
**Risk Type:** Turn  
**Risk Level:** High  
**Speed Limit:** 15 KM/Hr  
**Coordinates:** 12.31360, 78.07464

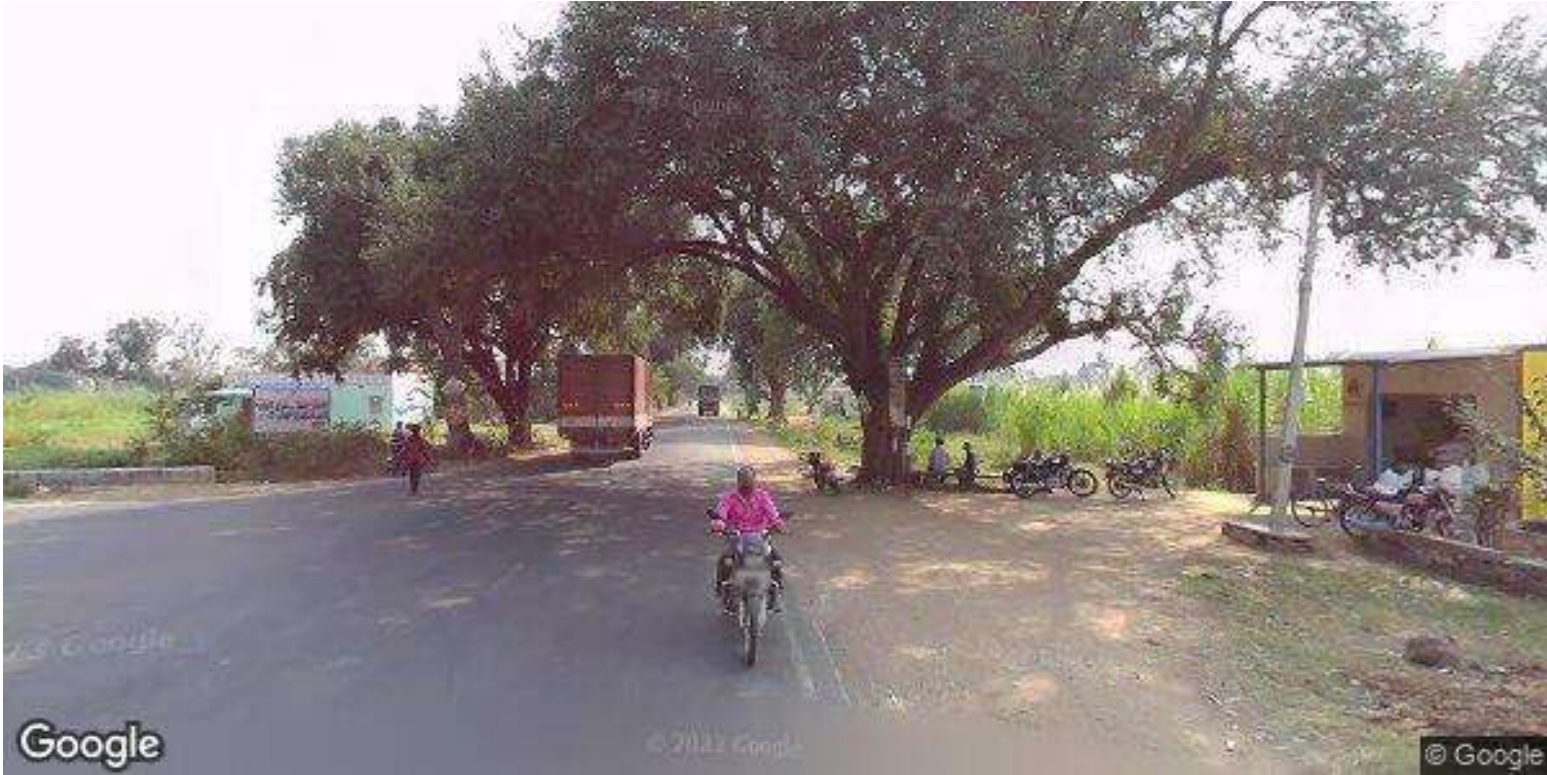
**Risk Type:** Turn  
**Risk Level:** High  
**Speed Limit:** 15 KM/Hr  
**Coordinates:** 12.32018, 78.07656

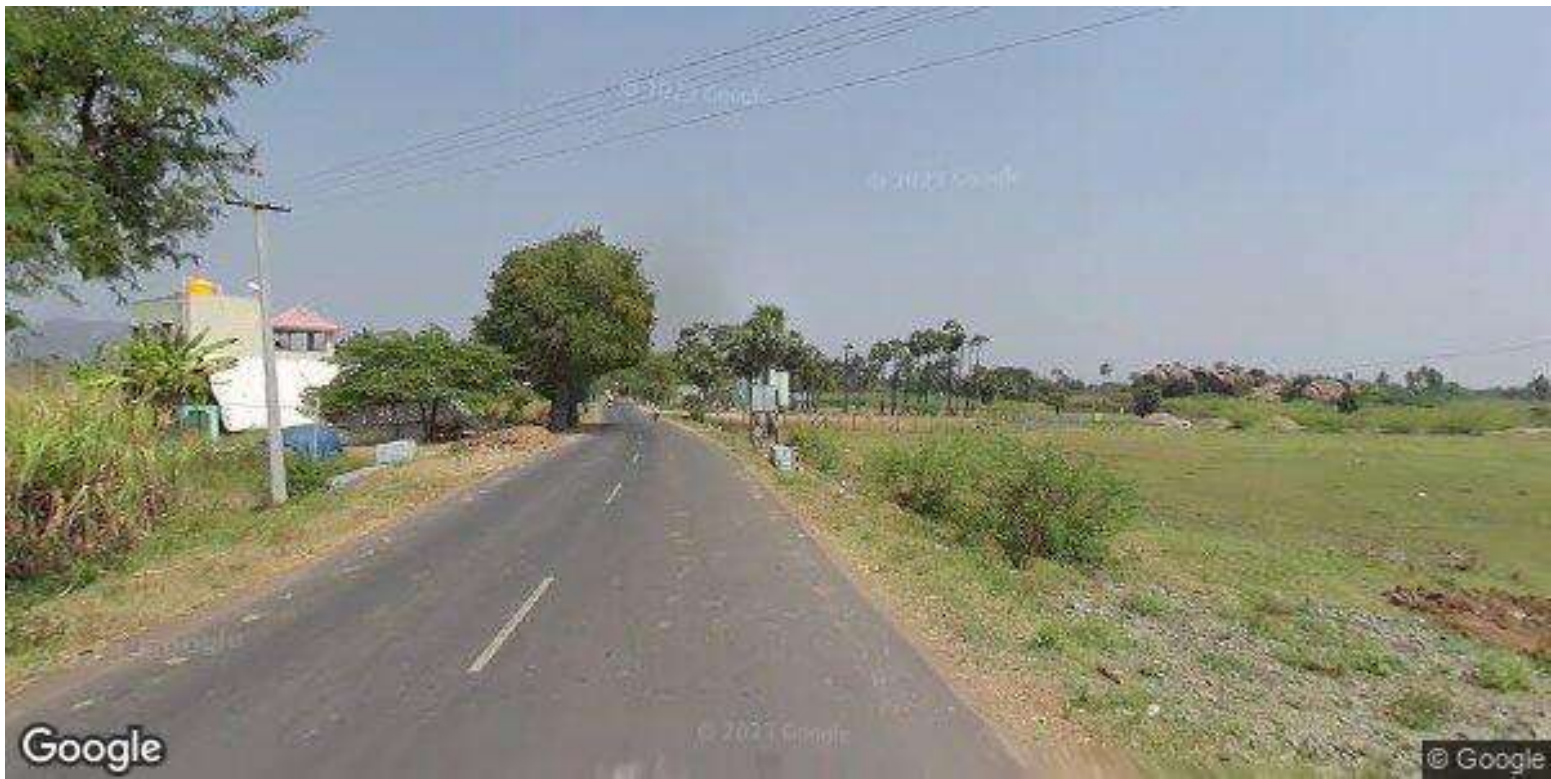
**Risk Type:** Turn  
**Risk Level:** Medium  
**Speed Limit:** 30 KM/Hr  
**Coordinates:** 12.32065, 78.08368

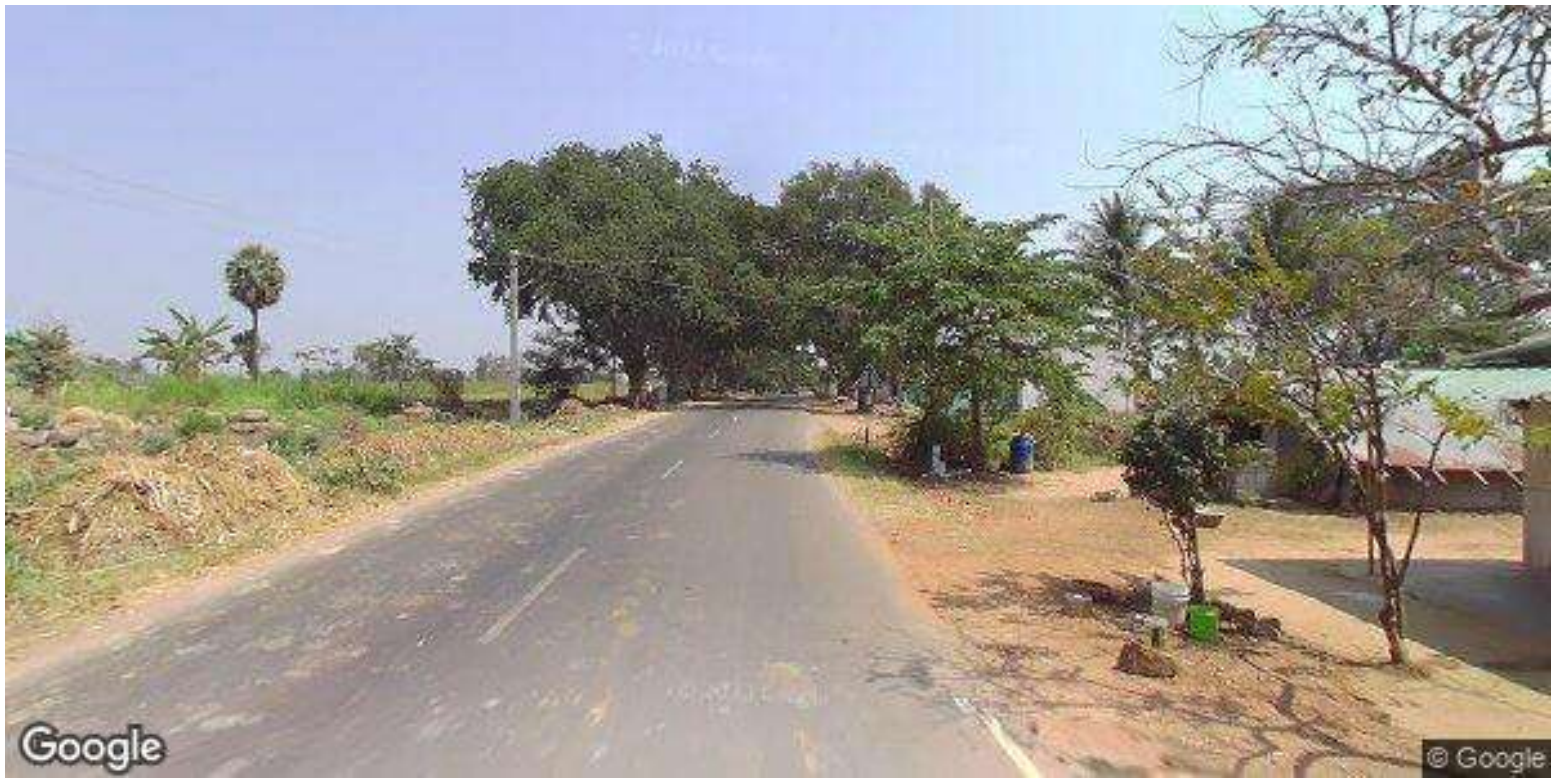
**Risk Type:** Turn  
**Risk Level:** Medium  
**Speed Limit:** 30 KM/Hr  
**Coordinates:** 12.32338, 78.08719
