# IndianOil

## JOURNEY RISK MANAGEMENT (JRM) STUDY

### Salem Terminal TO A.C.M.PETROLEUM AGENCIES

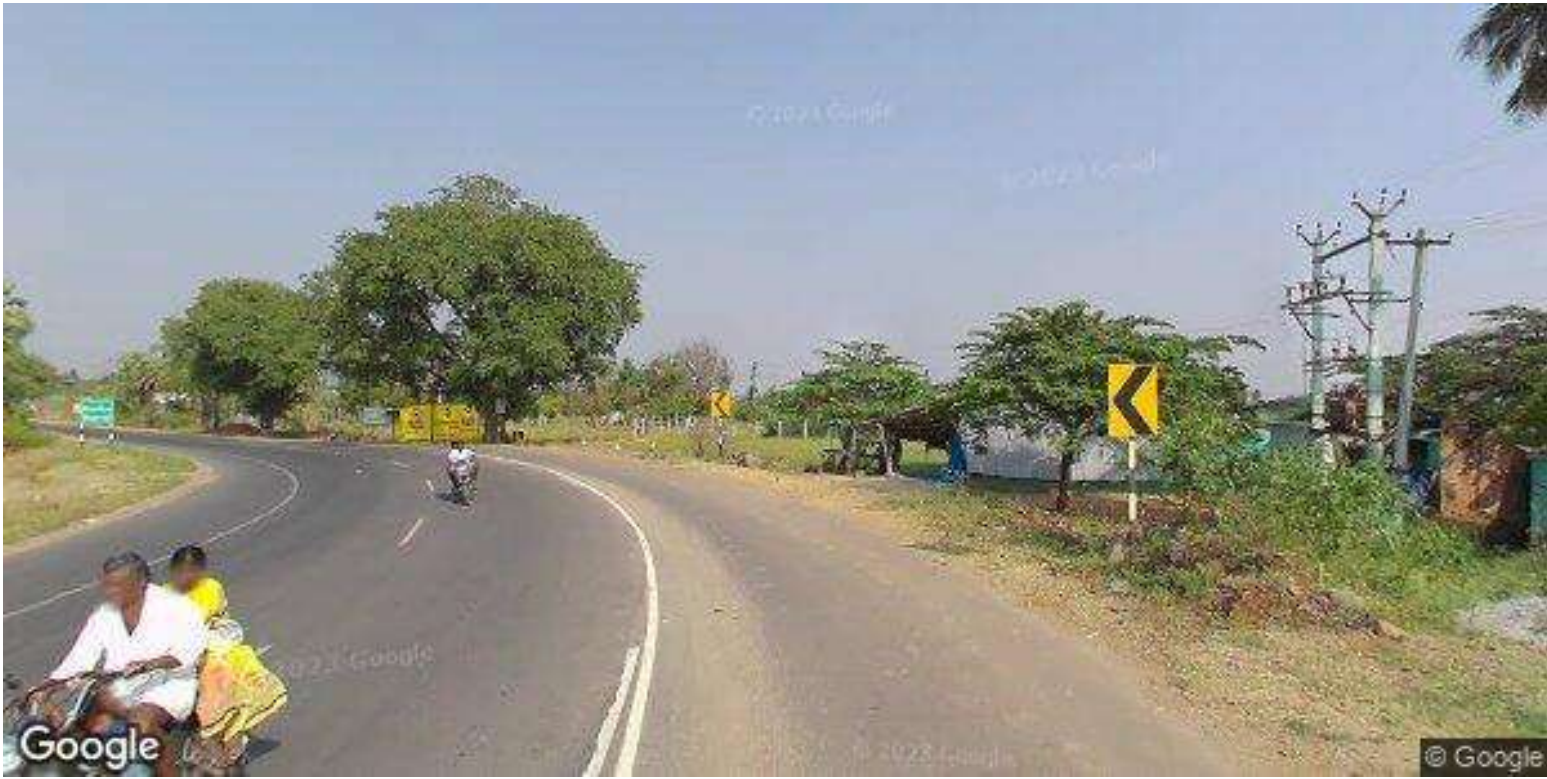
**Risk Type:** Turn  
**Risk Level:** High  
**Speed Limit:** 15 KM/Hr  
**Coordinates:** 12.32321, 78.09514

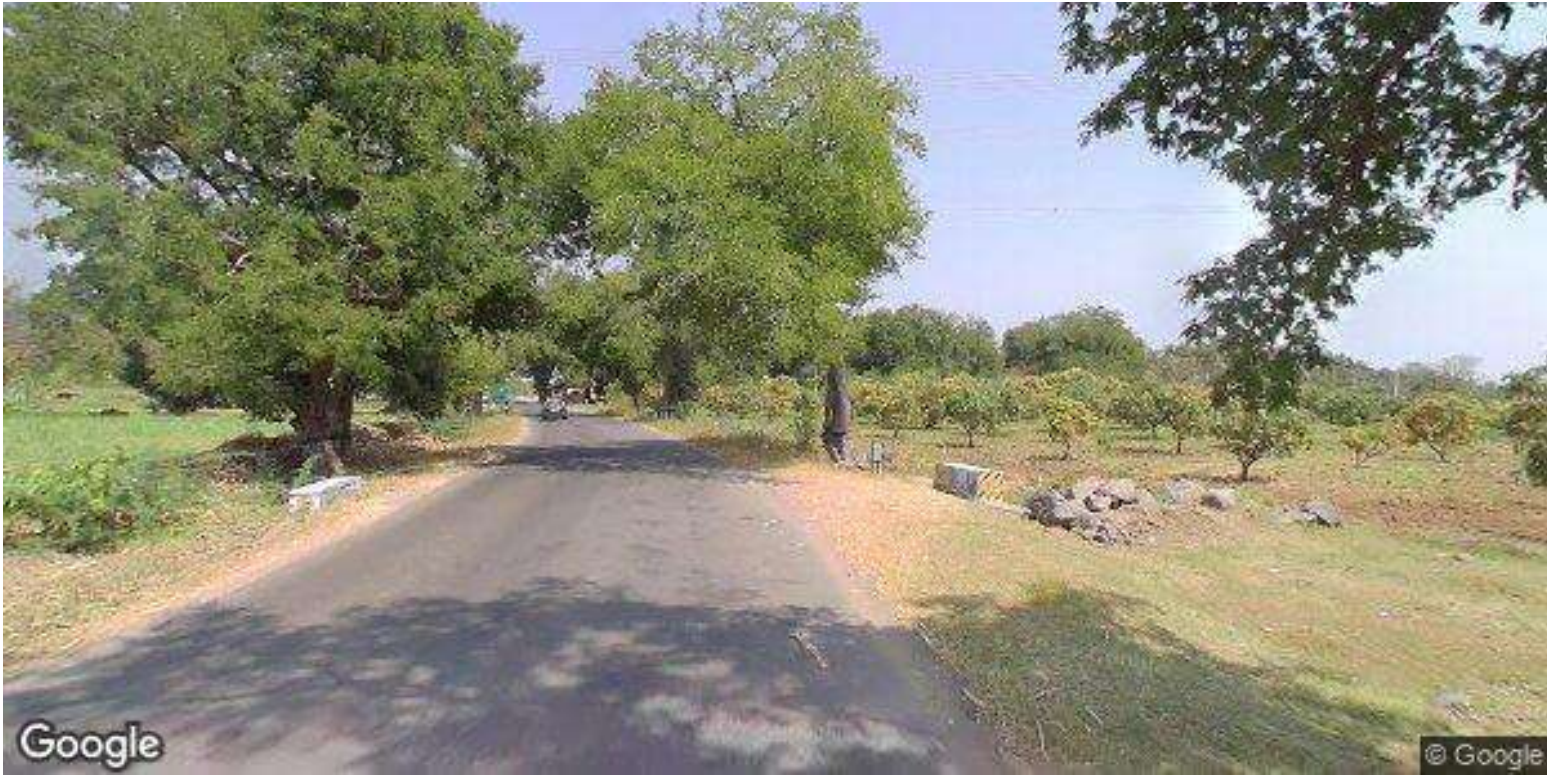
**Risk Type:** Turn  
**Risk Level:** Medium  
**Speed Limit:** 30 KM/Hr  
**Coordinates:** 12.33151, 78.10541

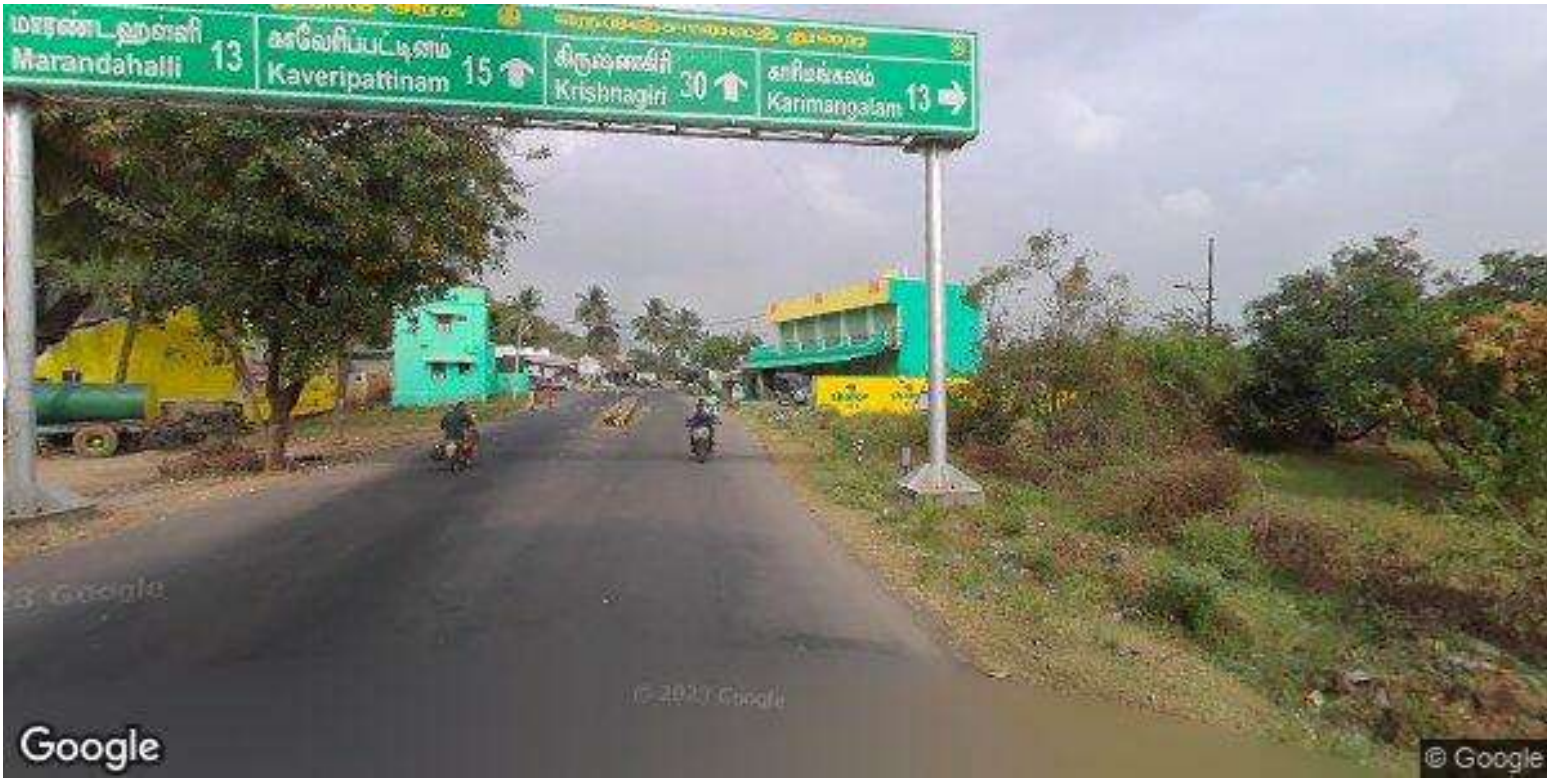
**Risk Type:** Turn

**Risk Level:** Medium

**Speed Limit:** 30 KM/Hr

**Coordinates:** 12.33697, 78.10836
