## JOURNEY RISK MANAGEMENT (JRM) STUDY

### Salem Terminal TO M.S TAMILVAANI AGENCIES

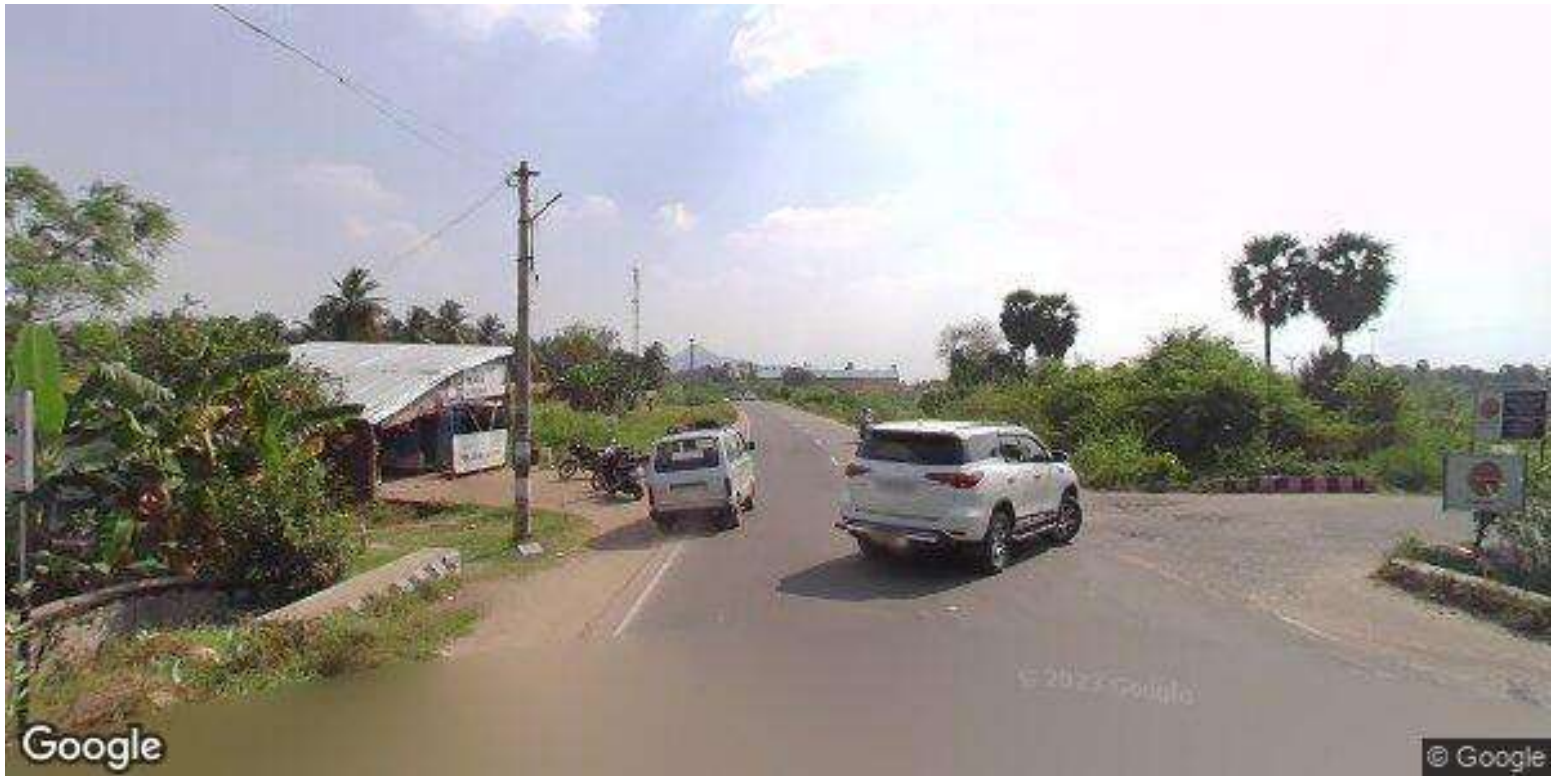
Coordinates: 11.44029, 77.87544

Risk Type: Turn

Risk Level: High

Speed Limit: 15 KM/Hr

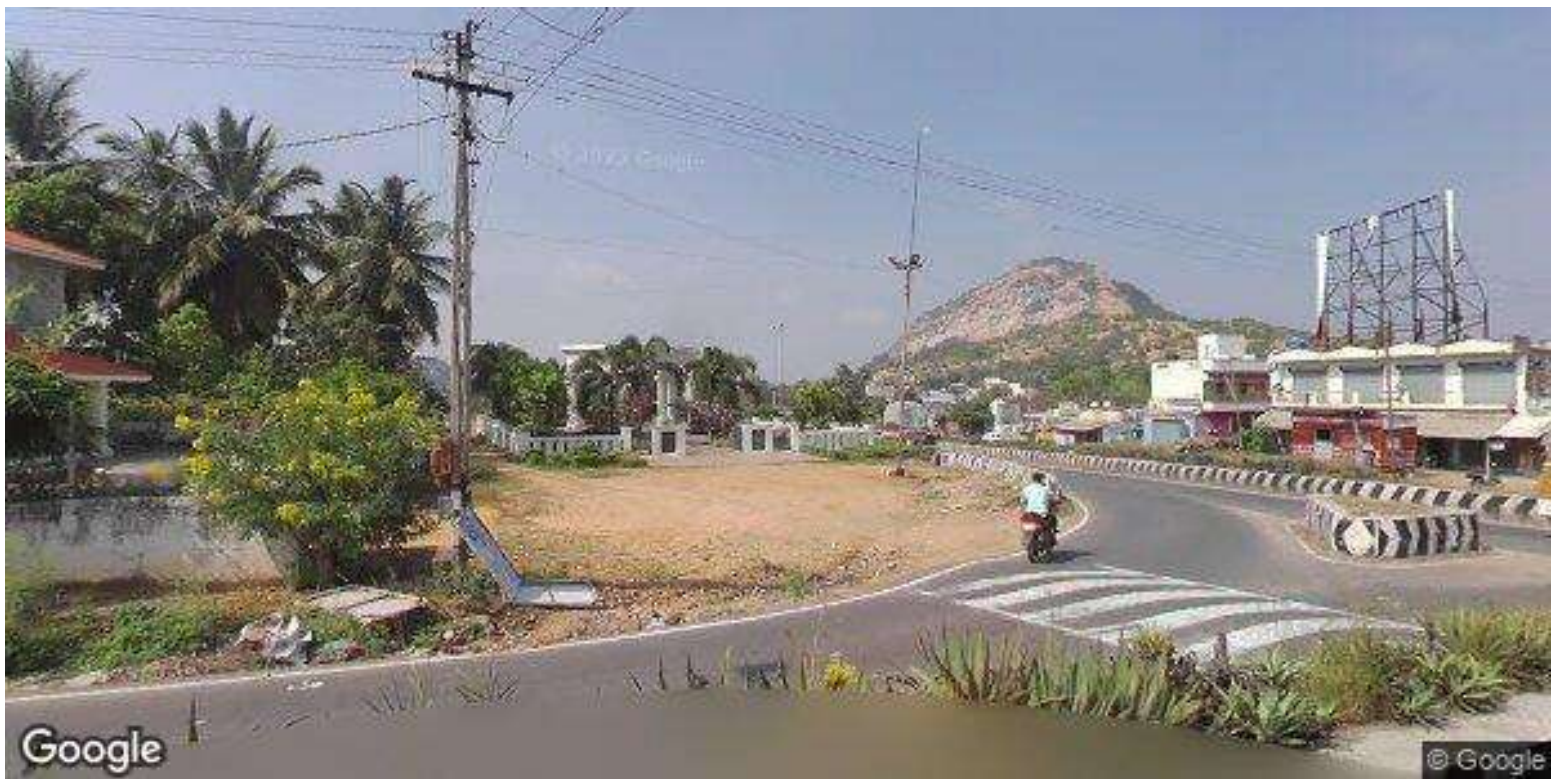
Coordinates: 11.46307, 77.84941

Risk Type: Turn

Risk Level: Medium

Speed Limit: 30 KM/Hr

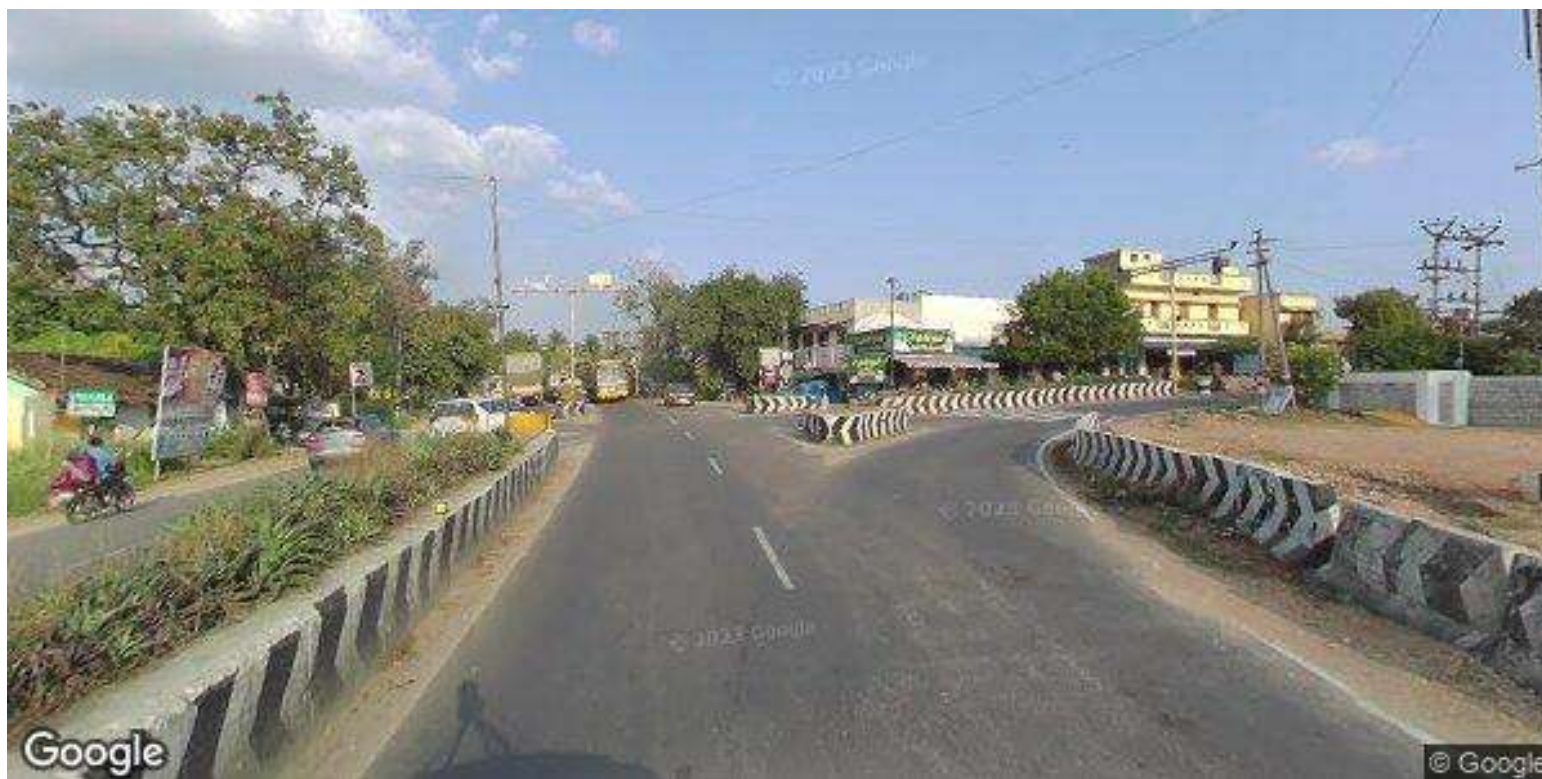
**Coordinates:** 11.46318, 77.84913

**Risk Type:** Turn

**Risk Level:** Medium

**Speed Limit:** 30 KM/Hr

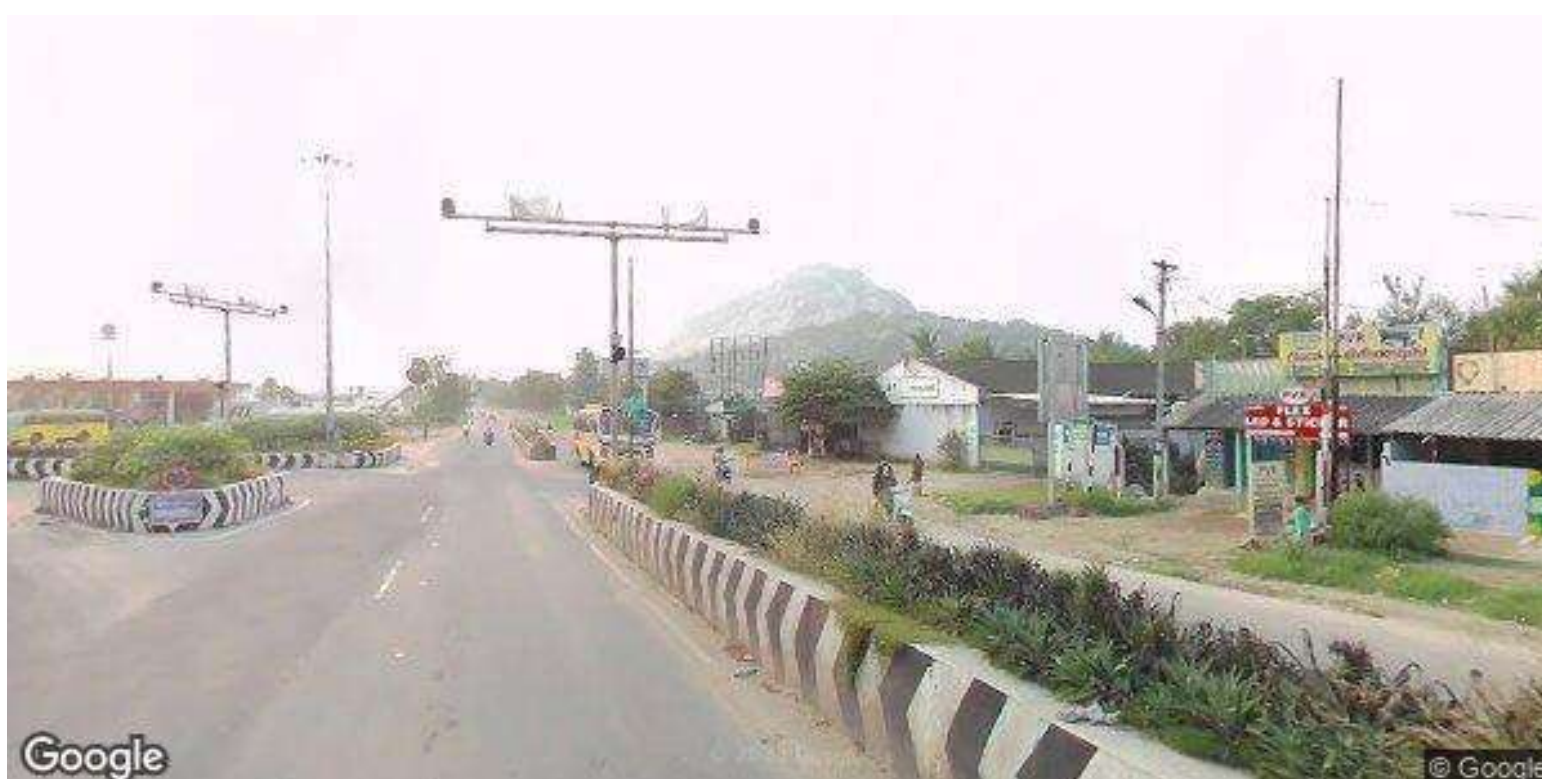
**Coordinates:** 11.46312, 77.84886

**Risk Type:** Turn

**Risk Level:** Medium

**Speed Limit:** 30 KM/Hr

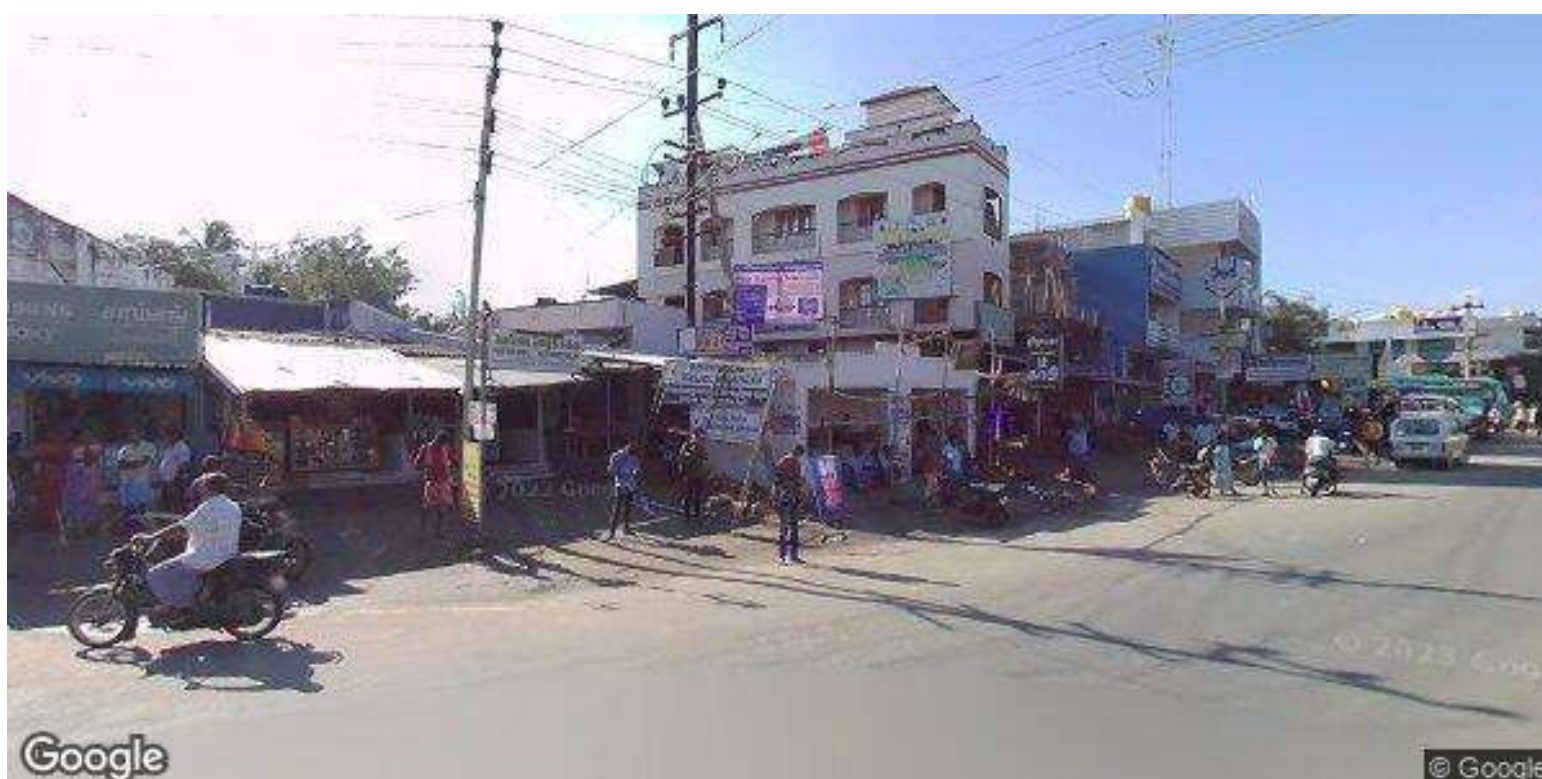
Coordinates: 11.40574, 77.78829

Risk Type: Turn

Risk Level: High

Speed Limit: 15 KM/Hr

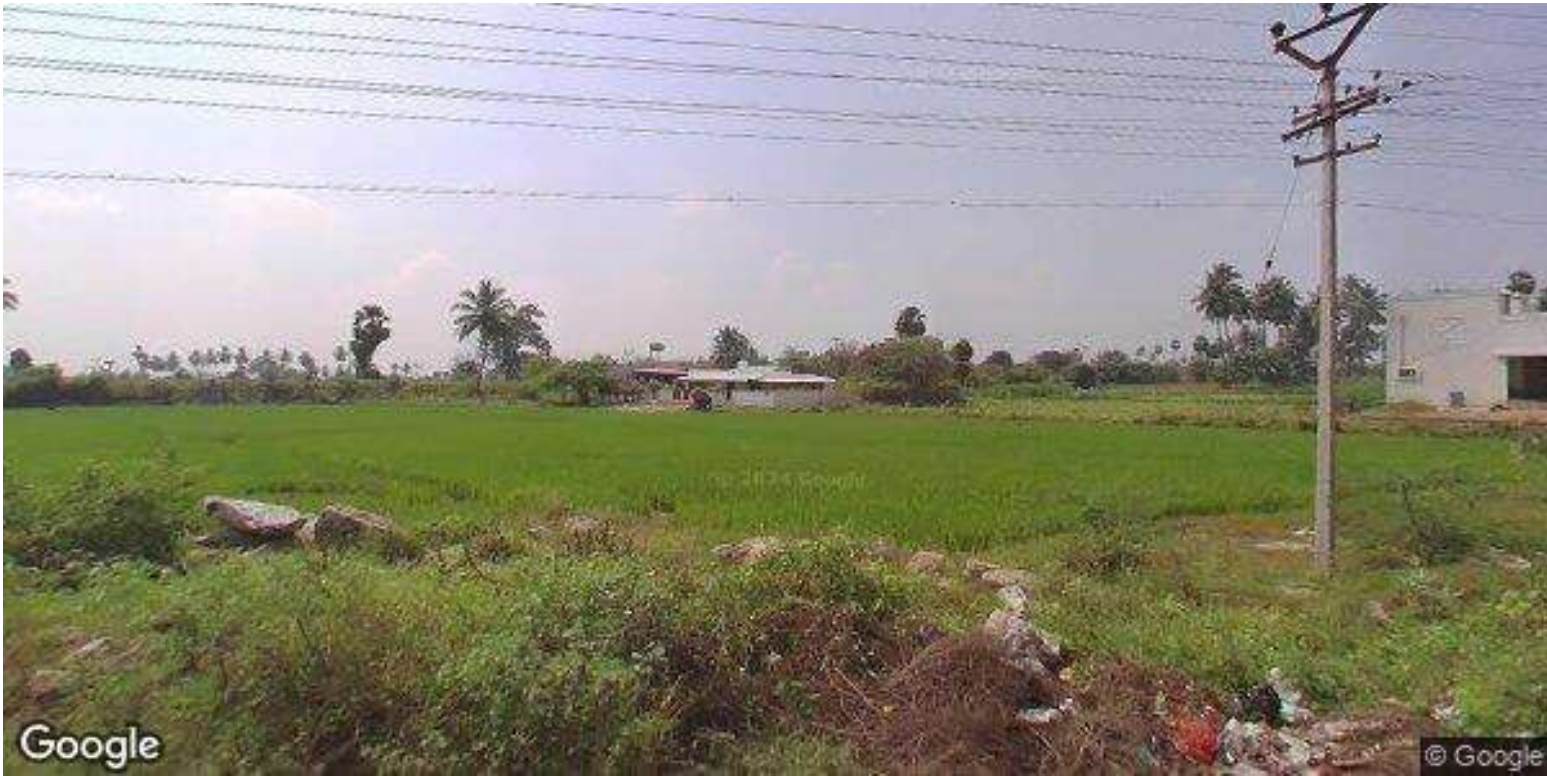
Coordinates: 11.41493, 77.76777

Risk Type: Turn

Risk Level: High

Speed Limit: 15 KM/Hr
