# IndianOil

## JOURNEY RISK MANAGEMENT (JRM) STUDY

### Salem Terminal TO SRI MURUGA AGENCIES

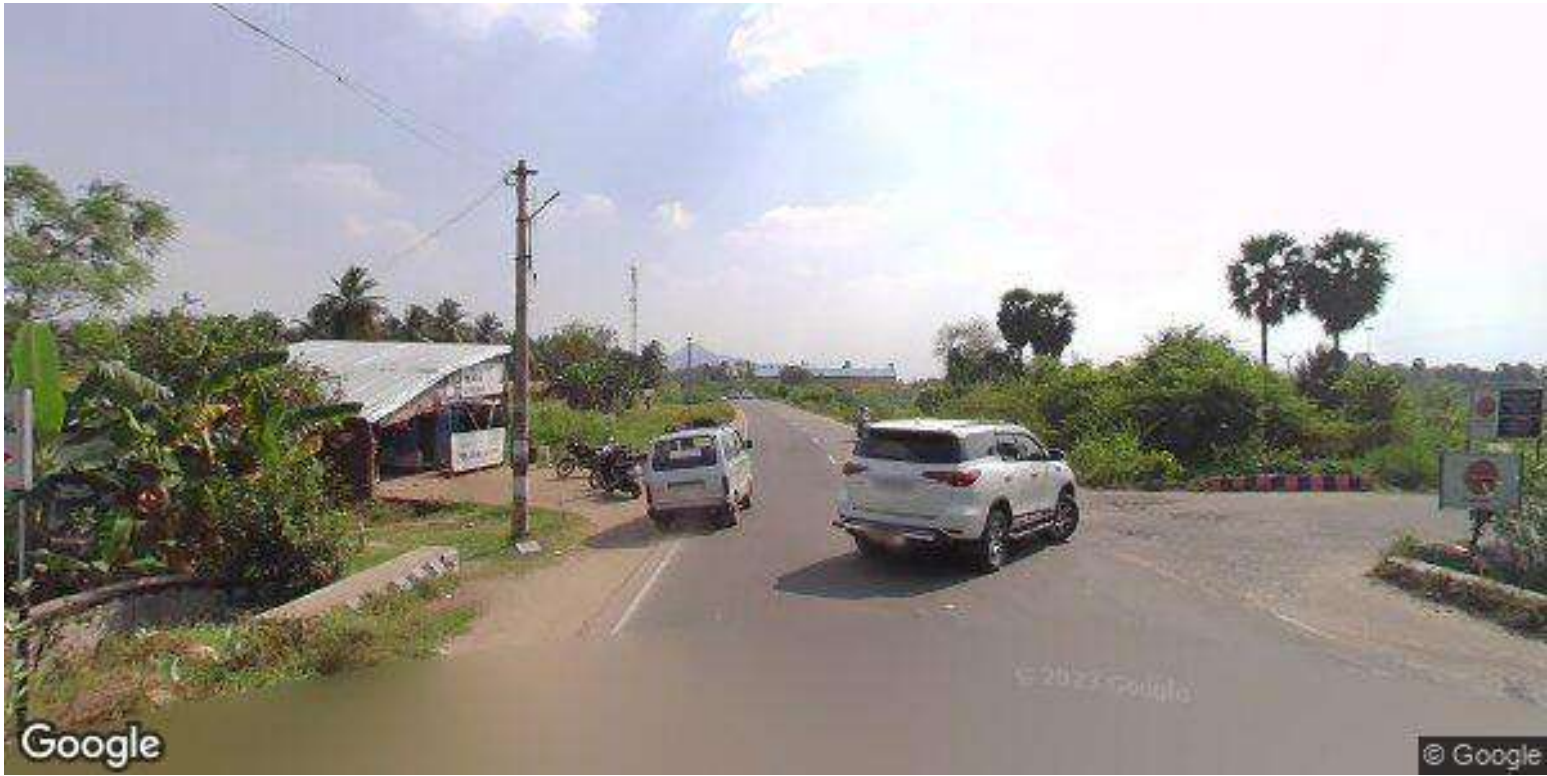
**Coordinates:** 11.44029, 77.87544

**Risk Type:** Turn

**Risk Level:** High

**Speed Limit:** 15 KM/Hr

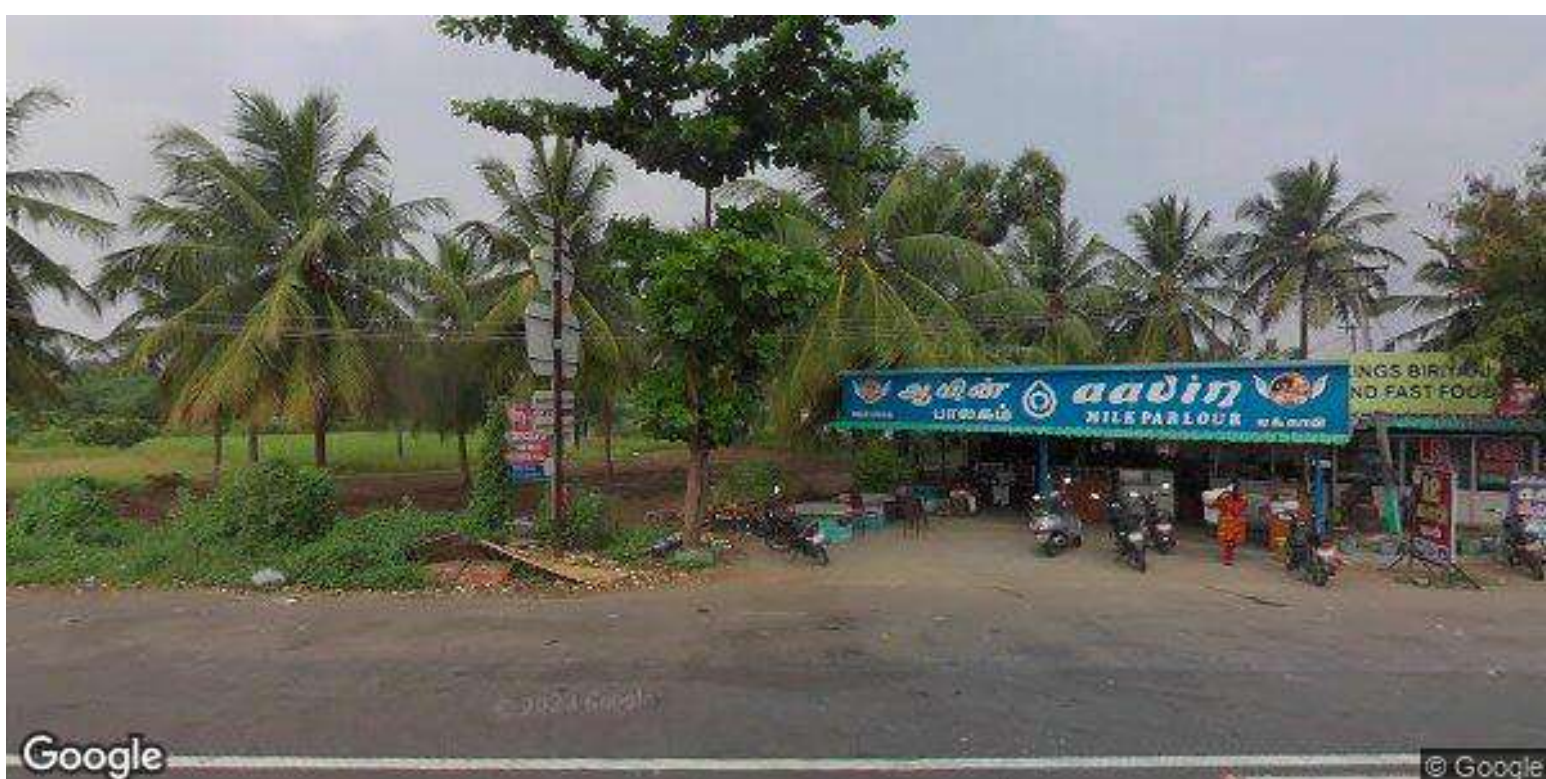
**Risk Type:** Turn  
**Risk Level:** High  
**Speed Limit:** 15 KM/Hr  
**Coordinates:** 11.45631, 77.81668

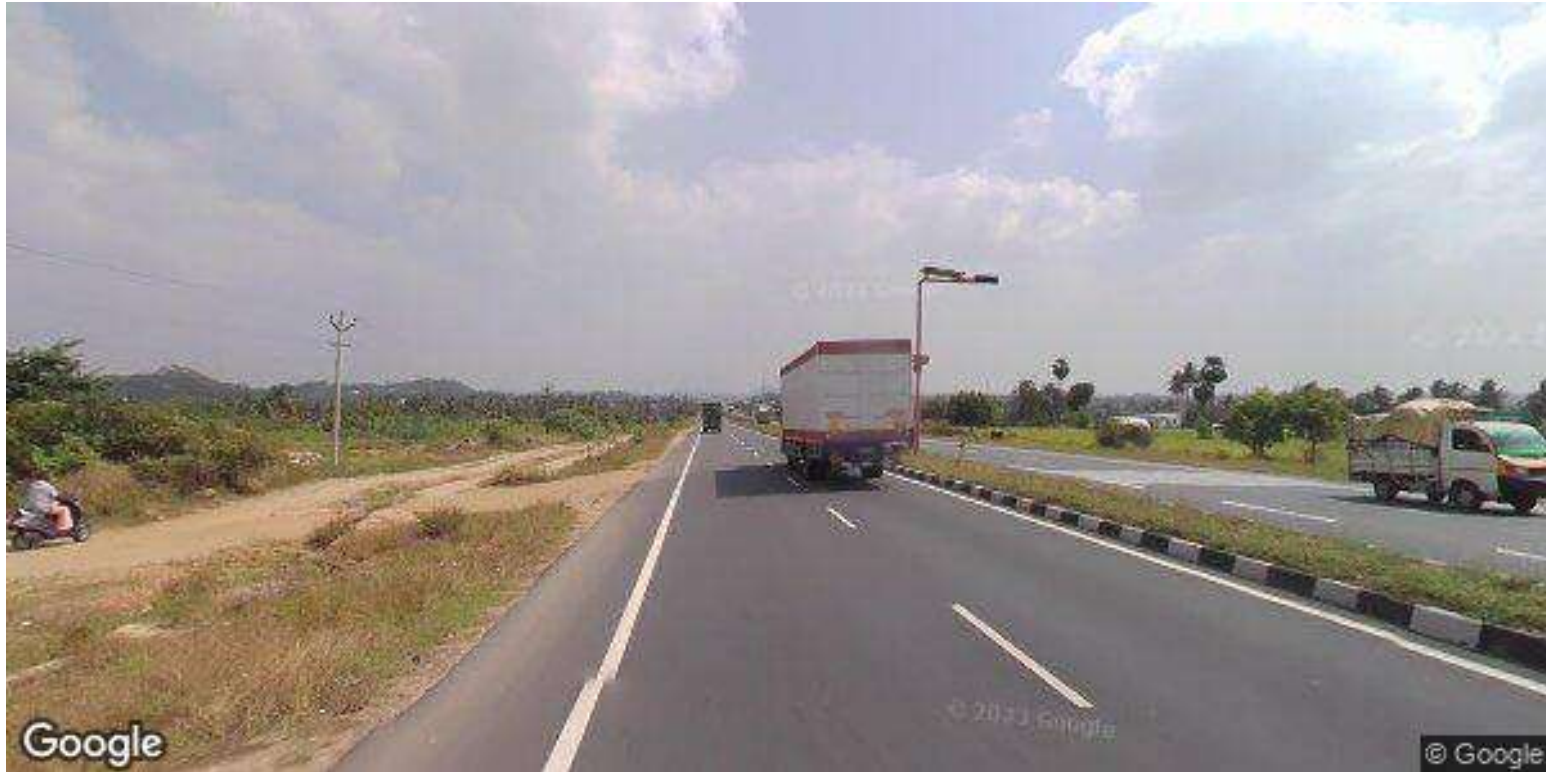
**Risk Type:** Turn  
**Risk Level:** High  
**Speed Limit:** 15 KM/Hr  
**Coordinates:** 11.49409, 77.88004

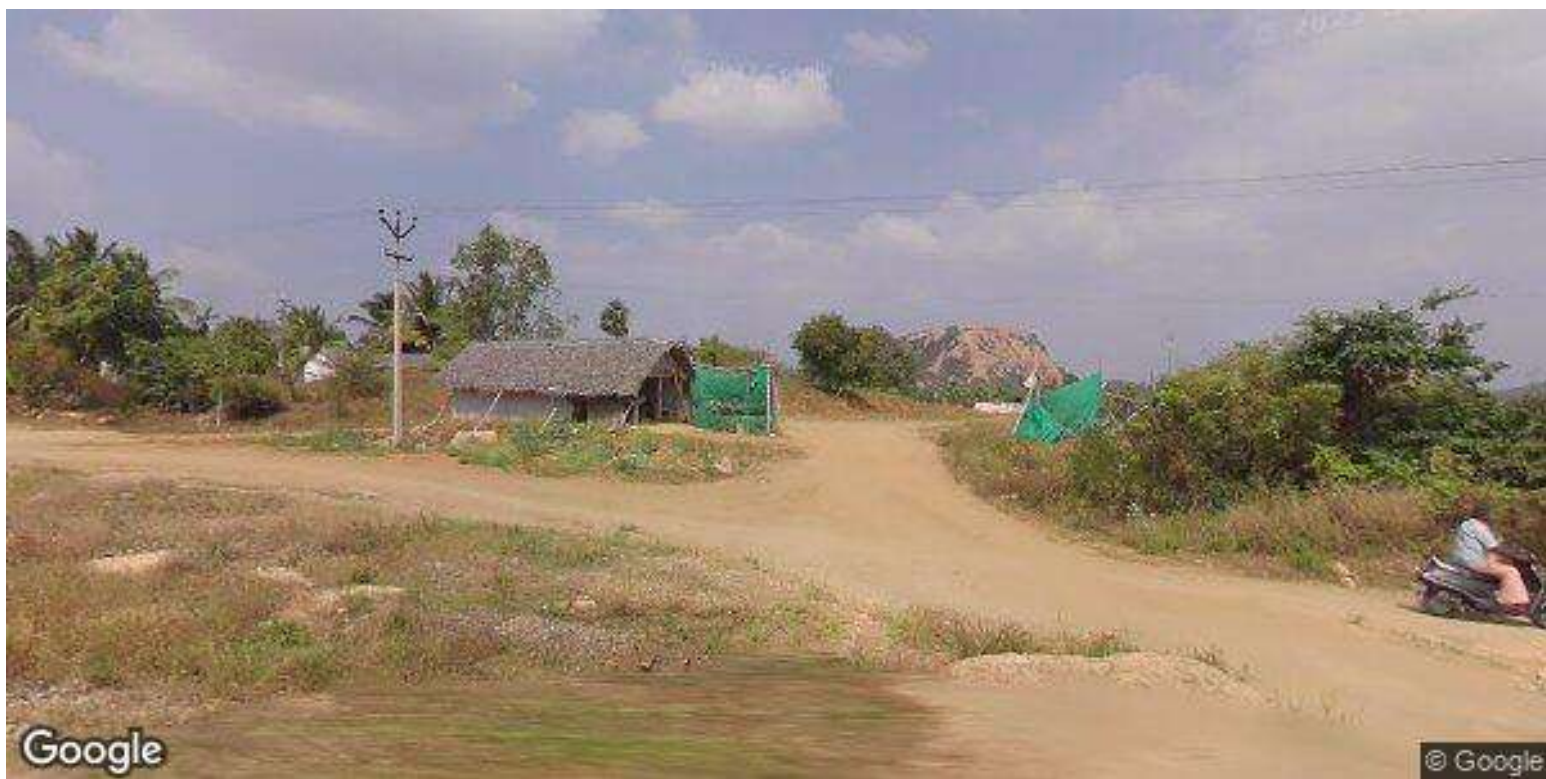
**Risk Type:** Turn  
**Risk Level:** Medium  
**Speed Limit:** 30 KM/Hr  
**Coordinates:** 11.49419, 77.88015

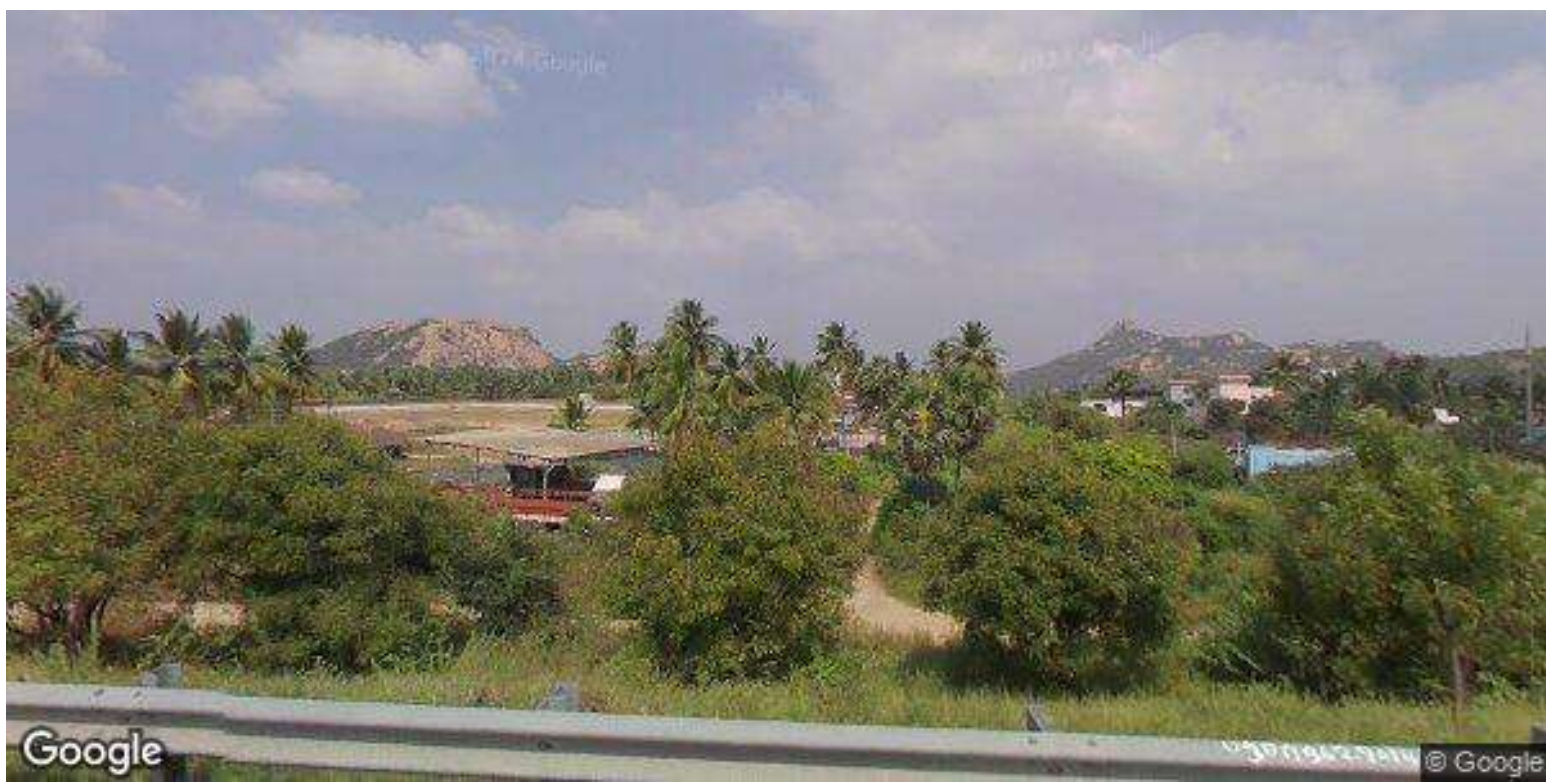
**Coordinates:** 11.49383, 77.88442

**Risk Type:** Turn

**Risk Level:** High

**Speed Limit:** 15 KM/Hr

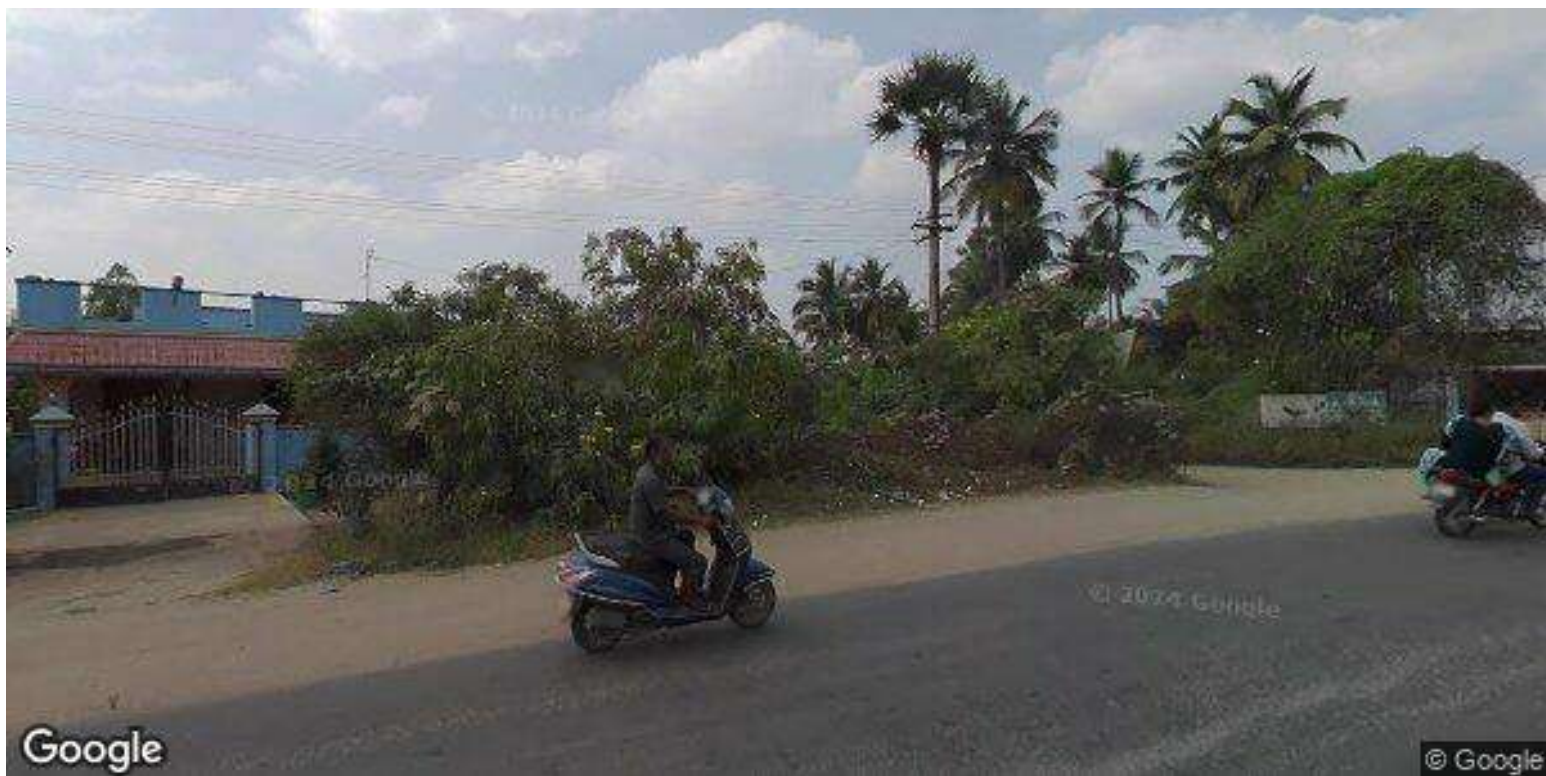
**Coordinates:** 11.49419, 77.88454

**Risk Type:** Turn

**Risk Level:** Medium

**Speed Limit:** 30 KM/Hr

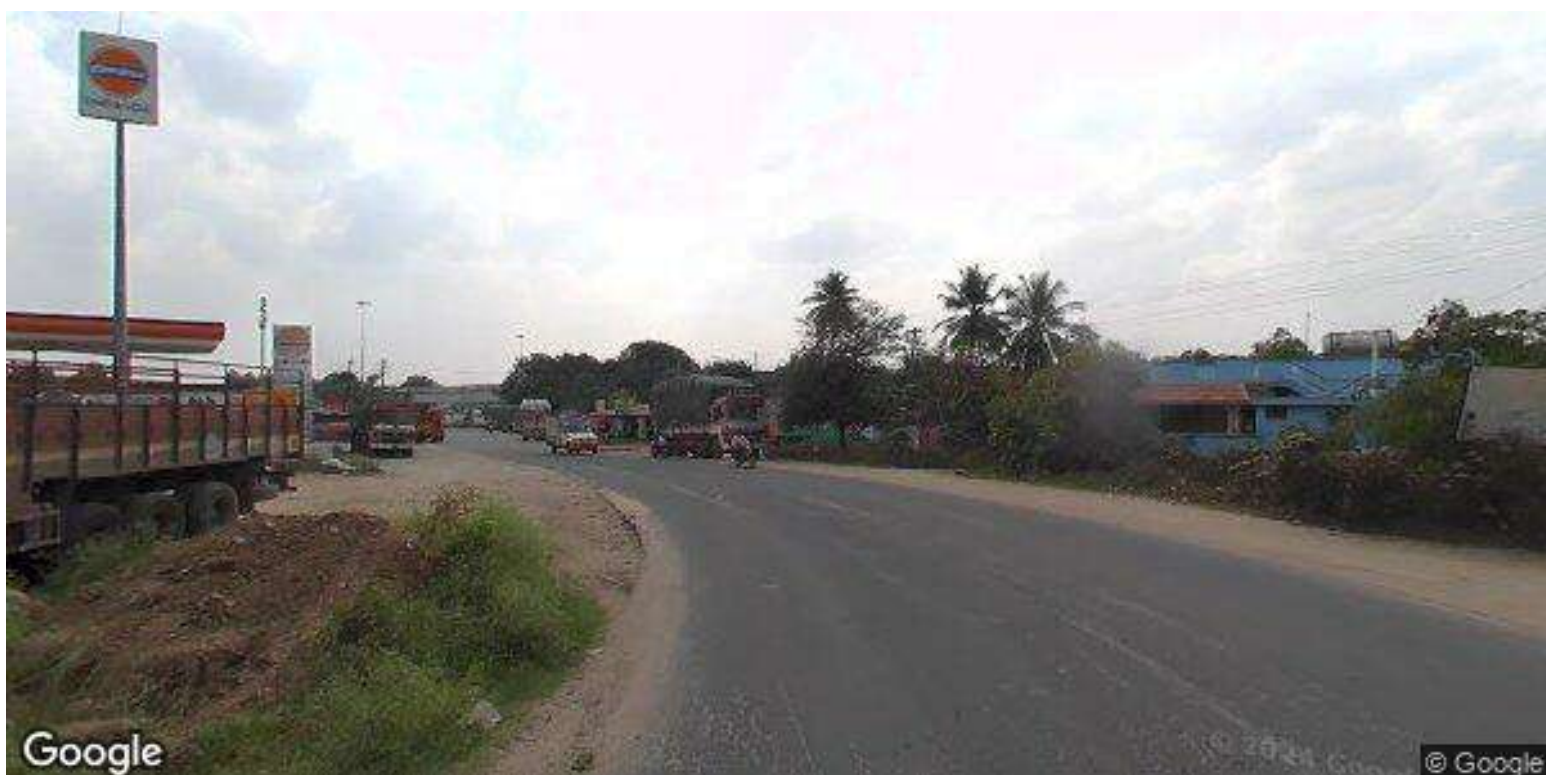
**Risk Type:** Turn  
**Risk Level:** Medium  
**Speed Limit:** 30 KM/Hr  
**Coordinates:** 11.49448, 77.88490

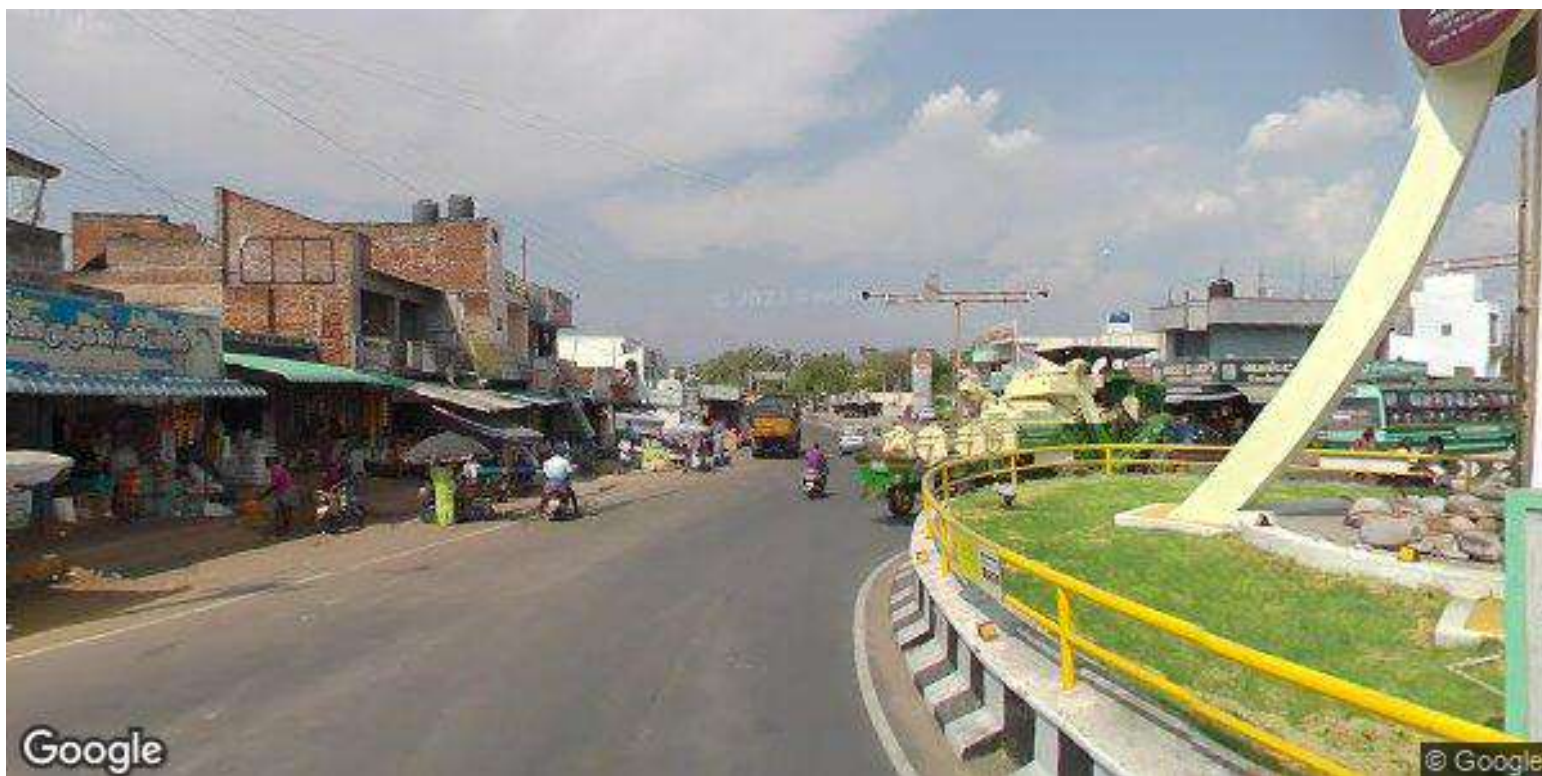
**Risk Type:** Turn  
**Risk Level:** Medium  
**Speed Limit:** 30 KM/Hr  
**Coordinates:** 11.57048, 77.90224

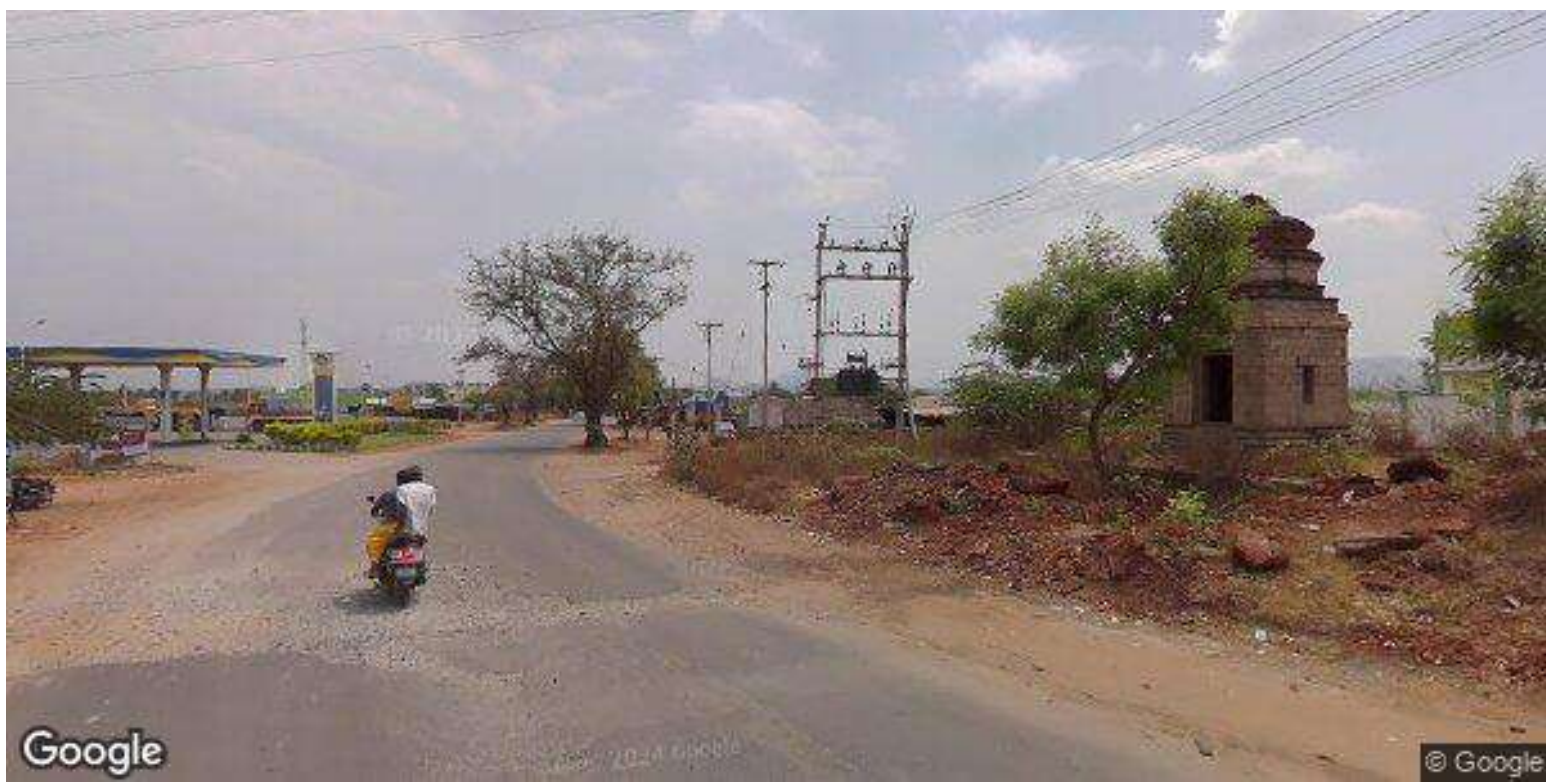
**Coordinates:** 11.58304, 77.90656

**Risk Type:** Turn

**Risk Level:** Medium

**Speed Limit:** 30 KM/Hr

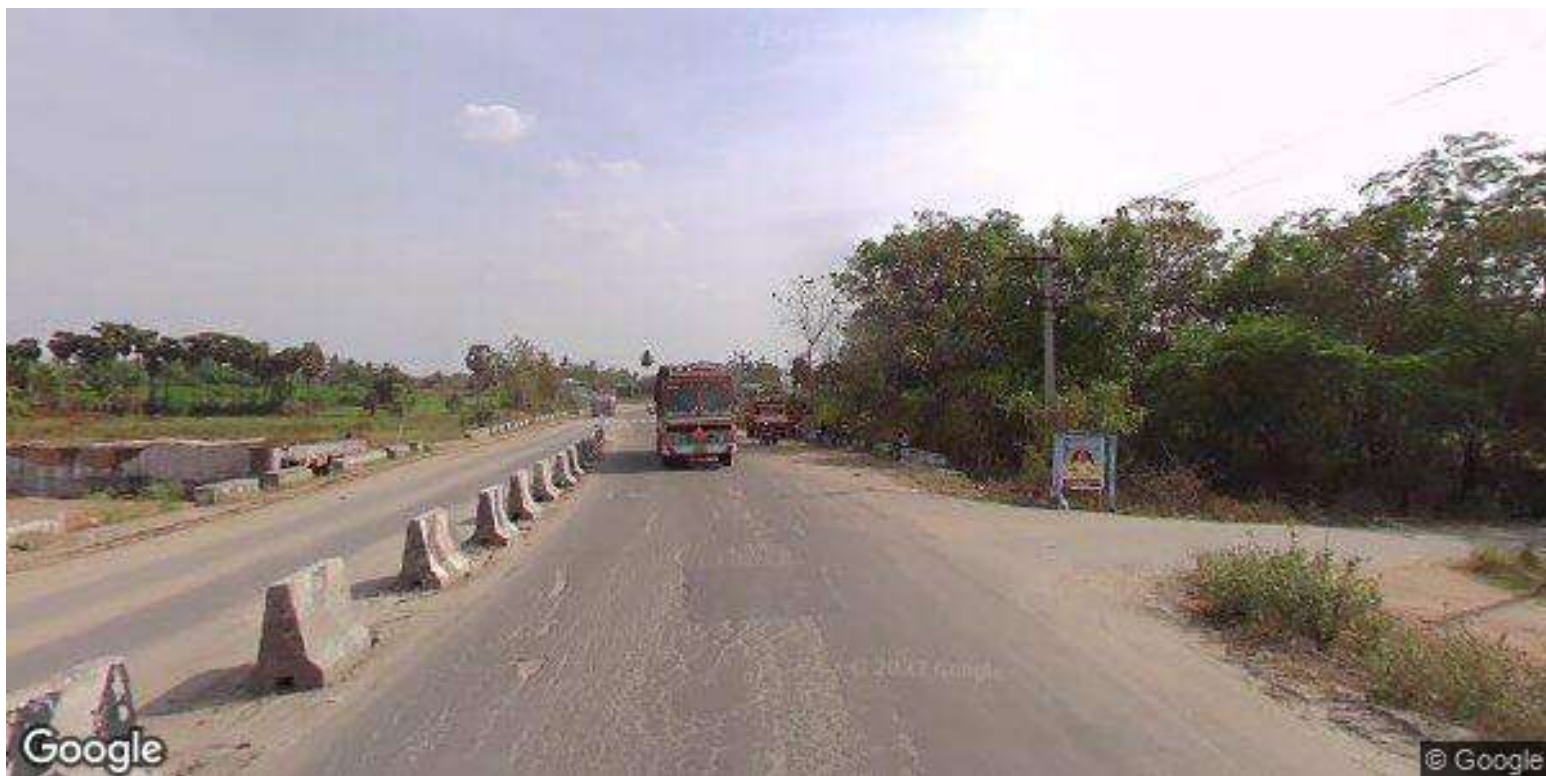
**Coordinates:** 11.63840, 77.94820

**Risk Type:** Turn

**Risk Level:** Medium

**Speed Limit:** 30 KM/Hr

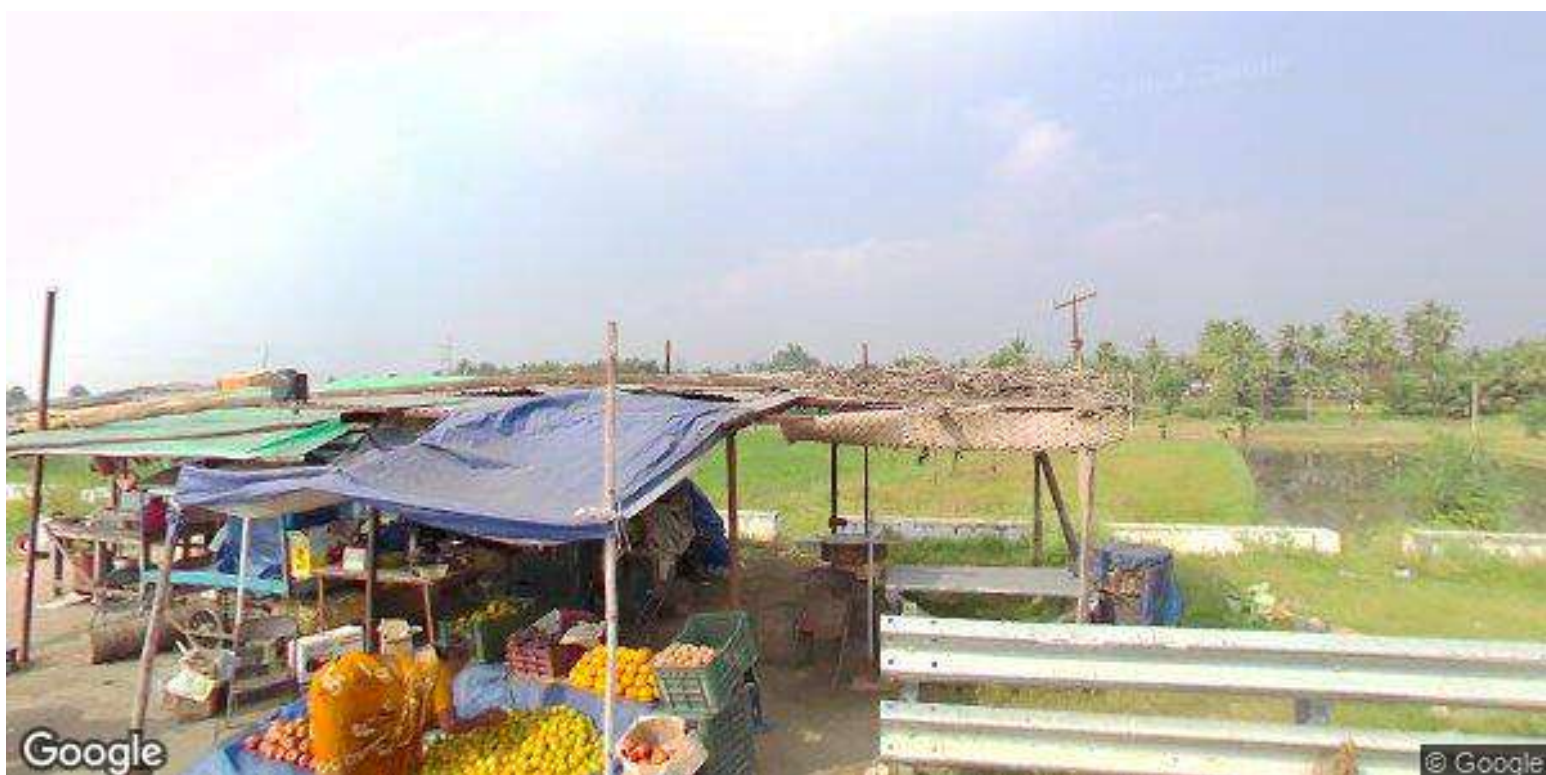
**Coordinates:** 11.67858, 77.96834

**Risk Type:** Turn

**Risk Level:** Medium

**Speed Limit:** 30 KM/Hr

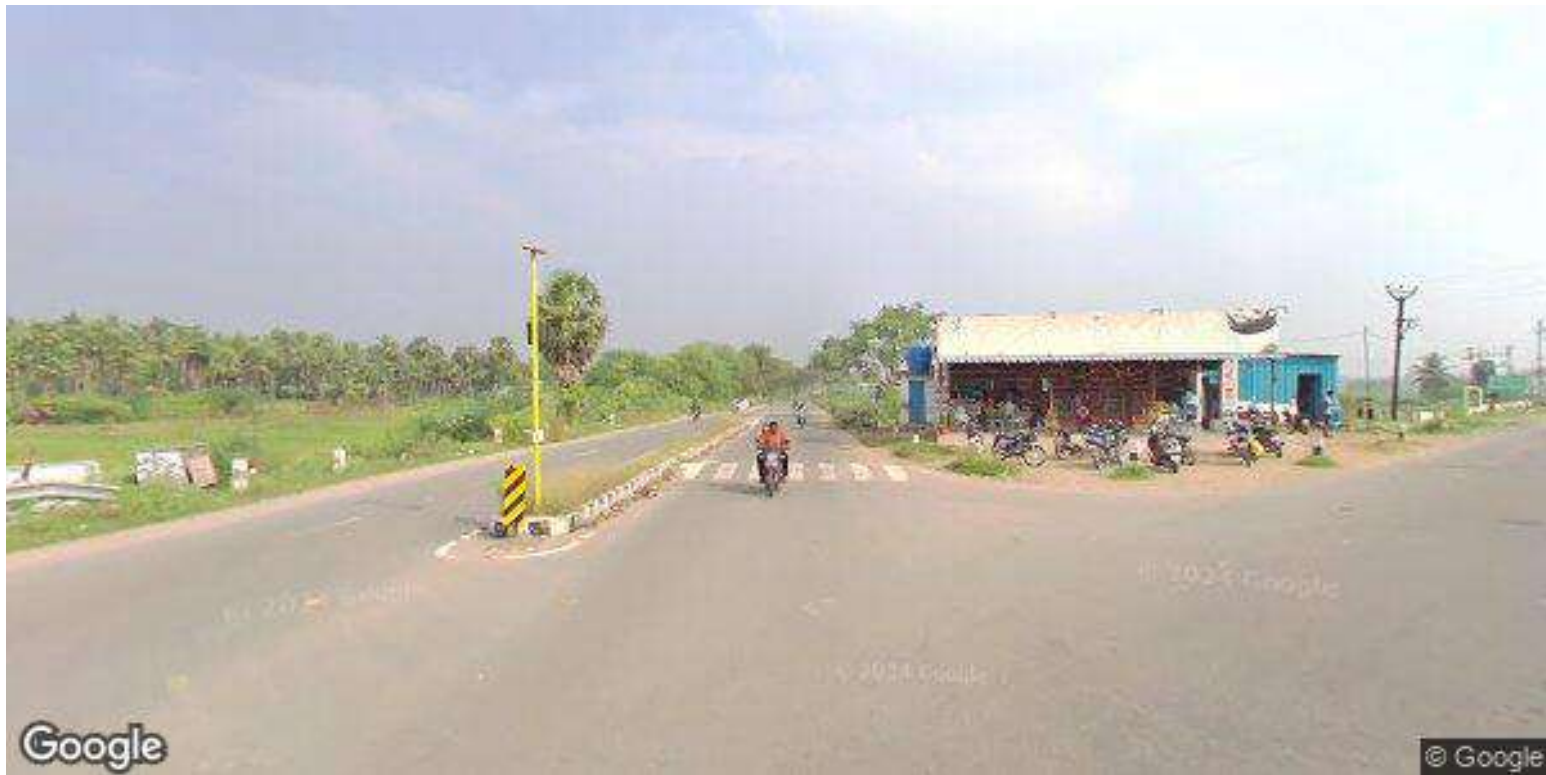
**Coordinates:** 11.67870, 77.96846

**Risk Type:** Turn

**Risk Level:** Medium

**Speed Limit:** 30 KM/Hr

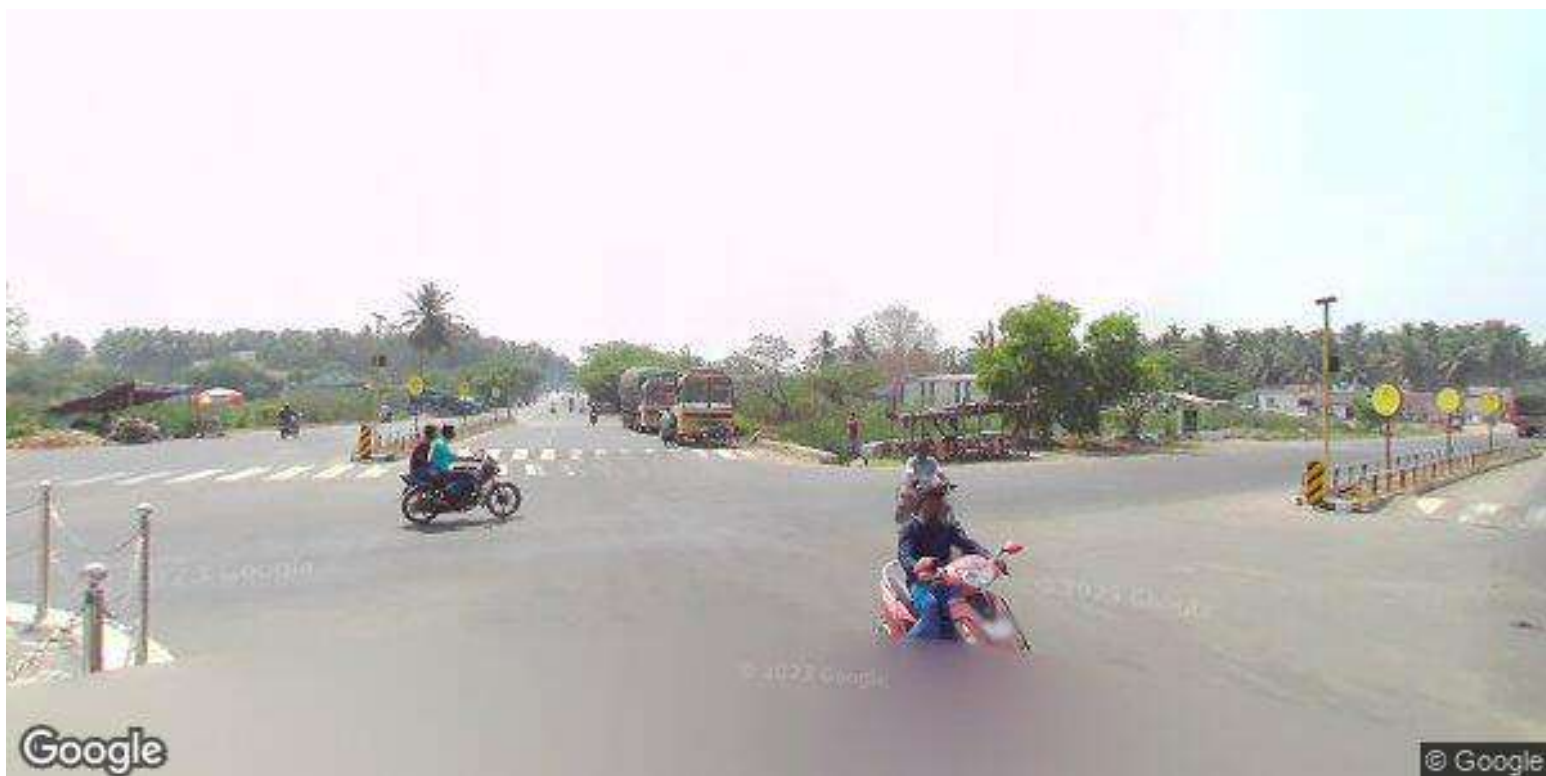
**Coordinates:** 11.68905, 77.97736

**Risk Type:** Turn

**Risk Level:** Medium

**Speed Limit:** 30 KM/Hr

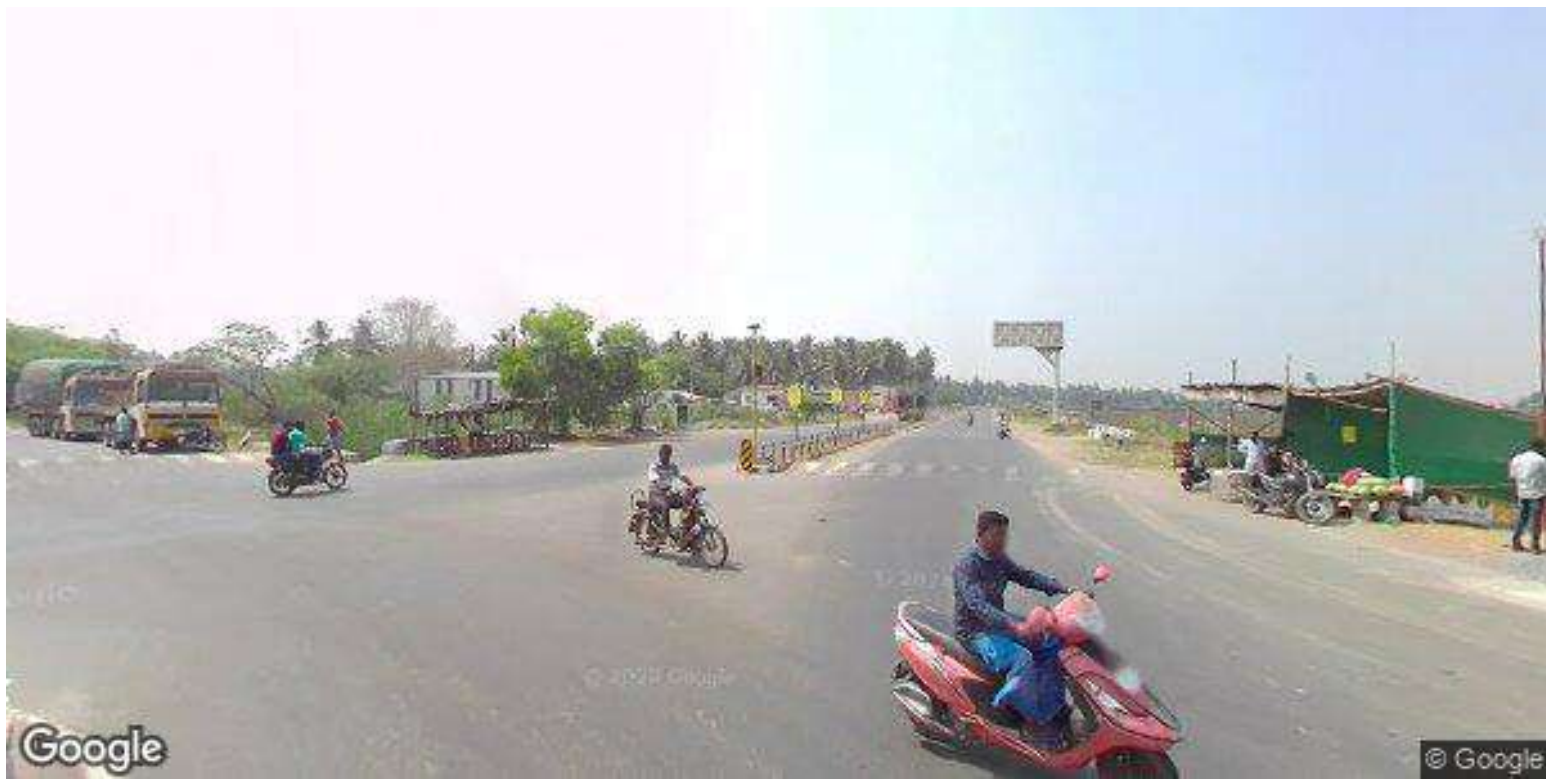
**Coordinates:** 11.68913, 77.97734

**Risk Type:** Turn

**Risk Level:** Medium

**Speed Limit:** 30 KM/Hr

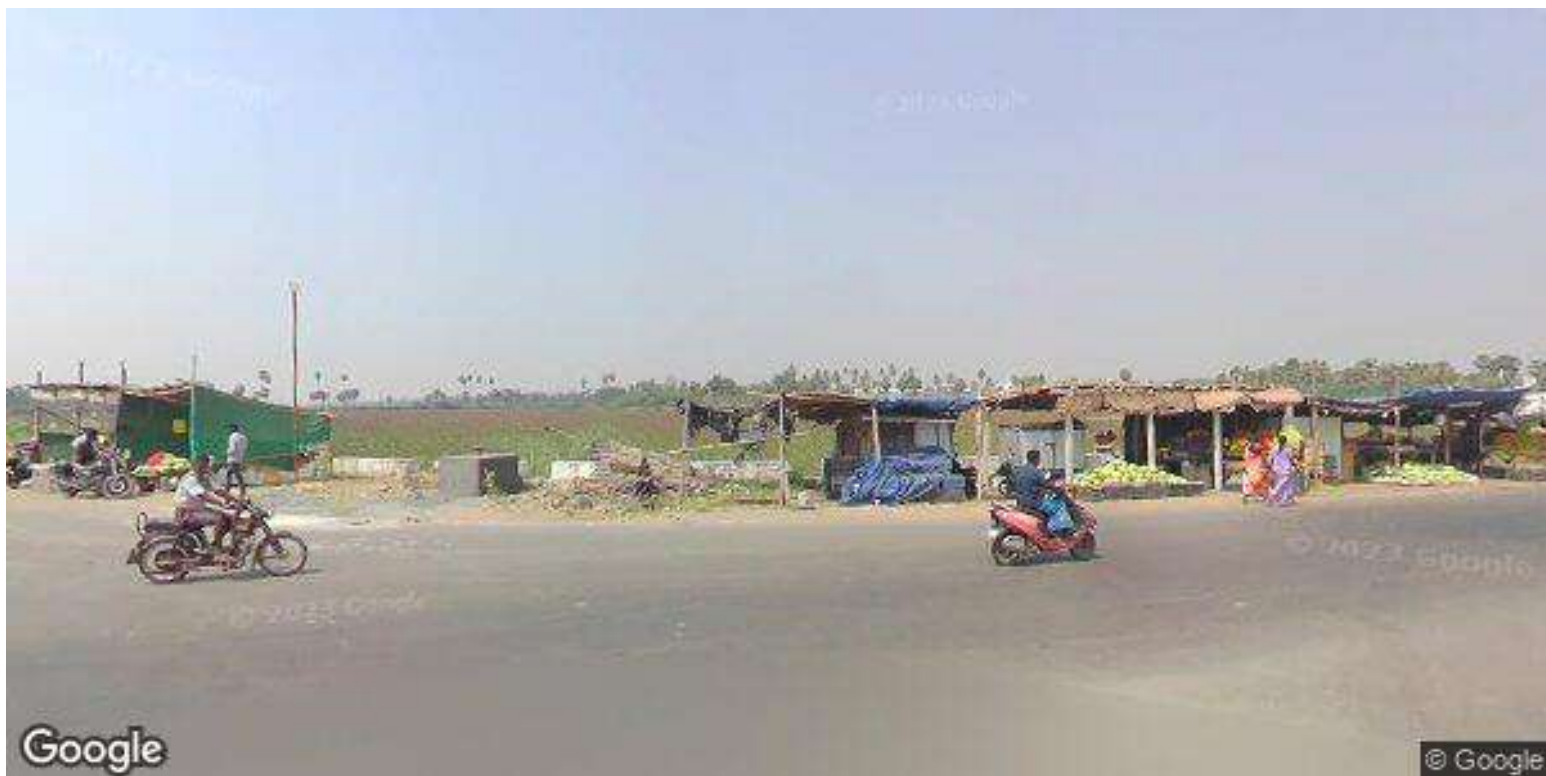
**Coordinates:** 11.68925, 77.97741

**Risk Type:** Turn

**Risk Level:** Medium

**Speed Limit:** 30 KM/Hr

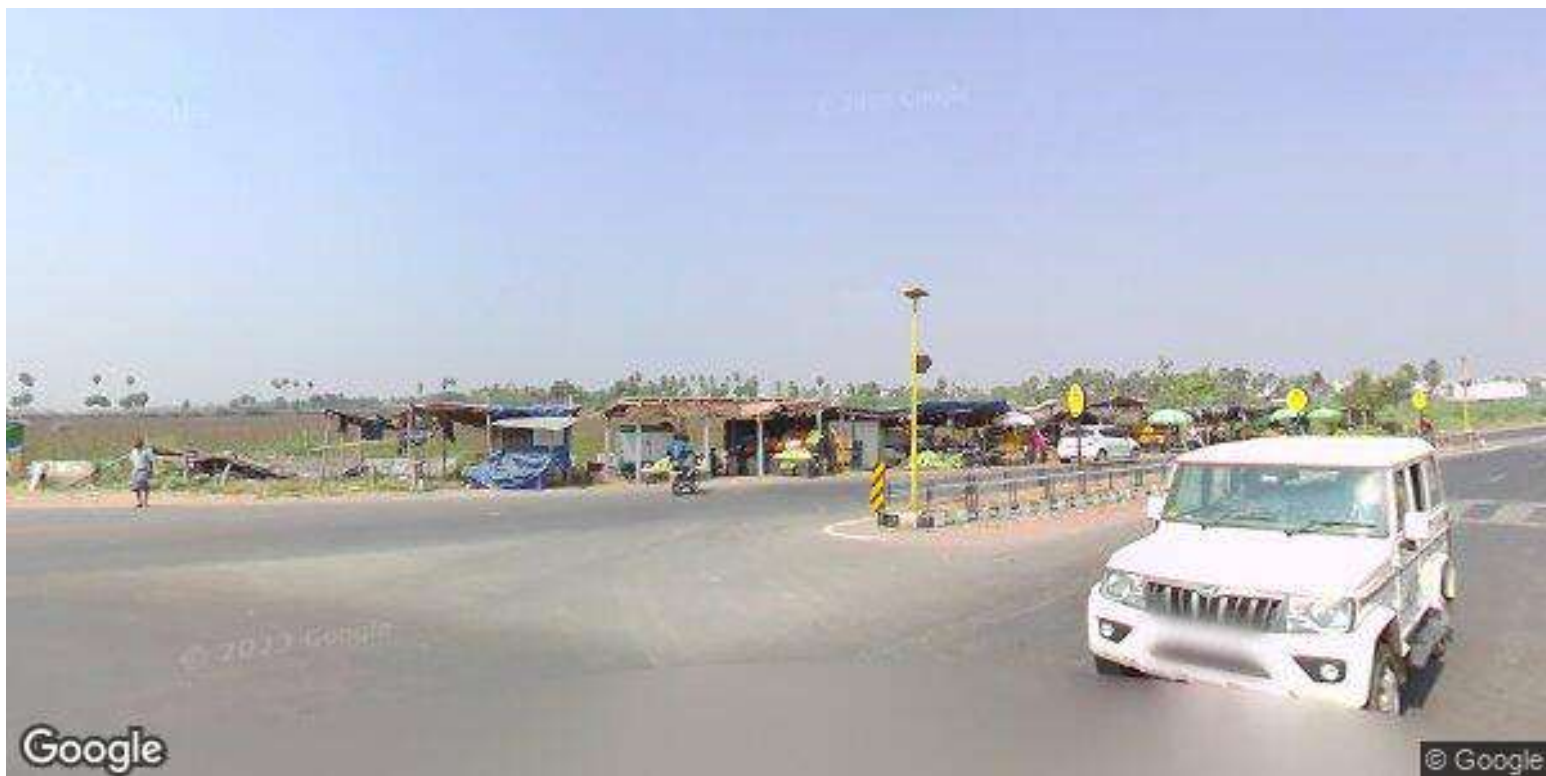
**Coordinates:** 11.68927, 77.97747

**Risk Type:** Turn

**Risk Level:** High

**Speed Limit:** 15 KM/Hr

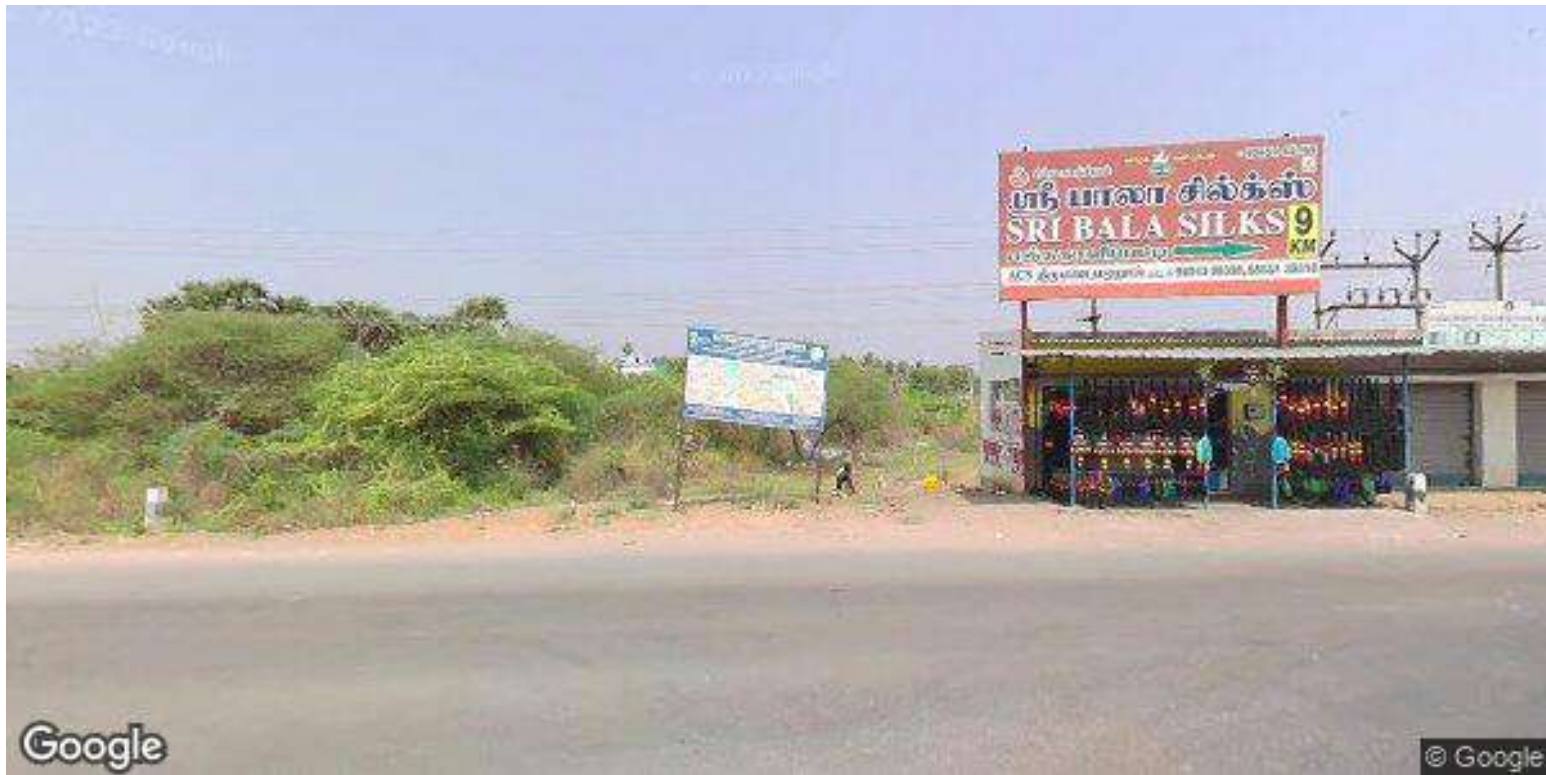
**Coordinates:** 11.70223, 77.97860

**Risk Type:** Turn

**Risk Level:** High

**Speed Limit:** 15 KM/Hr

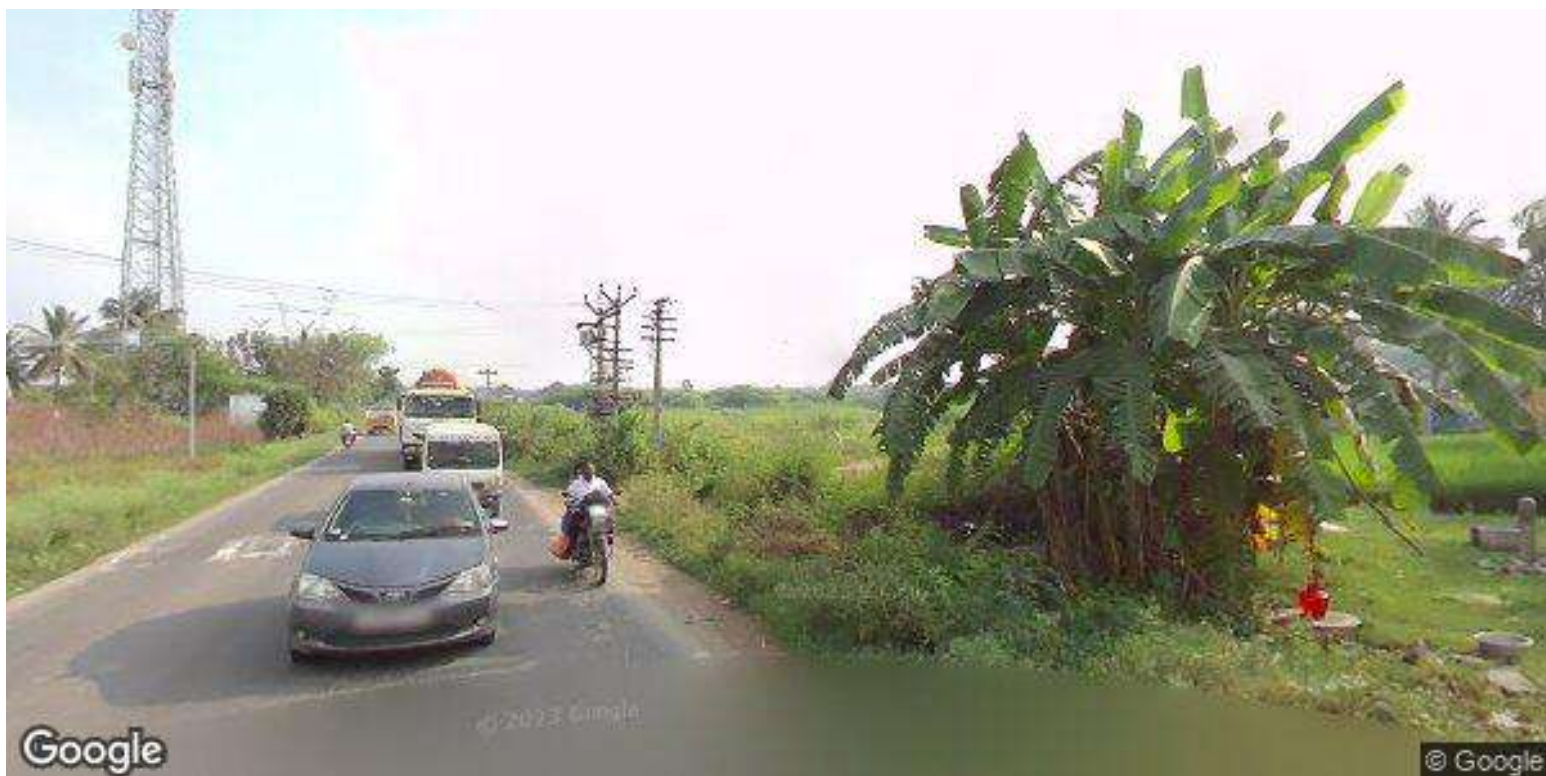
**Coordinates:** 11.71394, 77.99572

**Risk Type:** Turn

**Risk Level:** Medium

**Speed Limit:** 30 KM/Hr

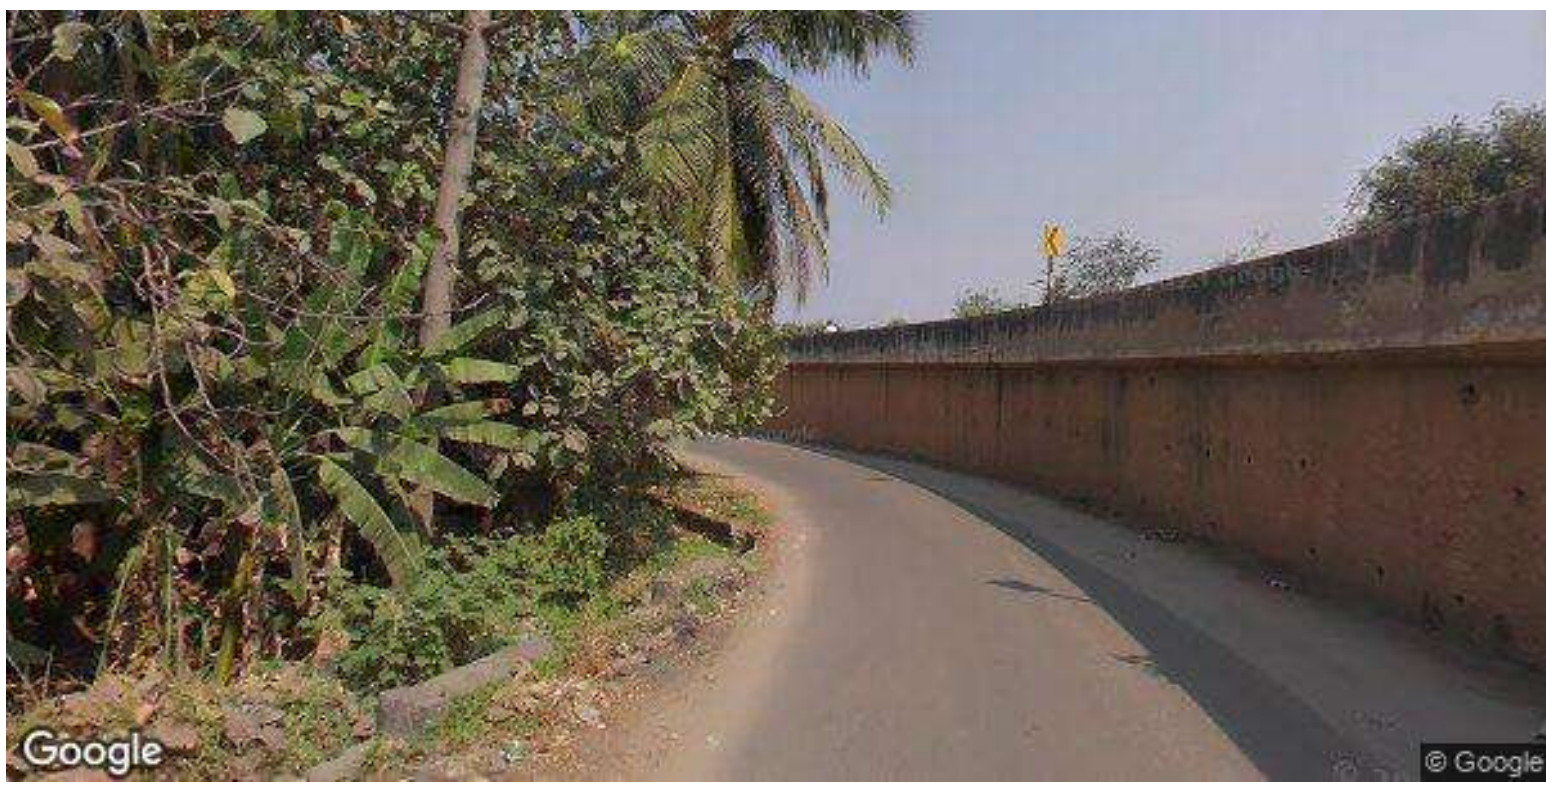
**Coordinates:** 11.73661, 78.03864

**Risk Type:** Turn

**Risk Level:** Medium

**Speed Limit:** 30 KM/Hr
