# IndianOil

## JOURNEY RISK MANAGEMENT (JRM) STUDY

### Salem Terminal TO SRI MURUGA AGENCIES

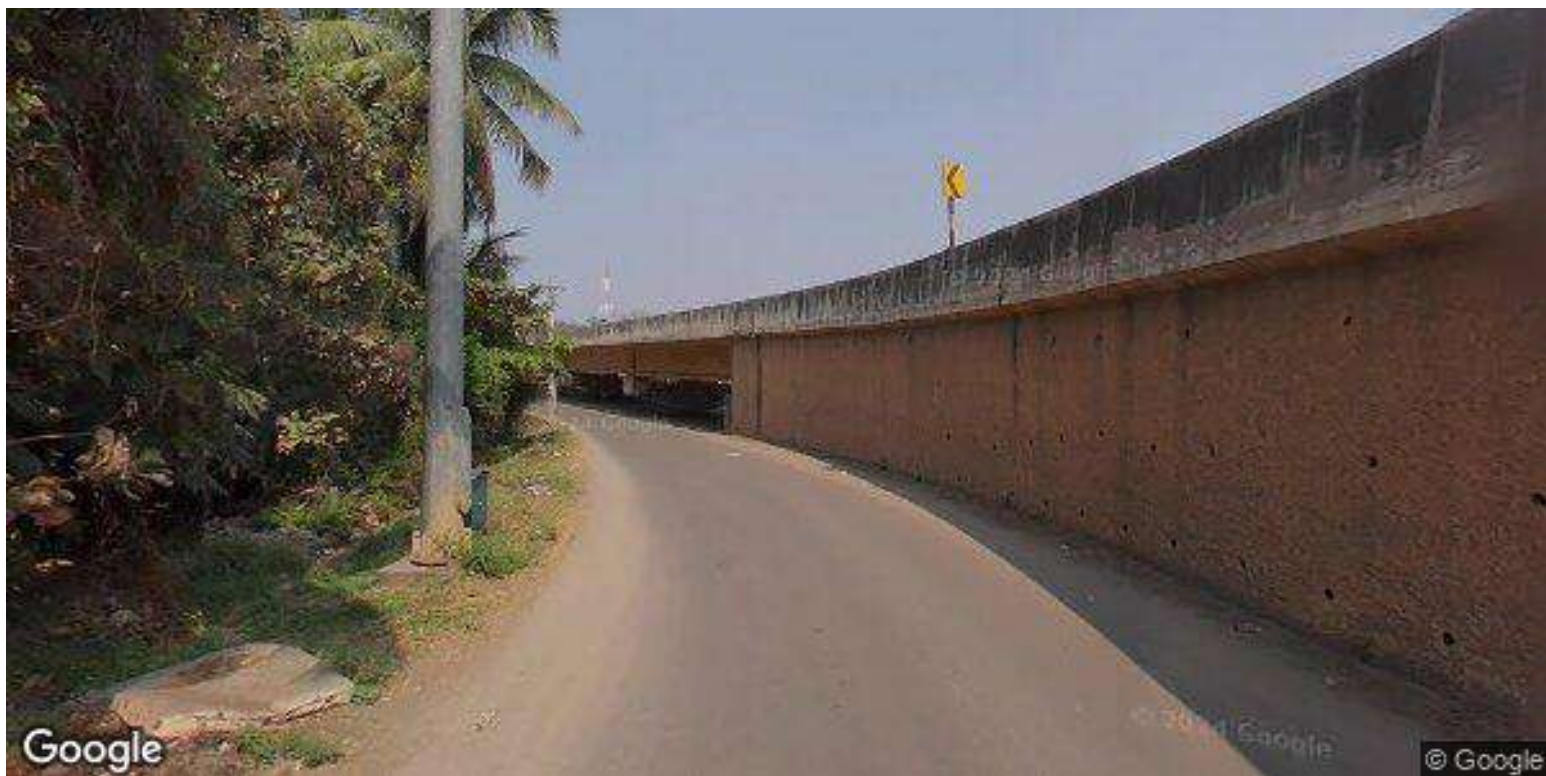
**Coordinates:** 11.73661, 78.03886

**Risk Type:** Turn

**Risk Level:** Medium

**Speed Limit:** 30 KM/Hr

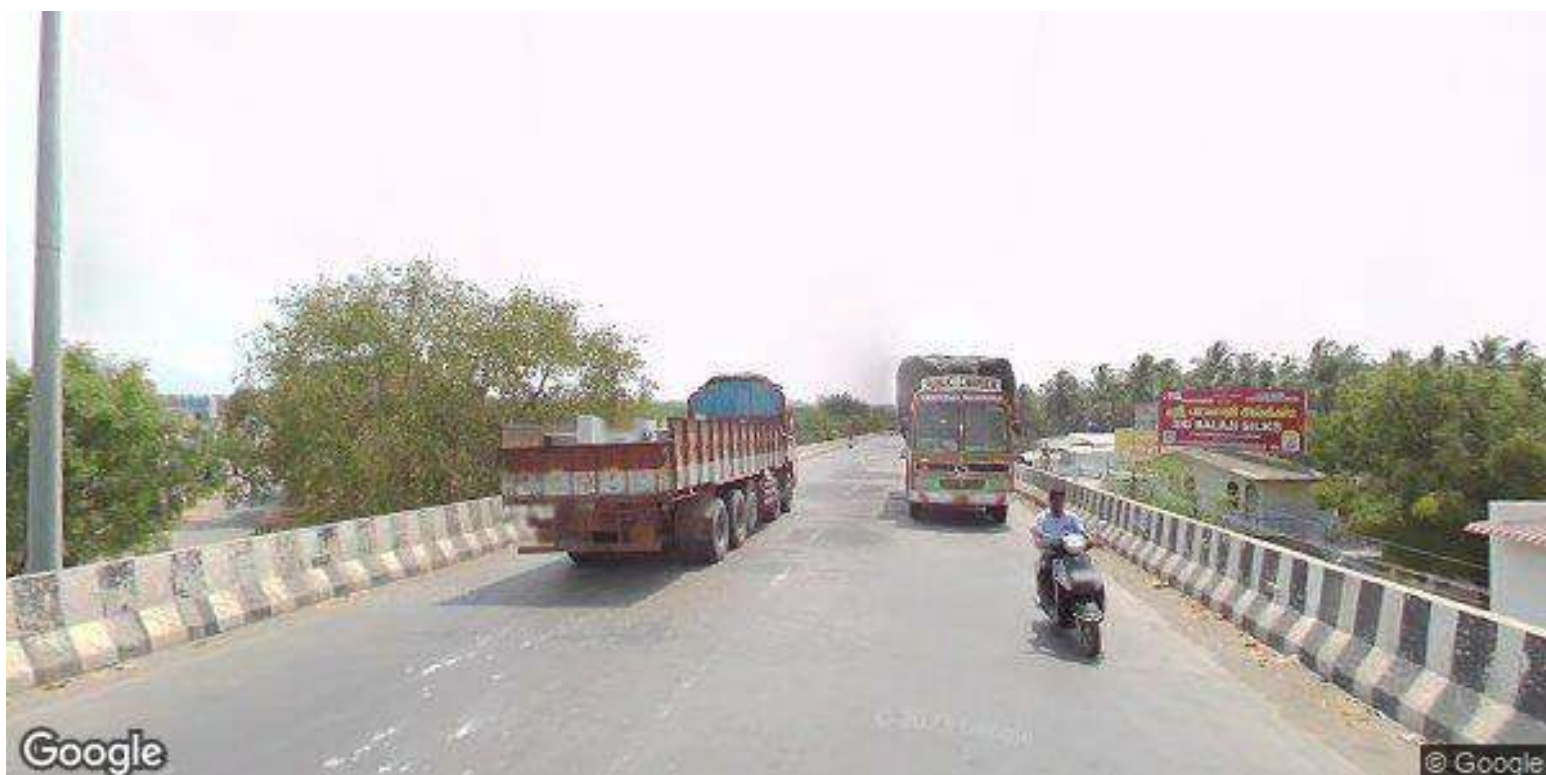
**Coordinates: 11.73772, 78.04016**

**Risk Type: Turn**

**Risk Level: High**

**Speed Limit: 15 KM/Hr**

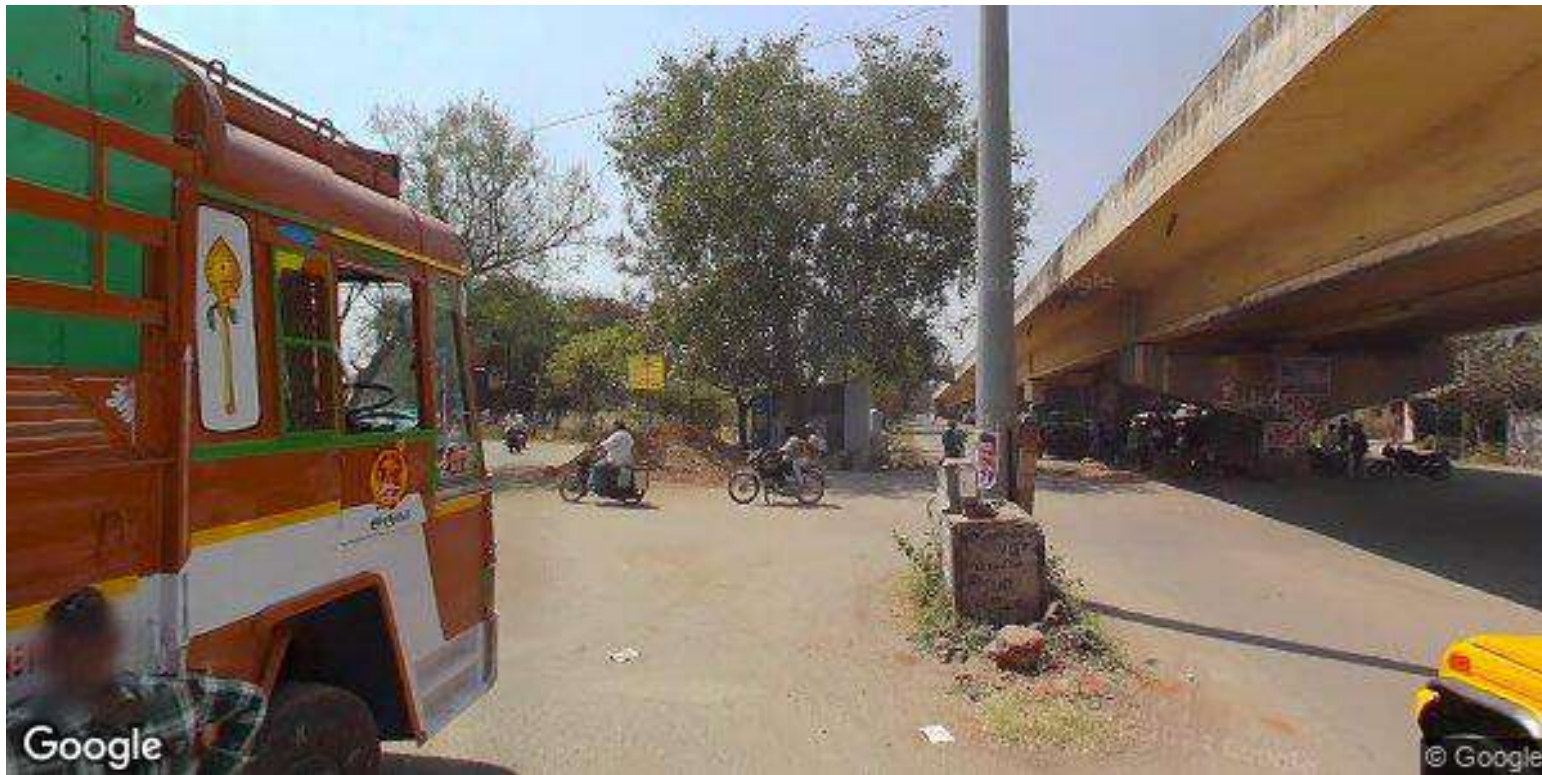
**Coordinates: 11.73763, 78.04027**

**Risk Type: Blind Spot**

**Risk Level: Blind Spot**

**Speed Limit: 10 KM/Hr**

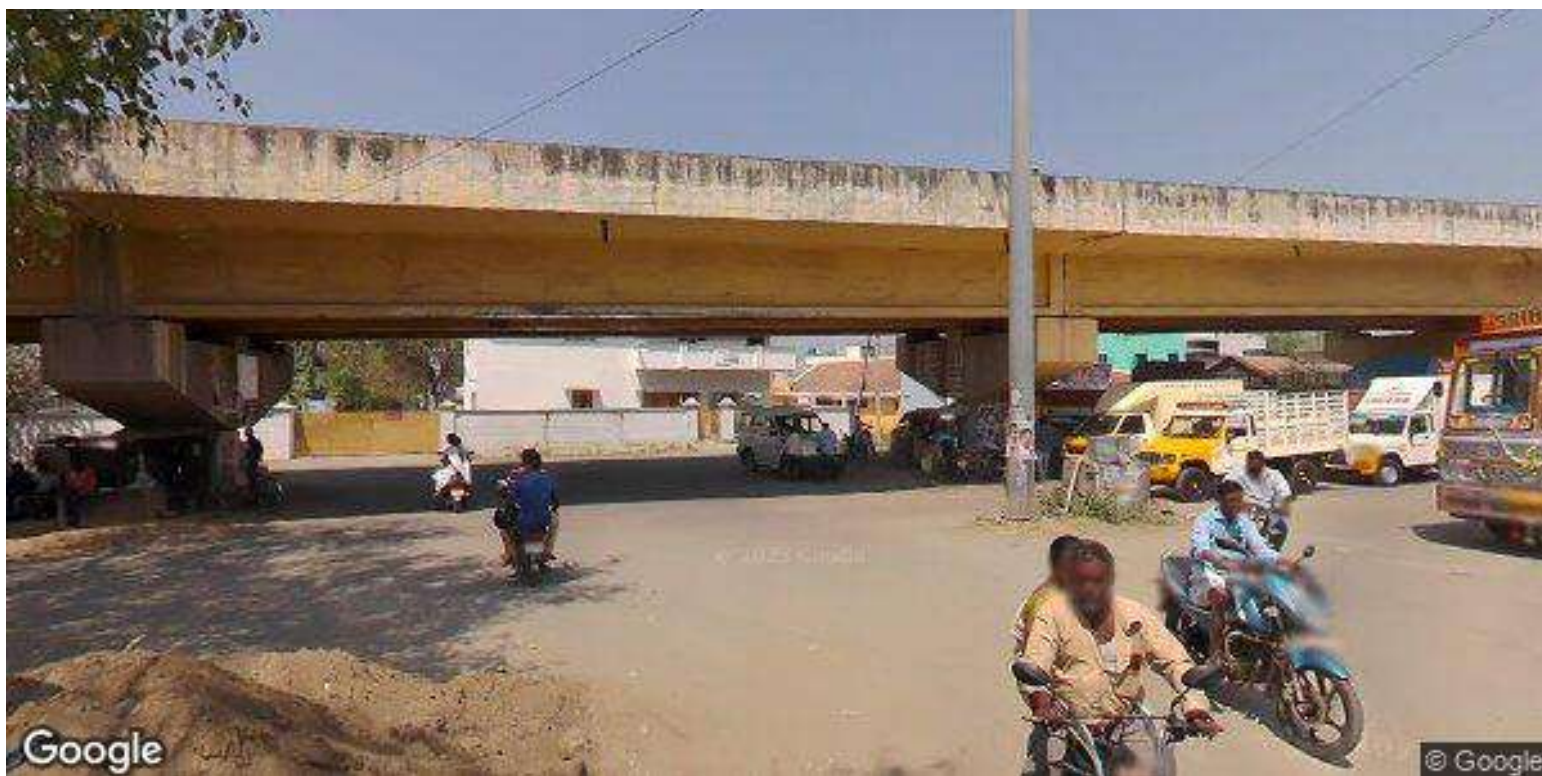
**Coordinates: 11.73751, 78.04016**

**Risk Type: Blind Spot**

**Risk Level: Blind Spot**

**Speed Limit: 10 KM/Hr**

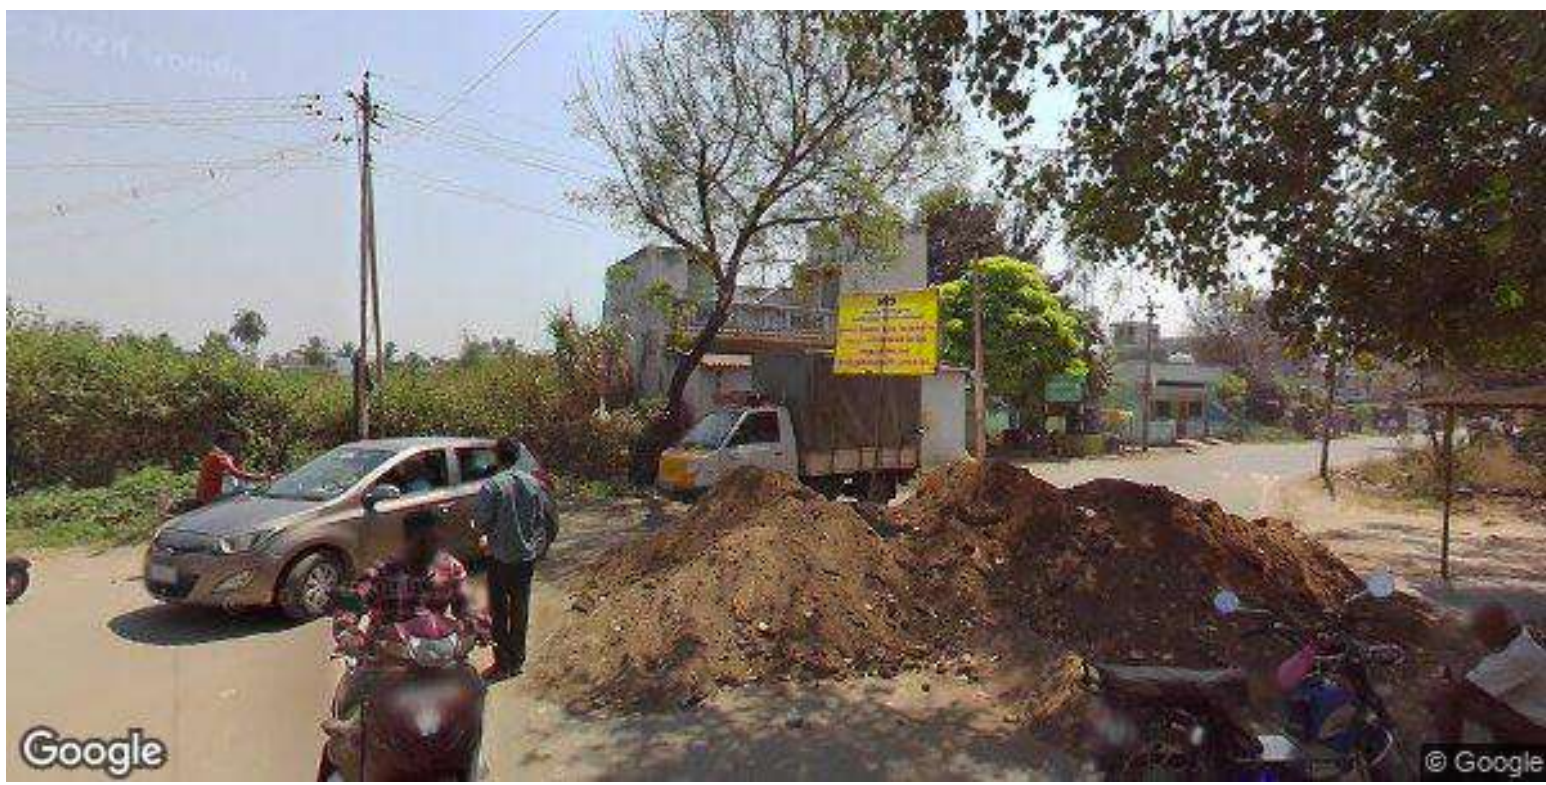
**Coordinates:** 11.73756, 78.04012

**Risk Type:** Blind Spot

**Risk Level:** Blind Spot

**Speed Limit:** 10 KM/Hr

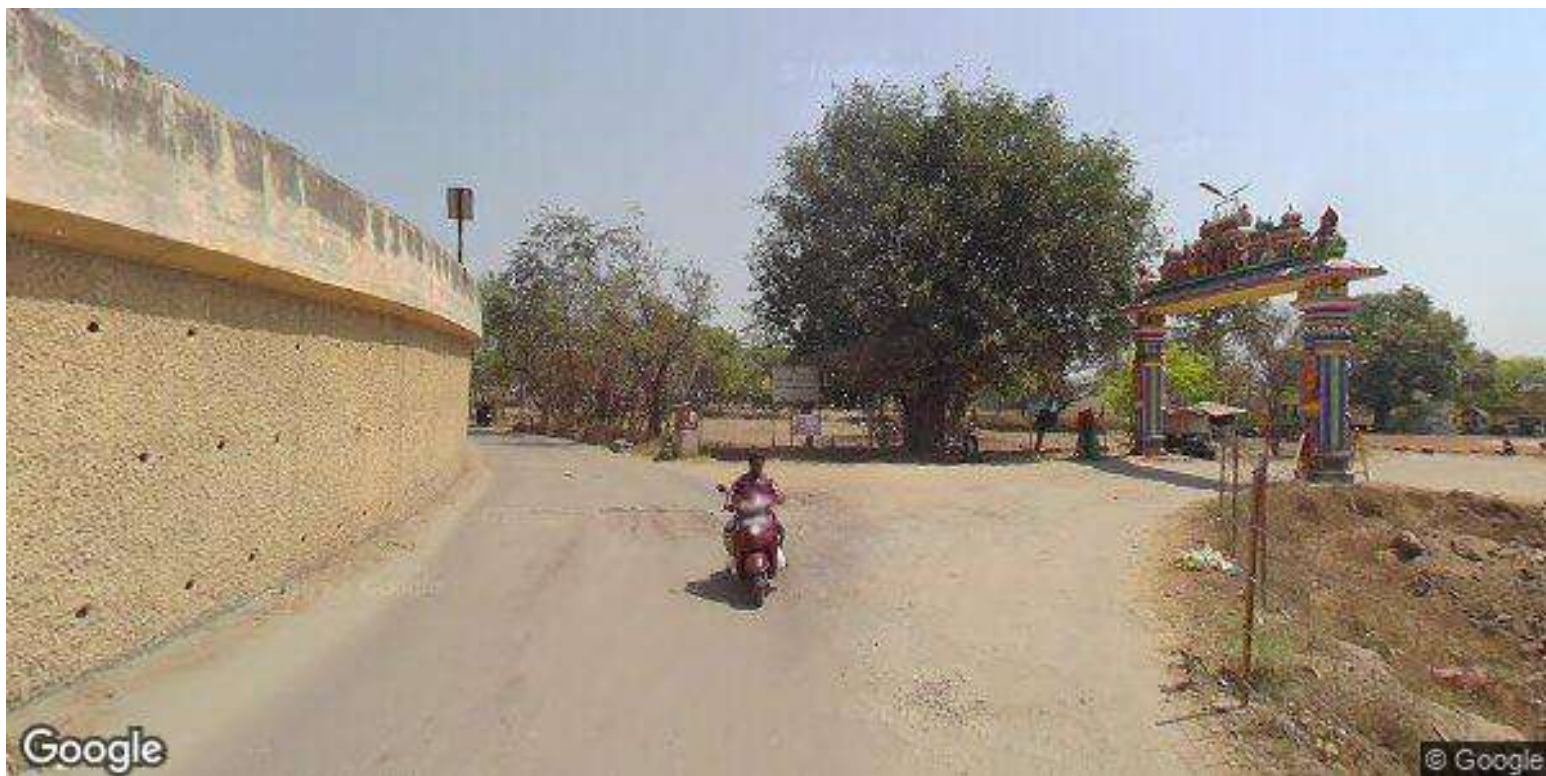
**Coordinates:** 11.73643, 78.03869

**Risk Type:** Turn

**Risk Level:** Medium

**Speed Limit:** 30 KM/Hr
