# IndianOil

## JOURNEY RISK MANAGEMENT (JRM) STUDY

### Salem Terminal to SHREE RENGGA AGENCY

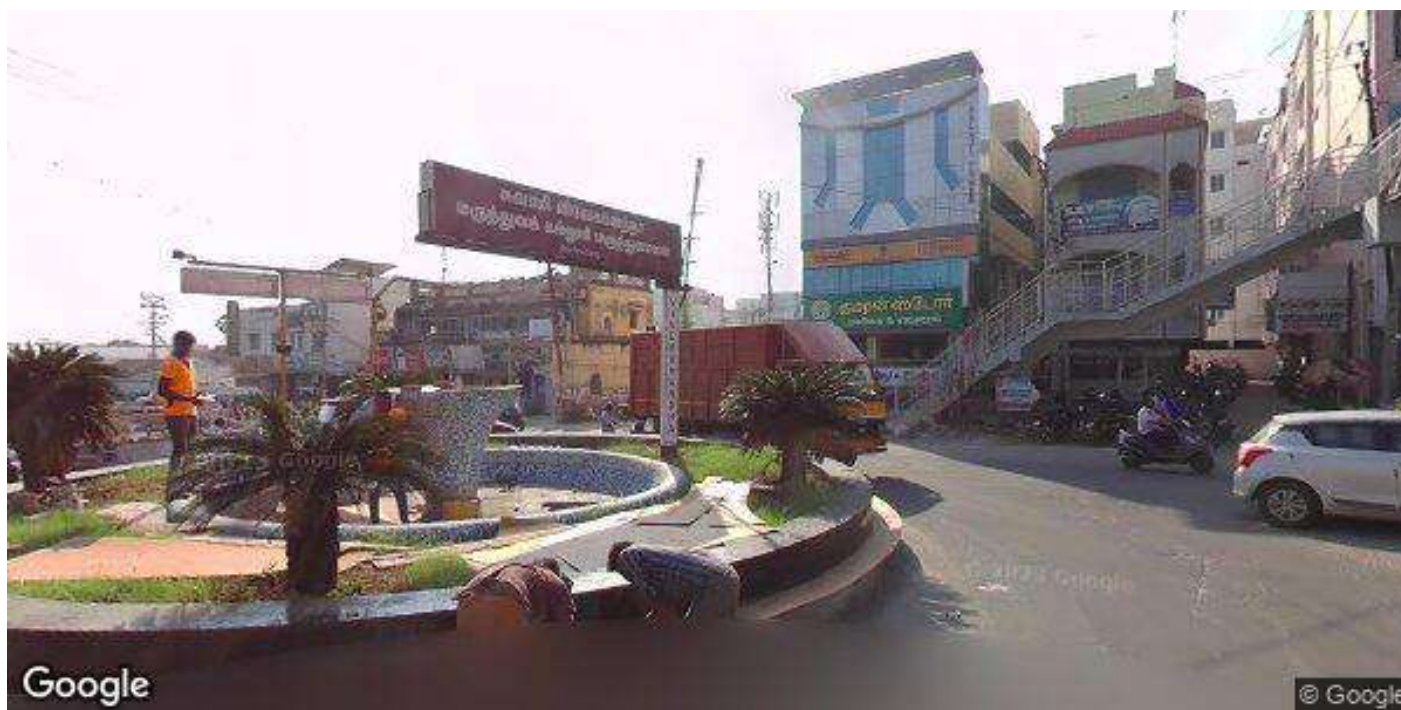
**Coordinates:** 11.38395, 77.89480

**Risk Type:** Roundabout

**Risk Level:** High

**Speed Limit:** 15 KM/Hr

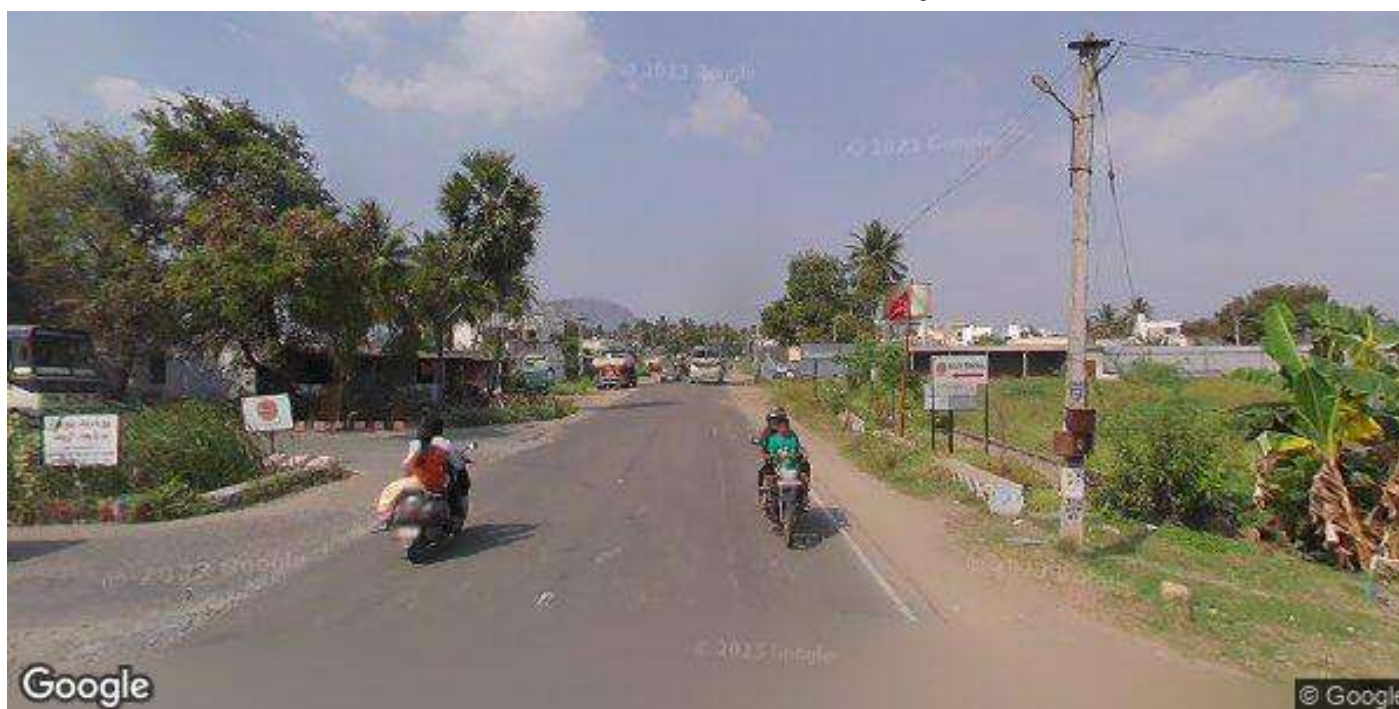
**Risk Type:** Turn  
**Risk Level:** High  
**Speed Limit:** 15 KM/Hr  
**Coordinates:** 11.44019, 77.87547

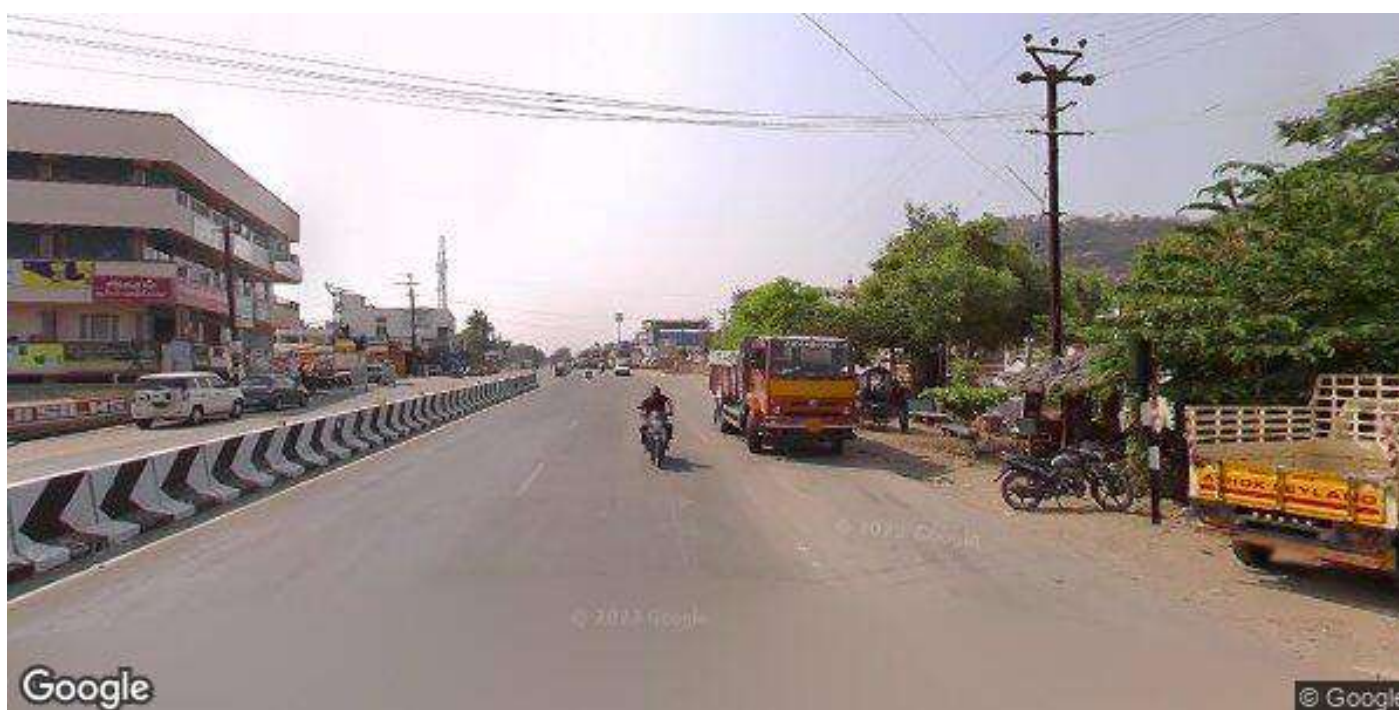
**Risk Type:** Turn  
**Risk Level:** Medium  
**Speed Limit:** 30 KM/Hr  
**Coordinates:** 11.39685, 77.88861

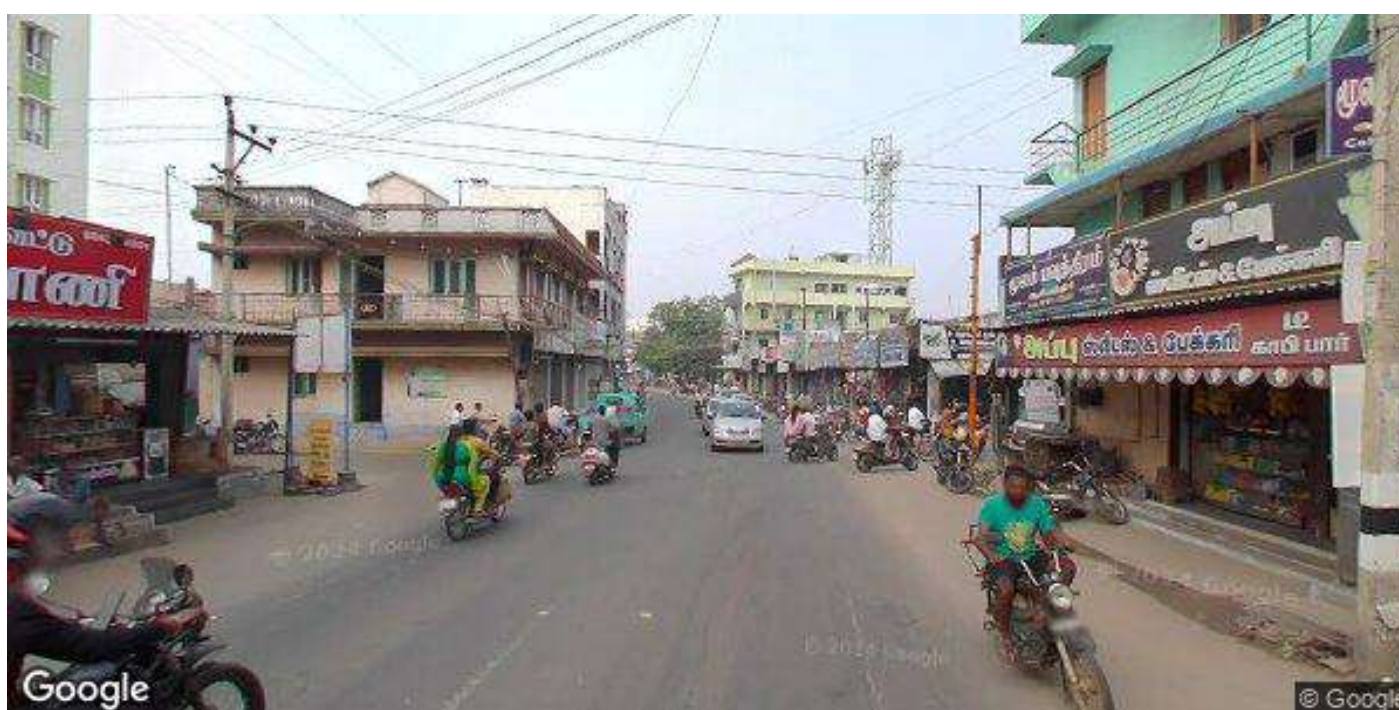
**Risk Type:** Turn  
**Risk Level:** Medium  
**Speed Limit:** 30 KM/Hr  
**Coordinates:** 11.38376, 77.89914

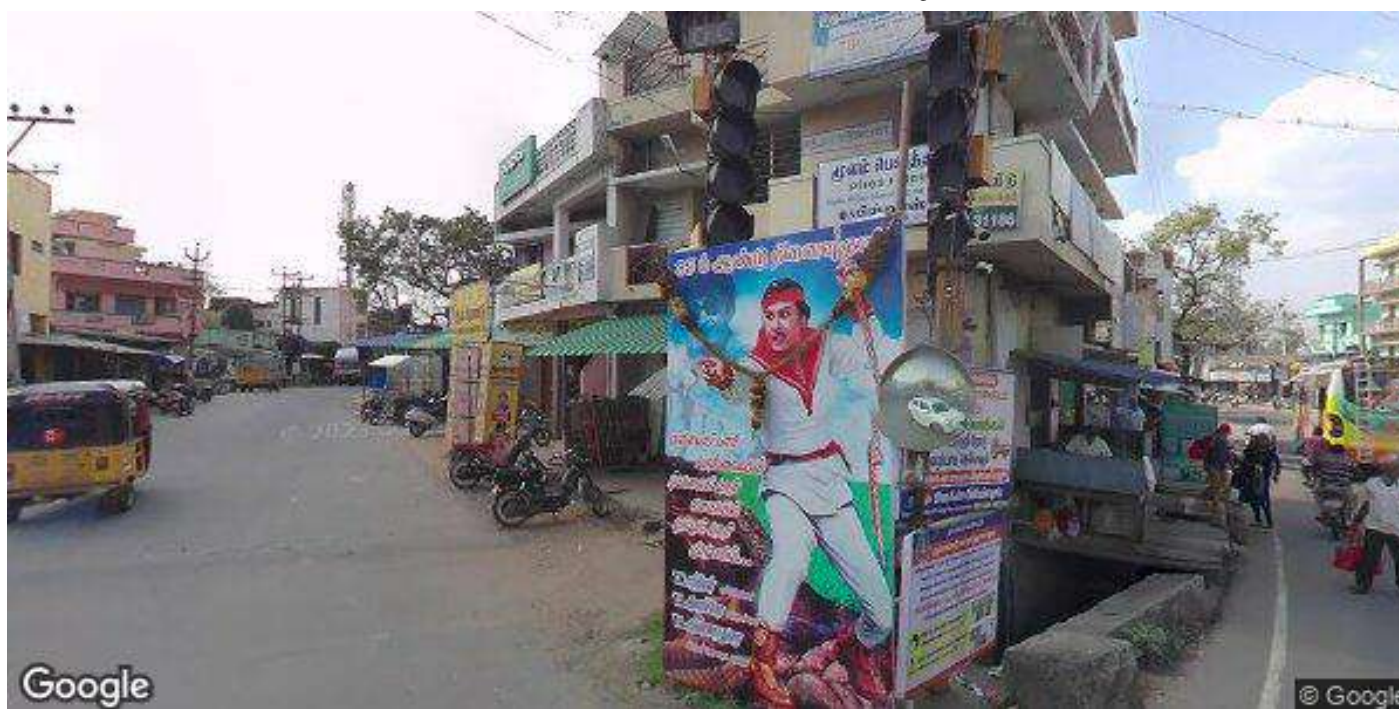
**Risk Type:** Turn  
**Risk Level:** Medium  
**Speed Limit:** 30 KM/Hr  
**Coordinates:** 11.38342, 77.89975

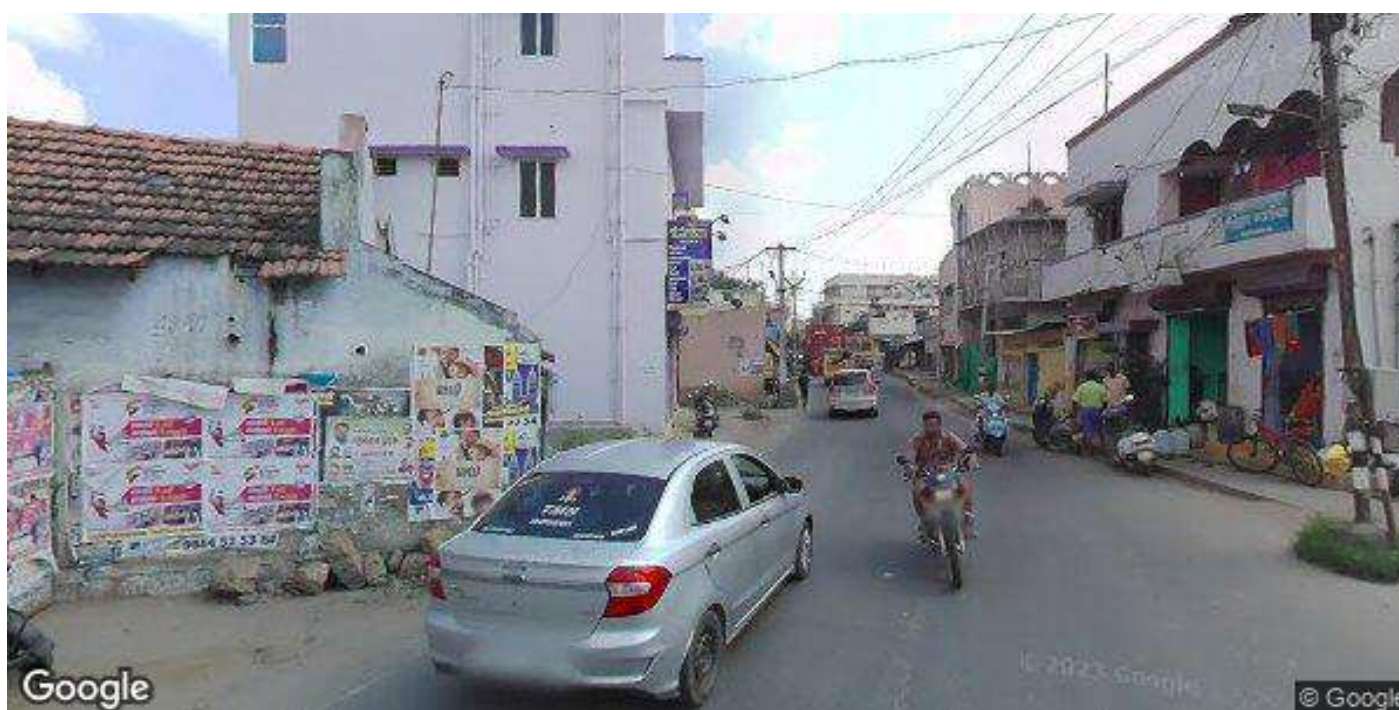
**Risk Type:** Turn  
**Risk Level:** Medium  
**Speed Limit:** 30 KM/Hr  
**Coordinates:** 11.38295, 77.90001

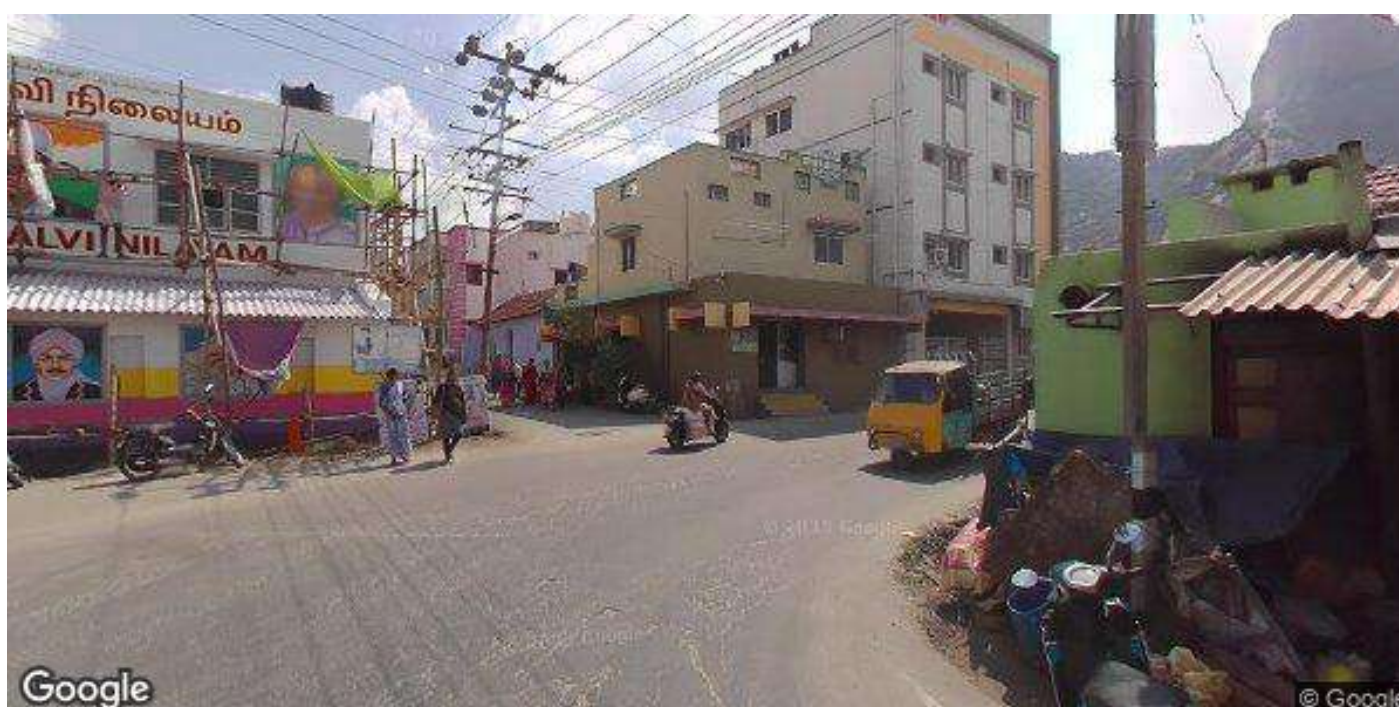
**Risk Type:** Turn  
**Risk Level:** High  
**Speed Limit:** 15 KM/Hr  
**Coordinates:** 11.38186, 77.90258

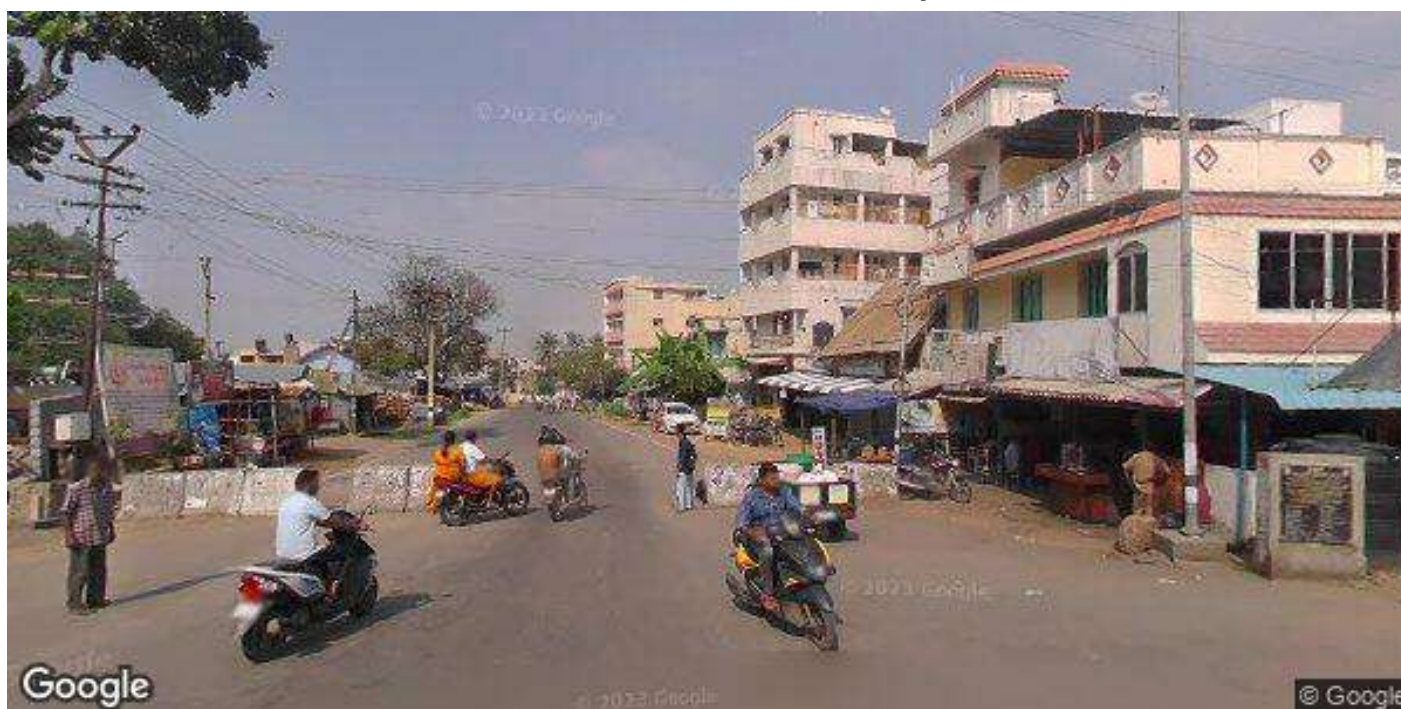
**Risk Type:** Blind Spot  
**Risk Level:** Blind Spot  
**Speed Limit:** 10 KM/Hr  
**Coordinates:** 11.37841, 77.90140

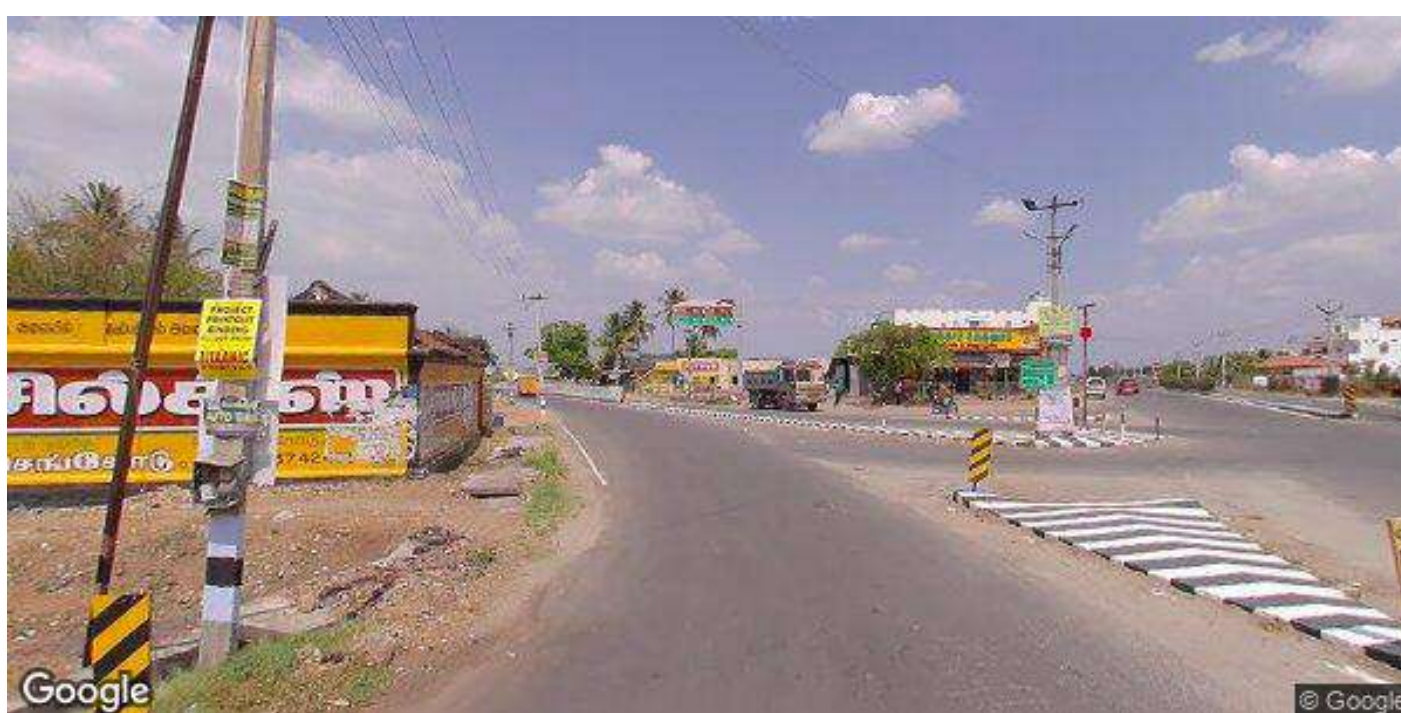
**Risk Type:** Turn  
**Risk Level:** Medium  
**Speed Limit:** 30 KM/Hr  
**Coordinates:** 11.36745, 77.93951

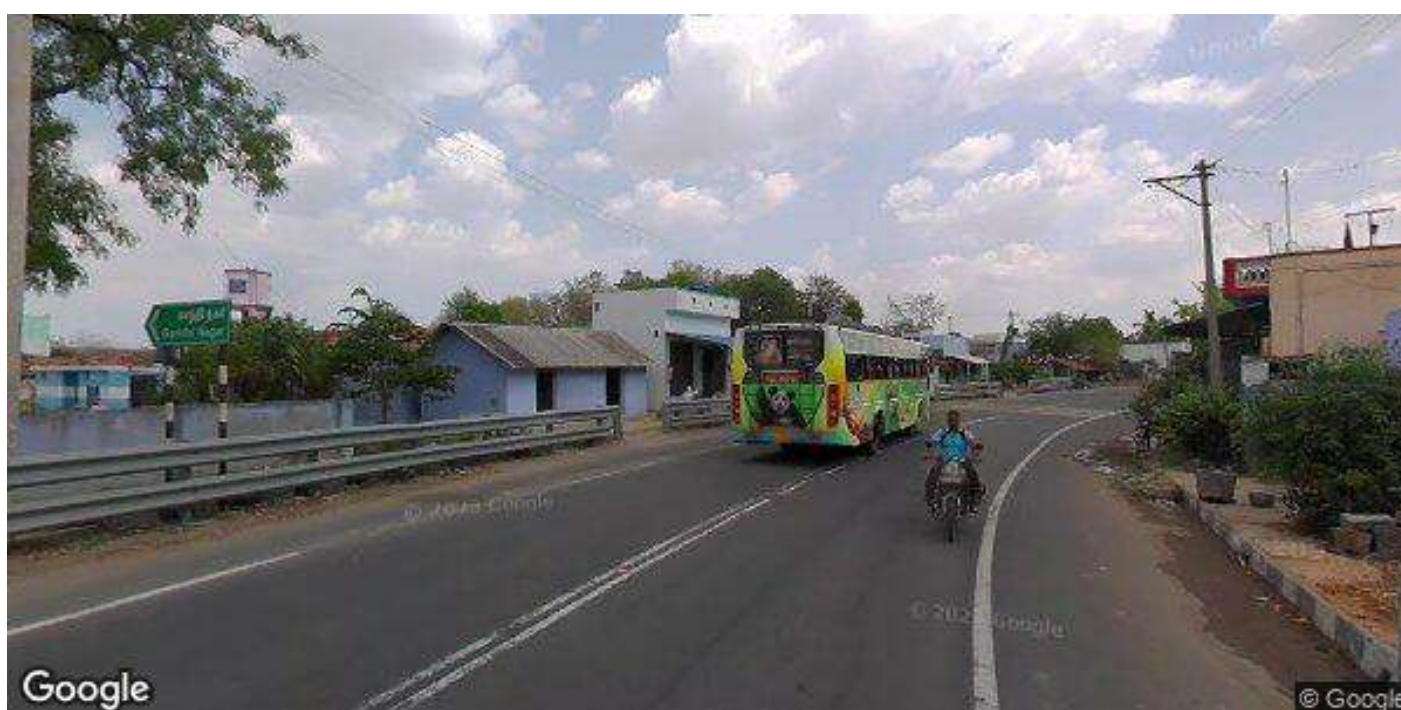
**Risk Type:** Turn  
**Risk Level:** Medium  
**Speed Limit:** 30 KM/Hr  
**Coordinates:** 11.41354, 78.08075

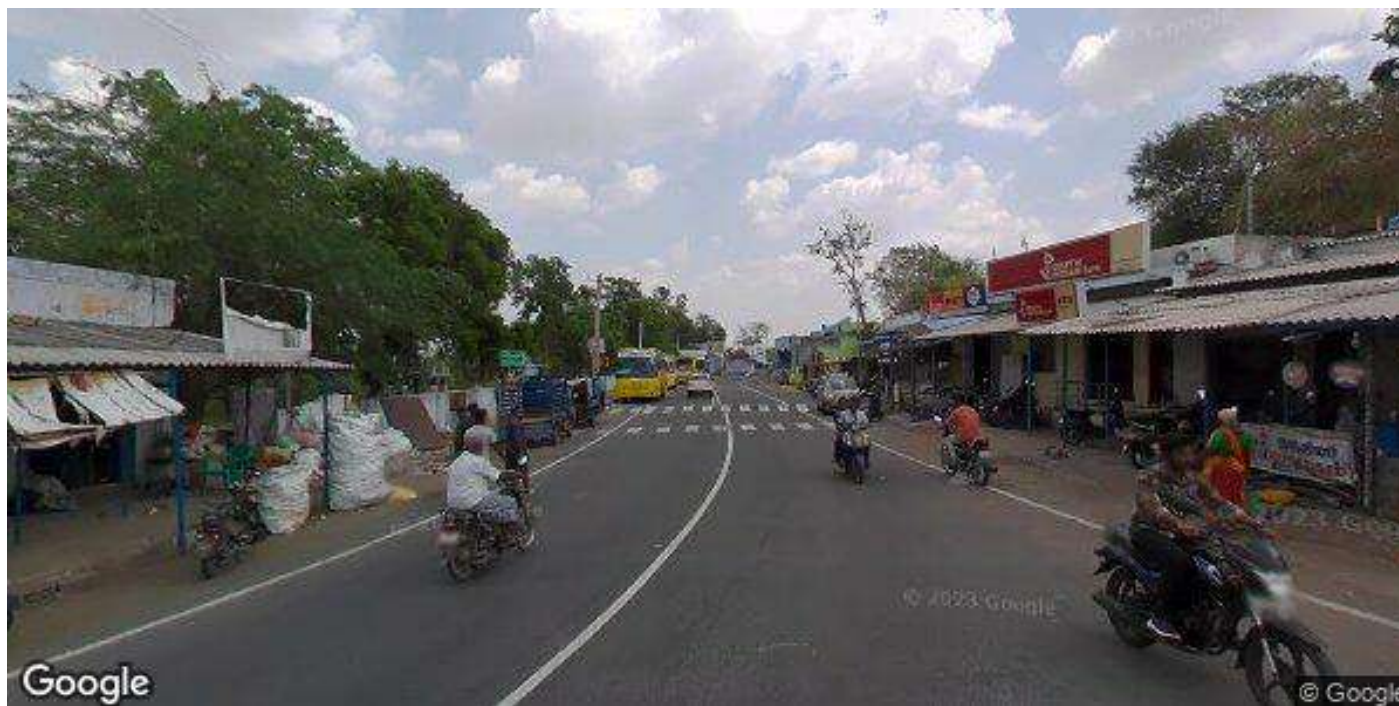
**Risk Type:** Turn  
**Risk Level:** High  
**Speed Limit:** 15 KM/Hr  
**Coordinates:** 11.41447, 78.08063

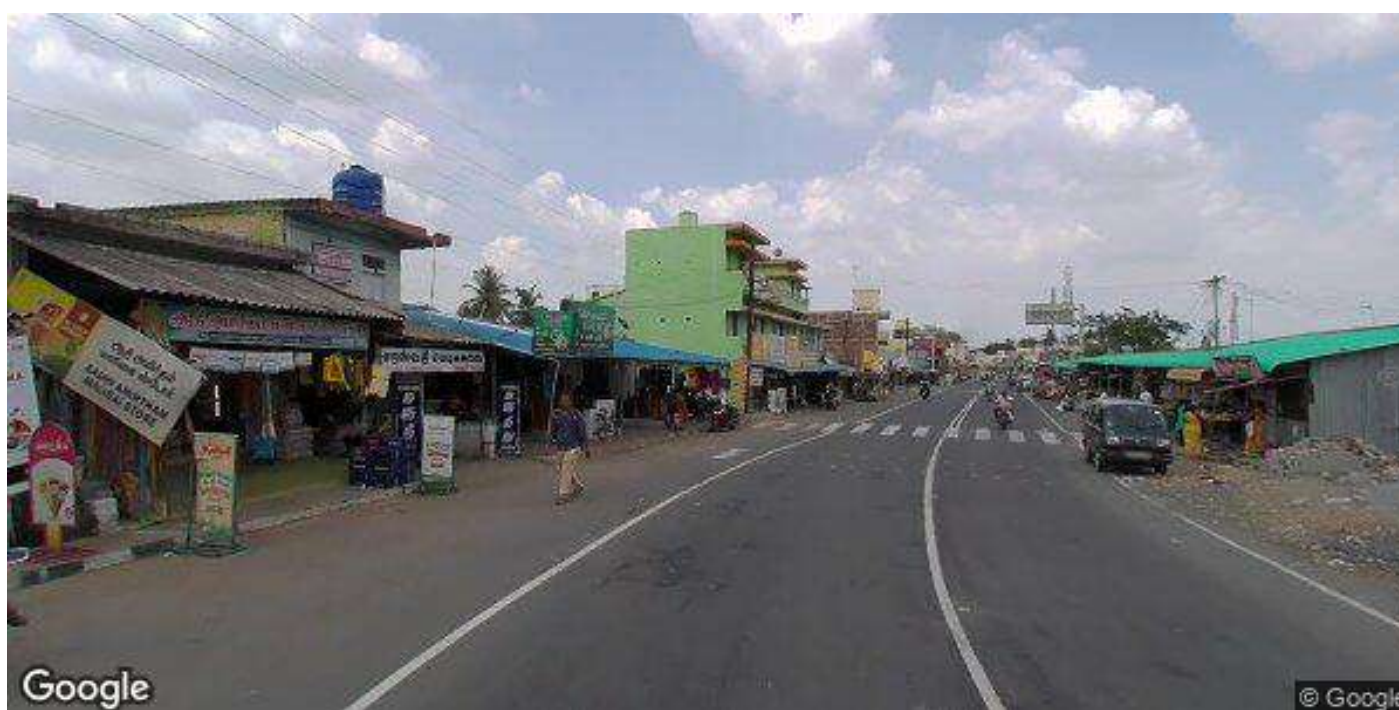
**Risk Type:** Turn  
**Risk Level:** High  
**Speed Limit:** 15 KM/Hr  
**Coordinates:** 11.41475, 78.08087

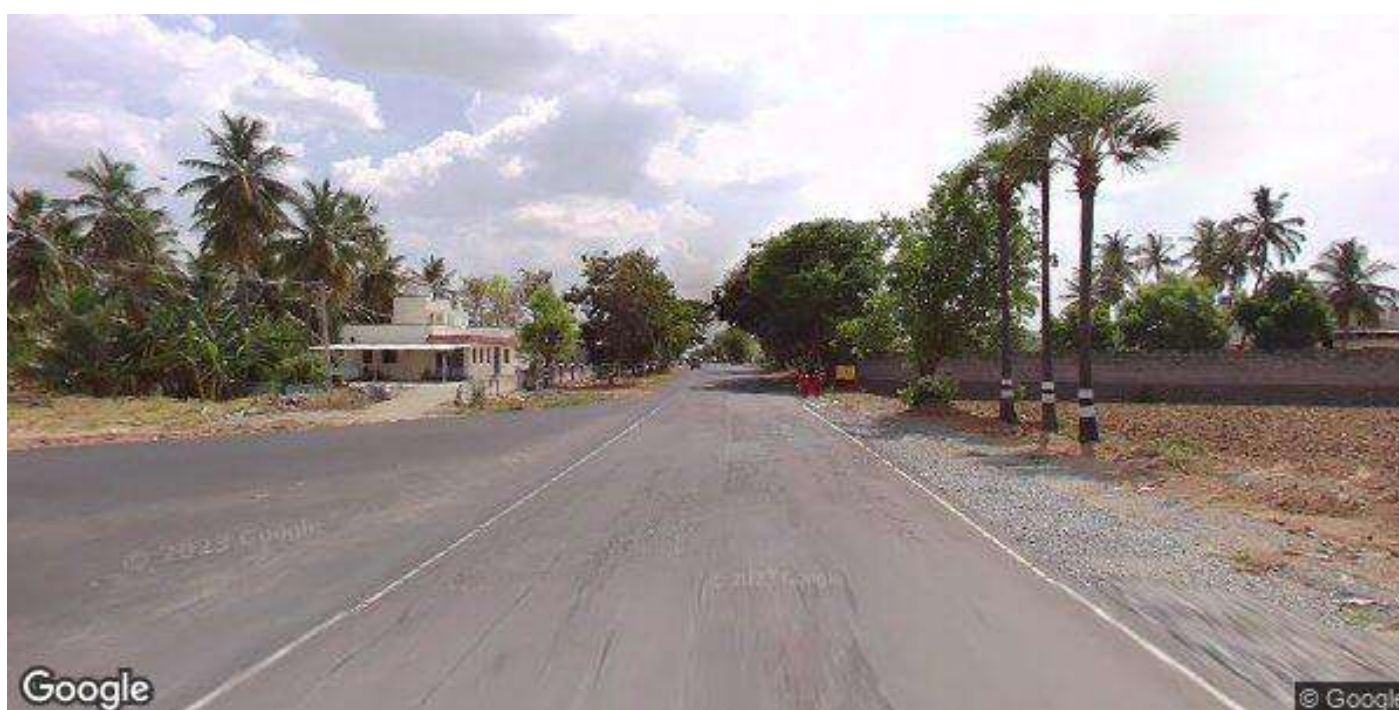
**Risk Type:** Turn  
**Risk Level:** High  
**Speed Limit:** 15 KM/Hr  
**Coordinates:** 11.42964, 78.11587

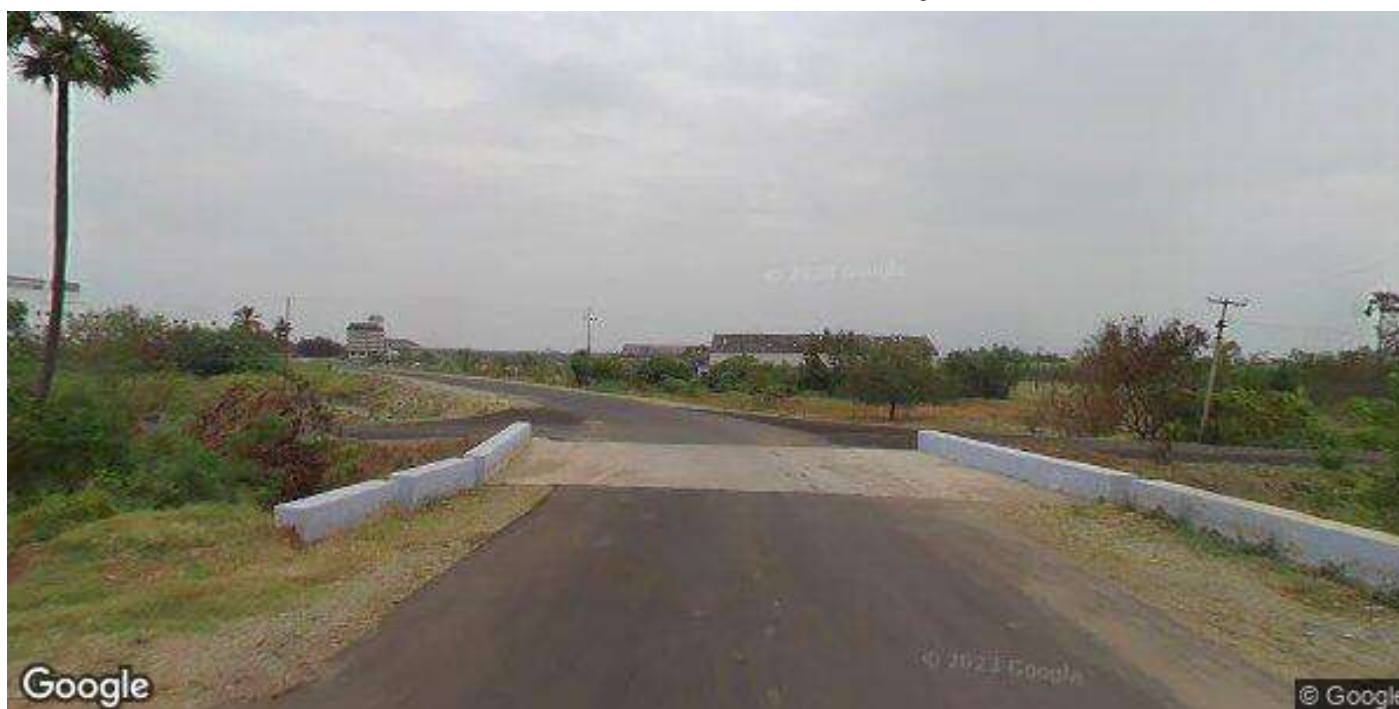
**Risk Type:** Turn  
**Risk Level:** Medium  
**Speed Limit:** 30 KM/Hr  
**Coordinates:** 11.42447, 78.15264

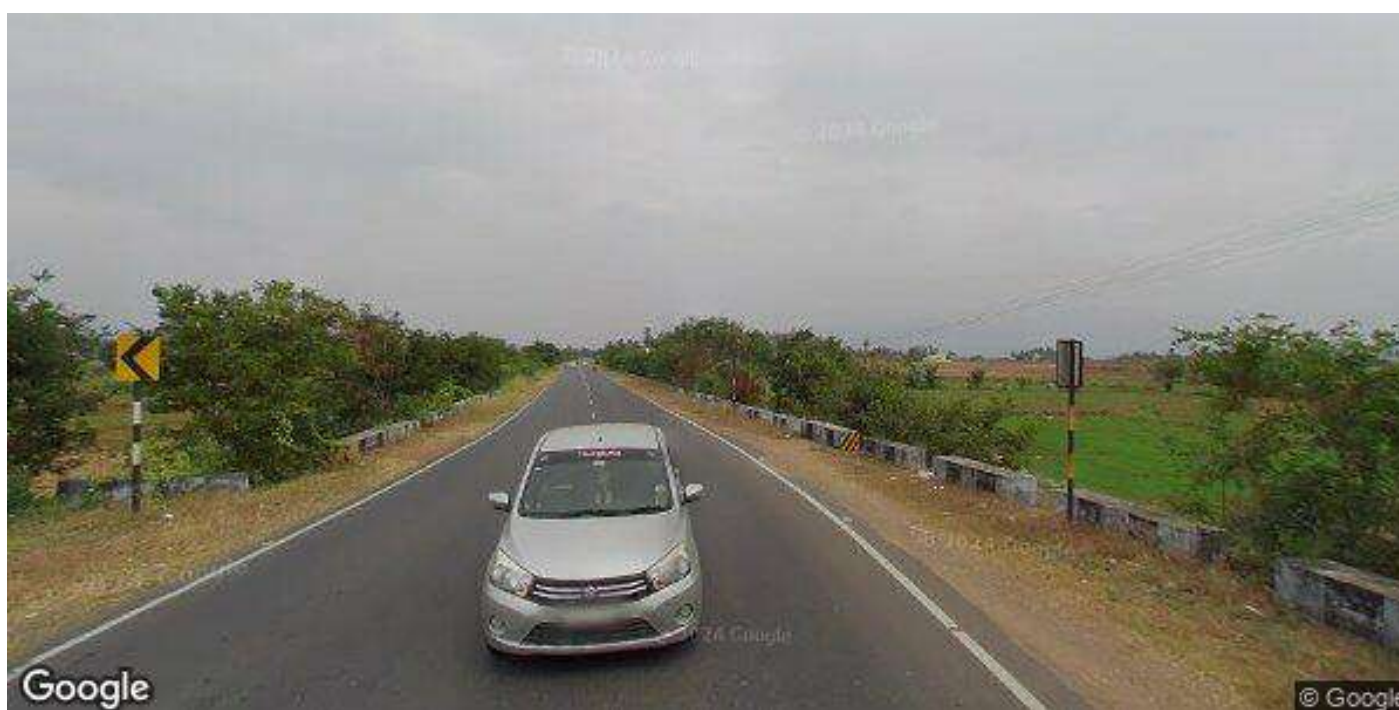
**Risk Type:** Turn  
**Risk Level:** Medium  
**Speed Limit:** 30 KM/Hr  
**Coordinates:** 11.43142, 78.18808

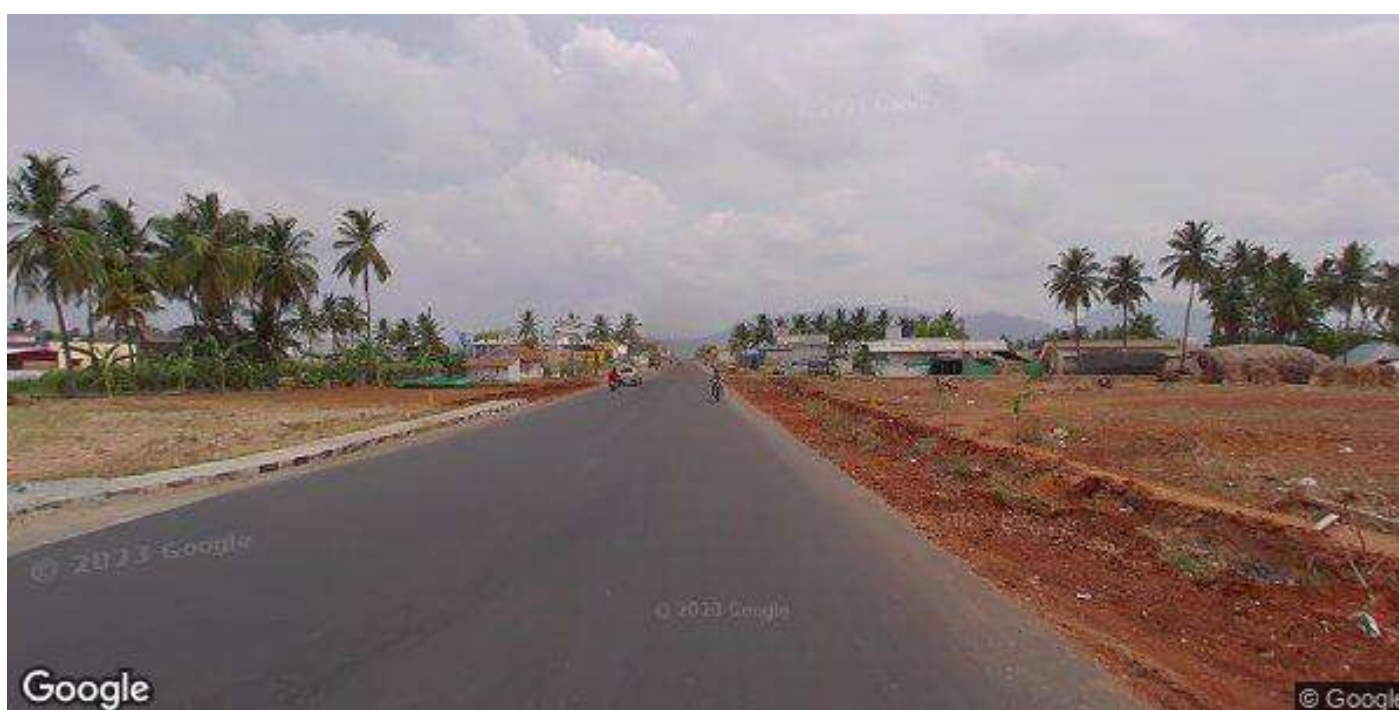
**Risk Type:** Turn  
**Risk Level:** High  
**Speed Limit:** 15 KM/Hr  
**Coordinates:** 11.43542, 78.20754

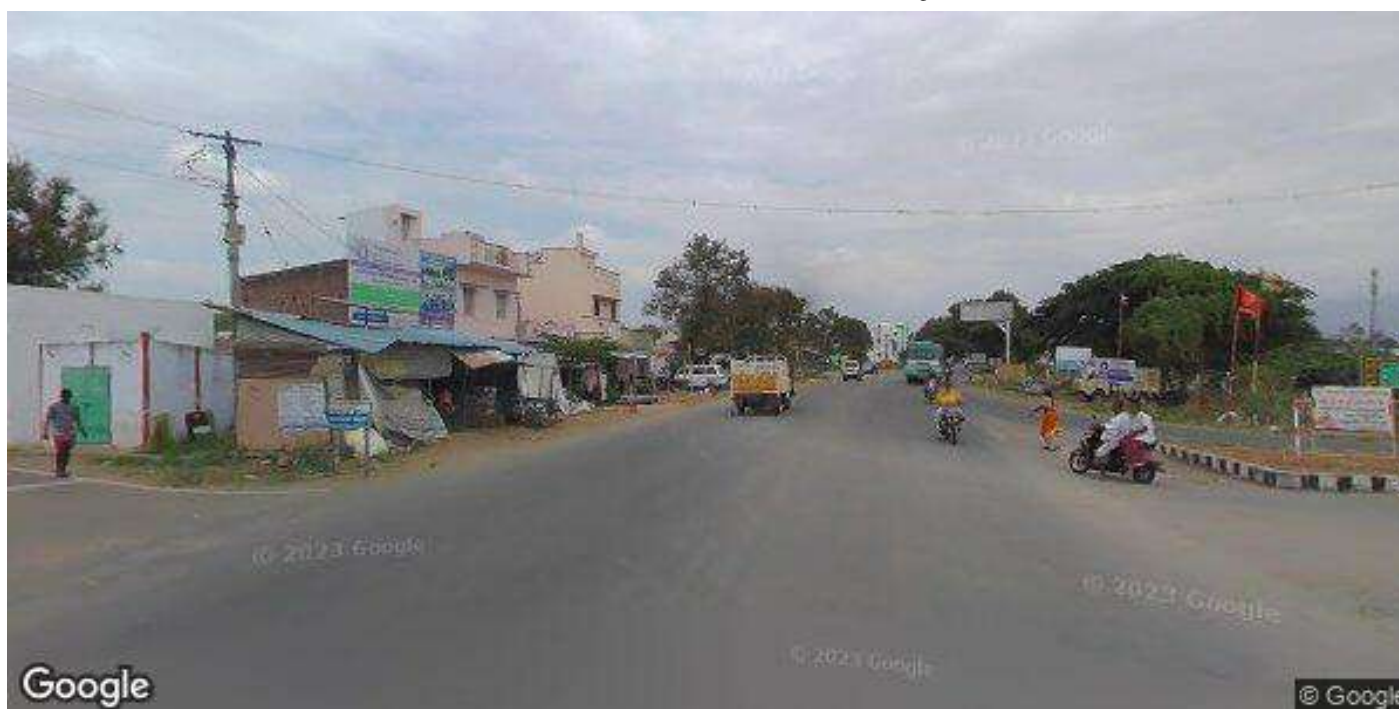
**Risk Type:** Blind Spot  
**Risk Level:** Blind Spot  
**Speed Limit:** 10 KM/Hr  
**Coordinates:** 11.45100, 78.20385

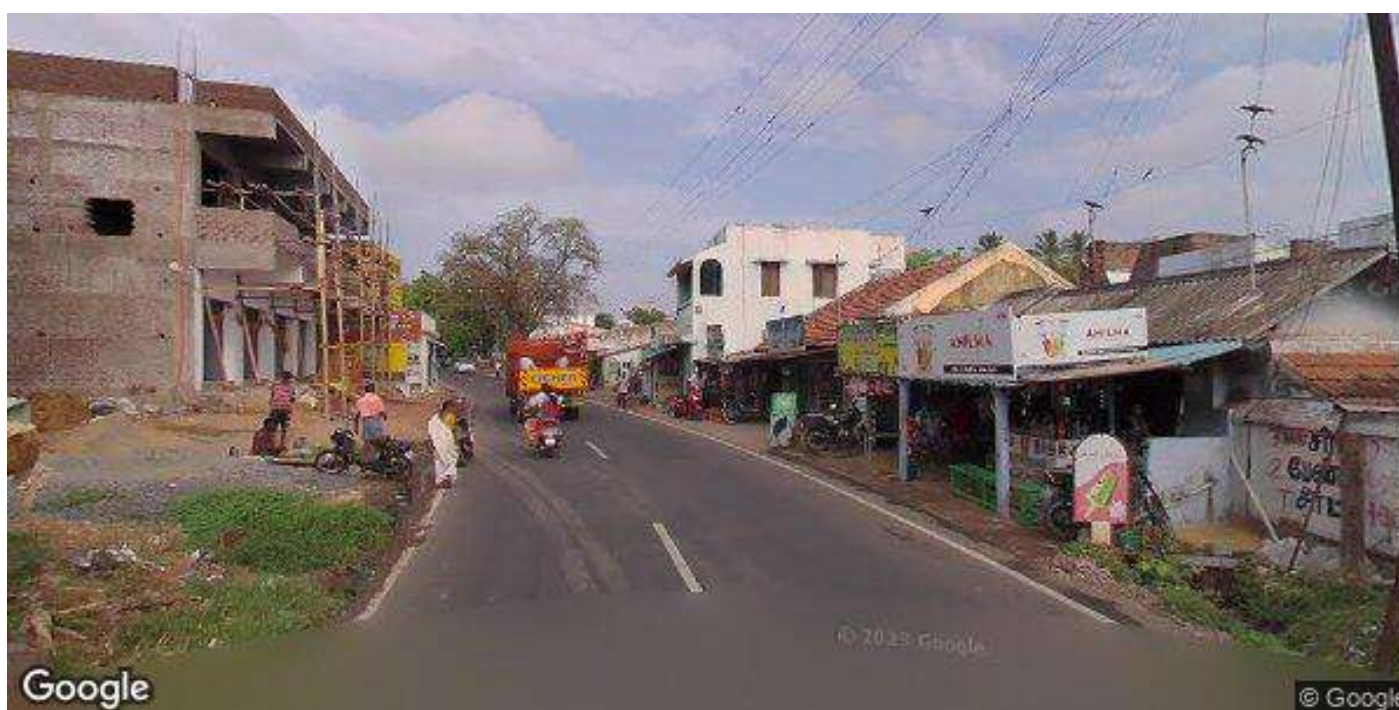
**Risk Type:** Turn  
**Risk Level:** Medium  
**Speed Limit:** 30 KM/Hr  
**Coordinates:** 11.44993, 78.22152

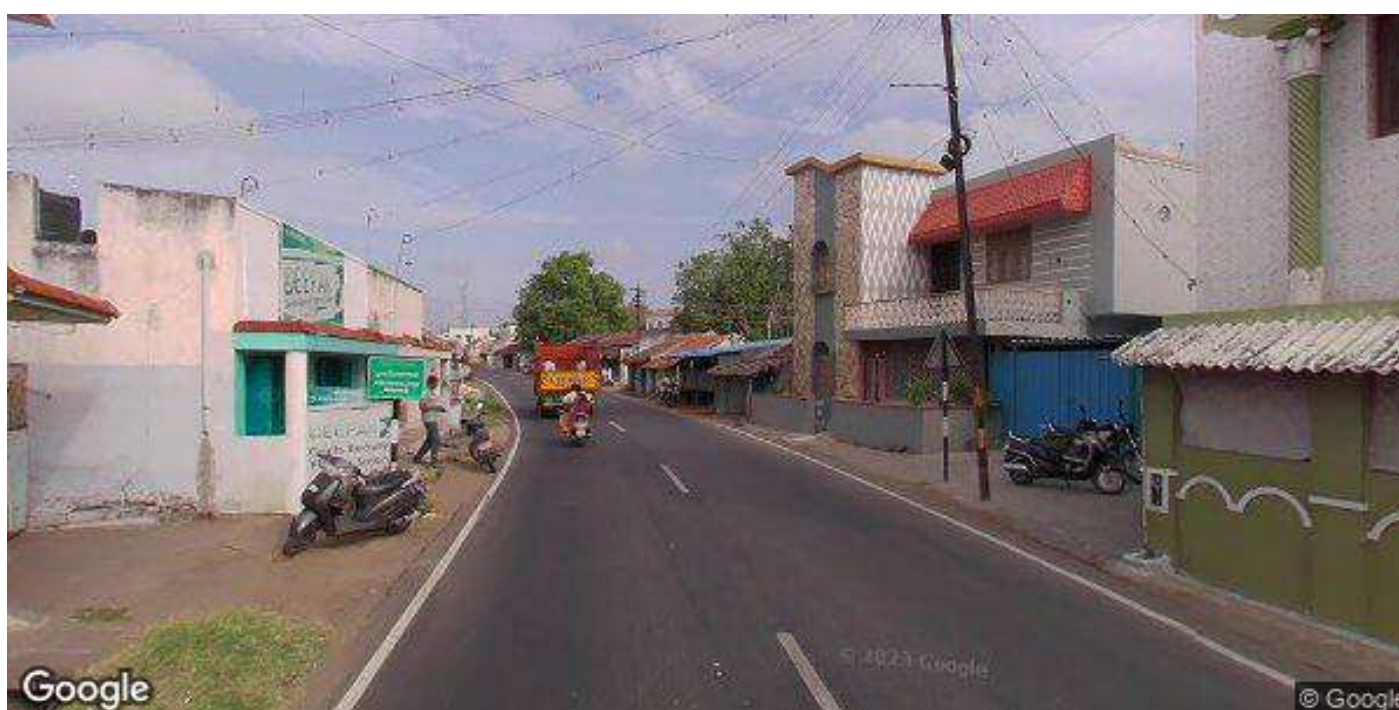
**Risk Type:** Turn  
**Risk Level:** Medium  
**Speed Limit:** 30 KM/Hr  
**Coordinates:** 11.44951, 78.22263

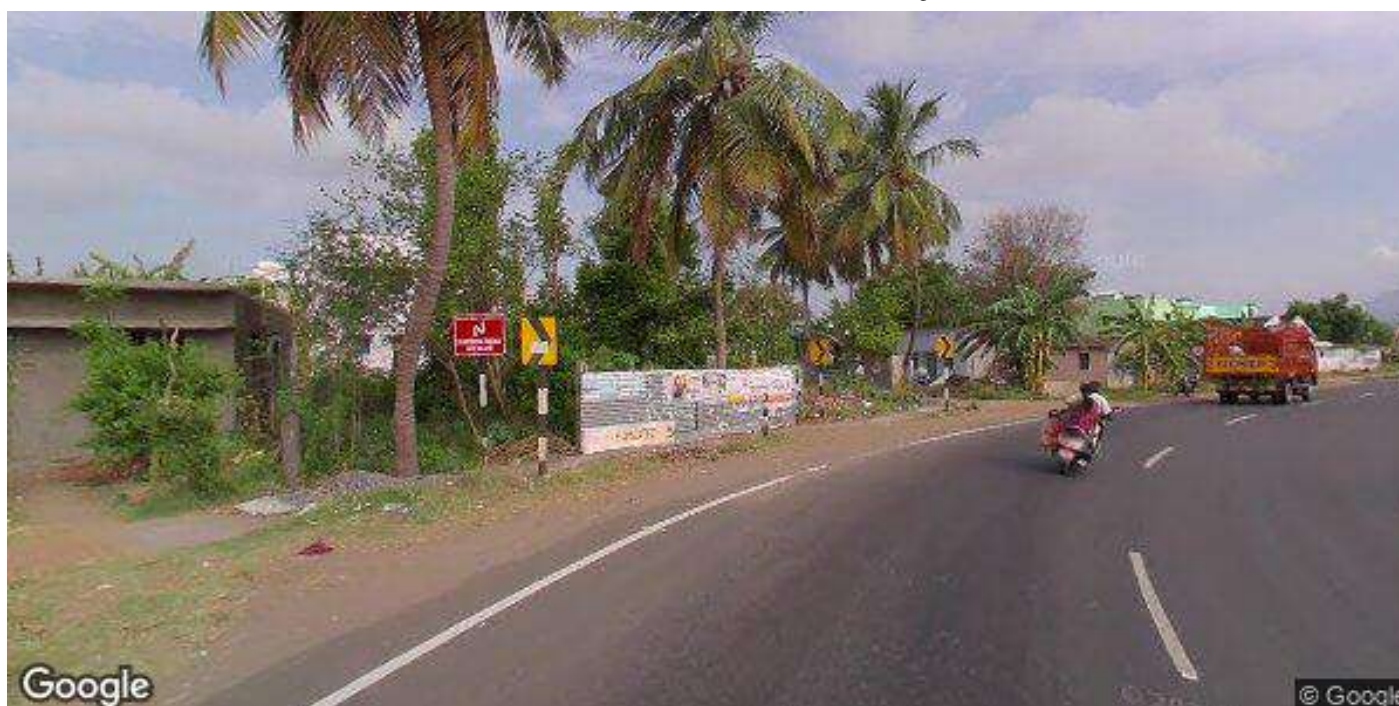
**Risk Type:** Turn  
**Risk Level:** High  
**Speed Limit:** 15 KM/Hr  
**Coordinates:** 11.44797, 78.22314

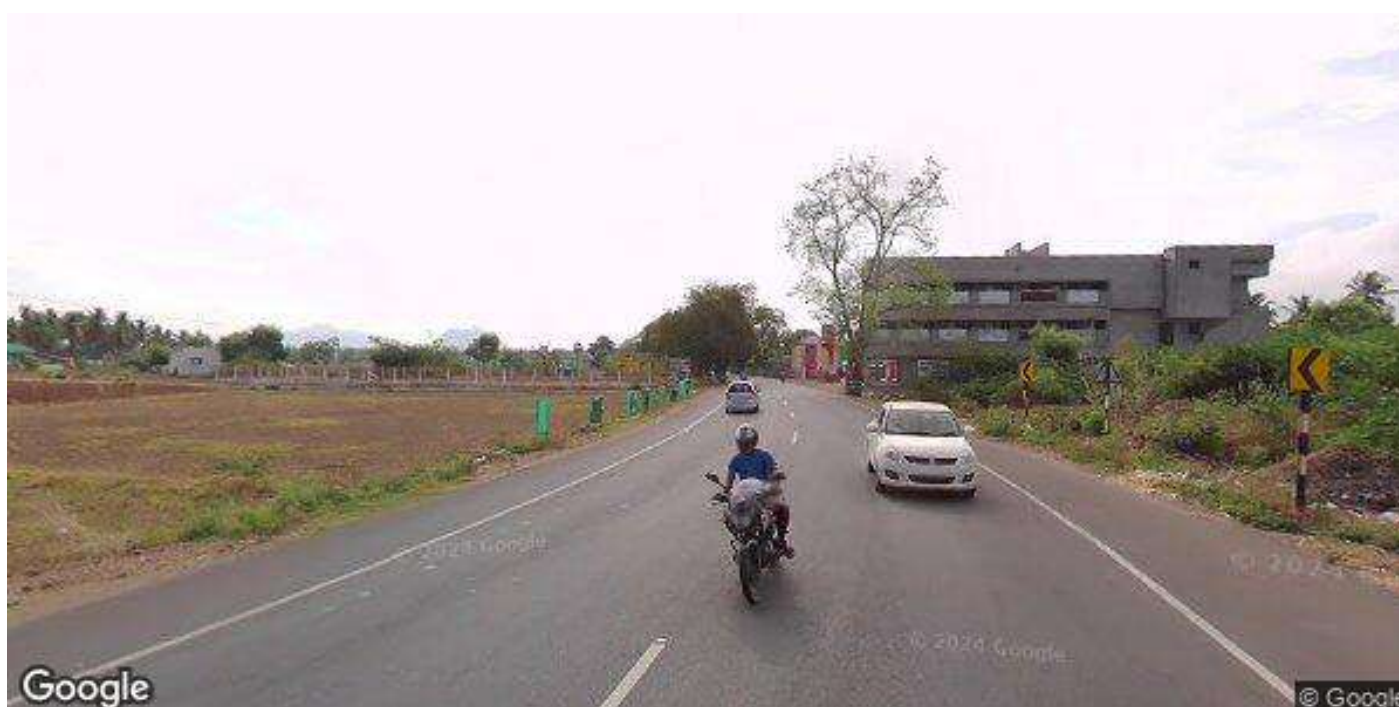
**Risk Type:** Turn  
**Risk Level:** Medium  
**Speed Limit:** 30 KM/Hr  
**Coordinates:** 11.44756, 78.22414

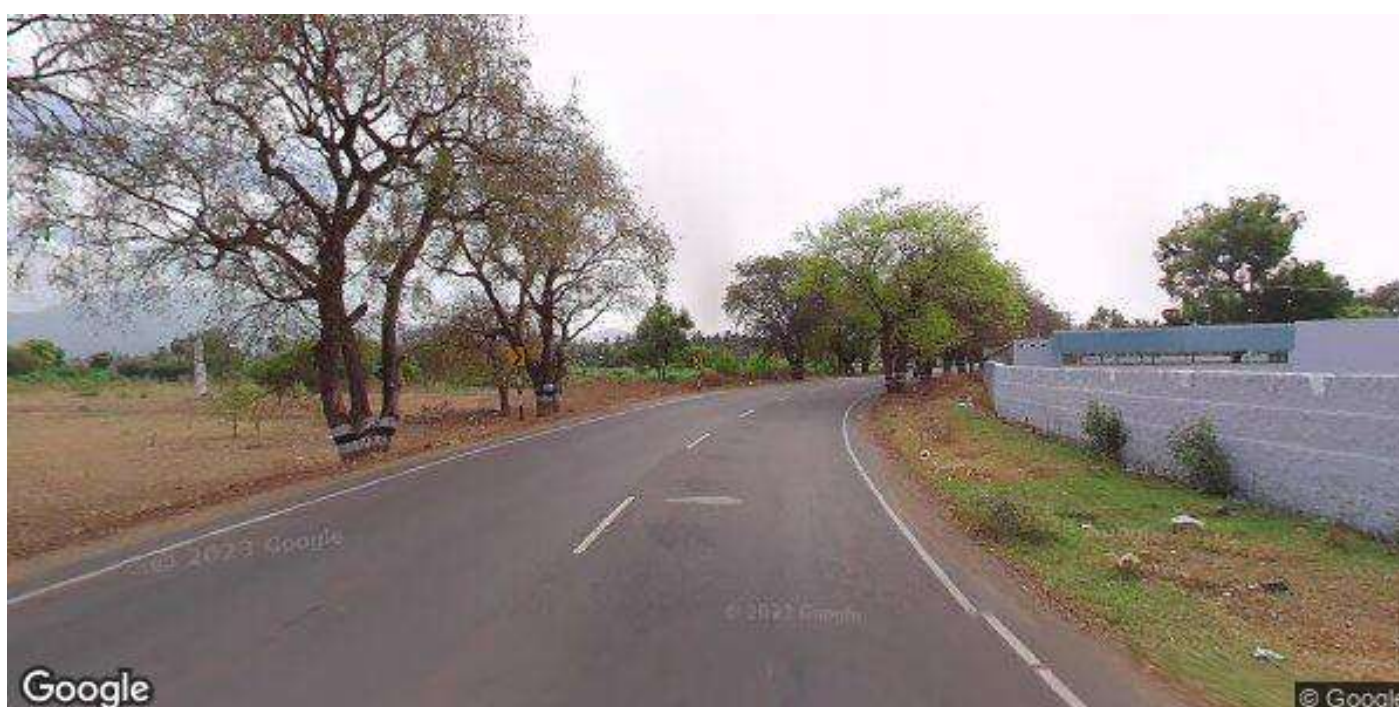
**Risk Type:** Turn  
**Risk Level:** Medium  
**Speed Limit:** 30 KM/Hr  
**Coordinates:** 11.45353, 78.23584
