# IndianOil

## JOURNEY RISK MANAGEMENT (JRM) STUDY

### Salem Terminal to SHREE RENGGA AGENCY

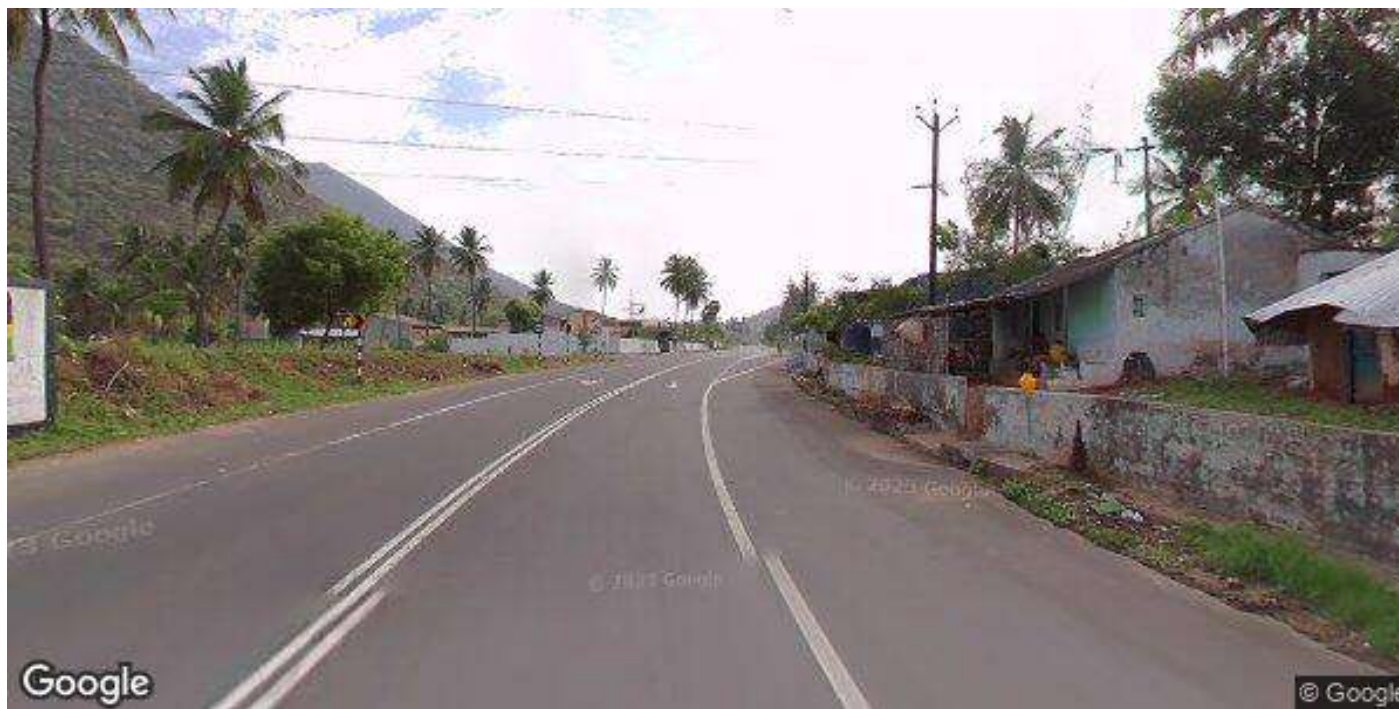
**Risk Type:** Turn  
**Risk Level:** Medium  
**Speed Limit:** 30 KM/Hr  
**Coordinates:** 11.49835, 78.32417

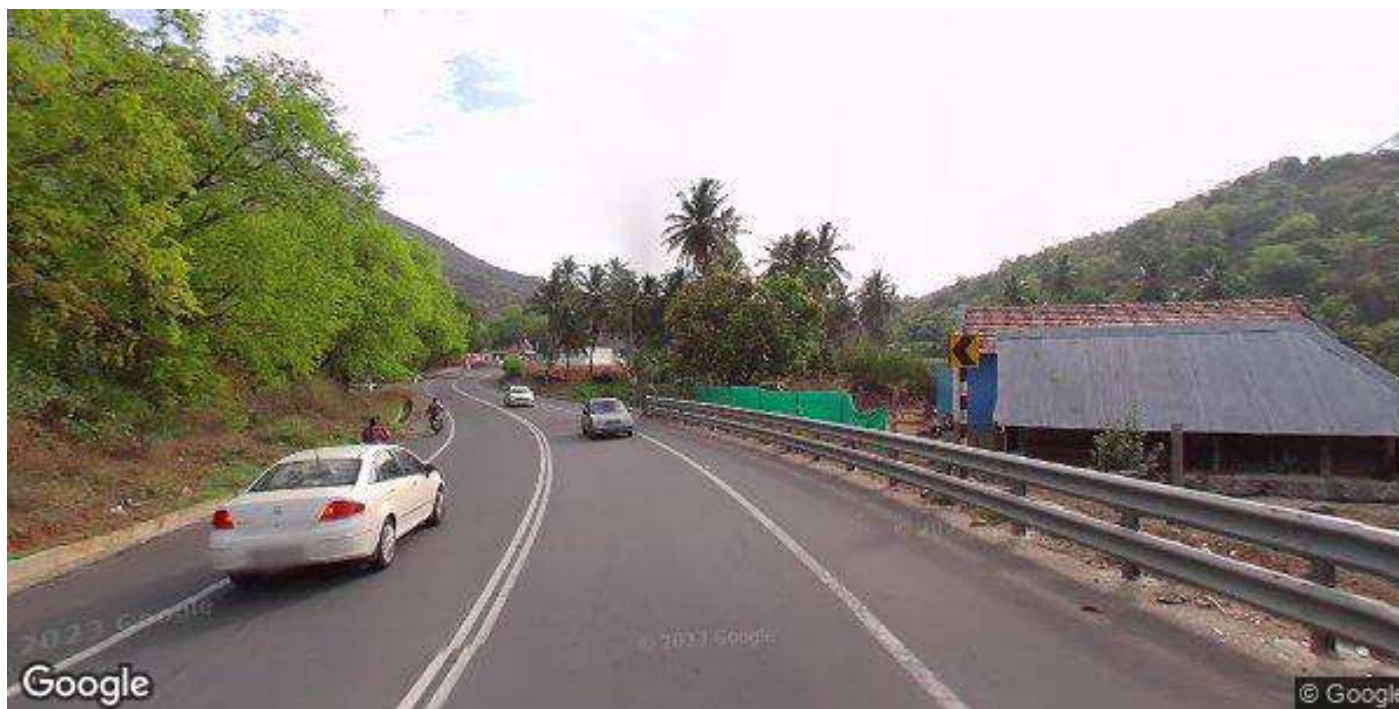
**Risk Type:** Turn  
**Risk Level:** Medium  
**Speed Limit:** 30 KM/Hr  
**Coordinates:** 11.50506, 78.33087

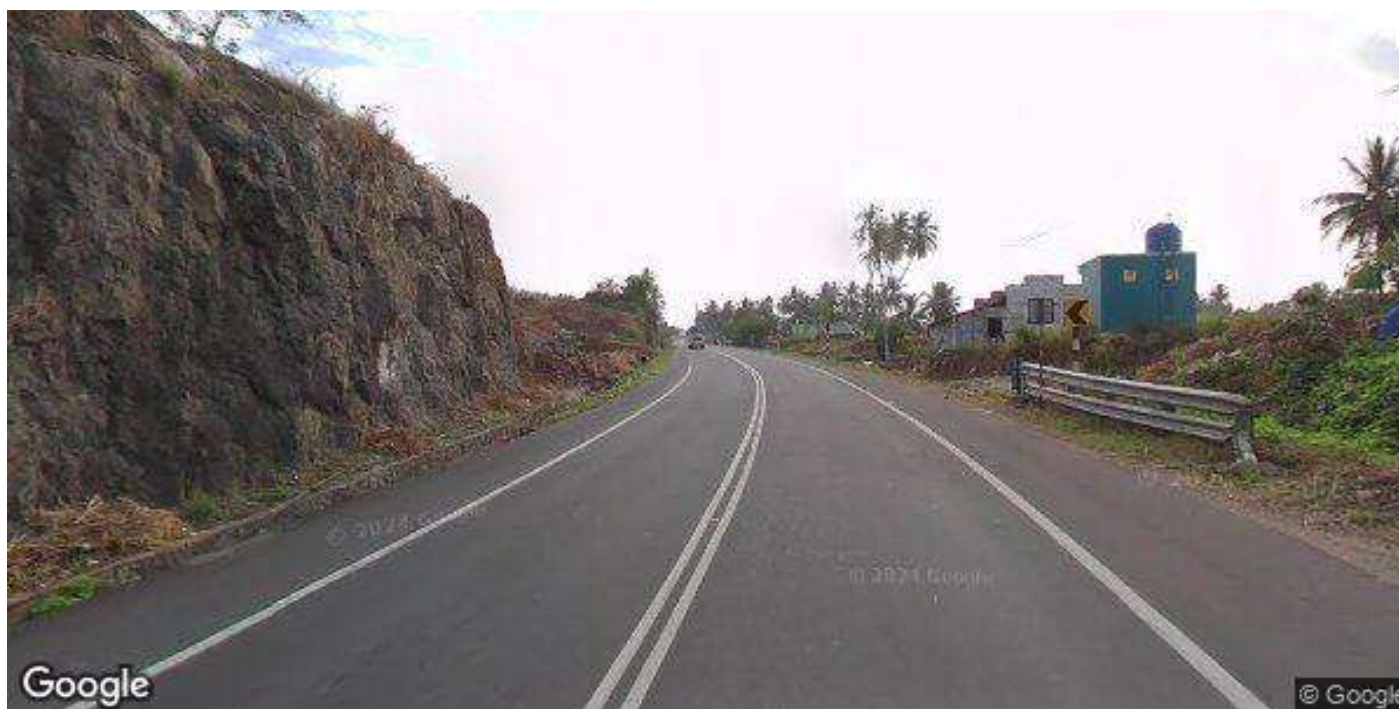
**Risk Type:** Turn  
**Risk Level:** Medium  
**Speed Limit:** 30 KM/Hr  
**Coordinates:** 11.50865, 78.33966

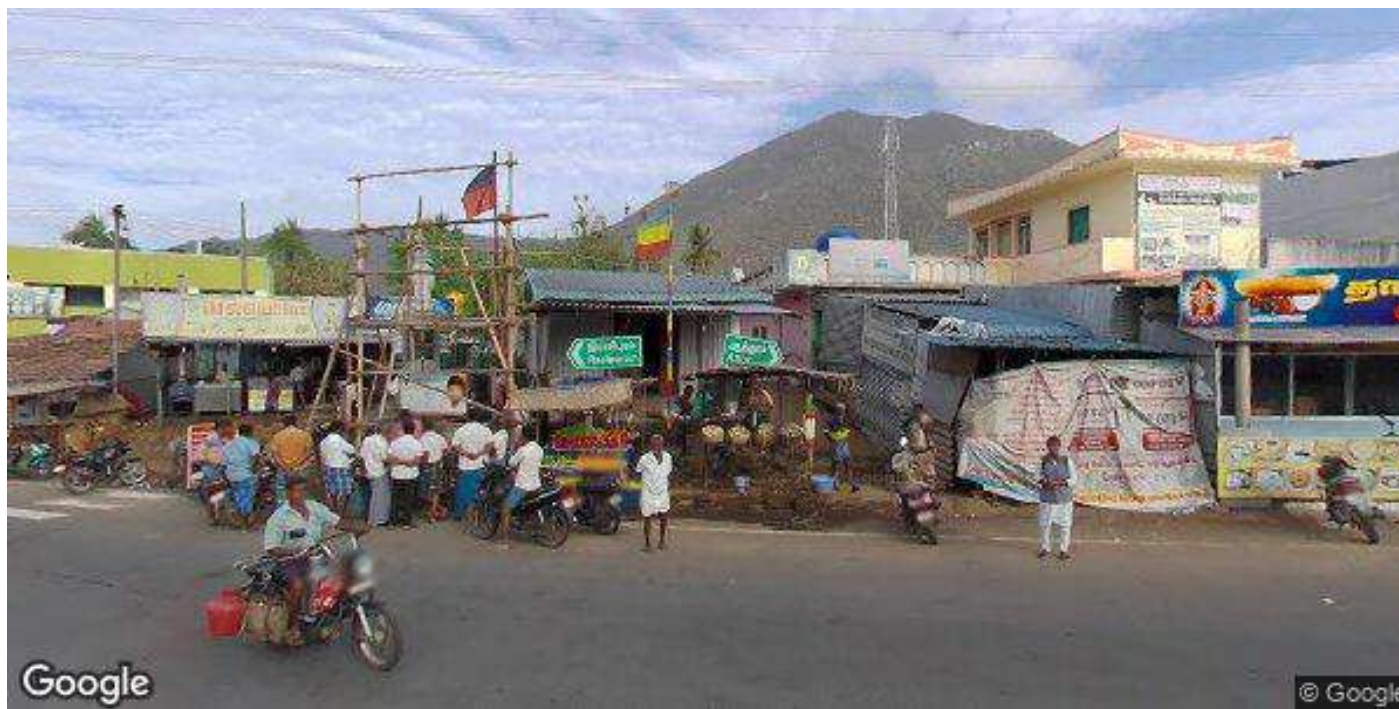
**Risk Type:** Turn  
**Risk Level:** High  
**Speed Limit:** 15 KM/Hr  
**Coordinates:** 11.51183, 78.34416

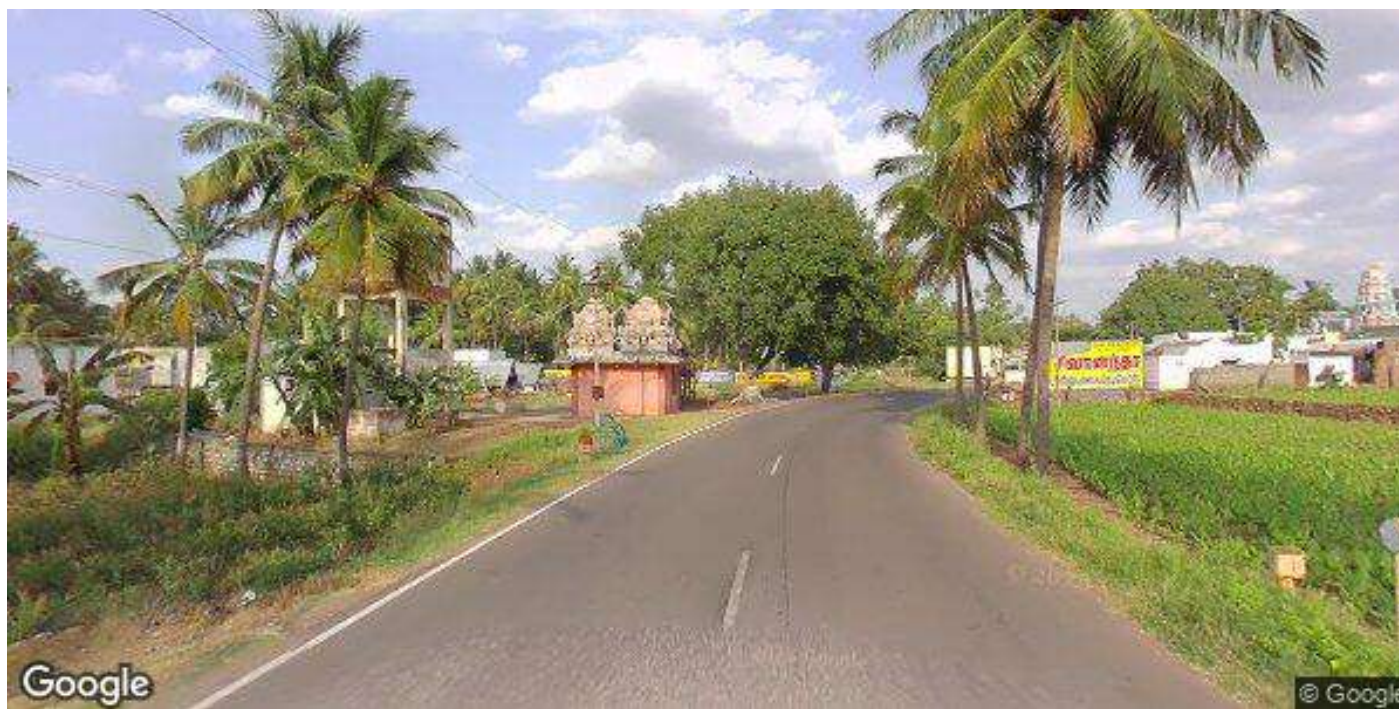
**Risk Type:** Turn  
**Risk Level:** Medium  
**Speed Limit:** 30 KM/Hr  
**Coordinates:** 11.51042, 78.34865

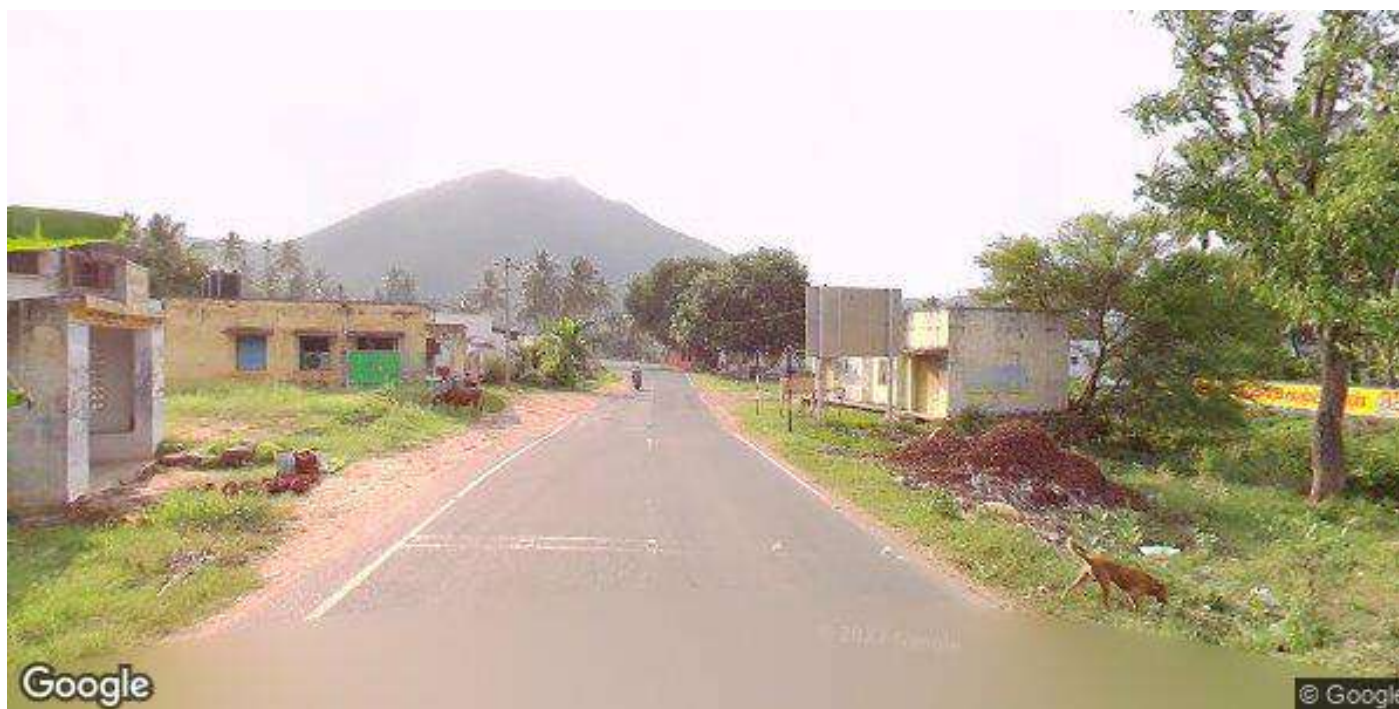
**Risk Type:** Turn  
**Risk Level:** Medium  
**Speed Limit:** 30 KM/Hr  
**Coordinates:** 11.50973, 78.34962

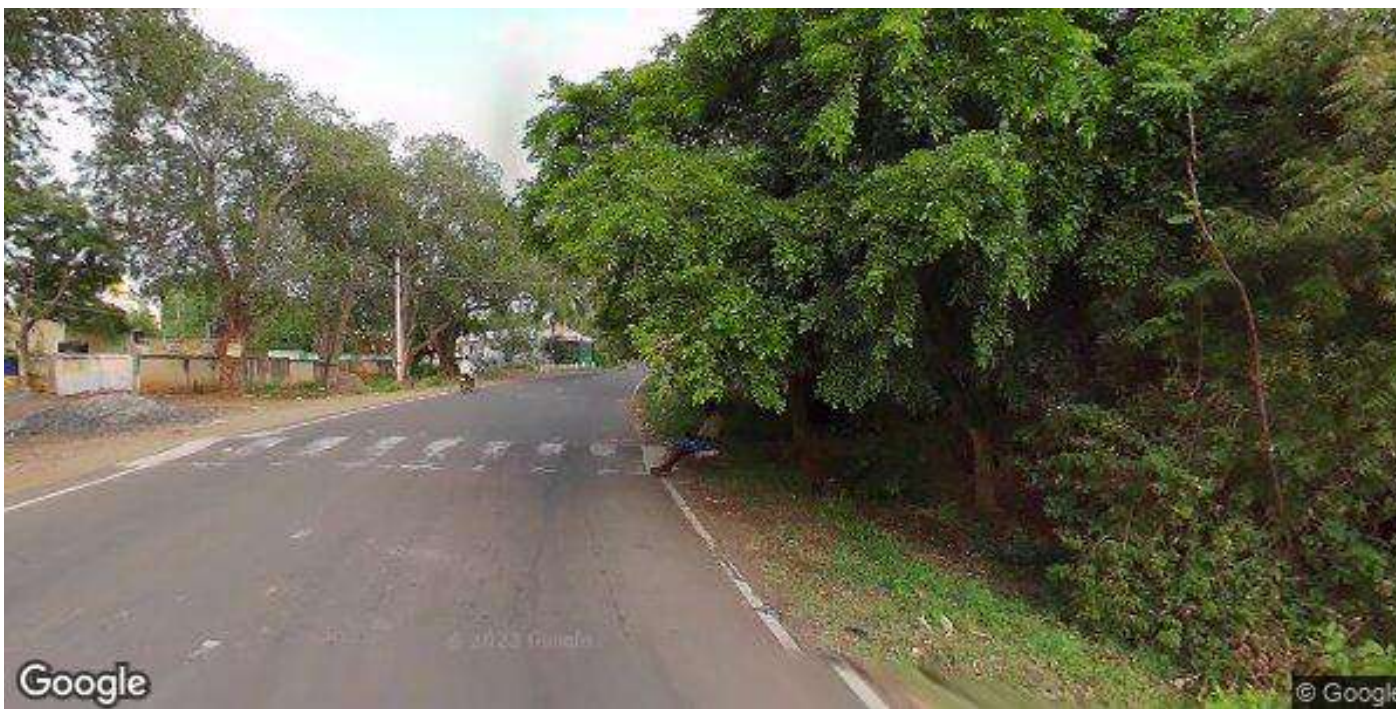
**Risk Type:** Turn  
**Risk Level:** Medium  
**Speed Limit:** 30 KM/Hr  
**Coordinates:** 11.50909, 78.35278

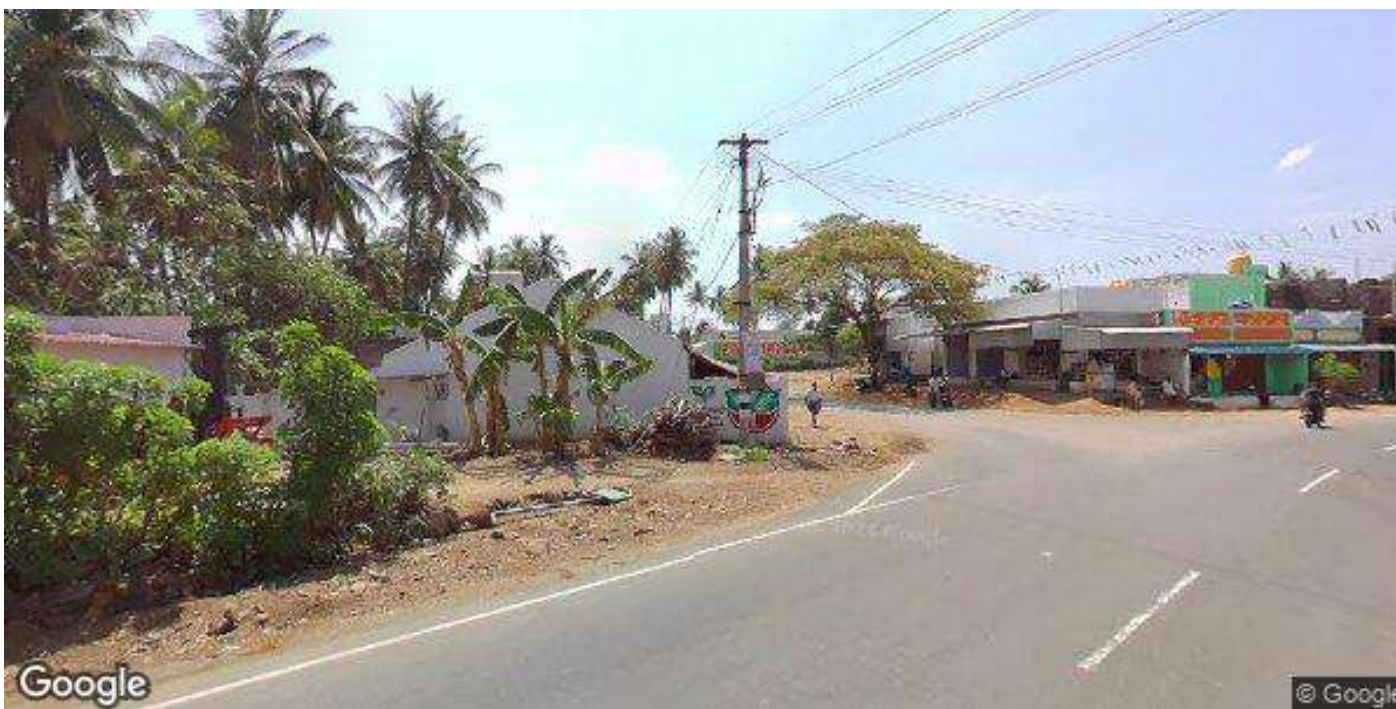
**Risk Type:** Turn  
**Risk Level:** Medium  
**Speed Limit:** 30 KM/Hr  
**Coordinates:** 11.47991, 78.38028

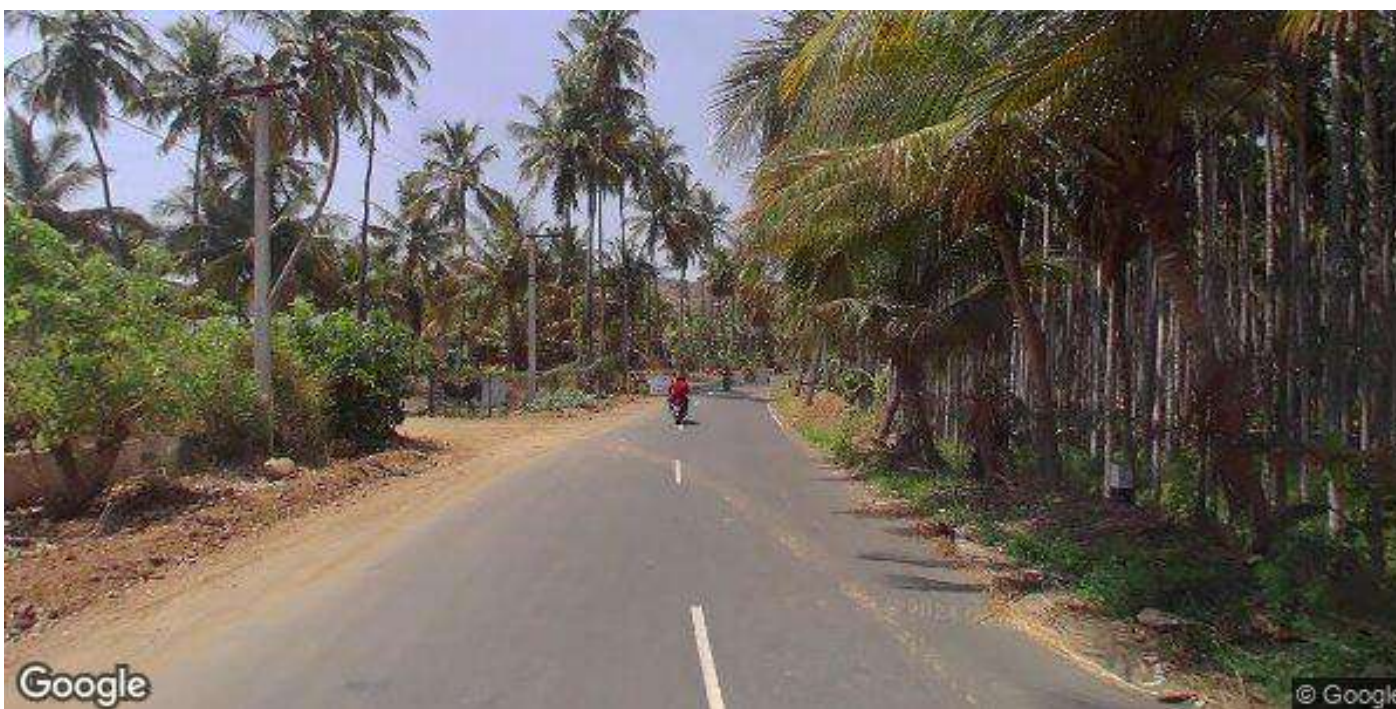
**Risk Type:** Turn  
**Risk Level:** Medium  
**Speed Limit:** 30 KM/Hr  
**Coordinates:** 11.46964, 78.39358

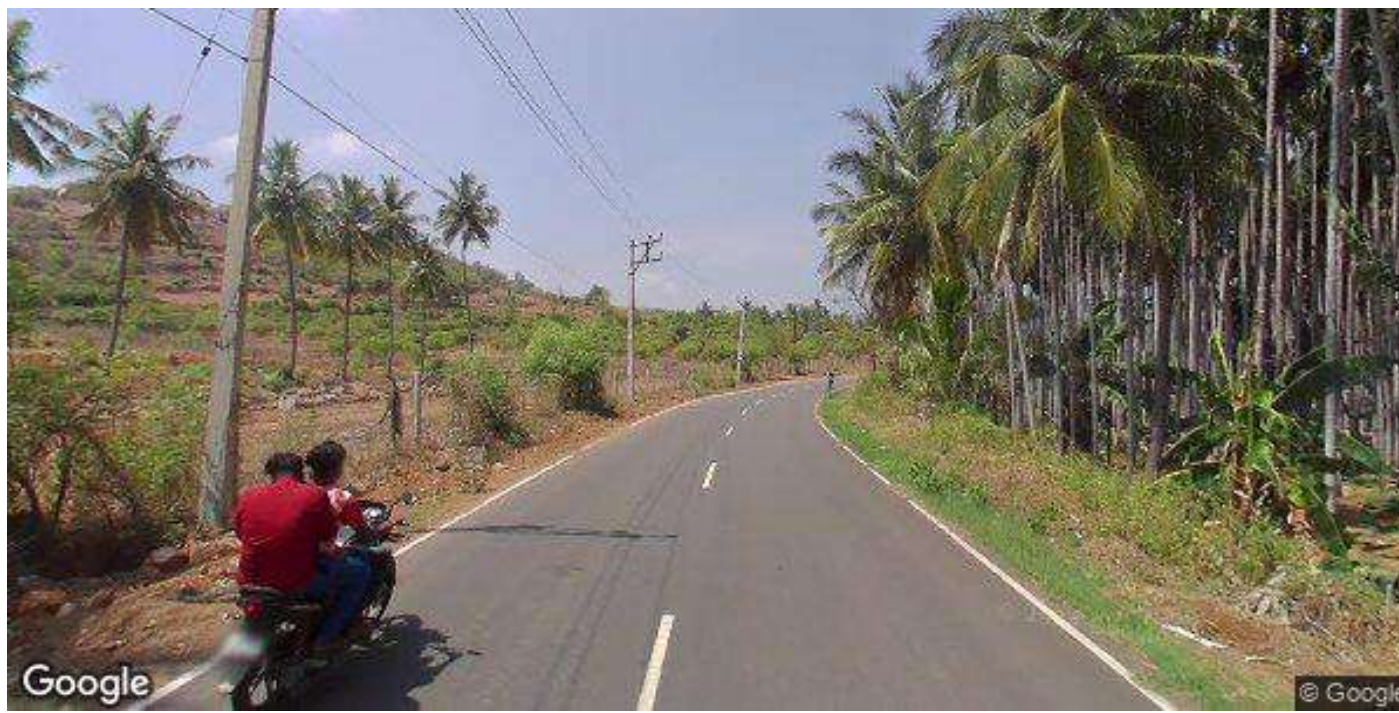
**Risk Type:** Turn  
**Risk Level:** Medium  
**Speed Limit:** 30 KM/Hr  
**Coordinates:** 11.46790, 78.39420

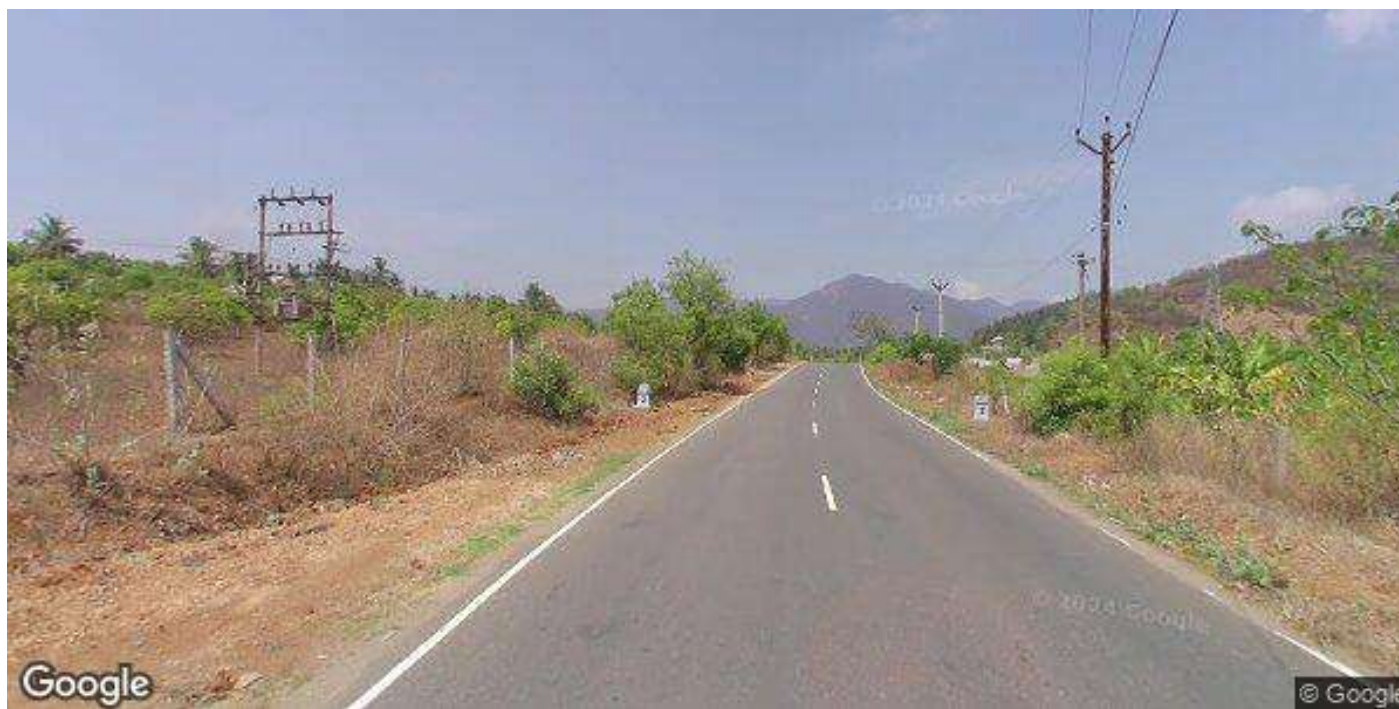
**Risk Type:** Turn  
**Risk Level:** Medium  
**Speed Limit:** 30 KM/Hr  
**Coordinates:** 11.46691, 78.39407

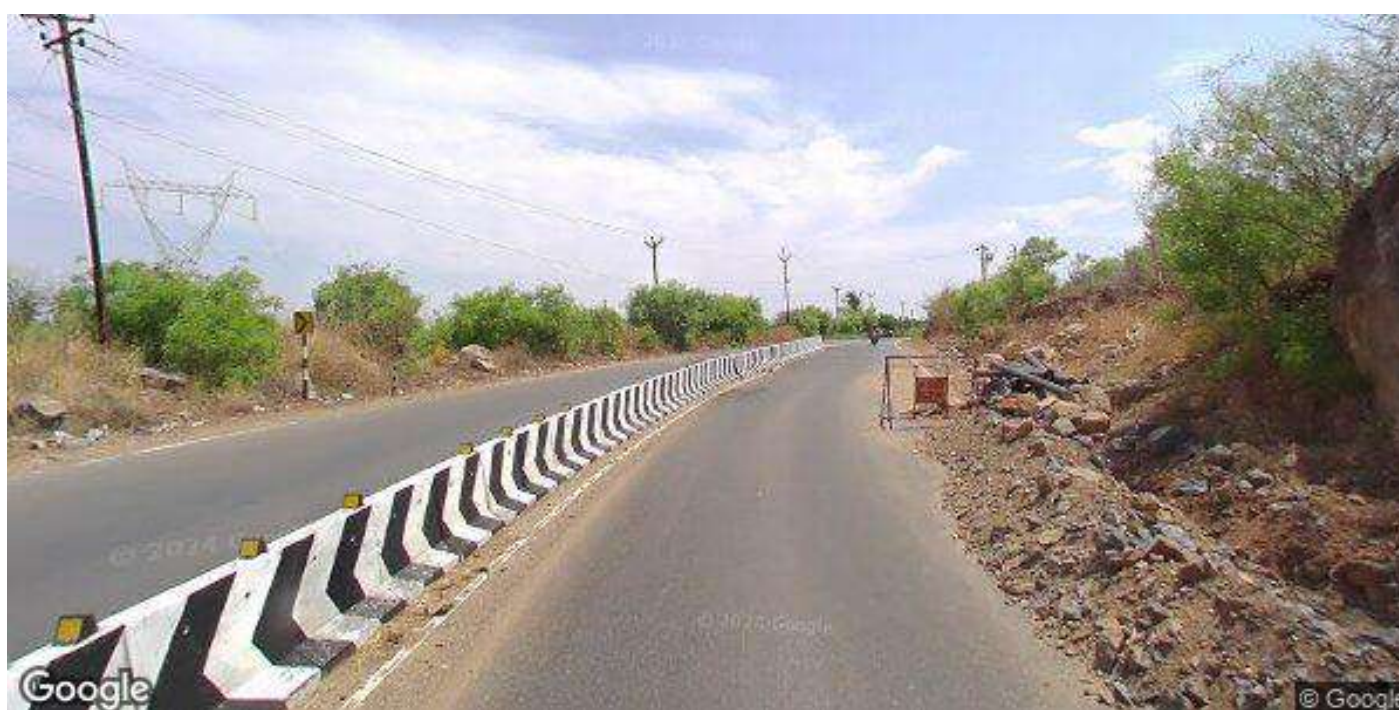
**Risk Type:** Turn  
**Risk Level:** Medium  
**Speed Limit:** 30 KM/Hr  
**Coordinates:** 11.46466, 78.39289

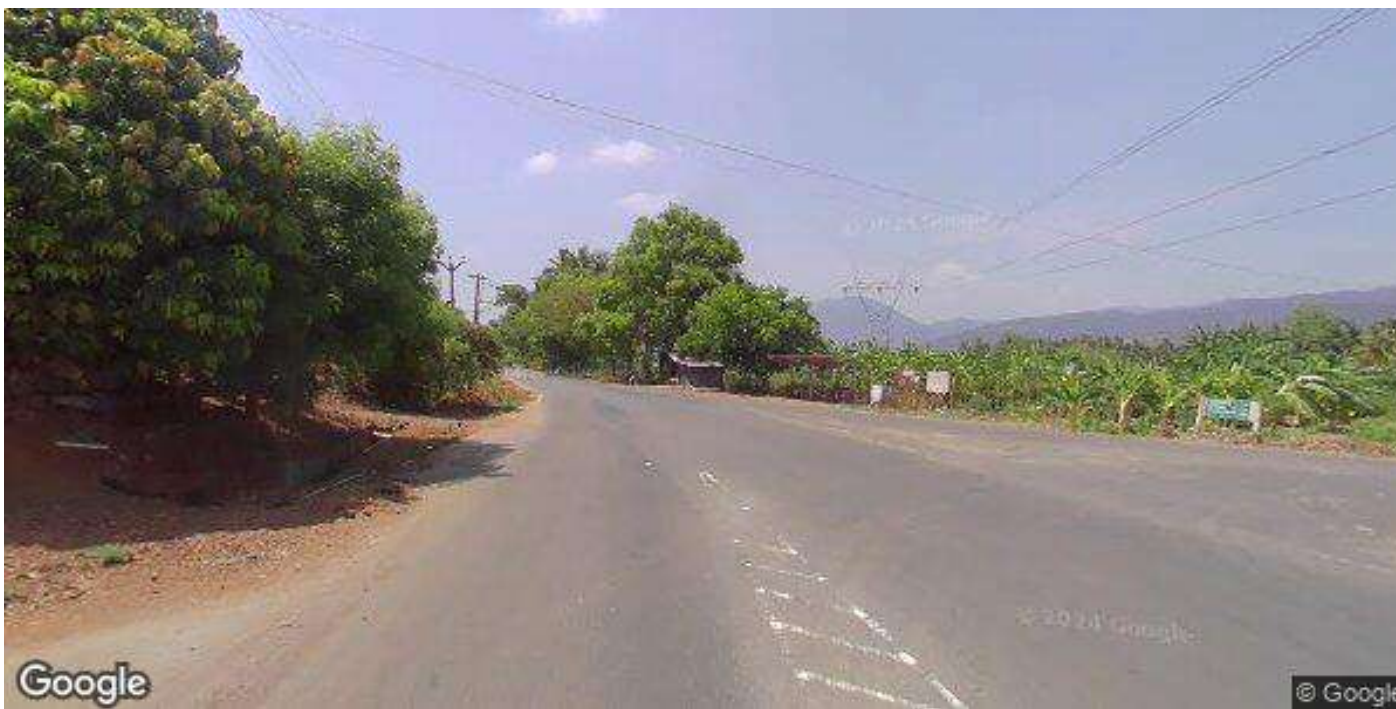
**Risk Type:** Turn  
**Risk Level:** Medium  
**Speed Limit:** 30 KM/Hr  
**Coordinates:** 11.46410, 78.39311

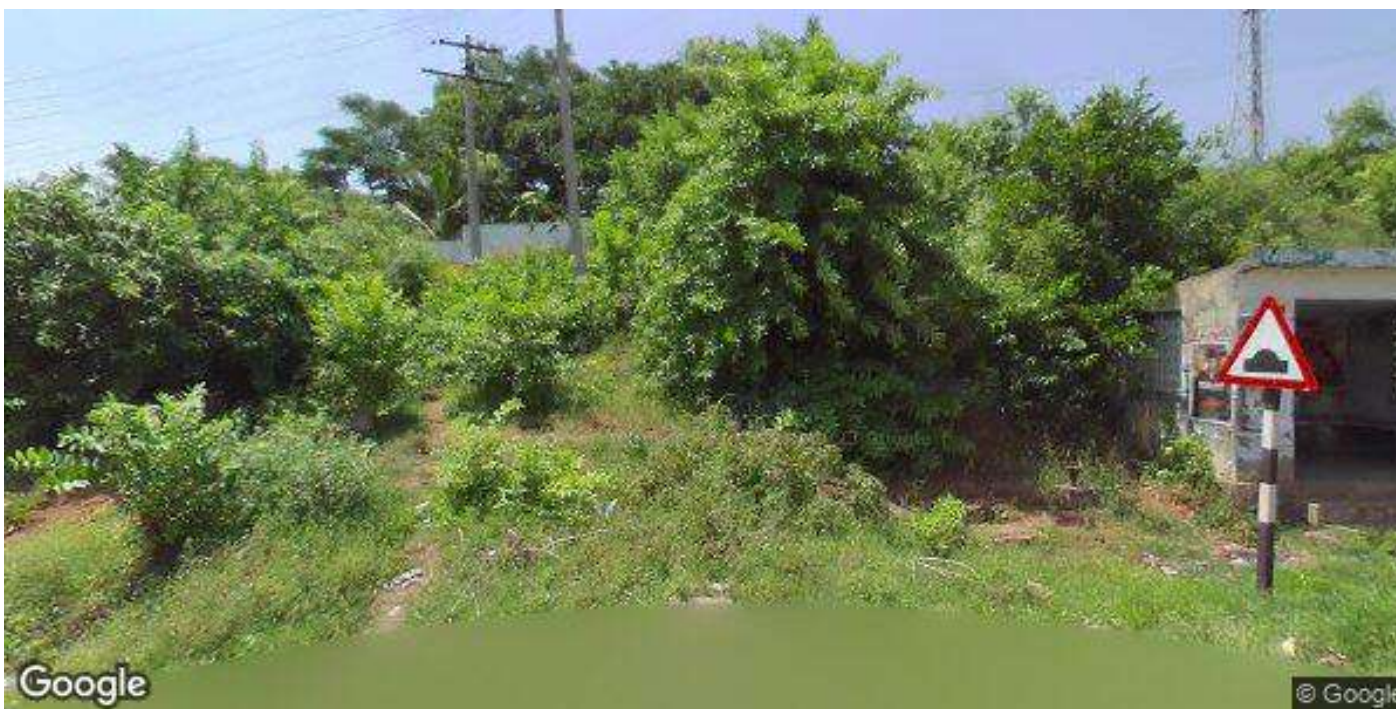
**Risk Type:** Turn  
**Risk Level:** High  
**Speed Limit:** 15 KM/Hr  
**Coordinates:** 11.45597, 78.40096

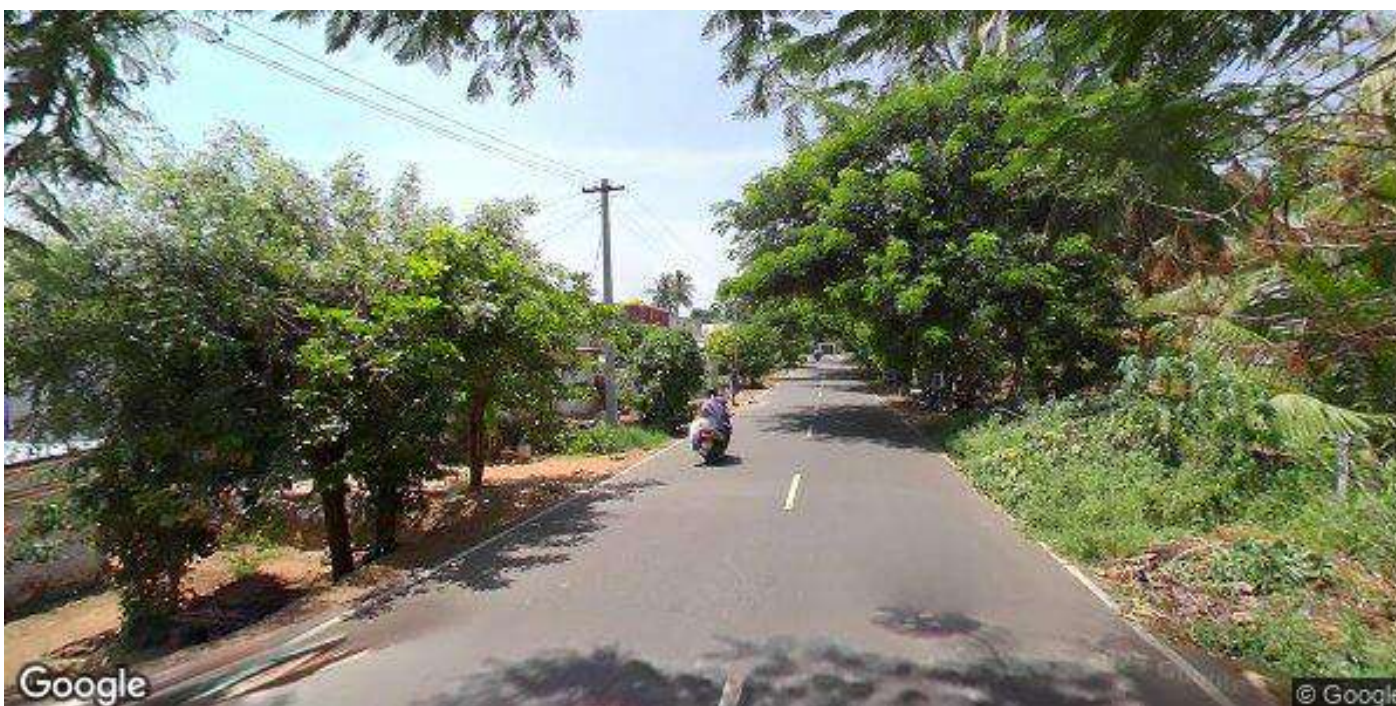
**Risk Type:** Turn  
**Risk Level:** Medium  
**Speed Limit:** 30 KM/Hr  
**Coordinates:** 11.45563, 78.40251

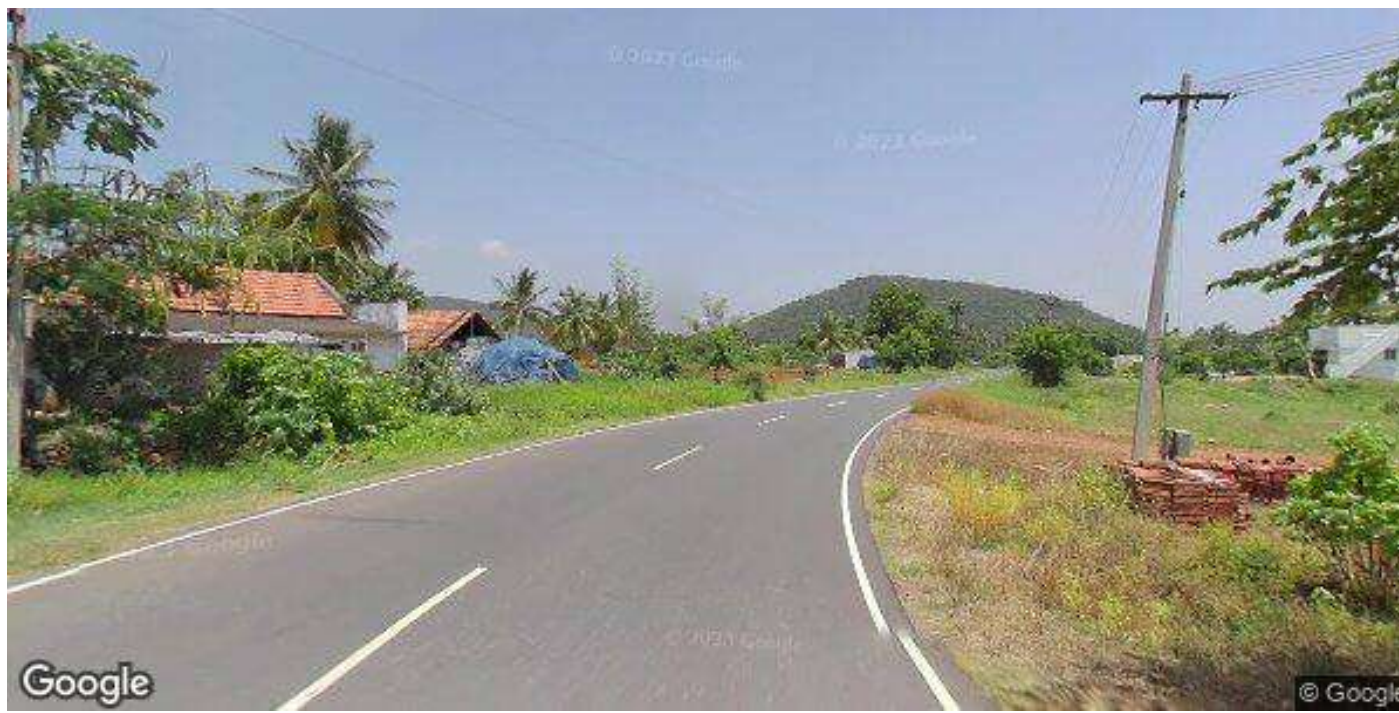
**Risk Type:** Turn  
**Risk Level:** Medium  
**Speed Limit:** 30 KM/Hr  
**Coordinates:** 11.45658, 78.40441

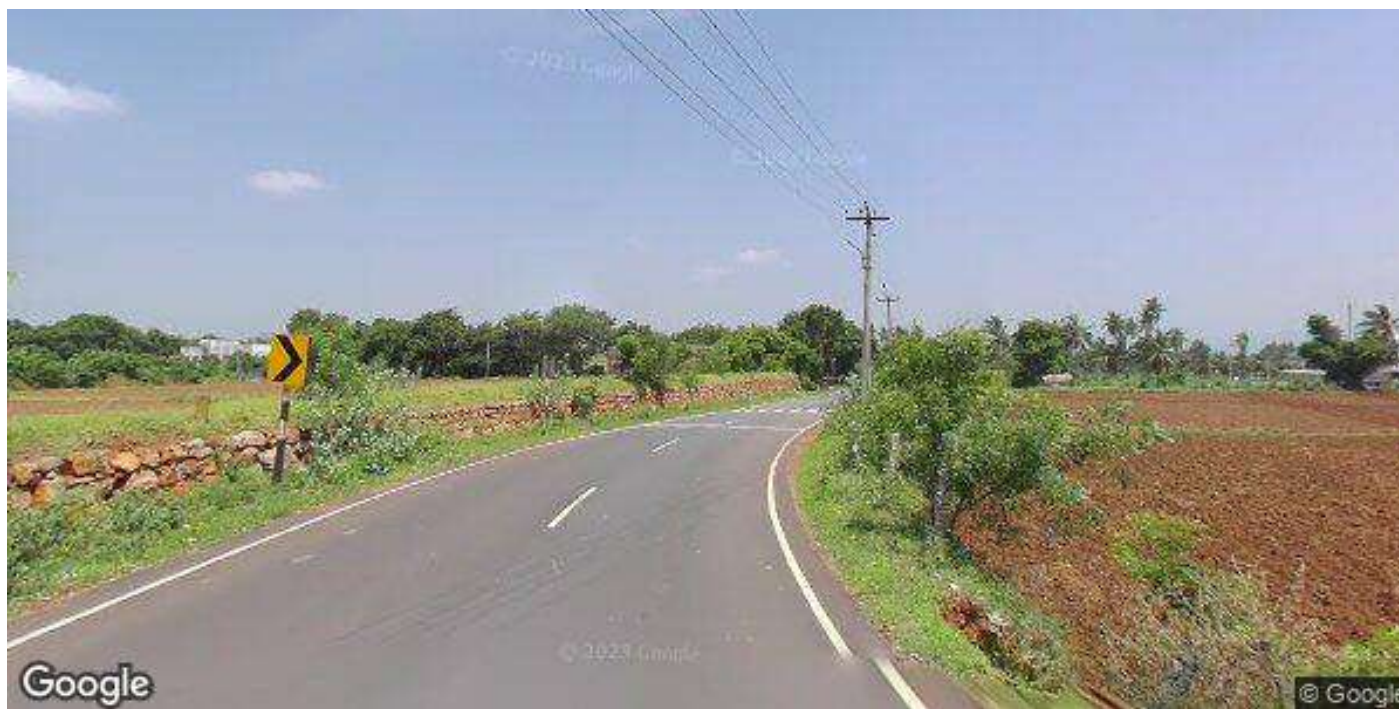
**Risk Type:** Turn  
**Risk Level:** Medium  
**Speed Limit:** 30 KM/Hr  
**Coordinates:** 11.46740, 78.45082

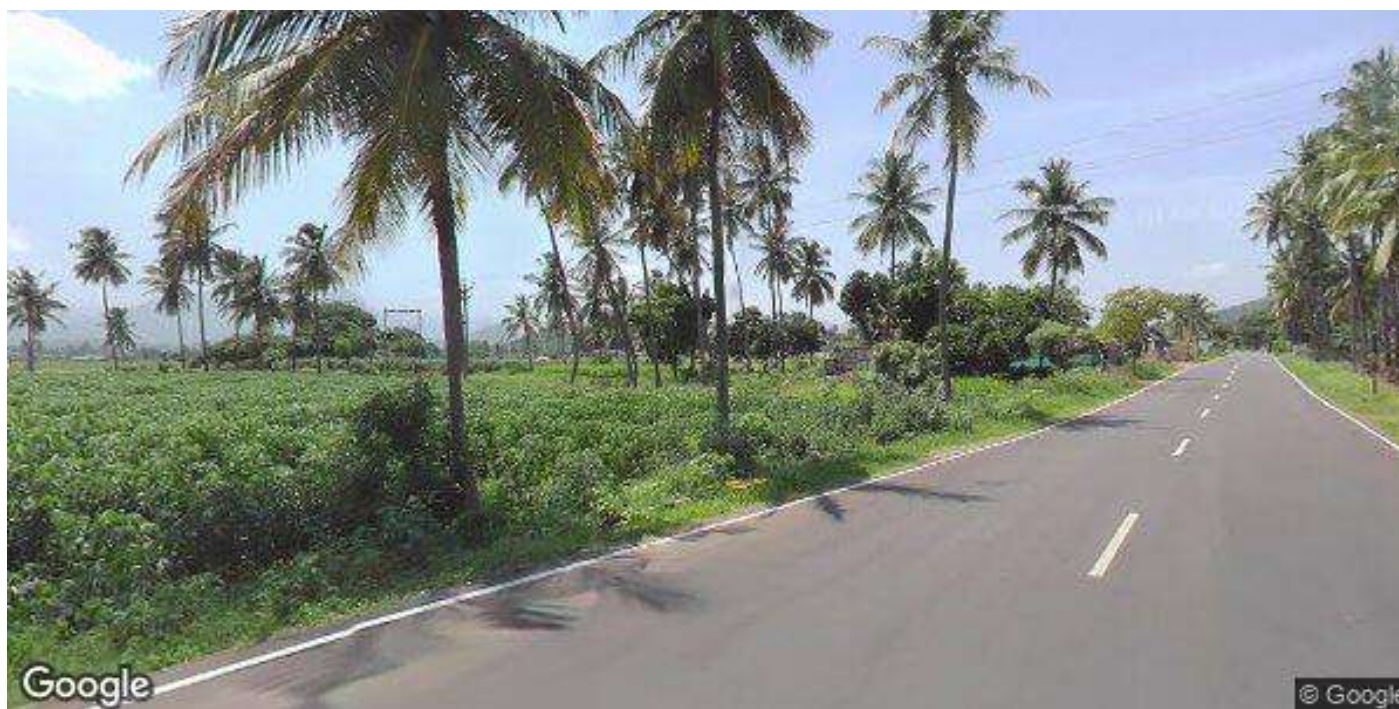
**Risk Type:** Turn  
**Risk Level:** Medium  
**Speed Limit:** 30 KM/Hr  
**Coordinates:** 11.46728, 78.45442

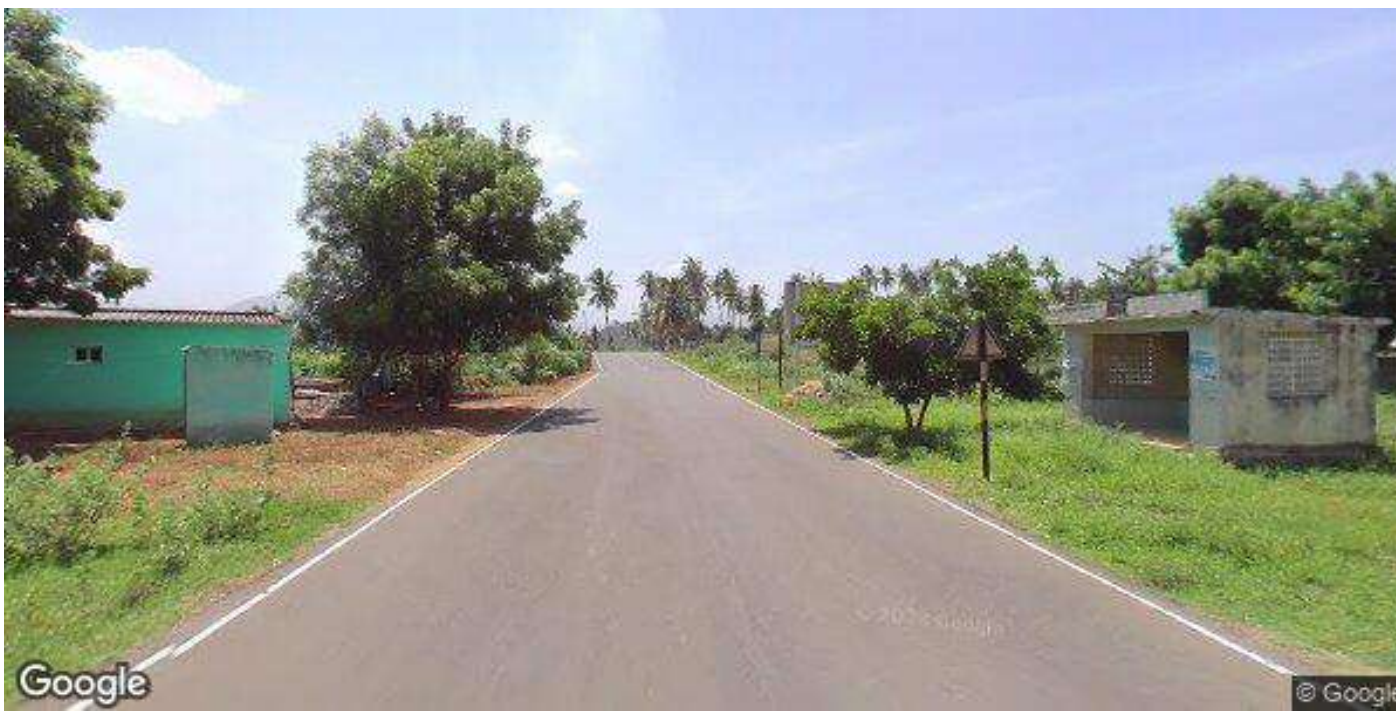
**Risk Type:** Turn  
**Risk Level:** Medium  
**Speed Limit:** 30 KM/Hr  
**Coordinates:** 11.46798, 78.45523

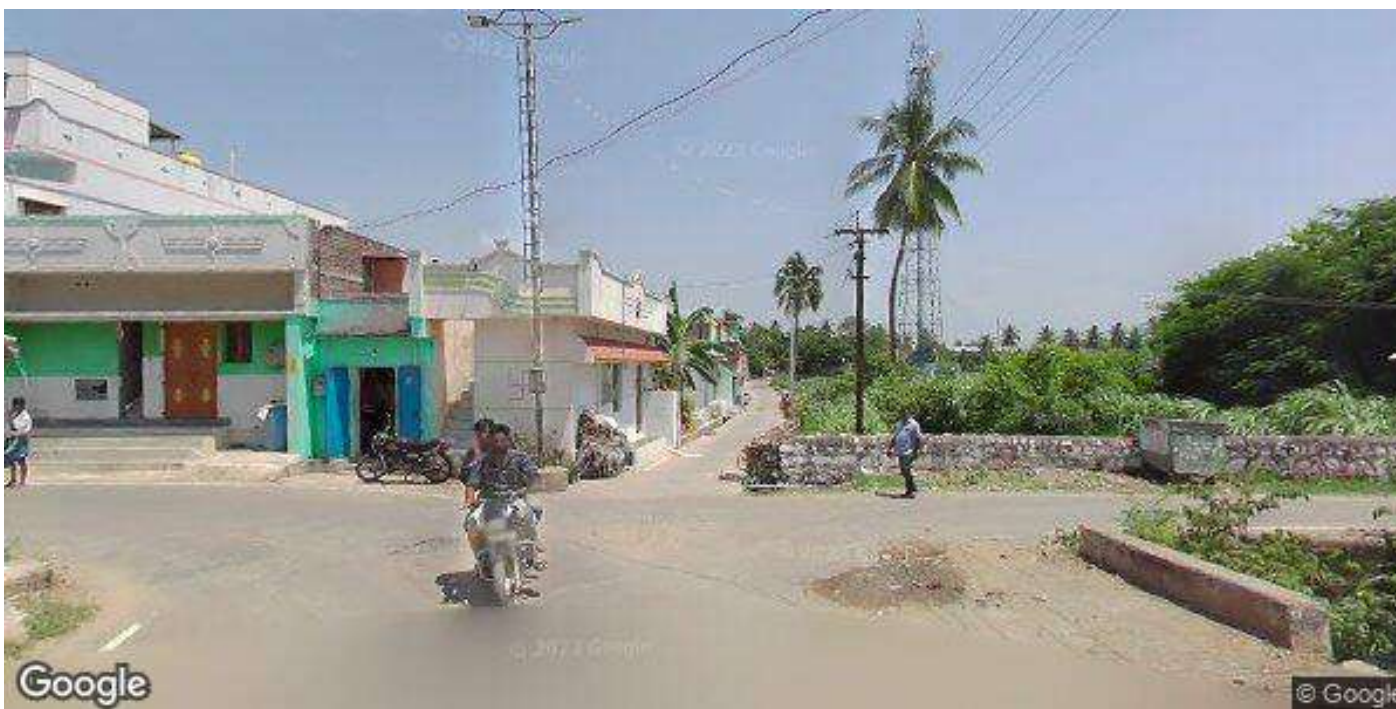
**Risk Type:** Blind Spot  
**Risk Level:** Blind Spot  
**Speed Limit:** 10 KM/Hr  
**Coordinates:** 11.46798, 78.45844

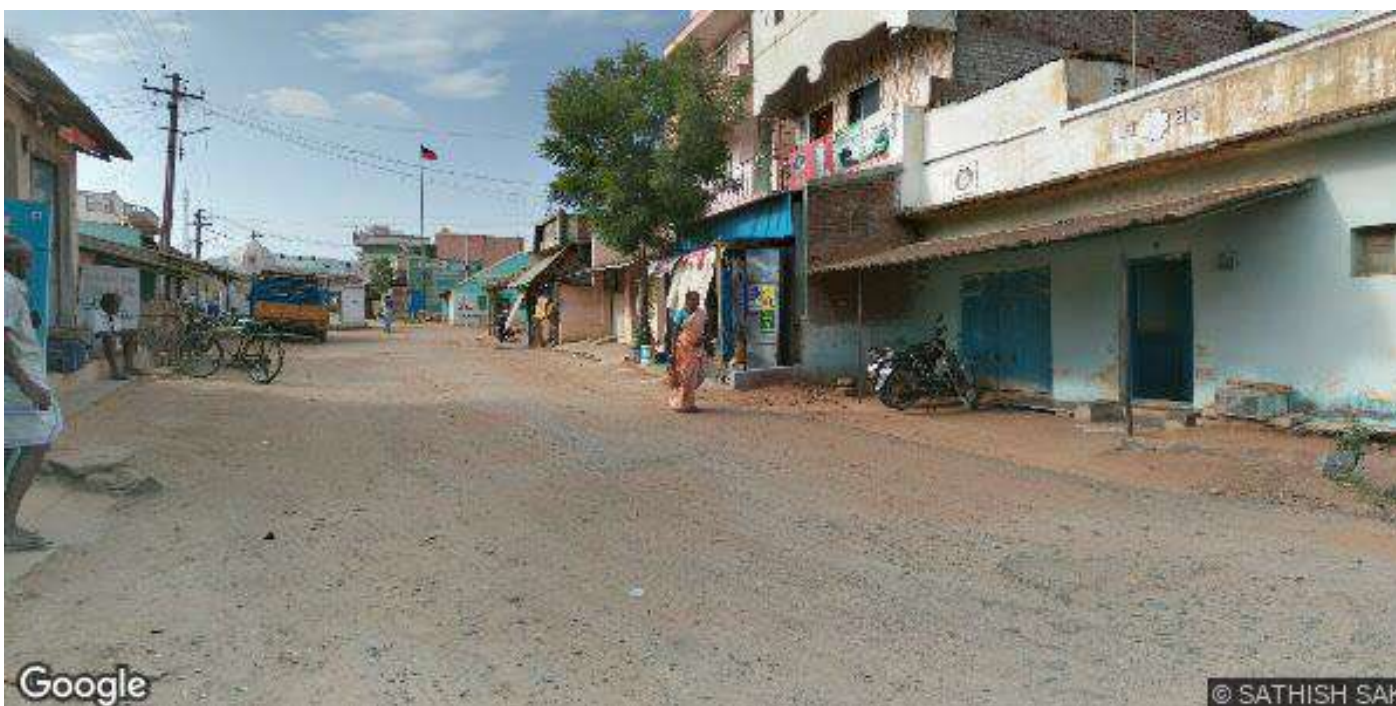
**Risk Type:** Blind Spot  
**Risk Level:** Blind Spot  
**Speed Limit:** 10 KM/Hr  
**Coordinates:** 11.46857, 78.45844

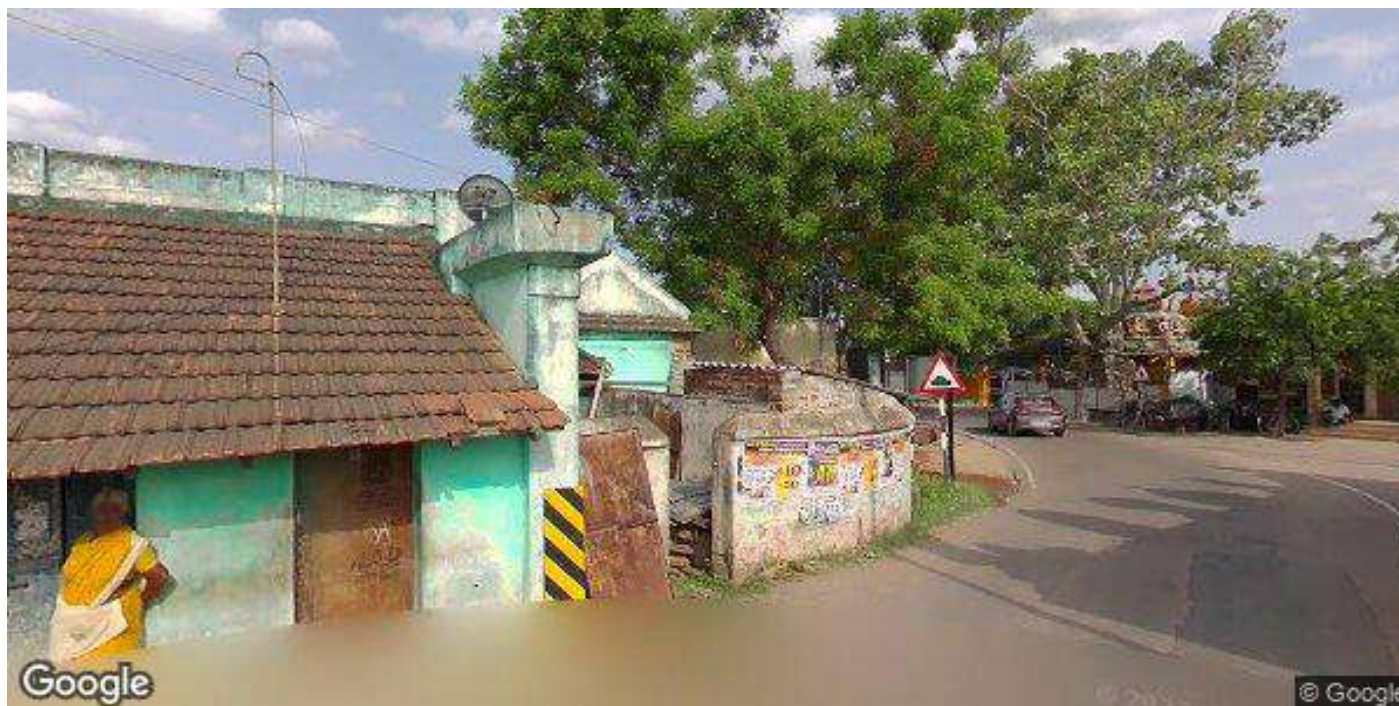
**Risk Type:** Turn  
**Risk Level:** Medium  
**Speed Limit:** 30 KM/Hr  
**Coordinates:** 11.46835, 78.45959
