# IndianOil

## JOURNEY RISK MANAGEMENT (JRM) STUDY

### Salem Terminal to SHREE RENGGA AGENCY

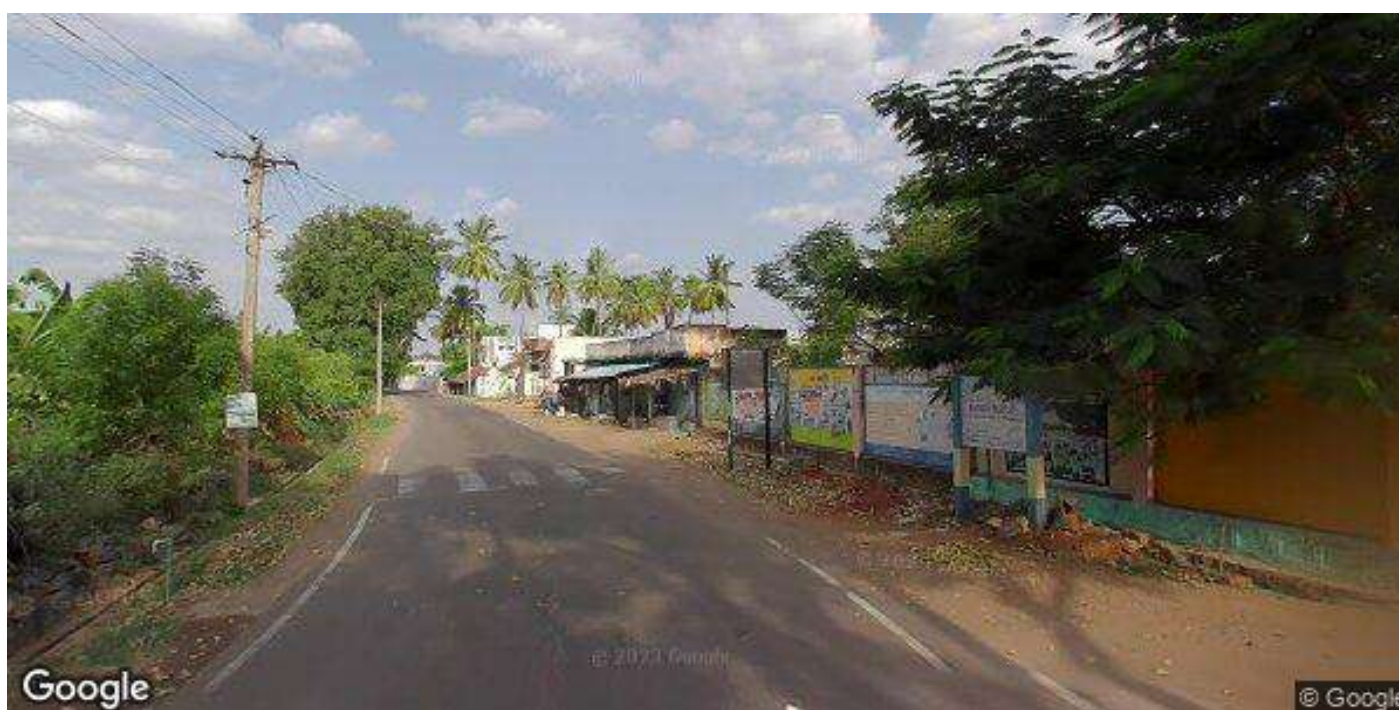
**Risk Type:** Turn  
**Risk Level:** Medium  
**Speed Limit:** 30 KM/Hr  
**Coordinates:** 11.46800, 78.45987

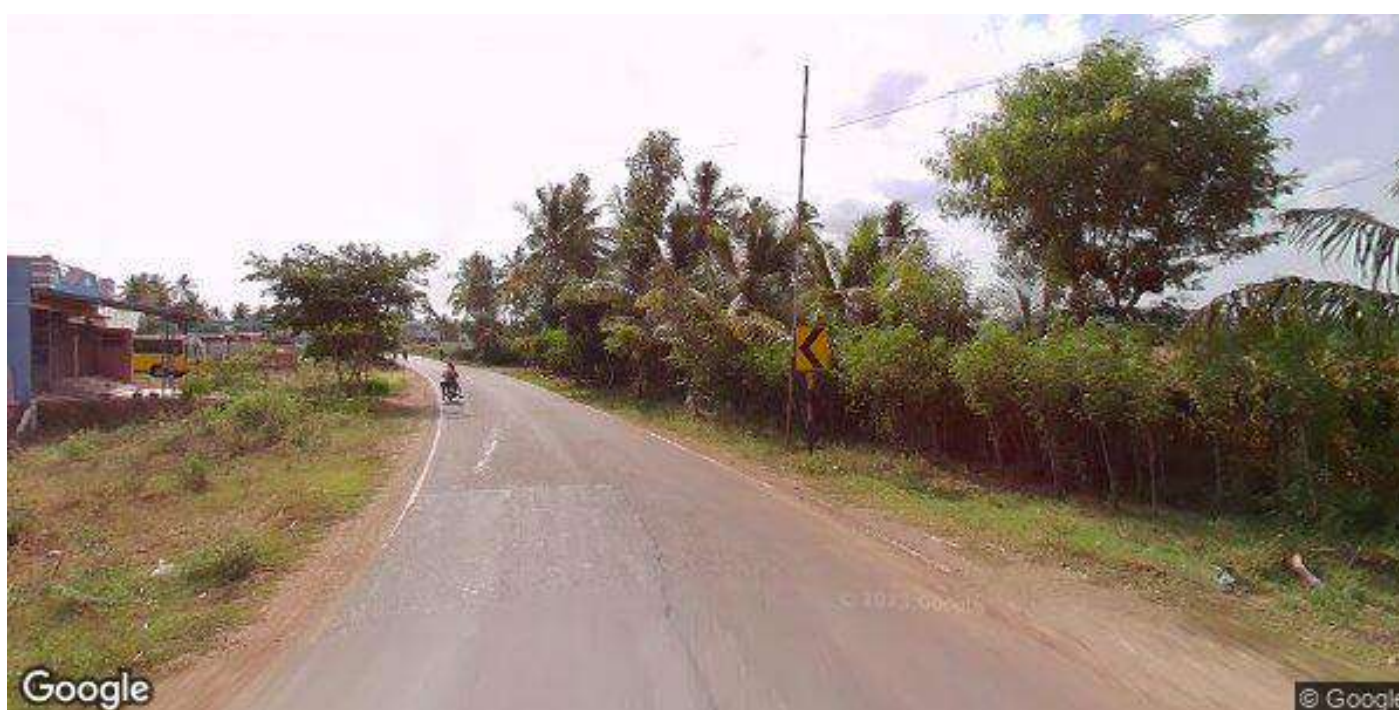
**Risk Type:** Turn  
**Risk Level:** Medium  
**Speed Limit:** 30 KM/Hr  
**Coordinates:** 11.46461, 78.47397

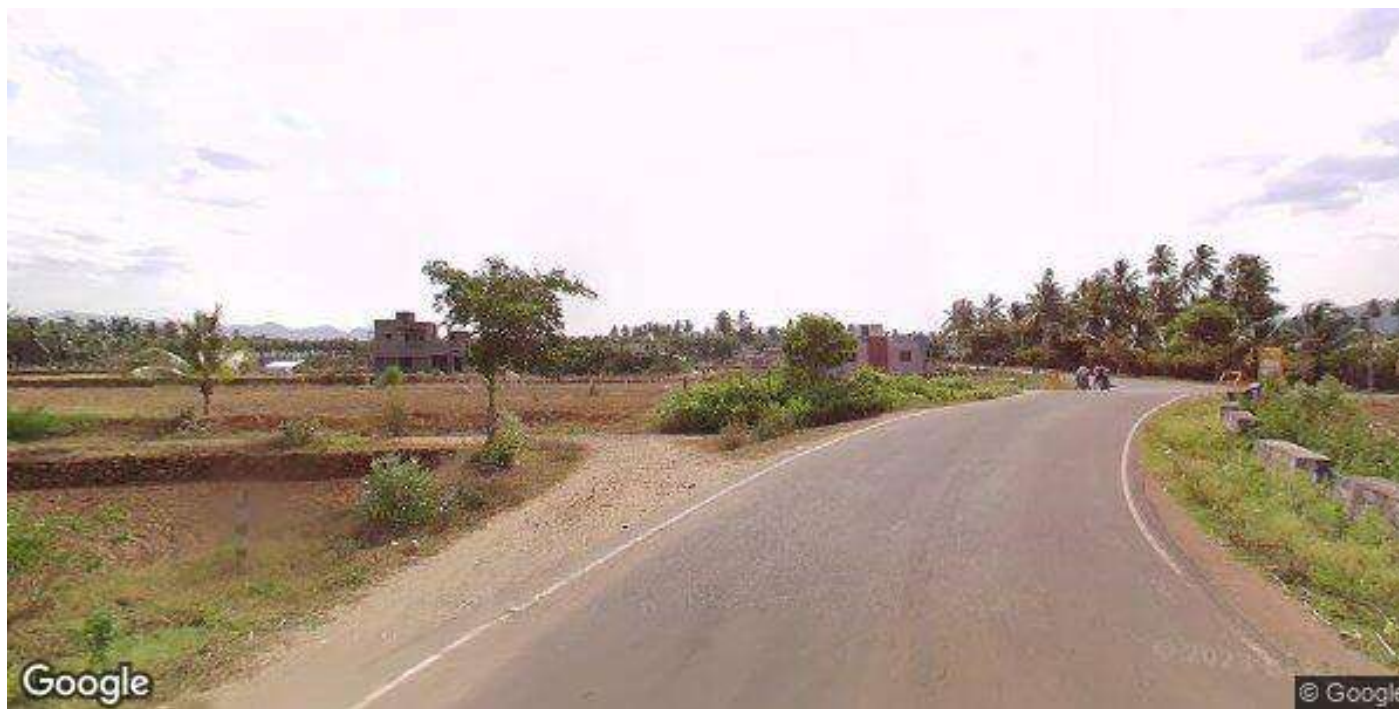
**Risk Type:** Turn  
**Risk Level:** Medium  
**Speed Limit:** 30 KM/Hr  
**Coordinates:** 11.46419, 78.47445

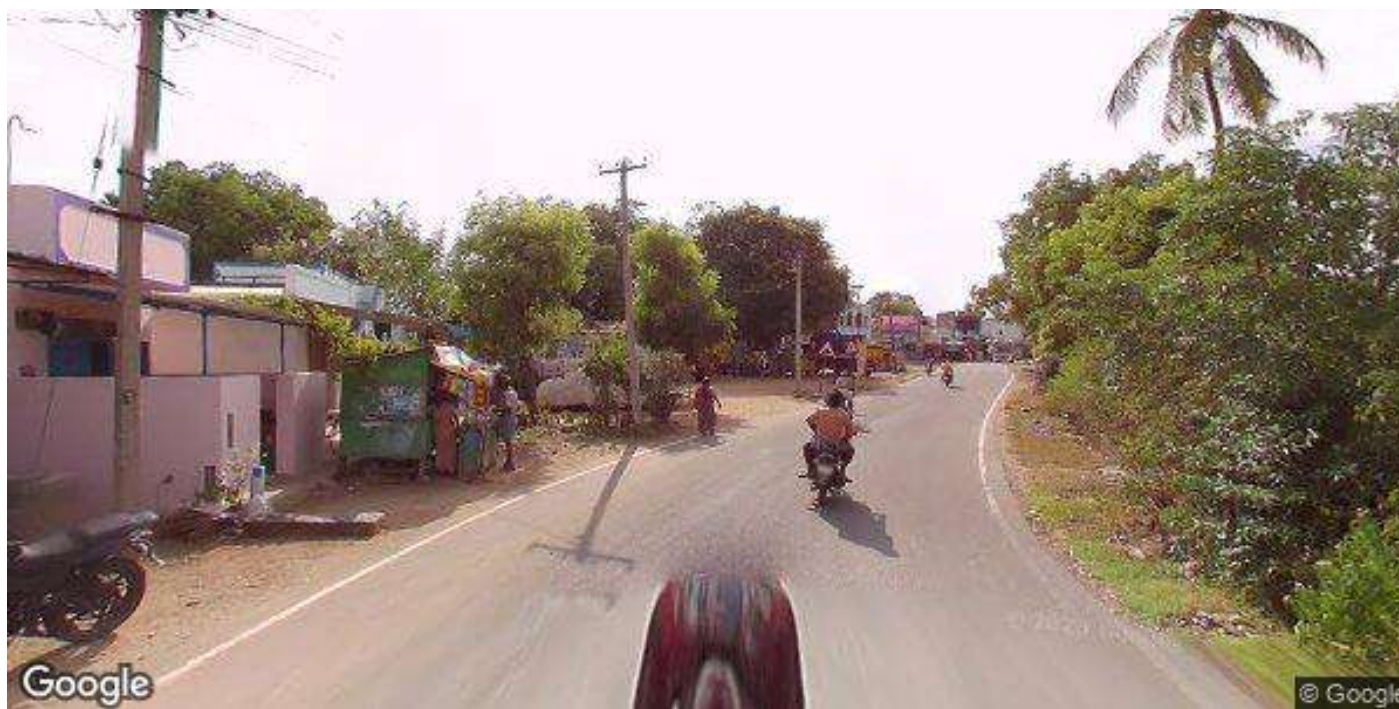
**Risk Type:** Turn  
**Risk Level:** Medium  
**Speed Limit:** 30 KM/Hr  
**Coordinates:** 11.46211, 78.48159

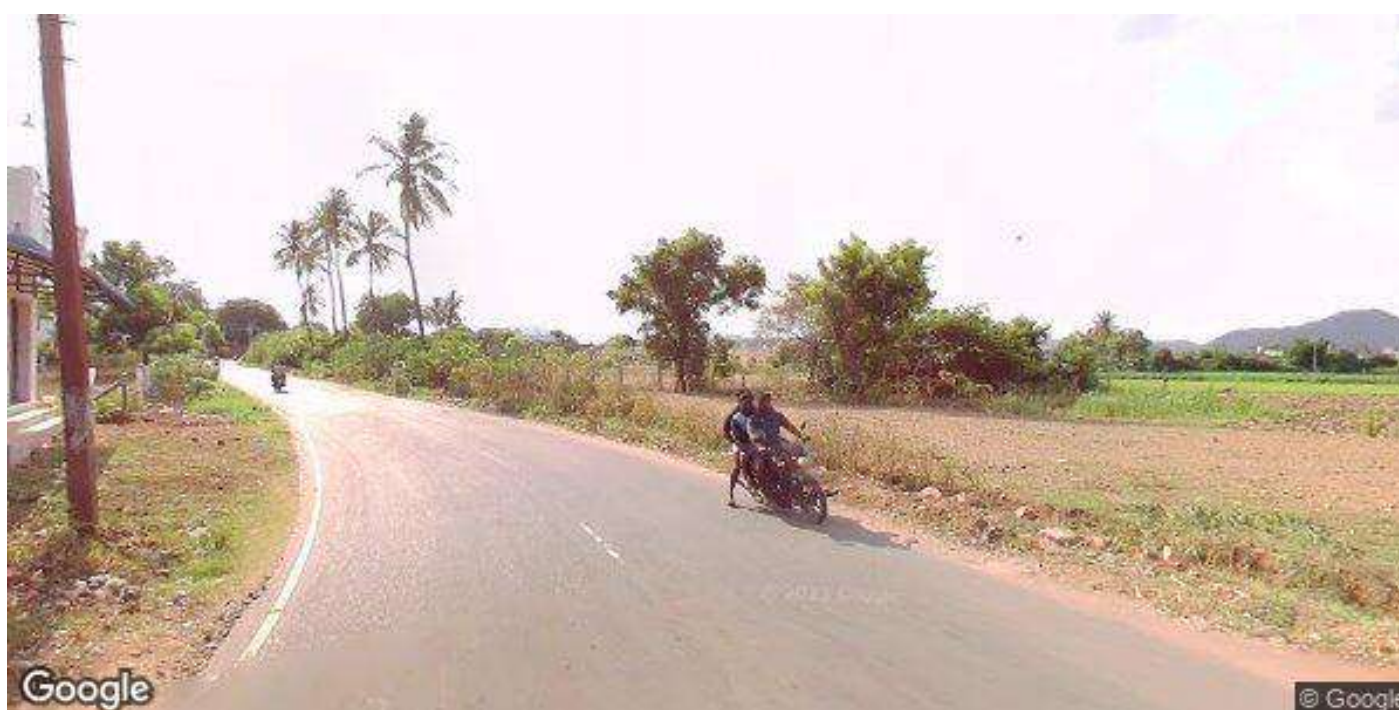
**Risk Type:** Turn  
**Risk Level:** Medium  
**Speed Limit:** 30 KM/Hr  
**Coordinates:** 11.46184, 78.48270

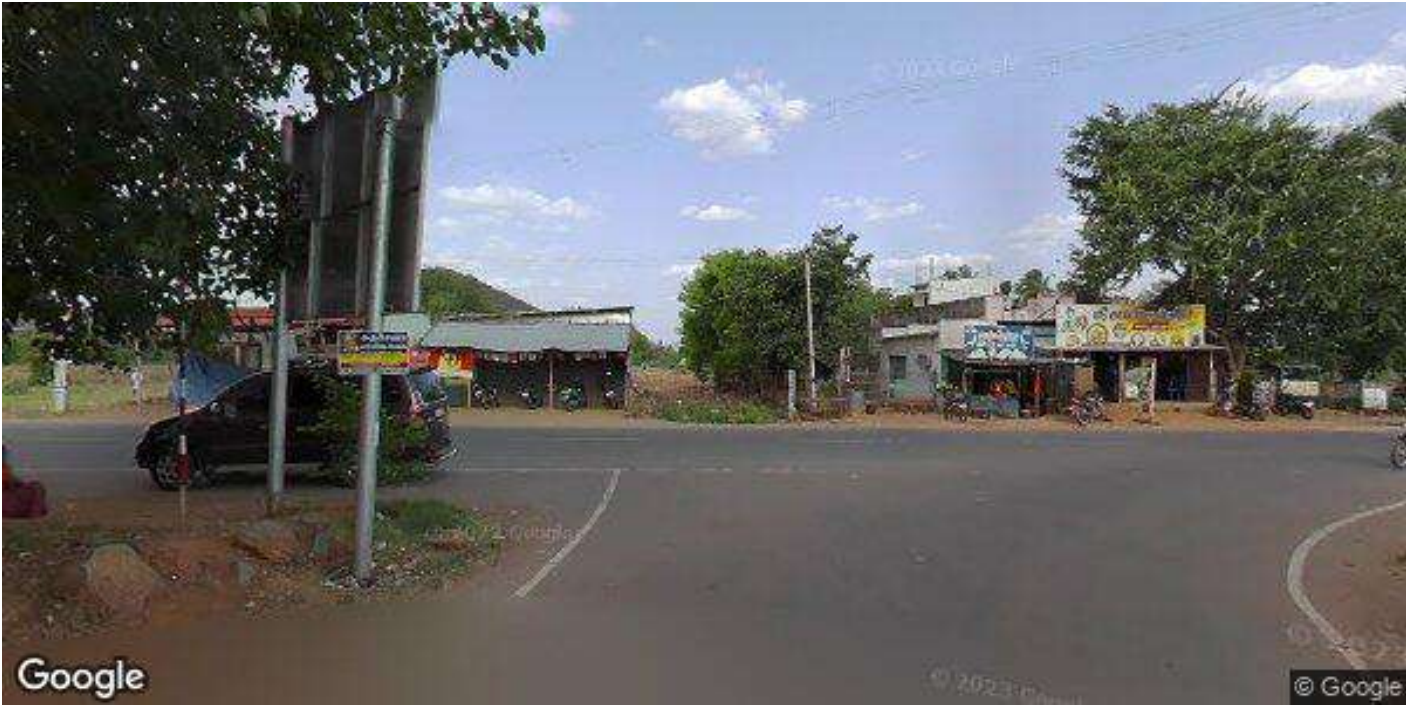
**Risk Type:** Turn  
**Risk Level:** High  
**Speed Limit:** 15 KM/Hr  
**Coordinates:** 11.46106, 78.48357
