# IndianOil

## JOURNEY RISK MANAGEMENT (JRM) STUDY

### Salem Terminal TO VIJAYALAKSHMI AGENCIES

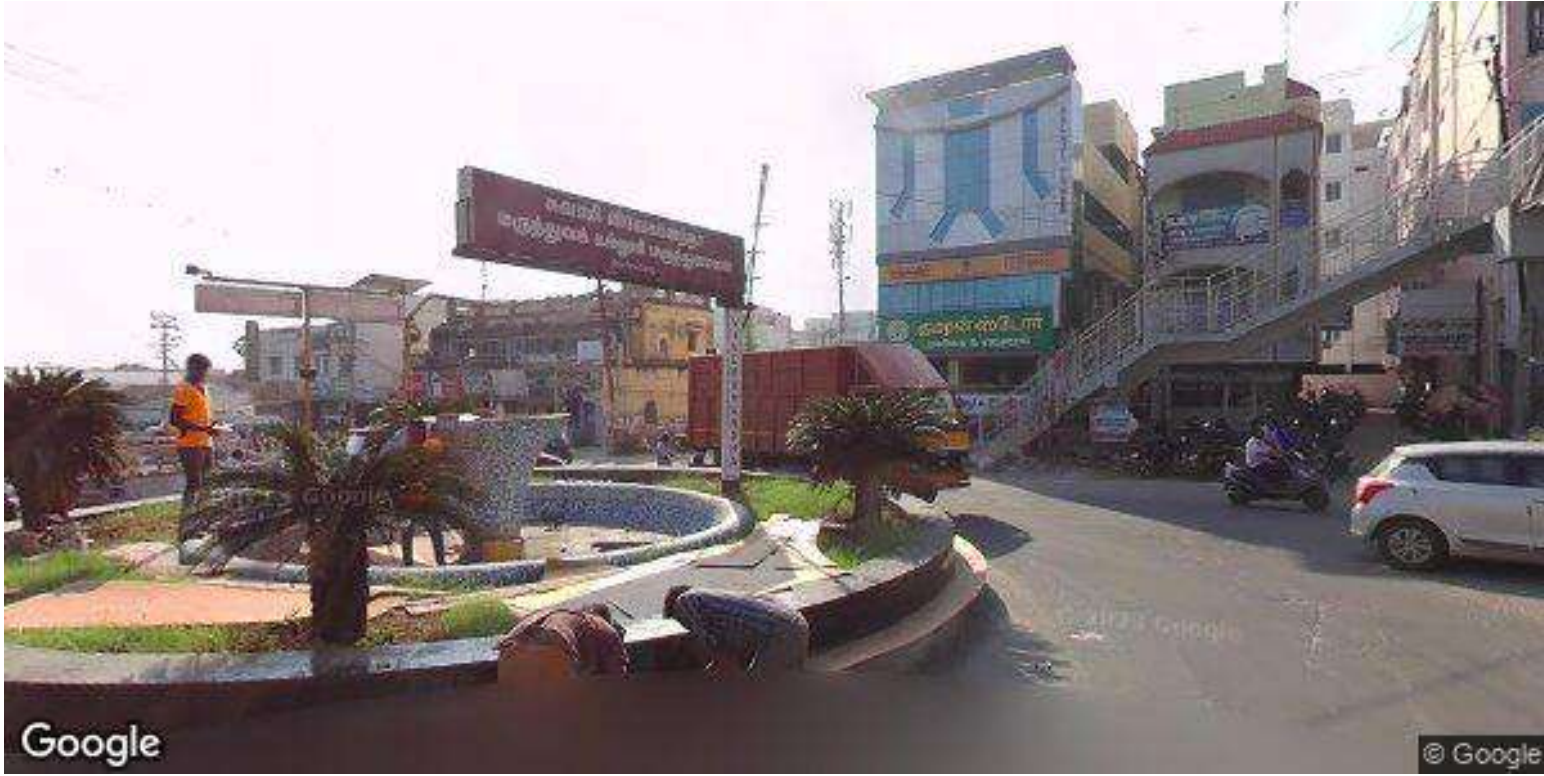
**Coordinates:** 11.38395, 77.89480

**Risk Type:** Roundabout

**Risk Level:** High

**Speed Limit:** 15 KM/Hr

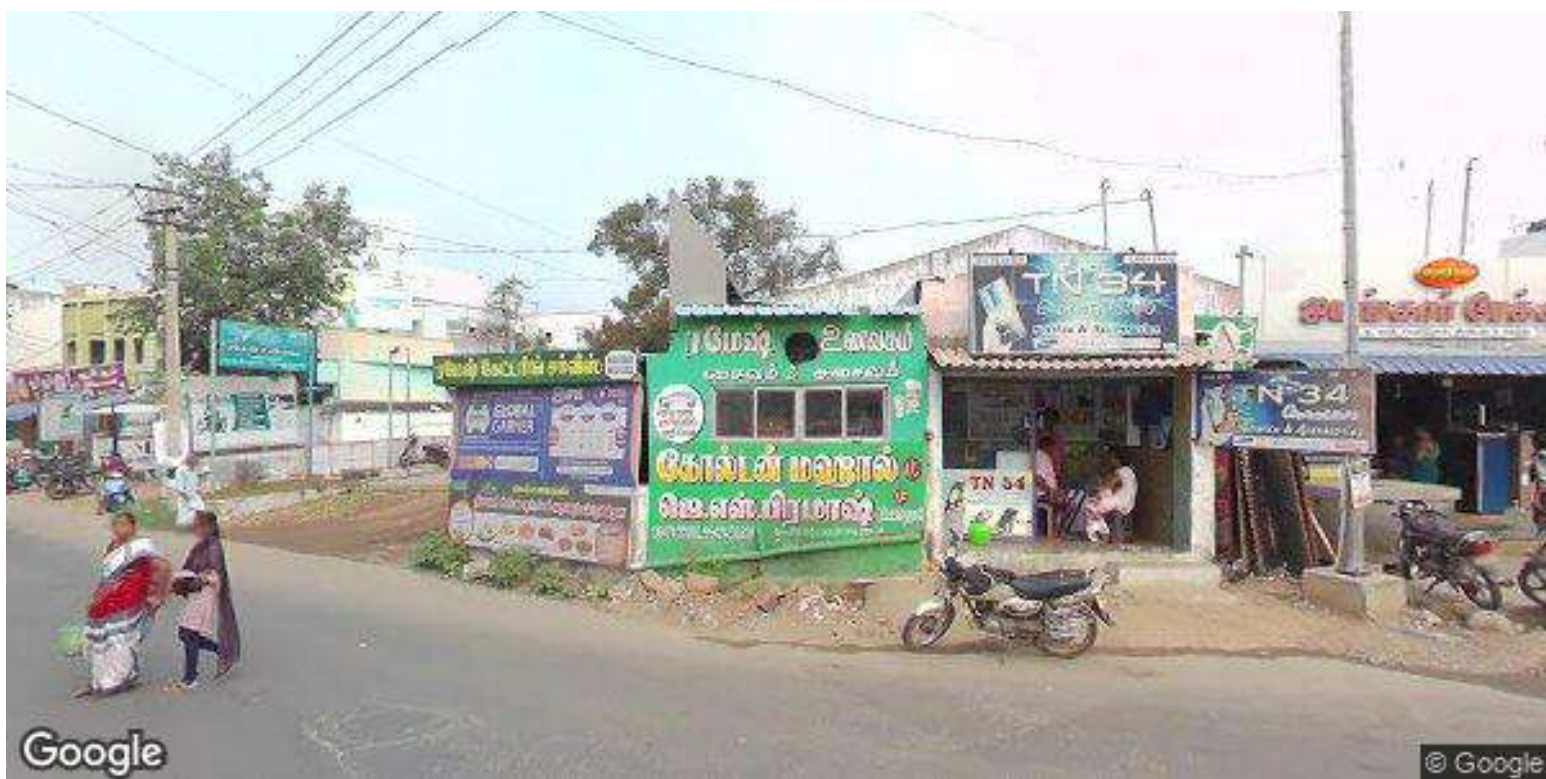
**Coordinates:** 11.38346, 77.89975

**Risk Type:** Turn

**Risk Level:** Medium

**Speed Limit:** 30 KM/Hr

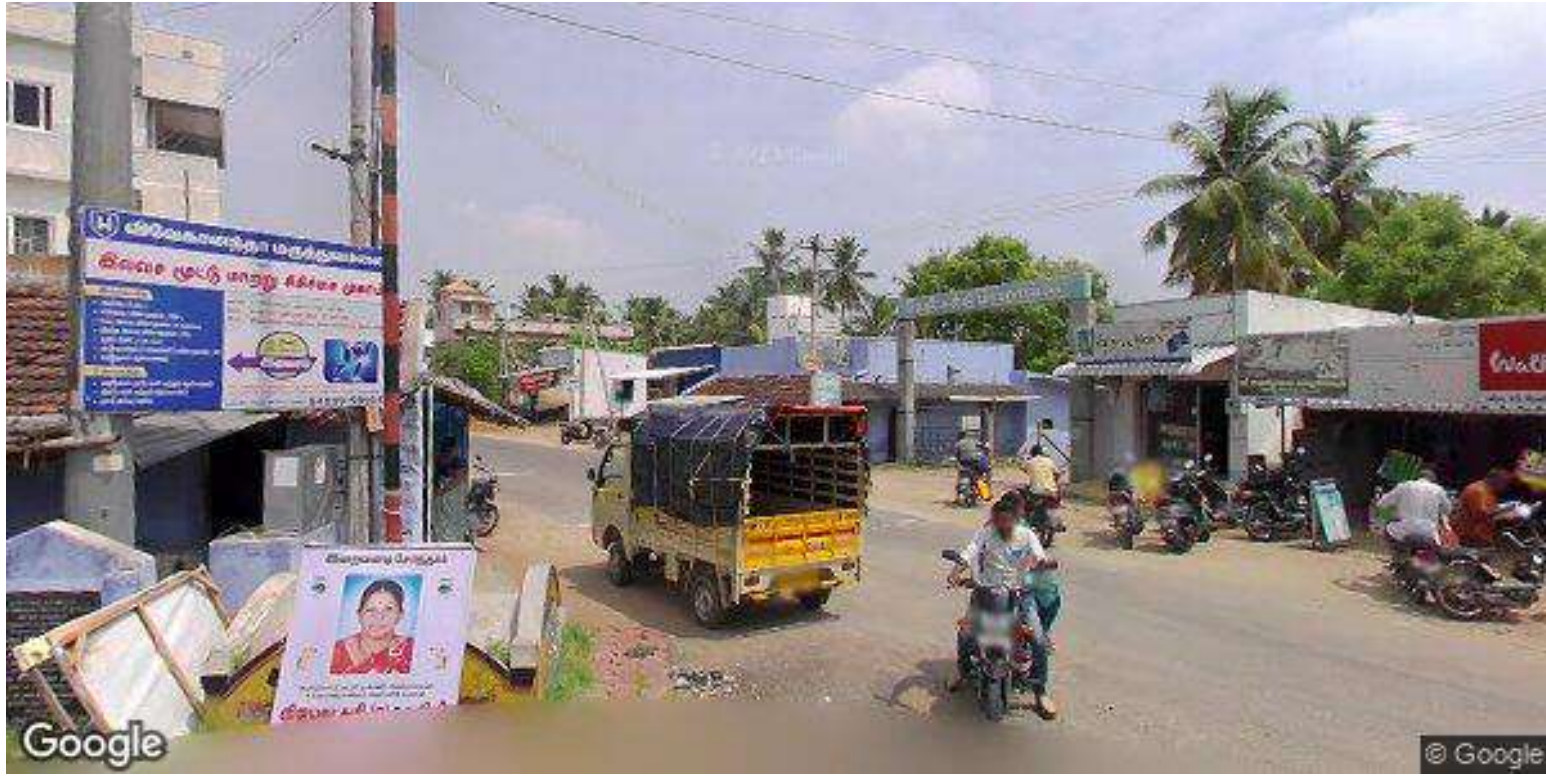
**Risk Type:** Blind Spot  
**Risk Level:** Blind Spot  
**Speed Limit:** 10 KM/Hr  
**Coordinates:** 11.44391, 77.96278

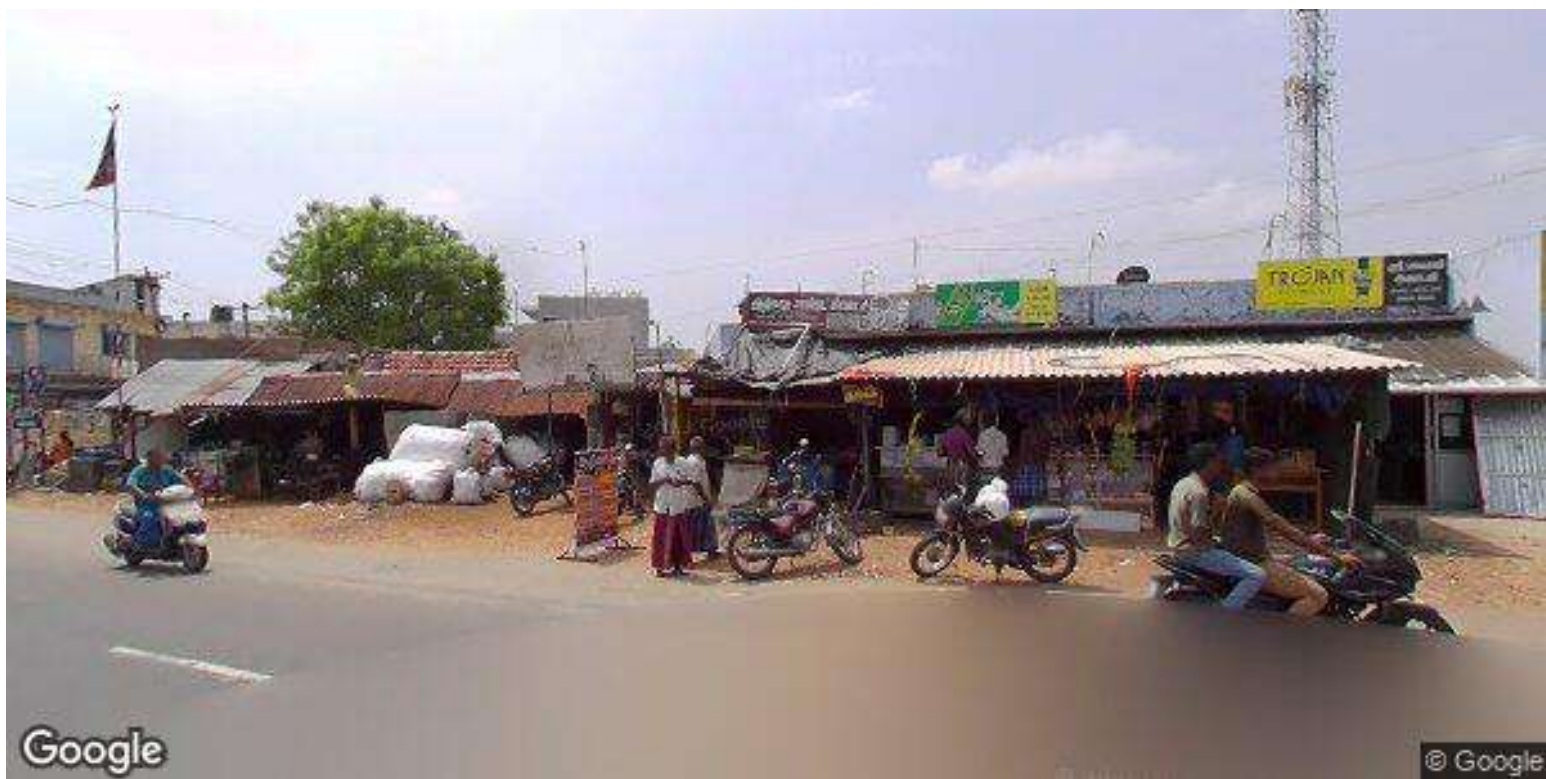
**Risk Type:** Turn  
**Risk Level:** High  
**Speed Limit:** 15 KM/Hr  
**Coordinates:** 11.44387, 77.96283

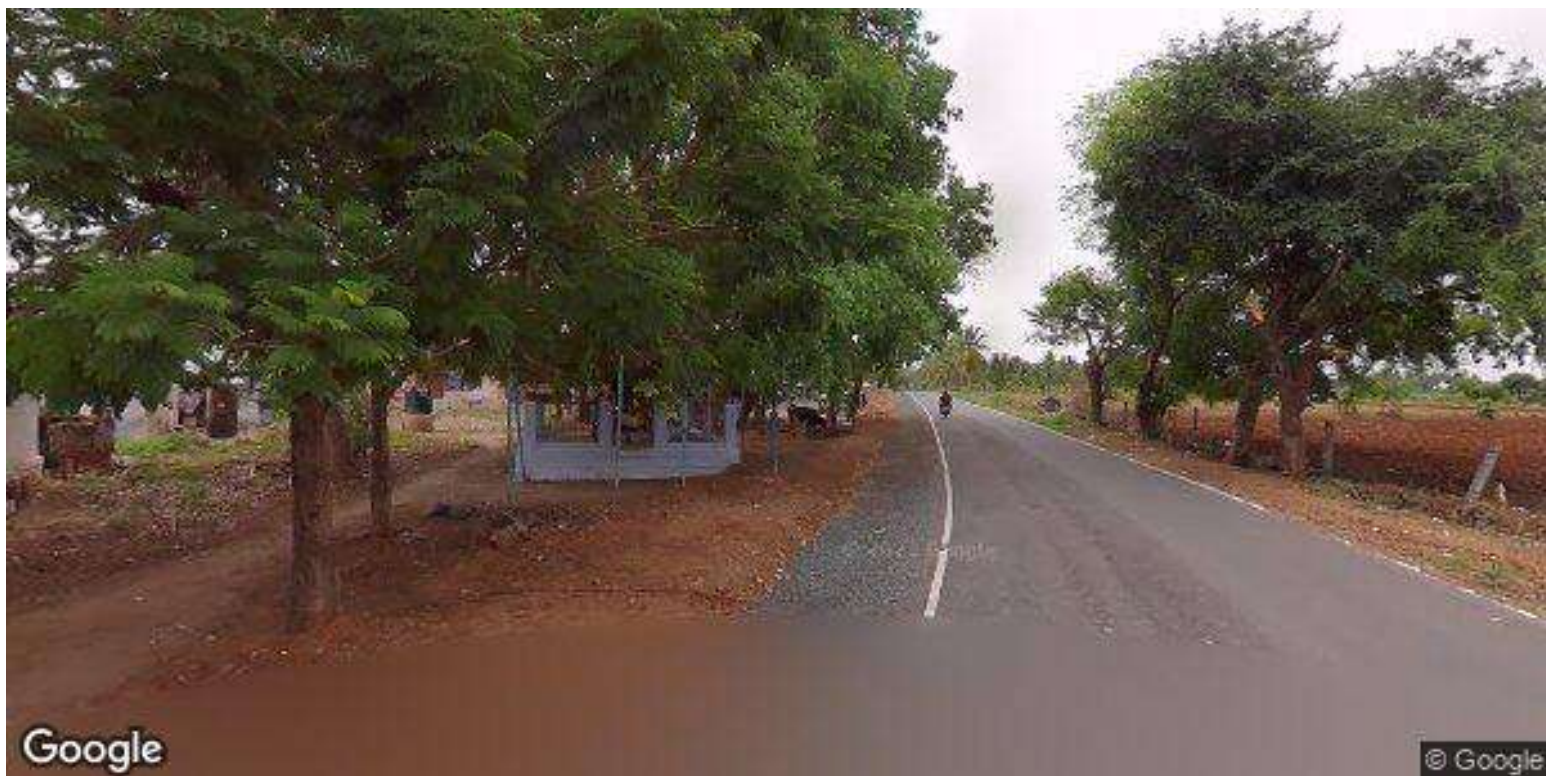
**Coordinates:** 11.46721, 78.04520

**Risk Type:** Turn

**Risk Level:** Medium

**Speed Limit:** 30 KM/Hr
