# IndianOil

## **JOURNEY RISK MANAGEMENT (JRM) STUDY**

### **Salem Terminal TO SRE AMMAN AGENCIES**

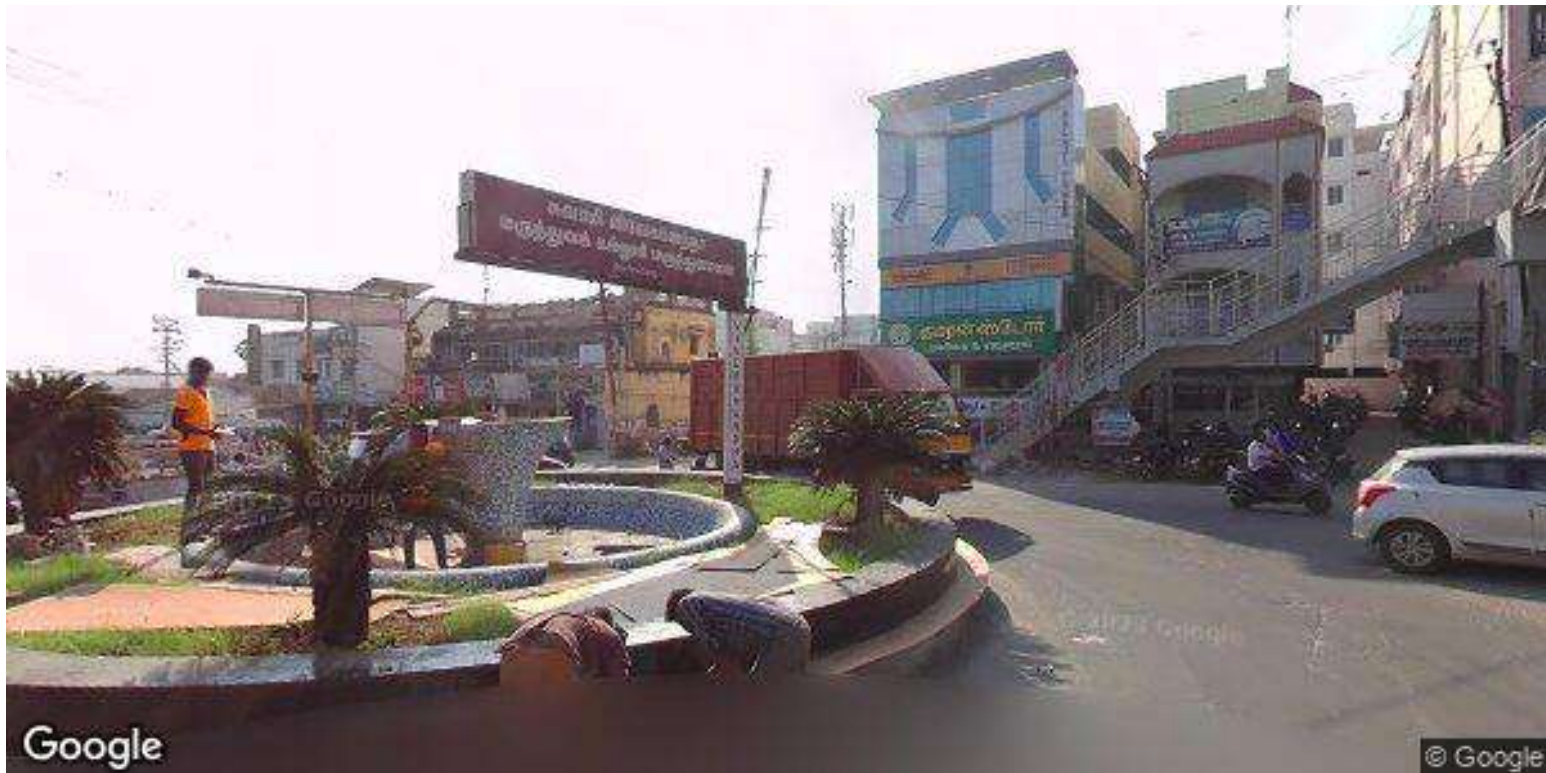
**Speed Limit: 15 KM/Hr**  
**Coordinates: 11.38395, 77.89480**

**Risk Type:** Roundabout

**Risk Level:** High

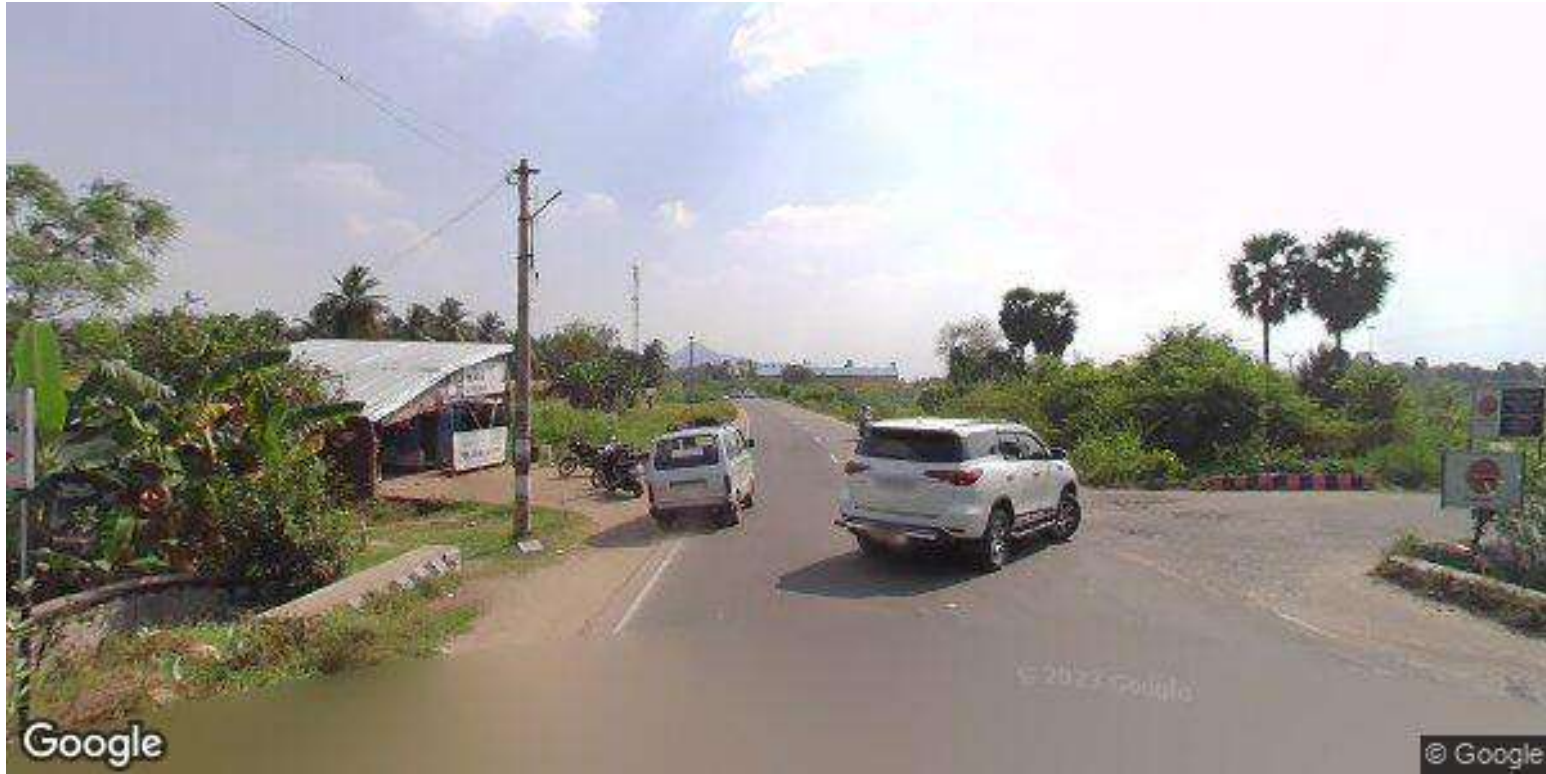
**Risk Type: Blind Spot**  
**Risk Level: Blind Spot**  
**Speed Limit: 10 KM/Hr**  
**Coordinates: 11.44029, 77.87544**

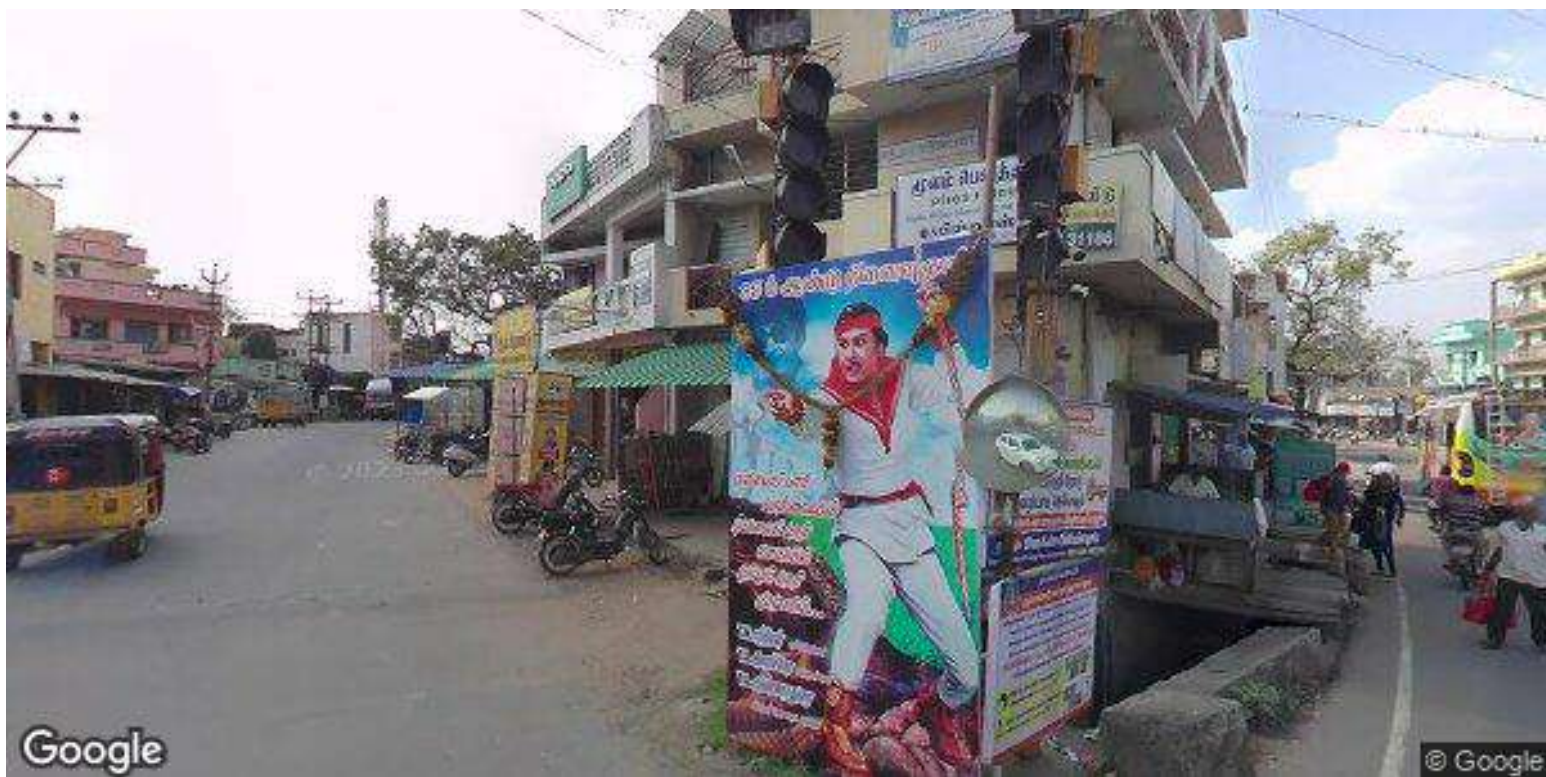
**Risk Type: Turn**  
**Risk Level: Medium**  
**Speed Limit: 30 KM/Hr**  
**Coordinates: 11.38342, 77.89975**

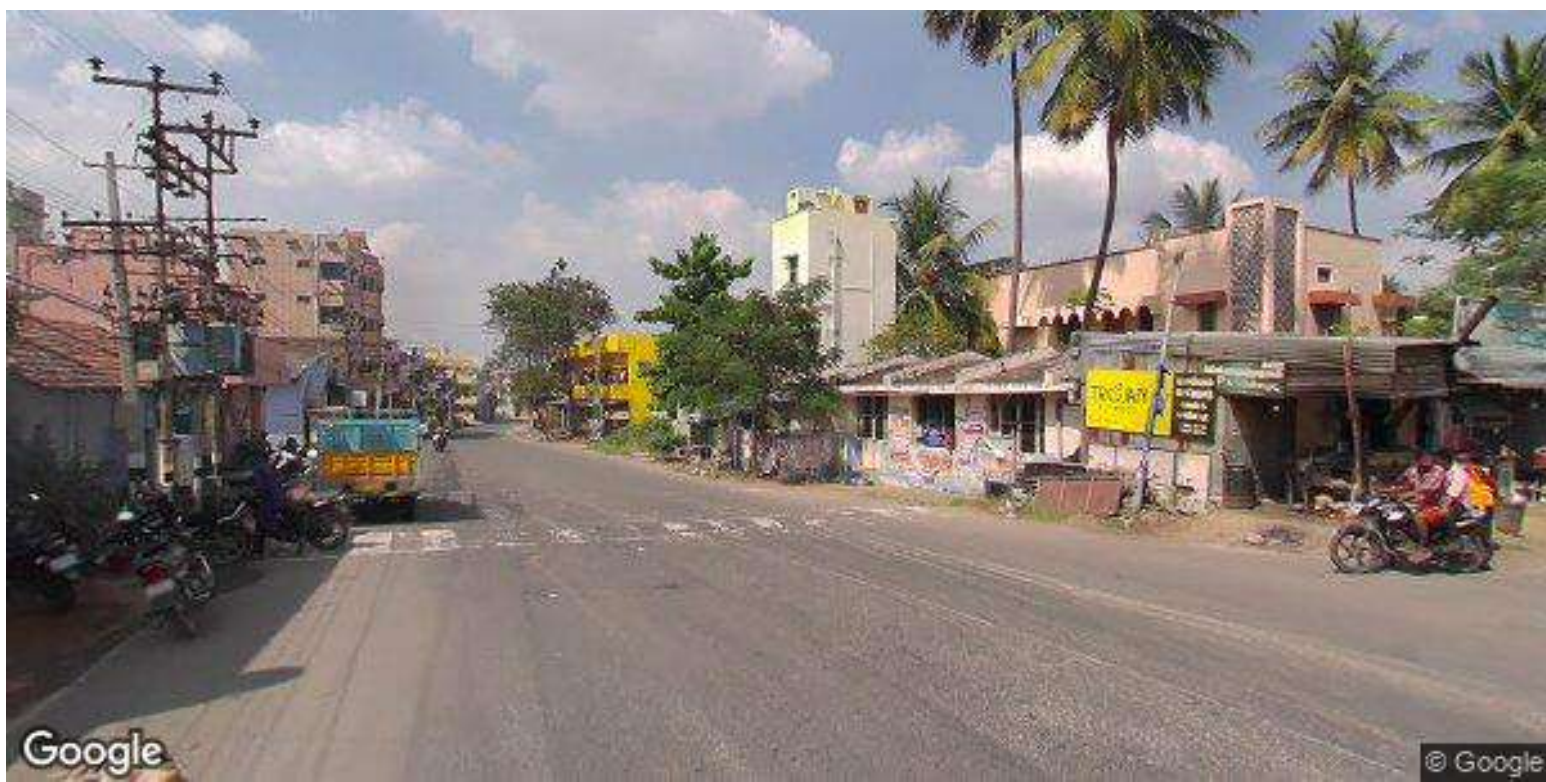
**Coordinates:** 11.38190, 77.90254

**Risk Type:** Turn

**Risk Level:** High

**Speed Limit:** 15 KM/Hr

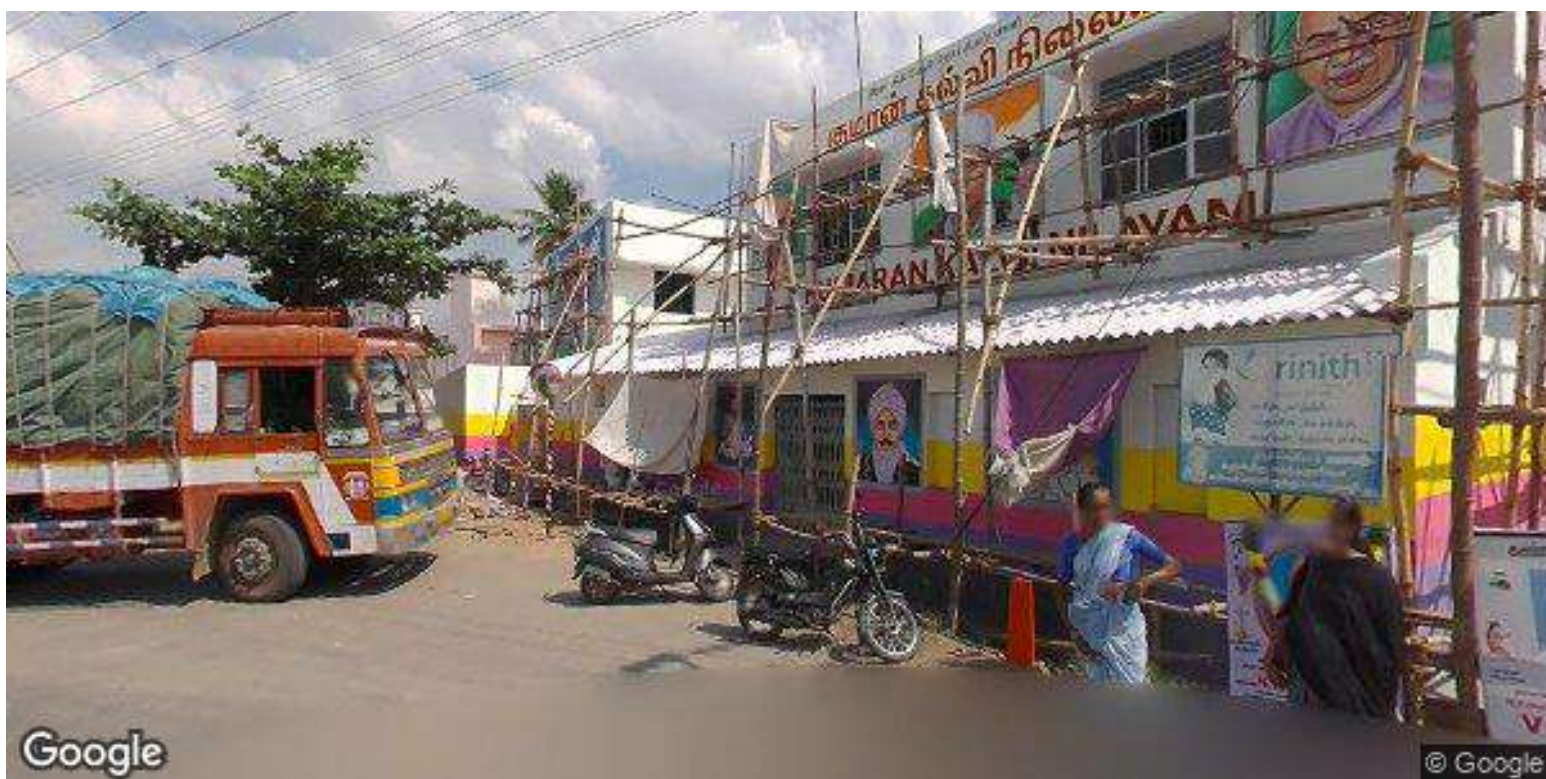
**Coordinates:** 11.38182, 77.90259

**Risk Type:** Turn

**Risk Level:** Medium

**Speed Limit:** 30 KM/Hr

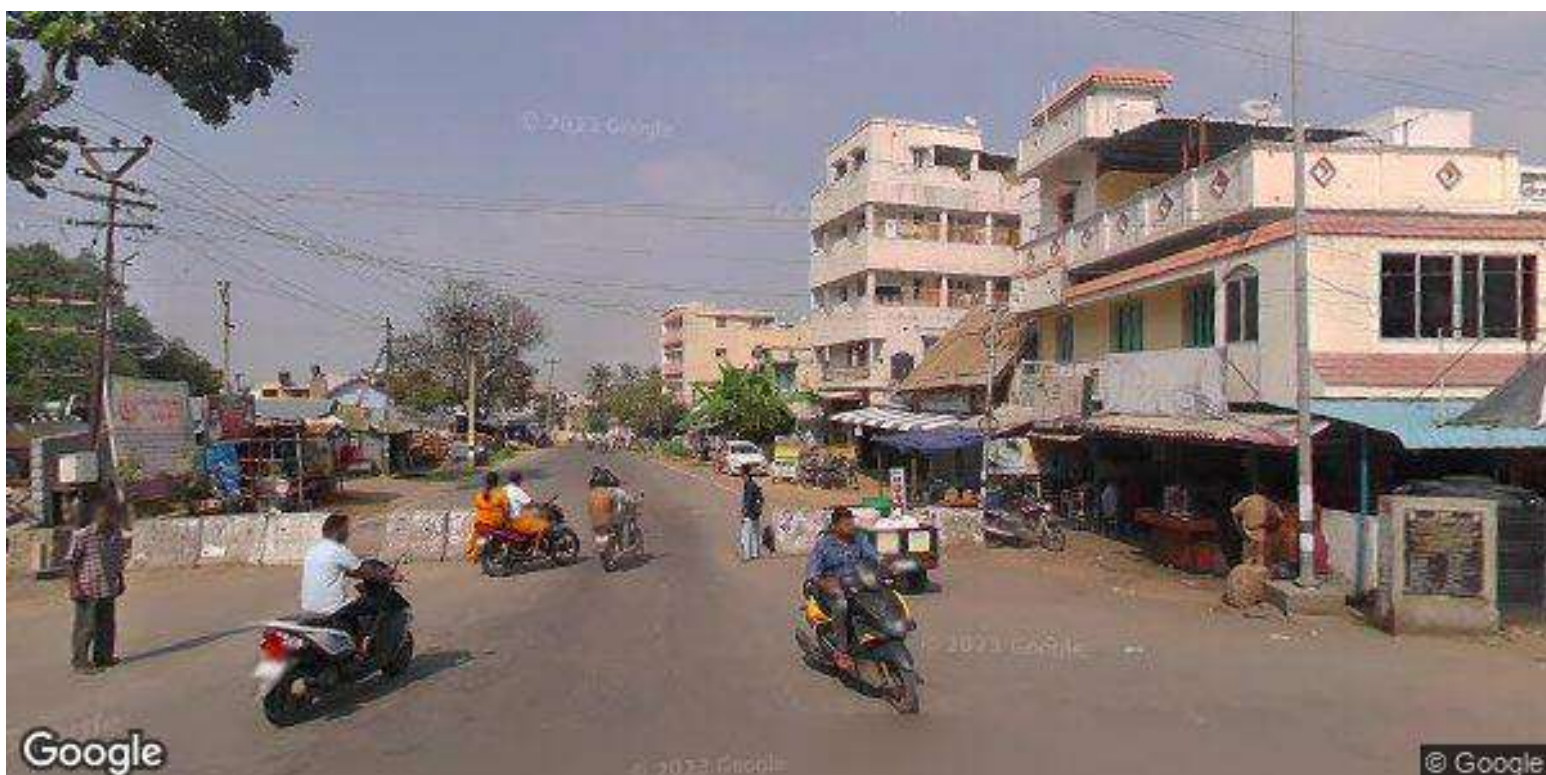
**Risk Type:** Blind Spot  
**Risk Level:** Blind Spot  
**Speed Limit:** 10 KM/Hr  
**Coordinates:** 11.37841, 77.90140

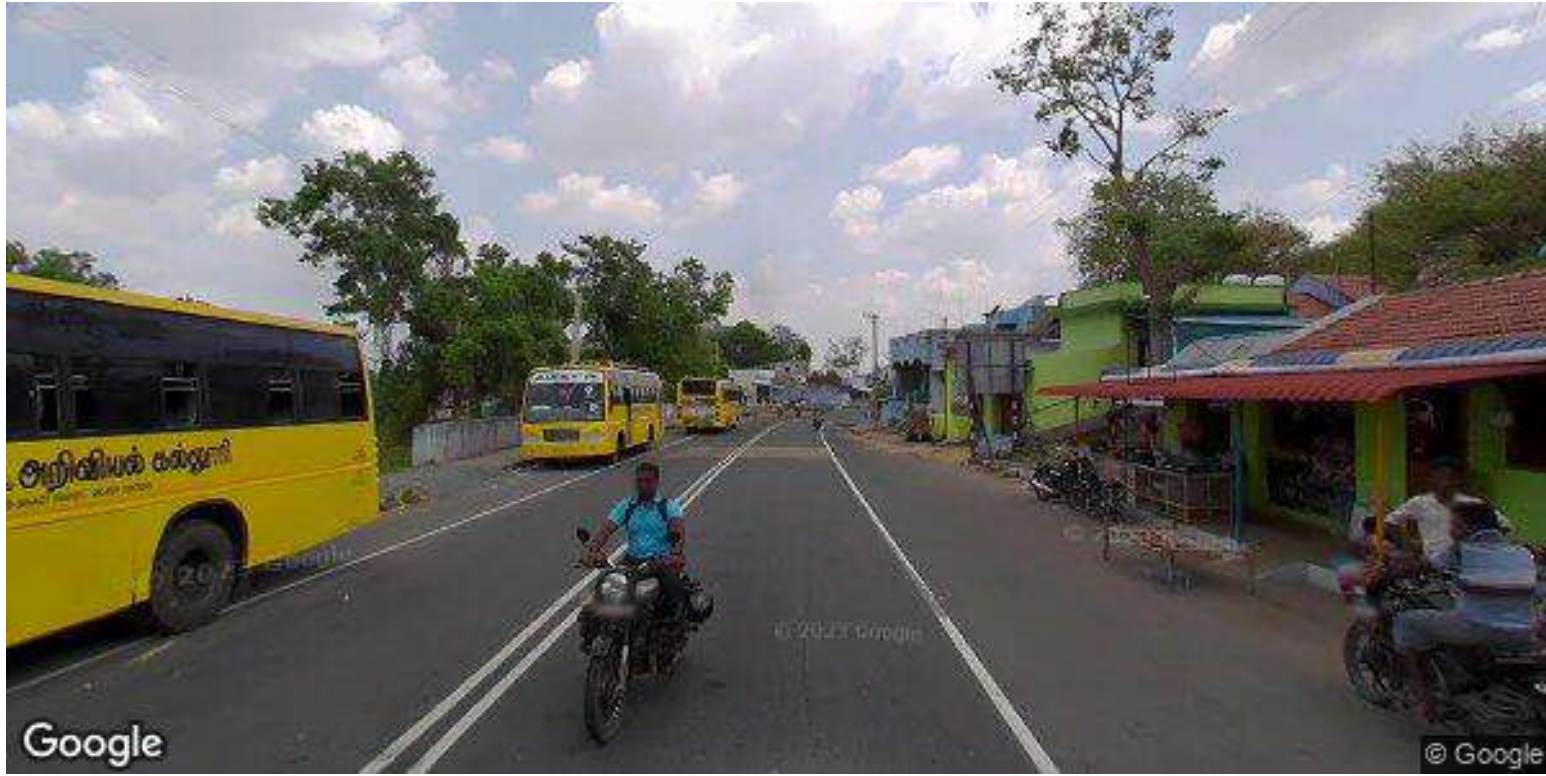
**Risk Type:** Blind Spot  
**Risk Level:** Blind Spot  
**Speed Limit:** 10 KM/Hr  
**Coordinates:** 11.41410, 78.08065

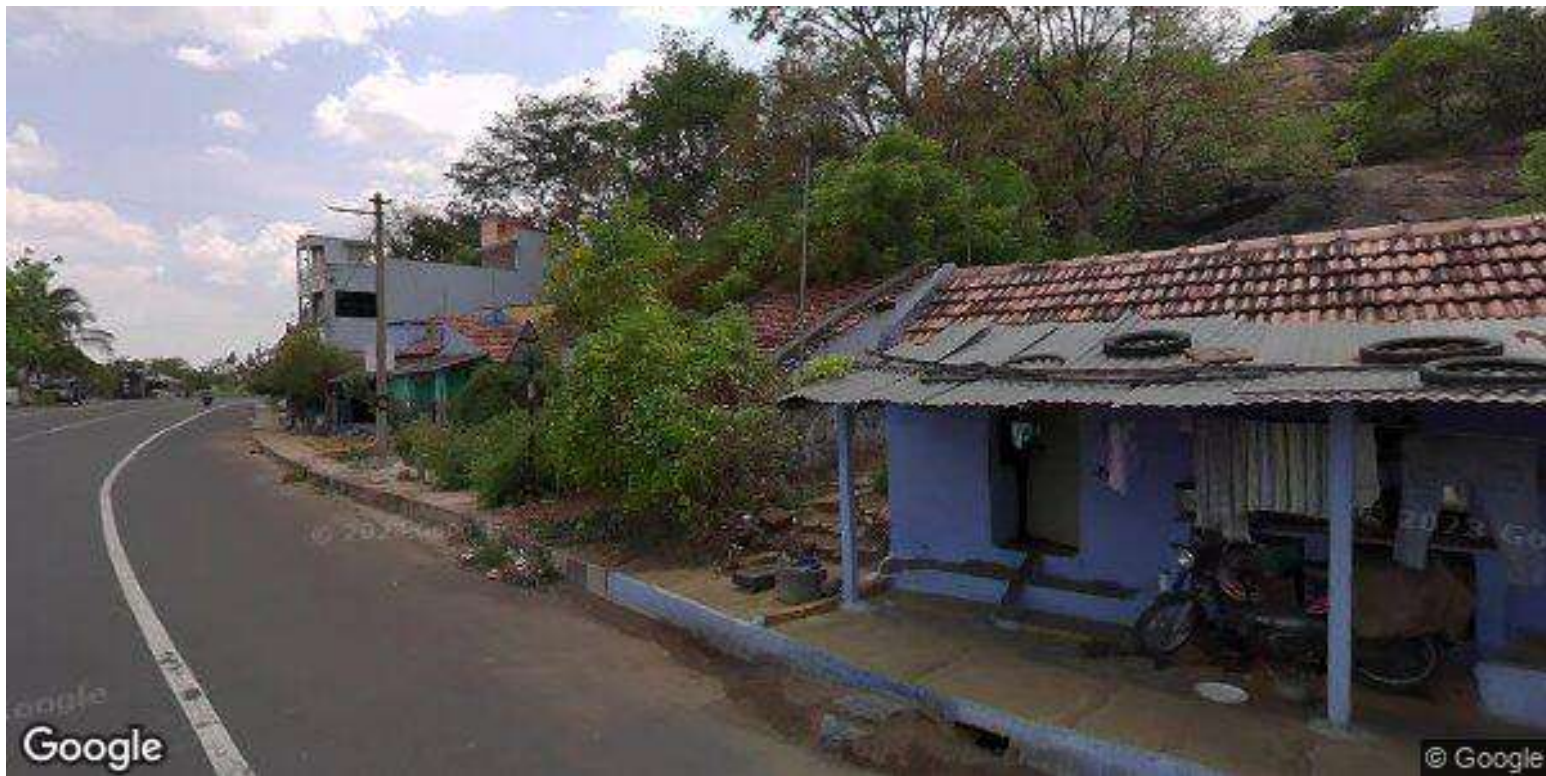
**Risk Type:** Turn  
**Risk Level:** Medium  
**Speed Limit:** 30 KM/Hr  
**Coordinates:** 11.41321, 78.08067

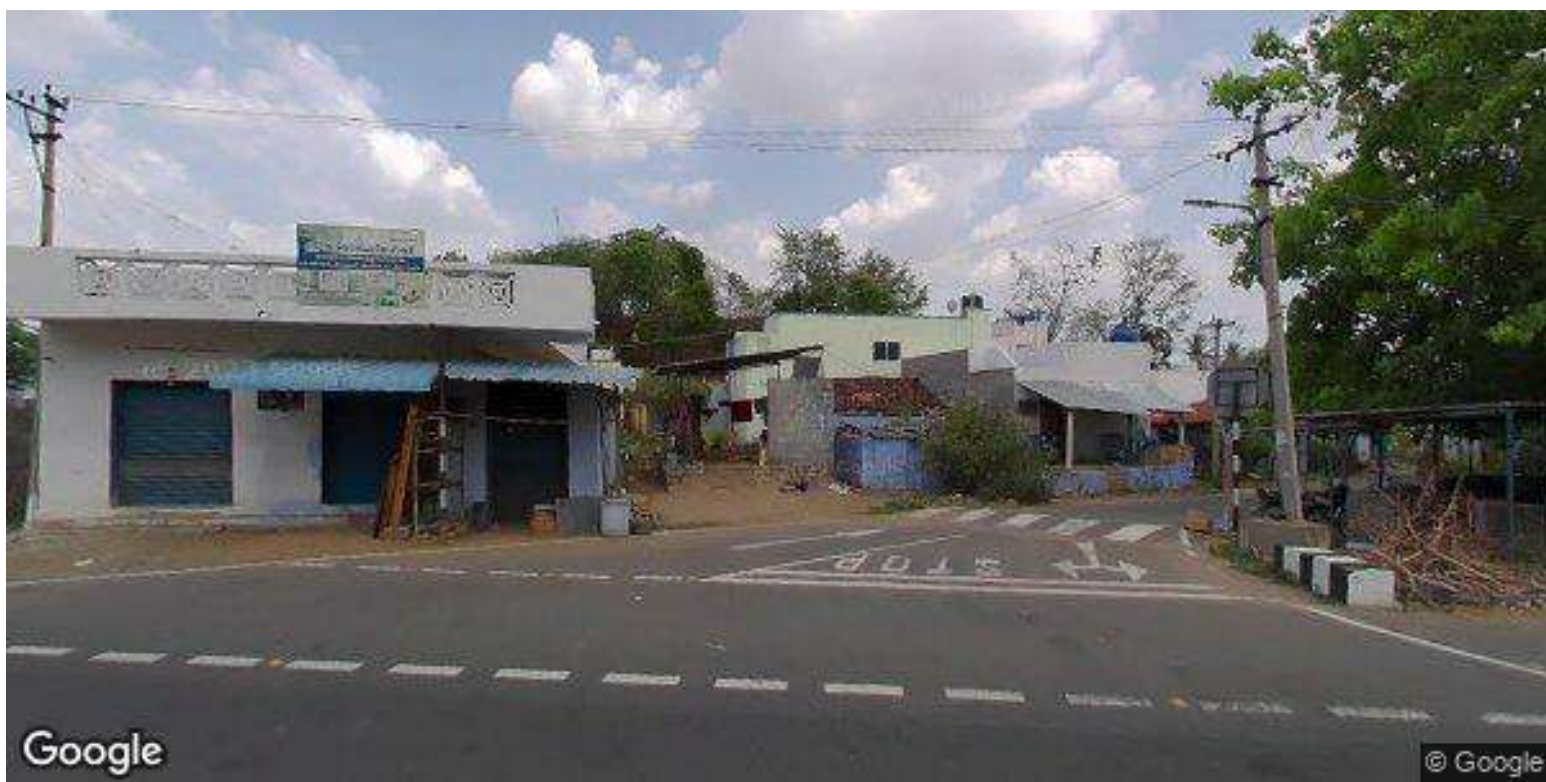
**Coordinates:** 11.41276, 78.08042

**Risk Type:** Turn

**Risk Level:** Medium

**Speed Limit:** 30 KM/Hr

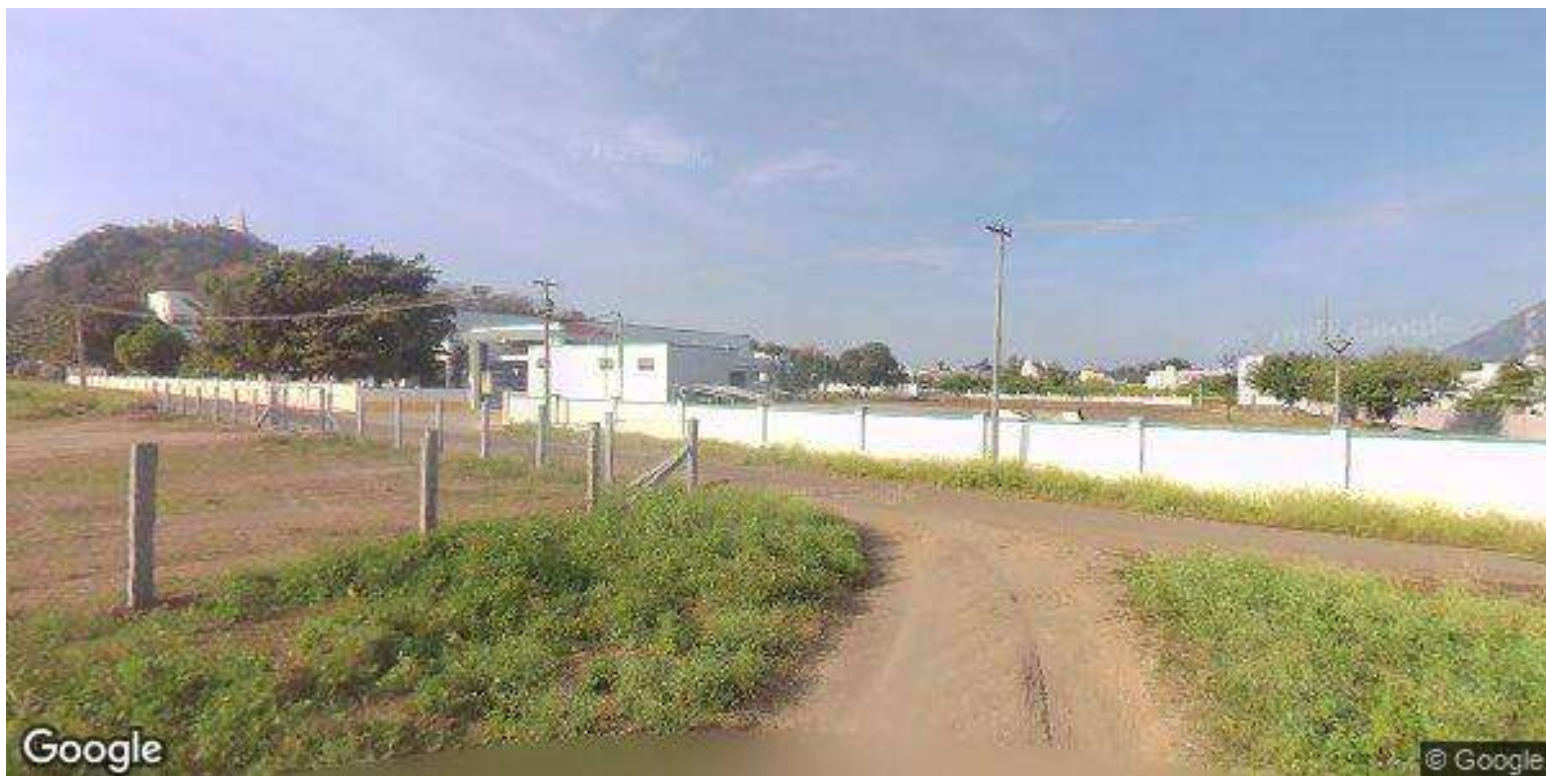
**Coordinates:** 11.41113, 78.08228

**Risk Type:** Turn

**Risk Level:** High

**Speed Limit:** 15 KM/Hr

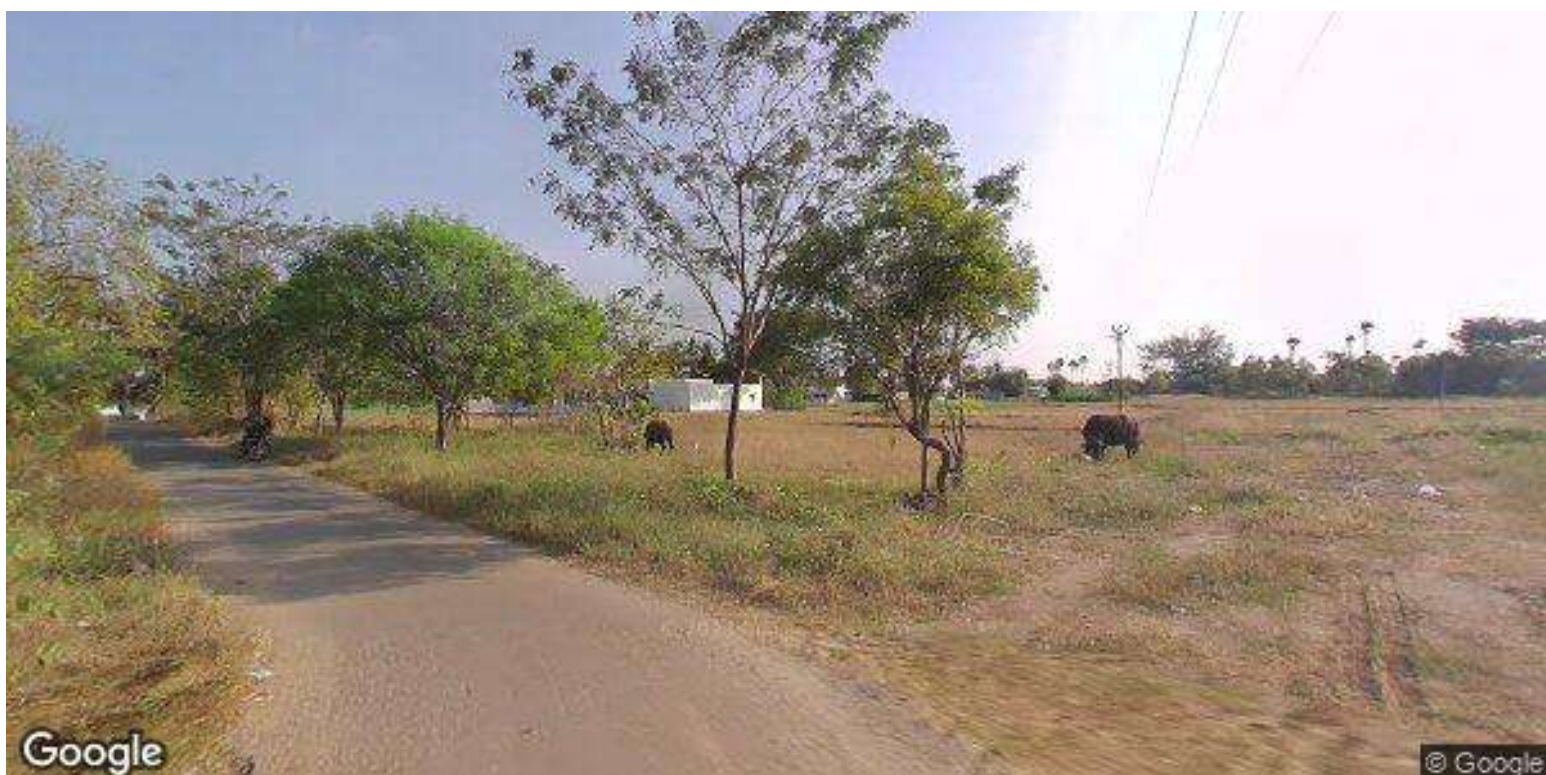
**Risk Type:** Turn  
**Risk Level:** High  
**Speed Limit:** 15 KM/Hr  
**Coordinates:** 11.41077, 78.08224

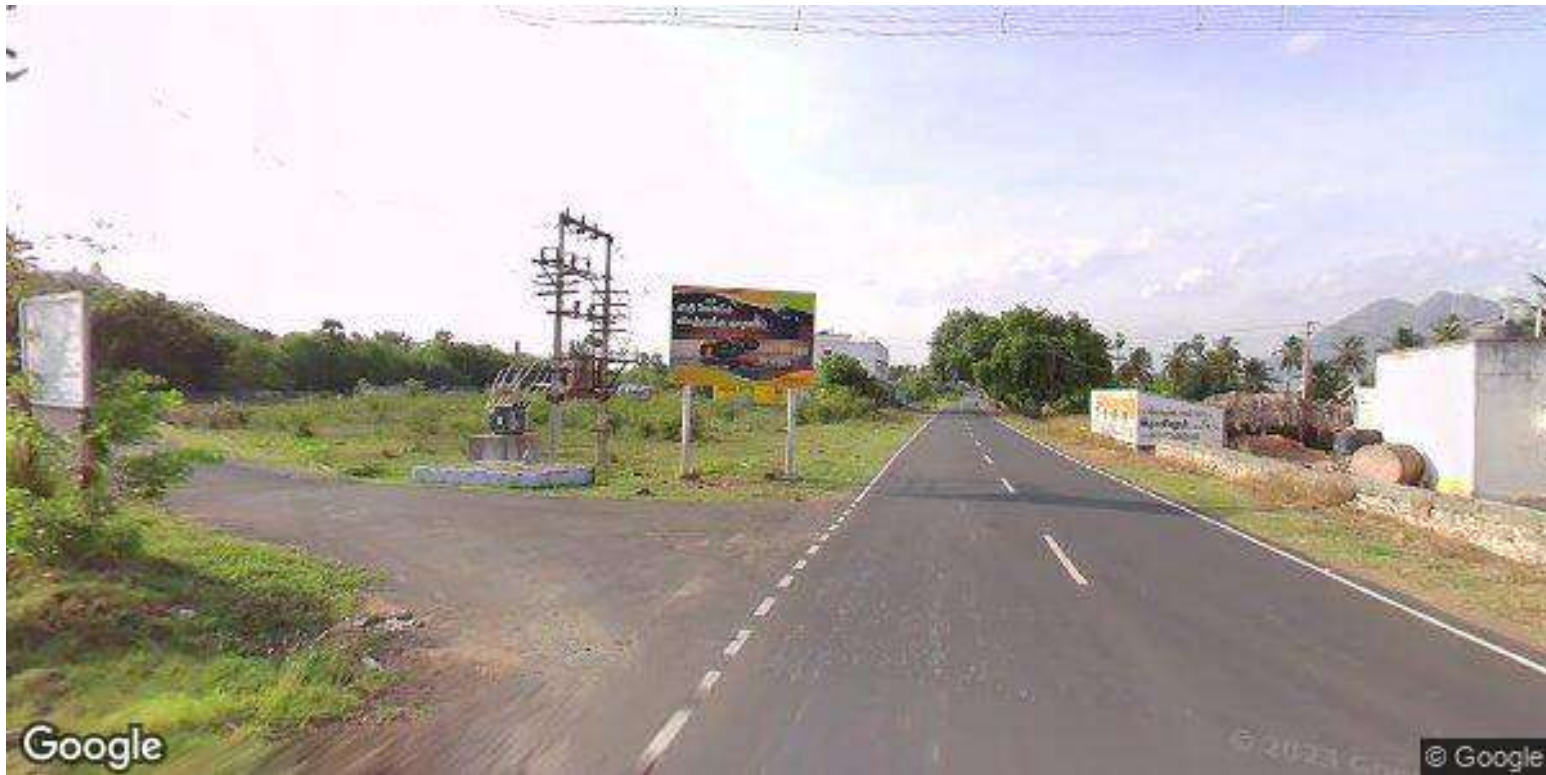
**Risk Type:** Turn  
**Risk Level:** High  
**Speed Limit:** 15 KM/Hr  
**Coordinates:** 11.40979, 78.08384

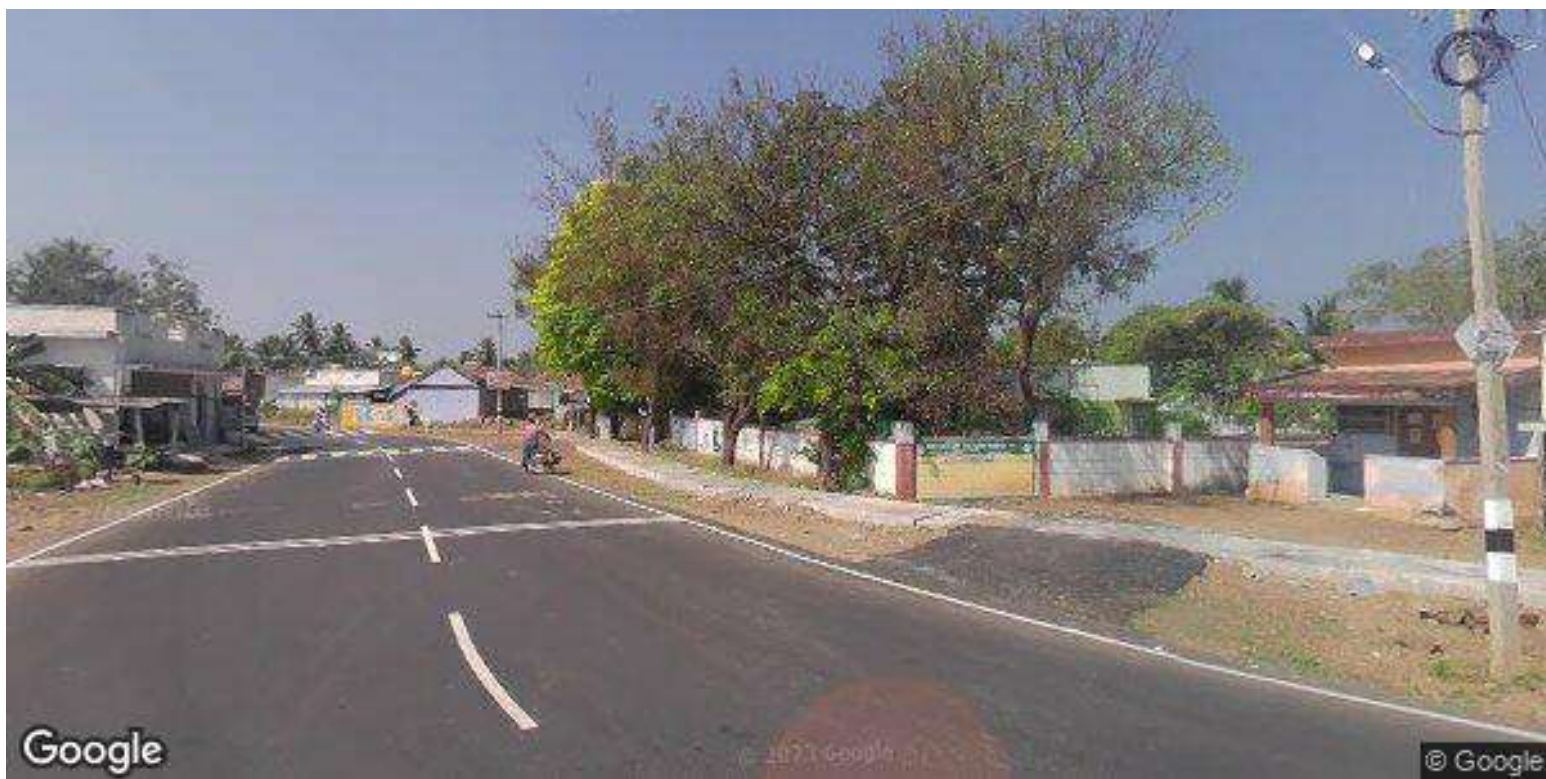
**Risk Type:** Turn  
**Risk Level:** High  
**Speed Limit:** 15 KM/Hr  
**Coordinates:** 11.39425, 78.08455

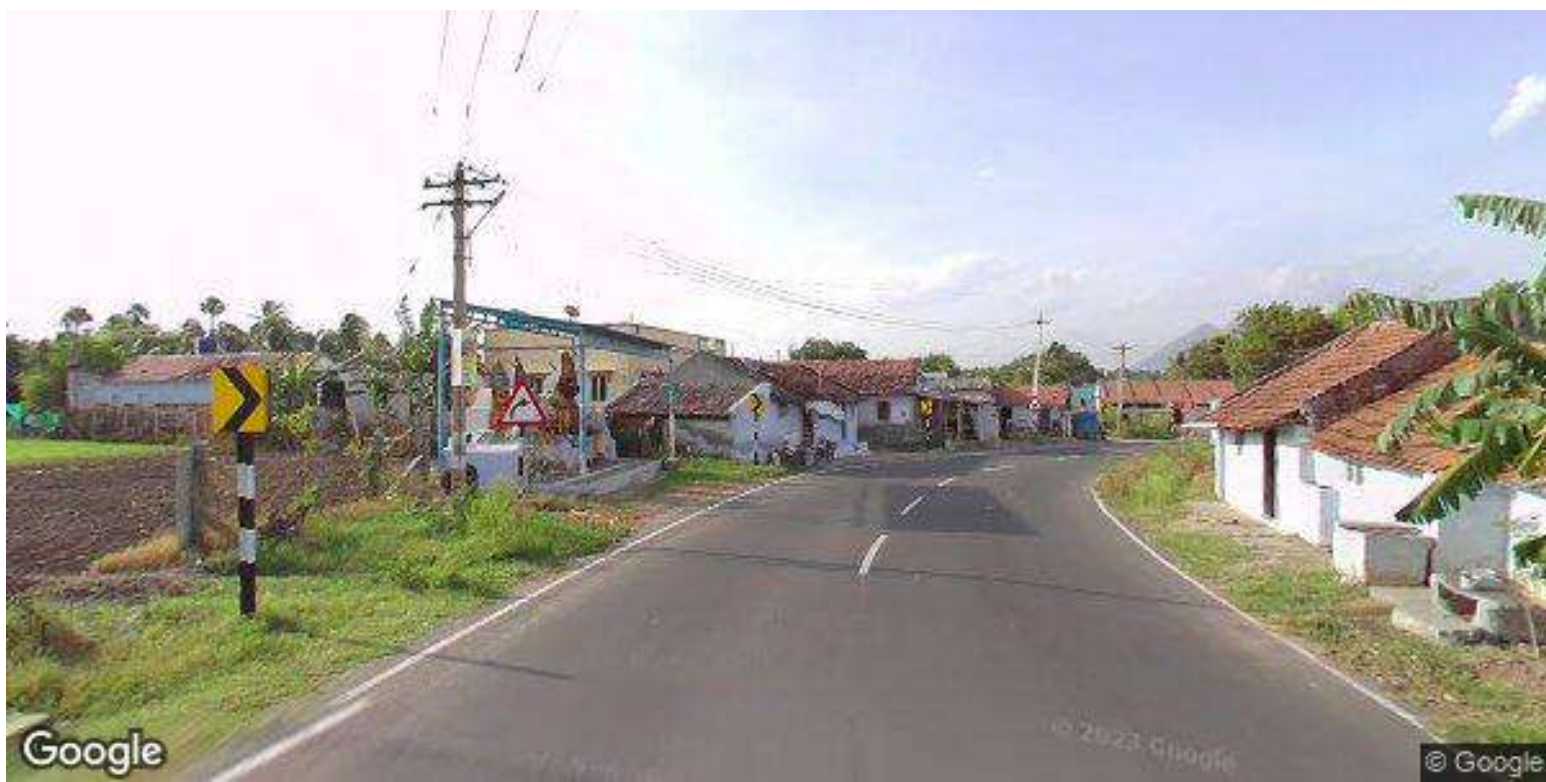
**Coordinates:** 11.39350, 78.08368

**Risk Type:** Turn

**Risk Level:** Medium

**Speed Limit:** 30 KM/Hr

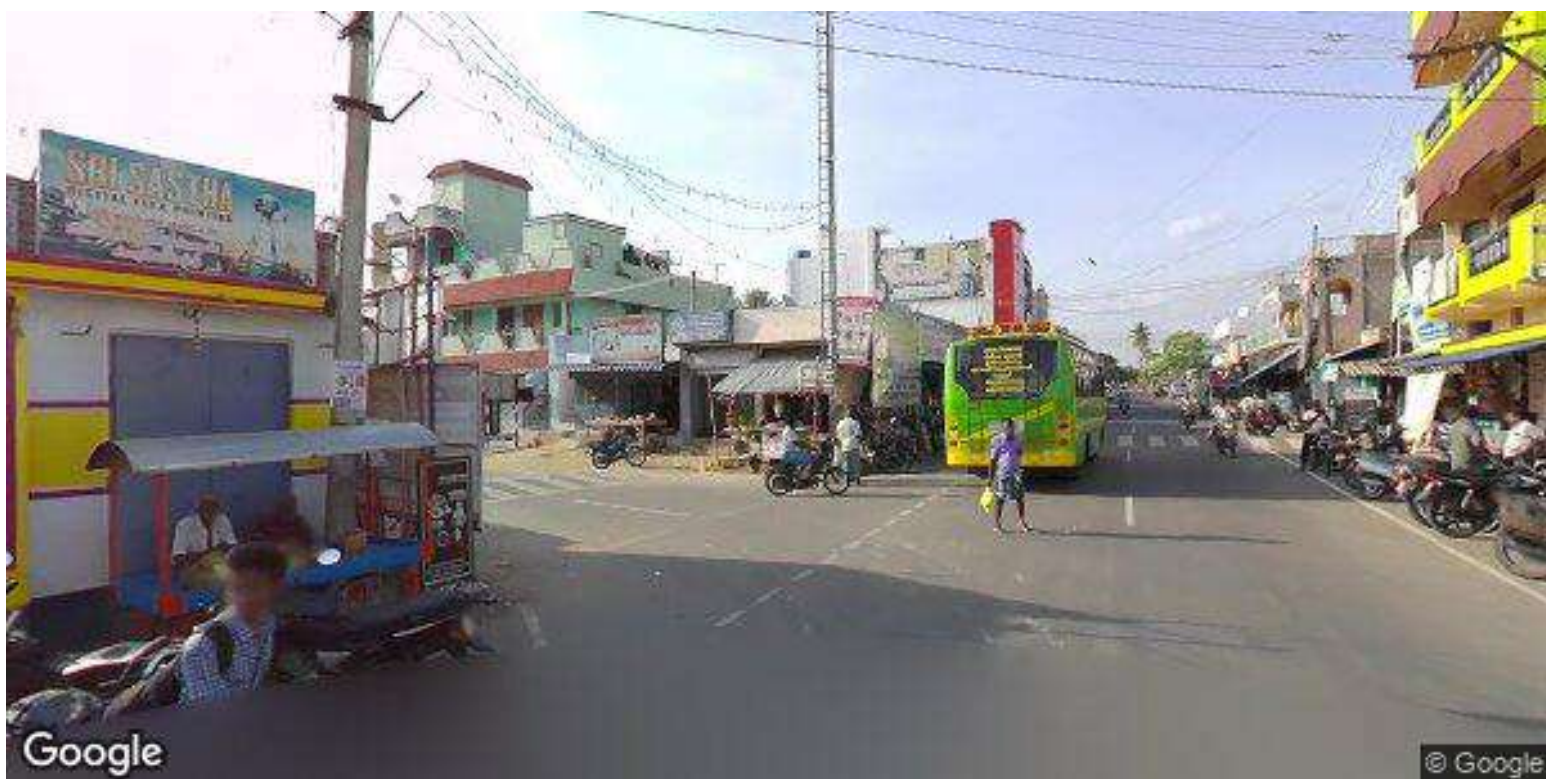
**Coordinates:** 11.37119, 78.07401

**Risk Type:** Turn

**Risk Level:** High

**Speed Limit:** 15 KM/Hr

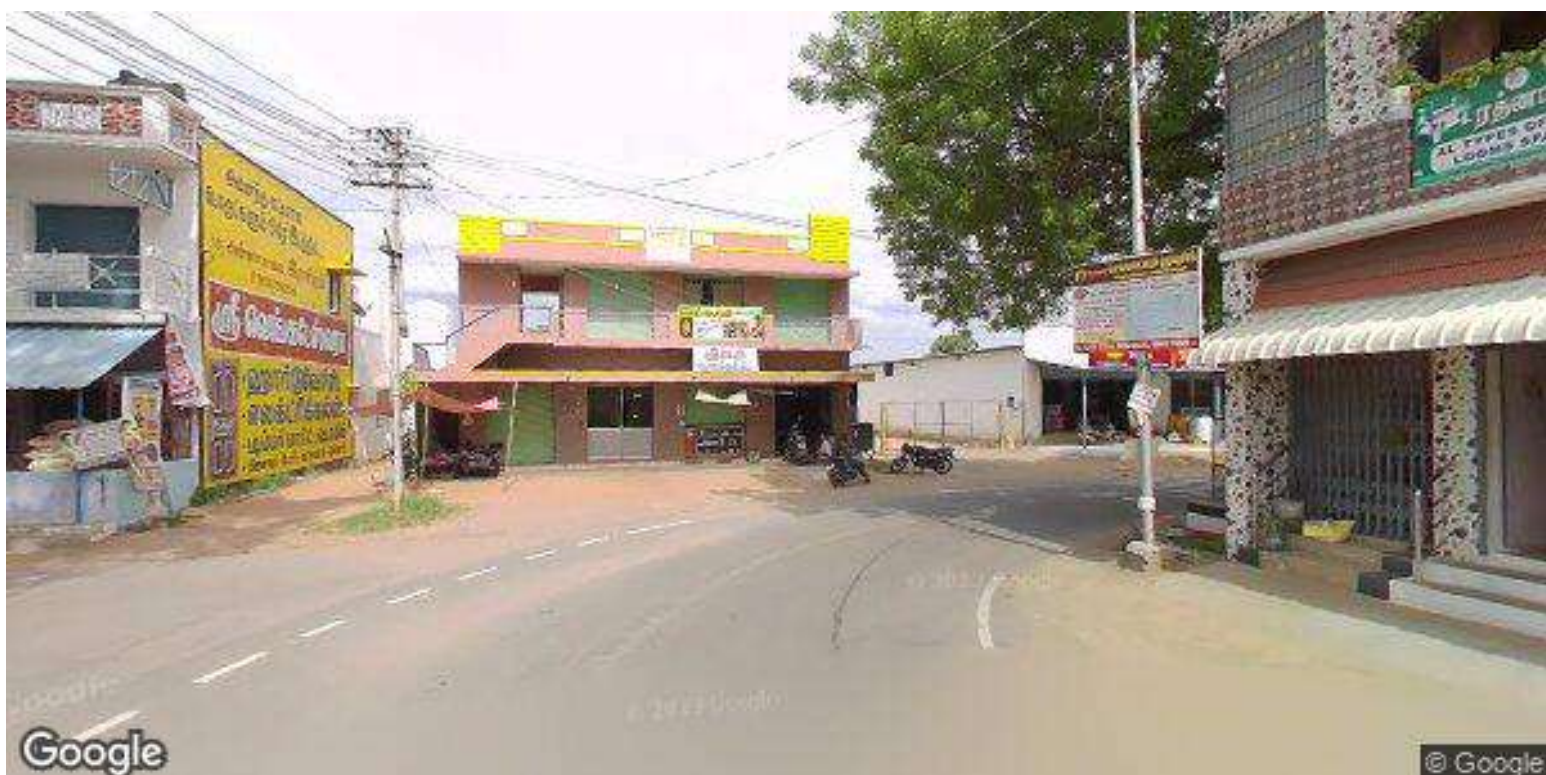
**Coordinates: 11.36691, 78.08320**

**Risk Type: Turn**

**Risk Level: High**

**Speed Limit: 15 KM/Hr**

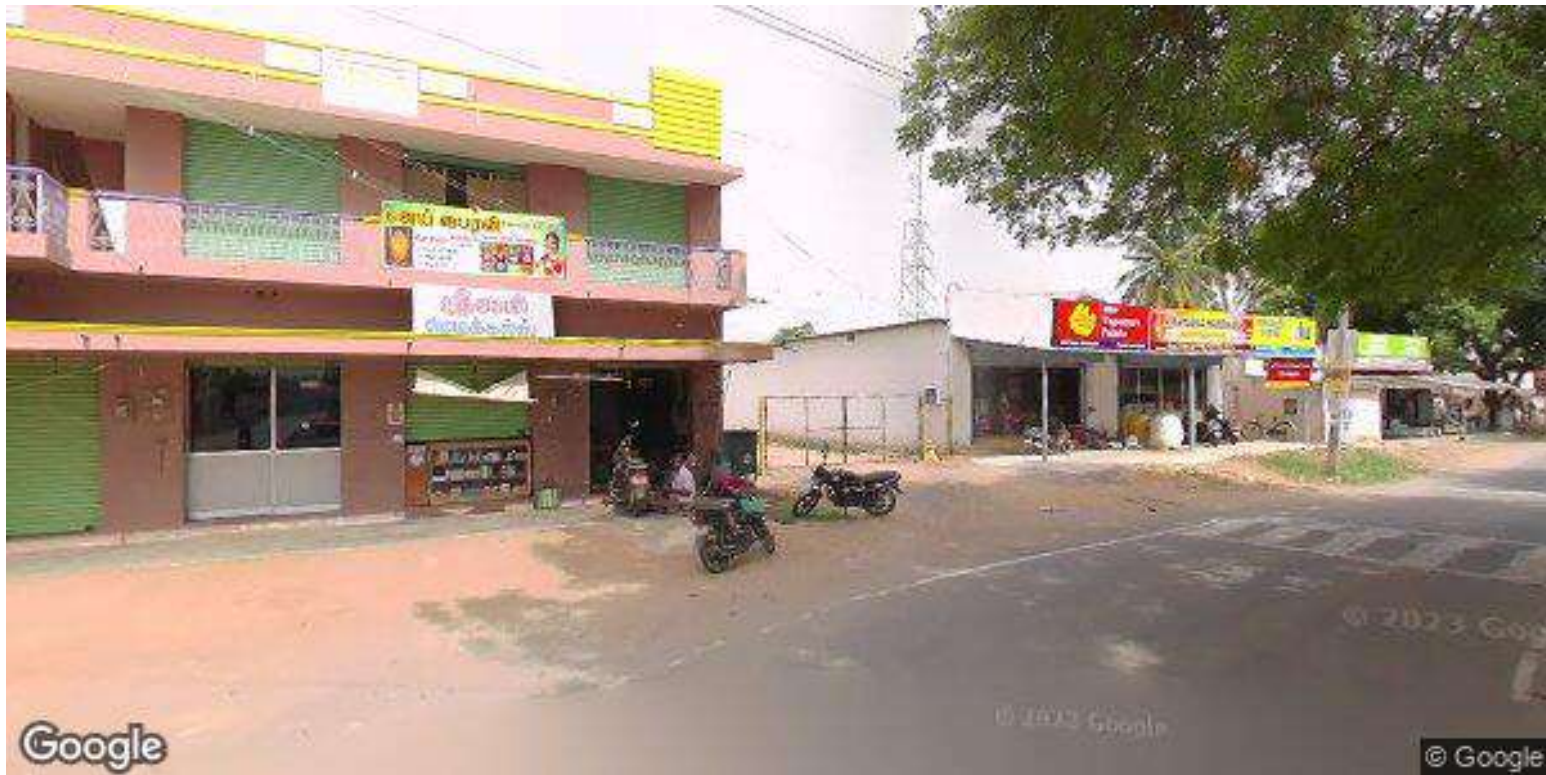
**Coordinates: 11.36684, 78.08323**

**Risk Type: Turn**

**Risk Level: Medium**

**Speed Limit: 30 KM/Hr**

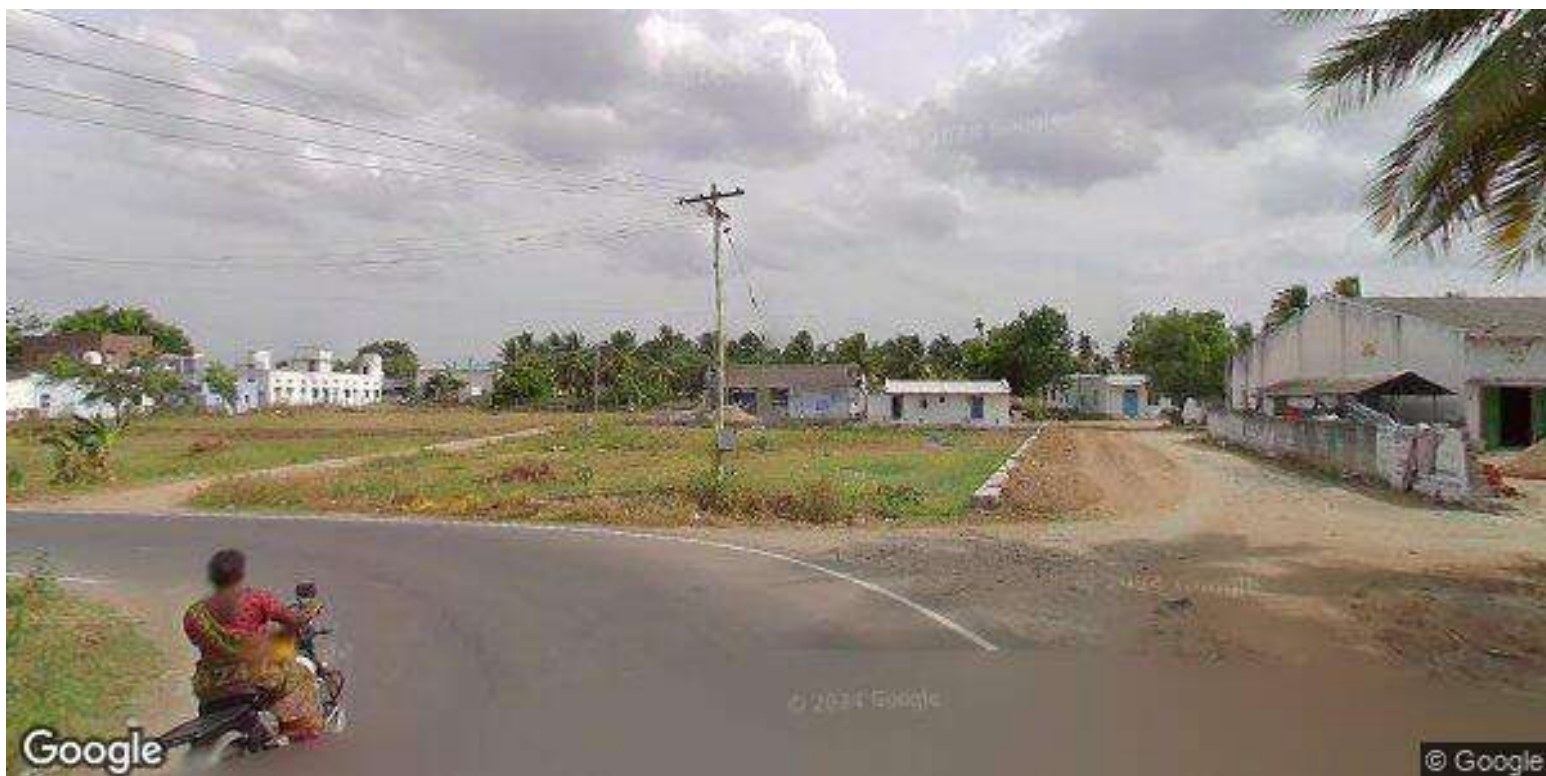
**Coordinates: 11.36525, 78.08282**

**Risk Type: Turn**

**Risk Level: High**

**Speed Limit: 15 KM/Hr**

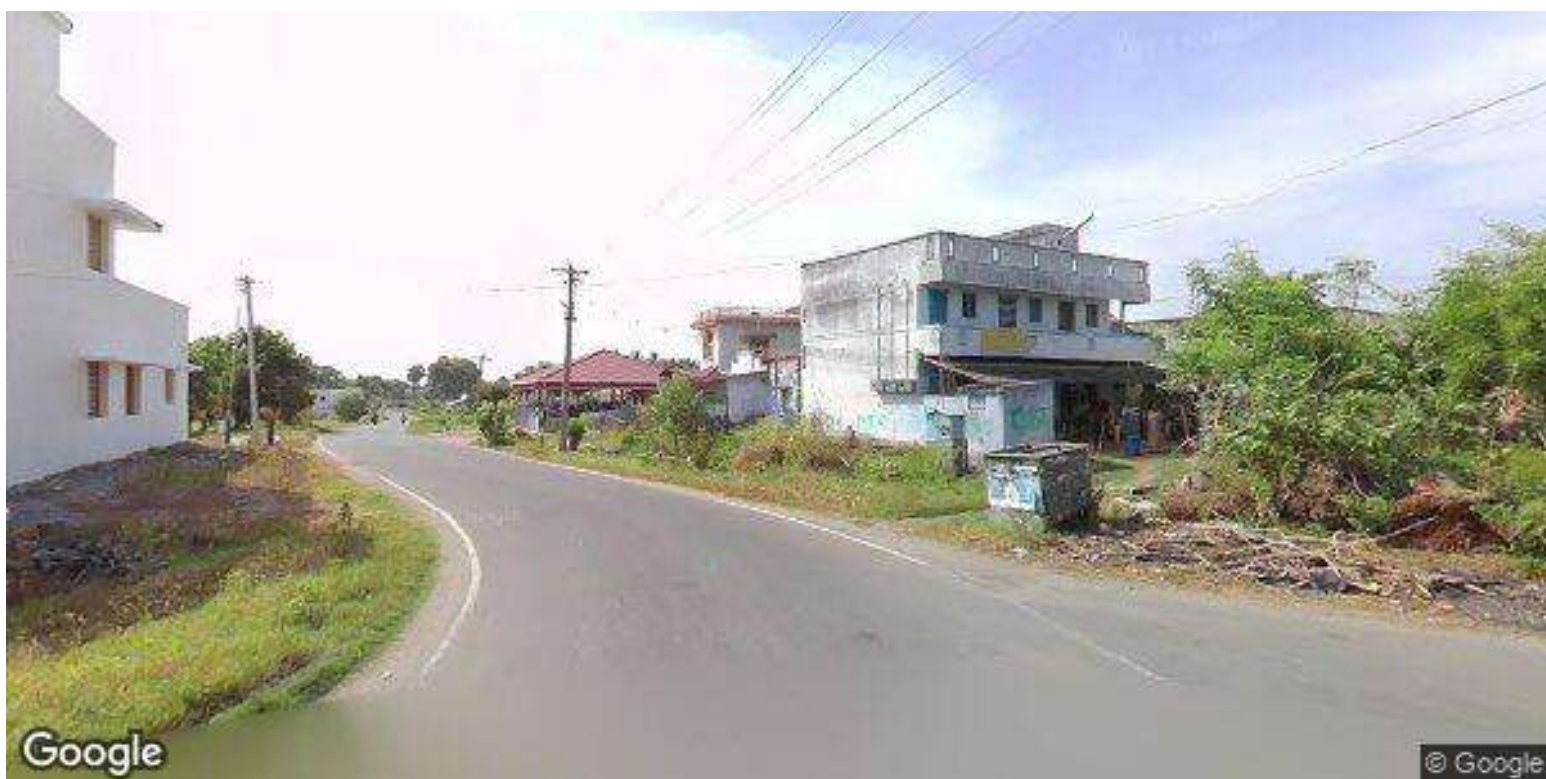
**Coordinates:** 11.36435, 78.08389

**Risk Type:** Turn

**Risk Level:** High

**Speed Limit:** 15 KM/Hr
