# IndianOil

## **JOURNEY RISK MANAGEMENT (JRM) STUDY**

### **Salem Terminal TO SRE AMMAN AGENCIES**

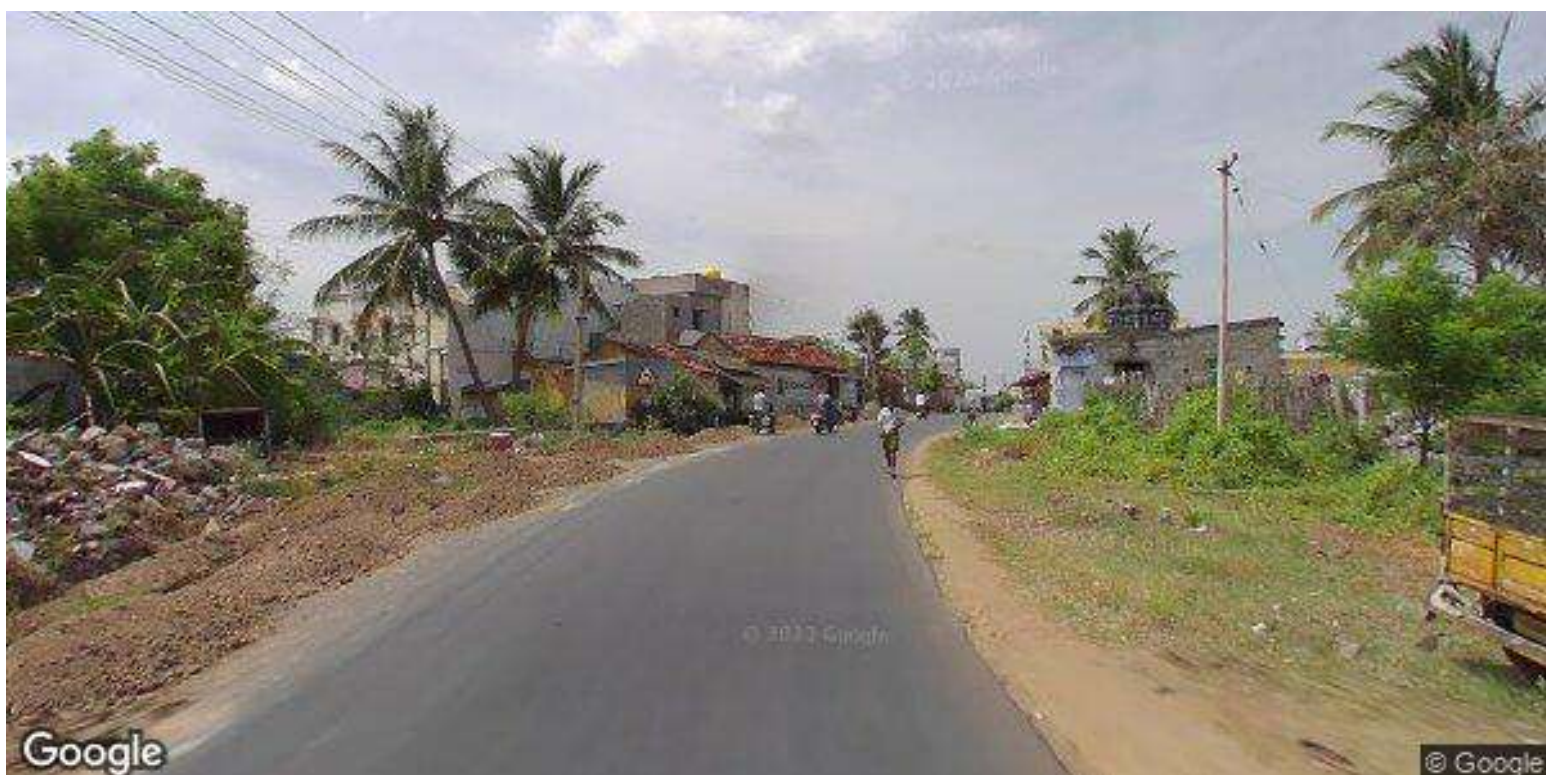
**Coordinates:** 11.35168, 78.10819

**Risk Type:** Turn

**Risk Level:** Medium

**Speed Limit:** 30 KM/Hr

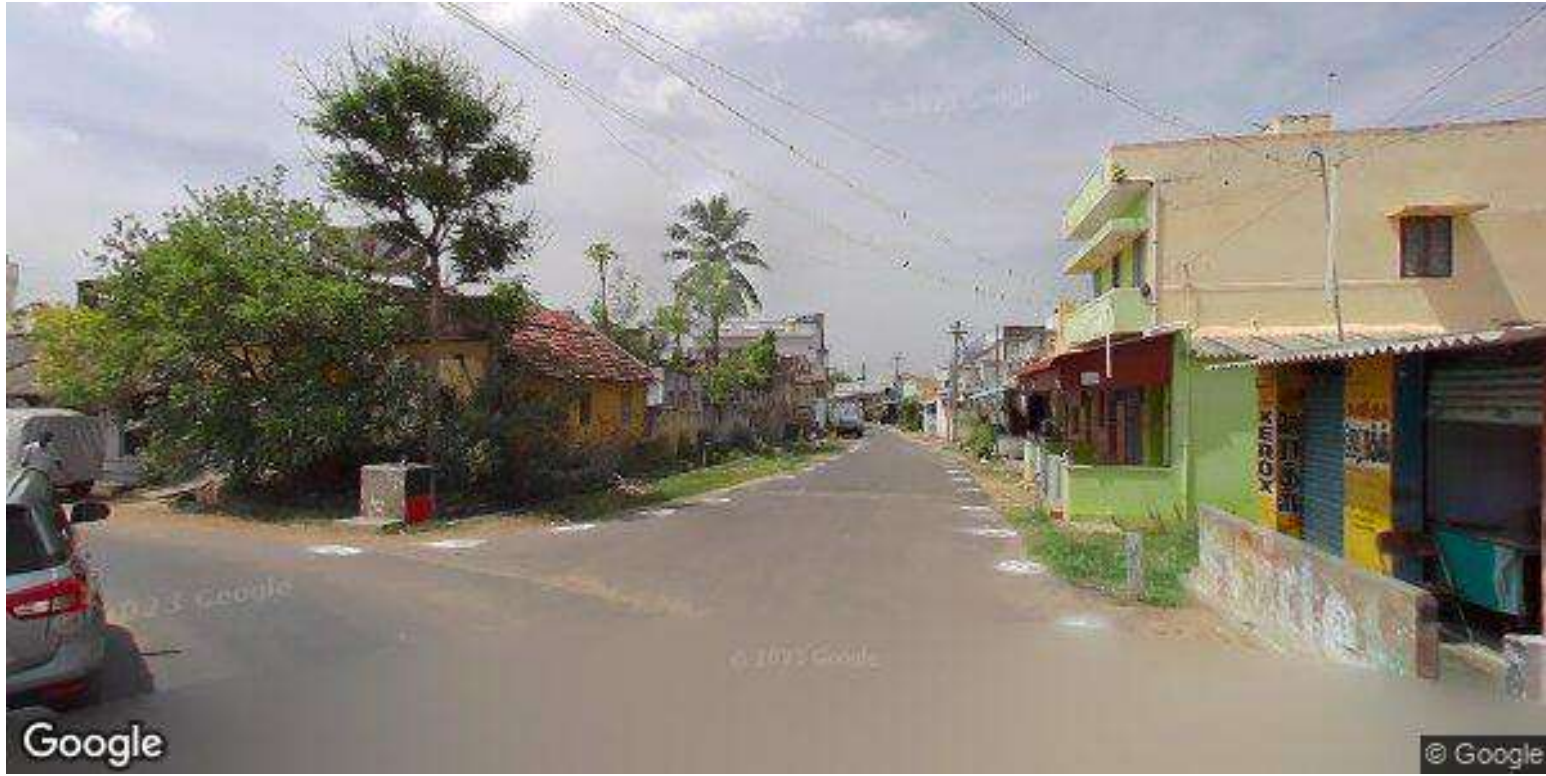
**Coordinates:** 11.35121, 78.10818

**Risk Type:** Turn

**Risk Level:** High

**Speed Limit:** 15 KM/Hr
