# IndianOil

## JOURNEY RISK MANAGEMENT (JRM) STUDY

### Salem Terminal to N.S.K.AGENCIE

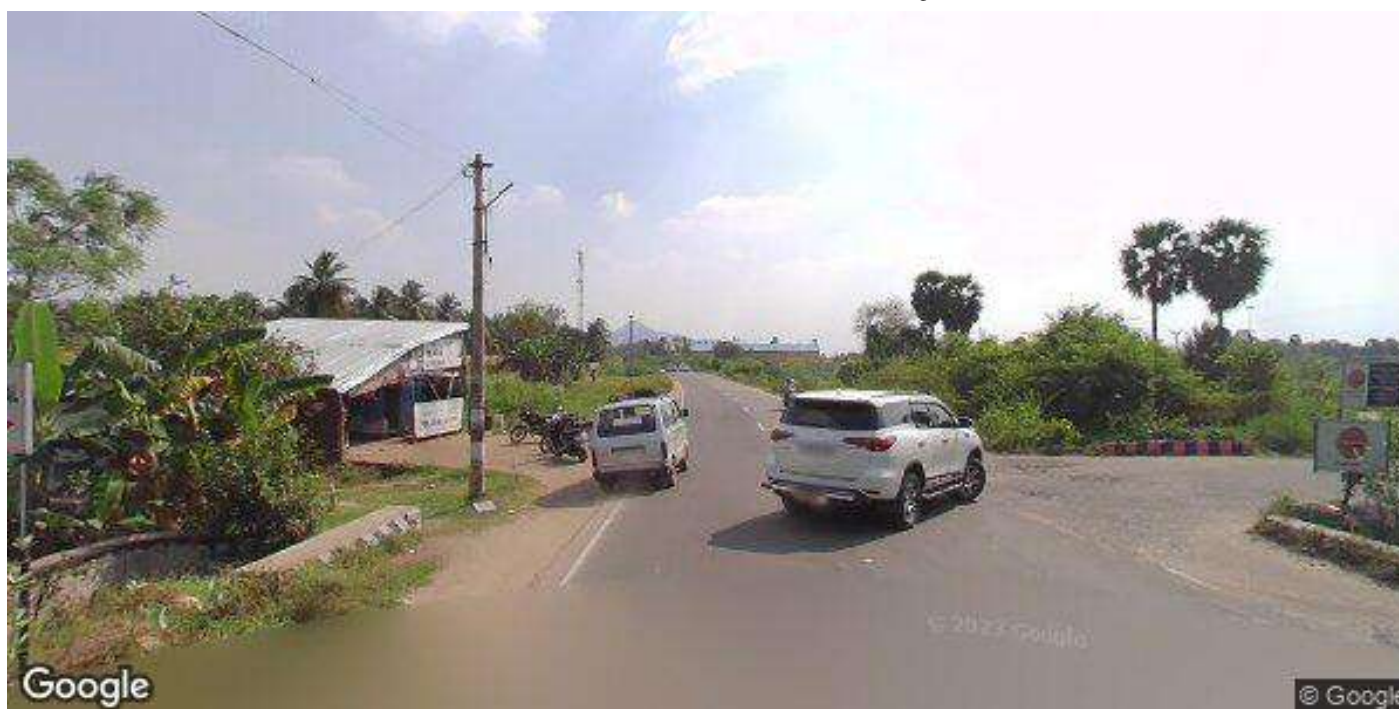
**Risk Type:** Turn  
**Risk Level:** High  
**Speed Limit:** 15 KM/Hr  
**Coordinates:** 11.44029, 77.87544

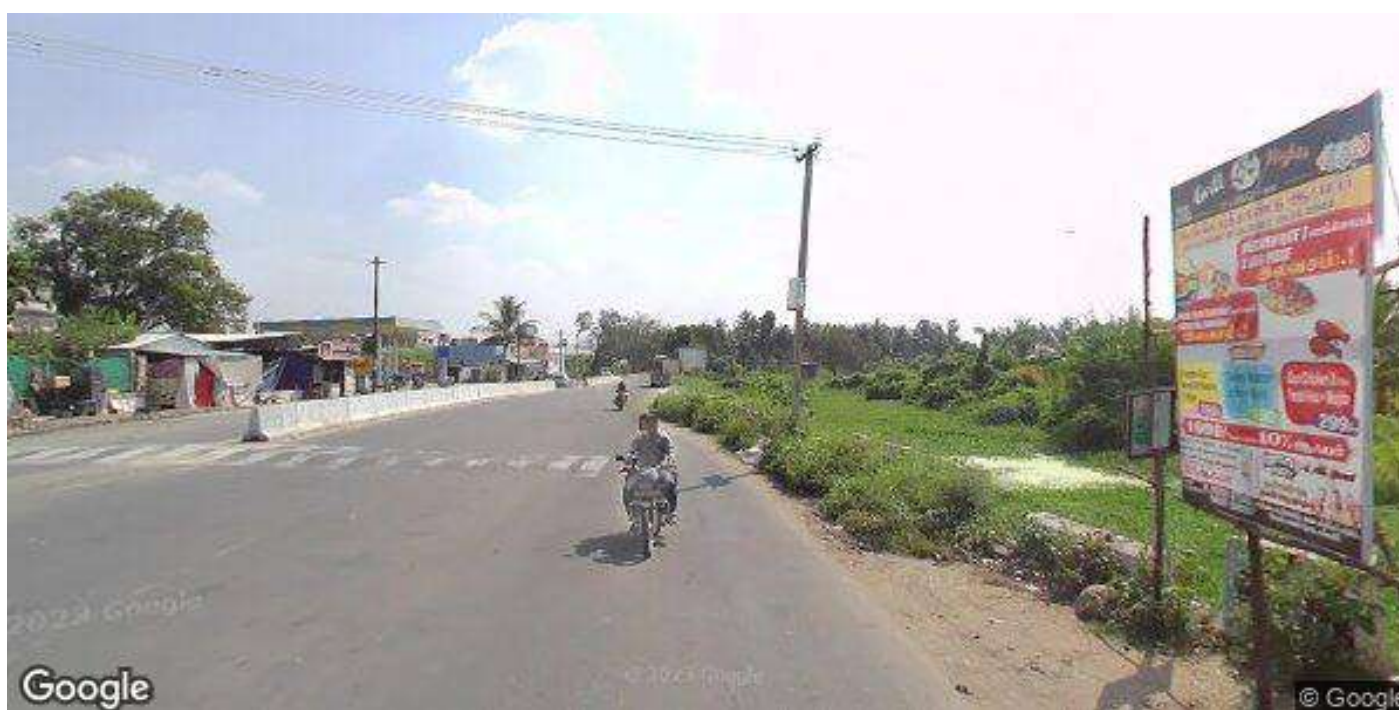
**Risk Type:** Blind Spot  
**Risk Level:** Blind Spot  
**Speed Limit:** 10 KM/Hr  
**Coordinates:** 11.44861, 77.87429

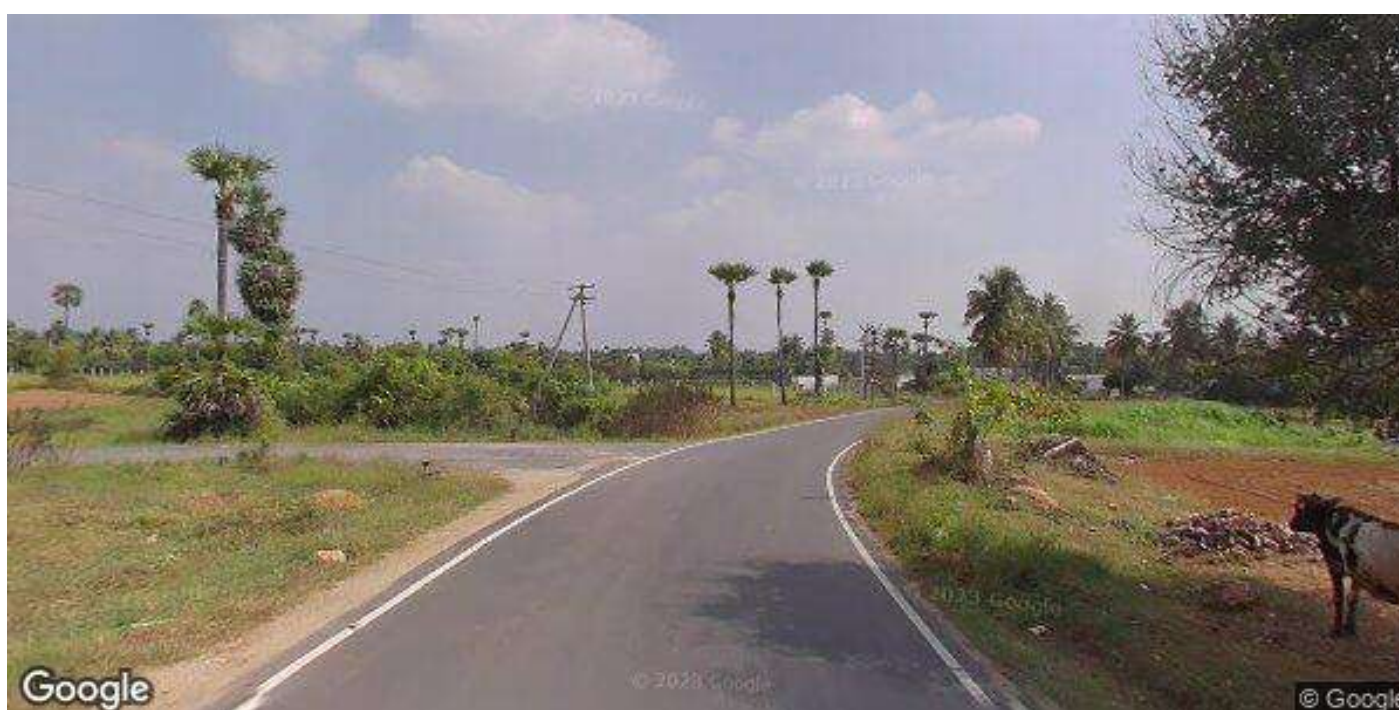
**Risk Type:** Turn  
**Risk Level:** Medium  
**Speed Limit:** 30 KM/Hr  
**Coordinates:** 11.45478, 77.88925

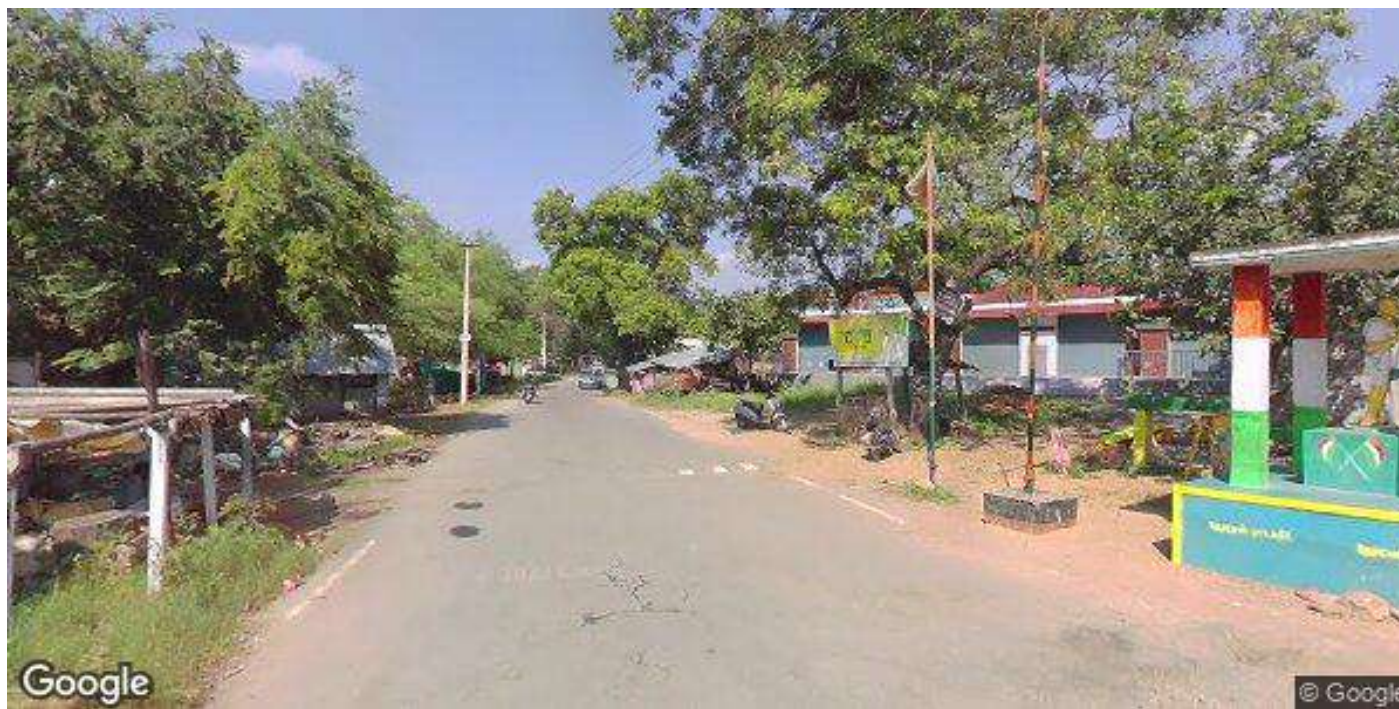
**Risk Type:** Turn  
**Risk Level:** High  
**Speed Limit:** 15 KM/Hr  
**Coordinates:** 11.43673, 77.91703

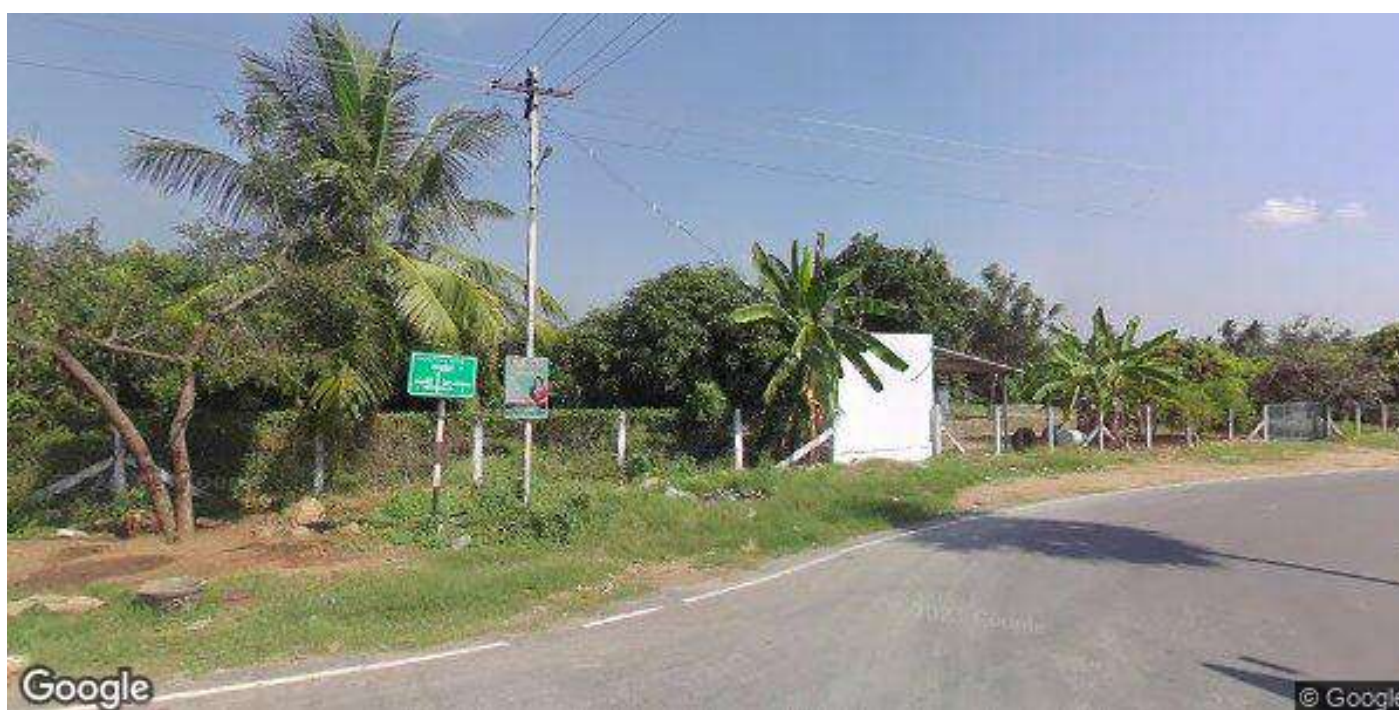
**Risk Type:** Turn  
**Risk Level:** High  
**Speed Limit:** 15 KM/Hr  
**Coordinates:** 11.43926, 77.91705

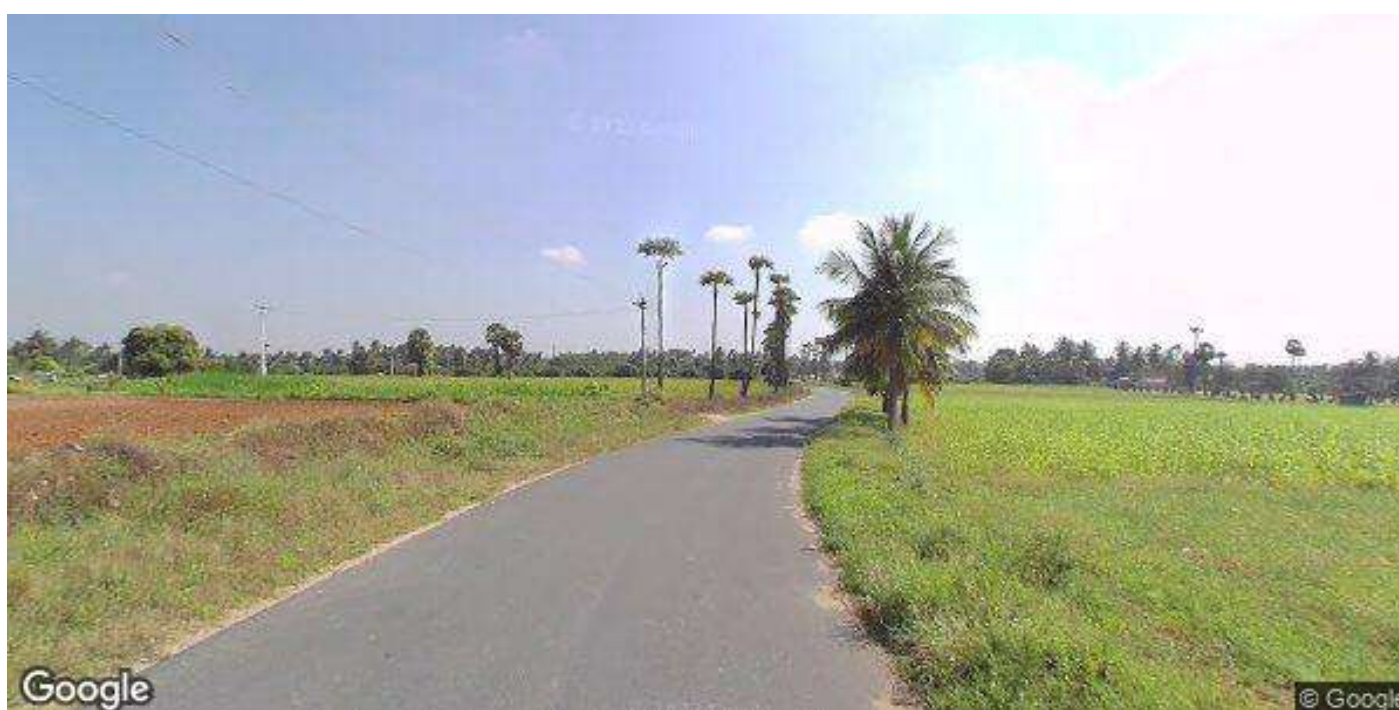
**Risk Type:** Turn  
**Risk Level:** Medium  
**Speed Limit:** 30 KM/Hr  
**Coordinates:** 11.43967, 77.92345

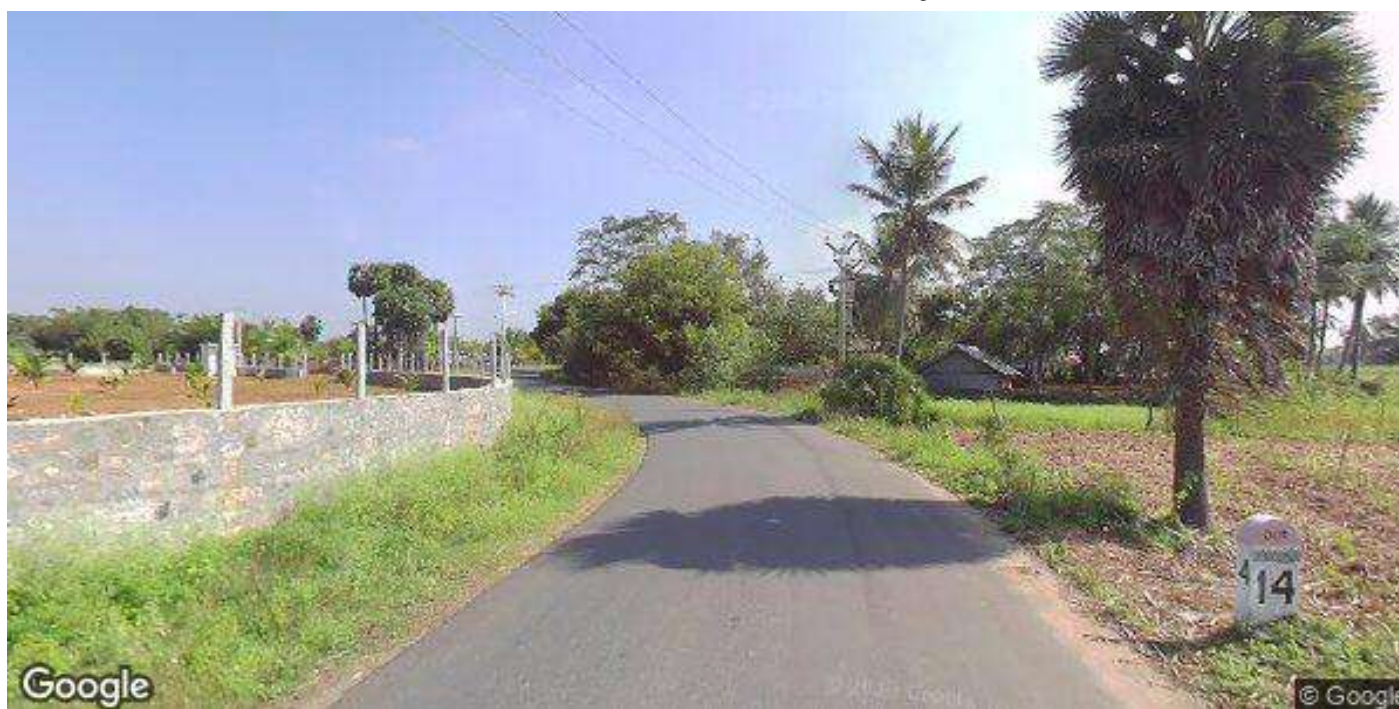
**Risk Type:** Turn  
**Risk Level:** Medium  
**Speed Limit:** 30 KM/Hr  
**Coordinates:** 11.43979, 77.93009

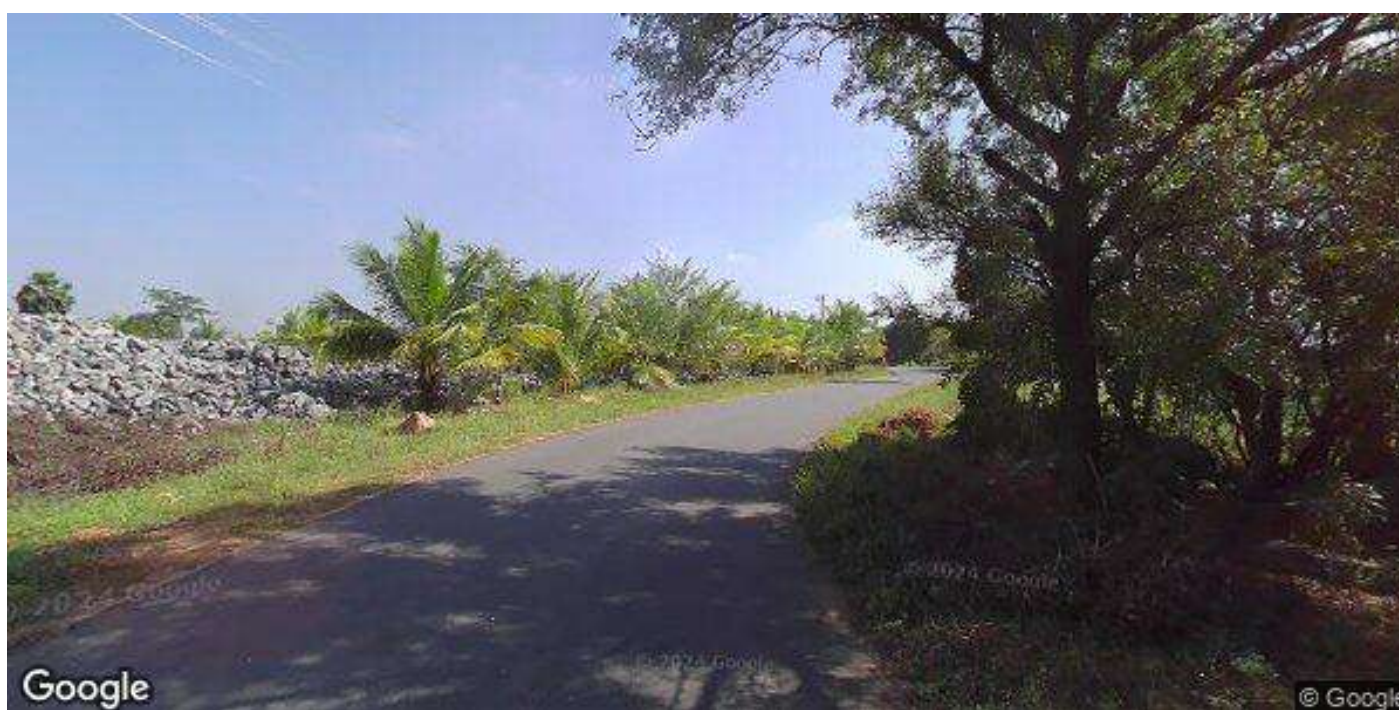
**Risk Type:** Turn  
**Risk Level:** Medium  
**Speed Limit:** 30 KM/Hr  
**Coordinates:** 11.44030, 77.93066

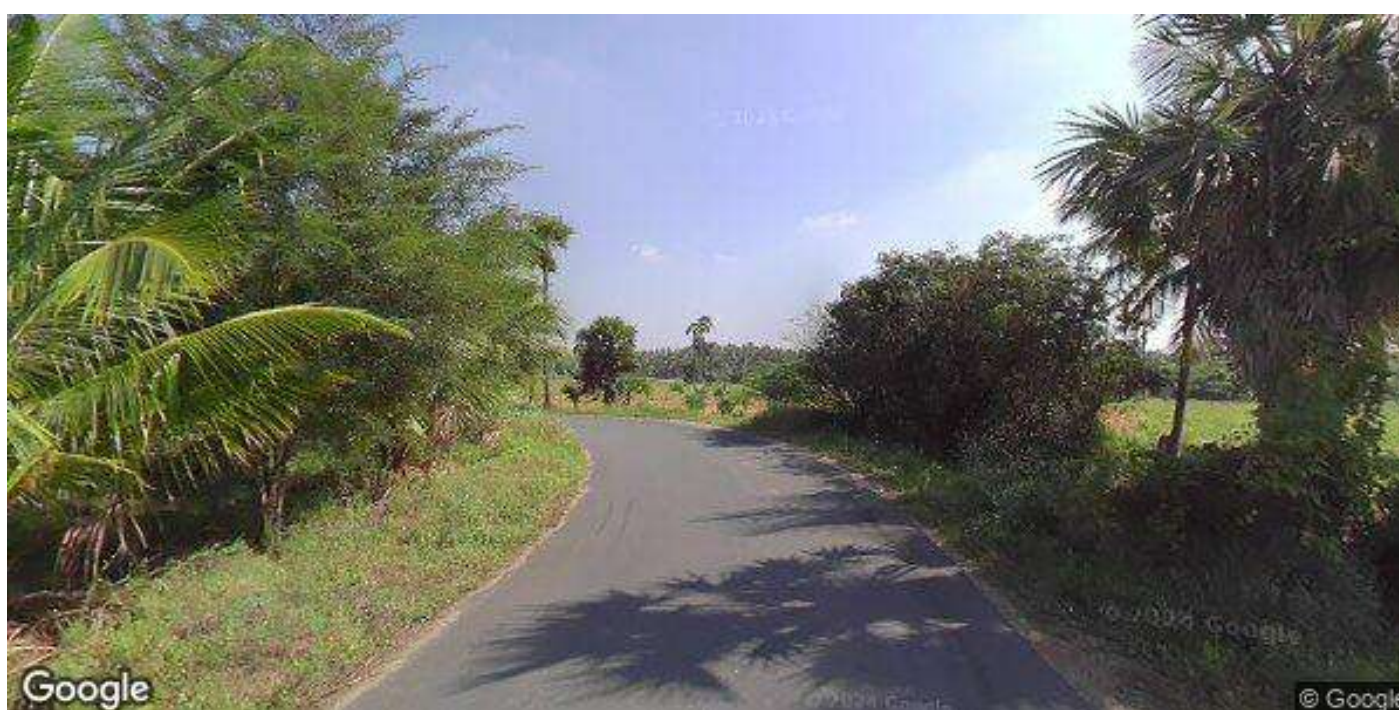
**Risk Type:** Turn  
**Risk Level:** Medium  
**Speed Limit:** 30 KM/Hr  
**Coordinates:** 11.44067, 77.93203

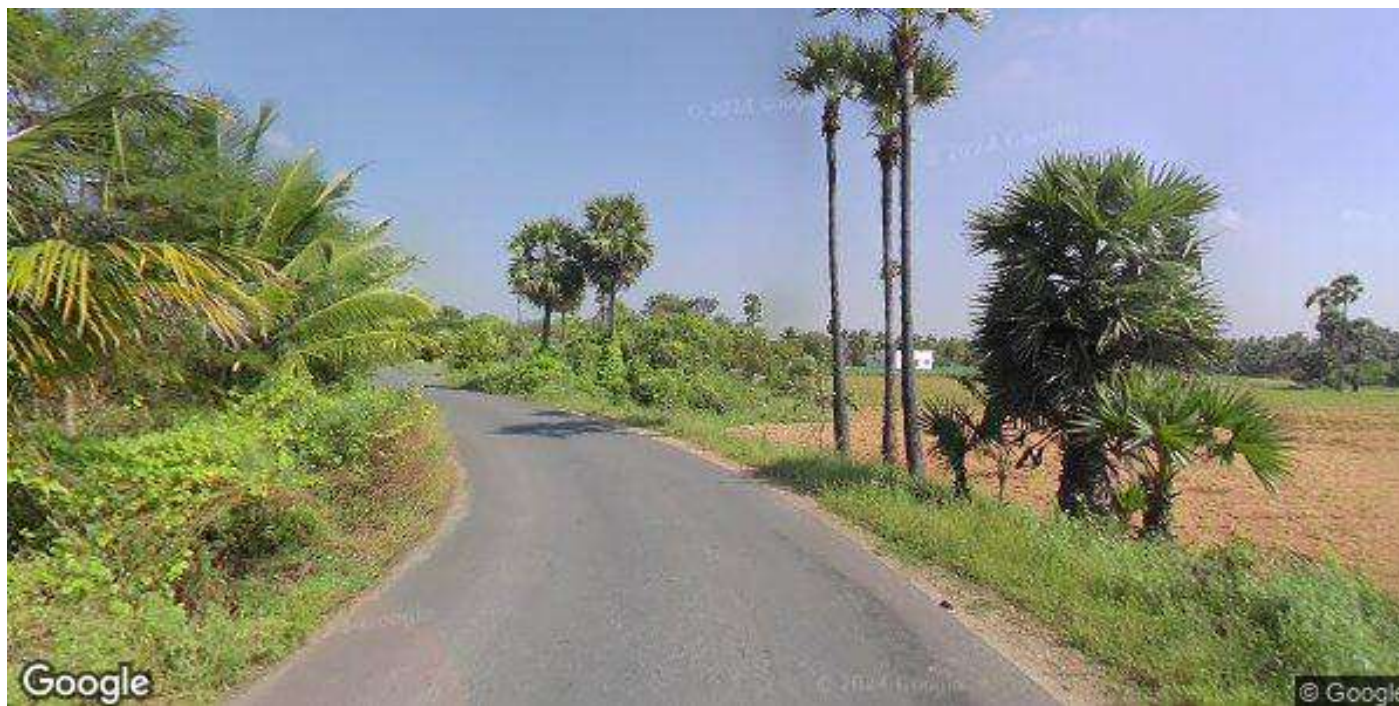
**Risk Type:** Turn  
**Risk Level:** High  
**Speed Limit:** 15 KM/Hr  
**Coordinates:** 11.44088, 77.93223

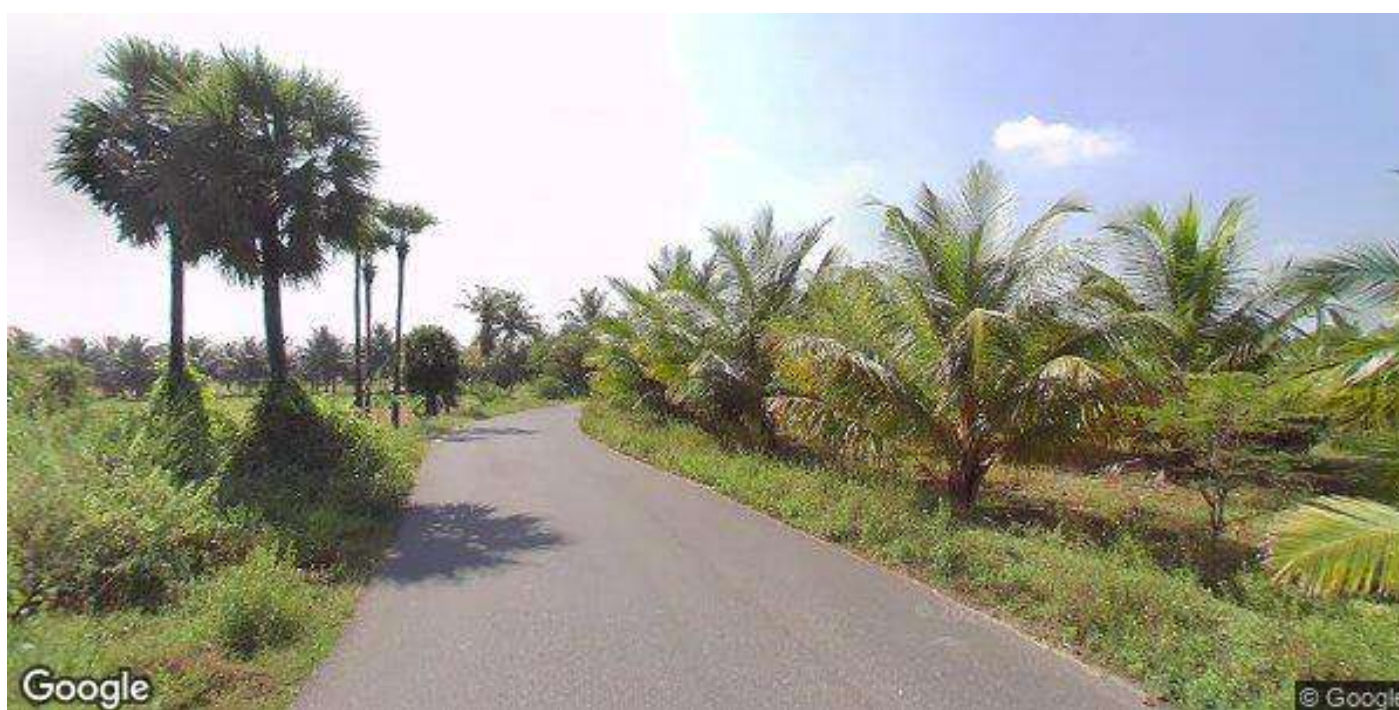
**Risk Type:** Turn  
**Risk Level:** Medium  
**Speed Limit:** 30 KM/Hr  
**Coordinates:** 11.44127, 77.93218

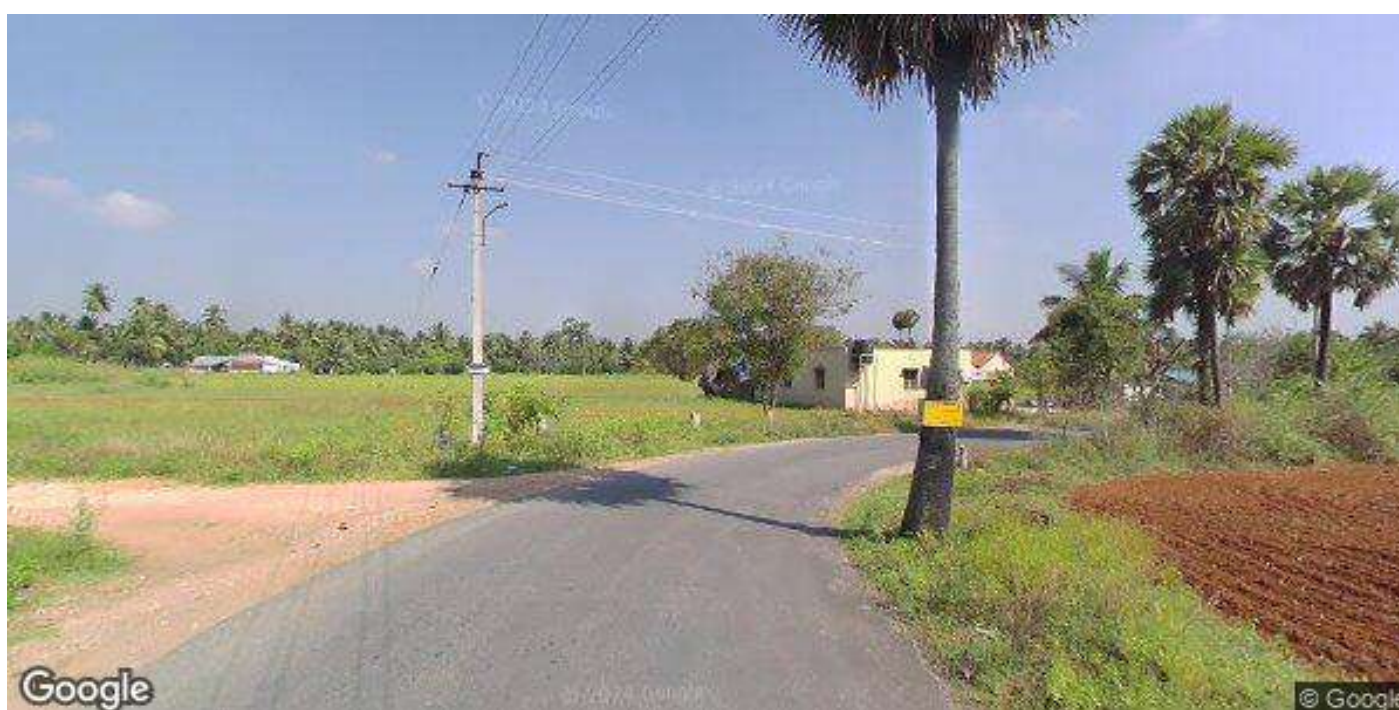
**Risk Type:** Turn  
**Risk Level:** High  
**Speed Limit:** 15 KM/Hr  
**Coordinates:** 11.44243, 77.93244

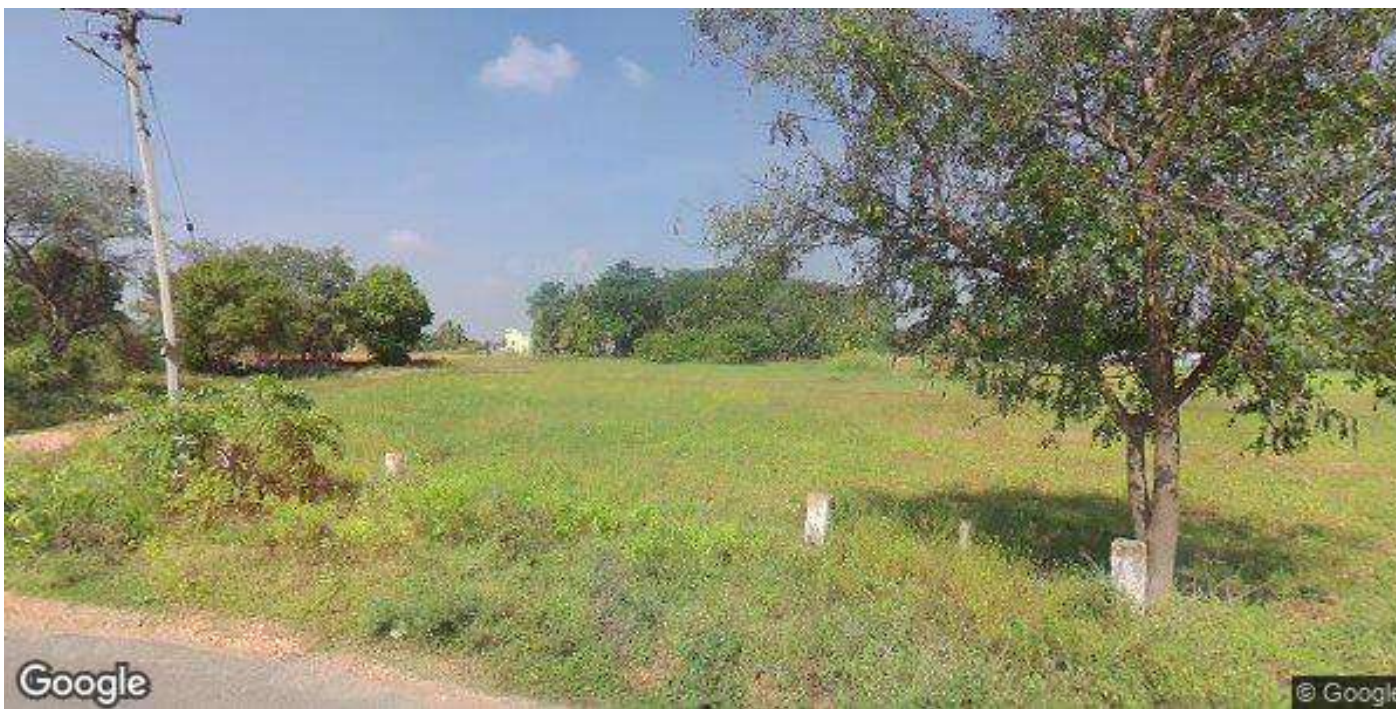
**Risk Type:** Turn  
**Risk Level:** Medium  
**Speed Limit:** 30 KM/Hr  
**Coordinates:** 11.44254, 77.93256

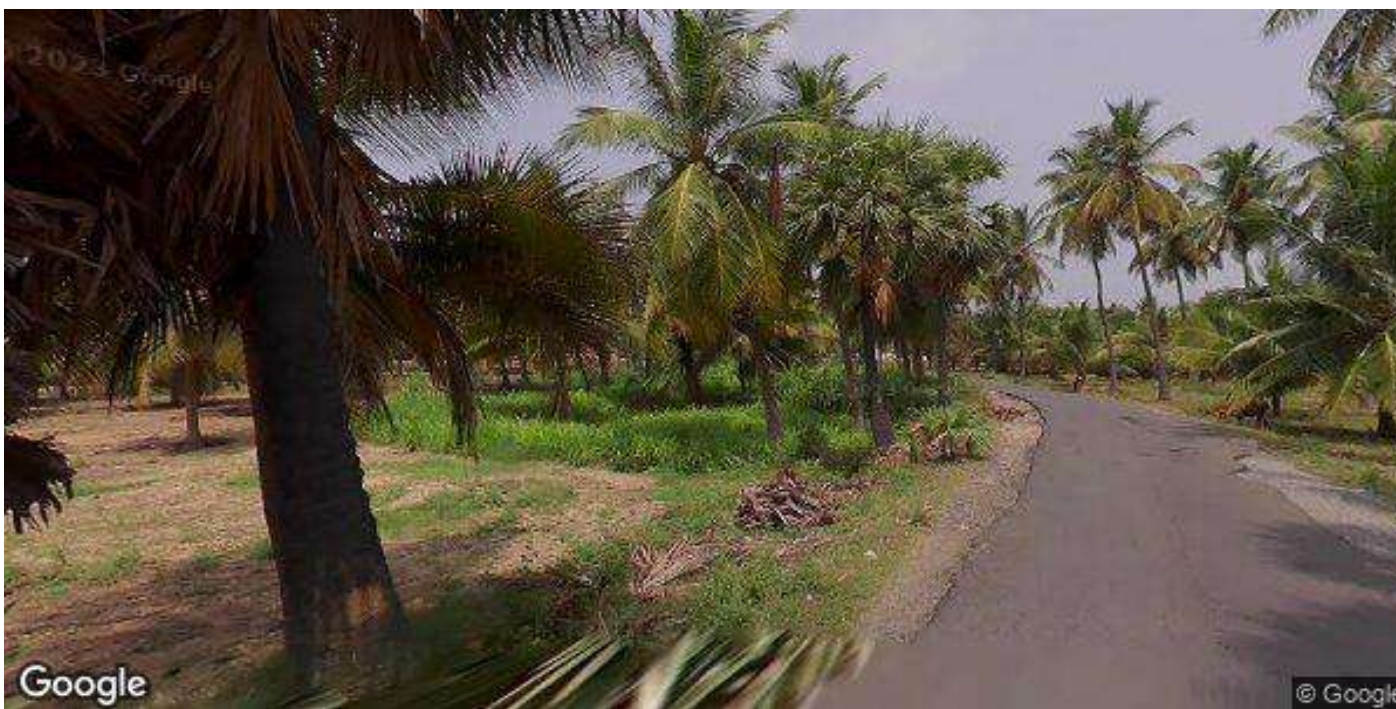
**Risk Type:** Turn  
**Risk Level:** Medium  
**Speed Limit:** 30 KM/Hr  
**Coordinates:** 11.44285, 77.93440

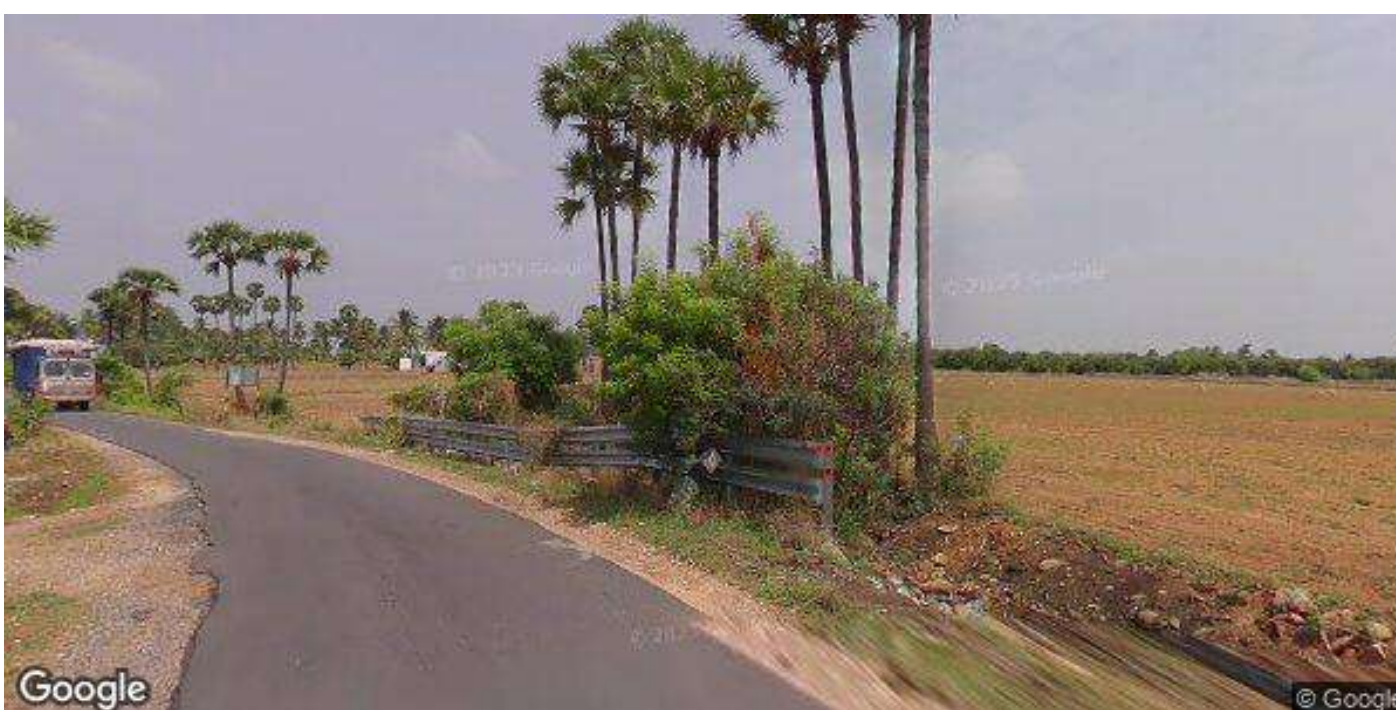
**Risk Type:** Turn  
**Risk Level:** Medium  
**Speed Limit:** 30 KM/Hr  
**Coordinates:** 11.44550, 77.95329

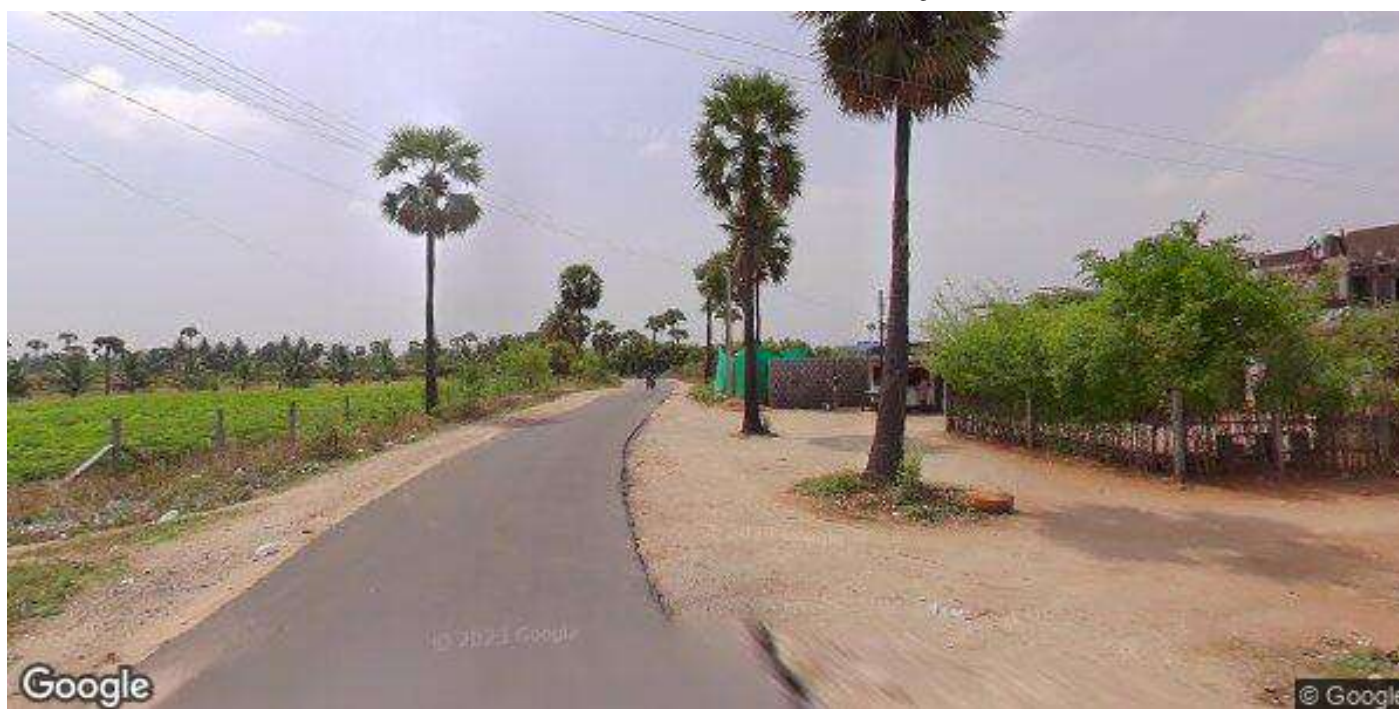
**Risk Type:** Turn  
**Risk Level:** Medium  
**Speed Limit:** 30 KM/Hr  
**Coordinates:** 11.44468, 77.95810

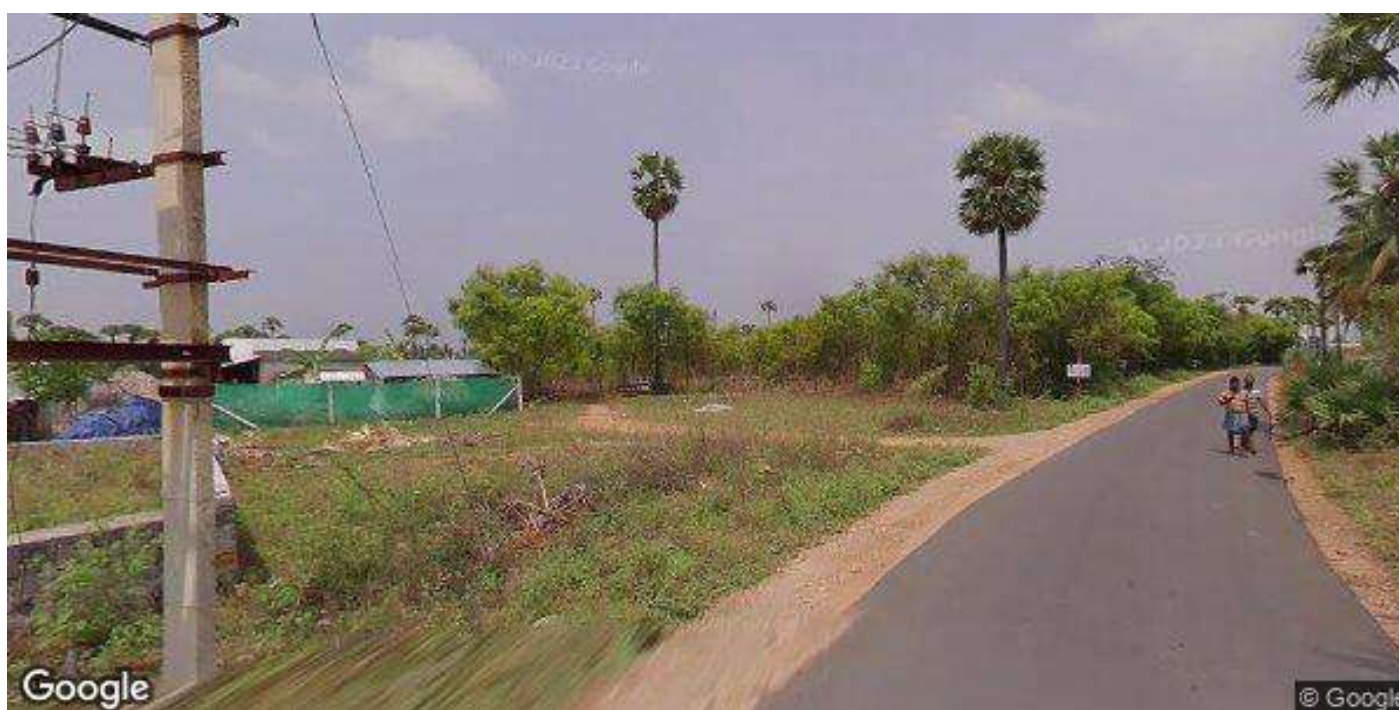
**Risk Type:** Turn  
**Risk Level:** Medium  
**Speed Limit:** 30 KM/Hr  
**Coordinates:** 11.44369, 77.96036

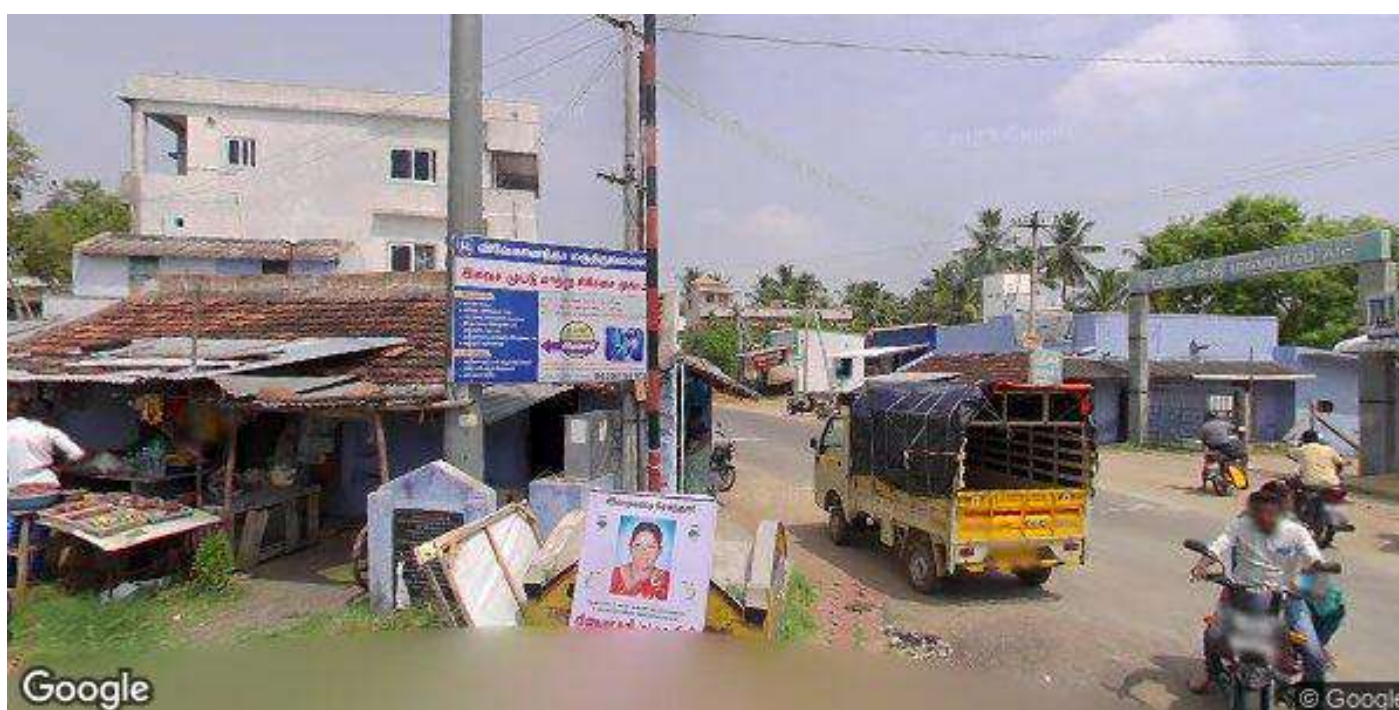
**Risk Type:** Turn  
**Risk Level:** Medium  
**Speed Limit:** 30 KM/Hr  
**Coordinates:** 11.44391, 77.96277

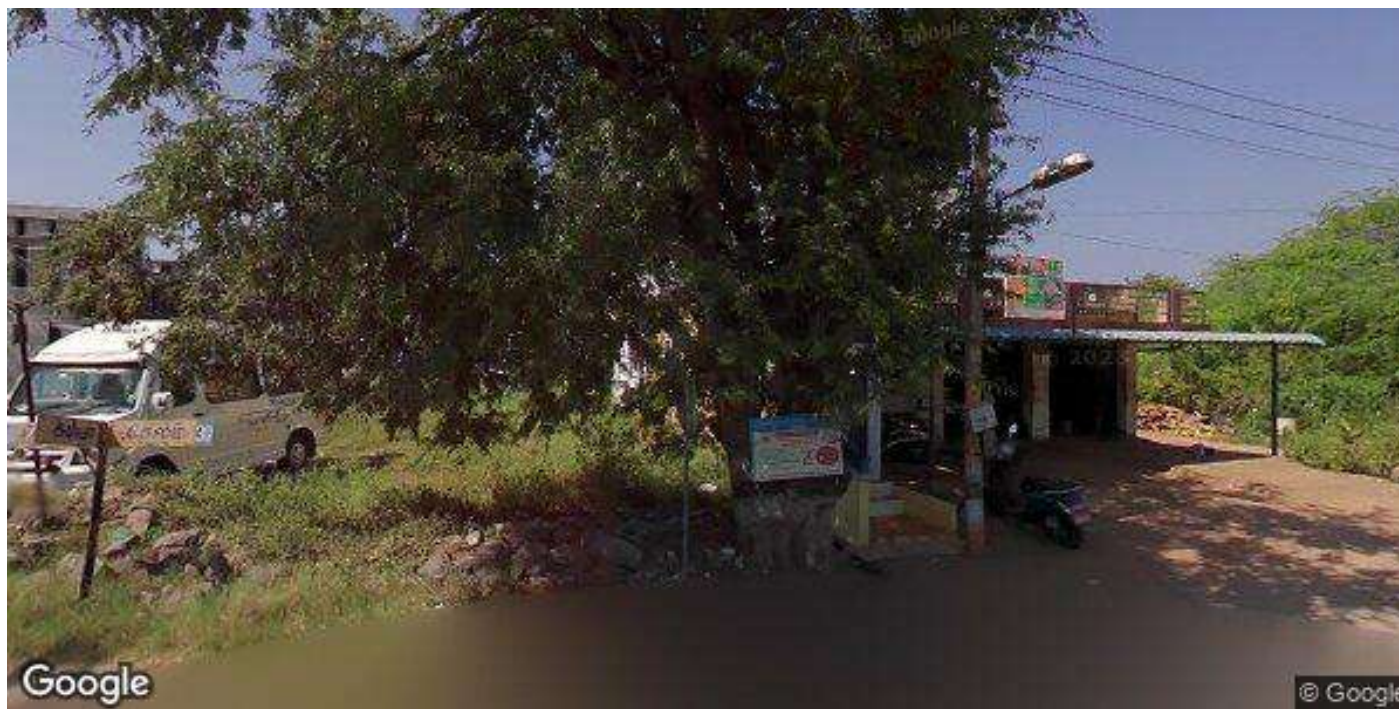
**Risk Type:** Turn  
**Risk Level:** High  
**Speed Limit:** 15 KM/Hr  
**Coordinates:** 11.49063, 78.02680

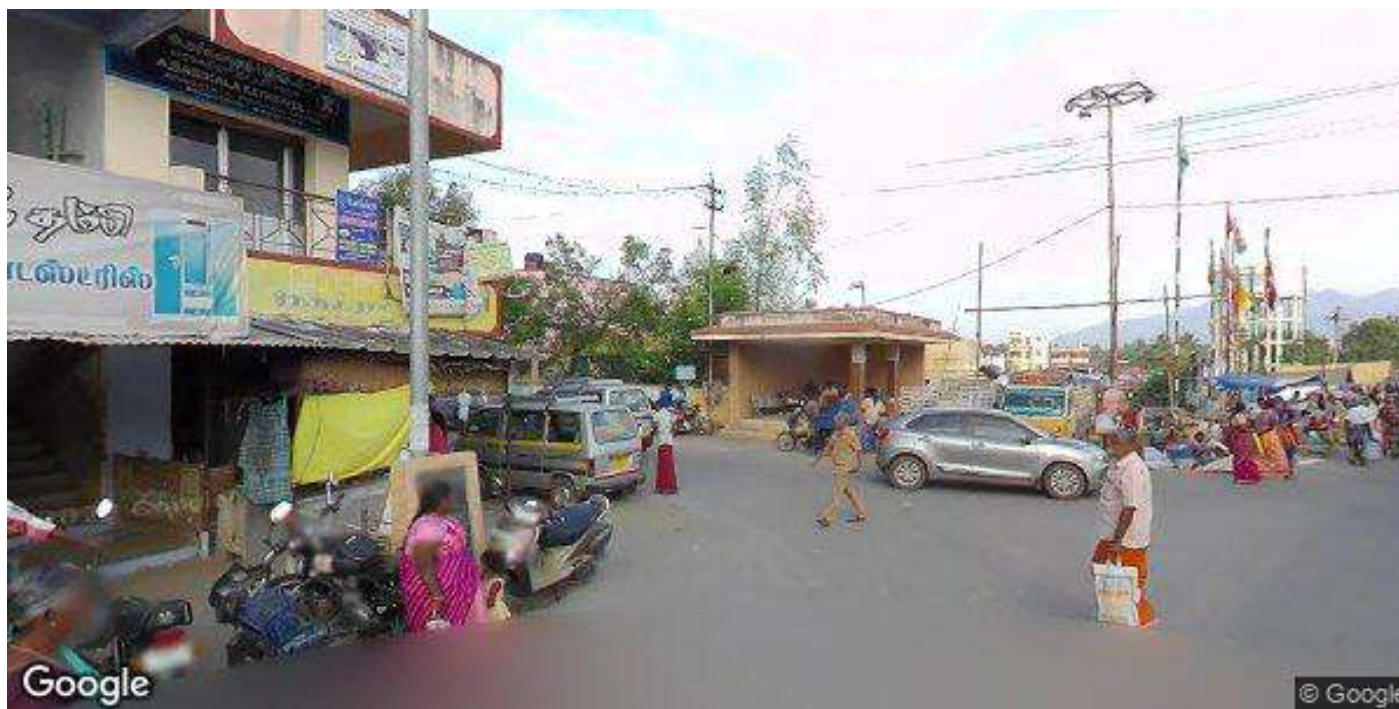
**Risk Type:** Turn  
**Risk Level:** High  
**Speed Limit:** 15 KM/Hr  
**Coordinates:** 11.49135, 78.03252

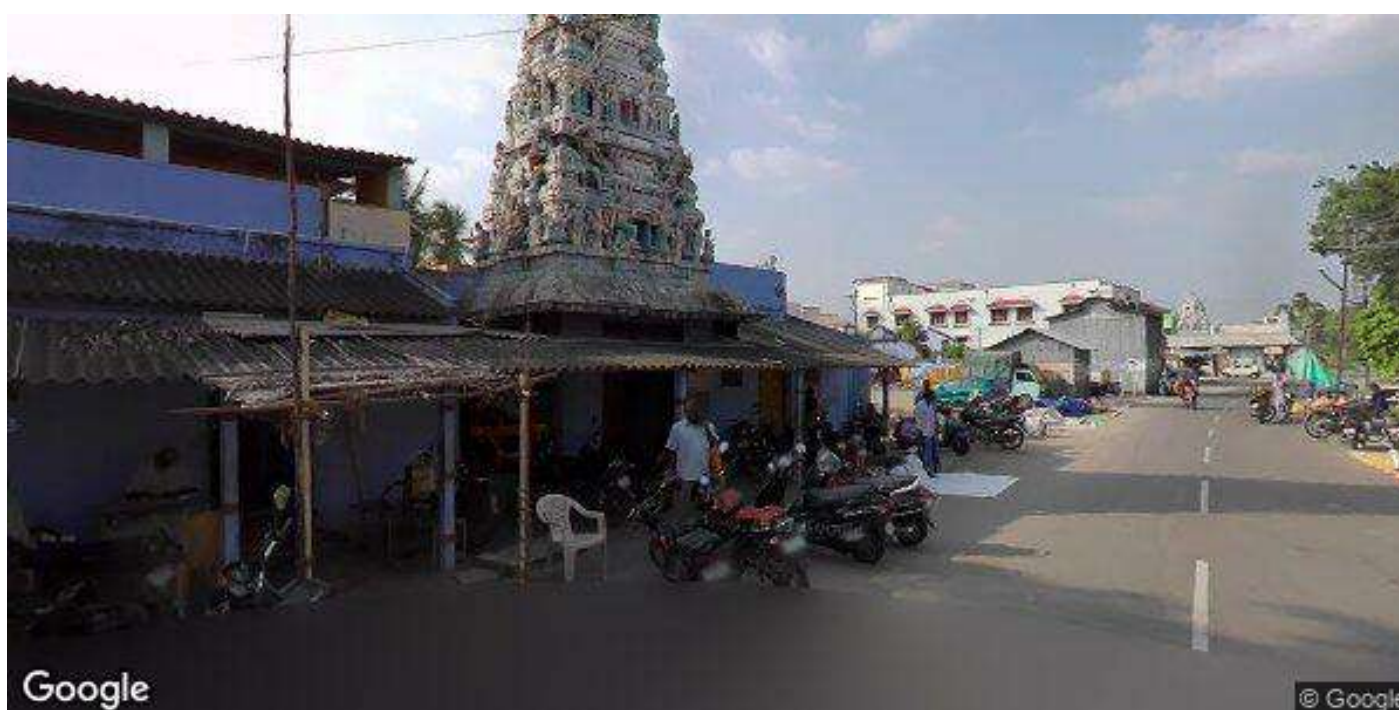
**Risk Type:** Turn  
**Risk Level:** High  
**Speed Limit:** 15 KM/Hr  
**Coordinates:** 11.49183, 78.03257

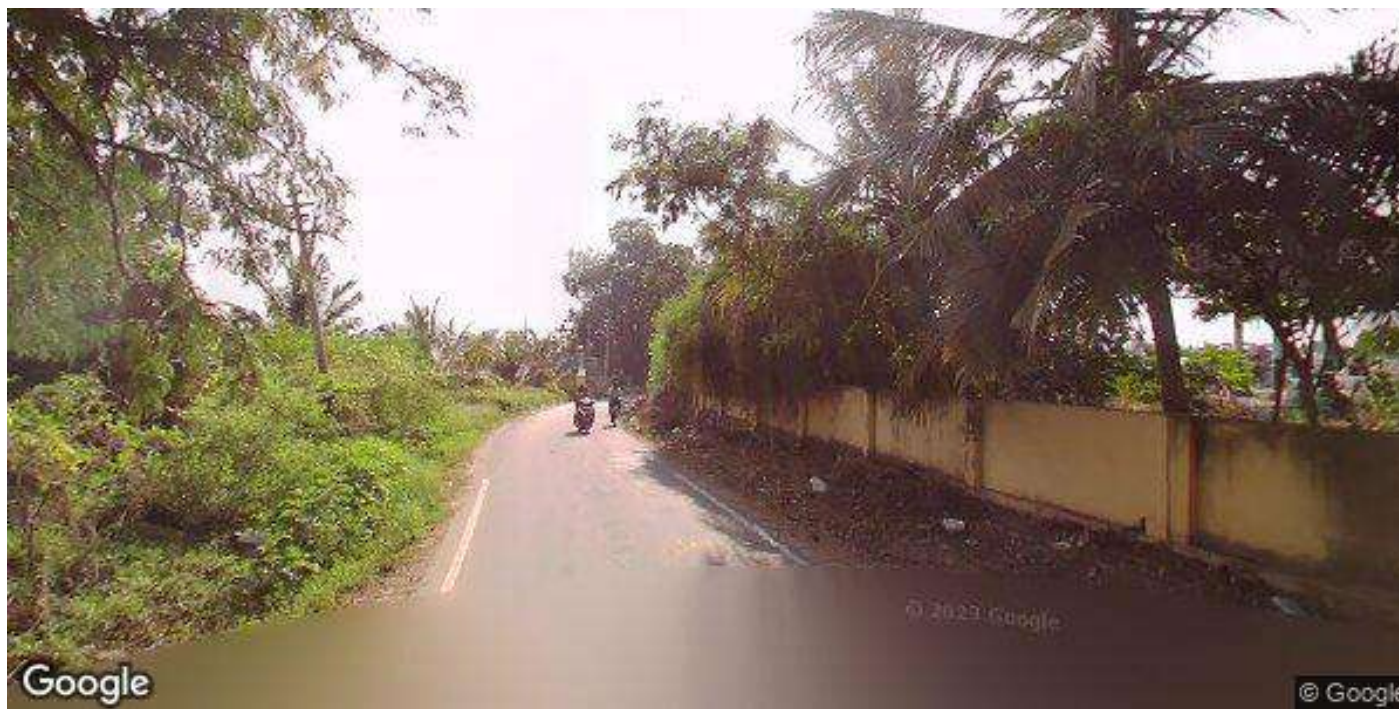
**Risk Type:** Turn  
**Risk Level:** Medium  
**Speed Limit:** 30 KM/Hr  
**Coordinates:** 11.49355, 78.03703
