# IndianOil

## JOURNEY RISK MANAGEMENT (JRM) STUDY

### Salem Terminal to N.S.K.AGENCIE

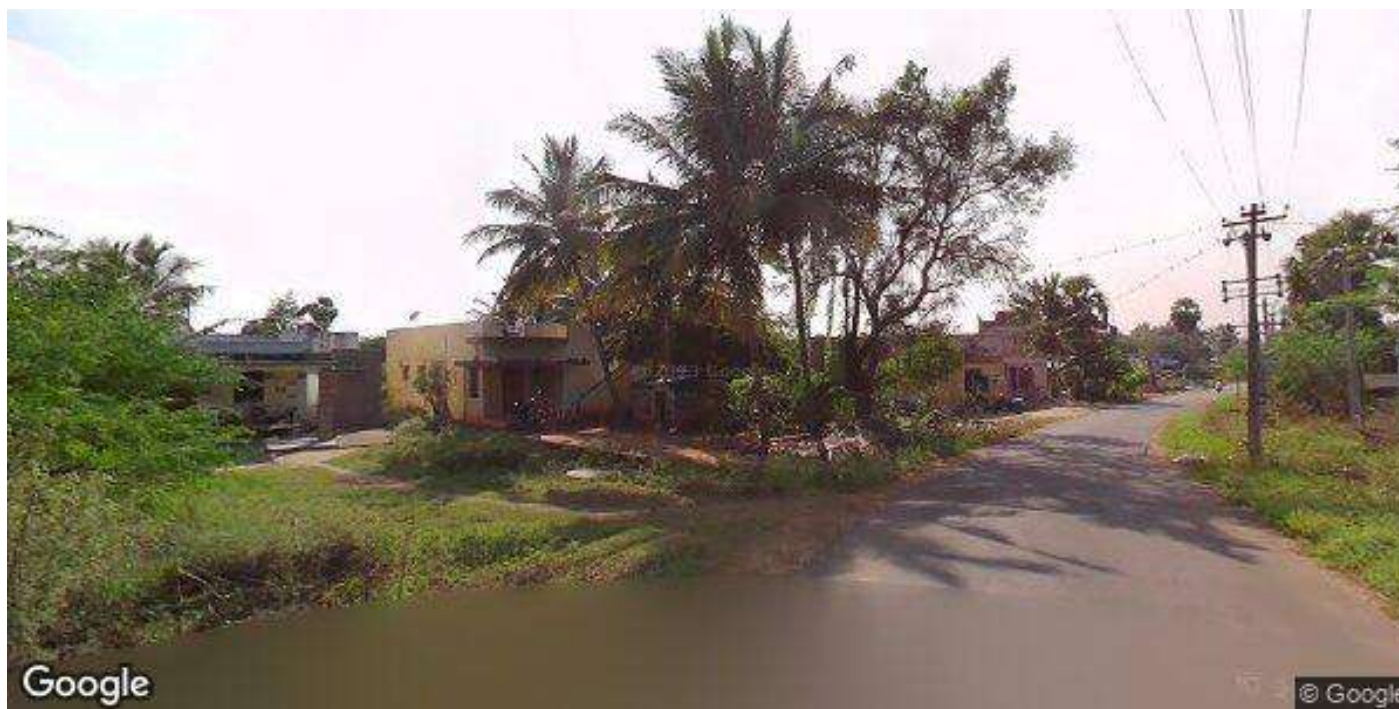
**Risk Type:** Turn  
**Risk Level:** Medium  
**Speed Limit:** 30 KM/Hr  
**Coordinates:** 11.49374, 78.04232

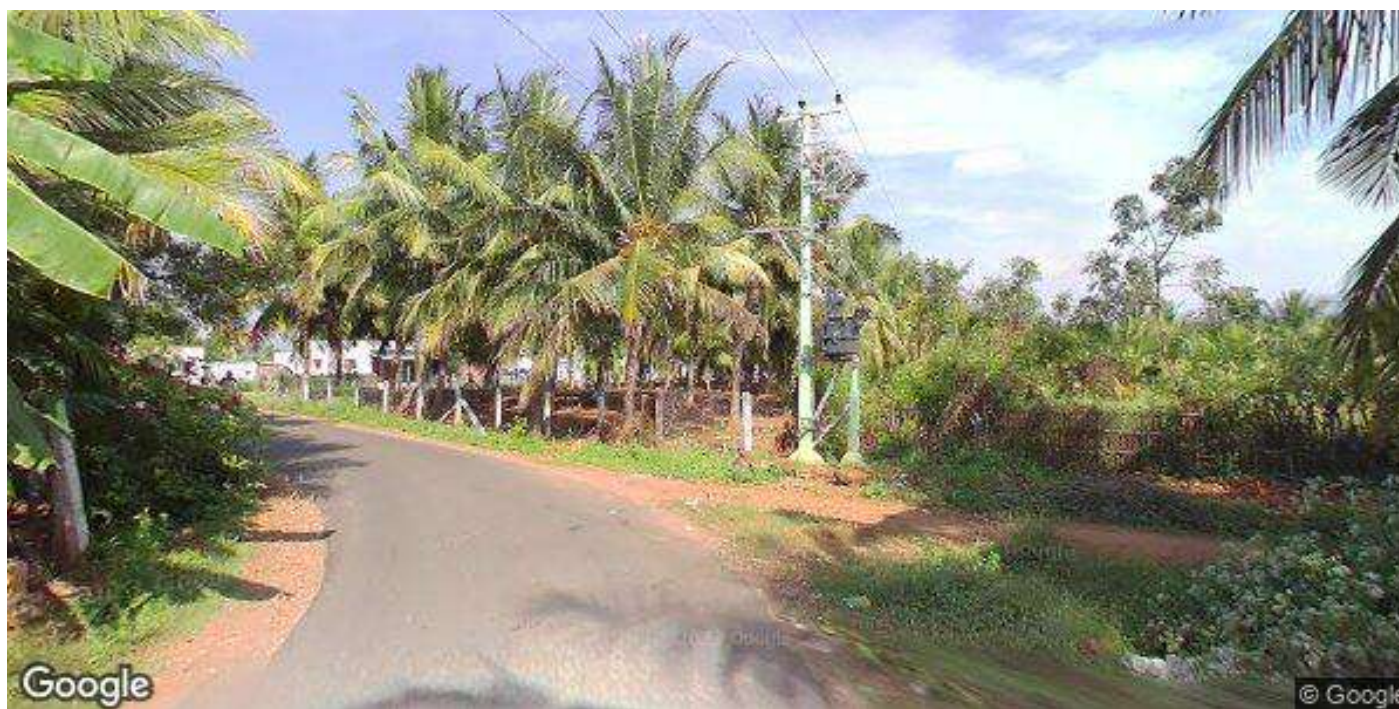
**Risk Type:** Turn  
**Risk Level:** Medium  
**Speed Limit:** 30 KM/Hr  
**Coordinates:** 11.49637, 78.04986

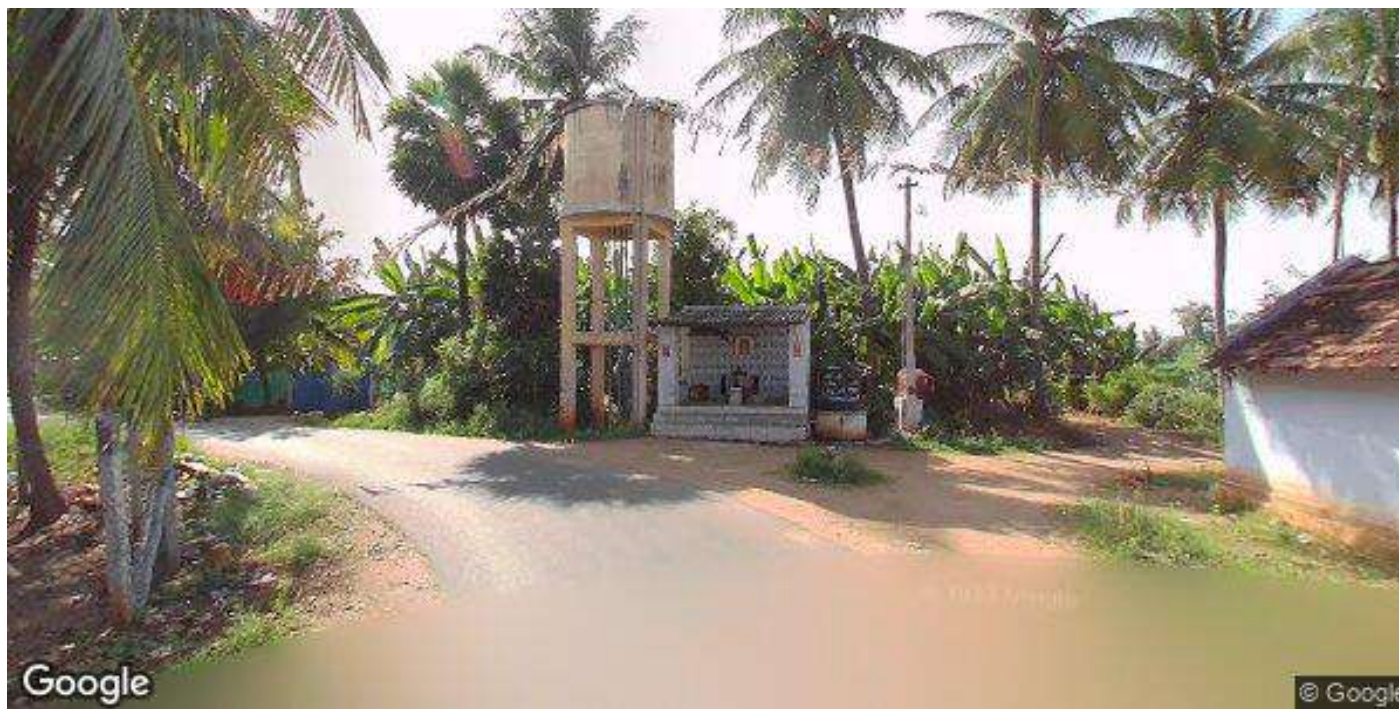
**Risk Type:** Turn  
**Risk Level:** High  
**Speed Limit:** 15 KM/Hr  
**Coordinates:** 11.49676, 78.05010

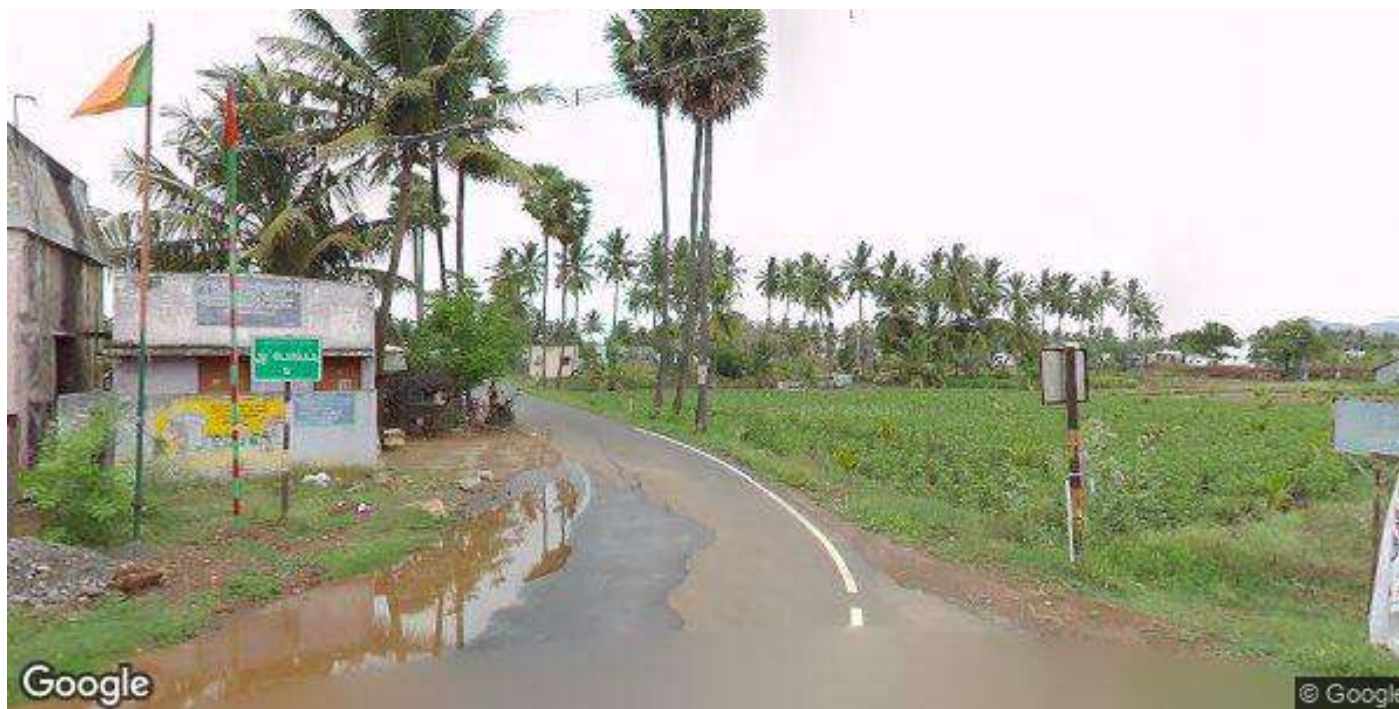
**Risk Type:** Blind Spot  
**Risk Level:** Blind Spot  
**Speed Limit:** 10 KM/Hr  
**Coordinates:** 11.49723, 78.05308

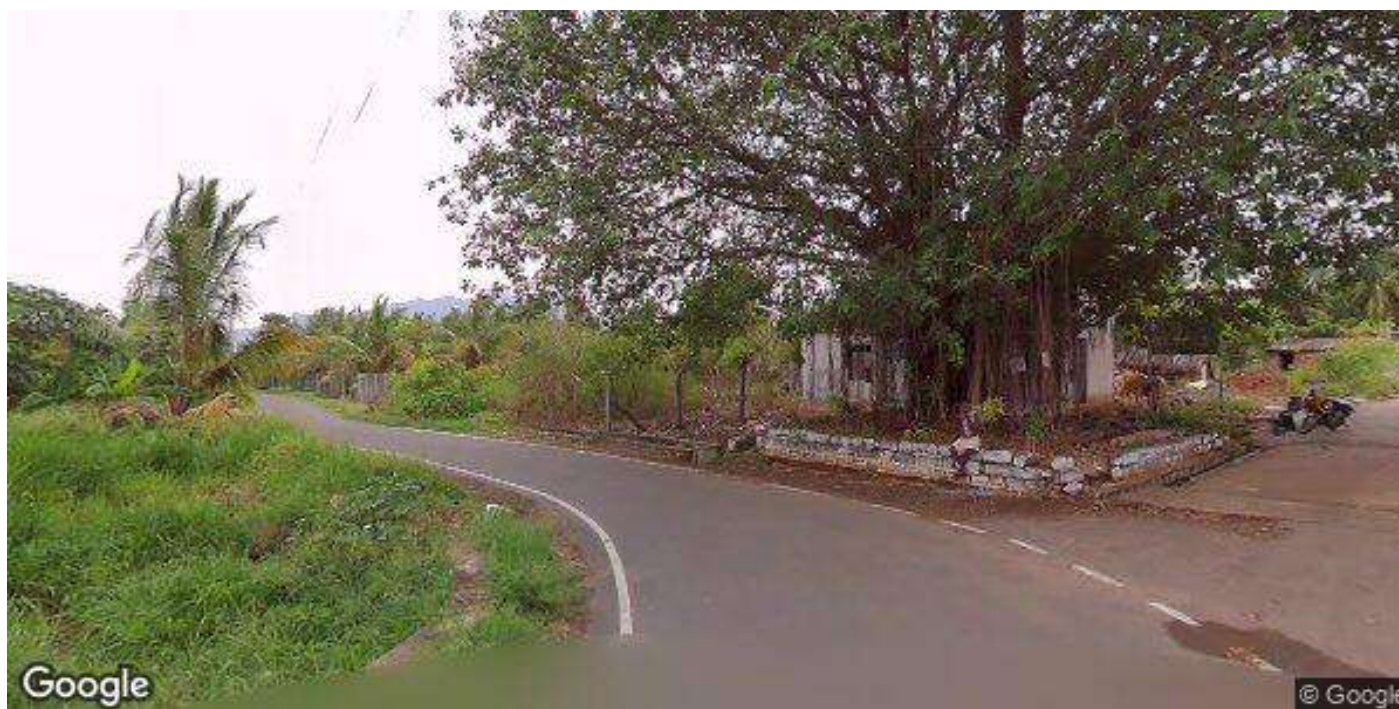
**Risk Type:** Turn  
**Risk Level:** High  
**Speed Limit:** 15 KM/Hr  
**Coordinates:** 11.49553, 78.05338

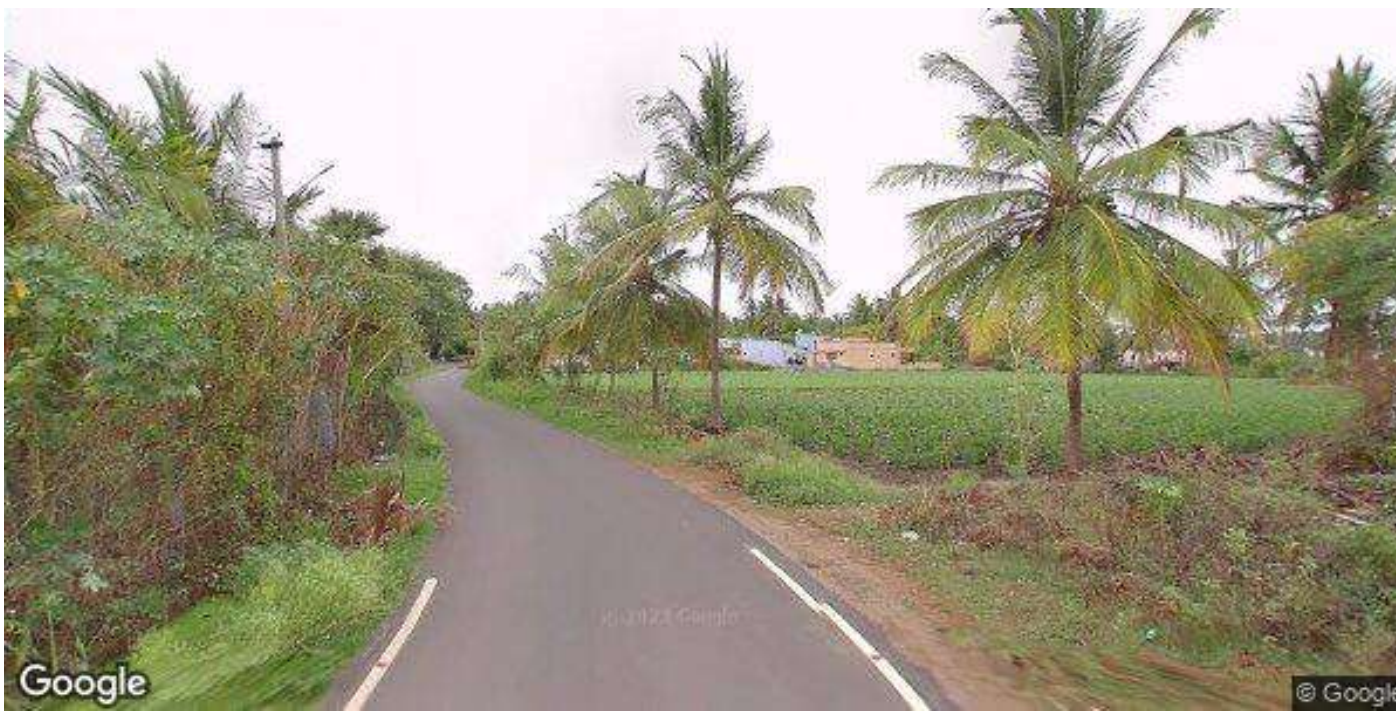
**Risk Type:** Turn  
**Risk Level:** Medium  
**Speed Limit:** 30 KM/Hr  
**Coordinates:** 11.49547, 78.05442

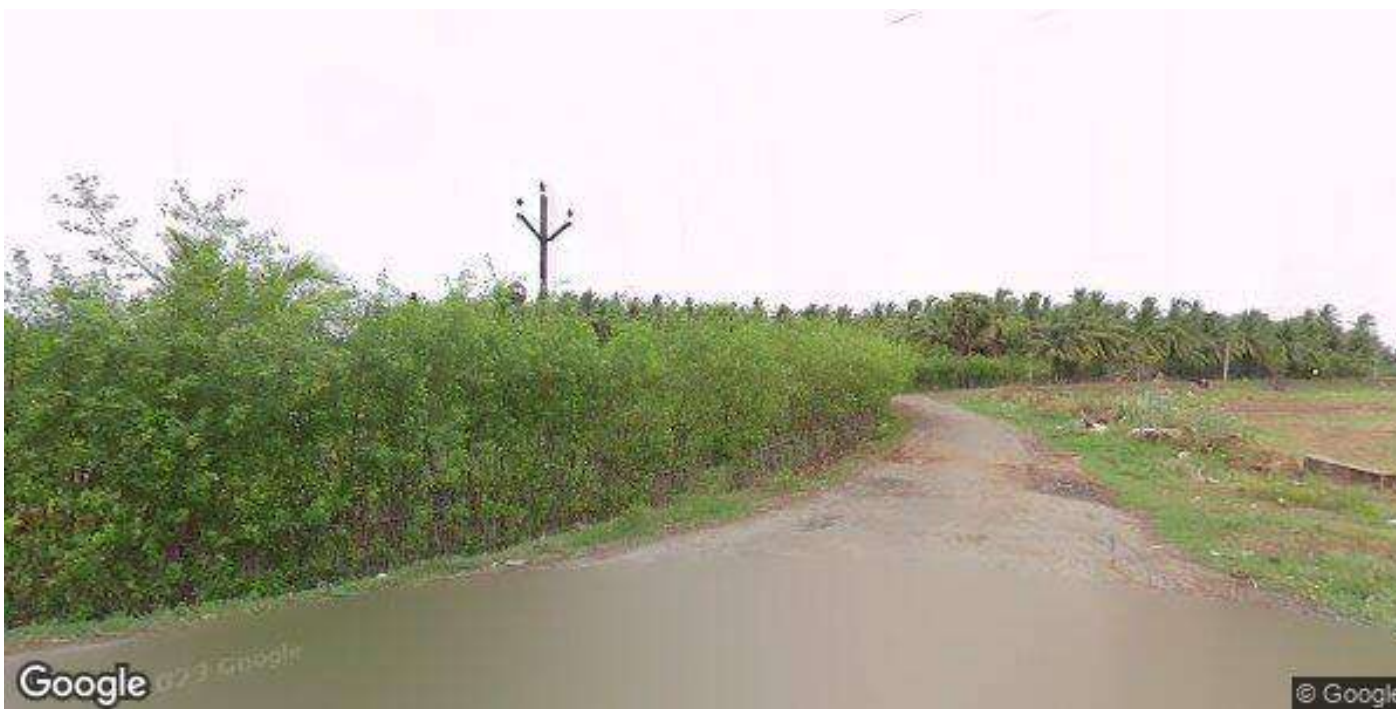
**Risk Type:** Turn  
**Risk Level:** High  
**Speed Limit:** 15 KM/Hr  
**Coordinates:** 11.49518, 78.05498

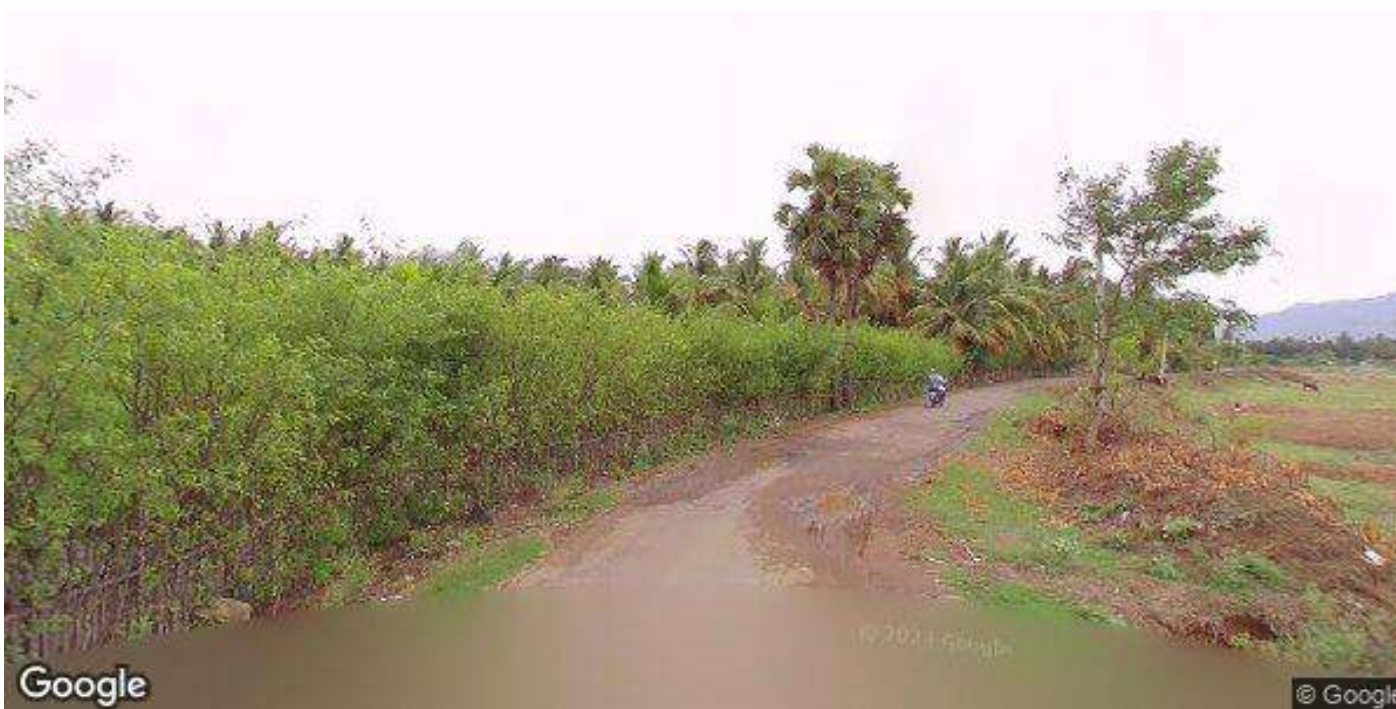
**Risk Type:** Turn  
**Risk Level:** Medium  
**Speed Limit:** 30 KM/Hr  
**Coordinates:** 11.49544, 78.05538

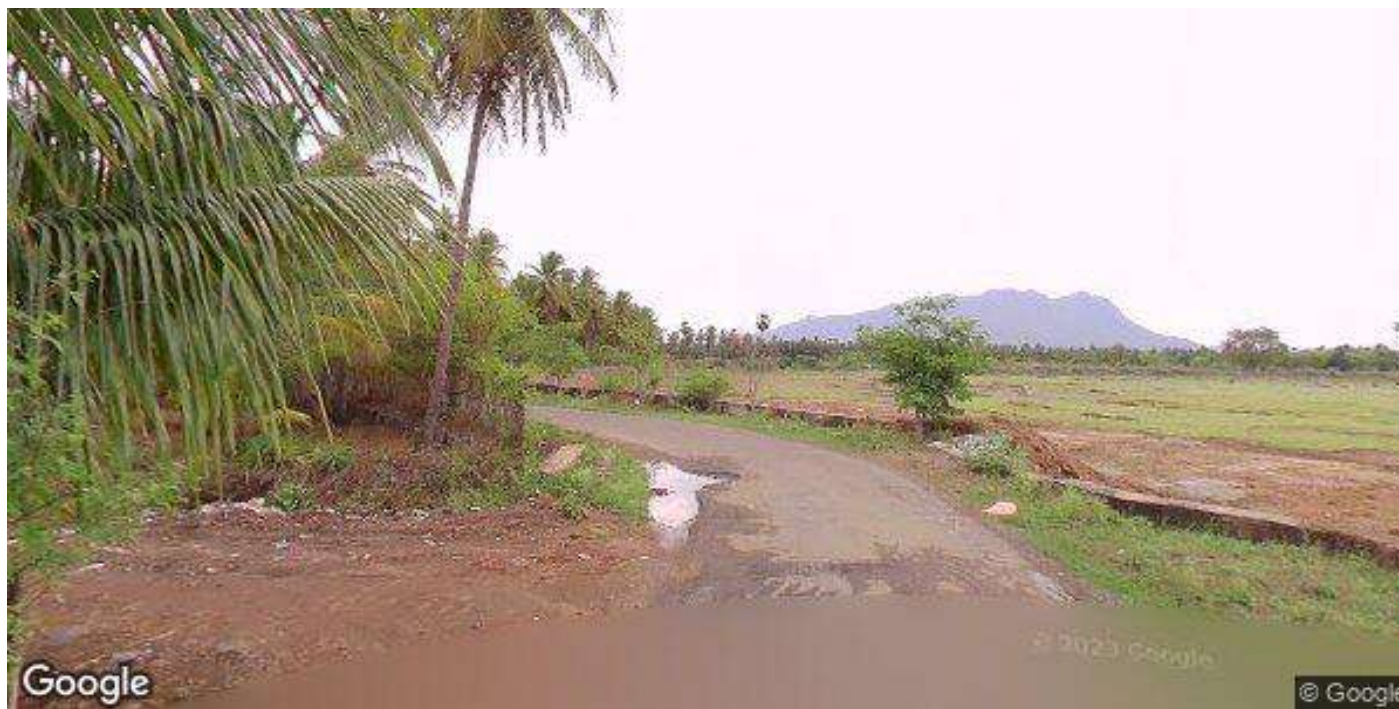
**Risk Type:** Turn  
**Risk Level:** Medium  
**Speed Limit:** 30 KM/Hr  
**Coordinates:** 11.49525, 78.05686

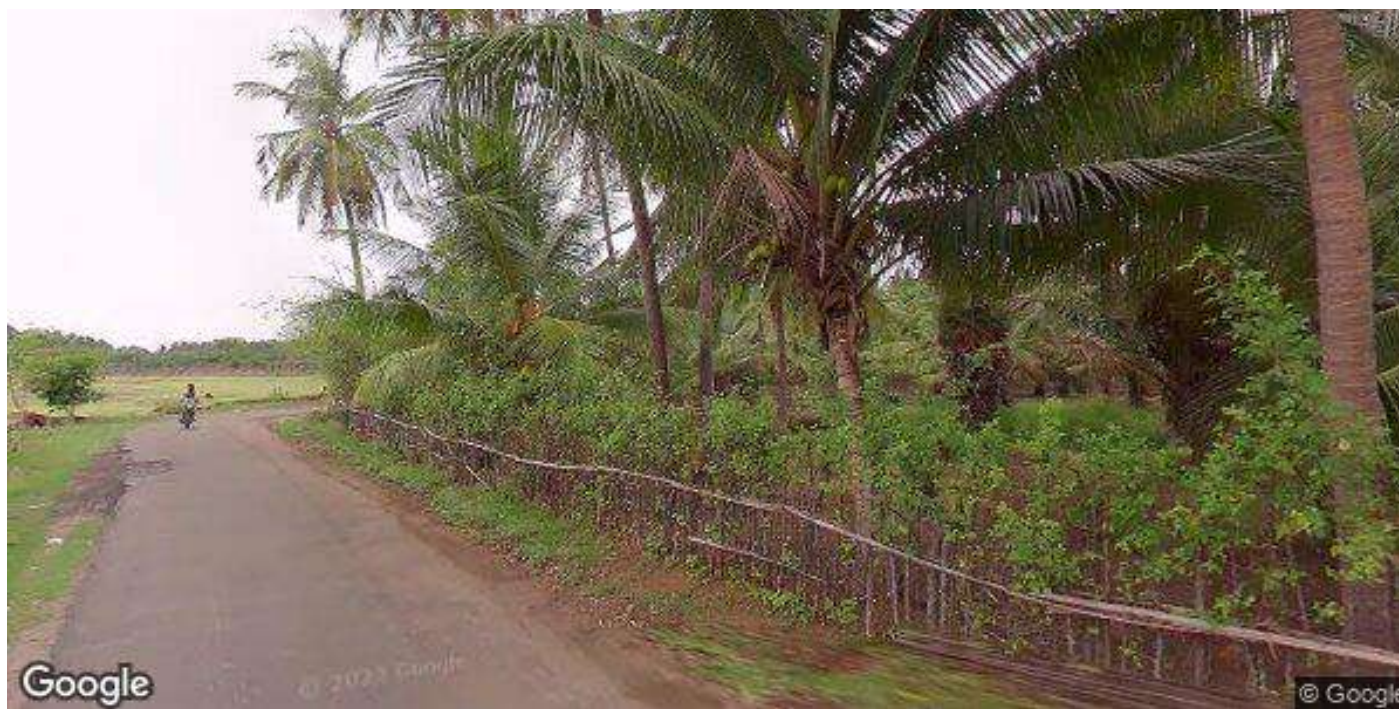
**Risk Type:** Turn  
**Risk Level:** Medium  
**Speed Limit:** 30 KM/Hr  
**Coordinates:** 11.49546, 78.05719

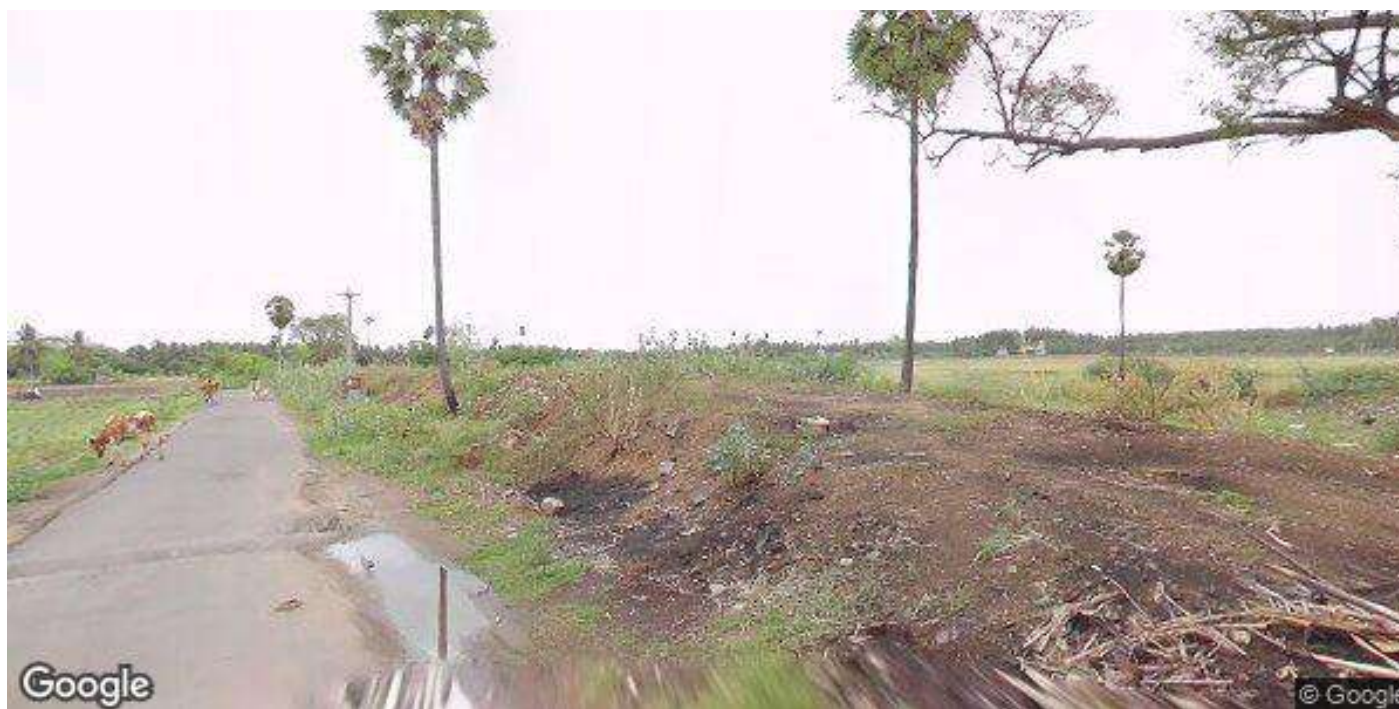
**Risk Type:** Turn  
**Risk Level:** High  
**Speed Limit:** 15 KM/Hr  
**Coordinates:** 11.49548, 78.05904

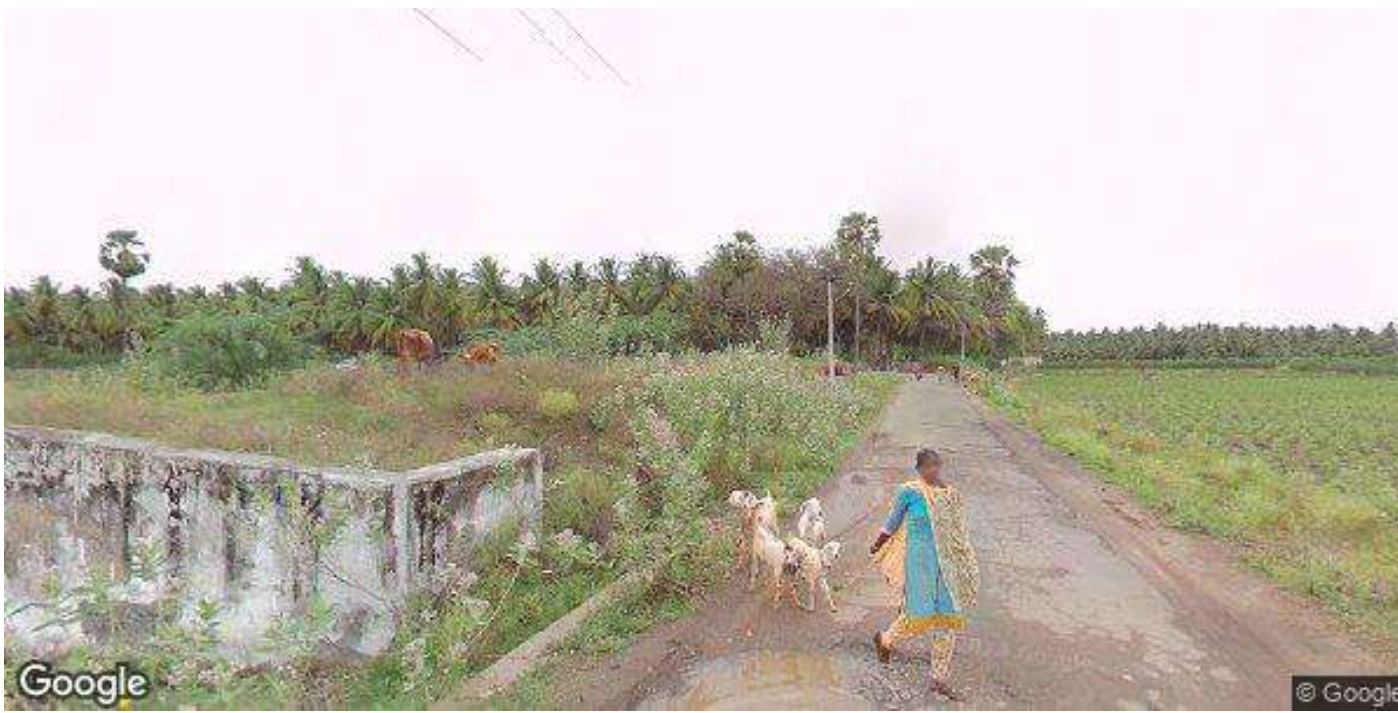
**Risk Type:** Turn  
**Risk Level:** Medium  
**Speed Limit:** 30 KM/Hr  
**Coordinates:** 11.49477, 78.05905

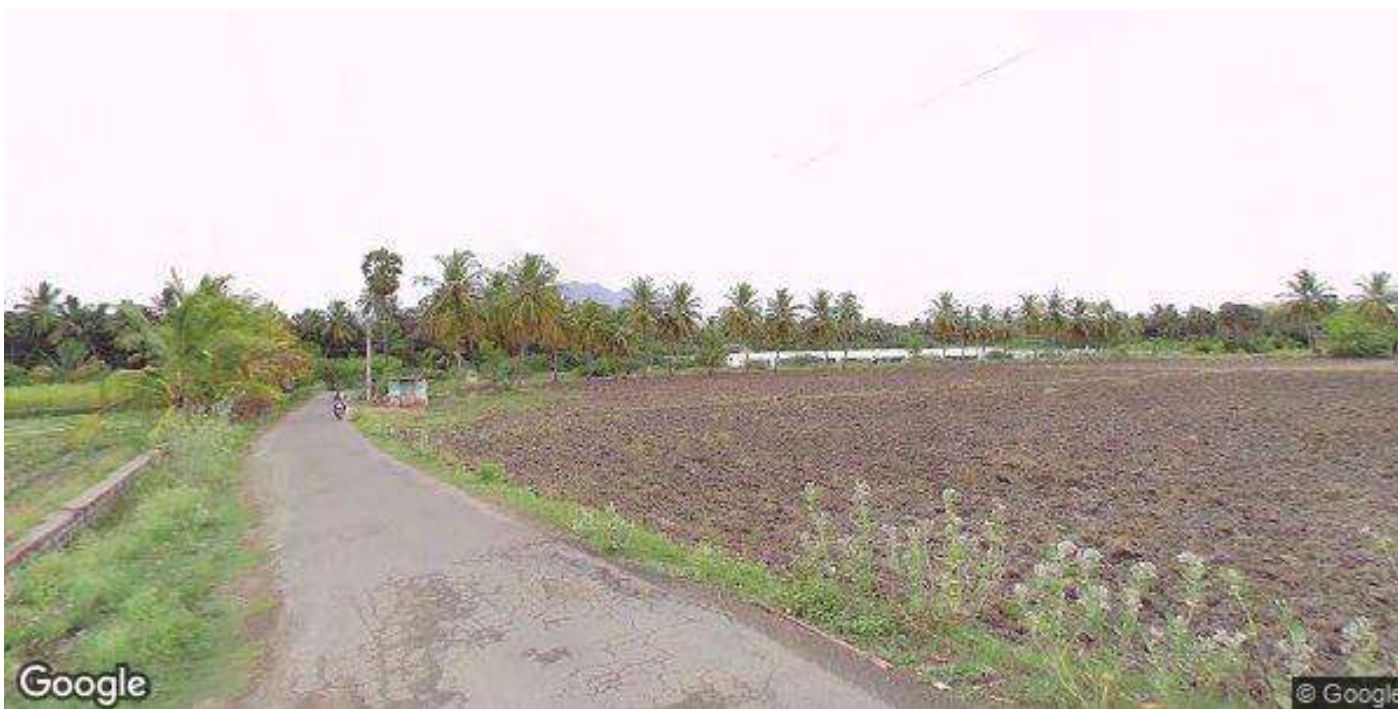
**Risk Type:** Turn  
**Risk Level:** High  
**Speed Limit:** 15 KM/Hr  
**Coordinates:** 11.49465, 78.05912

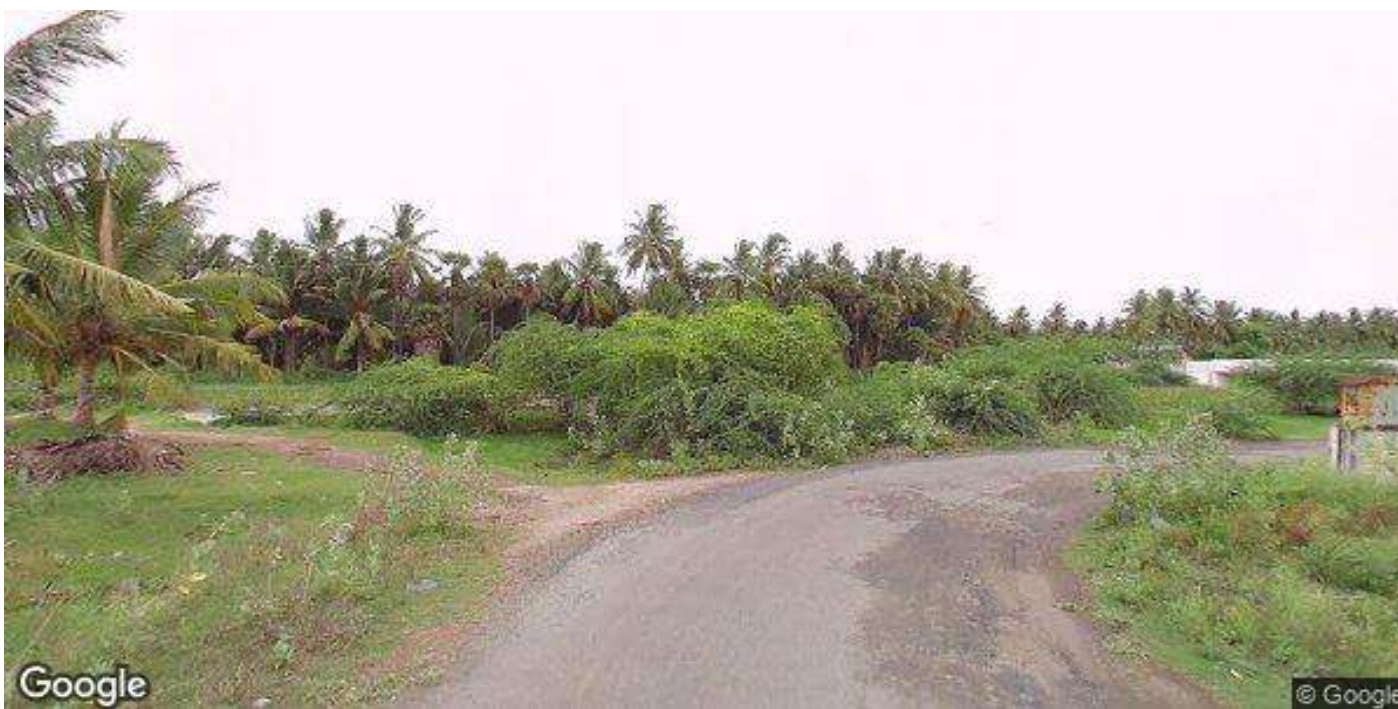
**Risk Type:** Turn  
**Risk Level:** Medium  
**Speed Limit:** 30 KM/Hr  
**Coordinates:** 11.49458, 78.05989

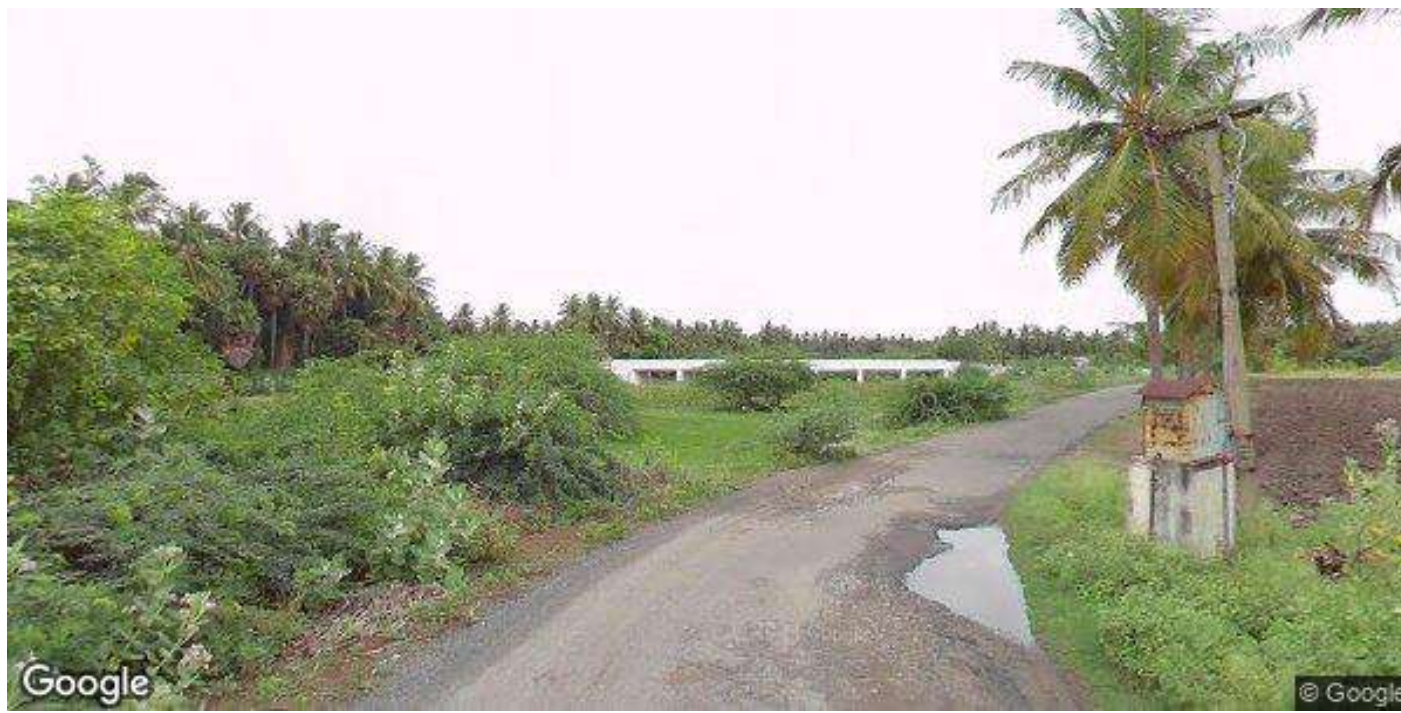
**Risk Type:** Turn  
**Risk Level:** High  
**Speed Limit:** 15 KM/Hr  
**Coordinates:** 11.49451, 78.05995

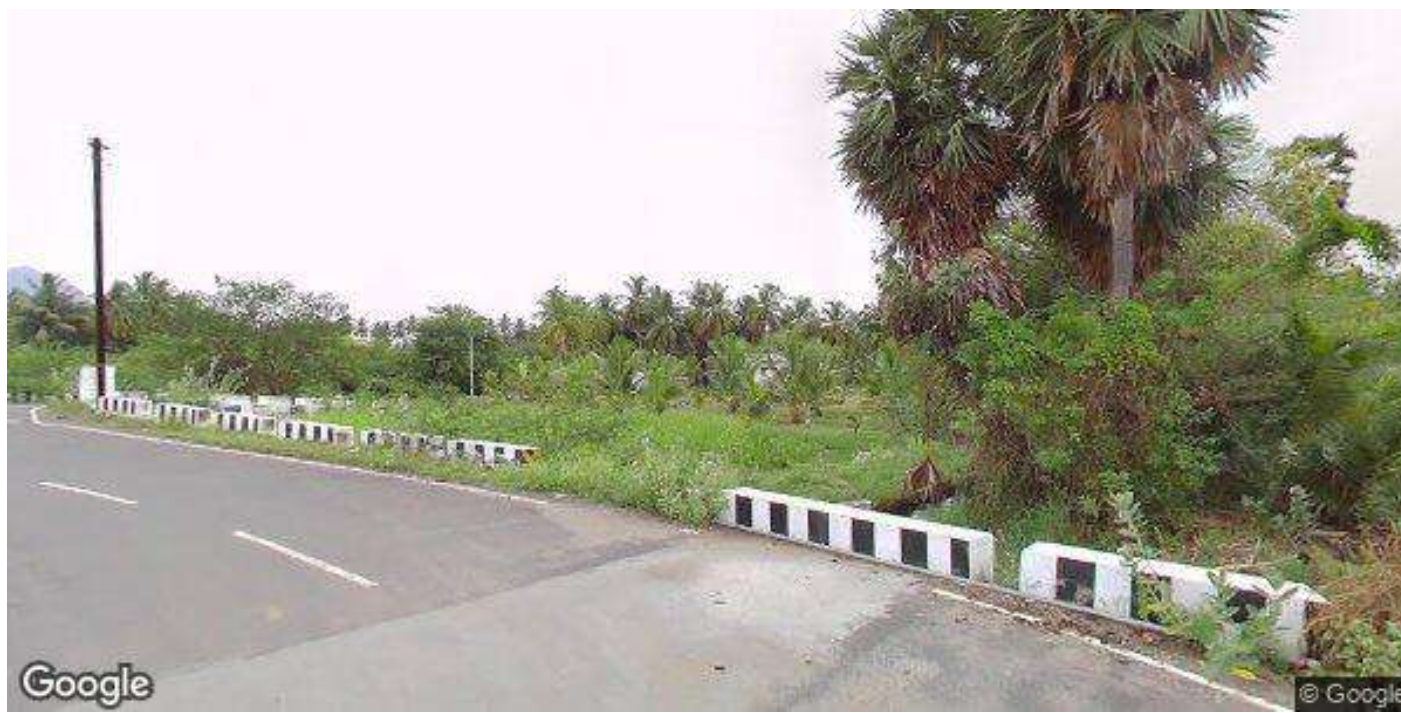
**Risk Type:** Turn  
**Risk Level:** High  
**Speed Limit:** 15 KM/Hr  
**Coordinates:** 11.49309, 78.05982

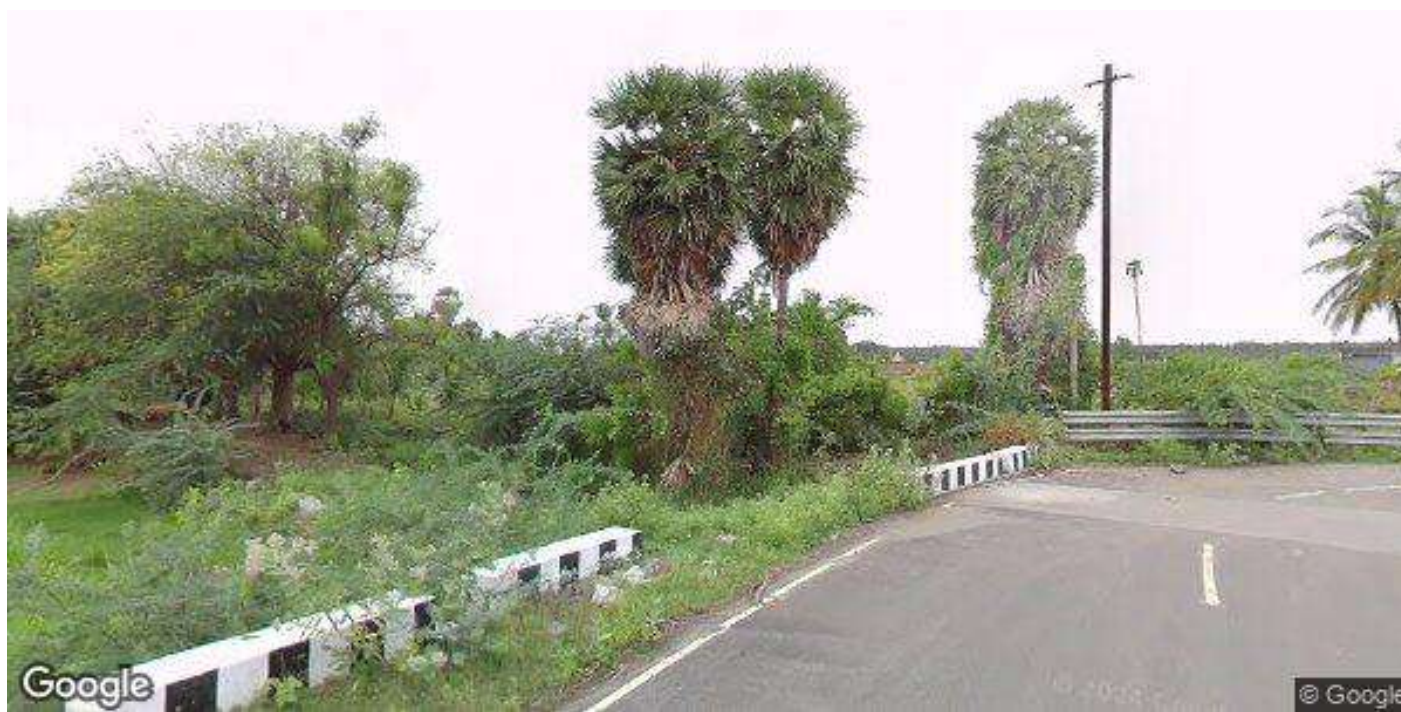
**Risk Type:** Turn  
**Risk Level:** Medium  
**Speed Limit:** 30 KM/Hr  
**Coordinates:** 11.49303, 78.05997

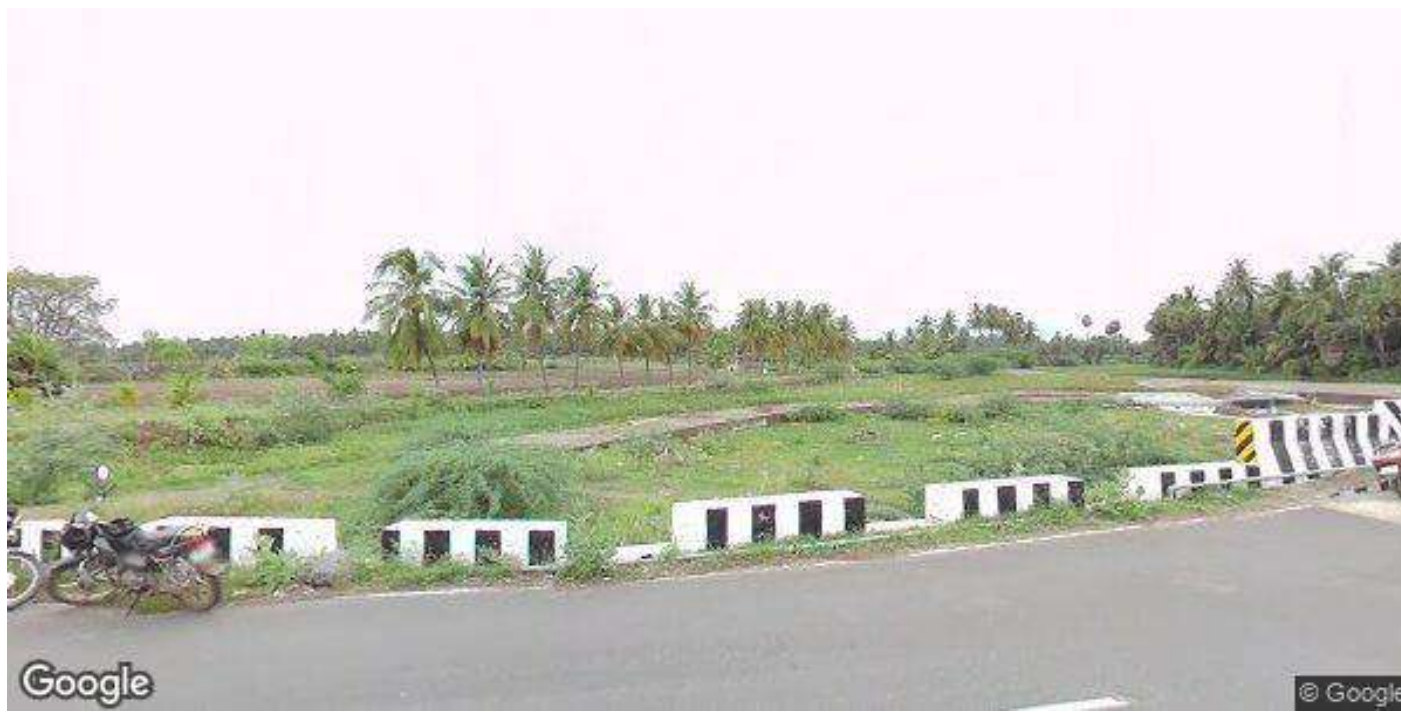
**Risk Type:** Turn  
**Risk Level:** Medium  
**Speed Limit:** 30 KM/Hr  
**Coordinates:** 11.49306, 78.06011

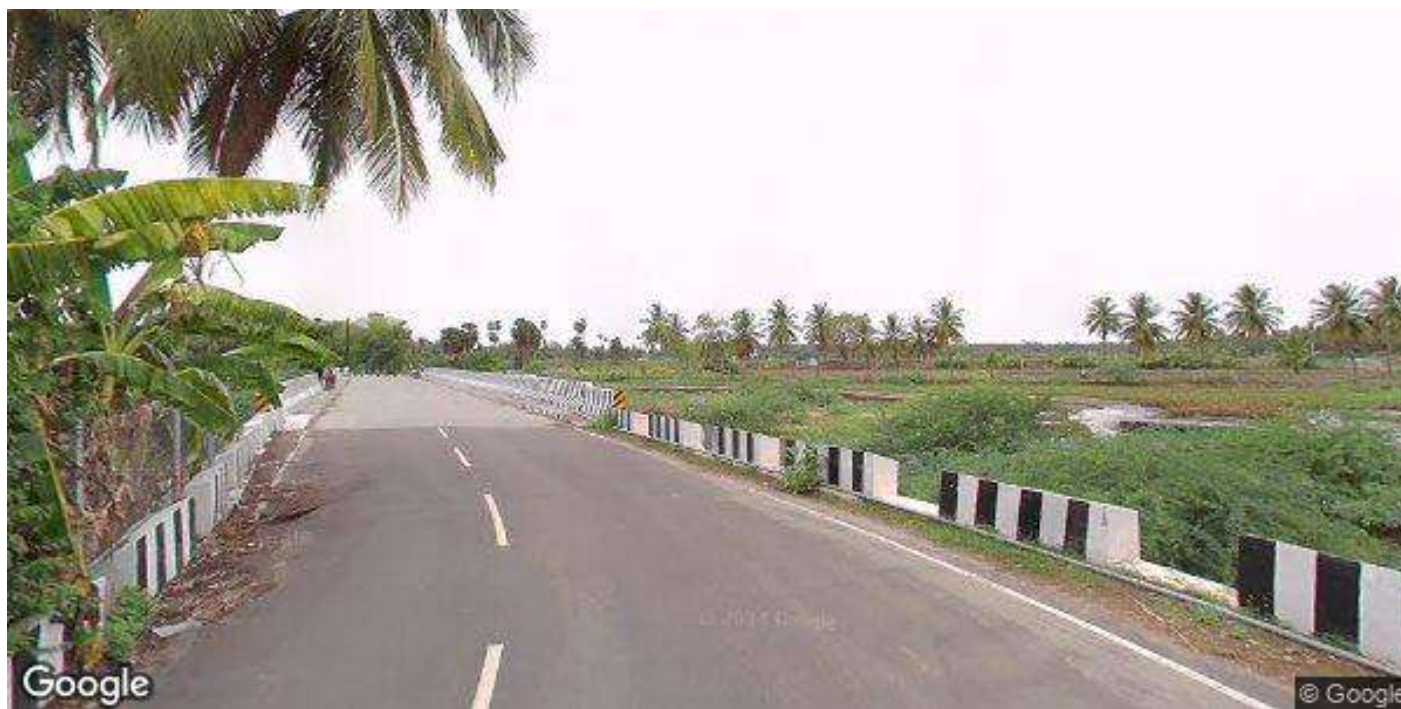
**Risk Type:** Turn  
**Risk Level:** Medium  
**Speed Limit:** 30 KM/Hr  
**Coordinates:** 11.49362, 78.06091

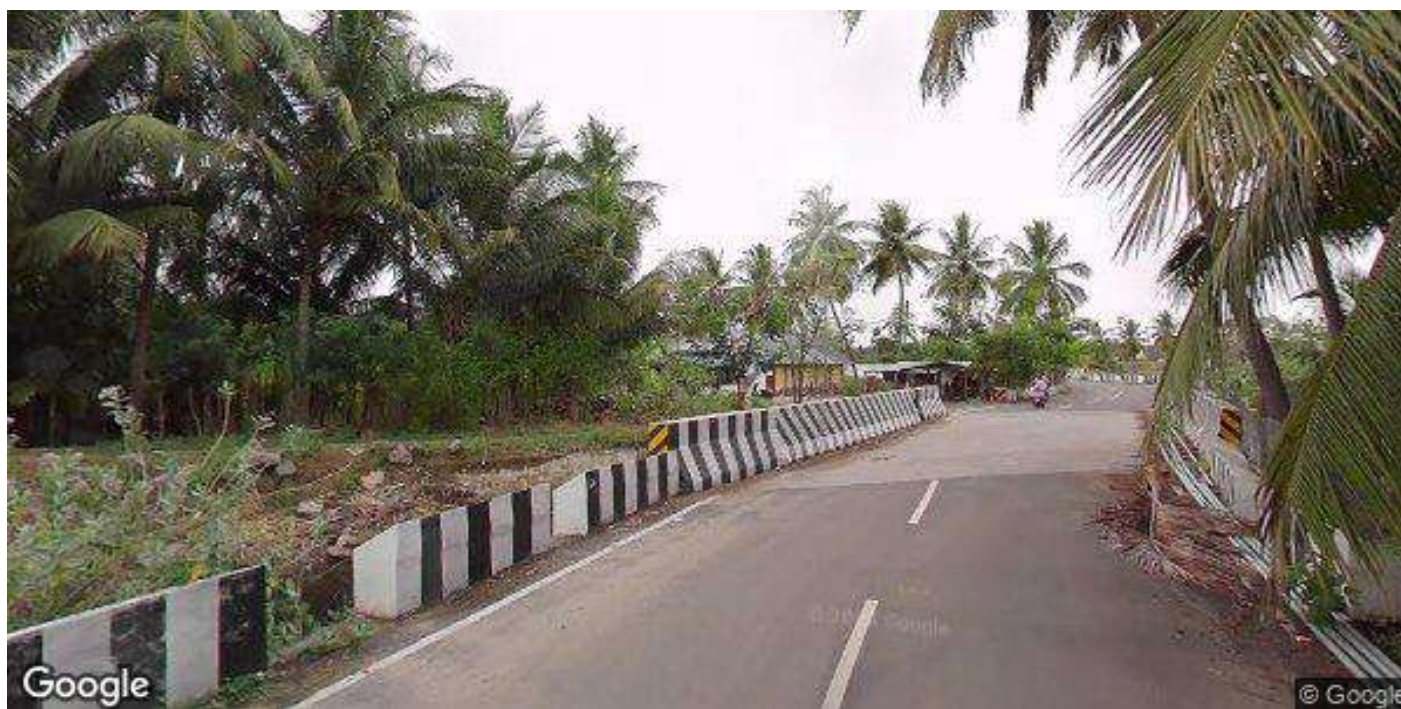
**Risk Type:** Turn  
**Risk Level:** High  
**Speed Limit:** 15 KM/Hr  
**Coordinates:** 11.49366, 78.06136

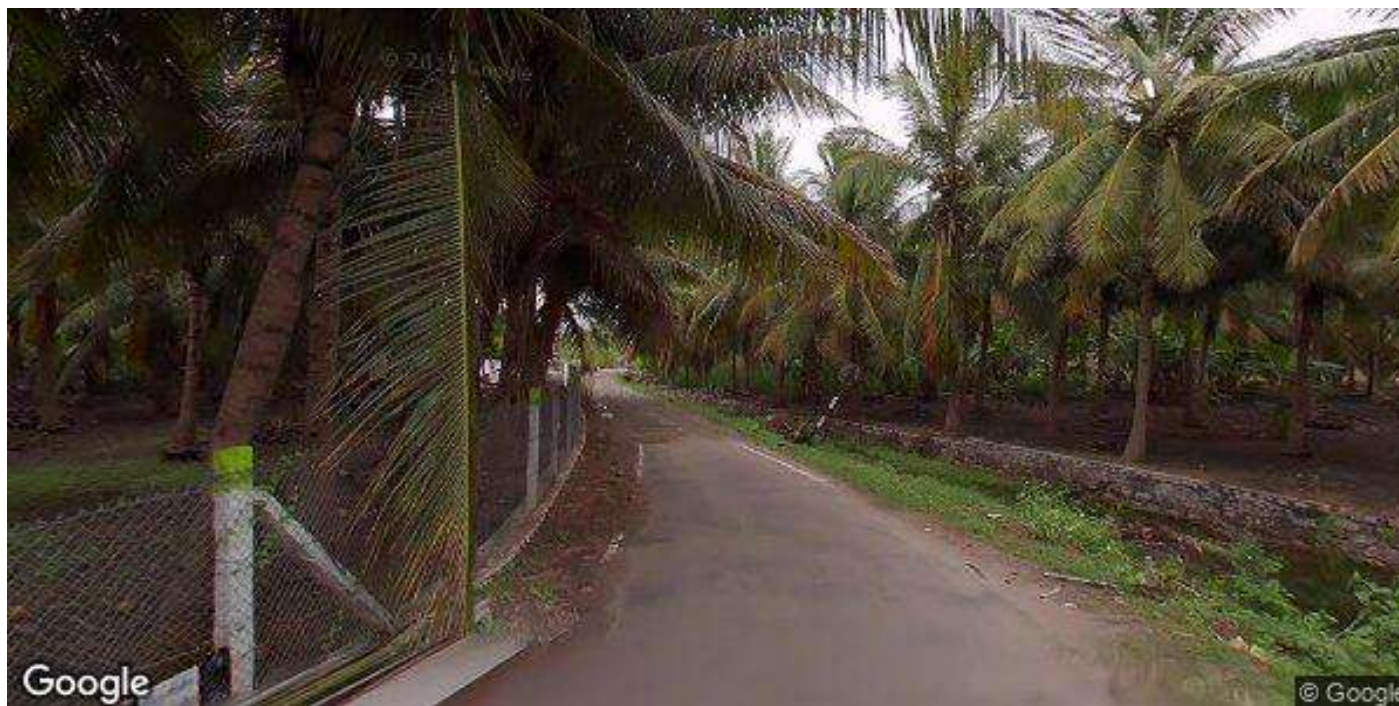
**Risk Type:** Turn  
**Risk Level:** Medium  
**Speed Limit:** 30 KM/Hr  
**Coordinates:** 11.49378, 78.06146

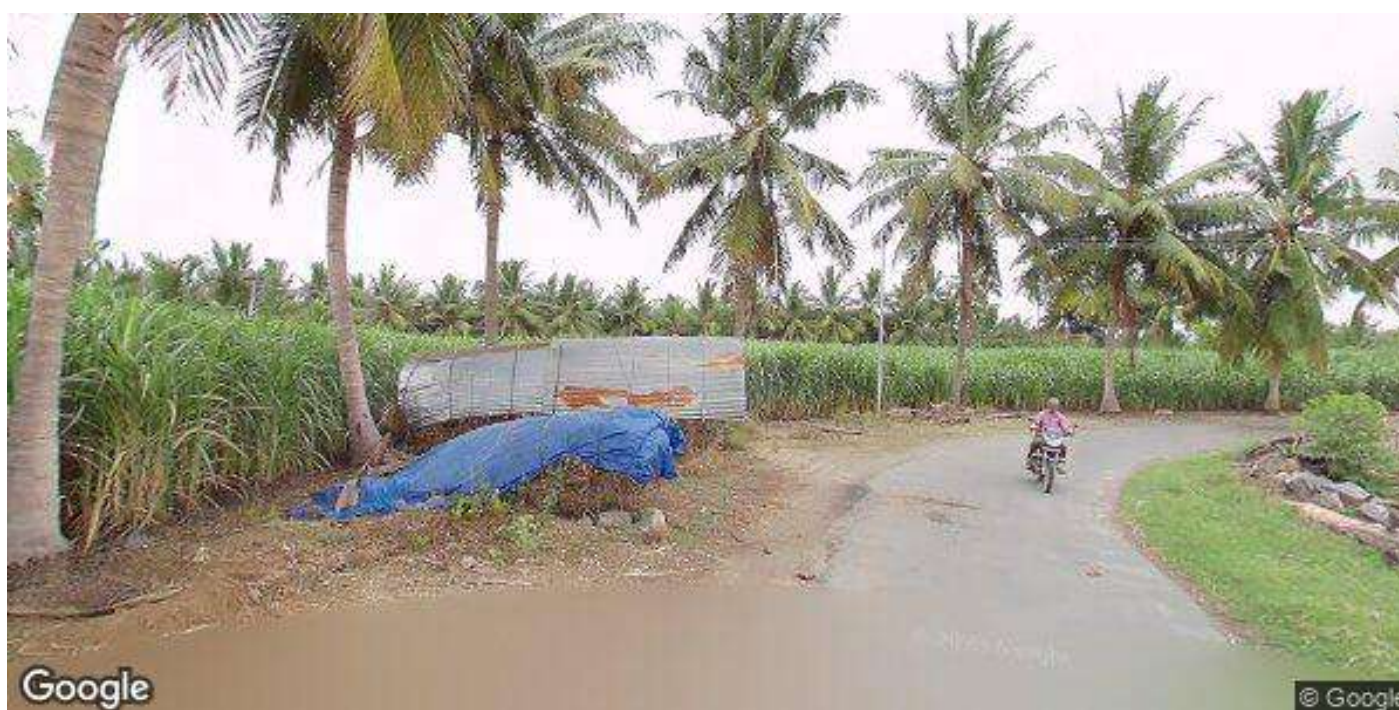
**Risk Type:** Turn  
**Risk Level:** Medium  
**Speed Limit:** 30 KM/Hr  
**Coordinates:** 11.49553, 78.06186
