# IndianOil

## JOURNEY RISK MANAGEMENT (JRM) STUDY

### Salem Terminal to N.S.K.AGENCIE

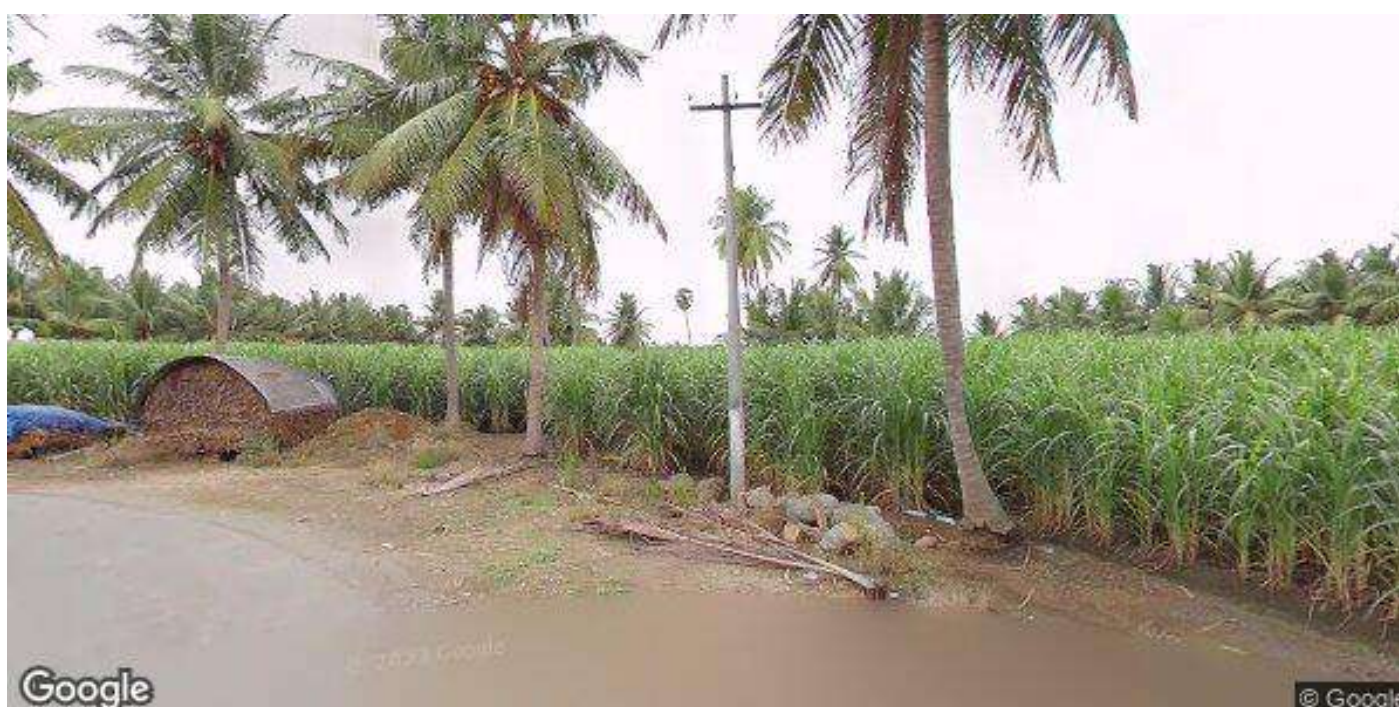
**Risk Type:** Turn  
**Risk Level:** Medium  
**Speed Limit:** 30 KM/Hr  
**Coordinates:** 11.49563, 78.06201

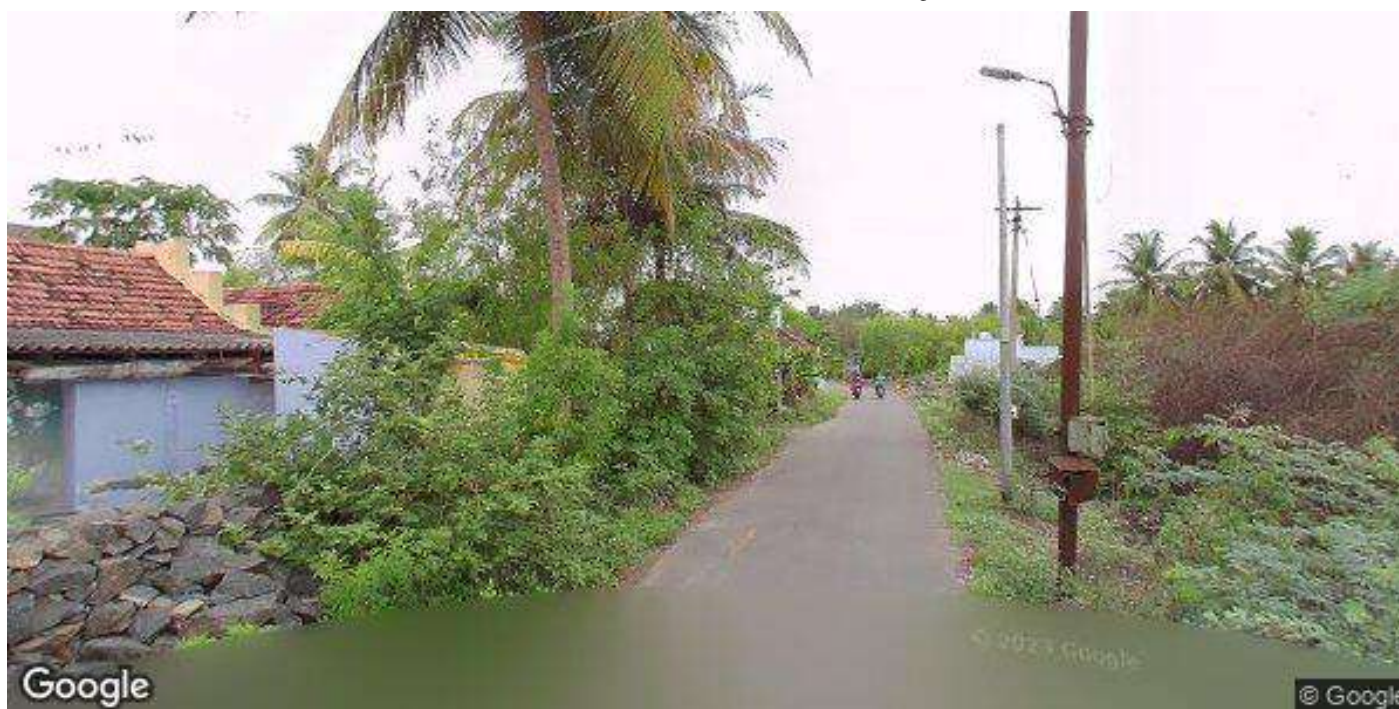
**Risk Type:** Turn  
**Risk Level:** Medium  
**Speed Limit:** 30 KM/Hr  
**Coordinates:** 11.49660, 78.06782

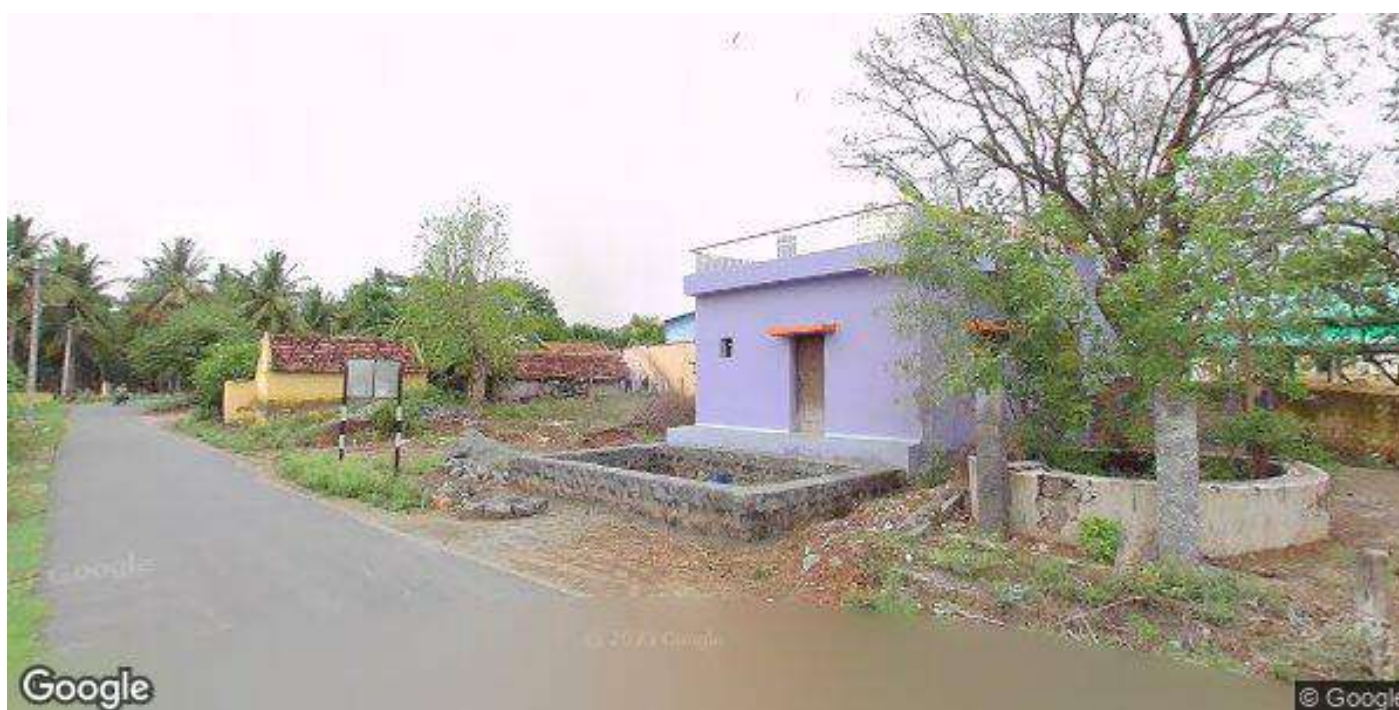
**Risk Type:** Turn  
**Risk Level:** Medium  
**Speed Limit:** 30 KM/Hr  
**Coordinates:** 11.49669, 78.06790

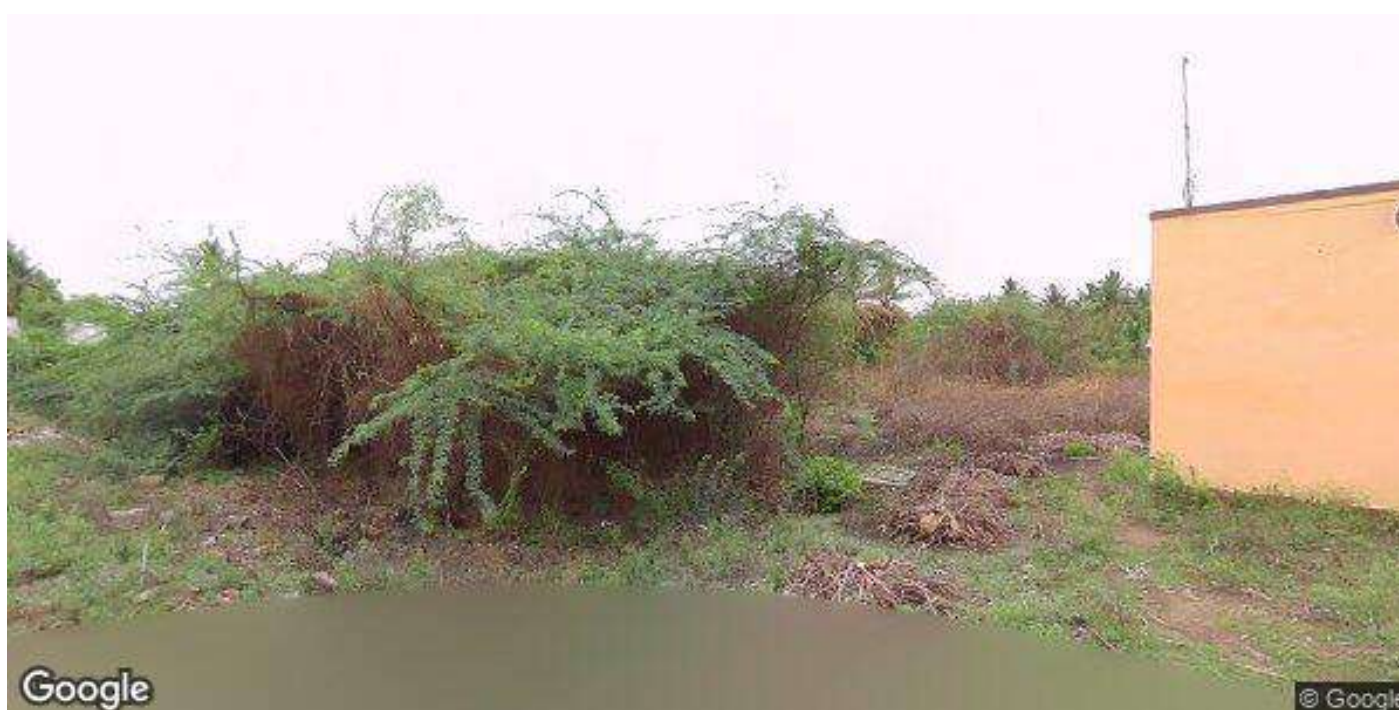
**Risk Type:** Turn  
**Risk Level:** High  
**Speed Limit:** 15 KM/Hr  
**Coordinates:** 11.49730, 78.06790

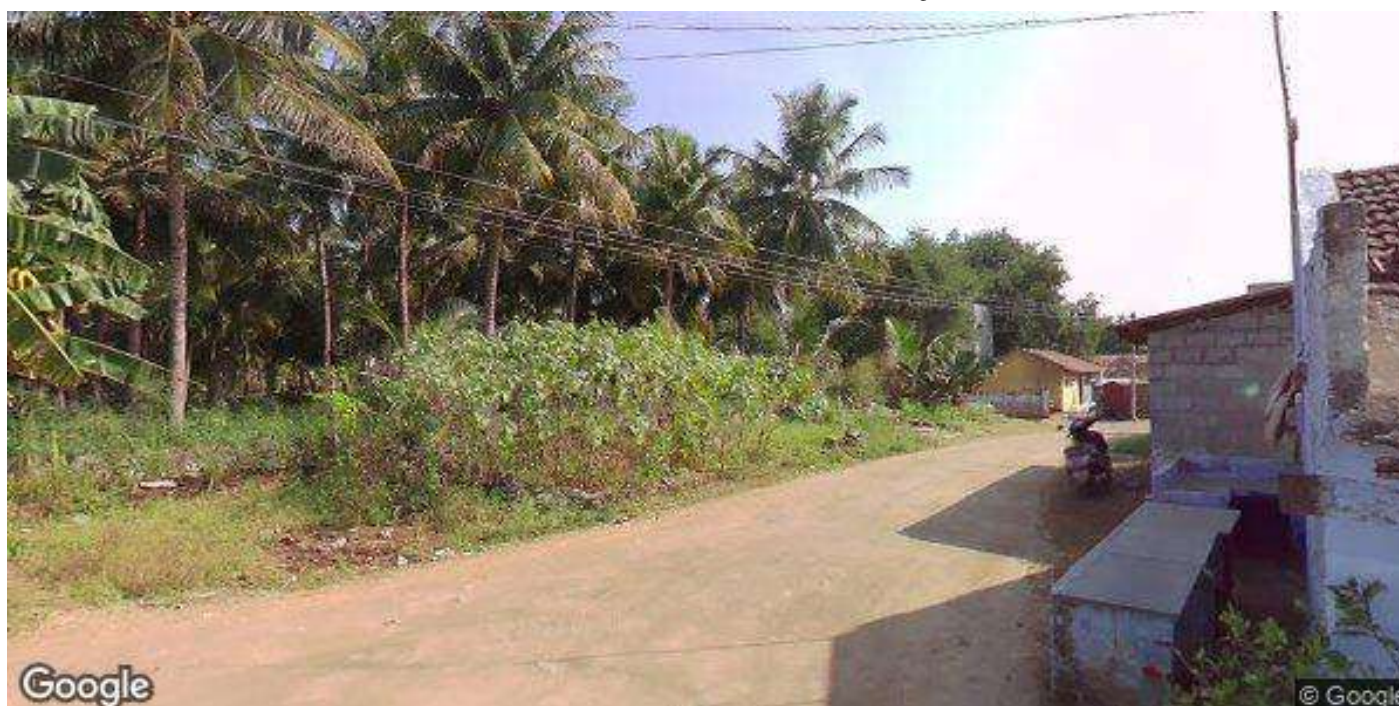
**Risk Type:** Turn  
**Risk Level:** High  
**Speed Limit:** 15 KM/Hr  
**Coordinates:** 11.49738, 78.06877

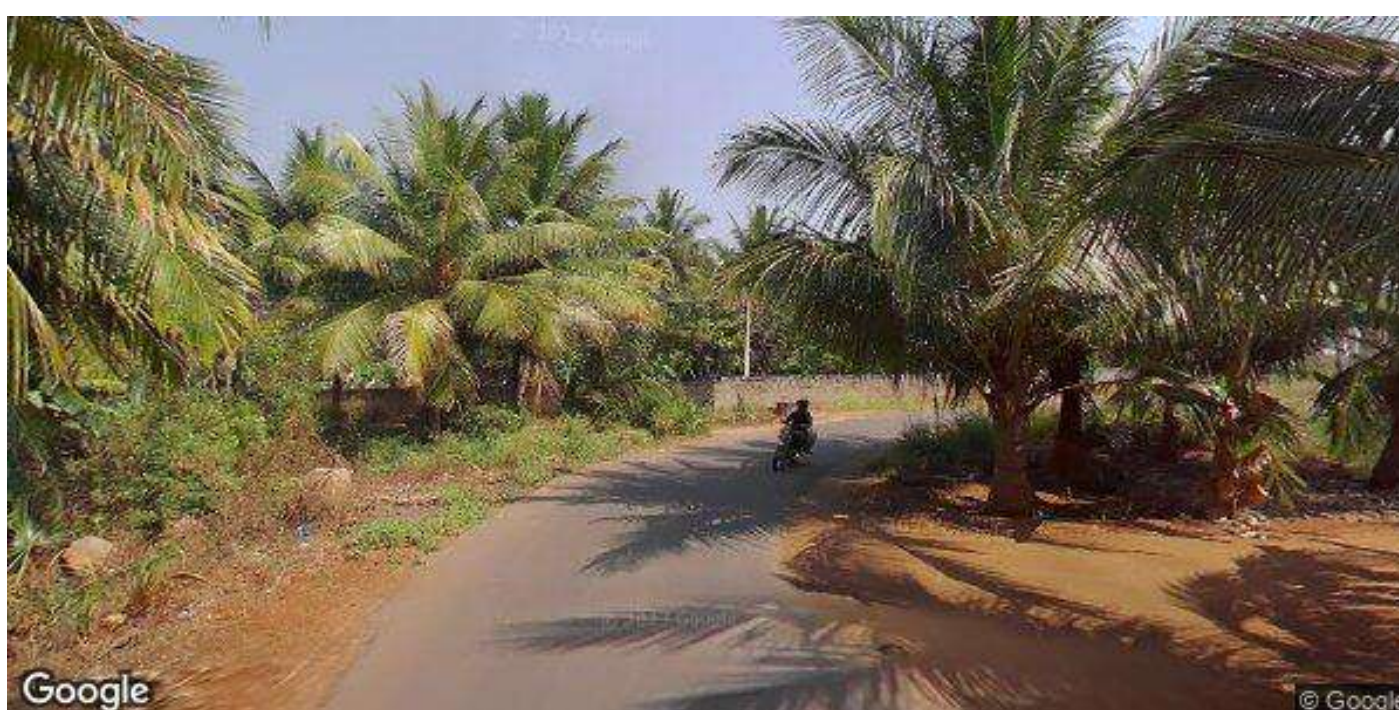
**Risk Type:** Turn  
**Risk Level:** Medium  
**Speed Limit:** 30 KM/Hr  
**Coordinates:** 11.49906, 78.06934

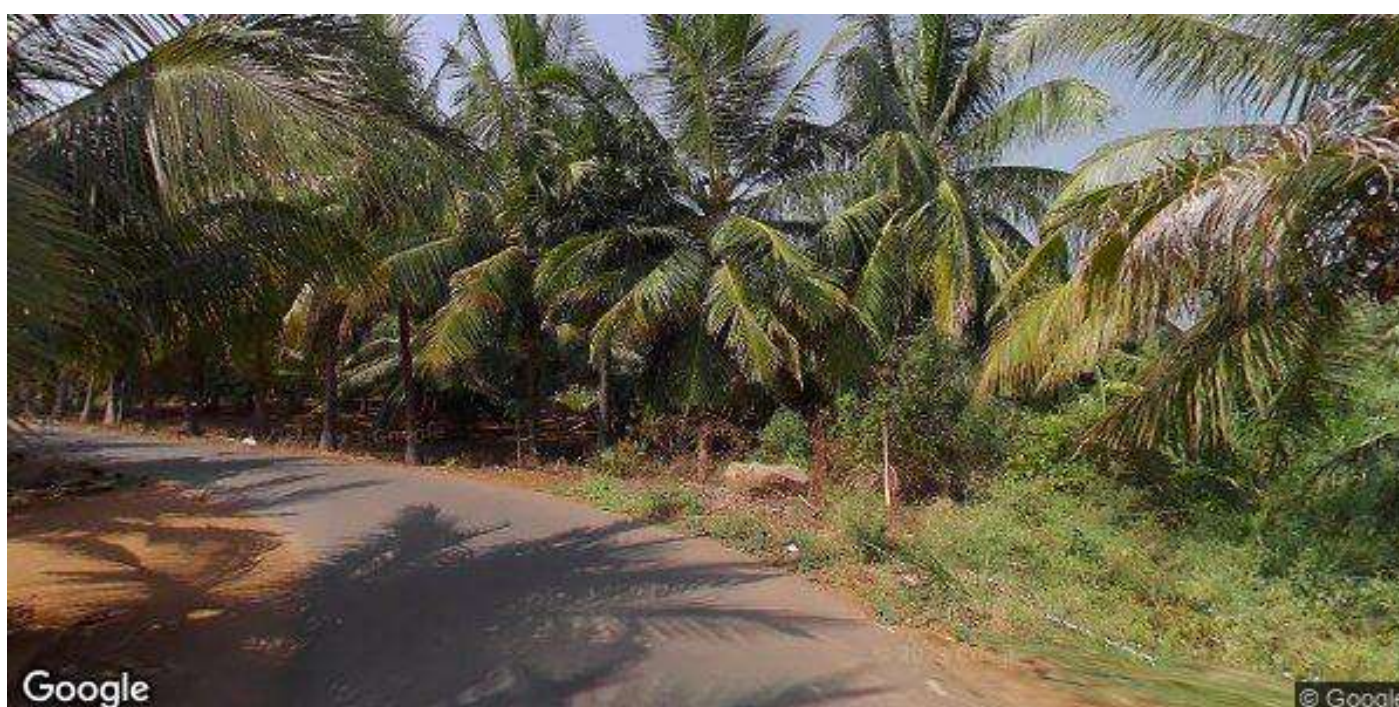
**Risk Type:** Turn  
**Risk Level:** Medium  
**Speed Limit:** 30 KM/Hr  
**Coordinates:** 11.49914, 78.06944

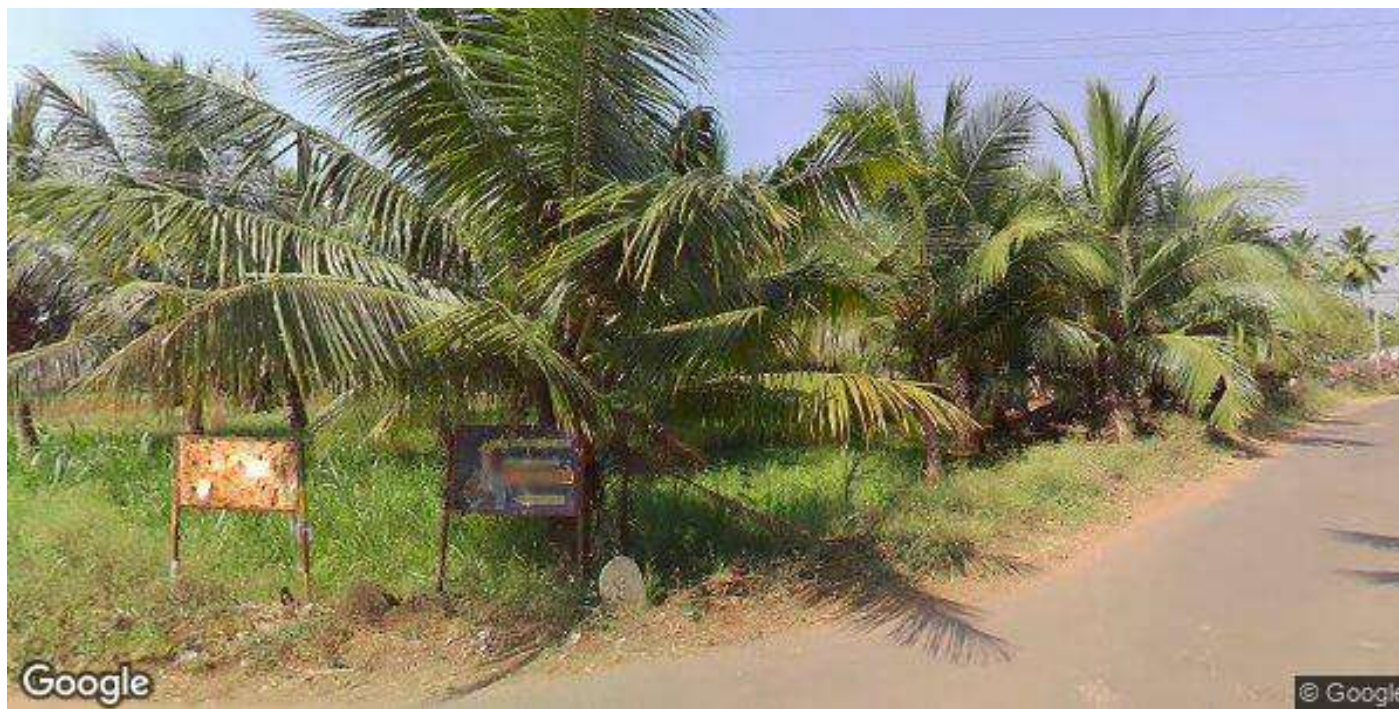
**Risk Type:** Blind Spot  
**Risk Level:** Blind Spot  
**Speed Limit:** 10 KM/Hr  
**Coordinates:** 11.50124, 78.07191

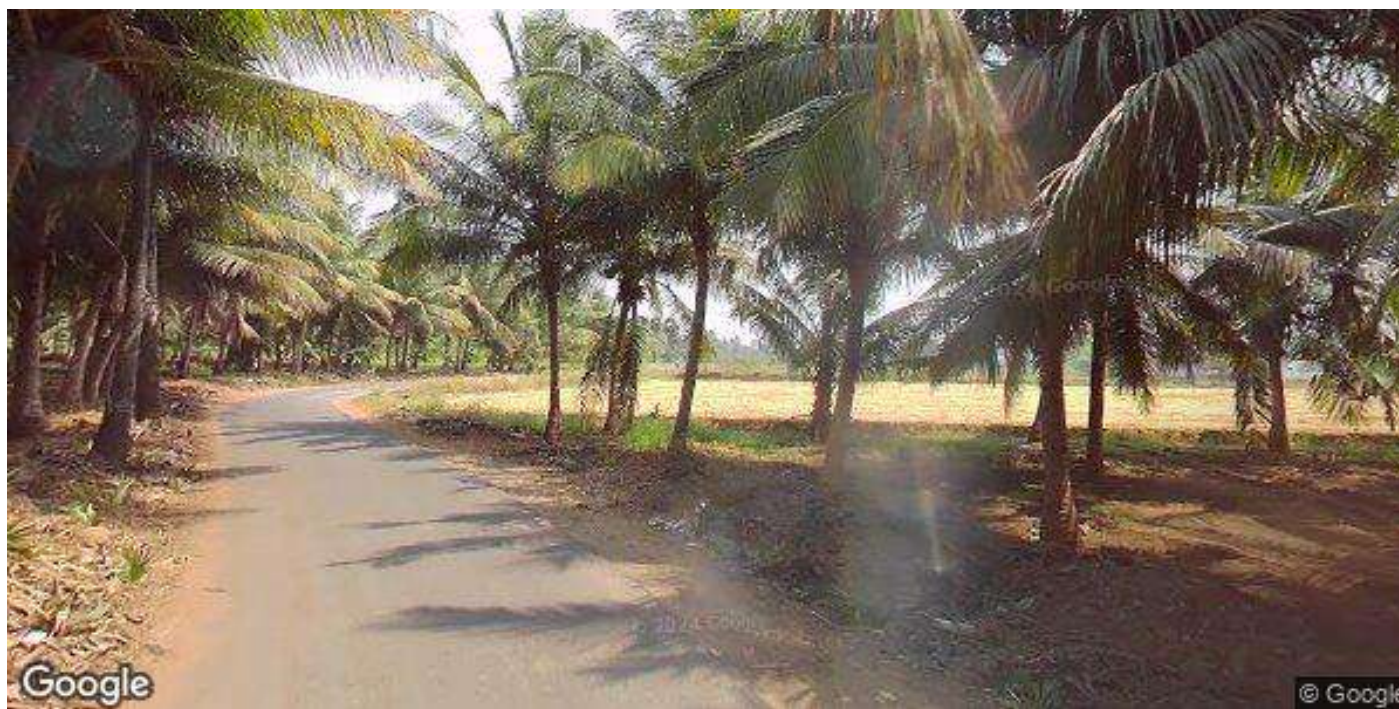
**Risk Type:** Turn  
**Risk Level:** Medium  
**Speed Limit:** 30 KM/Hr  
**Coordinates:** 11.50070, 78.07343

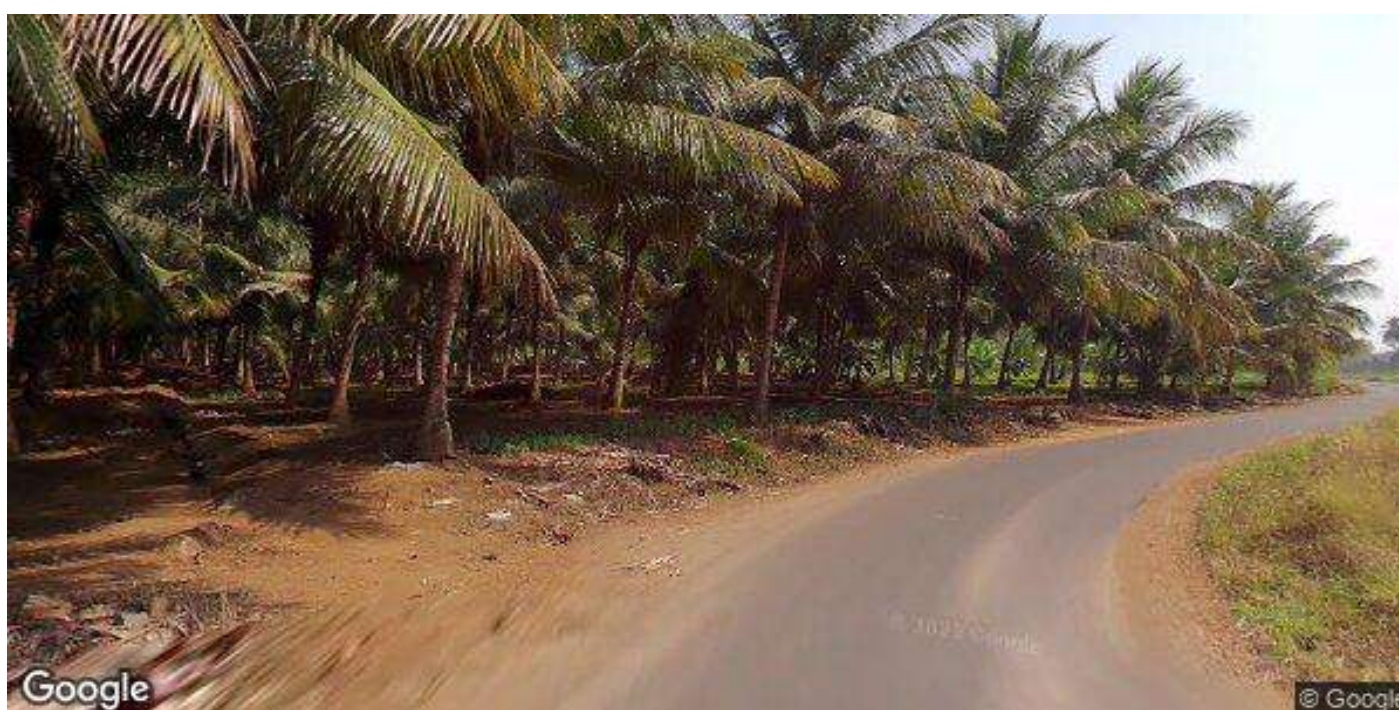
**Risk Type:** Turn  
**Risk Level:** Medium  
**Speed Limit:** 30 KM/Hr  
**Coordinates:** 11.50092, 78.07374

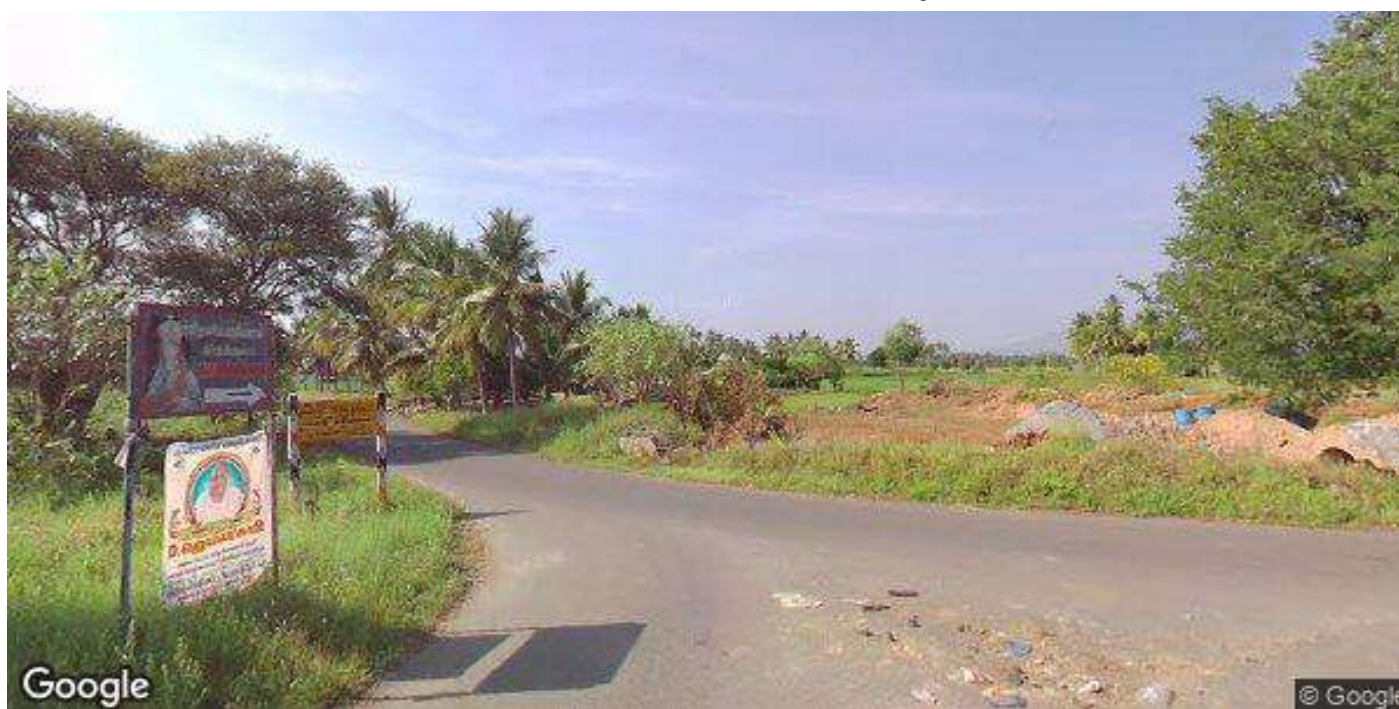
**Risk Type:** Turn  
**Risk Level:** High  
**Speed Limit:** 15 KM/Hr  
**Coordinates:** 11.50082, 78.07865

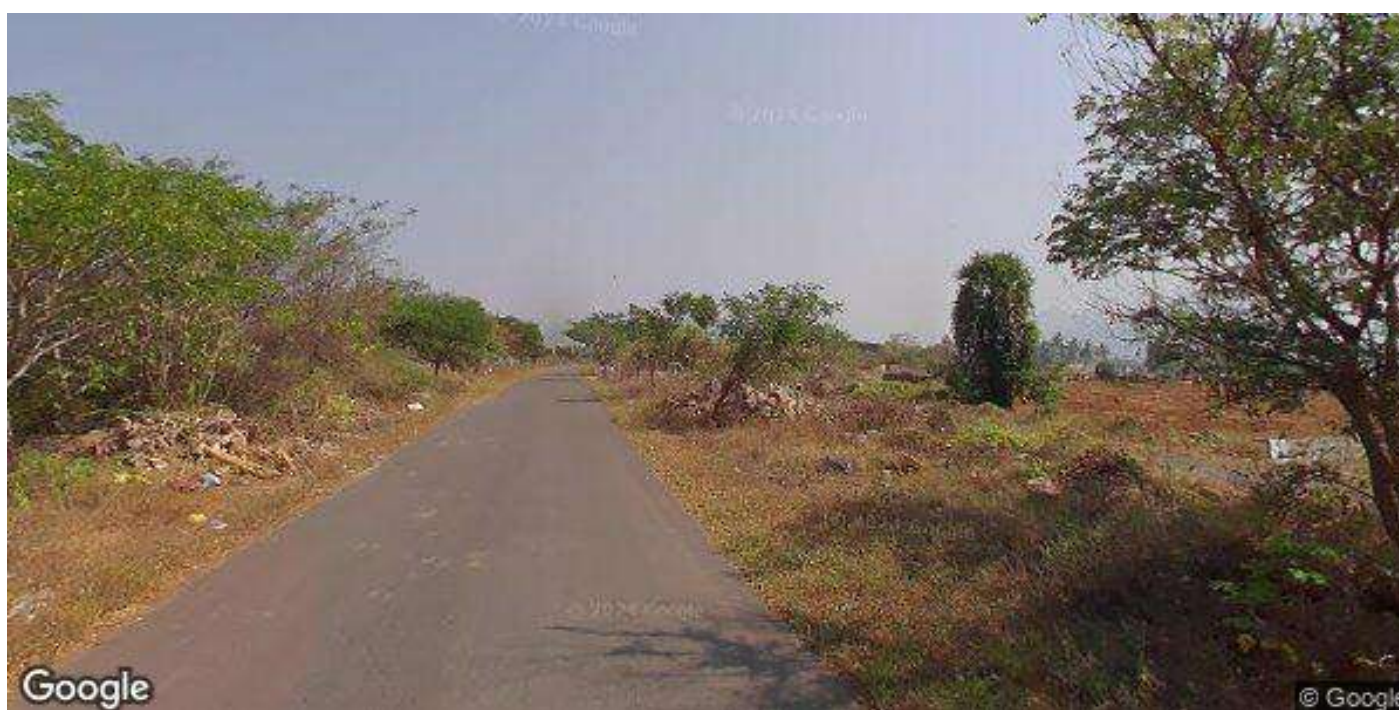
**Risk Type:** Turn  
**Risk Level:** Medium  
**Speed Limit:** 30 KM/Hr  
**Coordinates:** 11.50374, 78.08048

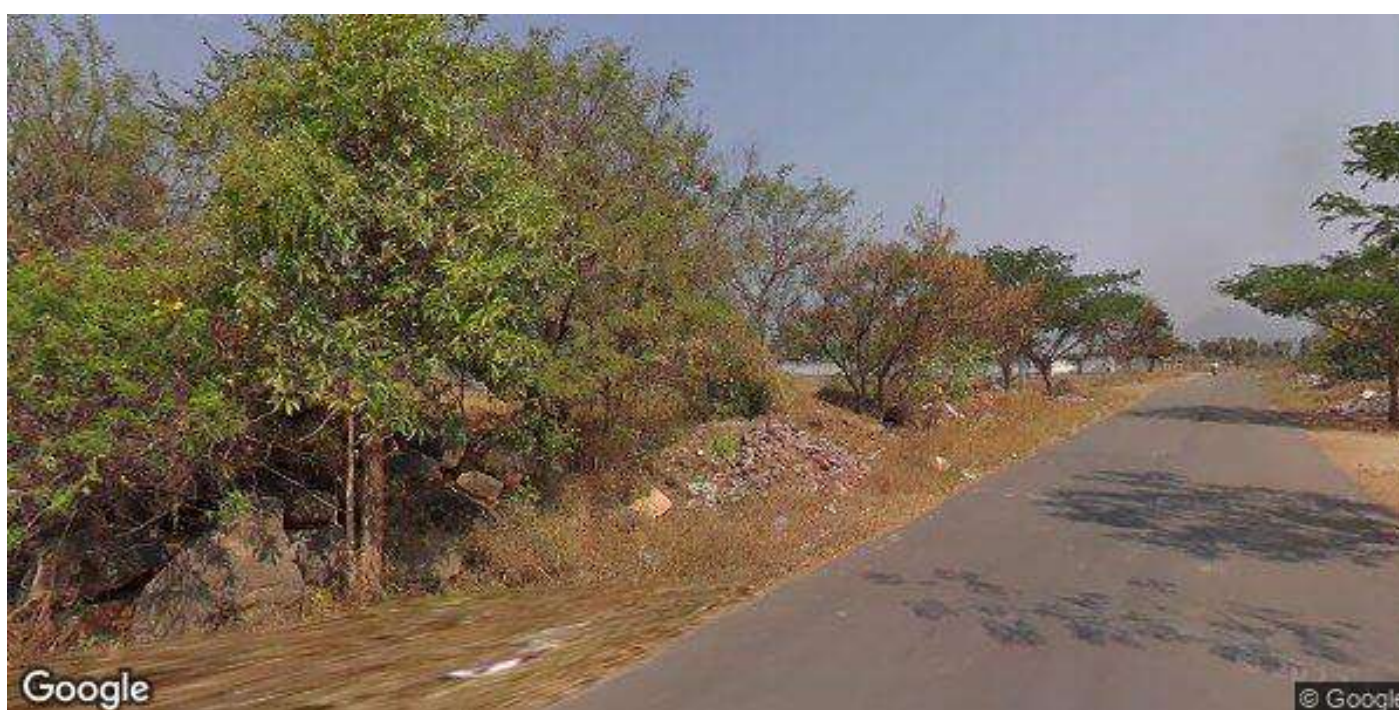
**Risk Type:** Turn  
**Risk Level:** Medium  
**Speed Limit:** 30 KM/Hr  
**Coordinates:** 11.50424, 78.08040

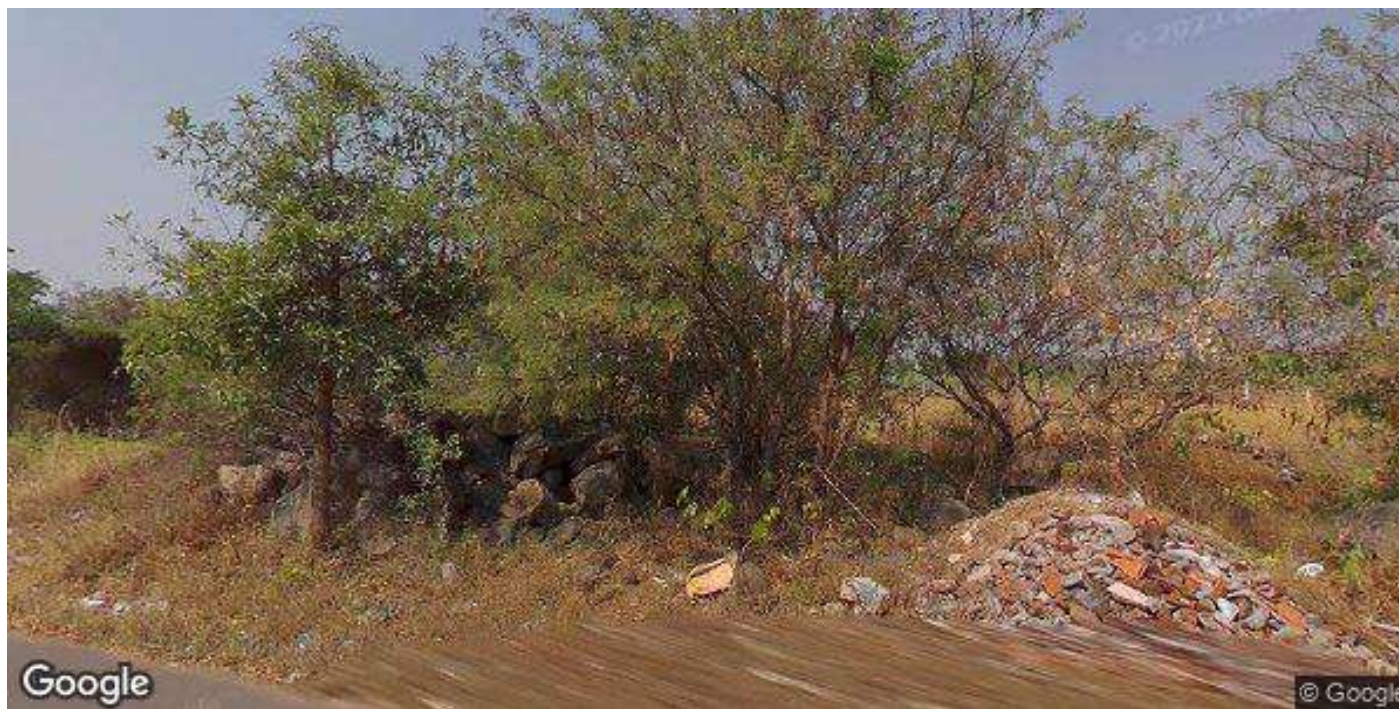
**Risk Type:** Turn  
**Risk Level:** High  
**Speed Limit:** 15 KM/Hr  
**Coordinates:** 11.50435, 78.08045

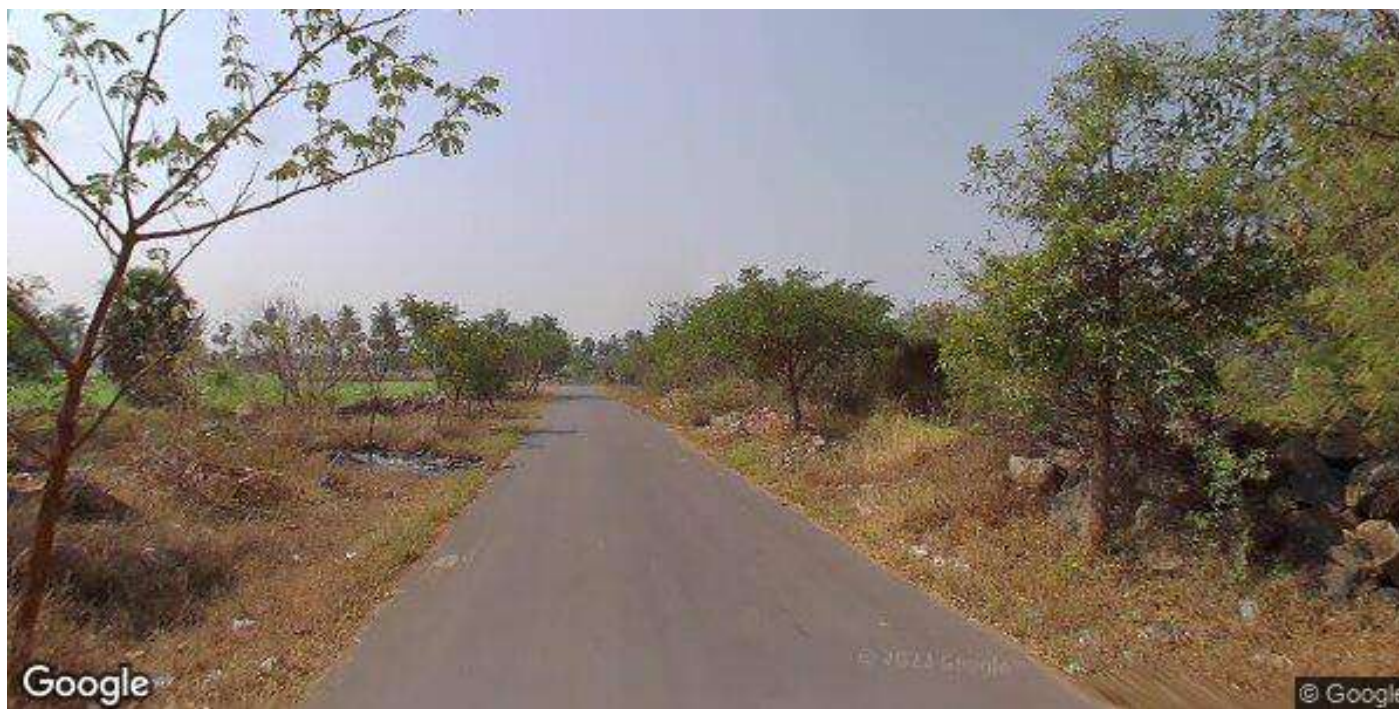
**Risk Type:** Turn  
**Risk Level:** High  
**Speed Limit:** 15 KM/Hr  
**Coordinates:** 11.50434, 78.08055

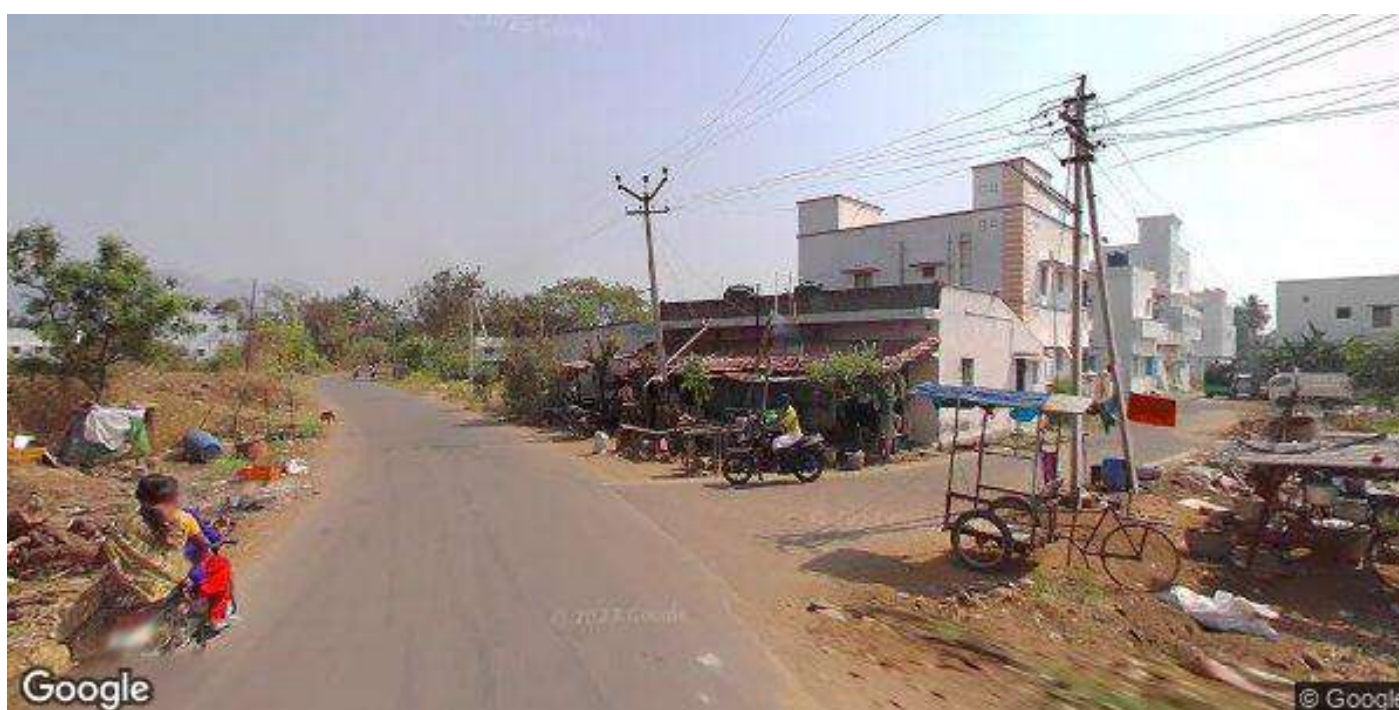
**Risk Type:** Turn  
**Risk Level:** Medium  
**Speed Limit:** 30 KM/Hr  
**Coordinates:** 11.50978, 78.08636

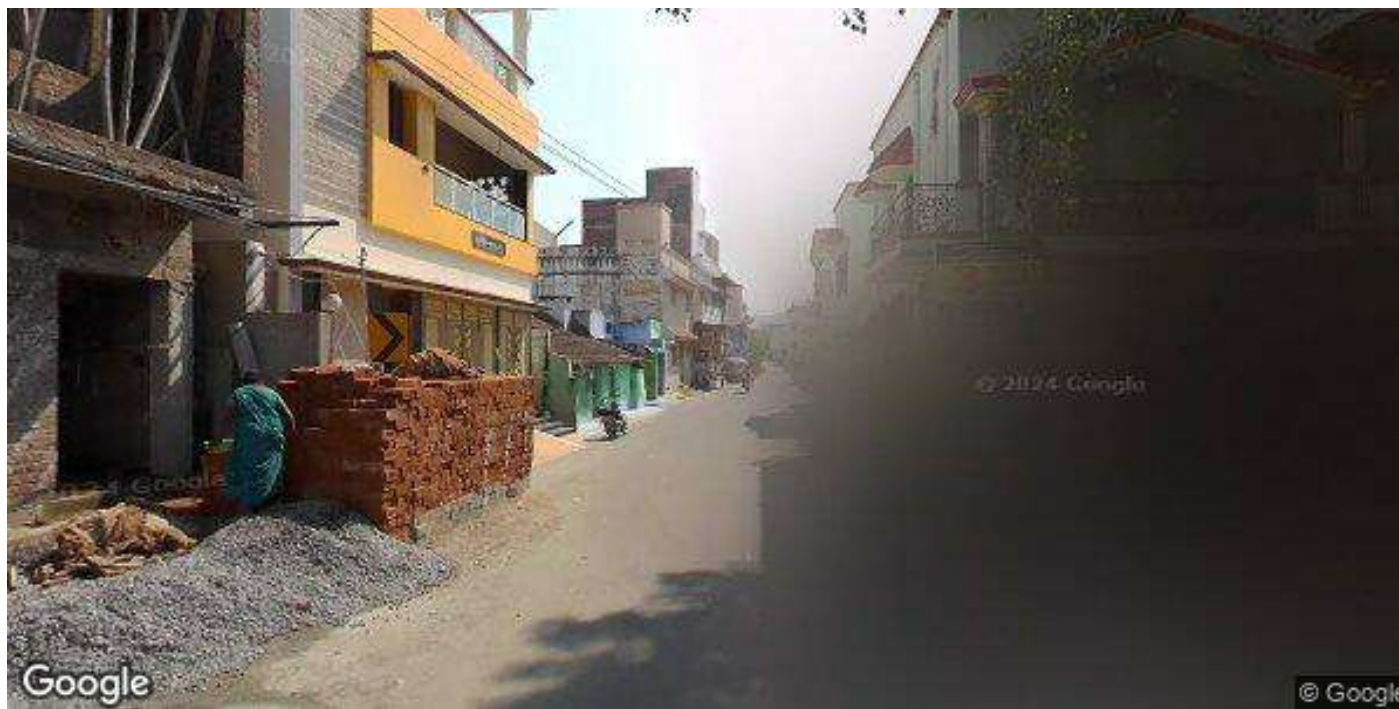
**Risk Type:** Blind Spot  
**Risk Level:** Blind Spot  
**Speed Limit:** 10 KM/Hr  
**Coordinates:** 11.51452, 78.08915

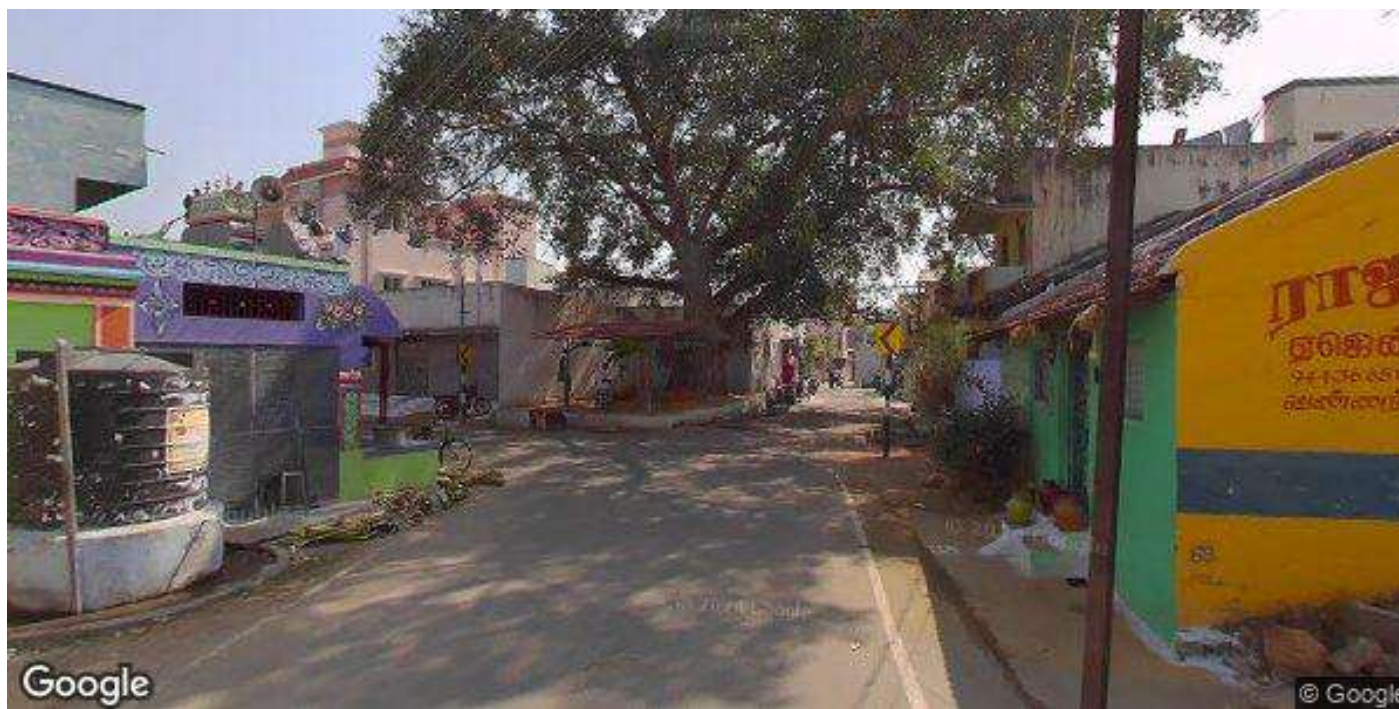
**Risk Type:** Turn  
**Risk Level:** High  
**Speed Limit:** 15 KM/Hr  
**Coordinates:** 11.51417, 78.09091

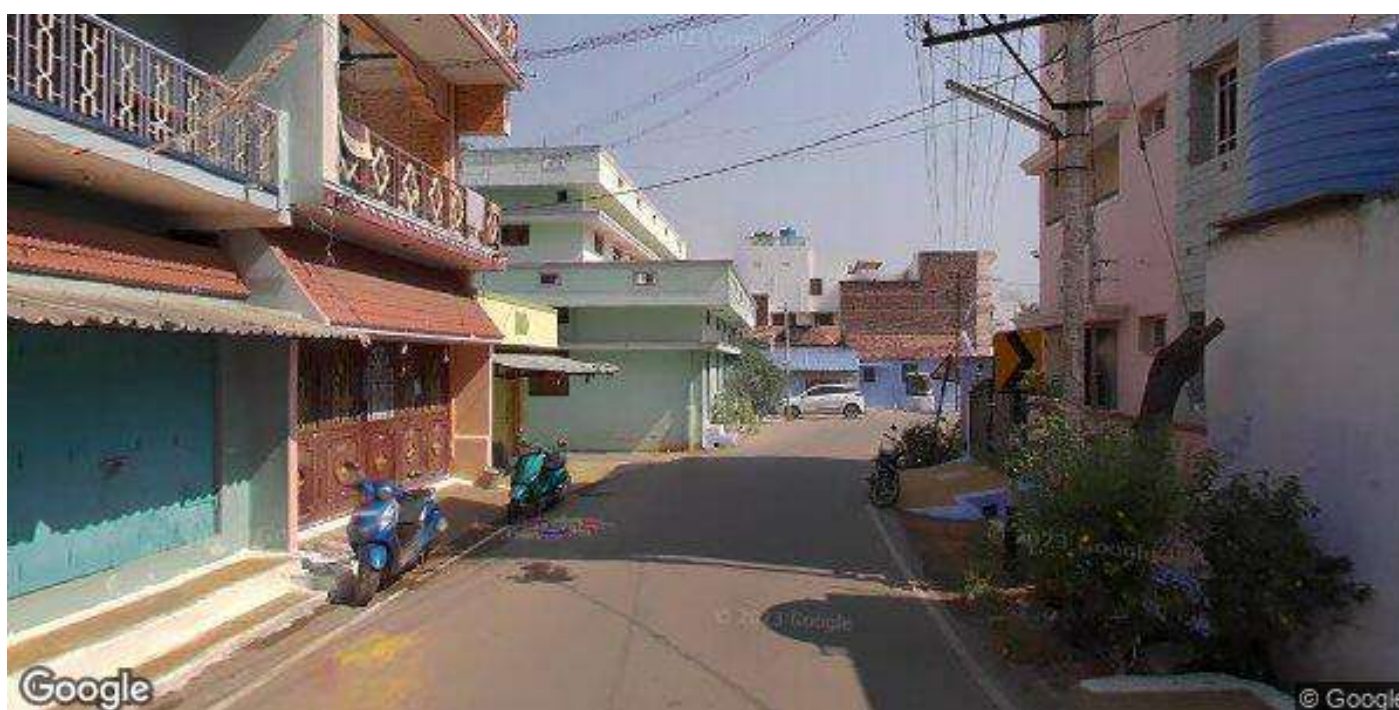
**Risk Type:** Turn  
**Risk Level:** Medium  
**Speed Limit:** 30 KM/Hr  
**Coordinates:** 11.51439, 78.09102

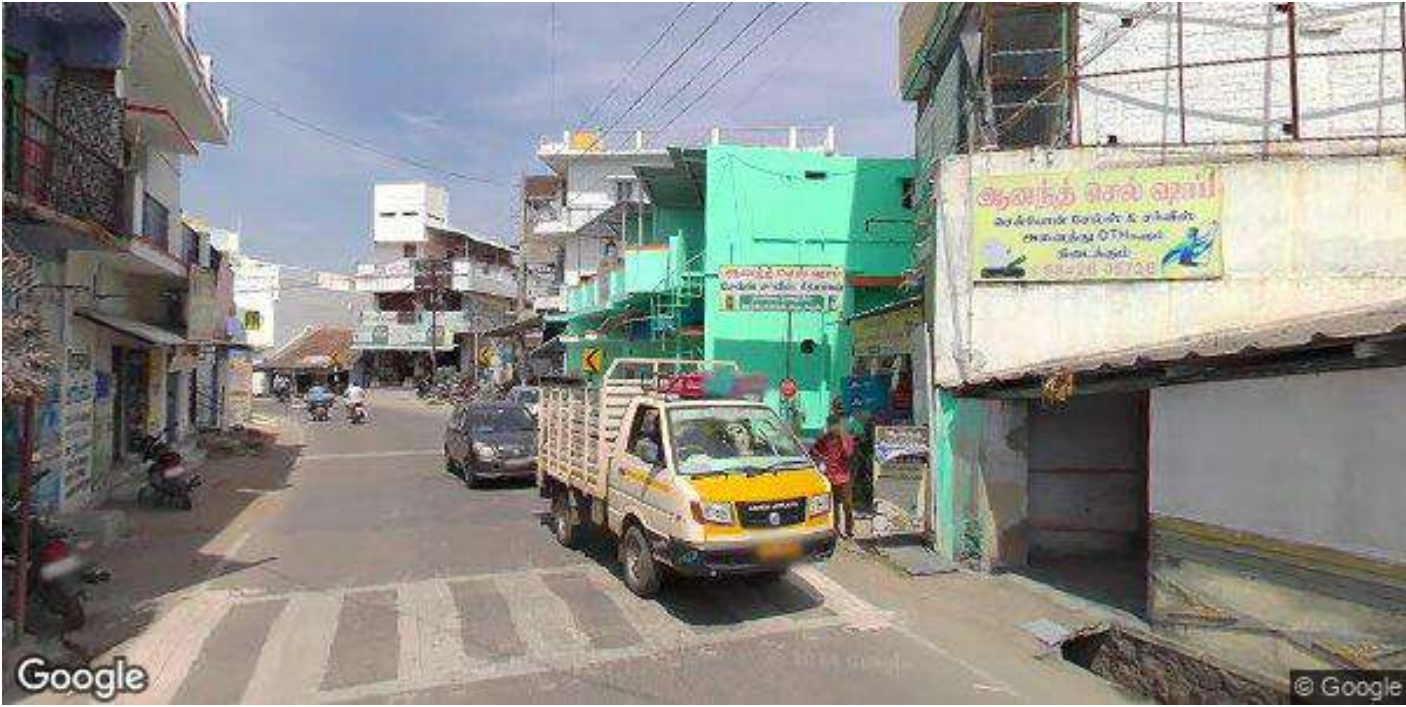
**Risk Type:** Blind Spot  
**Risk Level:** Blind Spot  
**Speed Limit:** 10 KM/Hr  
**Coordinates:** 11.51500, 78.09169
