# IndianOil

## JOURNEY RISK MANAGEMENT (JRM) STUDY

### Salem Terminal TO V.T.S. THIRUMURUGAN FUELS

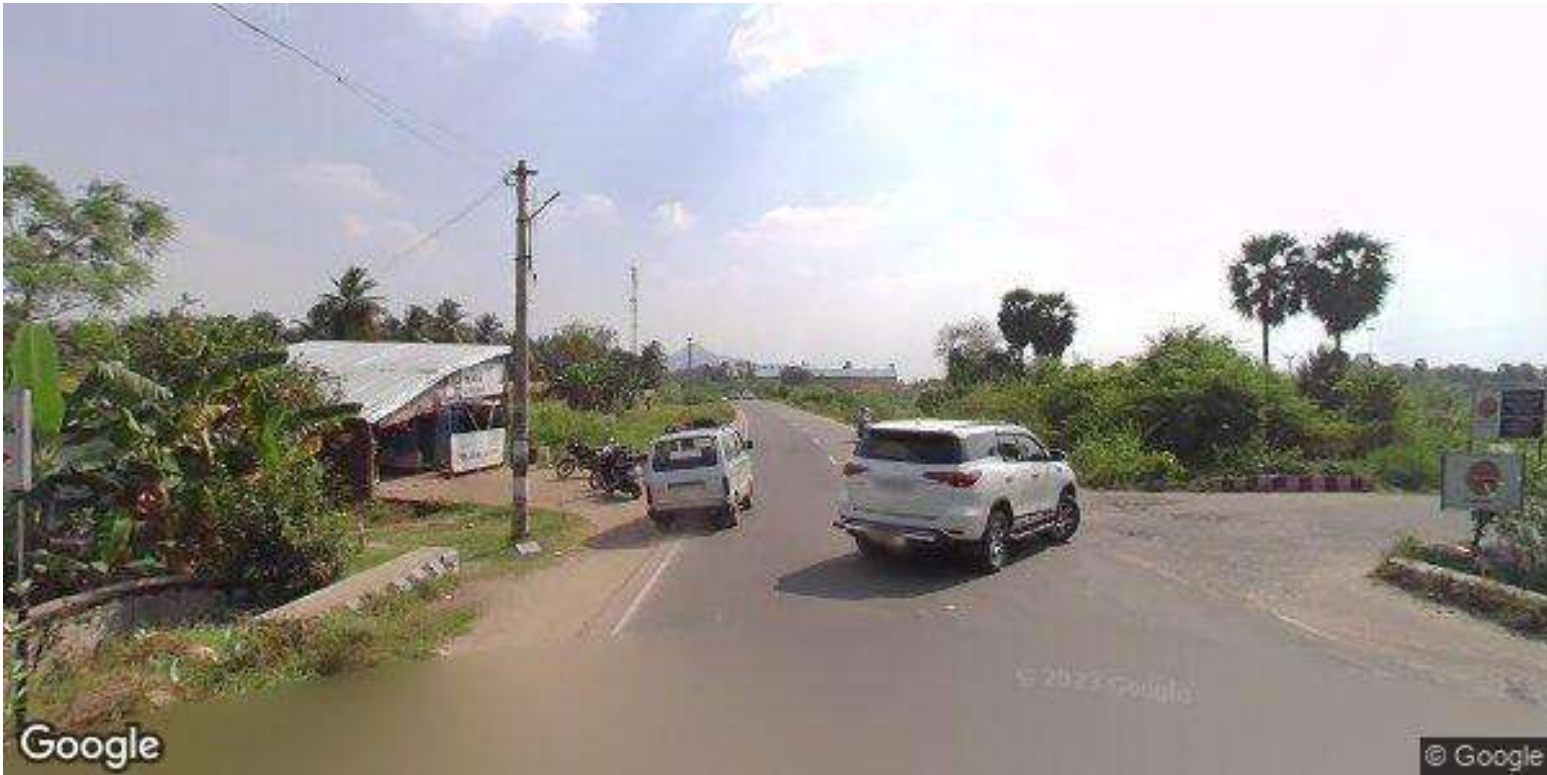
Coordinates: 11.44029, 77.87544

Risk Type: Turn

Risk Level: High

Speed Limit: 15 KM/Hr

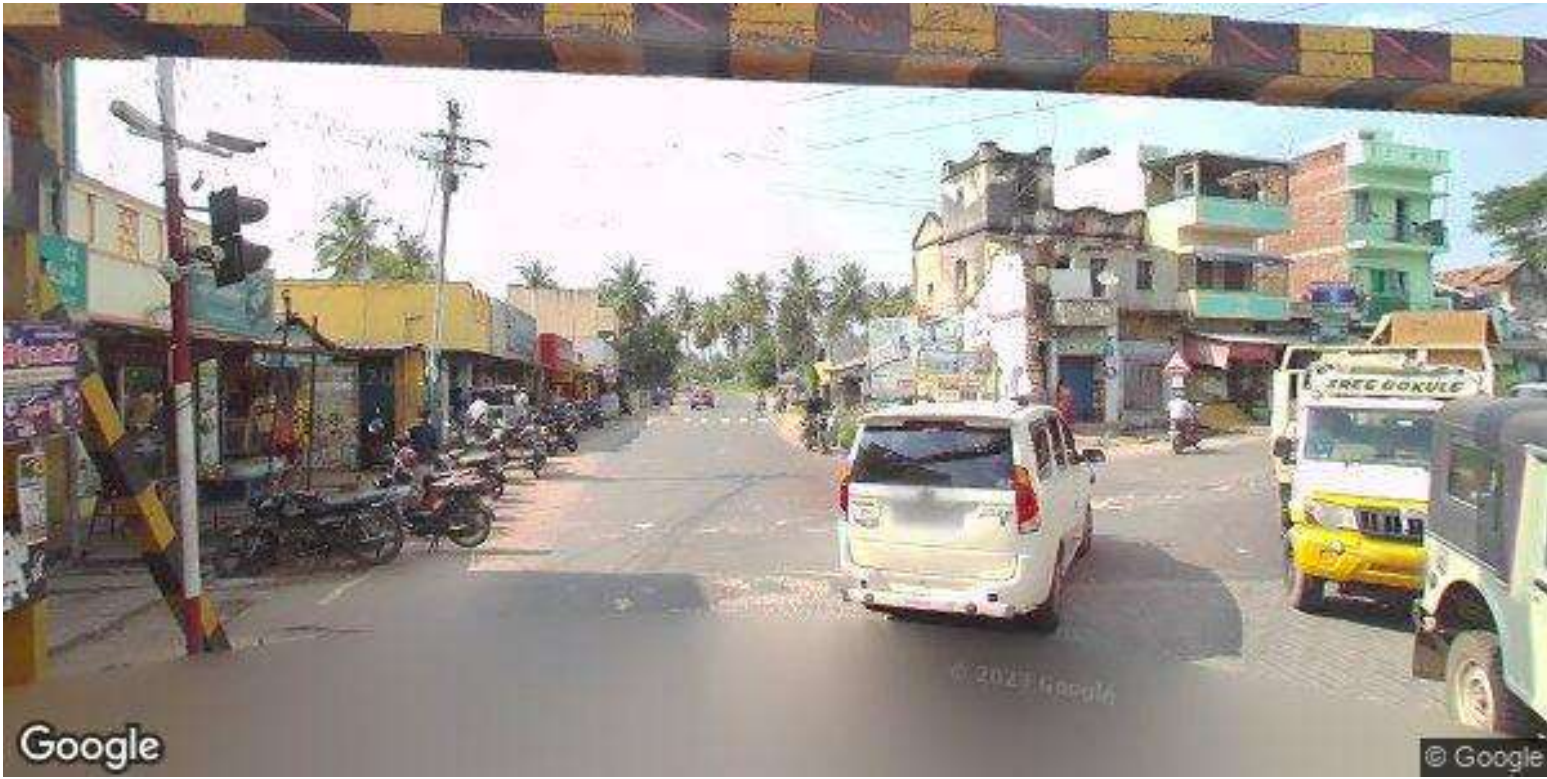
Risk Type: Turn  
Risk Level: High  
Speed Limit: 15 KM/Hr  
Coordinates: 11.45004, 77.87206

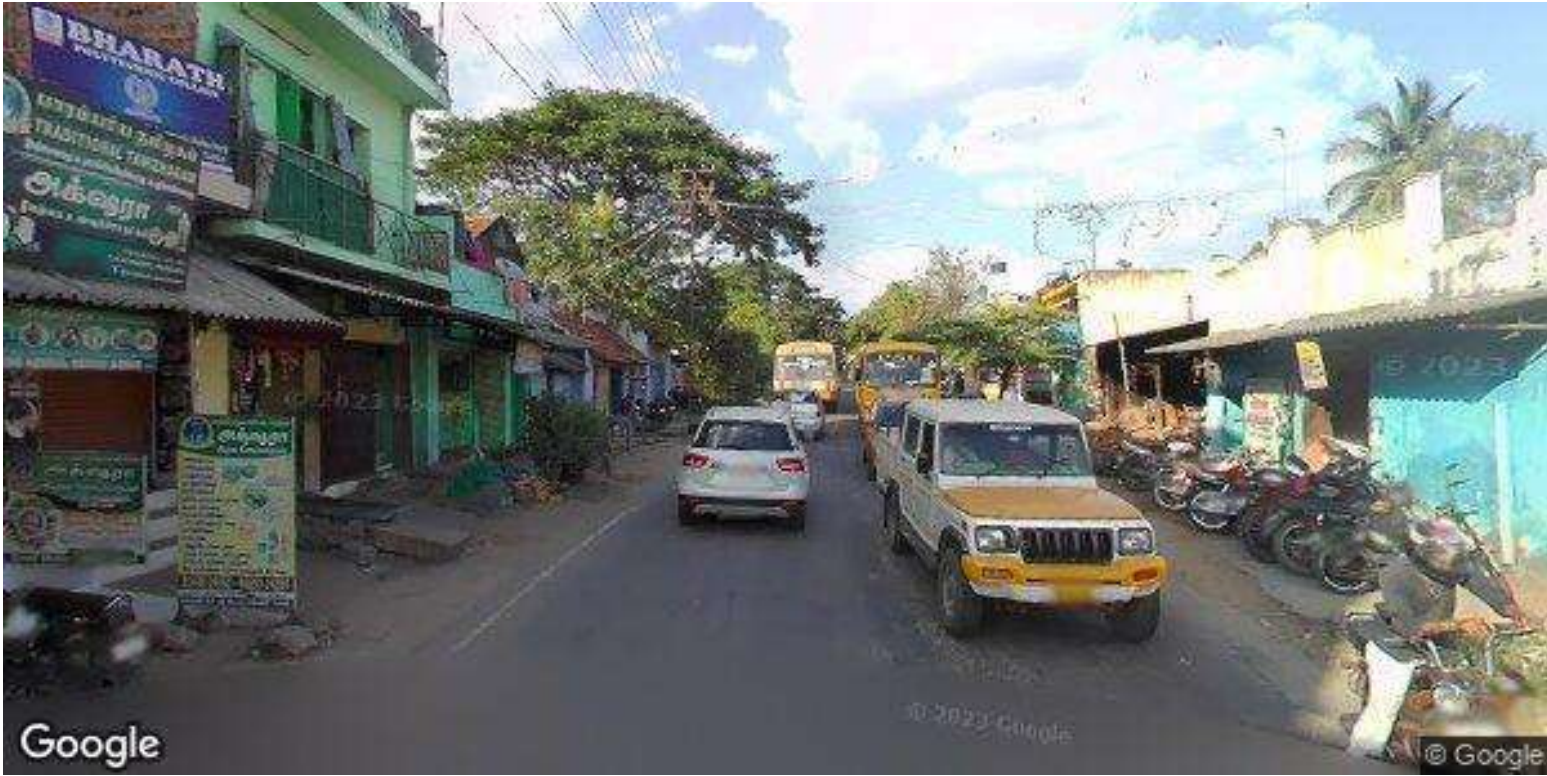
Risk Type: Turn  
Risk Level: Medium  
Speed Limit: 30 KM/Hr  
Coordinates: 11.45028, 77.87202

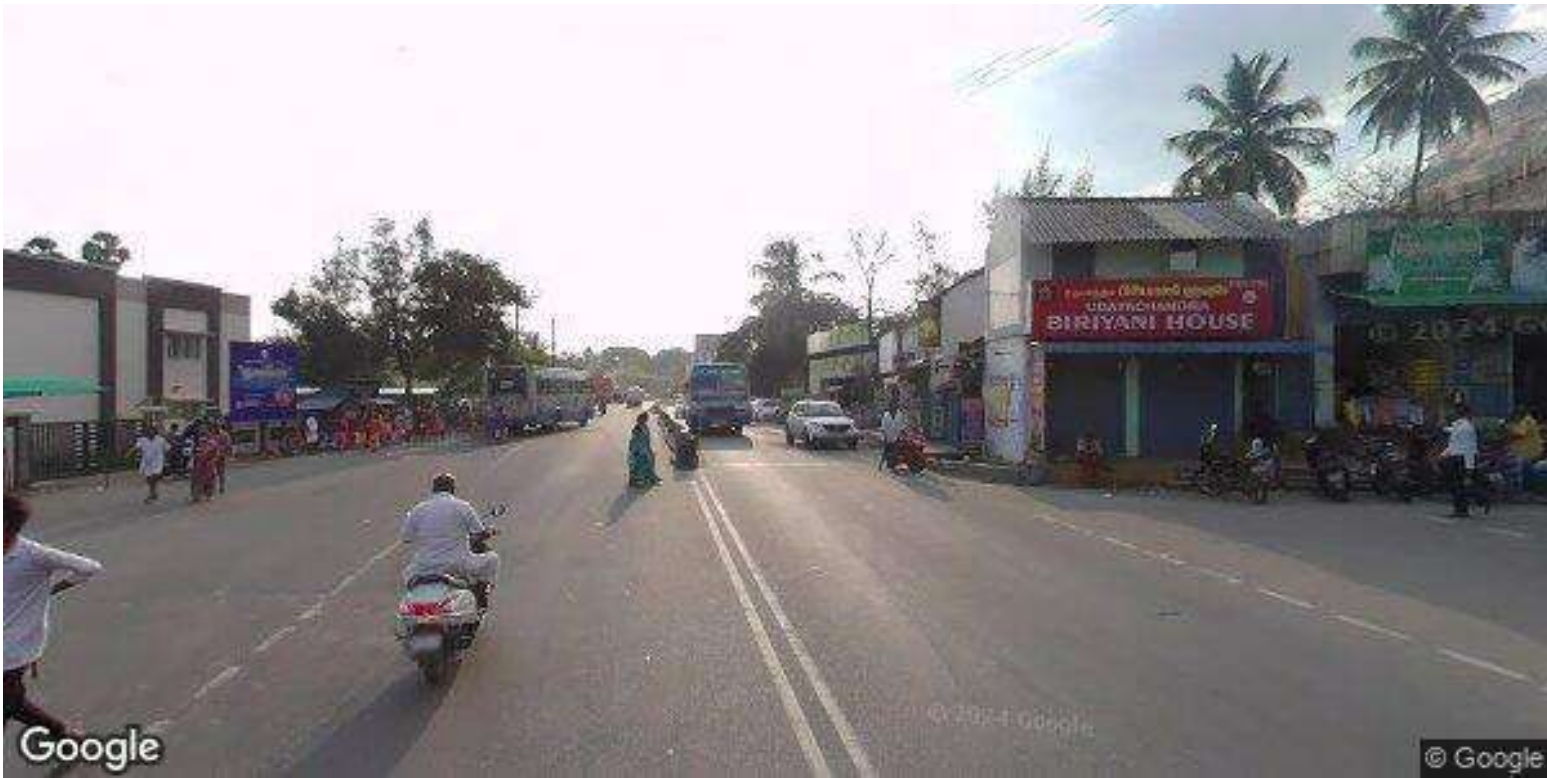
Coordinates: 11.47403, 77.86841

Risk Type: Turn

Risk Level: High

Speed Limit: 15 KM/Hr

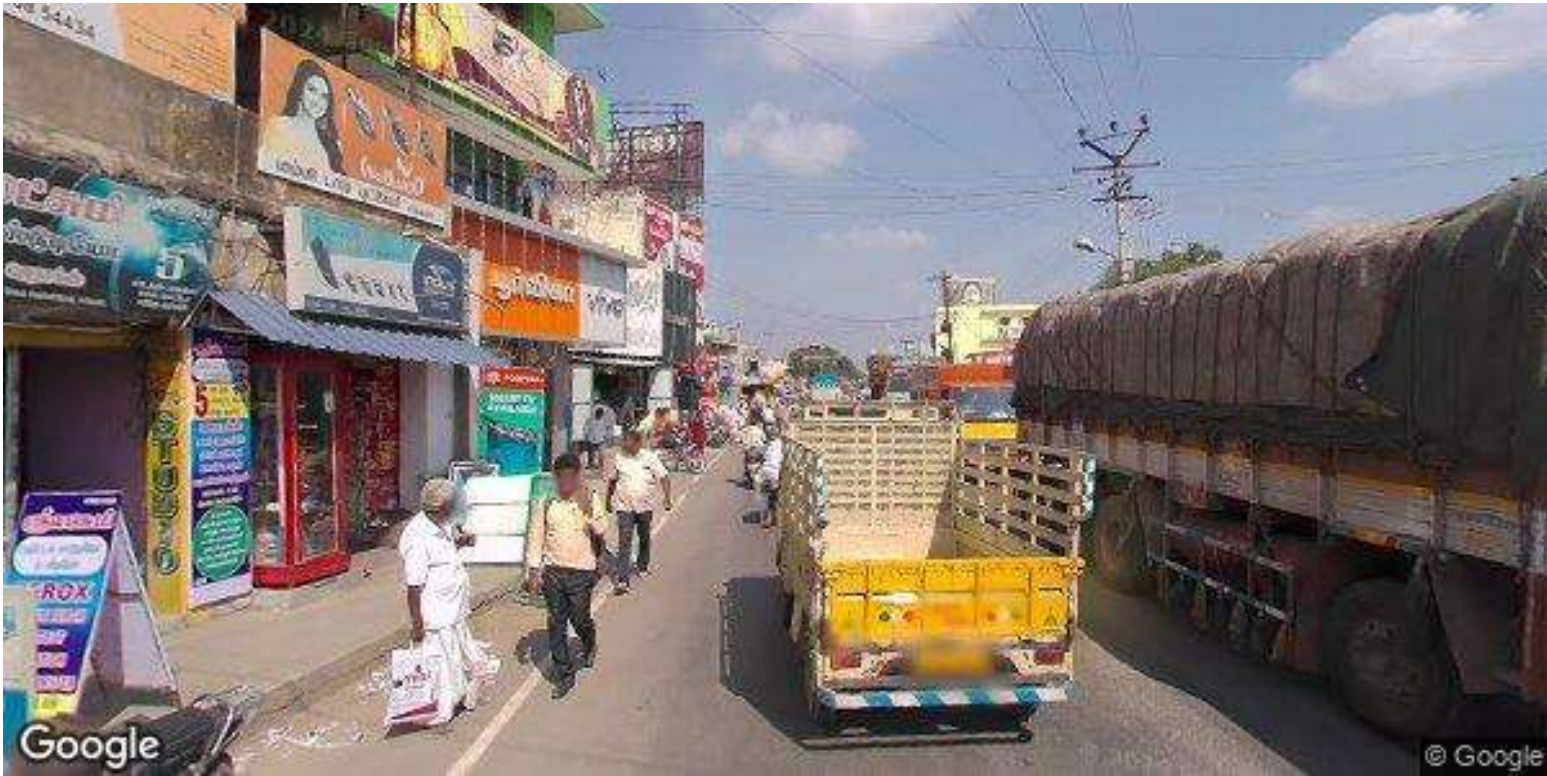
Coordinates: 11.47410, 77.86845

Risk Type: Turn

Risk Level: Medium

Speed Limit: 30 KM/Hr

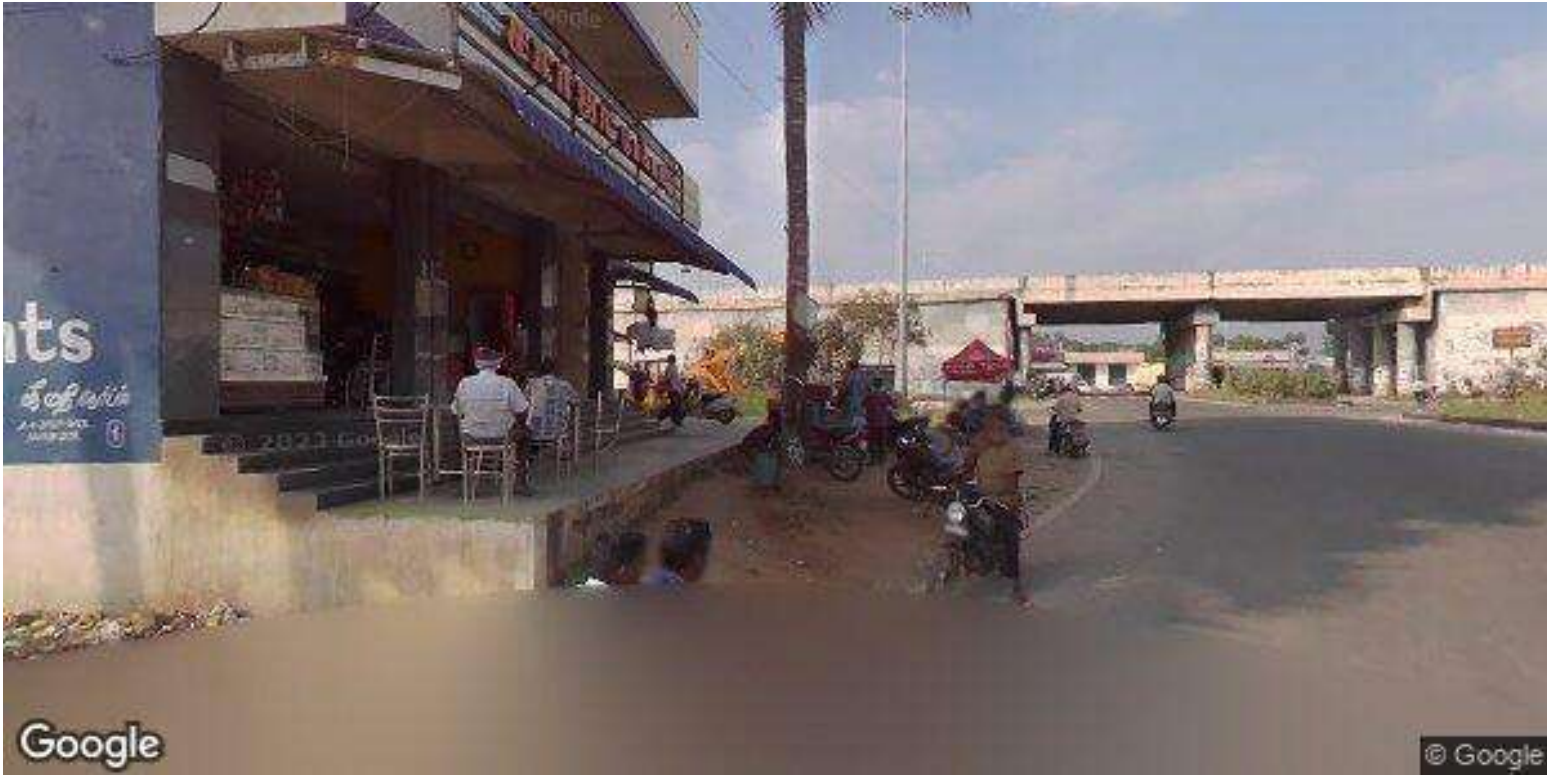
Coordinates: 11.49149, 77.89601

Risk Type: Turn

Risk Level: High

Speed Limit: 15 KM/Hr

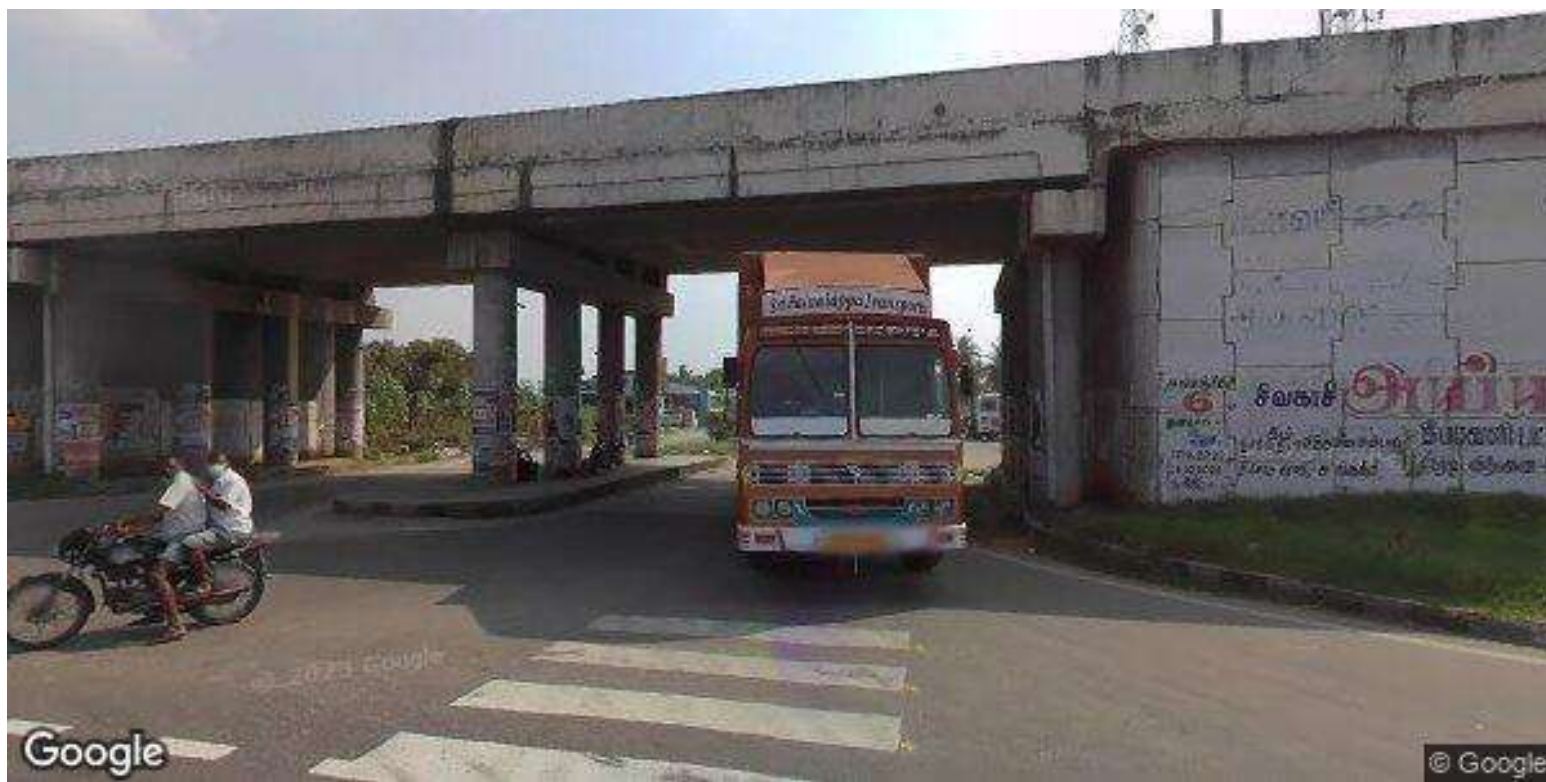
**Coordinates:** 11.49224, 77.89601

**Risk Type:** Turn

**Risk Level:** High

**Speed Limit:** 15 KM/Hr

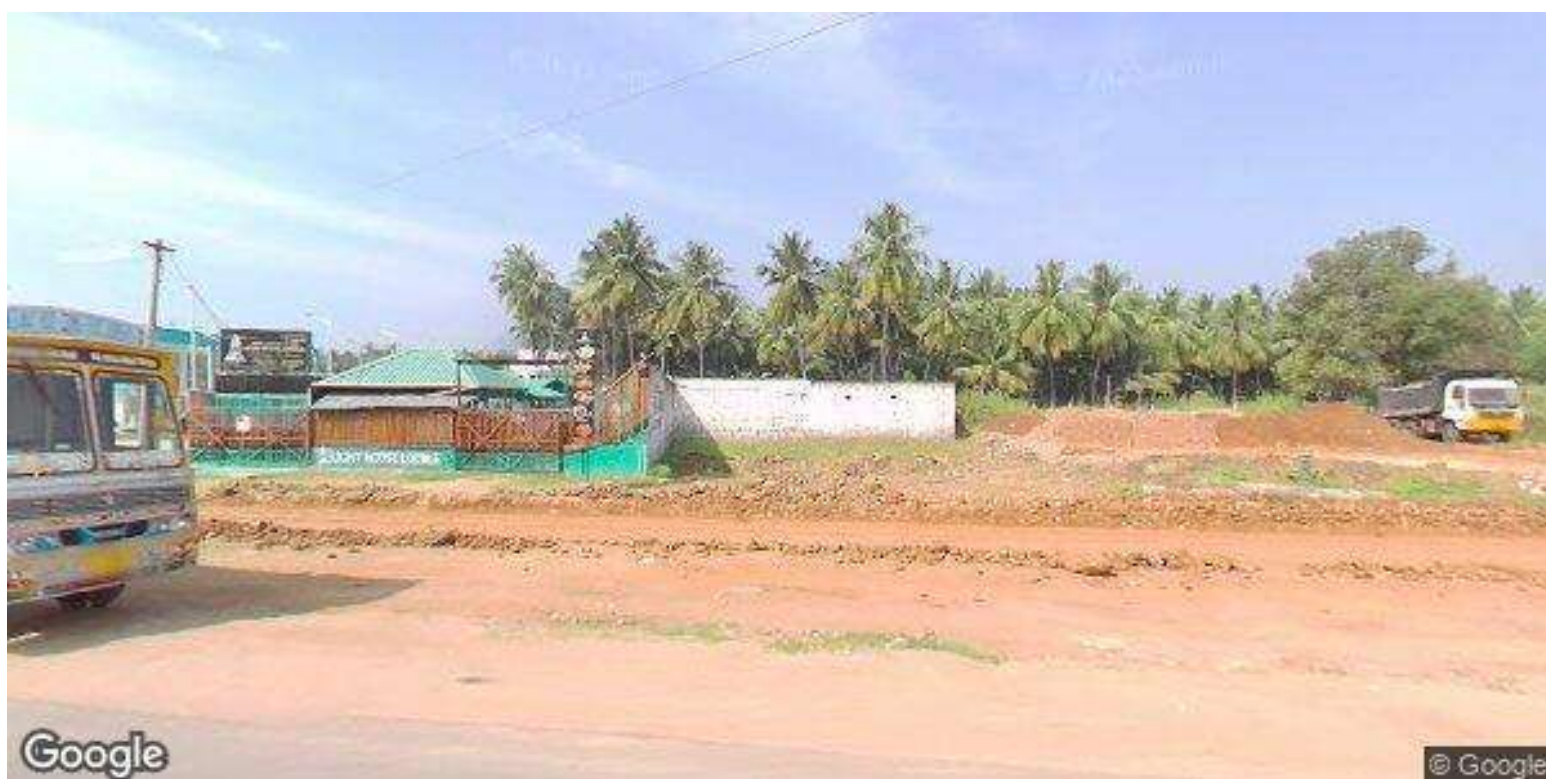
**Coordinates:** 11.61736, 78.10588

**Risk Type:** Turn

**Risk Level:** Medium

**Speed Limit:** 30 KM/Hr

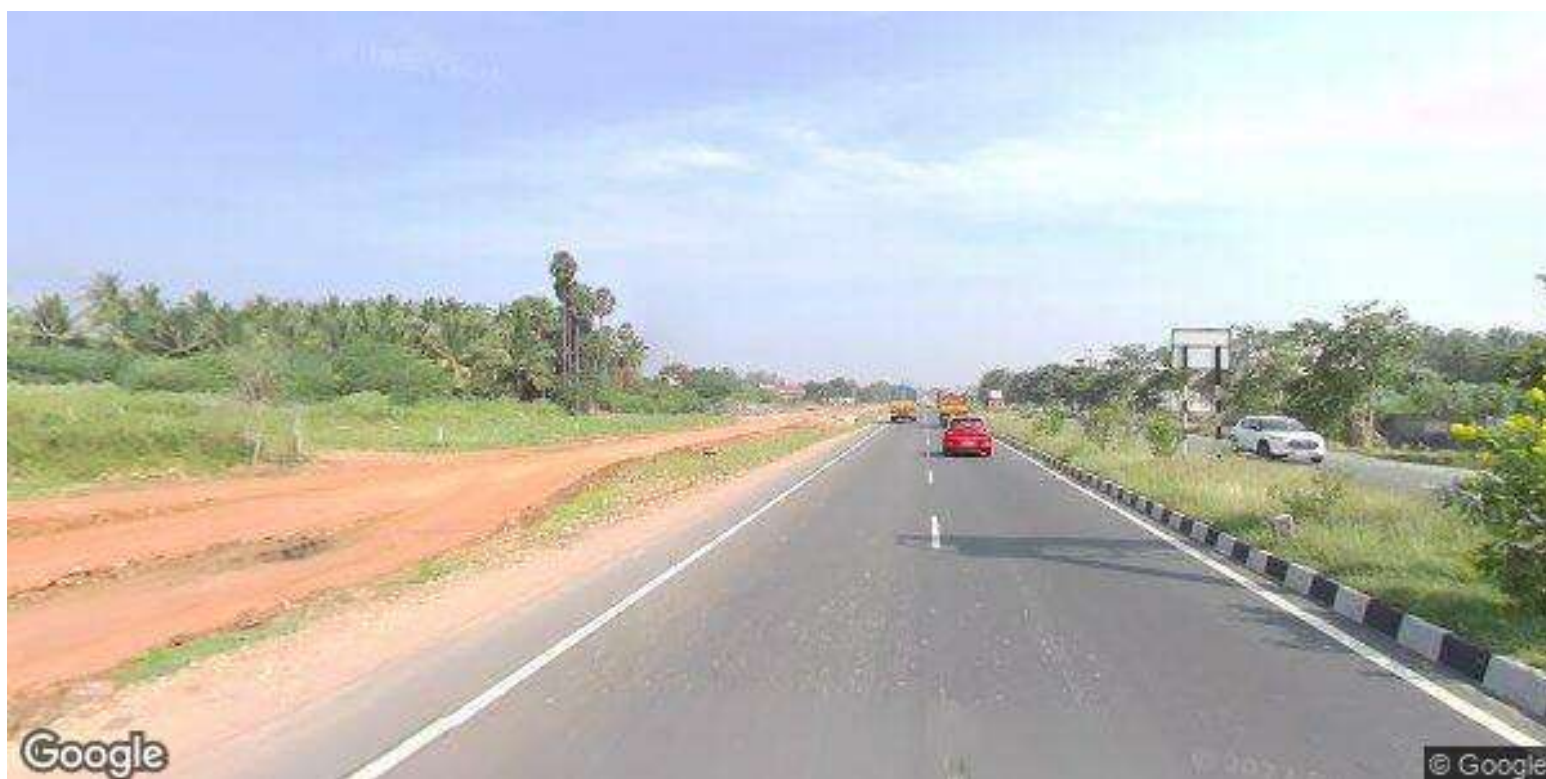
**Coordinates: 11.61753, 78.10608**

**Risk Type: Turn**

**Risk Level: Medium**

**Speed Limit: 30 KM/Hr**

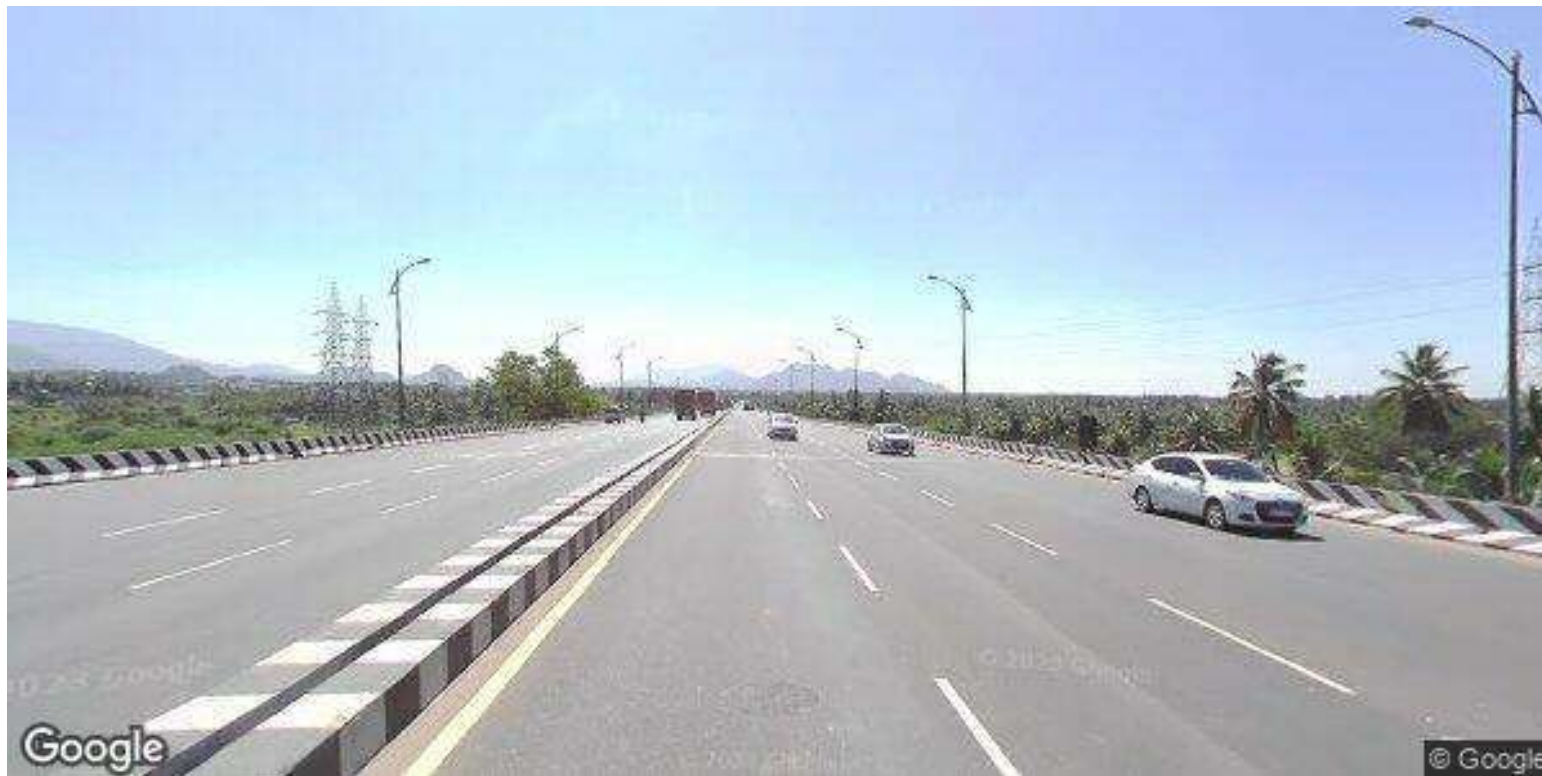
**Coordinates: 11.64007, 78.11794**

**Risk Type: Turn**

**Risk Level: Medium**

**Speed Limit: 30 KM/Hr**

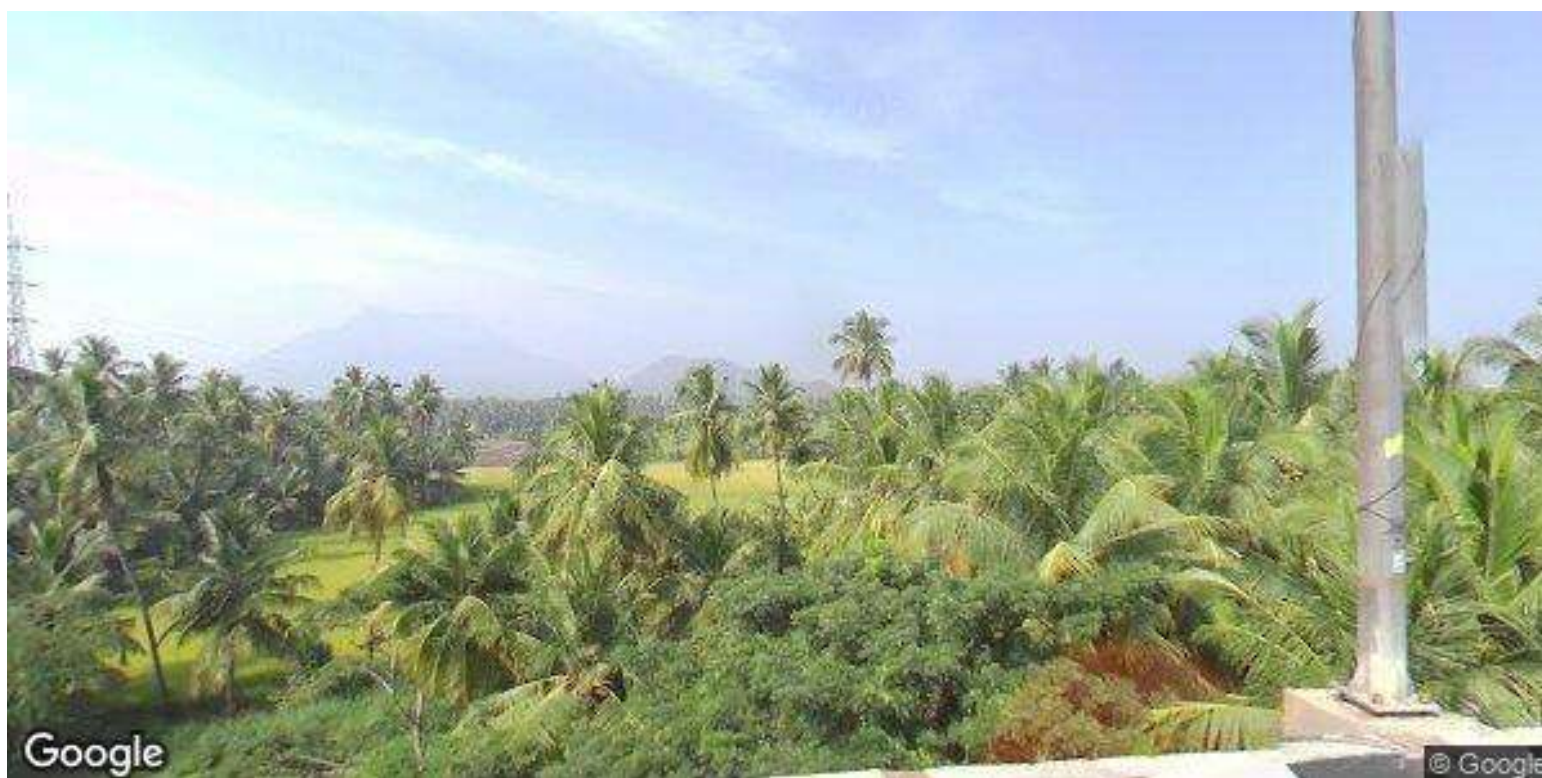
**Coordinates: 11.64020, 78.11786**

**Risk Type: Turn**

**Risk Level: Medium**

**Speed Limit: 30 KM/Hr**

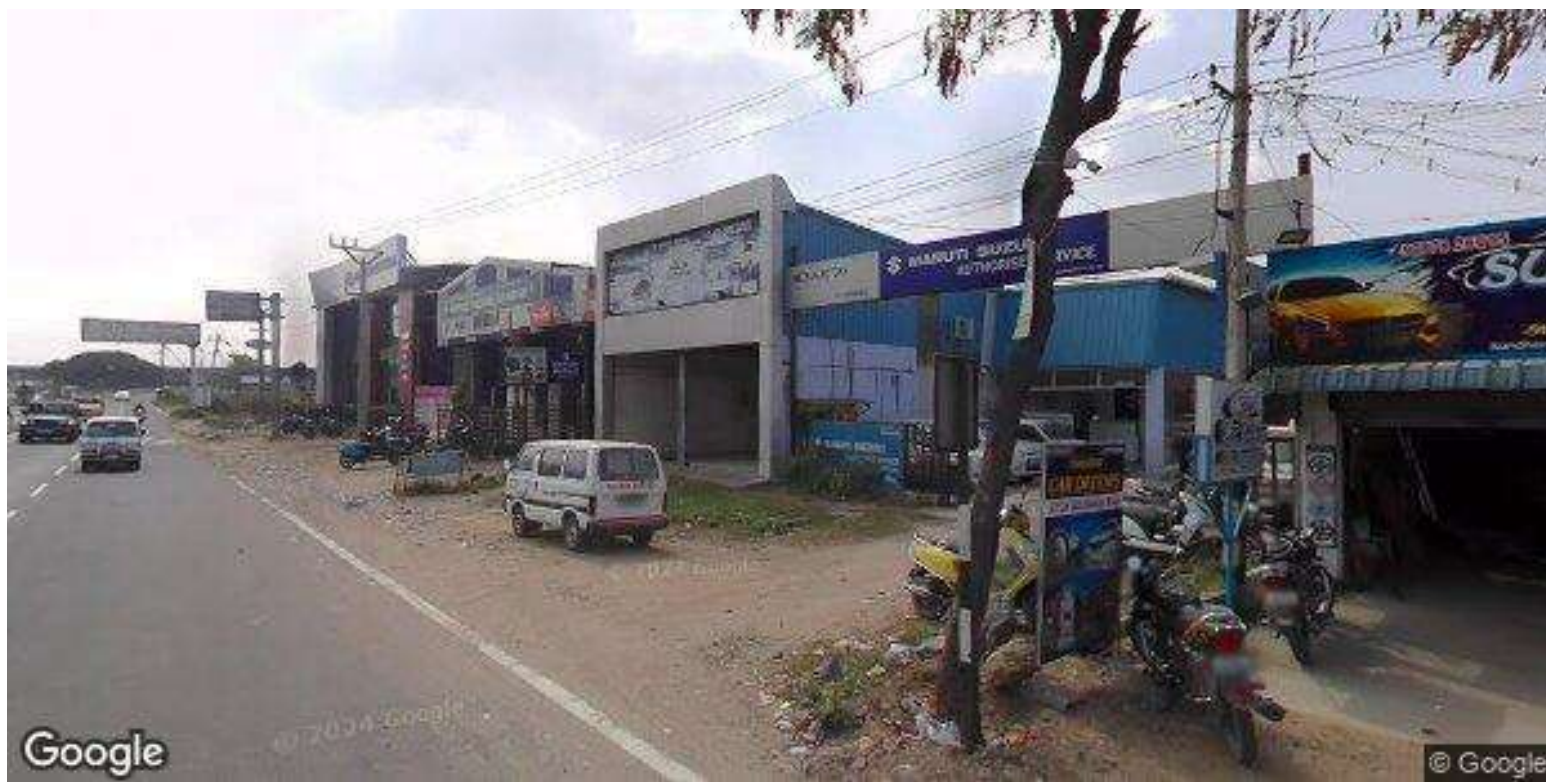
**Coordinates:** 11.64497, 78.12028

**Risk Type:** Turn

**Risk Level:** Medium

**Speed Limit:** 30 KM/Hr

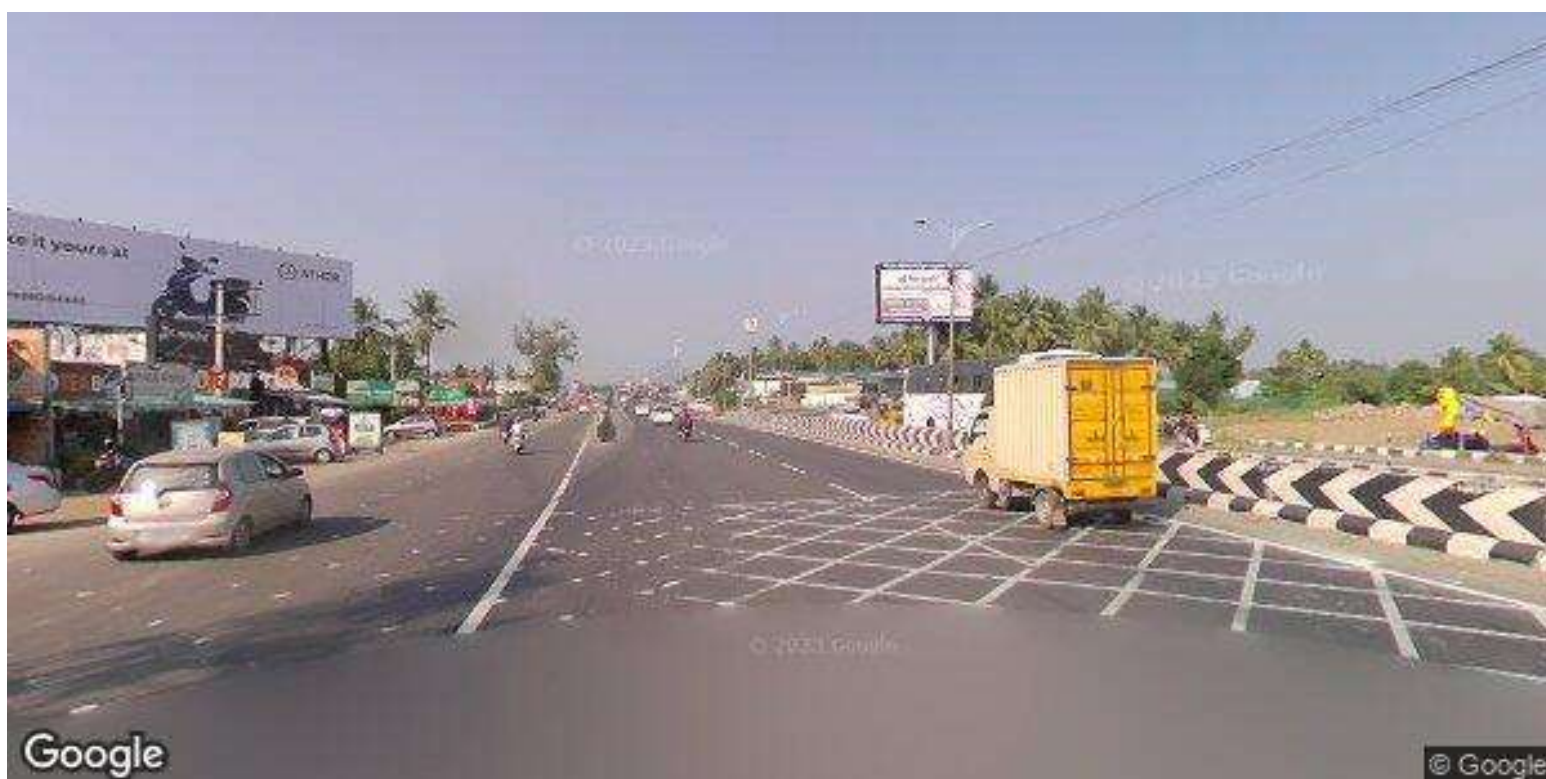
**Coordinates:** 11.64503, 78.12034

**Risk Type:** Turn

**Risk Level:** Medium

**Speed Limit:** 30 KM/Hr

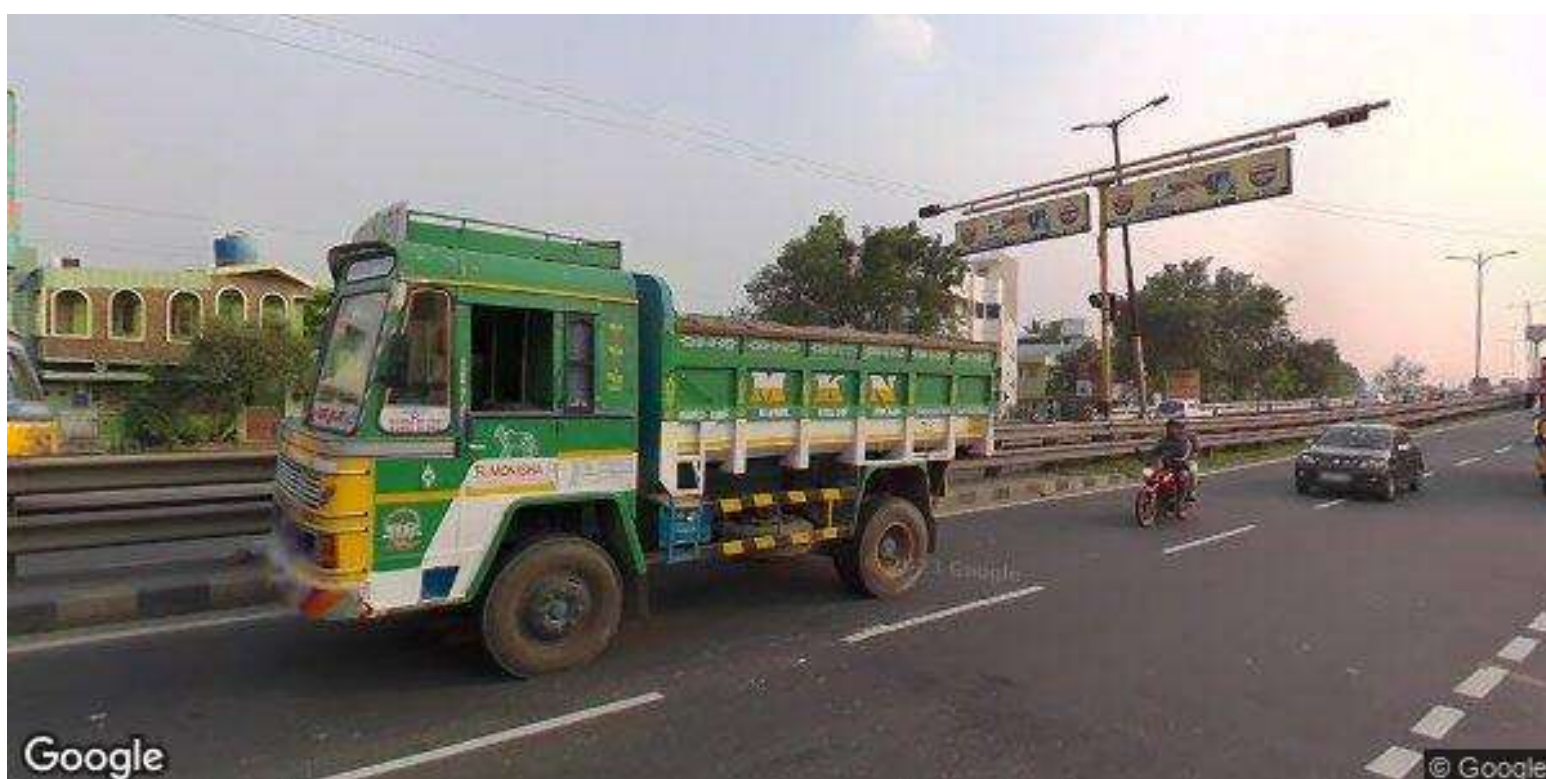
**Risk Type:** Turn  
**Risk Level:** High  
**Speed Limit:** 15 KM/Hr  
**Coordinates:** 11.66458, 78.12303

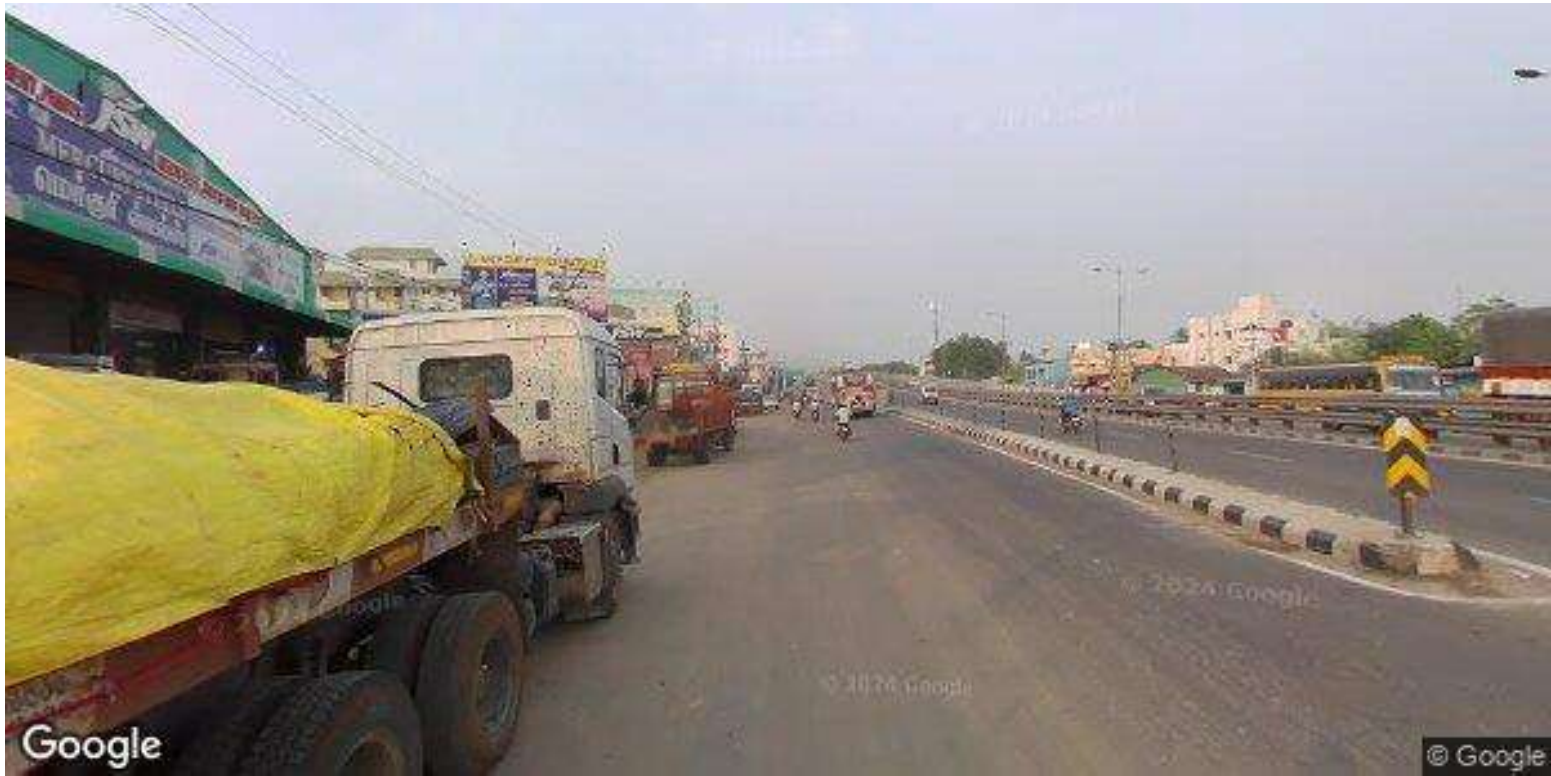
**Risk Type:** Turn  
**Risk Level:** High  
**Speed Limit:** 15 KM/Hr  
**Coordinates:** 11.66477, 78.12298

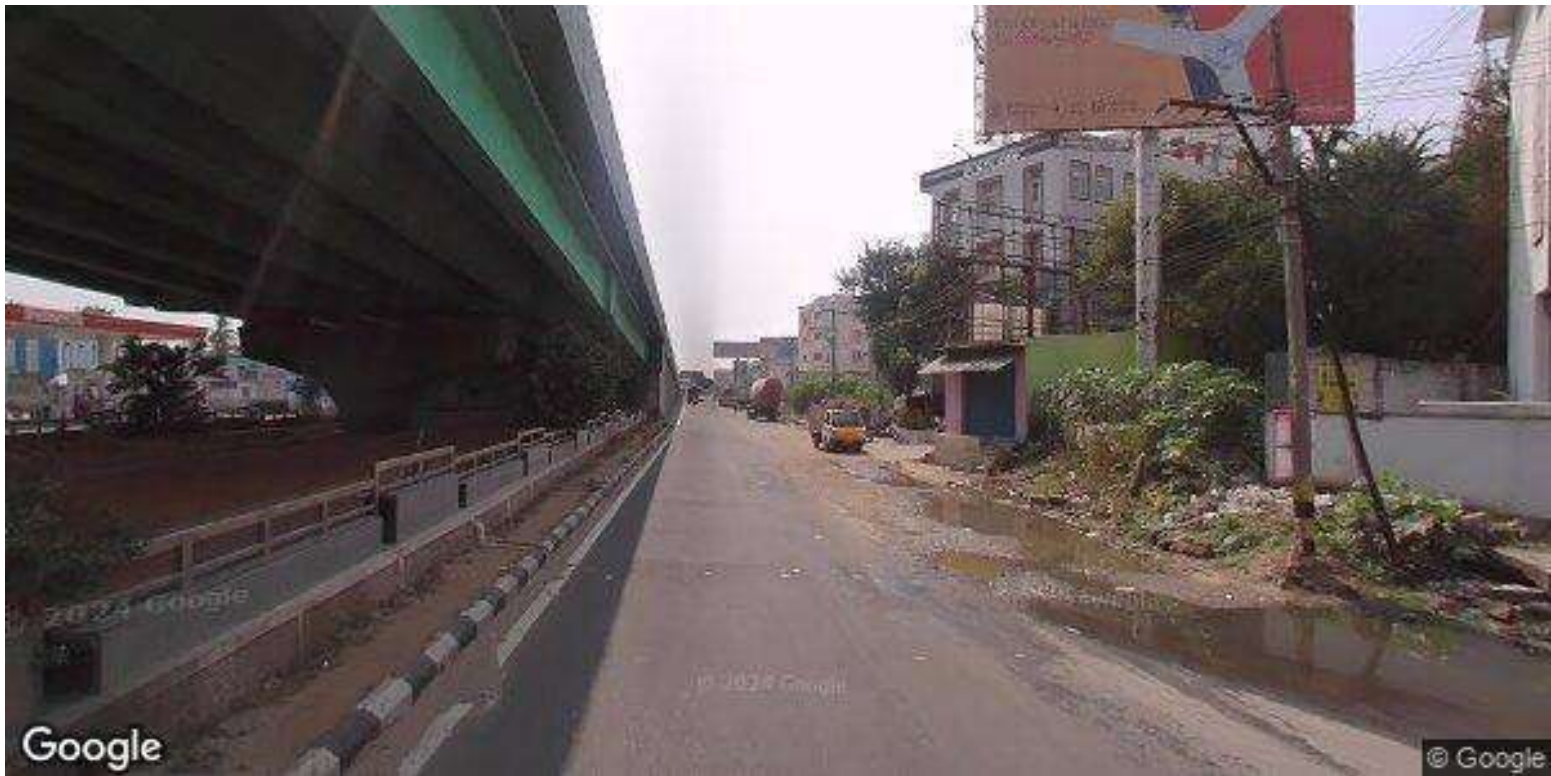
**Risk Type:** Turn  
**Risk Level:** High  
**Speed Limit:** 15 KM/Hr  
**Coordinates:** 11.66719, 78.12442

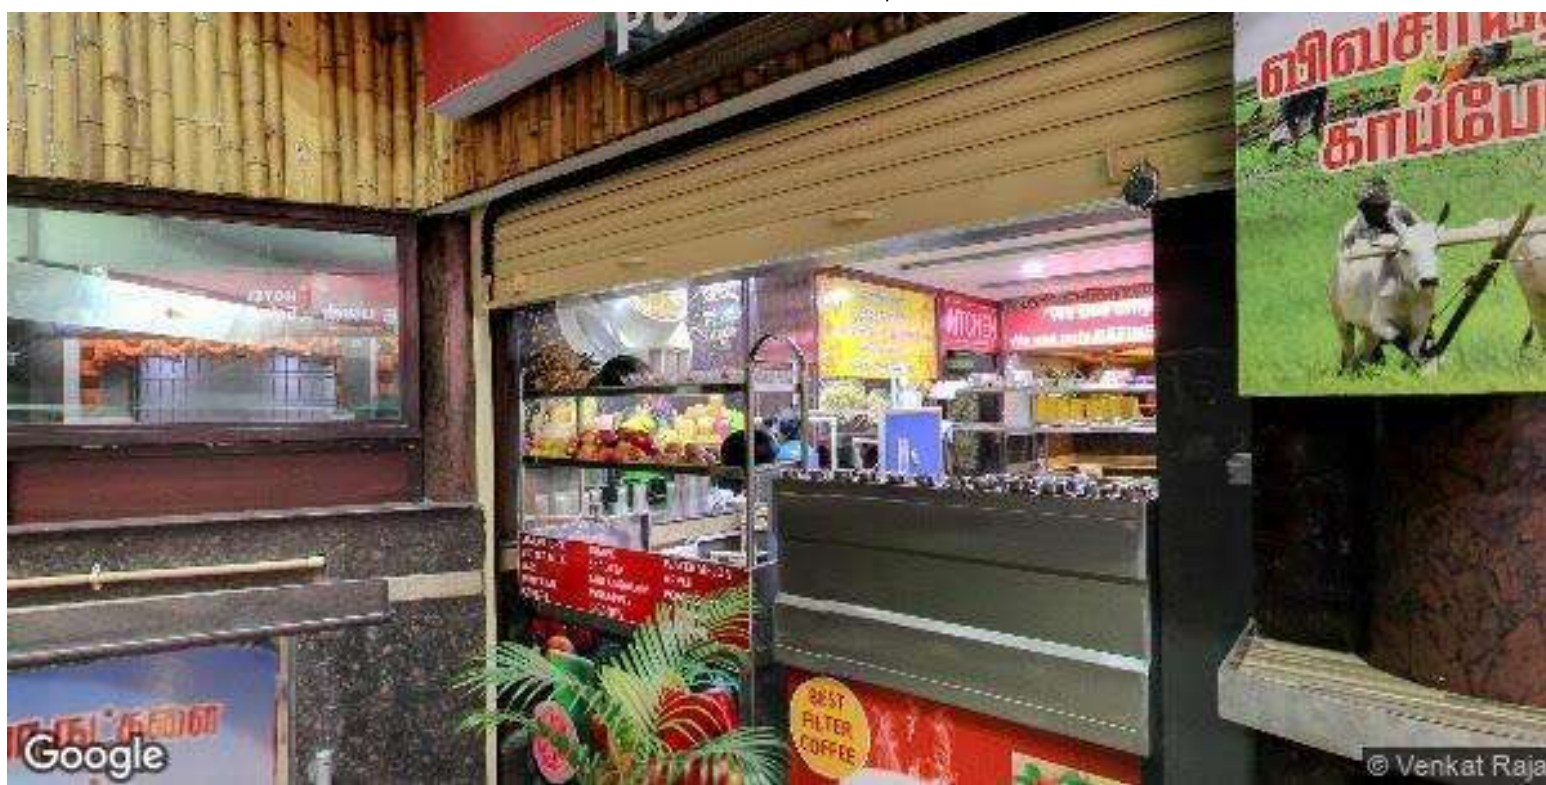
**Coordinates:** 11.66762, 78.12417

**Risk Type:** Turn

**Risk Level:** Medium

**Speed Limit:** 30 KM/Hr

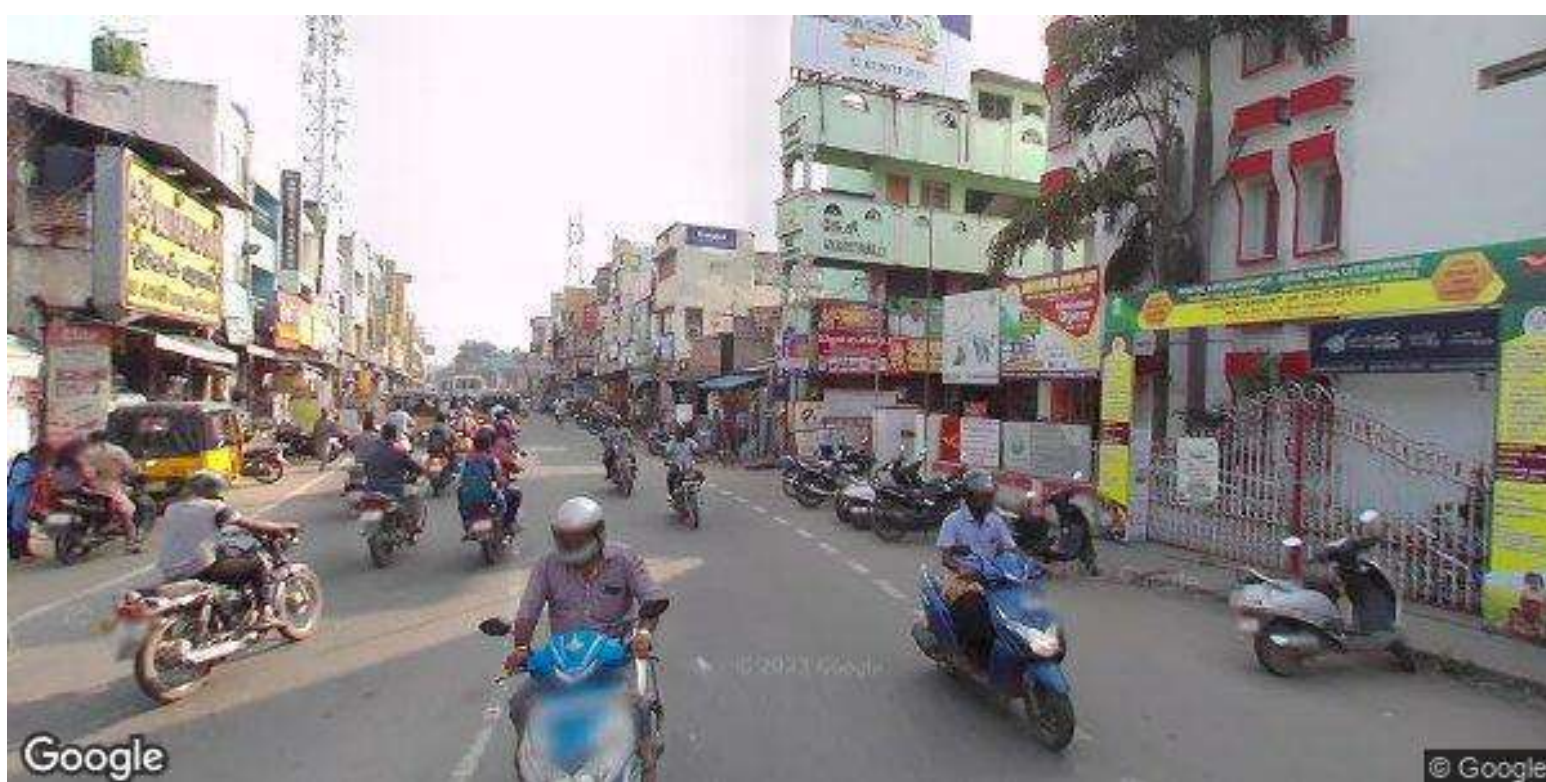
**Coordinates:** 11.67015, 78.11449

**Risk Type:** Turn

**Risk Level:** Medium

**Speed Limit:** 30 KM/Hr
