# IndianOil

## JOURNEY RISK MANAGEMENT (JRM) STUDY

### Salem Terminal TO V.T.S. THIRUMURUGAN FUELS

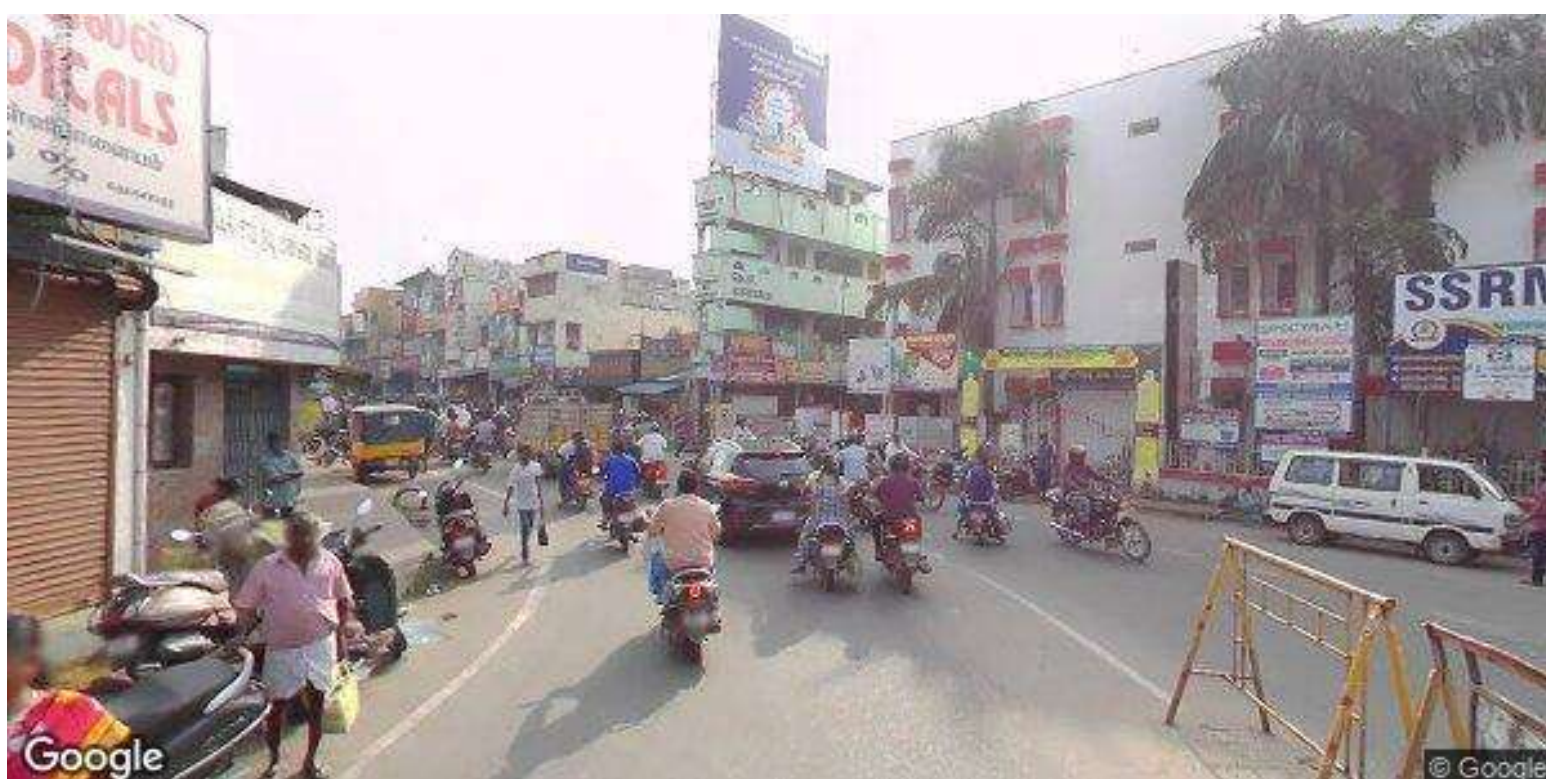
**Risk Type:** Turn  
**Risk Level:** Medium  
**Speed Limit:** 30 KM/Hr  
**Coordinates:** 11.67016, 78.11440

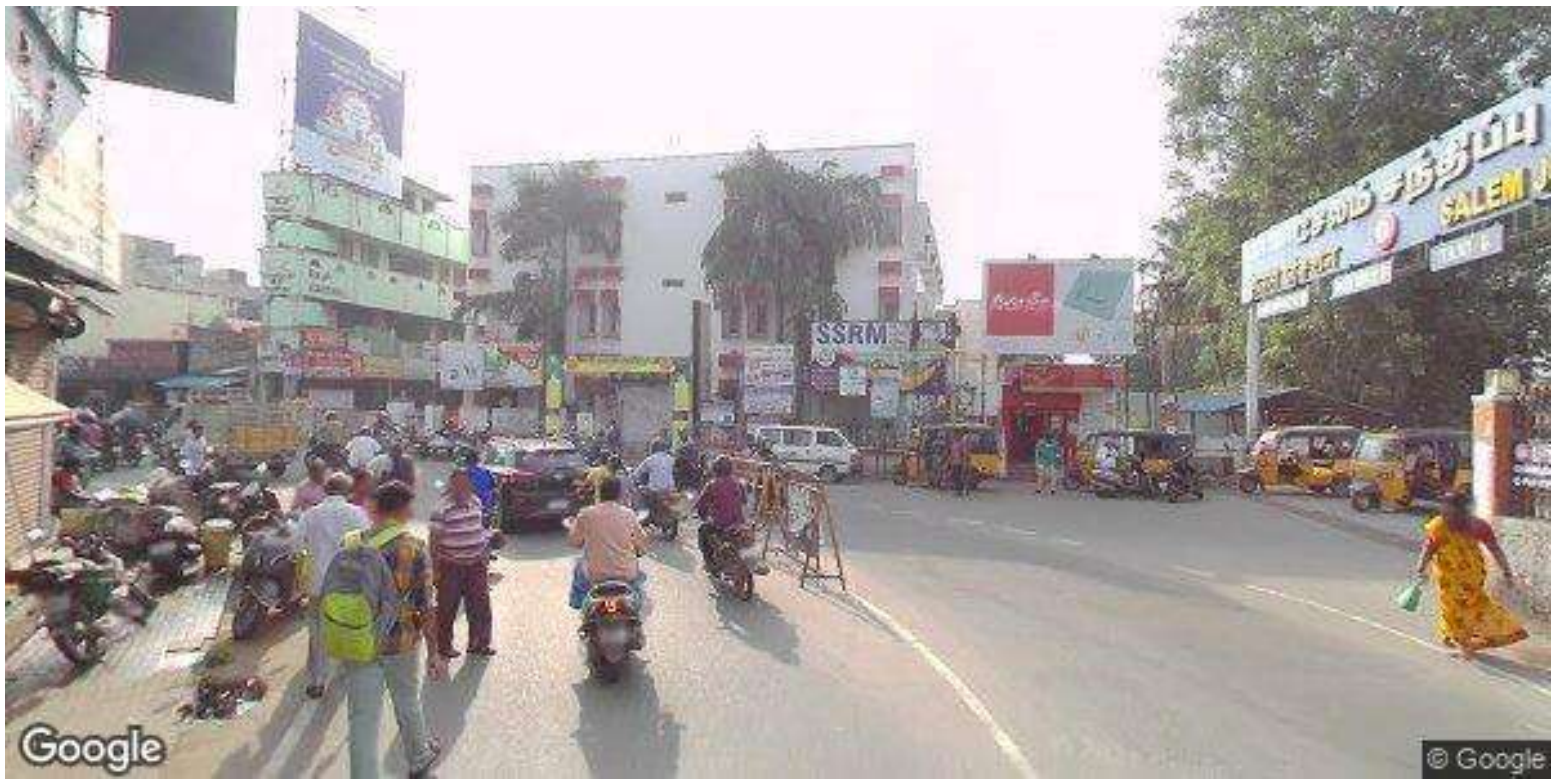
**Risk Type:** Turn  
**Risk Level:** Medium  
**Speed Limit:** 30 KM/Hr  
**Coordinates:** 11.67023, 78.11431

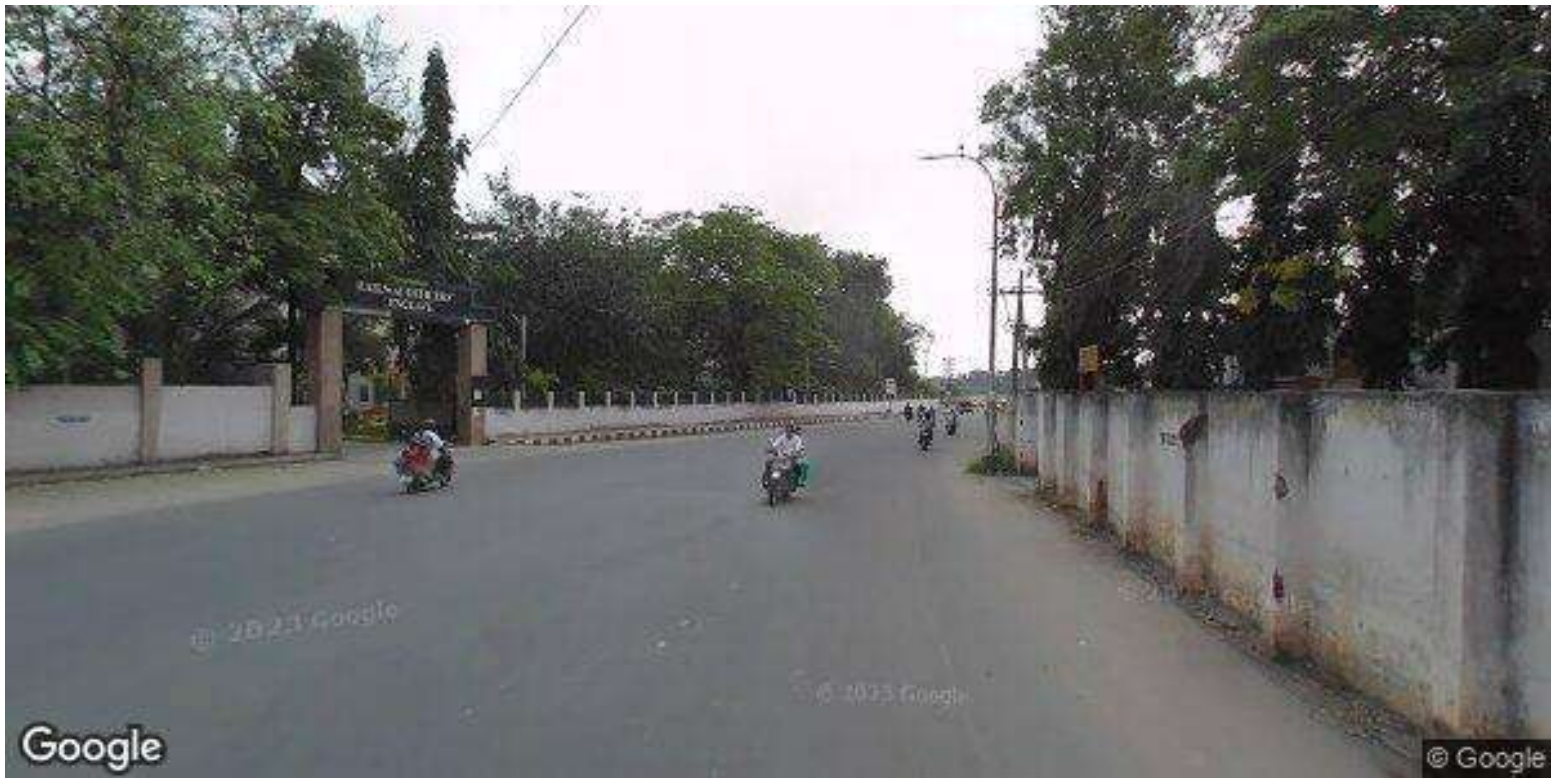
**Risk Type:** Turn  
**Risk Level:** Medium  
**Speed Limit:** 30 KM/Hr  
**Coordinates:** 11.67664, 78.11117

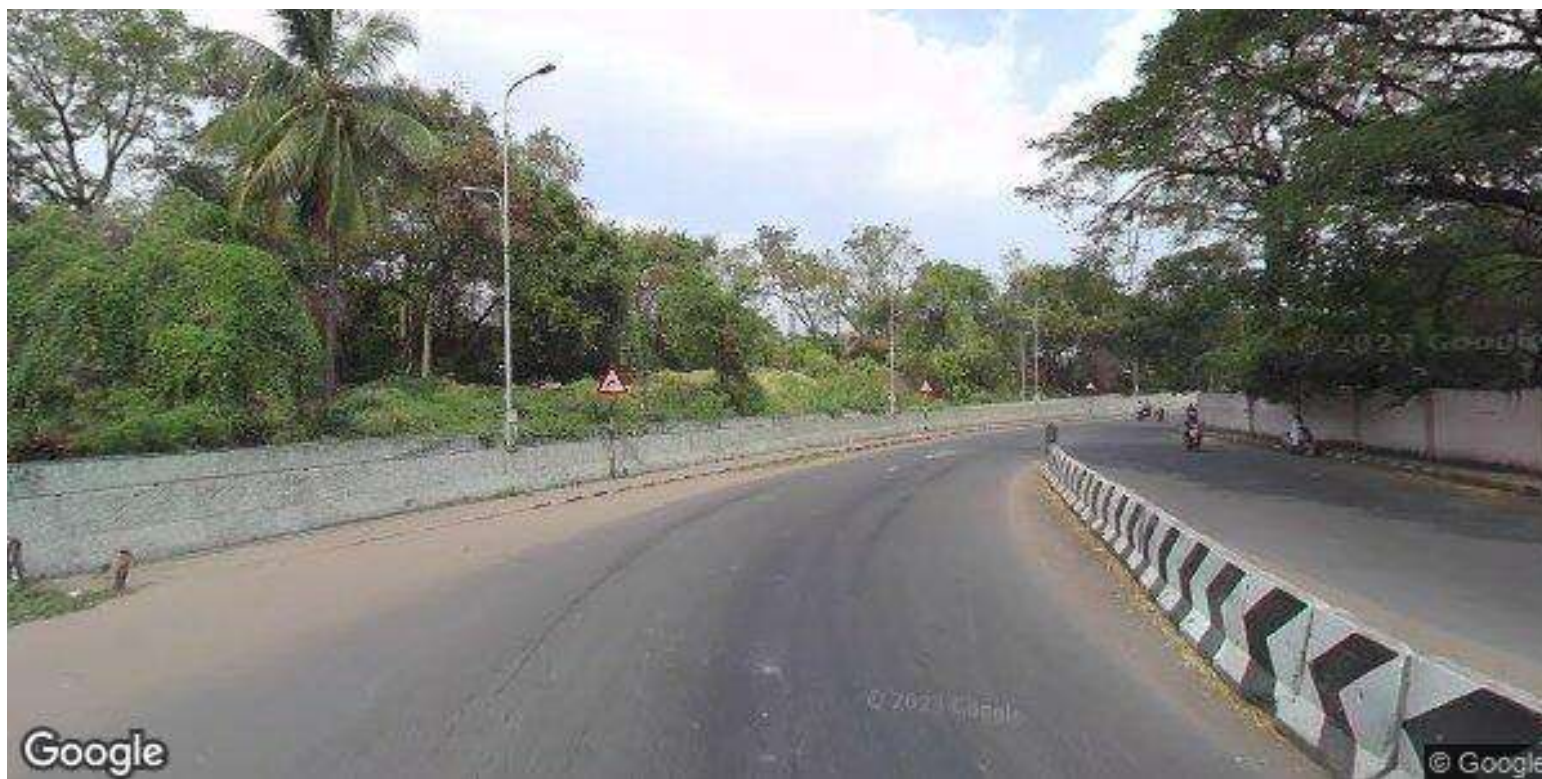
**Coordinates:** 11.67716, 78.11079

**Risk Type:** Turn

**Risk Level:** Medium

**Speed Limit:** 30 KM/Hr

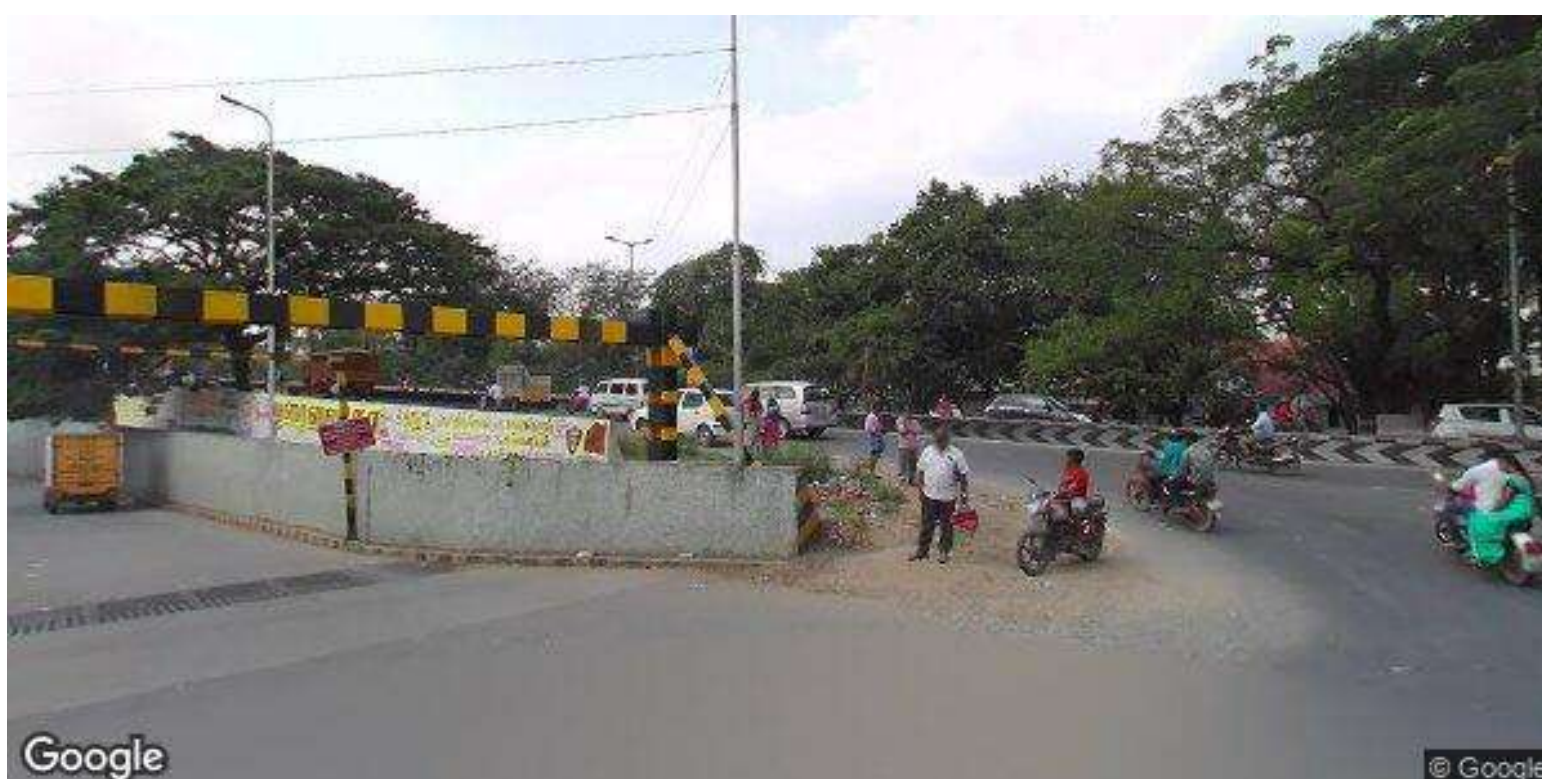
**Coordinates:** 11.67840, 78.11186

**Risk Type:** Turn

**Risk Level:** High

**Speed Limit:** 15 KM/Hr

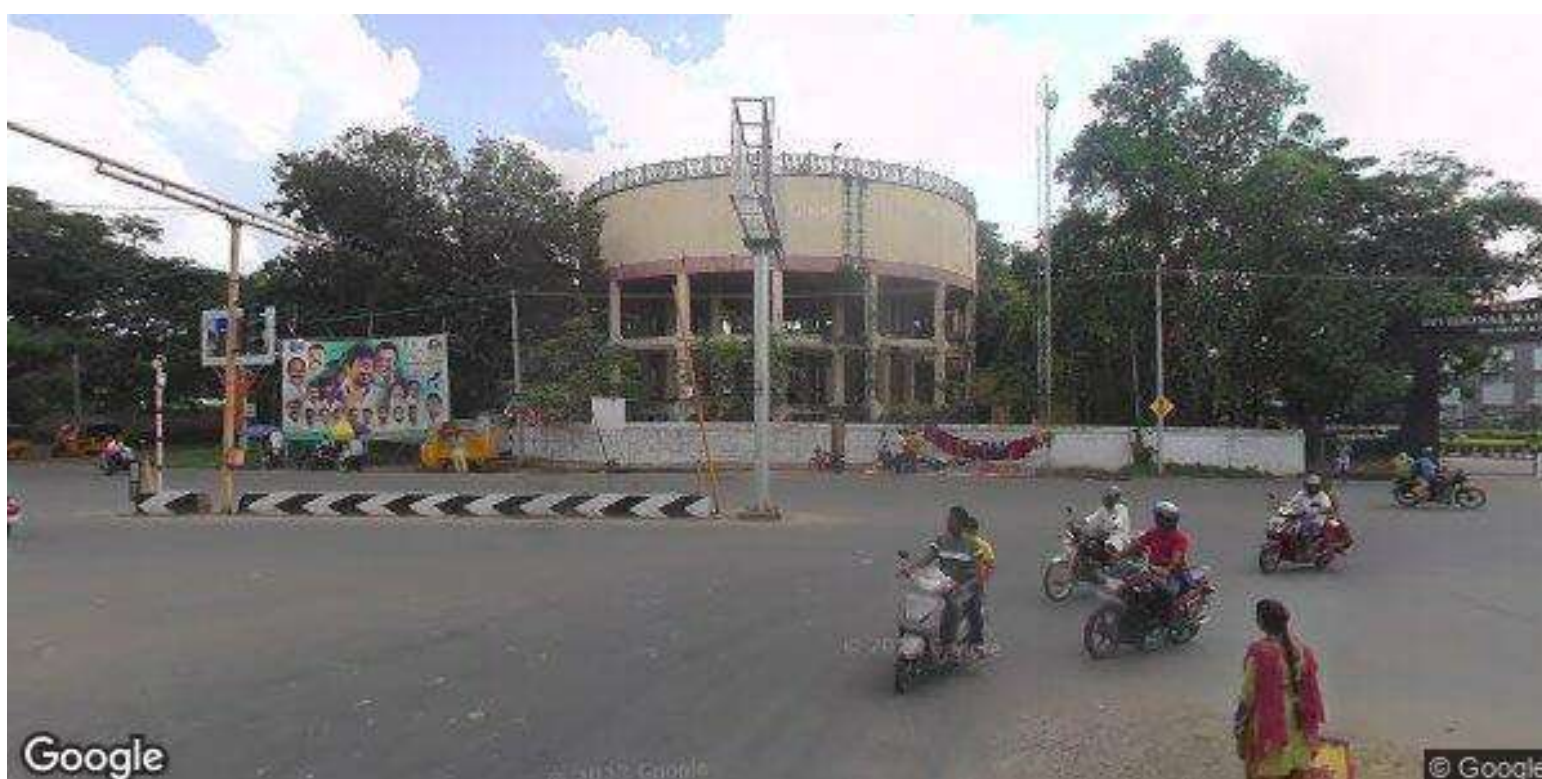
**Risk Type:** Turn  
**Risk Level:** Medium  
**Speed Limit:** 30 KM/Hr  
**Coordinates:** 11.67849, 78.11179

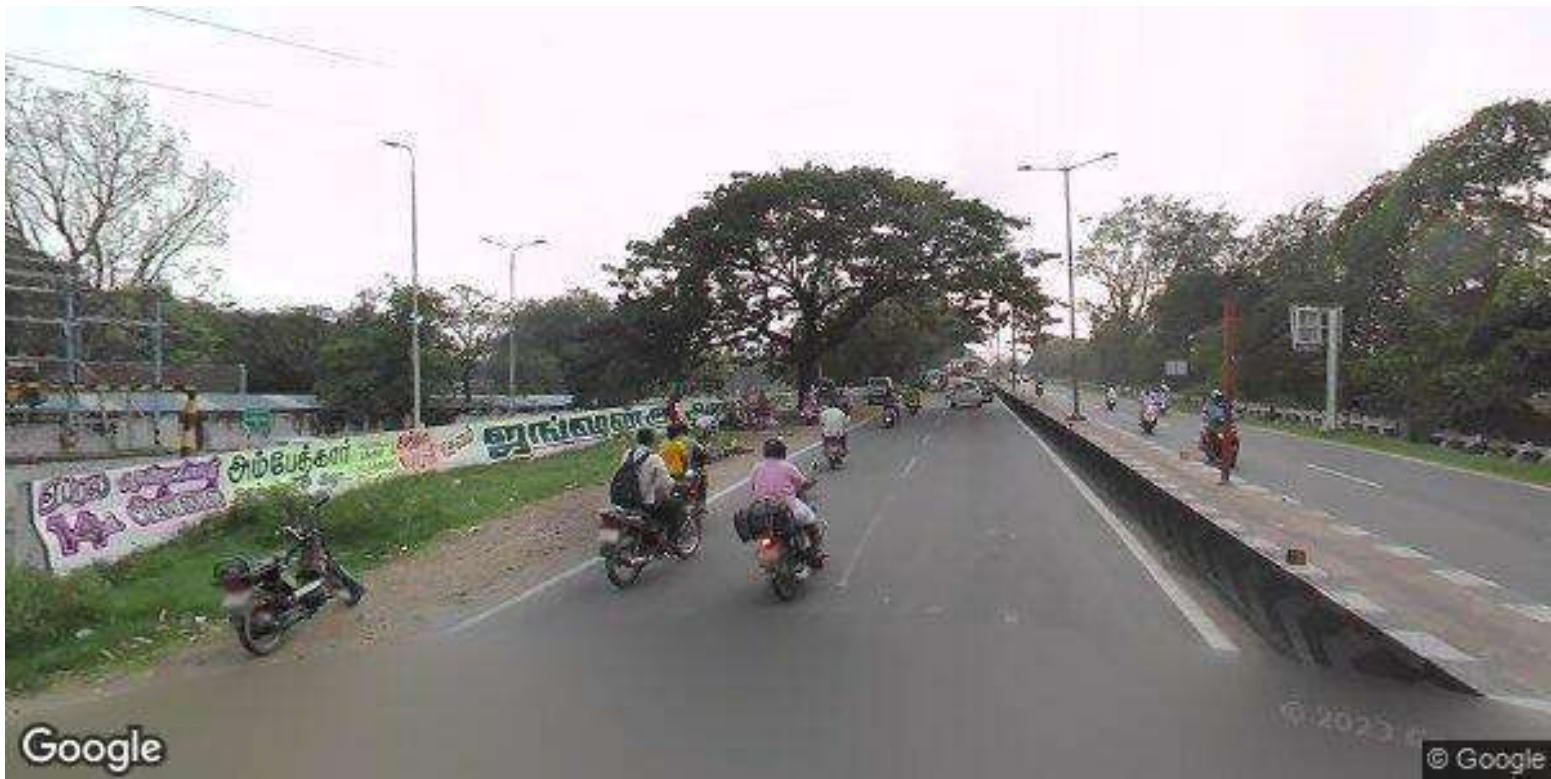
**Risk Type:** Turn  
**Risk Level:** High  
**Speed Limit:** 15 KM/Hr  
**Coordinates:** 11.67851, 78.11172

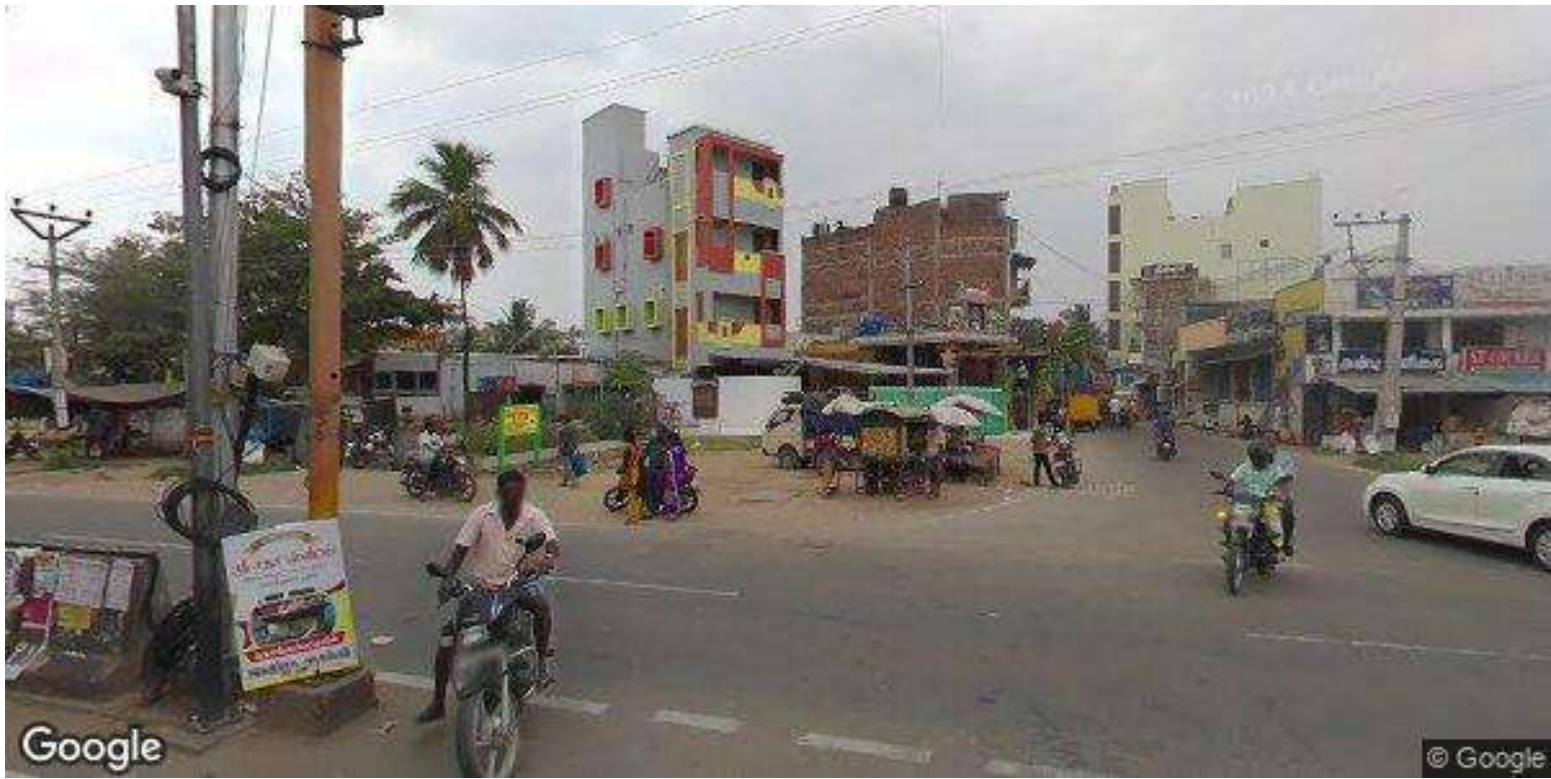
**Risk Type:** Blind Spot  
**Risk Level:** Blind Spot  
**Speed Limit:** 10 KM/Hr  
**Coordinates:** 11.67472, 78.10494
