# IndianOil

## JOURNEY RISK MANAGEMENT (JRM) STUDY

### Salem Terminal to SRI VENKATESHWARA AGENCIES

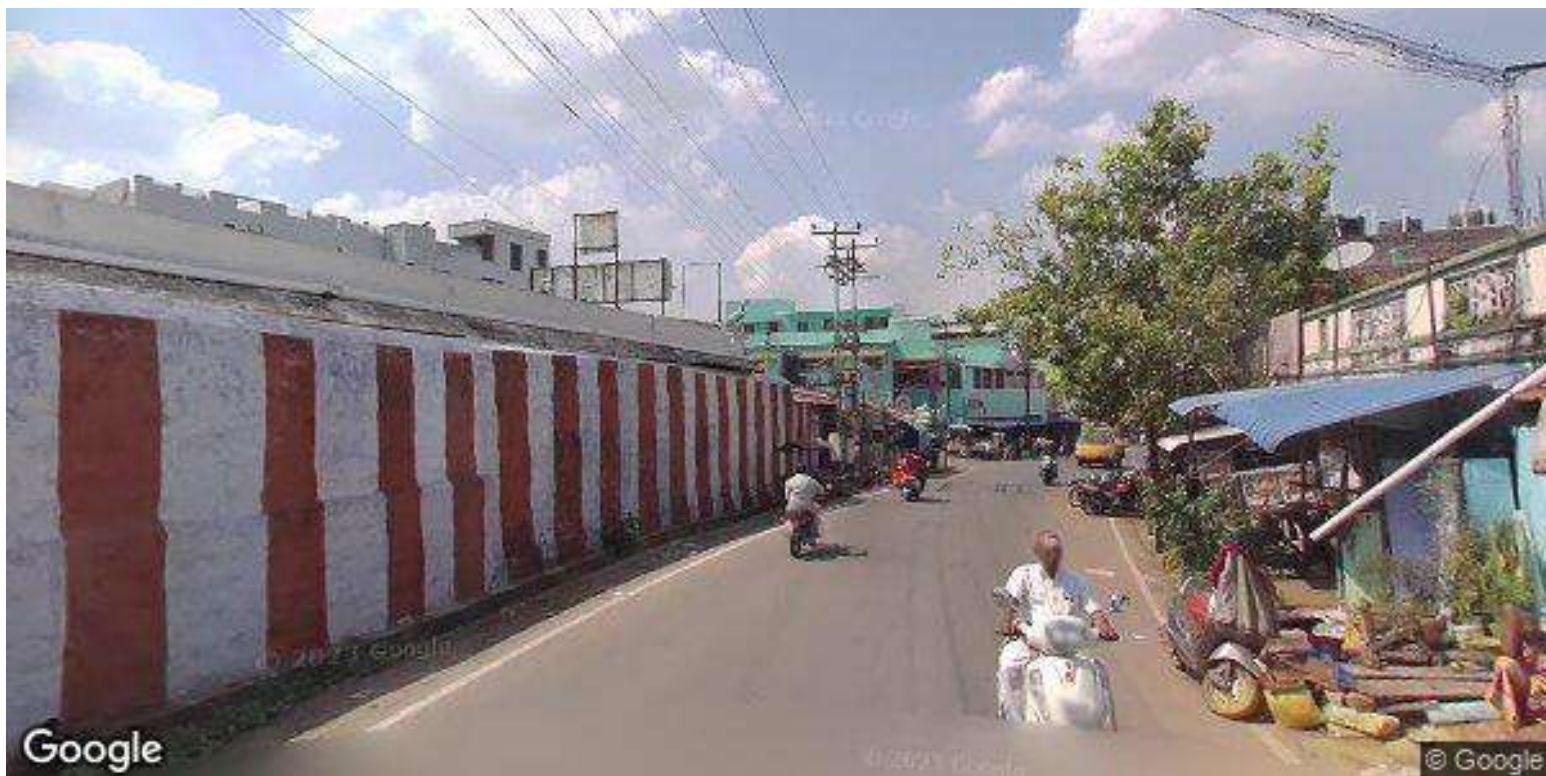
**Coordinates: 11.37809, 77.89834**

**Risk Type: Turn**

**Risk Level: Medium**

**Speed Limit: 30 KM/Hr**

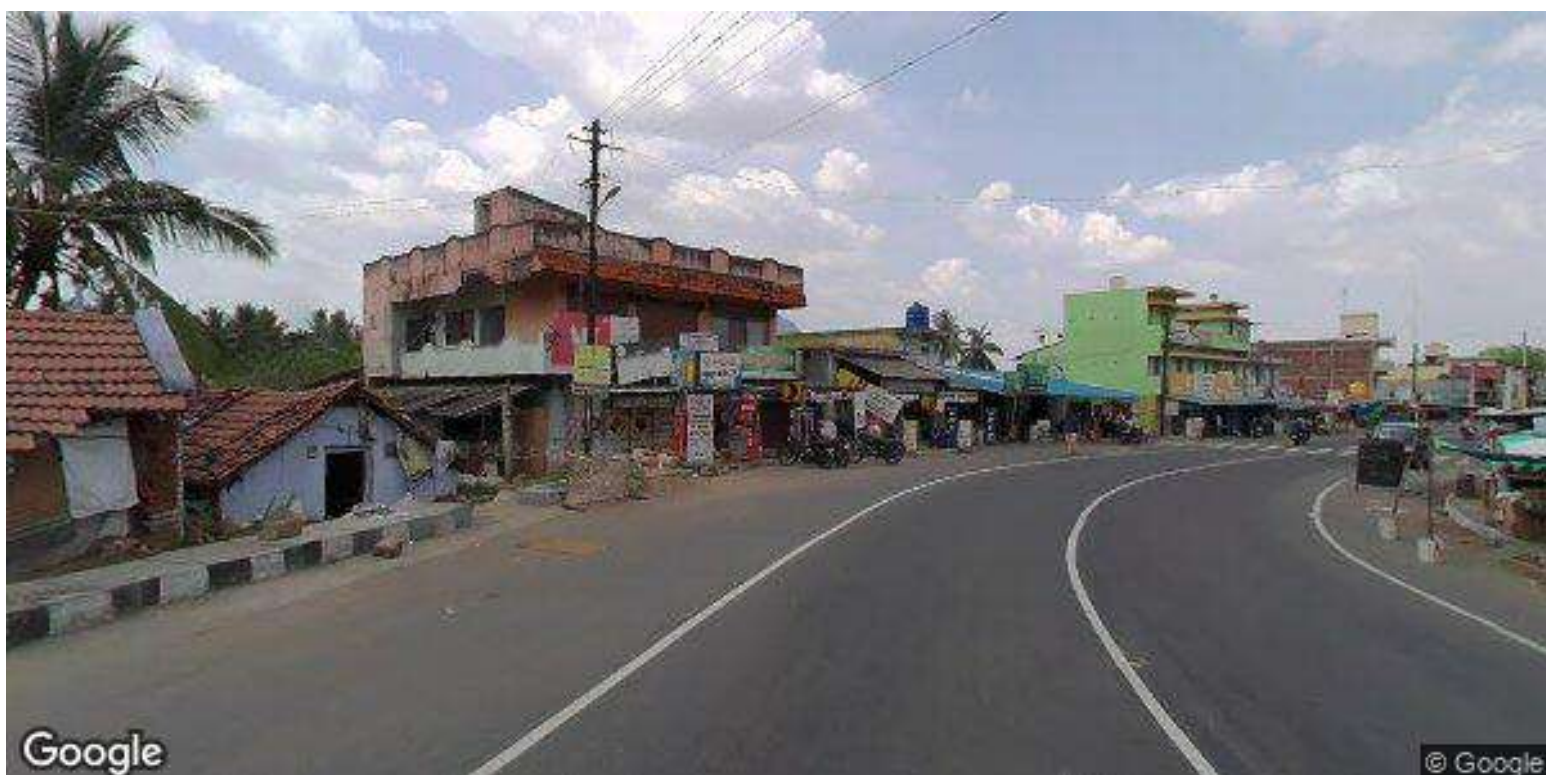
**Risk Type:** Turn  
**Risk Level:** High  
**Speed Limit:** 15 KM/Hr  
**Coordinates:** 11.41466, 78.08070

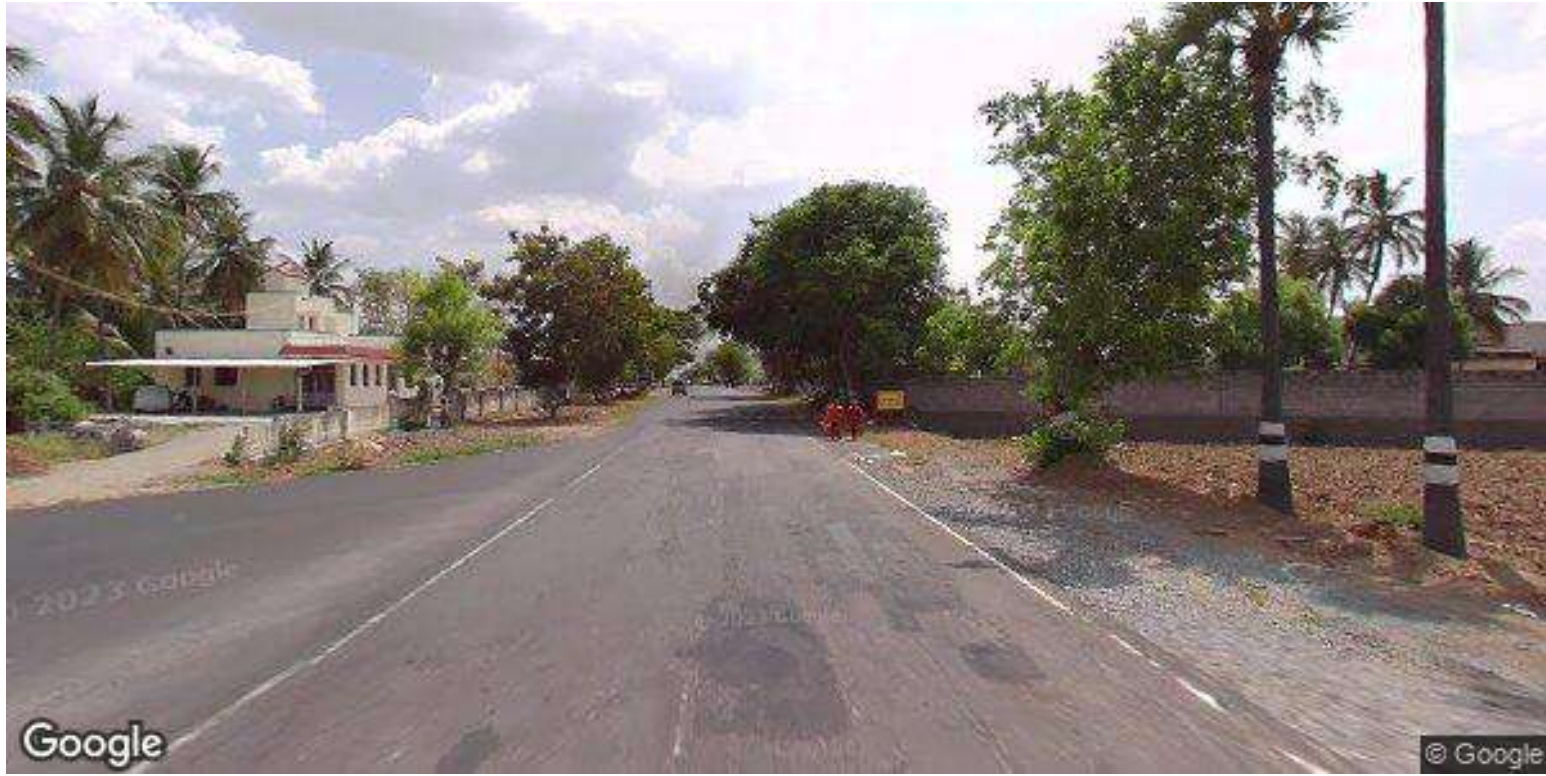
**Risk Type:** Turn  
**Risk Level:** High  
**Speed Limit:** 15 KM/Hr  
**Coordinates:** 11.42962, 78.11578

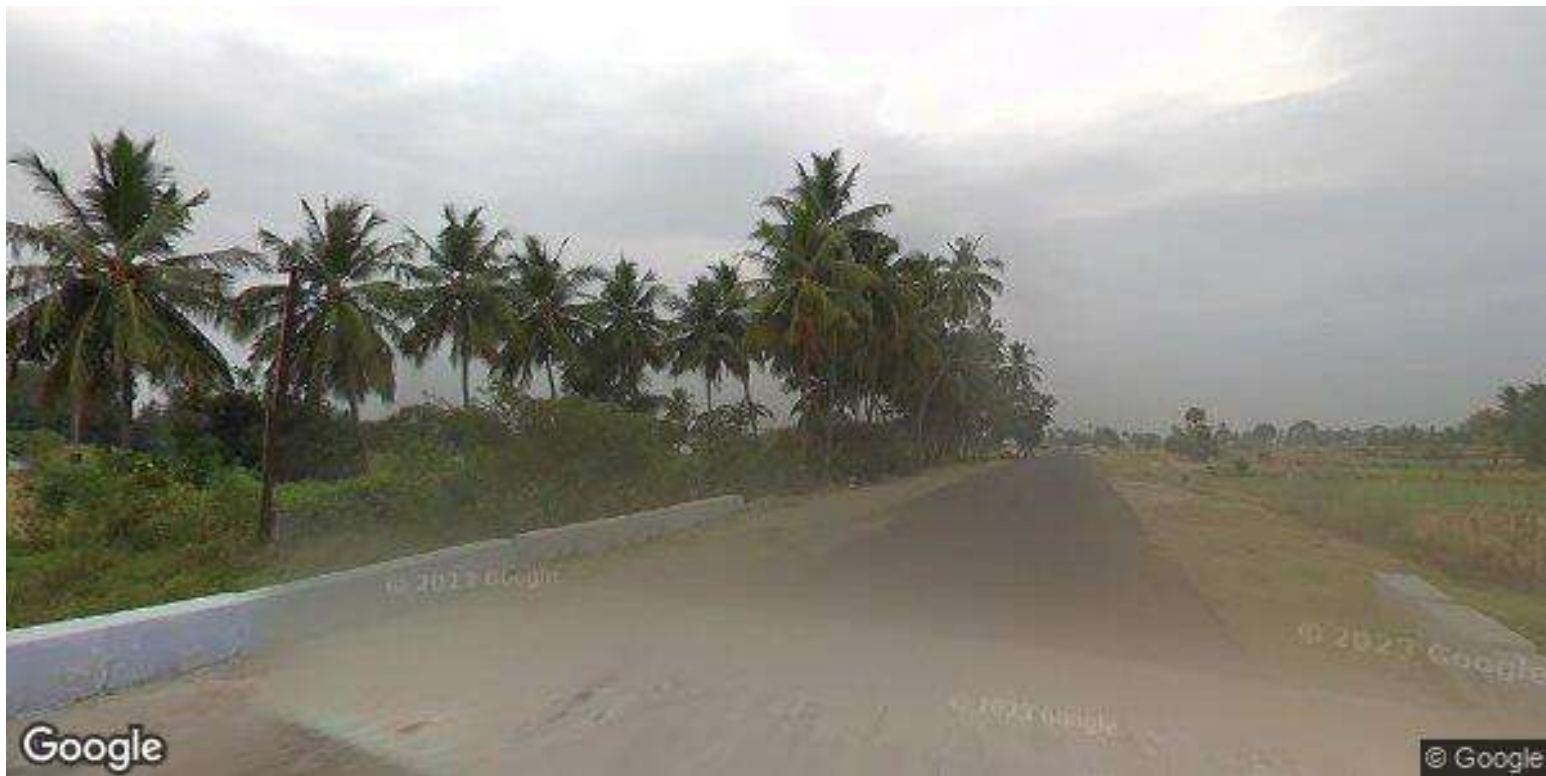
**Risk Type:** Turn  
**Risk Level:** Medium  
**Speed Limit:** 30 KM/Hr  
**Coordinates:** 11.42450, 78.15278

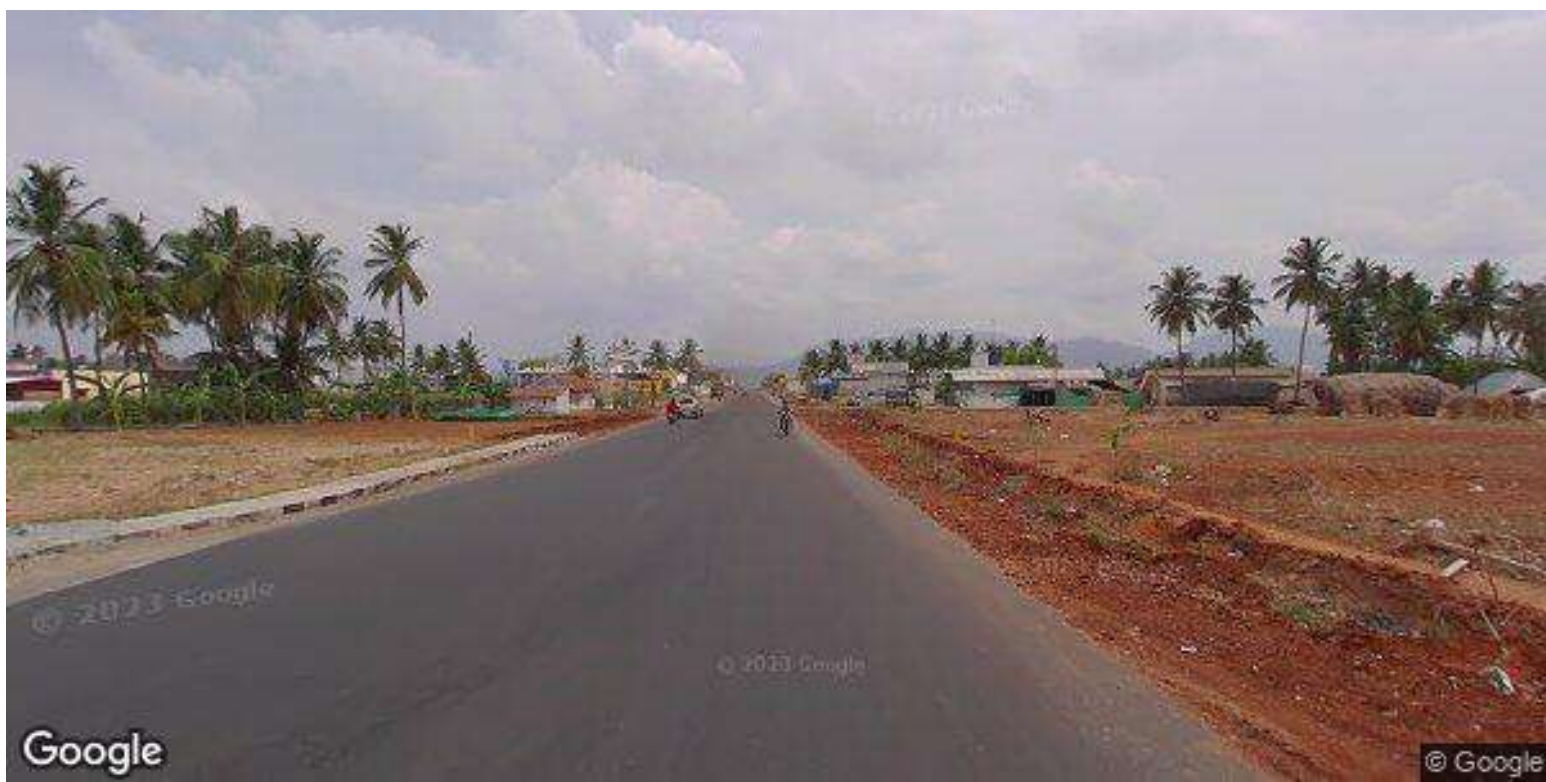
**Risk Type:** Blind Spot  
**Risk Level:** Blind Spot  
**Speed Limit:** 10 KM/Hr  
**Coordinates:** 11.43542, 78.20754

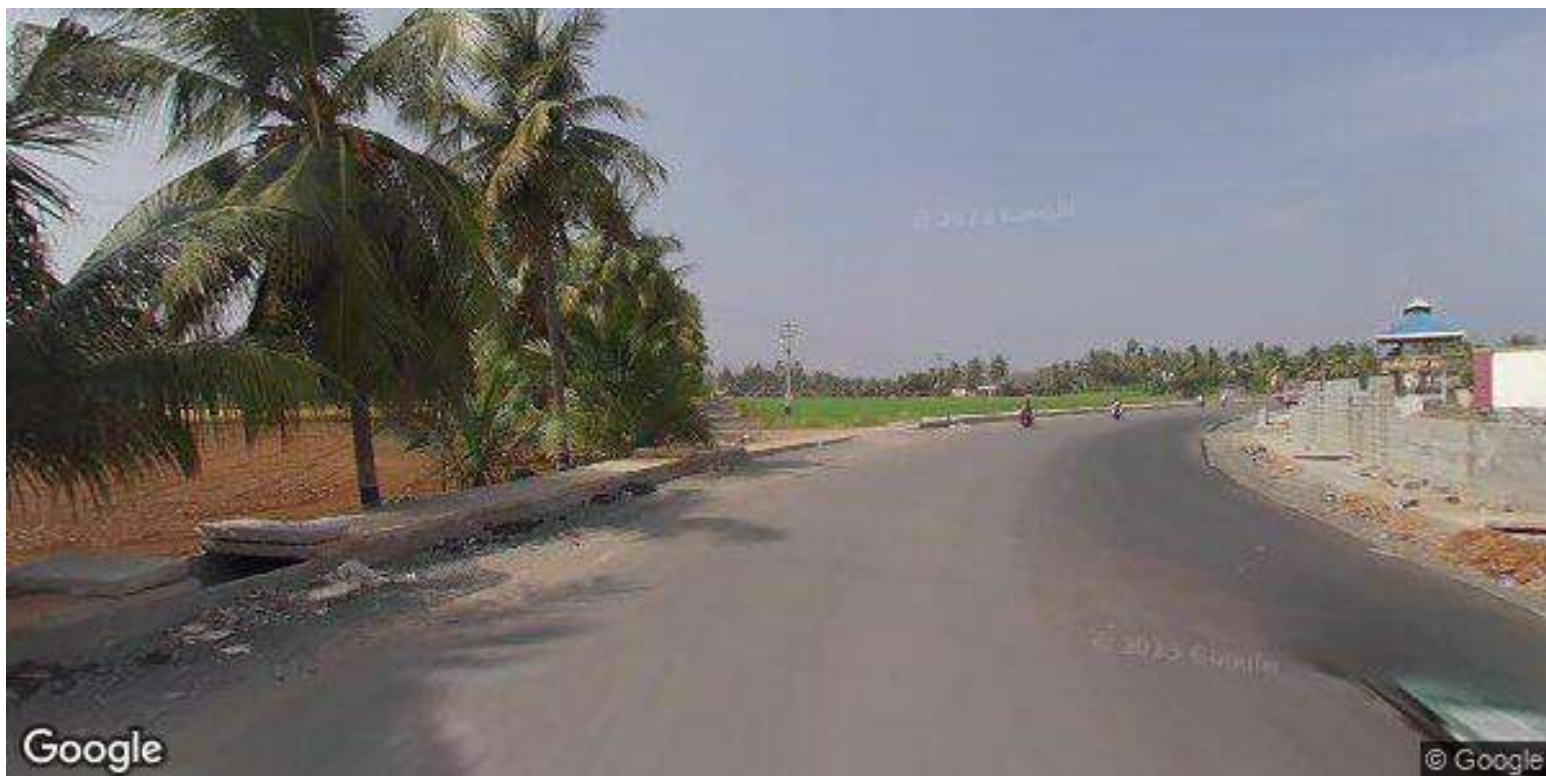
**Risk Type:** Turn  
**Risk Level:** Medium  
**Speed Limit:** 30 KM/Hr  
**Coordinates:** 11.43035, 78.20865

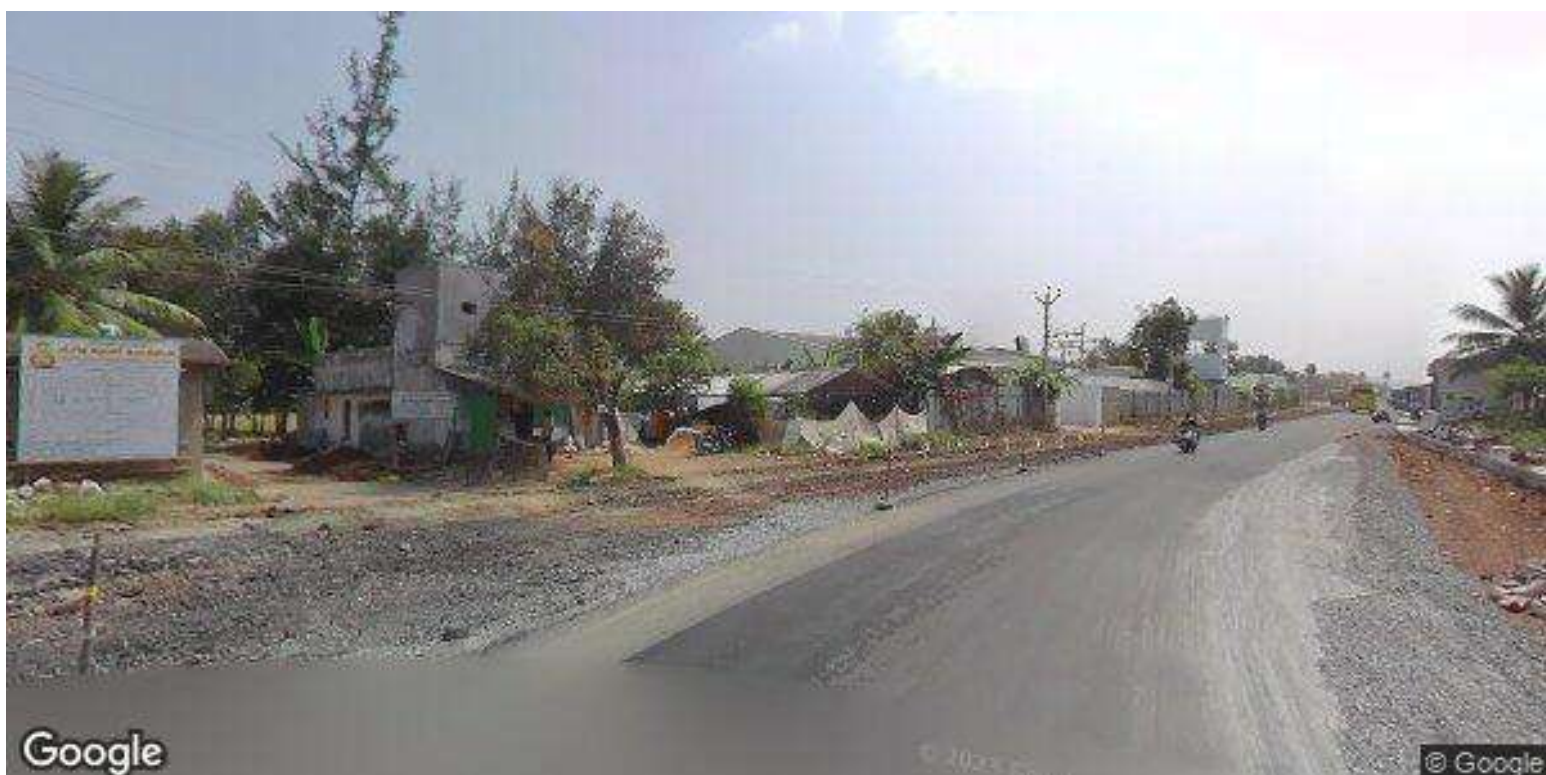
**Risk Type:** Turn  
**Risk Level:** Medium  
**Speed Limit:** 30 KM/Hr  
**Coordinates:** 11.42167, 78.21705

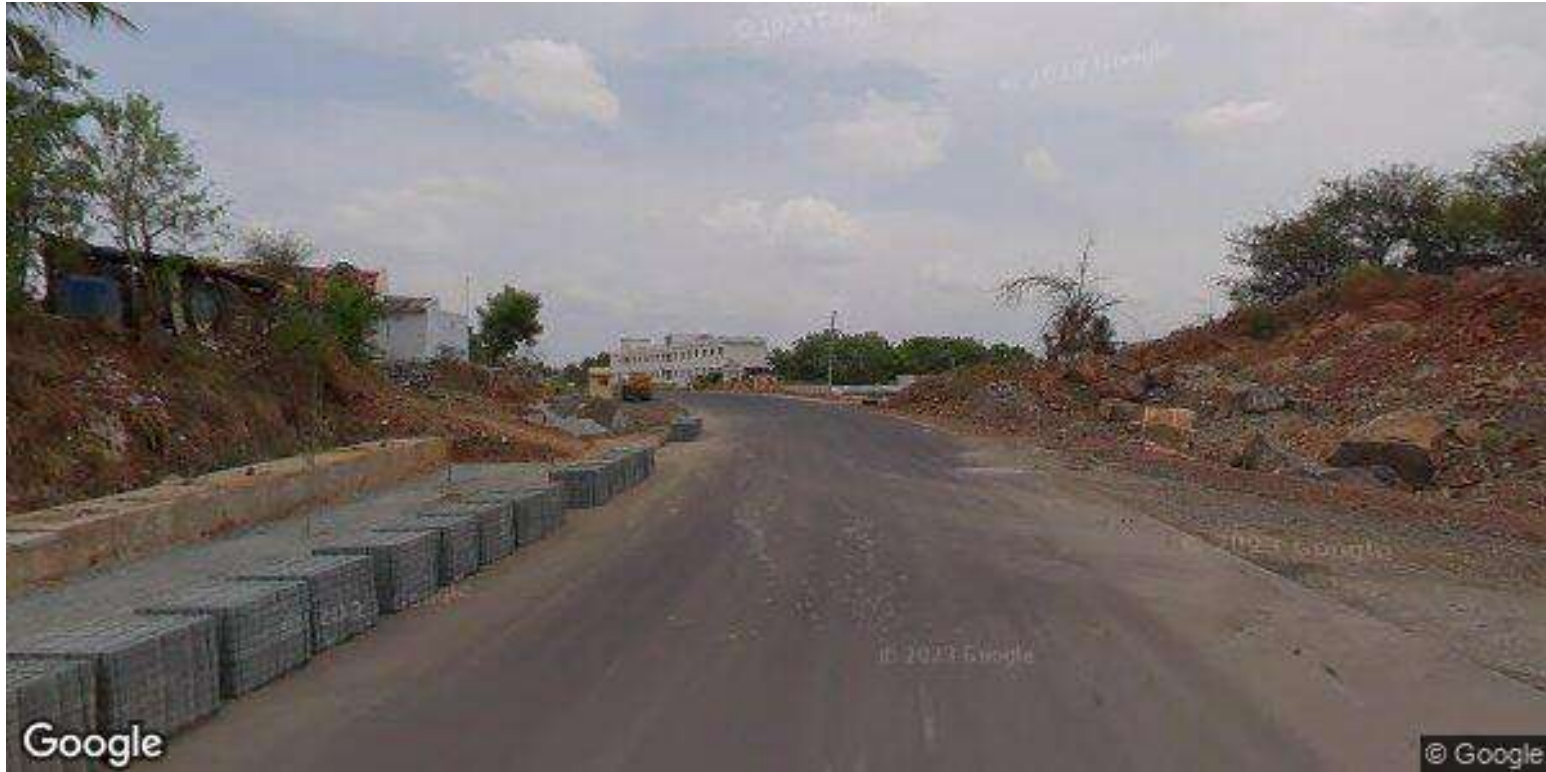
**Risk Type:** Turn  
**Risk Level:** Medium  
**Speed Limit:** 30 KM/Hr  
**Coordinates:** 11.39642, 78.25111

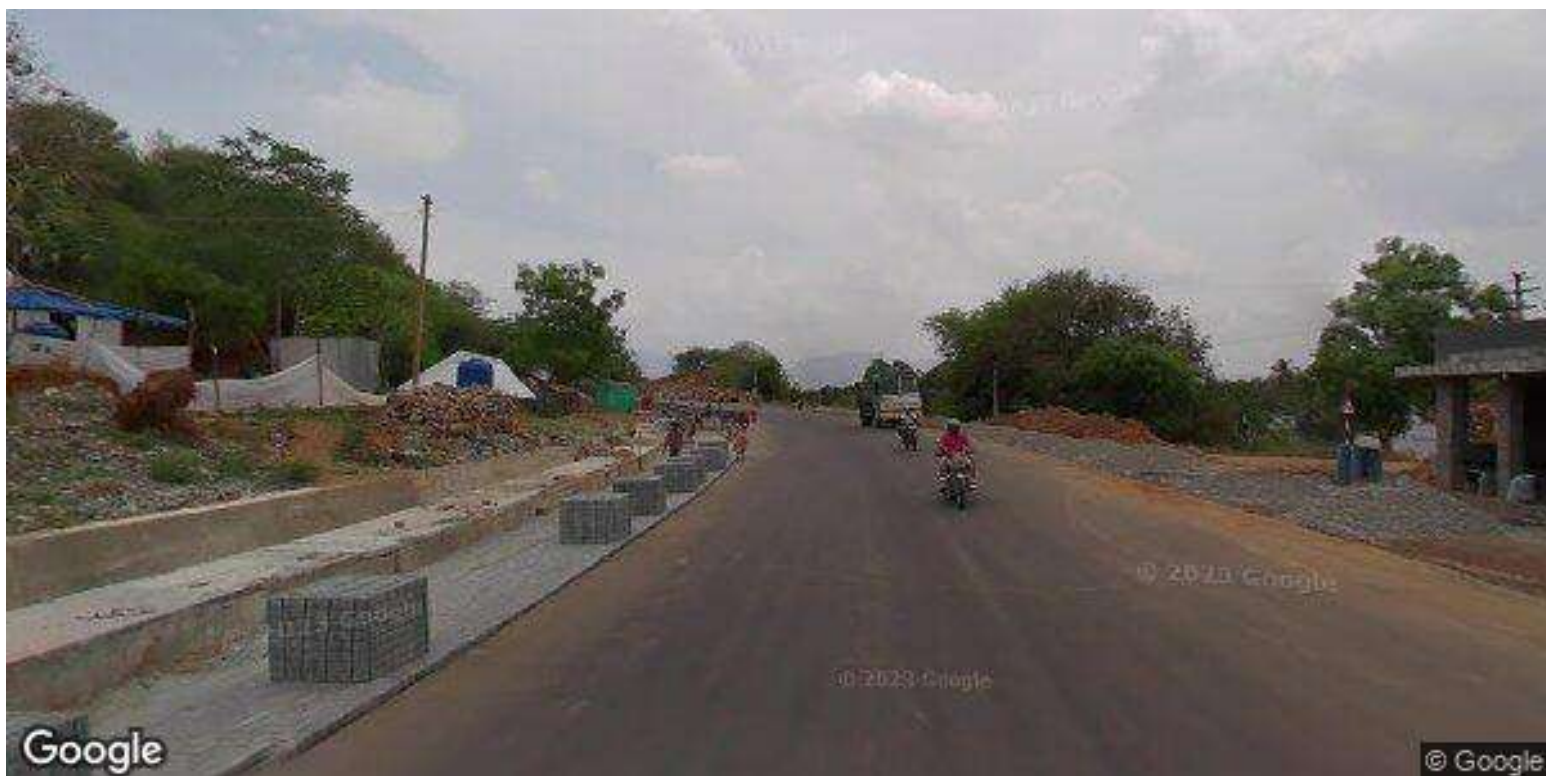
**Risk Type:** Turn  
**Risk Level:** Medium  
**Speed Limit:** 30 KM/Hr  
**Coordinates:** 11.39536, 78.25156

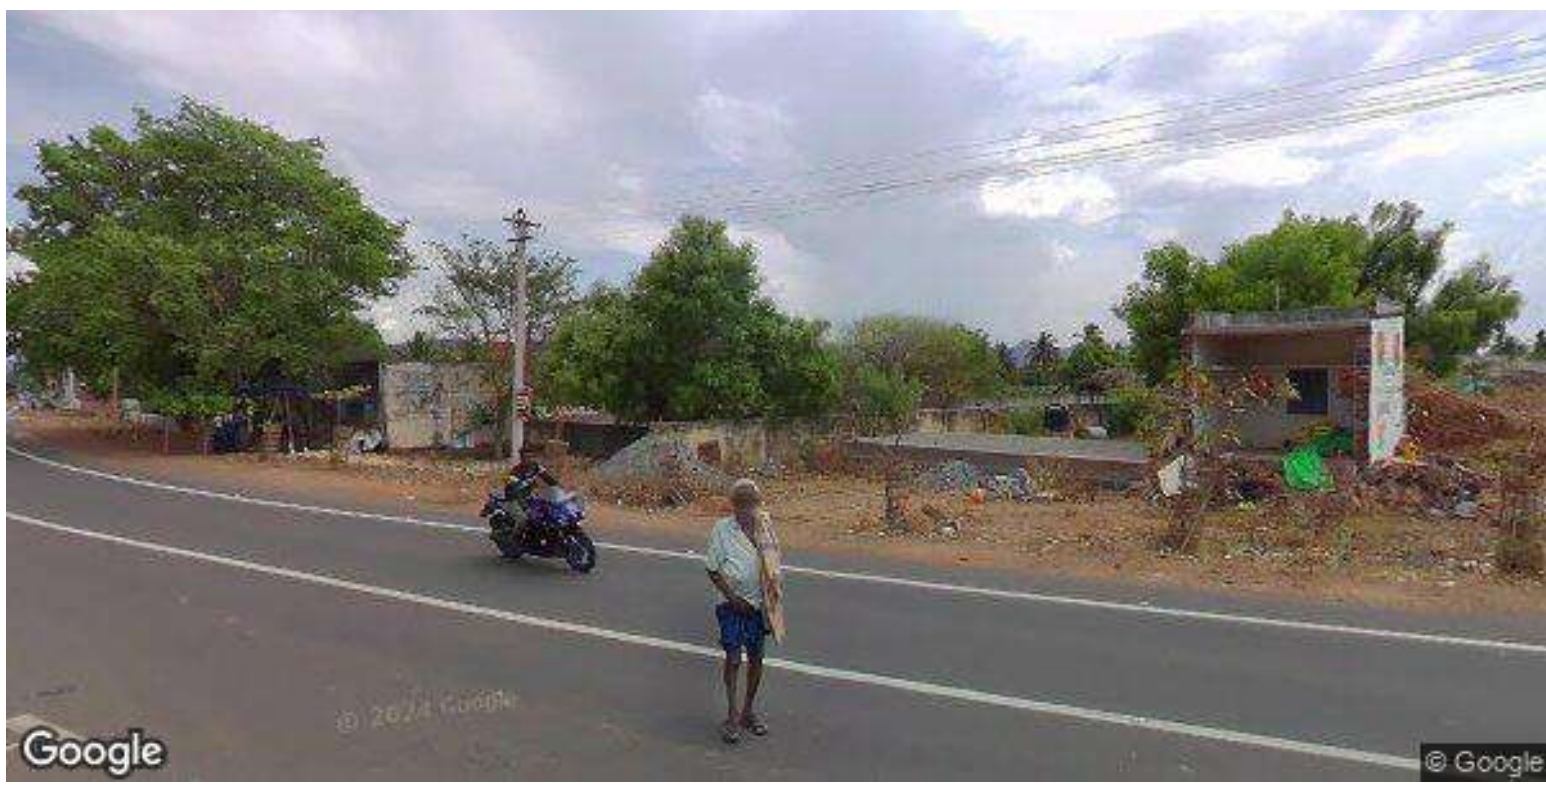
**Coordinates:** 11.38226, 78.25407

**Risk Type:** Turn

**Risk Level:** Medium

**Speed Limit:** 30 KM/Hr

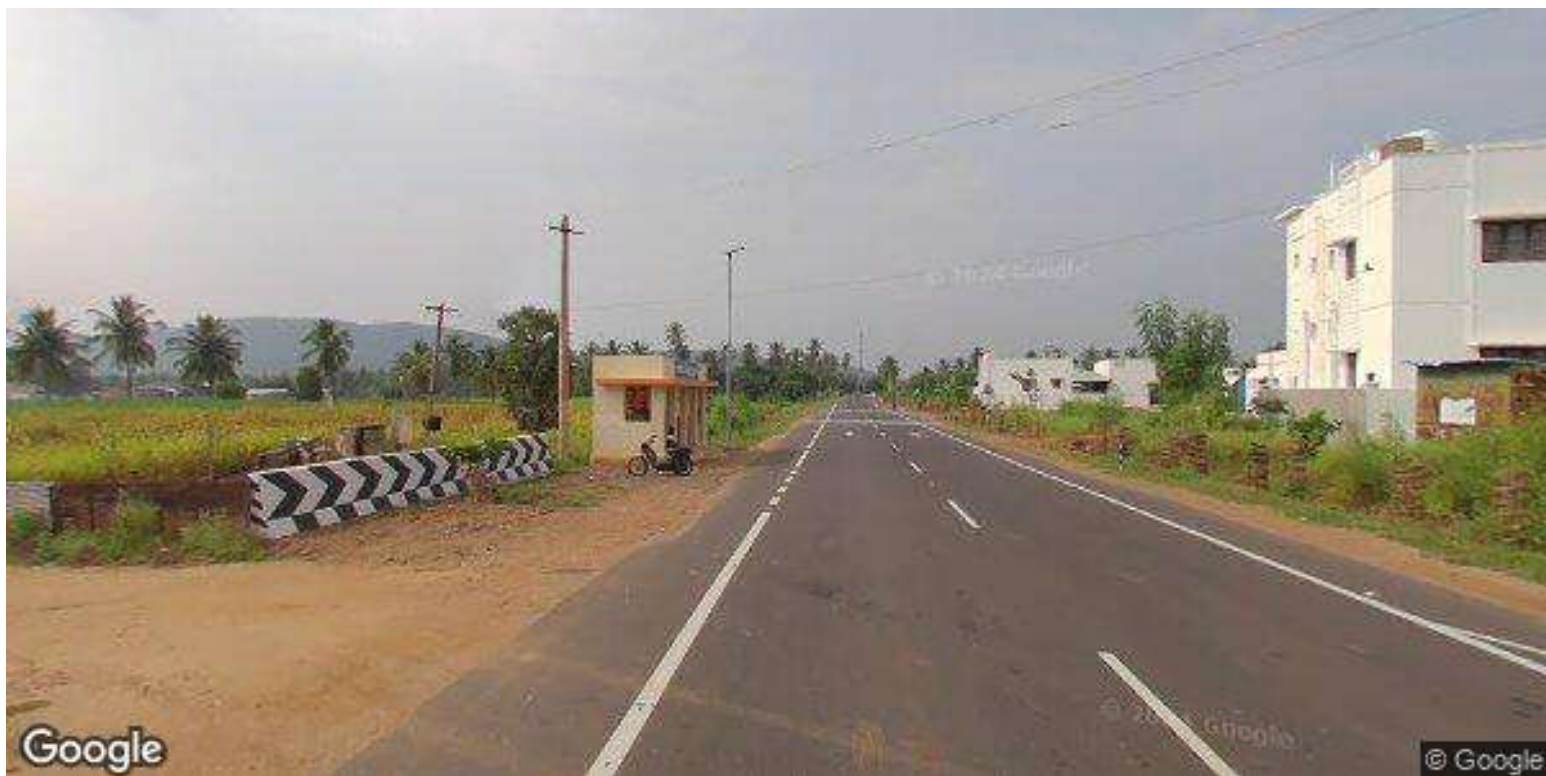
**Coordinates:** 11.37644, 78.25558

**Risk Type:** Turn

**Risk Level:** High

**Speed Limit:** 15 KM/Hr
