# IndianOil

## JOURNEY RISK MANAGEMENT (JRM) STUDY

### Salem Terminal to BHAVANI KOMARAPALAYAM LORRY

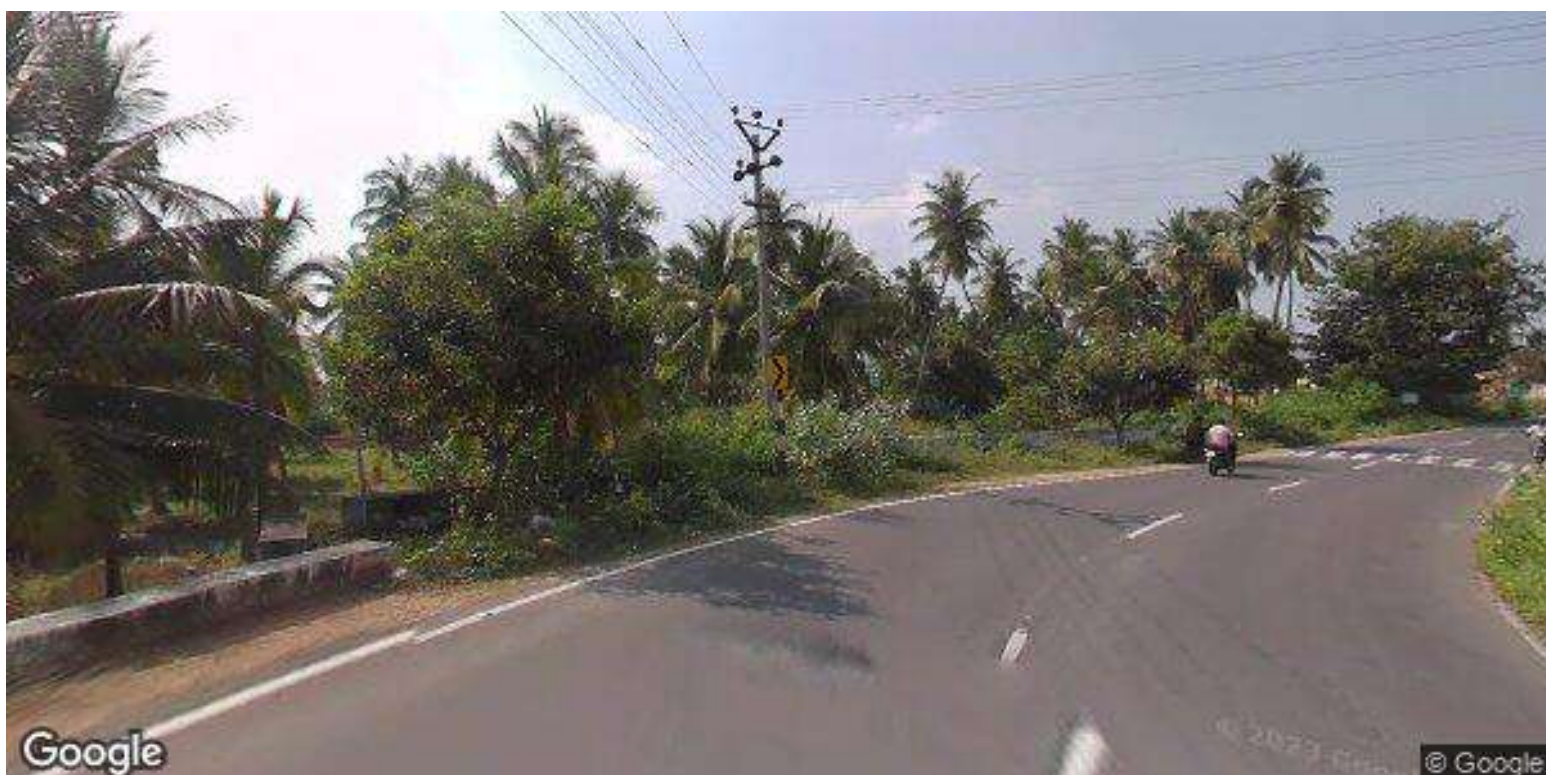
**Coordinates: 11.45348, 77.85706**

**Risk Type: Turn**

**Risk Level: Medium**

**Speed Limit: 30 KM/Hr**

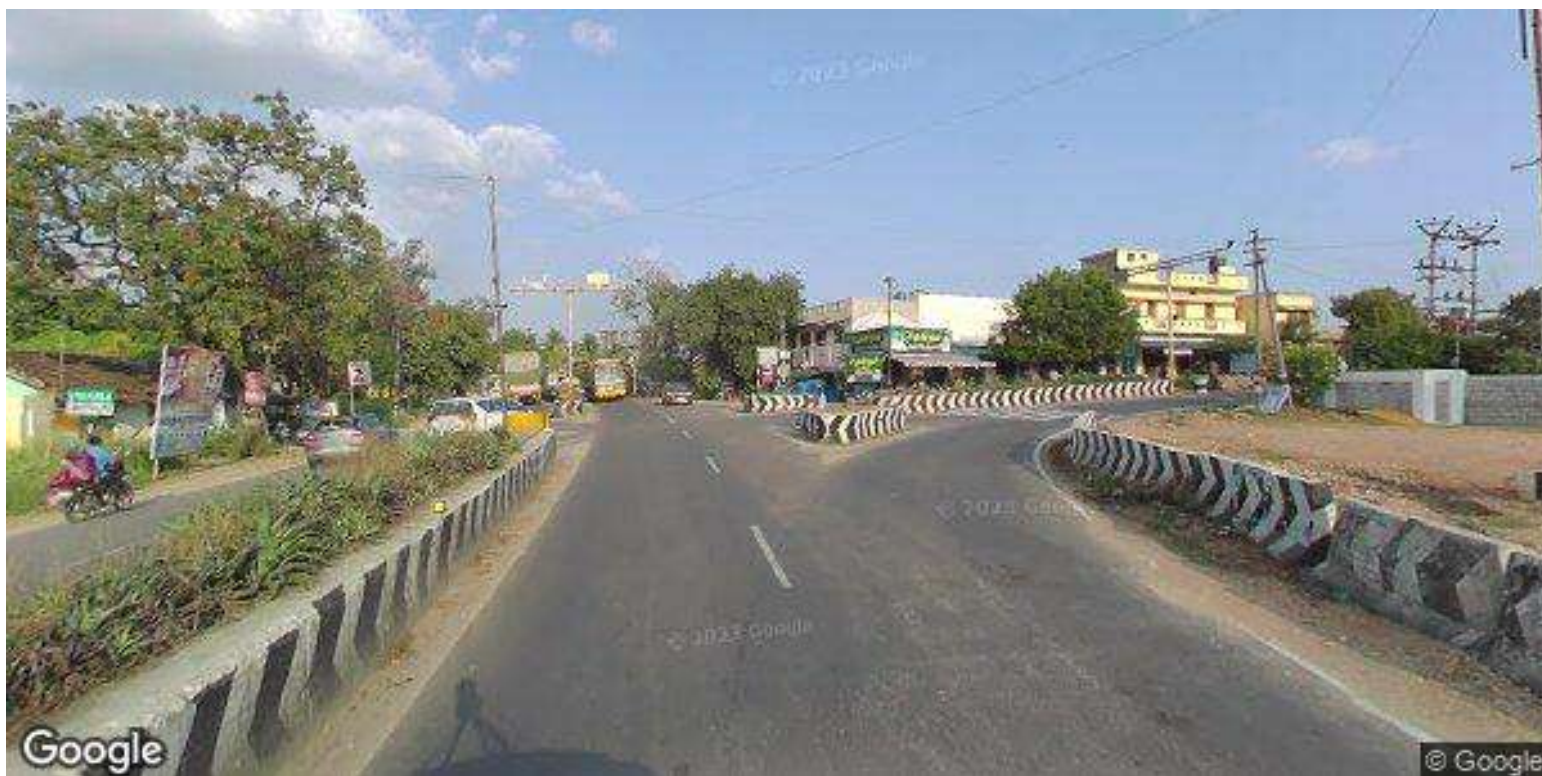
**Coordinates: 11.46318, 77.84913**

**Risk Type: Turn**

**Risk Level: Medium**

**Speed Limit: 30 KM/Hr**

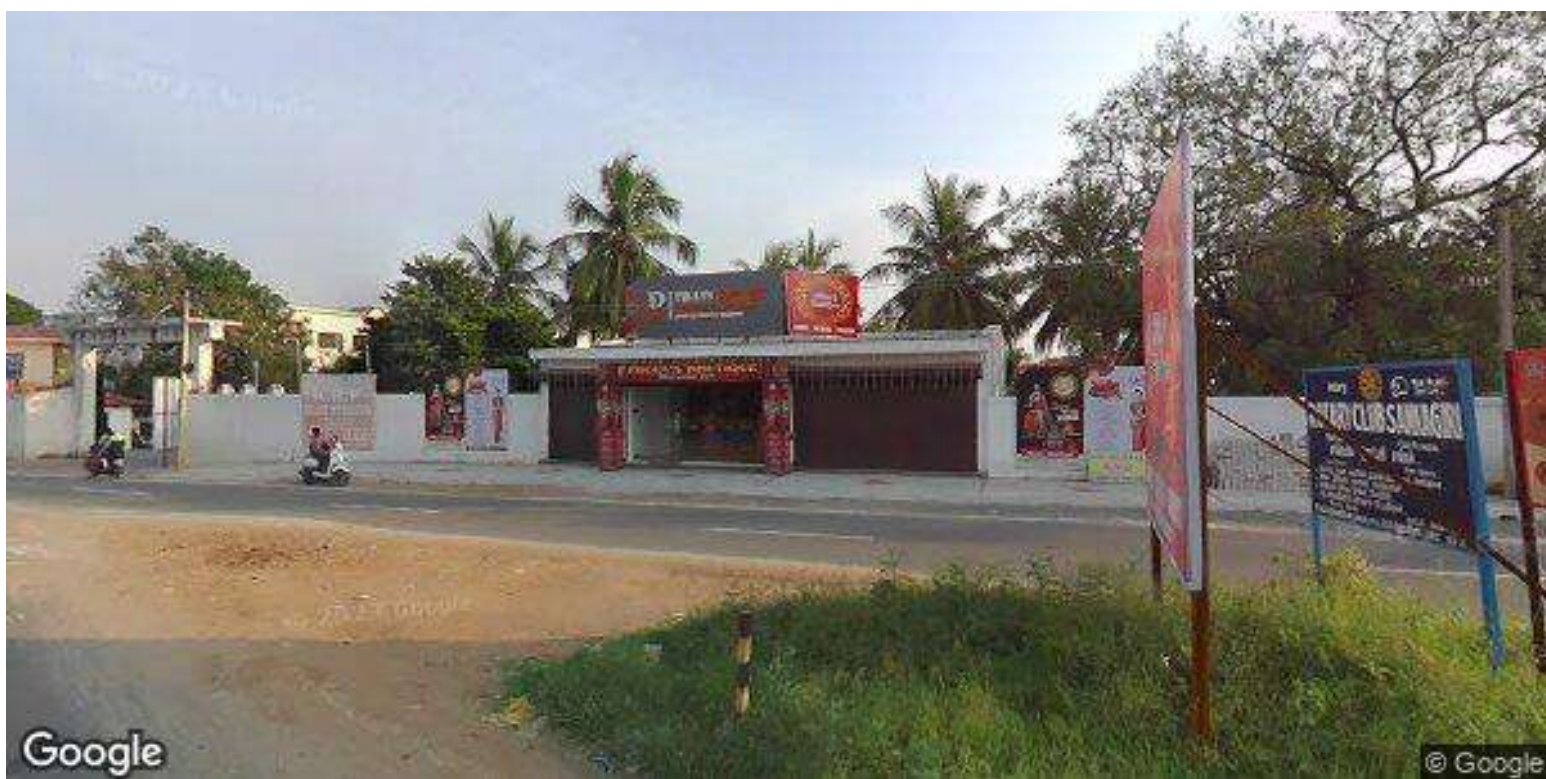
**Coordinates: 11.45516, 77.81346**

### Risk Type: Turn

**Risk Level: High**

**Speed Limit: 15 KM/Hr**

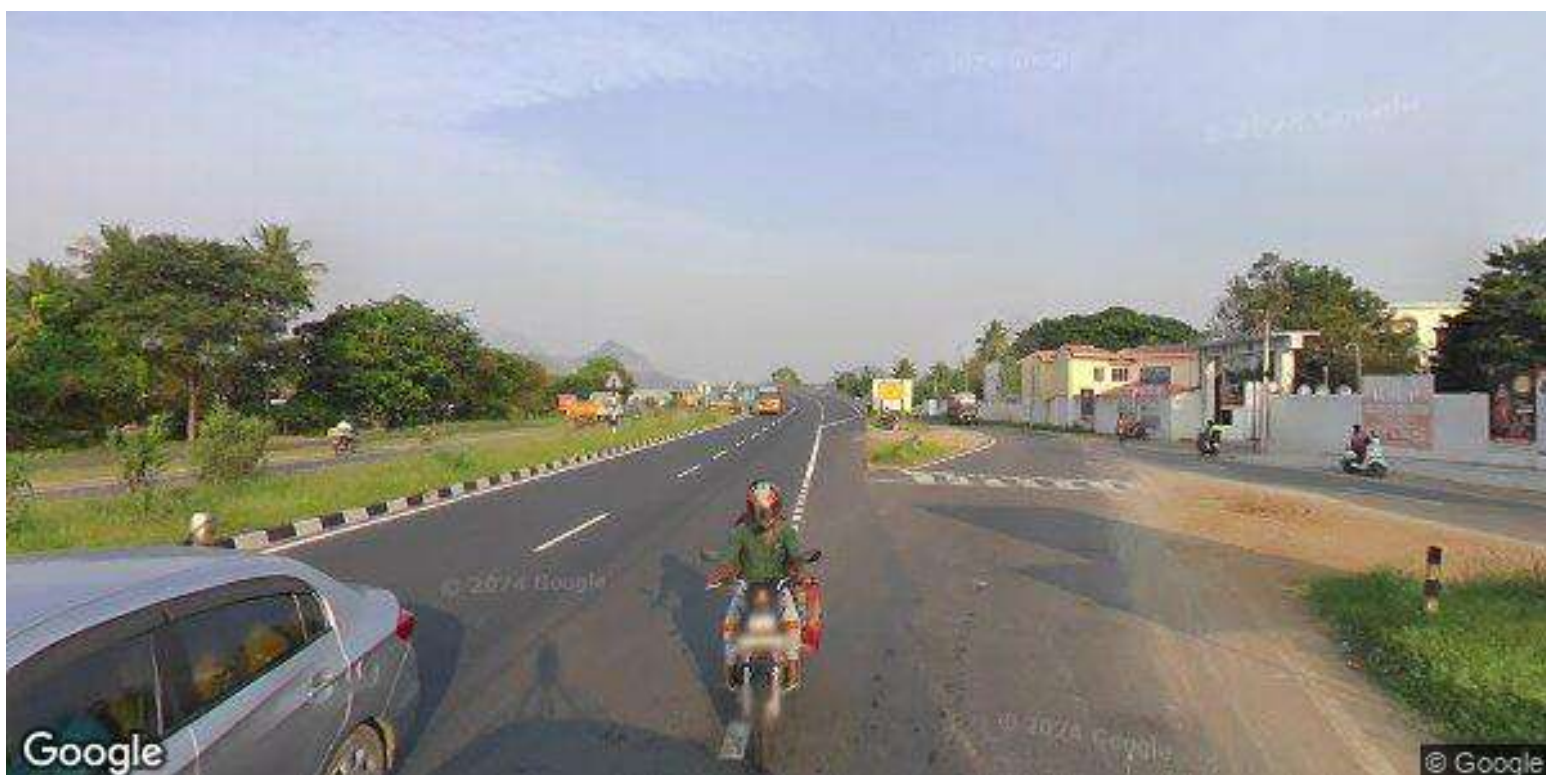
**Risk Type:** Turn  
**Risk Level:** High  
**Speed Limit:** 15 KM/Hr  
**Coordinates:** 11.45521, 77.81343

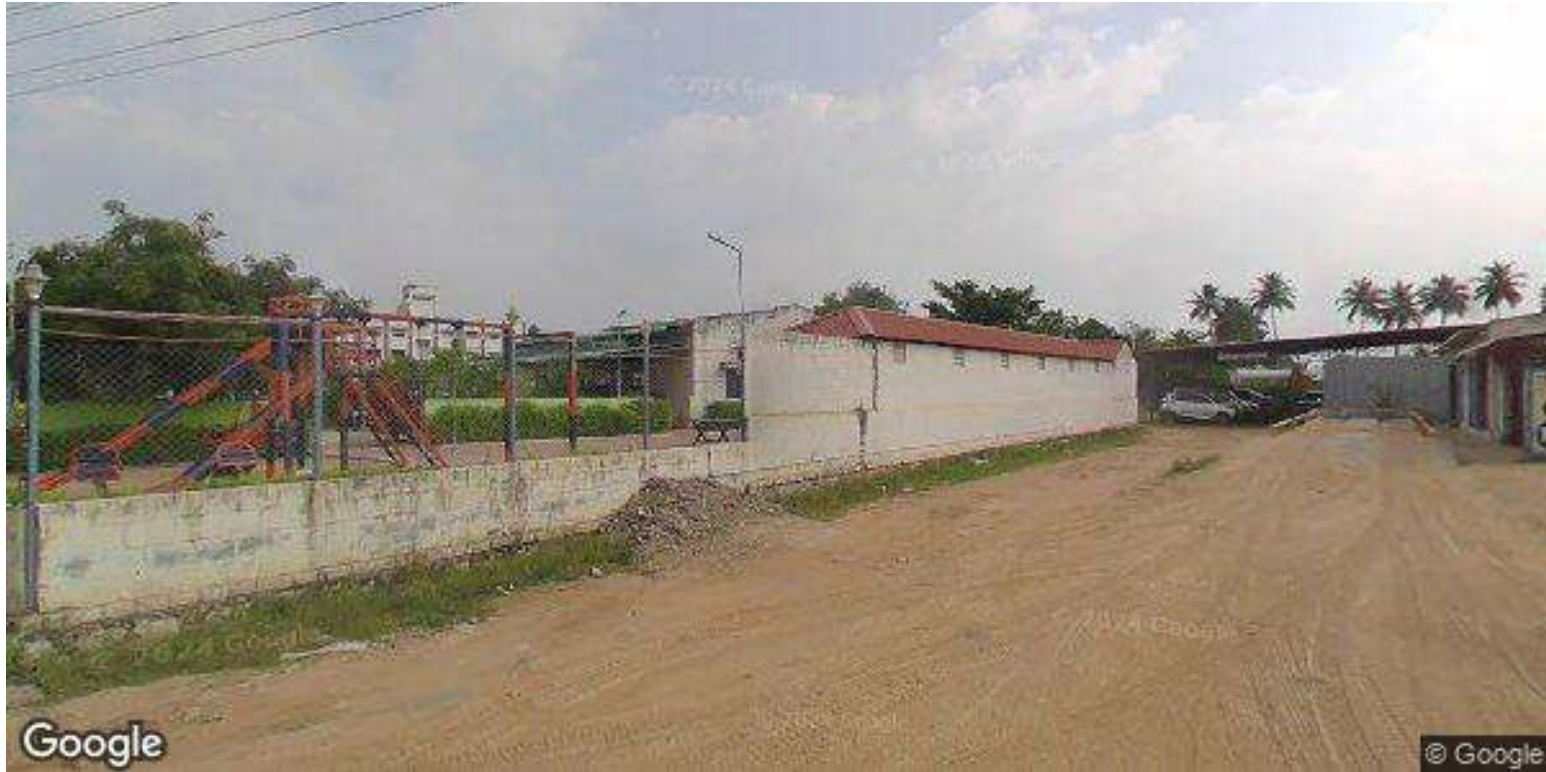
**Risk Type:** Turn  
**Risk Level:** High  
**Speed Limit:** 15 KM/Hr  
**Coordinates:** 11.44377, 77.71562

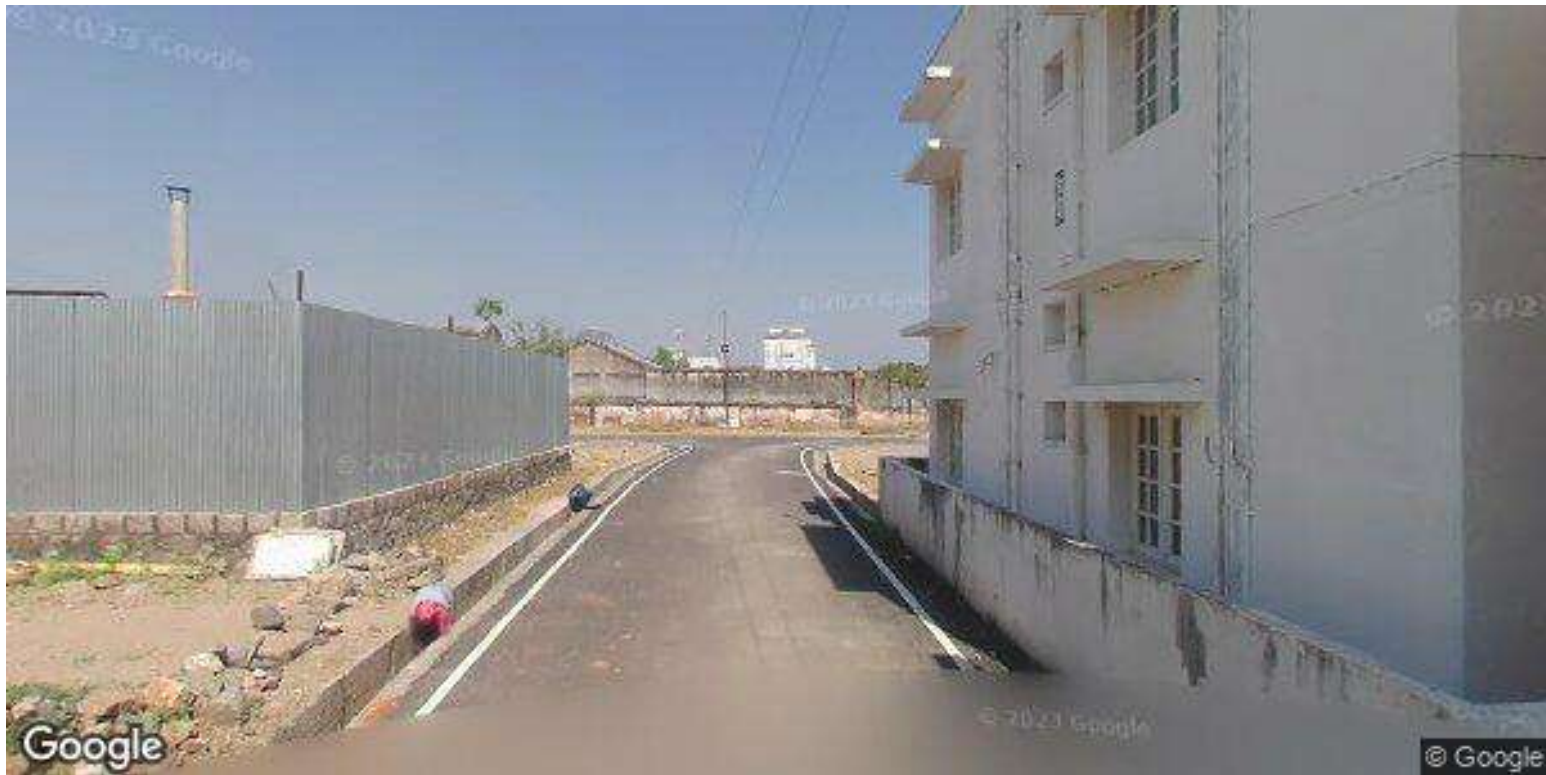
**Risk Type:** Turn  
**Risk Level:** High  
**Speed Limit:** 15 KM/Hr  
**Coordinates:** 11.44947, 77.68646

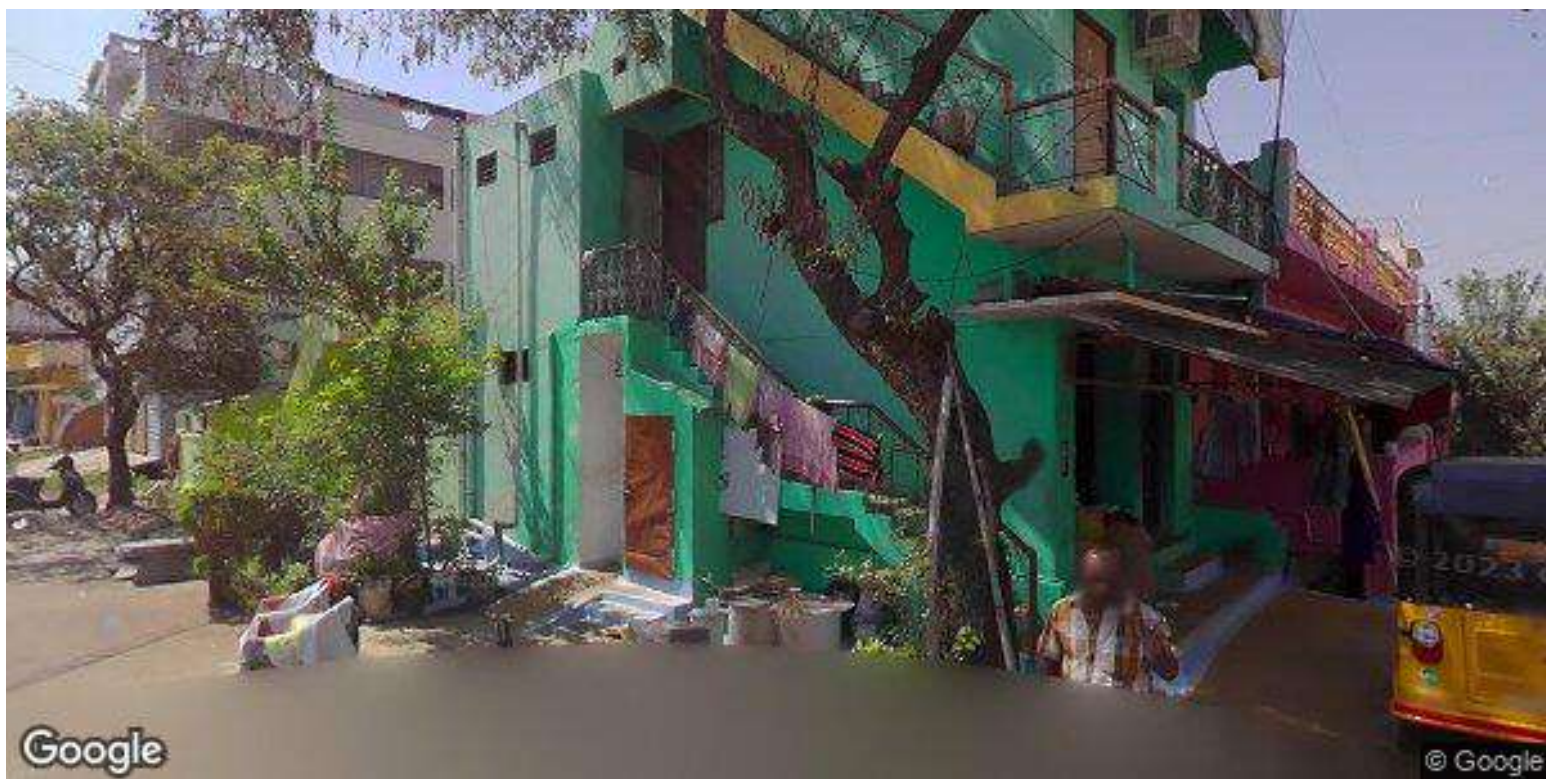
**Risk Type:** Turn  
**Risk Level:** High  
**Speed Limit:** 15 KM/Hr  
**Coordinates:** 11.44801, 77.68596

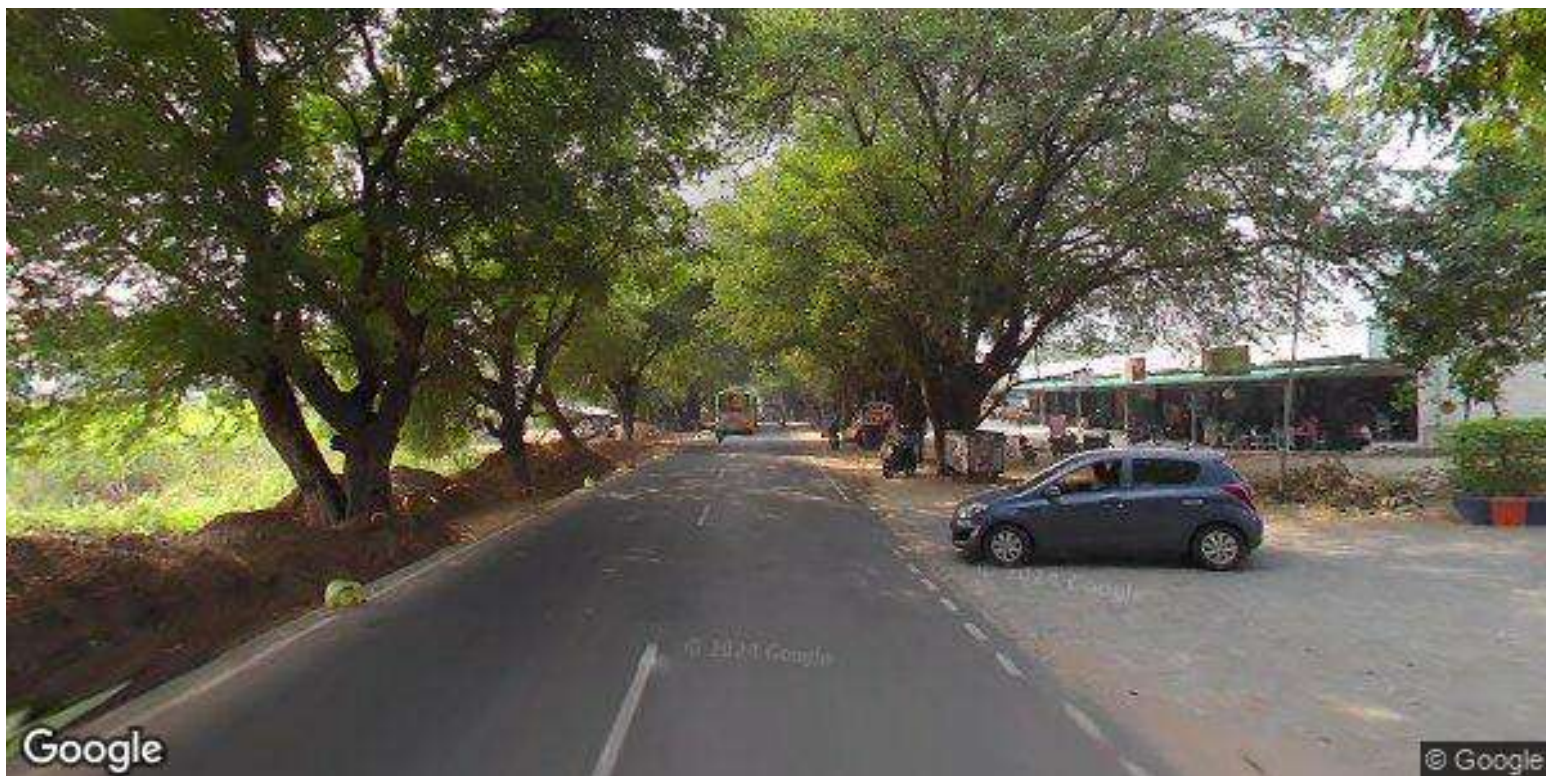
**Coordinates:** 11.49574, 77.69838

**Risk Type:** Turn

**Risk Level:** High

**Speed Limit:** 15 KM/Hr
