# IndianOil

## JOURNEY RISK MANAGEMENT (JRM) STUDY

### Salem Terminal to AANJANEYA FUELS

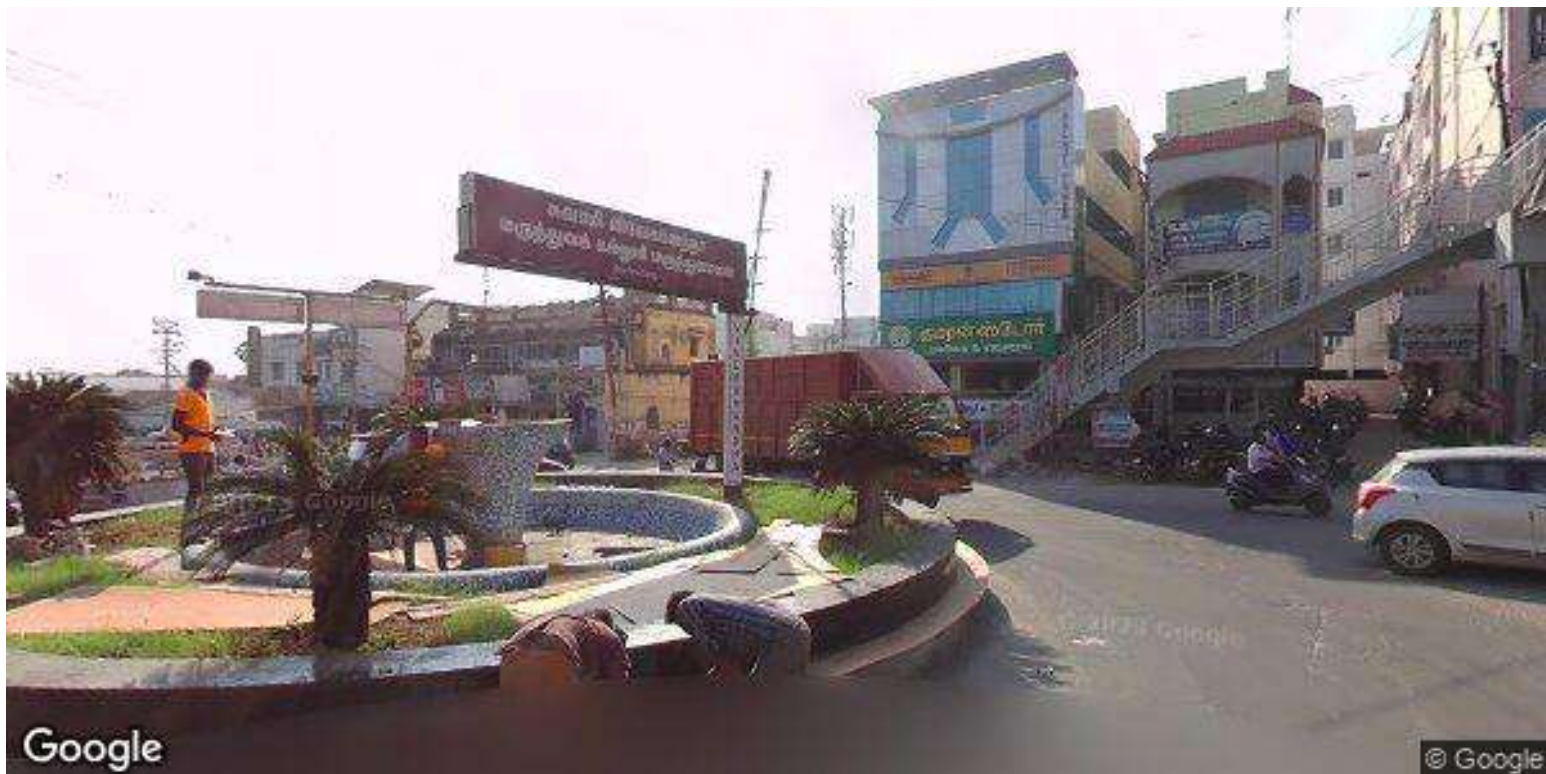
**Coordinates:** 11.38395, 77.89480

**Risk Type:** Roundabout

**Risk Level:** High

**Speed Limit:** 15 KM/Hr

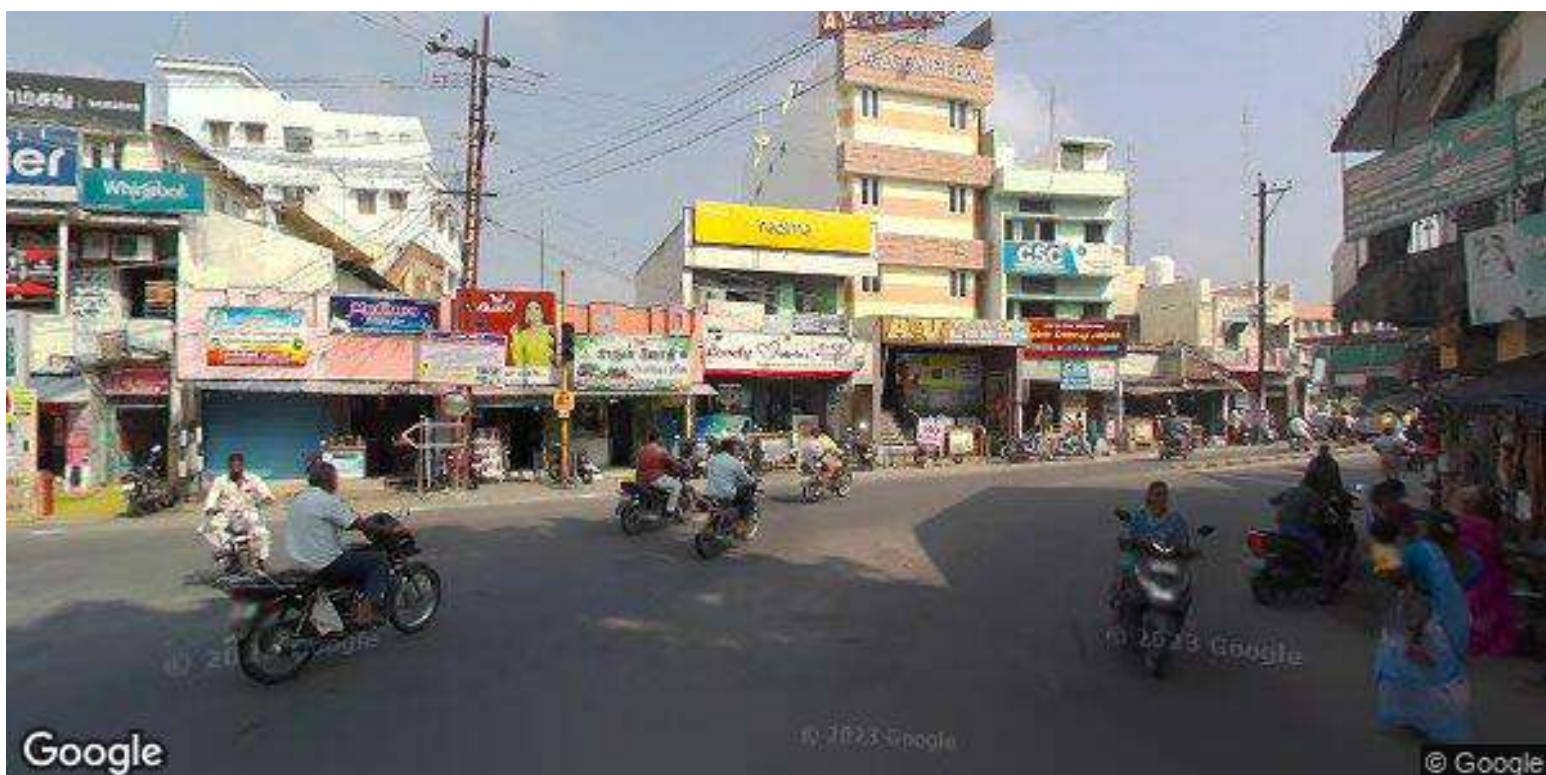
**Coordinates: 11.37842, 77.89452**

**Risk Type: Turn**

**Risk Level: Medium**

**Speed Limit: 30 KM/Hr**

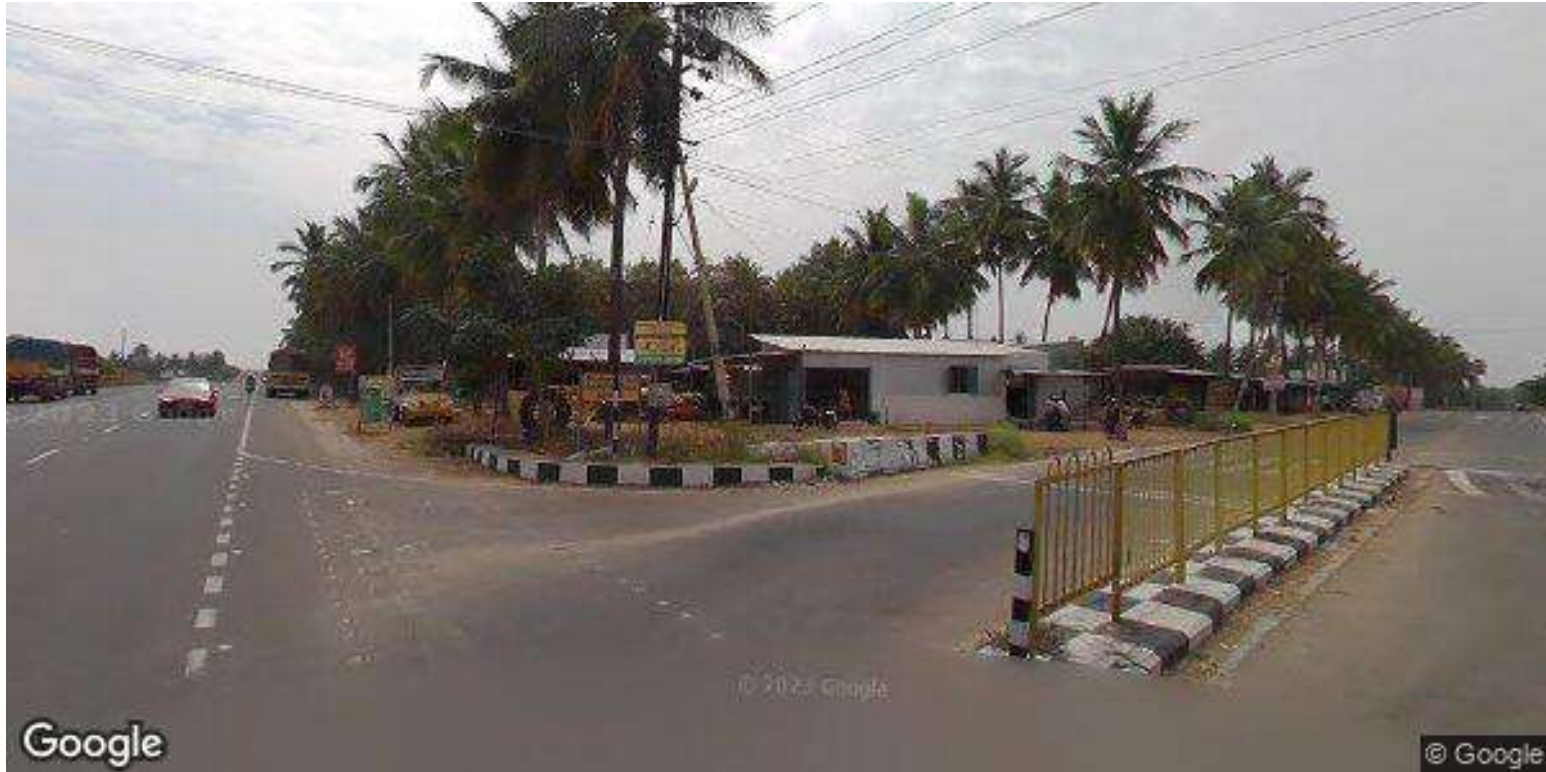
**Coordinates: 11.30859, 77.92918**

**Risk Type: Turn**

**Risk Level: High**

**Speed Limit: 15 KM/Hr**

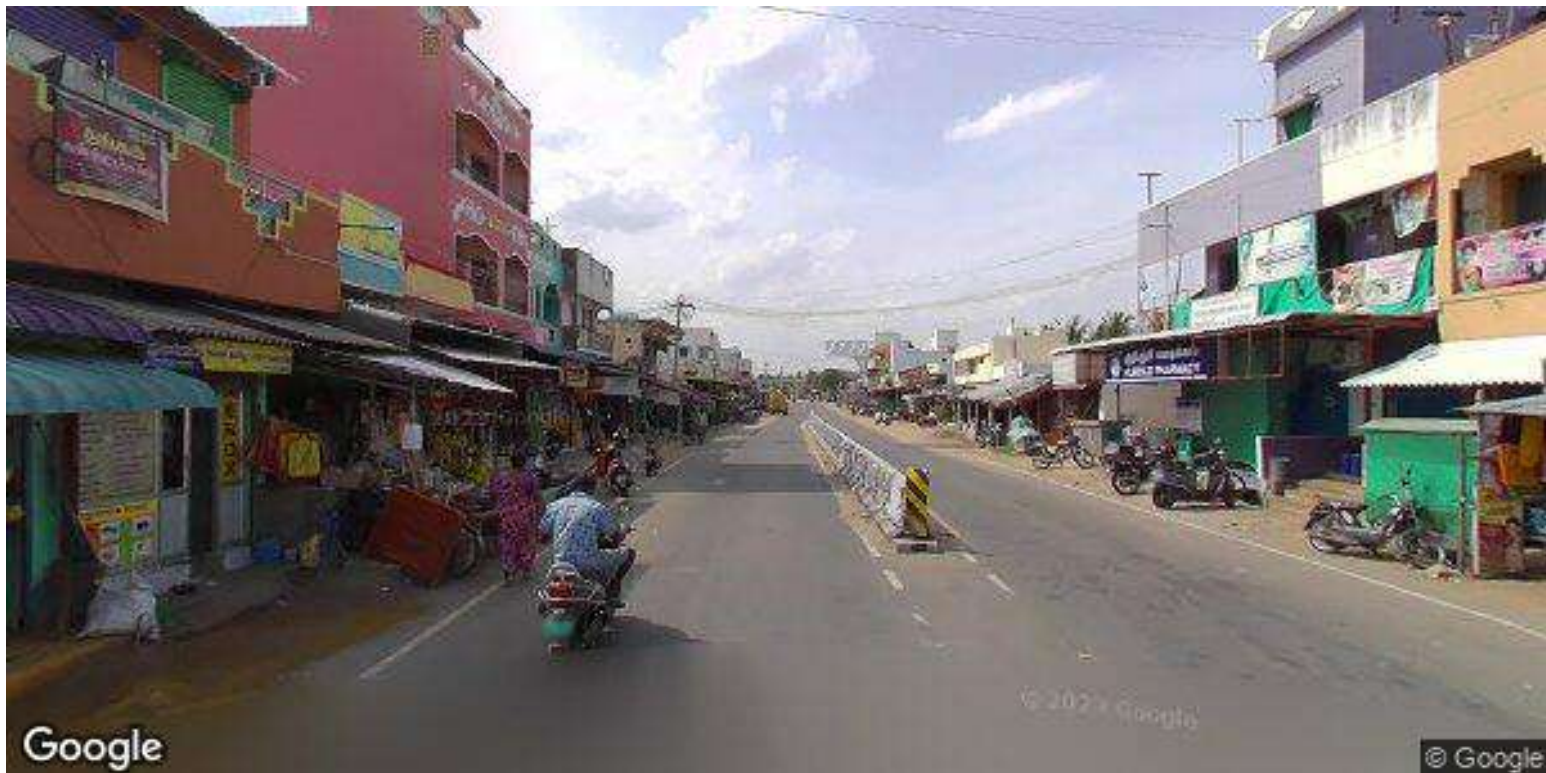
**Coordinates: 11.24000, 77.87363**

**Risk Type: Turn**

**Risk Level: High**

**Speed Limit: 15 KM/Hr**

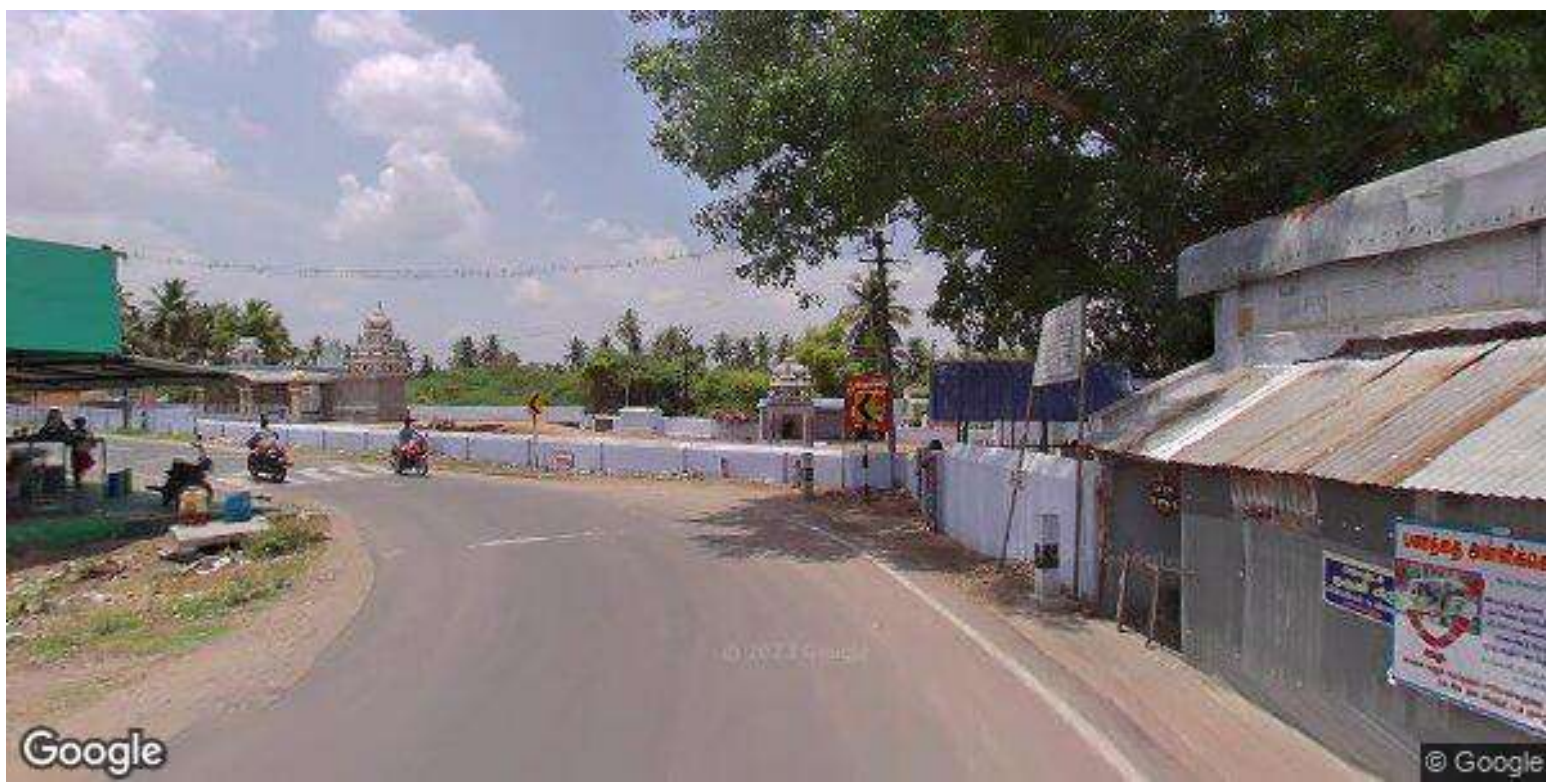
**Coordinates:** 11.24053, 77.86902

**Risk Type:** Turn

**Risk Level:** Medium

**Speed Limit:** 30 KM/Hr

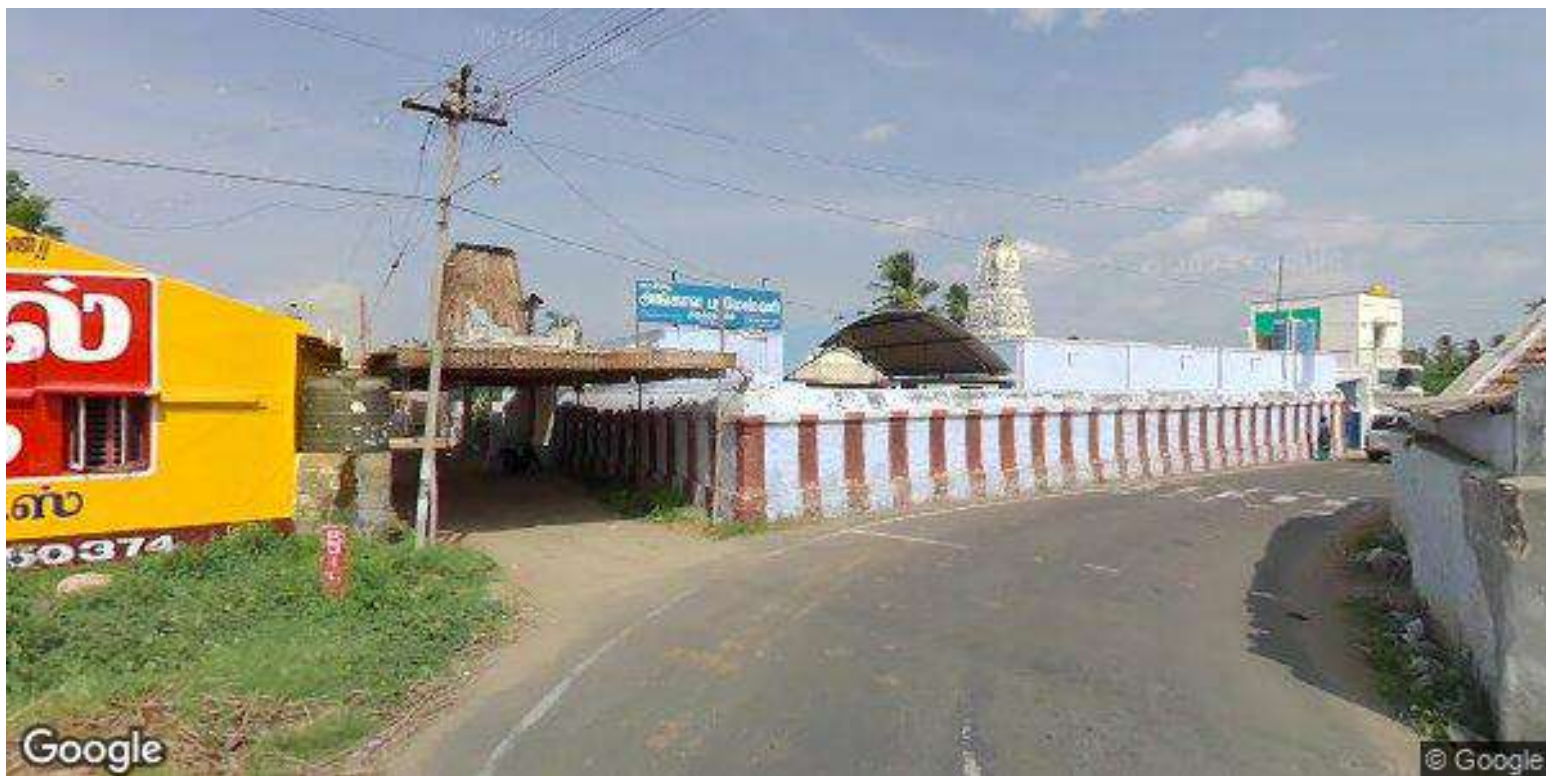
**Coordinates:** 11.24115, 77.86891

**Risk Type:** Turn

**Risk Level:** Medium

**Speed Limit:** 30 KM/Hr

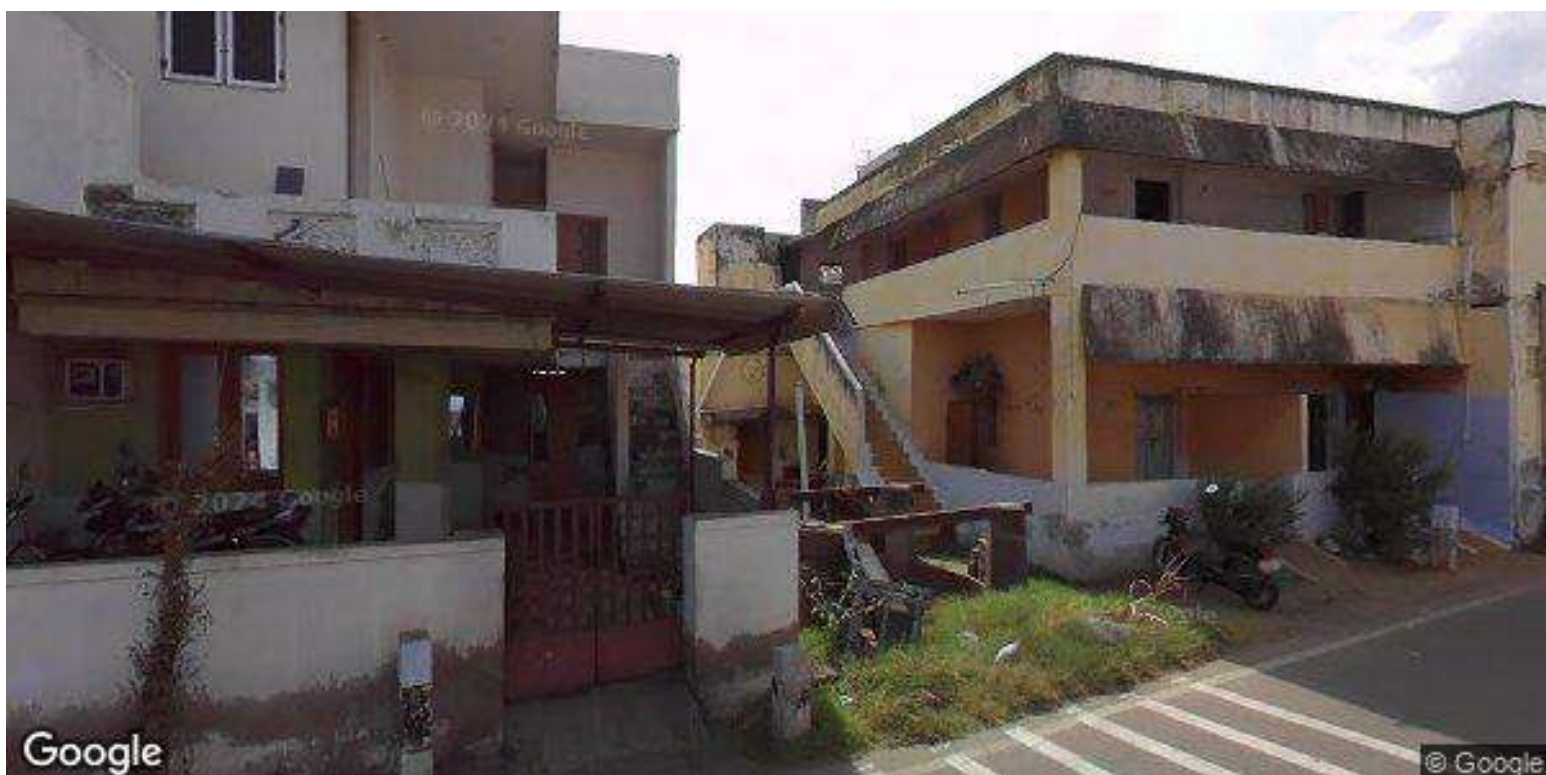
**Coordinates: 11.24122, 77.86883**

**Risk Type: Turn**

**Risk Level: Medium**

**Speed Limit: 30 KM/Hr**

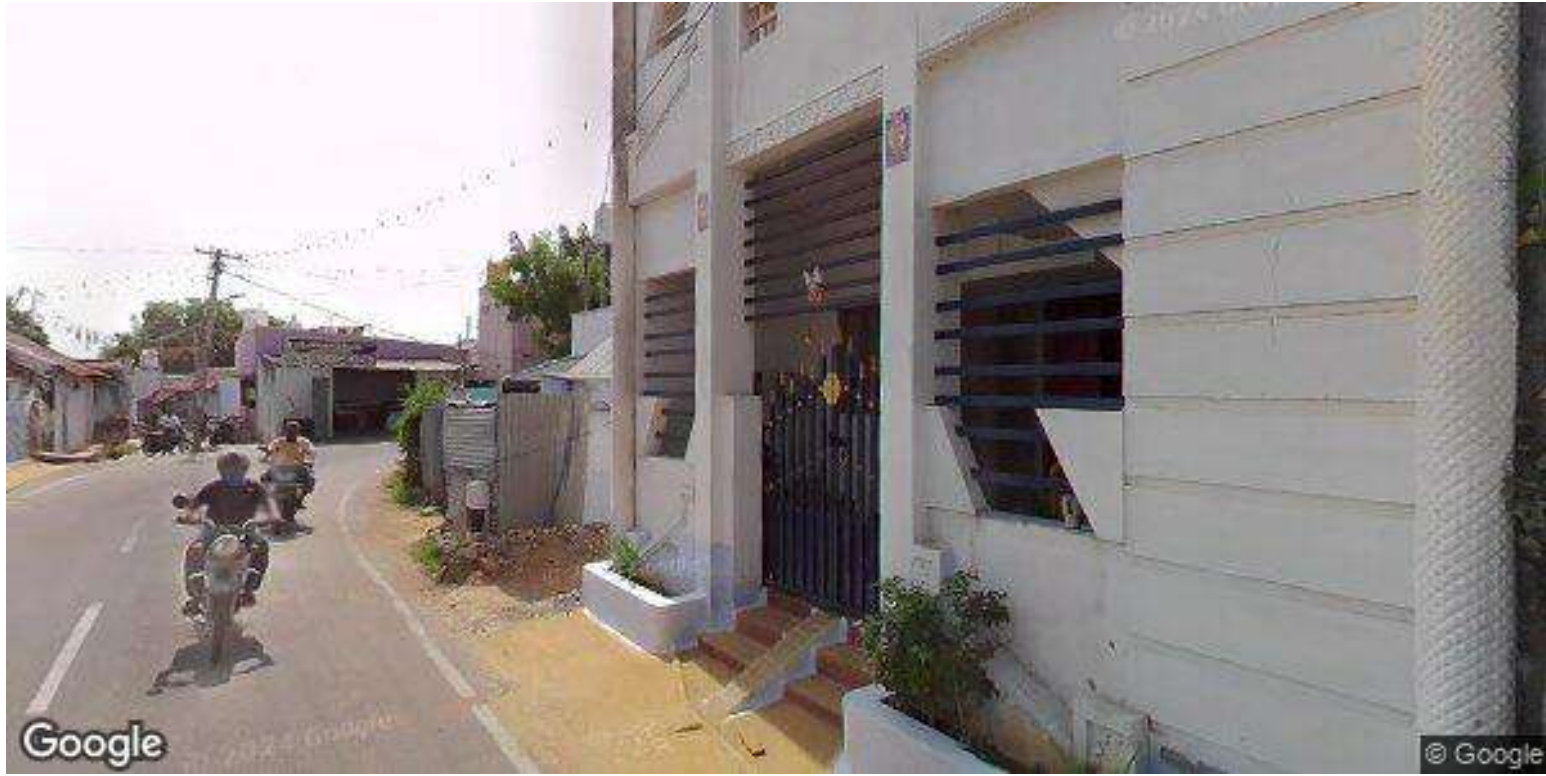
**Coordinates: 11.24159, 77.86874**

**Risk Type: Turn**

**Risk Level: High**

**Speed Limit: 15 KM/Hr**

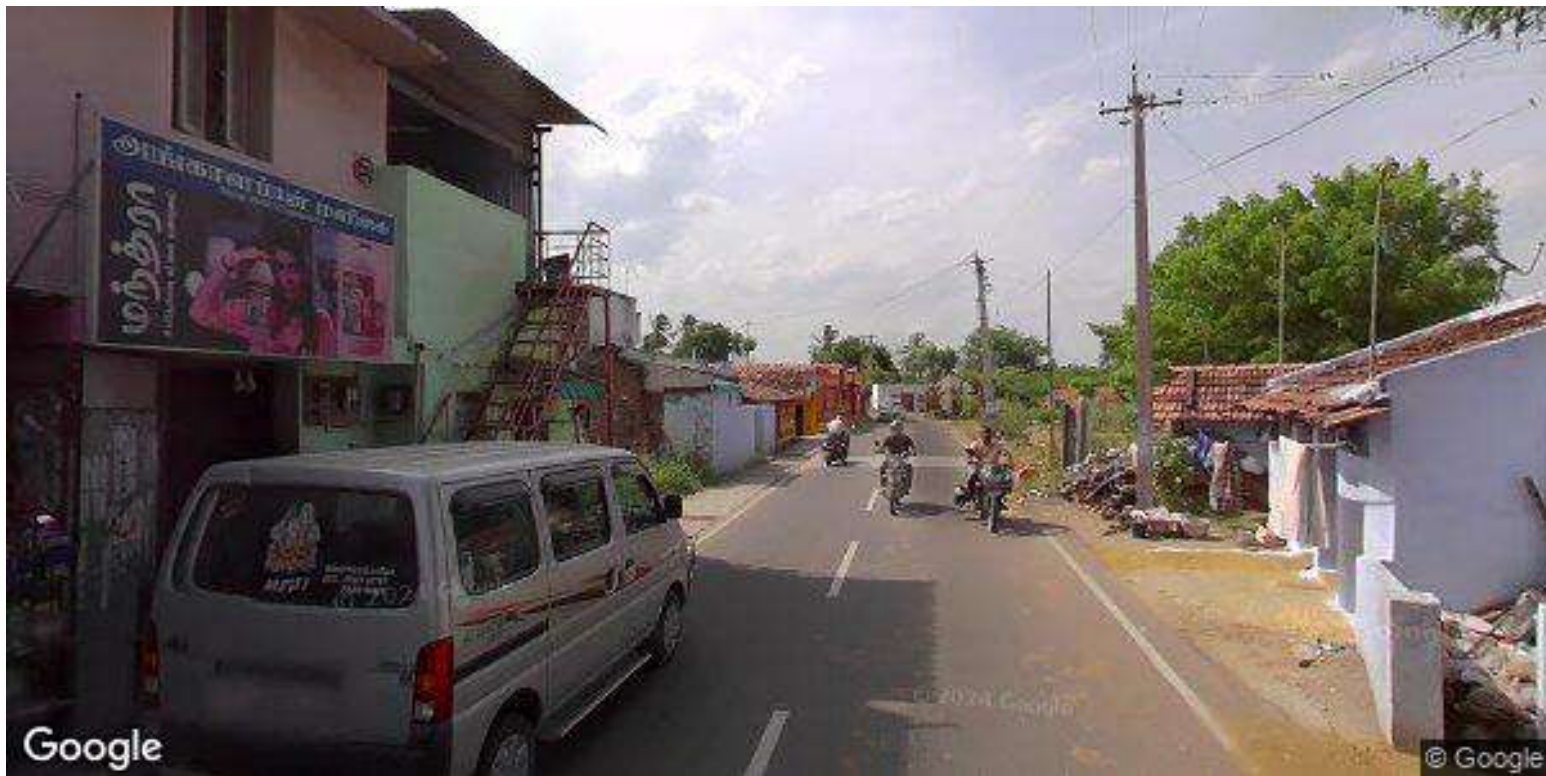
**Coordinates: 11.24170, 77.86842**

**Risk Type: Turn**

**Risk Level: High**

**Speed Limit: 15 KM/Hr**

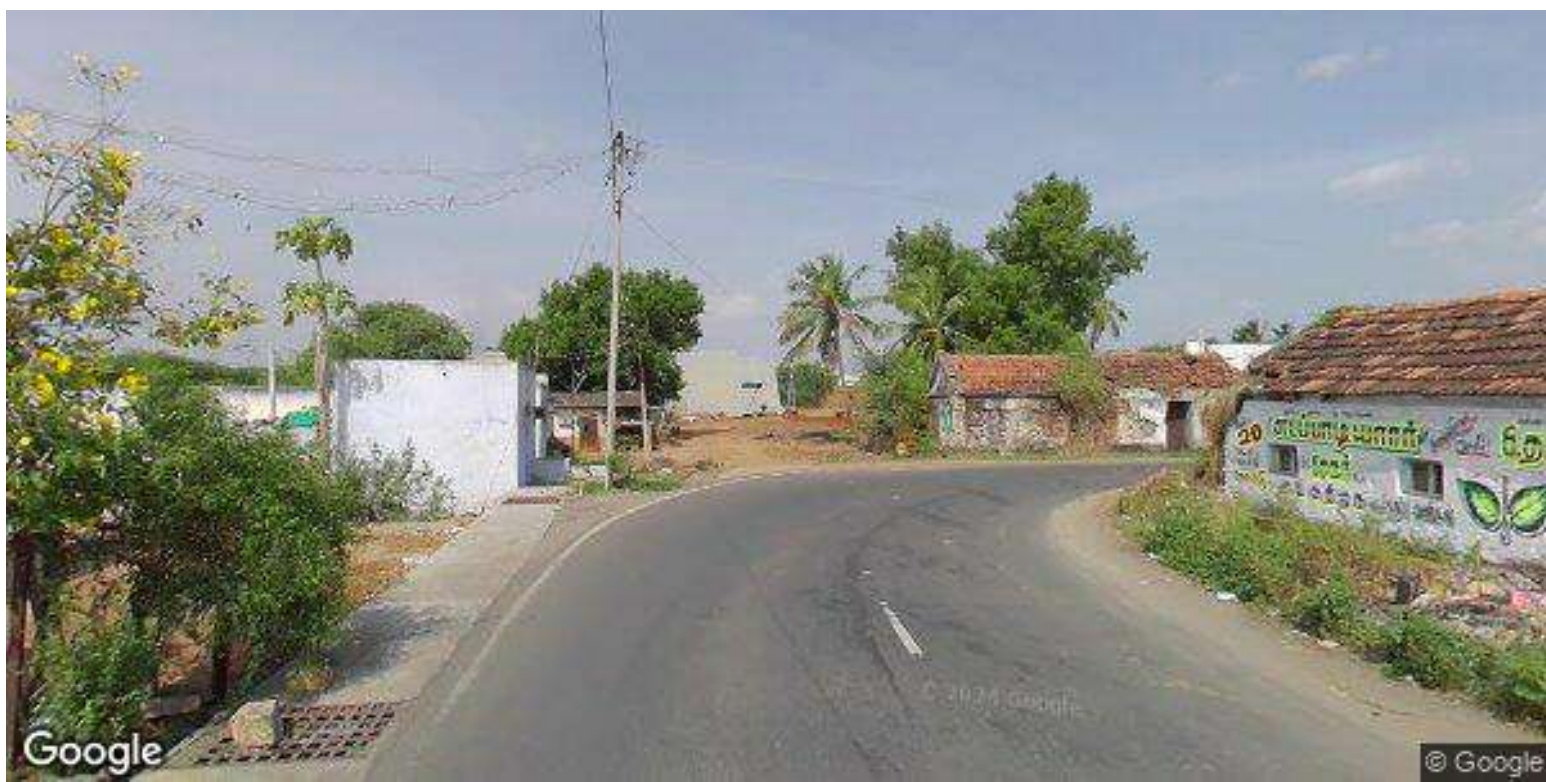
**Coordinates:** 11.24248, 77.86829

**Risk Type:** Turn

**Risk Level:** High

**Speed Limit:** 15 KM/Hr

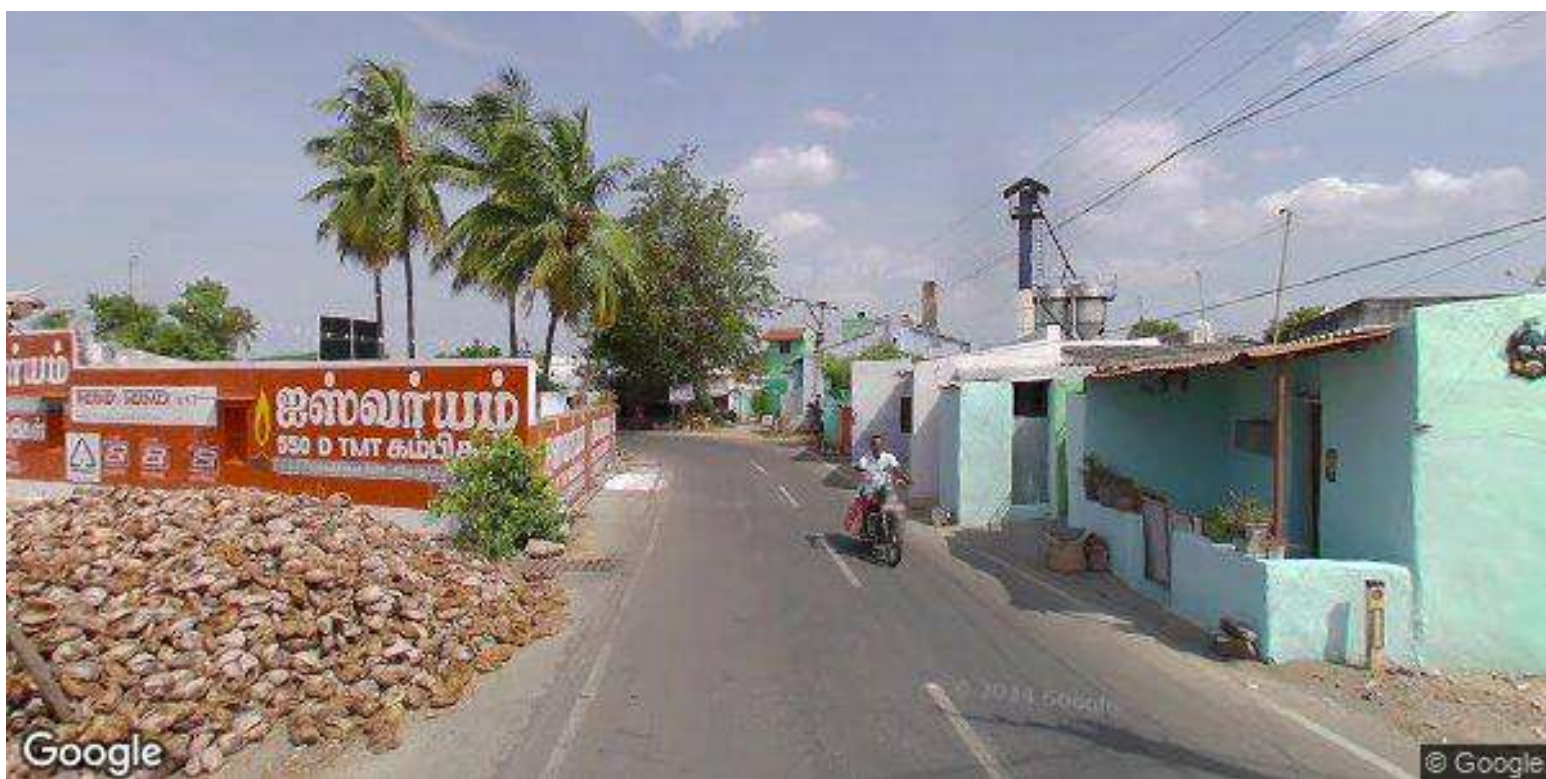
**Coordinates:** 11.24257, 77.86776

**Risk Type:** Turn

**Risk Level:** Medium

**Speed Limit:** 30 KM/Hr

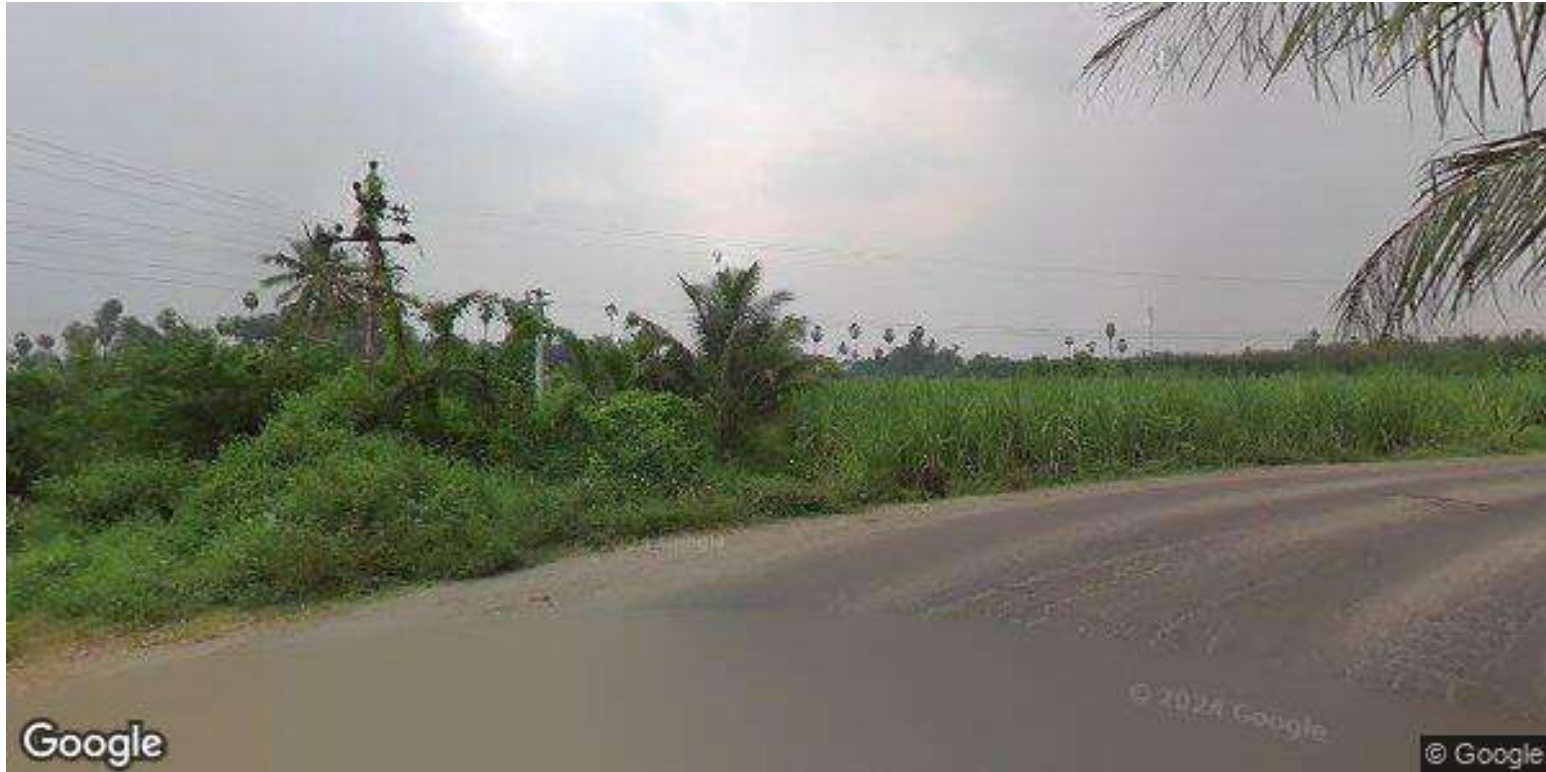
**Risk Type:** Turn  
**Risk Level:** Medium  
**Speed Limit:** 30 KM/Hr  
**Coordinates:** 11.24101, 77.86034

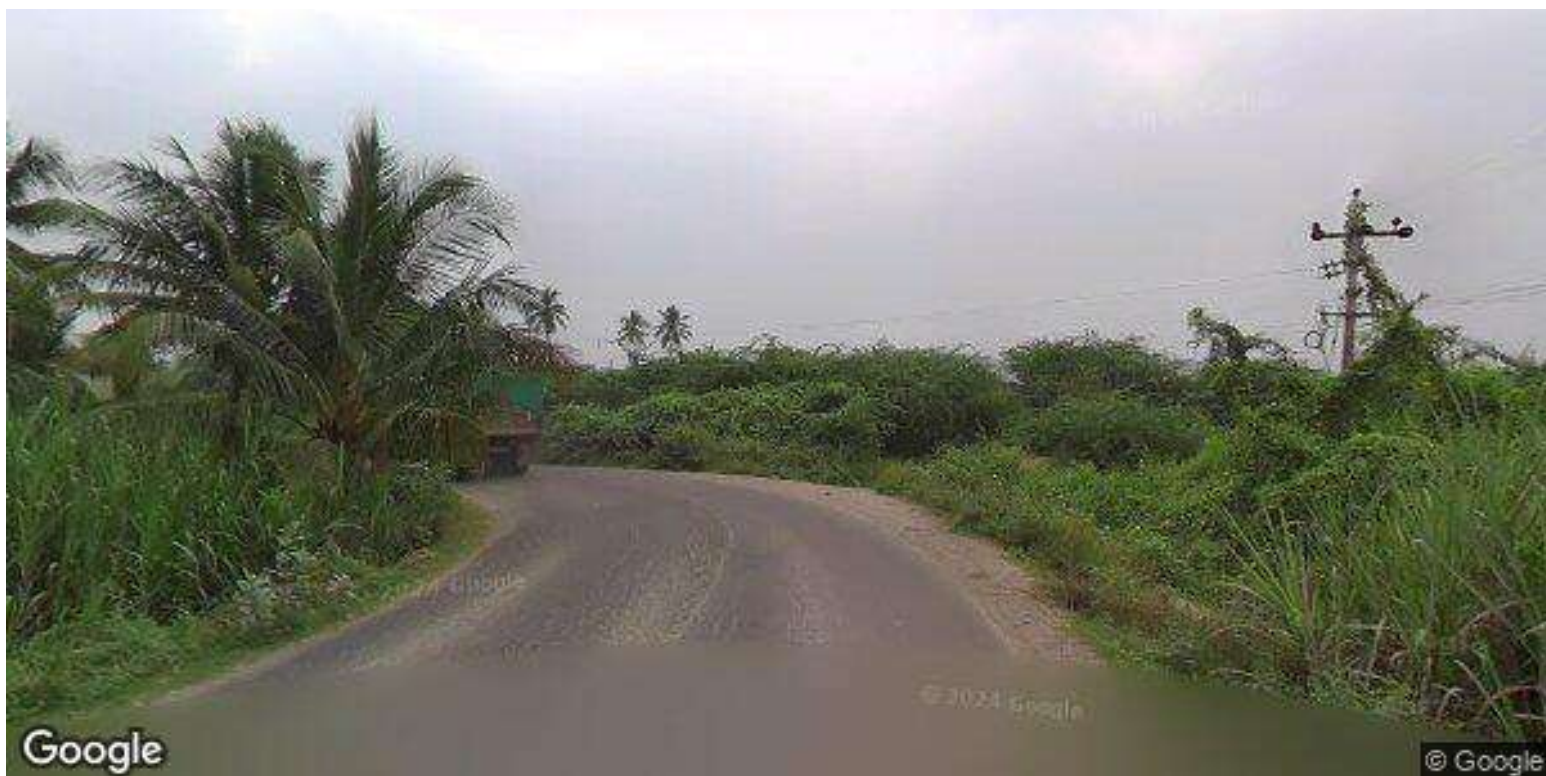
**Risk Type:** Turn  
**Risk Level:** Medium  
**Speed Limit:** 30 KM/Hr  
**Coordinates:** 11.24103, 77.86020

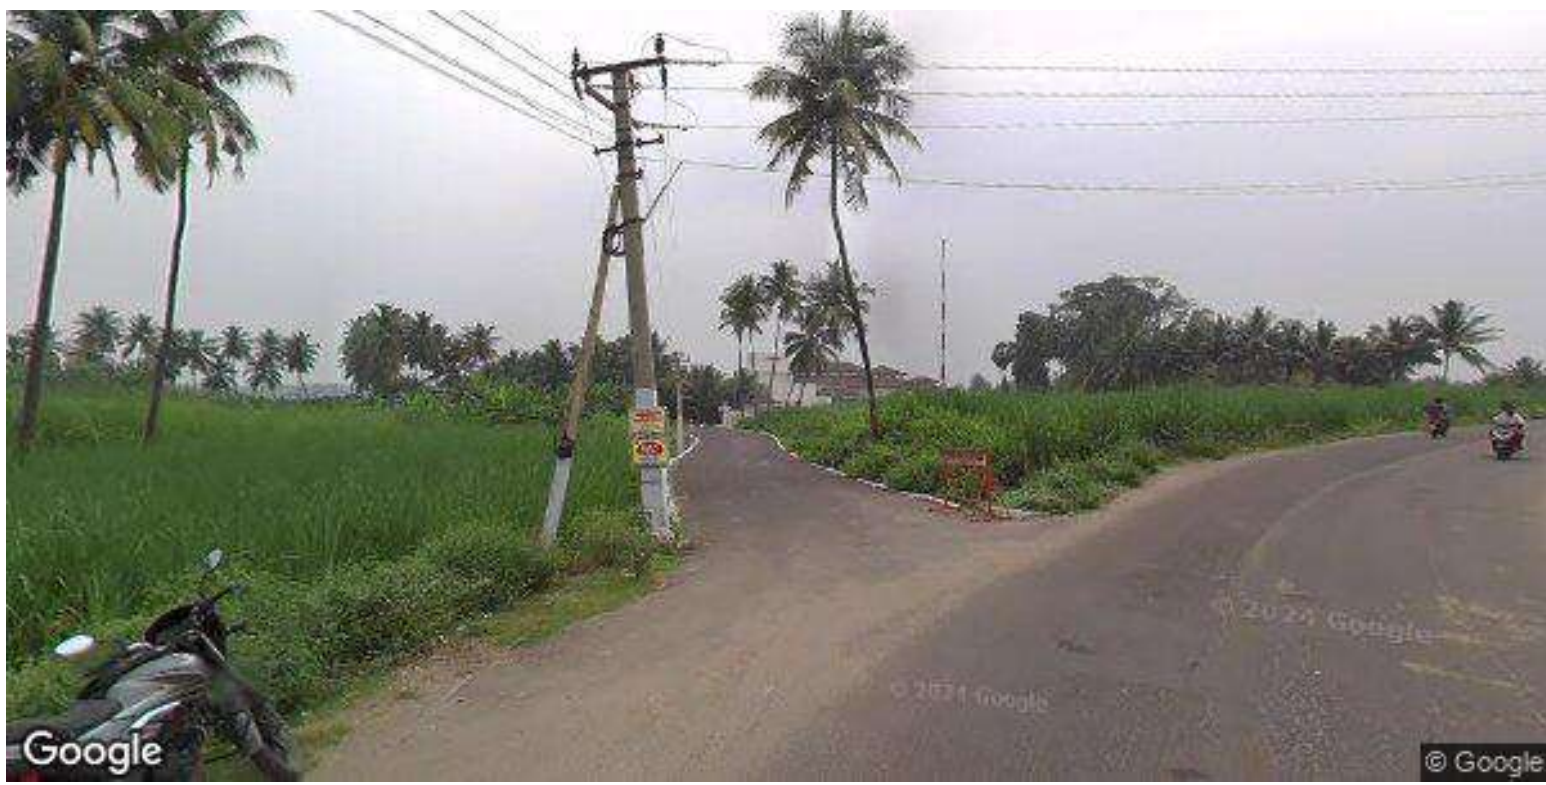
**Coordinates:** 11.24197, 77.85905

**Risk Type:** Turn

**Risk Level:** Medium

**Speed Limit:** 30 KM/Hr

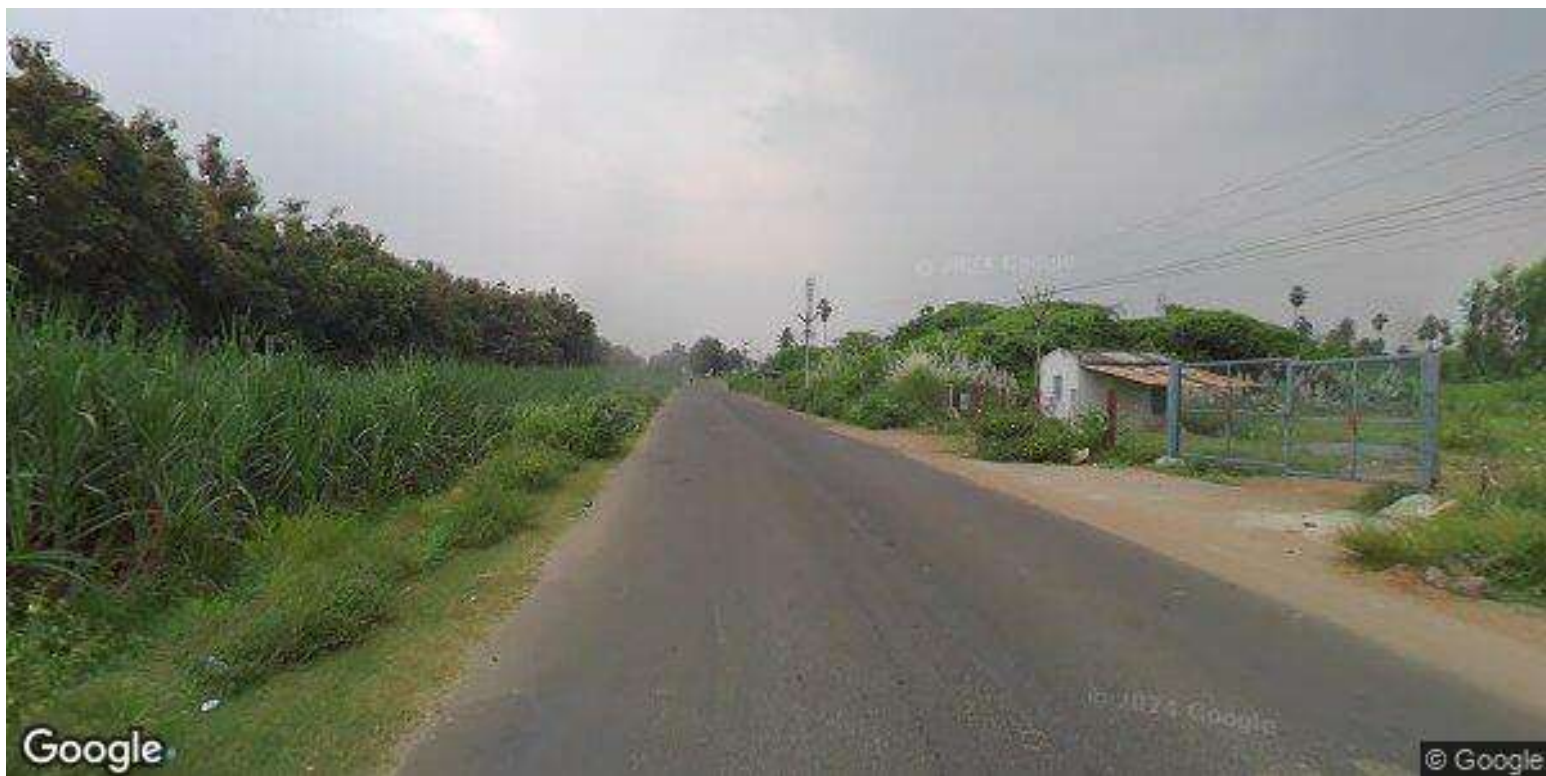
**Coordinates:** 11.24196, 77.85856

**Risk Type:** Turn

**Risk Level:** Medium

**Speed Limit:** 30 KM/Hr

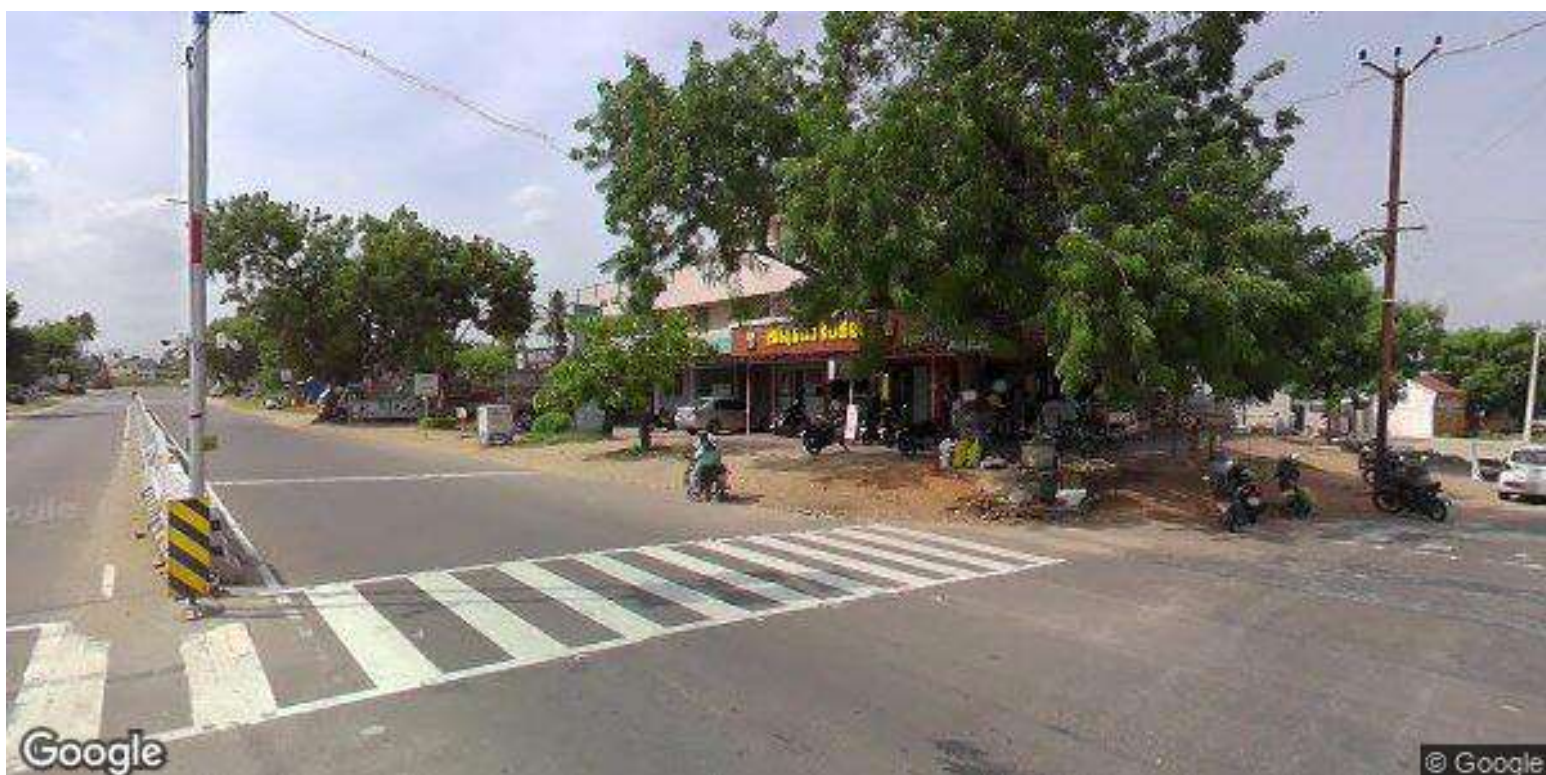
**Coordinates:** 11.22377, 77.83980

**Risk Type:** Turn

**Risk Level:** High

**Speed Limit:** 15 KM/Hr

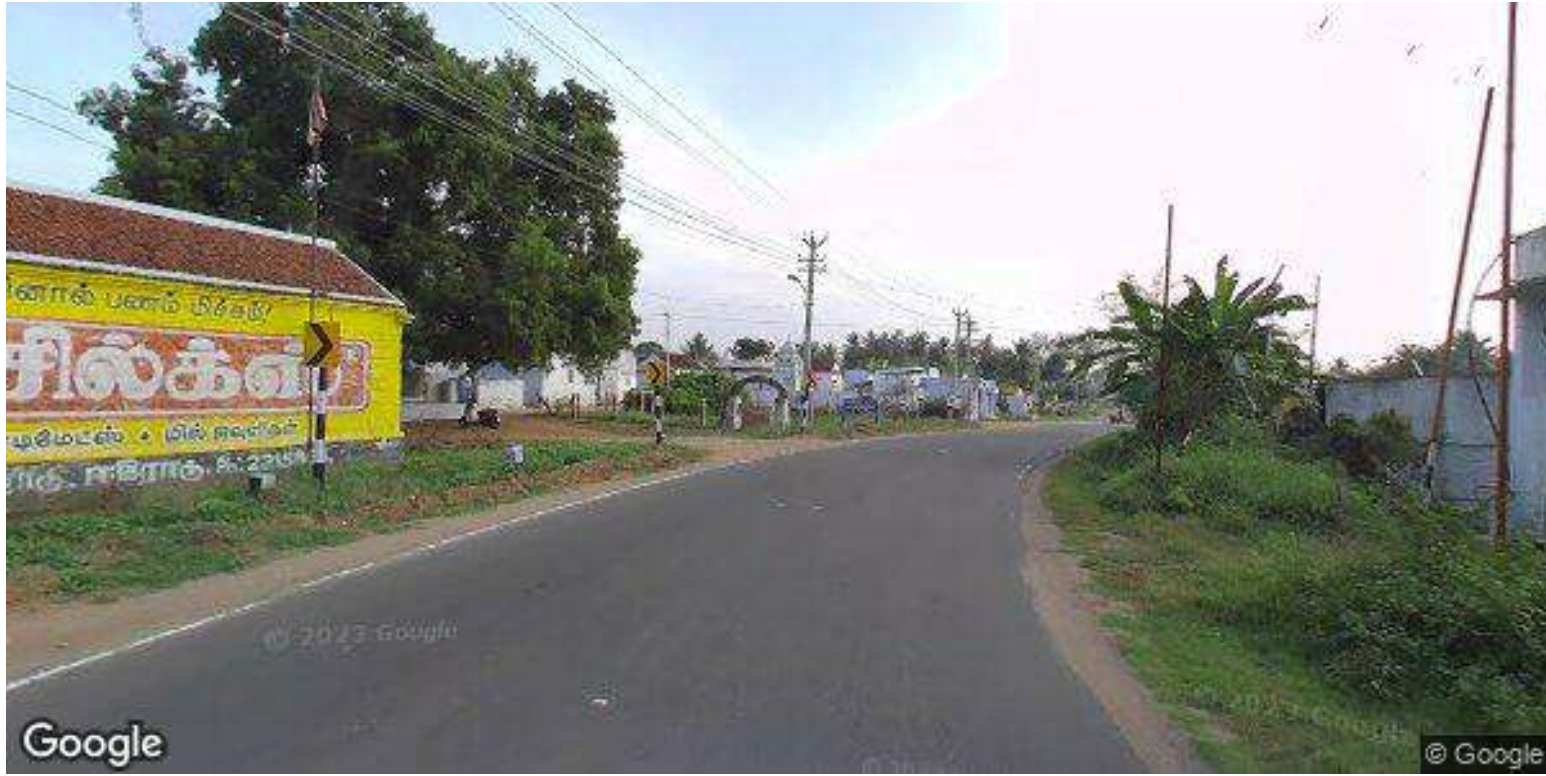
**Coordinates:** 11.14839, 77.84954

**Risk Type:** Turn

**Risk Level:** Medium

**Speed Limit:** 30 KM/Hr
