# IndianOil

## JOURNEY RISK MANAGEMENT (JRM) STUDY

### Salem Terminal TO UMA FUEL AGENCIES

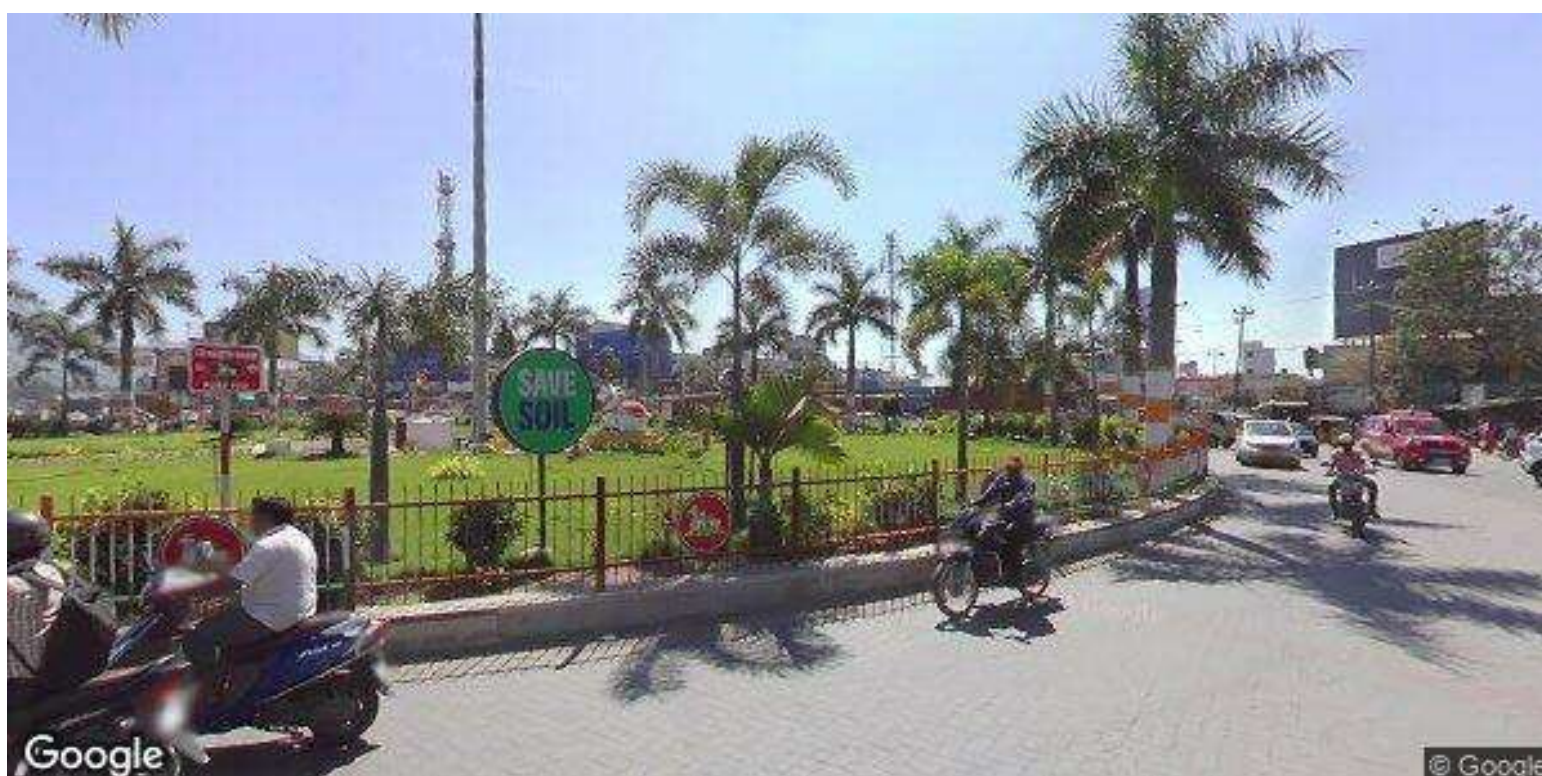
**Coordinates:** 11.63303, 78.12713

**Risk Type:** Roundabout

**Risk Level:** High

**Speed Limit:** 15 KM/Hr

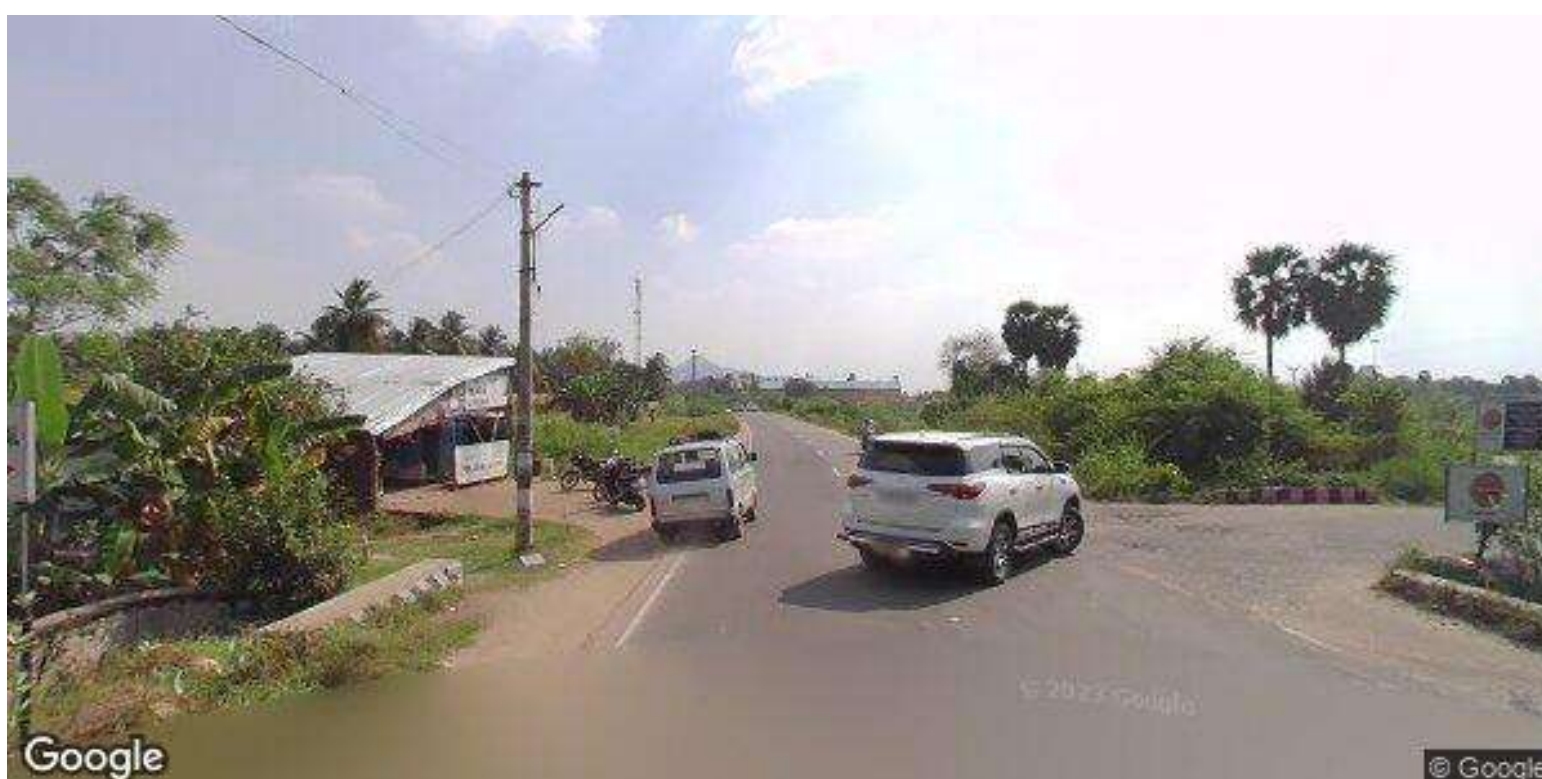
**Coordinates:** 11.44029, 77.87544

**Risk Type:** Turn

**Risk Level:** High

**Speed Limit:** 15 KM/Hr

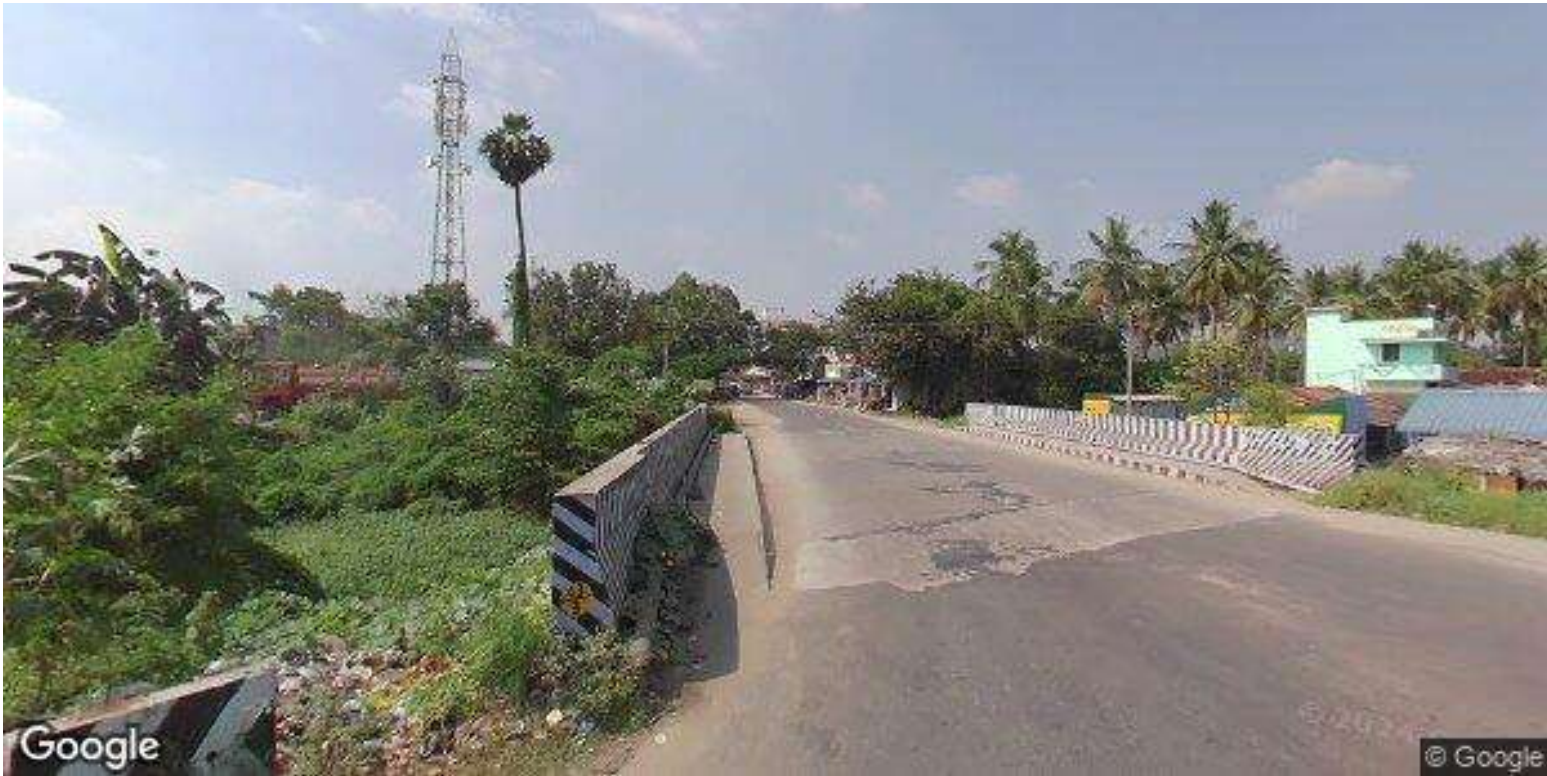
**Risk Type:** Turn  
**Risk Level:** Medium  
**Speed Limit:** 30 KM/Hr  
**Coordinates:** 11.44900, 77.87406

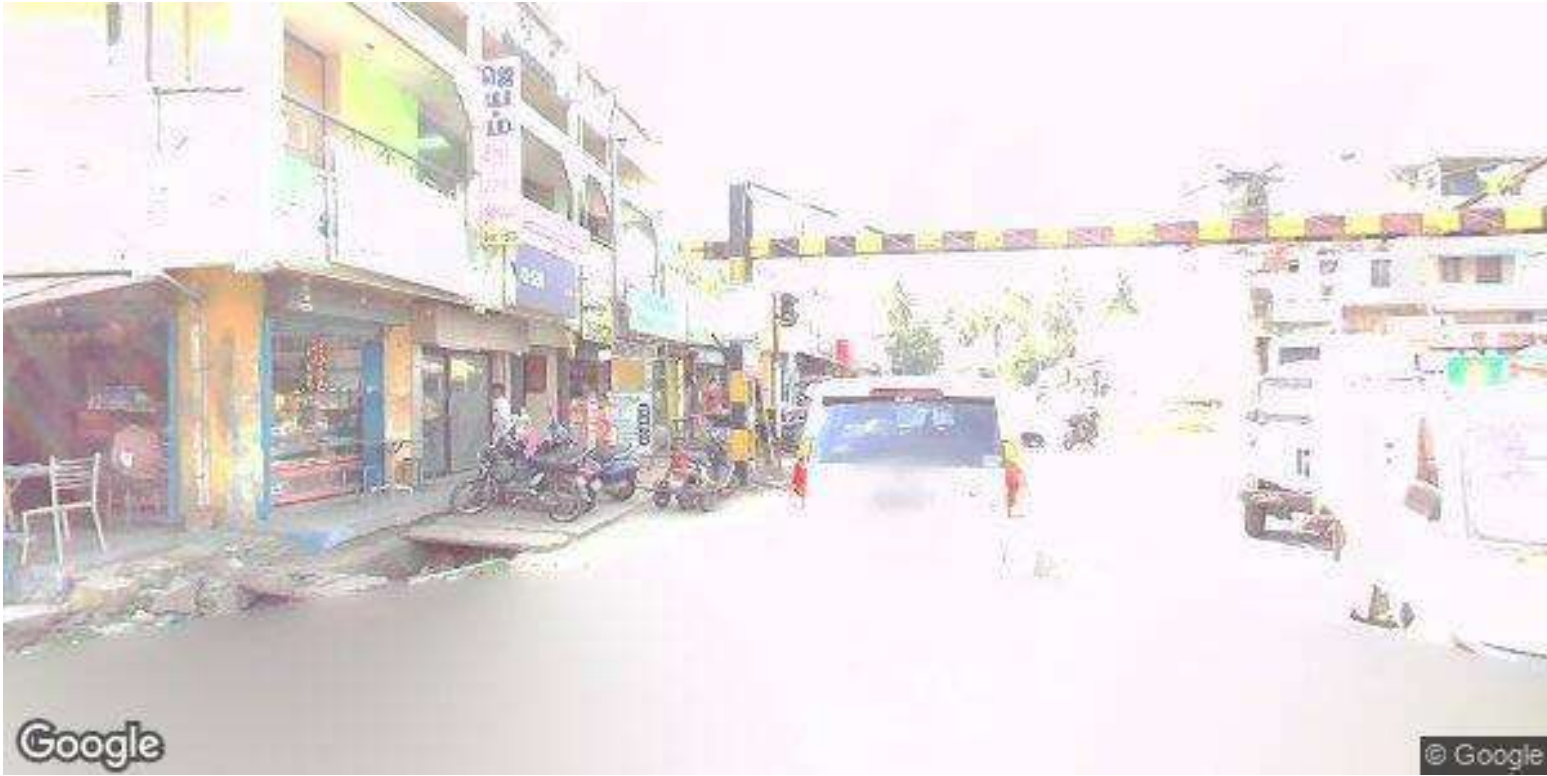
**Risk Type:** Turn  
**Risk Level:** Medium  
**Speed Limit:** 30 KM/Hr  
**Coordinates:** 11.45000, 77.87213

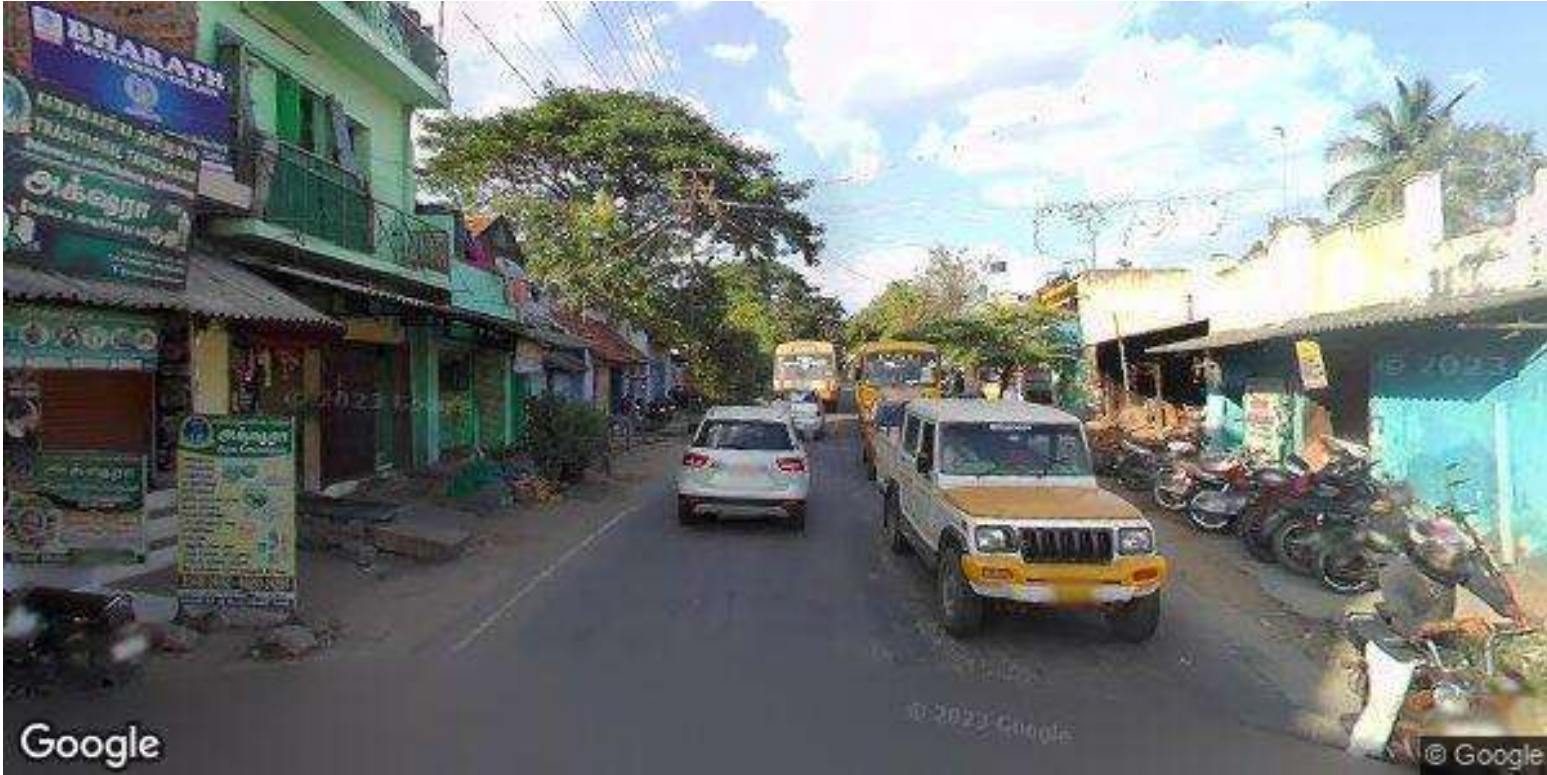
**Risk Type:** Turn  
**Risk Level:** High  
**Speed Limit:** 15 KM/Hr  
**Coordinates:** 11.45028, 77.87202

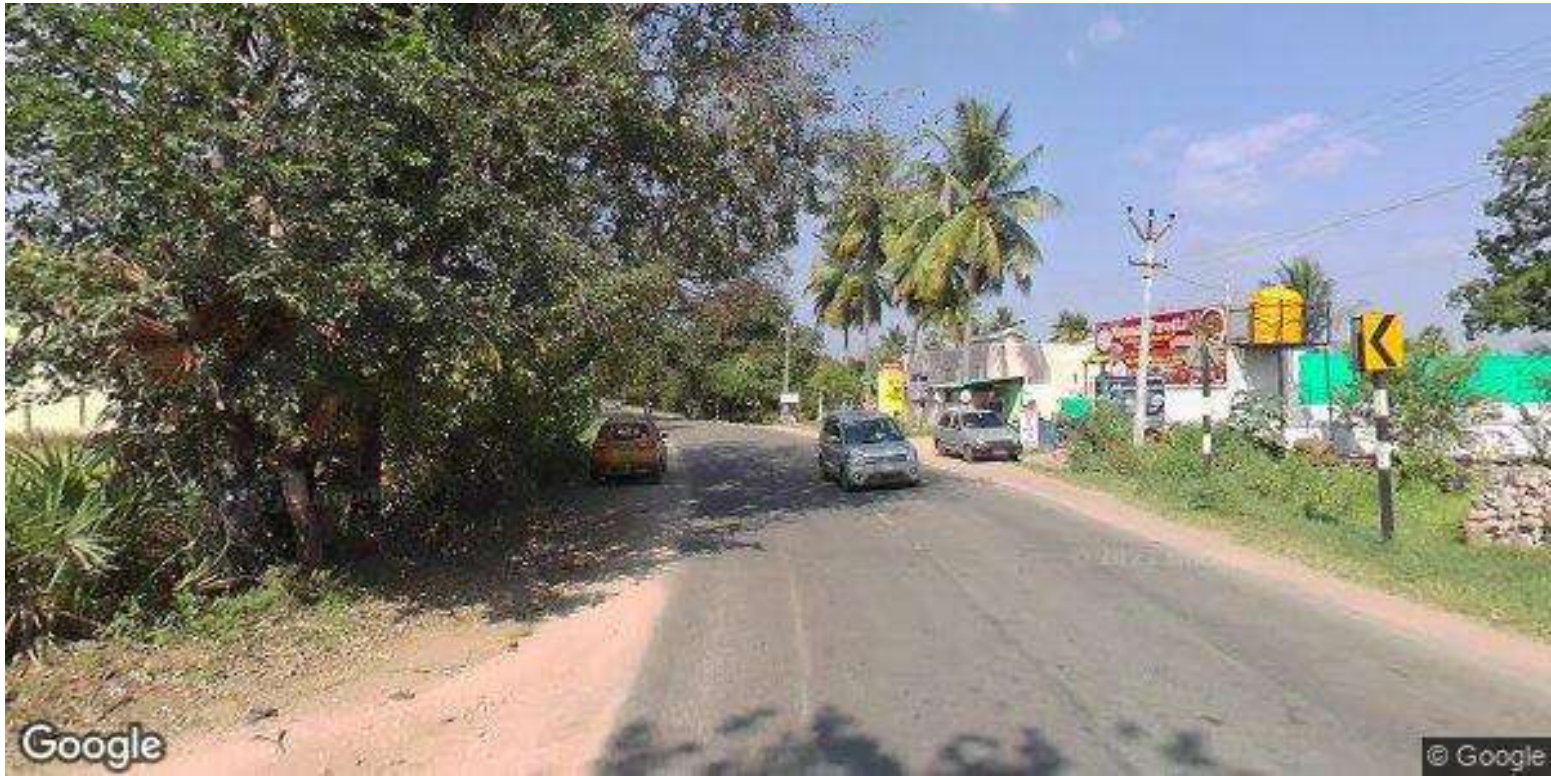
**Risk Type:** Turn  
**Risk Level:** Medium  
**Speed Limit:** 30 KM/Hr  
**Coordinates:** 11.45309, 77.87325

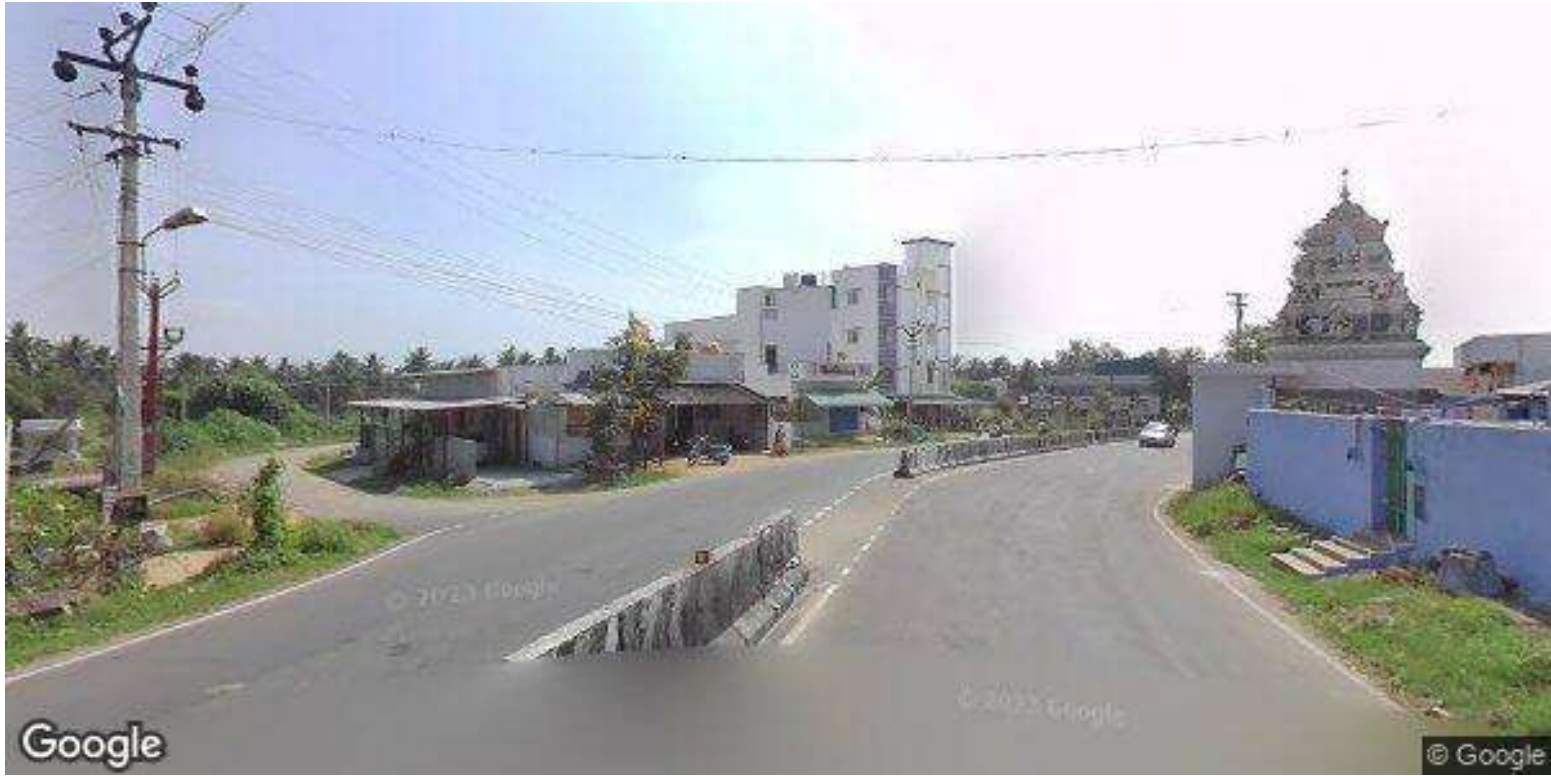
**Risk Type:** Turn  
**Risk Level:** Medium  
**Speed Limit:** 30 KM/Hr  
**Coordinates:** 11.46400, 77.87323

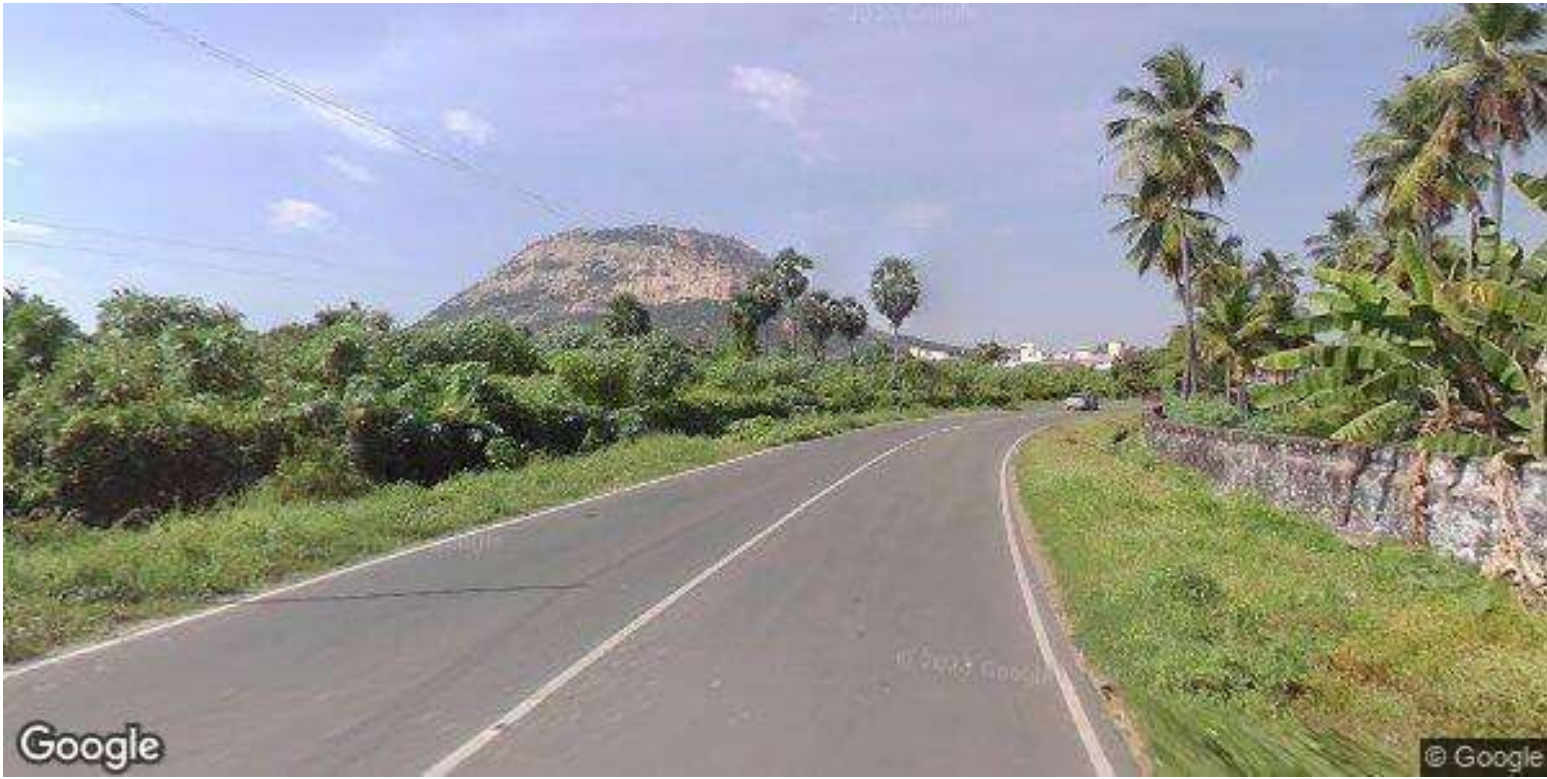
**Risk Type:** Turn  
**Risk Level:** Medium  
**Speed Limit:** 30 KM/Hr  
**Coordinates:** 11.46765, 77.87037

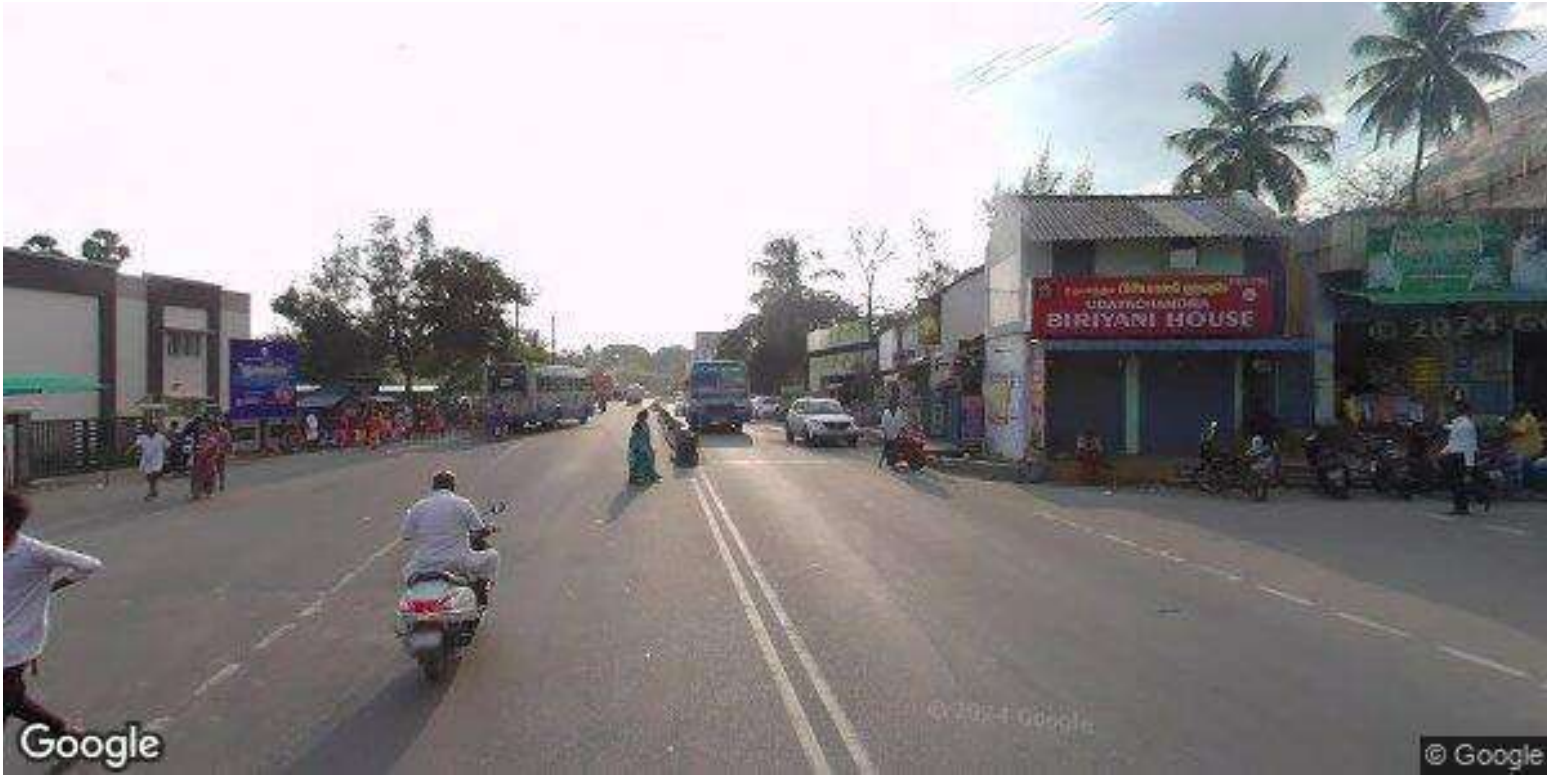
**Risk Type:** Turn  
**Risk Level:** High  
**Speed Limit:** 15 KM/Hr  
**Coordinates:** 11.47403, 77.86841

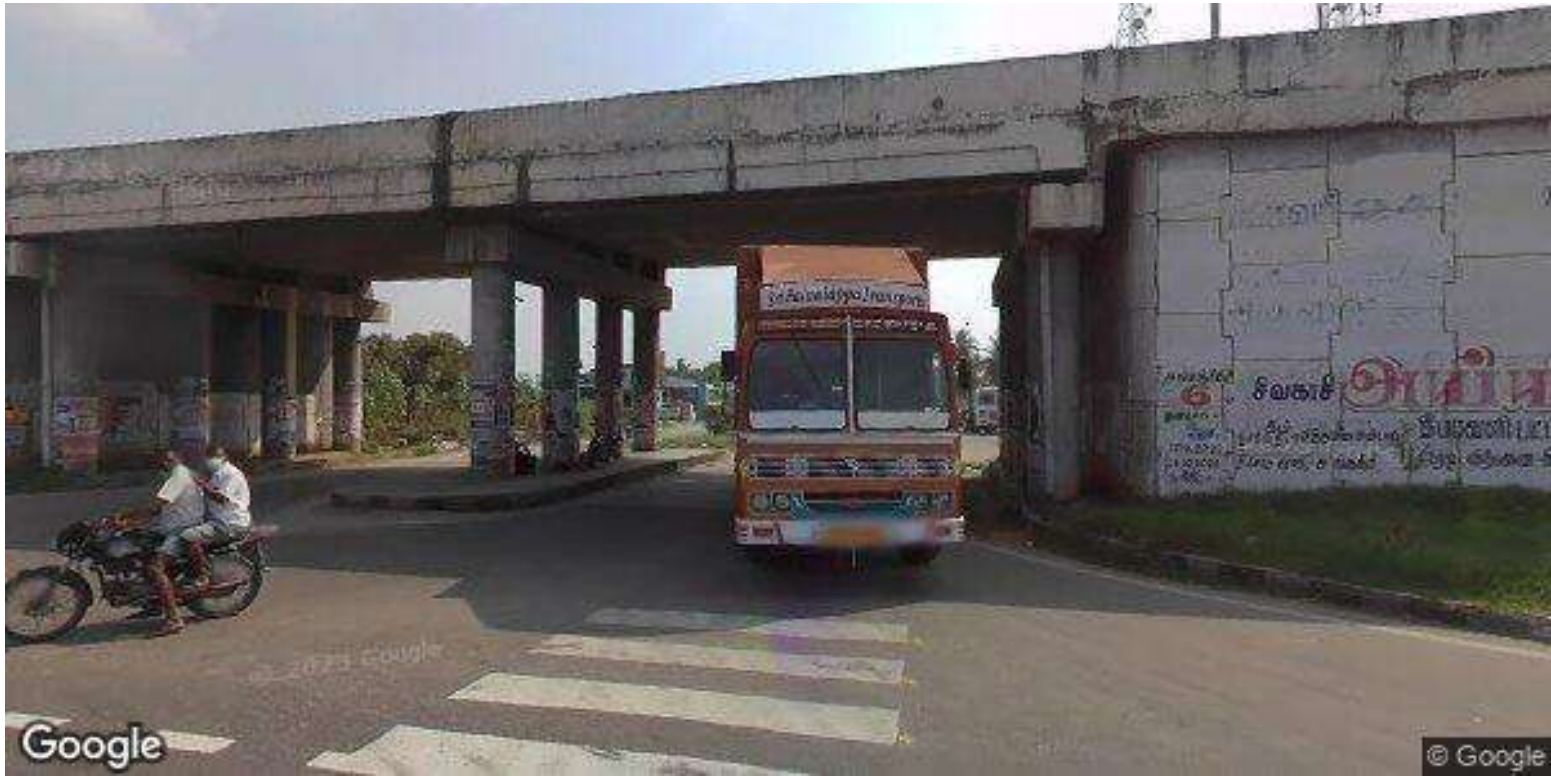
**Risk Type:** Turn  
**Risk Level:** High  
**Speed Limit:** 15 KM/Hr  
**Coordinates:** 11.49224, 77.89601

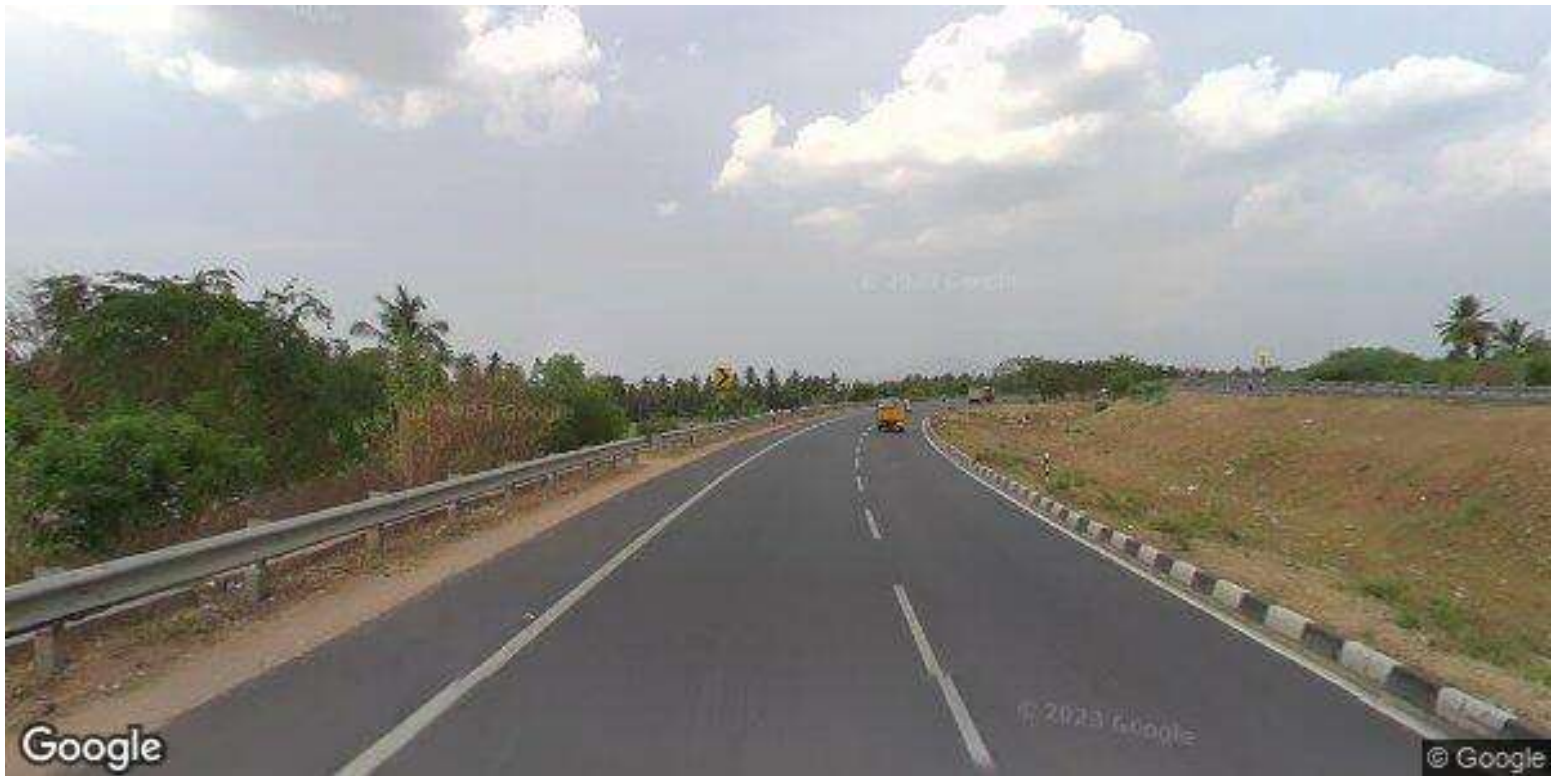
**Risk Type:** Turn  
**Risk Level:** Medium  
**Speed Limit:** 30 KM/Hr  
**Coordinates:** 11.53501, 77.95707

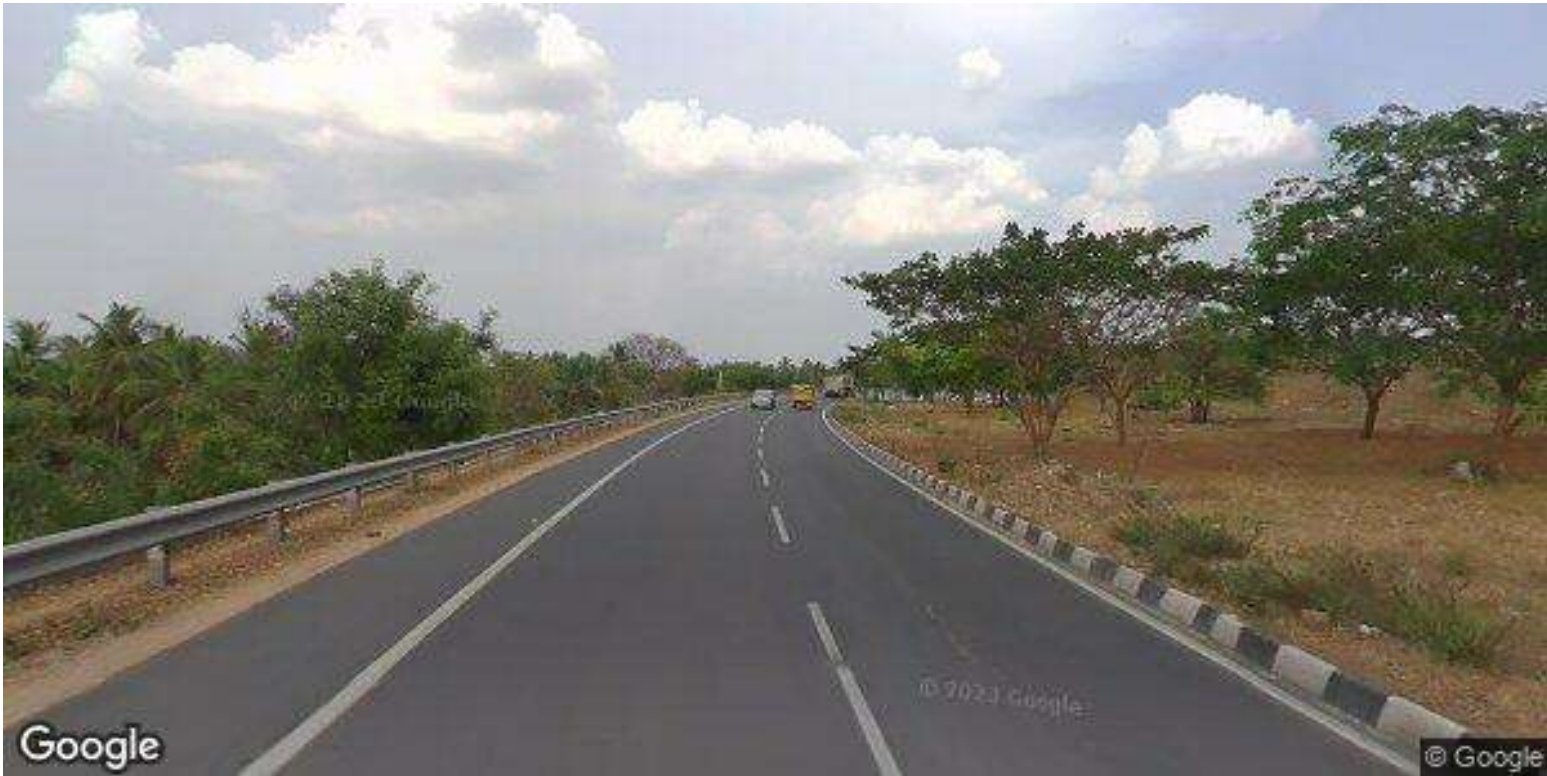
**Risk Type:** Turn  
**Risk Level:** Medium  
**Speed Limit:** 30 KM/Hr  
**Coordinates:** 11.53601, 77.95856

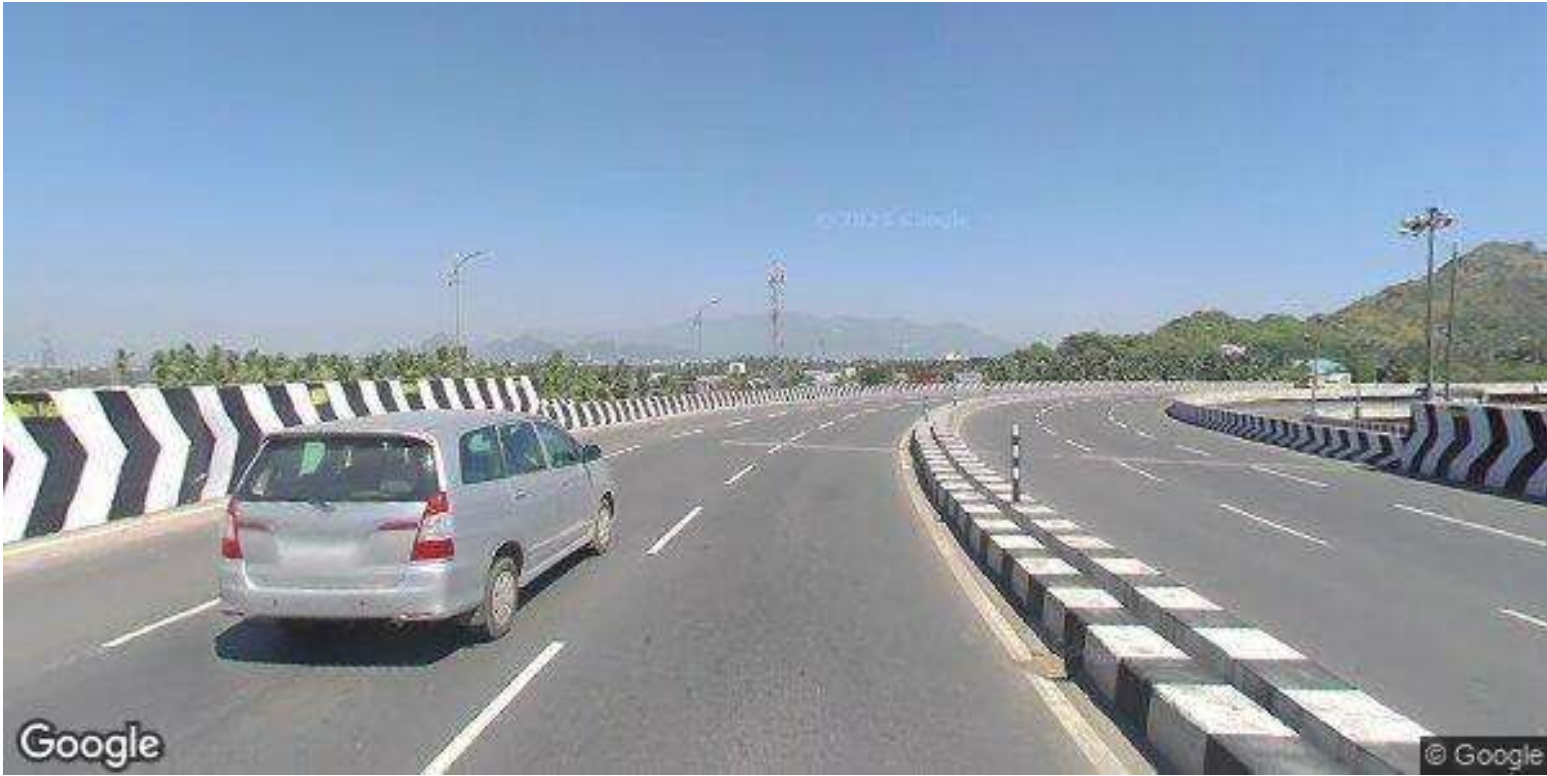
**Risk Type:** Turn  
**Risk Level:** High  
**Speed Limit:** 15 KM/Hr  
**Coordinates:** 11.64172, 78.11817

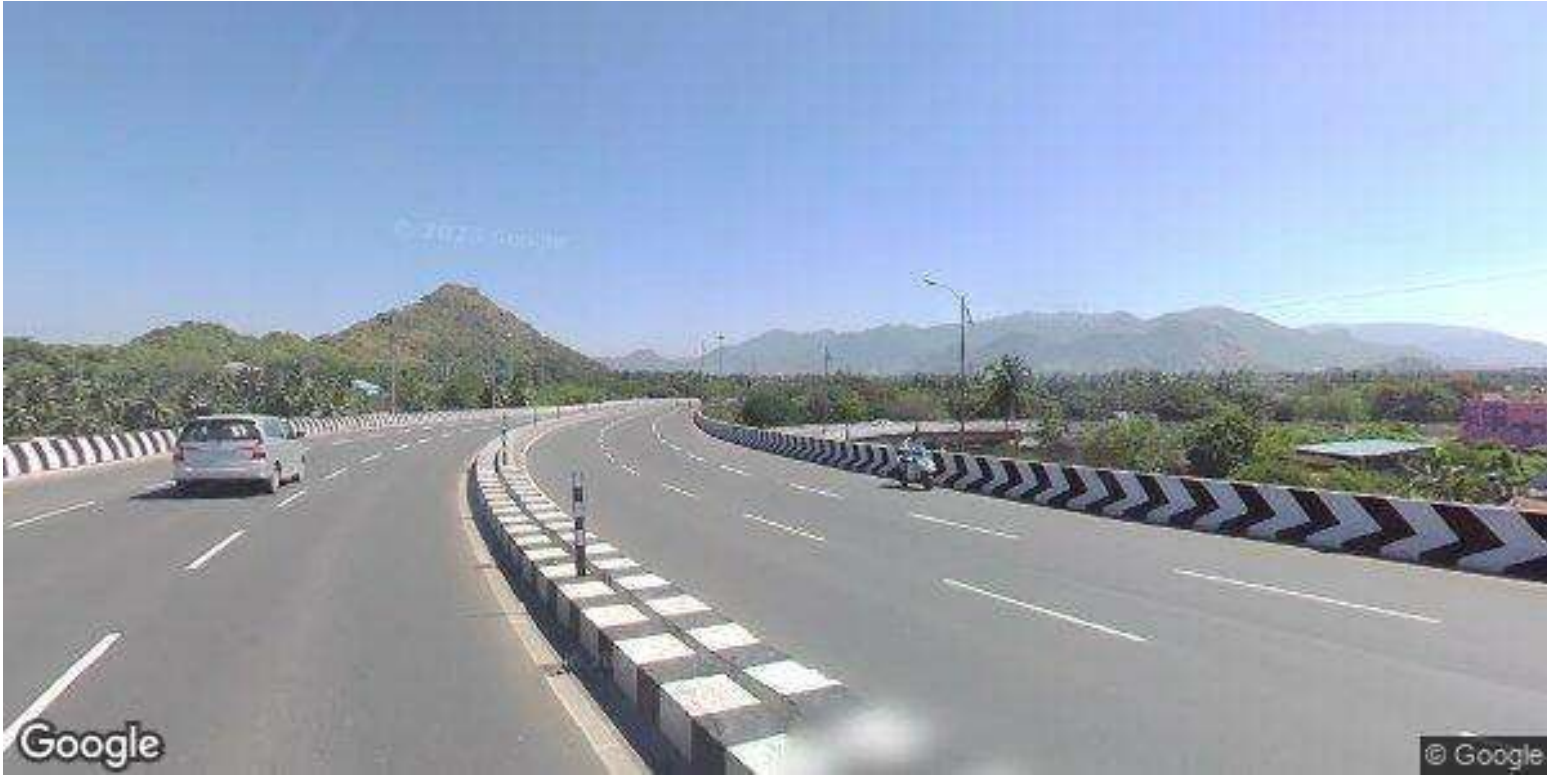
**Coordinates: 11.64216, 78.11875**

**Risk Type: Turn**

**Risk Level: Medium**

**Speed Limit: 30 KM/Hr**

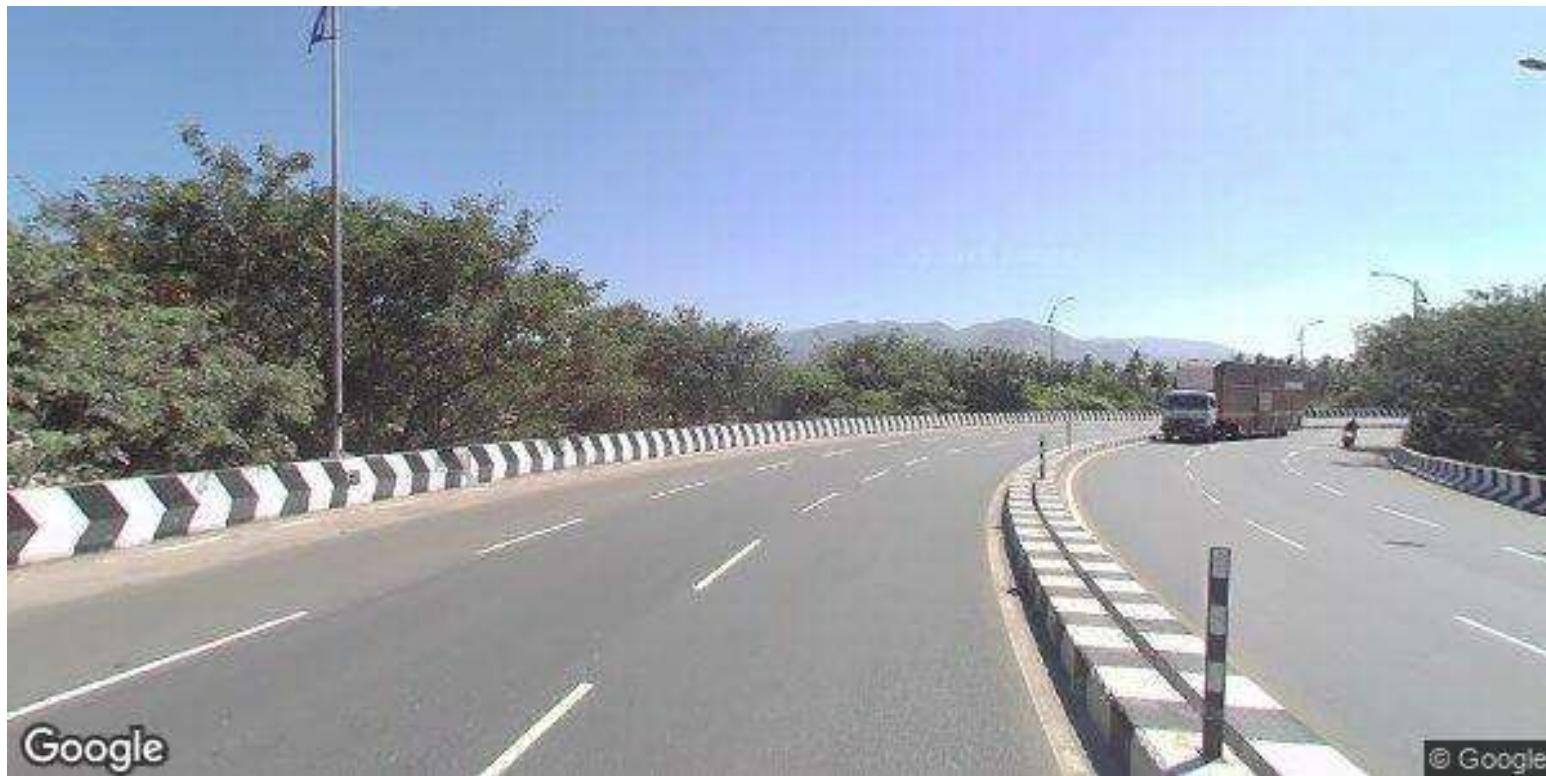
**Coordinates: 11.64195, 78.12129**

**Risk Type: Turn**

**Risk Level: High**

**Speed Limit: 15 KM/Hr**

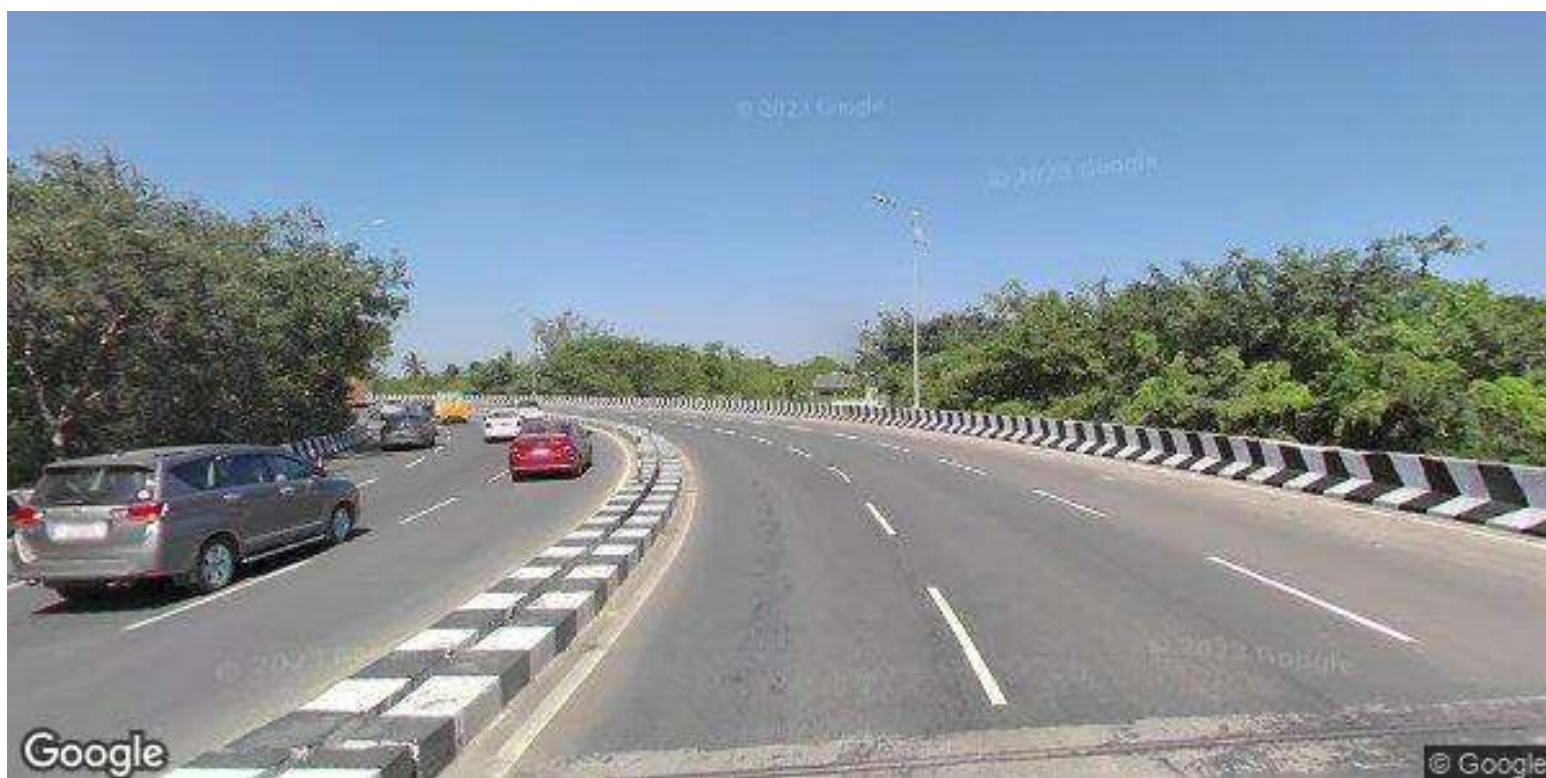
**Coordinates: 11.64120, 78.12168**

**Risk Type: Turn**

**Risk Level: High**

**Speed Limit: 15 KM/Hr**

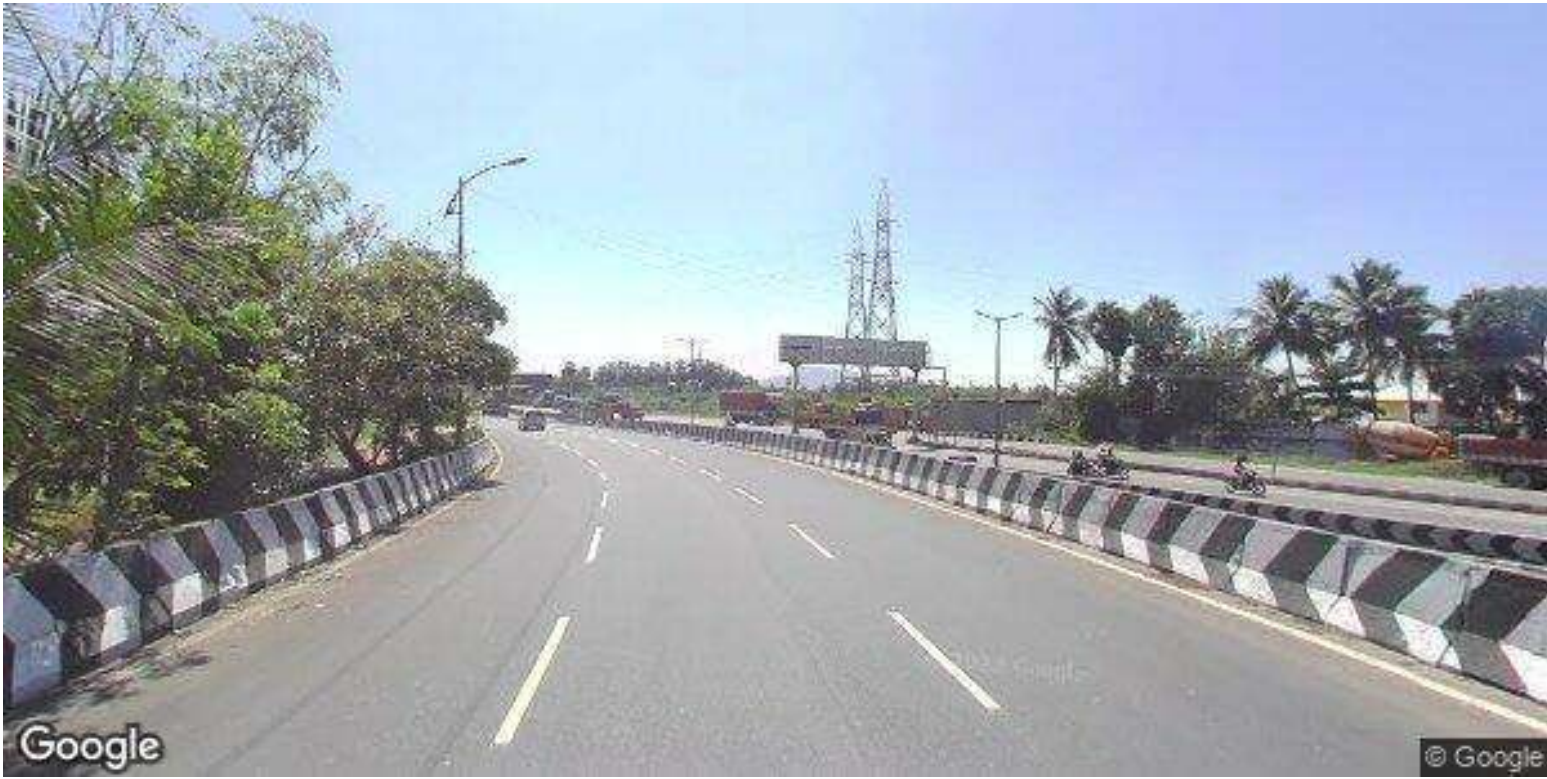
**Risk Type:** Turn  
**Risk Level:** Medium  
**Speed Limit:** 30 KM/Hr  
**Coordinates:** 11.63948, 78.12081

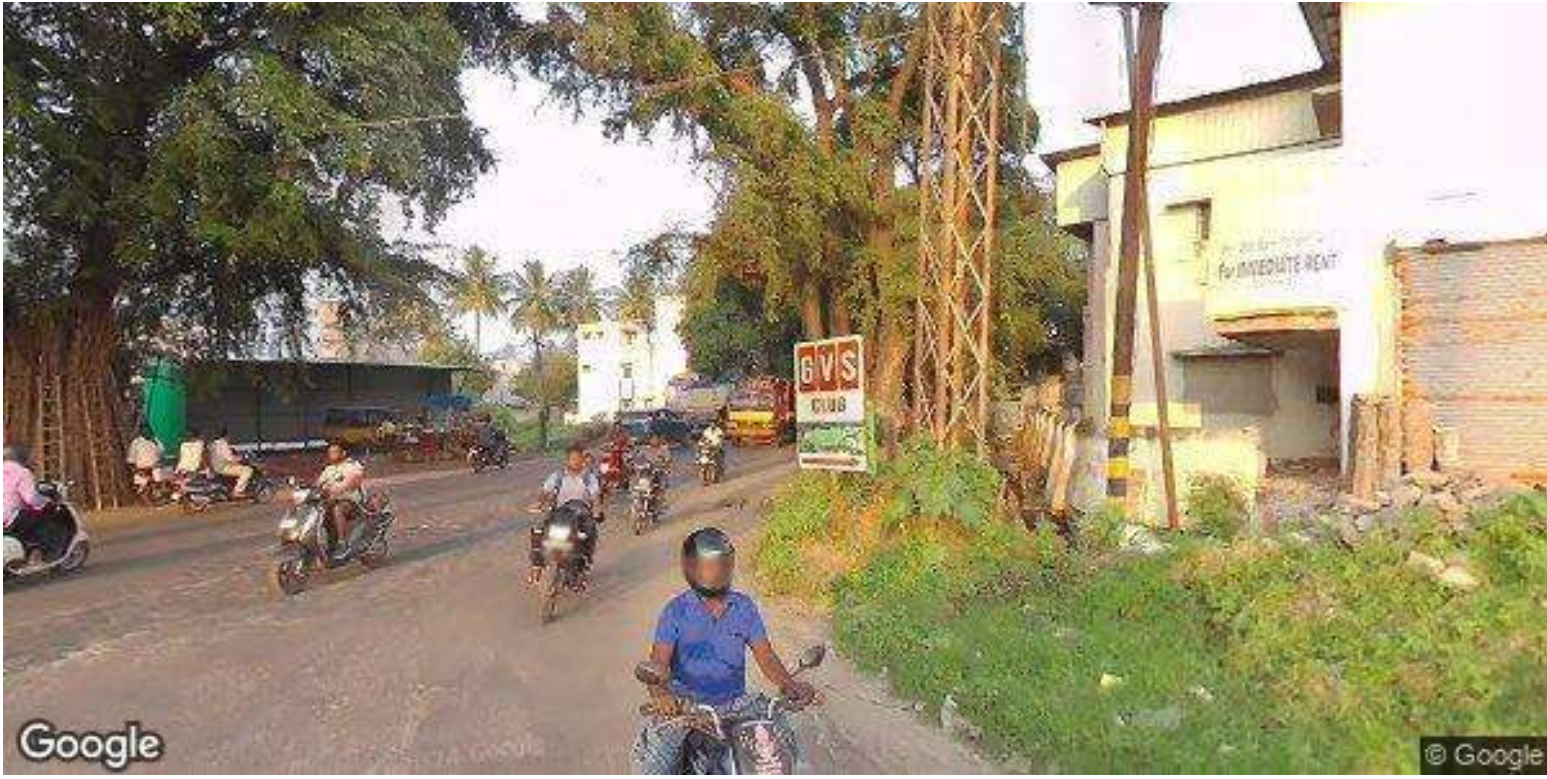
**Risk Type:** Turn  
**Risk Level:** Medium  
**Speed Limit:** 30 KM/Hr  
**Coordinates:** 11.66366, 78.20649
