# IndianOil

## JOURNEY RISK MANAGEMENT (JRM) STUDY

### Salem Terminal TO UMA FUEL AGENCIES

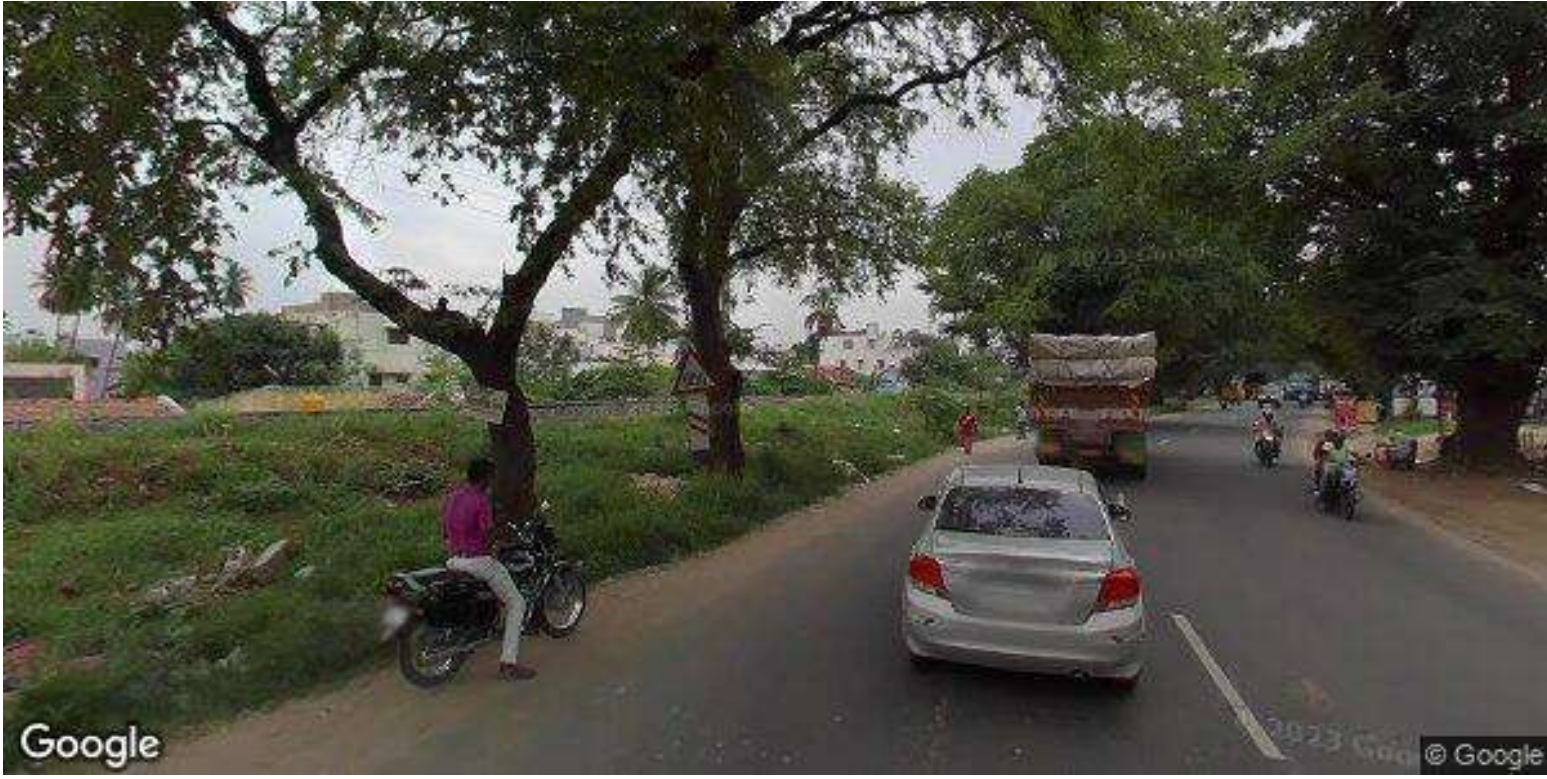
**Risk Type:** Turn  
**Risk Level:** Medium  
**Speed Limit:** 30 KM/Hr  
**Coordinates:** 11.67129, 78.22978

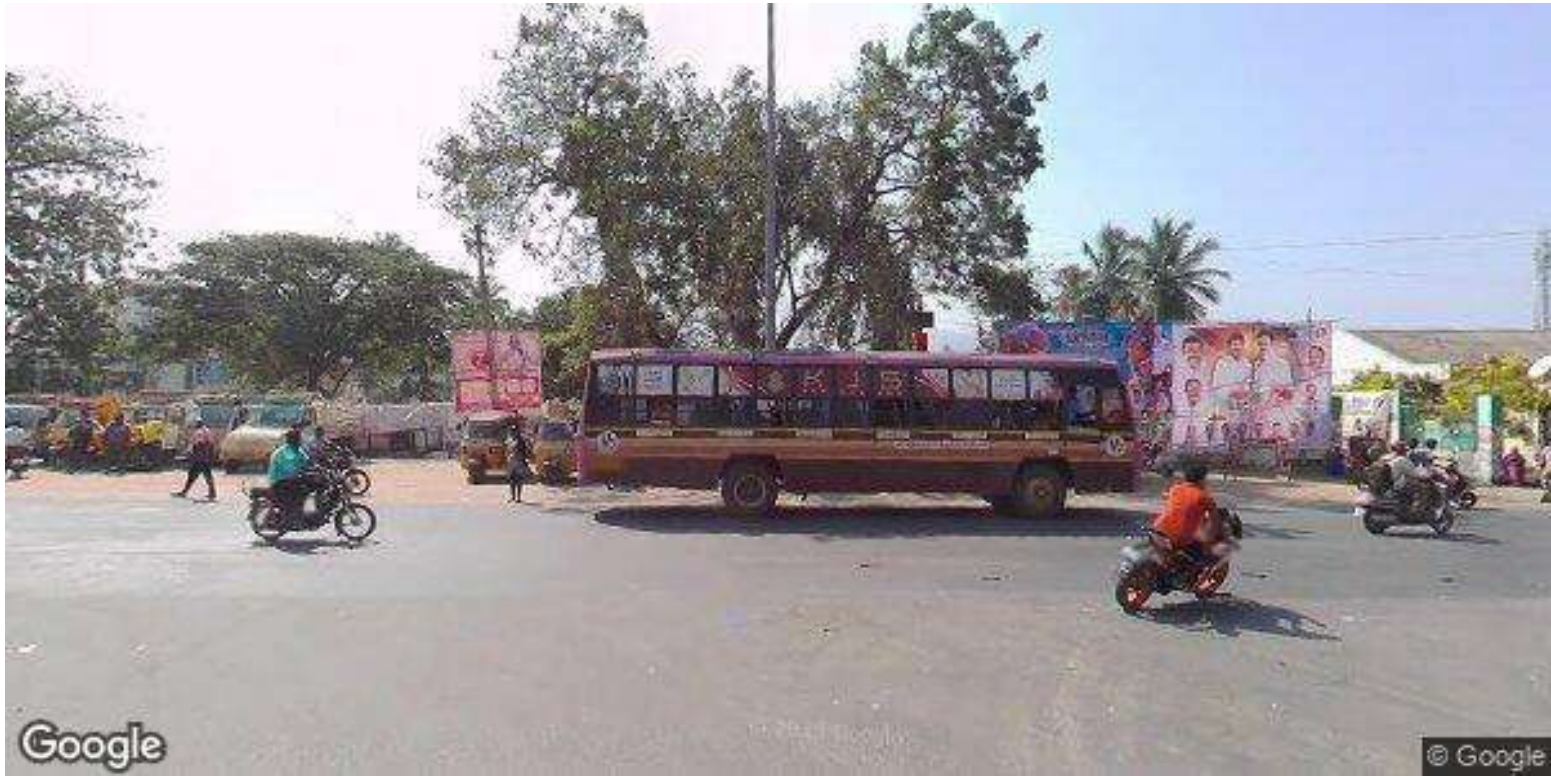
**Risk Type:** Turn  
**Risk Level:** High  
**Speed Limit:** 15 KM/Hr  
**Coordinates:** 11.67120, 78.23136

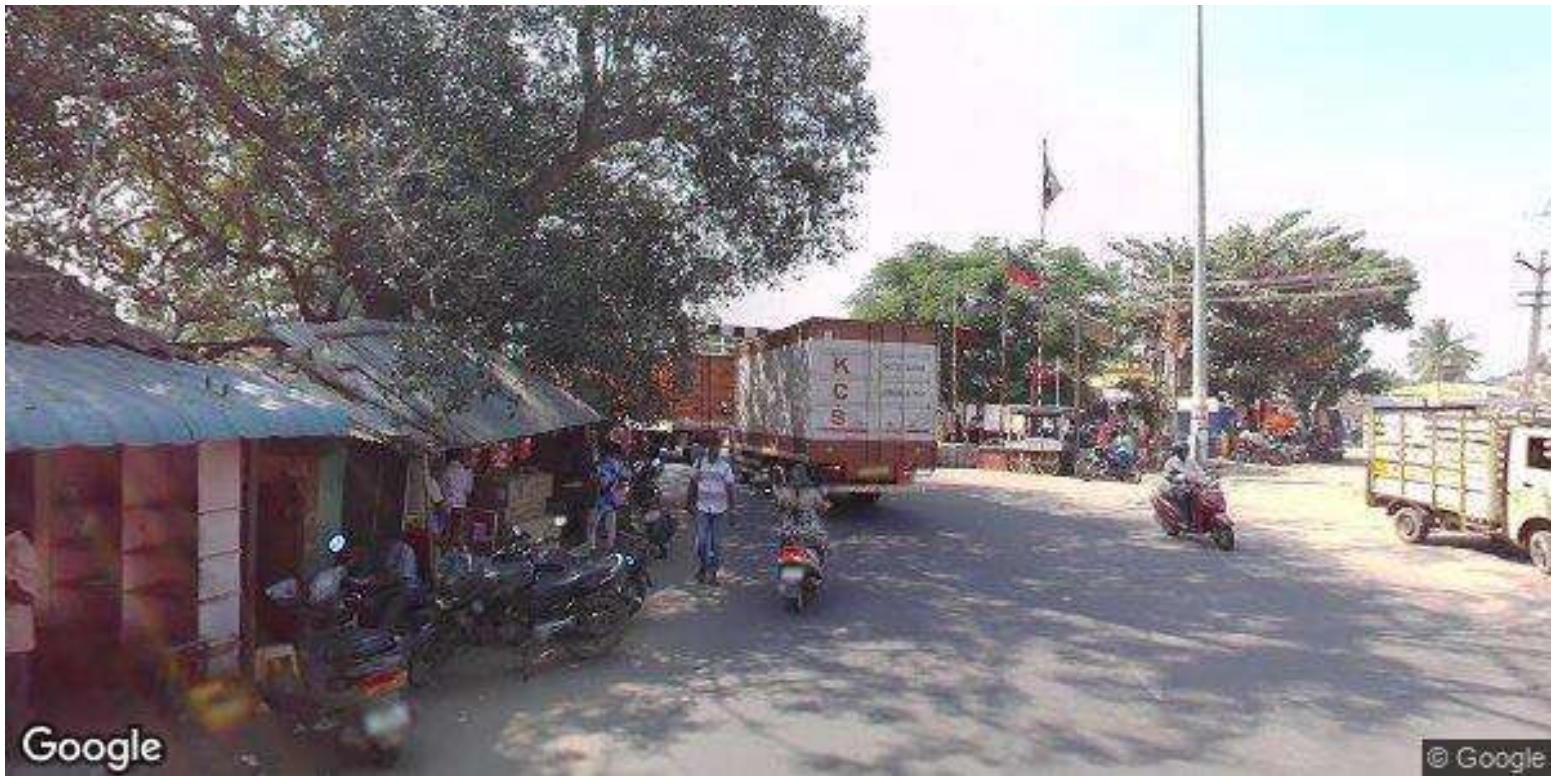
**Risk Type:** Turn  
**Risk Level:** Medium  
**Speed Limit:** 30 KM/Hr  
**Coordinates:** 11.67198, 78.23148

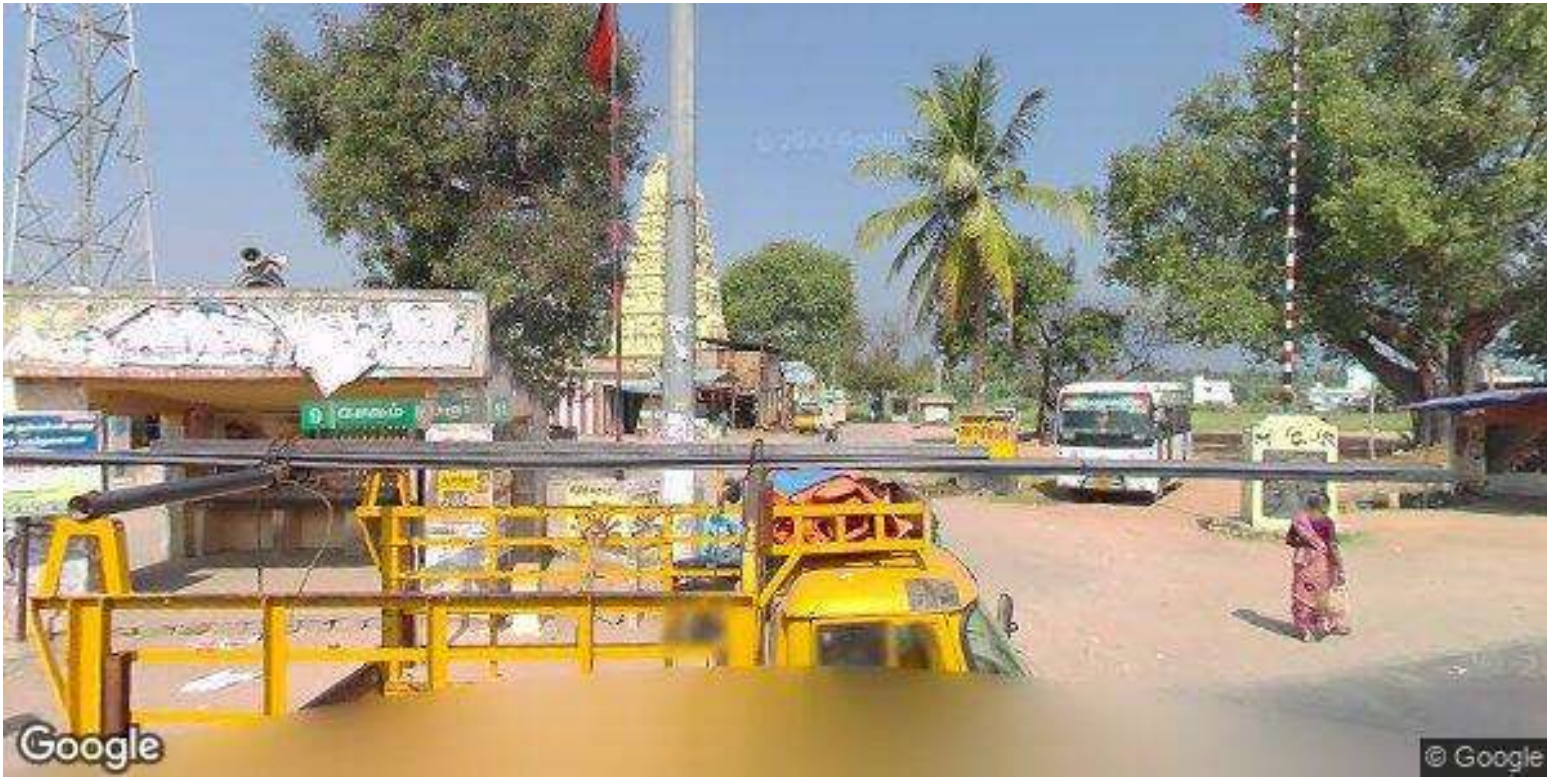
**Risk Type:** Turn  
**Risk Level:** Medium  
**Speed Limit:** 30 KM/Hr  
**Coordinates:** 11.67440, 78.23914

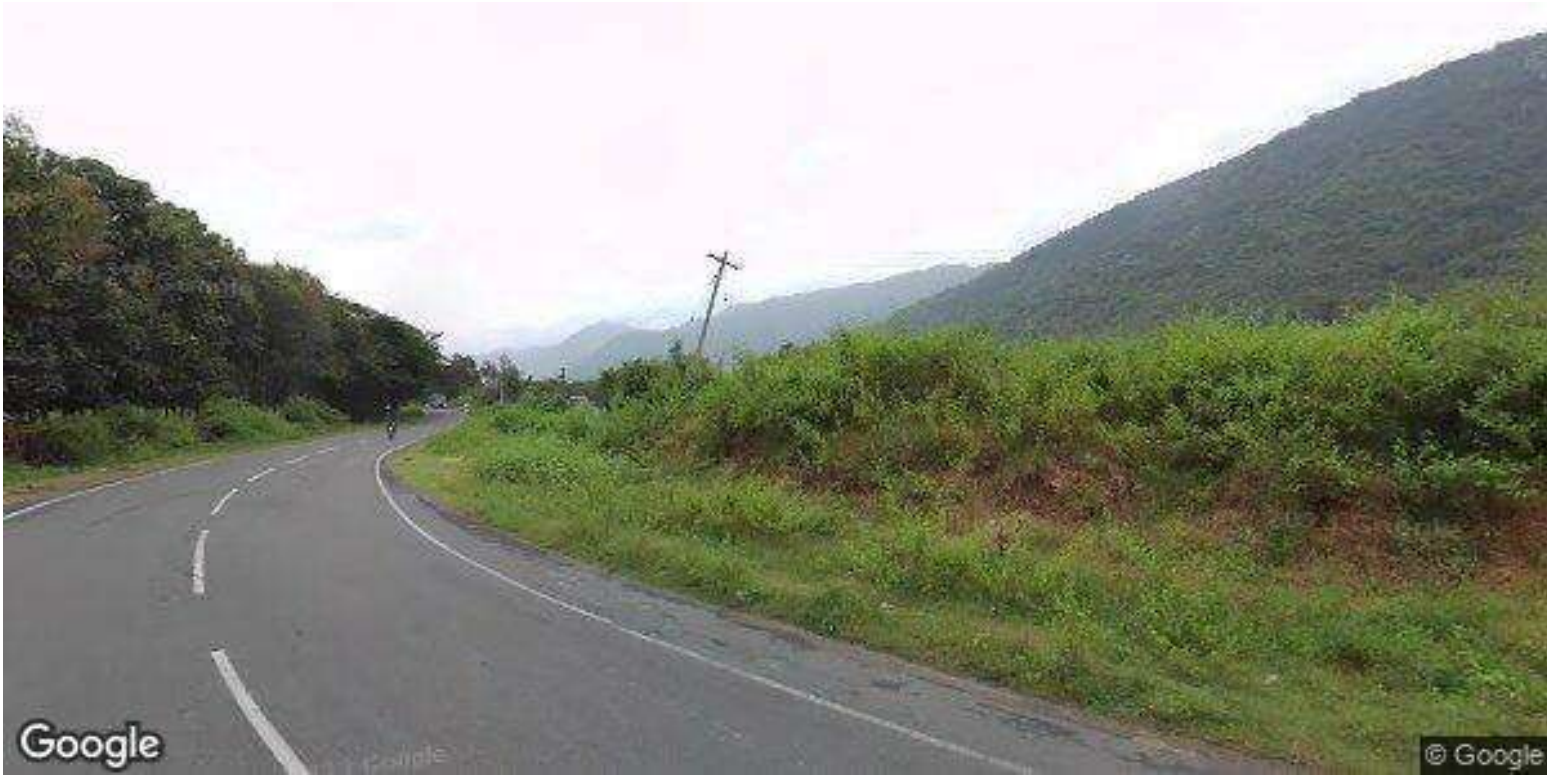
**Risk Type:** Turn  
**Risk Level:** Medium  
**Speed Limit:** 30 KM/Hr  
**Coordinates:** 11.80440, 78.33325

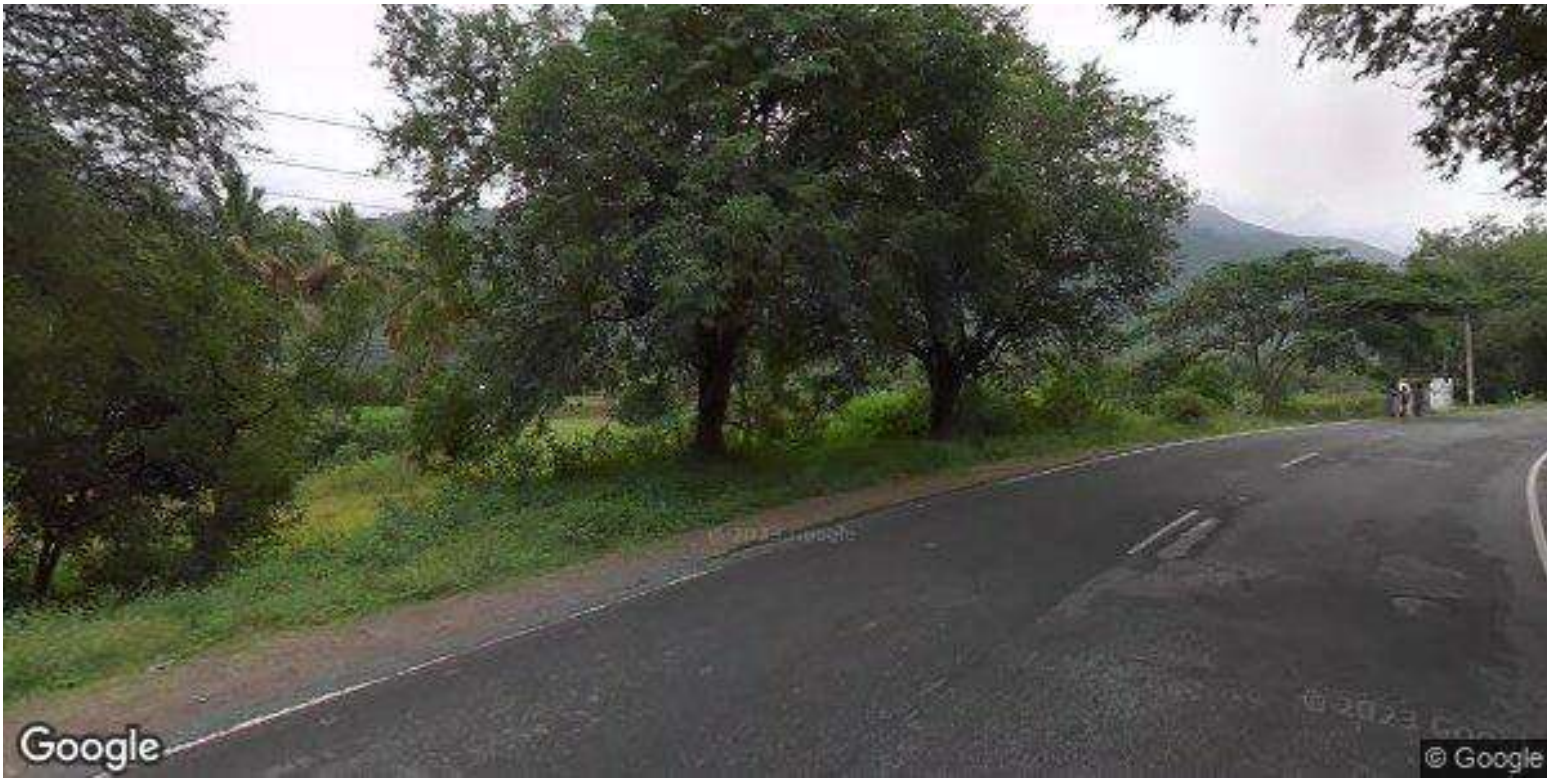
**Risk Type:** Turn  
**Risk Level:** Medium  
**Speed Limit:** 30 KM/Hr  
**Coordinates:** 11.81235, 78.34084

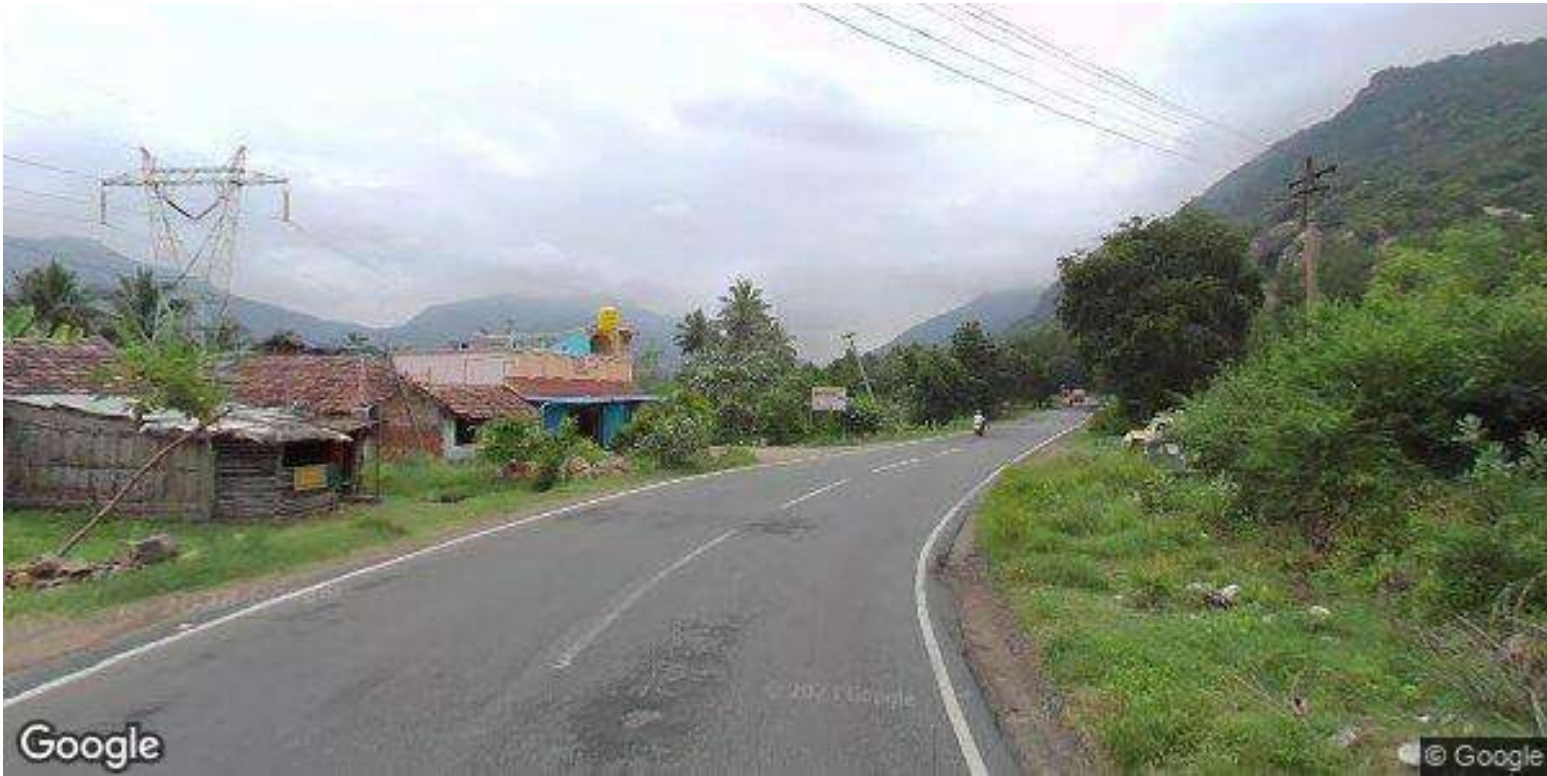
**Risk Type:** Turn  
**Risk Level:** Medium  
**Speed Limit:** 30 KM/Hr  
**Coordinates:** 11.83482, 78.35294

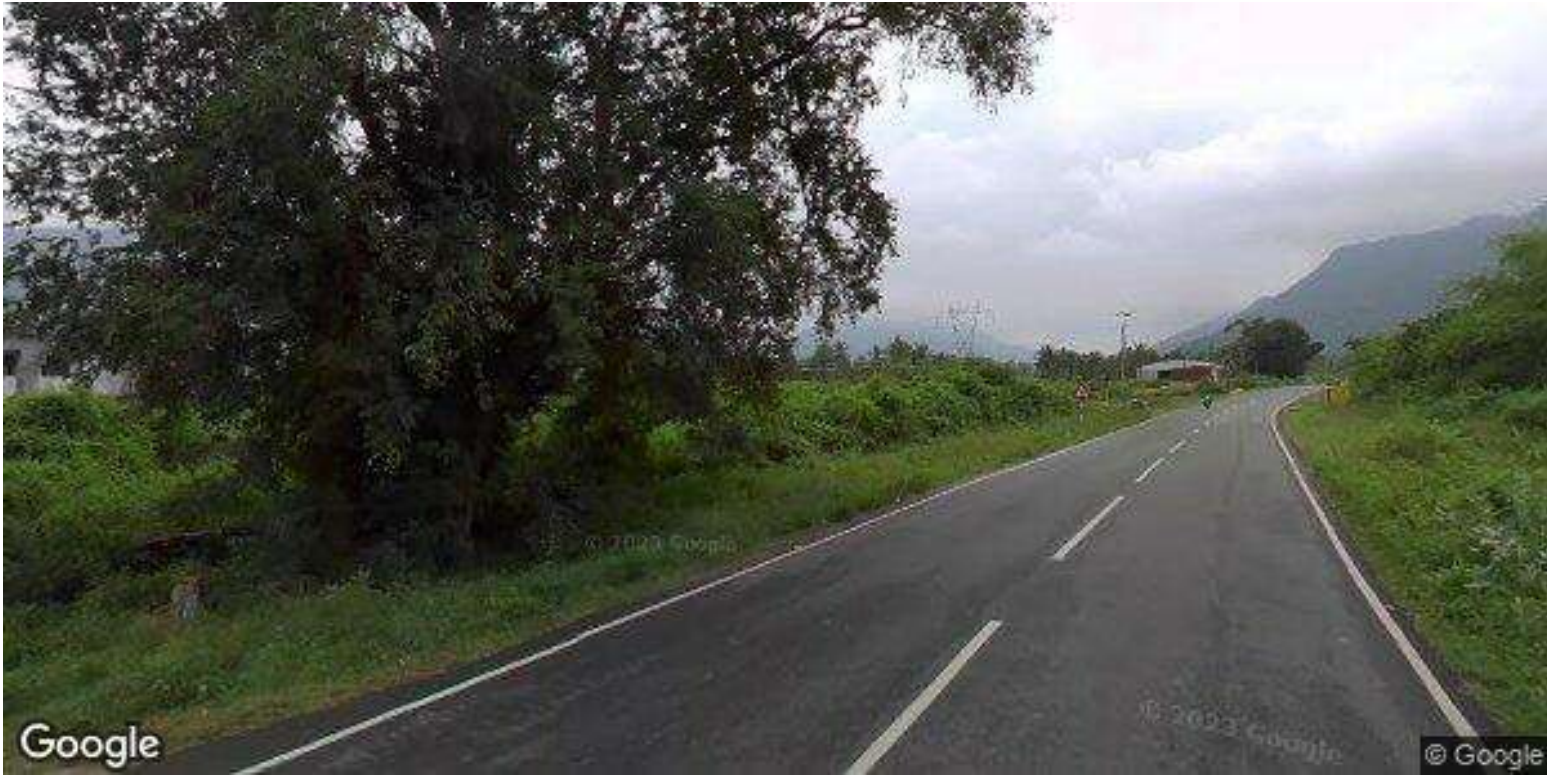
**Risk Type:** Turn  
**Risk Level:** Medium  
**Speed Limit:** 30 KM/Hr  
**Coordinates:** 11.84738, 78.36062

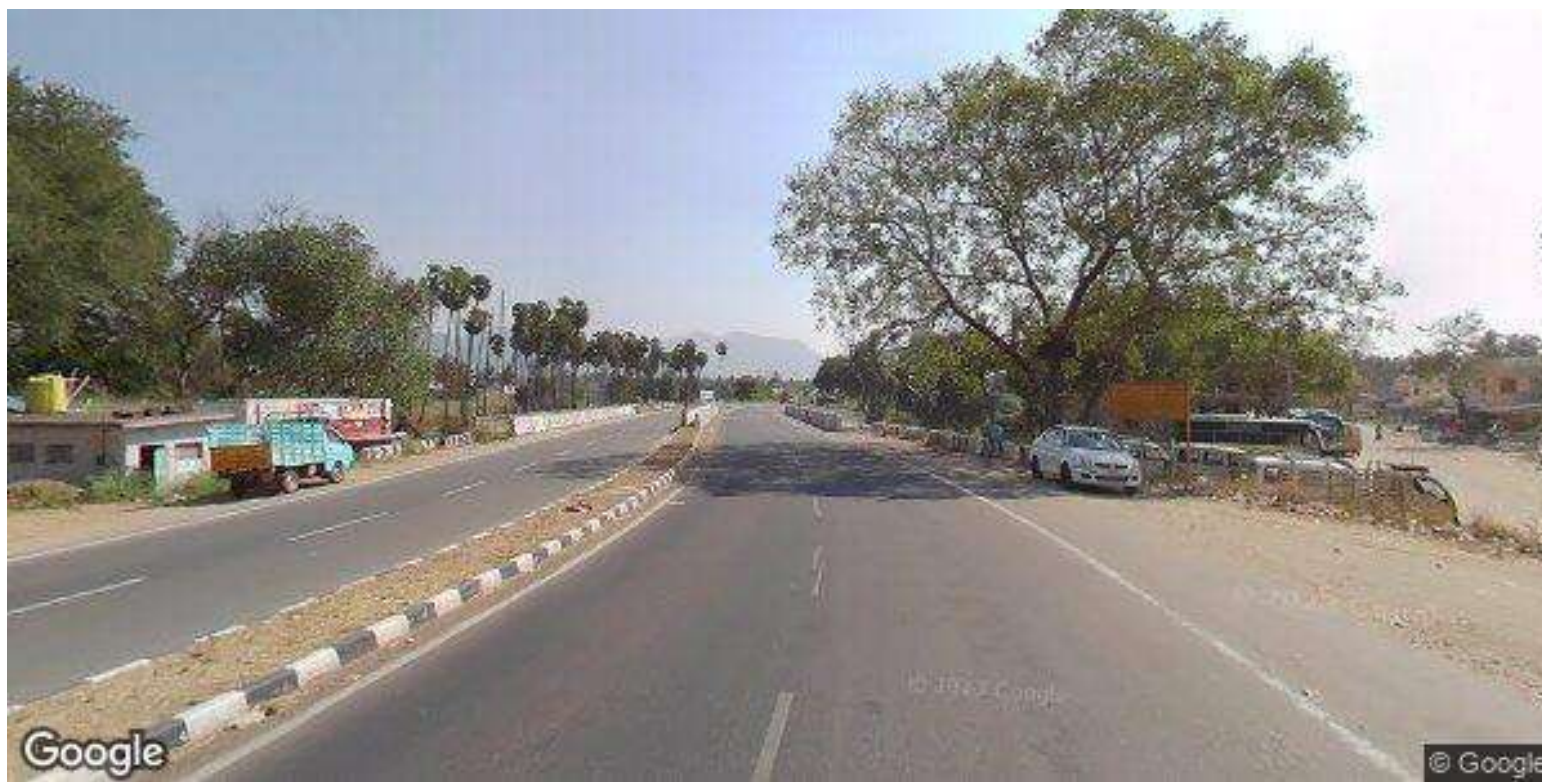
**Coordinates:** 11.99554, 78.44553

**Risk Type:** Turn

**Risk Level:** Medium

**Speed Limit:** 30 KM/Hr

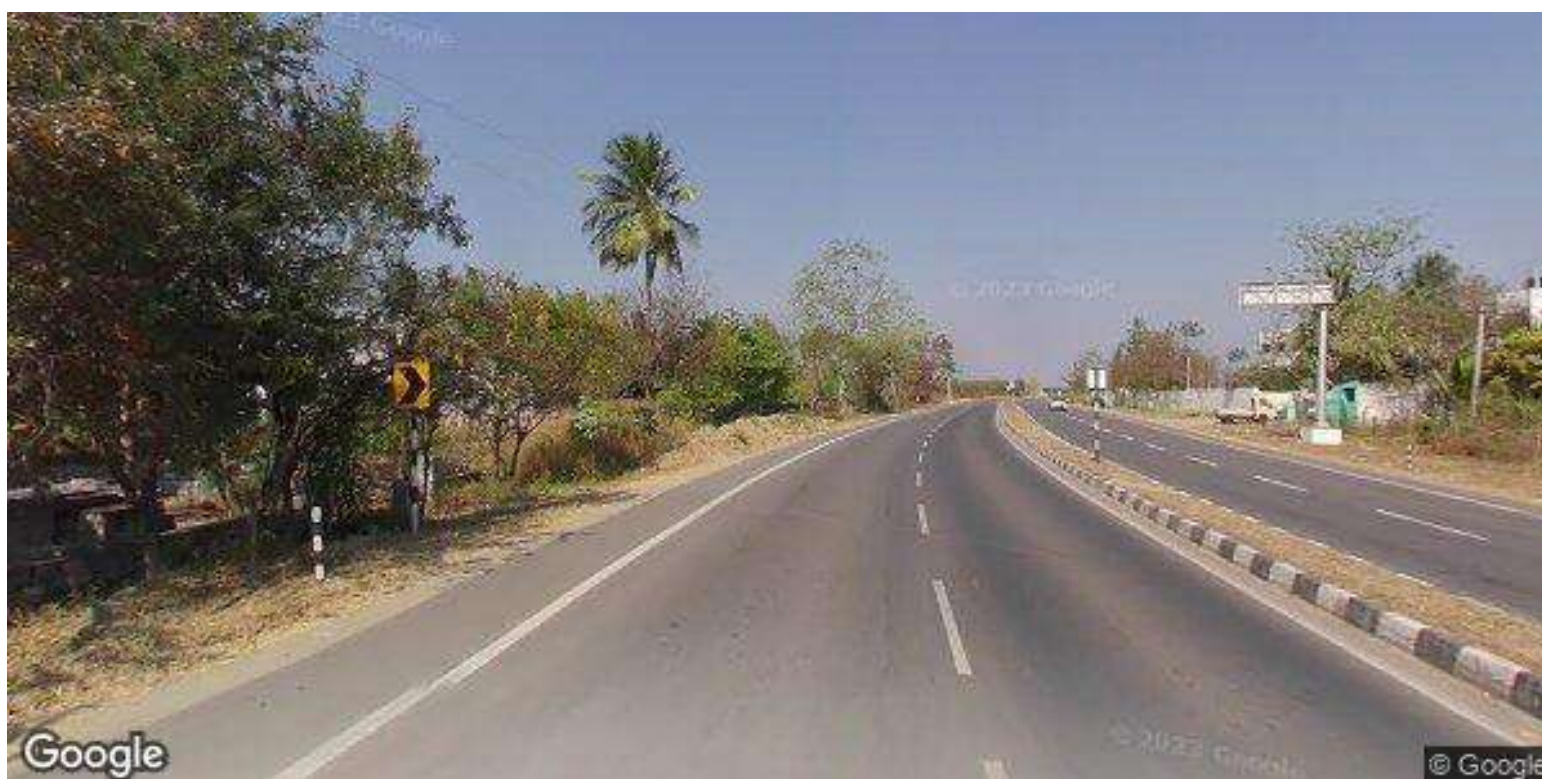
**Coordinates:** 12.01577, 78.45673

**Risk Type:** Turn

**Risk Level:** Medium

**Speed Limit:** 30 KM/Hr

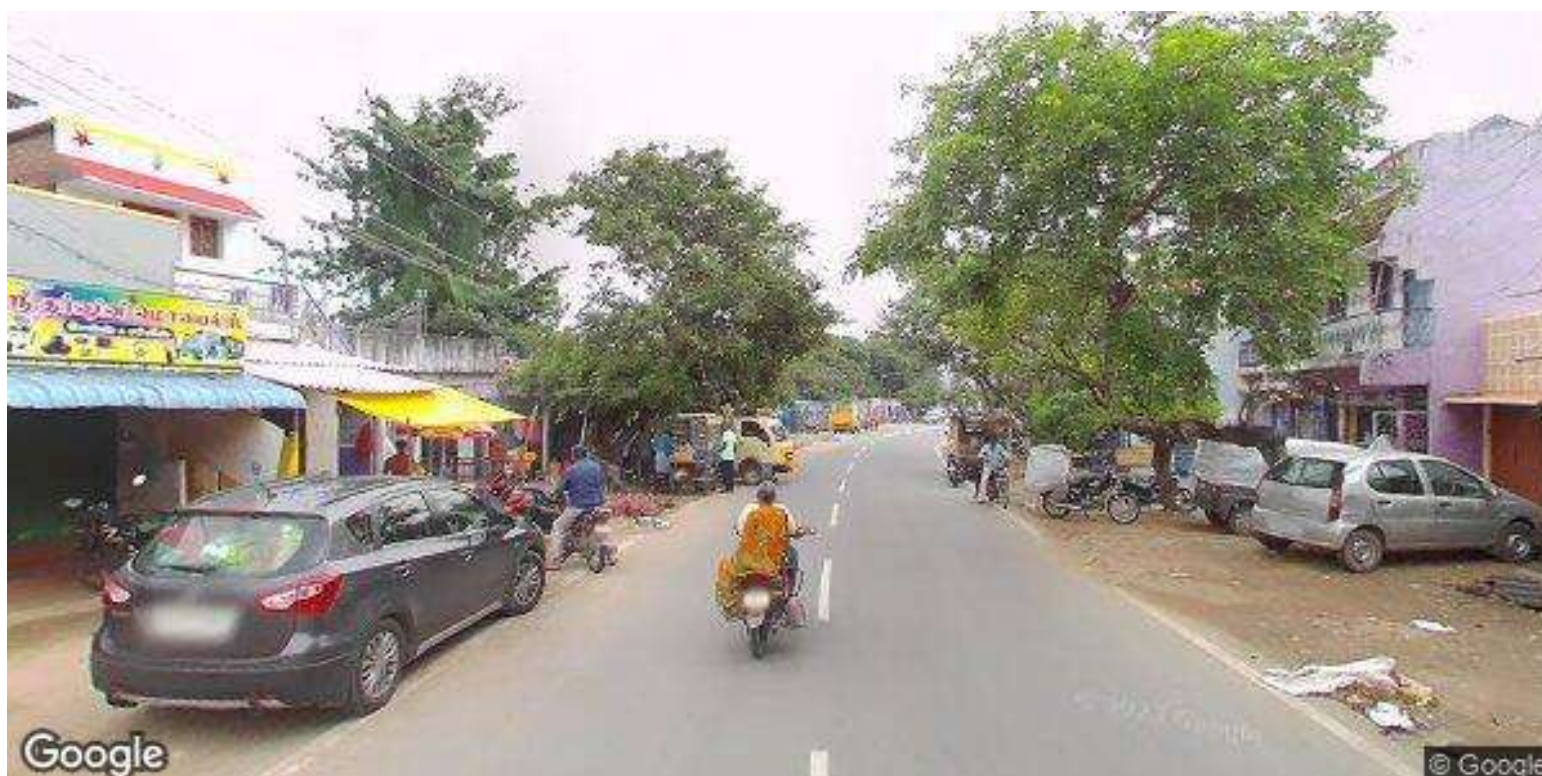
**Coordinates:** 12.04808, 78.48399

**Risk Type:** Turn

**Risk Level:** Medium

**Speed Limit:** 30 KM/Hr

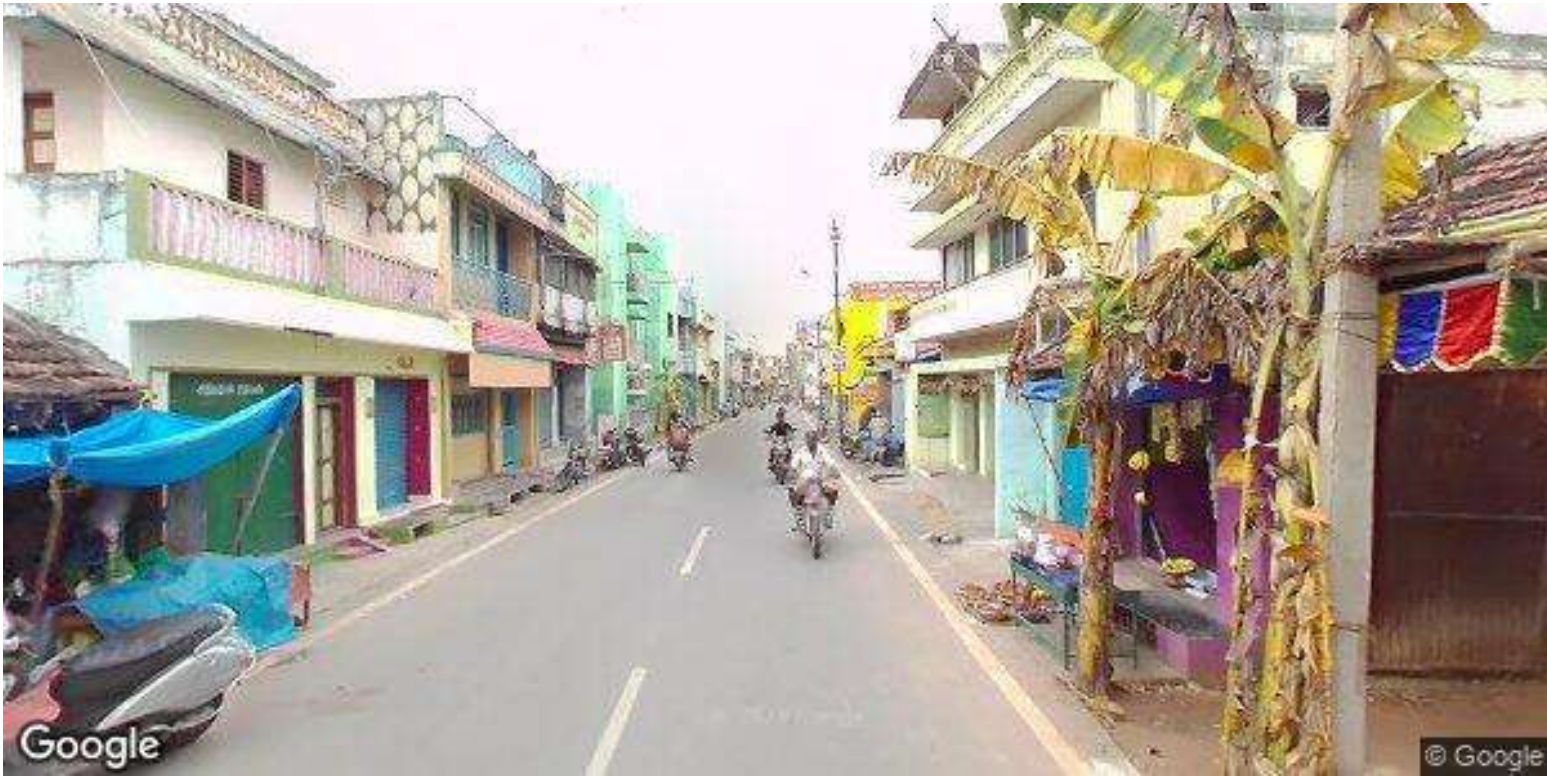
**Coordinates:** 12.04979, 78.48303

**Risk Type:** Turn

**Risk Level:** Medium

**Speed Limit:** 30 KM/Hr
