## JOURNEY RISK MANAGEMENT (JRM) STUDY

### Salem Terminal TO VADIVELAN AGENCIES

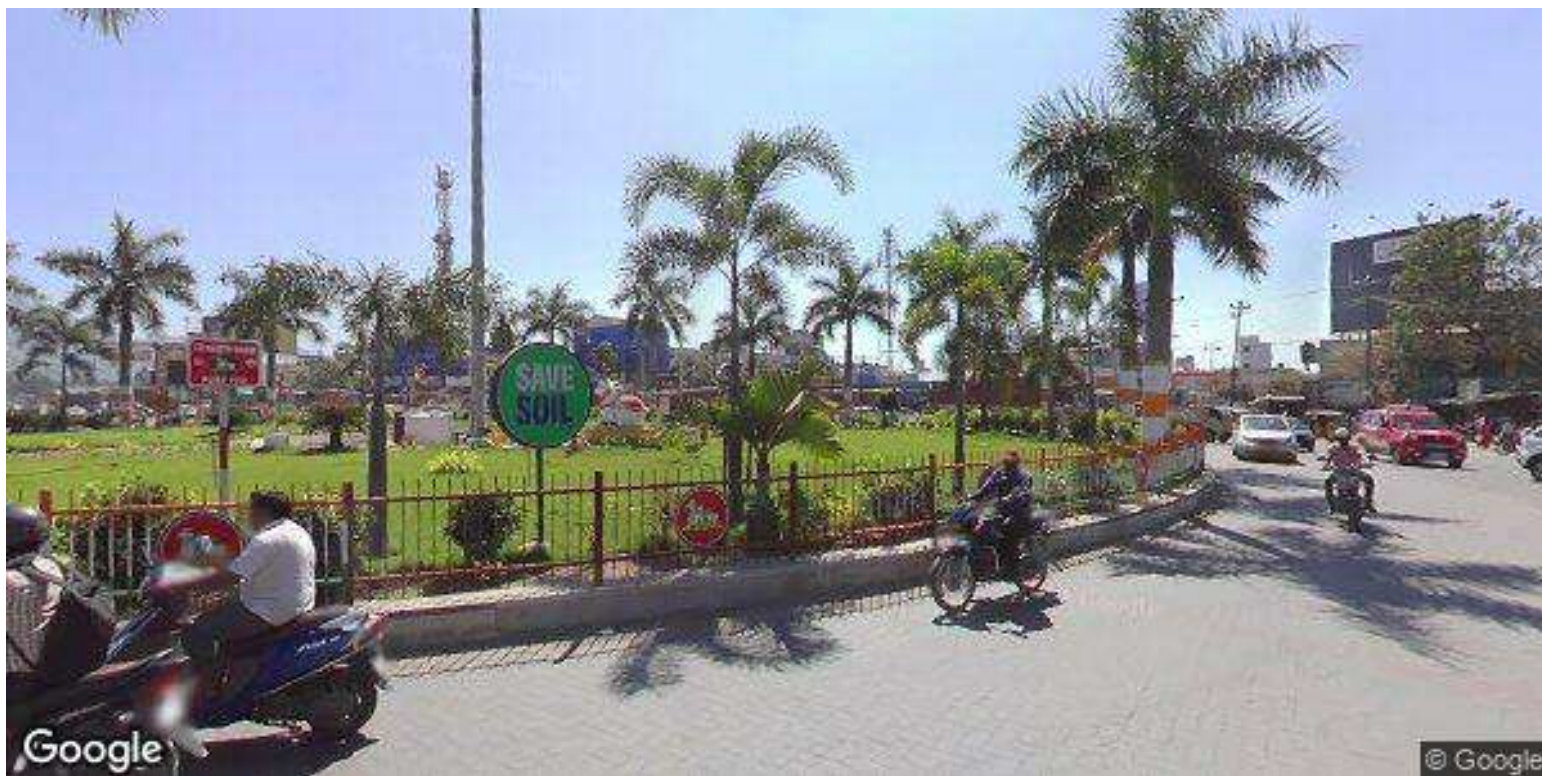
**Coordinates:** 11.63303, 78.12713

**Risk Type:** Roundabout

**Risk Level:** High

**Speed Limit:** 15 KM/Hr

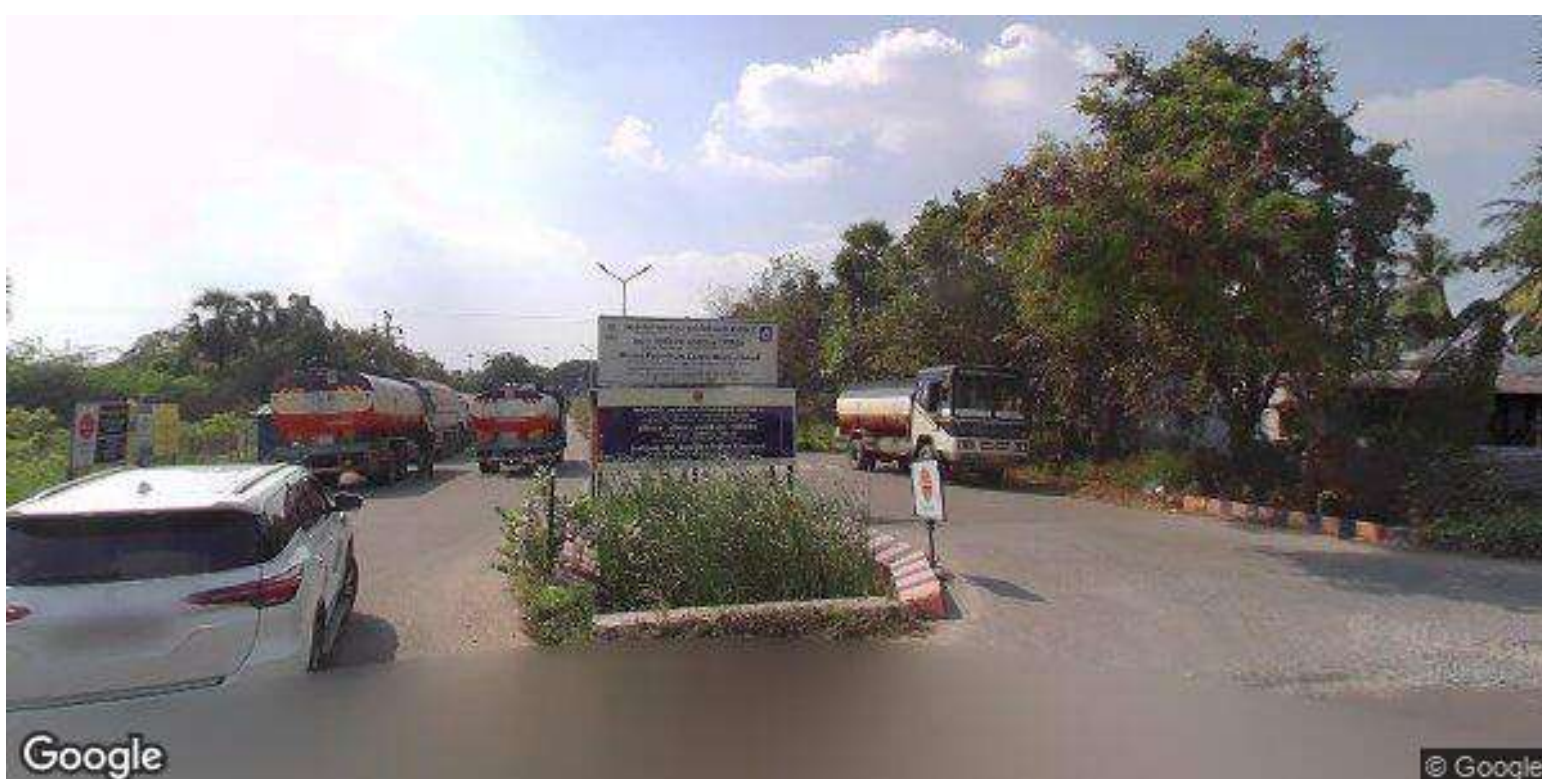
**Coordinates:** 11.44024, 77.87528

**Risk Type:** Turn

**Risk Level:** High

**Speed Limit:** 15 KM/Hr

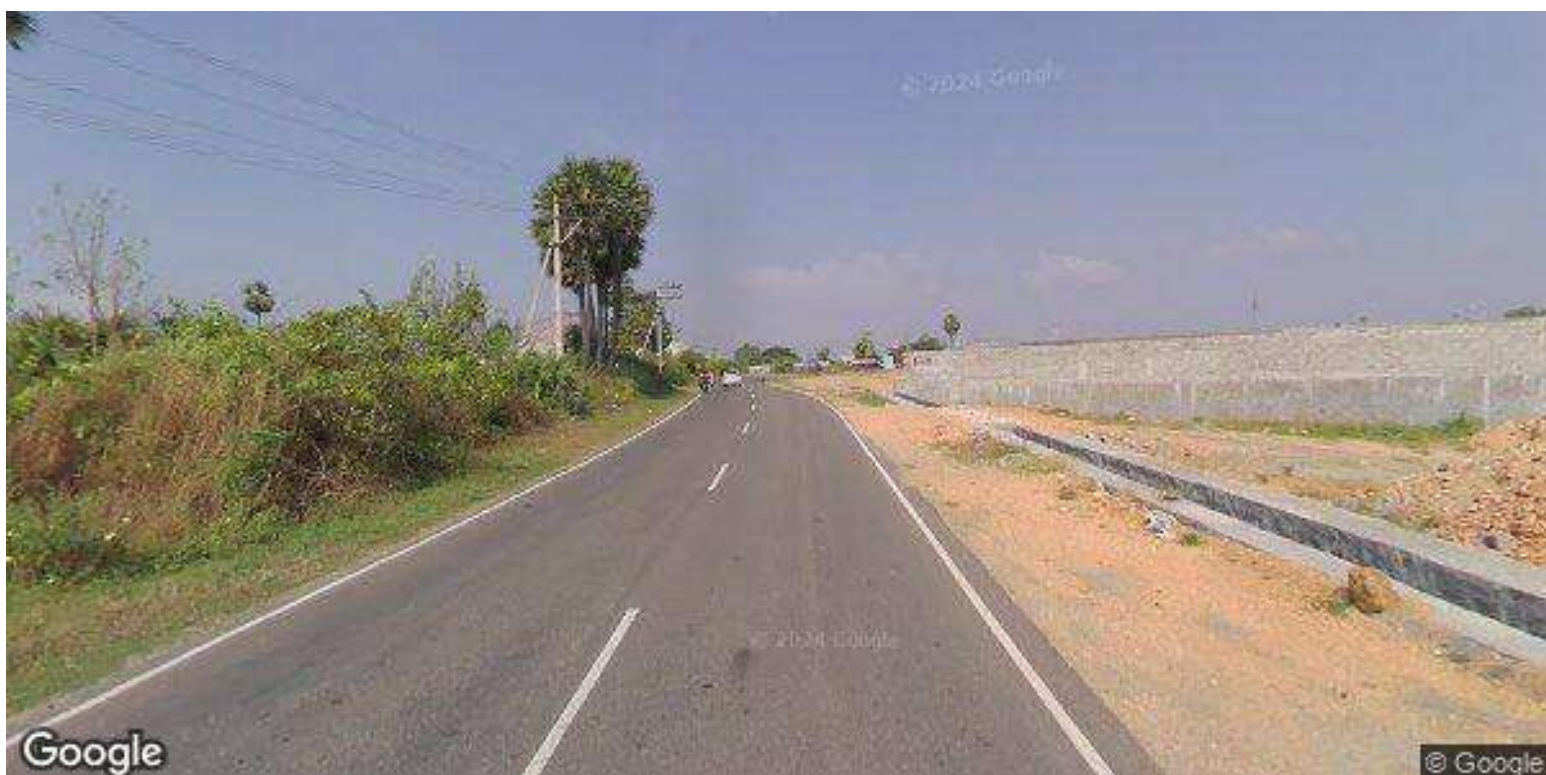
**Coordinates: 11.45764, 77.85219**

**Risk Type: Turn**

**Risk Level: Medium**

**Speed Limit: 30 KM/Hr**

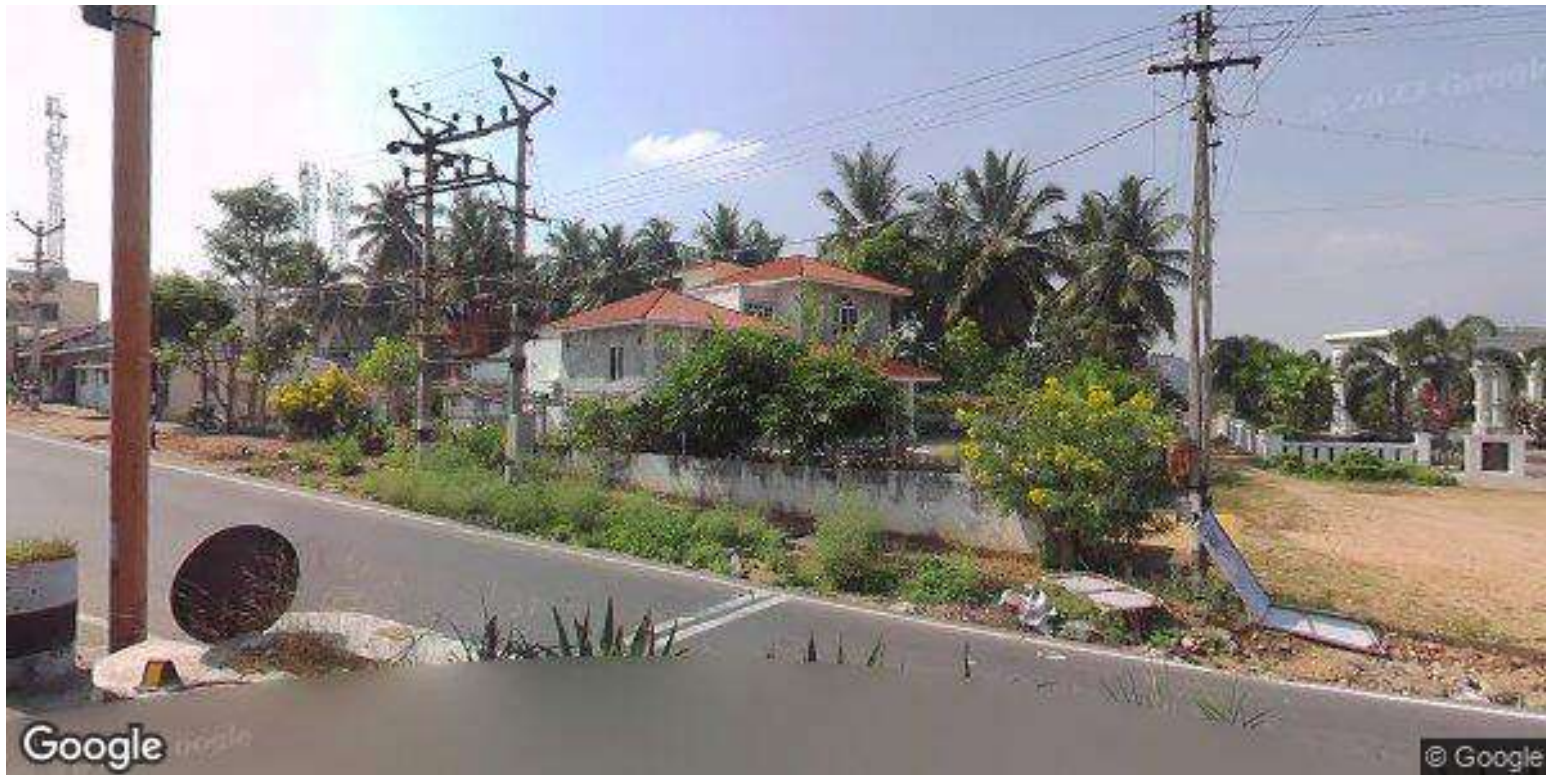
**Coordinates: 11.46303, 77.84945**

**Risk Type: Turn**

**Risk Level: High**

**Speed Limit: 15 KM/Hr**

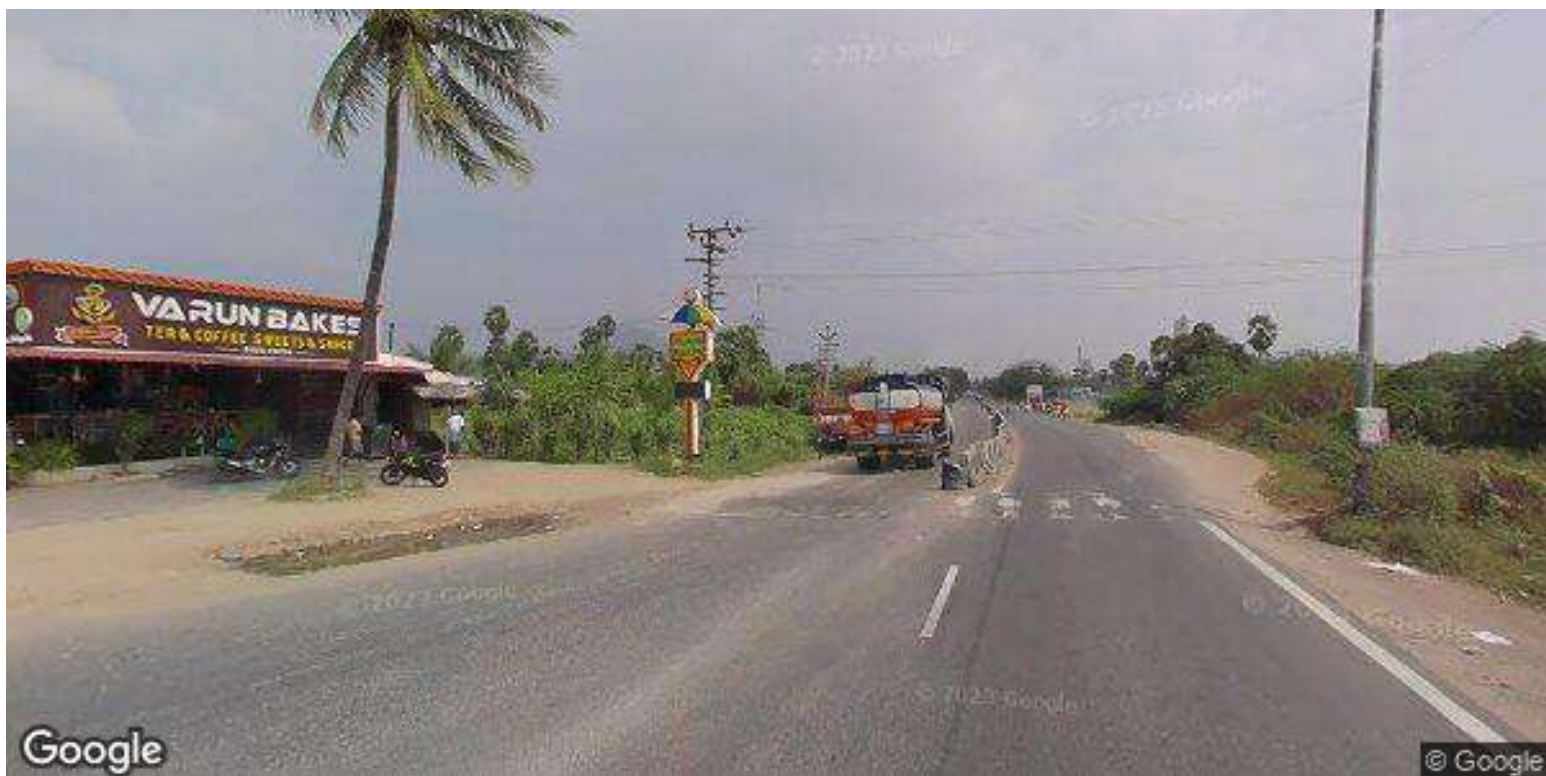
**Coordinates: 11.45543, 77.81740**

**Risk Type: Turn**

**Risk Level: Medium**

**Speed Limit: 30 KM/Hr**

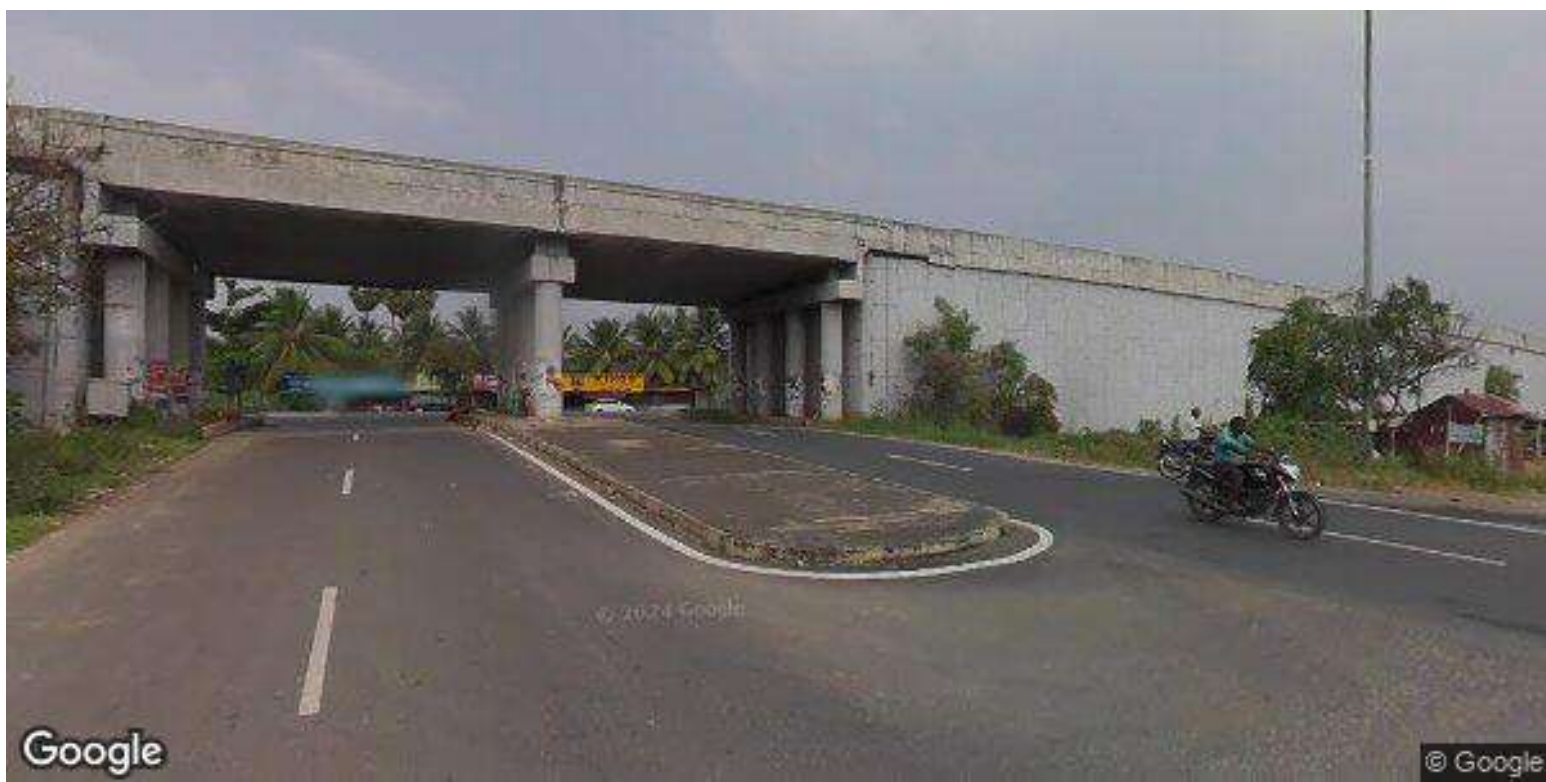
**Coordinates:** 11.45584, 77.81695

**Risk Type:** Turn

**Risk Level:** High

**Speed Limit:** 15 KM/Hr

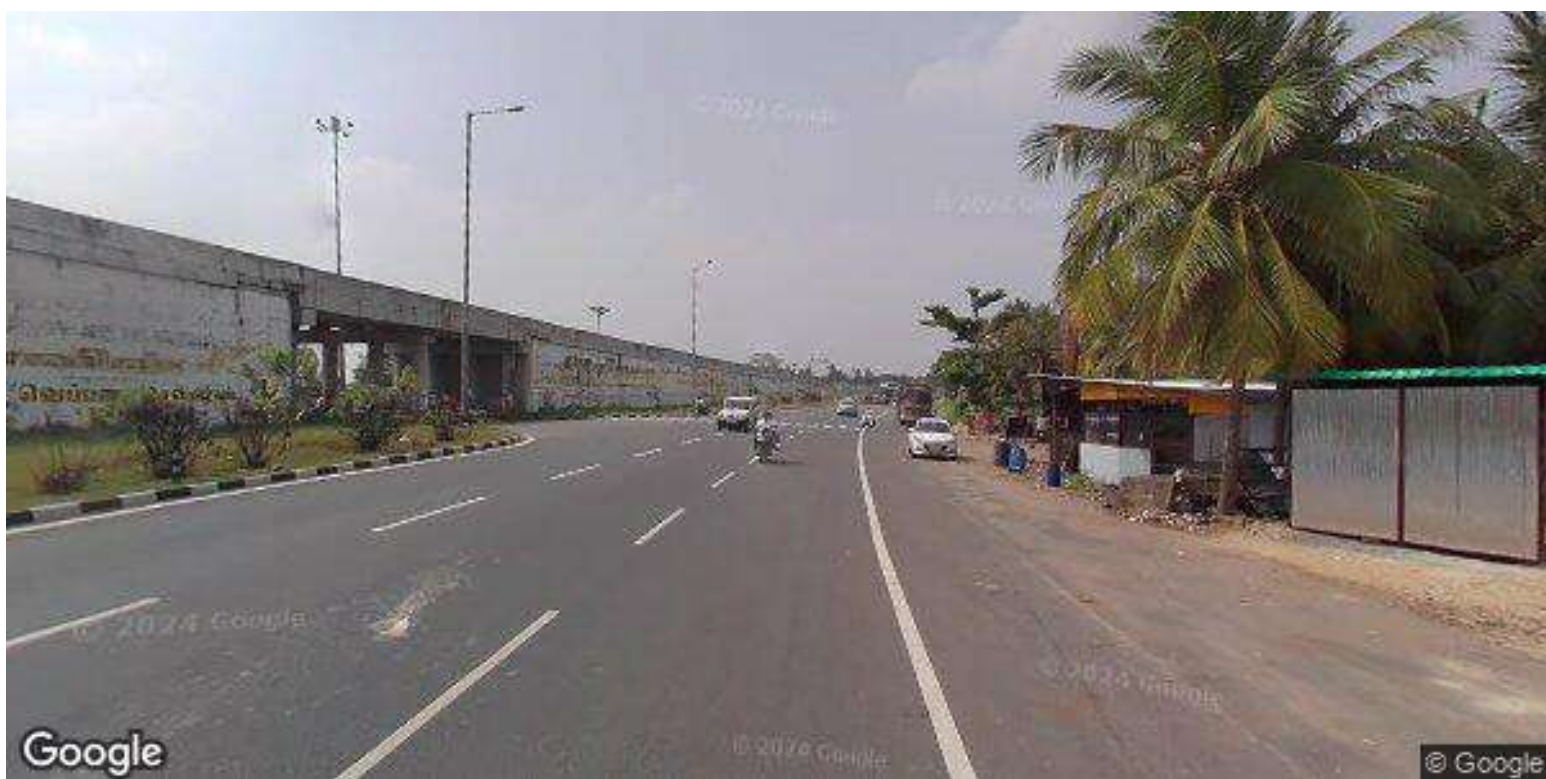
**Coordinates:** 11.45656, 77.81709

**Risk Type:** Turn

**Risk Level:** Medium

**Speed Limit:** 30 KM/Hr

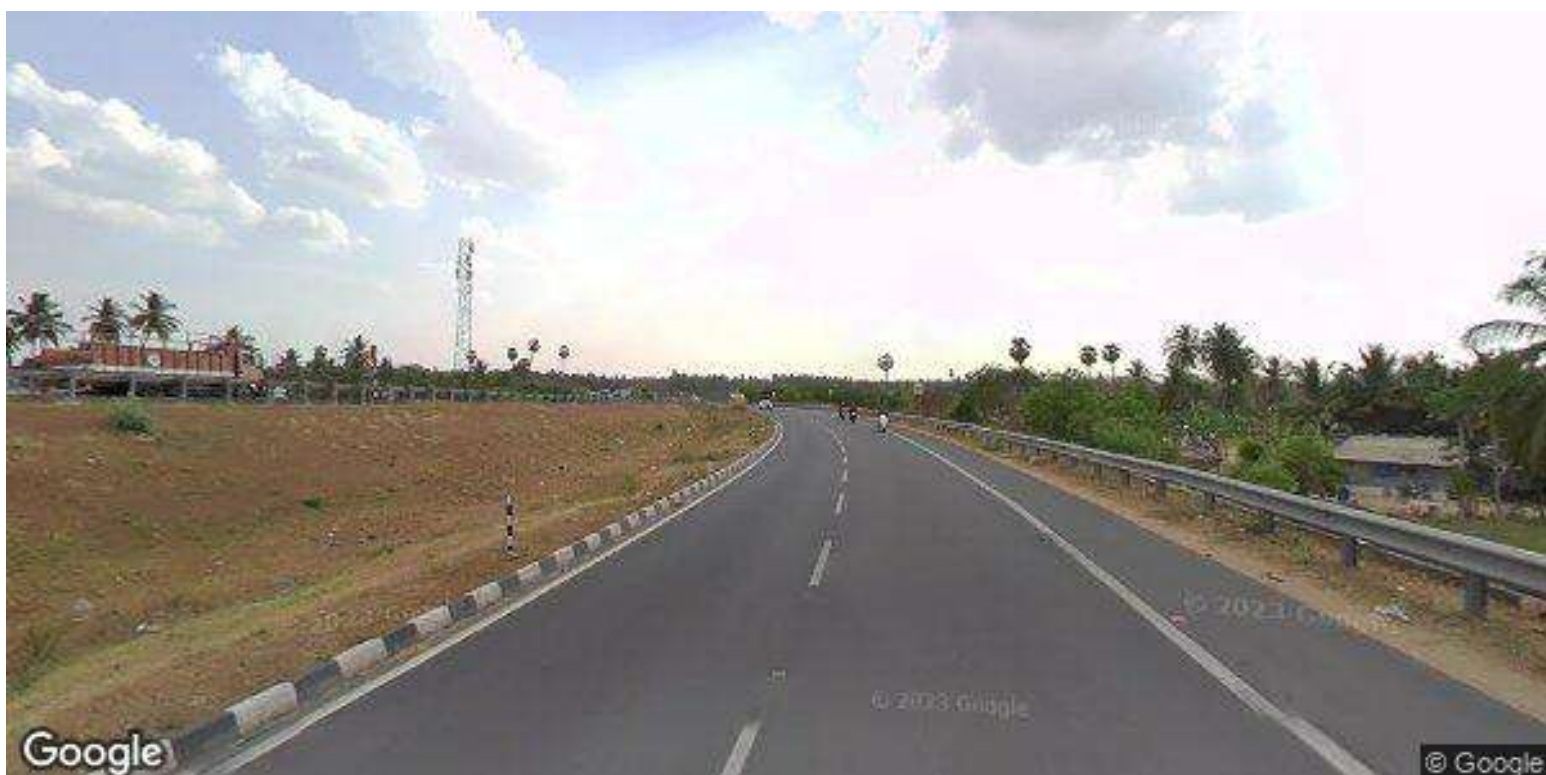
**Risk Type:** Turn  
**Risk Level:** Medium  
**Speed Limit:** 30 KM/Hr  
**Coordinates:** 11.53552, 77.95763

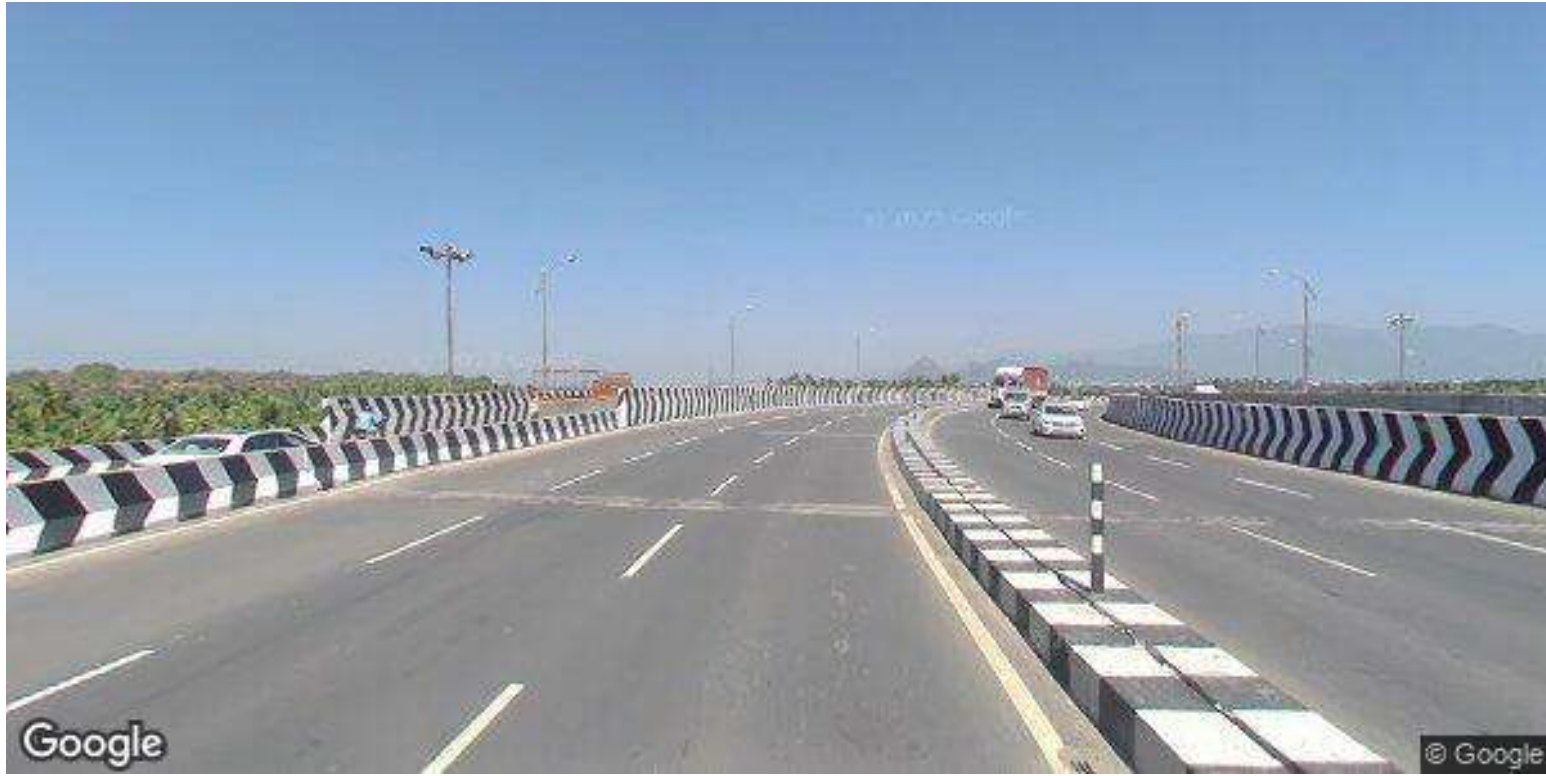
**Risk Type:** Turn  
**Risk Level:** Medium  
**Speed Limit:** 30 KM/Hr  
**Coordinates:** 11.64096, 78.11795

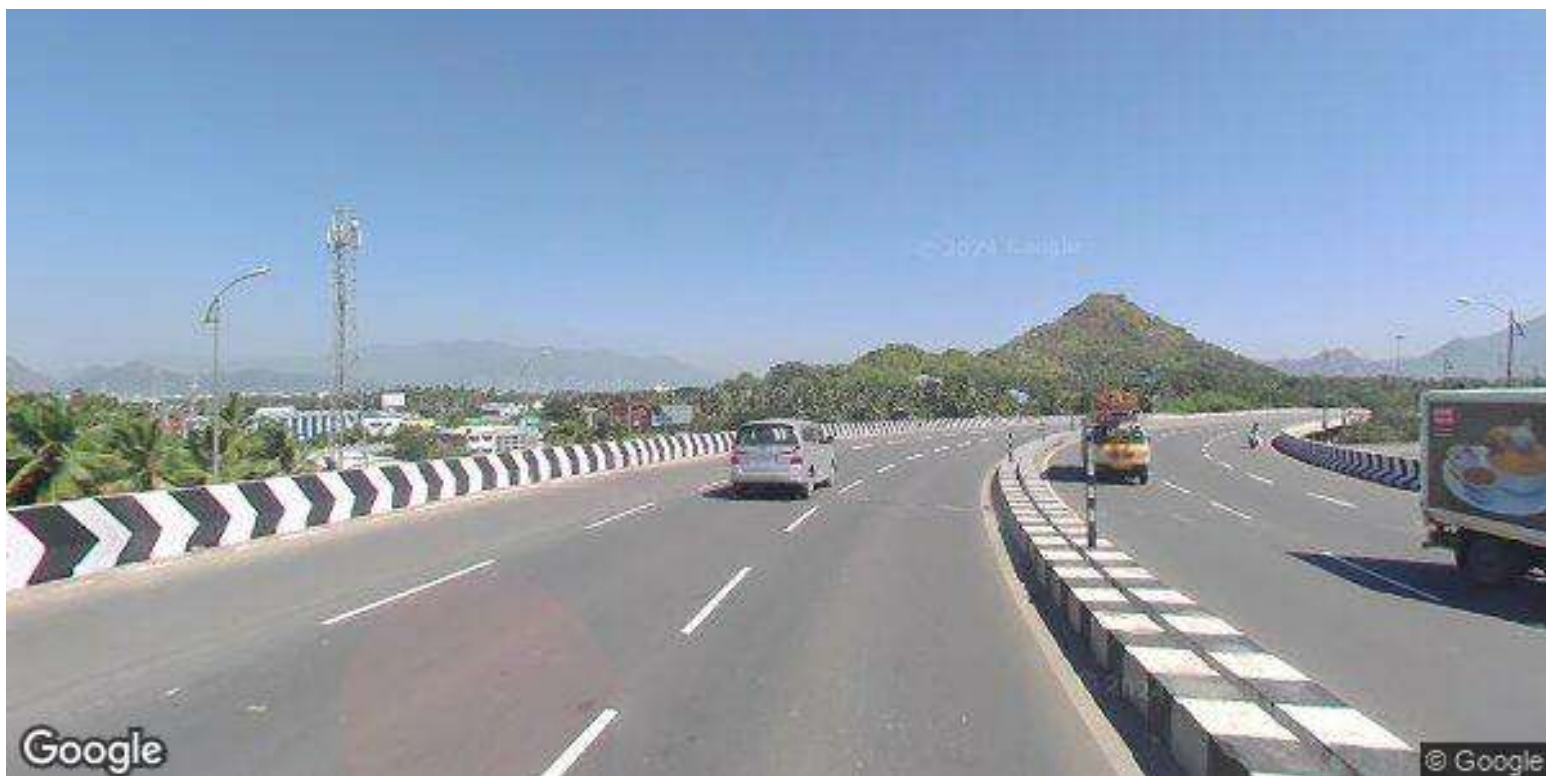
**Risk Type:** Turn  
**Risk Level:** High  
**Speed Limit:** 15 KM/Hr  
**Coordinates:** 11.64210, 78.11860

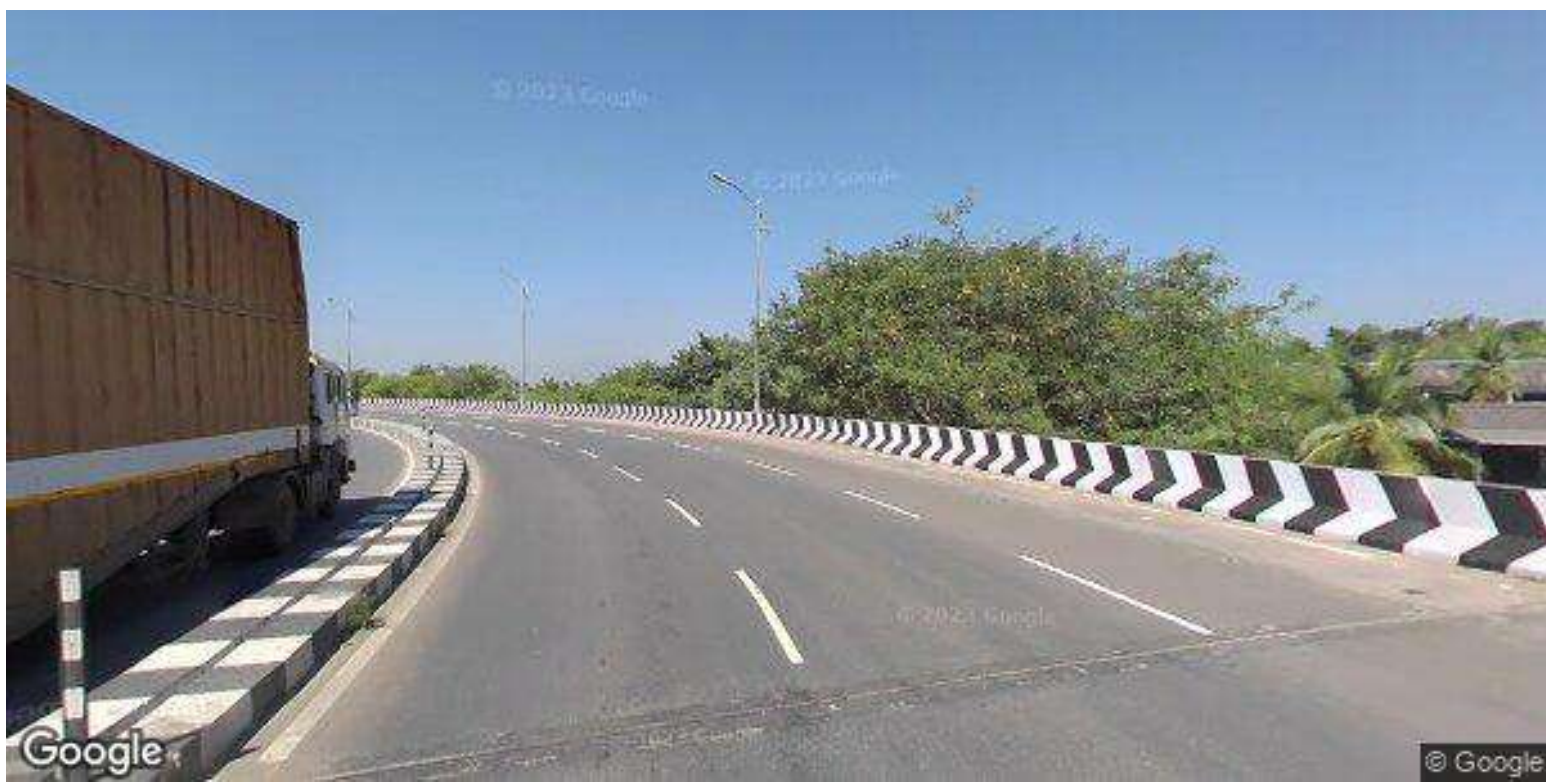
**Coordinates:** 11.64172, 78.12154

**Risk Type:** Turn

**Risk Level:** High

**Speed Limit:** 15 KM/Hr

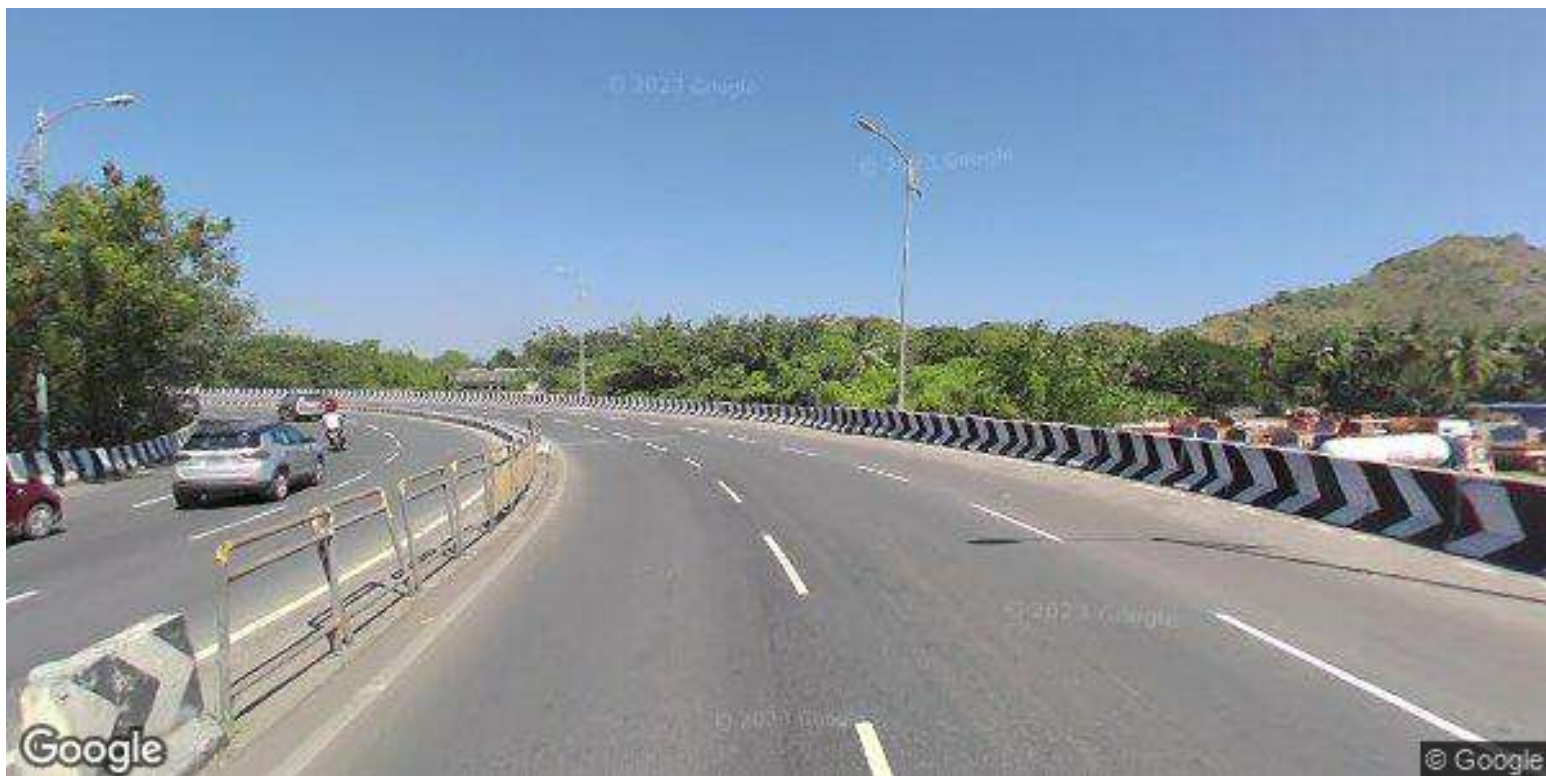
**Coordinates:** 11.64098, 78.12163

**Risk Type:** Turn

**Risk Level:** Medium

**Speed Limit:** 30 KM/Hr

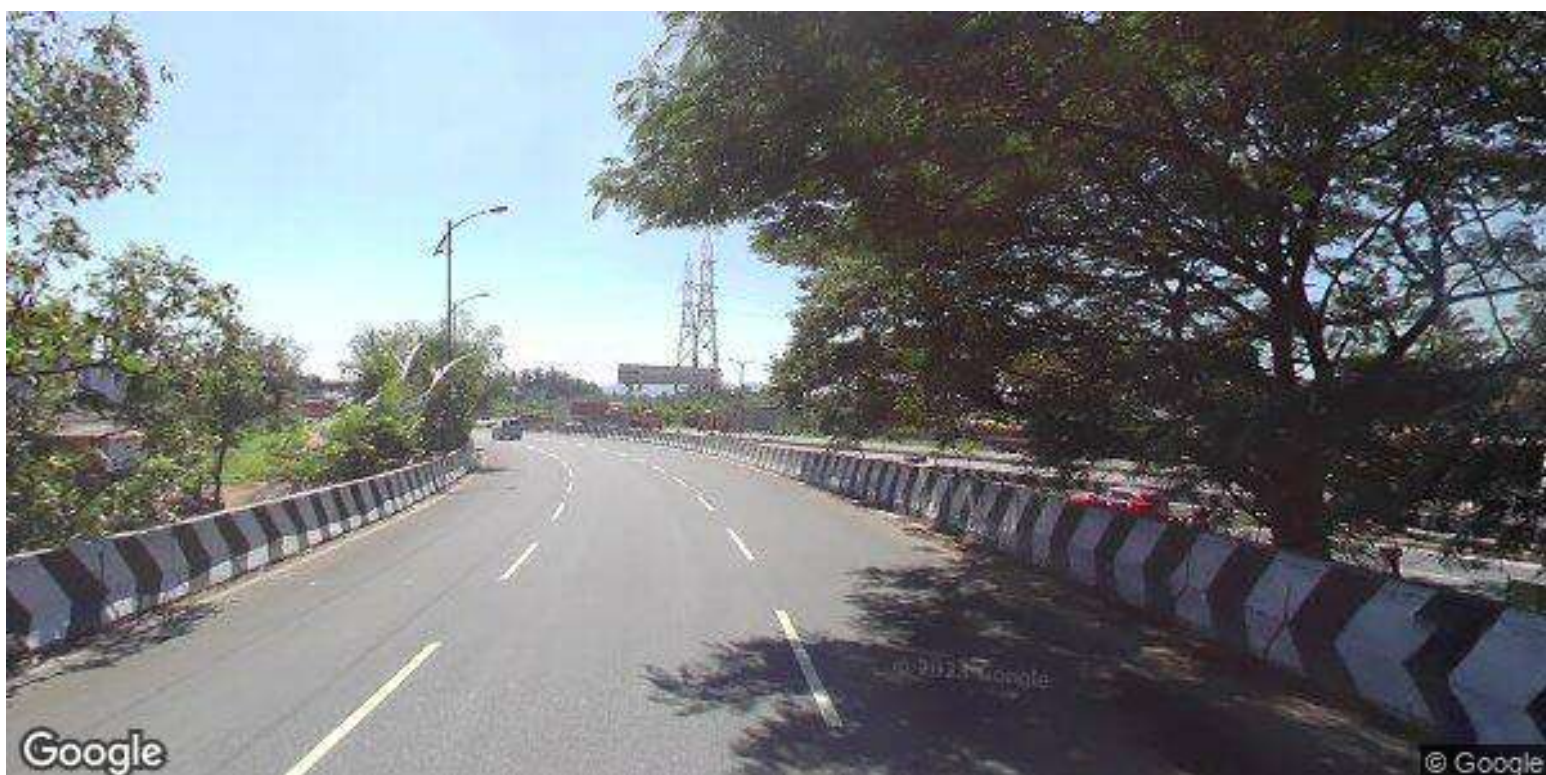
**Risk Type:** Turn  
**Risk Level:** High  
**Speed Limit:** 15 KM/Hr  
**Coordinates:** 11.63972, 78.12083

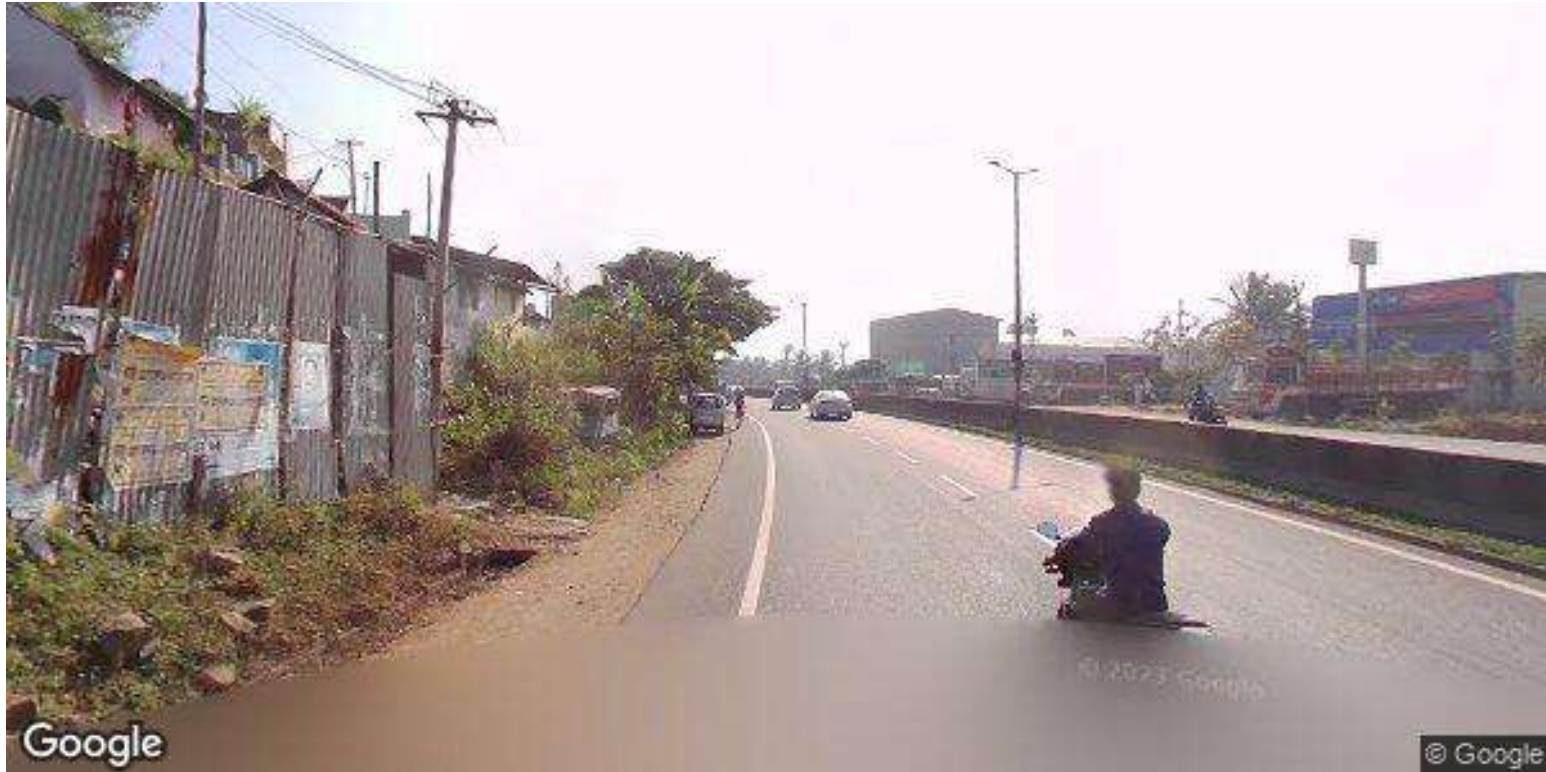
**Risk Type:** Turn  
**Risk Level:** Medium  
**Speed Limit:** 30 KM/Hr  
**Coordinates:** 11.62826, 78.13337

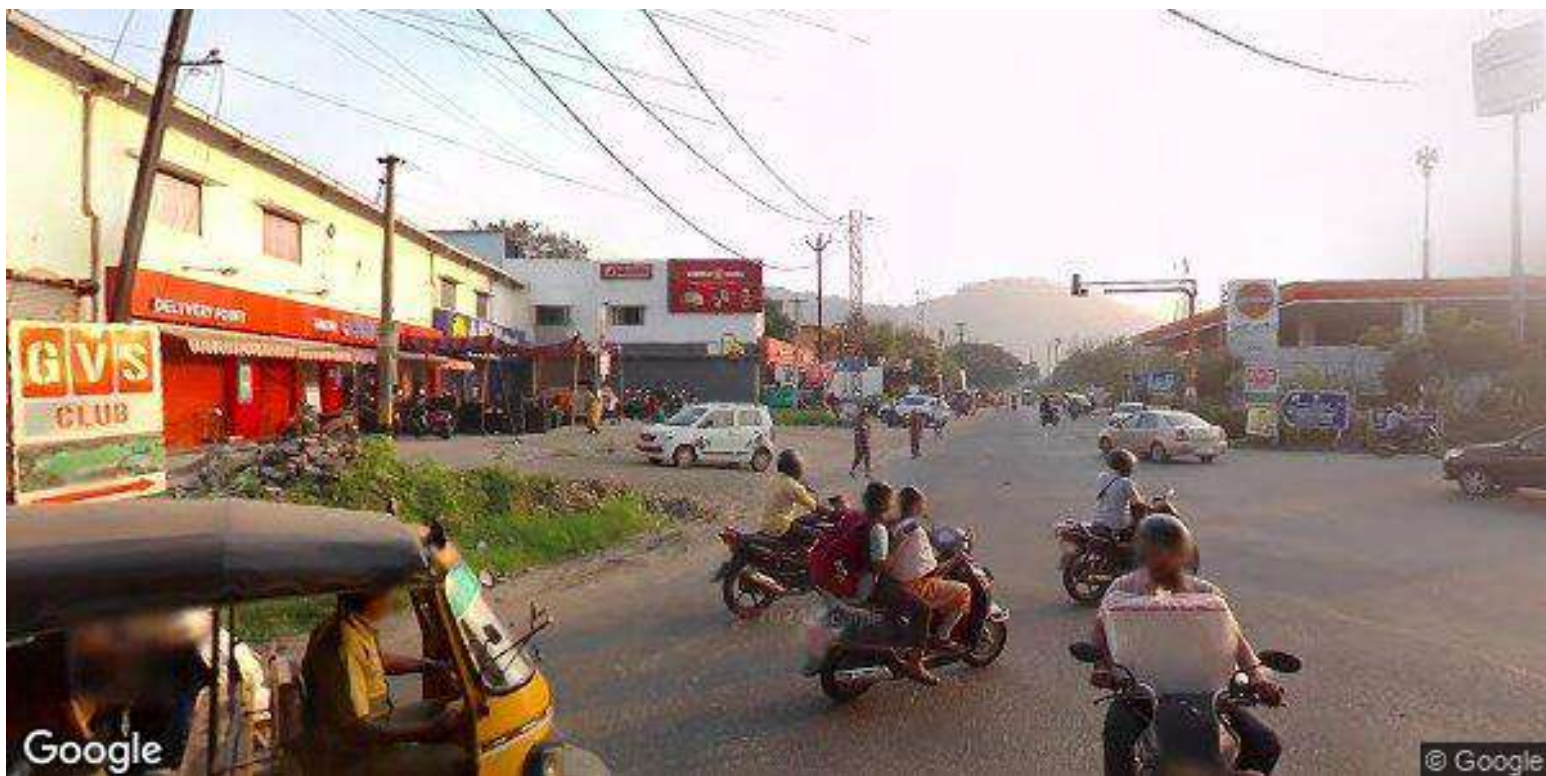
**Risk Type:** Turn  
**Risk Level:** High  
**Speed Limit:** 15 KM/Hr  
**Coordinates:** 11.66372, 78.20649

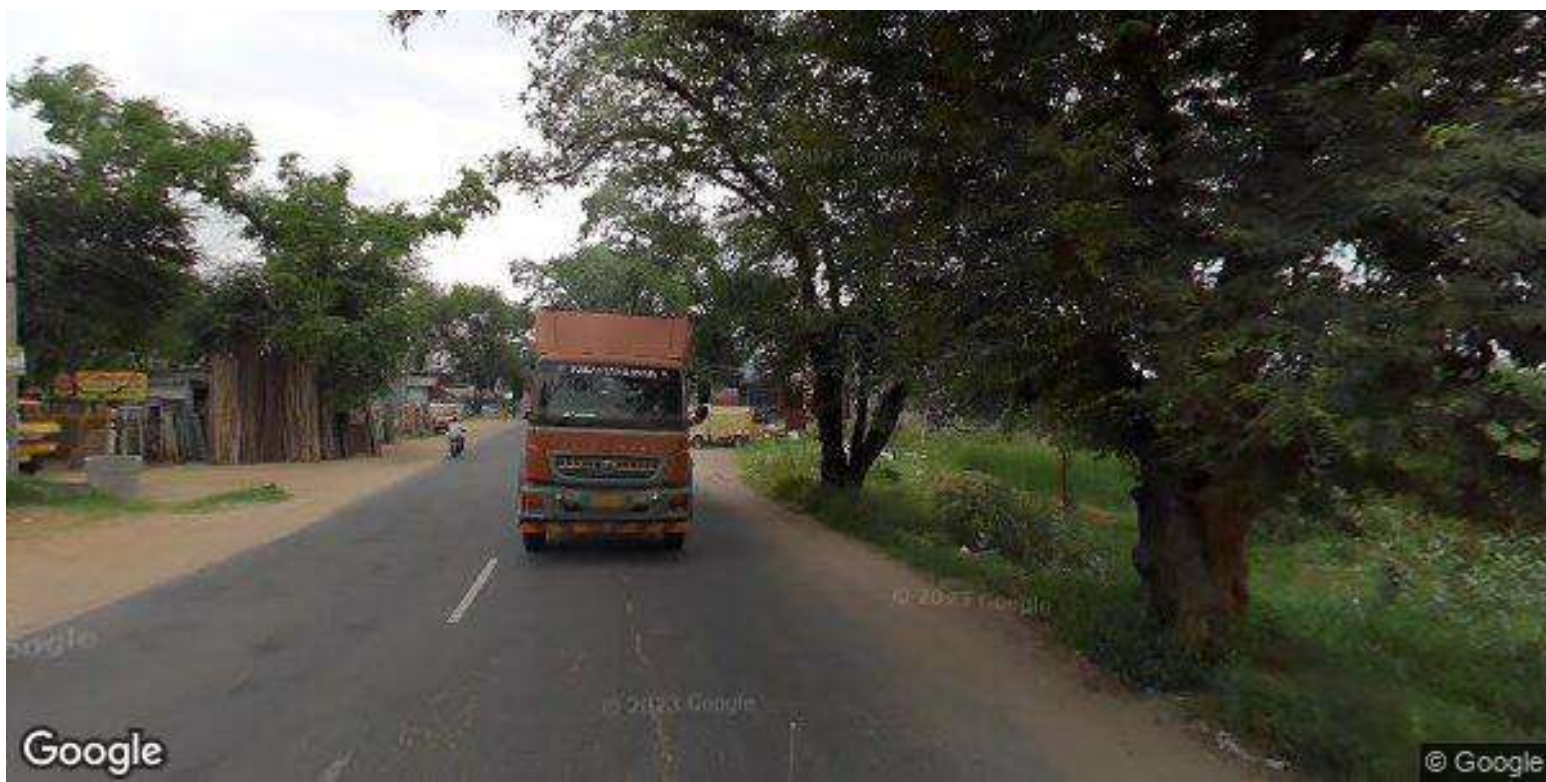
**Coordinates:** 11.67124, 78.22961

**Risk Type:** Turn

**Risk Level:** Medium

**Speed Limit:** 30 KM/Hr

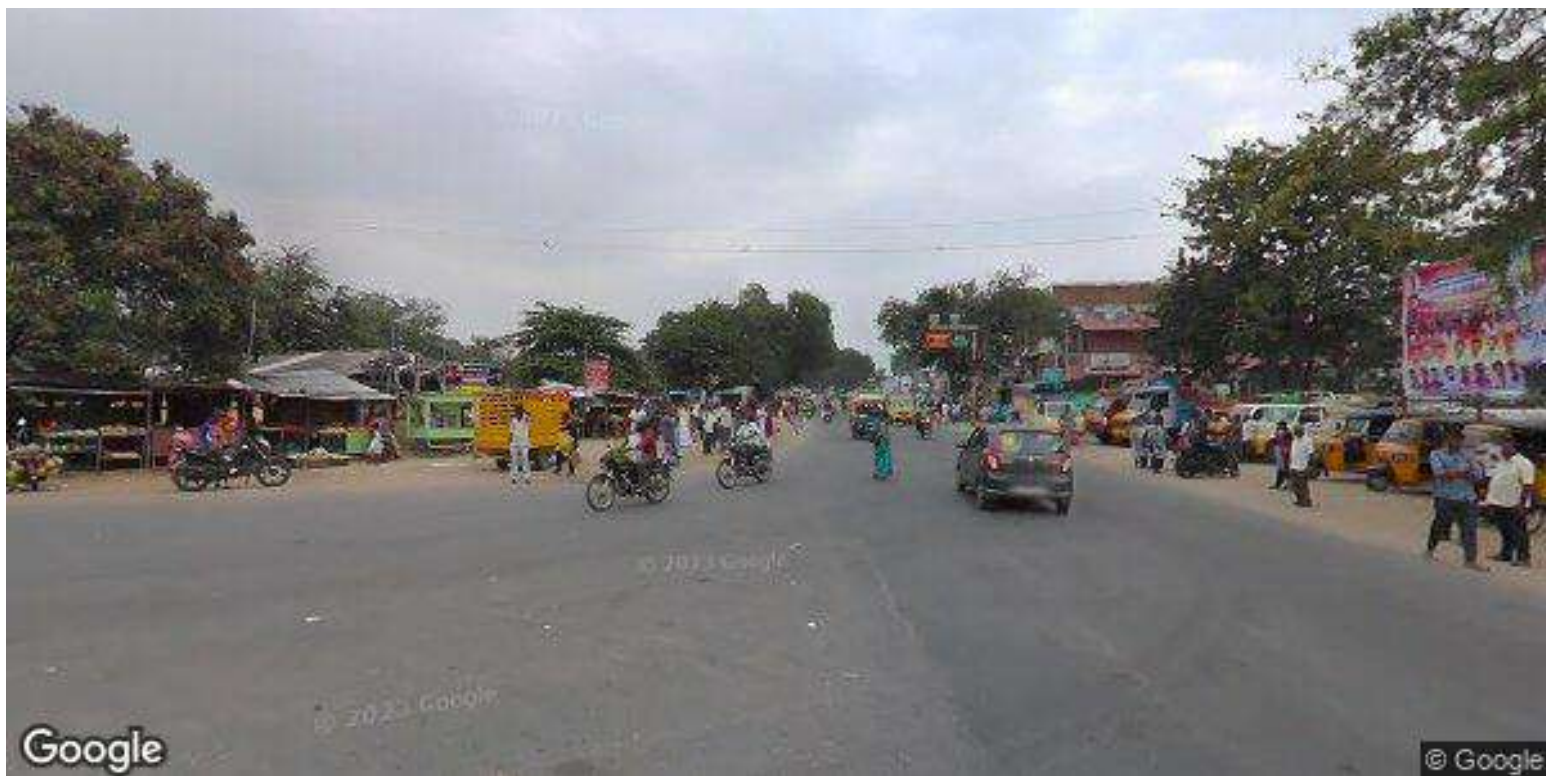
**Coordinates:** 11.67111, 78.23134

**Risk Type:** Turn

**Risk Level:** High

**Speed Limit:** 15 KM/Hr

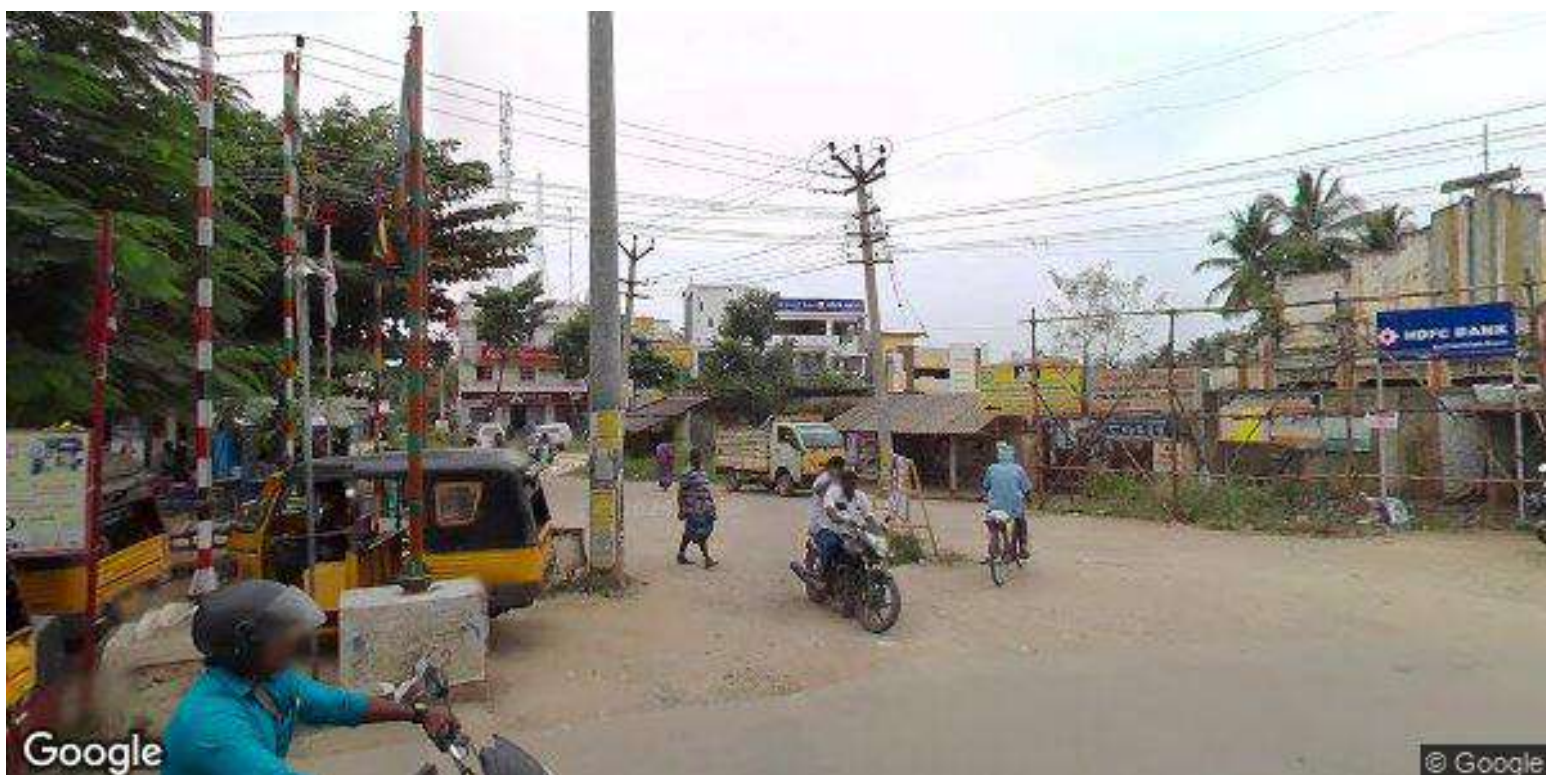
**Risk Type:** Turn  
**Risk Level:** High  
**Speed Limit:** 15 KM/Hr  
**Coordinates:** 11.67187, 78.23142

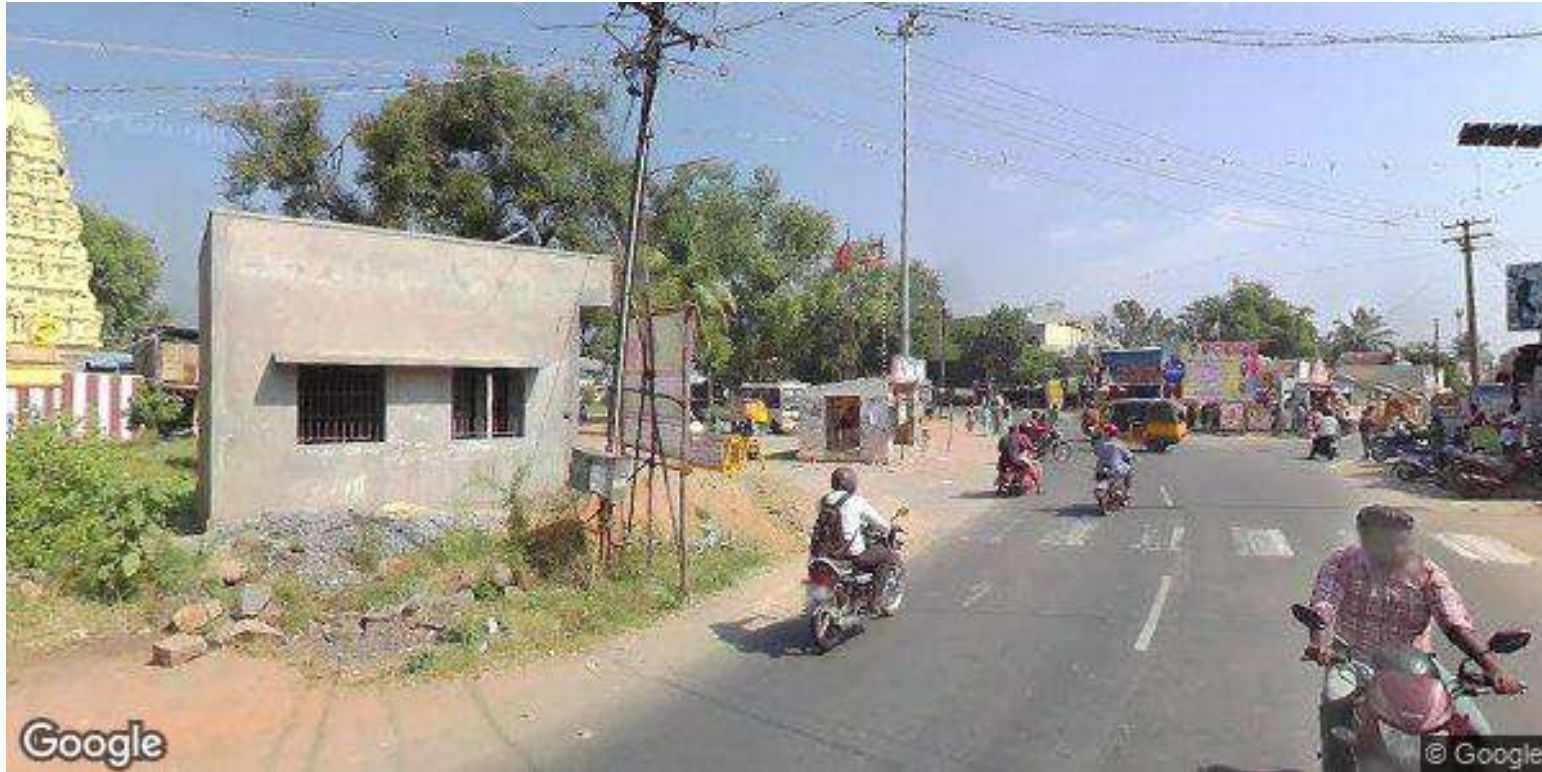
**Risk Type:** Turn  
**Risk Level:** Medium  
**Speed Limit:** 30 KM/Hr  
**Coordinates:** 11.67427, 78.23892
