## JOURNEY RISK MANAGEMENT (JRM) STUDY

### Salem Terminal TO VADIVELAN AGENCIES

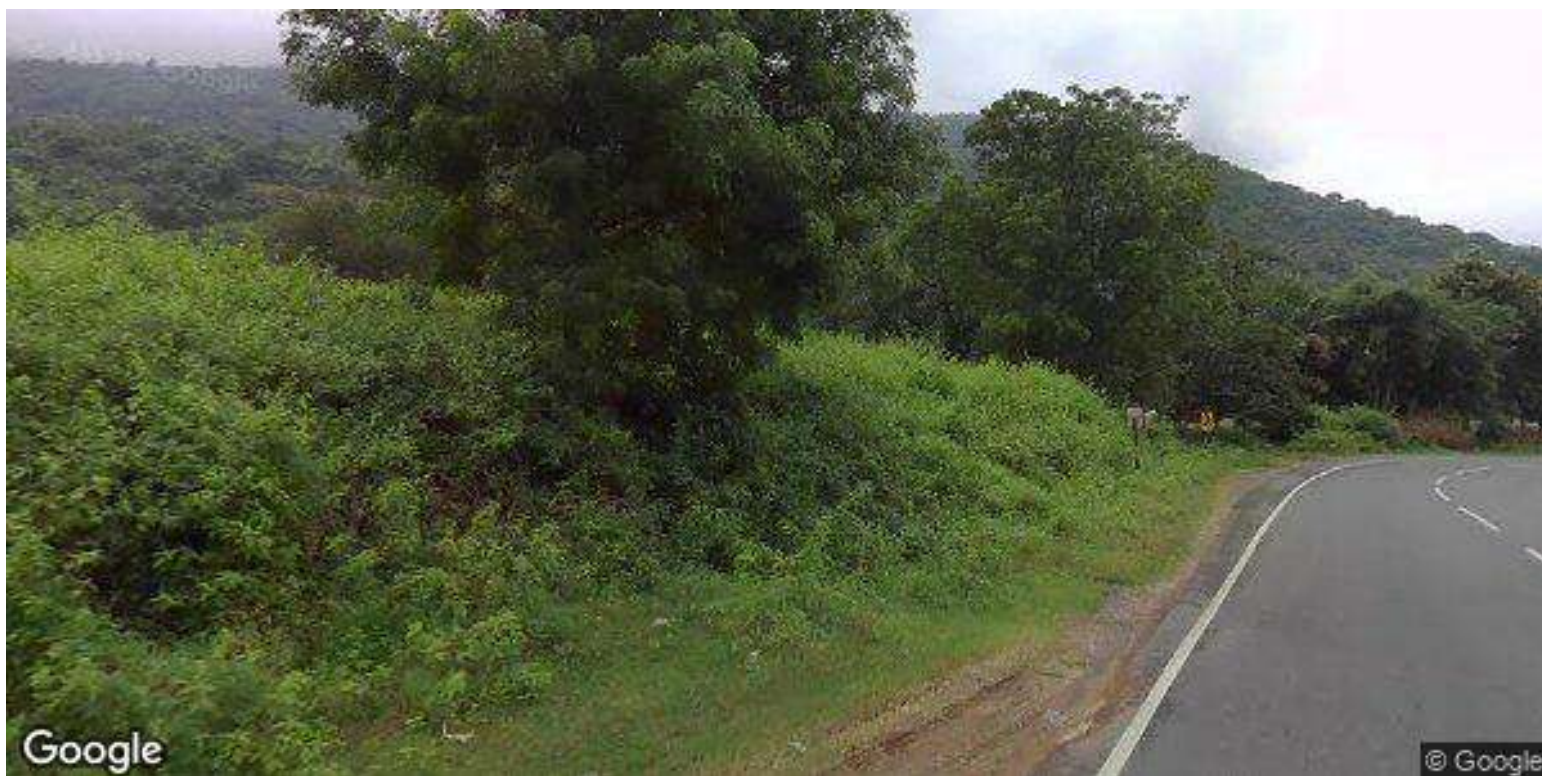
**Risk Type:** Turn  
**Risk Level:** Medium  
**Speed Limit:** 30 KM/Hr  
**Coordinates:** 11.80401, 78.33316

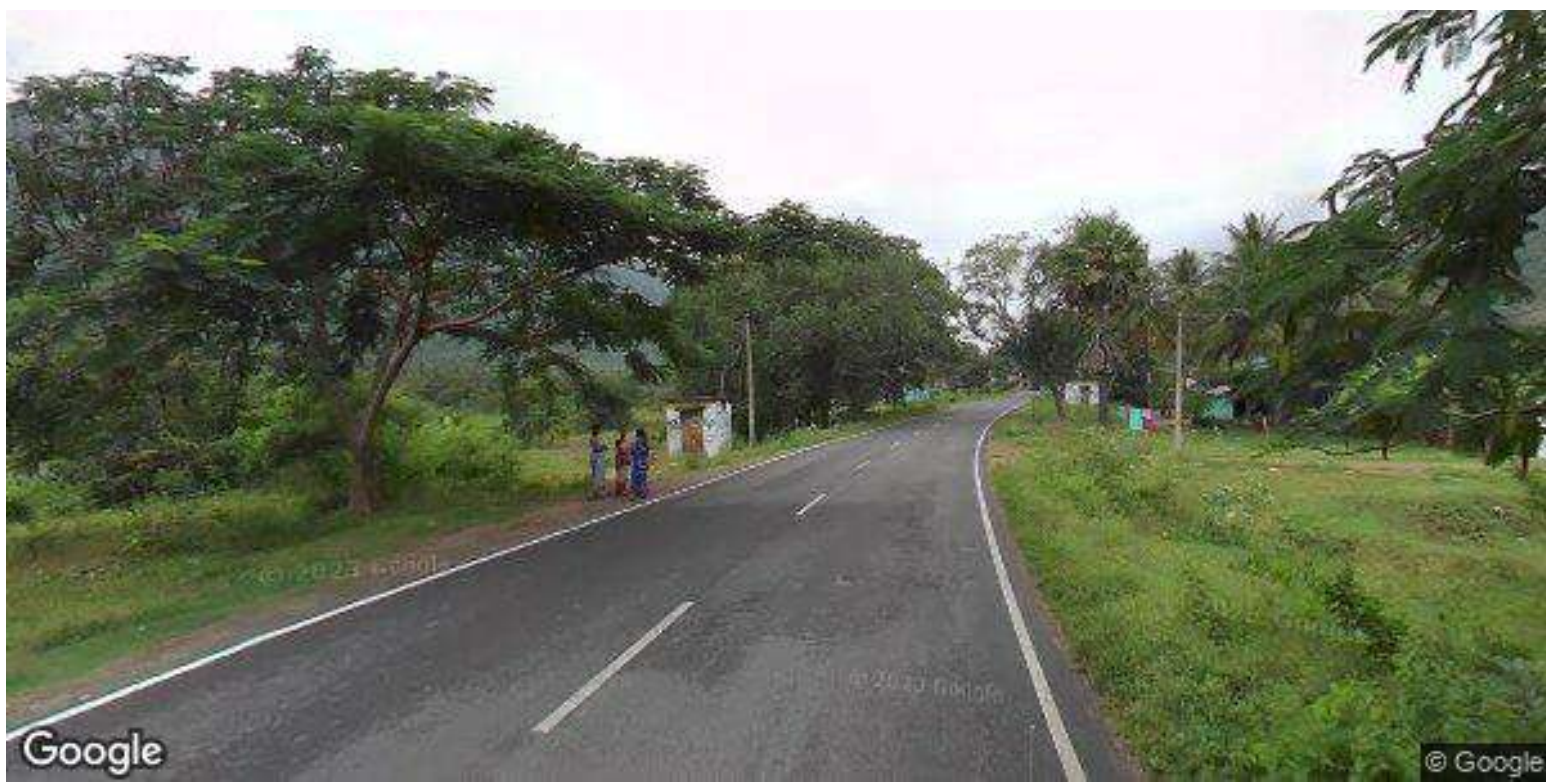
**Coordinates:** 11.81208, 78.34071

**Risk Type:** Turn

**Risk Level:** Medium

**Speed Limit:** 30 KM/Hr

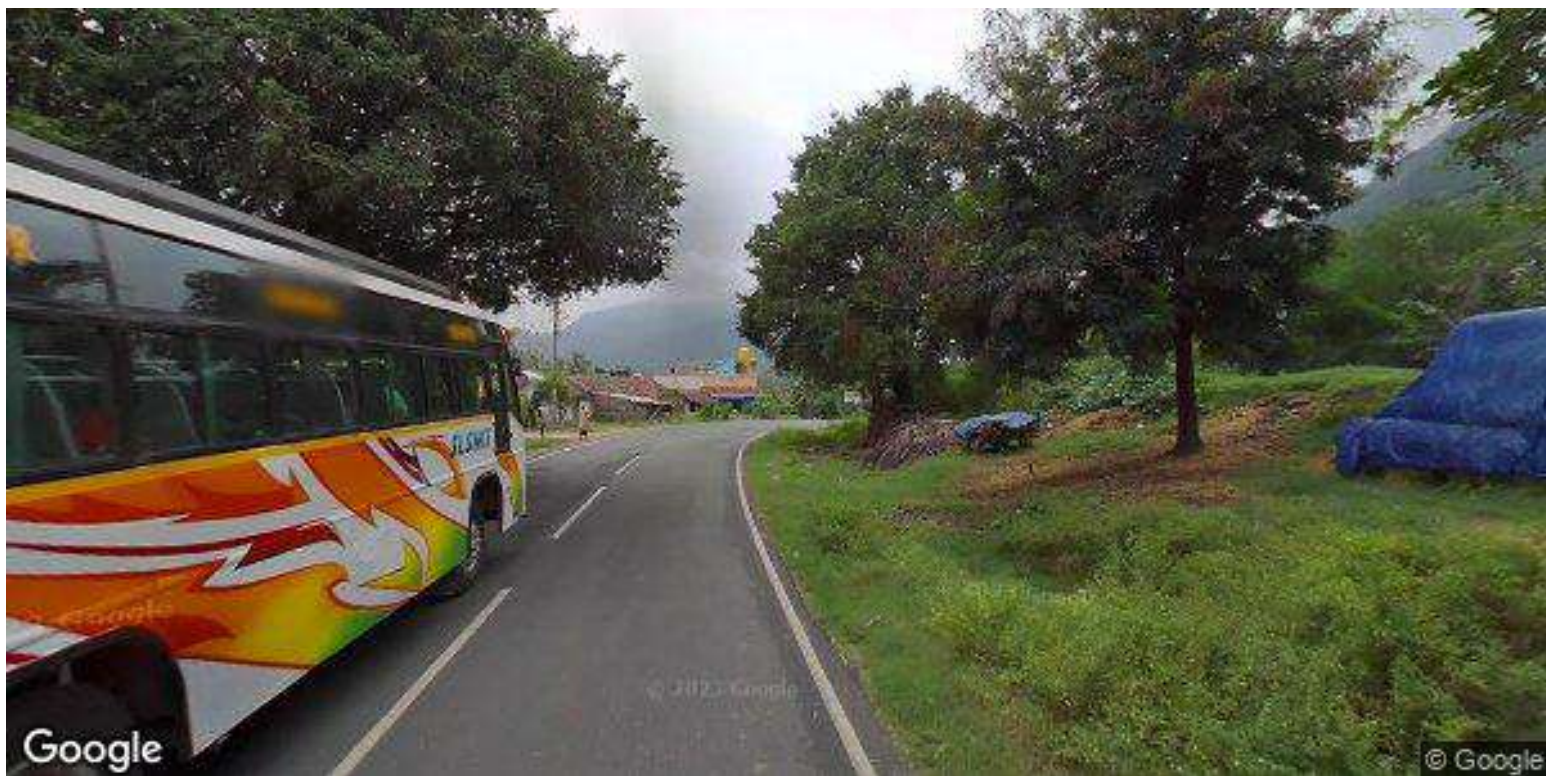
**Coordinates:** 11.83518, 78.35305

**Risk Type:** Turn

**Risk Level:** Medium

**Speed Limit:** 30 KM/Hr

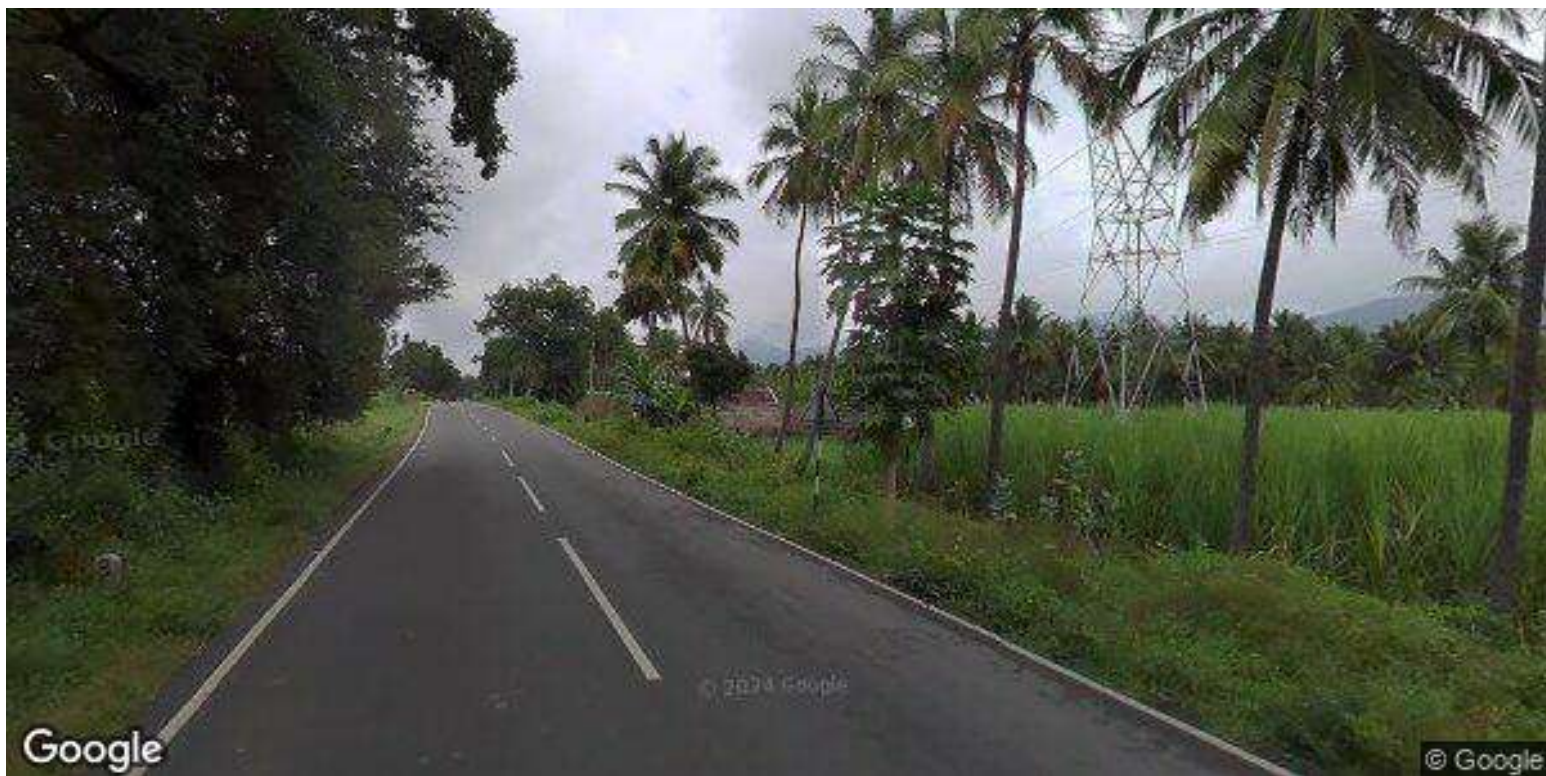
**Coordinates: 11.84832, 78.36115**

**Risk Type: Turn**

**Risk Level: Medium**

**Speed Limit: 30 KM/Hr**

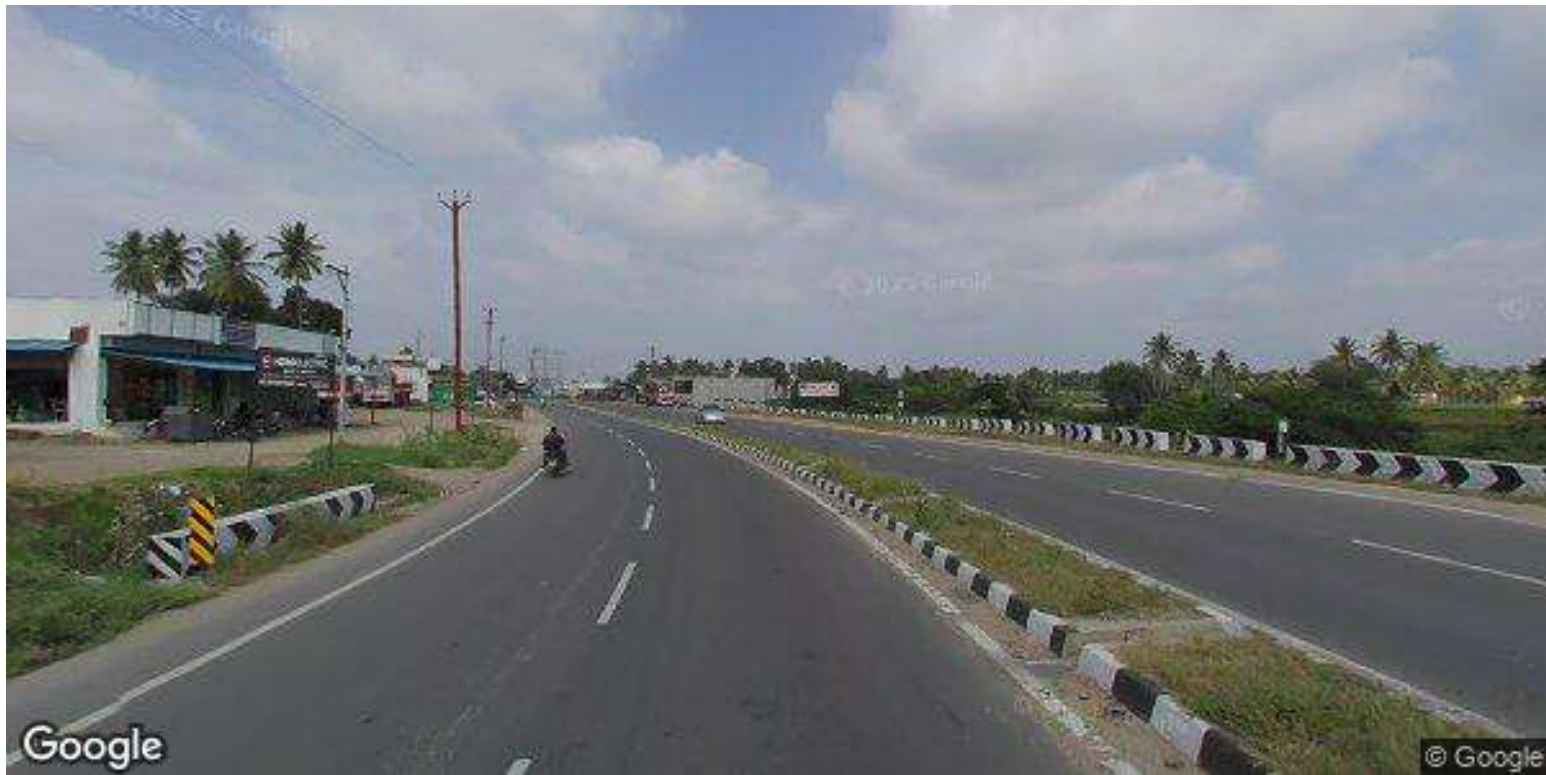
**Coordinates: 12.04286, 78.48352**

**Risk Type: Turn**

**Risk Level: Medium**

**Speed Limit: 30 KM/Hr**

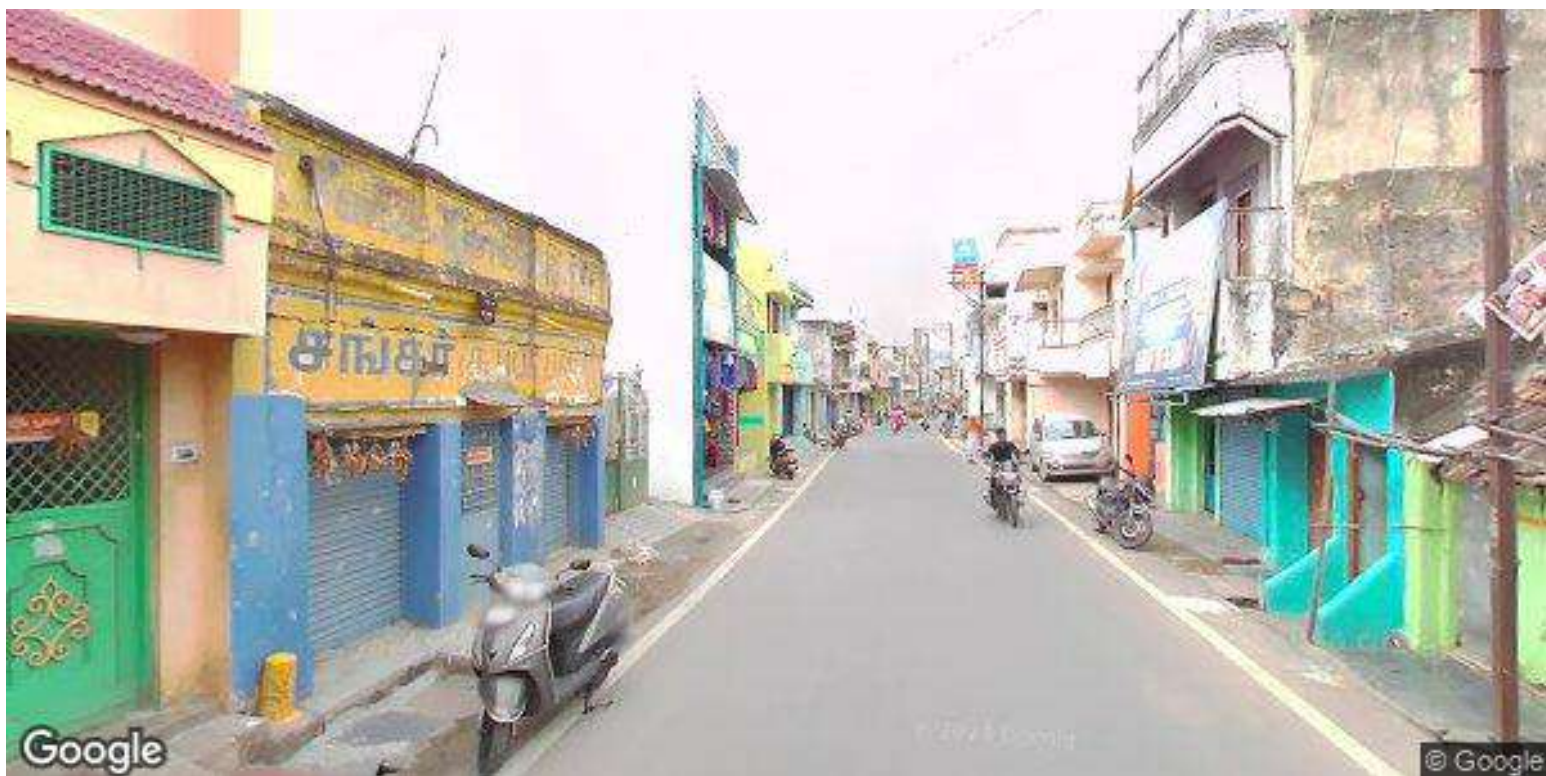
**Coordinates: 12.05026, 78.48298**

**Risk Type: Turn**

**Risk Level: Medium**

**Speed Limit: 30 KM/Hr**

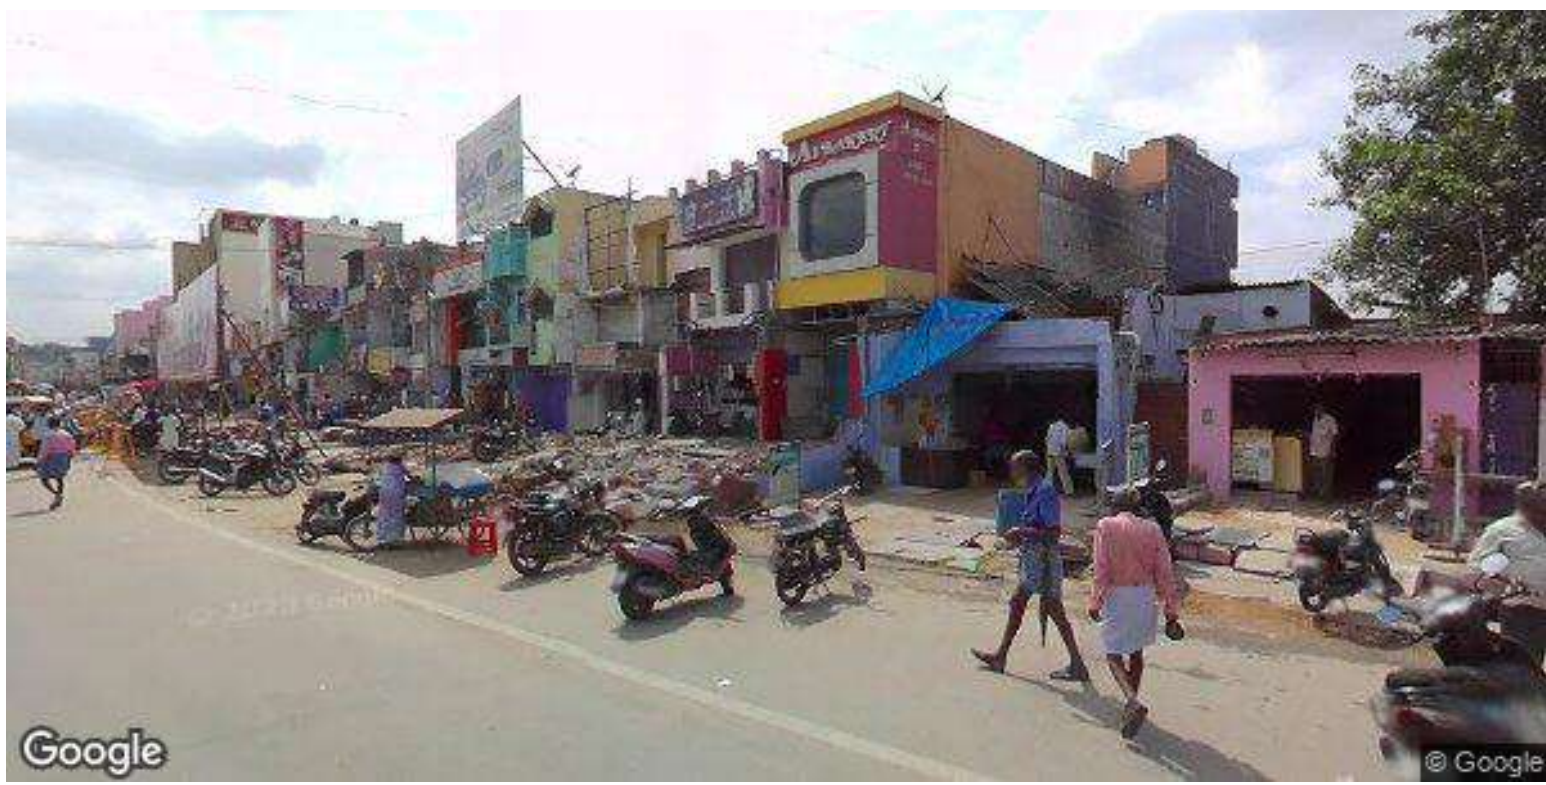
**Coordinates:** 12.05407, 78.48313

**Risk Type:** Turn

**Risk Level:** Medium

**Speed Limit:** 30 KM/Hr

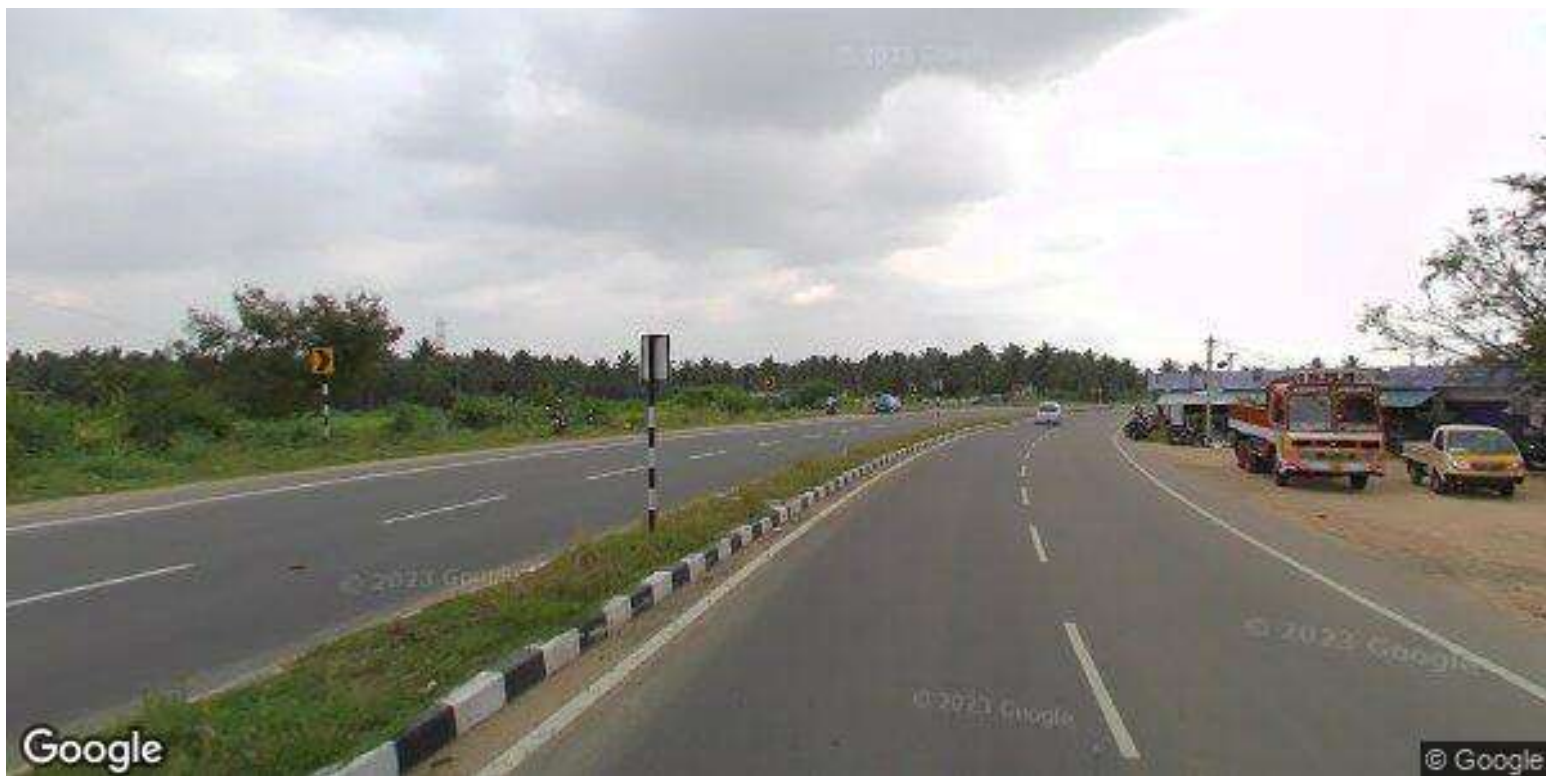
**Coordinates:** 12.07232, 78.47720

**Risk Type:** Turn

**Risk Level:** Medium

**Speed Limit:** 30 KM/Hr

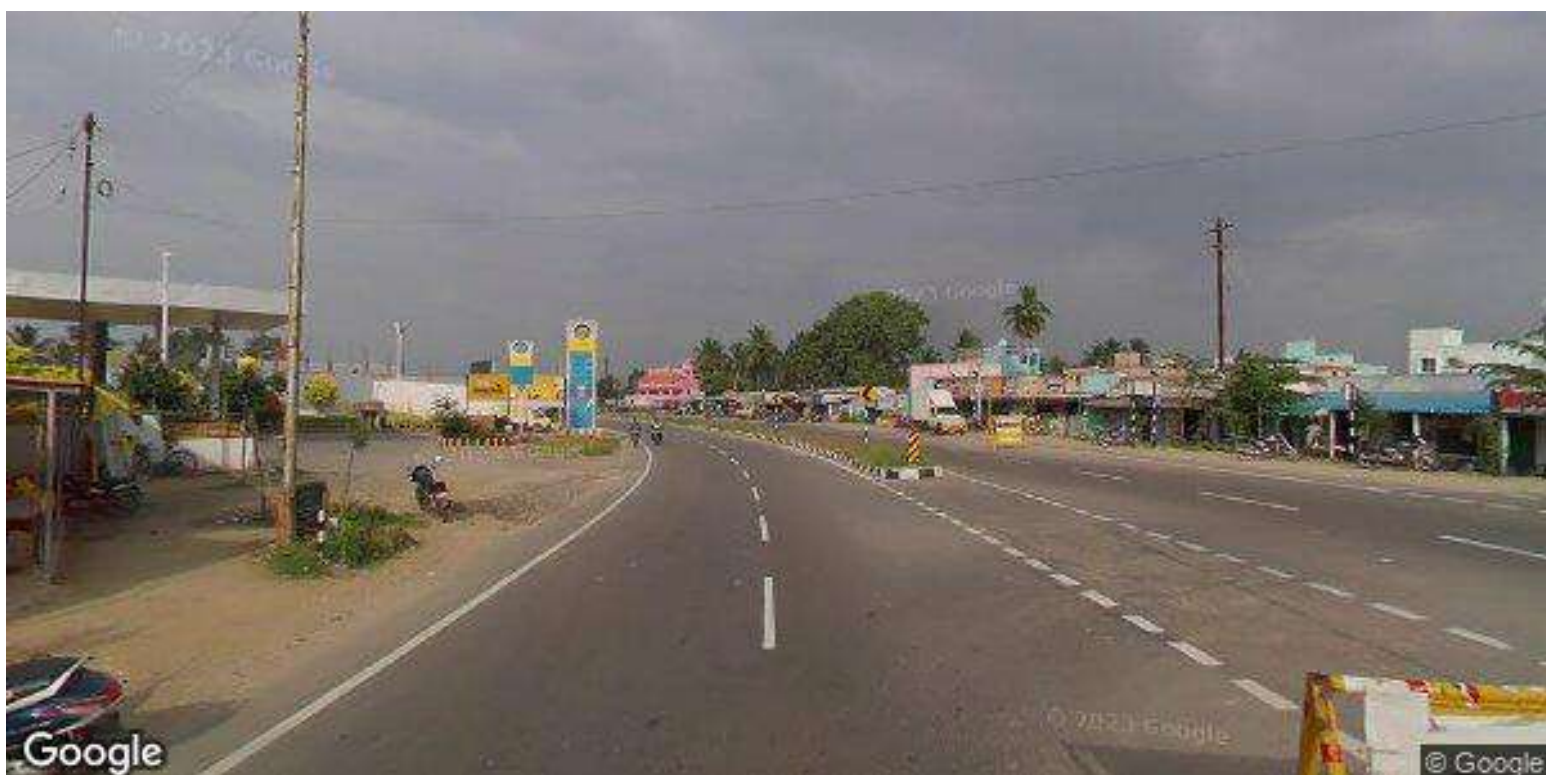
**Risk Type:** Turn  
**Risk Level:** Medium  
**Speed Limit:** 30 KM/Hr  
**Coordinates:** 12.17751, 78.54783

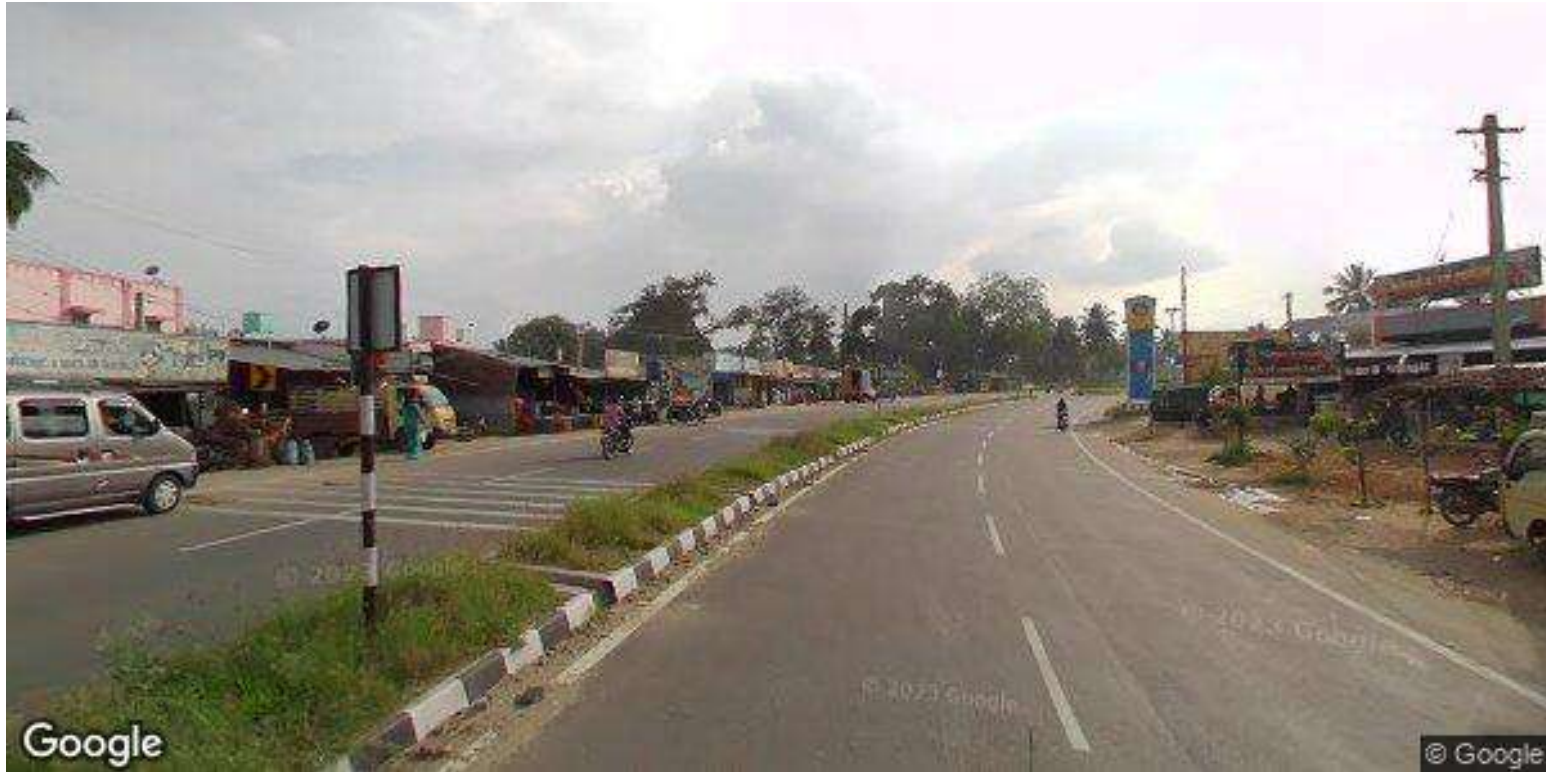
**Risk Type:** Turn  
**Risk Level:** Medium  
**Speed Limit:** 30 KM/Hr  
**Coordinates:** 12.17821, 78.54845

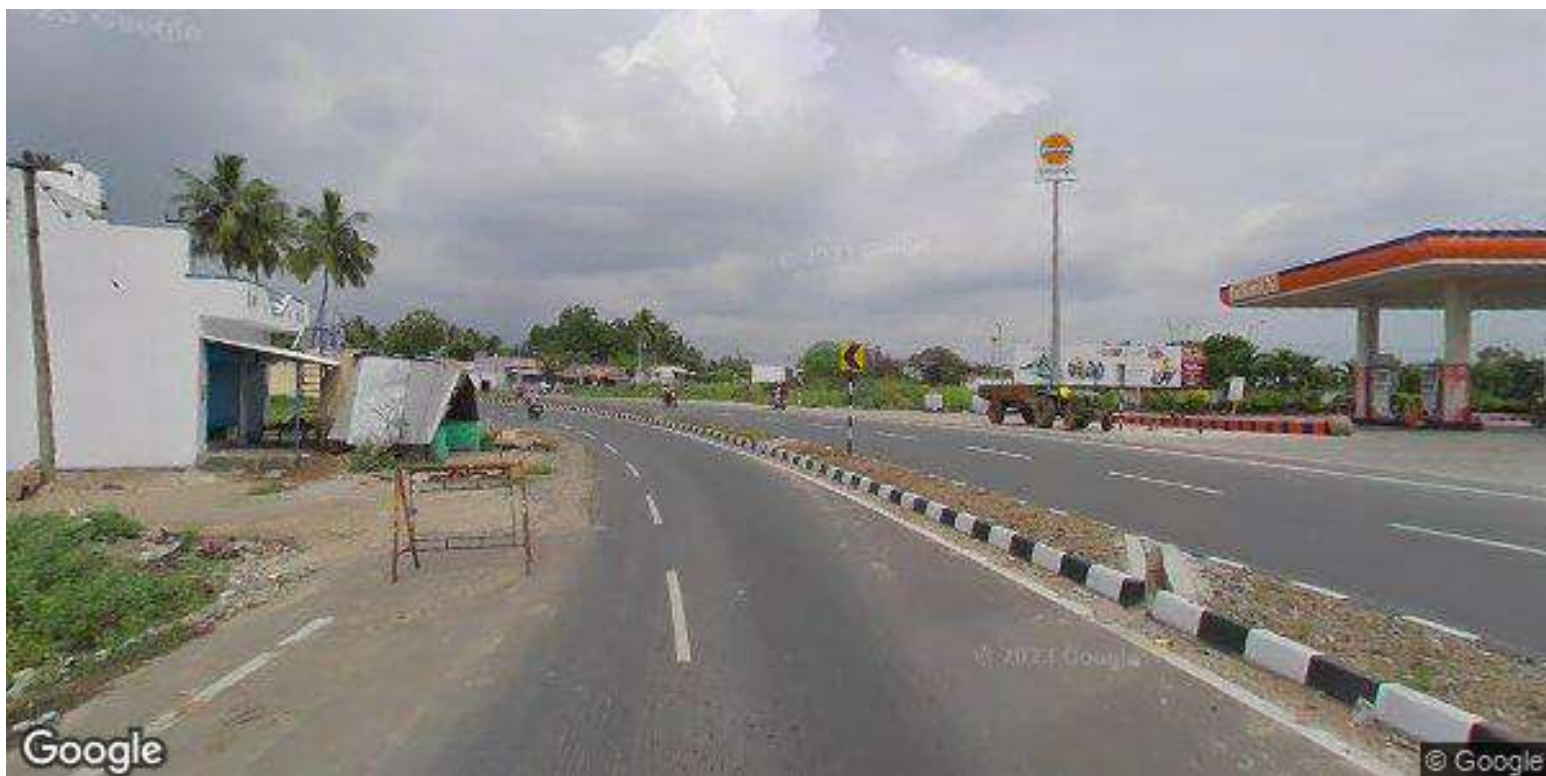
**Risk Type:** Turn  
**Risk Level:** High  
**Speed Limit:** 15 KM/Hr  
**Coordinates:** 12.18592, 78.54966

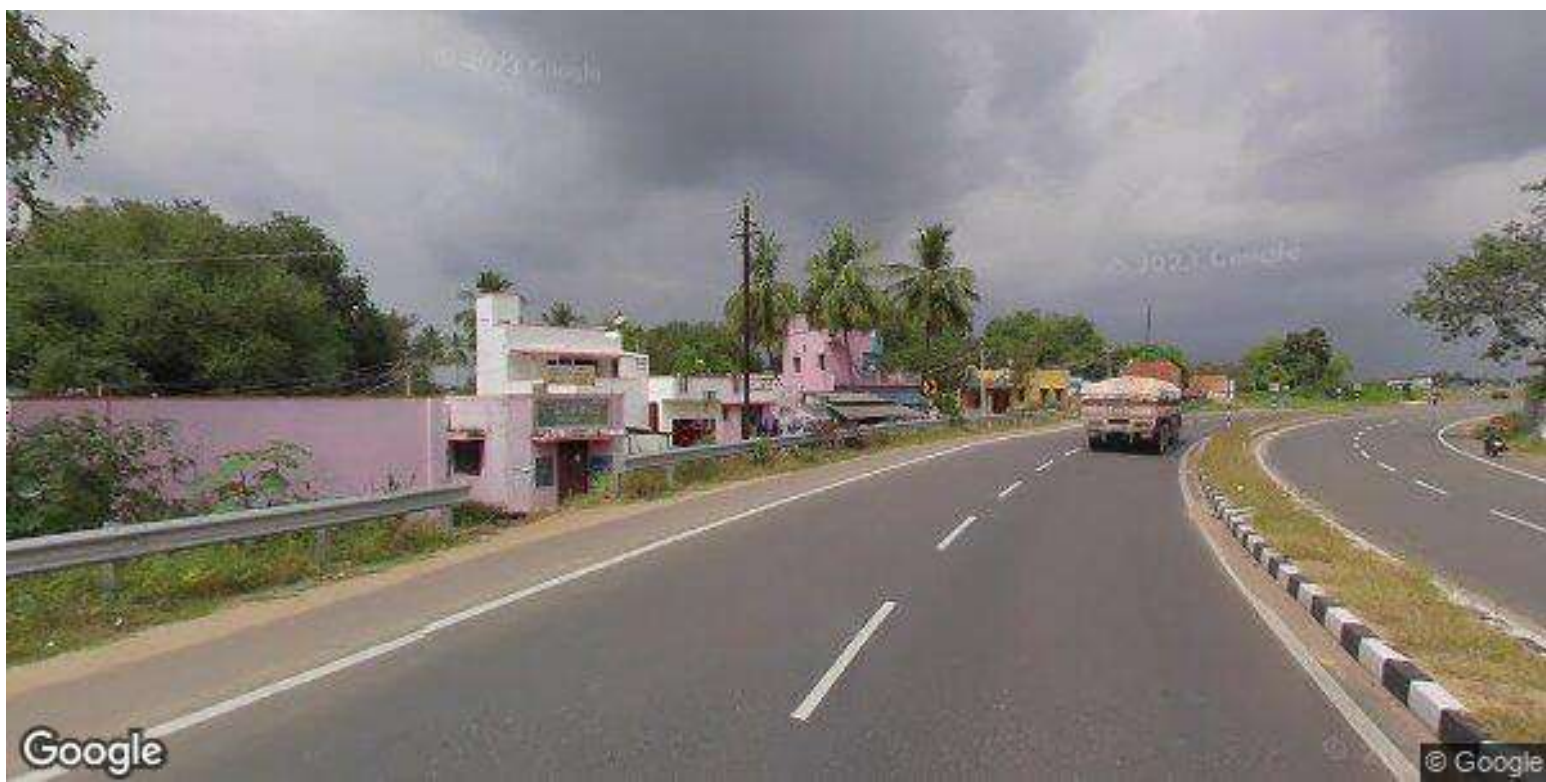
**Coordinates:** 12.20108, 78.54385

**Risk Type:** Turn

**Risk Level:** Medium

**Speed Limit:** 30 KM/Hr

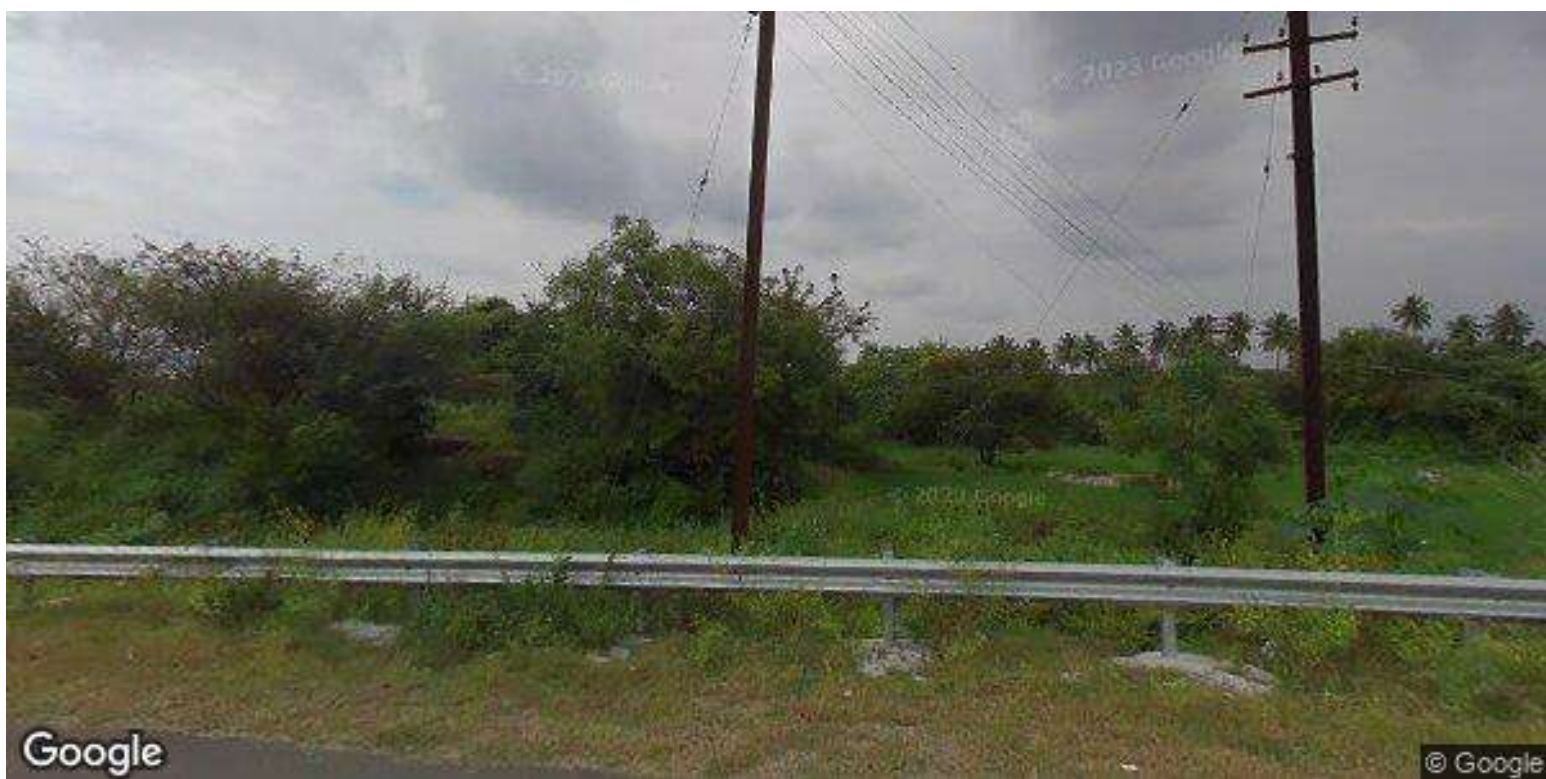
**Coordinates:** 12.20933, 78.54354

**Risk Type:** Turn

**Risk Level:** Medium

**Speed Limit:** 30 KM/Hr

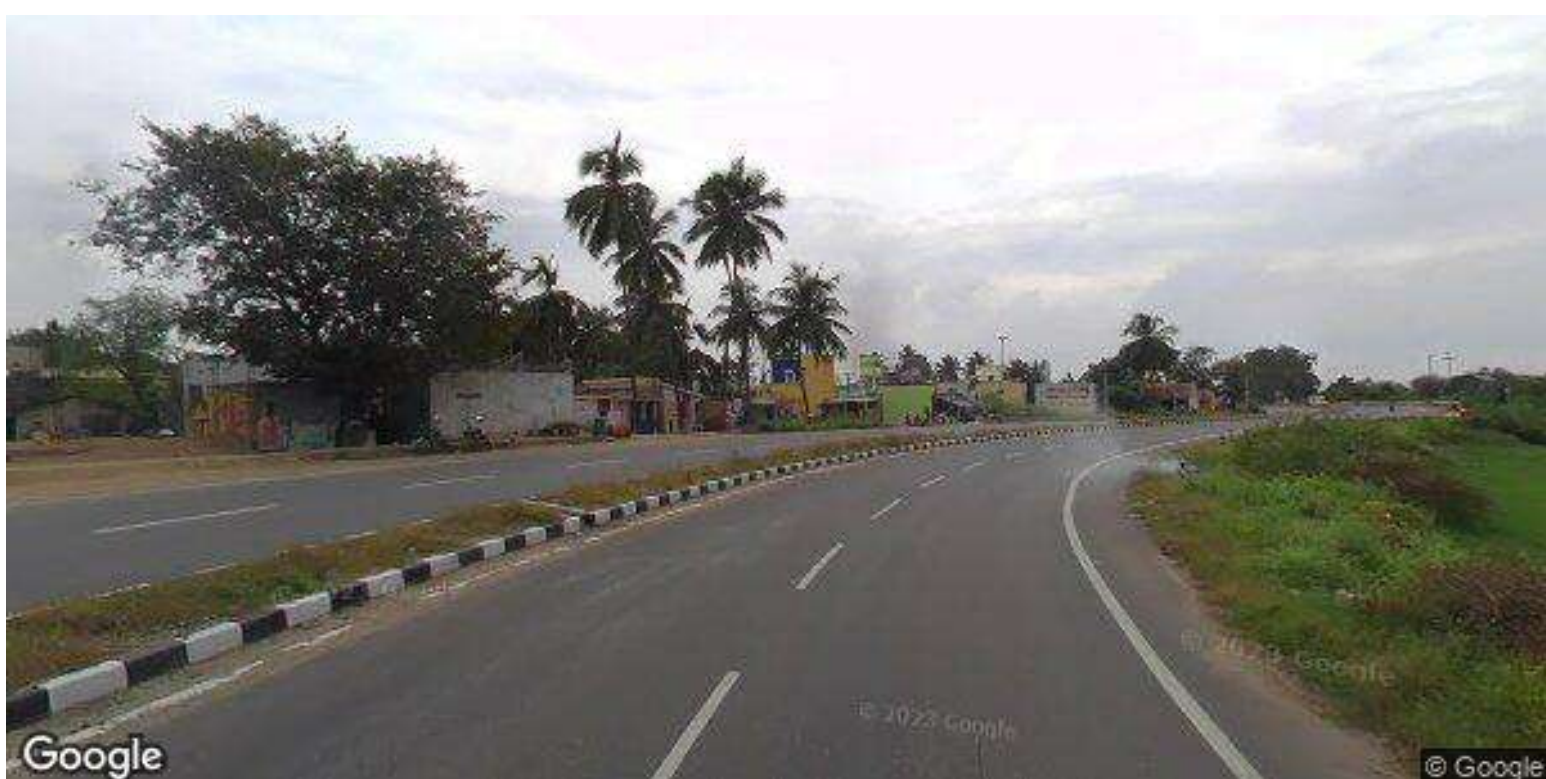
**Coordinates:** 12.21071, 78.54412

**Risk Type:** Turn

**Risk Level:** Medium

**Speed Limit:** 30 KM/Hr

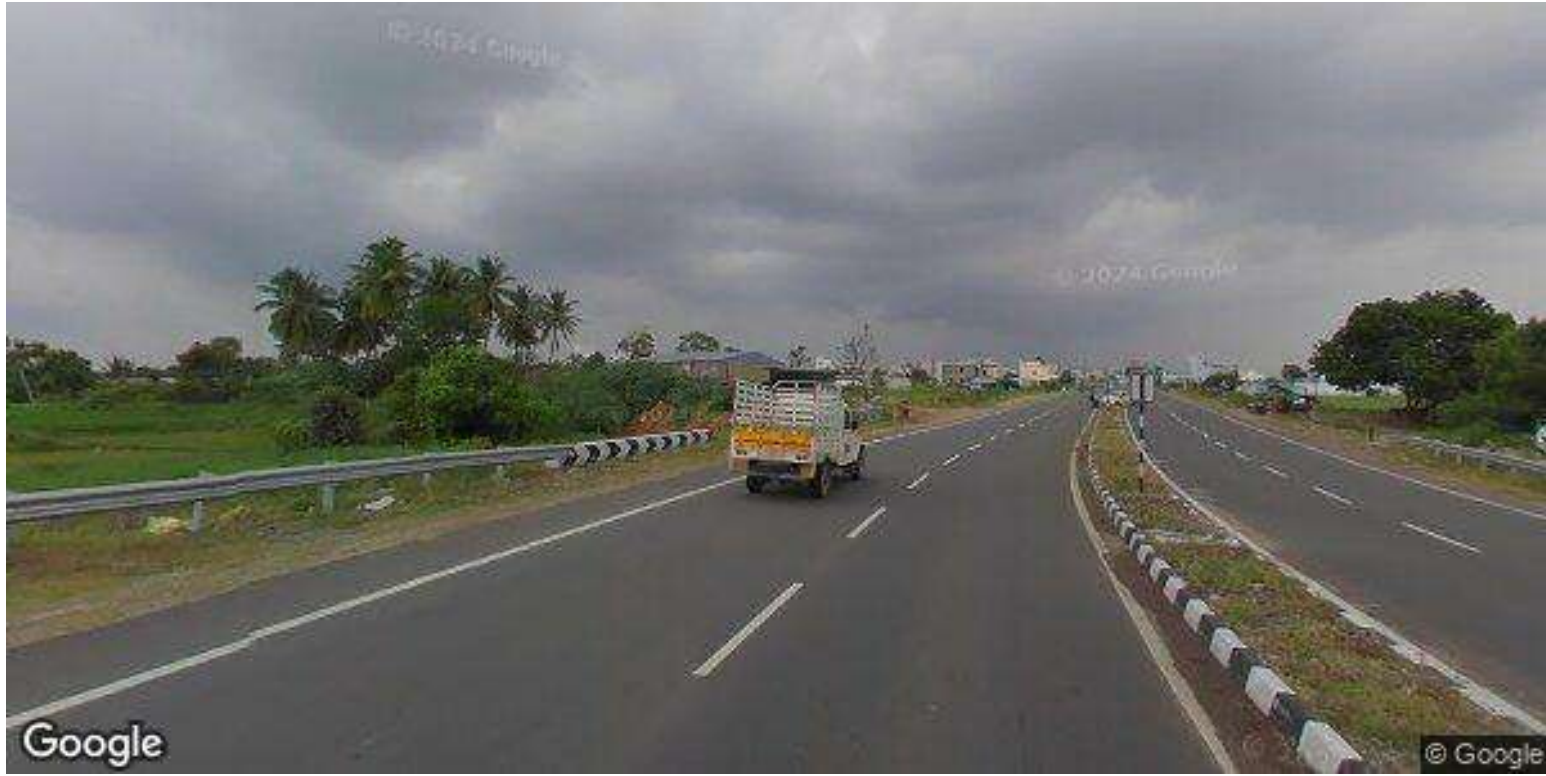
**Coordinates:** 12.24997, 78.53501

**Risk Type:** Turn

**Risk Level:** Medium

**Speed Limit:** 30 KM/Hr

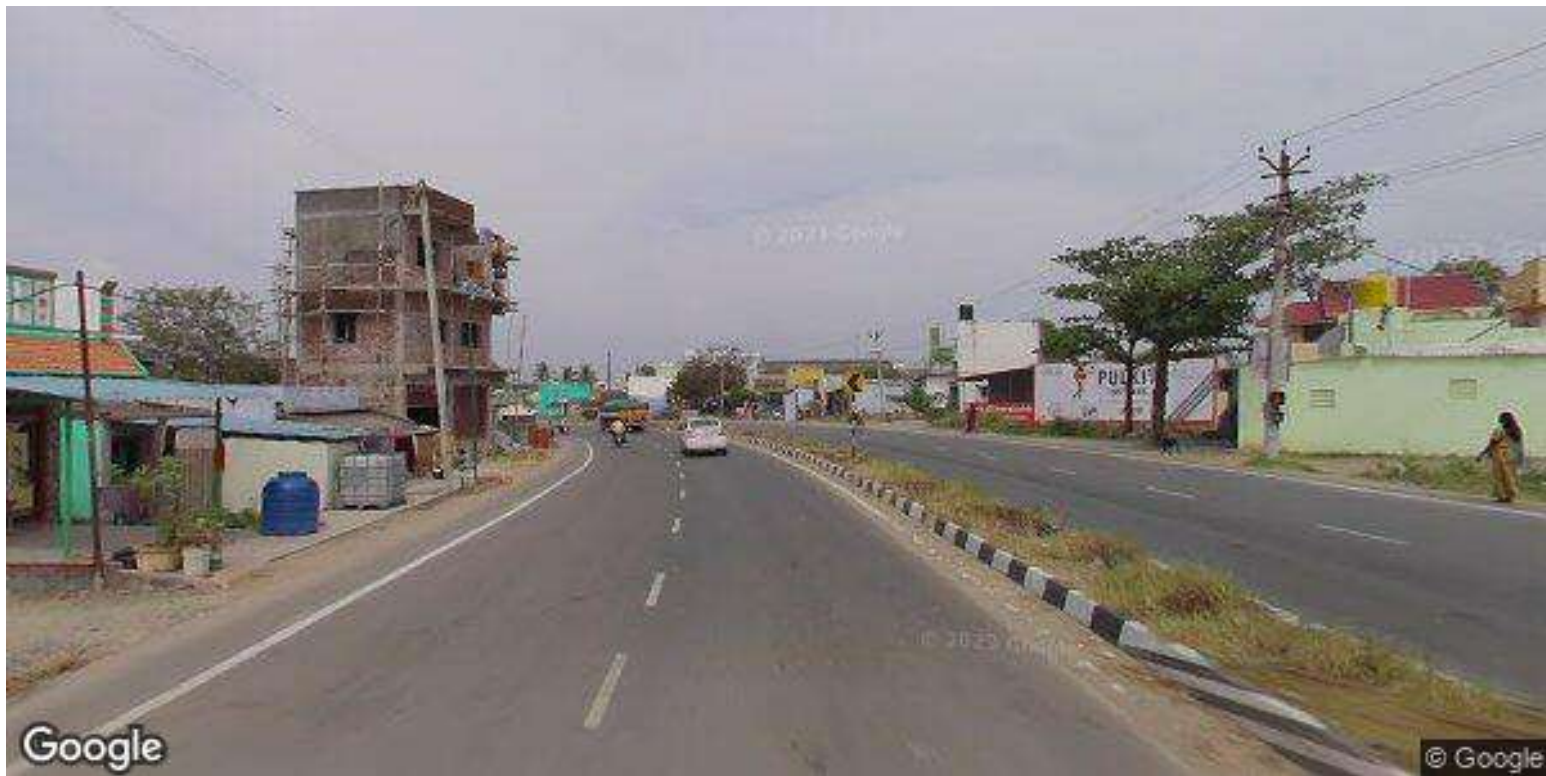
**Coordinates:** 12.25781, 78.53395

**Risk Type:** Turn

**Risk Level:** Medium

**Speed Limit:** 30 KM/Hr

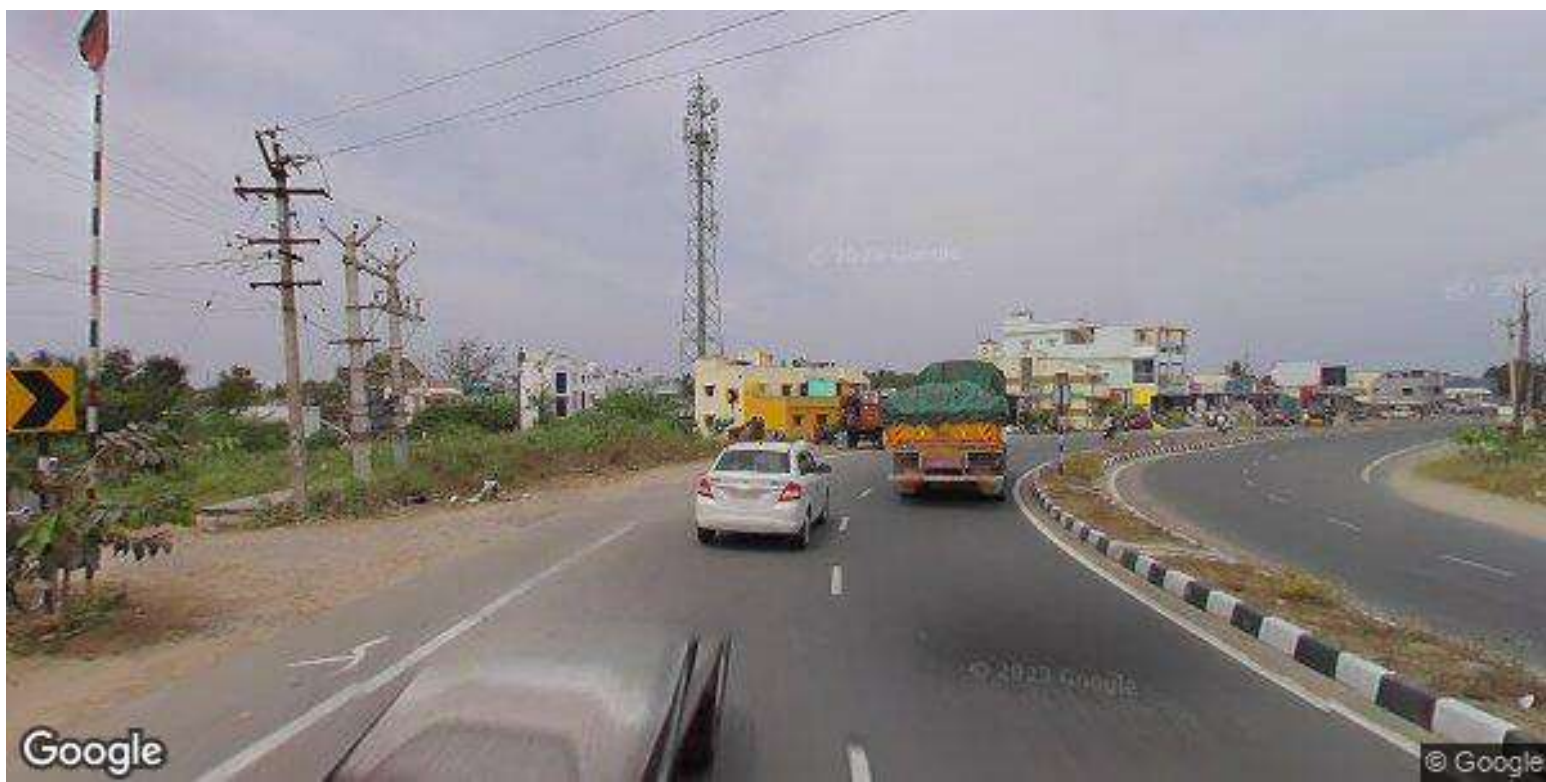
**Coordinates:** 12.25897, 78.53314

**Risk Type:** Turn

**Risk Level:** Medium

**Speed Limit:** 30 KM/Hr

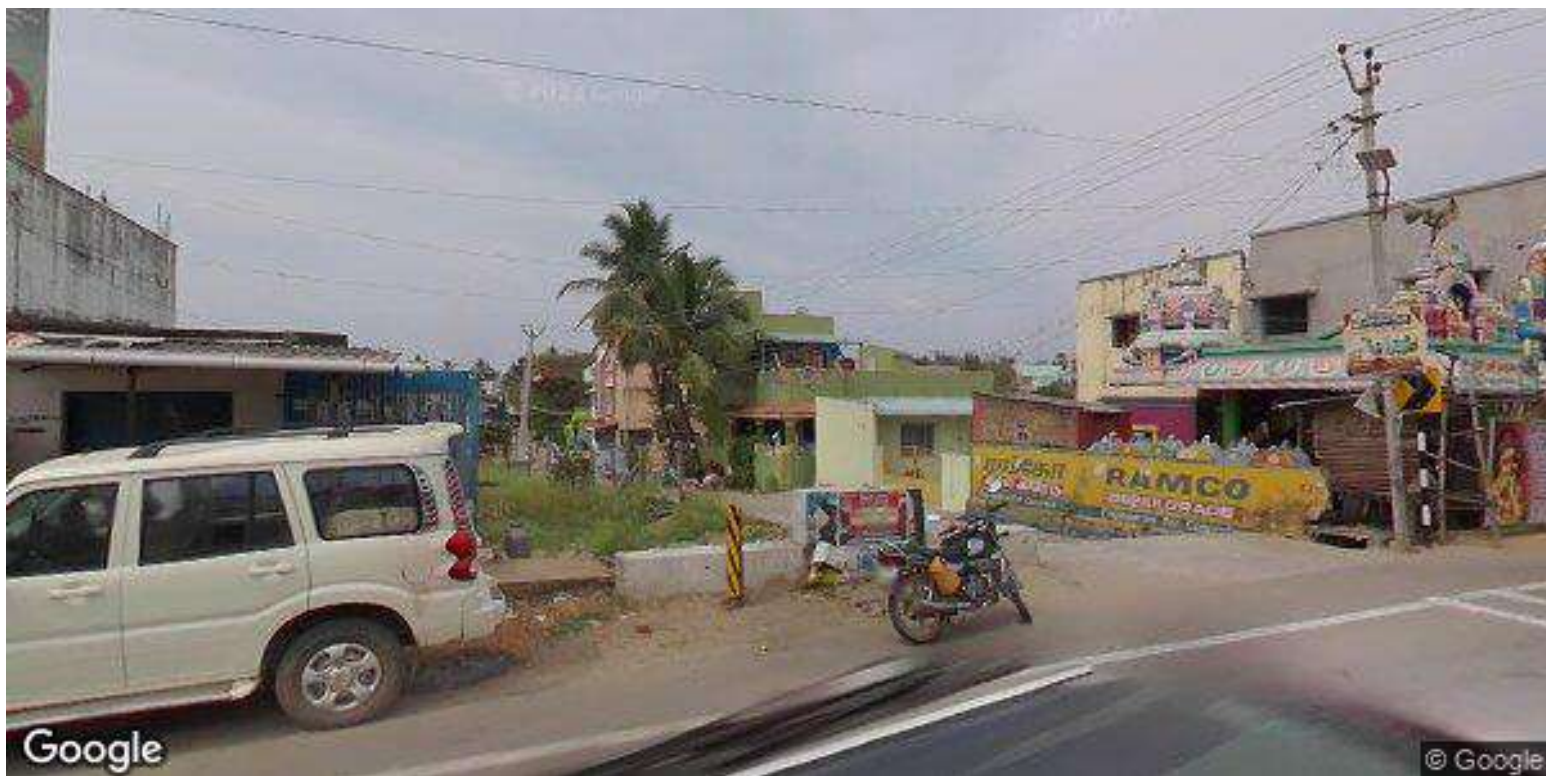
**Coordinates:** 12.26049, 78.53306

**Risk Type:** Turn

**Risk Level:** Medium

**Speed Limit:** 30 KM/Hr

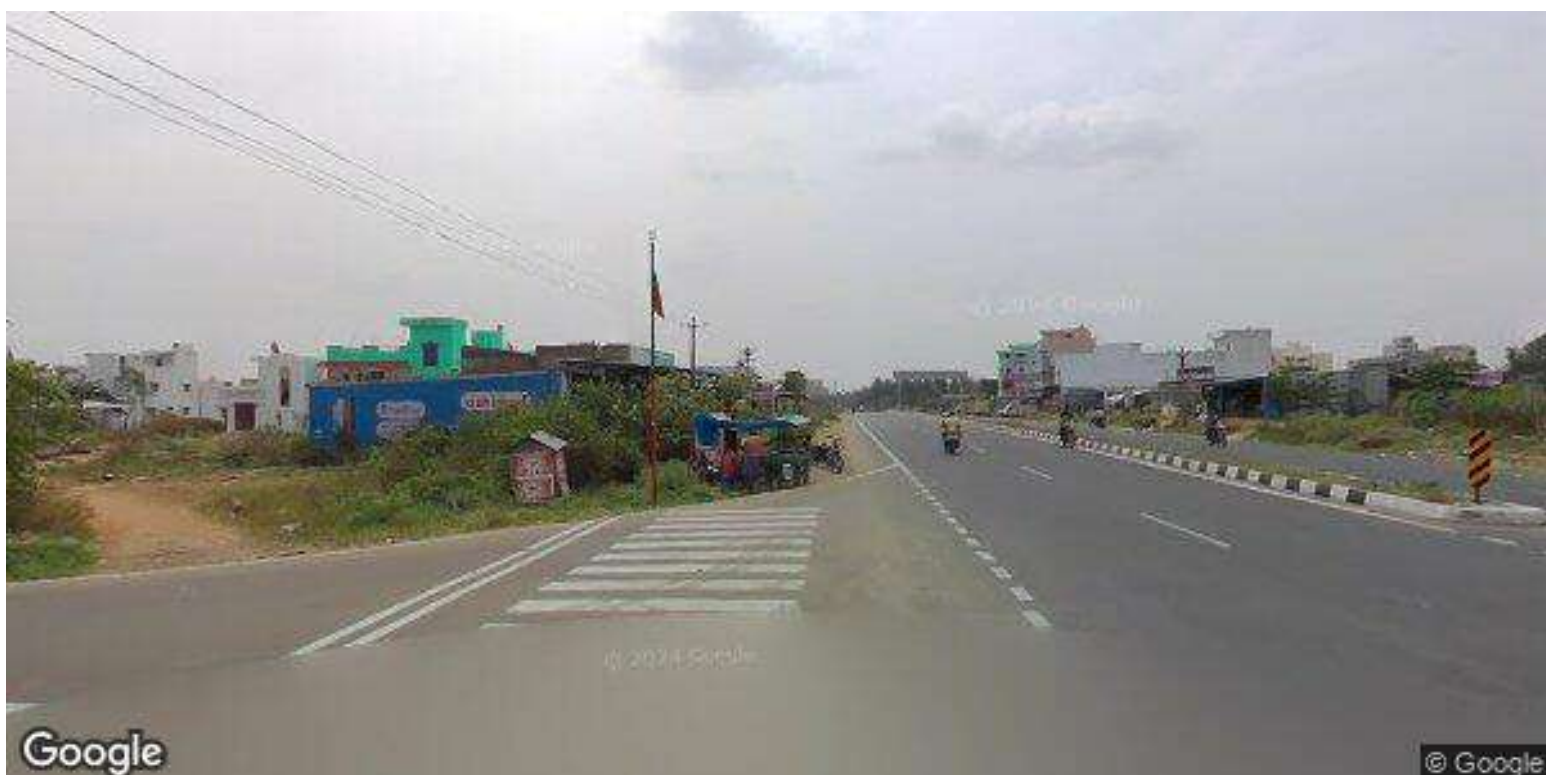
**Coordinates:** 12.27845, 78.53587

**Risk Type:** Blind Spot

**Risk Level:** Blind Spot

**Speed Limit:** 10 KM/Hr
