# IndianOil

## JOURNEY RISK MANAGEMENT (JRM) STUDY

### Salem Terminal TO SAKTHI FUELS

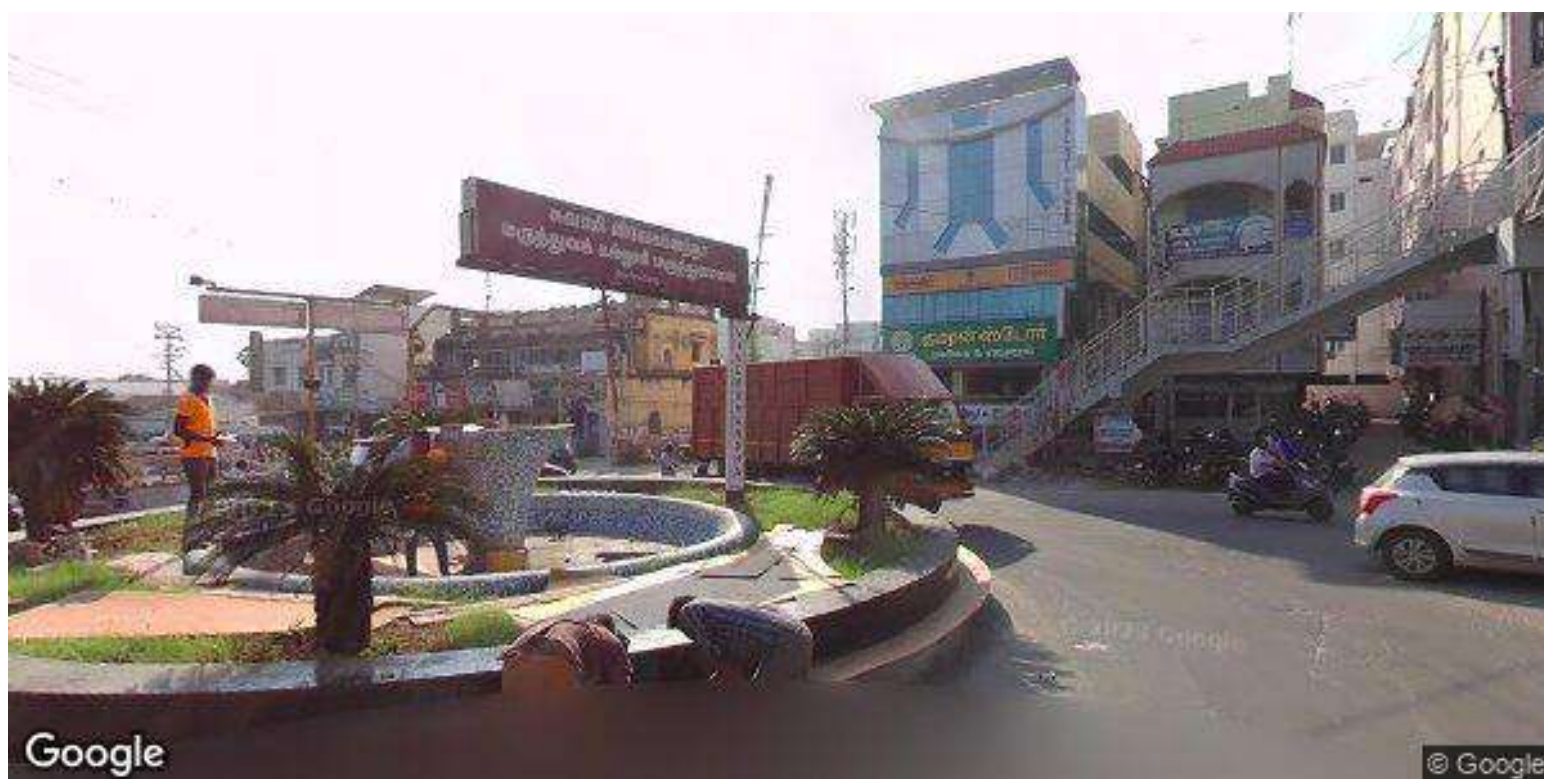
**Coordinates:** 11.38395, 77.89480

**Risk Type:** Roundabout

**Risk Level:** High

**Speed Limit:** 15 KM/Hr

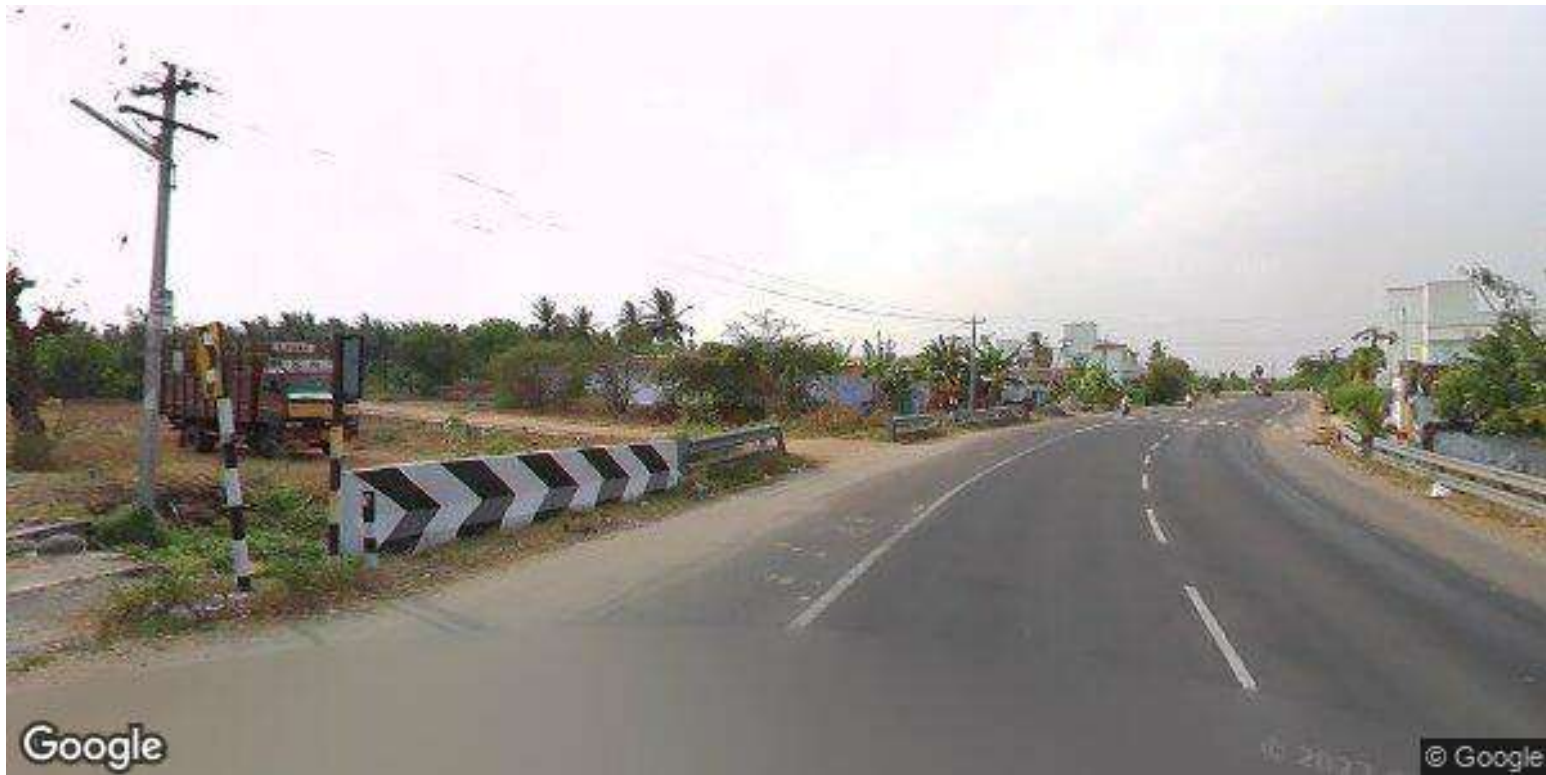
**Coordinates:** 11.16755, 78.01568

**Risk Type:** Turn

**Risk Level:** Medium

**Speed Limit:** 30 KM/Hr

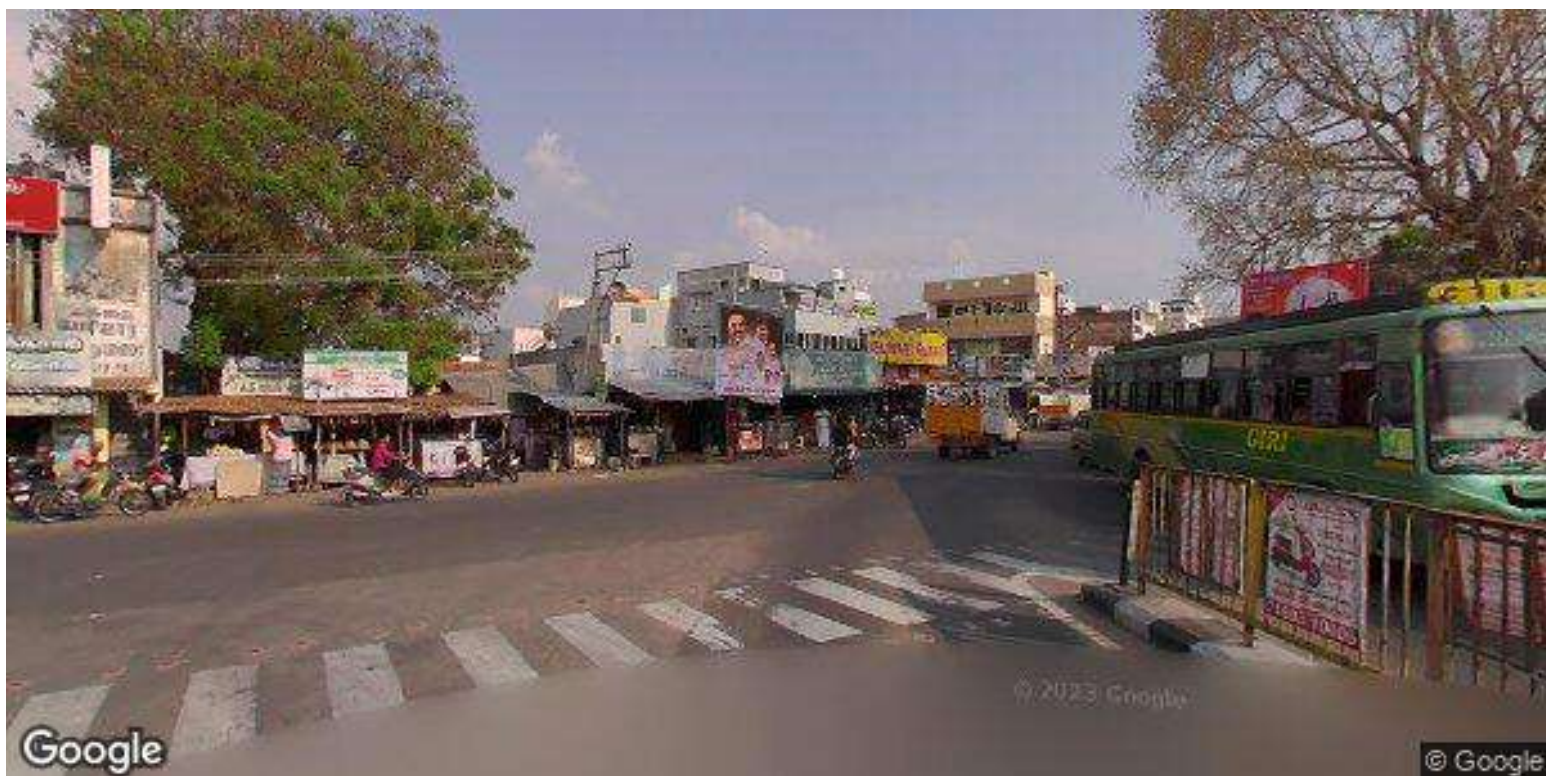
**Coordinates:** 11.15579, 78.02169

**Risk Type:** Turn

**Risk Level:** Medium

**Speed Limit:** 30 KM/Hr

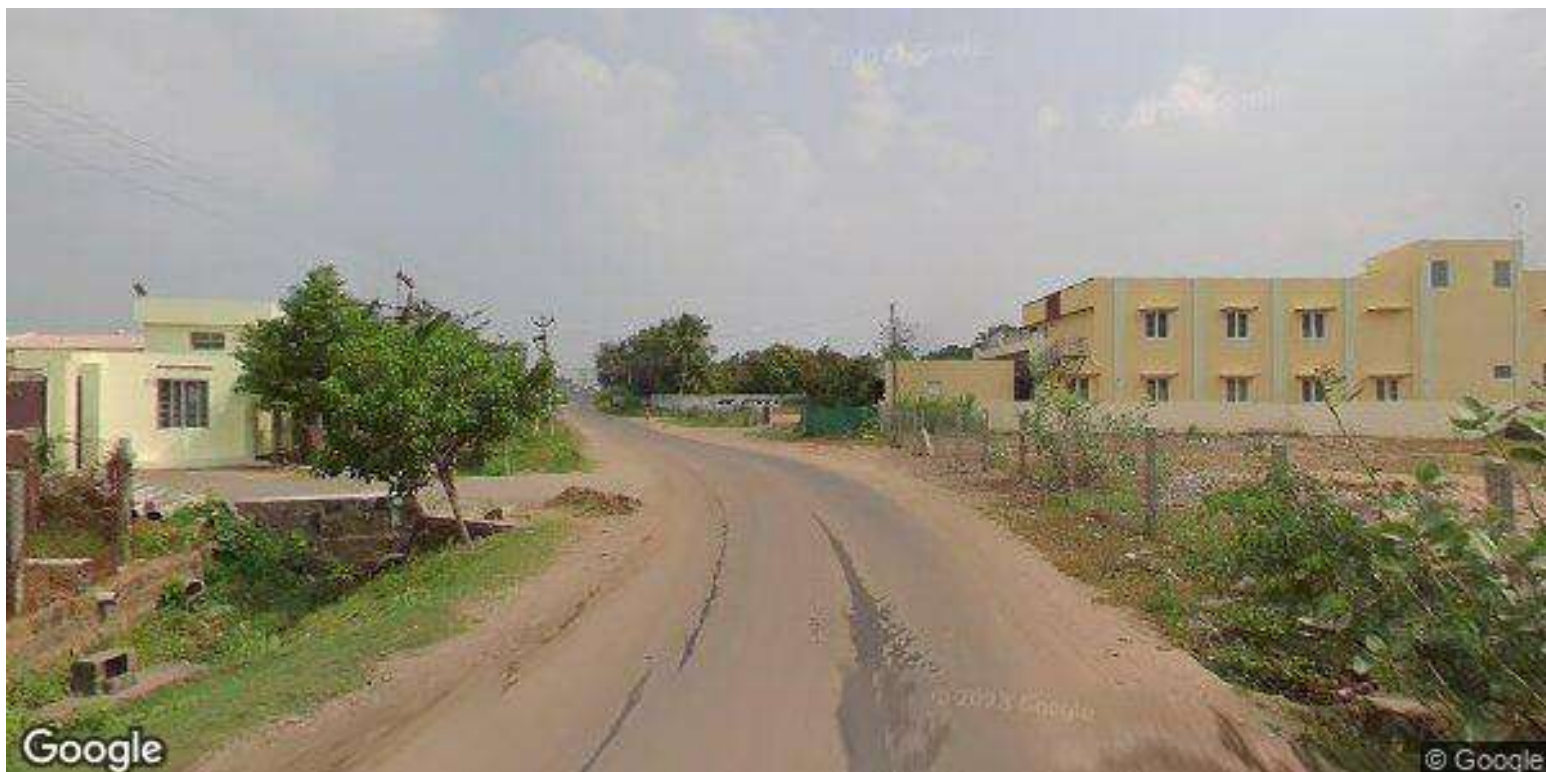
**Risk Type:** Turn  
**Risk Level:** Medium  
**Speed Limit:** 30 KM/Hr  
**Coordinates:** 10.95026, 78.04855

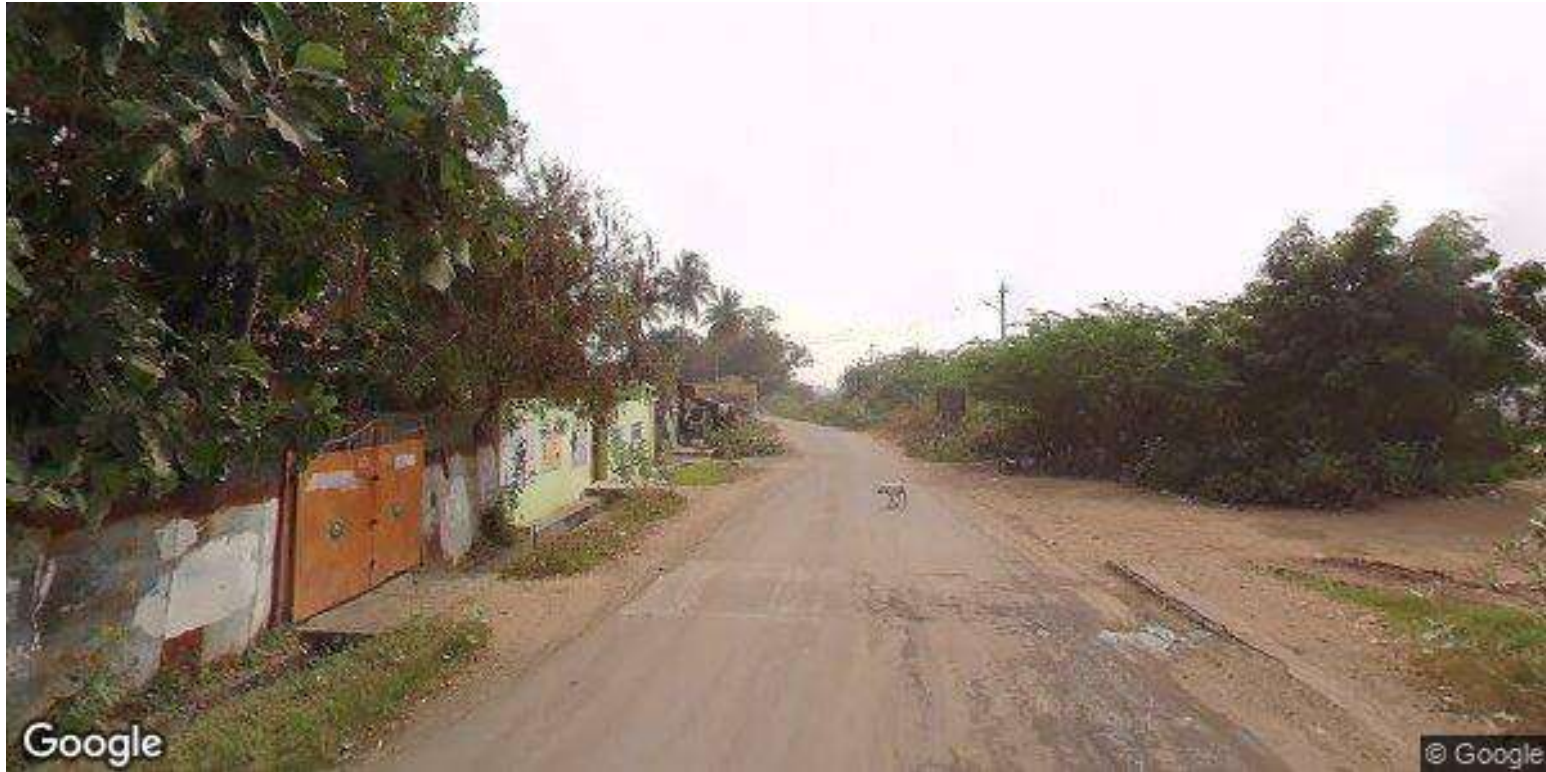
**Risk Type:** Turn  
**Risk Level:** High  
**Speed Limit:** 15 KM/Hr  
**Coordinates:** 10.95212, 78.03978

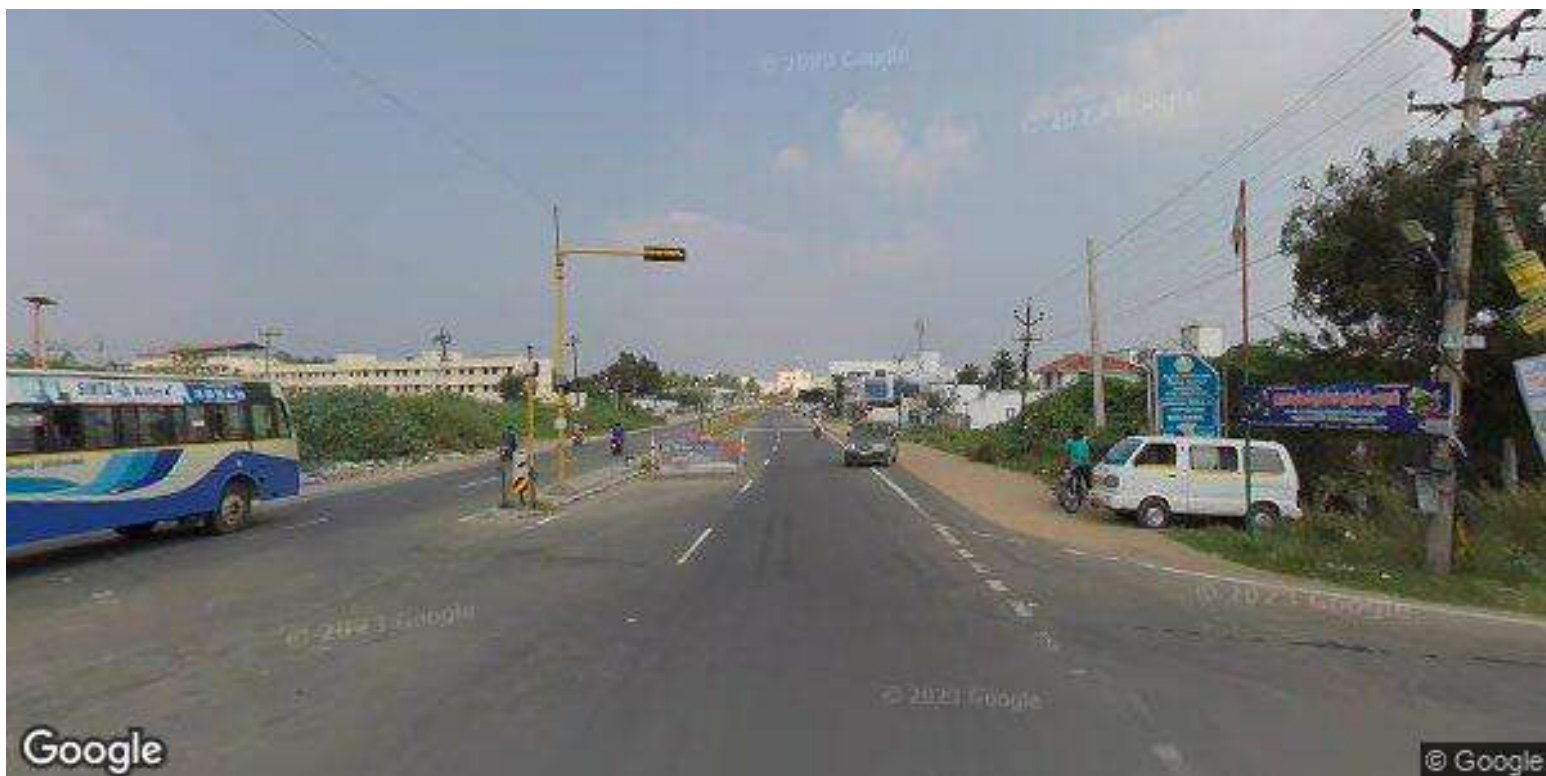
**Risk Type:** Blind Spot  
**Risk Level:** Blind Spot  
**Speed Limit:** 10 KM/Hr  
**Coordinates:** 10.96305, 78.04058
