# IndianOil

## JOURNEY RISK MANAGEMENT (JRM) STUDY

### Salem Terminal to P.N.ANNA PETROL BUNK

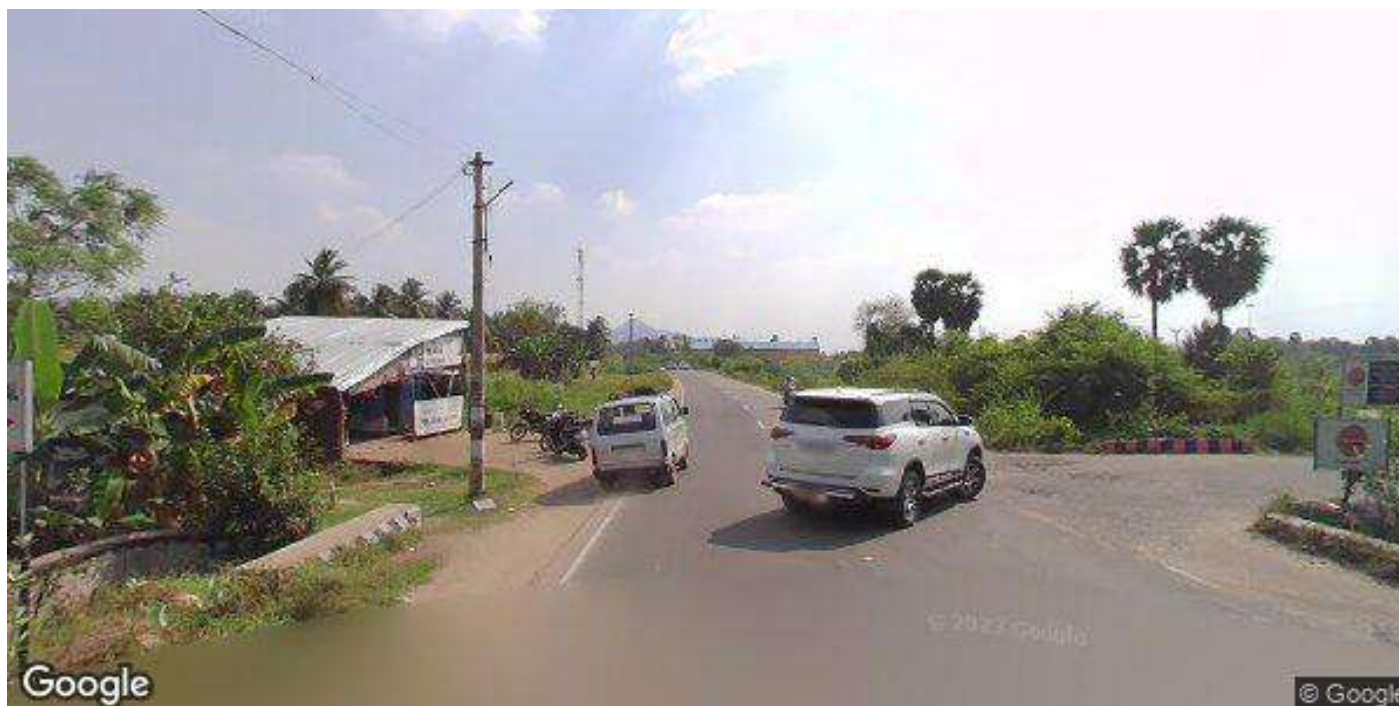
**Risk Type:** Turn  
**Risk Level:** High  
**Speed Limit:** 15 KM/Hr  
**Coordinates:** 11.44029, 77.87544

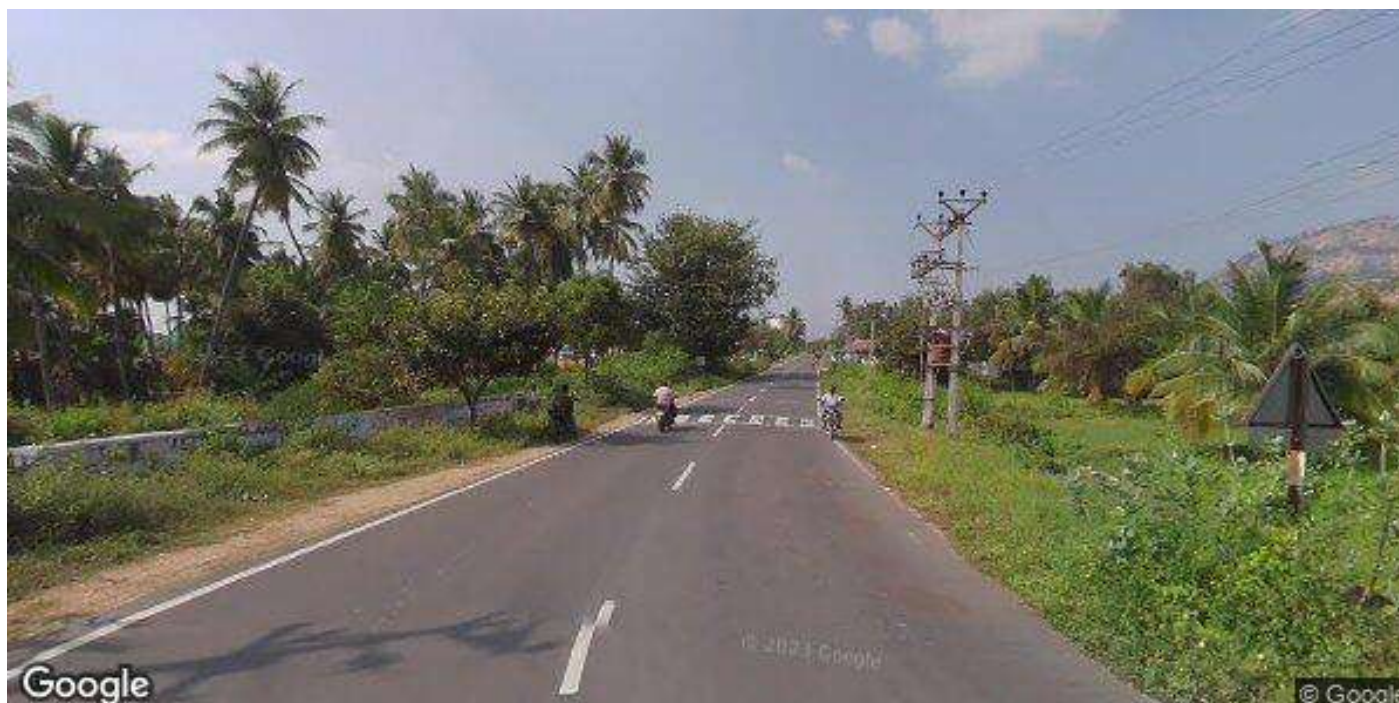
**Risk Type:** Turn  
**Risk Level:** Medium  
**Speed Limit:** 30 KM/Hr  
**Coordinates:** 11.45353, 77.85697

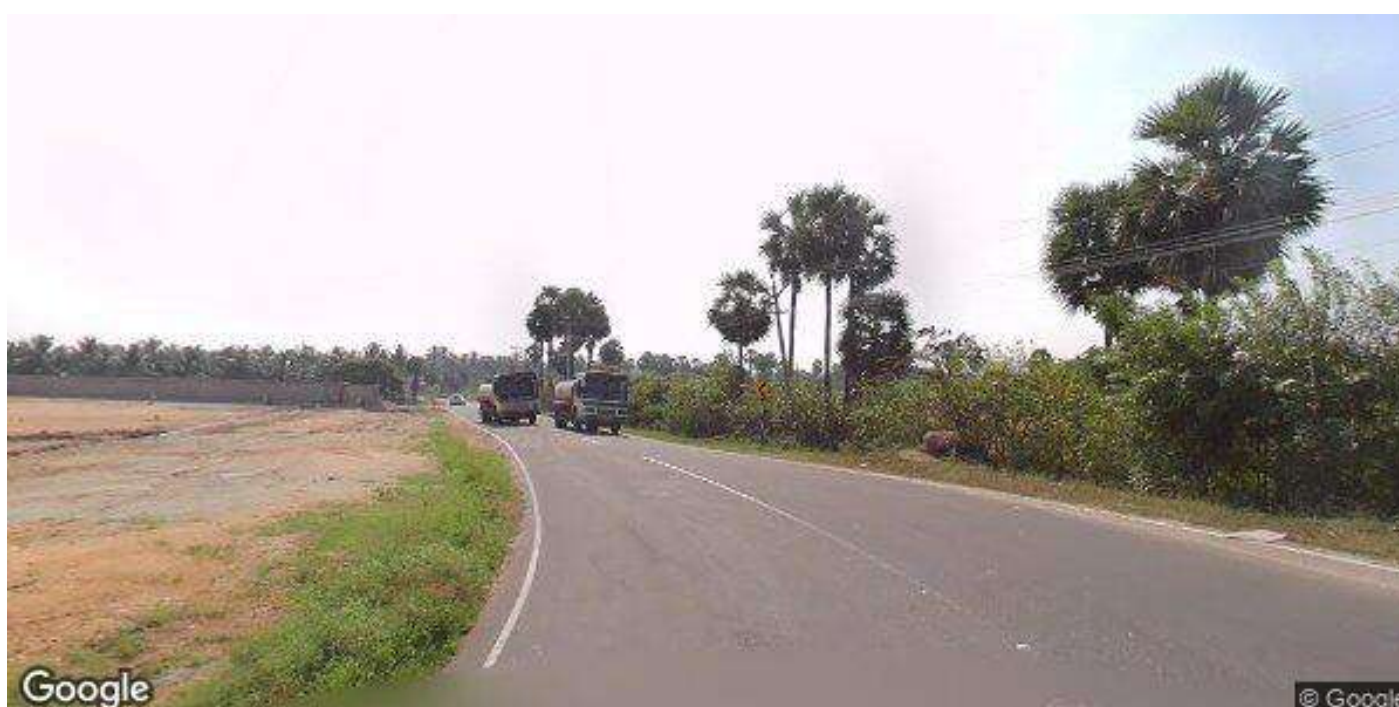
**Risk Type:** Turn  
**Risk Level:** Medium

**Speed Limit: 30 KM/Hr**  
**Coordinates: 11.45839, 77.85143**

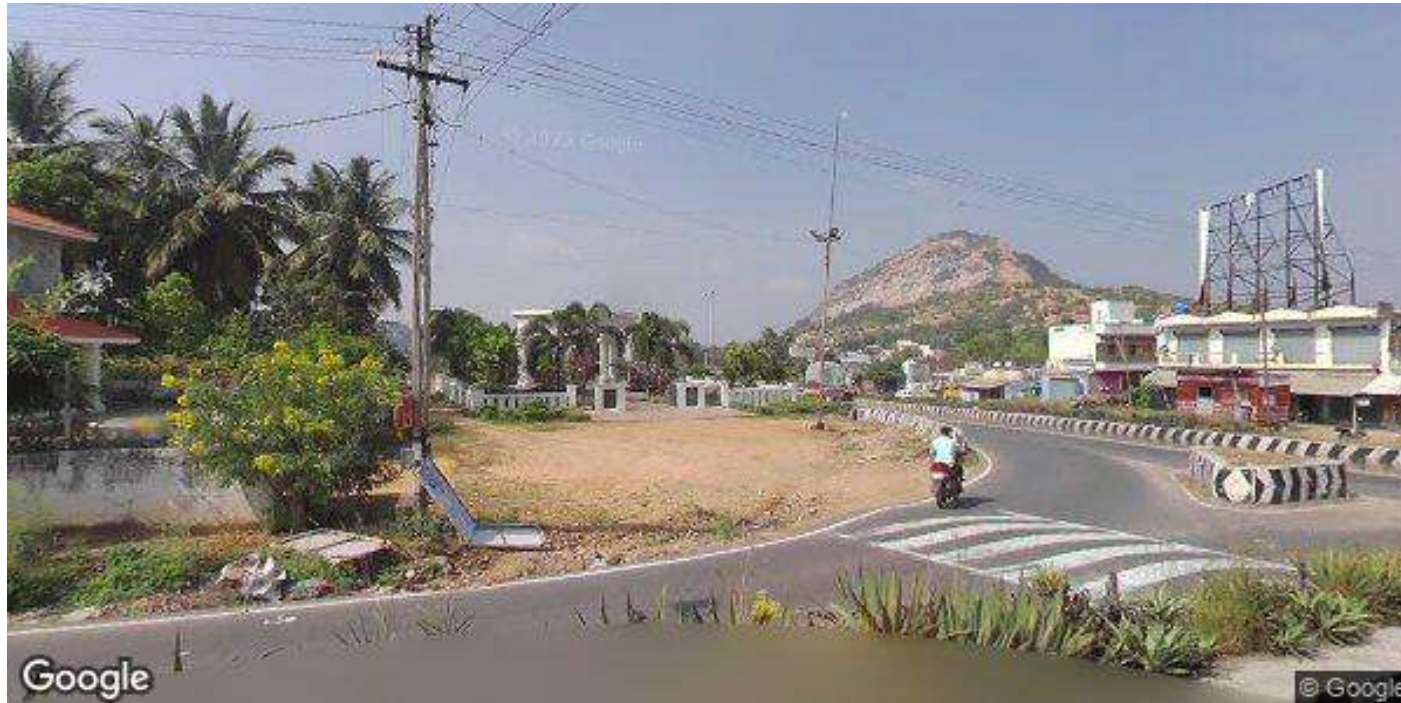
**Risk Type: Turn**  
**Risk Level: Medium**  
**Speed Limit: 30 KM/Hr**  
**Coordinates: 11.46307, 77.84941**

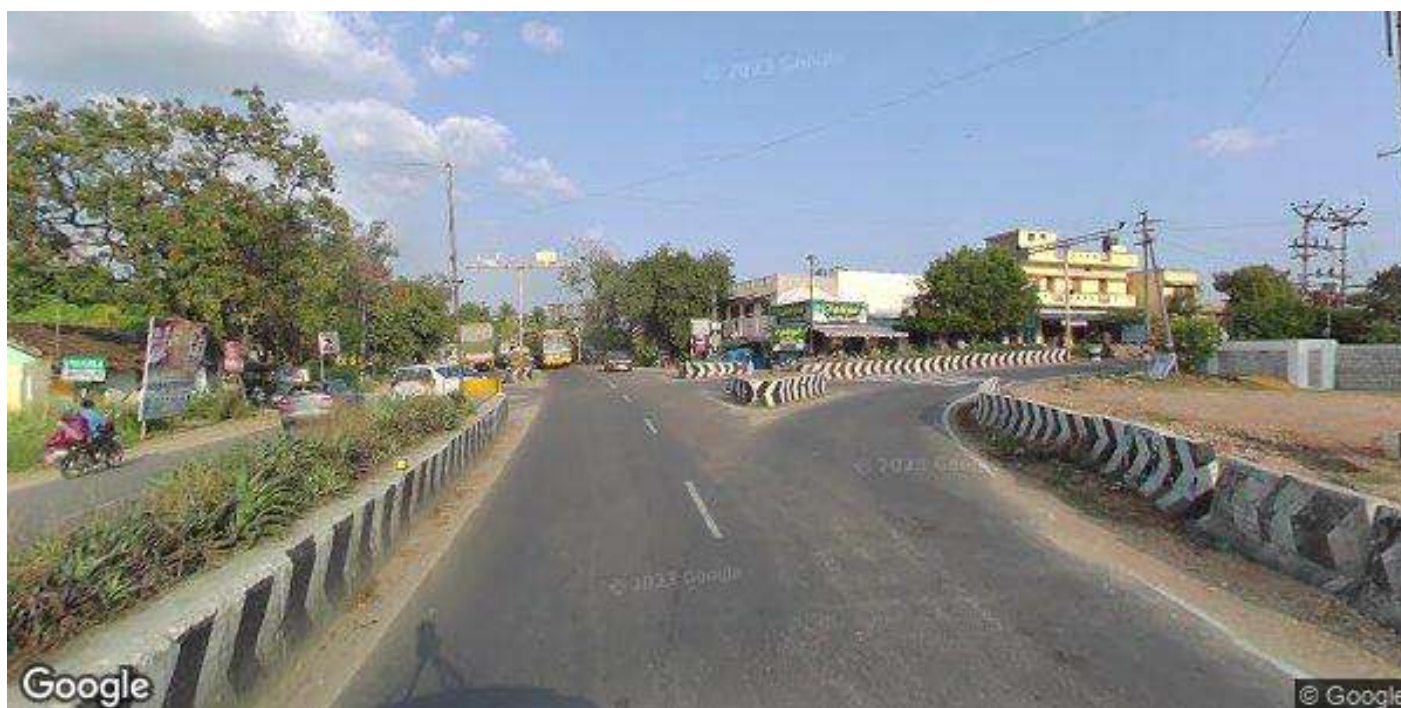
**Risk Type: Turn**  
**Risk Level: Medium**  
**Speed Limit: 30 KM/Hr**  
**Coordinates: 11.46318, 77.84913**

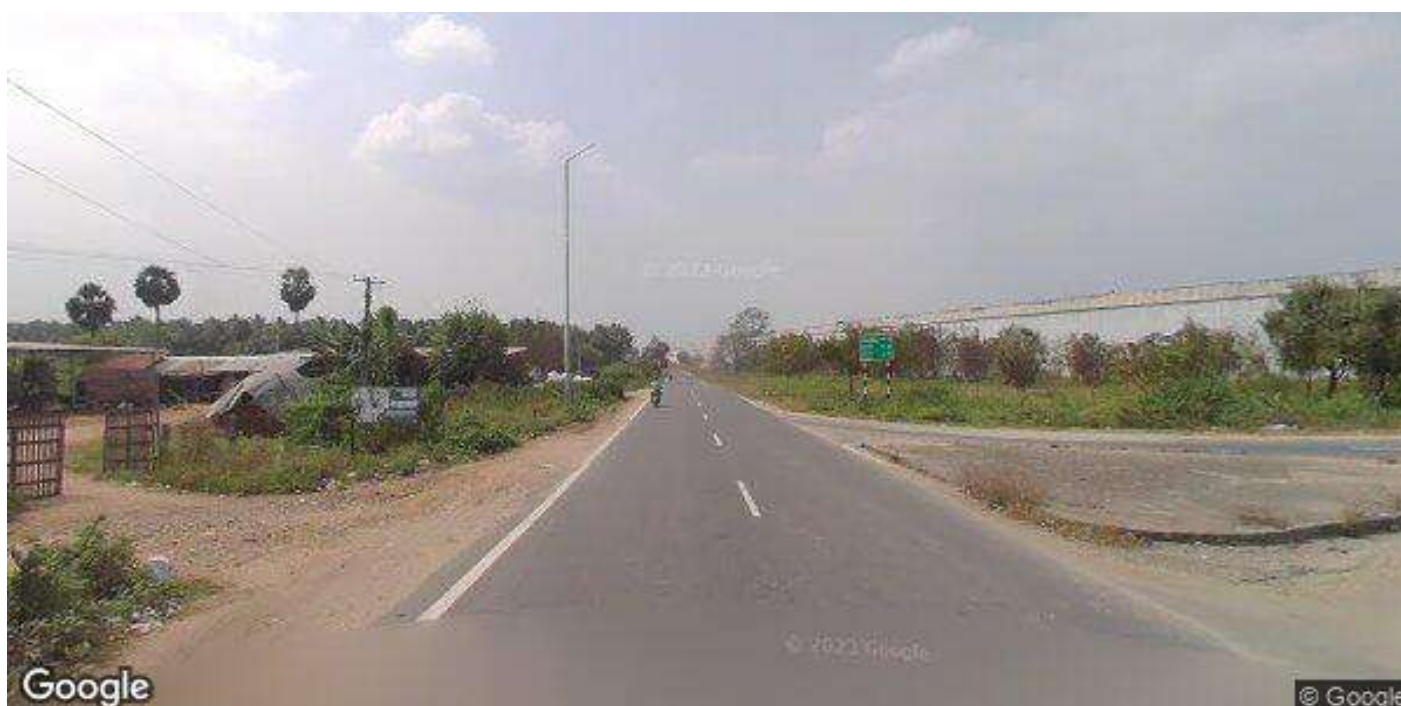
**Risk Type:** Turn  
**Risk Level:** High  
**Speed Limit:** 15 KM/Hr  
**Coordinates:** 11.45542, 77.81725
