# IndianOil

## JOURNEY RISK MANAGEMENT (JRM) STUDY

### Salem Terminal TO JAYANTHI PETROLEUM AGENCY

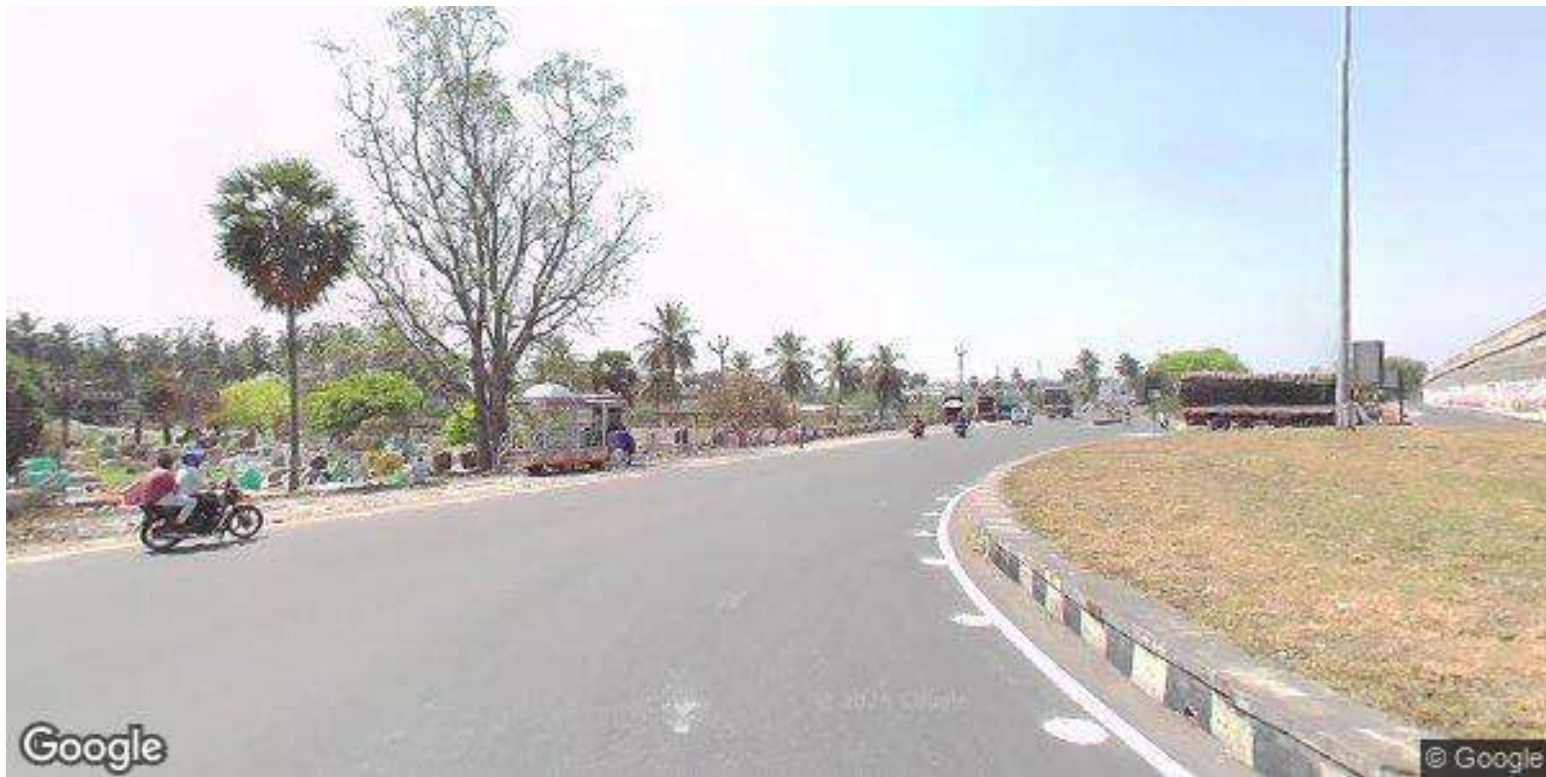
**Coordinates:** 11.73740, 78.05319

**Risk Type:** Roundabout

**Risk Level:** High

**Speed Limit:** 15 KM/Hr

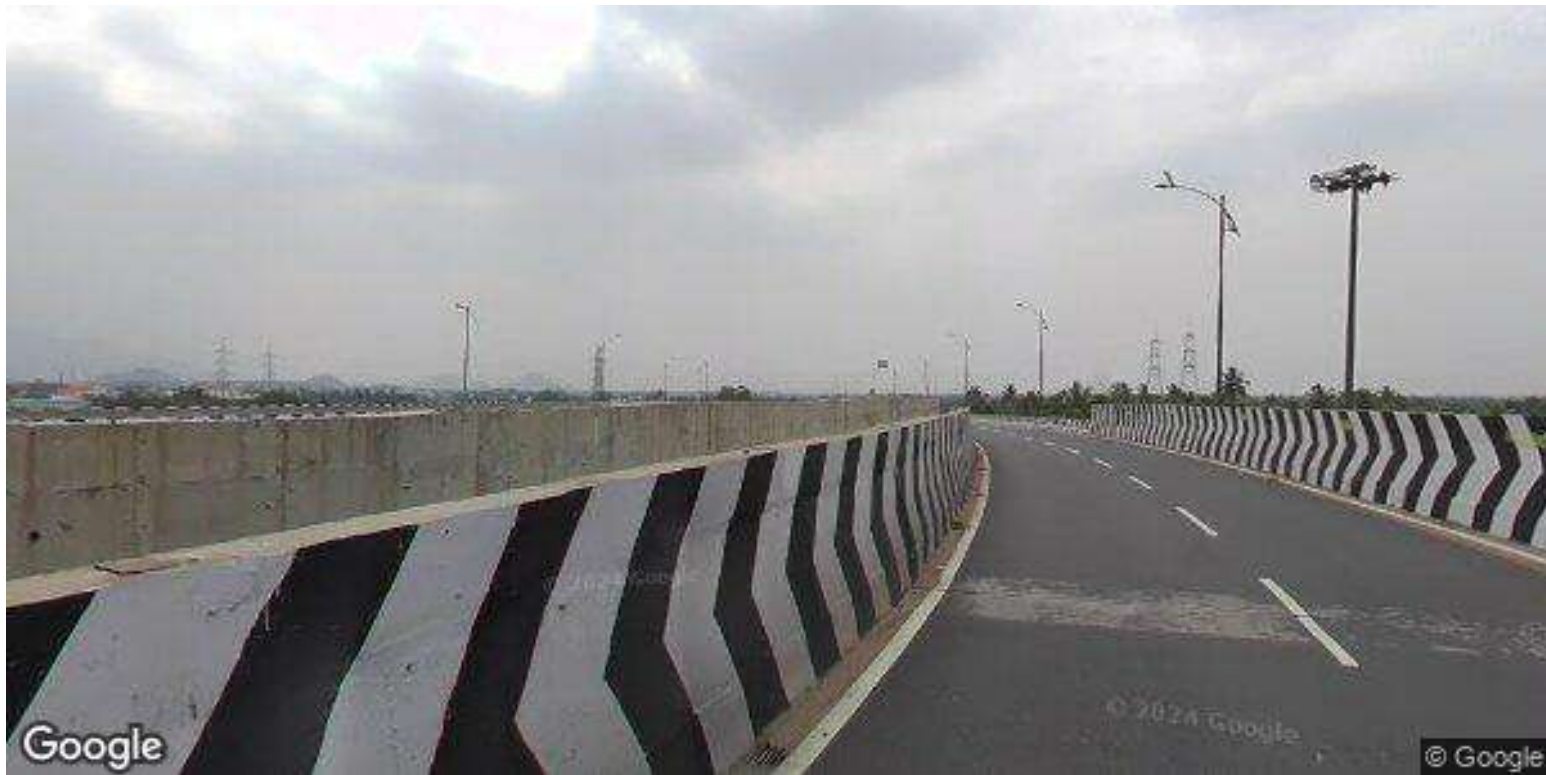
**Risk Type:** Turn  
**Risk Level:** High  
**Speed Limit:** 15 KM/Hr  
**Coordinates:** 11.64158, 78.11796

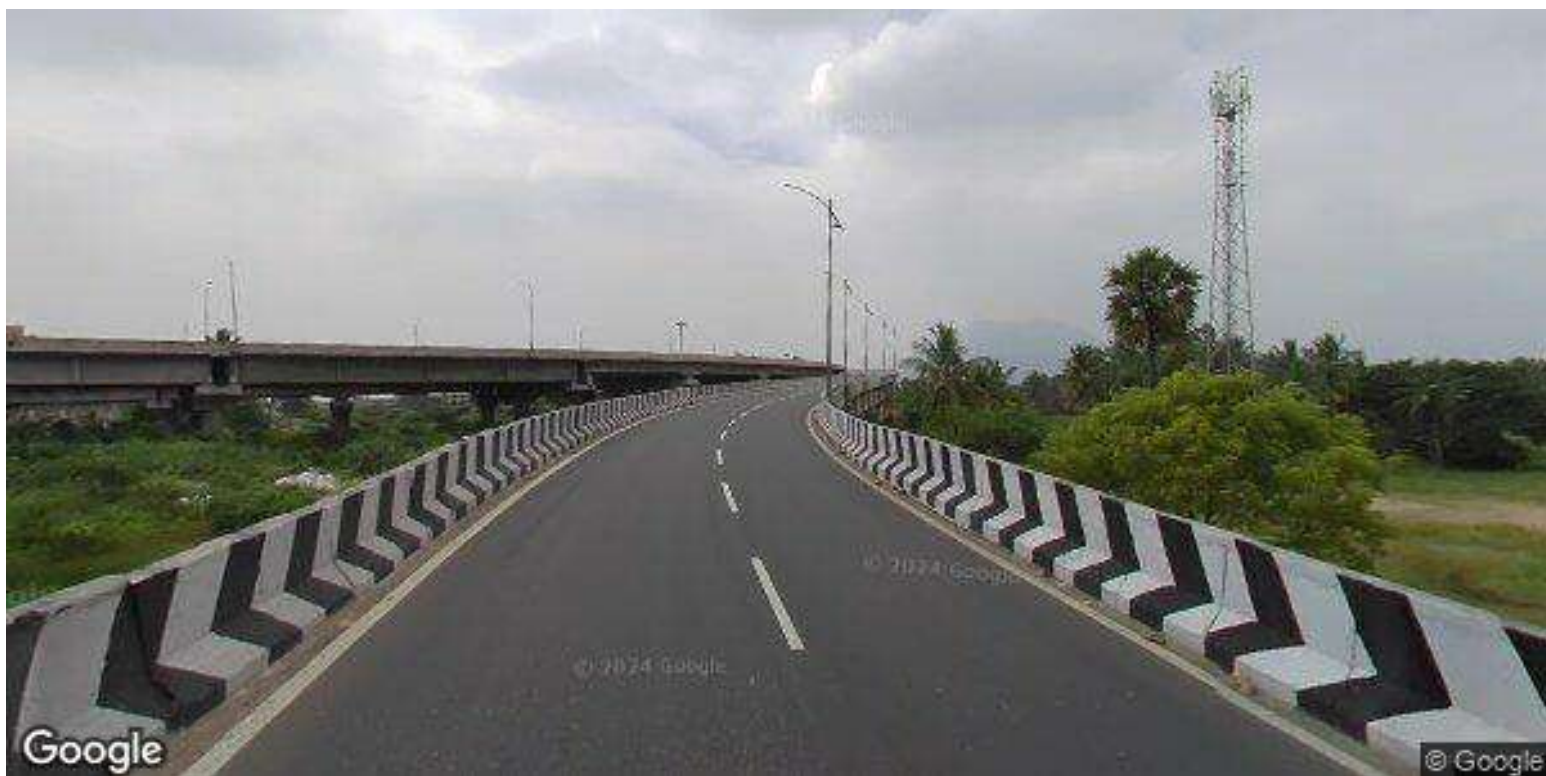
**Risk Type:** Turn  
**Risk Level:** Medium  
**Speed Limit:** 30 KM/Hr  
**Coordinates:** 11.64310, 78.11982

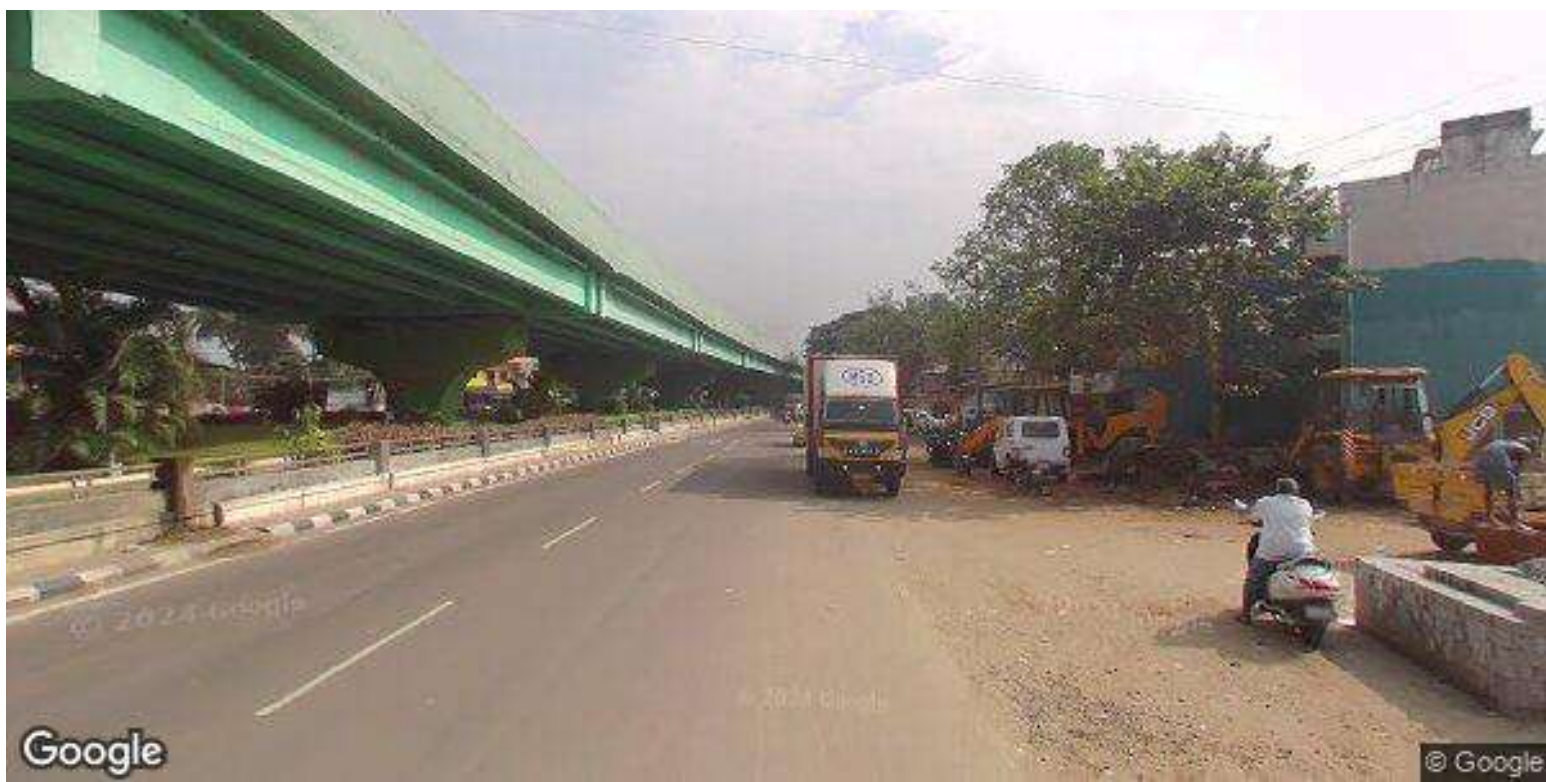
**Coordinates:** 11.68022, 78.12748

**Risk Type:** Turn

**Risk Level:** Medium

**Speed Limit:** 30 KM/Hr

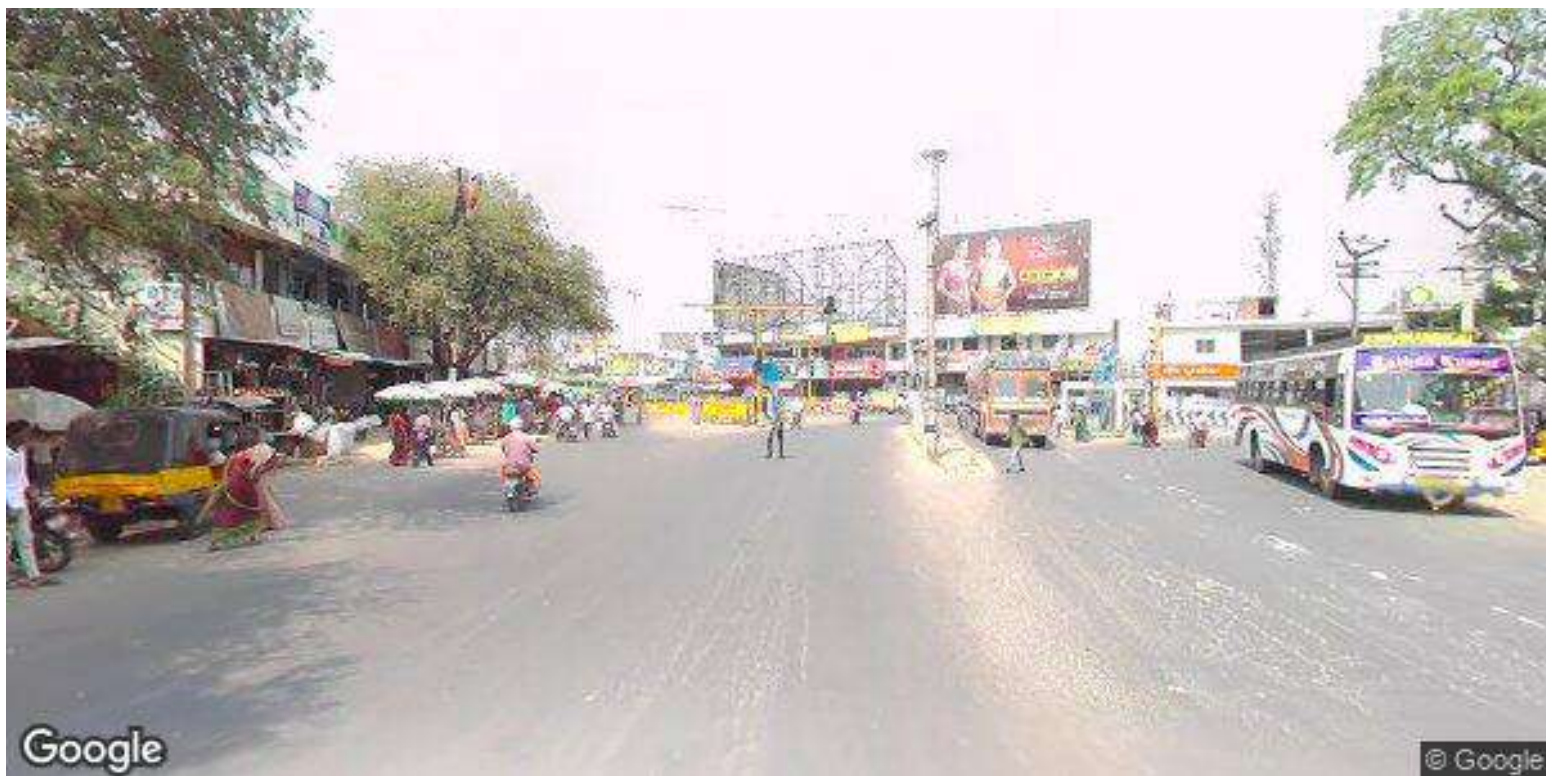
**Coordinates:** 11.74252, 78.04705

**Risk Type:** Turn

**Risk Level:** High

**Speed Limit:** 15 KM/Hr

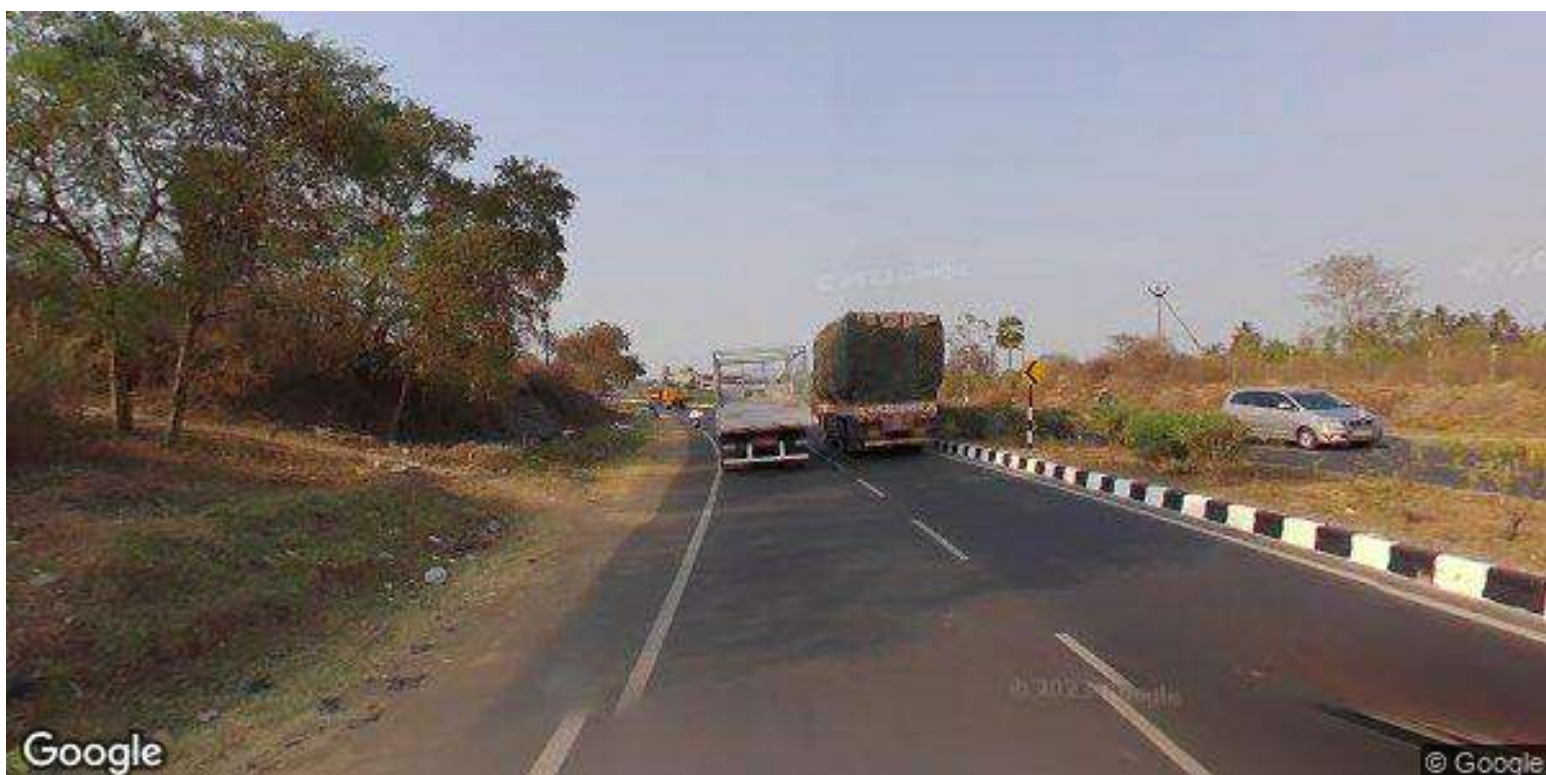
**Risk Type:** Turn  
**Risk Level:** Medium  
**Speed Limit:** 30 KM/Hr  
**Coordinates:** 11.78027, 78.05791

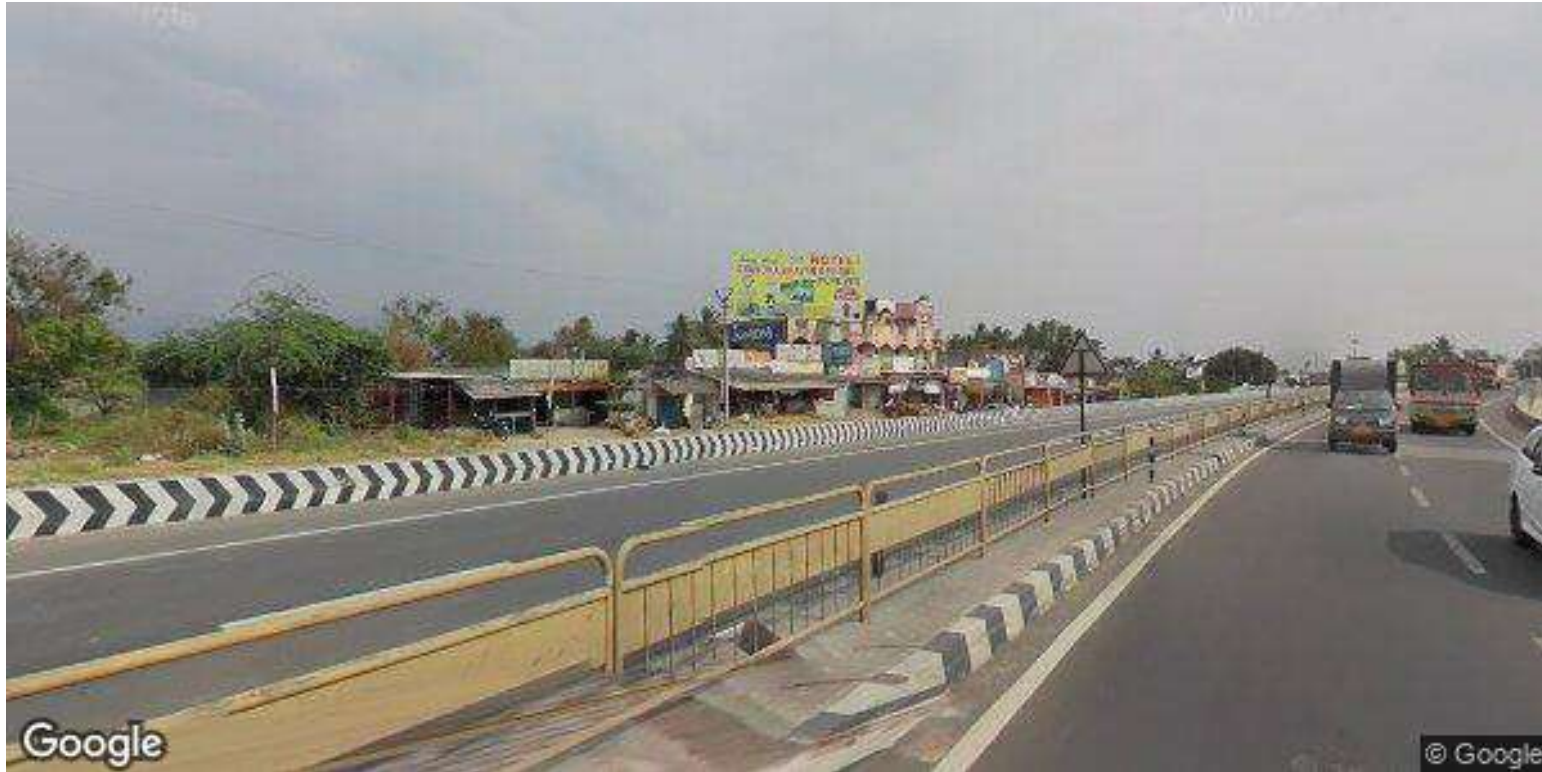
**Risk Type:** Turn  
**Risk Level:** Medium  
**Speed Limit:** 30 KM/Hr  
**Coordinates:** 11.86967, 78.08387

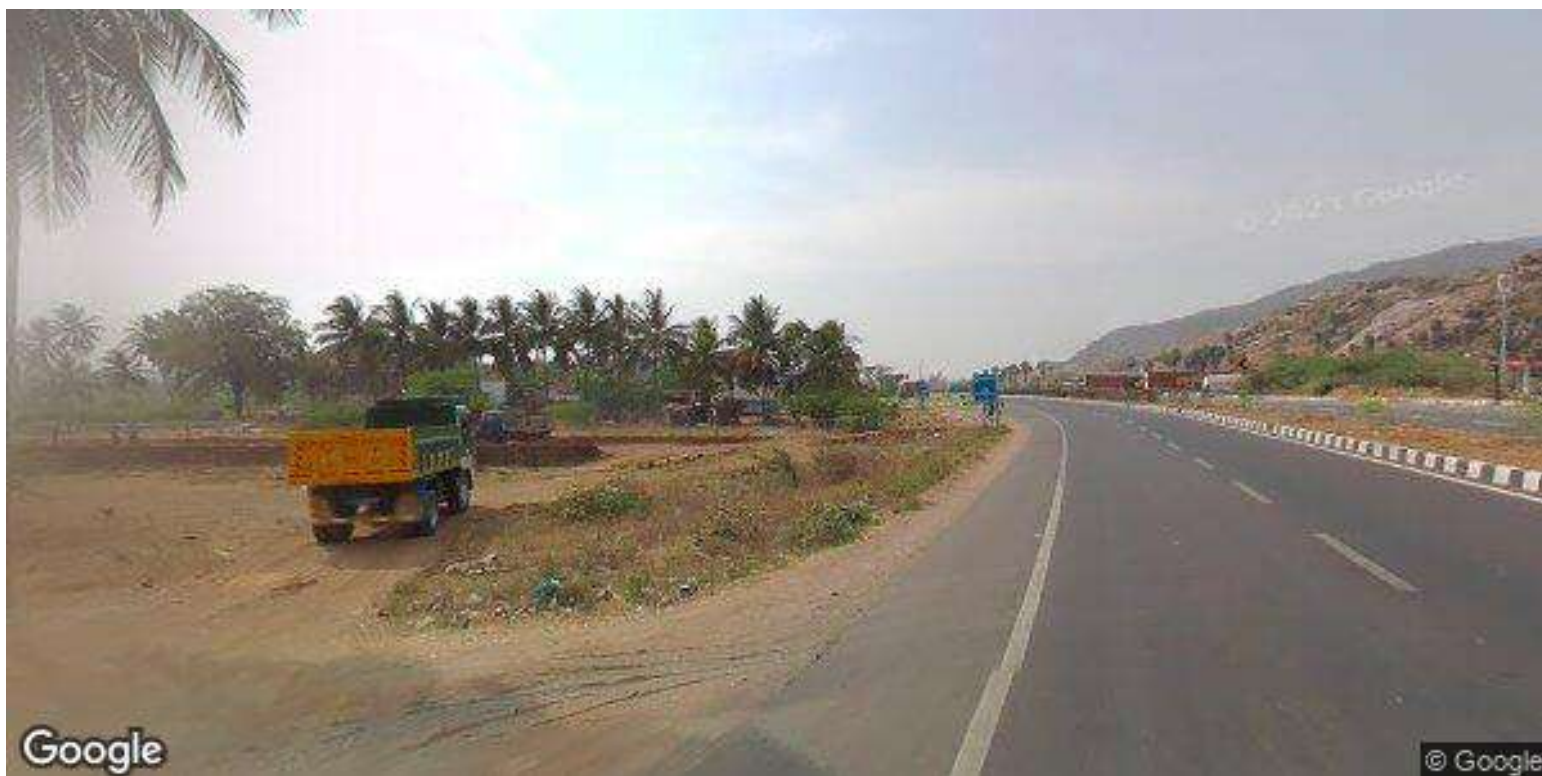
**Risk Type:** Turn  
**Risk Level:** Medium  
**Speed Limit:** 30 KM/Hr  
**Coordinates:** 11.88030, 78.08150

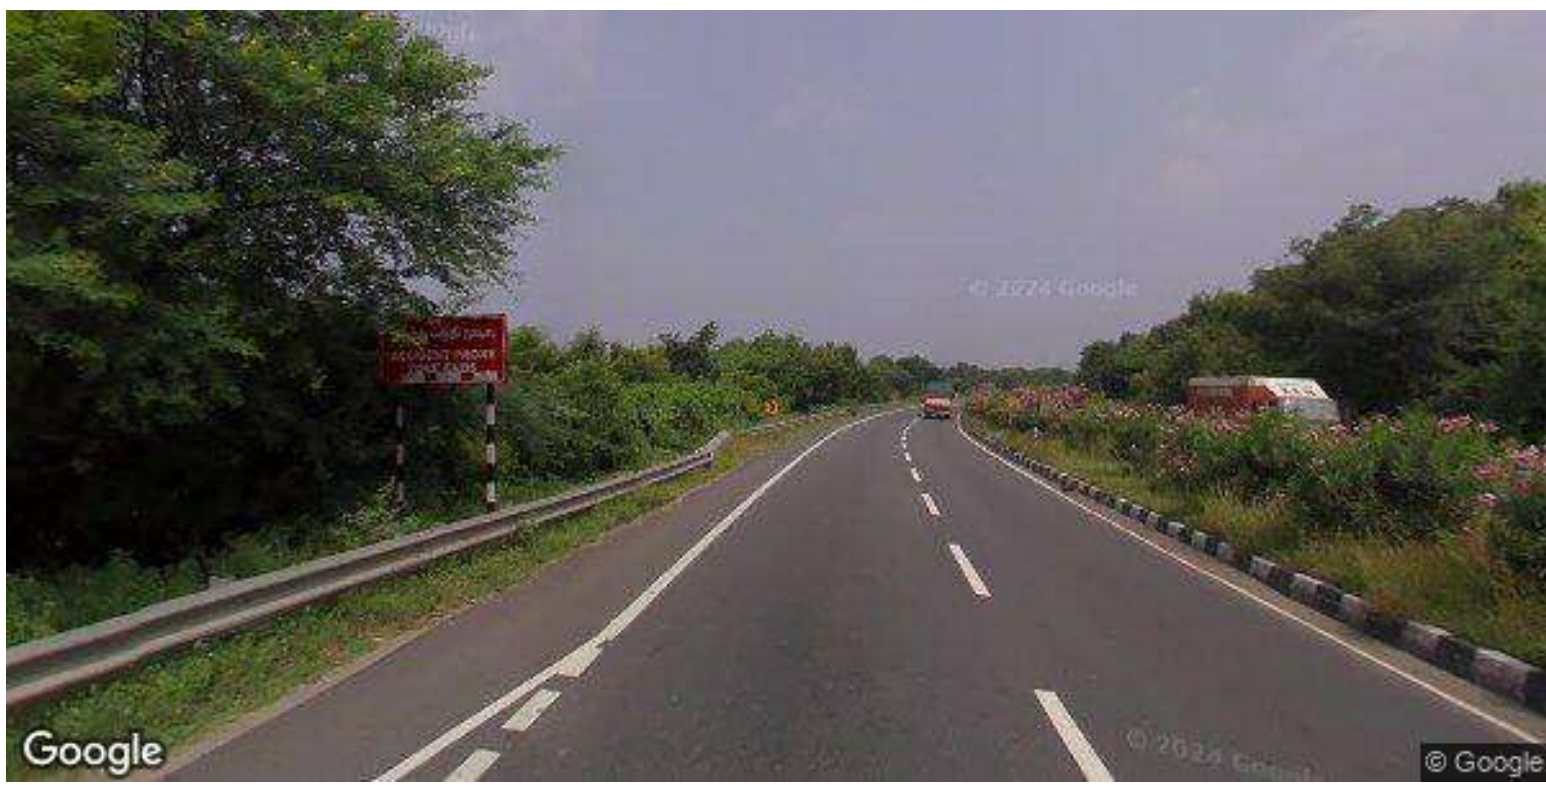
**Coordinates:** 11.91289, 78.05854

**Risk Type:** Turn

**Risk Level:** Medium

**Speed Limit:** 30 KM/Hr

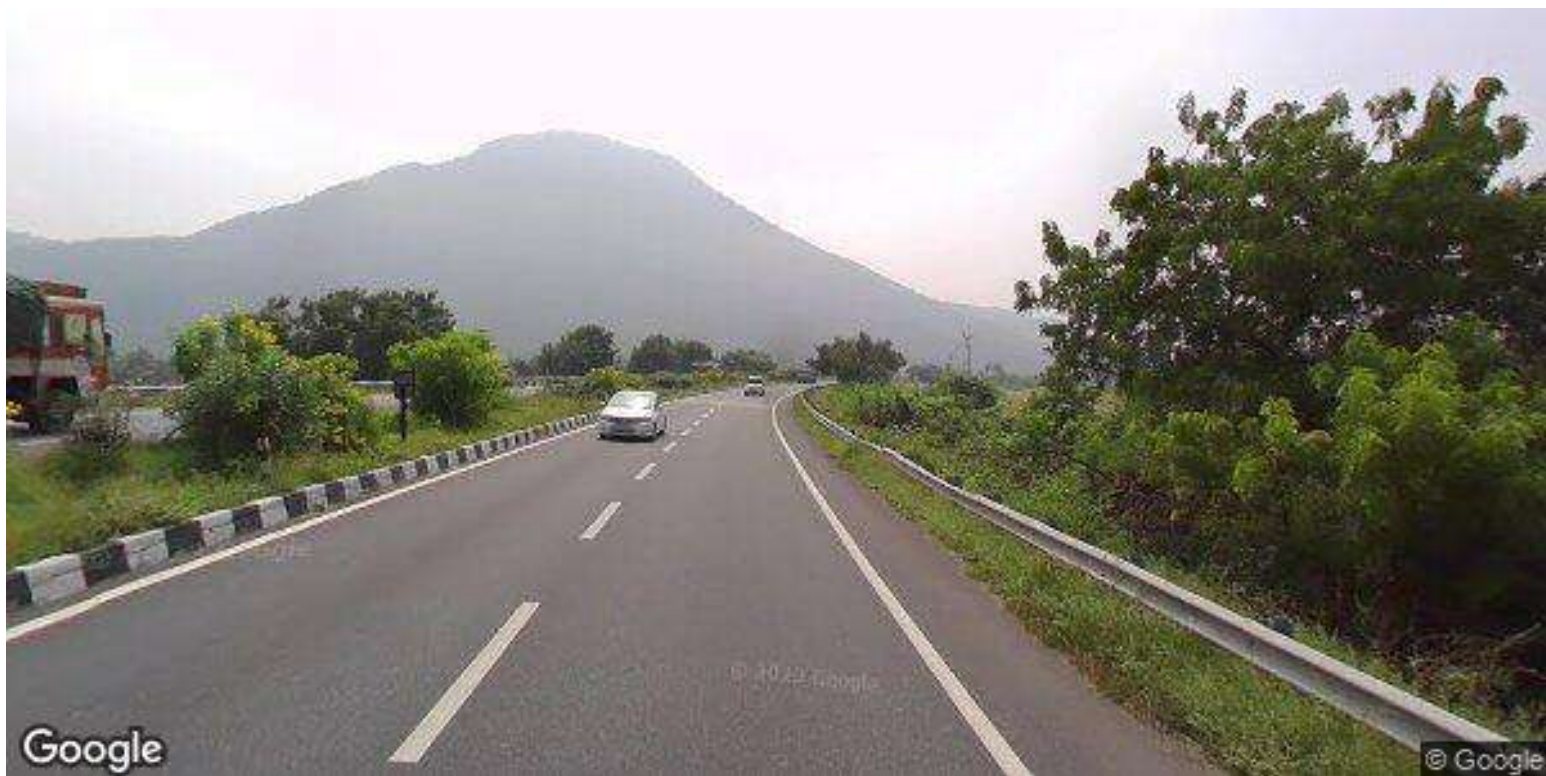
**Coordinates:** 11.93237, 78.06459

**Risk Type:** Turn

**Risk Level:** Medium

**Speed Limit:** 30 KM/Hr

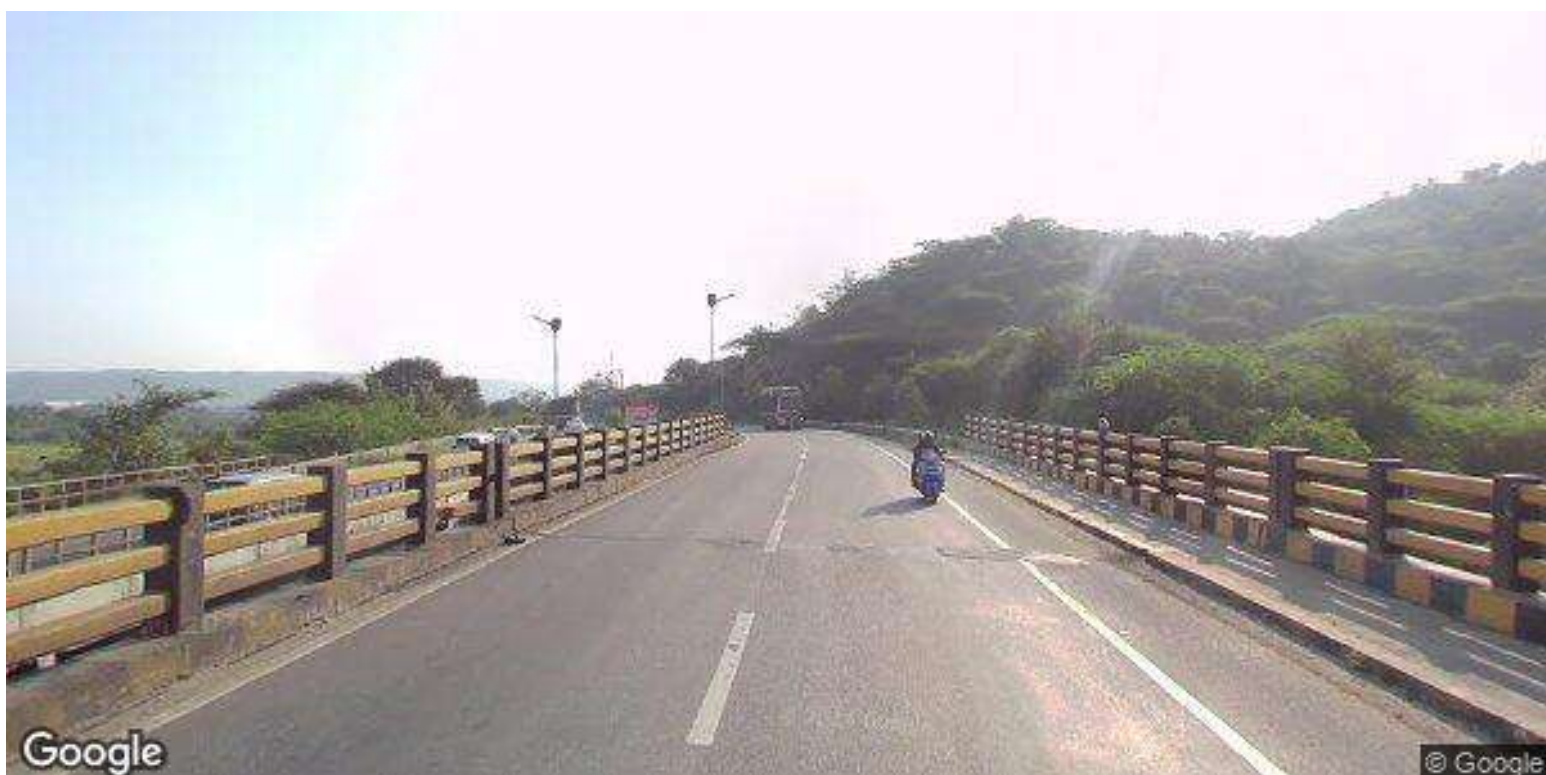
**Risk Type:** Turn  
**Risk Level:** Medium  
**Speed Limit:** 30 KM/Hr  
**Coordinates:** 11.95594, 78.04730

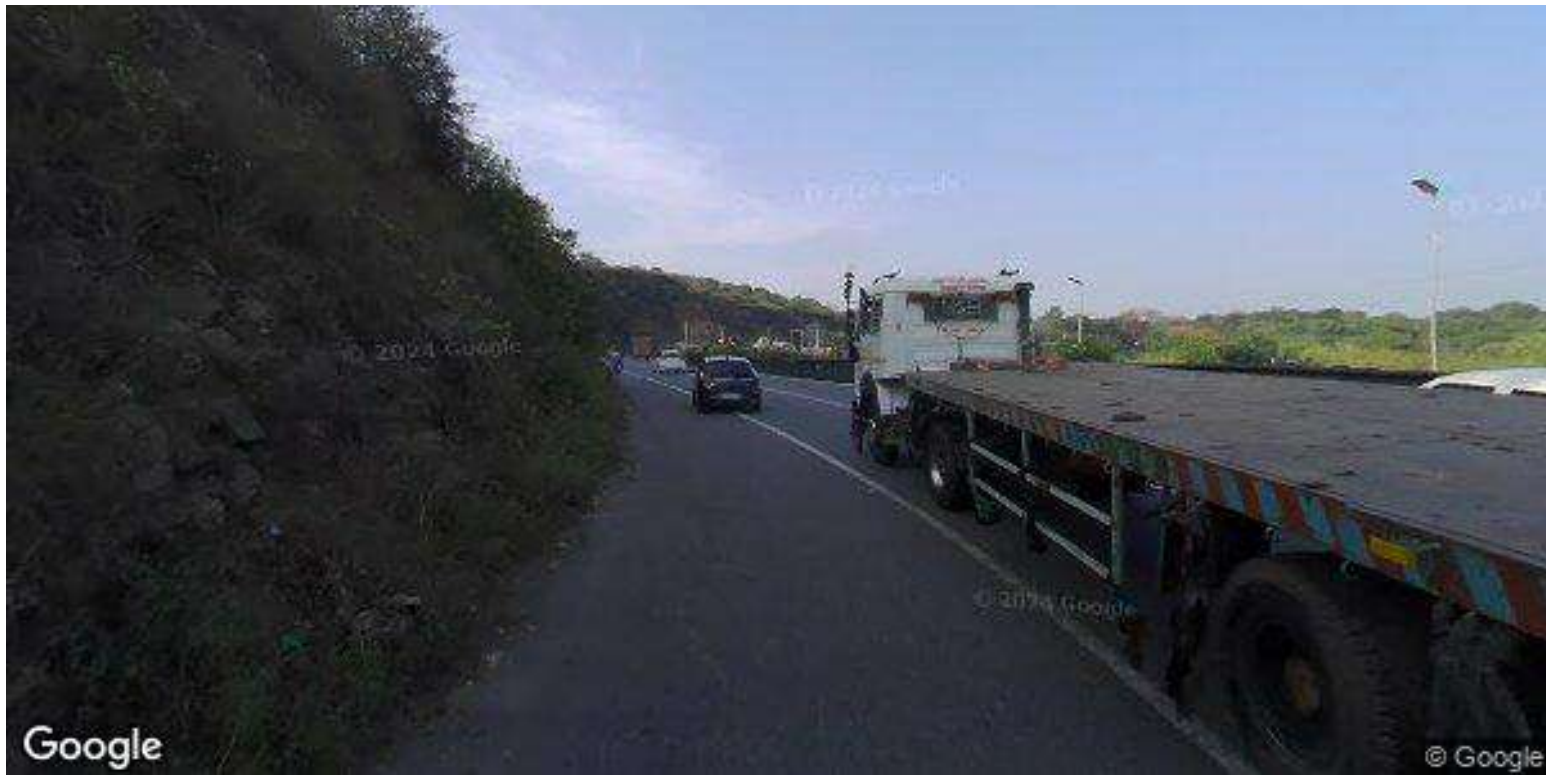
**Risk Type:** Turn  
**Risk Level:** High  
**Speed Limit:** 15 KM/Hr  
**Coordinates:** 11.95876, 78.04990

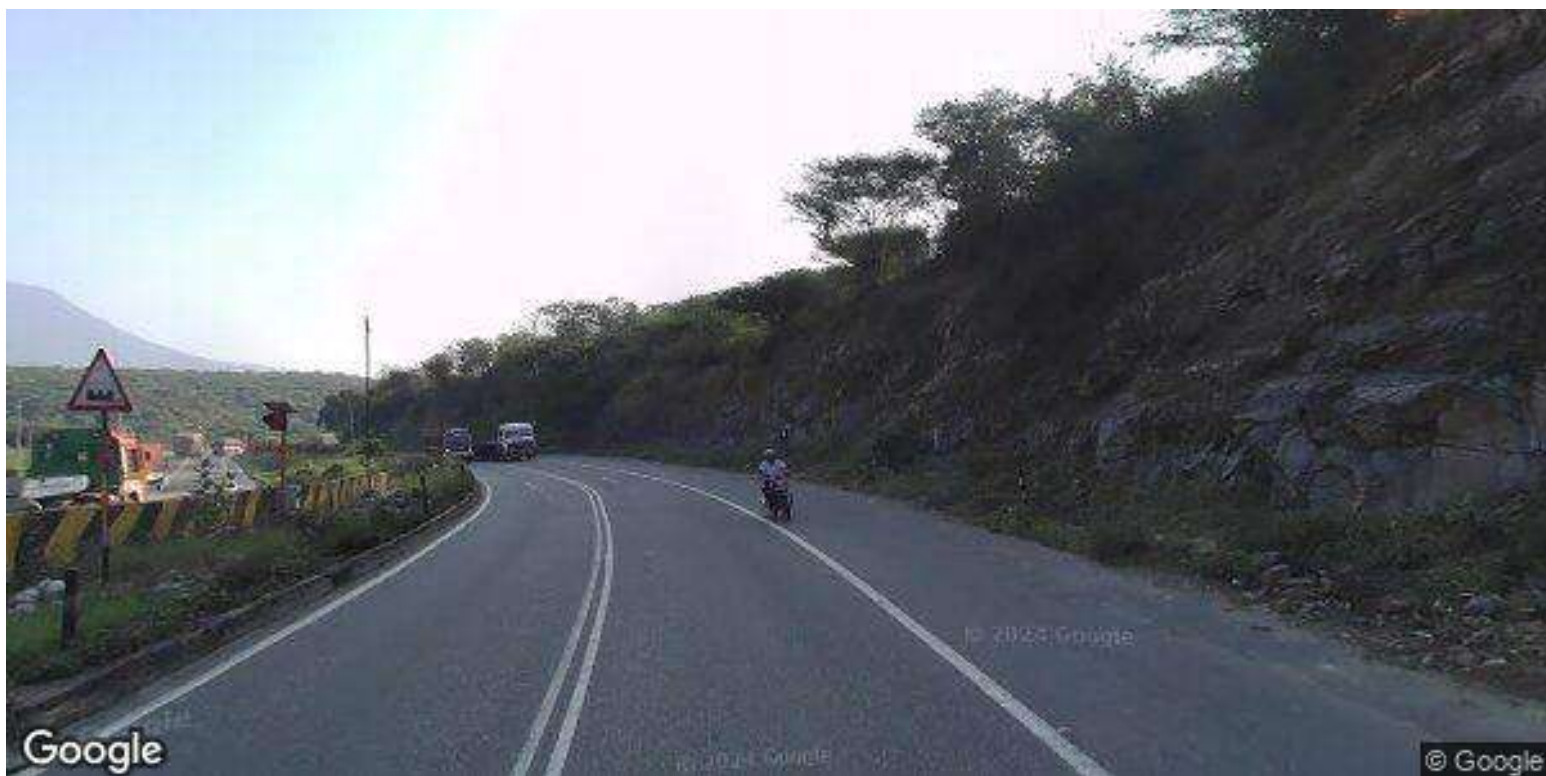
**Risk Type:** Turn  
**Risk Level:** High  
**Speed Limit:** 15 KM/Hr  
**Coordinates:** 11.96035, 78.04946

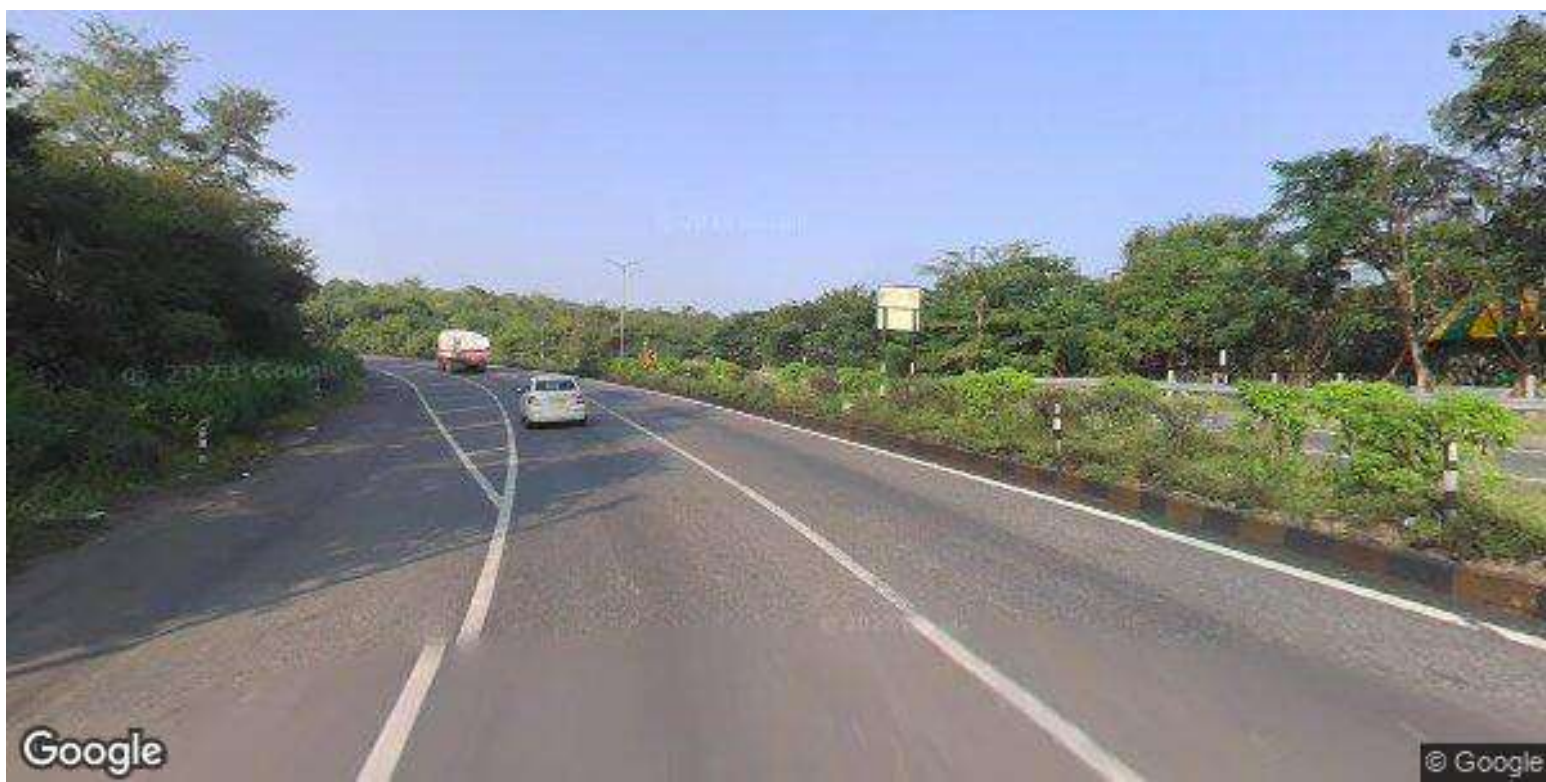
**Coordinates:** 11.96304, 78.05136

**Risk Type:** Turn

**Risk Level:** Medium

**Speed Limit:** 30 KM/Hr

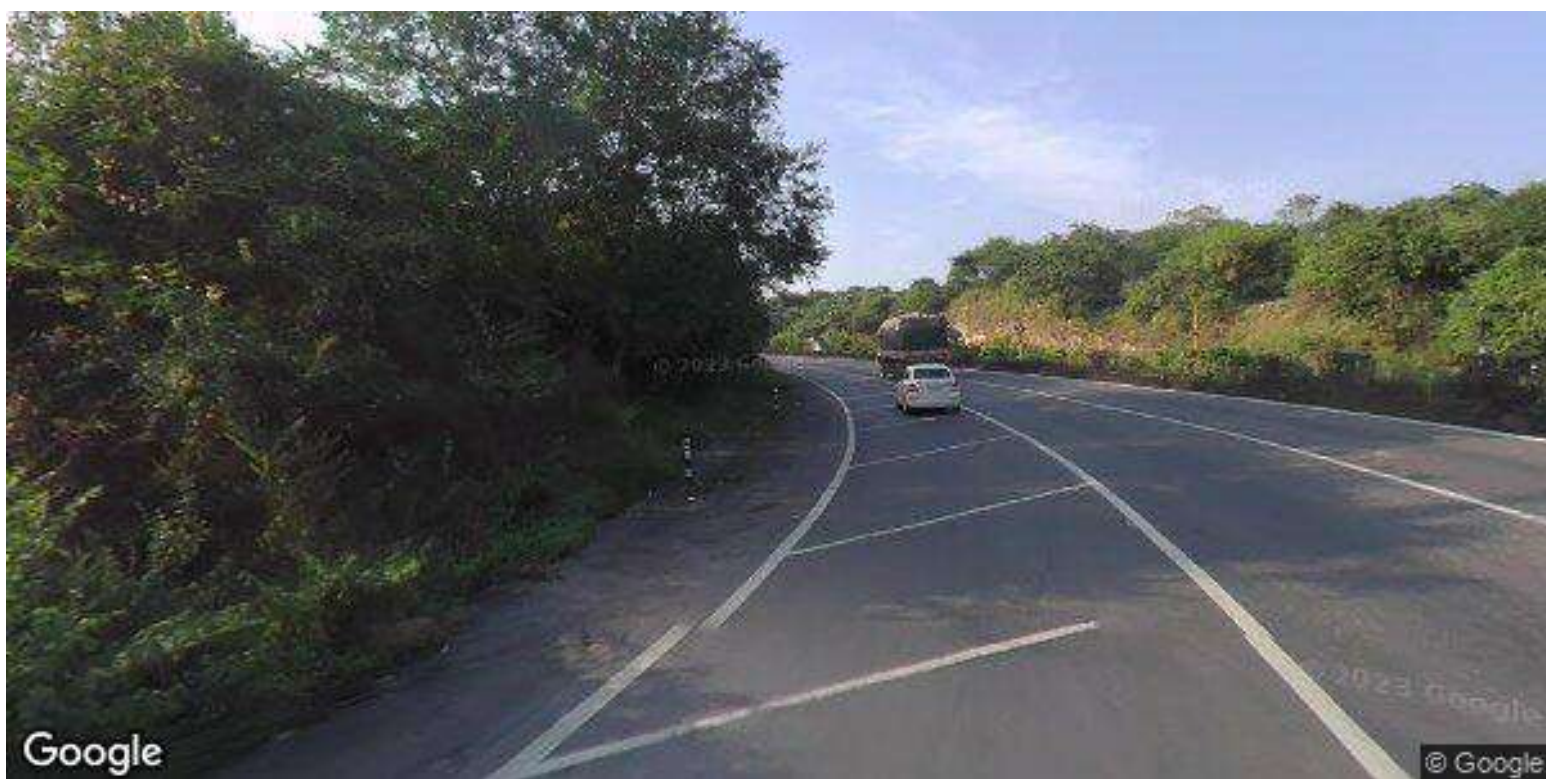
**Coordinates:** 11.96399, 78.05135

**Risk Type:** Turn

**Risk Level:** Medium

**Speed Limit:** 30 KM/Hr

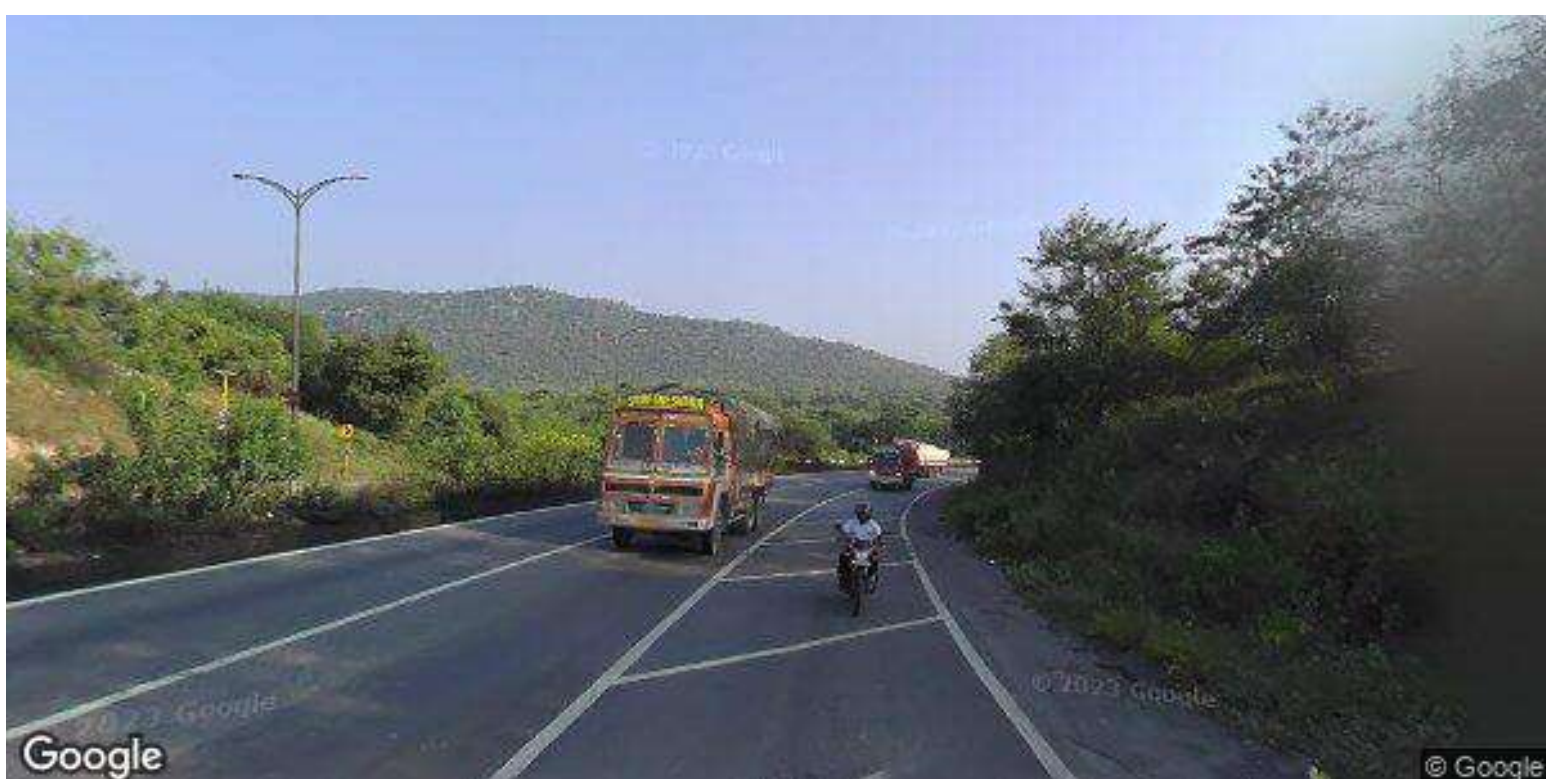
**Risk Type:** Turn  
**Risk Level:** Medium  
**Speed Limit:** 30 KM/Hr  
**Coordinates:** 11.96458, 78.05084

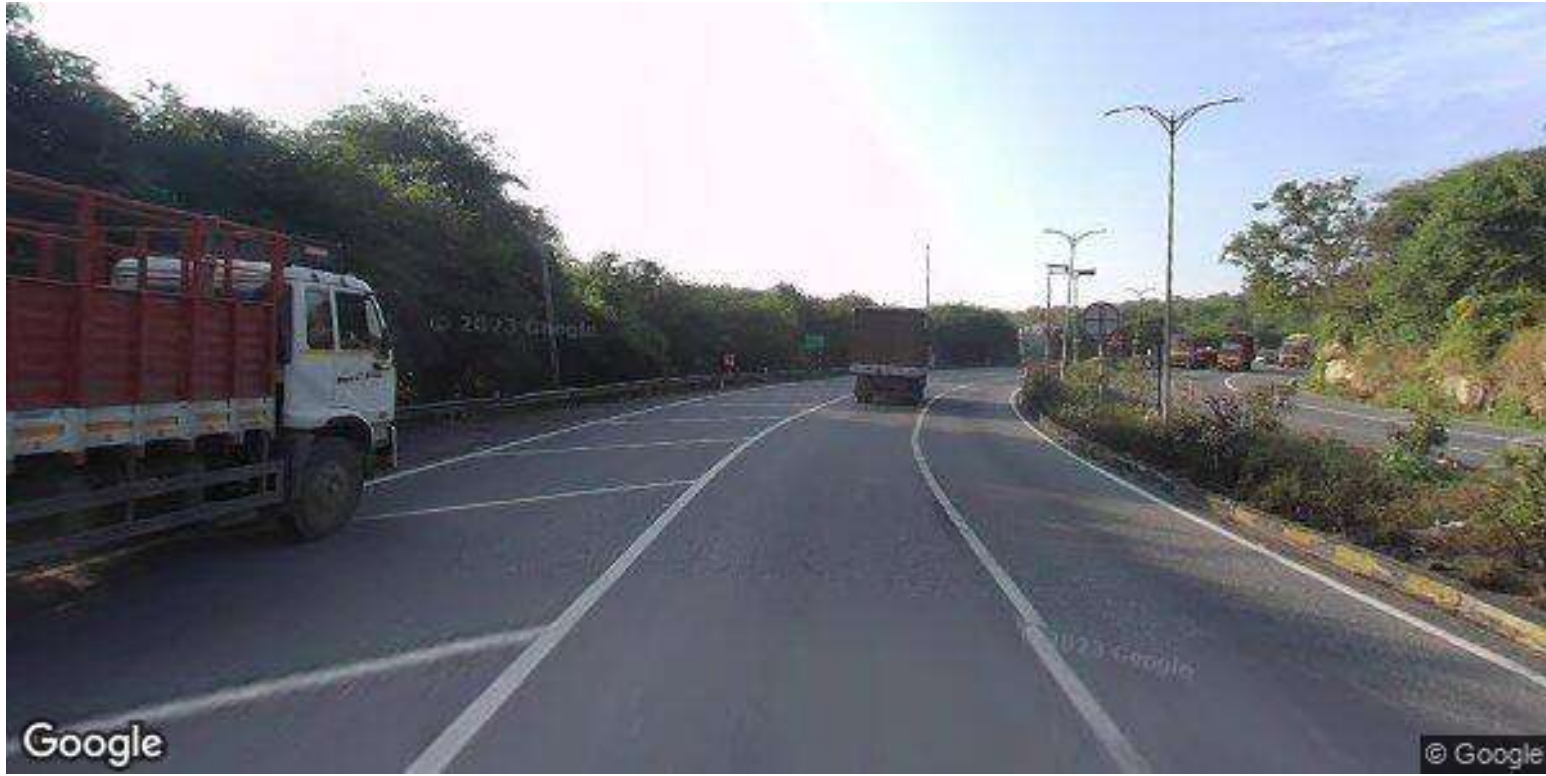
**Risk Type:** Turn  
**Risk Level:** Medium  
**Speed Limit:** 30 KM/Hr  
**Coordinates:** 11.96496, 78.04988

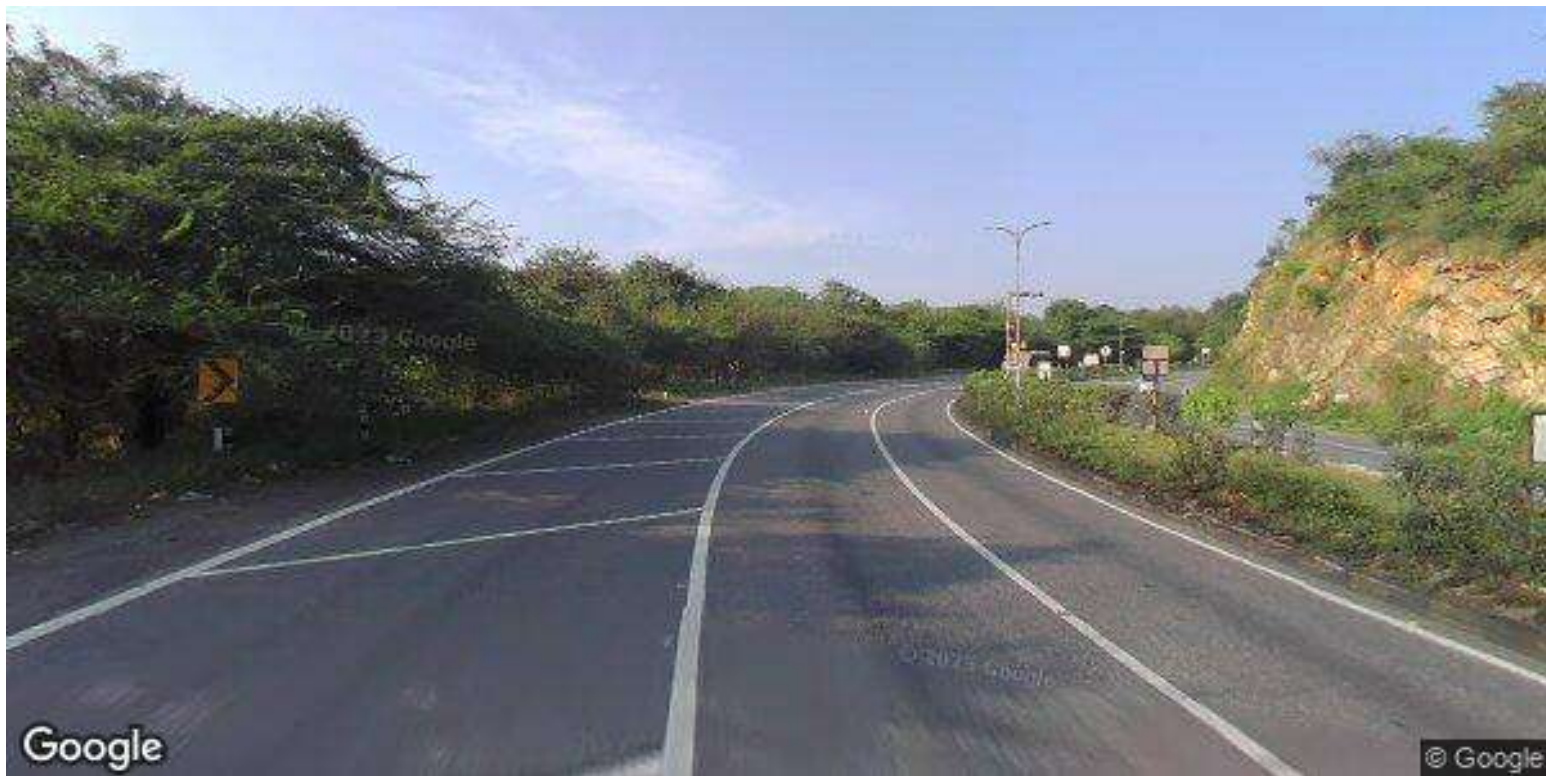
**Risk Type:** Turn  
**Risk Level:** High  
**Speed Limit:** 15 KM/Hr  
**Coordinates:** 11.96580, 78.04923

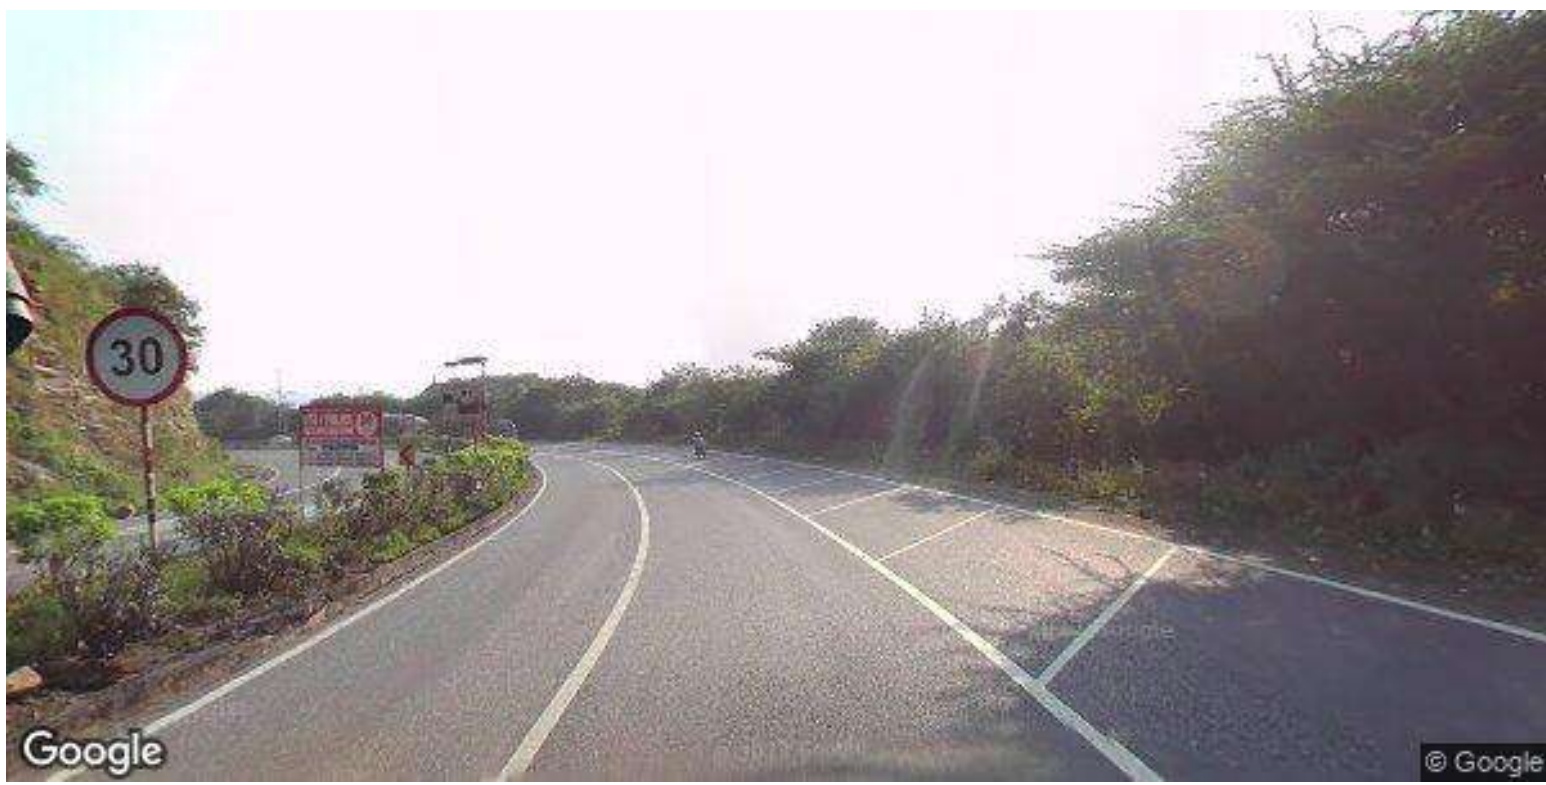
**Coordinates:** 11.96675, 78.04939

**Risk Type:** Turn

**Risk Level:** Medium

**Speed Limit:** 30 KM/Hr
