# IndianOil

## JOURNEY RISK MANAGEMENT (JRM) STUDY

### Salem Terminal TO JAYANTHI PETROLEUM AGENCY

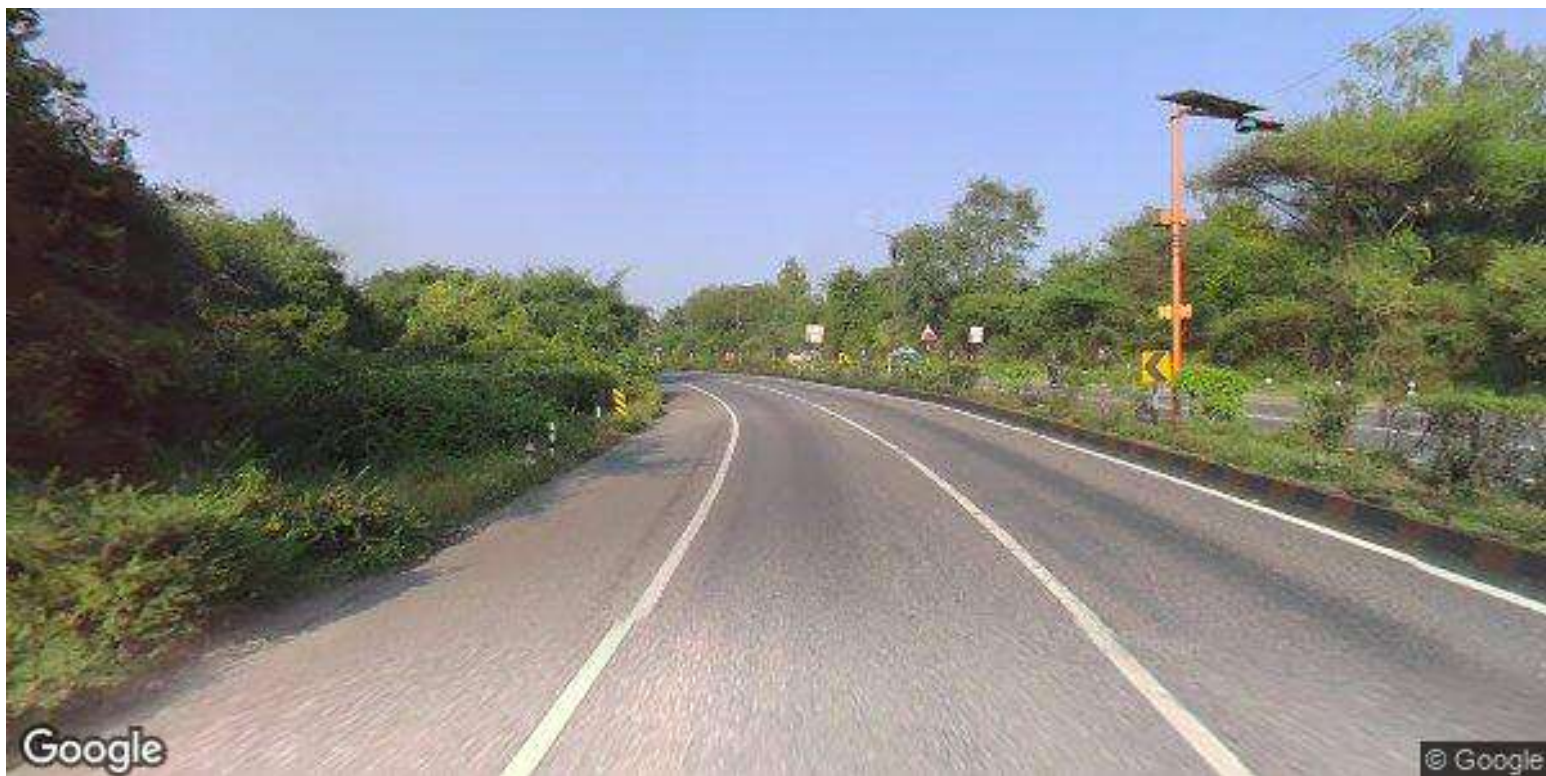
**Coordinates:** 11.96791, 78.05070

**Risk Type:** Turn

**Risk Level:** Medium

**Speed Limit:** 30 KM/Hr

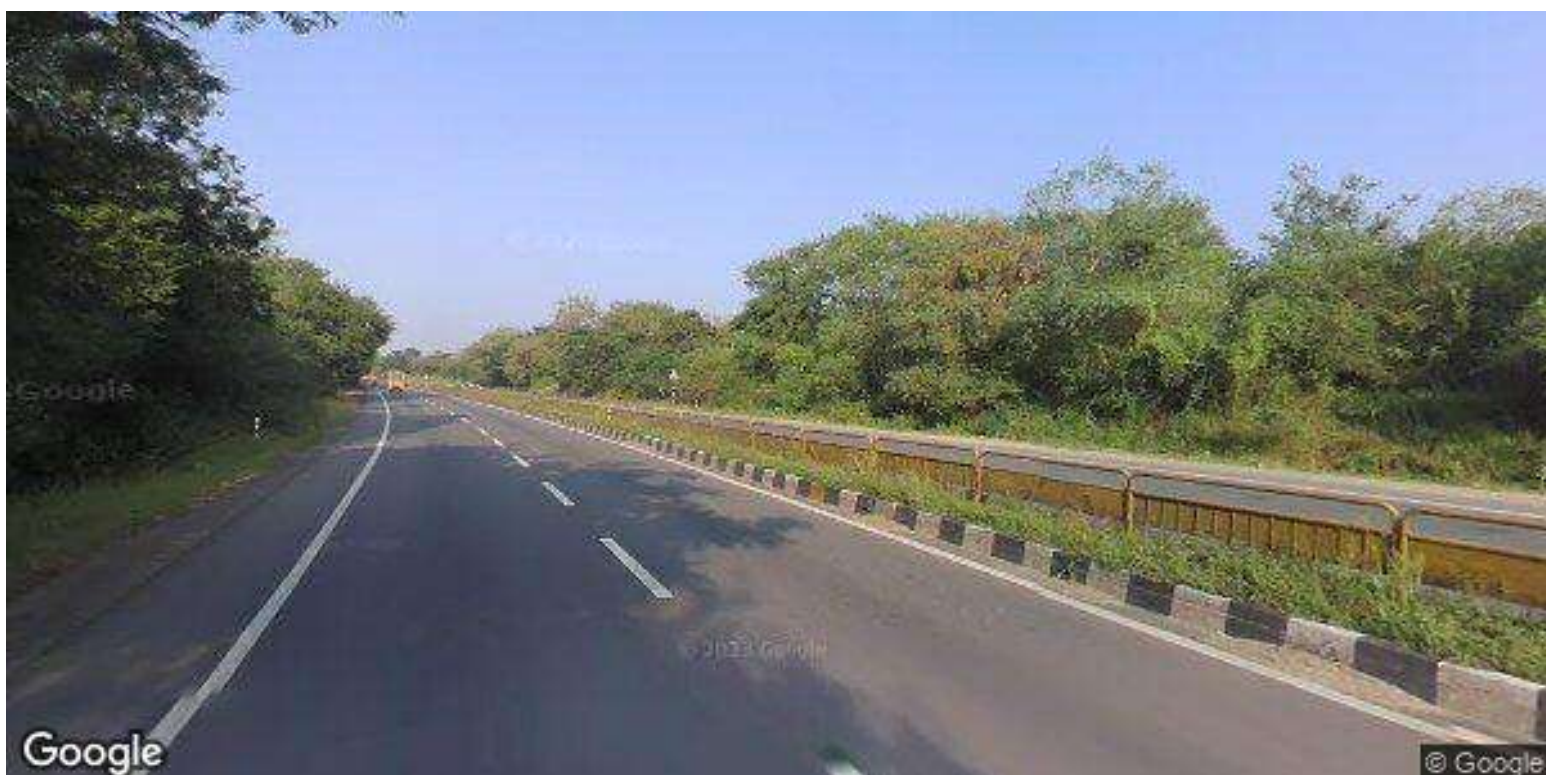
**Coordinates:** 11.98490, 78.06275

**Risk Type:** Turn

**Risk Level:** Medium

**Speed Limit:** 30 KM/Hr

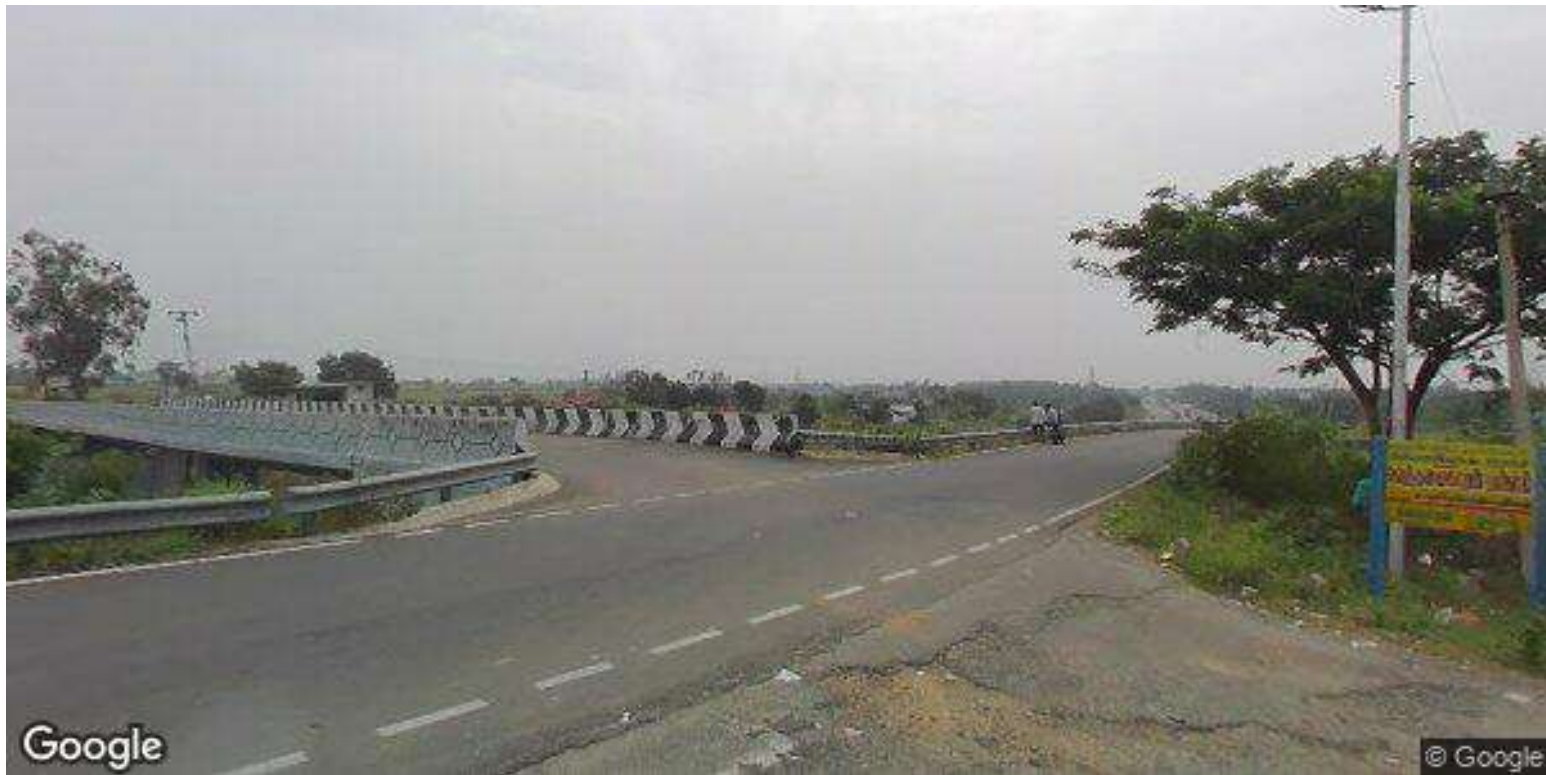
**Coordinates:** 12.09202, 78.11459

**Risk Type:** Blind Spot

**Risk Level:** Blind Spot

**Speed Limit:** 10 KM/Hr

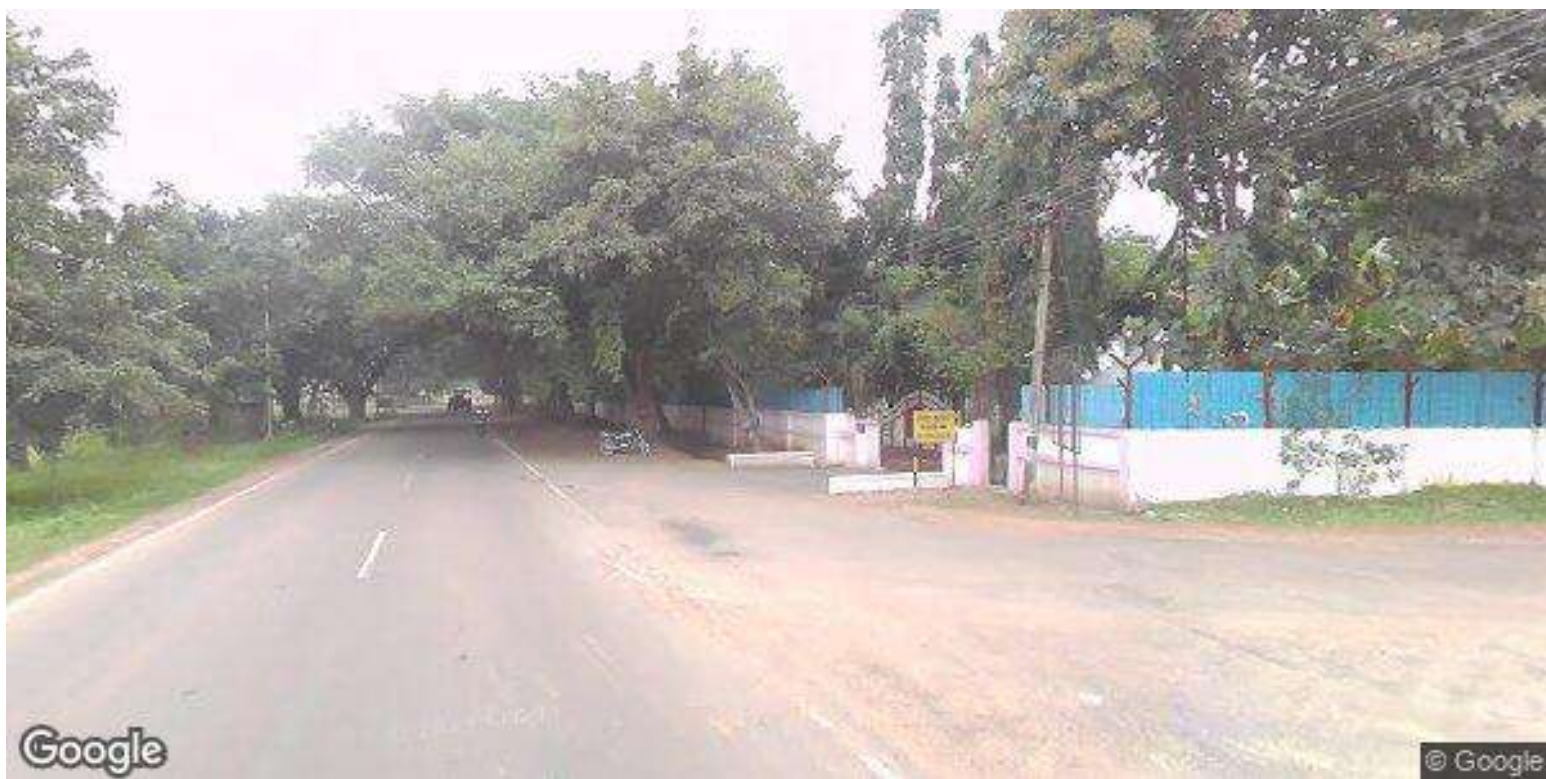
**Coordinates:** 12.08780, 78.12237

**Risk Type:** Turn

**Risk Level:** High

**Speed Limit:** 15 KM/Hr

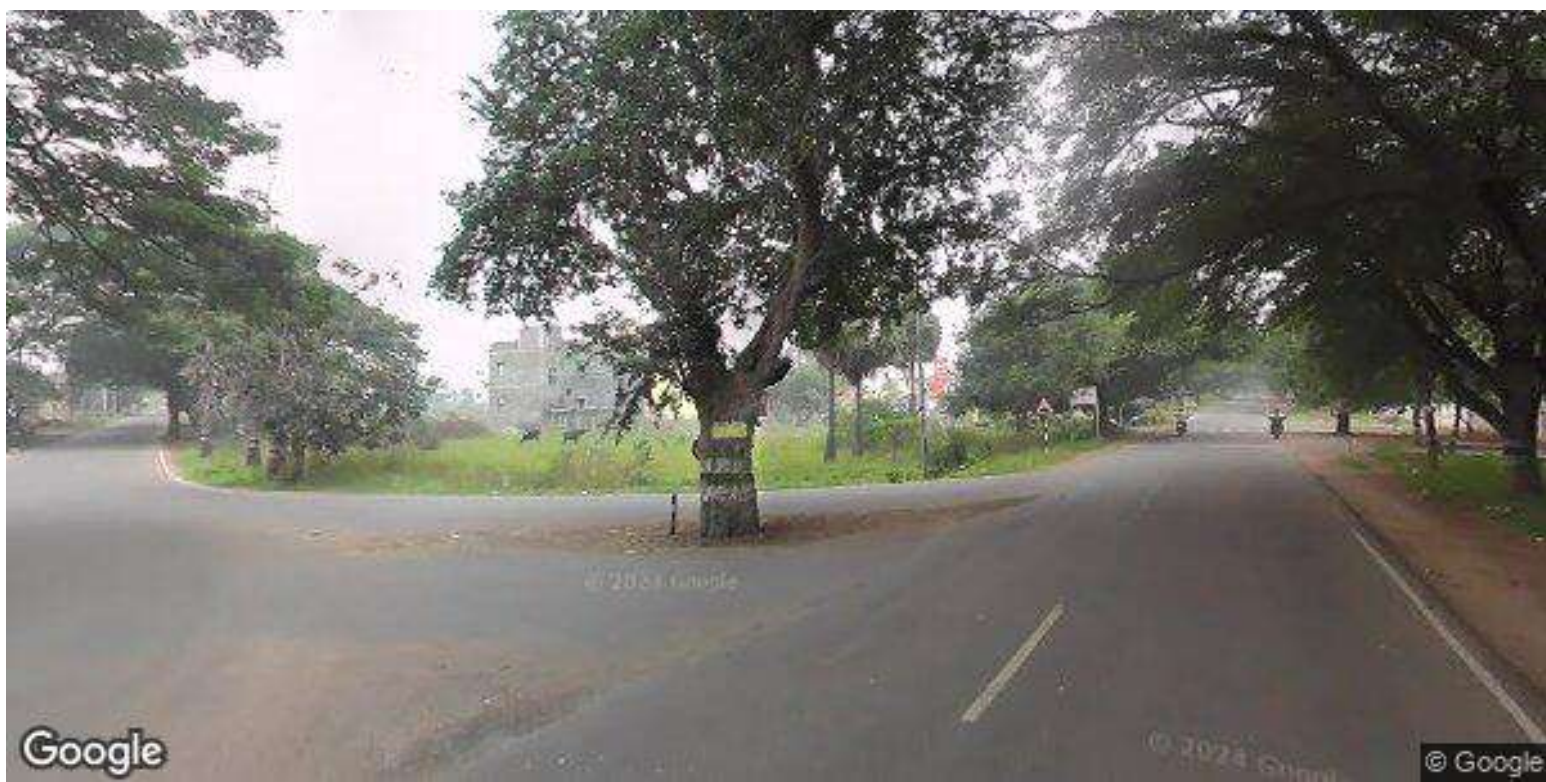
**Coordinates:** 12.08688, 78.12234

**Risk Type:** Turn

**Risk Level:** High

**Speed Limit:** 15 KM/Hr

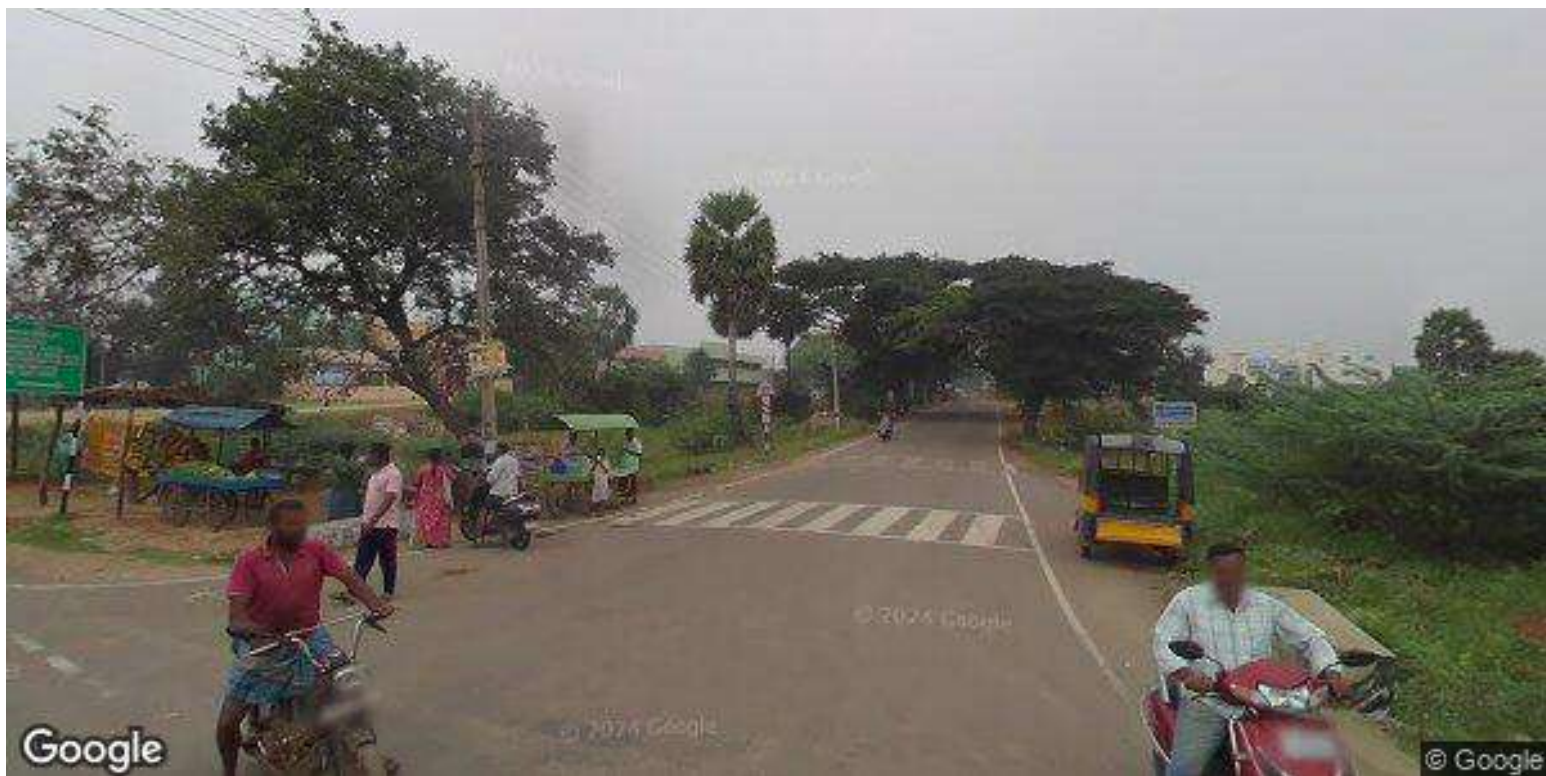
**Coordinates:** 12.08465, 78.12762

**Risk Type:** Blind Spot

**Risk Level:** Blind Spot

**Speed Limit:** 10 KM/Hr

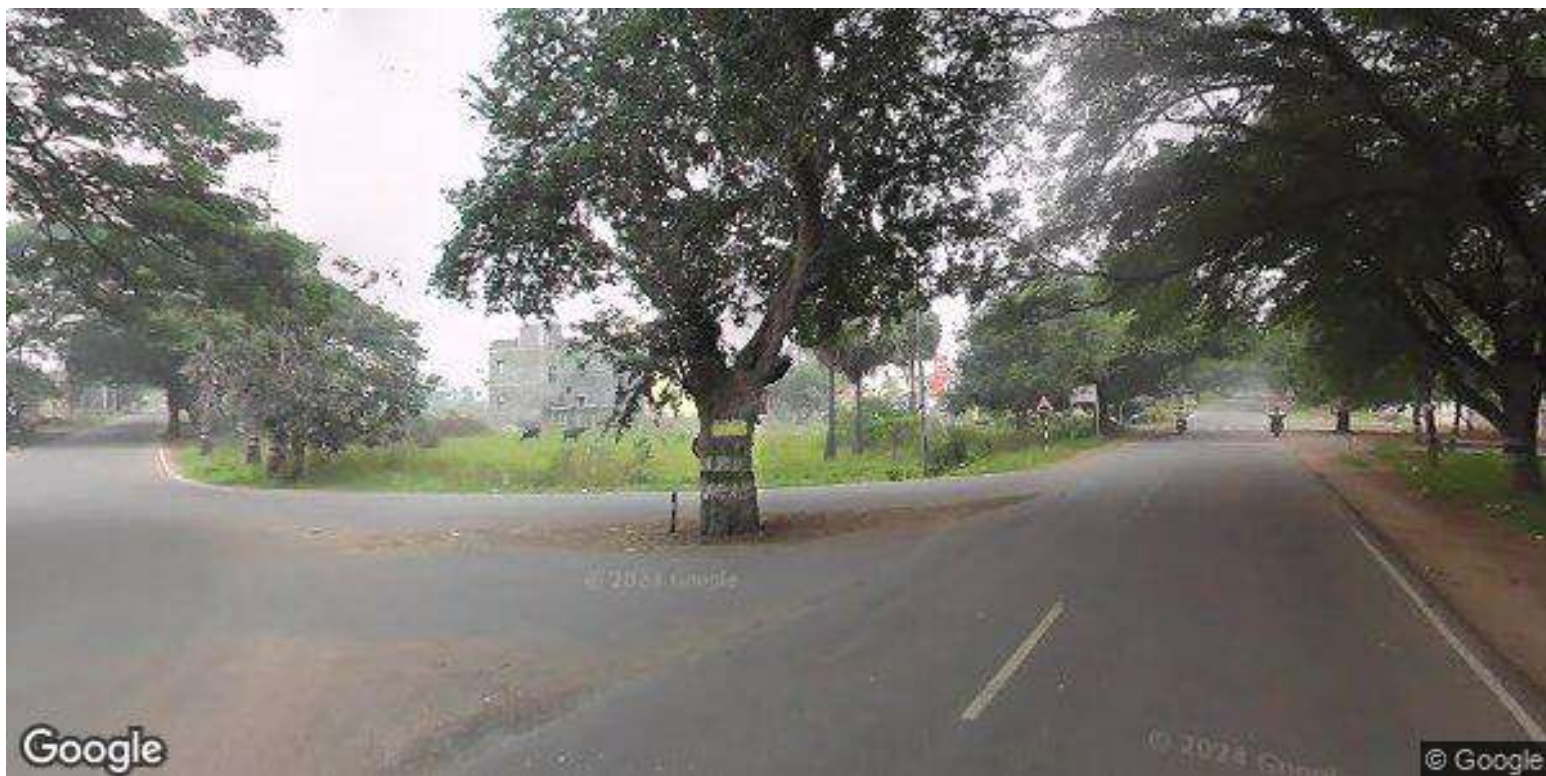
**Risk Type:** Turn  
**Risk Level:** High  
**Speed Limit:** 15 KM/Hr  
**Coordinates:** 12.08688, 78.12234

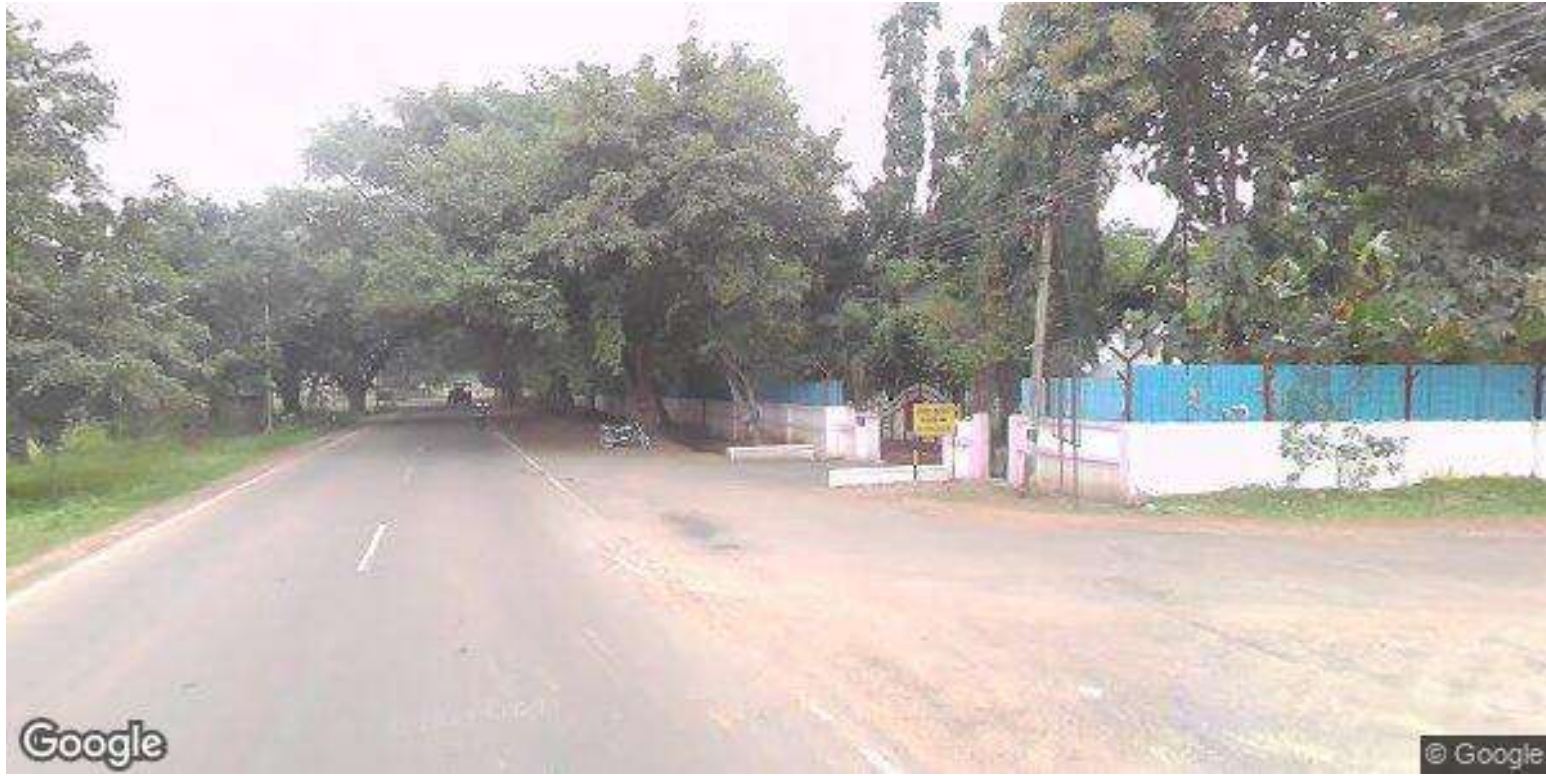
**Risk Type:** Turn  
**Risk Level:** High  
**Speed Limit:** 15 KM/Hr  
**Coordinates:** 12.08780, 78.12237

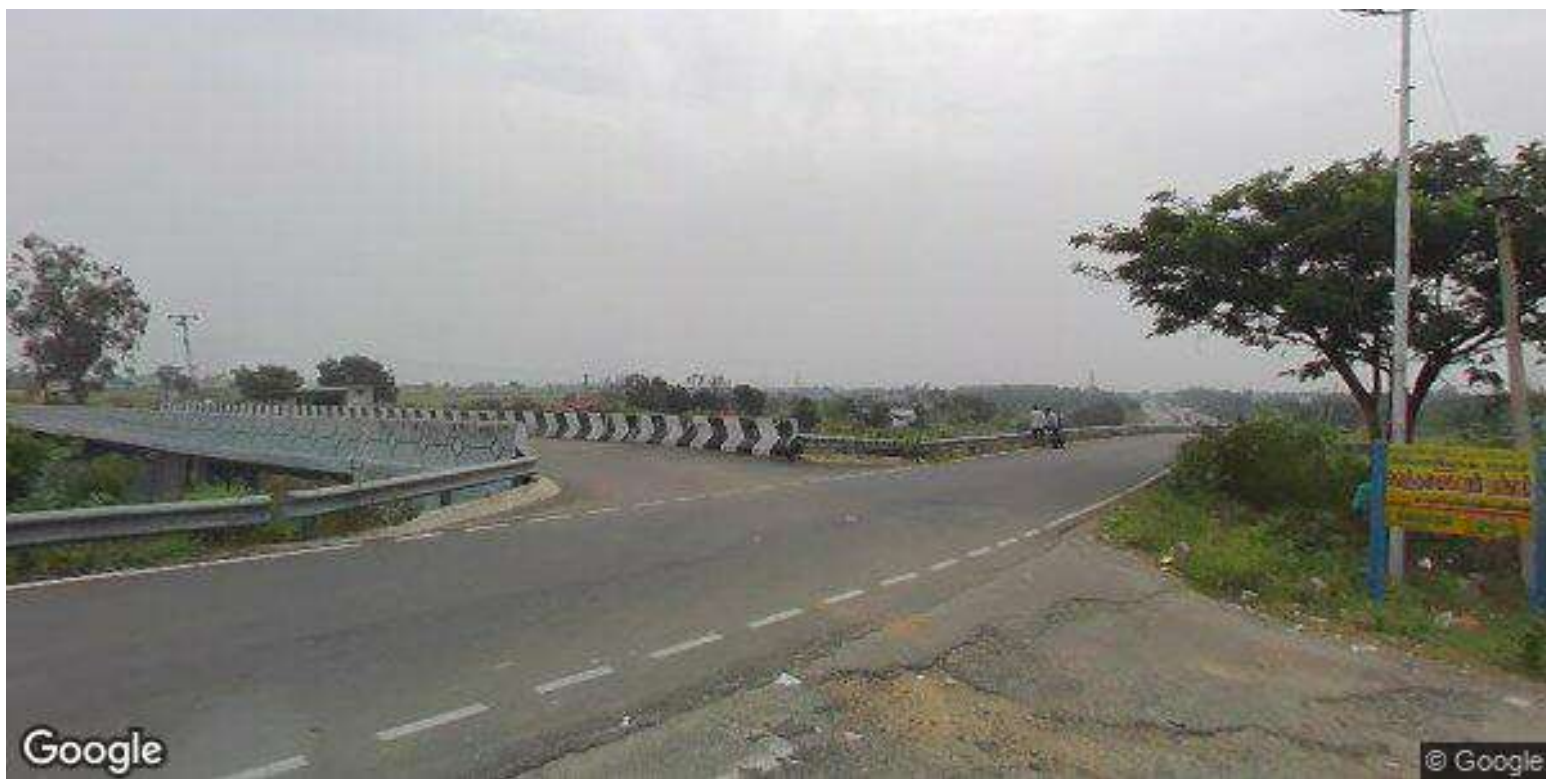
**Risk Type:** Turn  
**Risk Level:** High  
**Speed Limit:** 15 KM/Hr  
**Coordinates:** 12.09202, 78.11459

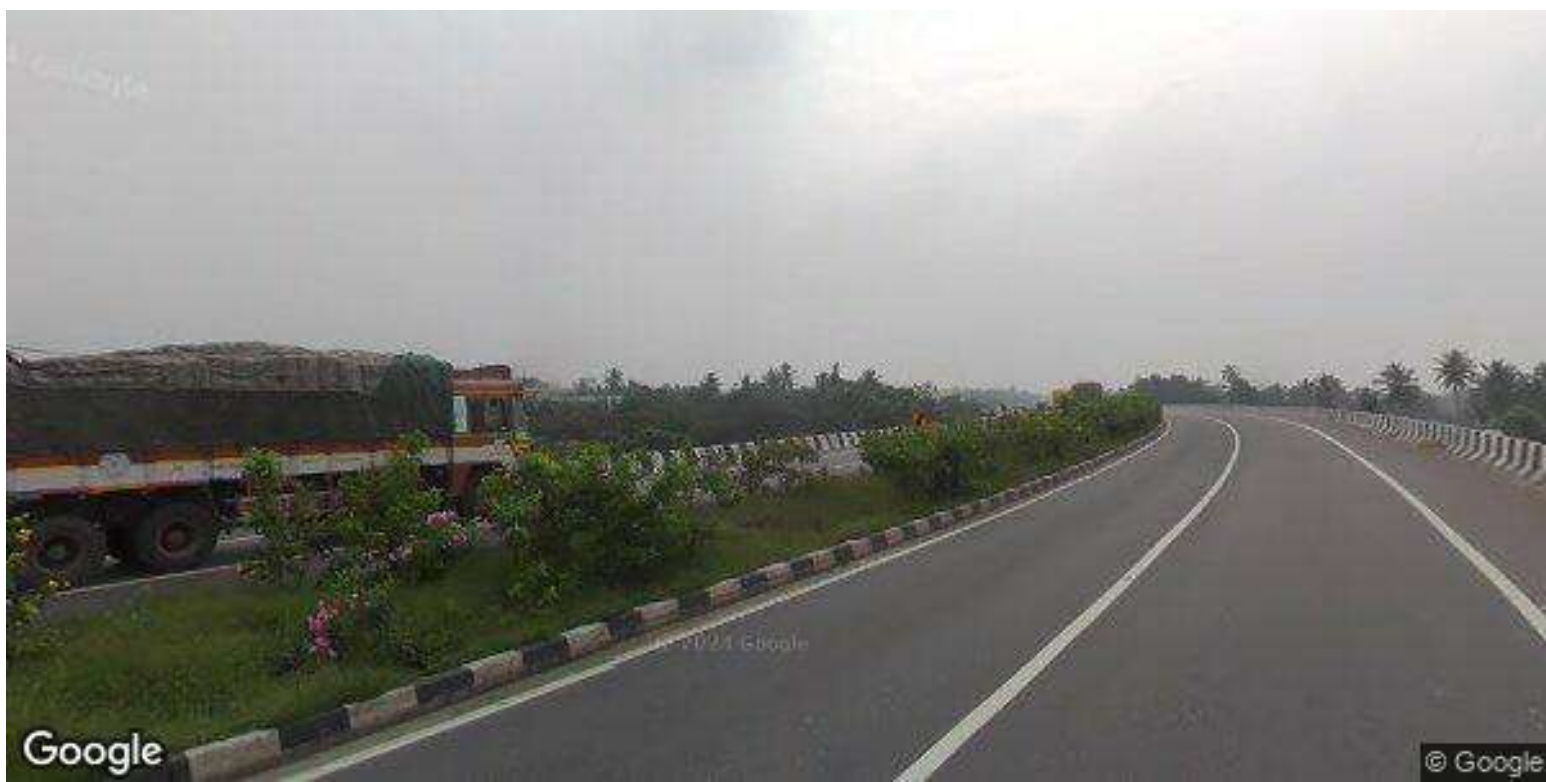
**Coordinates:** 12.24590, 78.19512

**Risk Type:** Turn

**Risk Level:** Medium

**Speed Limit:** 30 KM/Hr

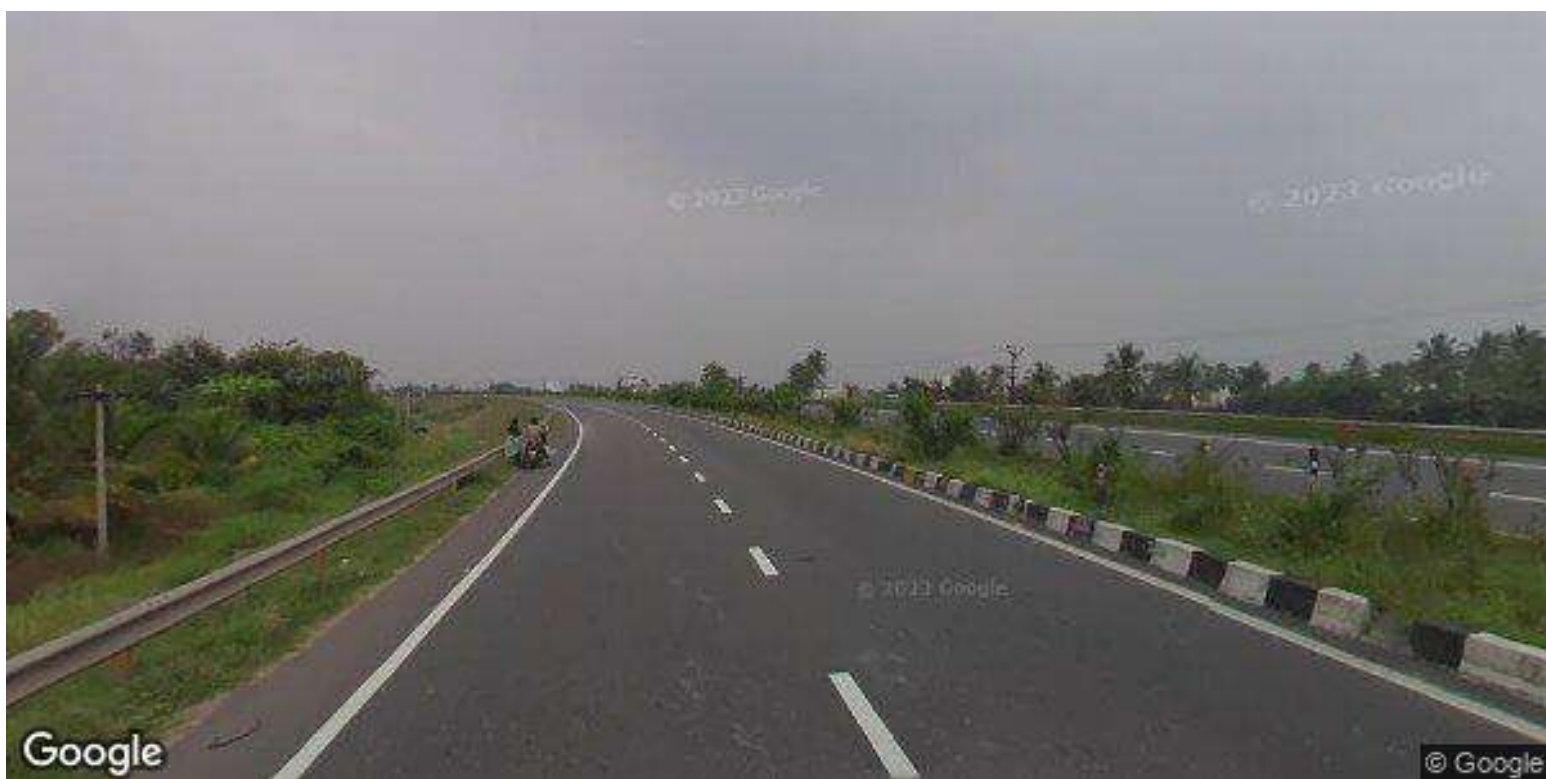
**Coordinates:** 12.25185, 78.20031

**Risk Type:** Turn

**Risk Level:** Medium

**Speed Limit:** 30 KM/Hr

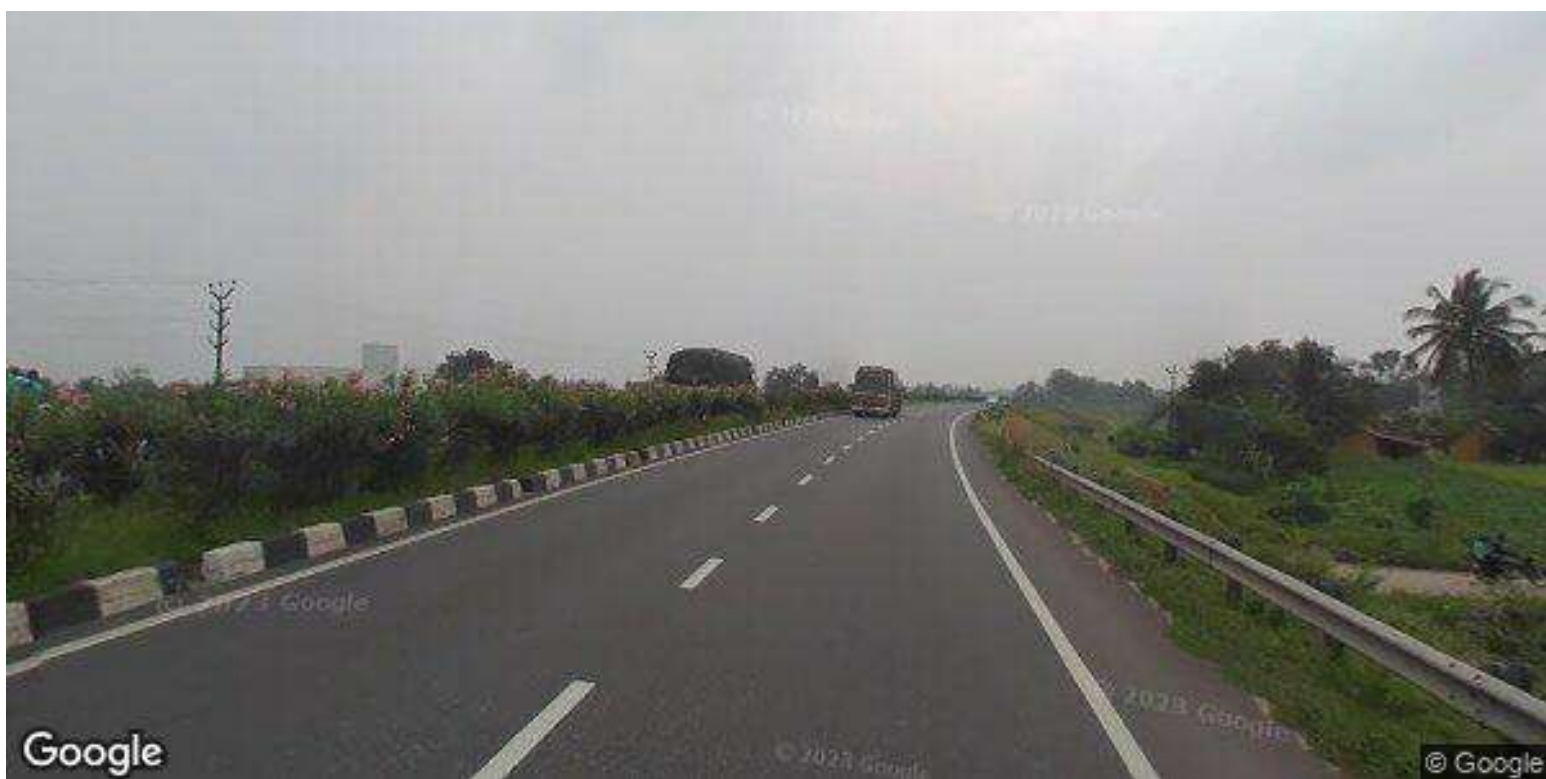
**Risk Type:** Turn  
**Risk Level:** Medium  
**Speed Limit:** 30 KM/Hr  
**Coordinates:** 12.25477, 78.20000

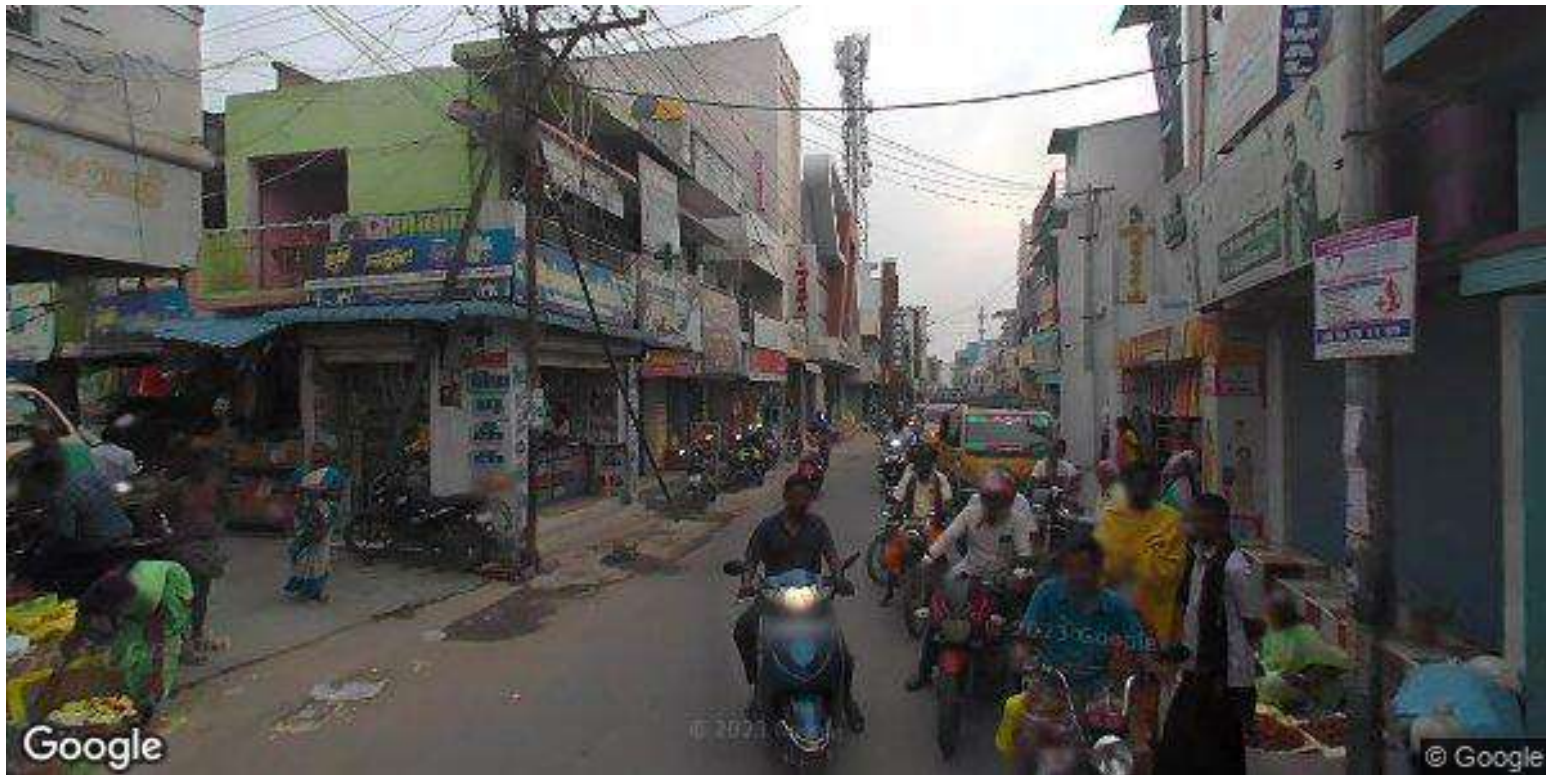
**Risk Type:** Turn  
**Risk Level:** High  
**Speed Limit:** 15 KM/Hr  
**Coordinates:** 12.30916, 78.20317

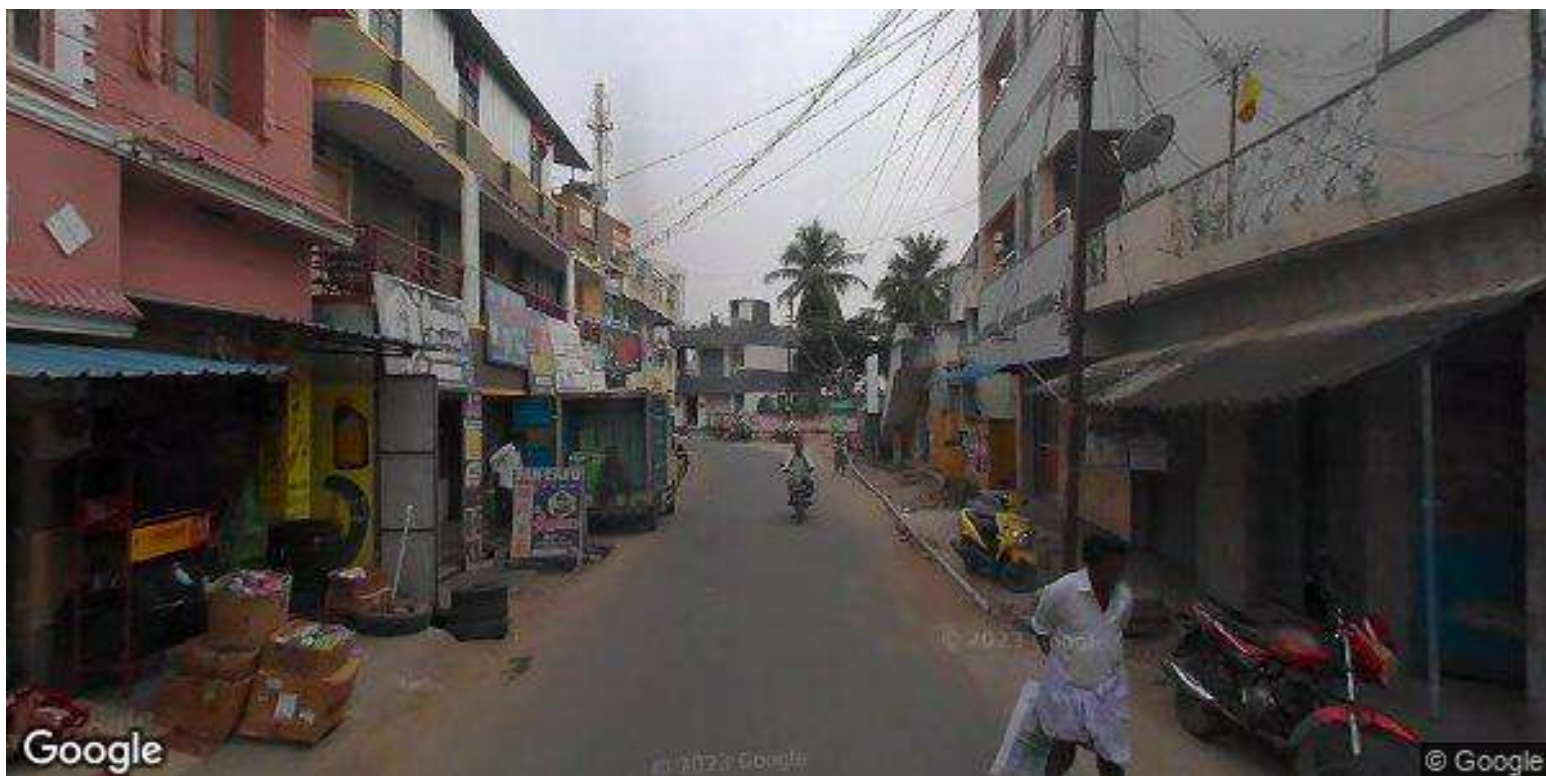
**Risk Type:** Turn  
**Risk Level:** Medium  
**Speed Limit:** 30 KM/Hr  
**Coordinates:** 12.31000, 78.20220

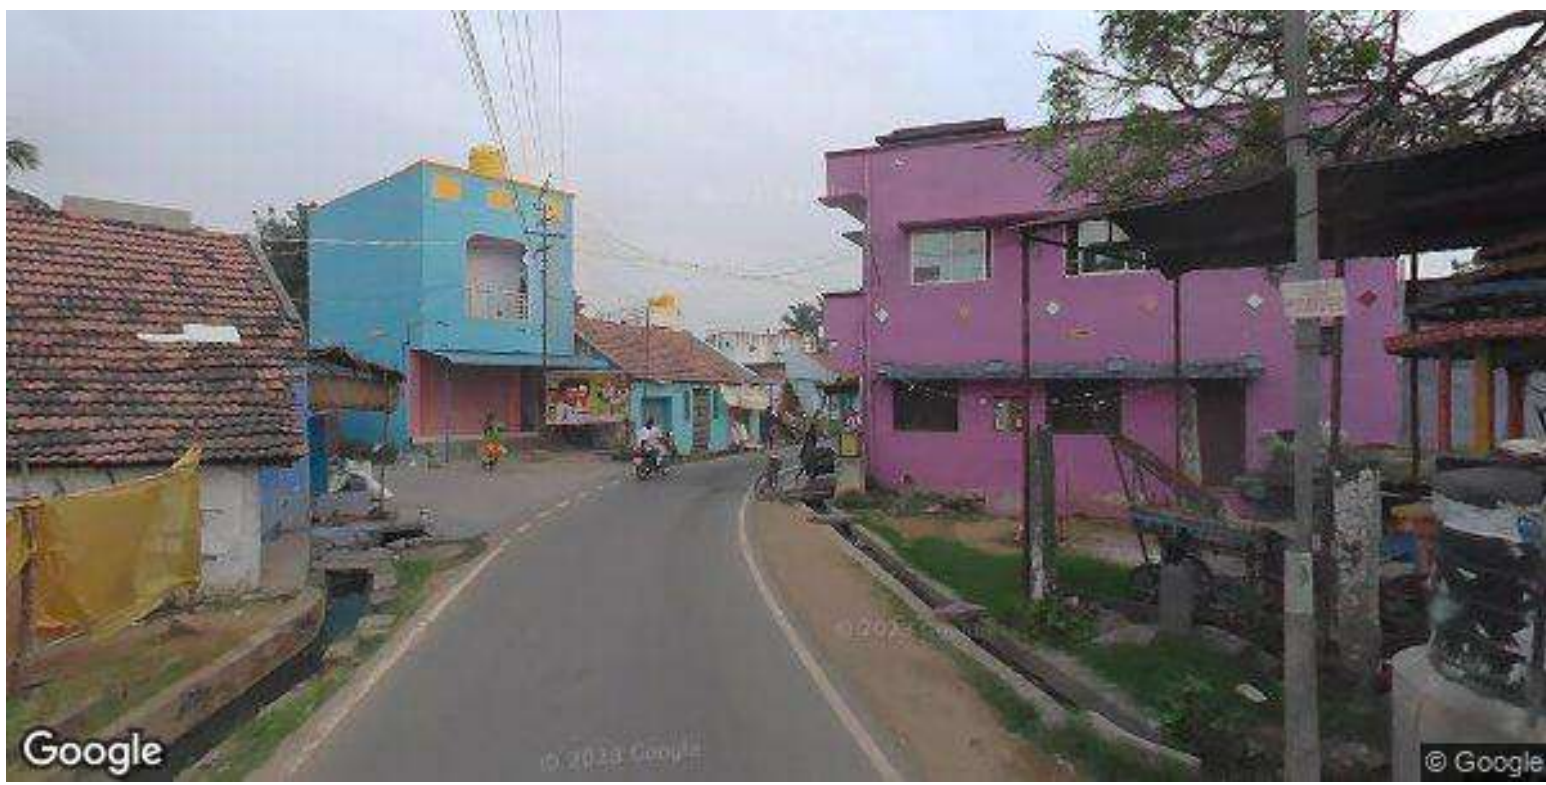
**Coordinates:** 12.31077, 78.20193

**Risk Type:** Turn

**Risk Level:** High

**Speed Limit:** 15 KM/Hr
