# IndianOil

## JOURNEY RISK MANAGEMENT (JRM) STUDY

### Salem Terminal to ARAVINTH AGENCIES

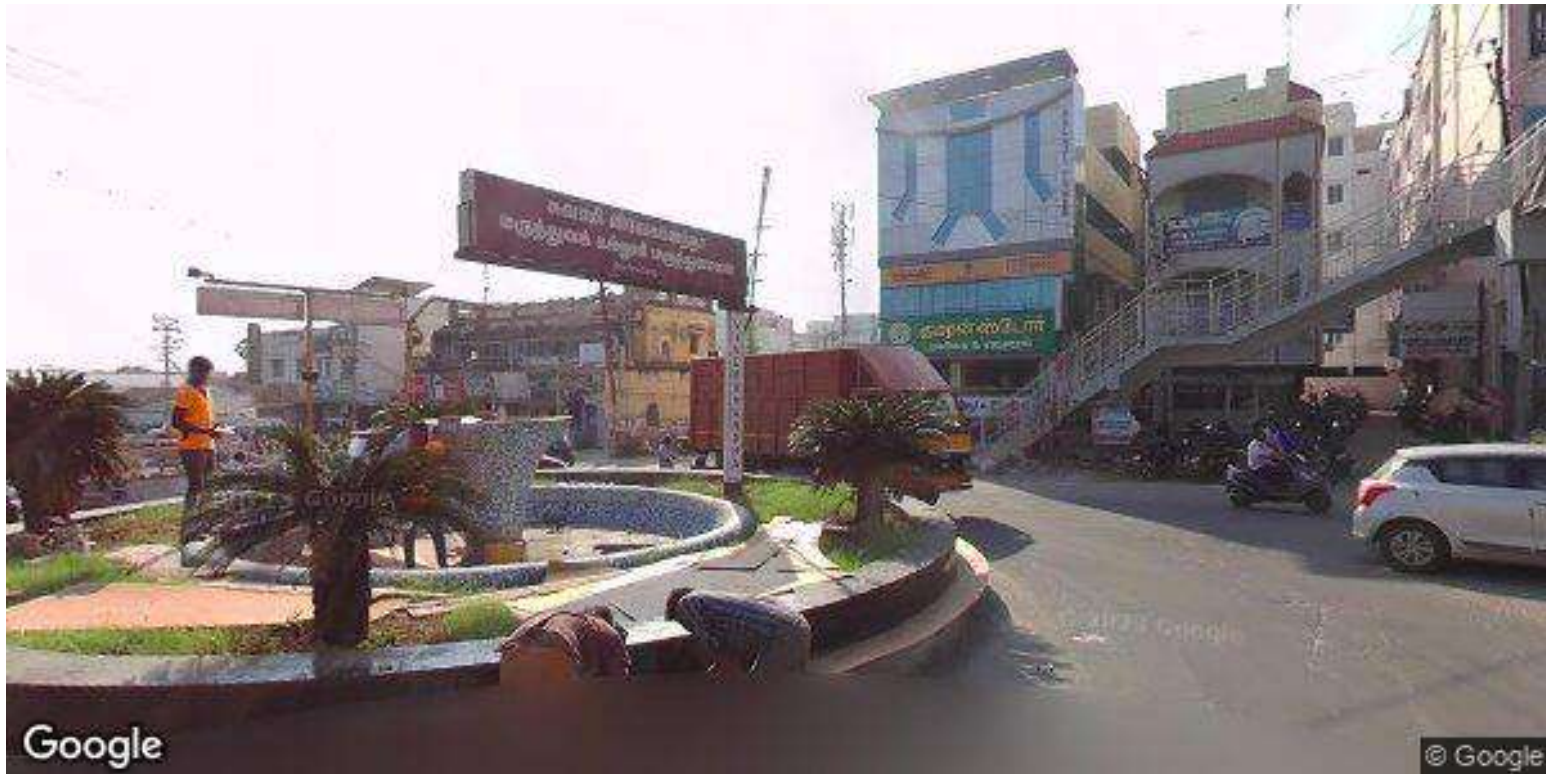
**Coordinates:** 11.38395, 77.89480

**Risk Type:** Roundabout

**Risk Level:** High

**Speed Limit:** 15 KM/Hr

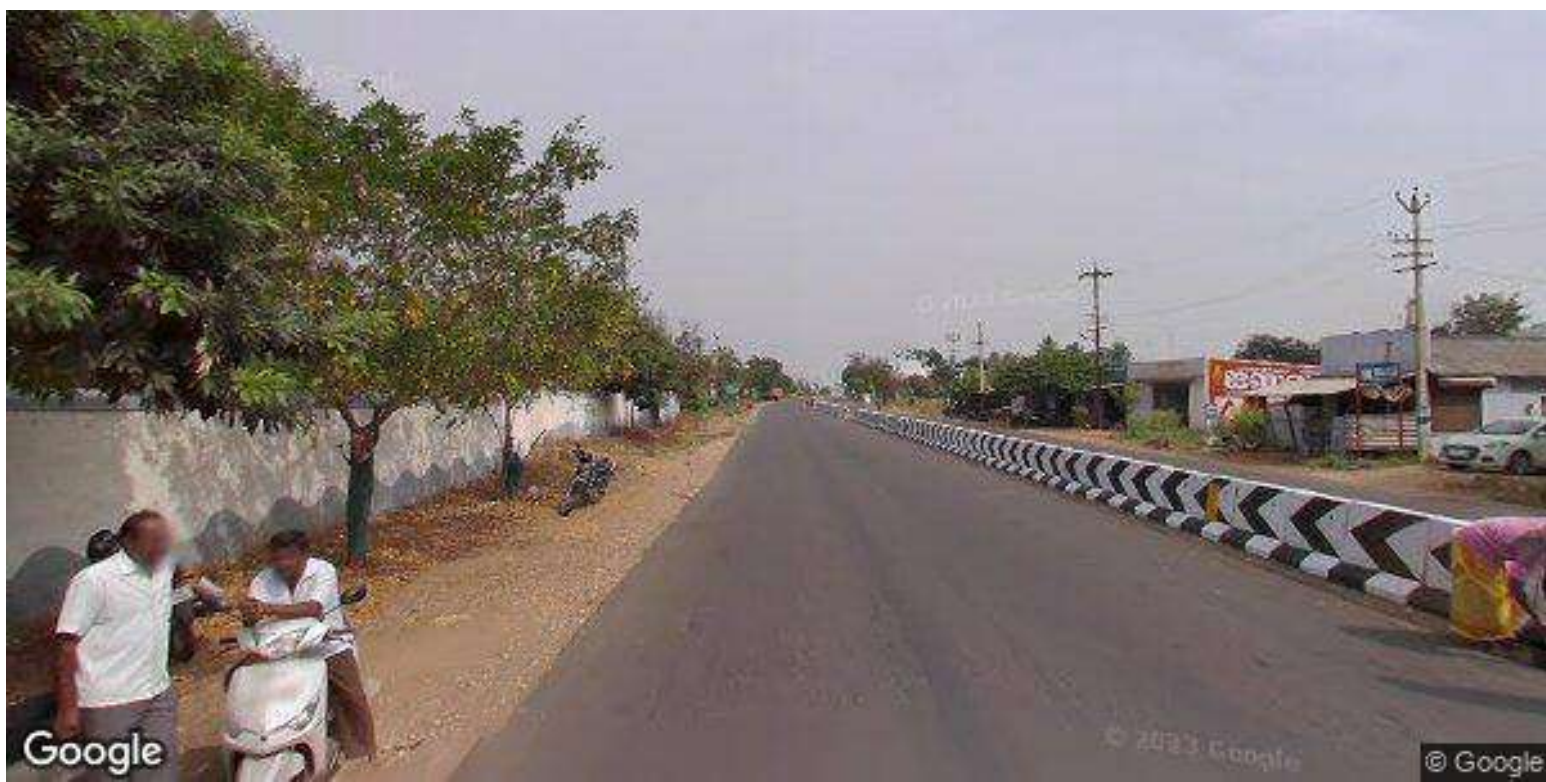
**Coordinates:** 11.0131468, 77.5636391

**Risk Type:** U-Turn

**Risk Level:** High

**Speed Limit:** 10 KM/Hr

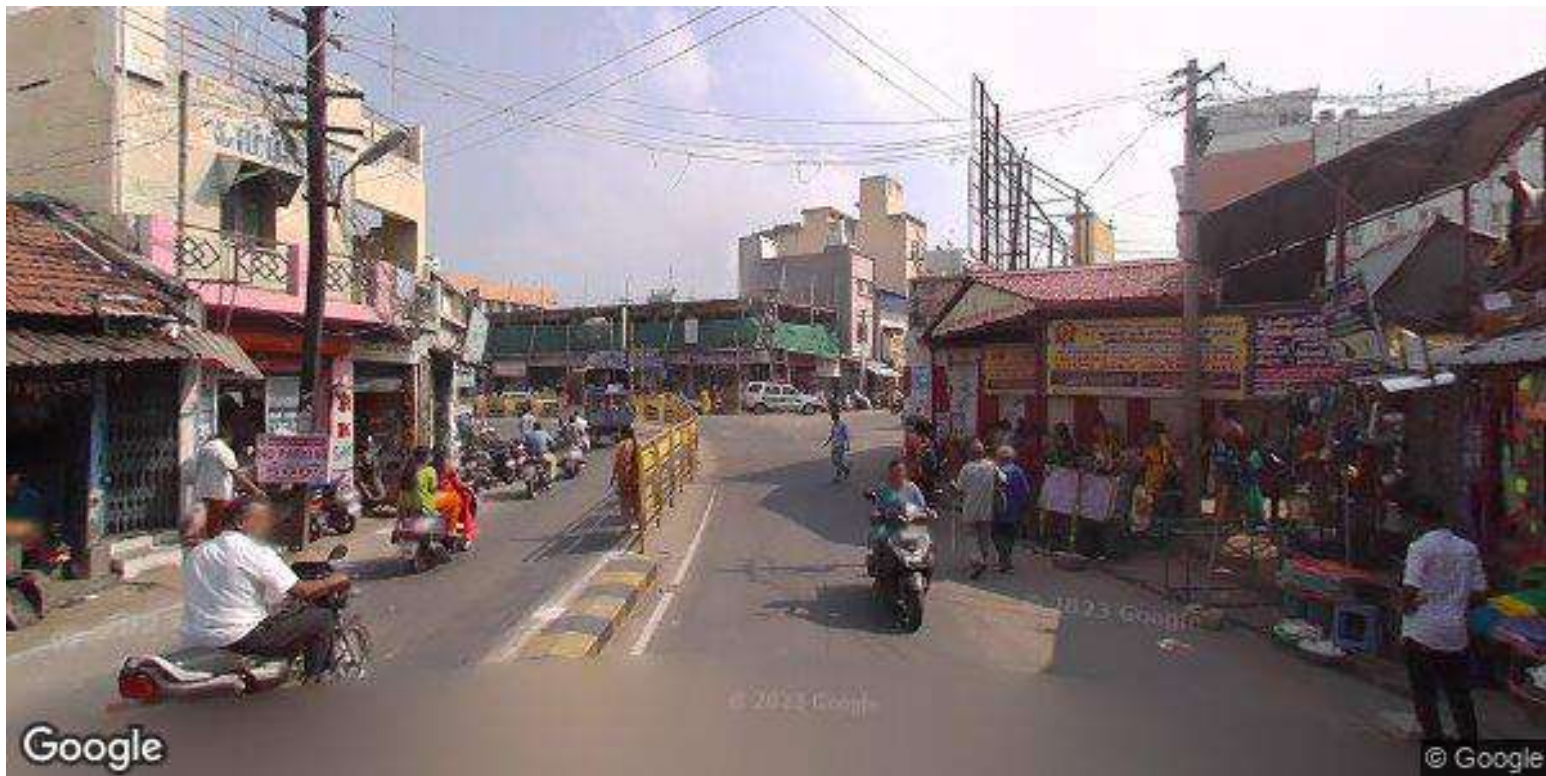
**Coordinates: 11.37857, 77.89473**

**Risk Type: Turn**

**Risk Level: Medium**

**Speed Limit: 30 KM/Hr**

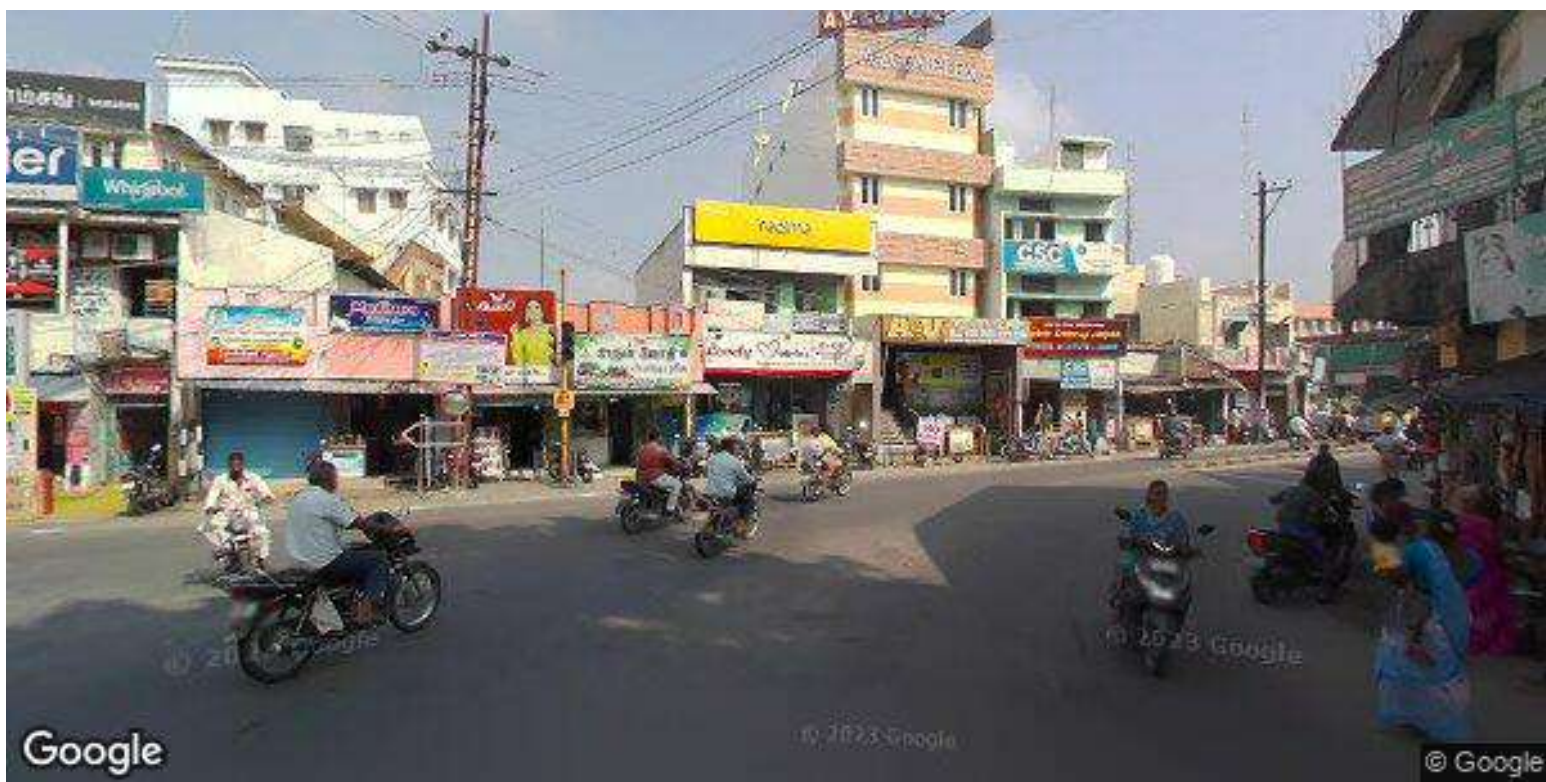
**Coordinates:** 11.37842, 77.89452

**Risk Type:** Turn

**Risk Level:** Medium

**Speed Limit:** 30 KM/Hr

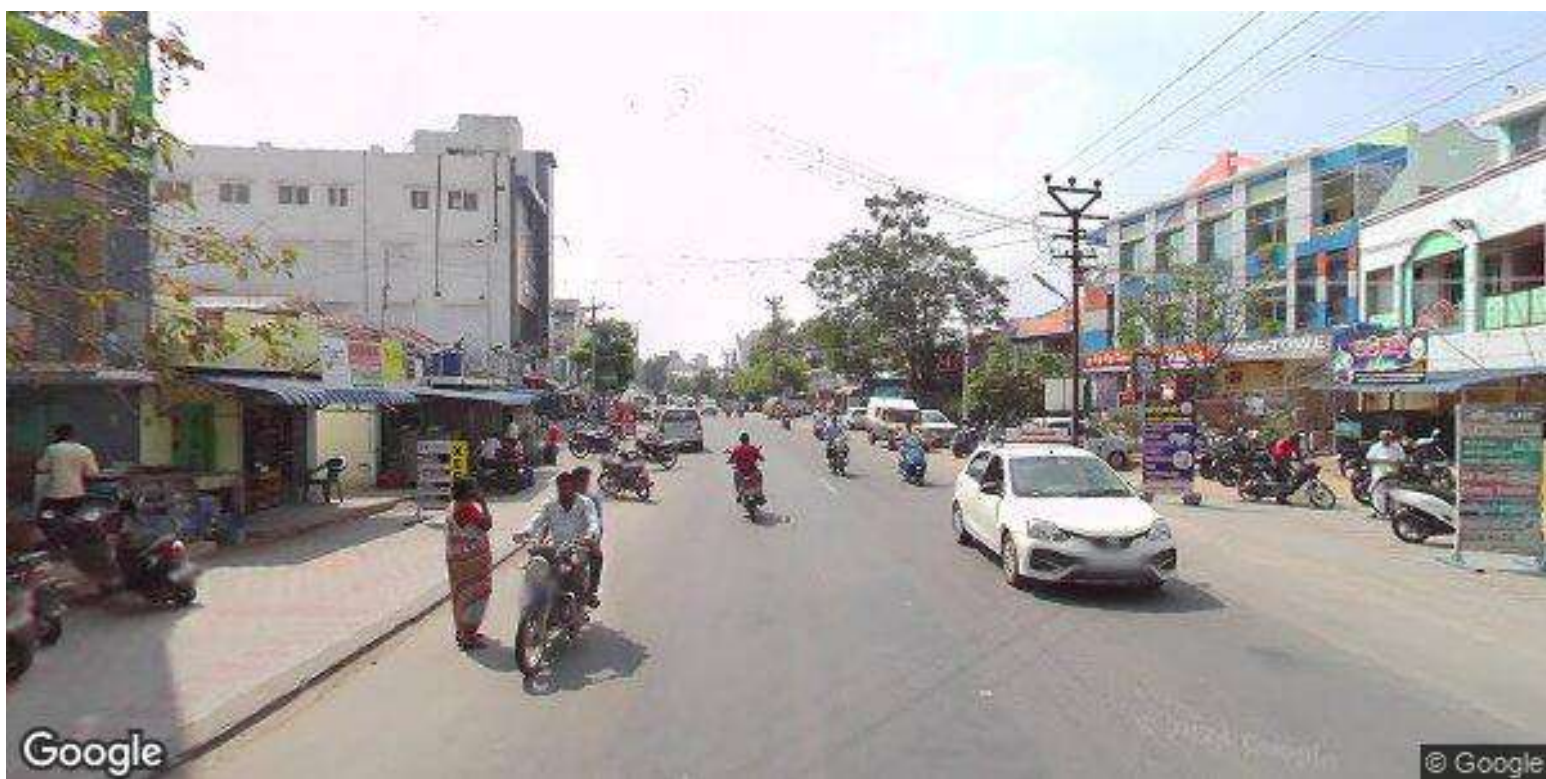
**Coordinates:** 11.36919, 77.88934

**Risk Type:** Turn

**Risk Level:** Medium

**Speed Limit:** 30 KM/Hr

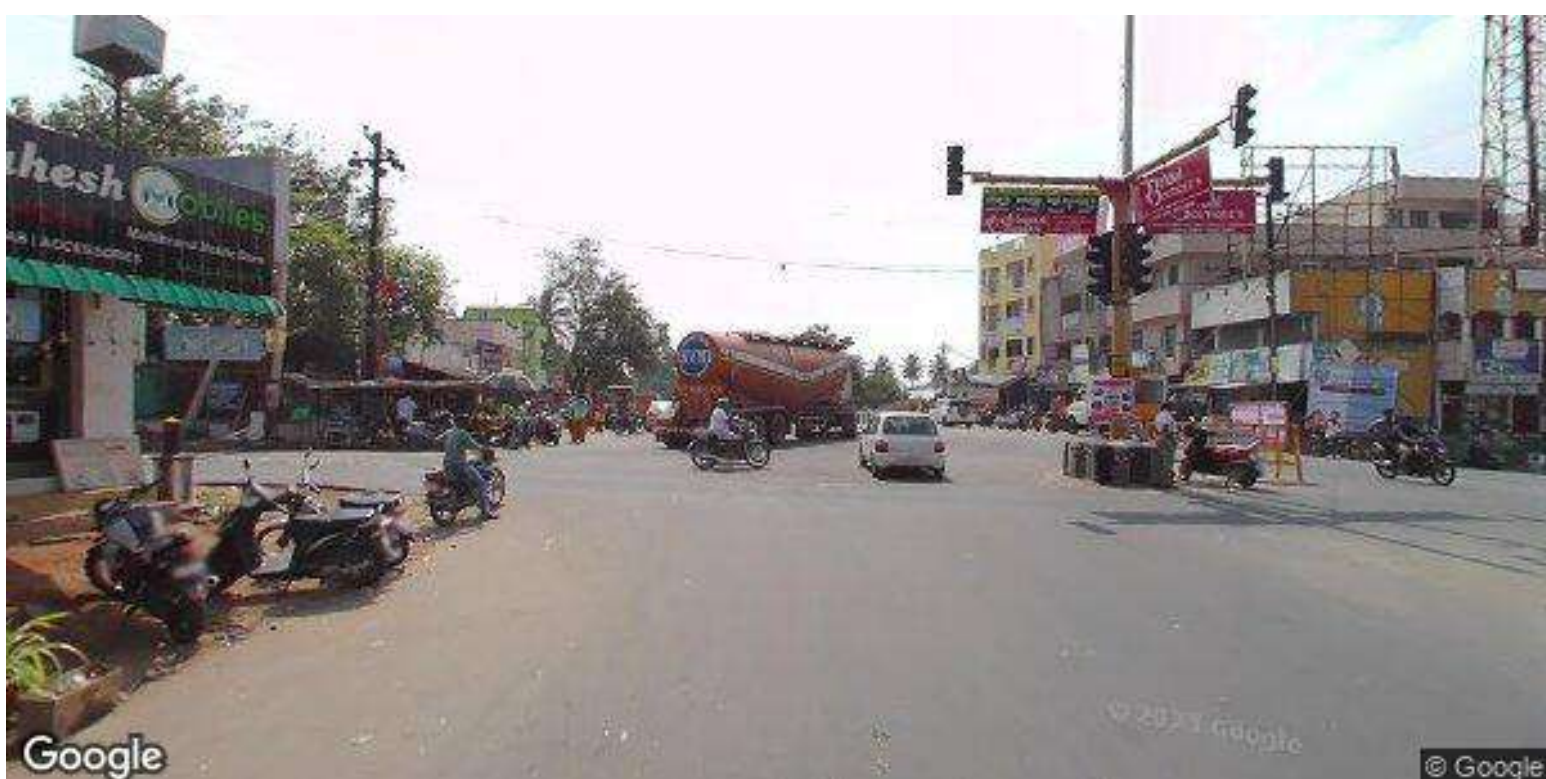
**Coordinates: 11.36616, 77.88885**

**Risk Type: Turn**

**Risk Level: Medium**

**Speed Limit: 30 KM/Hr**

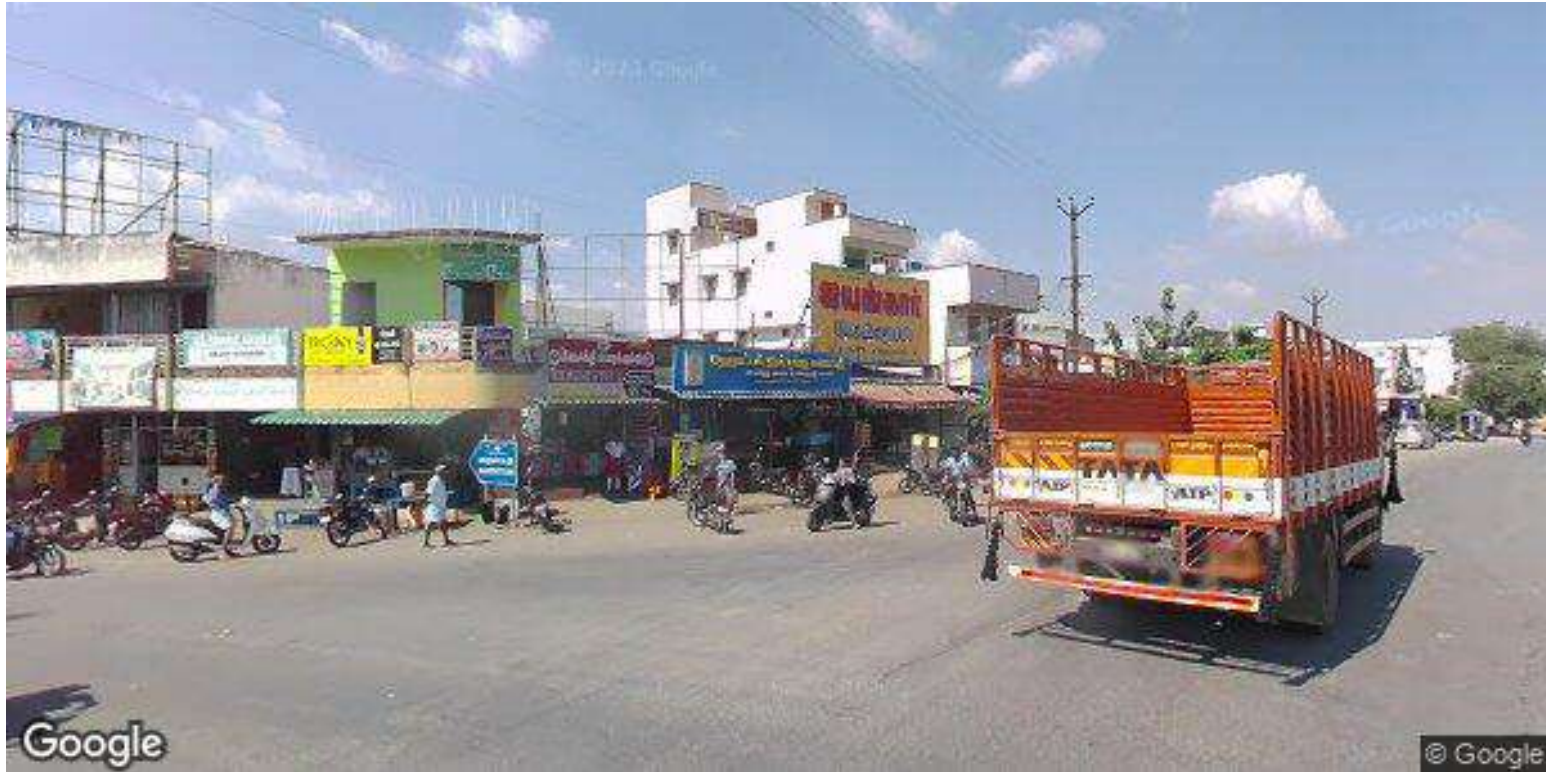
**Coordinates: 11.36602, 77.88875**

**Risk Type: Turn**

**Risk Level: Medium**

**Speed Limit: 30 KM/Hr**

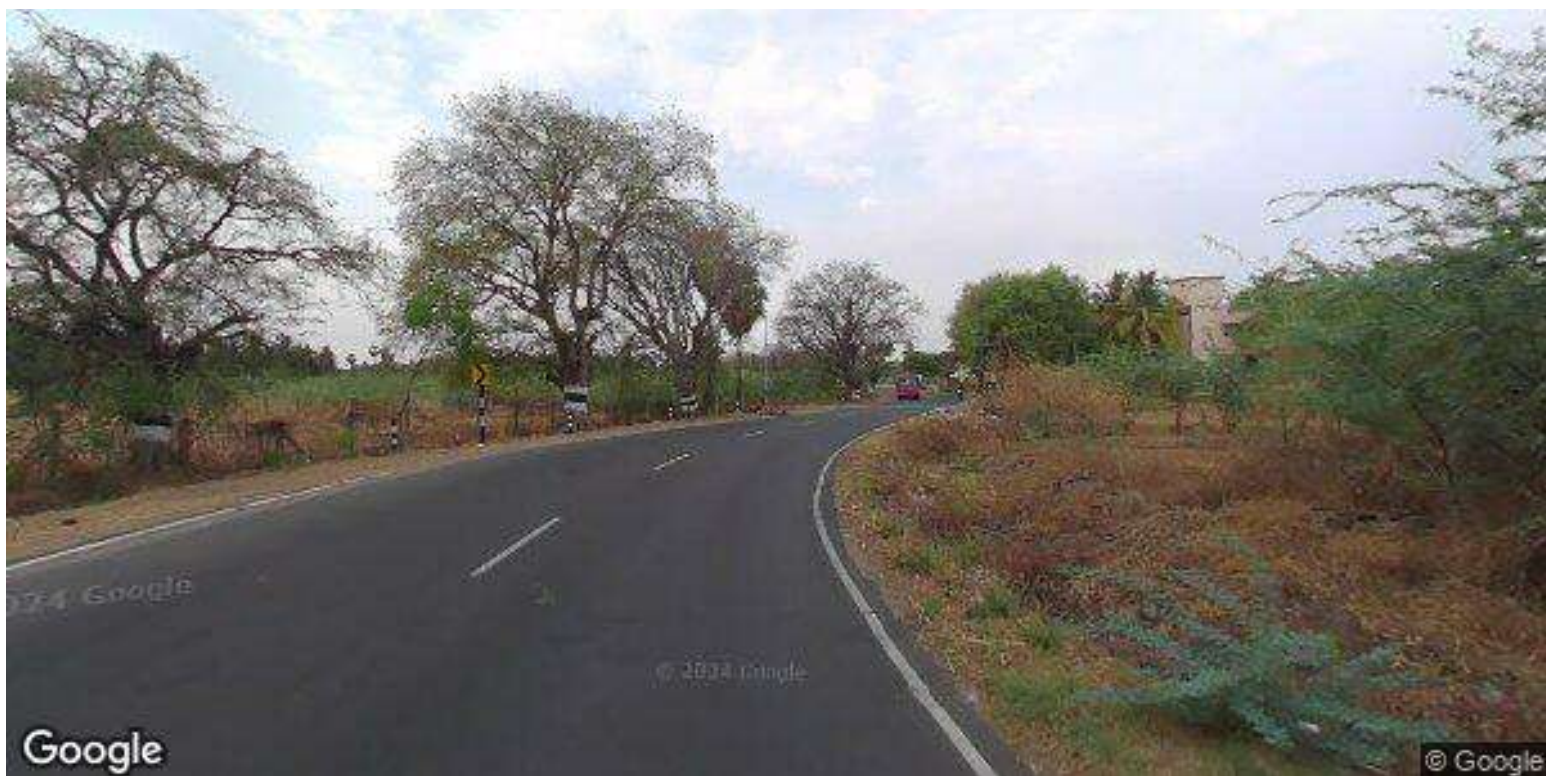
**Coordinates: 11.34067, 77.86347**

**Risk Type: Turn**

**Risk Level: Medium**

**Speed Limit: 30 KM/Hr**

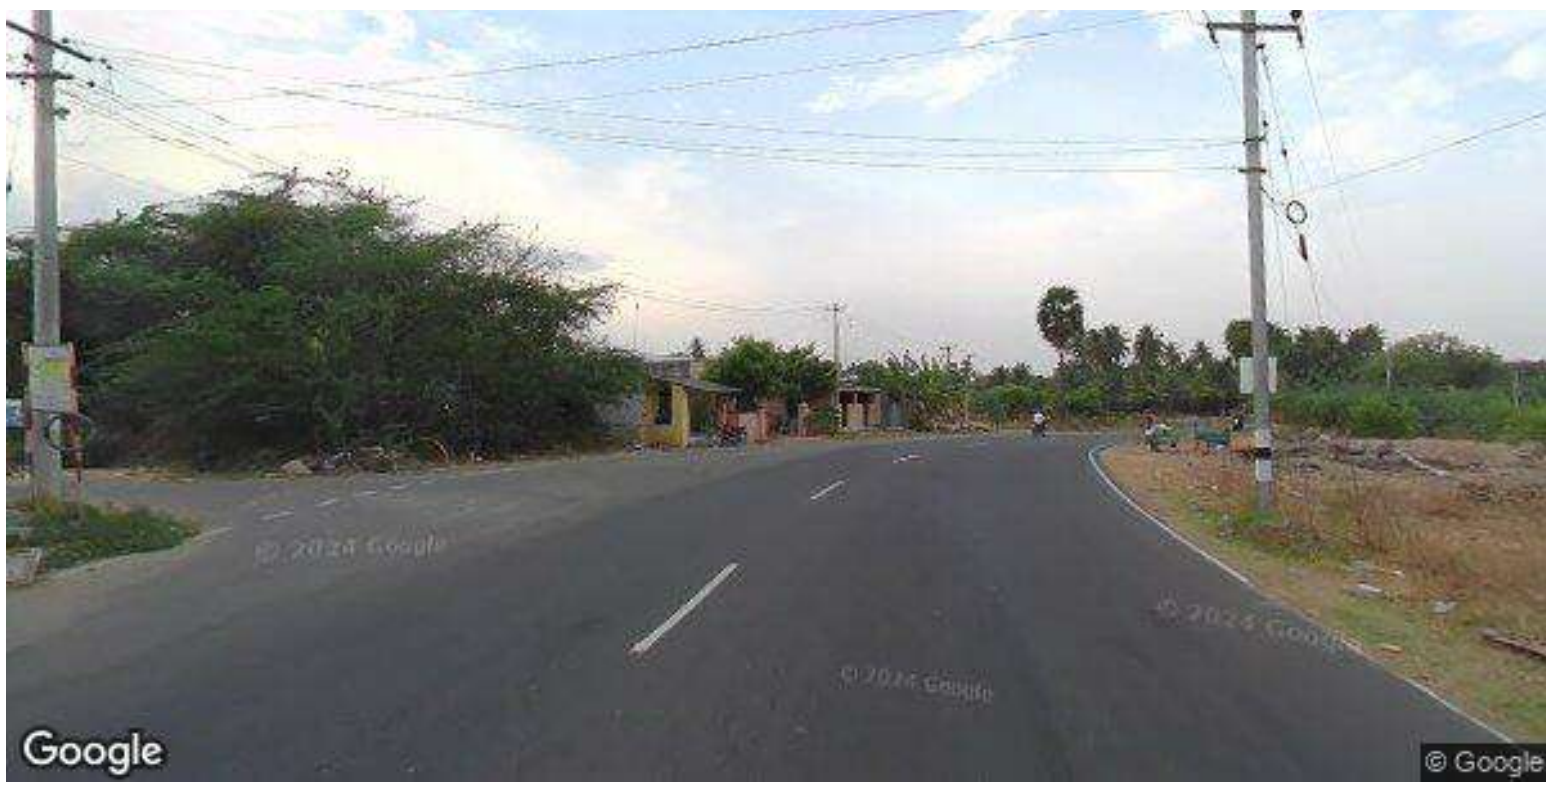
**Coordinates:** 11.33854, 77.86216

**Risk Type:** Turn

**Risk Level:** Medium

**Speed Limit:** 30 KM/Hr

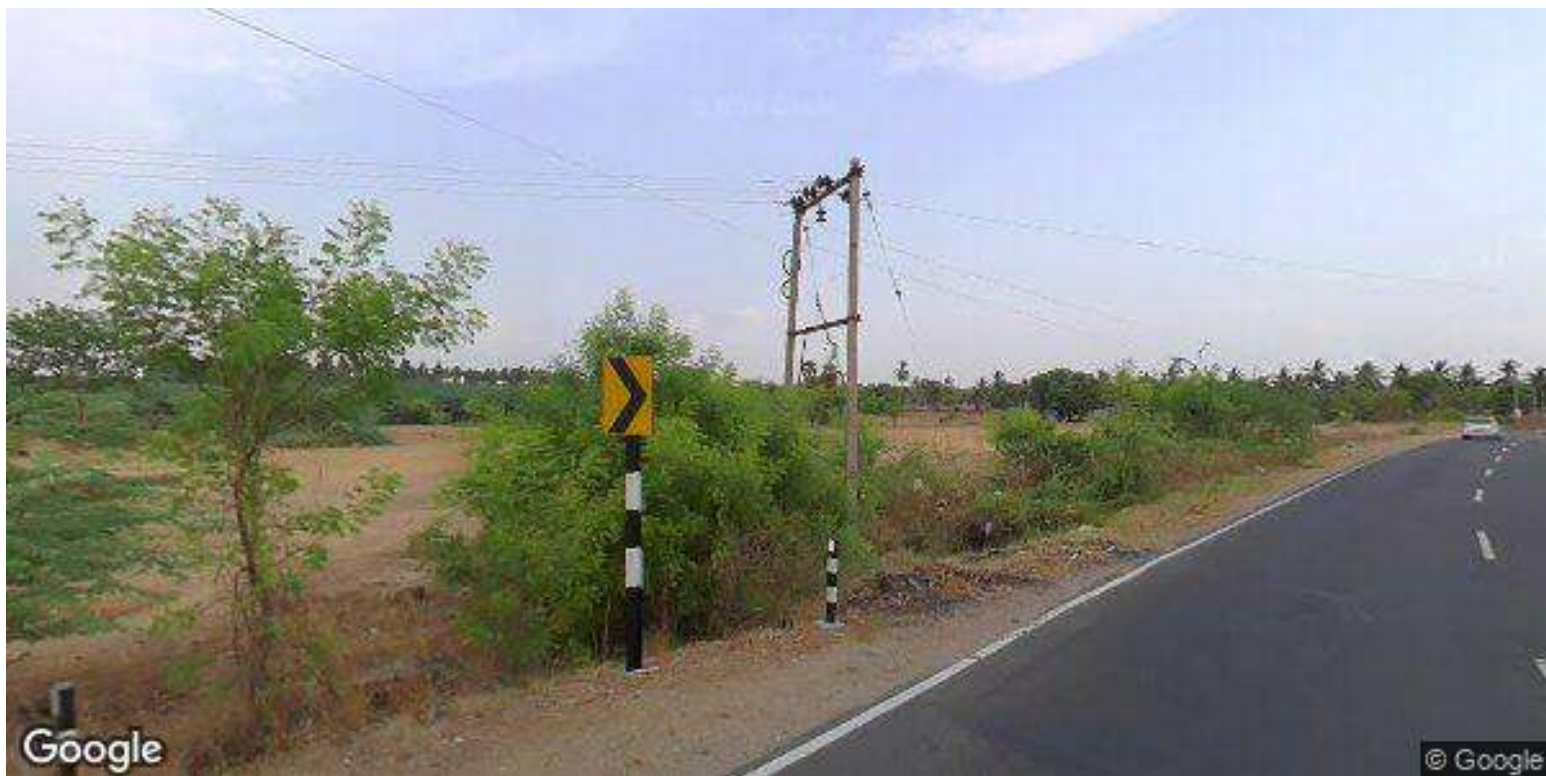
**Coordinates:** 11.33778, 77.86236

**Risk Type:** Turn

**Risk Level:** Medium

**Speed Limit:** 30 KM/Hr

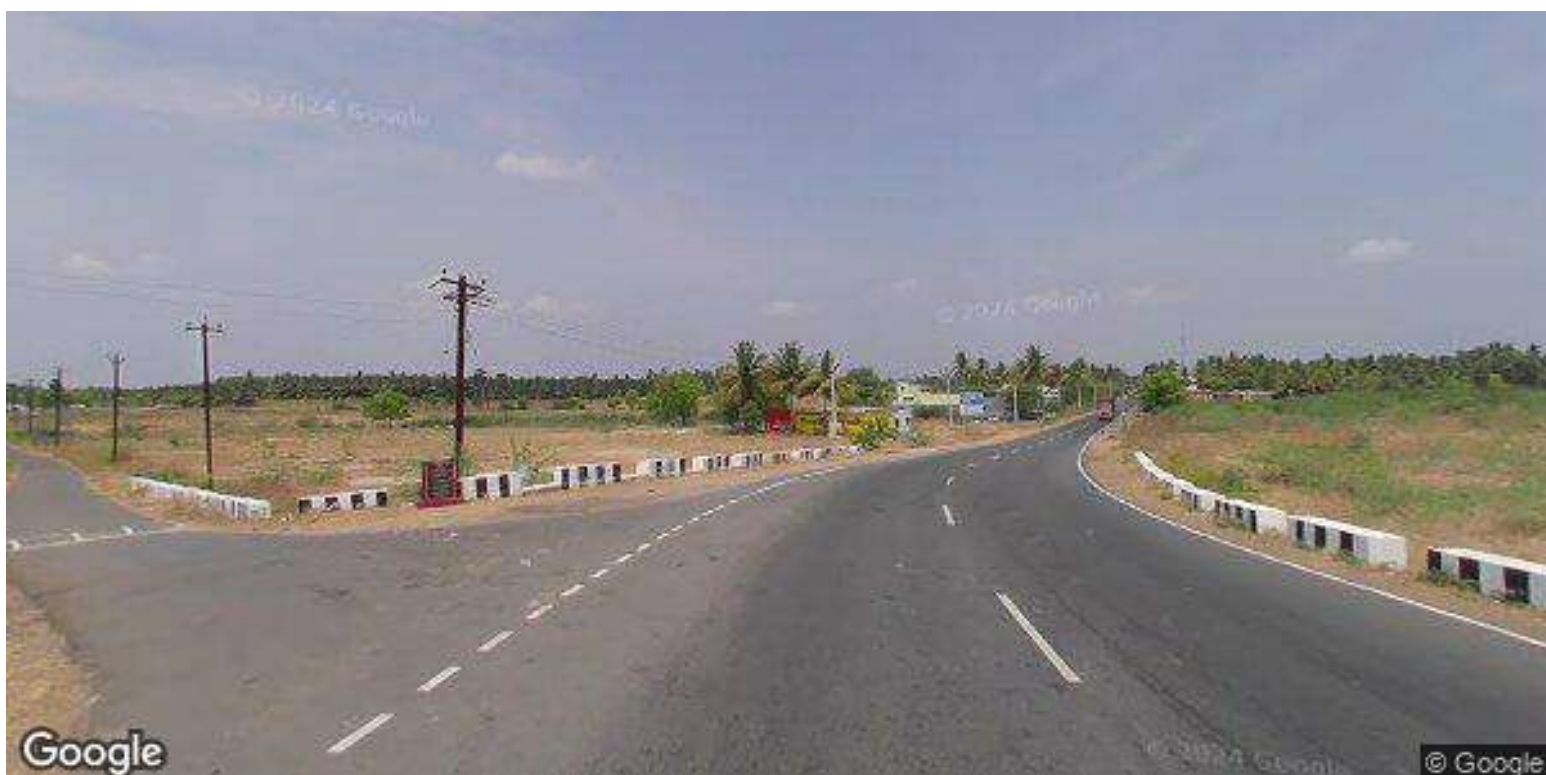
**Risk Type:** Turn  
**Risk Level:** Medium  
**Speed Limit:** 30 KM/Hr  
**Coordinates:** 11.31752, 77.84260

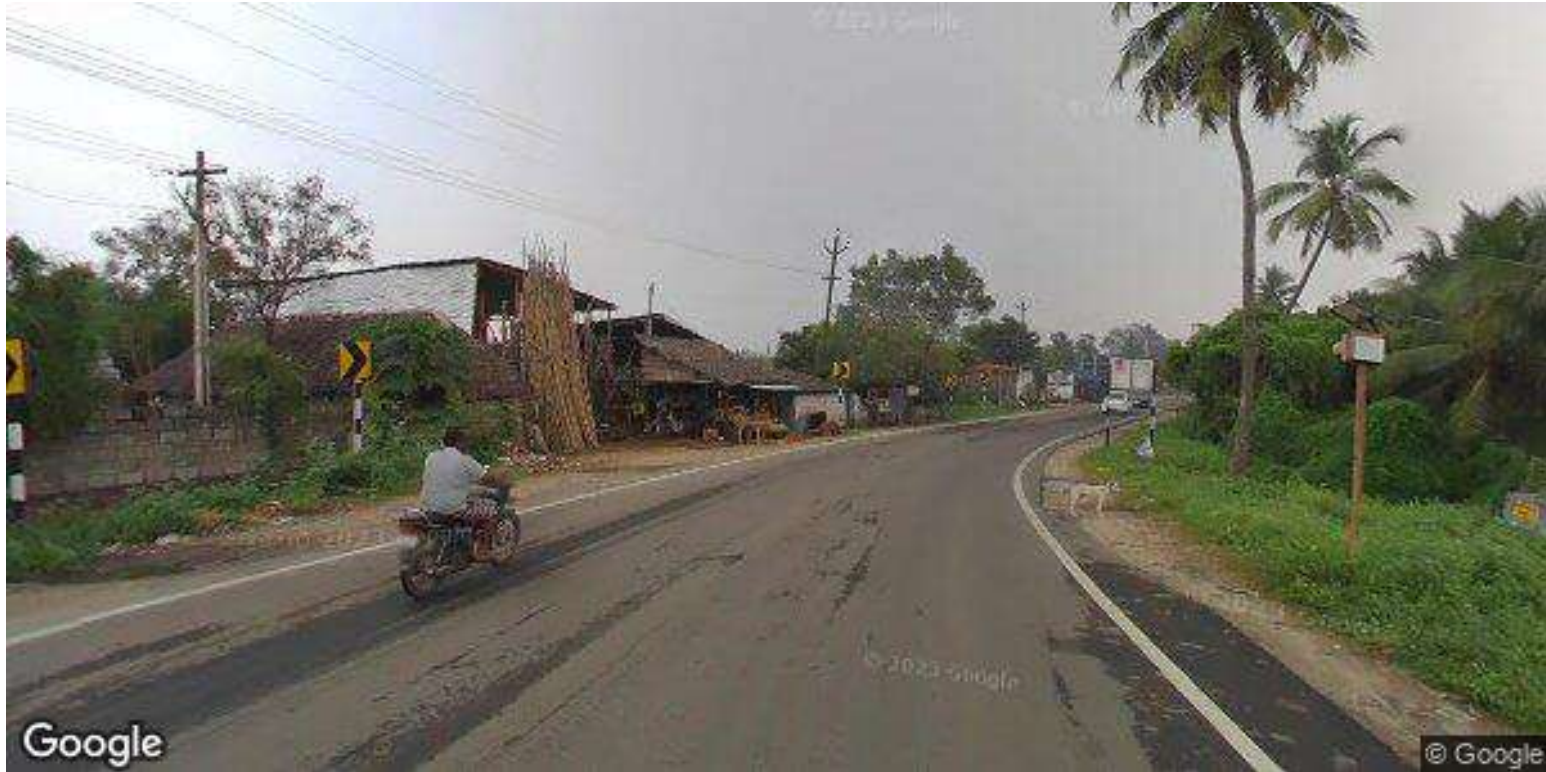
**Risk Type:** Turn  
**Risk Level:** Medium  
**Speed Limit:** 30 KM/Hr  
**Coordinates:** 11.30963, 77.76695

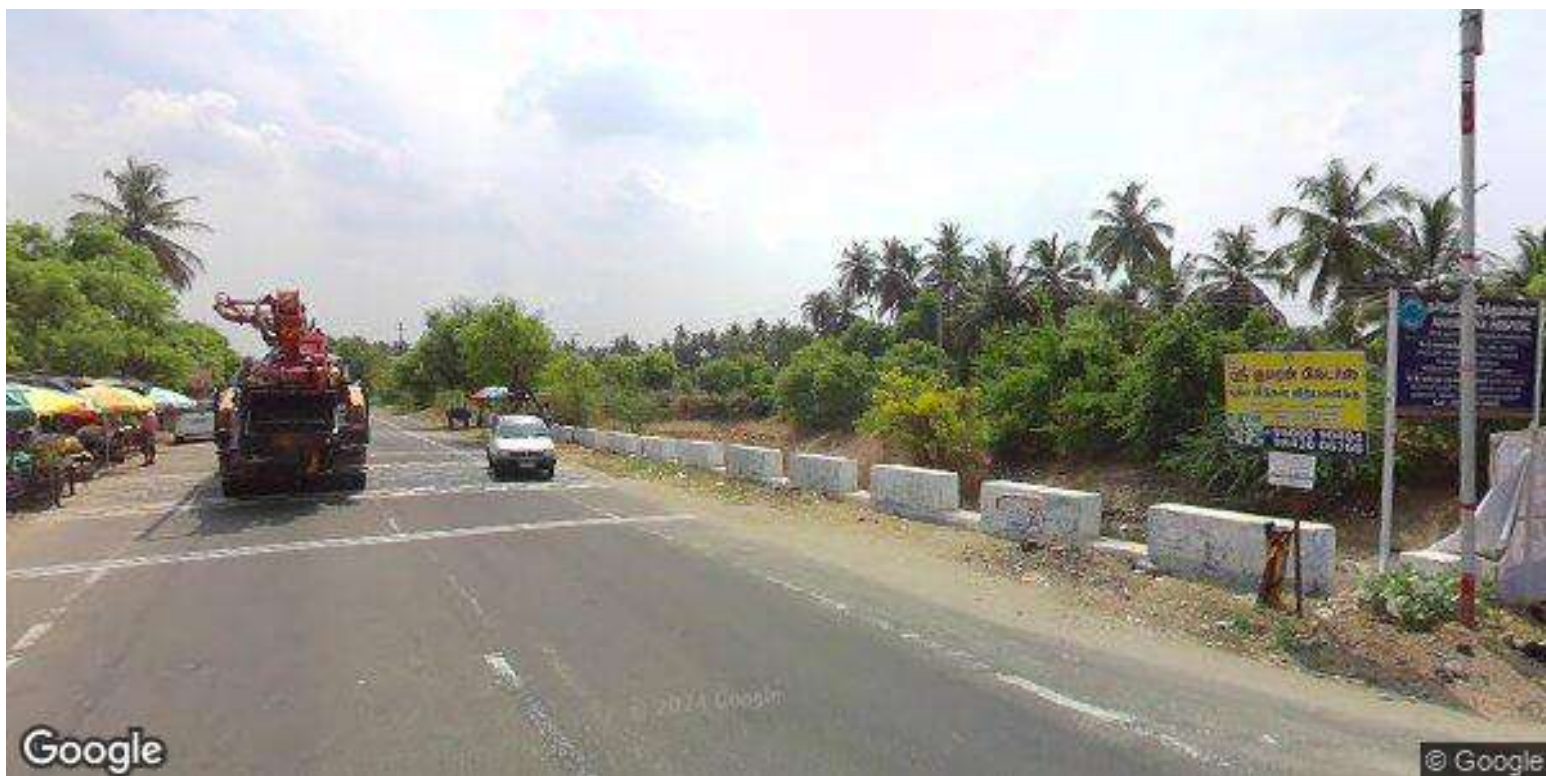
**Risk Type:** Turn  
**Risk Level:** High  
**Speed Limit:** 15 KM/Hr  
**Coordinates:** 11.29490, 77.74685

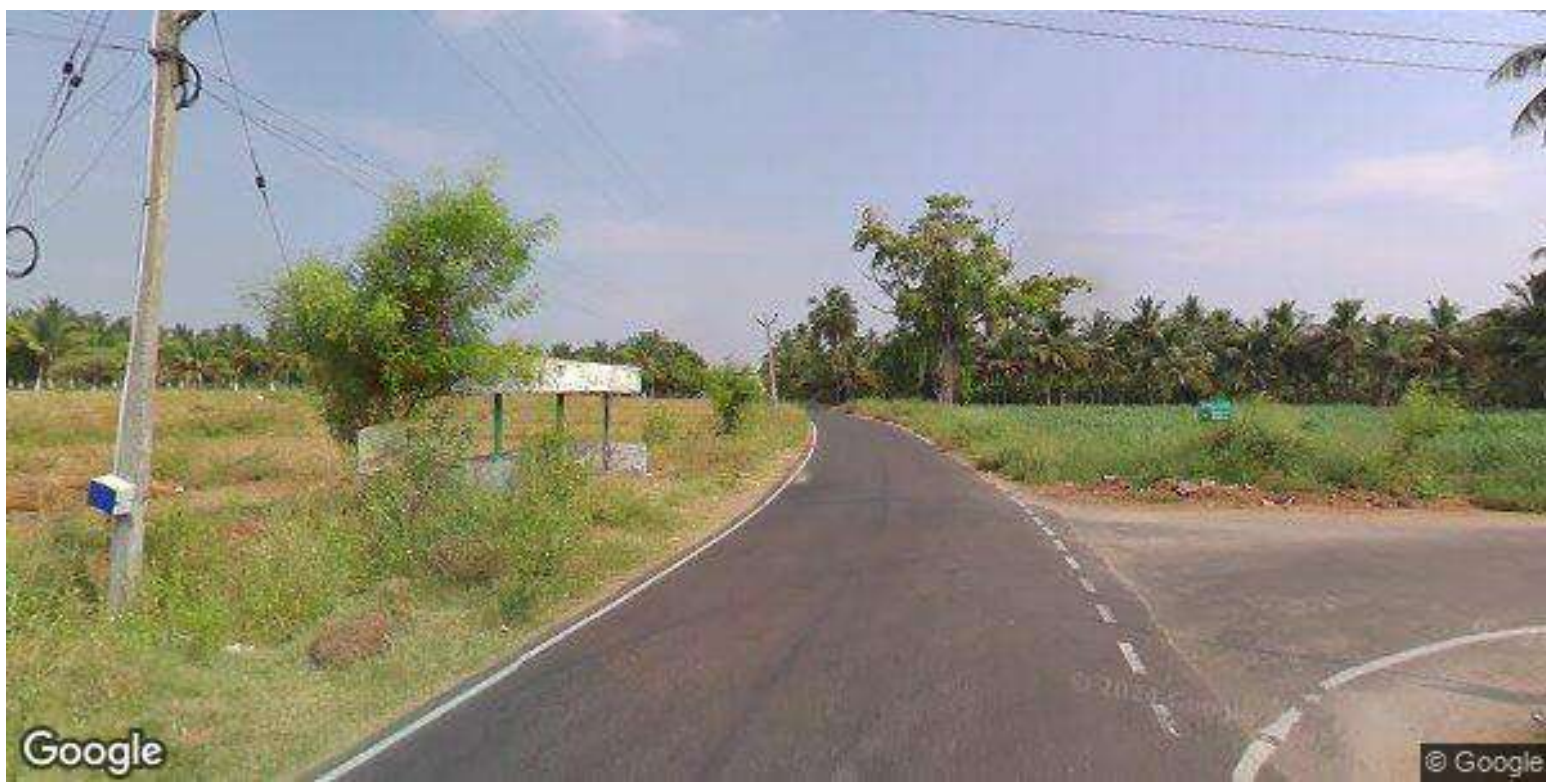
**Coordinates: 11.29141, 77.74662**

**Risk Type: Turn**

**Risk Level: High**

**Speed Limit: 15 KM/Hr**

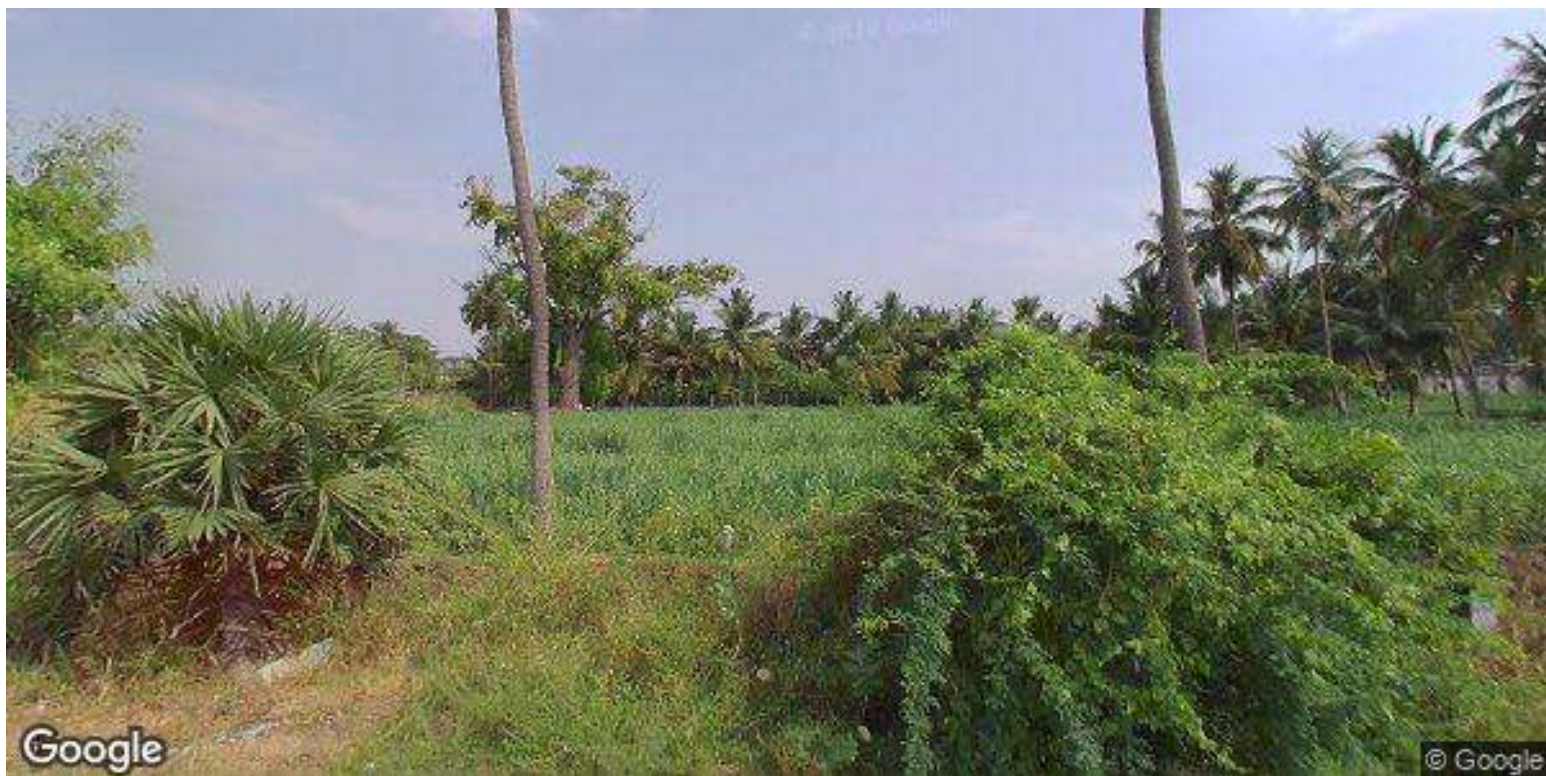
**Coordinates: 11.29125, 77.74646**

**Risk Type: Turn**

**Risk Level: Medium**

**Speed Limit: 30 KM/Hr**

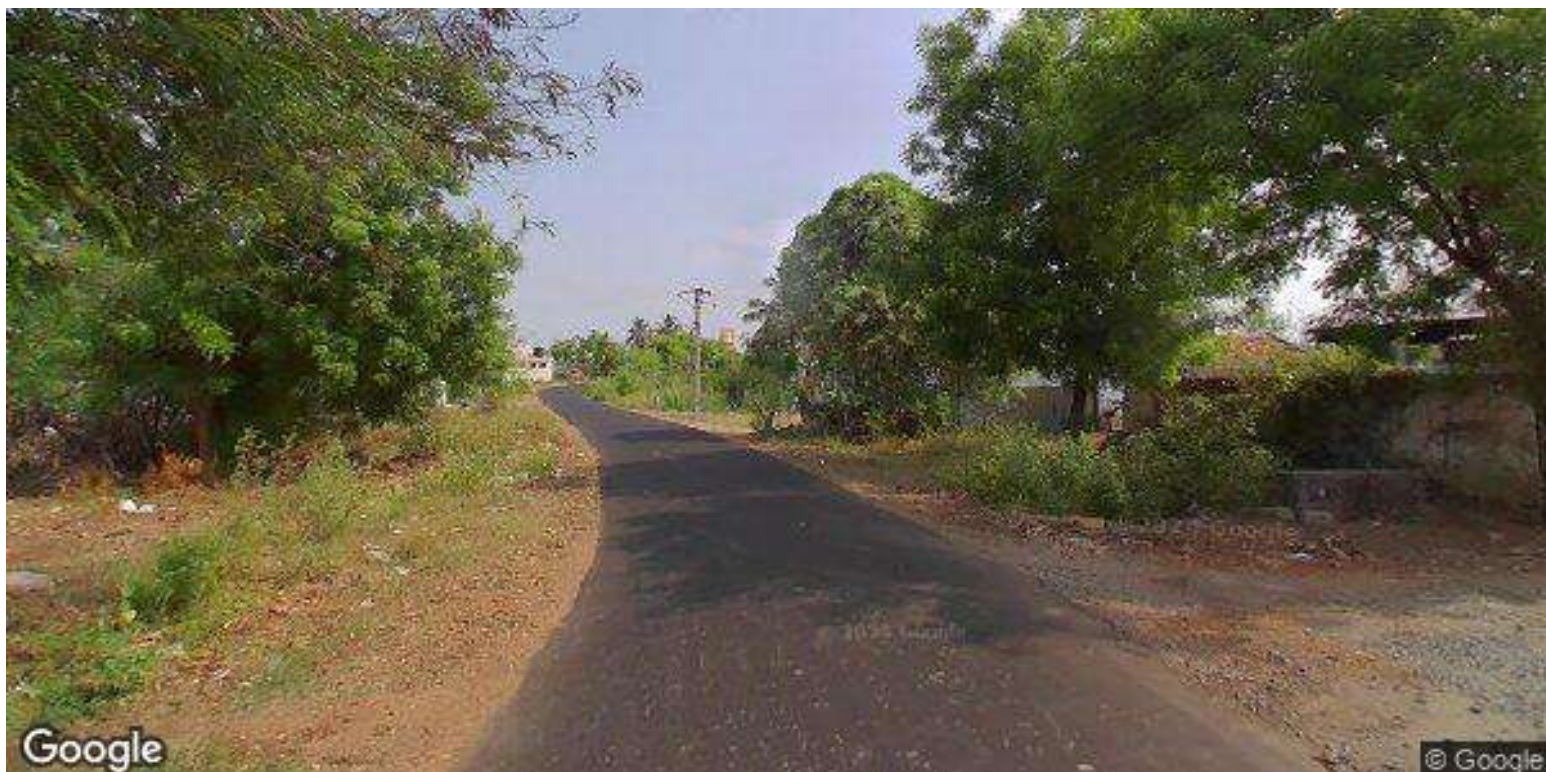
**Risk Type:** Turn  
**Risk Level:** Medium  
**Speed Limit:** 30 KM/Hr  
**Coordinates:** 11.28844, 77.74319

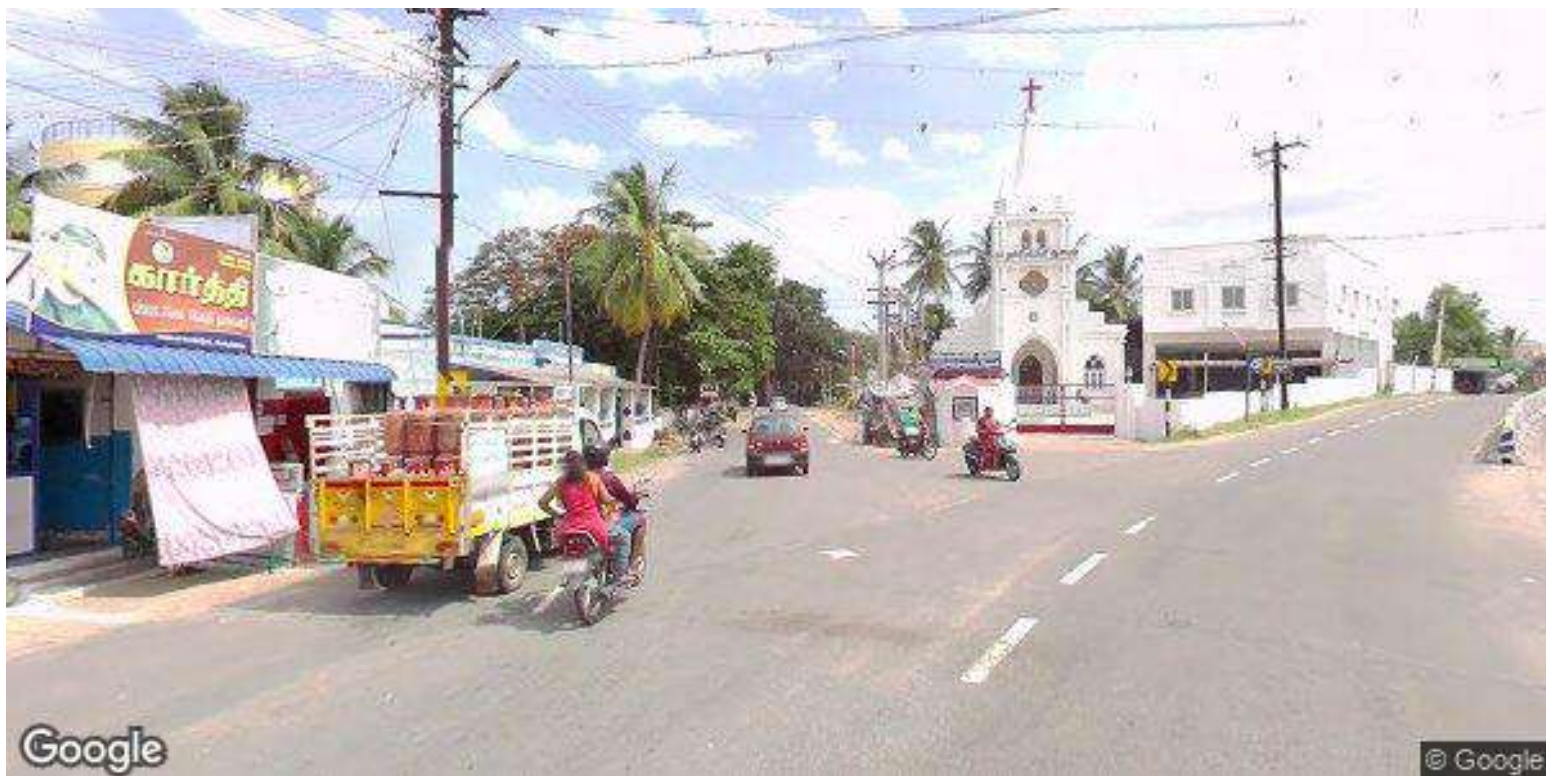
**Risk Type:** Turn  
**Risk Level:** Medium  
**Speed Limit:** 30 KM/Hr  
**Coordinates:** 11.23054, 77.71796

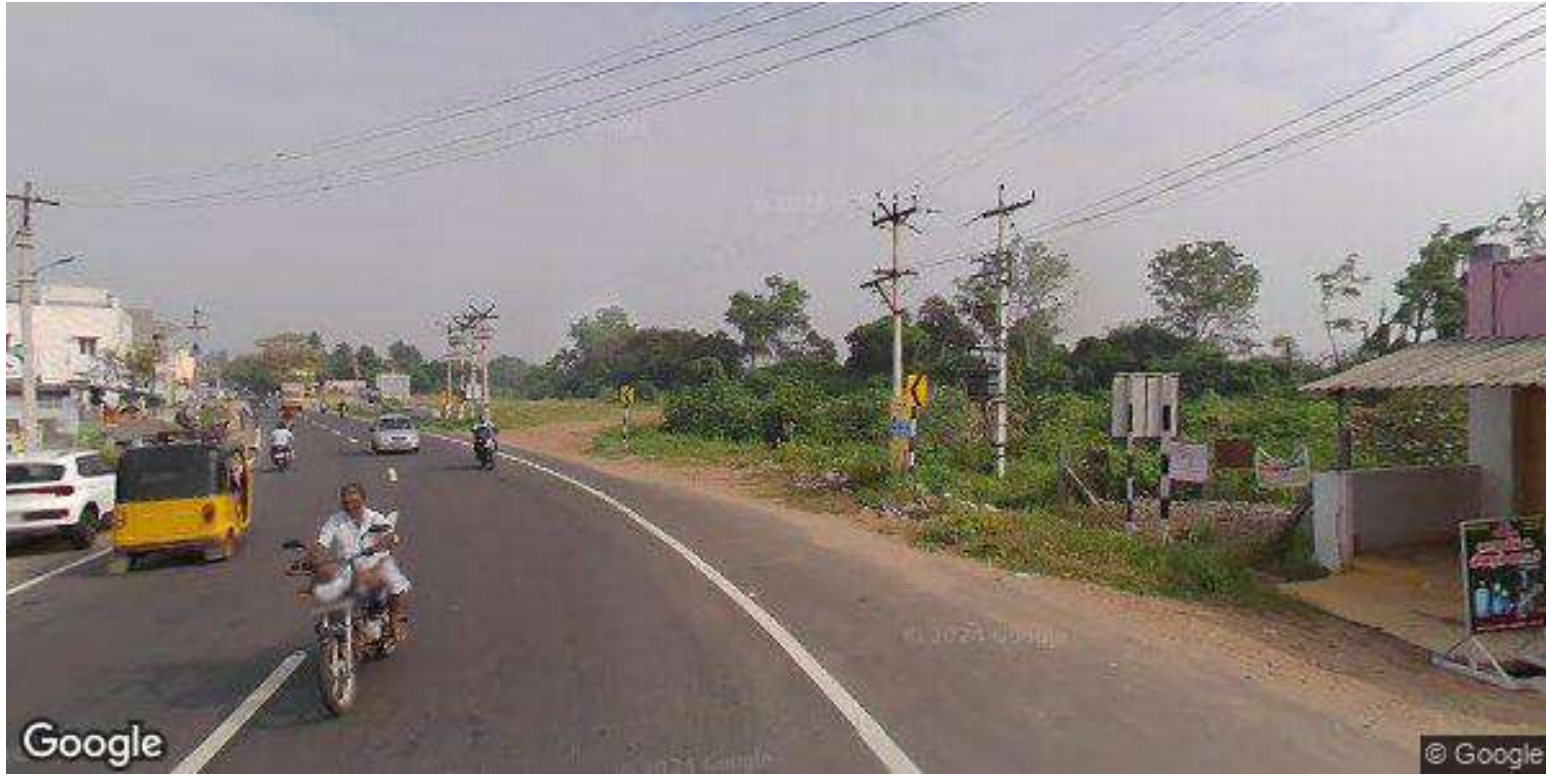
**Risk Type:** Turn  
**Risk Level:** Medium  
**Speed Limit:** 30 KM/Hr  
**Coordinates:** 11.16078, 77.70122

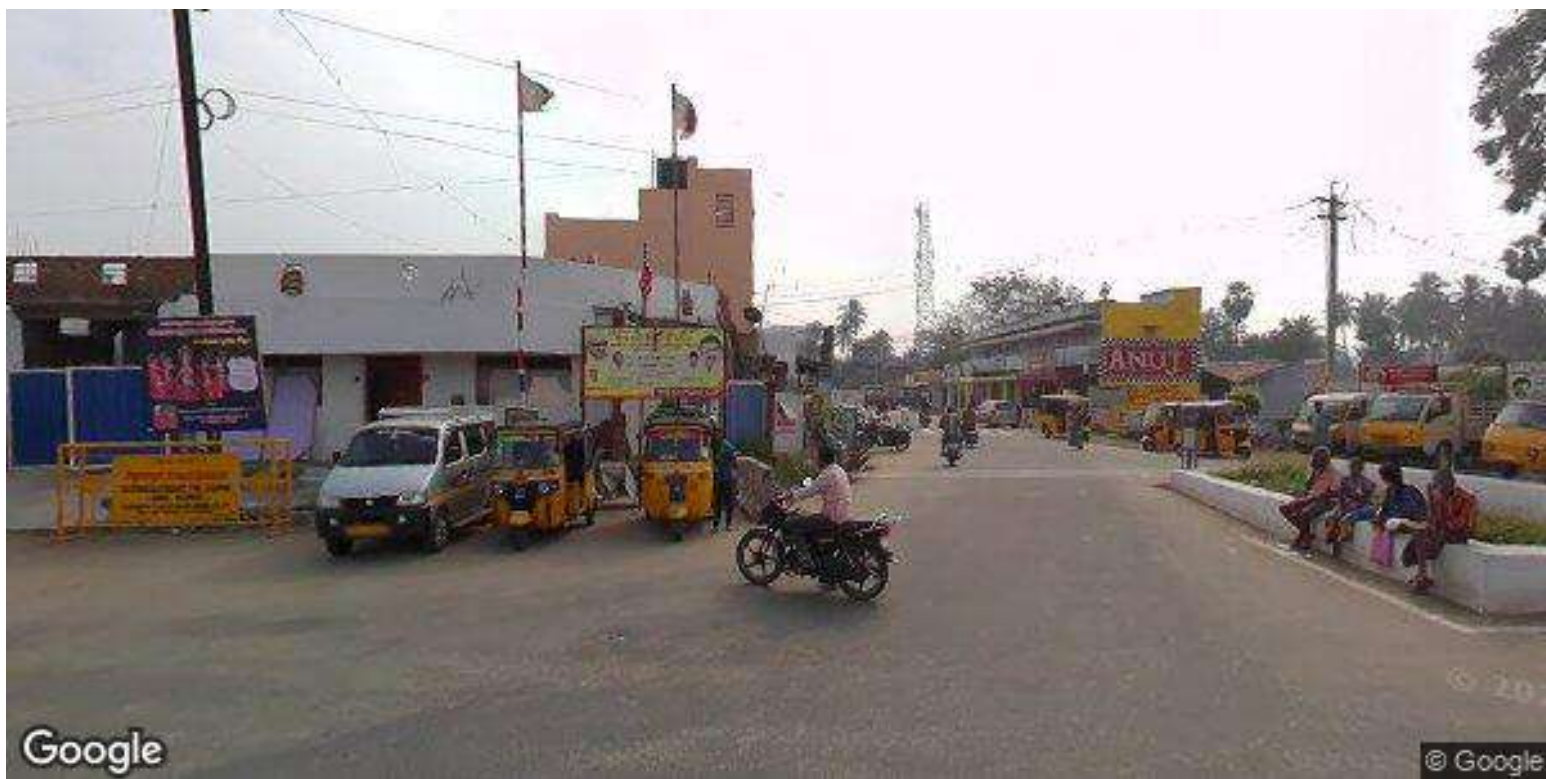
**Risk Type:** Turn  
**Risk Level:** Medium  
**Speed Limit:** 30 KM/Hr  
**Coordinates:** 11.15953, 77.70067
