# IndianOil

## JOURNEY RISK MANAGEMENT (JRM) STUDY

### Salem Terminal to ARAVINTH AGENCIES

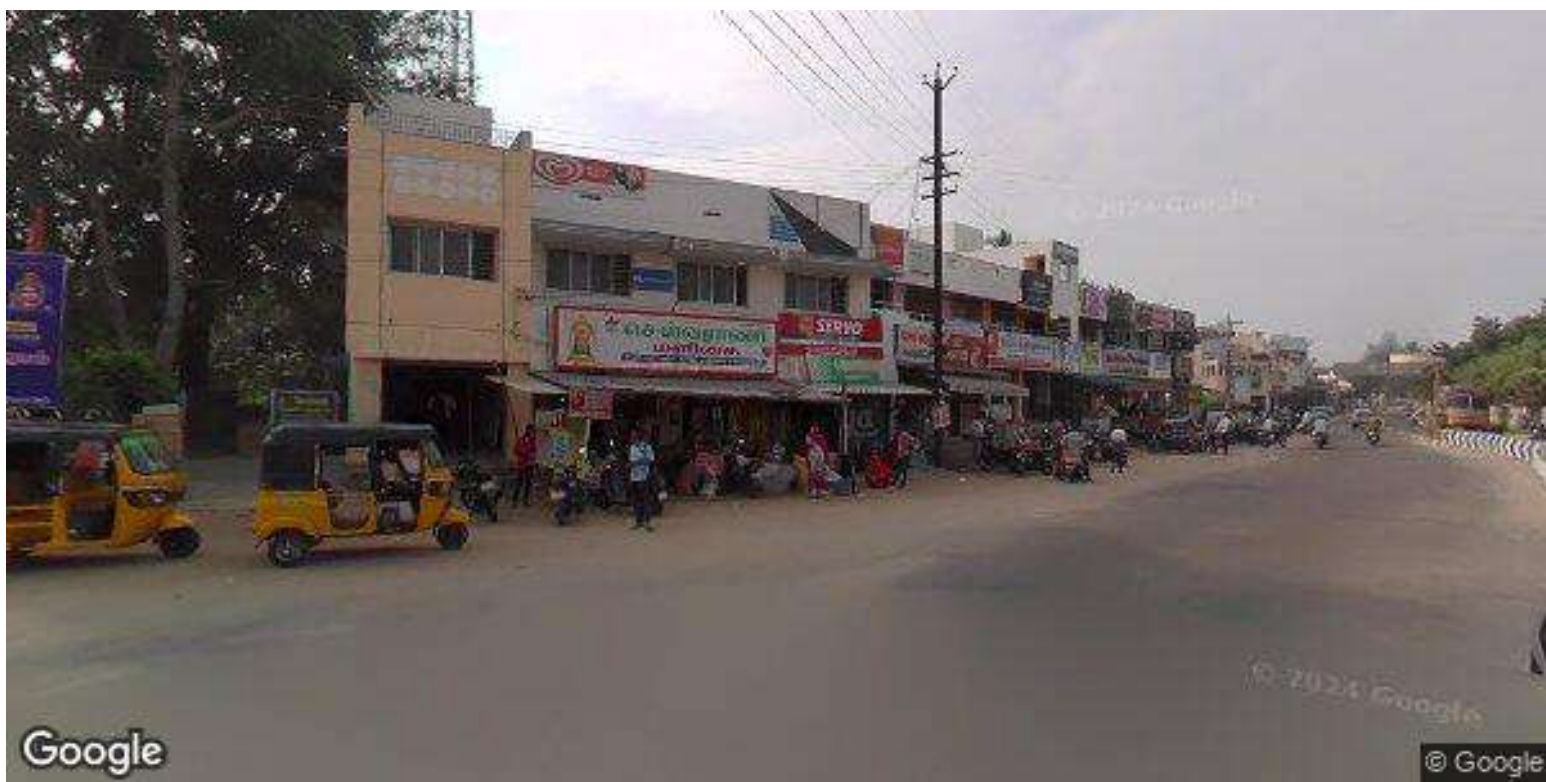
**Coordinates:** 11.15944, 77.70068

**Risk Type:** Turn

**Risk Level:** High

**Speed Limit:** 15 KM/Hr

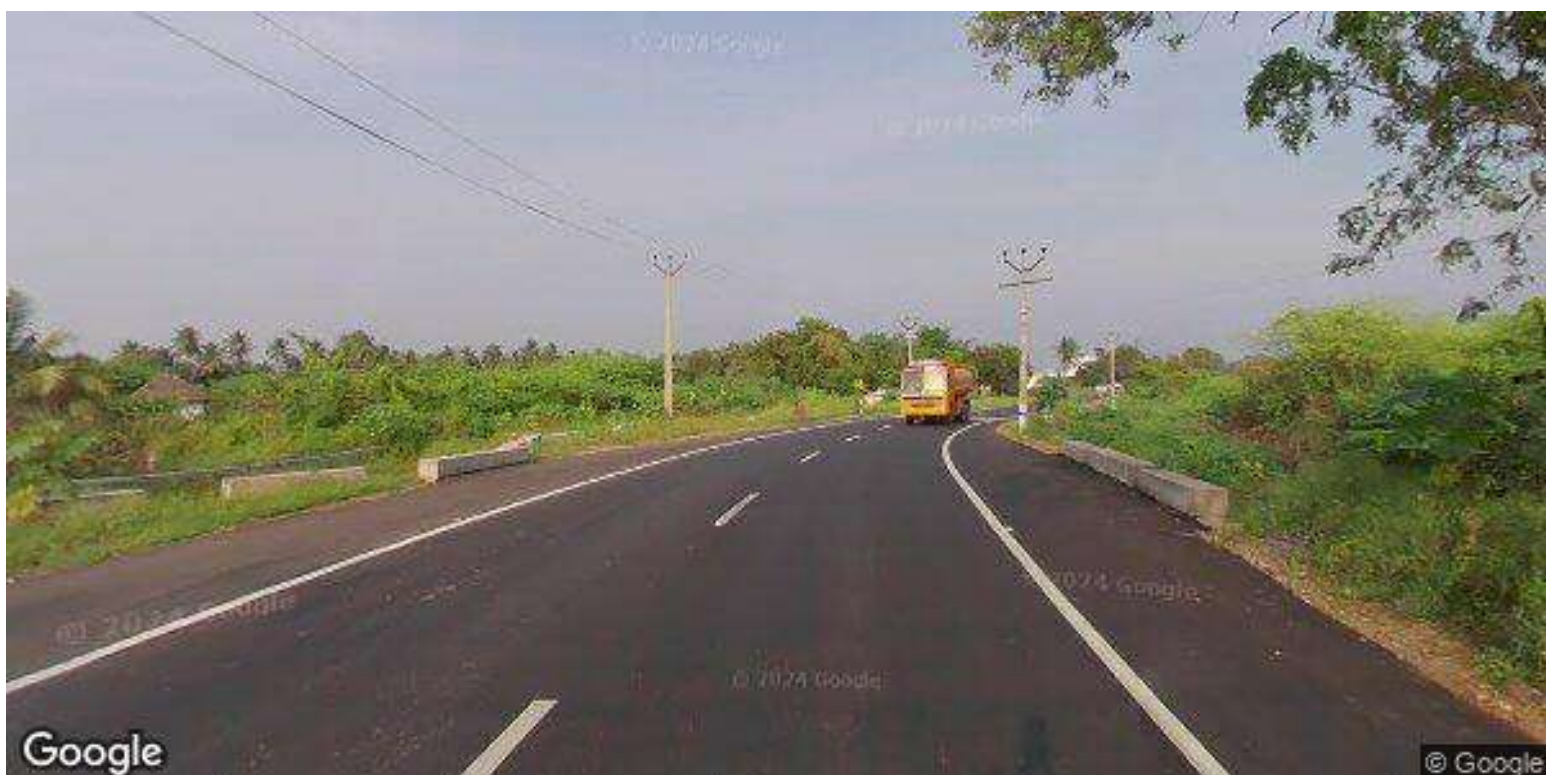
**Coordinates: 11.11740, 77.67198**

**Risk Type: Turn**

**Risk Level: Medium**

**Speed Limit: 30 KM/Hr**

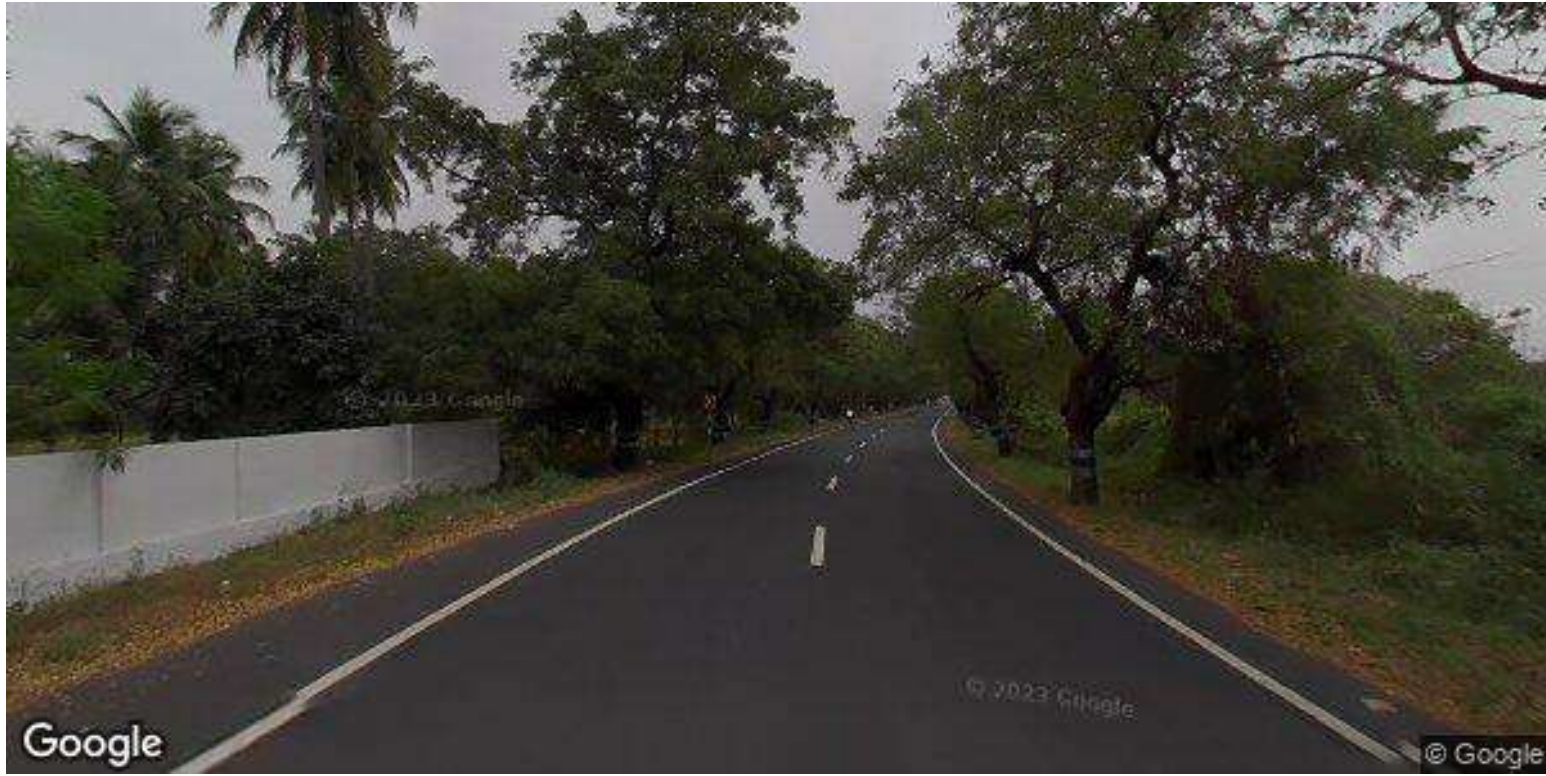
**Coordinates: 11.10481, 77.67060**

**Risk Type: Turn**

**Risk Level: Medium**

**Speed Limit: 30 KM/Hr**

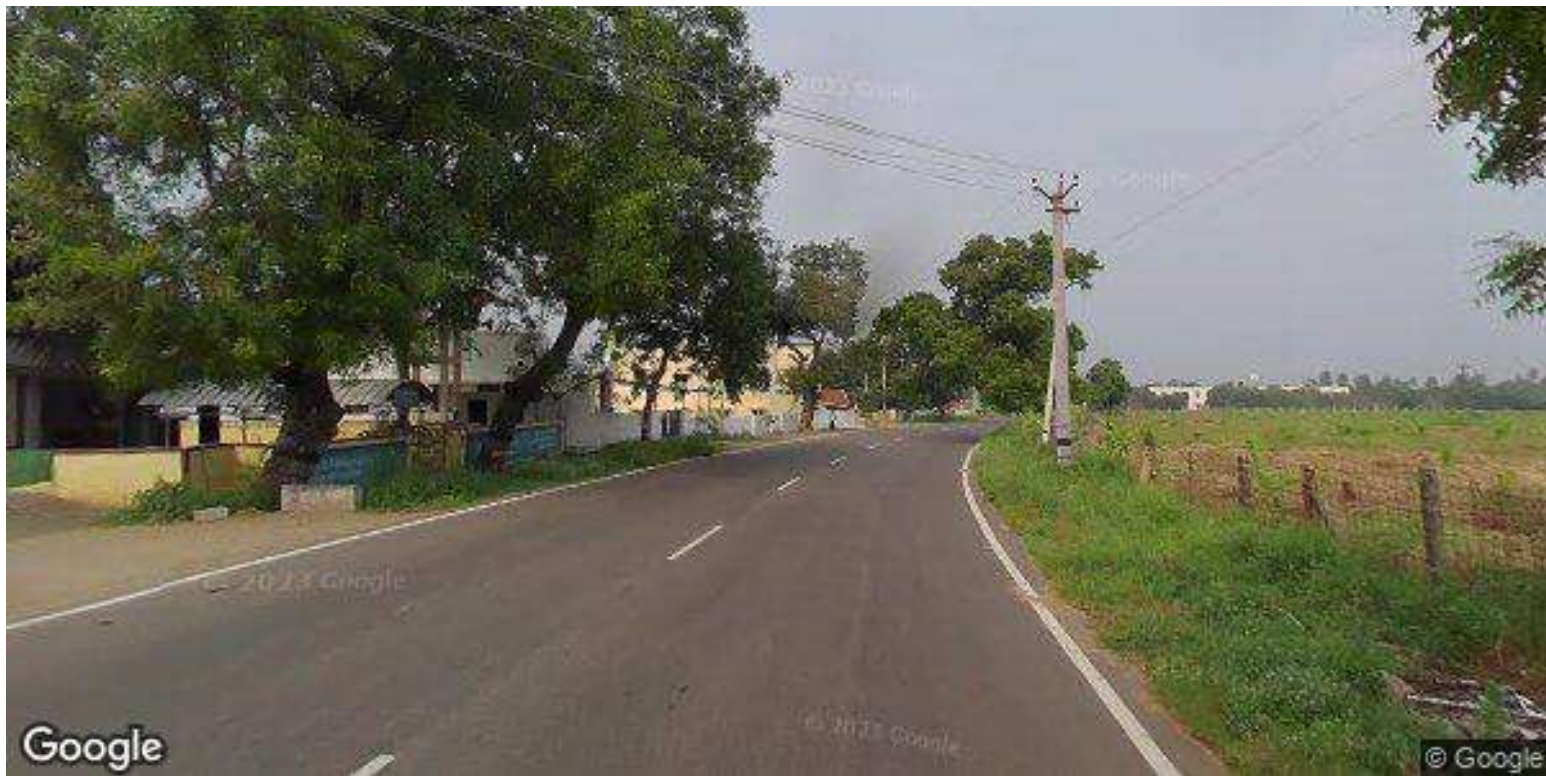
**Coordinates: 11.09509, 77.66612**

**Risk Type: Turn**

**Risk Level: Medium**

**Speed Limit: 30 KM/Hr**

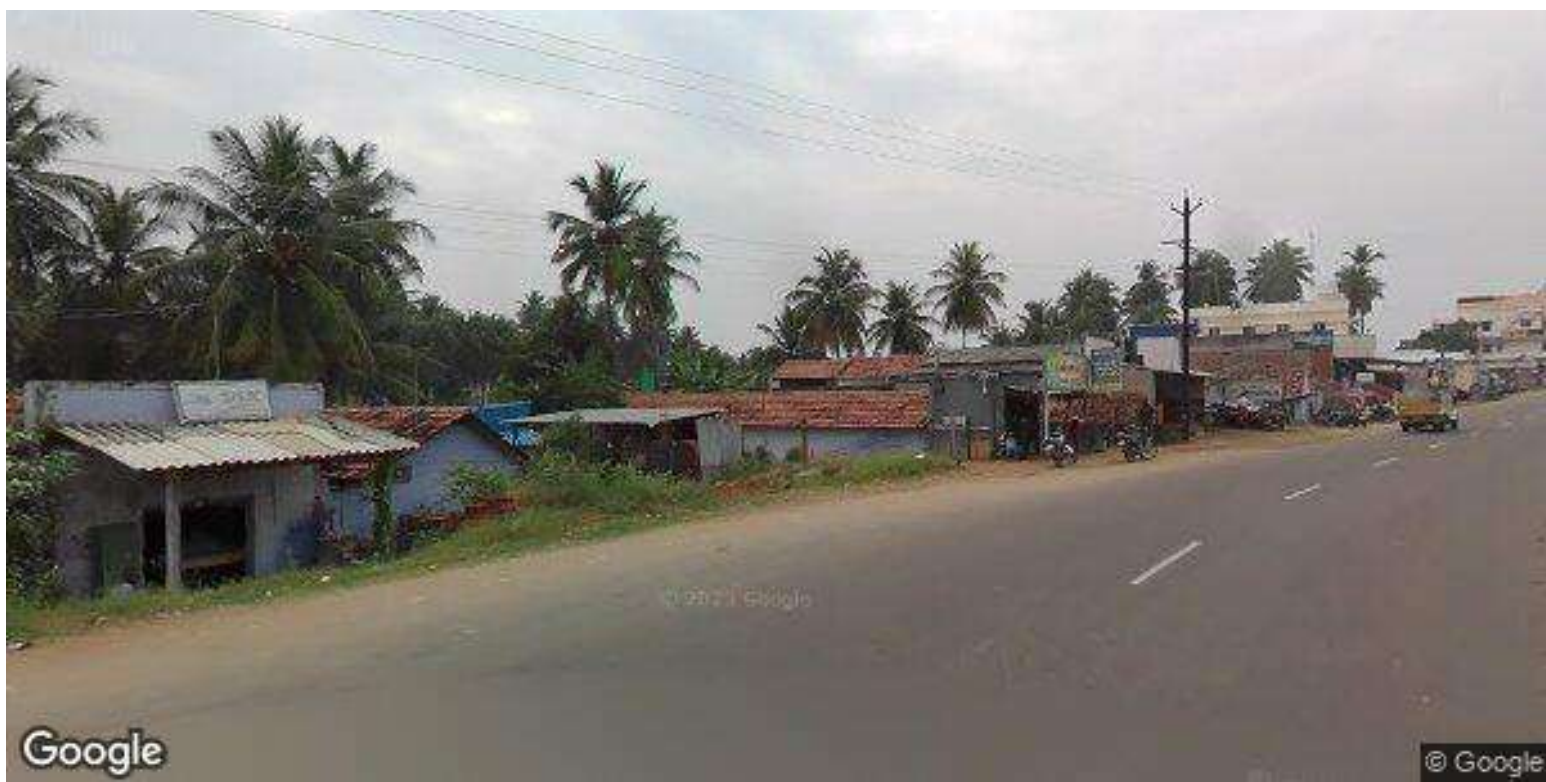
**Coordinates:** 11.08730, 77.66436

**Risk Type:** Turn

**Risk Level:** Medium

**Speed Limit:** 30 KM/Hr

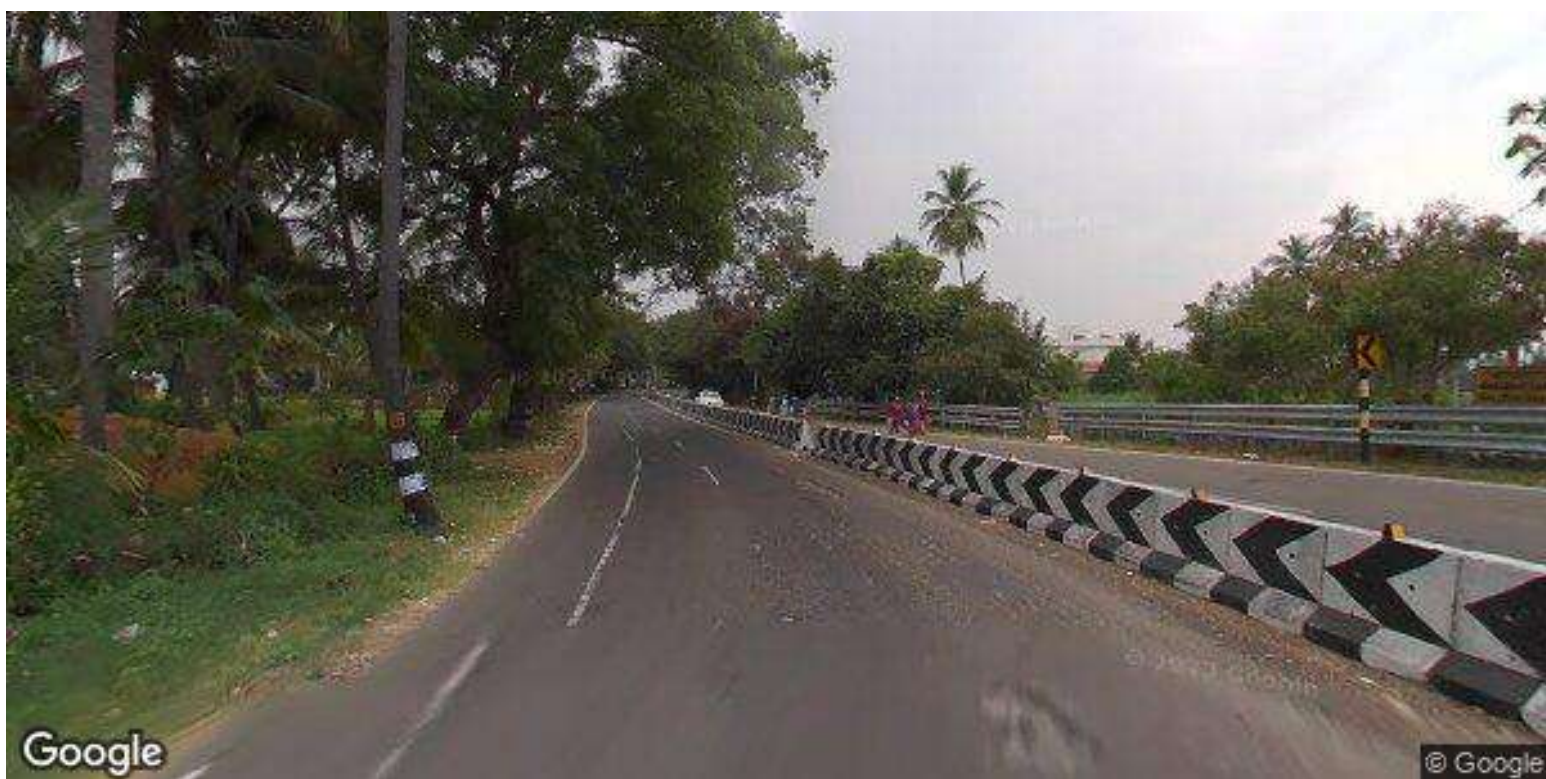
**Coordinates:** 11.08282, 77.65837

**Risk Type:** Turn

**Risk Level:** Medium

**Speed Limit:** 30 KM/Hr

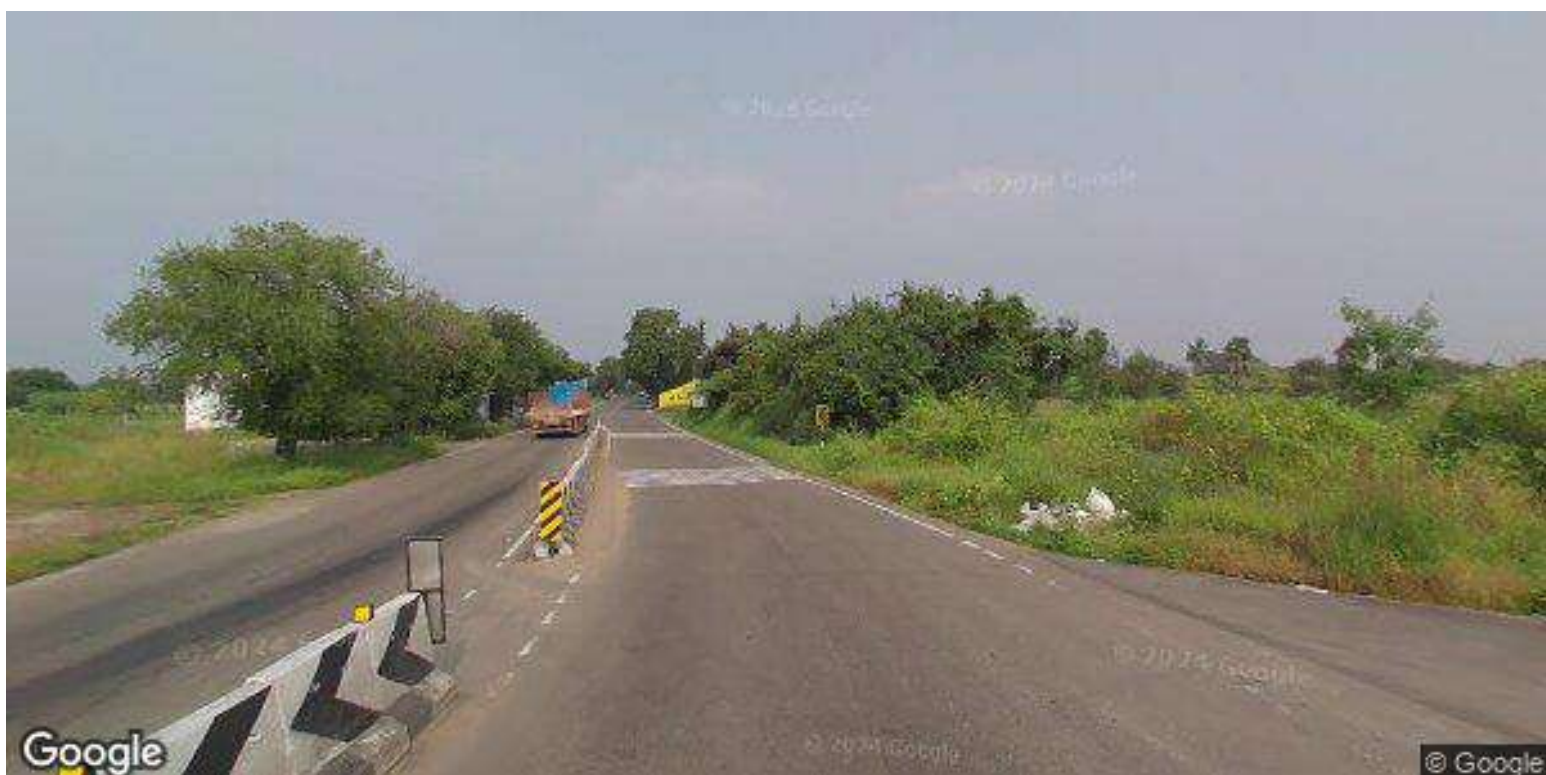
**Risk Type:** Turn  
**Risk Level:** High  
**Speed Limit:** 15 KM/Hr  
**Coordinates:** 11.06189, 77.63943

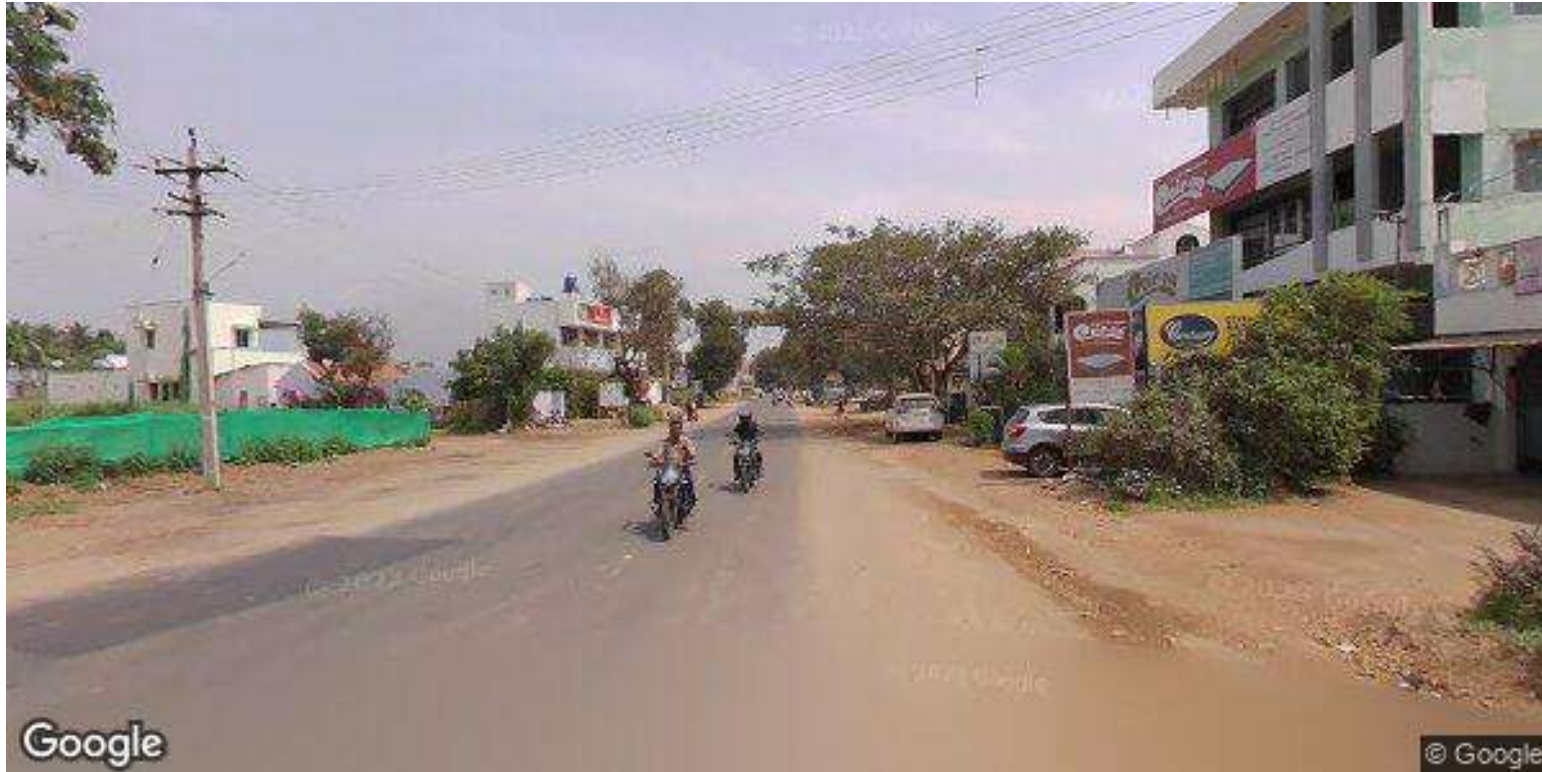
**Risk Type:** Turn  
**Risk Level:** Medium  
**Speed Limit:** 30 KM/Hr  
**Coordinates:** 11.00744, 77.56586

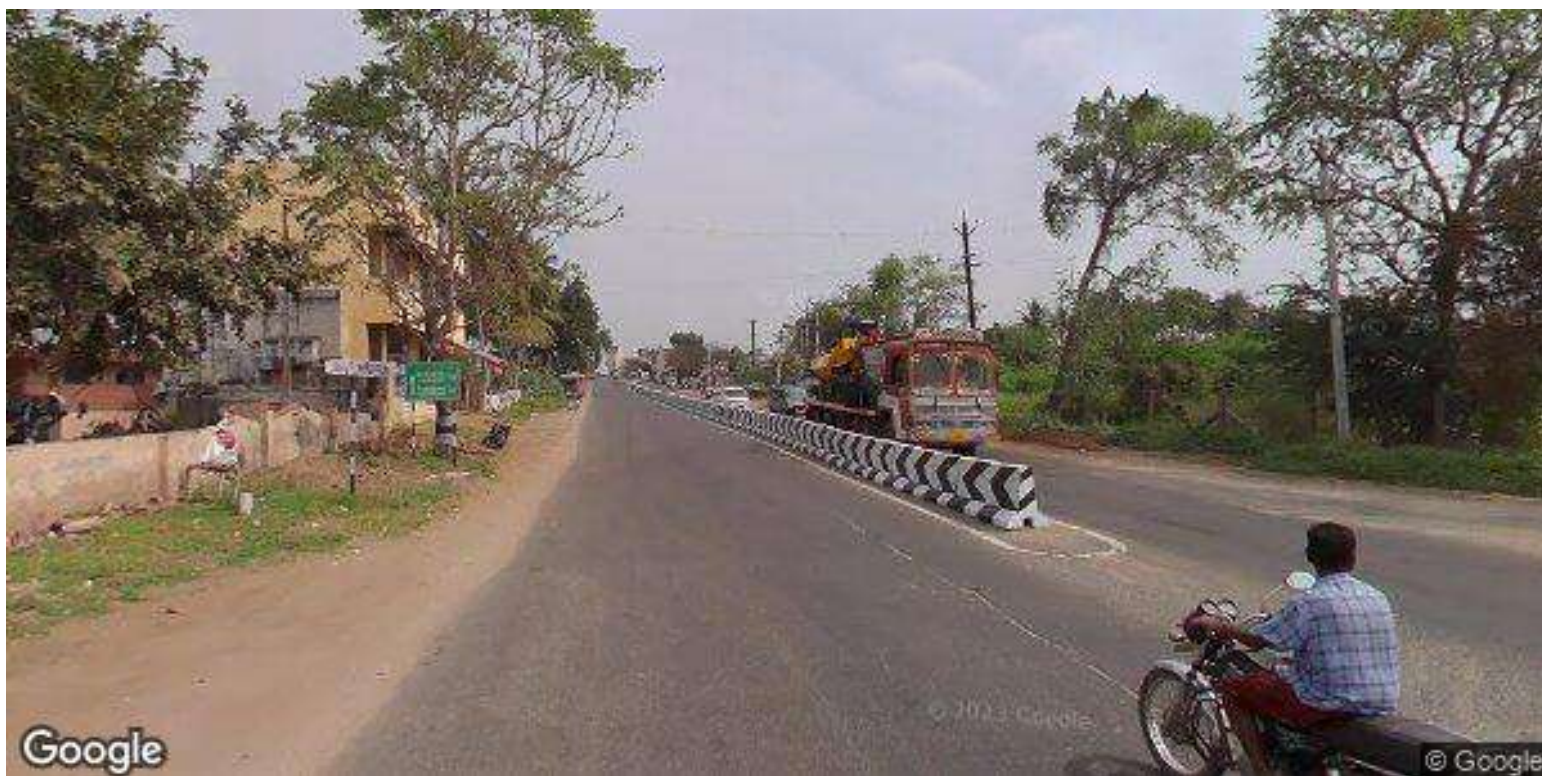
**Risk Type:** Turn  
**Risk Level:** High  
**Speed Limit:** 15 KM/Hr  
**Coordinates:** 11.00915, 77.56212

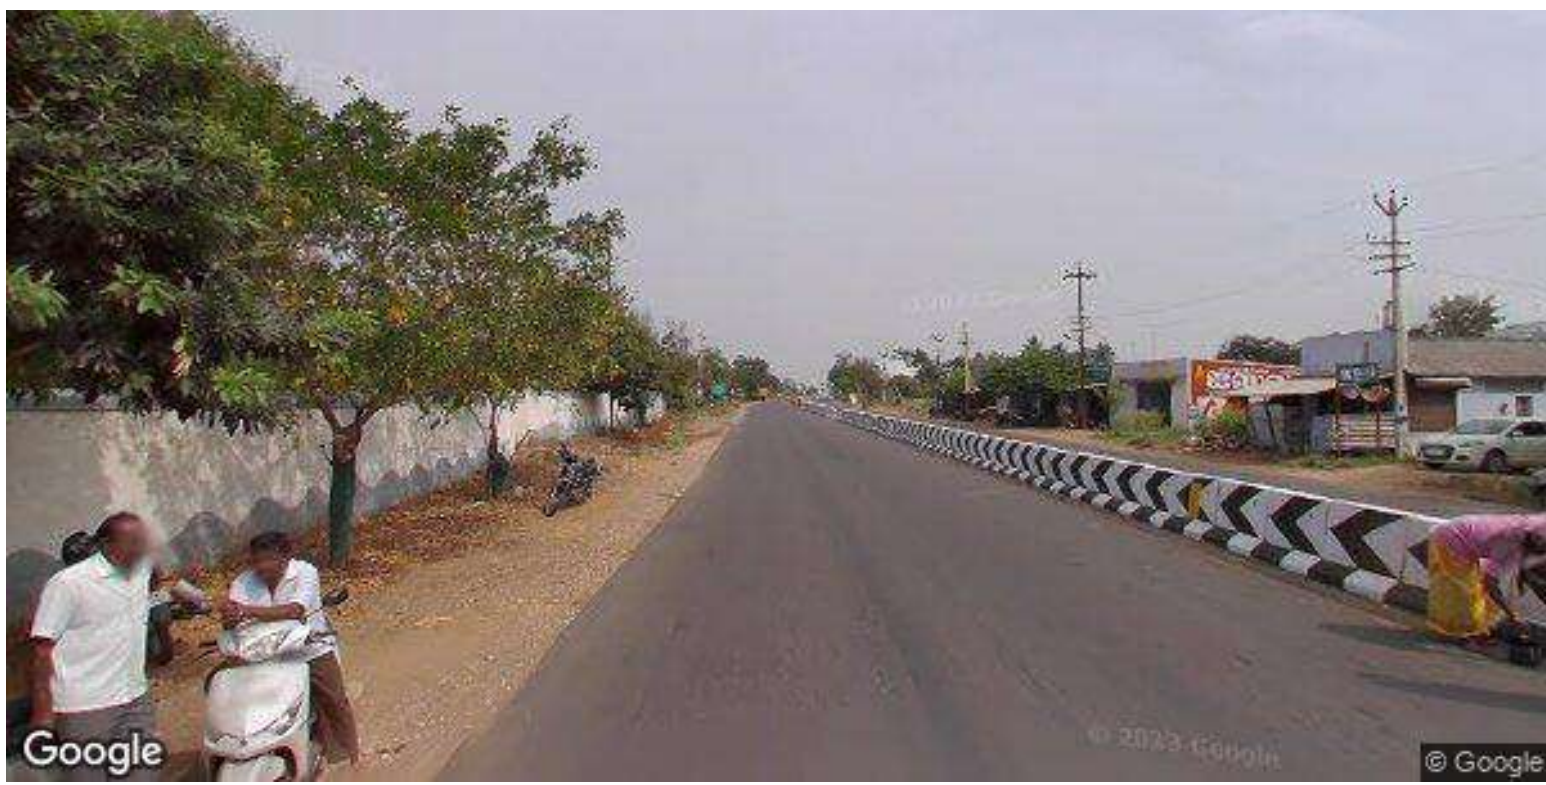
**Coordinates:** 11.01315, 77.56364

**Risk Type:** Blind Spot

**Risk Level:** Blind Spot

**Speed Limit:** 10 KM/Hr
