# IndianOil

## JOURNEY RISK MANAGEMENT (JRM) STUDY

### Salem Terminal to PALANIMALAI TRADERS

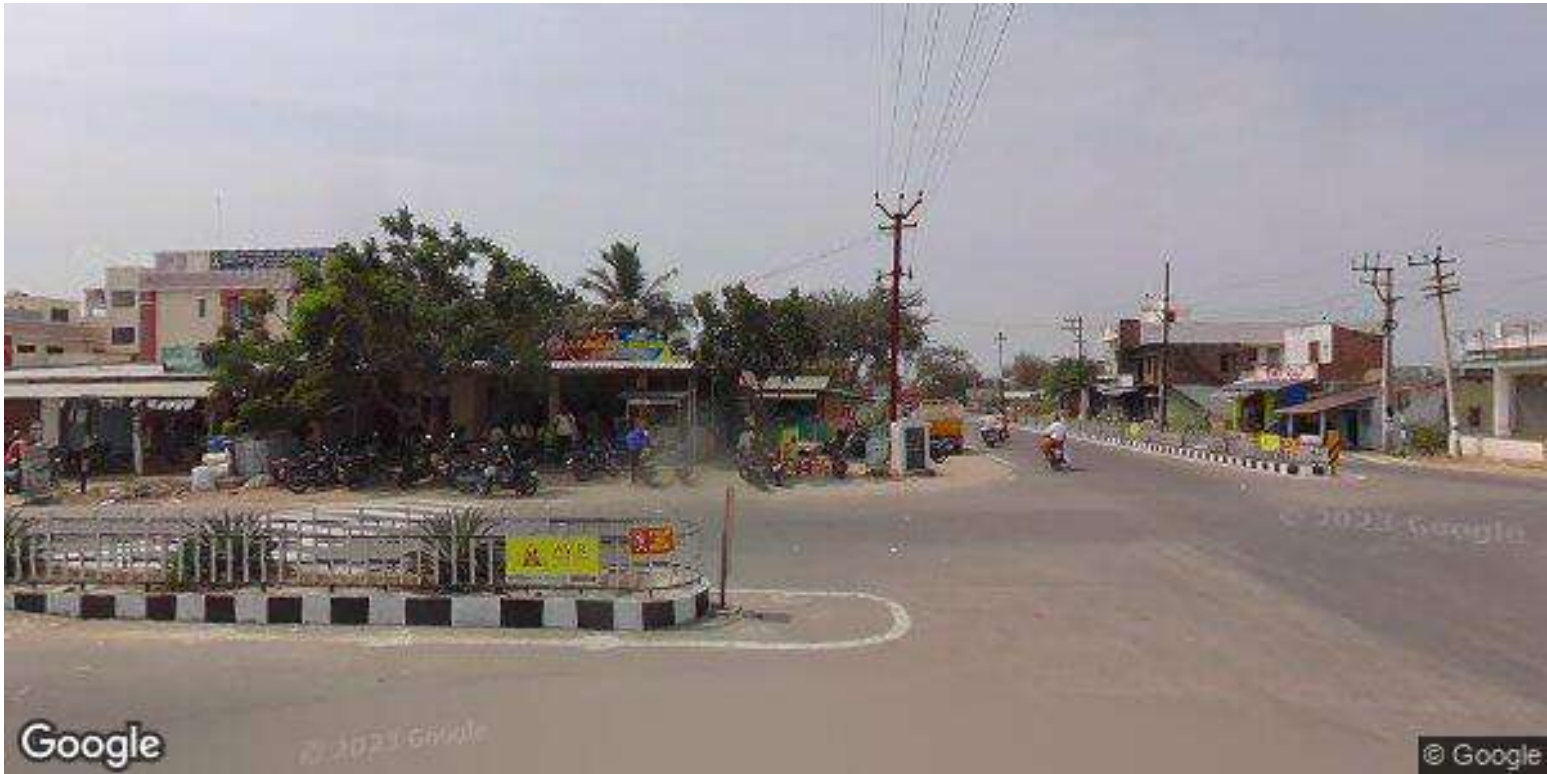
**Risk Type:** Roundabout  
**Risk Level:** High  
**Speed Limit:** 15 KM/Hr  
**Coordinates:** 11.58300, 77.85813

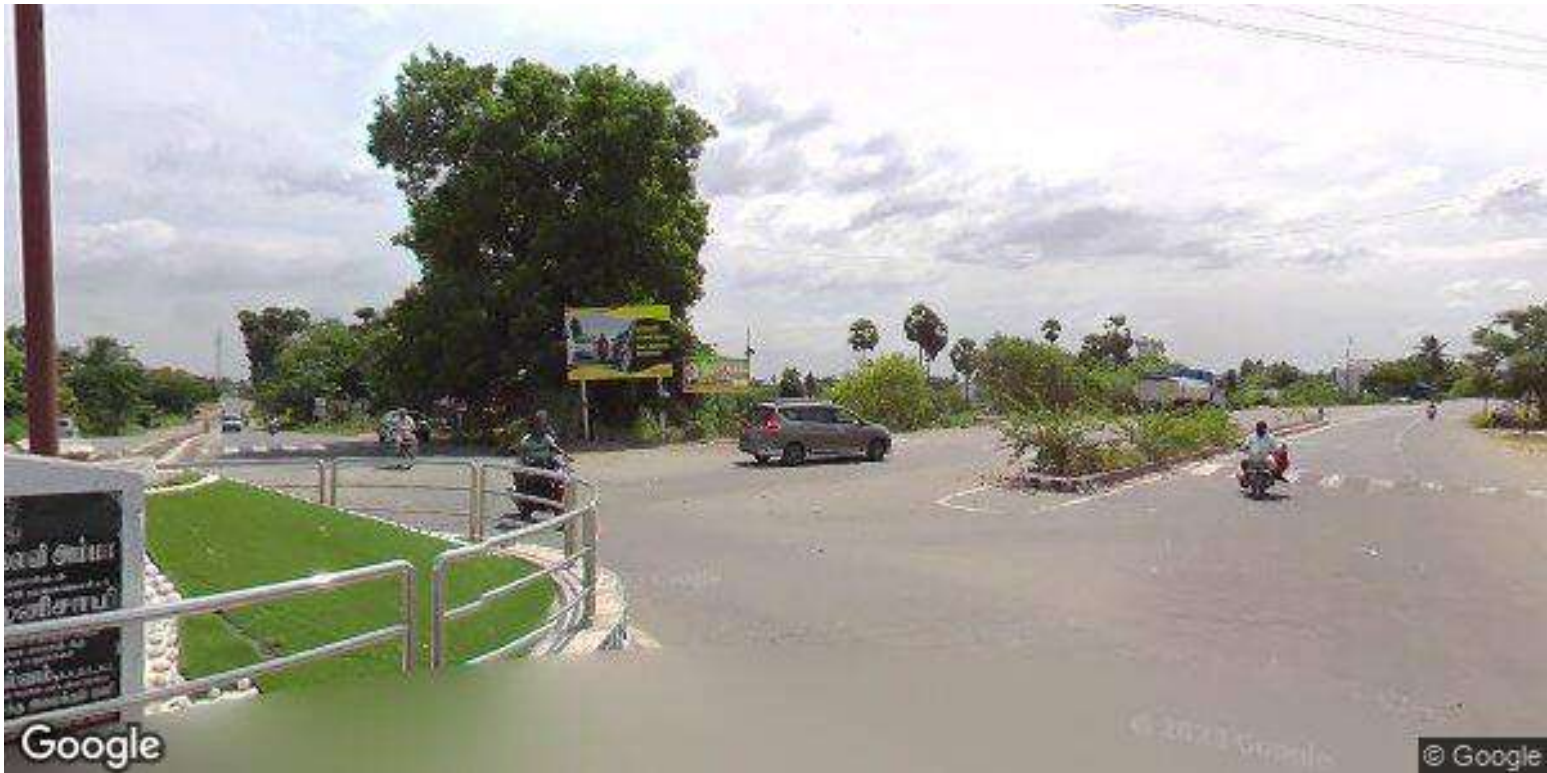
**Risk Type:** Roundabout  
**Risk Level:** High  
**Speed Limit:** 15 KM/Hr  
**Coordinates:** 11.60348, 77.83967

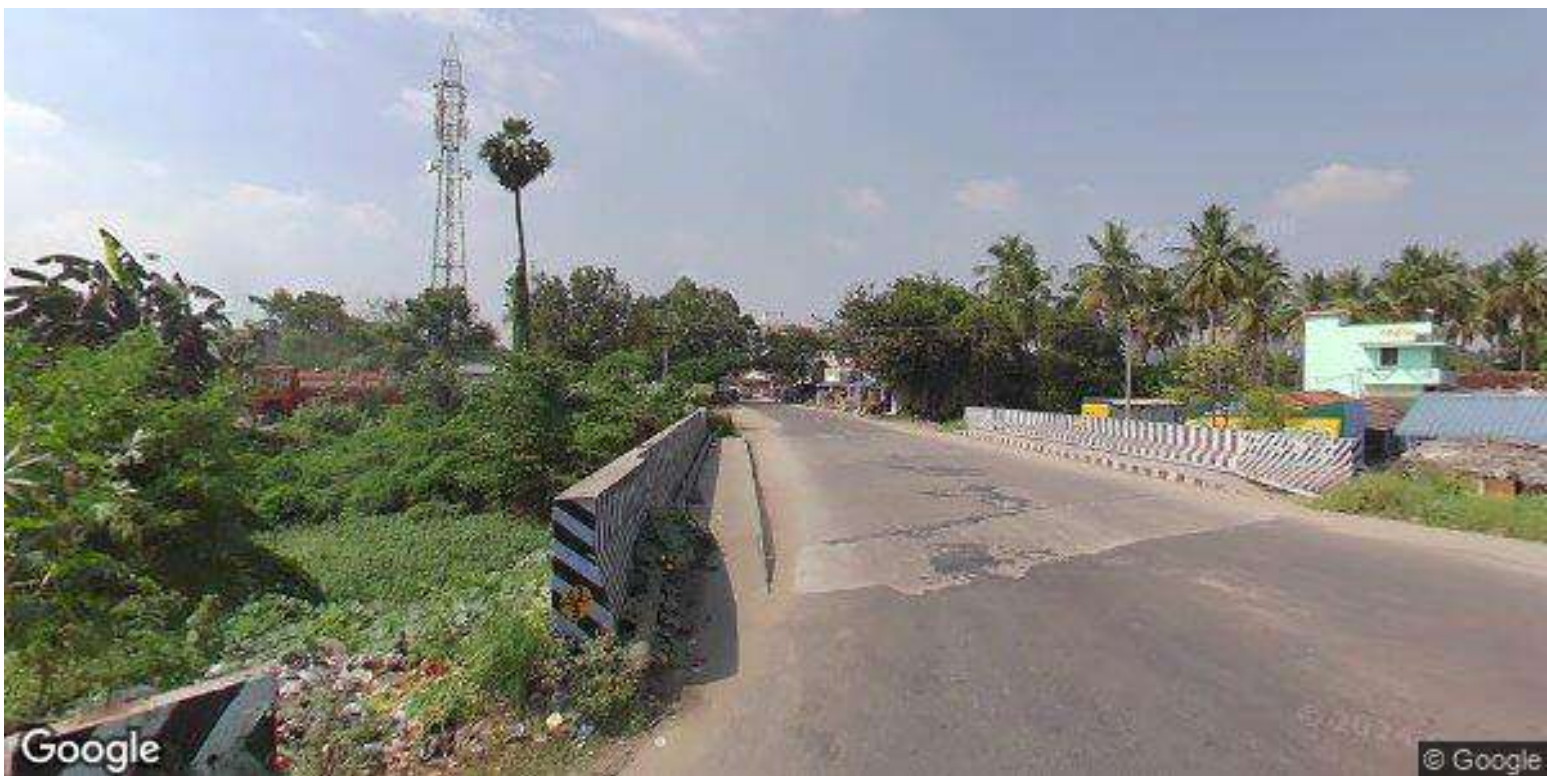
**Coordinates:** 11.44900, 77.87406

**Risk Type:** Turn

**Risk Level:** Medium

**Speed Limit:** 30 KM/Hr

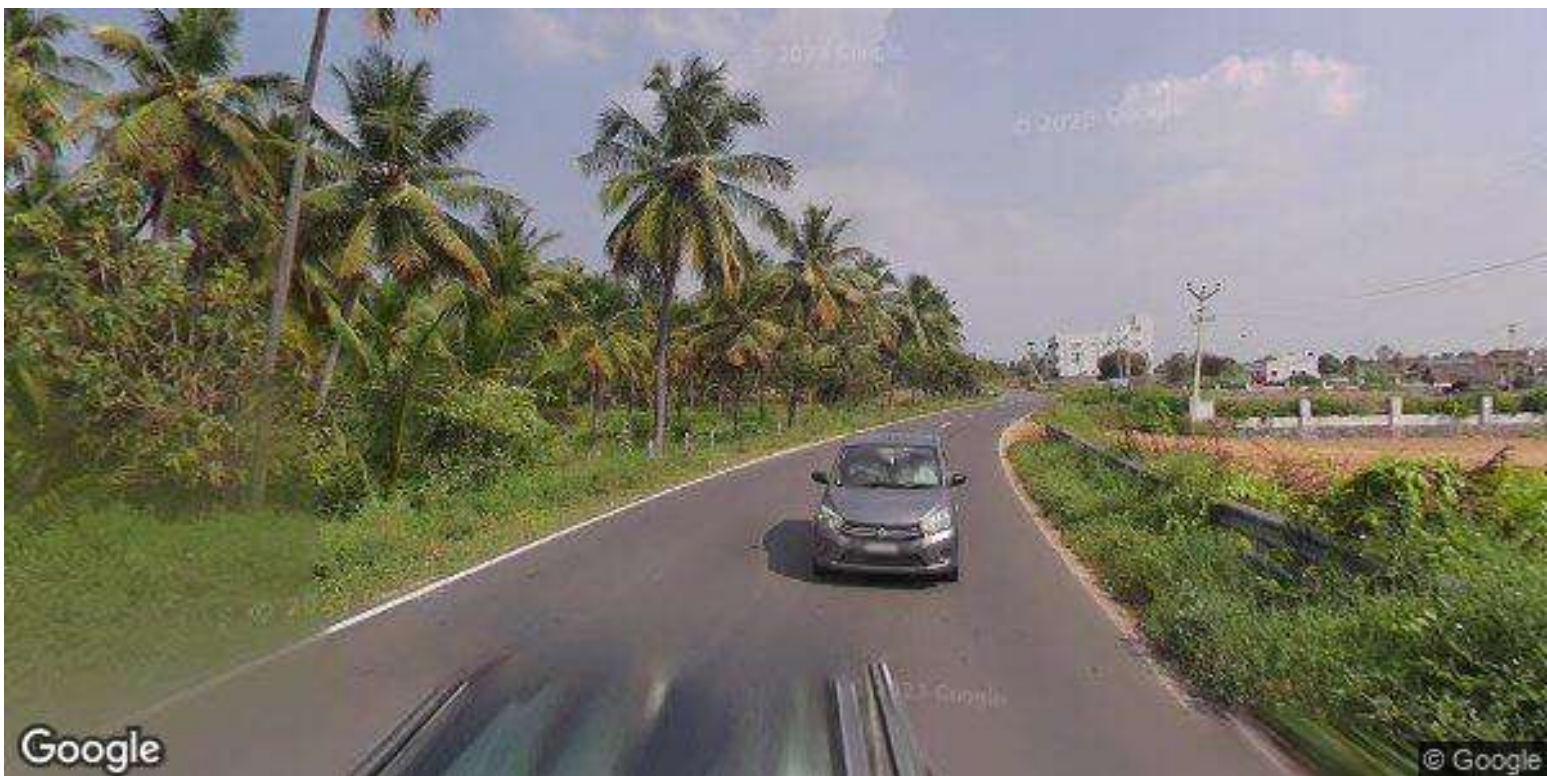
**Risk Type:** Turn  
**Risk Level:** Medium  
**Speed Limit:** 30 KM/Hr  
**Coordinates:** 11.45357, 77.85789

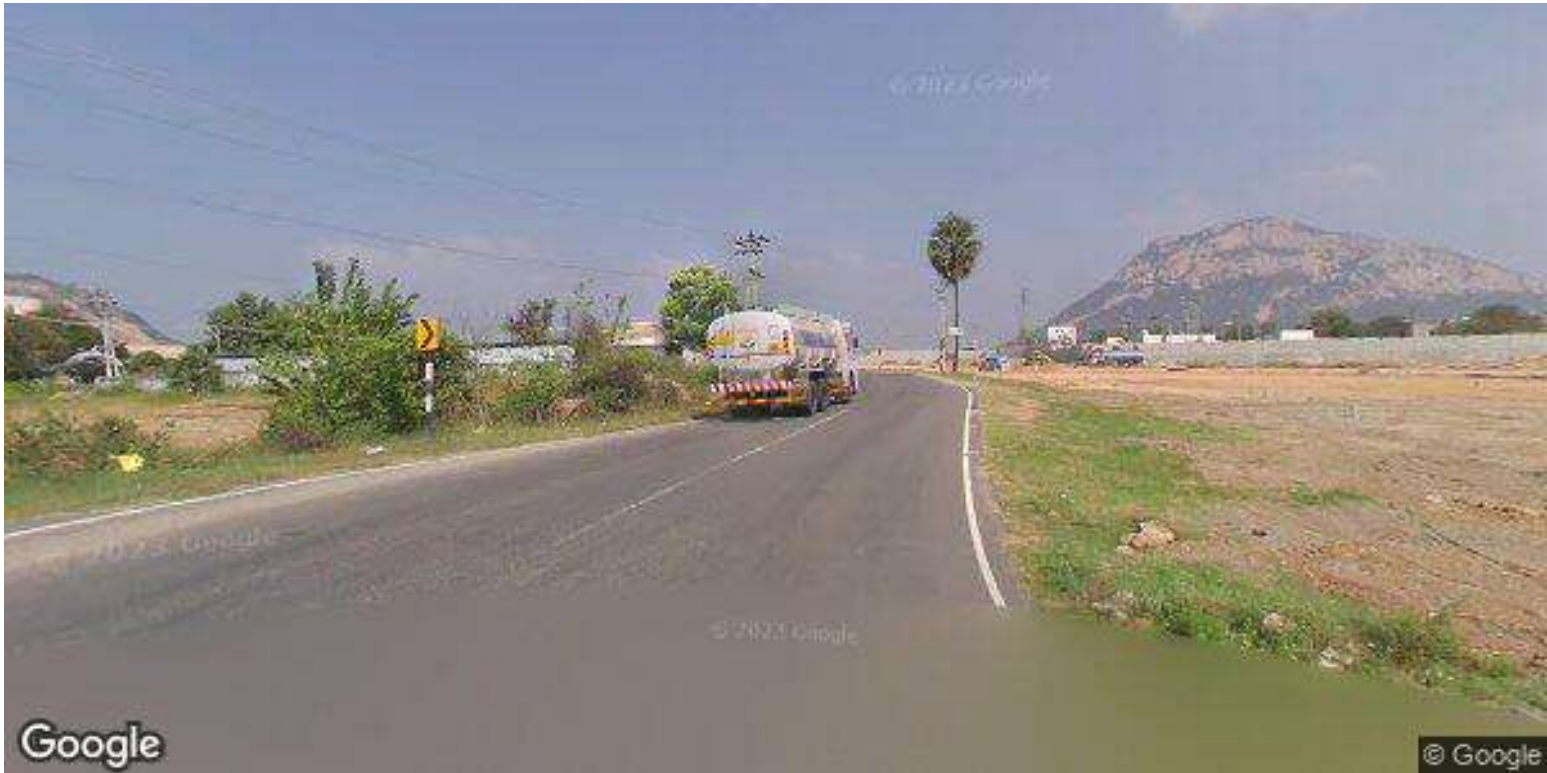
**Risk Type:** Turn  
**Risk Level:** Medium  
**Speed Limit:** 30 KM/Hr  
**Coordinates:** 11.45847, 77.85140

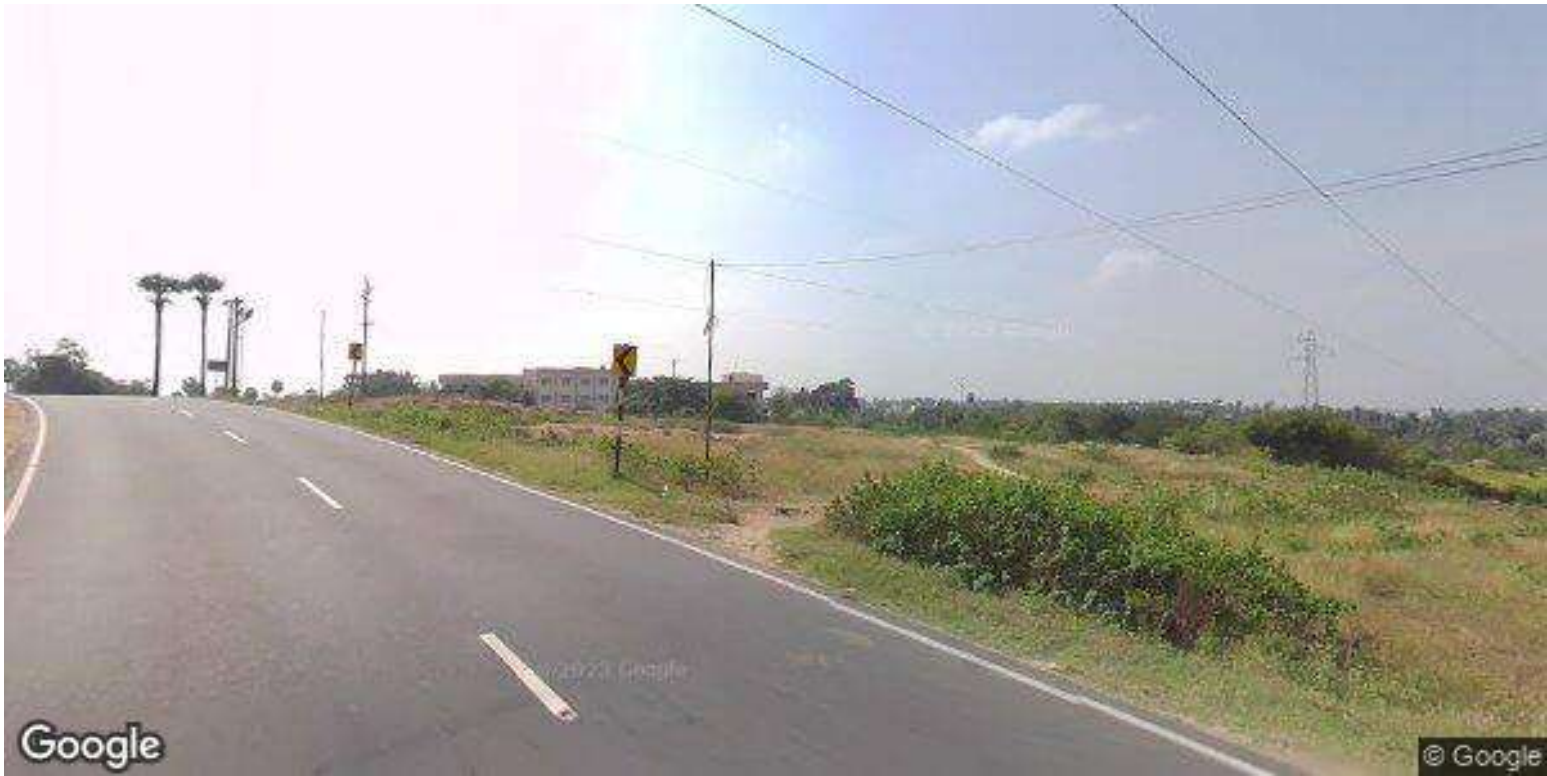
**Risk Type:** Turn  
**Risk Level:** Medium  
**Speed Limit:** 30 KM/Hr  
**Coordinates:** 11.46048, 77.85036

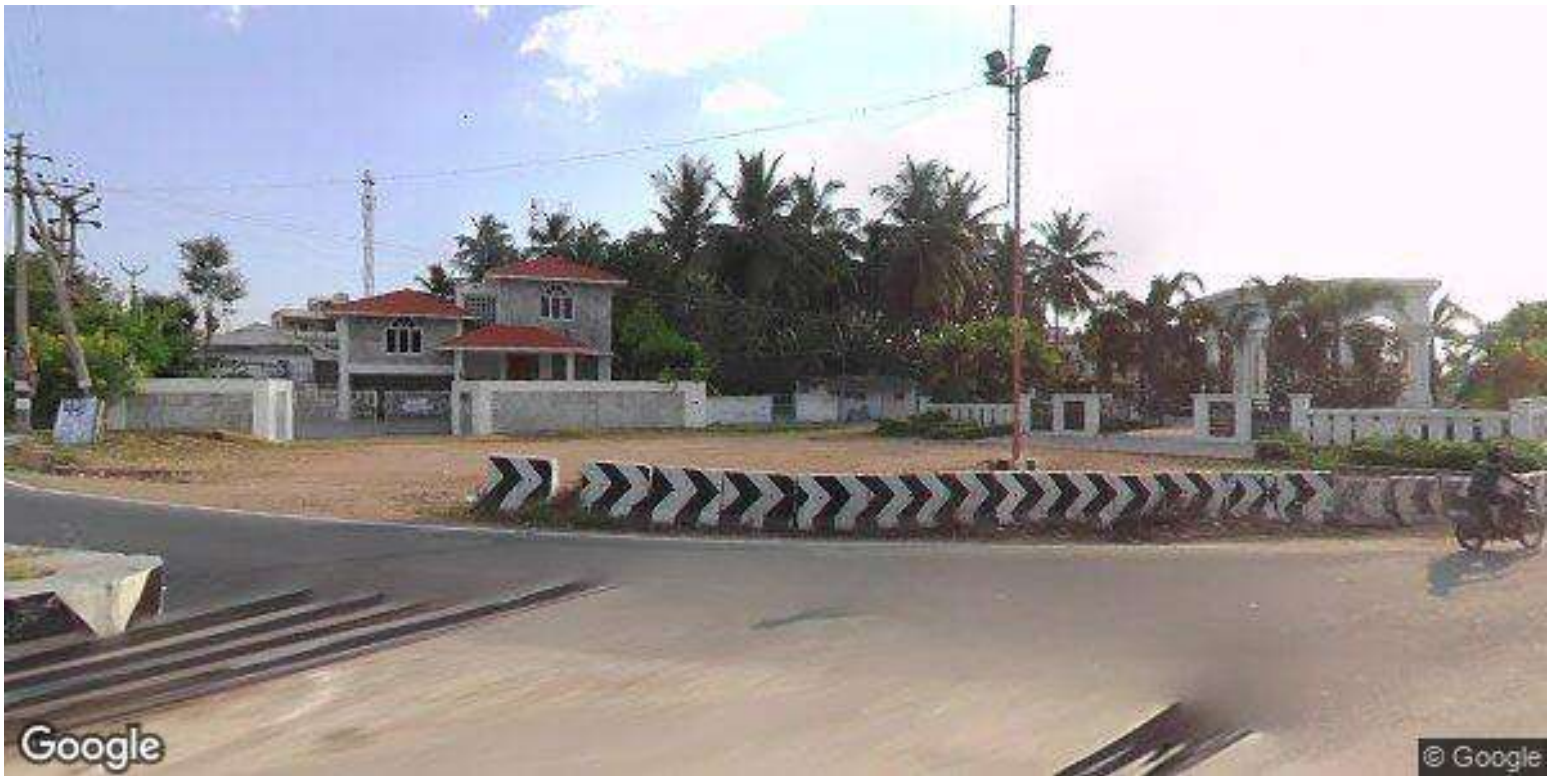
**Risk Type:** Turn  
**Risk Level:** Medium  
**Speed Limit:** 30 KM/Hr  
**Coordinates:** 11.46314, 77.84928

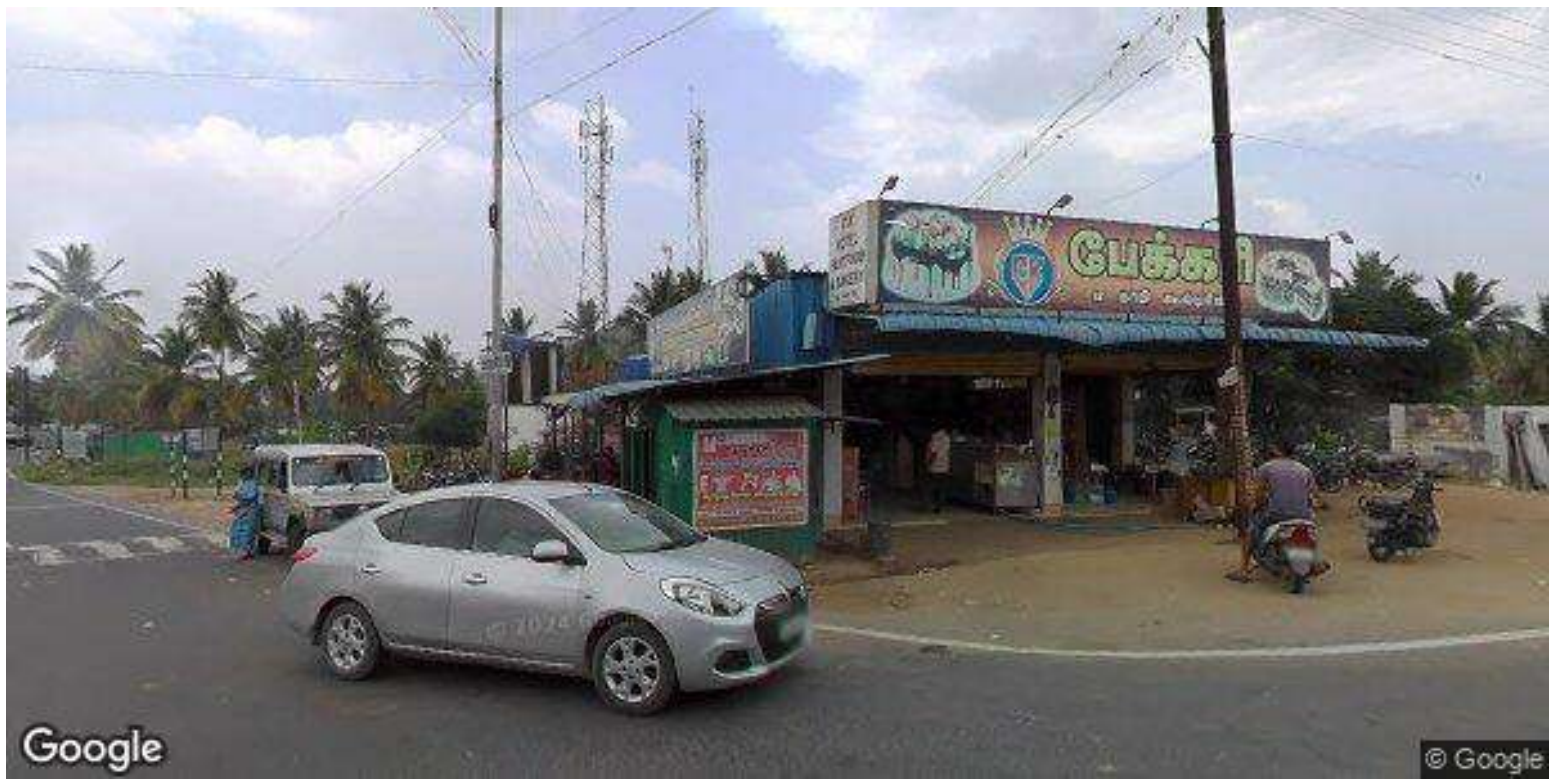
**Risk Type:** Blind Spot  
**Risk Level:** Blind Spot  
**Speed Limit:** 10 KM/Hr  
**Coordinates:** 11.49390, 77.86748

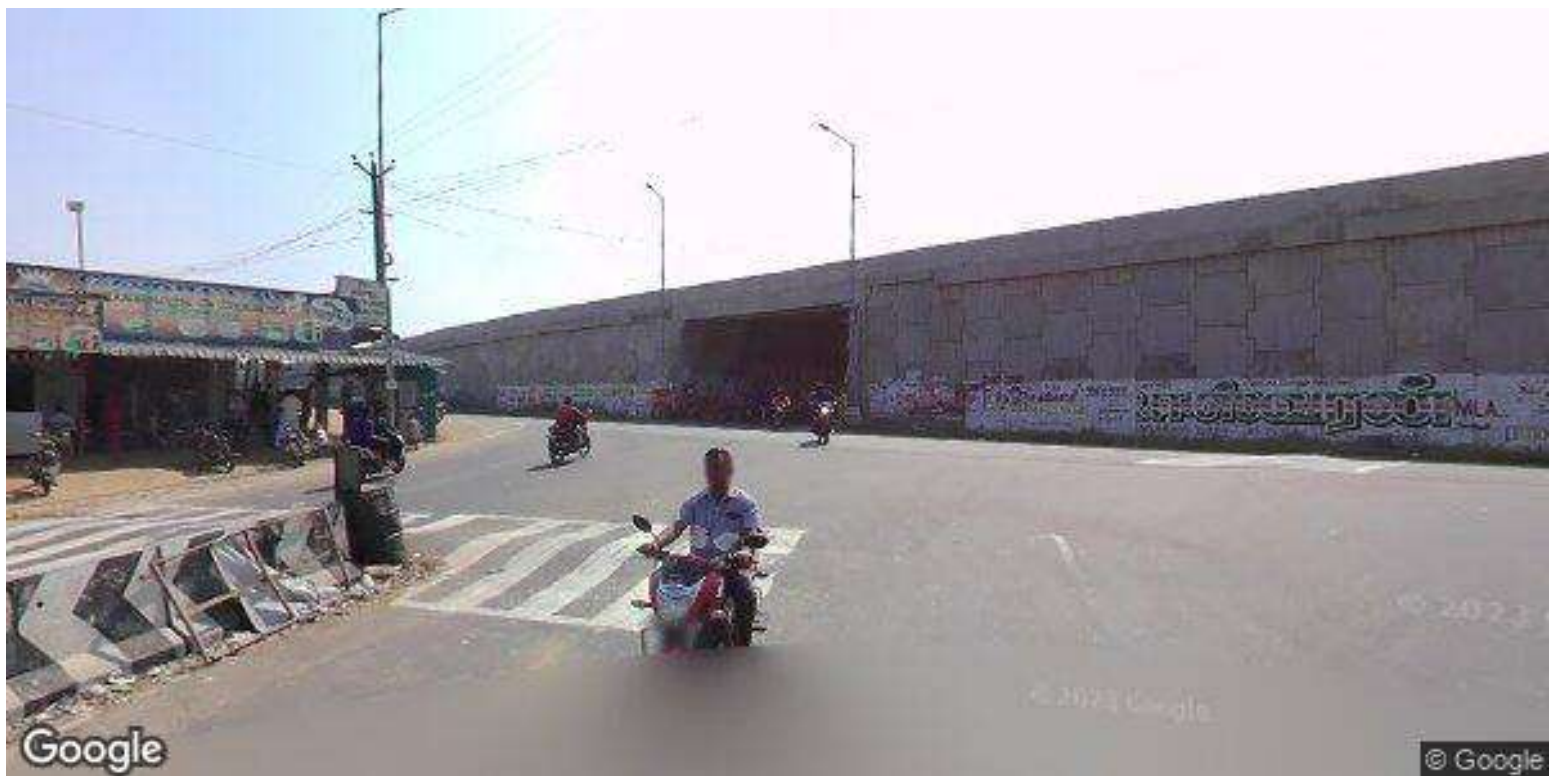
**Risk Type:** Turn  
**Risk Level:** Medium  
**Speed Limit:** 30 KM/Hr  
**Coordinates:** 11.49404, 77.86724

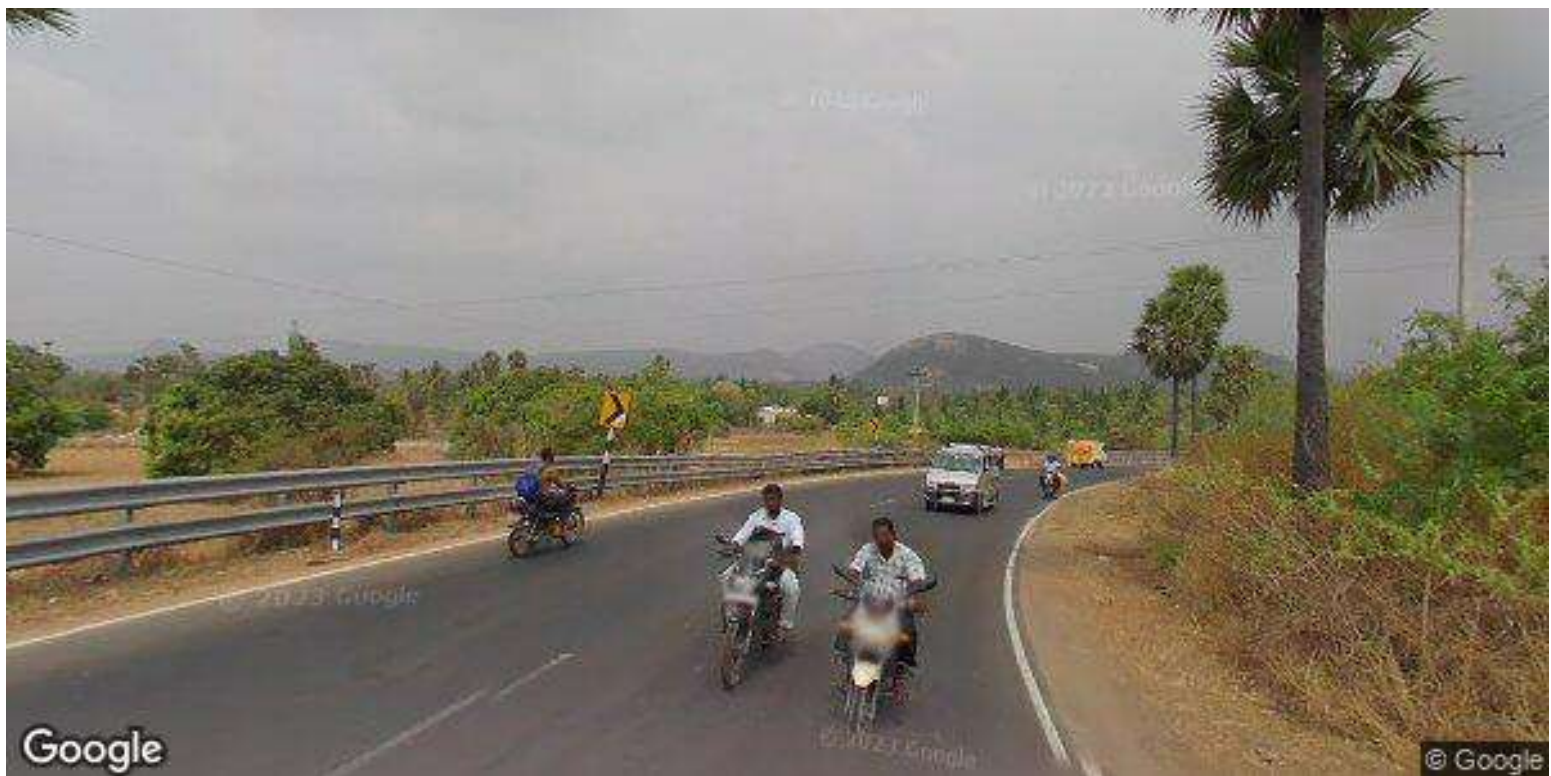
**Risk Type:** Turn  
**Risk Level:** Medium  
**Speed Limit:** 30 KM/Hr  
**Coordinates:** 11.50866, 77.86053

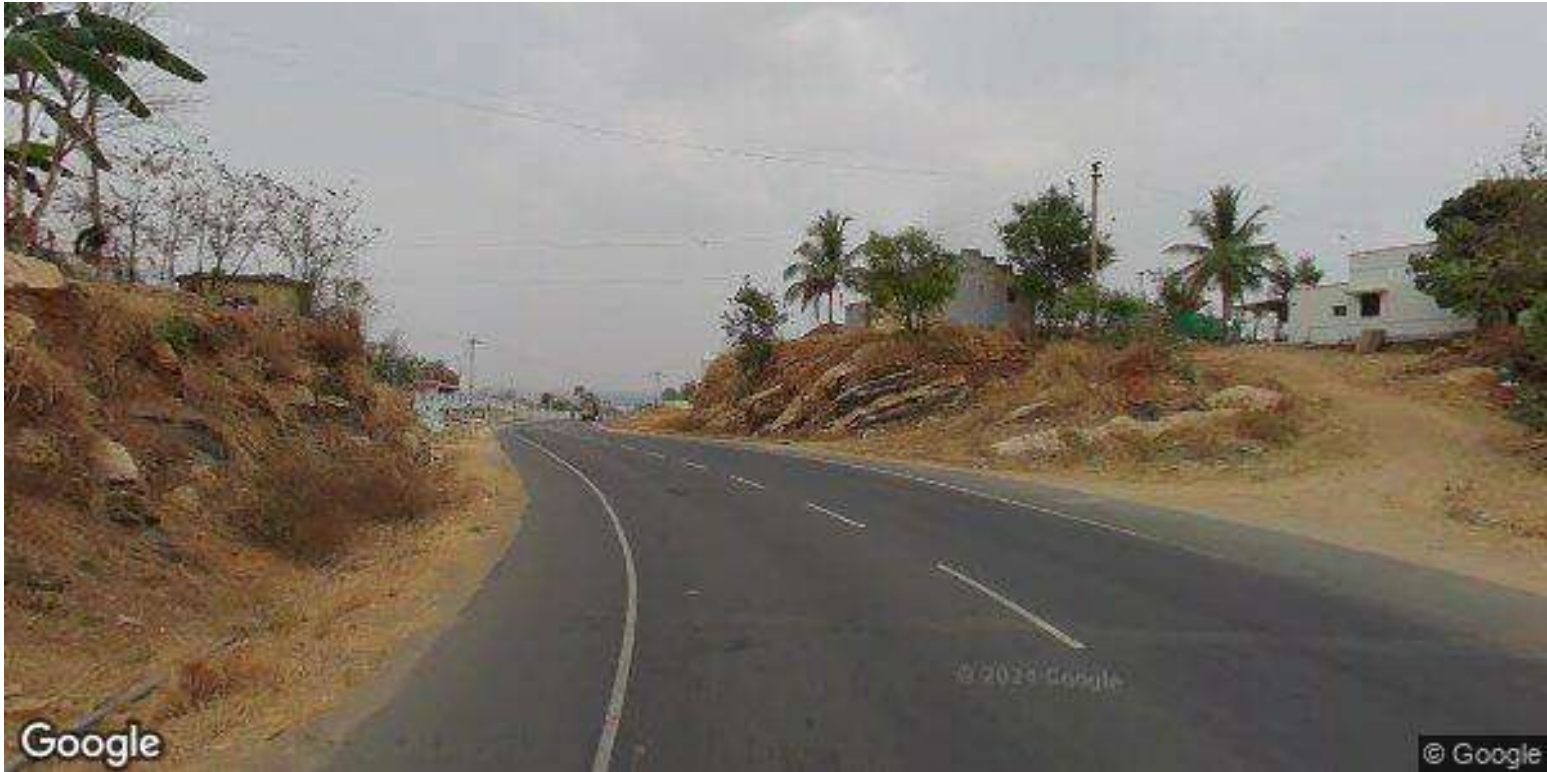
**Risk Type:** Turn  
**Risk Level:** Medium  
**Speed Limit:** 30 KM/Hr  
**Coordinates:** 11.55039, 77.85511

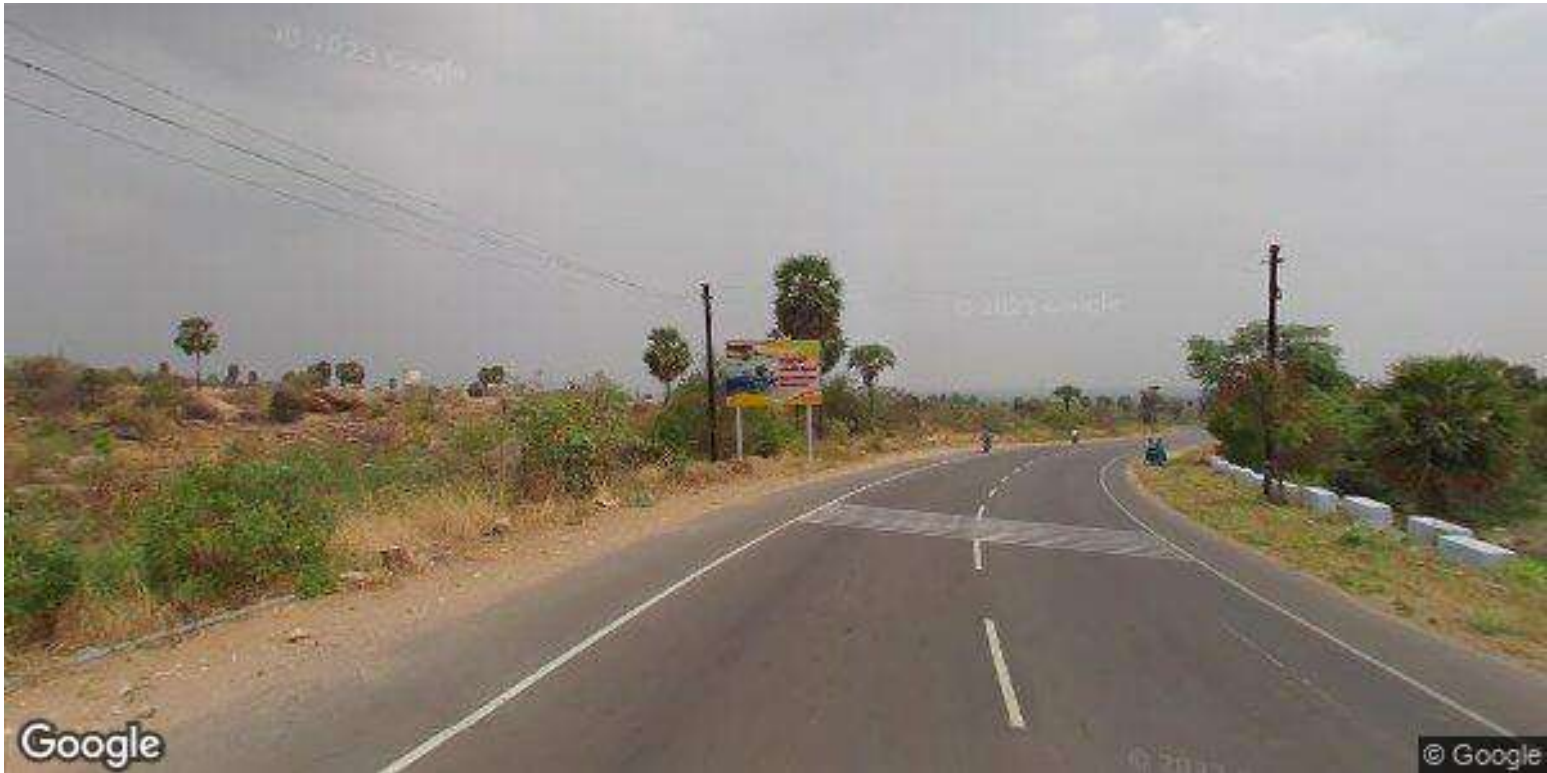
**Risk Type:** Turn  
**Risk Level:** Medium  
**Speed Limit:** 30 KM/Hr  
**Coordinates:** 11.55460, 77.85624

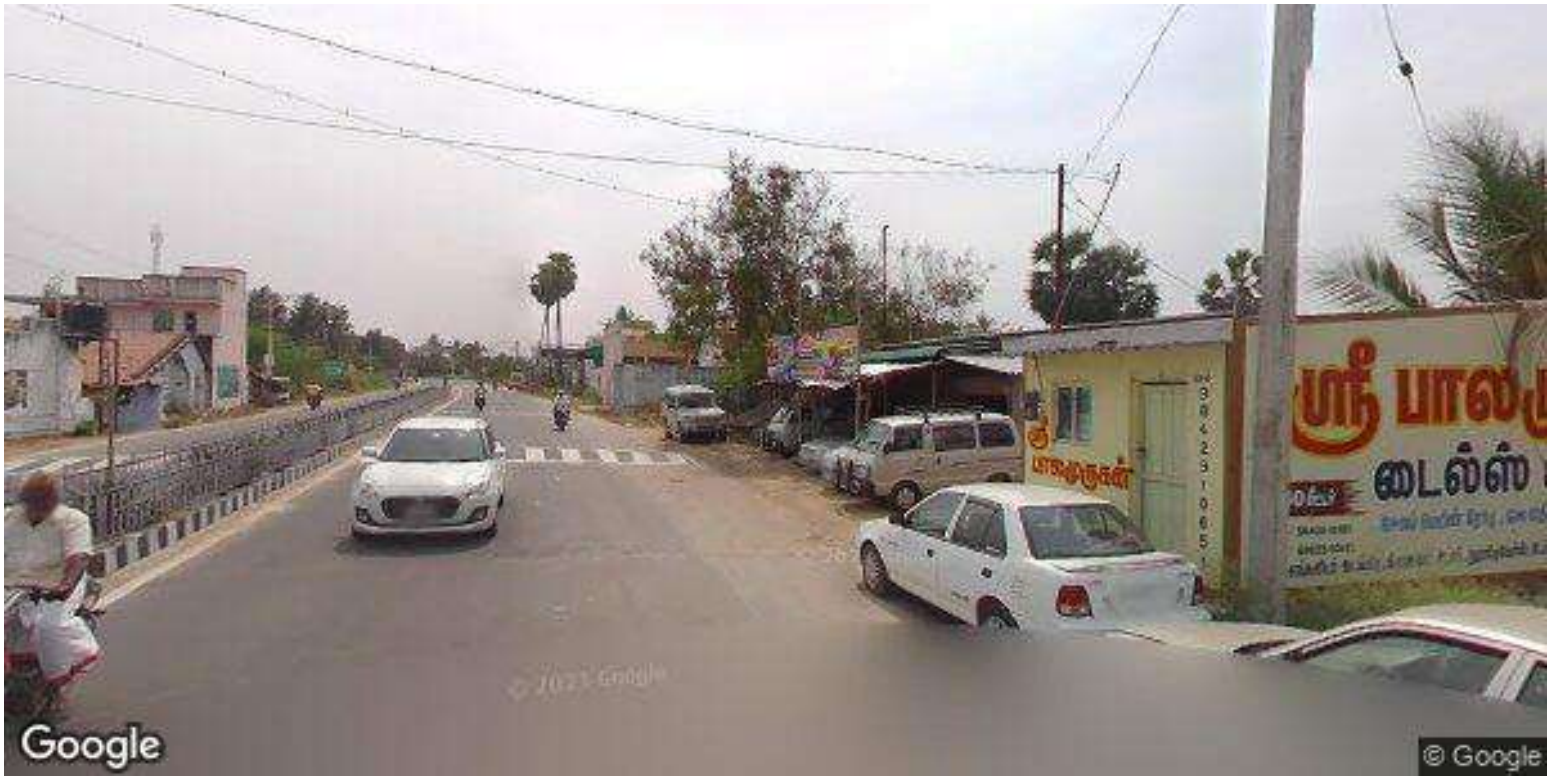
**Risk Type:** Turn  
**Risk Level:** High  
**Speed Limit:** 15 KM/Hr  
**Coordinates:** 11.57893, 77.85430

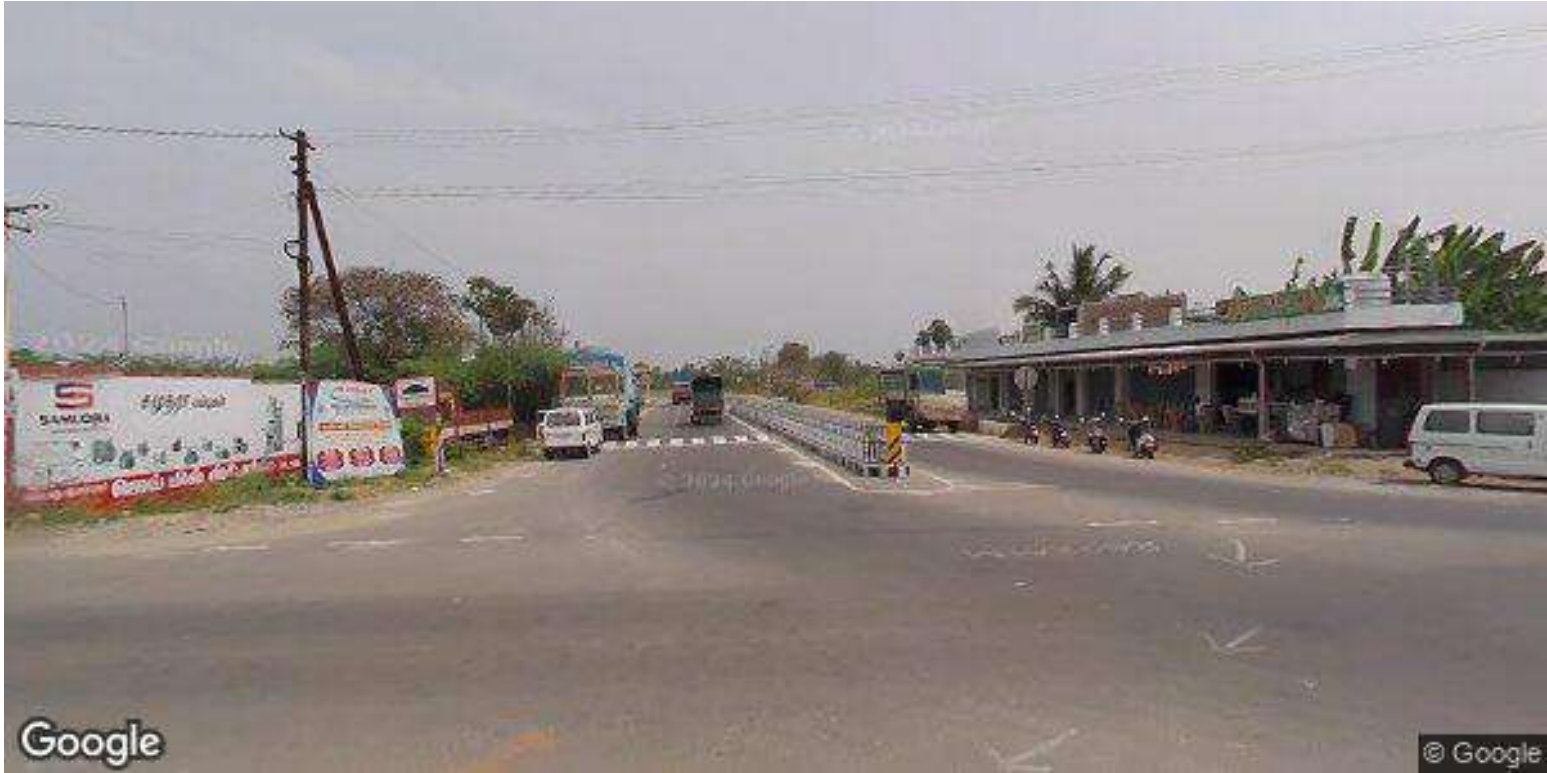
**Risk Type:** Turn  
**Risk Level:** Medium  
**Speed Limit:** 30 KM/Hr  
**Coordinates:** 11.57903, 77.85441

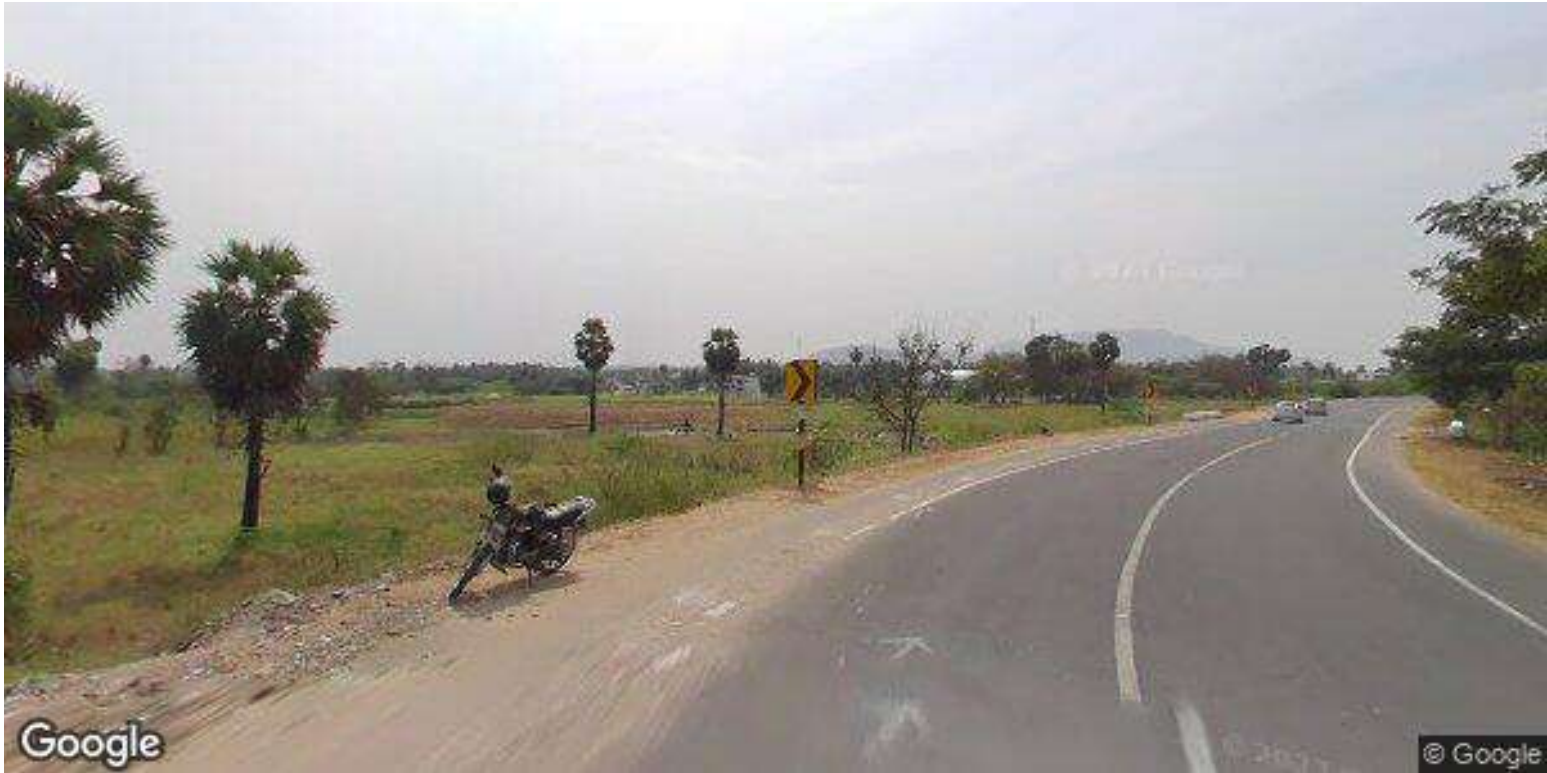
**Risk Type:** Turn  
**Risk Level:** Medium  
**Speed Limit:** 30 KM/Hr  
**Coordinates:** 11.58022, 77.85744

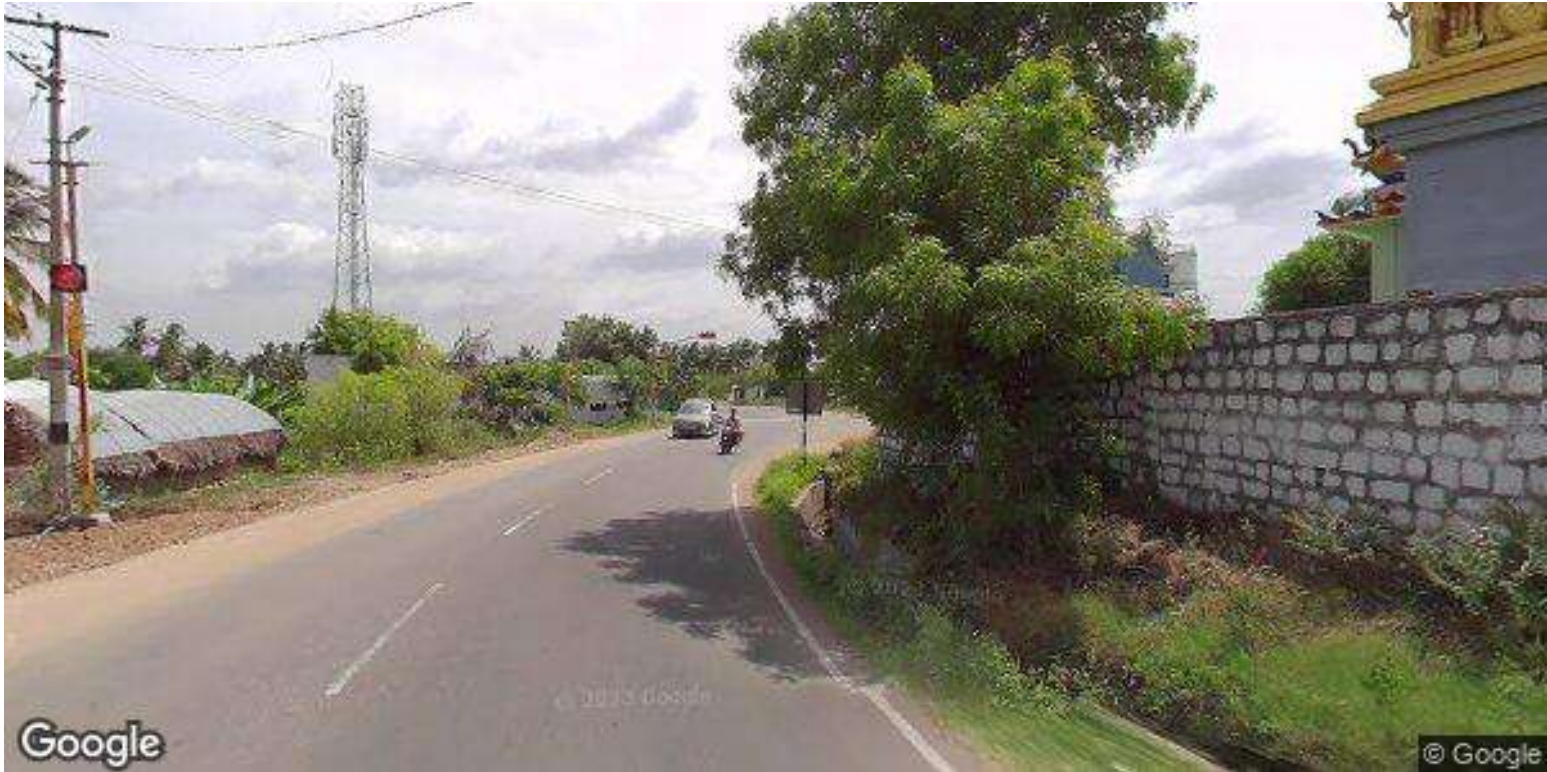
**Risk Type:** Turn  
**Risk Level:** Medium  
**Speed Limit:** 30 KM/Hr  
**Coordinates:** 11.60727, 77.84032

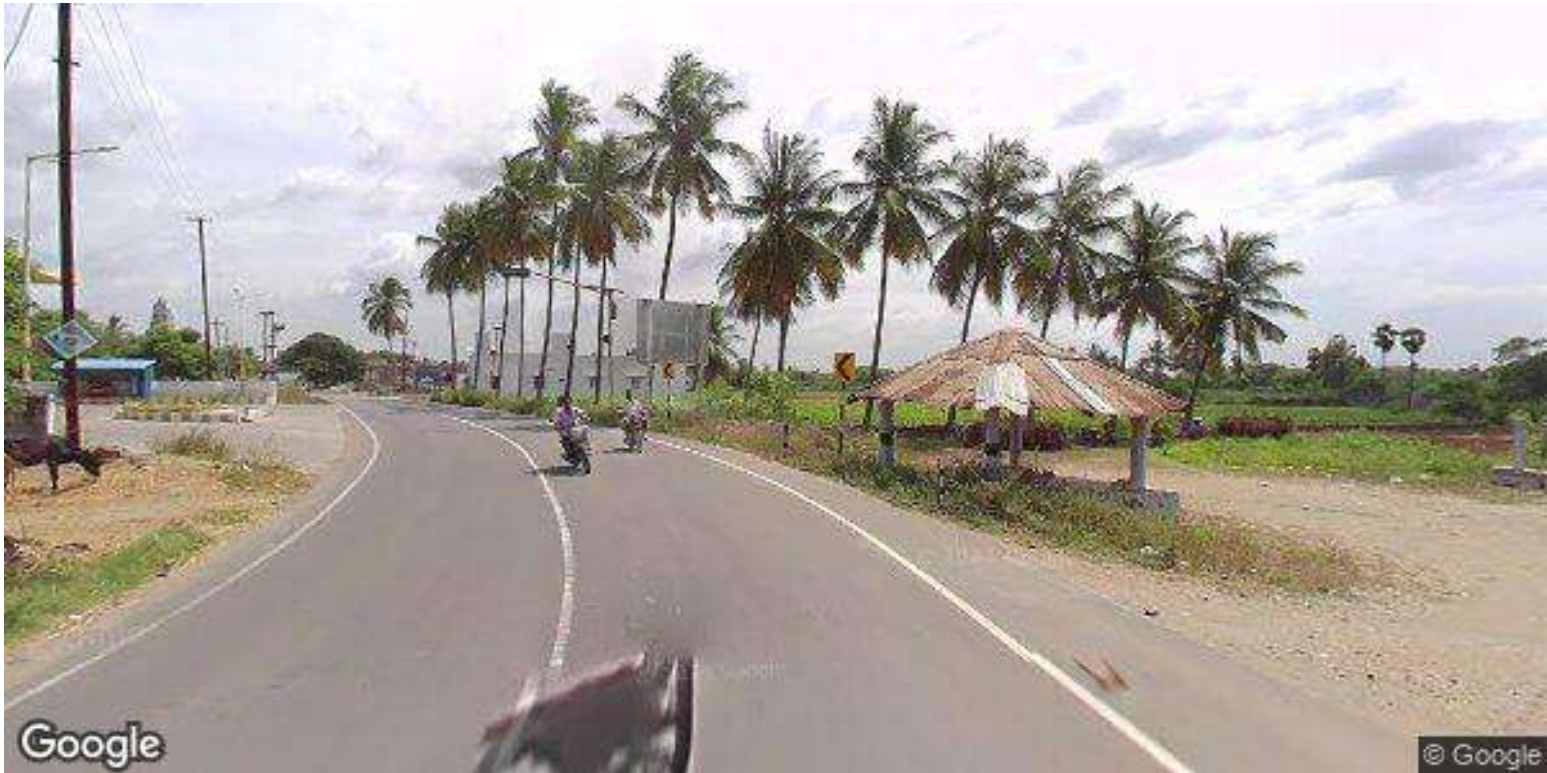
**Risk Type:** Turn  
**Risk Level:** Medium  
**Speed Limit:** 30 KM/Hr  
**Coordinates:** 11.60972, 77.84164

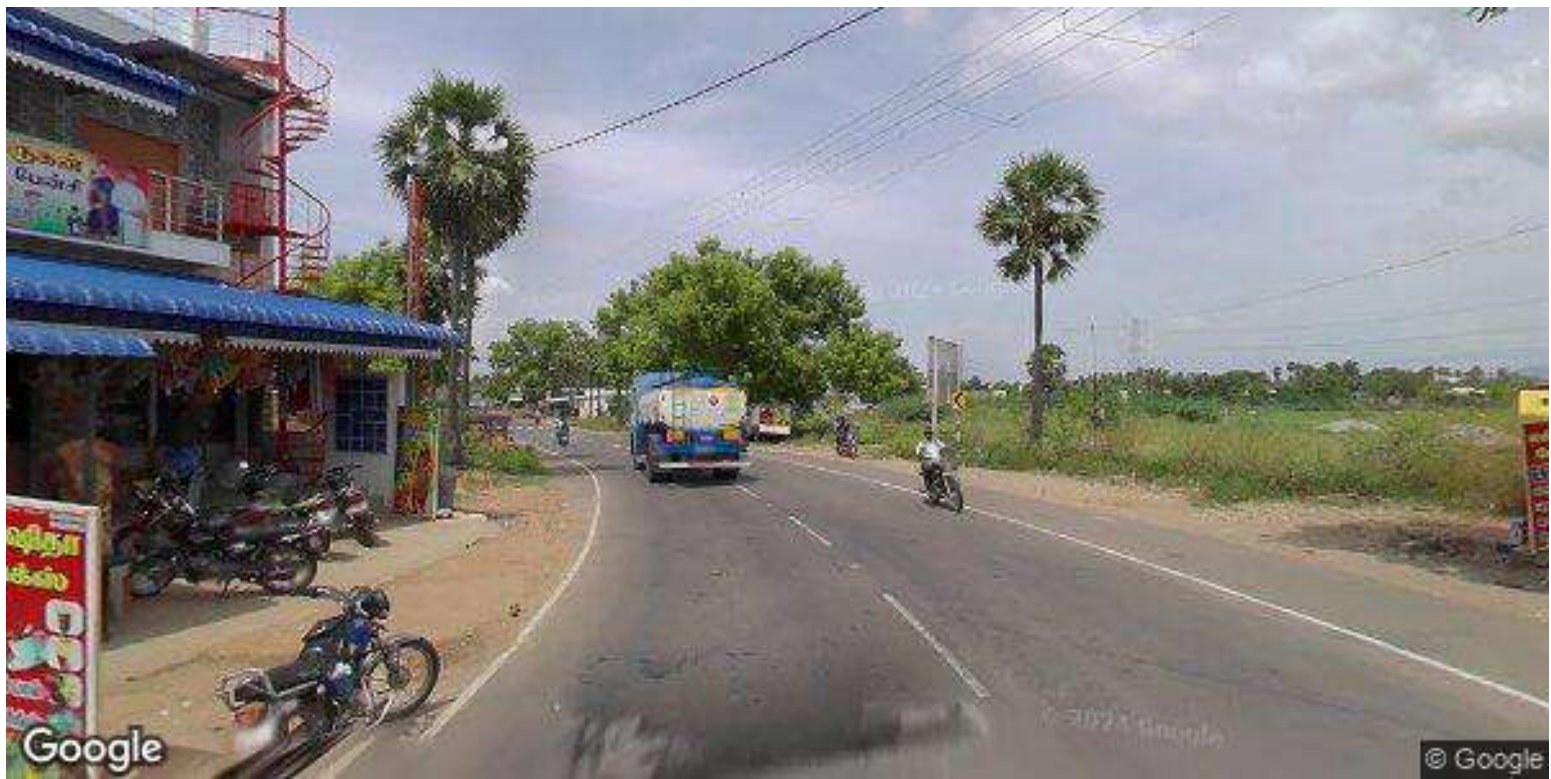
**Coordinates:** 11.64064, 77.84611

**Risk Type:** Turn

**Risk Level:** Medium

**Speed Limit:** 30 KM/Hr

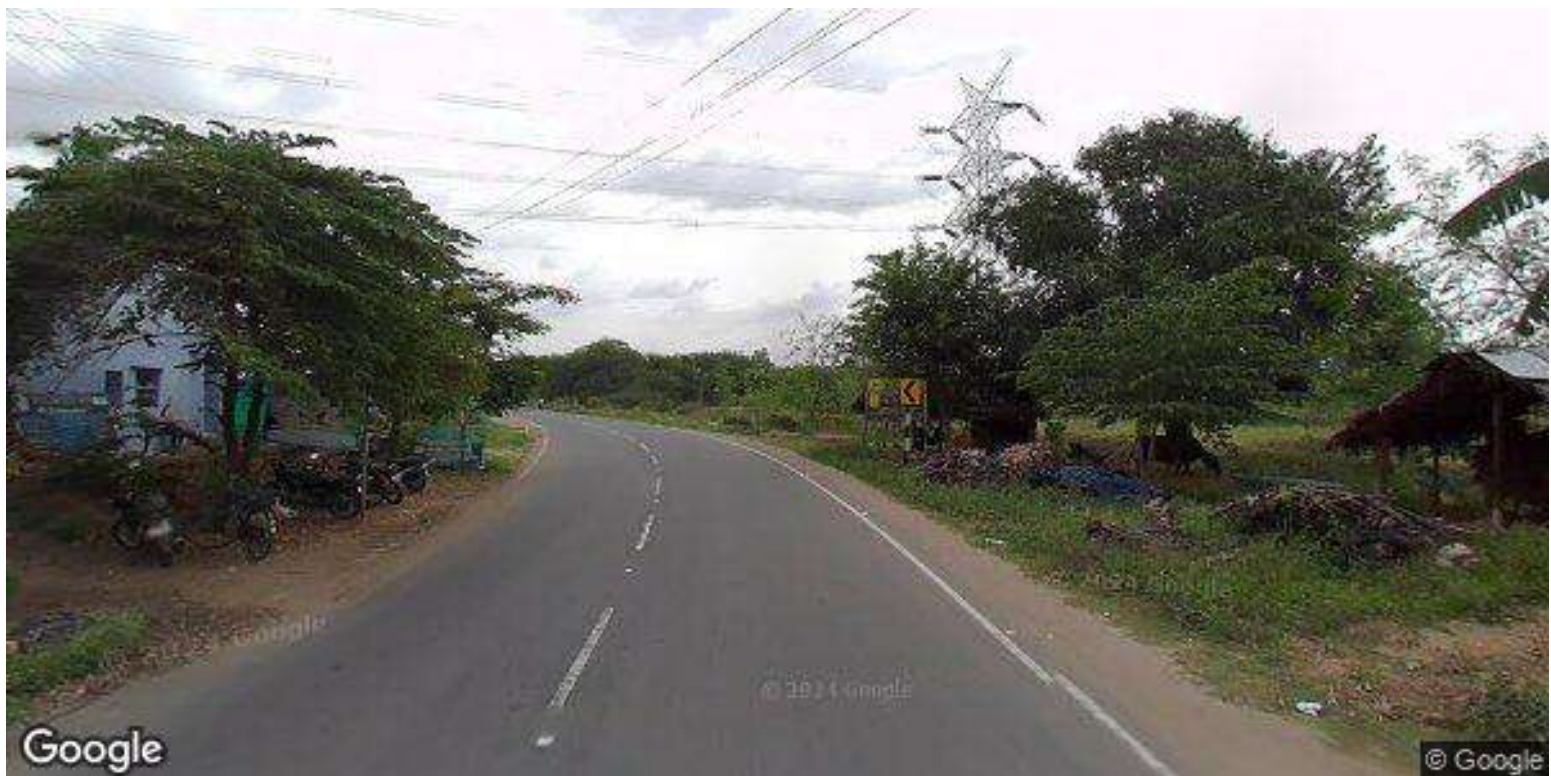
**Coordinates:** 11.64535, 77.85122

**Risk Type:** Turn

**Risk Level:** Medium

**Speed Limit:** 30 KM/Hr
