# IndianOil

## JOURNEY RISK MANAGEMENT (JRM) STUDY

### Salem Terminal to PALANIMALAI TRADERS

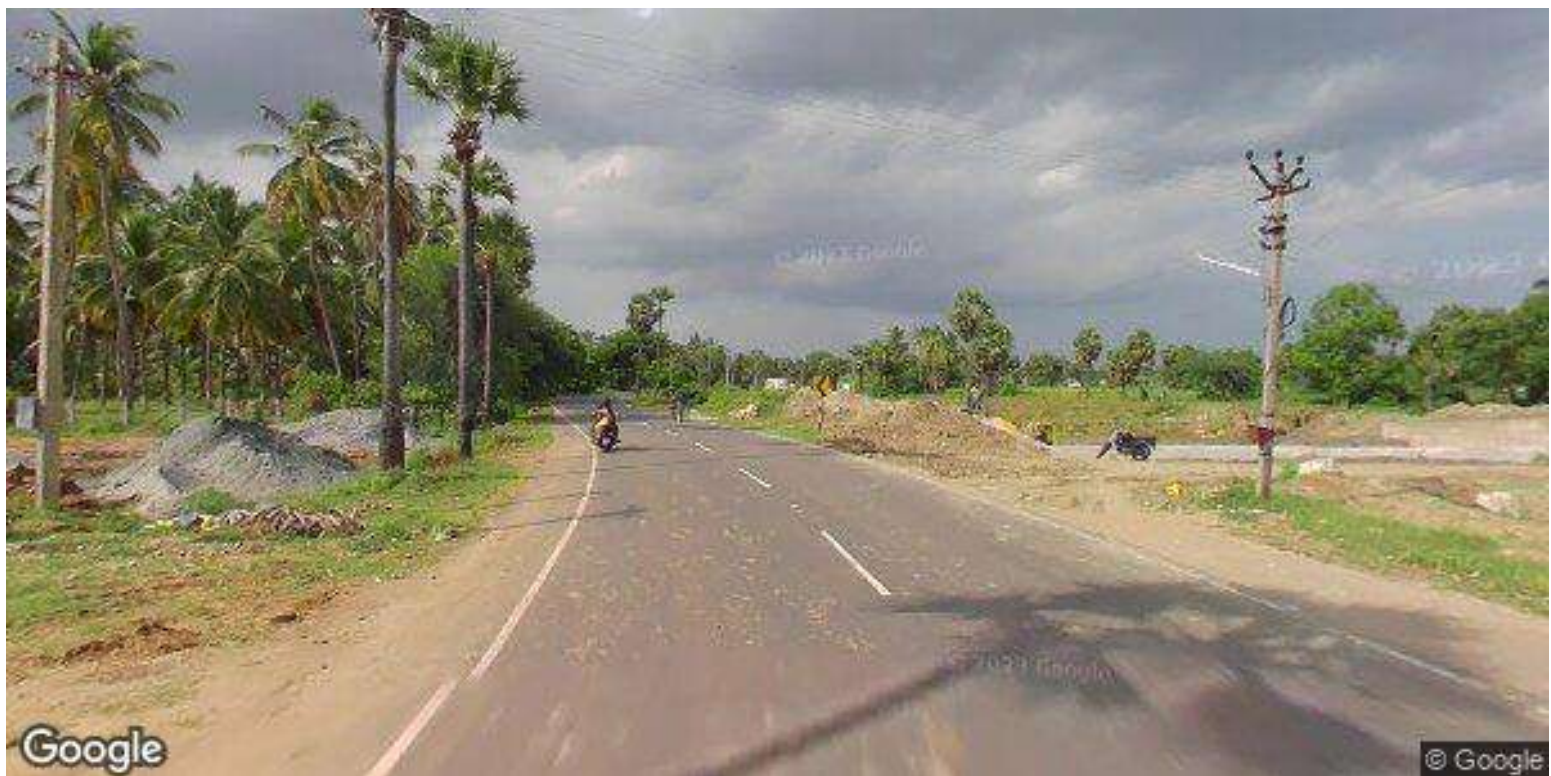
**Risk Type:** Turn  
**Risk Level:** Medium  
**Speed Limit:** 30 KM/Hr  
**Coordinates:** 11.66467, 77.85599

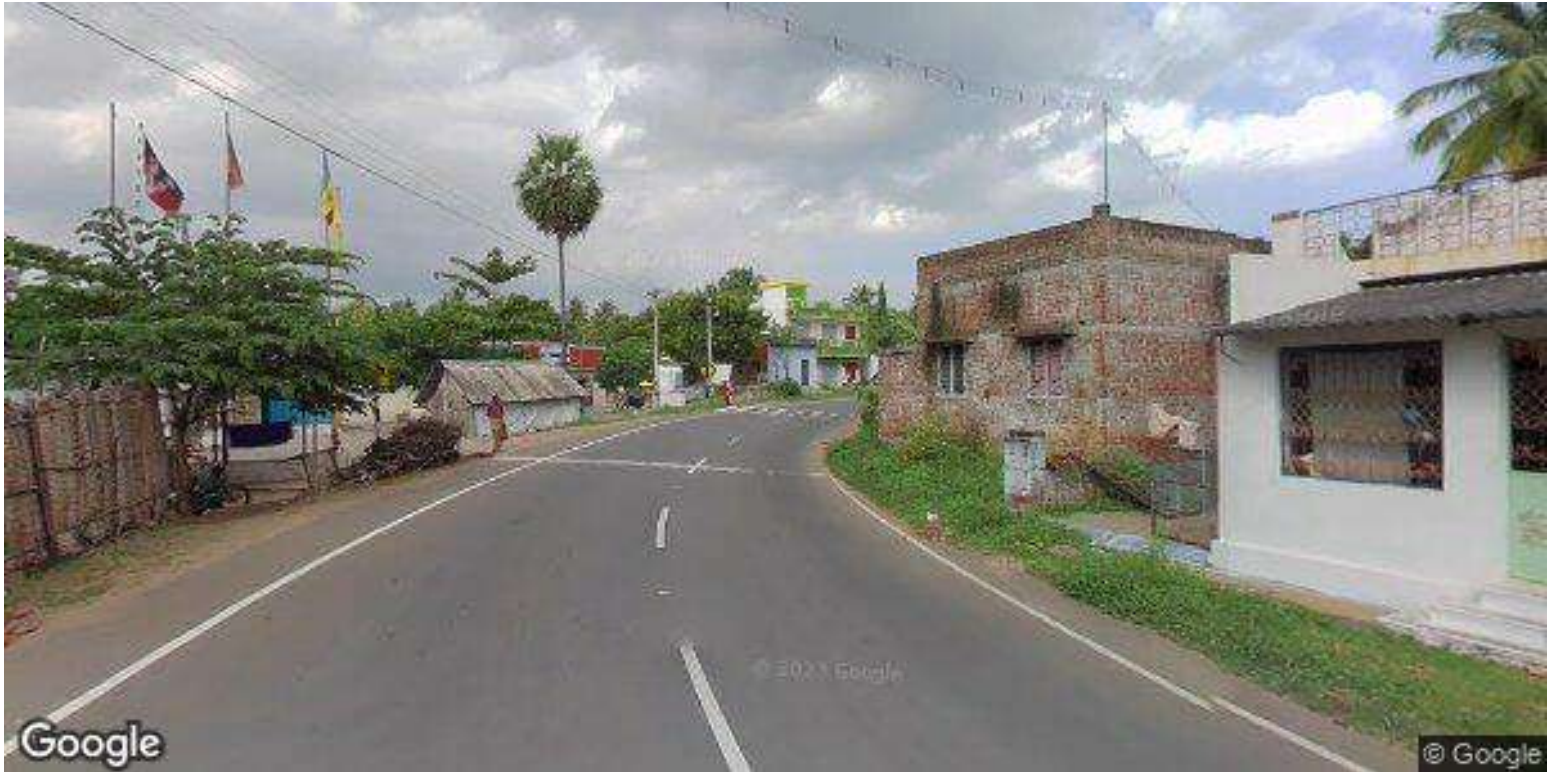
**Risk Type:** Turn  
**Risk Level:** Medium  
**Speed Limit:** 30 KM/Hr  
**Coordinates:** 11.67301, 77.86024

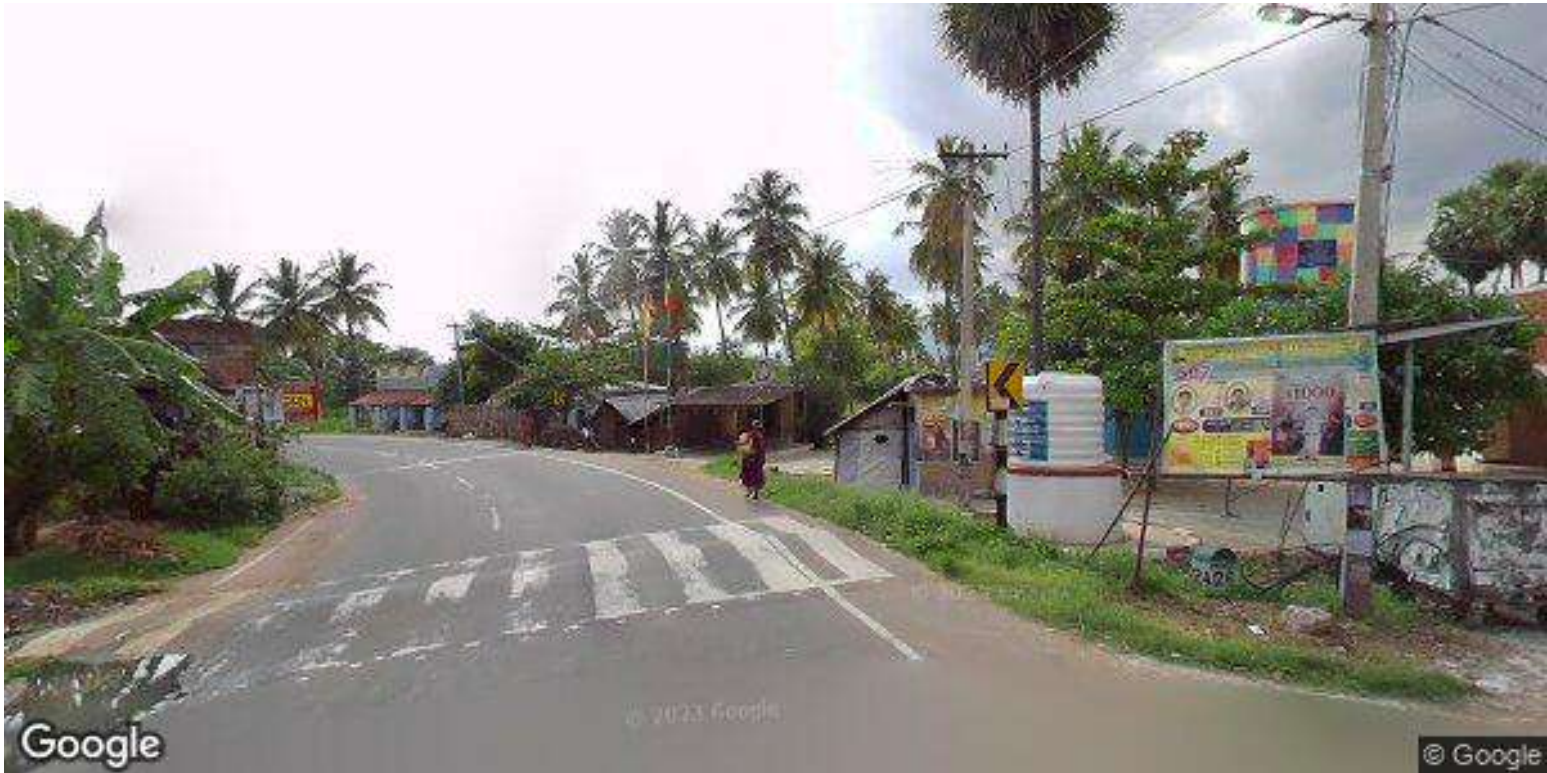
**Risk Type:** Turn  
**Risk Level:** Medium  
**Speed Limit:** 30 KM/Hr  
**Coordinates:** 11.67326, 77.86058

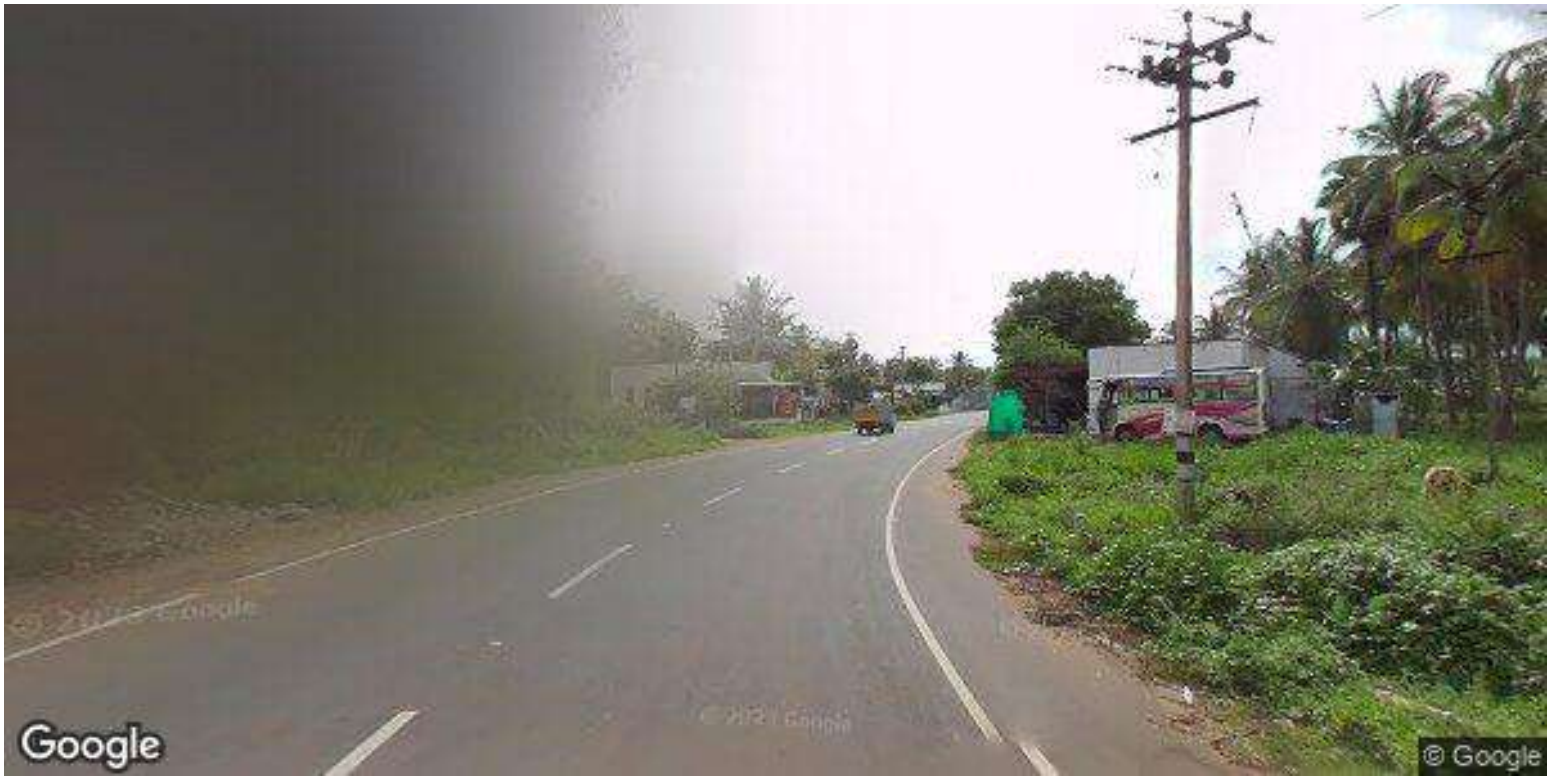
**Risk Type:** Turn  
**Risk Level:** Medium  
**Speed Limit:** 30 KM/Hr  
**Coordinates:** 11.67373, 77.86230

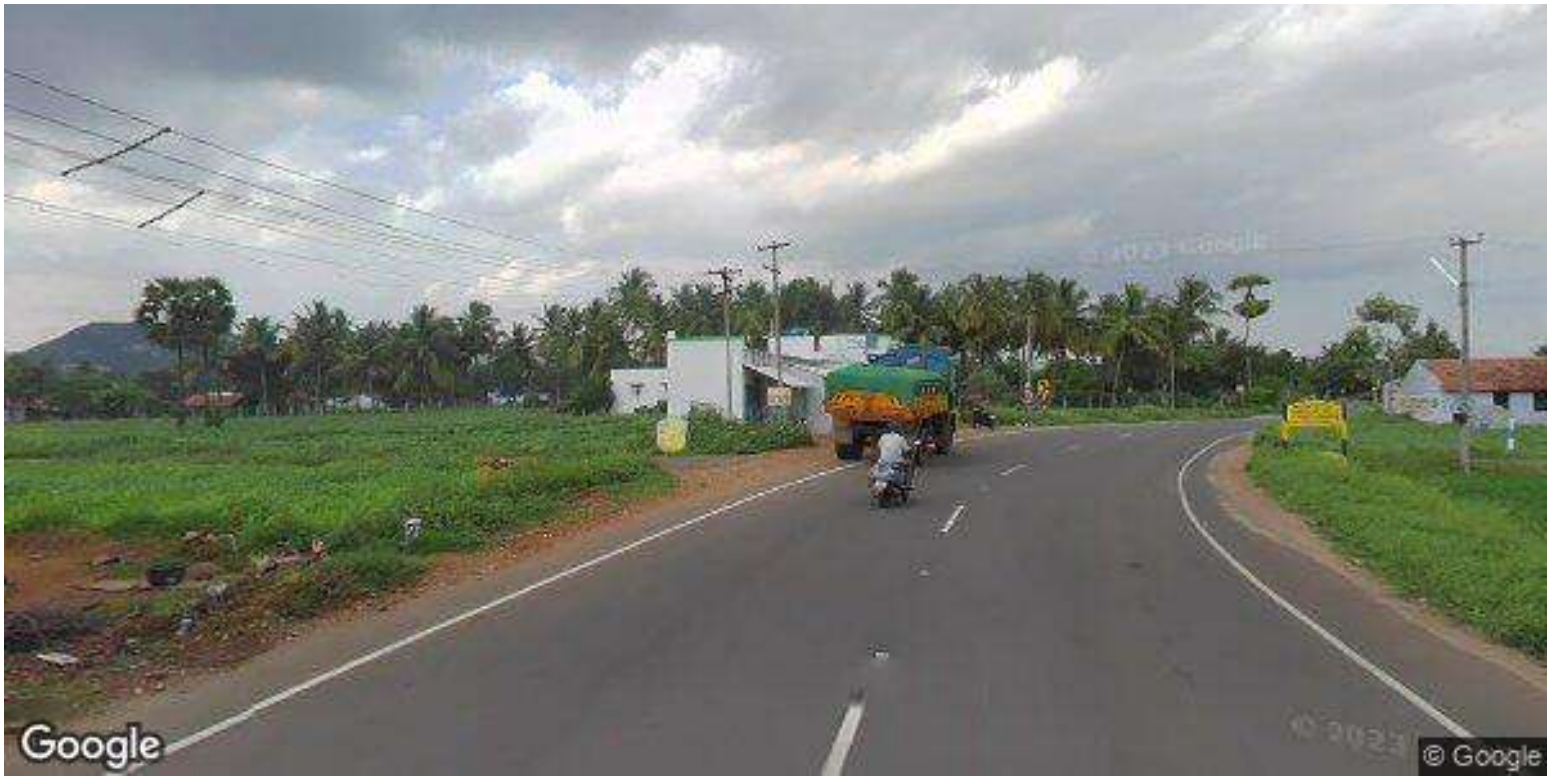
**Risk Type:** Turn  
**Risk Level:** Medium  
**Speed Limit:** 30 KM/Hr  
**Coordinates:** 11.68171, 77.86676

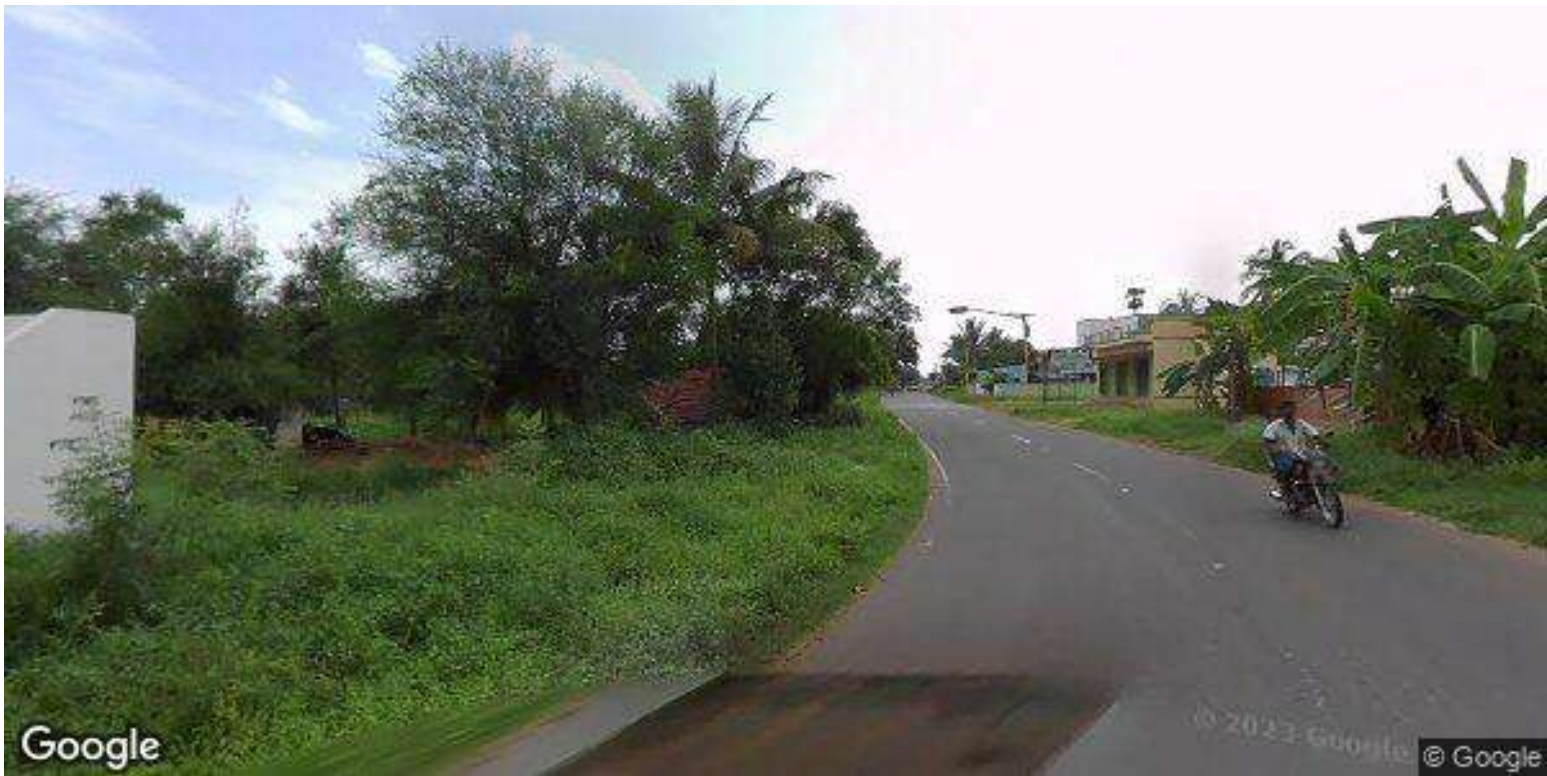
**Coordinates: 11.68490, 77.86893**

**Risk Type: Turn**

**Risk Level: High**

**Speed Limit: 15 KM/Hr**

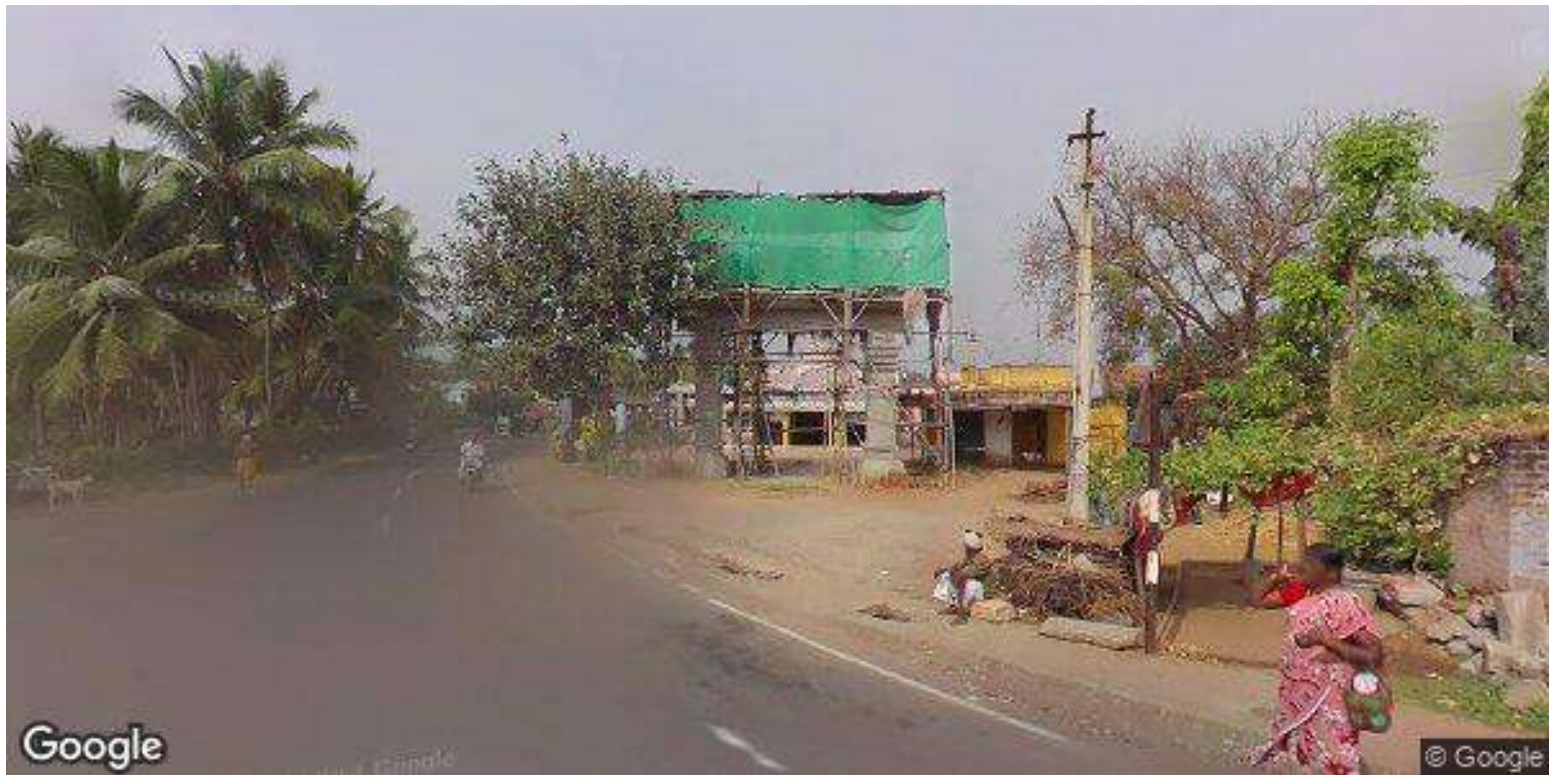
**Coordinates: 11.68472, 77.87281**

**Risk Type: Turn**

**Risk Level: High**

**Speed Limit: 15 KM/Hr**

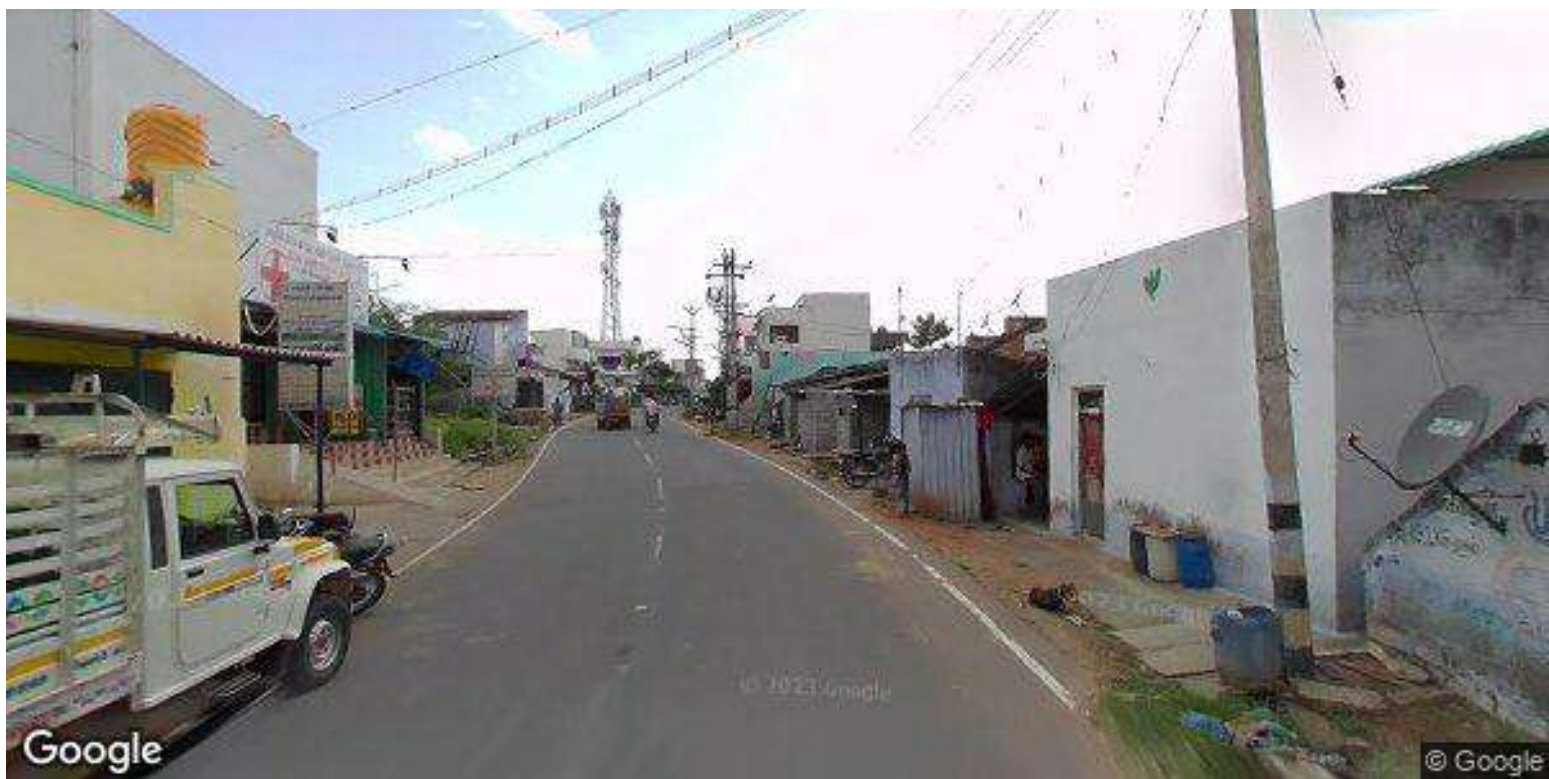
**Coordinates: 11.69280, 77.87439**

**Risk Type: Turn**

**Risk Level: Medium**

**Speed Limit: 30 KM/Hr**

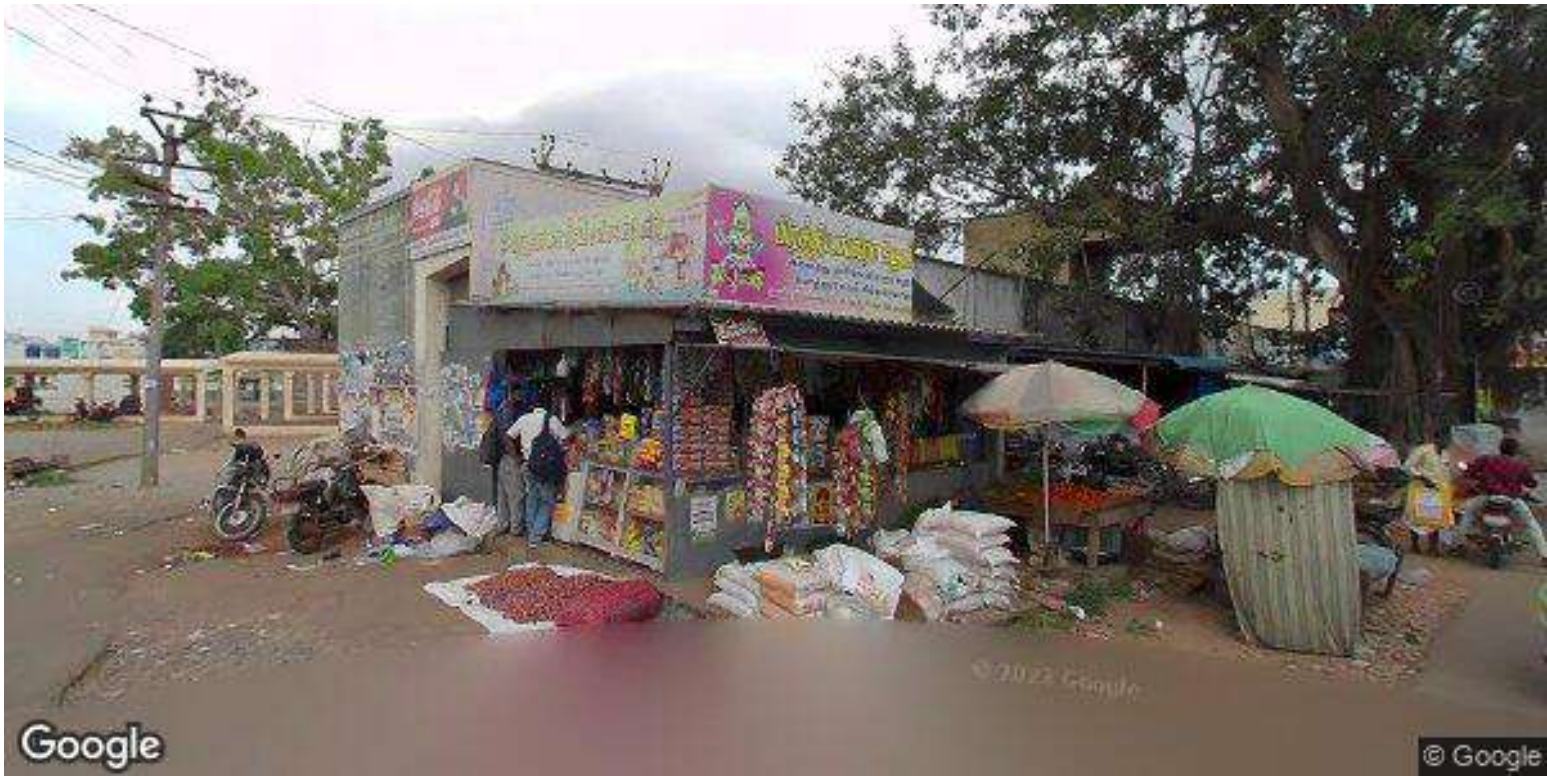
**Risk Type:** Turn  
**Risk Level:** Medium  
**Speed Limit:** 30 KM/Hr  
**Coordinates:** 11.69458, 77.87589

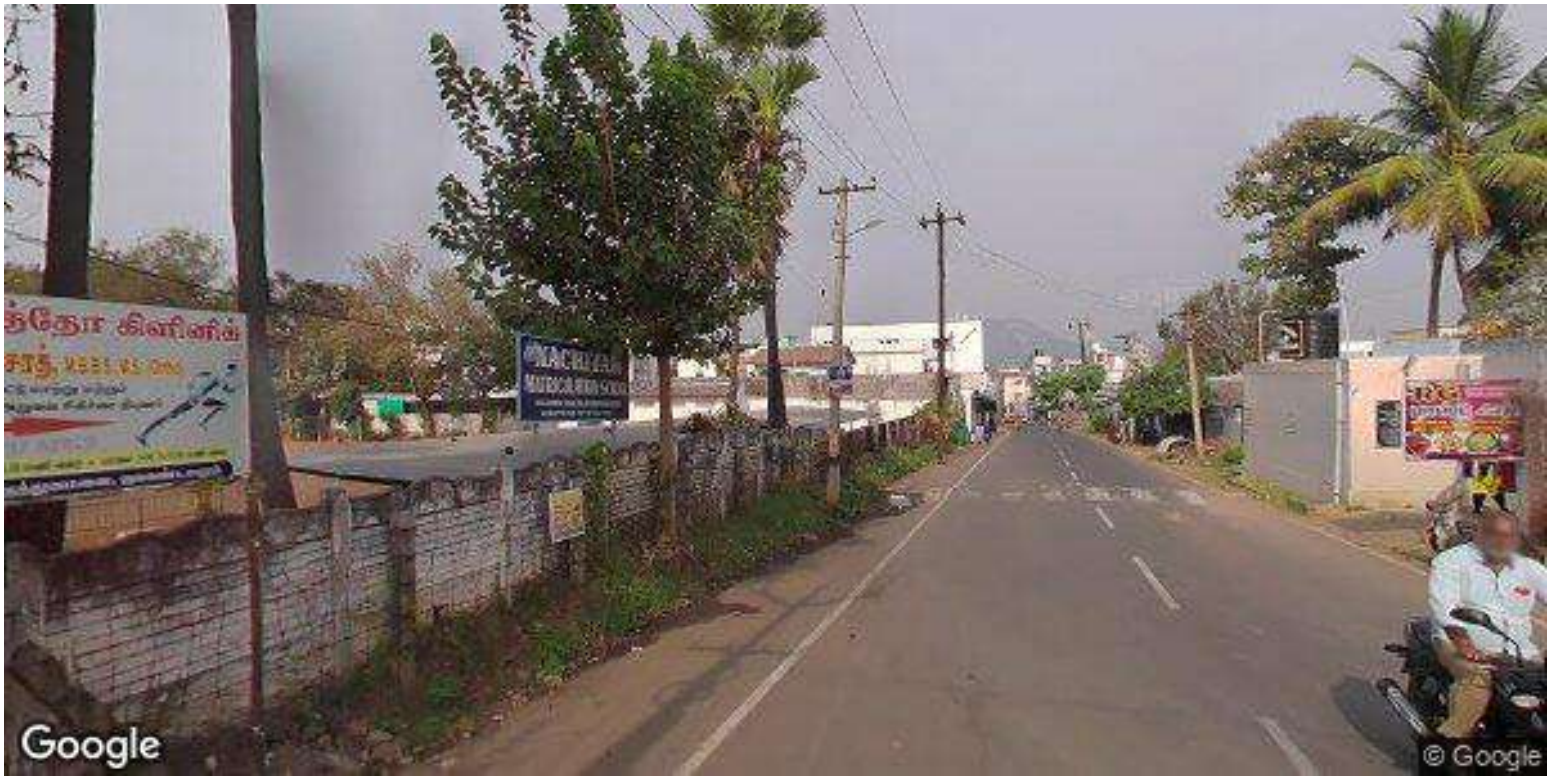
**Risk Type:** Blind Spot  
**Risk Level:** Blind Spot  
**Speed Limit:** 10 KM/Hr  
**Coordinates:** 11.69360, 77.87831

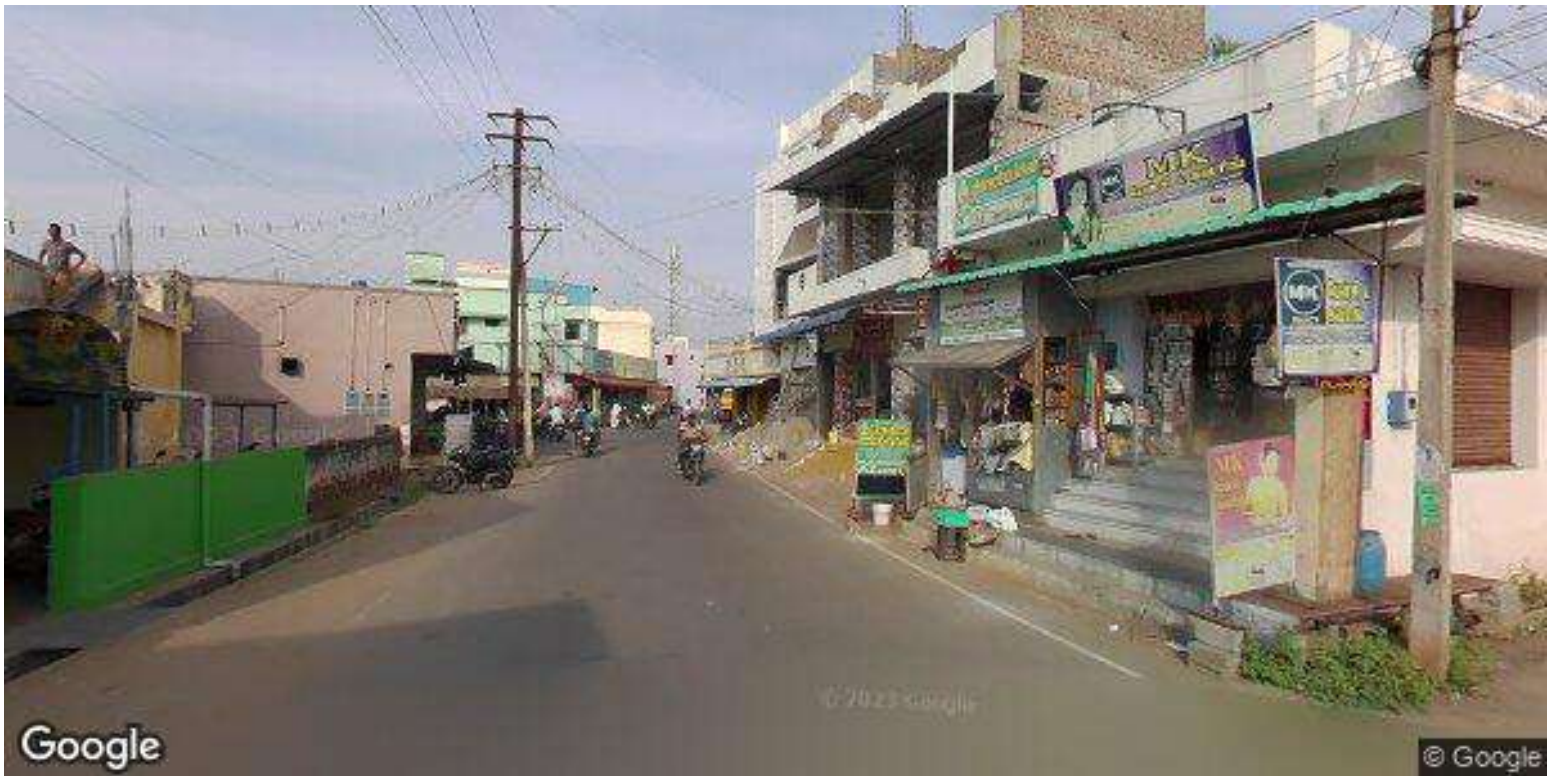
Coordinates: 11.69523, 77.87892

Risk Type: Turn

Risk Level: Medium

Speed Limit: 30 KM/Hr

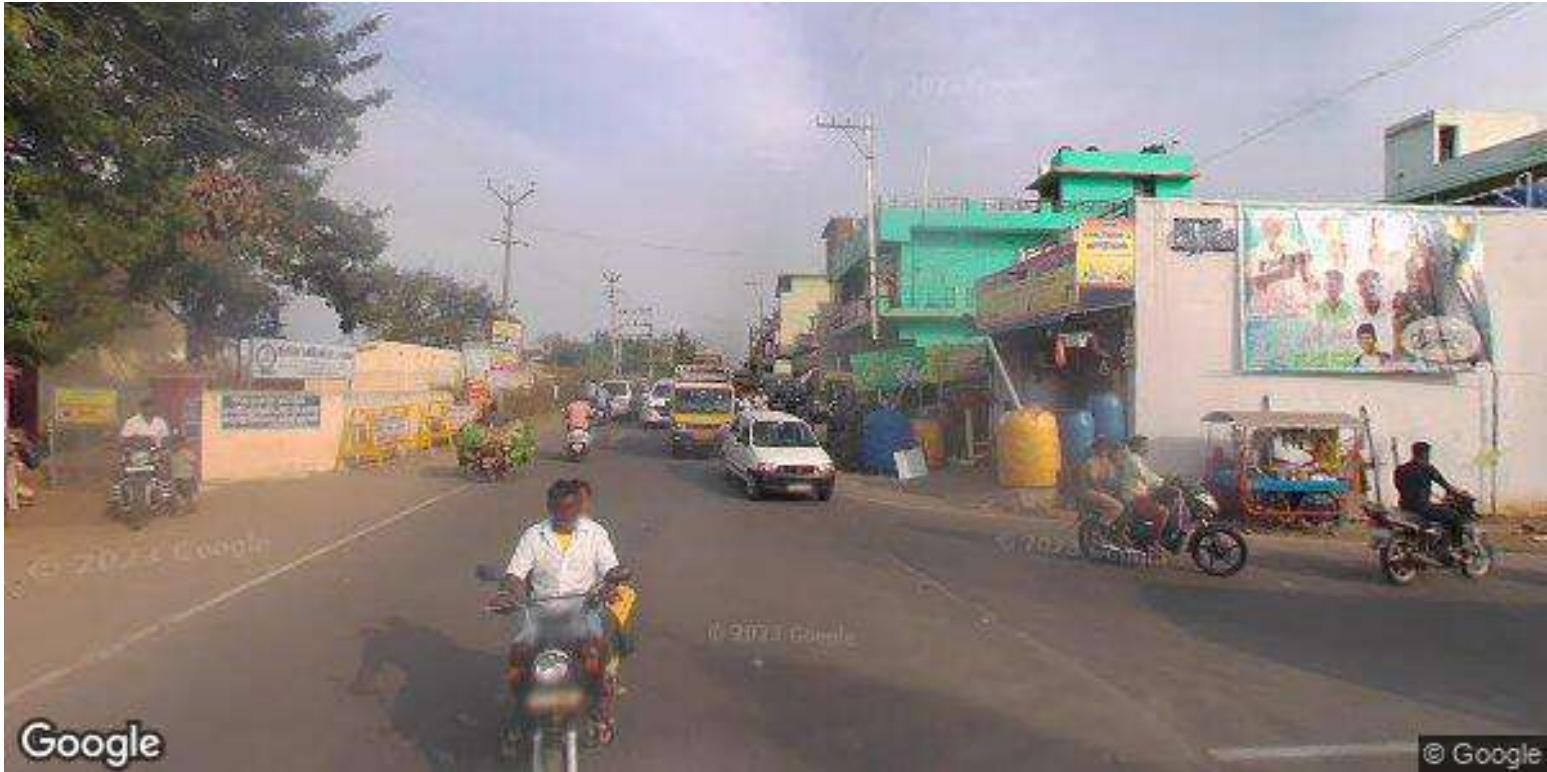
Coordinates: 11.69918, 77.88105

Risk Type: Turn

Risk Level: High

Speed Limit: 15 KM/Hr
