# IndianOil

## JOURNEY RISK MANAGEMENT (JRM) STUDY

### Salem Terminal TO SRINIVASA AGENCY

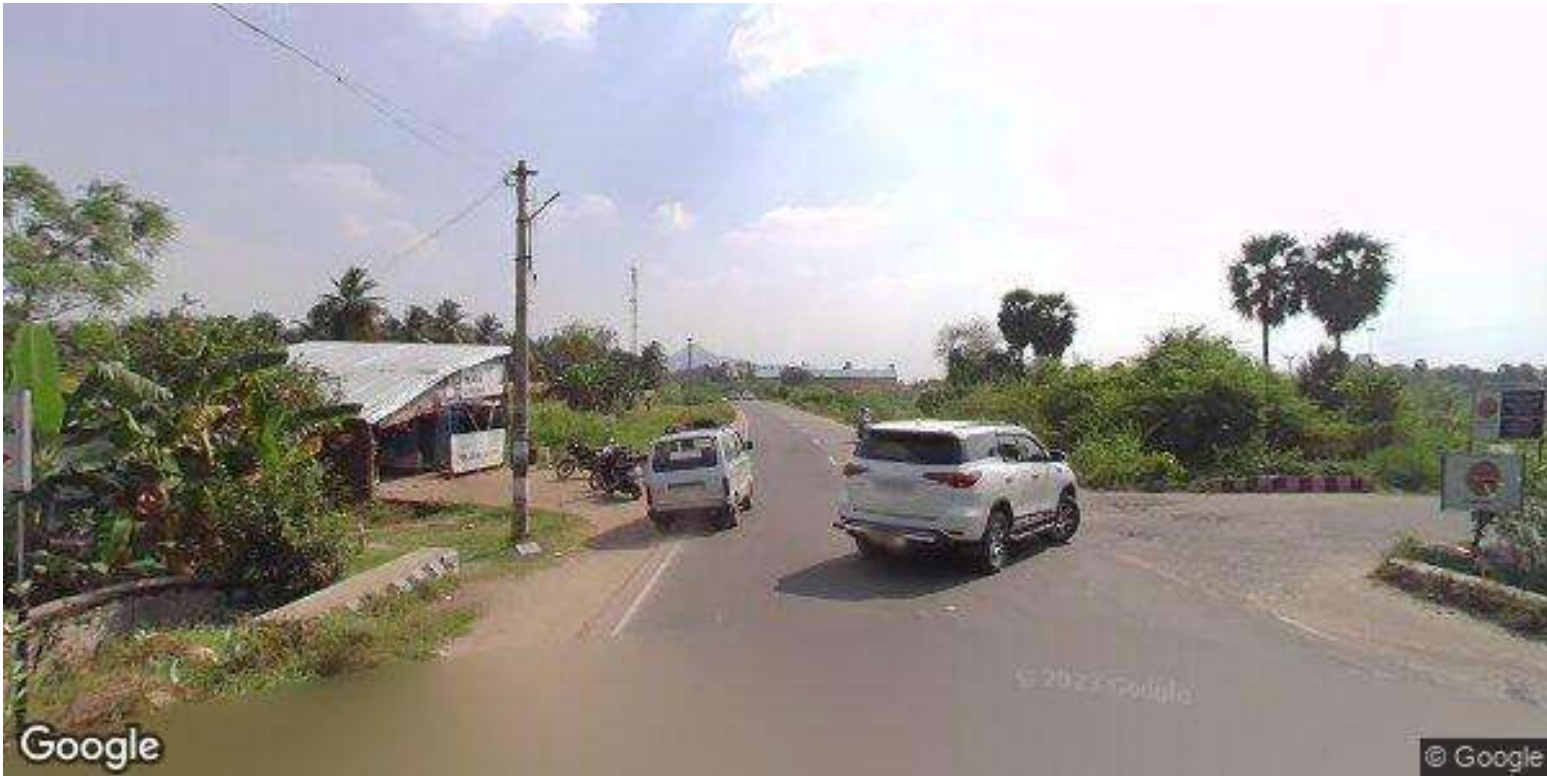
**Risk Type:** Turn  
**Risk Level:** High  
**Speed Limit:** 15 KM/Hr  
**Coordinates:** 11.44029, 77.87544

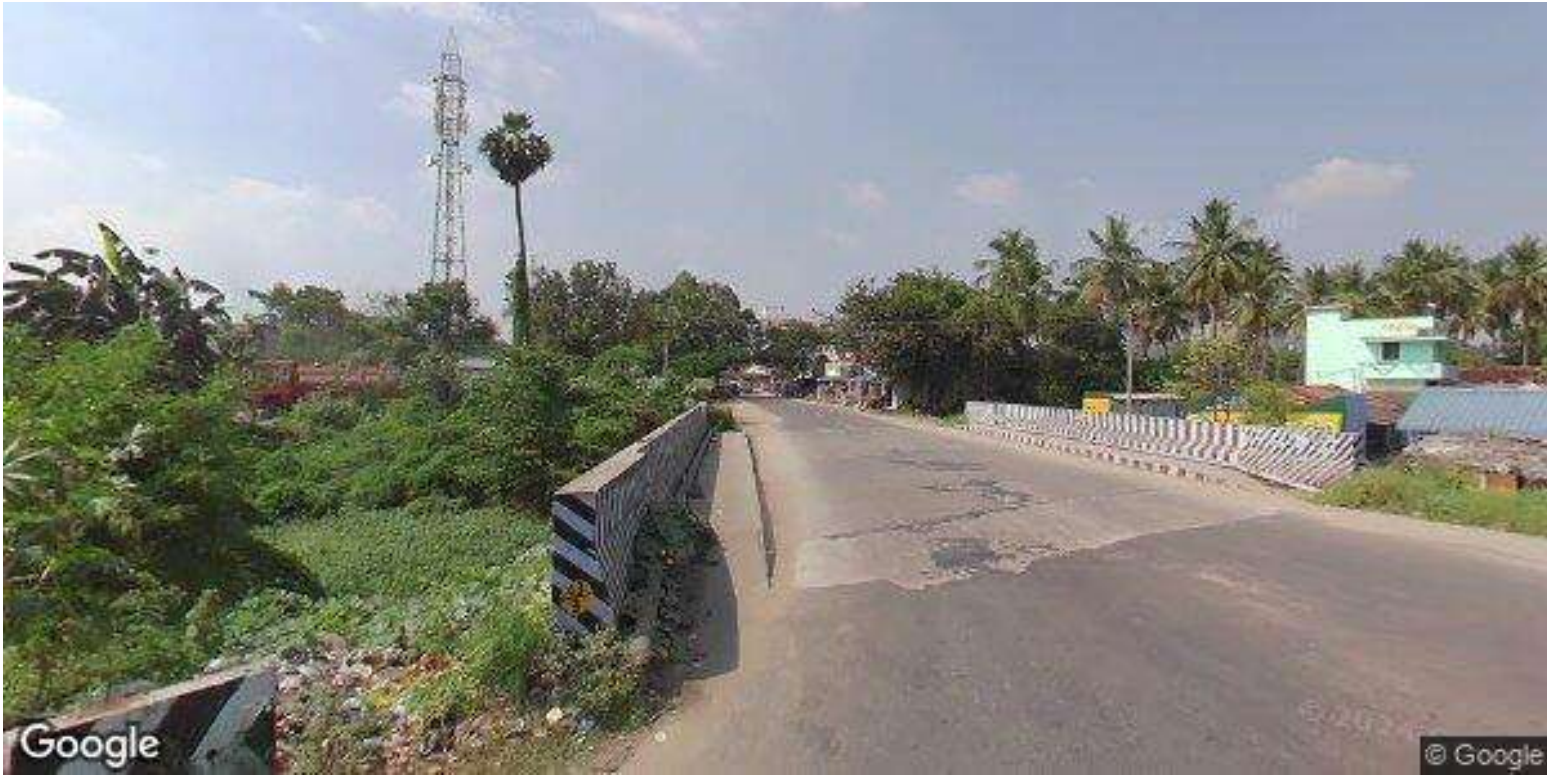
**Risk Type:** Turn  
**Risk Level:** High  
**Speed Limit:** 15 KM/Hr  
**Coordinates:** 11.44900, 77.87406

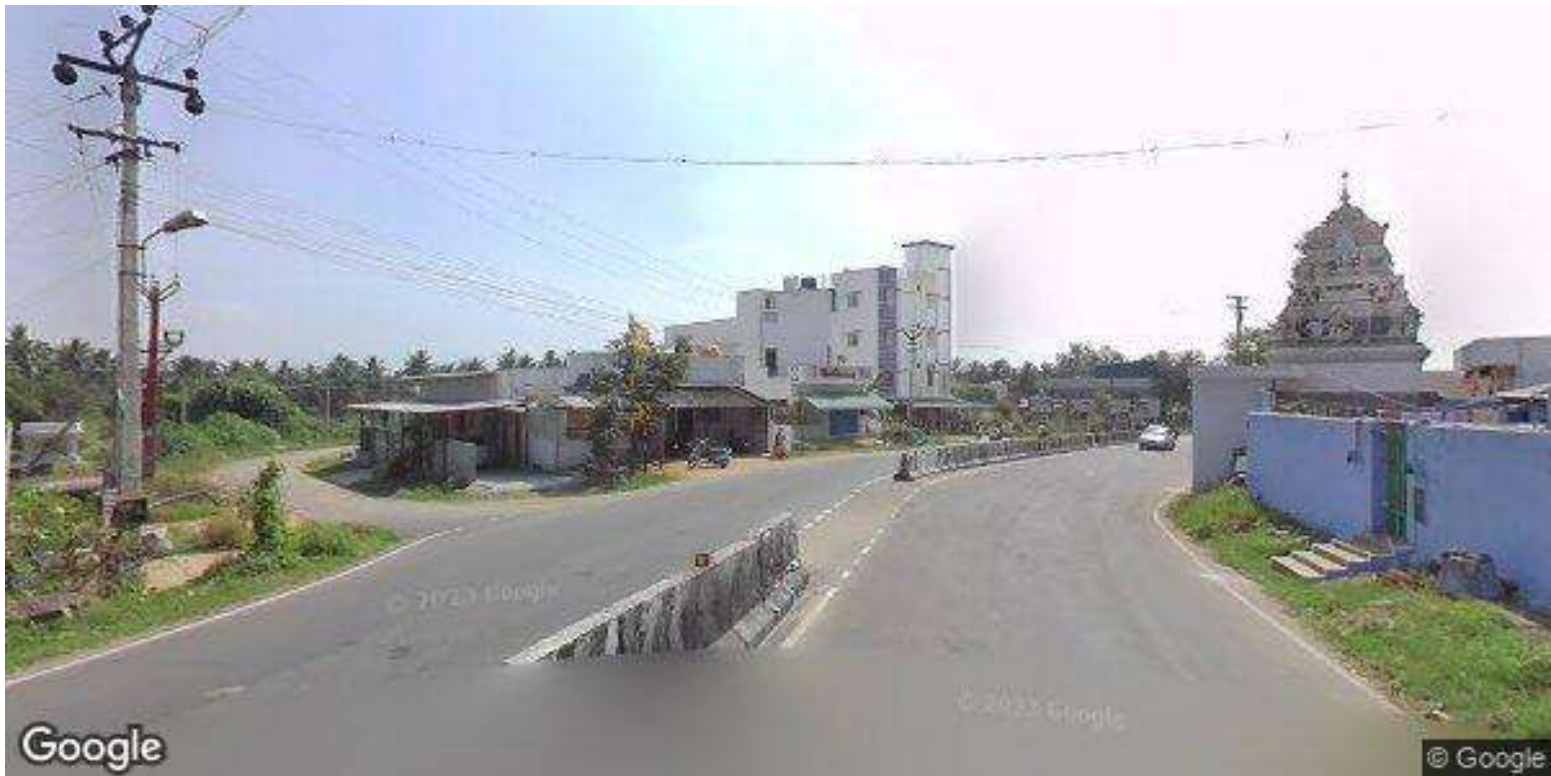
**Risk Type:** Turn  
**Risk Level:** Medium  
**Speed Limit:** 30 KM/Hr  
**Coordinates:** 11.46400, 77.87323

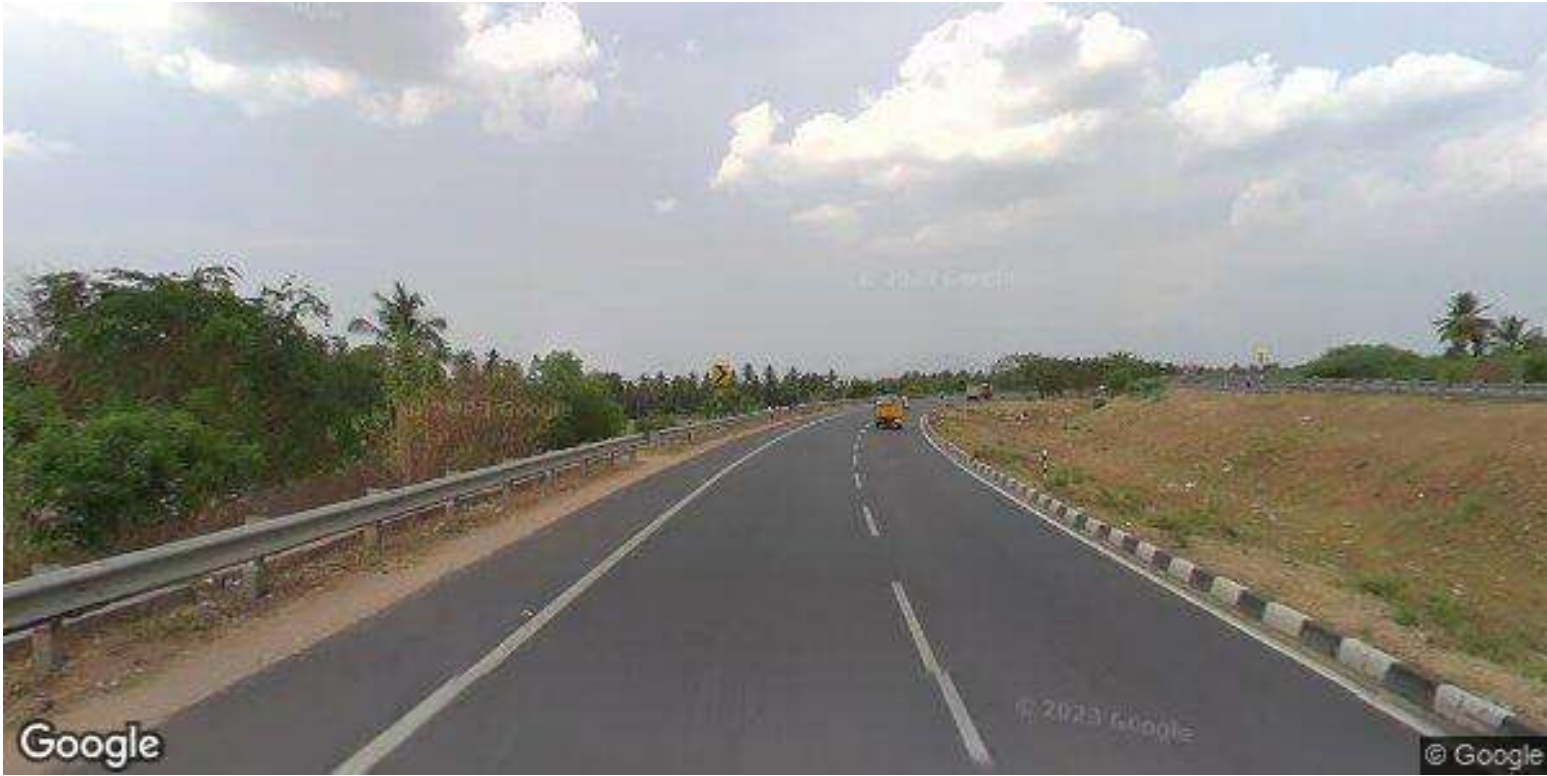
**Risk Type:** Turn  
**Risk Level:** Medium  
**Speed Limit:** 30 KM/Hr  
**Coordinates:** 11.53501, 77.95707

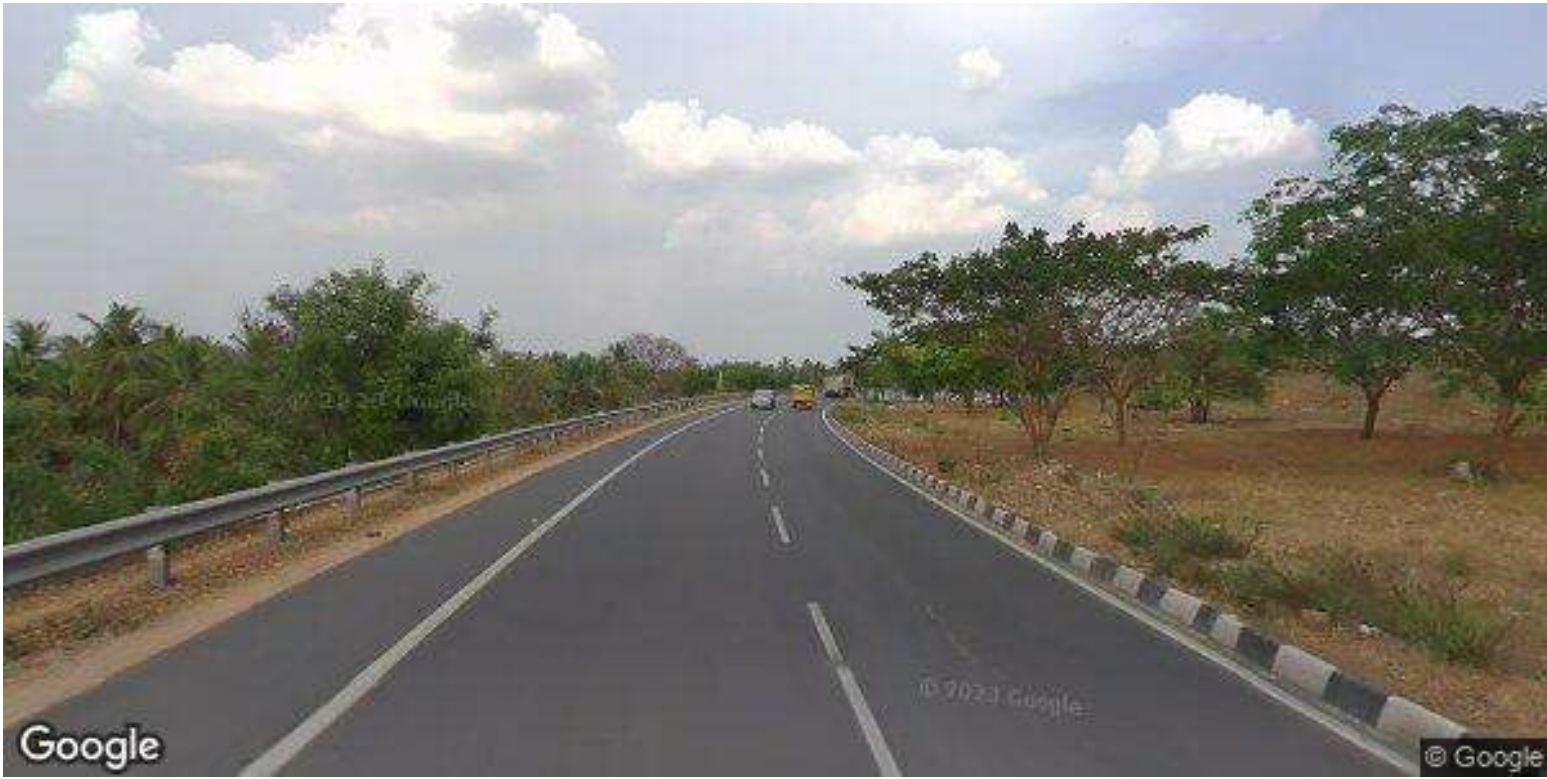
**Risk Type:** Turn  
**Risk Level:** Medium  
**Speed Limit:** 30 KM/Hr  
**Coordinates:** 11.53601, 77.95856

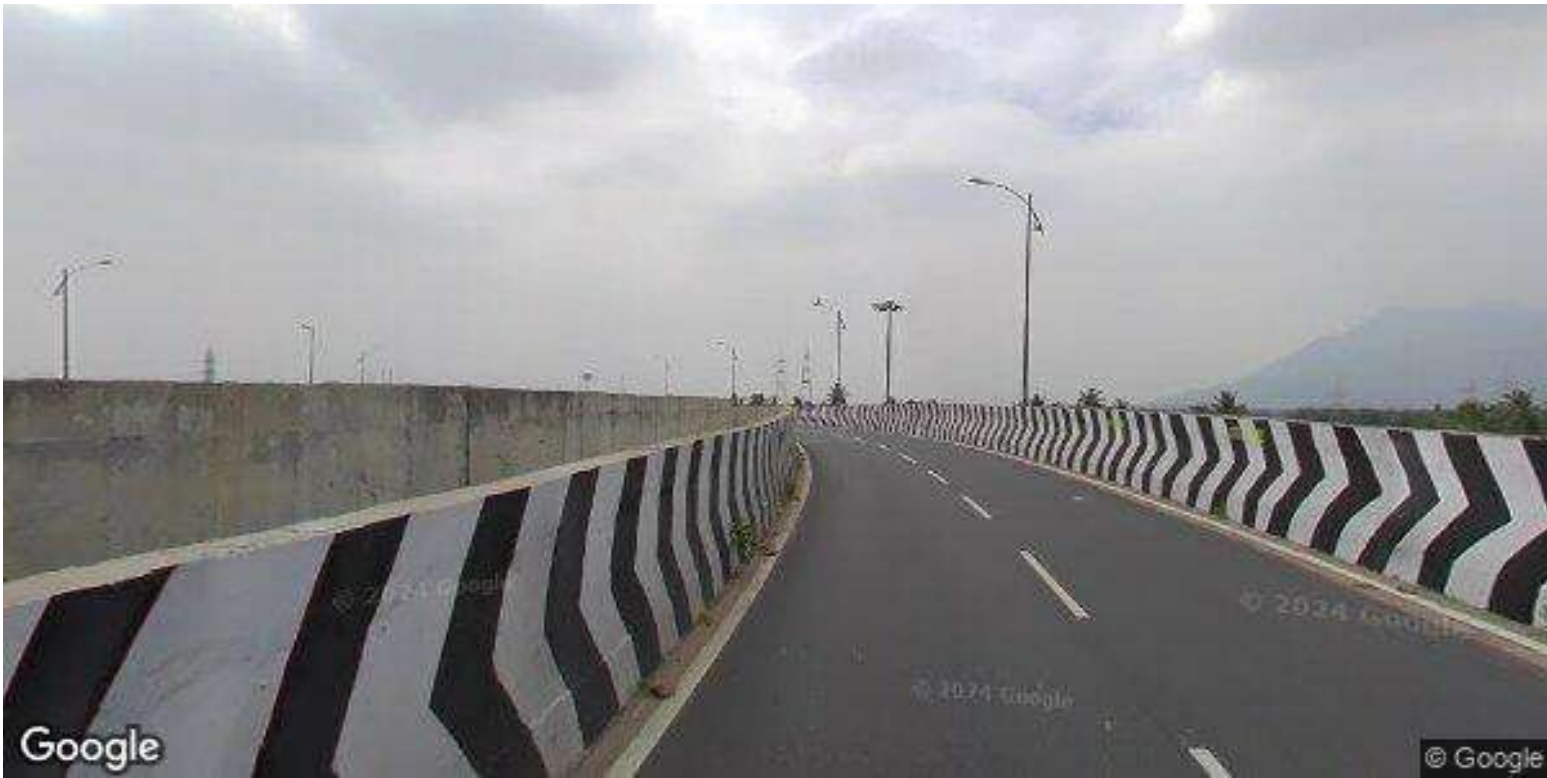
**Risk Type:** Turn  
**Risk Level:** Medium  
**Speed Limit:** 30 KM/Hr  
**Coordinates:** 11.64180, 78.11808

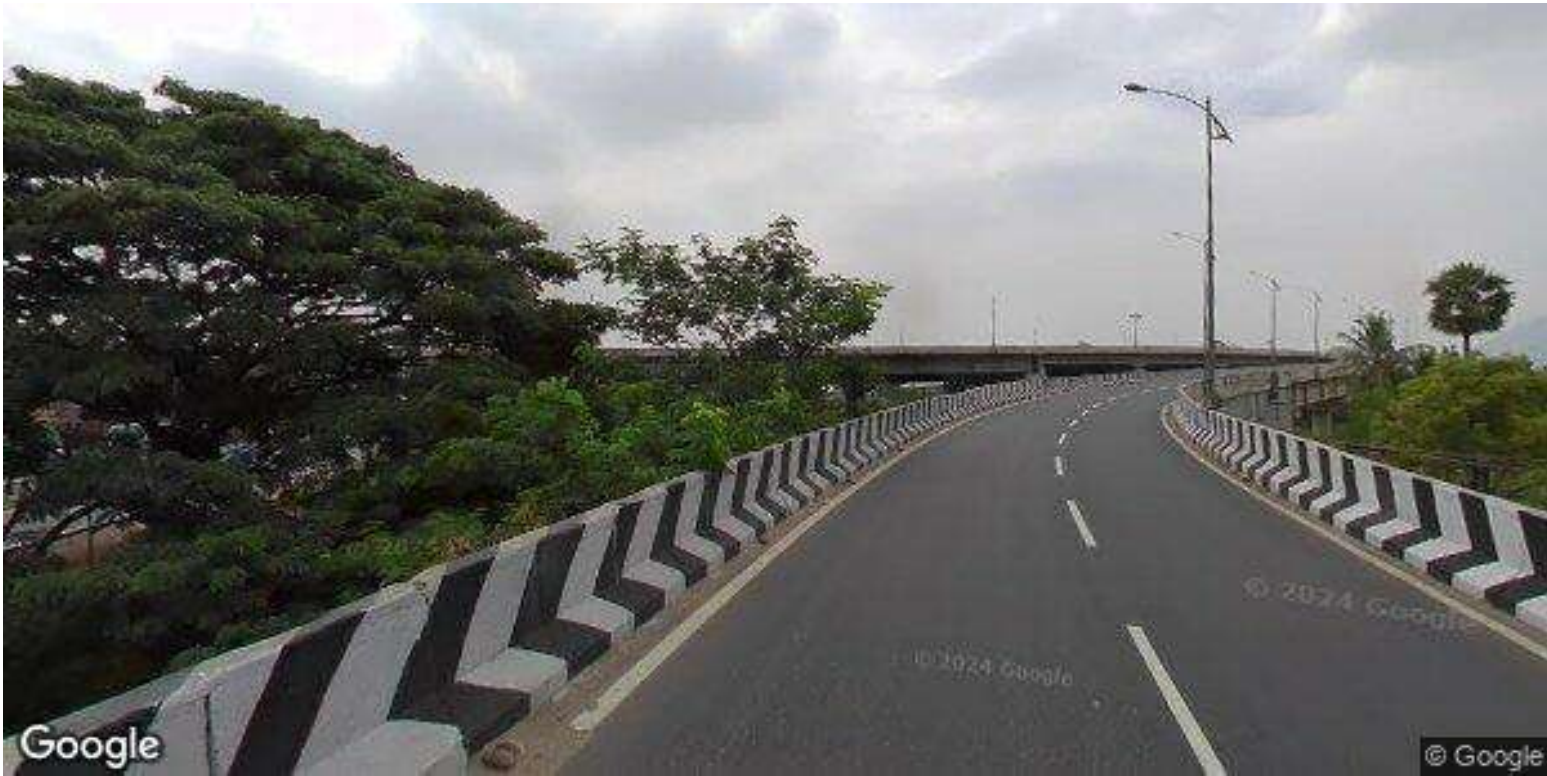
**Risk Type:** Turn  
**Risk Level:** Medium  
**Speed Limit:** 30 KM/Hr  
**Coordinates:** 11.64325, 78.11993

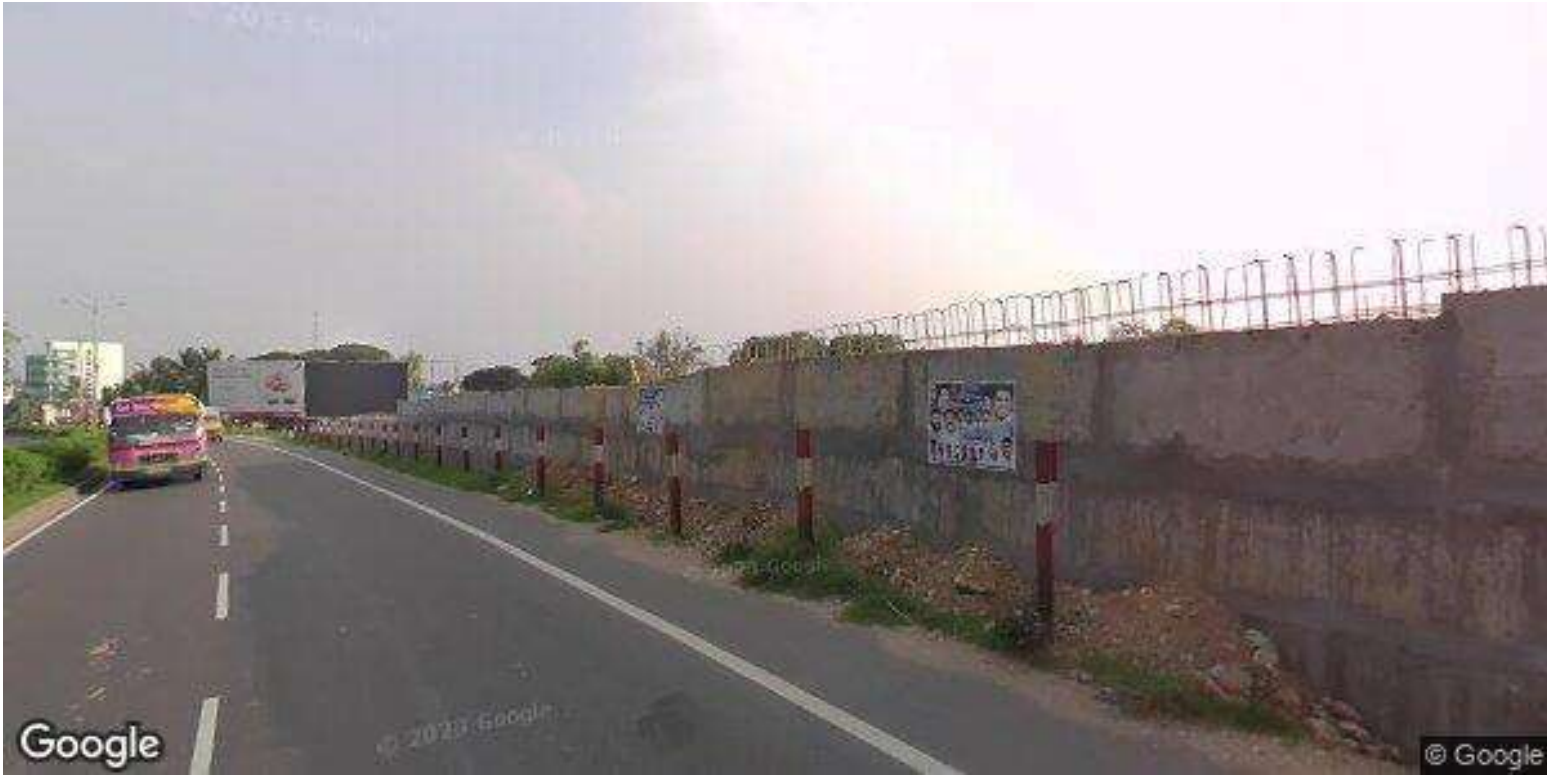
**Risk Type:** Turn  
**Risk Level:** Medium  
**Speed Limit:** 30 KM/Hr  
**Coordinates:** 11.69519, 78.10775

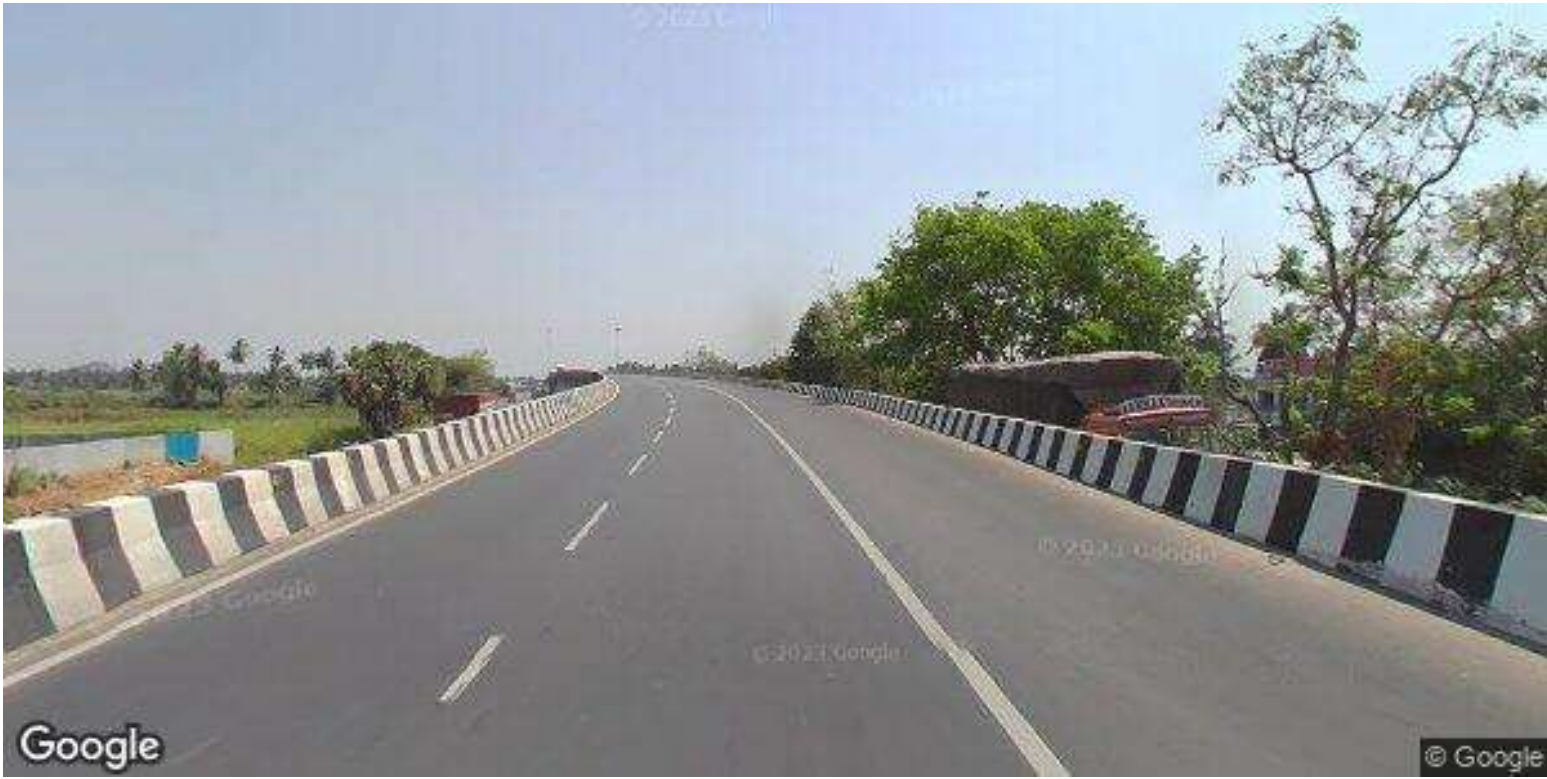
**Risk Type:** Turn  
**Risk Level:** Medium  
**Speed Limit:** 30 KM/Hr  
**Coordinates:** 11.73958, 78.05105

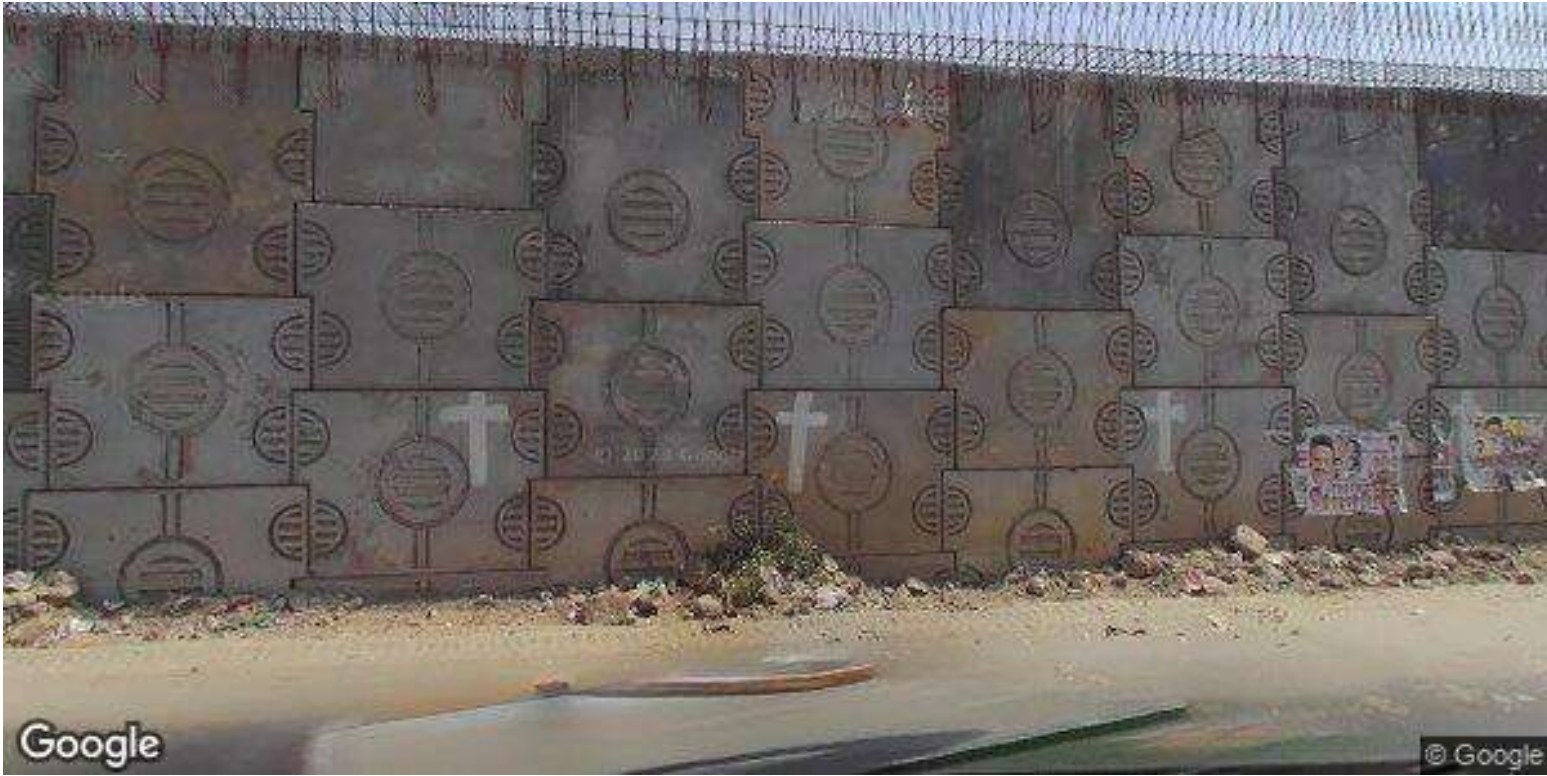
**Risk Type:** Turn  
**Risk Level:** Medium  
**Speed Limit:** 30 KM/Hr  
**Coordinates:** 11.75835, 78.05016

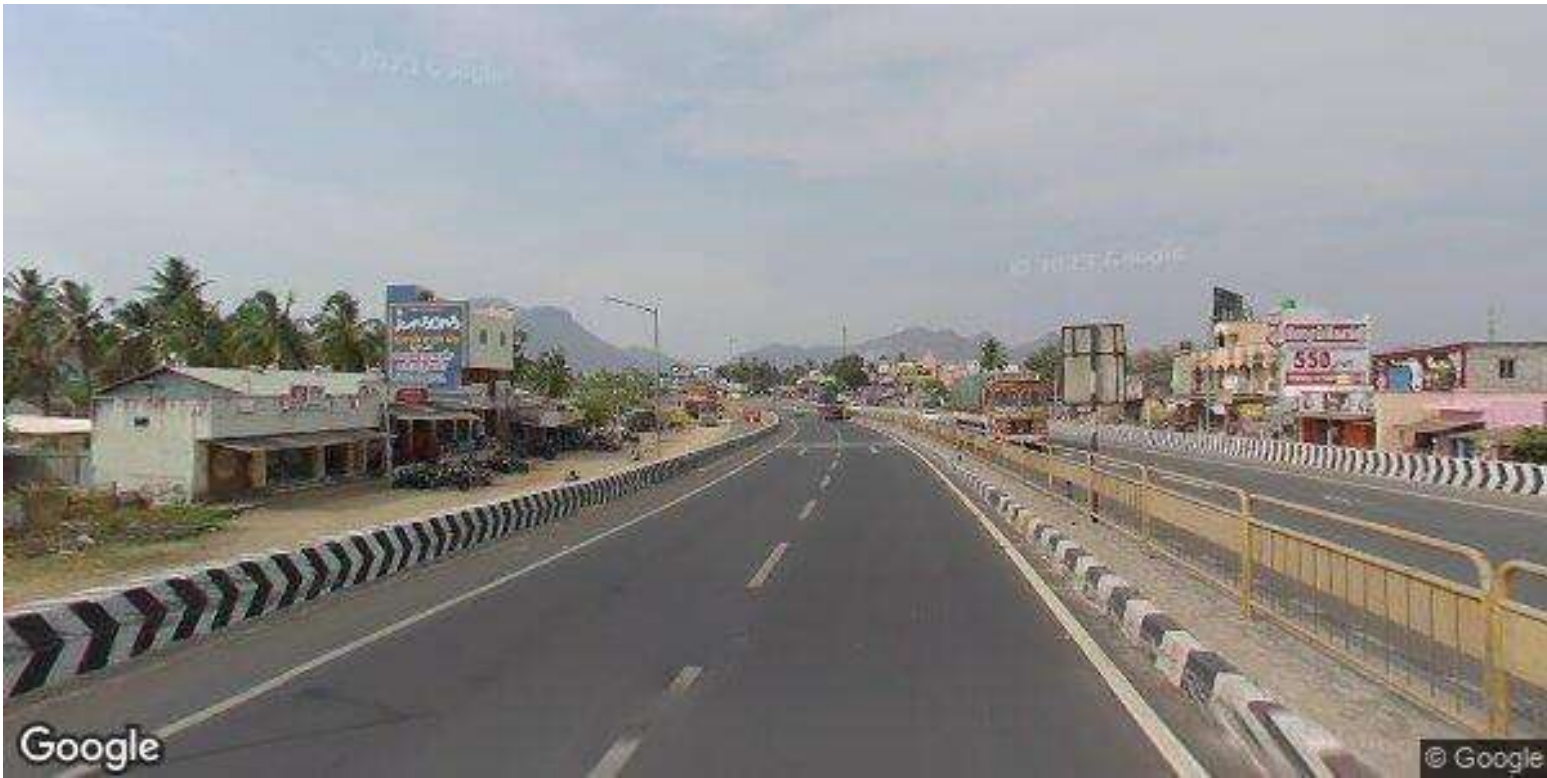
**Risk Type:** Turn  
**Risk Level:** Medium  
**Speed Limit:** 30 KM/Hr  
**Coordinates:** 11.86847, 78.08367

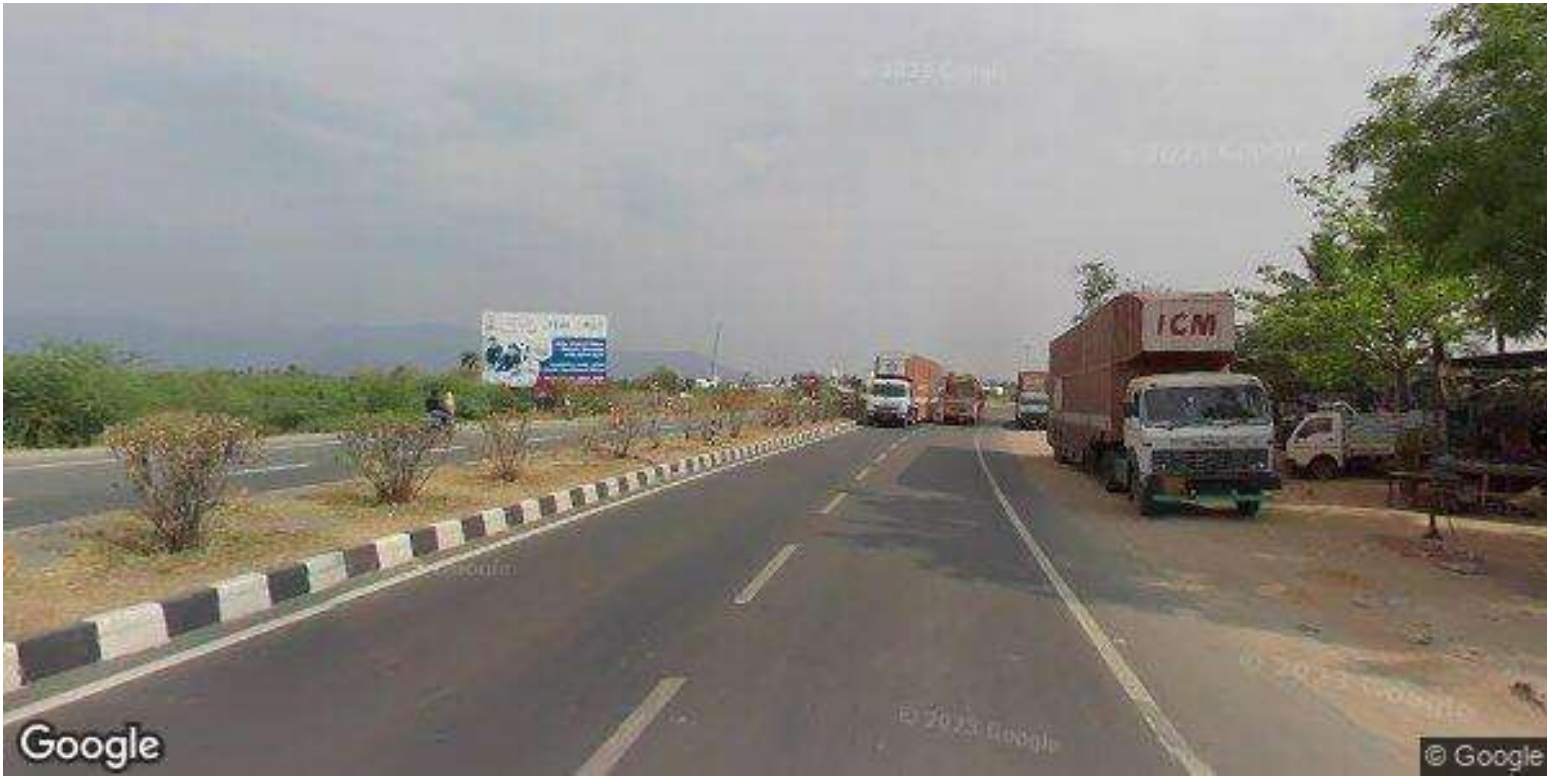
**Risk Type:** Turn  
**Risk Level:** Medium  
**Speed Limit:** 30 KM/Hr  
**Coordinates:** 11.87942, 78.08197

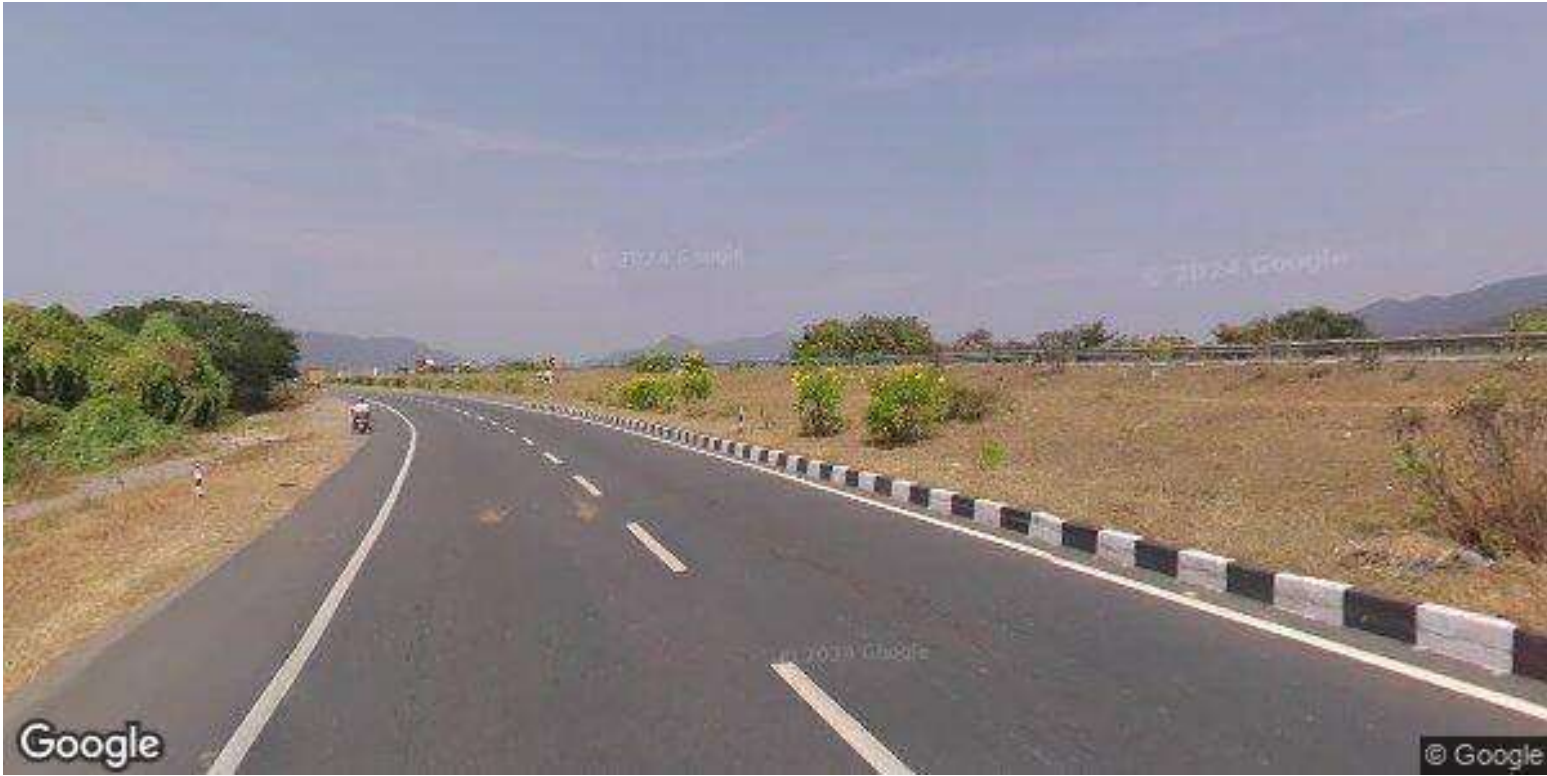
**Risk Type:** Turn  
**Risk Level:** Medium  
**Speed Limit:** 30 KM/Hr  
**Coordinates:** 11.92585, 78.06507

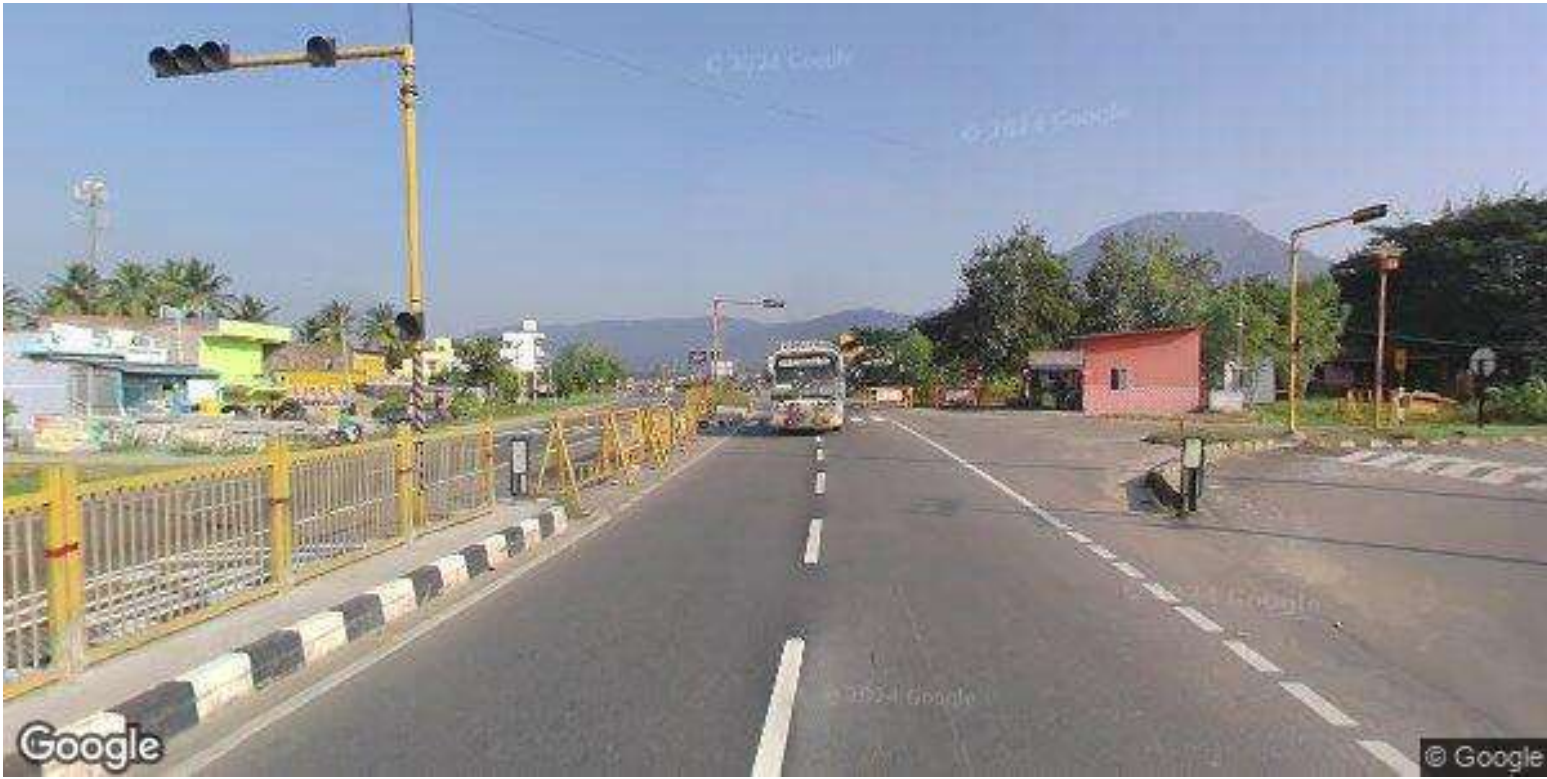
**Risk Type:** Turn  
**Risk Level:** Medium  
**Speed Limit:** 30 KM/Hr  
**Coordinates:** 11.93704, 78.05402

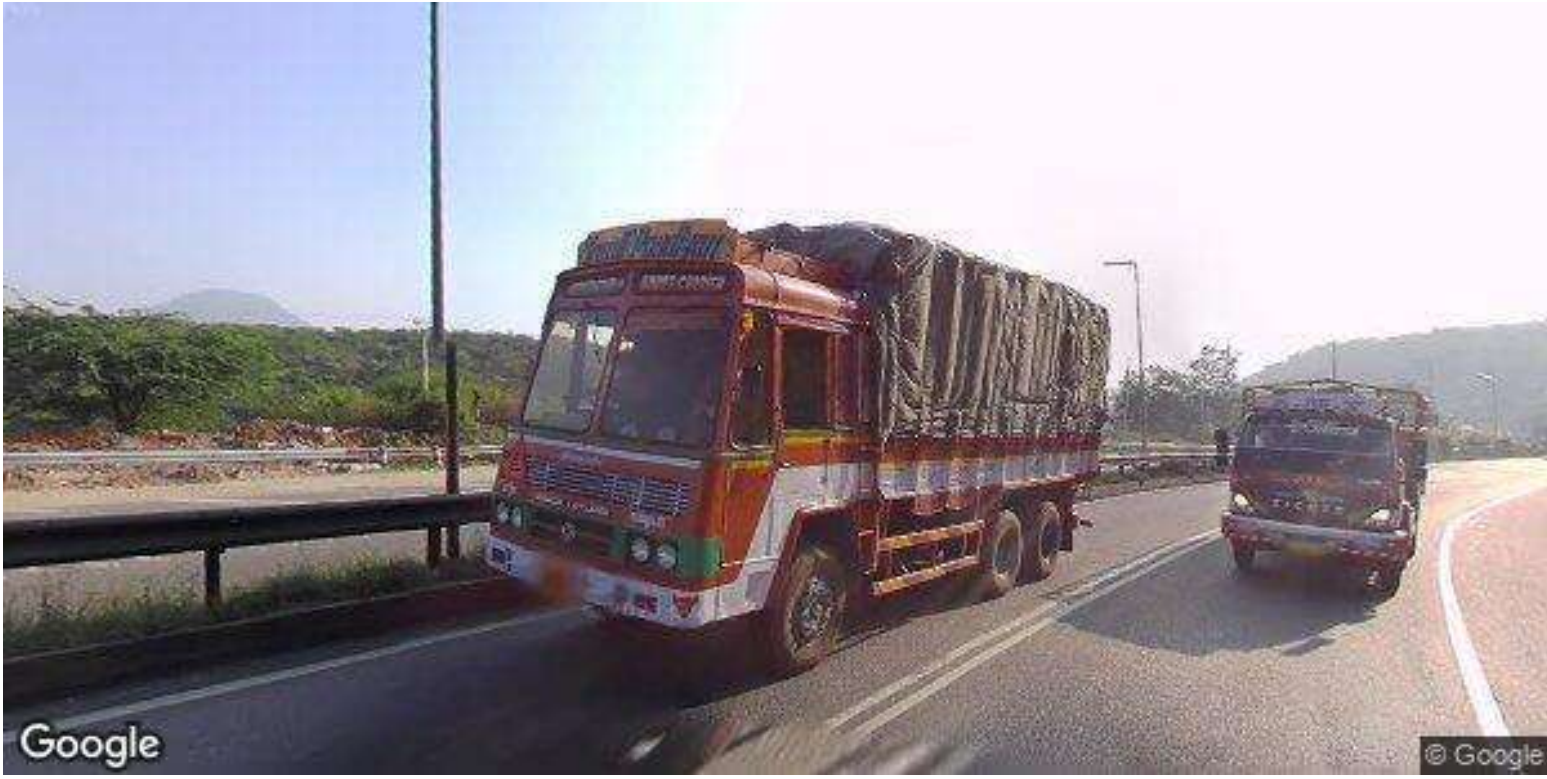
**Risk Type:** Turn  
**Risk Level:** High  
**Speed Limit:** 15 KM/Hr  
**Coordinates:** 11.95818, 78.04978

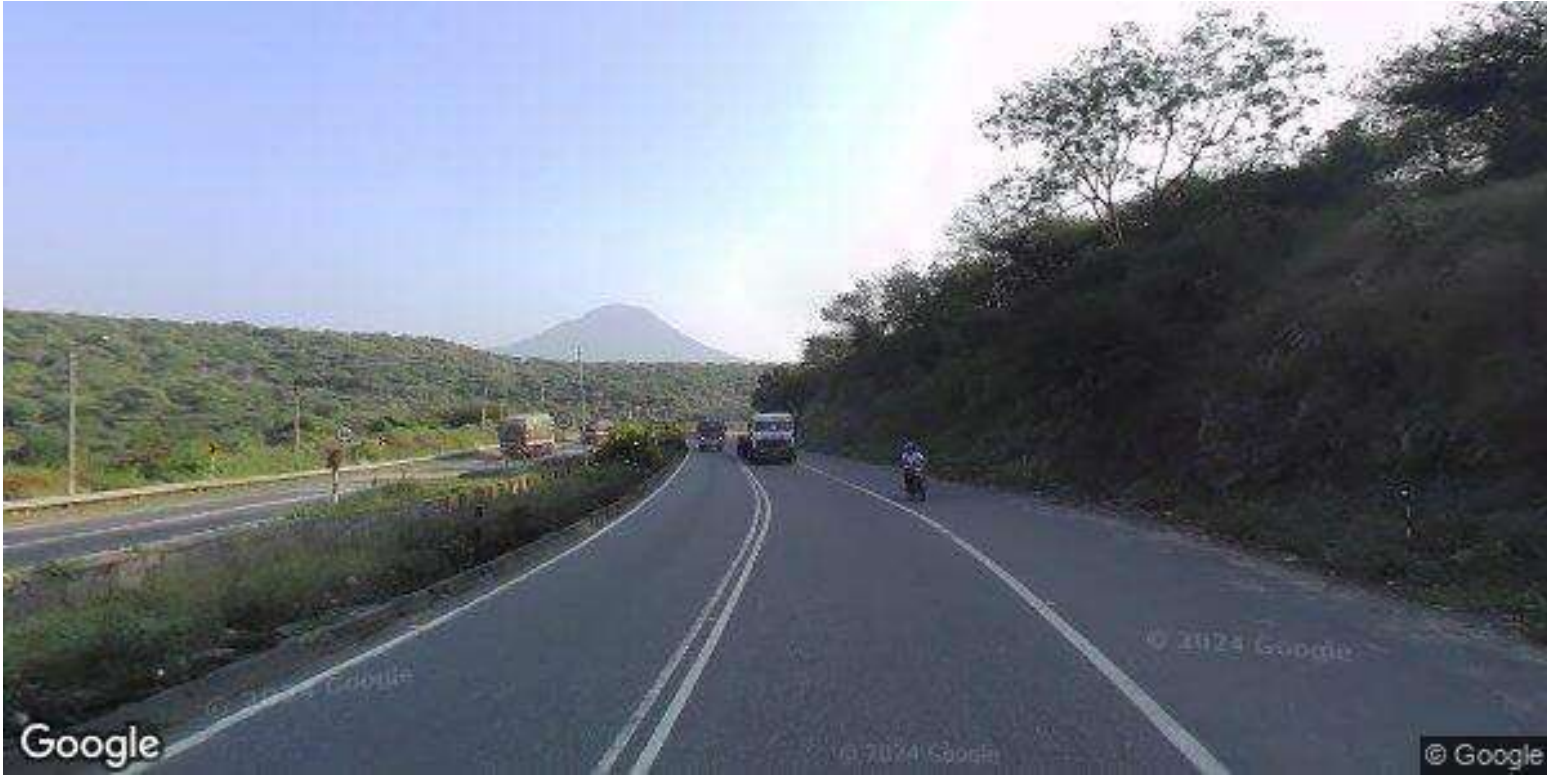
**Risk Type:** Turn  
**Risk Level:** Medium  
**Speed Limit:** 30 KM/Hr  
**Coordinates:** 11.95988, 78.04948

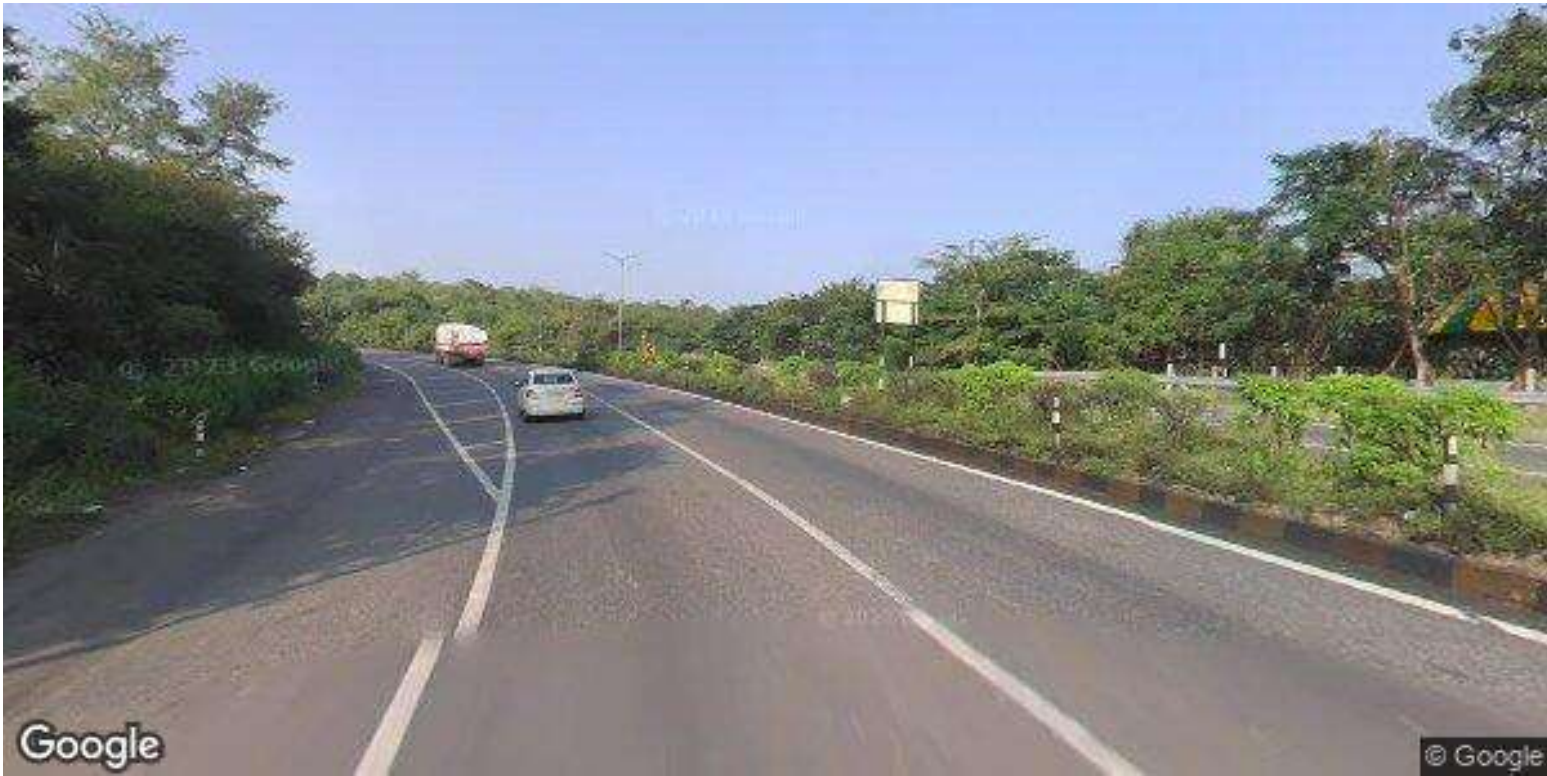
**Risk Type:** Turn  
**Risk Level:** Medium  
**Speed Limit:** 30 KM/Hr  
**Coordinates:** 11.96304, 78.05136

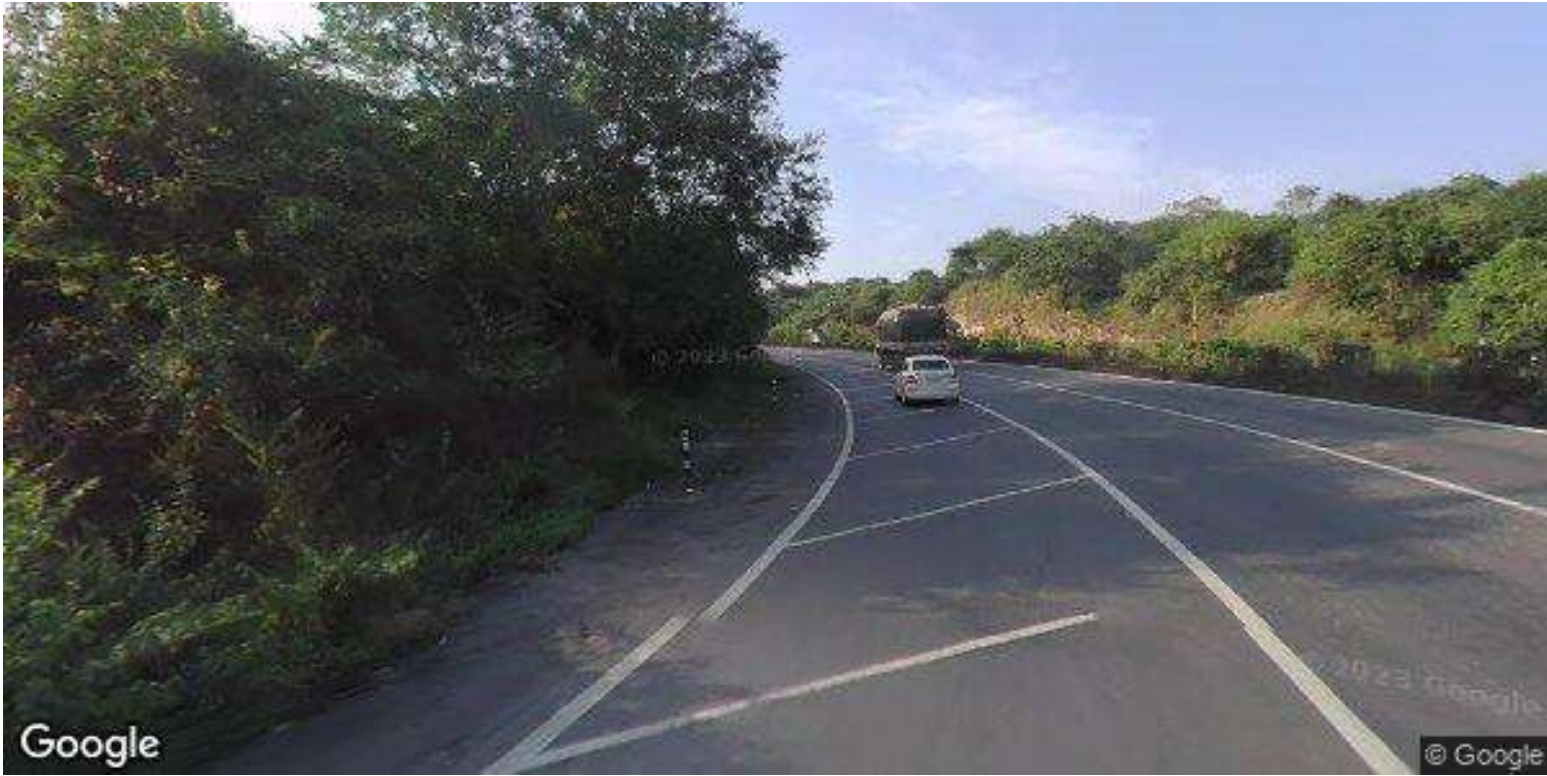
**Risk Type:** Turn  
**Risk Level:** High  
**Speed Limit:** 15 KM/Hr  
**Coordinates:** 11.96399, 78.05135
