# IndianOil

## JOURNEY RISK MANAGEMENT (JRM) STUDY

### Salem Terminal TO SRINIVASA AGENCY

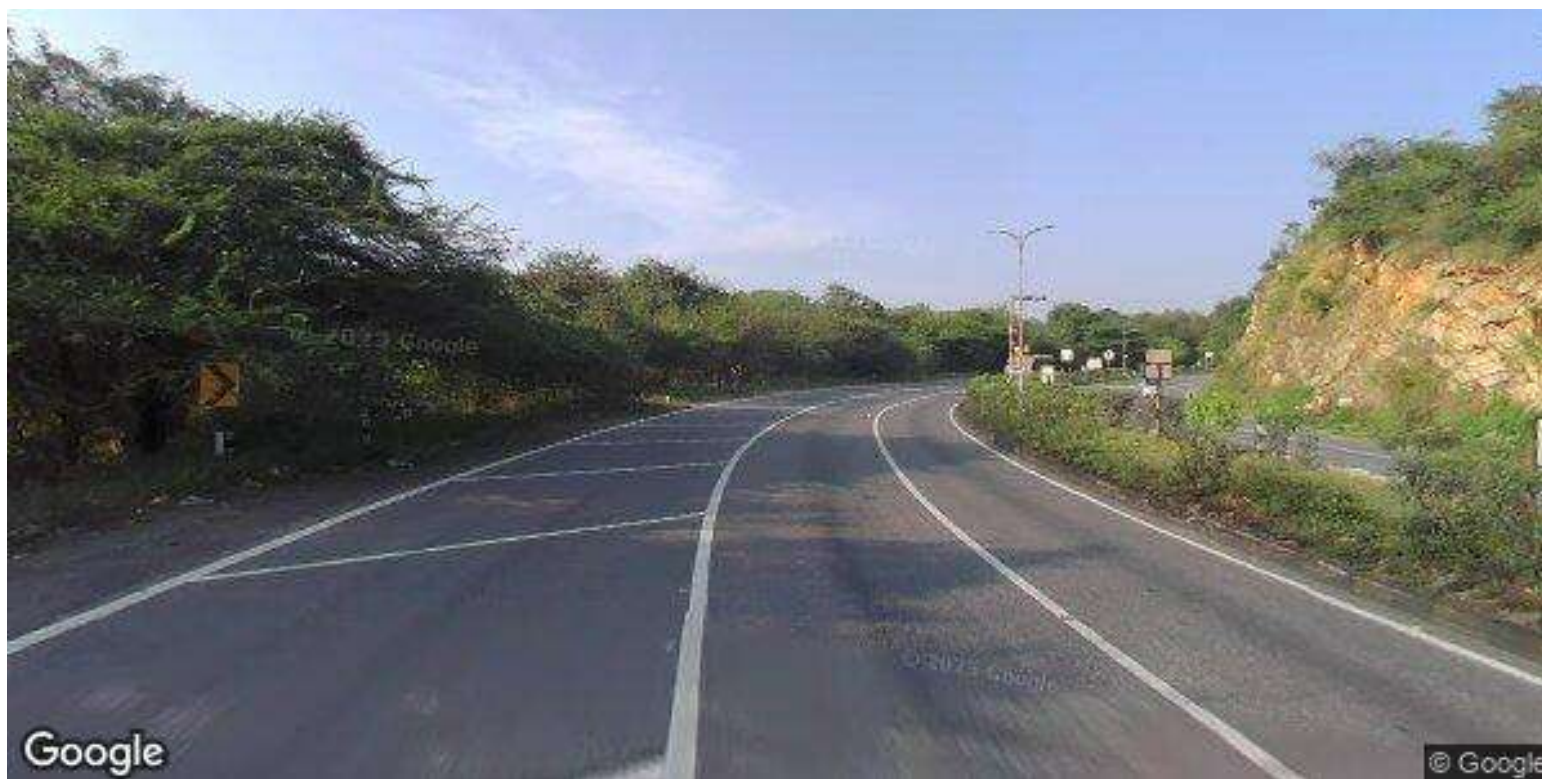
**Risk Type:** Turn

**Risk Level:** High

**Speed Limit:** 15 KM/Hr

**Coordinates:** 11.96580, 78.04923

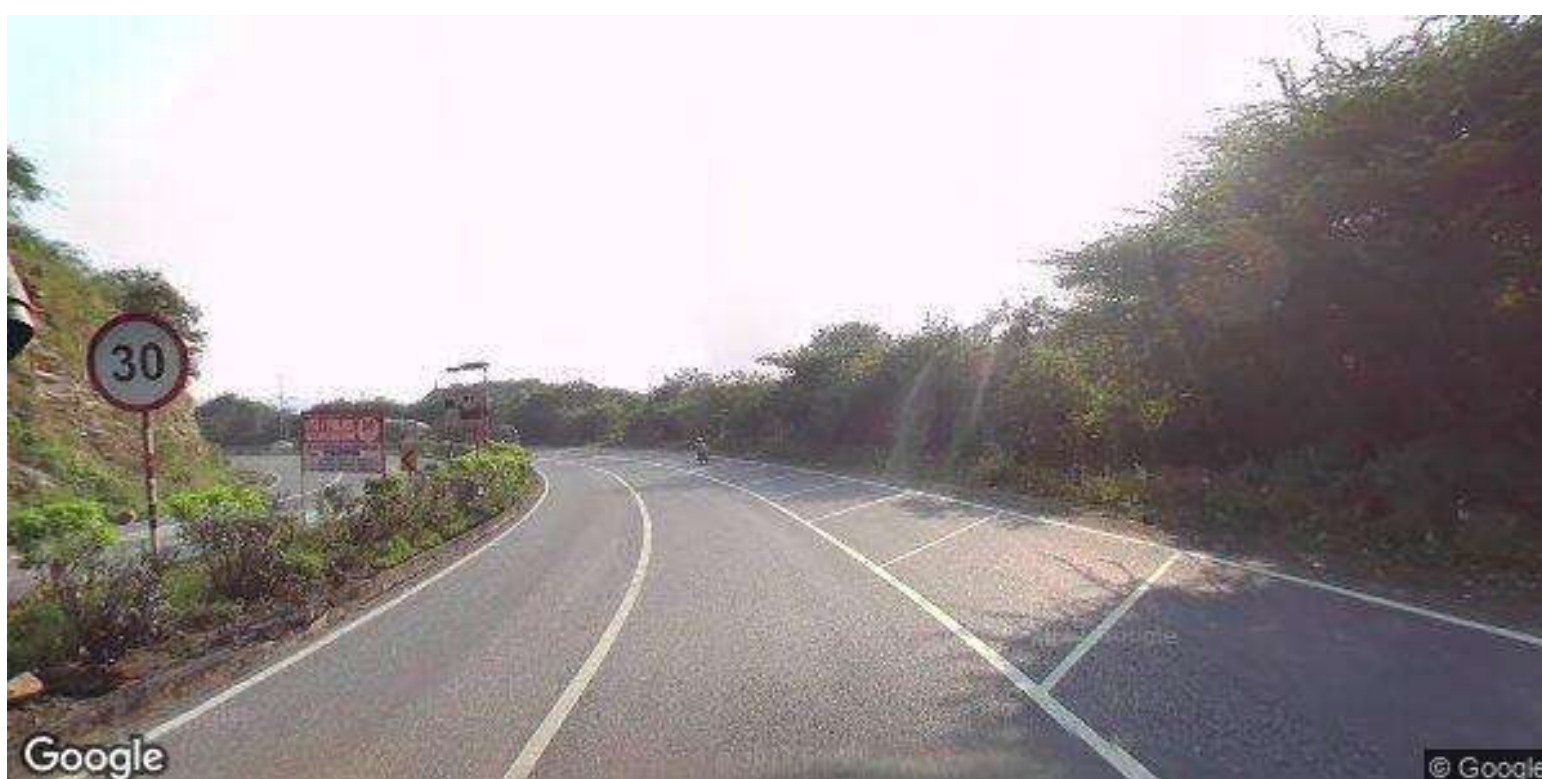
**Risk Type:** Turn

**Risk Level:** Medium

**Speed Limit:** 30 KM/Hr

**Coordinates:** 11.96675, 78.04939

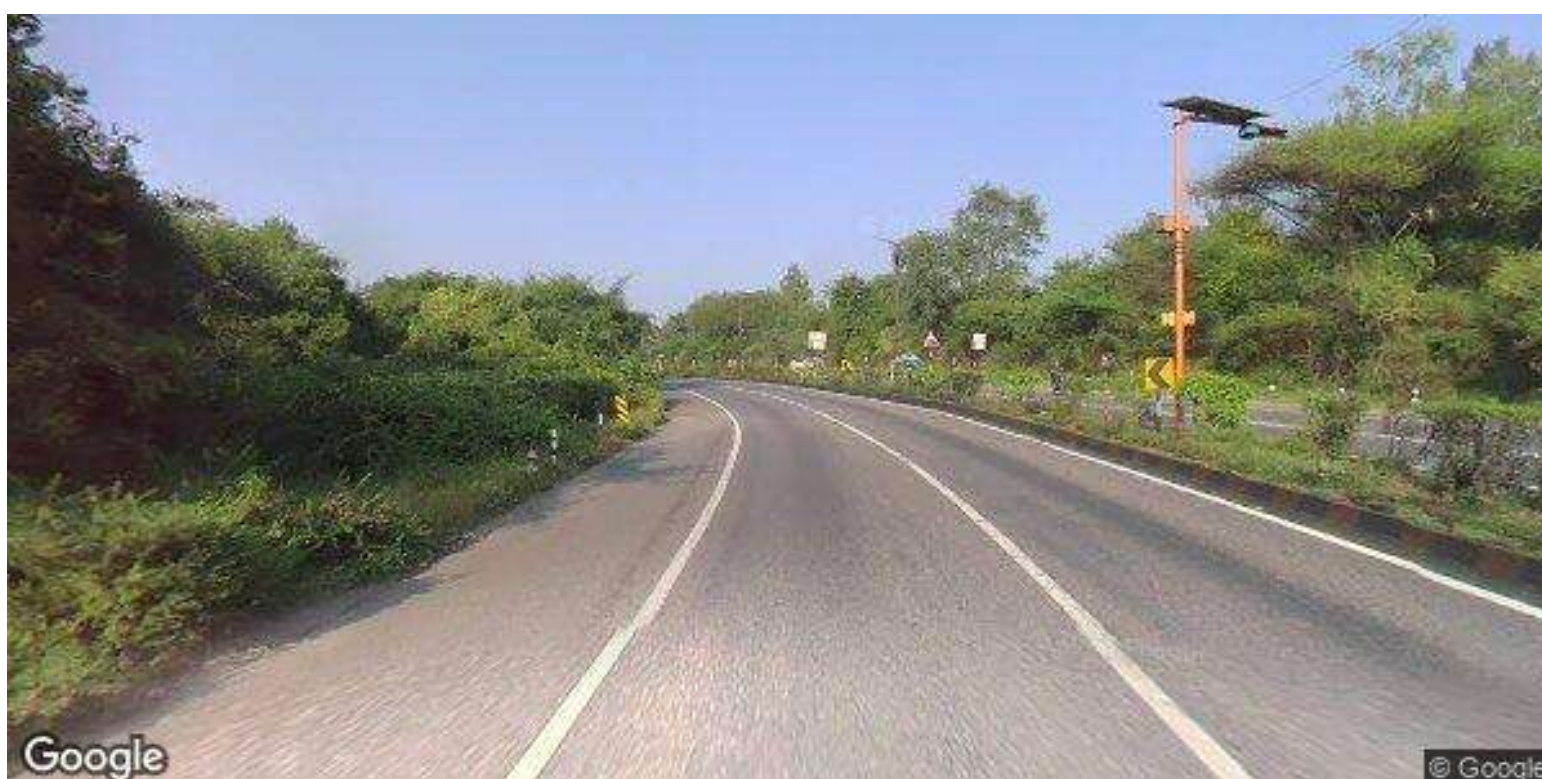
**Risk Type:** Turn  
**Risk Level:** Medium  
**Speed Limit:** 30 KM/Hr  
**Coordinates:** 11.96791, 78.05070

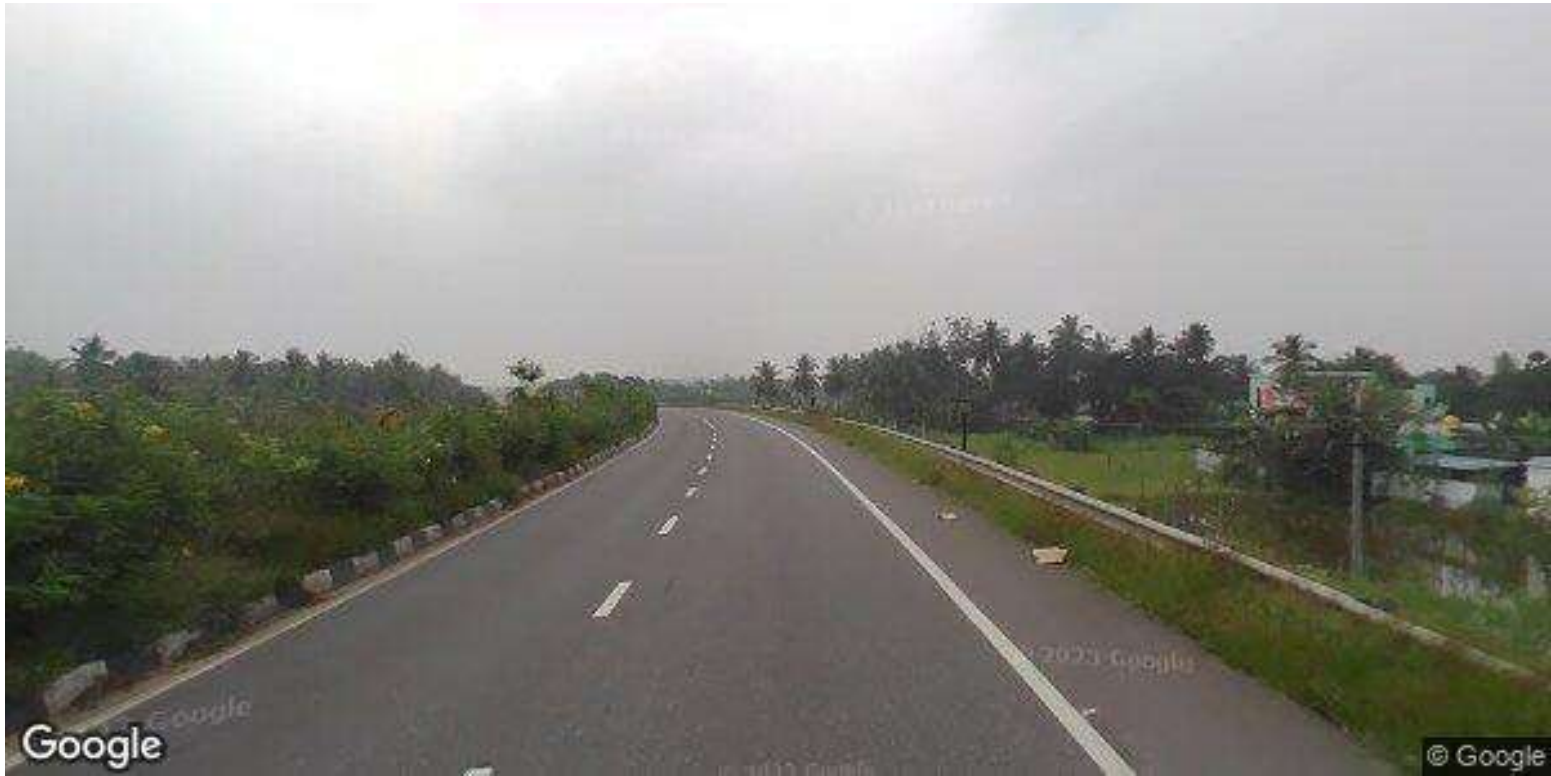
**Risk Type:** Turn  
**Risk Level:** Medium  
**Speed Limit:** 30 KM/Hr  
**Coordinates:** 12.22459, 78.19136

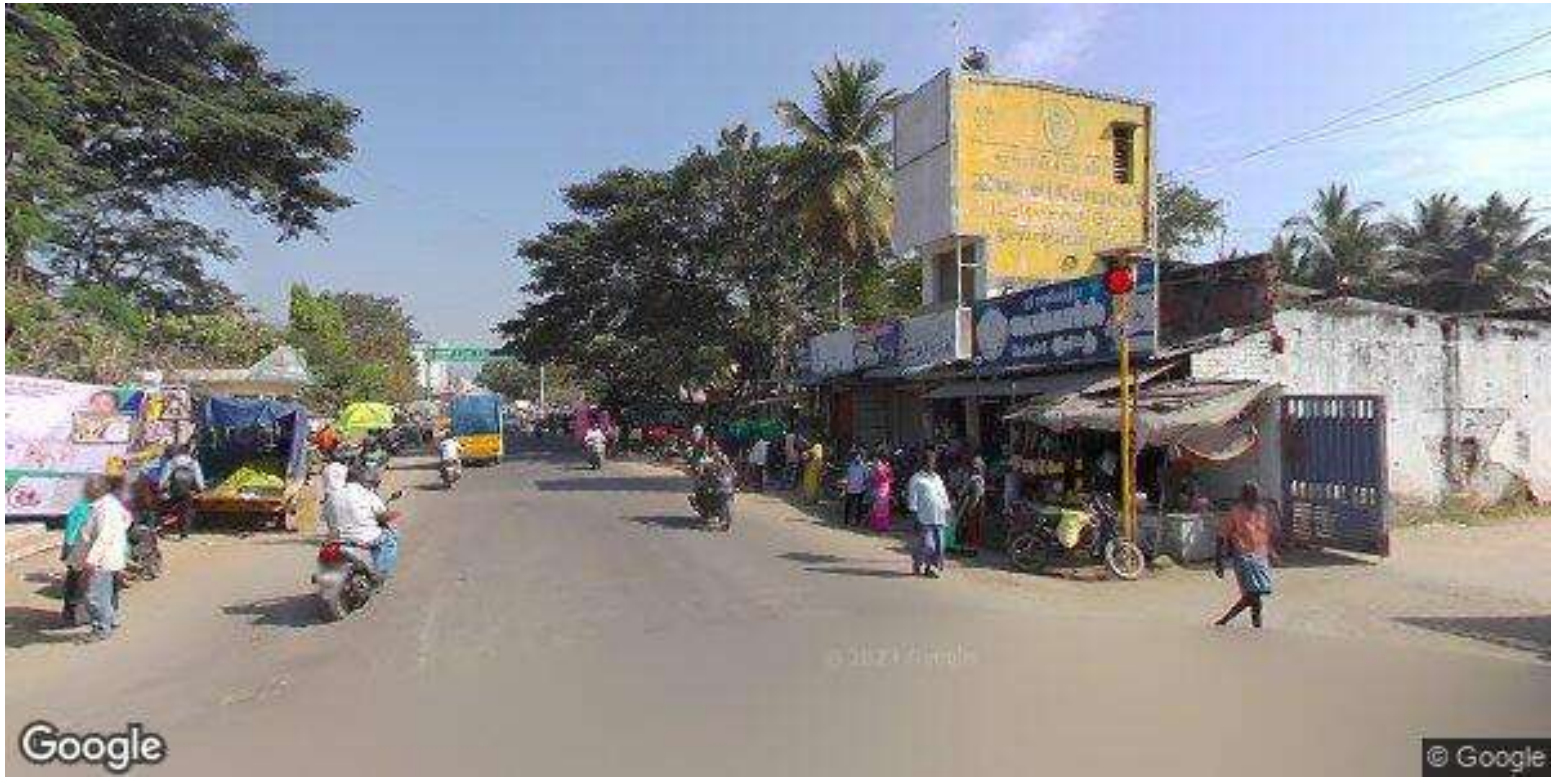
**Risk Type:** Blind Spot  
**Risk Level:** Blind Spot  
**Speed Limit:** 10 KM/Hr  
**Coordinates:** 12.41840, 78.21878
